# Submittal of Annual Reports and Other Compliance Documents for Municipal Separate Storm Sewer System (MS4) Permits

**Project Name:** 2023 Annual Report

**Municipality:** Oshkosh, City

**Permit Number:** S050075

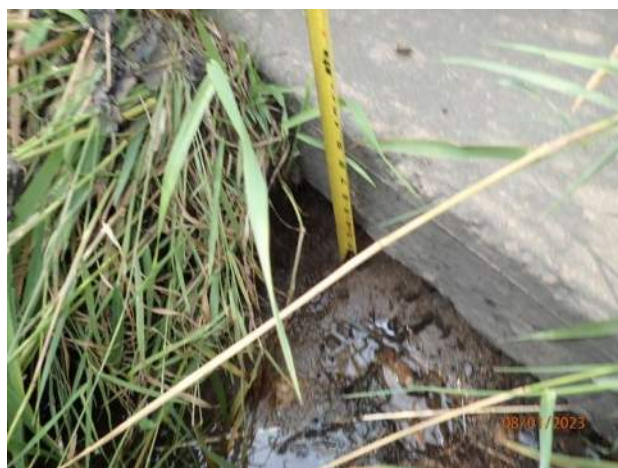
**Figure 1 – Outfall 06-2798**

Outfall	Severity	Description
06-2798	Minor	Apron undercut 4"
06-1136	Minor	3" joint displacement
06-478	Minor	3" joint displacement/deterioration
13-2332	Minor	2" joint displacement
13-3774	Minor	2" joint displacement
14-999	Minor	3" joint displacement, downed trees at end of pipe
15-3339	Minor	Debris (log) on apron
16-2092	Minor	3" joint displacement

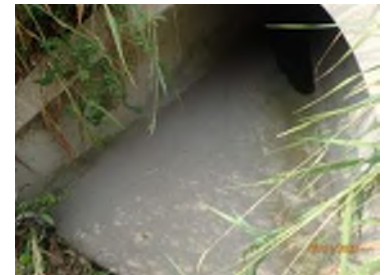
o20230801095920.JPG

Damage: Minor ☐ Displacement ☒ Undercut ☐ Crushed☐ Corrosion ☐ Cracks/Structural Damage
