IDDE Ongoing Screening Summary Report

2023 Inspection Year

Westwood

City of Oshkosh

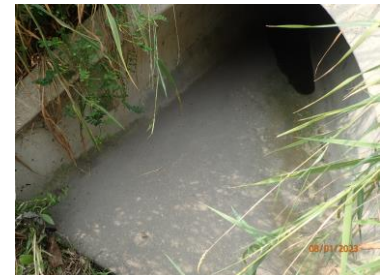
o20230801095920.JPG

Damage: Minor ☐ Displacement ☒ Undercut ☐ Crushed☐ Corrosion ☐ Cracks/Structural Damage

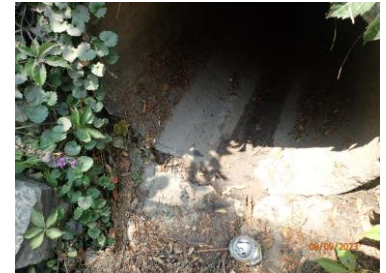
o20230809114110.JPG

Damage: Minor ☐ Displacement ☐ Undercut ☐ Crushed☐ Corrosion ☒ Cracks/Structural Damage

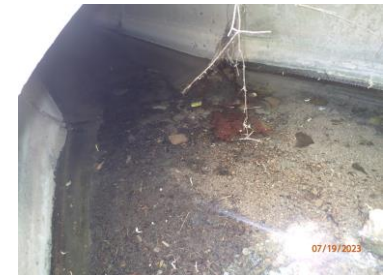
o20230719141018.JPG

Damage: Minor ☒ Displacement ☐ Undercut ☐ Crushed☐ Corrosion ☐ Cracks/Structural Damage
