# Ongoing Screening Summary Report 2013 Inspection Year

Illicit Discharge Detection and Elimination Program

City of Oshkosh

OMNNI Project No. N2029B13

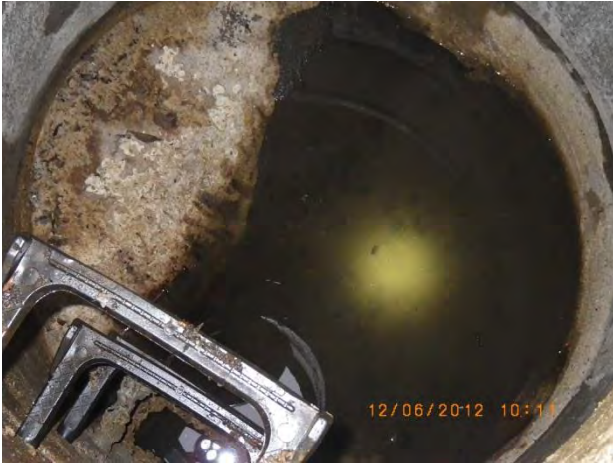
**Figure 15 - Pool in upstream manhole 02-184 US1 (2012)**

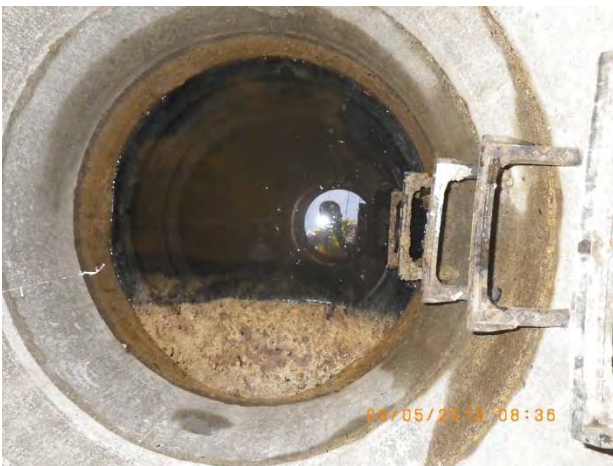
The outfall and upstream manhole were re-screened on September 5, 2013. At that time, a strong sewer odor was present in the upstream manhole. In addition, the sample had an ammonia concentration in excess of 6 ppm, and a detergent concentration of 1.3 mg/L. Both of these concentrations were higher than the 2012 screening. An update was provided to the Illicit Discharge Coordinator on September 6.

**Figure 16 - Pool in upstream manhole 02-184 US1 (2013)**

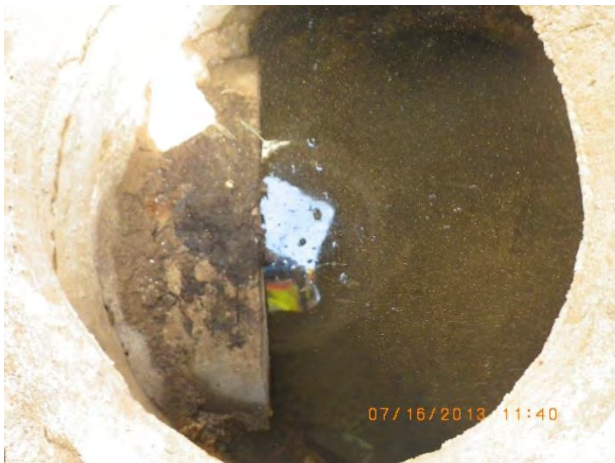
Because the pipe was submerged and could not be located, a sample was collected from the first upstream manhole. The manhole was located in the center of the cul-de-sac on Wood Duck Court. No abnormal physical indicators were observed; however, the sample had a detergent concentration of 1.3 mg/L.

**Figure 18 - Upstream manhole 12-1692 US1**

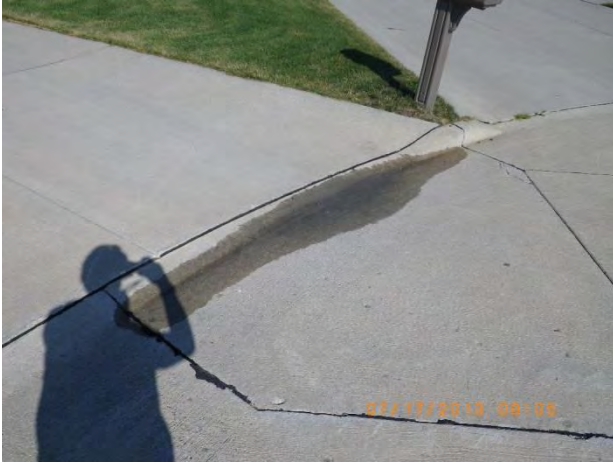
other upstream structures on July 17. However, a small puddle was observed at the end of the driveway for 3855 Wood Duck Court. A sample was collected from this puddle, and the detergent concentration was 1.3 mg/L. Based on this result, it appears that the detergent is entering the storm sewer from the surface, likely due to residential car washing or similar operations. Residential car washing is an allowed discharge under the MS4 general permit, and is not considered an illicit discharge.

**Figure 19 - Puddle near 3855 Wood Duck Court**

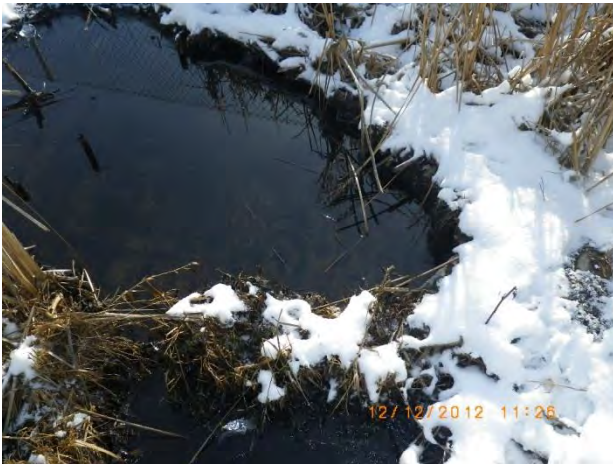
**Figure 21 - Pool at end of outfall 13-1748 (12/12/2012)**

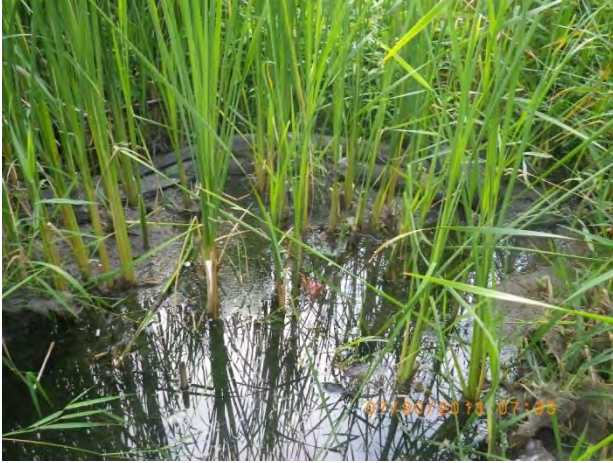
The outfall was re-screened on July 30, 2013. Oil containment booms were still present at the outfall, and the outfall pool had a slight oil sheen and petroleum odor. It could not be determined if the petroleum traces were due to continued discharge, flushing of the upstream storm sewer, or diffusion from the containment booms. It is unknown when the booms were last replaced.

**Figure 22 - Pool at end of outfall 13-1748 (2013)**

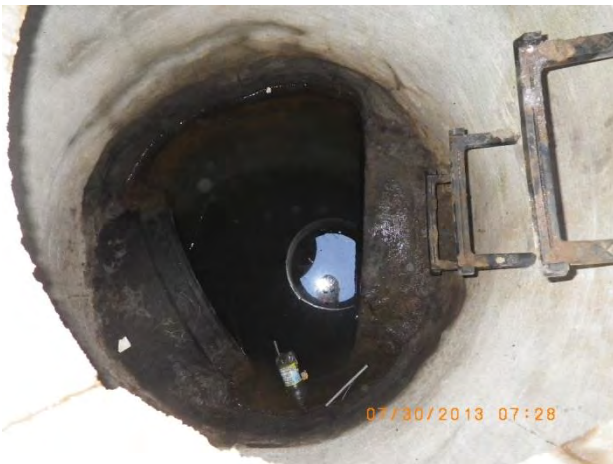
The upstream manhole (13-1748 US1) was screened, and a sample was collected. The manhole had a fairly strong petroleum odor, and the sample had a moderate petroleum sheen. The pipes entering and exiting the manhole had significant black stains from the petroleum discharge.

**Figure 23 - Upstream manhole 13-1748 US1 (2013)**

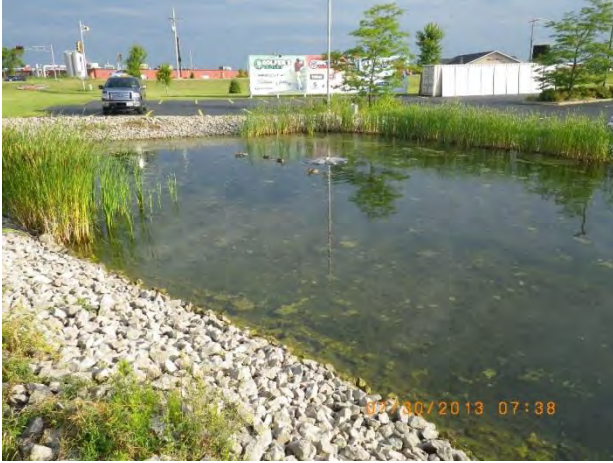
The detention basin, located between the discharge and the outfall, had a significant oil sheen at the time of the discharge. No sheen was observed on the surface of the pond during the re-screening.

**Figure 24 - Upstream detention basin (2013)**

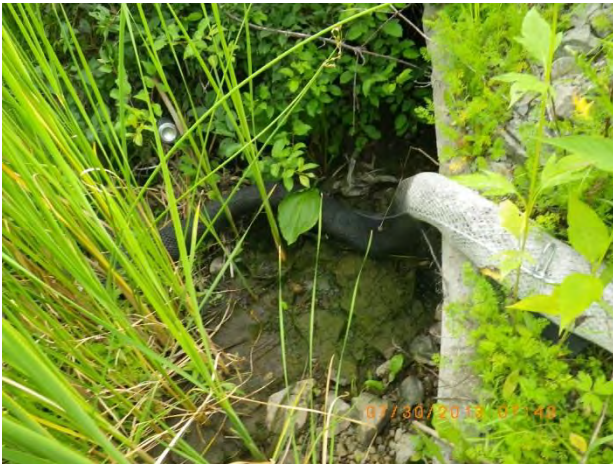
The actual sump discharge to the swale was not located during the re-screening. However, the pipe at the end of the swale, which leads to the storm sewer, was located. An oil absorbent sock was present, and appeared fairly saturated. There was no flow present at the time, but it appeared that the sock should be replaced.

**Figure 25 - Downstream end of swale (2013)**

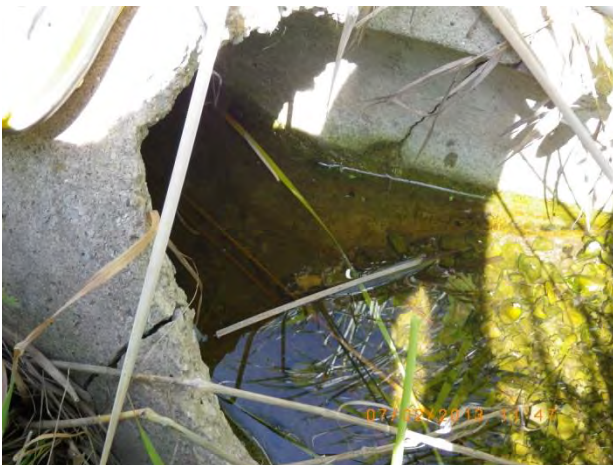
**Figure 26 - Crack on apron walls of outfall 12-1916 (minor damage)**

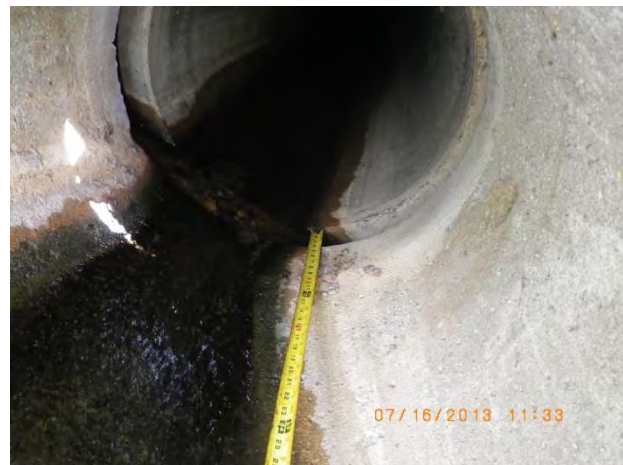
**Figure 27 - Outfall 06-1083 apron displacement (minor damage)**

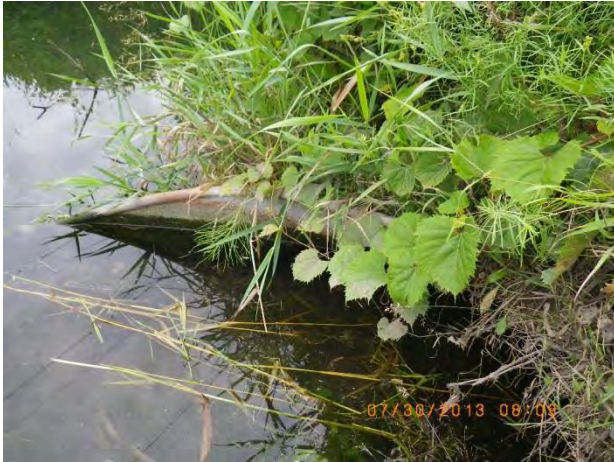
**Figure 28 - Outfall 13-1283 corrosion (minor damage)**

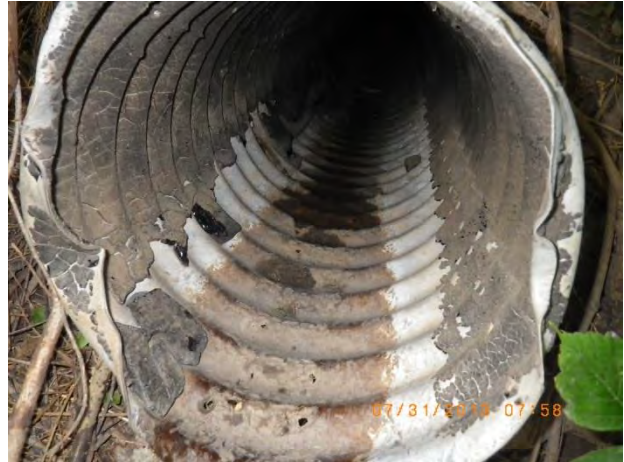
**Figure 29 – Corrosion and undercutting at outfall 14-124 (moderate damage)**

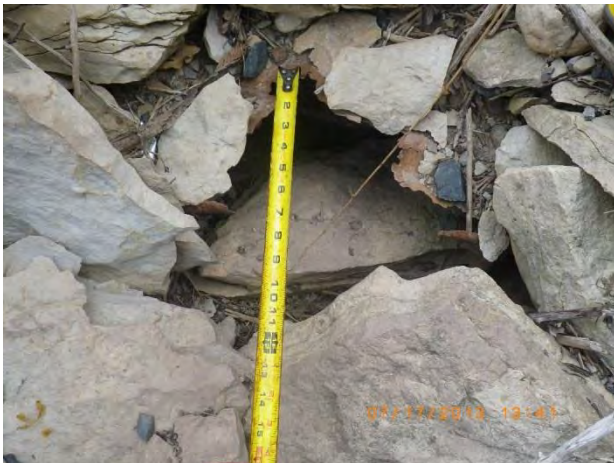
**Figure 30 - Outfall 14-1515 corrosion (moderate damage)**

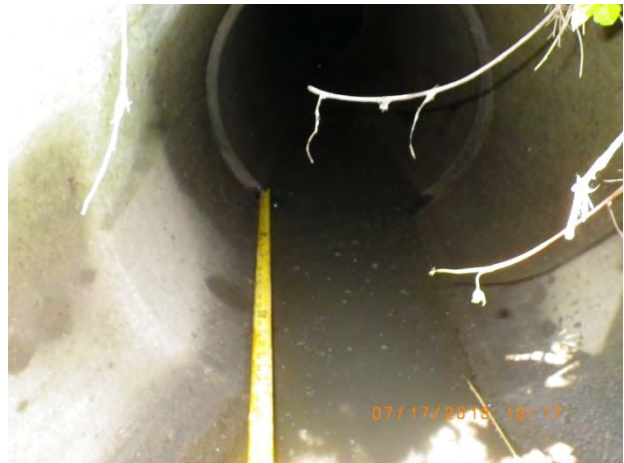
**Figure 31 - Outfall 14-645 apron displacement (minor damage)**

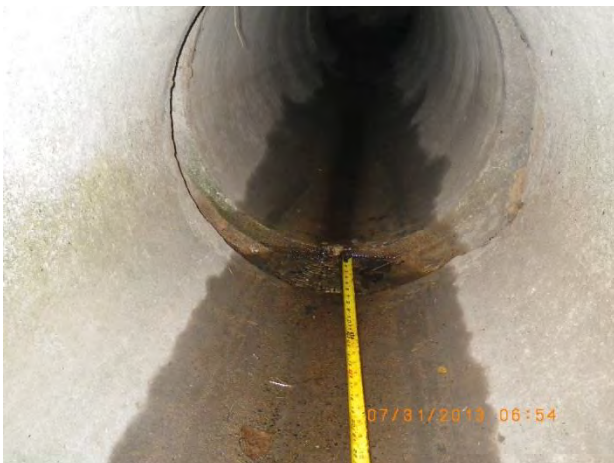
**Figure 32 - Outfall 14-659 apron displacement (moderate damage)**

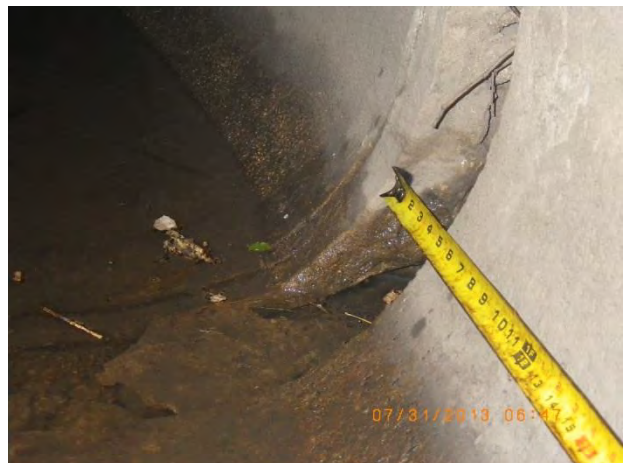
**Figure 33 - Outfall 14-660 apron displacement (moderate damage)**

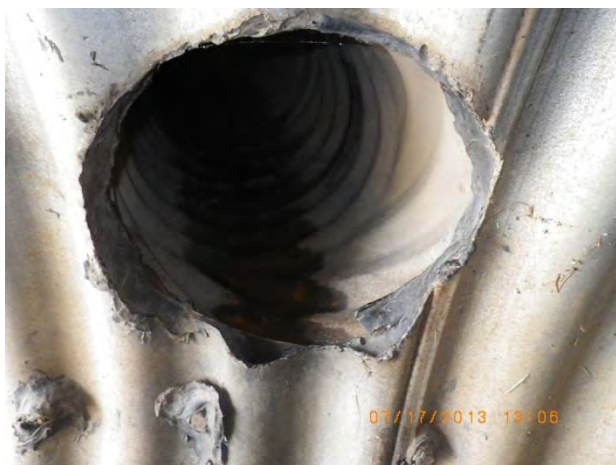
**Figure 34 - Outfall 14-675 corrosion (minor damage)**

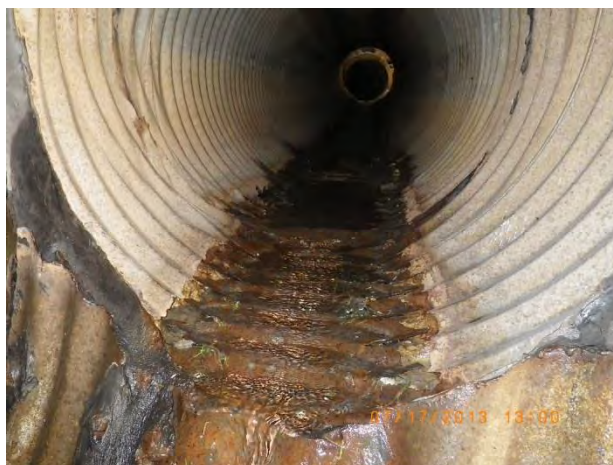
**Figure 35 - Outfall 14-676 corrosion (moderate damage)**

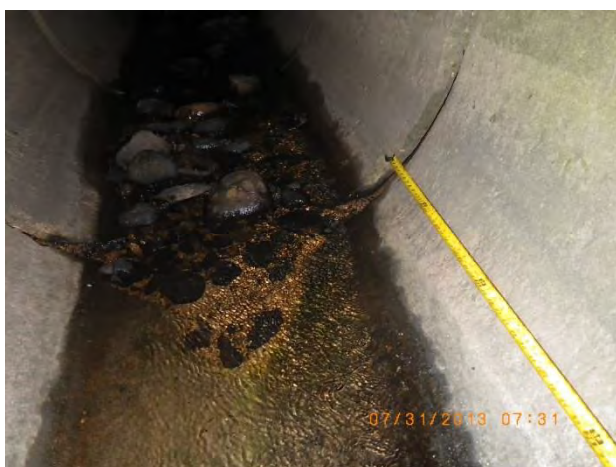
**Figure 36 - Outfall 14-999 apron displacement (minor damage)**

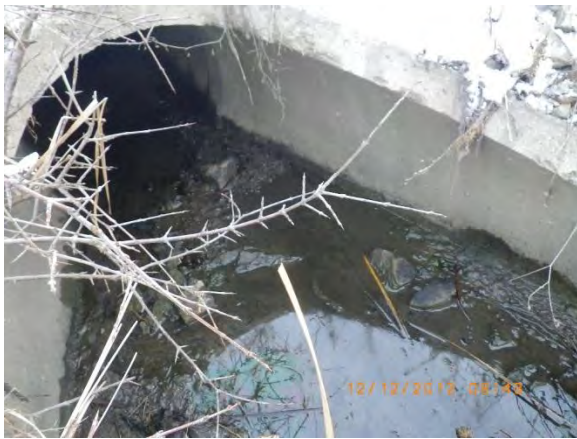
The investigation began by inspecting the various manholes in the storm sewer network to identify the extent of the oil contamination. An oil sheen and petroleum odor was observed at the pipe at the end of the drainage swale south of Quent's Service Center. The flow was traced upstream through the drainage swale for approximately 20 feet, at which point no additional surface flow was observed.

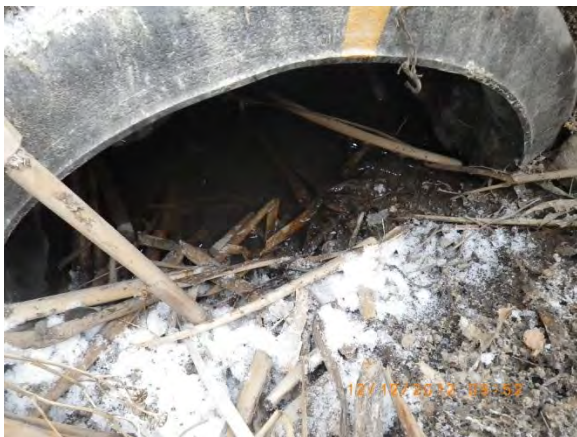
A private storm sewer is located in the west parking lot of Quent's Service Center. This storm sewer discharges to the drainage swale from the north. The outfall pipe was located, and was partially blocked by sediment and vegetation. A shallow pool of water was trapped at the end of the pipe. A sample was collected from this pool, and no sheen or odor was observed.

**Figure 3 – Private storm sewer outfall in swale**

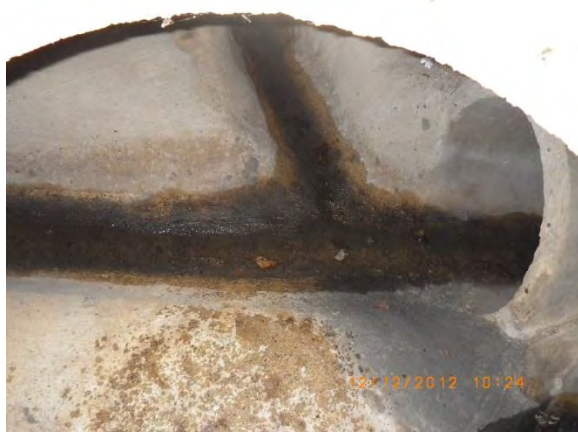
The branch of storm sewer along STH 44 south of Washburn Street was inspected. Based on the survey crew's activities on December 11, it was known that this branch entered manhole 13-1724 above the water level in the manhole. Manhole 13-2584 was inspected, and no sheen or stains were observed. A petroleum odor was present, but it was determined that this was likely venting from downstream manholes. Based on the observations in manhole 13-2584, it was determined that the discharge was not coming from this branch of the storm sewer.

**Figure 4 – Clean flow in manhole 13-2584**

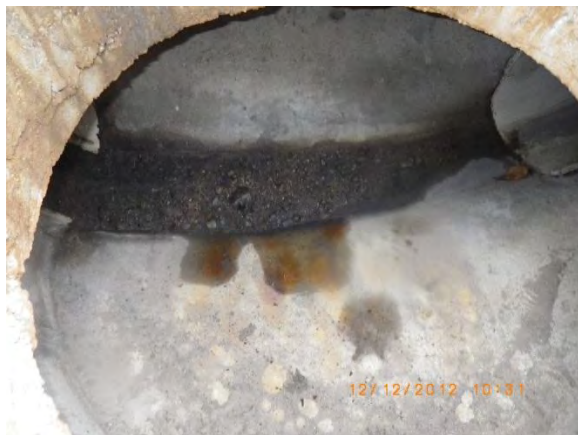
The branch on Washburn Street was investigated next. The manhole on the upstream end (13-1754) was inspected and found to be dry with no petroleum stains or odor. The next manhole (13-1749) was slightly submerged, and the flow appeared to be heading to the west (downstream). The flow entering from the east appeared to have a slight sheen, but did not have the dark, oily appearance that was observed at the end of the drainage swale.

**Figure 5 – No flow in manhole 13-1754**

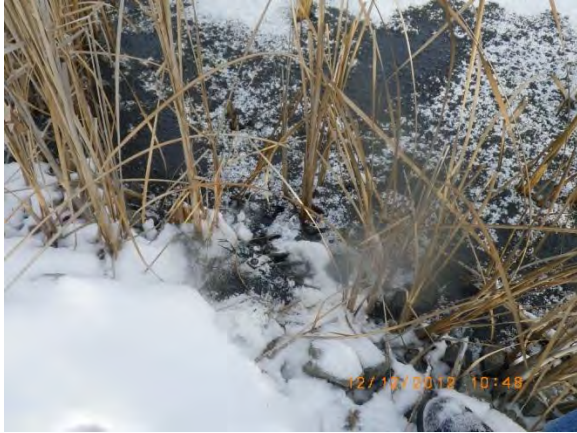
An oil sheen was observed on the surface of the detention pond. Near the inlet pipe, the sheen appeared to consist of clear oil droplets. Near the pond's outlet pipe, near manhole/inlet 13-1743, the oil sheen was more opaque. The pond is likely designed to discharge to the storm sewer in Washburn Street. However, due to the partially-submerged condition at the outfall and the backed-up water in the storm sewer, the pond surface was at the same level as the storm sewer flow, and the water was free to flow between the storm sewer and the pond based on wind and other influences on flow.

**Figure 8 – Detention pond outlet pipe**

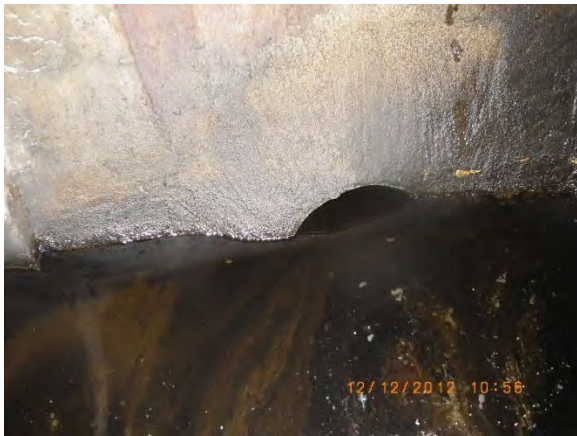
The junction of the detention pond and drainage swale with the storm sewer is located at manhole/inlet 13-1743. This inlet was inspected, and the opaque oil sheen observed in the drainage ditch was also observed in this inlet. No obvious source of the oil was identified, but there appeared to be a slight flow to the west (downstream).

**Figure 9 – Detention pond outlet pipe connection to manhole 13-1743**

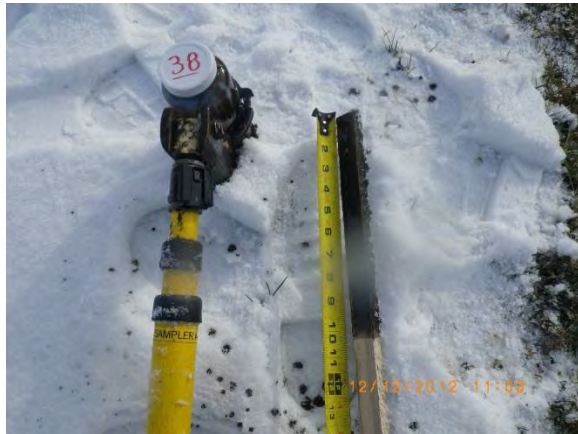
A water sample was collected from this manhole. The water was ten inches deep, with an opaque film on the surface. The oily substance coated the sample pole and sample bottle. A strong petroleum odor was present.

**Figure 11 – Sample collected from manhole 13-1743**

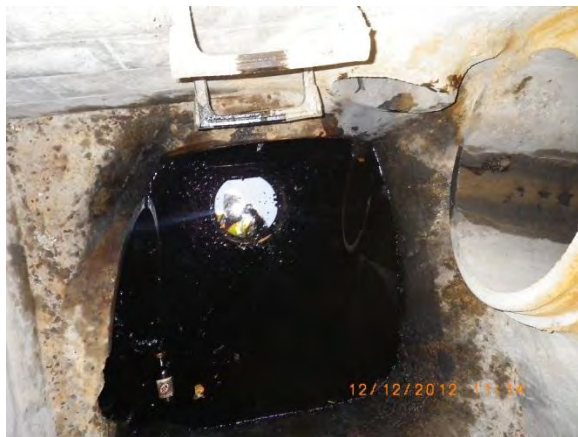
The remaining manholes between manhole 13-1743 and the outfall were inspected, and the oily substance was observed in each manhole. The inspection at manhole 13-1724 confirmed that the flow entering from the southwest branch did not contain oil.

**Figure 12 – Pipe from southwest branch entering manhole 13-1724 above the water level**

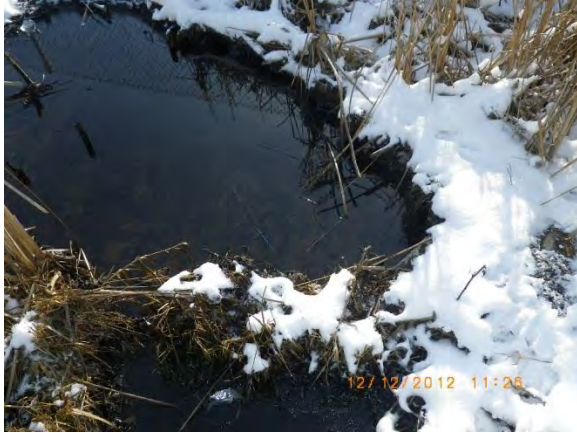
Outfall 13-1758 was located in the USH 41 right-of-way, south of the southbound on-ramp. The outfall pipe was approximately 90% submerged. The pool at the end of the outfall pipe had a brown-black opaque sheen with a strong petroleum odor, similar to the upstream manholes.

**Figure 13 – Pool at end of outfall 13-1758**

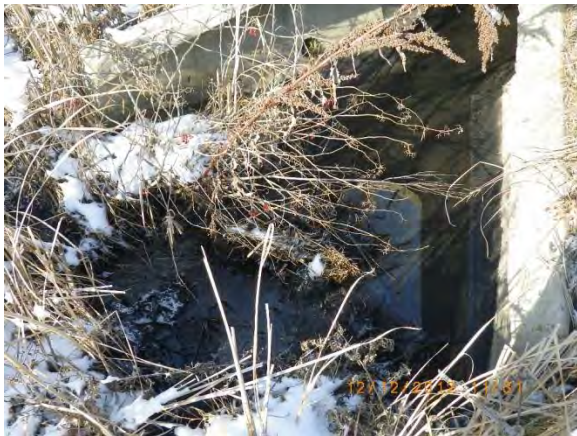
After leaving the outfall, the flow traveled northeast approximately 50 feet through a grass swale. A sheen was observed on this flow. The flow then entered a concrete culvert that traveled under STH 44 and discharged on the north side of STH 44. A dark sheen was observed on both the upstream and downstream ends of this culvert.

**Figure 14 – Sheen on pool in upstream end of STH 44 culvert**

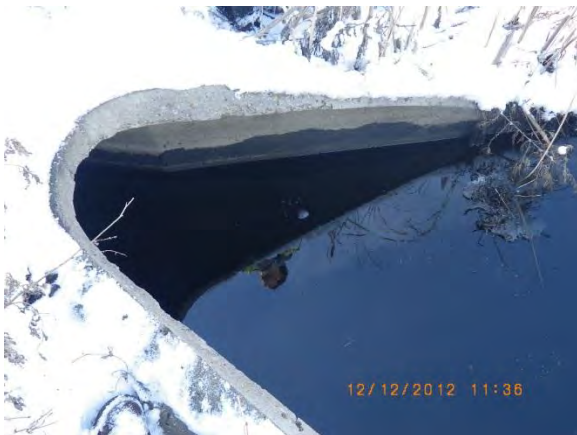
**Figure 15 – Sheen on pool in downstream end of STH 44 culvert**

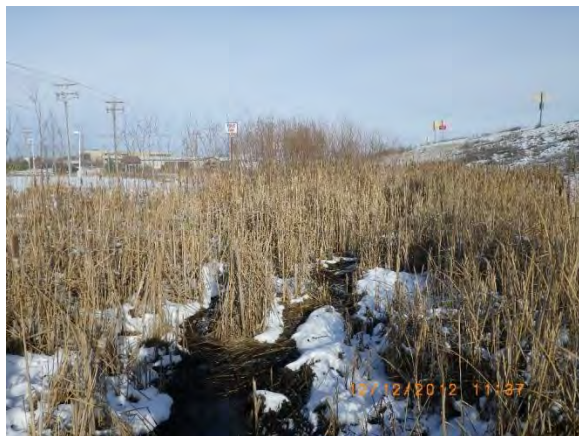
After leaving the STH 44 culvert, the flow traveled north along the USH 41 off-ramp ditch. The flow was traced for approximately 45 feet past the end of the culvert, at which point no surface flow was visible. The survey crew placed a pair of lath at the estimated downstream extent of the flow.

**Figure 16 – Downstream extent of oil sheen**
