# Ongoing Screening Summary Report 2016 Inspection Year

Illicit Discharge Detection and Elimination Program

City of Oshkosh

November 30, 2016

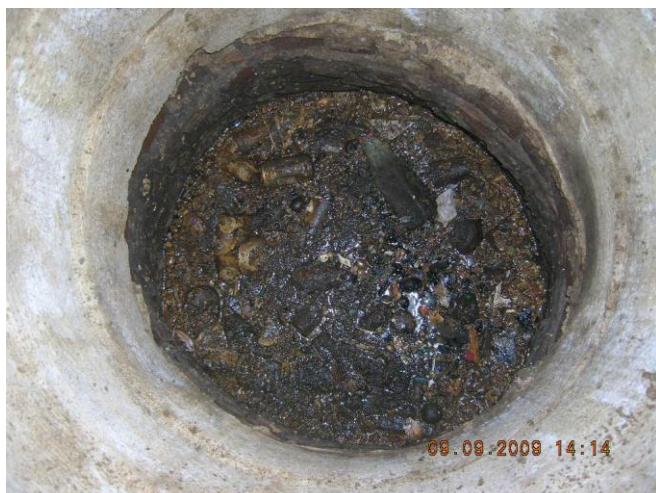
The outfall was first screened in 2009. The first upstream manhole was located on the south side of Pioneer Drive, behind the railroad control shed. When the manhole was opened, a strong smell of diesel fuel was detected inside the manhole. The manhole was also submerged, and had a significant amount of floatable debris, which appeared to be coated with oil and grease.

**Figure 14 – Floatable debris and grease in upstream manhole 03-81 US1 (2009)**

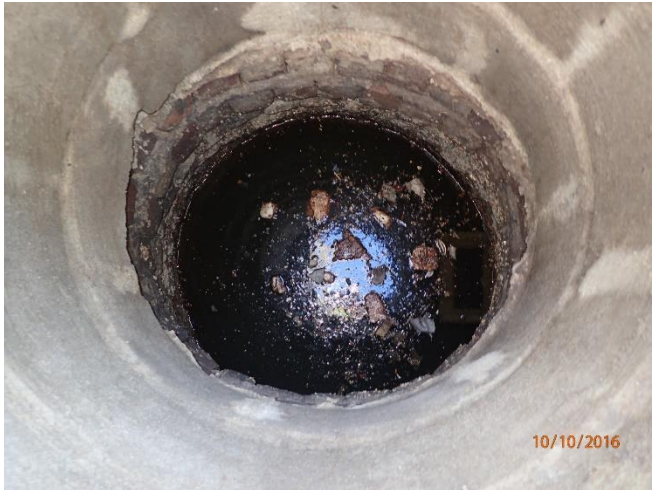
Date	Ammonia (ppm)	Petroleum	Gross Solids	Illicit Discharge Potential
9/9/2009	N/A	Strong odor, severe sheen/coated	Severe	Obvious
8/18/2010	0	Faint odor	Moderate	Potential
5/26/2011	N/A	None	Minor	Unlikely
10/11/2011	0.25	None	Minor	Unlikely
10/9/2014	0.5	Faint odor, slight sheen	Severe	Obvious
9/23/2015	1	None	Minor	Unlikely
10/10/2016	1	Faint odor, moderate sheen	Minor	Potential

**Figure 15 – Upstream manhole 03-81 US1 (2016)**

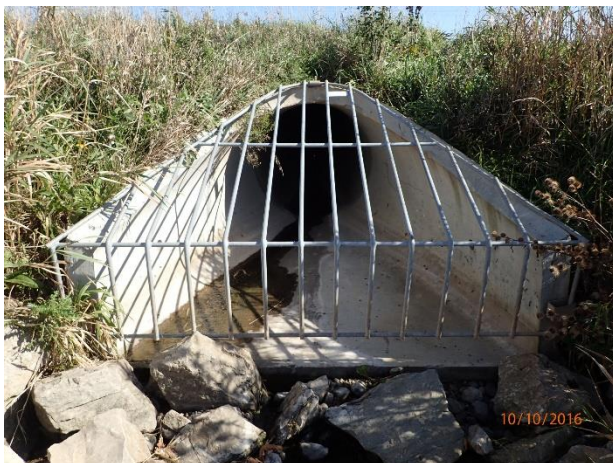
Outfall 12-1328a consists of a 42-inch reinforced concrete pipe that discharges the northeast corner of the detention basin located between W. Snell Road and Algoma Blvd. This segment of storm sewer was reconstructed in 2014 as part of the I-41 /Algoma Blvd (USH 45) overpass. This outfall replaces former outfall 12-1328, which was located at the west end of Fernau Avenue.

**Figure 16 – Outfall 12-1328a (10/10/2016)**

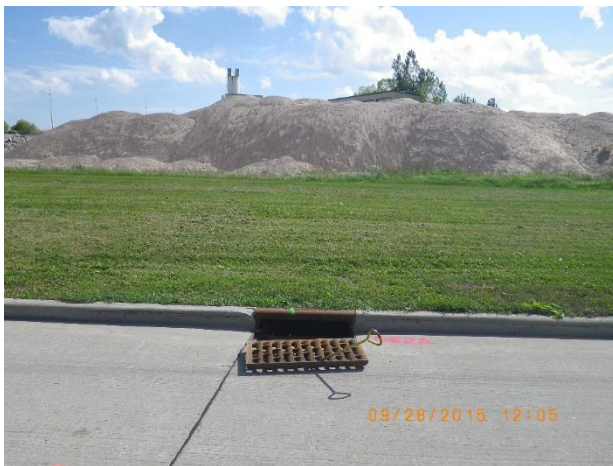
OMNNI traced the discharge on September 28, 2015. A sample from the outfall had a pH of 9.73. Upstream tracing was conducted primarily using visible flow and white staining, and supplemented with pH samples. The discharge was traced to a 6-inch pipe that was tapped into a curb inlet (582A) near the intersection of Walter Street and Fernau Avenue. The pipe appeared to be coming from the Carew concrete plant. A sample collected from this pipe had a pH of 12.28, and white staining was present in the pipe, confirming that it was the source of the discharge.

**Figure 17 – Inlet 582A (9/28/2015)**

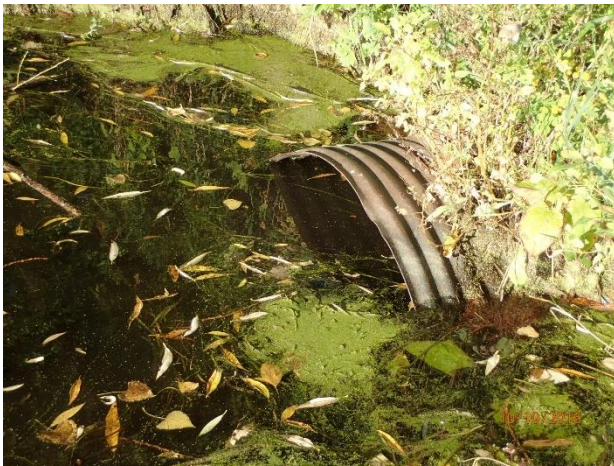
**Figure 19 – Corrosion at outfall 03-293 (minor damage)**

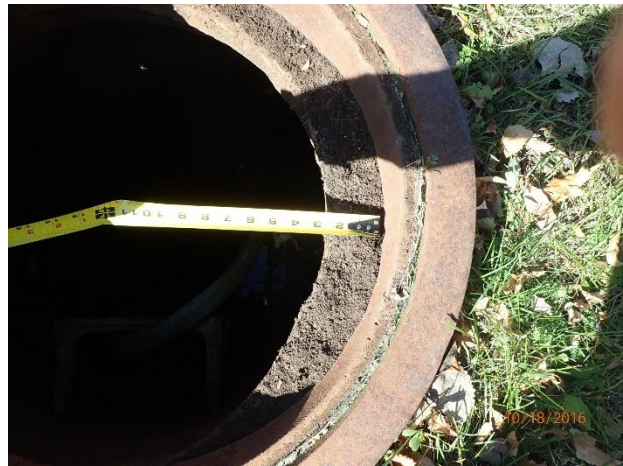
**Figure 20 – Displaced casting at manhole 06-221 US1 (minor damage)**

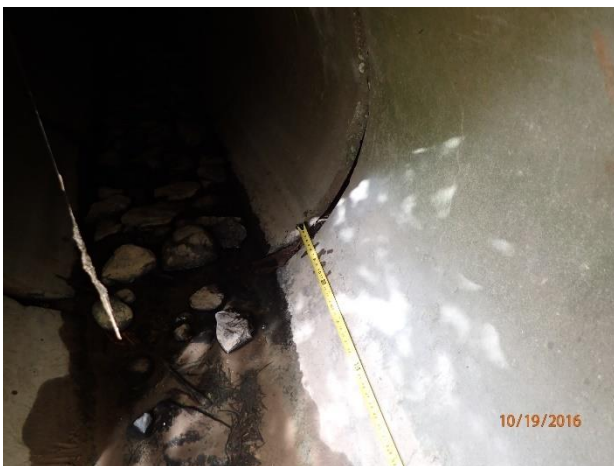
**Figure 21 – 4" joint displacement at outfall 14-999 (minor damage)**

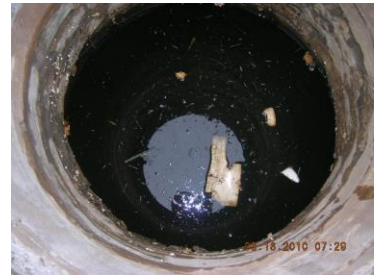
o20100818072942.JPG

<b>Inspection Date:</b> 8/18/2010 7:36:59 AM		<b>Type:</b> Ongoing	<b>Flow:</b> Submerged, indeterminate	<b>Previous Rainfall (hrs):</b> 72+
<b>Illicit Discharge Potential:</b> Unlikely		<b>Inspector:</b> JCW		
Submerged: Fully		Depth (in): 29		
<b>Sampling Results</b>		Notes		
Sample Location: Pool	Floatables: Slight	<div style="border: 1px solid black; padding: 5px;"> <b>Condition Assessment</b>            Graffiti: None            Erosion: None            Damage: None            Deposition: None 0 in.         </div>		
Total Chlorine: 0 ppm	Odor: Faint			
Free Chlorine: 0 ppm	Turbidity: None			
Ammonia: 0.5 ppm	Color: Faint in bottle			
pH: 7.06 units	Gross Solids: Slight			
Temperature 71 °F	Vegetation: None			
Conductivity: -- µS/cm	Benthic Growth: None			
Detergents: 0 mg/L	Stains: None			
	Non-illicit: Slight

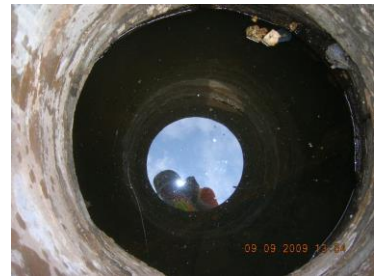
Osh09\_DSCN6743.JPG

<b>Inspection Date:</b> 9/9/2009		<b>Type:</b> Initial	<b>Flow:</b> Submerged, indeterminate	<b>Previous Rainfall (hrs):</b> 72+
<b>Illicit Discharge Potential:</b> Unlikely		<b>Inspector:</b> JCW		
Submerged: Fully		Depth (in): 27		
<b>Sampling Results</b>		Notes		
Sample Location: Pool	Floatables: None	<div style="border: 1px solid black; padding: 5px;"> <b>Condition Assessment</b>            Graffiti: None            Erosion: None            Damage: None            Deposition: None 0 in.         </div>		
Total Chlorine: 0 ppm	Odor: None			
Free Chlorine: 0 ppm	Turbidity: None			
Ammonia: -- ppm	Color: None			
pH: 7.87 units	Gross Solids: None			
Temperature 76 °F	Vegetation: None			
Conductivity: -- µS/cm	Benthic Growth: None			
Detergents: 0 mg/L	Stains: None			
	Non-illicit: None

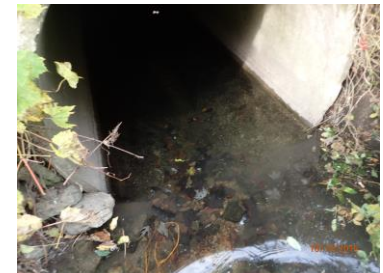
o20161019102420.JPG

Gross Solids: Slight ☒ Litter ☐ Debris ☐ Sediment ☐ OtherVegetation: None ☐ Inhibited ☐ ExcessiveBenthic Growth: Moderate ☒ Green ☐ BrownStains: None ☐ Flow Line ☐ Oil ☐ Rust Stains☐ Paint ☐ OtherNon-illicit: None ☐ Natural Sheen ☐ Natural Suds/Foam

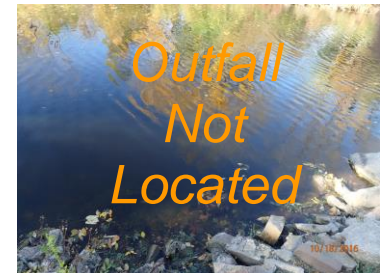
o20161018094900.JPG

**Notes:** Outfall fully submerged and not located - screened upstream at 16-93 US2.**Illicit Discharge Potential:** Unlikely☐ Field Follow-up☐ Office Follow-upFloatables:  ☐ Petrol. Sheen ☐ Suds ☐ Sewage ☐ Algae ☐ OtherOdor:  ☐ Petroleum ☐ Musty ☐ Sewage ☐ Chlorine ☐ Other☐ VOC/Solvent ☐ Fishy ☐ Sulfur ☐ FragrantTurbidity: Color: Gross Solids:  ☐ Litter ☐ Debris ☐ Sediment ☐ OtherVegetation:  ☐ Inhibited ☐ ExcessiveBenthic Growth:  ☐ Green ☐ BrownStains:  ☐ Flow Line ☐ Oil ☐ Rust Stains☐ Paint ☐ OtherNon-illicit:  ☐ Natural Sheen ☐ Natural Suds/Foam

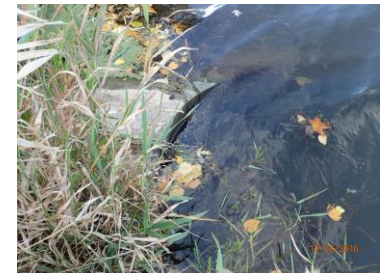
o20161018102052.JPG

Gross Solids: None ☐ Litter ☐ Debris ☐ Sediment ☐ OtherVegetation: None ☐ Inhibited ☐ ExcessiveBenthic Growth: Moderate ☒ Green ☐ BrownStains: None ☐ Flow Line ☐ Oil ☐ Rust Stains☐ Paint ☐ OtherNon-illicit: None ☐ Natural Sheen ☐ Natural Suds/Foam

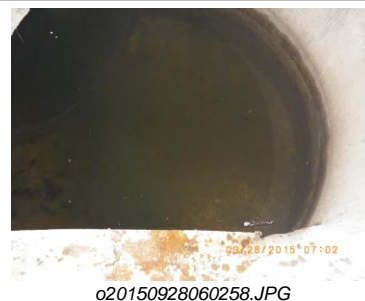
<b>Inspection Date:</b> 9/28/2015 7:00:26 AM		<b>Type:</b> Ongoing	<b>Flow:</b> Submerged, indeterminate	<b>Previous Rainfall (hrs):</b> 72+
<b>Illicit Discharge Potential:</b> Potential		<b>Inspector:</b> JCW		
Submerged: Partially		Depth (in): 23		
<b>Sampling Results</b>		<b>Notes</b> Elevated ammonia.		
Sample Location: Pool	Floatables: None	<b>Condition Assessment</b> Graffiti: None Erosion: None Damage: None Deposition: None in.		
Total Chlorine: 0 ppm	Odor: None			
Free Chlorine: 0 ppm	Turbidity: Slight cloudiness			
Ammonia: 3 ppm	Color: None			
pH: 7.28 units	Gross Solids: Slight			
Temperature 69 °F	Vegetation: None			
Conductivity: 1032 µS/cm	Benthic Growth: Moderate			
Detergents: 0 mg/L	Stains: Moderate			
	Non-illicit: None

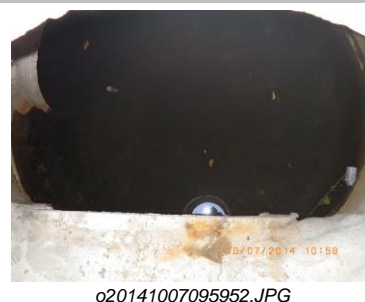
<b>Inspection Date:</b> 10/7/2014 11:02:53 AM		<b>Type:</b> Ongoing	<b>Flow:</b> Submerged, indeterminate	<b>Previous Rainfall (hrs):</b> 48-72
<b>Illicit Discharge Potential:</b> Potential		<b>Inspector:</b> JCW		
Submerged: Partially		Depth (in): 22		
<b>Sampling Results</b>		<b>Notes</b> Elevated ammonia. Park restrooms shut down for season.		
Sample Location: Pool	Floatables: None	<b>Condition Assessment</b> Graffiti: None Erosion: None Damage: None Deposition: None in.		
Total Chlorine: 0 ppm	Odor: None			
Free Chlorine: 0 ppm	Turbidity: None			
Ammonia: 3 ppm	Color: None			
pH: 8.1 units	Gross Solids: None			
Temperature -- °F	Vegetation: None			
Conductivity: 1387 µS/cm	Benthic Growth: Slight			
Detergents: 0 mg/L	Stains: Slight			
	Non-illicit: None
