Illicit Discharge Detection and Elimination
Conducted For
City of Oshkosh

Ongoing Screening Summary Report

2017 Inspection Year

OMNNI Project Number N2029C17

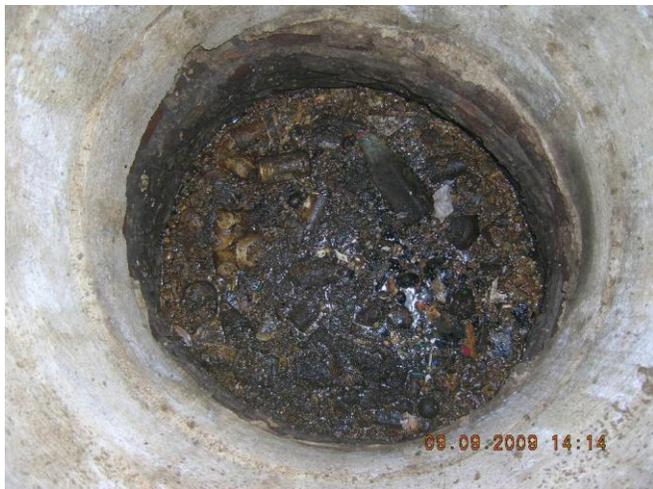
The outfall was first screened in 2009. The first upstream manhole was located on the south side of Pioneer Drive, behind the railroad control shed. When the manhole was opened, a strong smell of diesel fuel was detected inside the manhole. The manhole was also submerged, and had a significant amount of floatable debris, which appeared to be coated with oil and grease.

Figure 15 – Floatable debris and grease in upstream manhole 03-81 US1 (2009)

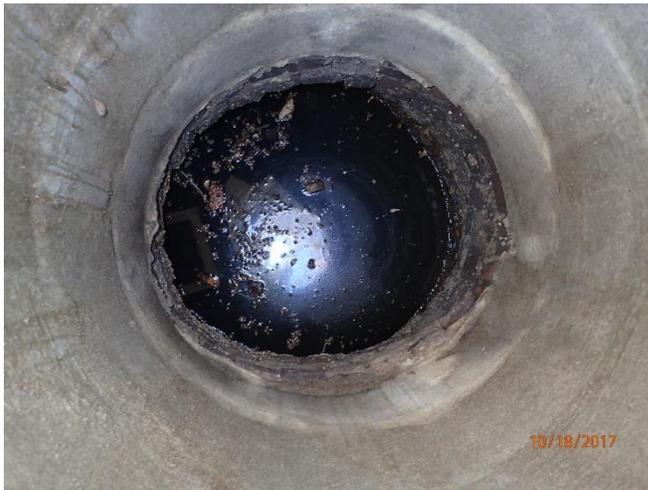
Date	Ammonia (ppm)	Detergent (mg/L)	Petroleum	Gross Solids	Illicit Discharge Potential
9/9/2009	N/A	0	Strong odor, severe sheen/coated	Severe	Obvious
8/18/2010	0	0	Faint odor	Moderate	Potential
5/26/2011	N/A	N/A	None	Minor	Unlikely
10/11/2011	0.25	N/A	None	Minor	Unlikely
10/9/2014	0.5	0	Faint odor, slight sheen	Severe	Obvious
9/23/2015	1	0	None	Minor	Unlikely
10/10/2016	1	0	Faint odor, moderate sheen	Minor	Potential
10/18/2017	1	0.8	Moderate sheen, no odor	Minor	Potential

Figure 16 – Upstream manhole 03-81 US1 (2017)

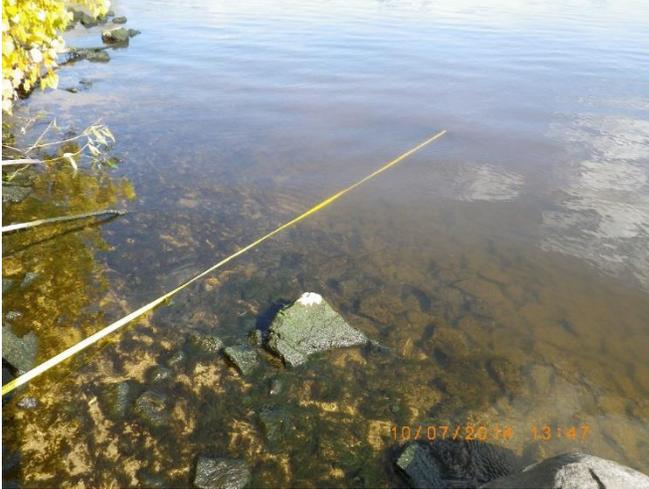
Outfall 03-173 consists of a 36-inch reinforced concrete pipe (RCP) that discharges to Lake Winnebago. The outfall is fully submerged, and the pipe is only visible in calm conditions.

Figure 17 - Outfall 03-173 (2014)

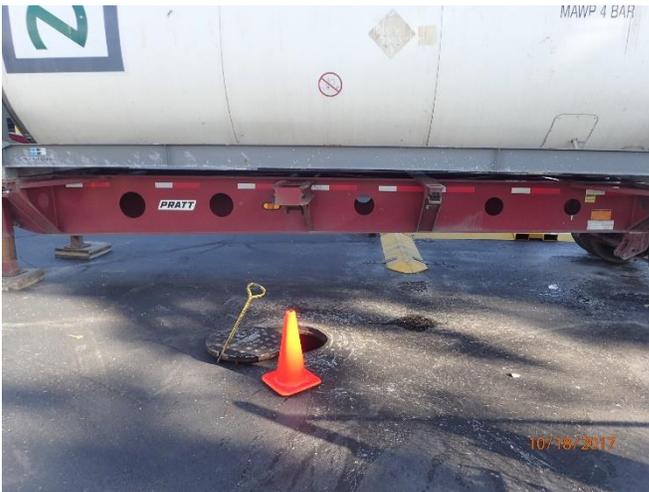
Figure 18 – Upstream manhole 03-173 US2 (2017)

Floating gross solids were observed in the upstream manhole(s) in 2010, 2011, 2014, 2015 and 2016, and the outfall was listed as a potential illicit discharge for this reason.

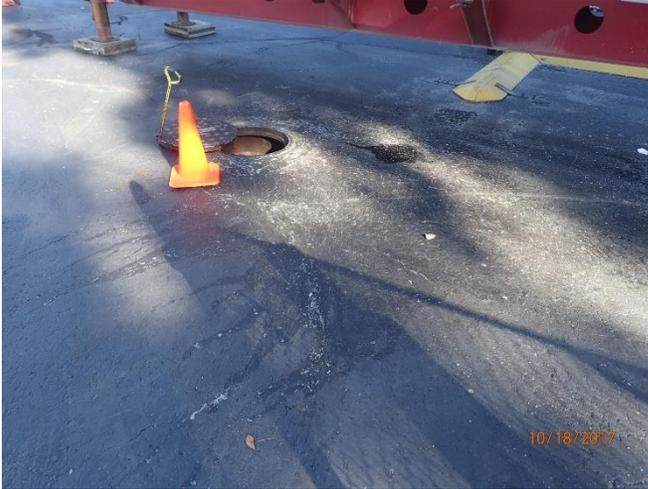
During the 2017 screening, gross solids were once again observed in manhole 03-173 US2. However, upon arriving at the manhole, stains were observed around the manhole, and the recesses in the manhole lid were filled with a white wax. A railroad tank car was parked over the manhole, and the markings appeared to indicate that it contained a type of wax.

Figure 19 – Wax stains near manhole 03-173 US2 (2017)

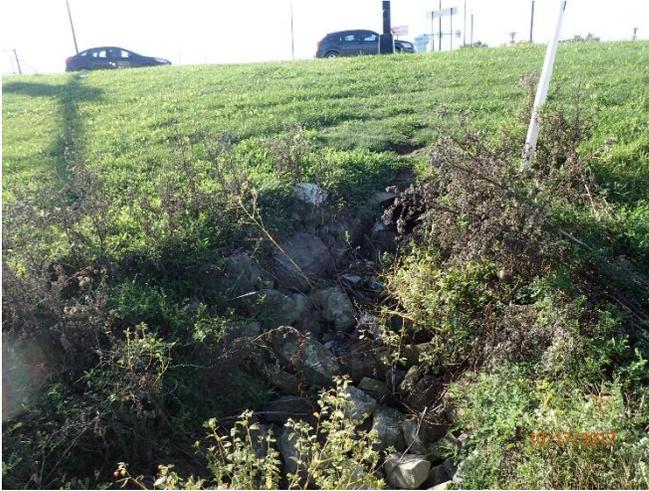
Outfall 06-1371 consists of an 18-inch RCP that discharges into the I-41 right-of-way near the southbound I-41 off-ramp. The storm sewer receives drainage from the roundabout at the intersection of Witzel Avenue and the I-41 off-ramp, and discharges at the top of an embankment. As a result, the pipe was dry at the time of inspection.

Figure 24 - Outfall 06-1371 (2017)

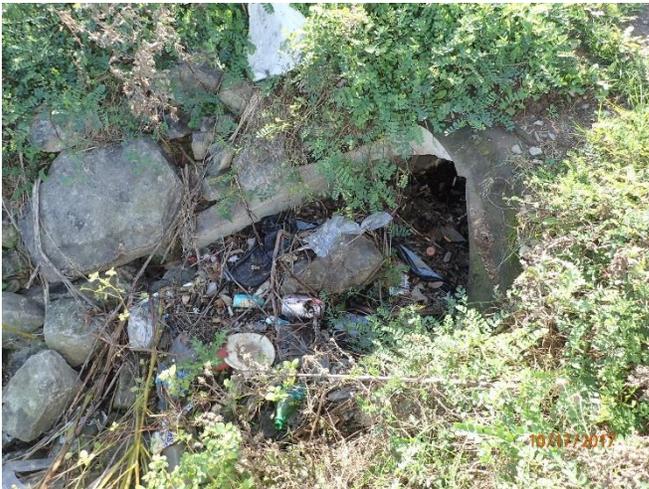
During the 2017 screening, a significant amount of gross solids (litter) was observed inside the pipe and immediately downstream. Due to the location, it appeared that the litter came through the storm sewer system, and was not simply blown into the right-of-way.

Figure 25 – Gross solids at outfall 06-1371 (2017)

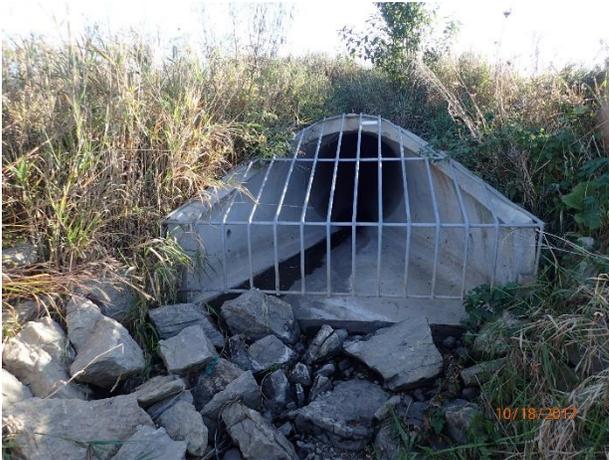
Outfall 12-1328a consists of a 42-inch reinforced concrete pipe that discharges the northeast corner of the detention basin located between W. Snell Road and Algoma Blvd. This segment of storm sewer was reconstructed in 2014 as part of the I-41 /Algoma Blvd (USH 45) overpass. This outfall replaces former outfall 12-1328, which was located at the west end of Fernau Avenue.

Figure 28 – Outfall 12-1328a (2017)

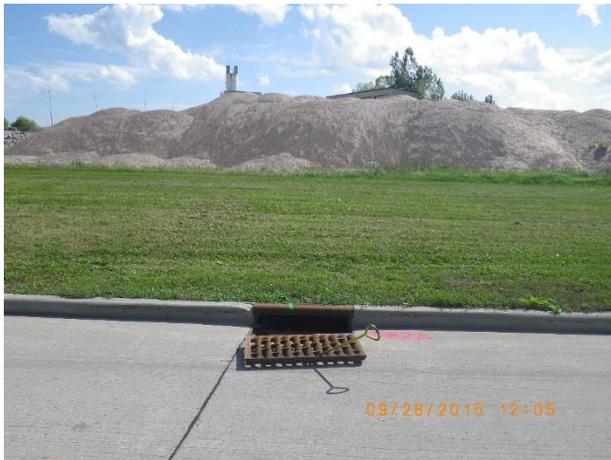
OMNNI traced the discharge on September 28, 2015. A sample from the outfall had a pH of 9.73. Upstream tracing was conducted primarily using visible flow and white staining, and supplemented with pH samples. The discharge was traced to a 6-inch pipe that was tapped into a curb inlet (582A) near the intersection of Walter Street and Fernau Avenue. The pipe appeared to be coming from the Carew concrete plant. A sample collected from this pipe had a pH of 12.28, and white staining was present in the pipe, confirming that it was the source of the discharge.

Figure 29 – Inlet 582A (9/28/2015)

During the 2016 screening on October 10, 2016, it was observed that the pipe in the upstream catchbasin had been permanently plugged.

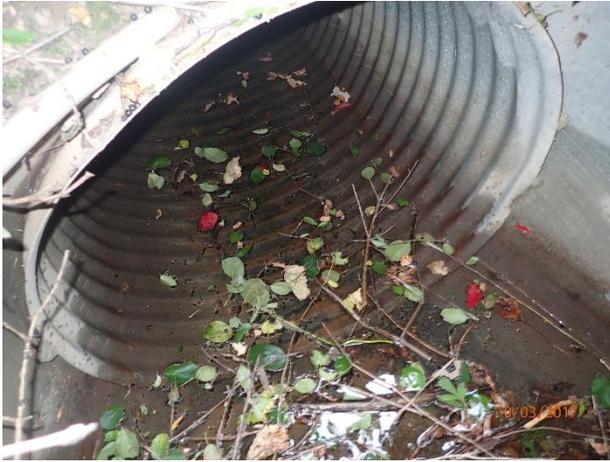
Figure 36 – Corrosion at outfall 06-3 (minor damage)

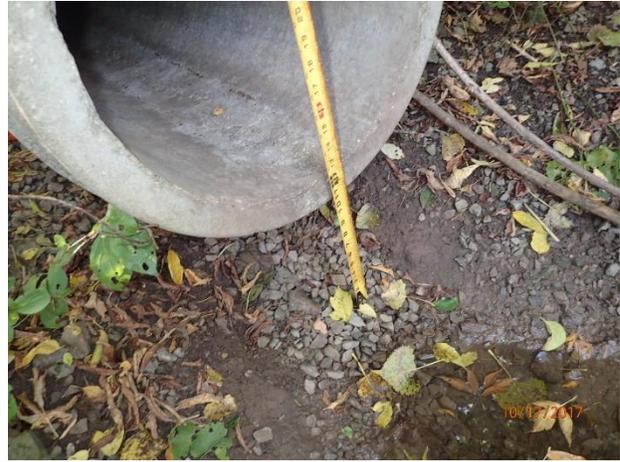
Figure 37 – Undercut pipe at outfall 06-961 (moderate damage)

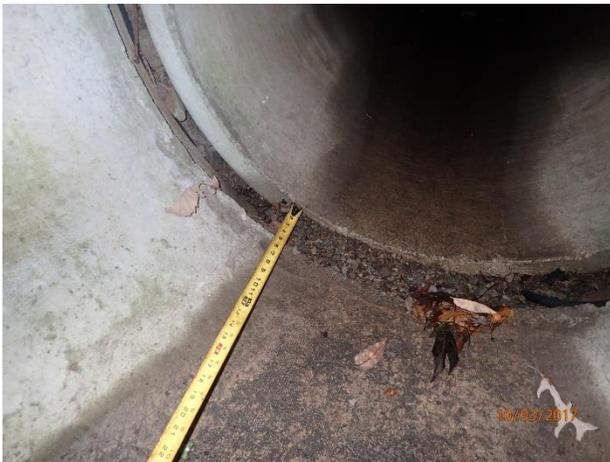
Figure 38 – Apron displacement at outfall 06-977 (moderate damage)

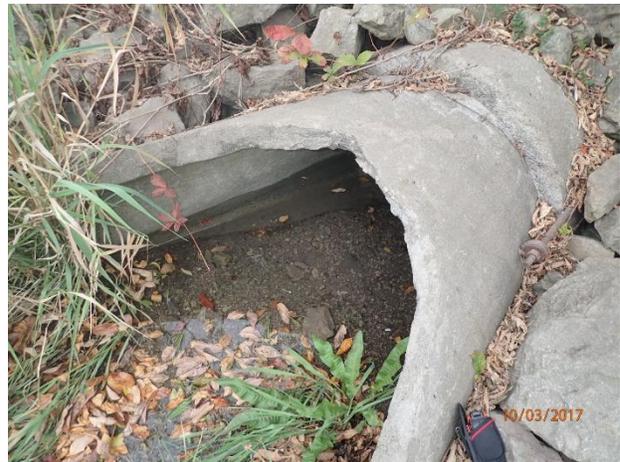
Figure 39 – Chipped concrete apron at outfall 06-1083 (minor damage)

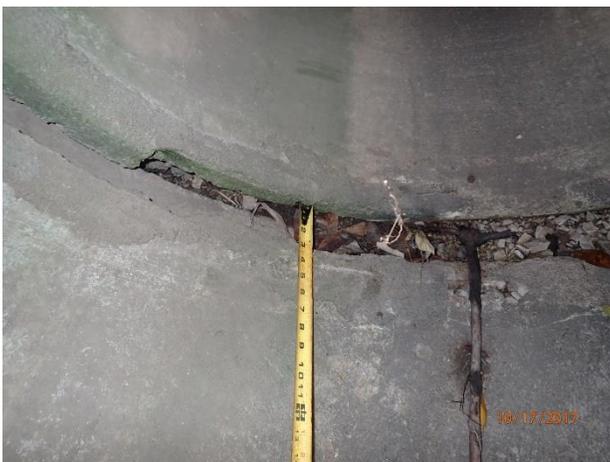
Figure 40 – Apron displacement at outfall 06-1132 (moderate damage)

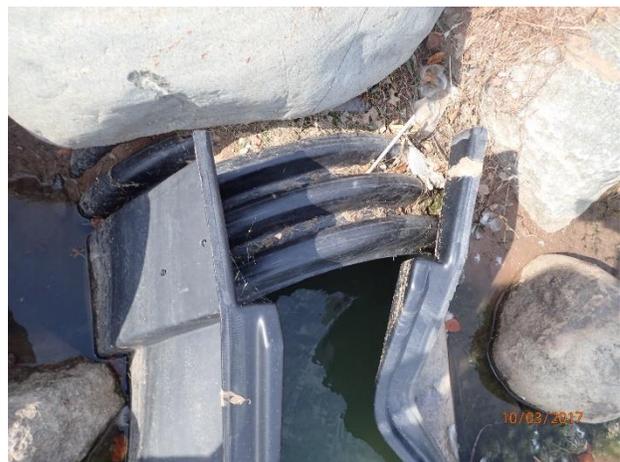
Figure 41 – Missing apron clamp at outfall 06-1495 (minor damage)

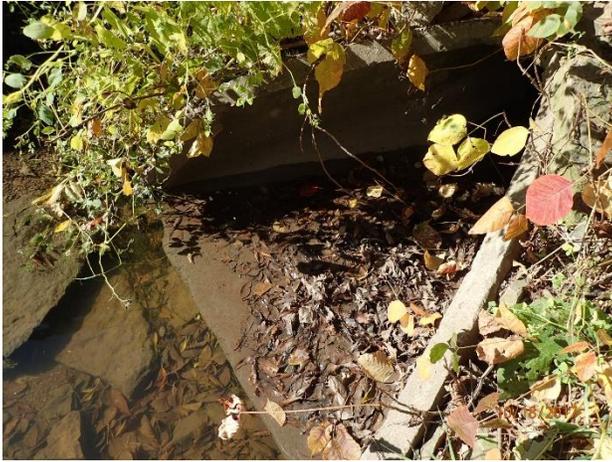
Figure 42 – Apron displacement at outfall 14-645 (minor damage)

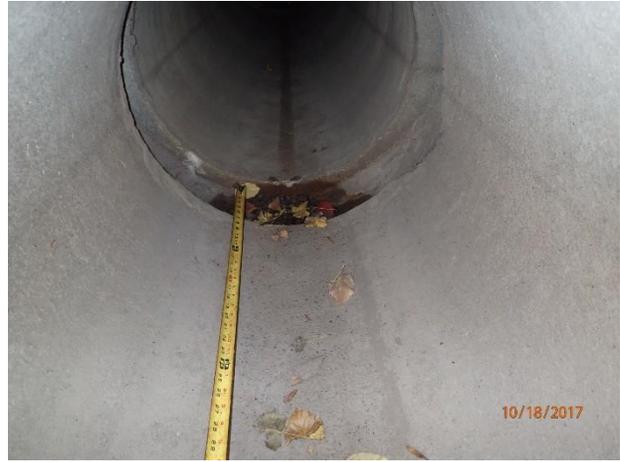
Figure 43 – Apron displacement at outfall 14-659 (moderate damage)

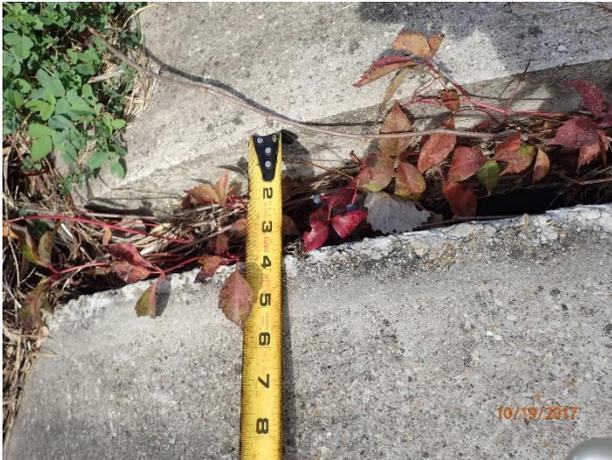
Figure 44 – Apron displacement at outfall 14-996 (moderate damage)

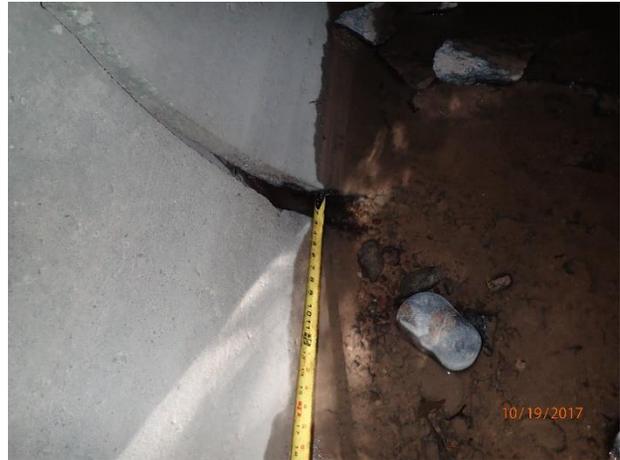
Figure 45 – Apron displacement at outfall 14-999 (moderate damage)

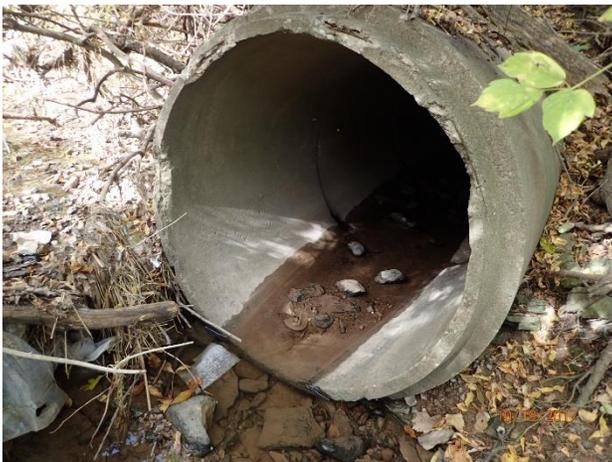
Figure 46 – Damaged concrete at outfall 14-999 (minor damage)

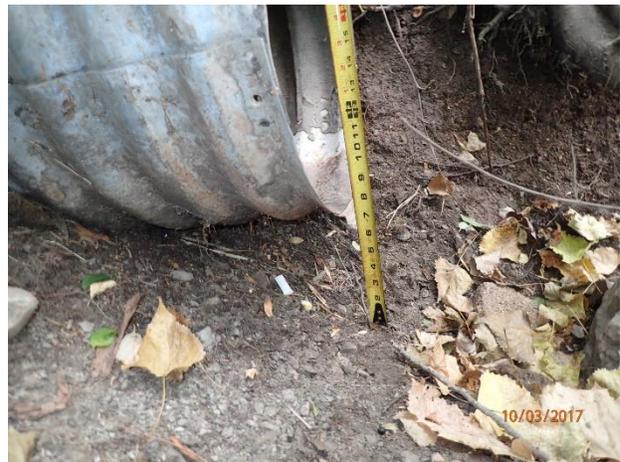
Figure 47 – Undercut pipe at outfall 16-622 (minor damage)

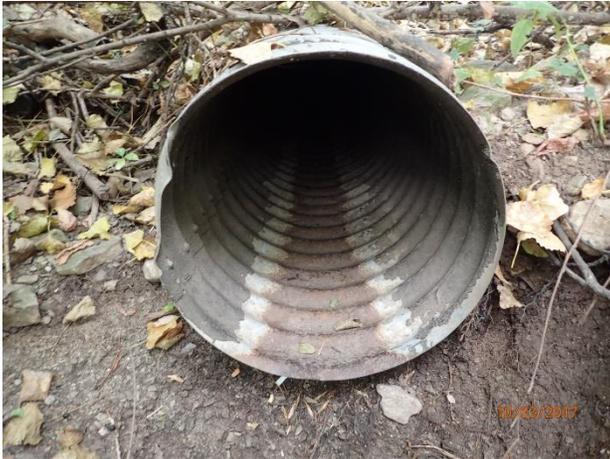
Figure 48 – Corrosion at outfall 16-622 (minor damage)

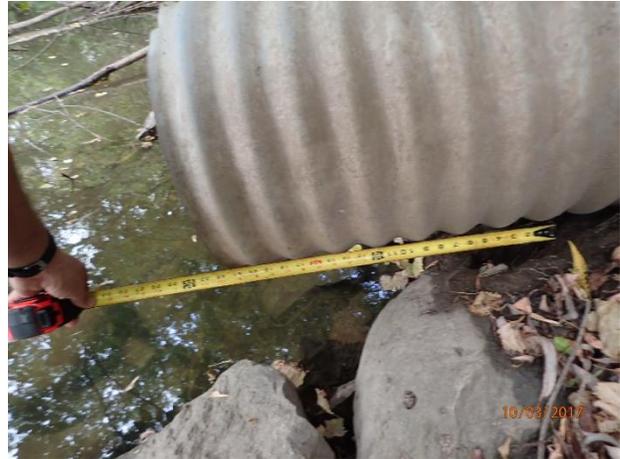
Figure 49 – Undercut pipe at outfall 16-629 (minor damage)

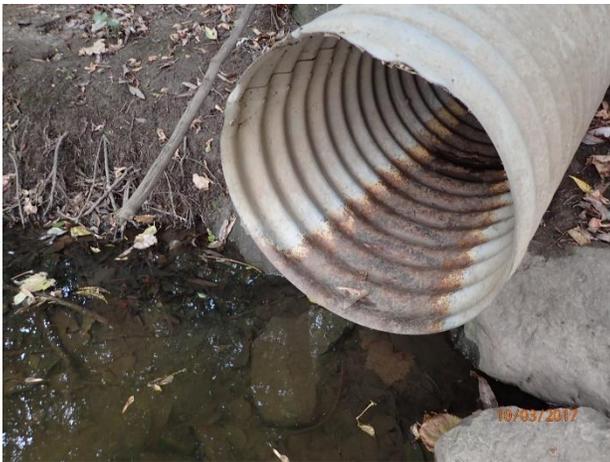
Figure 50 – Corrosion at outfall 16-629 (minor damage)

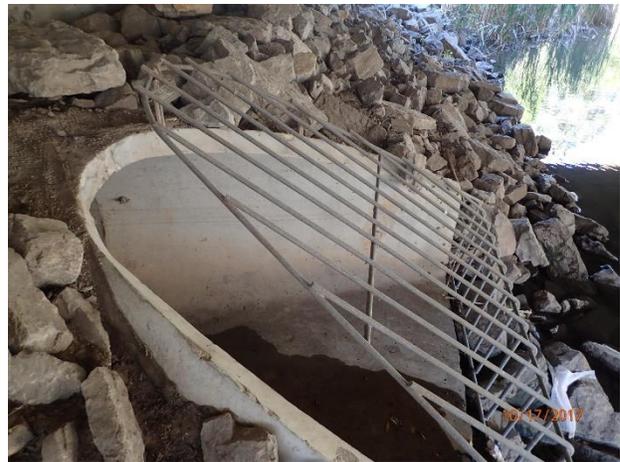
Figure 51 – Detached grate at outfall 16-646a (minor damage)

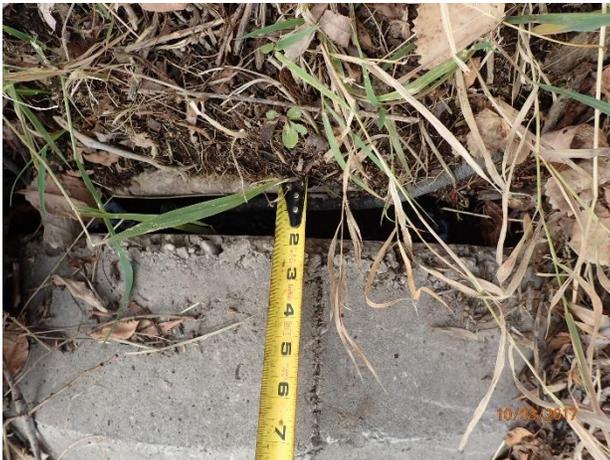
Figure 52 – Apron displacement at outfall 16-663 (moderate damage)

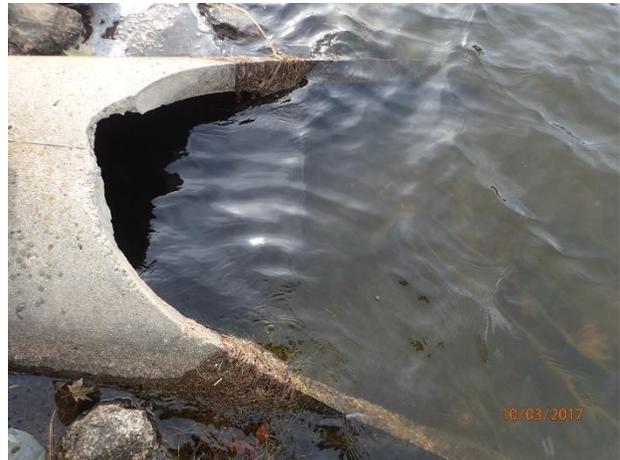
Figure 53 – Chipped concrete apron at outfall 16-941 (minor damage)
