Ongoing Screening Summary Report 2018 Inspection Year

Illicit Discharge Detection and Elimination Program

City of Oshkosh

January 25, 2019

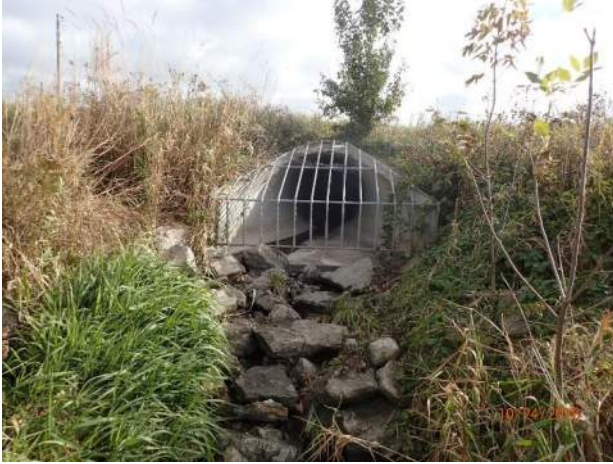
Figure 19 – Outfall 12-1328a (2018)

Outfall 12-1328a consists of a 42-inch reinforced concrete pipe that discharges the northeast corner of the detention basin located between W. Snell Road and Algoma Blvd. This segment of storm sewer was reconstructed in 2014 as part of the I-41 /Algoma Blvd (USH 45) overpass. This outfall replaces former outfall 12-1328, which was located at the west end of Fernau Avenue.

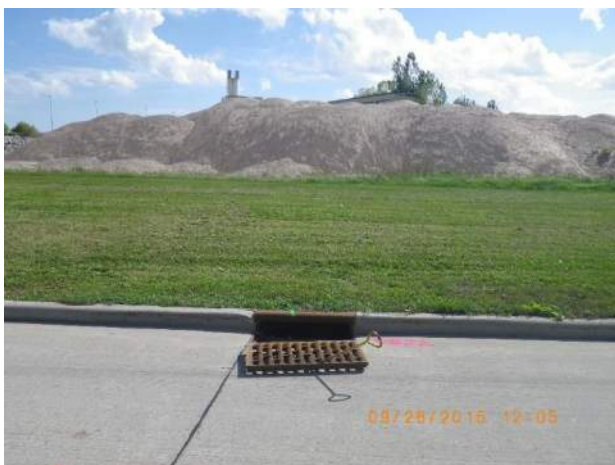
Figure 20 – Inlet 582A (9/28/2015)

OMNNI traced the discharge on September 28, 2015. A sample from the outfall had a pH of 9.73. Upstream tracing was conducted primarily using visible flow and white staining and supplemented with pH samples. The discharge was traced to a 6-inch pipe that was tapped into a curb inlet (582A) near the intersection of Walter Street and Fernau Avenue. The pipe appeared to be coming from the Carew concrete plant. A sample collected from this pipe had a pH of 12.28, and white staining was present in the pipe, confirming that it was the source of the discharge.

During the 2016 screening on October 10, 2016, it was observed that the pipe in the upstream catchbasin had been permanently plugged.

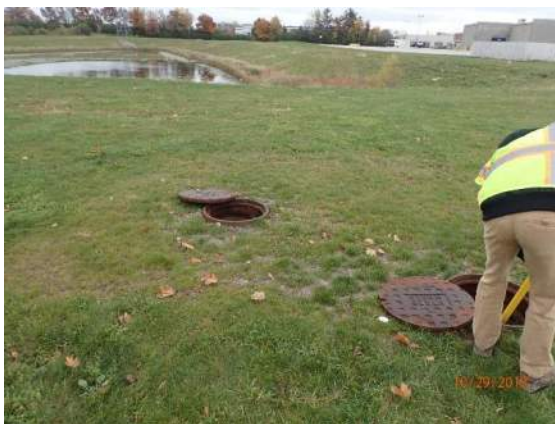
Figure 26 – Upstream manhole 13-3774 (2018)

Preliminary tracking activities were conducted on 10/29/2018. (The area received 0.2 inches of rain the previous day, which may have impacted the results.) Screening started at the first upstream manhole, which was the large vault immediately north of the outfall.

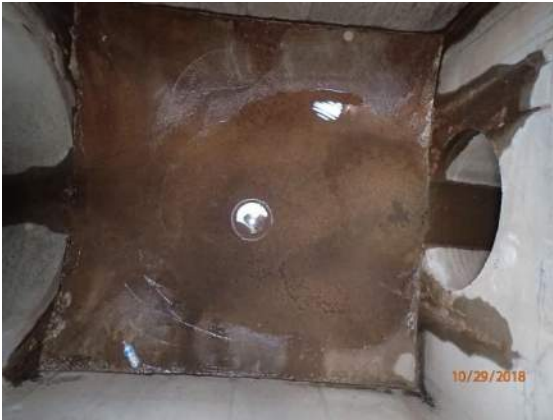
Figure 27 – Flowline of manhole 13-3774 (2018)

A sample was collected from the flowline of the manhole, at the upstream end of the 66" outfall pipe. This sample contained no detergent. However, suds were noted on the bench at the outlet of the pipe entering the manhole from the west. The detergent test for the sample collected from this pool was also negative.

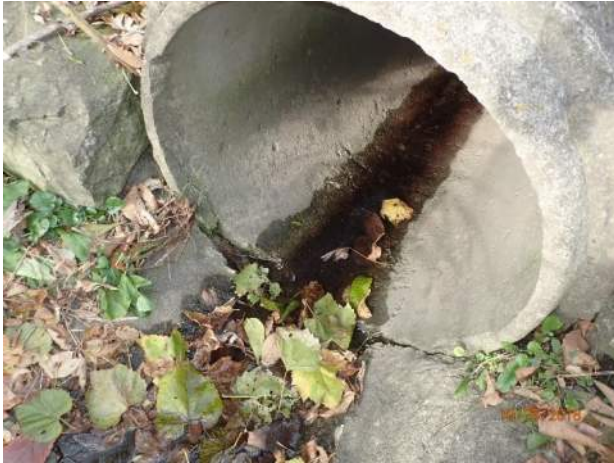
Figure 36 – Joint displacement at outfall 06-478 (minor damage)

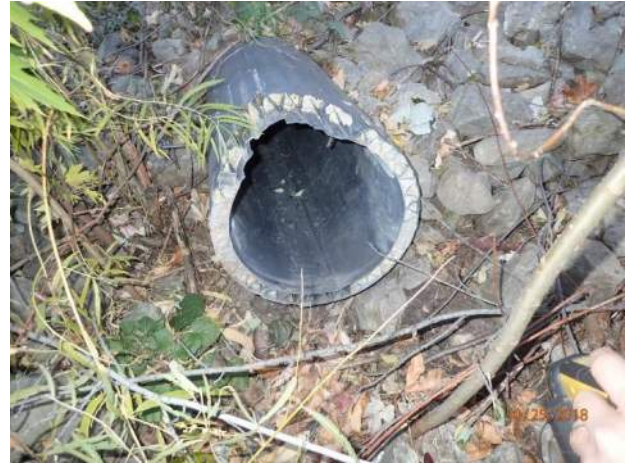
Figure 37 – Damaged end of pipe at outfall 13-1109 (minor damage)

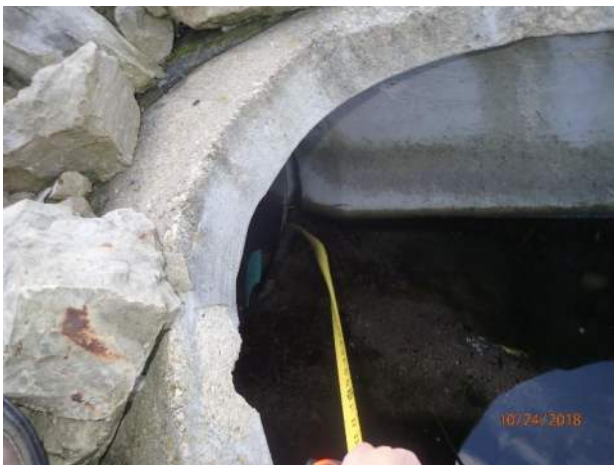
Figure 38 – Apron displacement at outfall 13-2872a (minor damage)

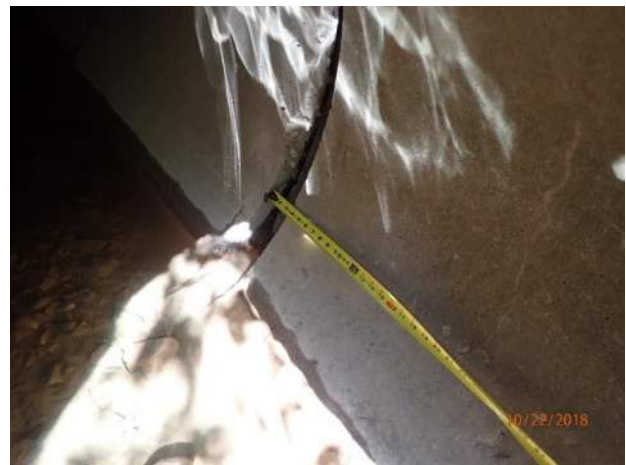
Figure 39 – Joint displacement at outfall 14-999 (moderate damage)
