Ongoing Screening Summary Report 2019 Inspection Year

Illicit Discharge Detection and Elimination Program

City of Oshkosh

January 3, 2020

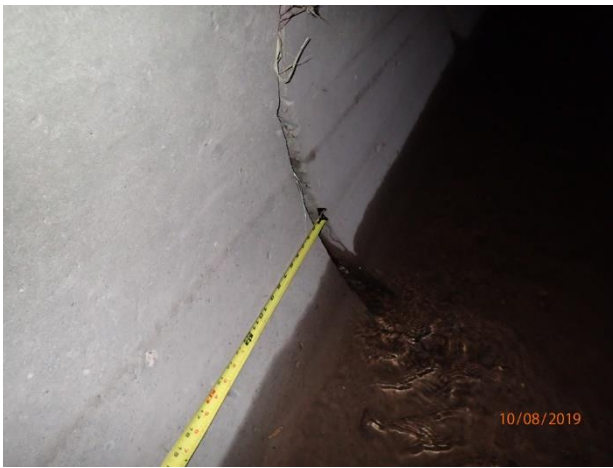
Figure 48 – Joint displacement at outfall 14-999 (minor damage)

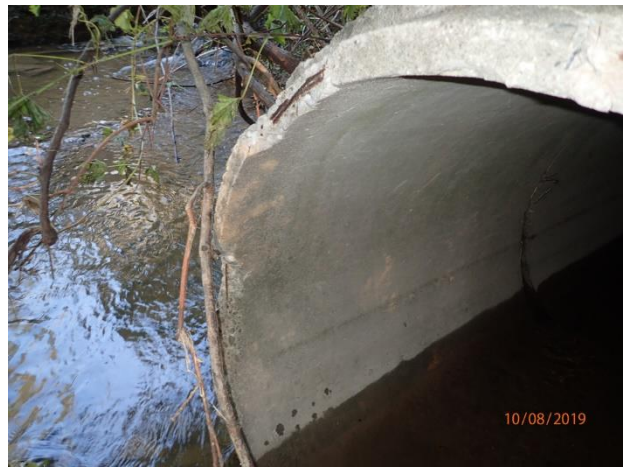
Figure 49 – Damaged end of pipe at outfall 14-999 (minor damage)

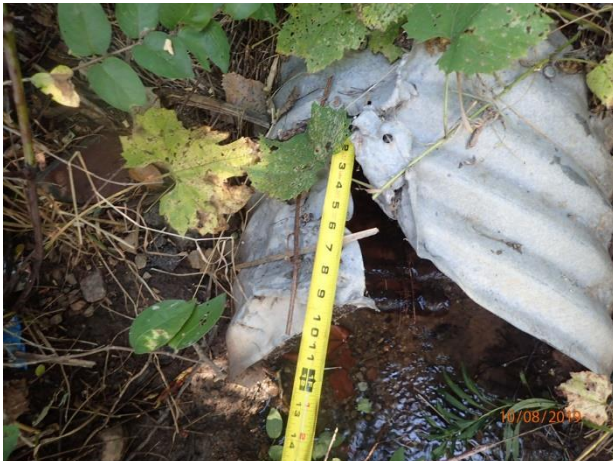
Figure 50 – Corrosion and damaged CMP at outfall 15-1219 (moderate damage)

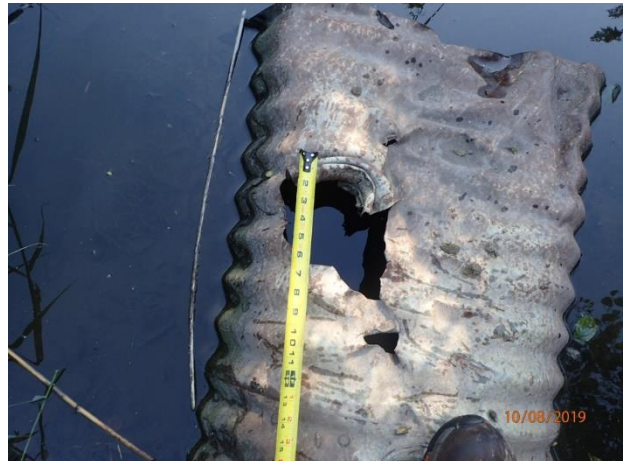
Figure 51 – Damaged CMP at outfall 15-1067 (moderate damage)

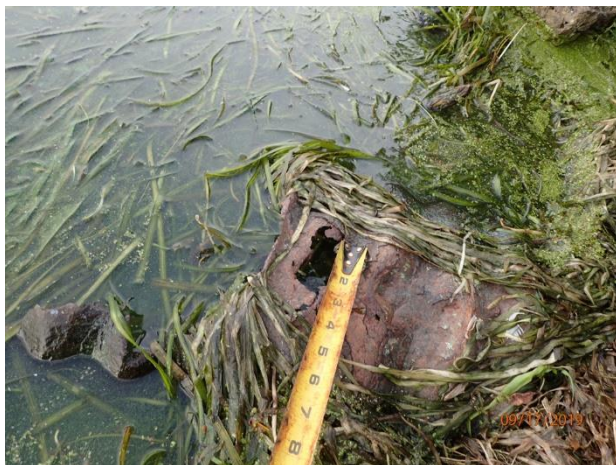
Figure 52 – Damaged CMP at outfall 15-690 (moderate damage)

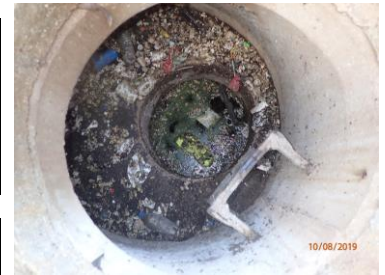
o20191008081524.JPG

Inspection Date: 10/8/2019 9:18:01 AM		Type: Ongoing	Flow: Submerged, indeterminate	Previous Rainfall (hrs): 48-72
Illicit Discharge Potential: Potential		Inspector: JCW		
Submerged: Partially		Depth (in): 73		
Sampling Results		Notes Sample collected from submerged pool in manhole. Floating gross solids (litter) in manhole. Detergent detected.		
Sample Location: Pool	Floatables: None	Condition Assessment Graffiti: None Erosion: None Deposition: None in. Damage: None		
Total Chlorine: 0 ppm	Odor: None			
Free Chlorine: 0 ppm	Turbidity: None			
Ammonia: 0 ppm	Color: None			
pH: 7.28 units	Gross Solids: Severe			
Temperature 61 °F	Vegetation: None			
Conductivity: 381 µS/cm	Benthic Growth: None			
Detergents: 0.9 mg/L	Stains: None			
	Non-illicit: None

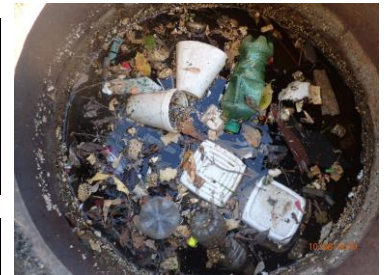
o20191008073520.jpg

Inspection Date: 10/8/2019 8:35:00 AM		Type: Repeat	Flow: Submerged, indeterminate	Previous Rainfall (hrs): 48-72
Illicit Discharge Potential: Potential		Inspector: JCW		
Submerged: Partially		Depth (in): 47		
Sampling Results		Notes Follow-up inspection for sampling - limited screening conducted. Floating gross solids (litter) in manhole.		
Sample Location: Pool	Floatables: None	Condition Assessment Graffiti: None Erosion: None Deposition: None in. Damage: None		
Total Chlorine: 0 ppm	Odor: None			
Free Chlorine: 0 ppm	Turbidity: None			
Ammonia: 0 ppm	Color: None			
pH: 7.58 units	Gross Solids: None			
Temperature 56 °F	Vegetation: None			
Conductivity: 381 µS/cm	Benthic Growth: None			
Detergents: 1.2 mg/L	Stains: None			
	Non-illicit: None

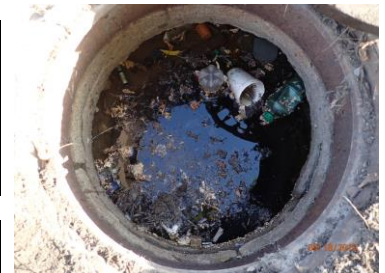
o20190918071726.JPG

Inspection Date: 9/18/2019 8:19:32 AM		Type: Ongoing	Flow: Submerged, indeterminate	Previous Rainfall (hrs): 72+
Illicit Discharge Potential: Potential		Inspector: JCW		
Submerged: Fully		Depth (in): 49		
Sampling Results		Notes Sample collected from submerged pool in manhole. Floating gross solids (litter) and detergent in manhole.		
Sample Location: Pool	Floatables: None	Condition Assessment Graffiti: None Erosion: None Deposition: None in. Damage: None		
Total Chlorine: 0 ppm	Odor: None			
Free Chlorine: 0 ppm	Turbidity: None			
Ammonia: 0 ppm	Color: None			
pH: 8.64 units	Gross Solids: Moderate			
Temperature 71 °F	Vegetation: None			
Conductivity: 372 µS/cm	Benthic Growth: None			
Detergents: 1 mg/L	Stains: None			
	Non-illicit: None

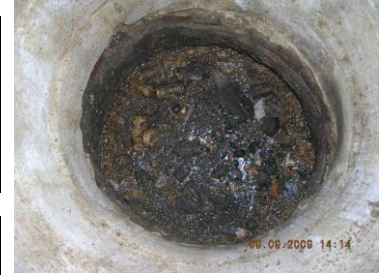
Osh09_DSCN6747.JPG

Sample Location: Pool	Floatables: Severe	Total Chlorine: 0 ppm	Odor: Easily detected	Free Chlorine: 0 ppm	Turbidity: None	Ammonia: -- ppm	Color: Faint in bottle	pH: 6.98 units	Gross Solids: Severe	Temperature: 73 °F	Vegetation: None	Conductivity: -- µS/cm	Benthic Growth: None	Detergents: 0 mg/L	Stains: None		Non-illicit: None	Notes Diesel/oil odor, sheen on surface. Floatables with grease. Brown/gray color.	
Sample Location: Pool	Floatables: Severe																				
Total Chlorine: 0 ppm	Odor: Easily detected																				
Free Chlorine: 0 ppm	Turbidity: None																				
Ammonia: -- ppm	Color: Faint in bottle																				
pH: 6.98 units	Gross Solids: Severe																				
Temperature: 73 °F	Vegetation: None																				
Conductivity: -- µS/cm	Benthic Growth: None																				
Detergents: 0 mg/L	Stains: None																				
	Non-illicit: None																				
		Condition Assessment Graffiti: None Erosion: None Deposition: None 0 in. Damage: None

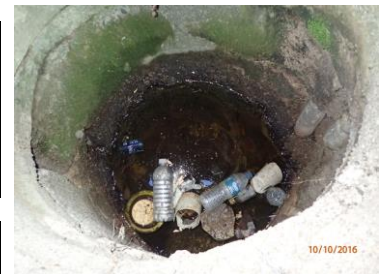
o20161010091822.JPG

Inspection Date: 10/10/2016 9:20:59 AM		Type: Ongoing	Flow: Submerged, indeterminate	Previous Rainfall (hrs): 72+
Illicit Discharge Potential: Potential		Inspector: JCW		
Submerged: Fully		Depth (in): 14		
Sampling Results		Notes Potential illicit discharge due to gross solids.		
Sample Location: Pool	Floatables: None	Condition Assessment Graffiti: None Erosion: None Deposition: None in. Damage: None		
Total Chlorine: 0 ppm	Odor: None			
Free Chlorine: 0 ppm	Turbidity: None			
Ammonia: 0 ppm	Color: Faint in bottle			
pH: 7.57 units	Gross Solids: Slight			
Temperature 65 °F	Vegetation: None			
Conductivity: 365 µS/cm	Benthic Growth: Moderate			
Detergents: 0 mg/L	Stains: None			
	Non-illicit: None

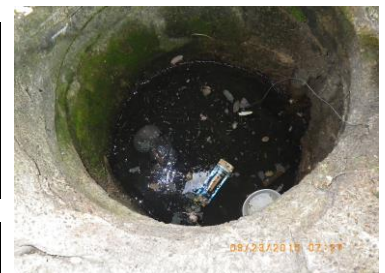
o20150923062728.JPG

Inspection Date: 9/23/2015 7:26:11 AM		Type: Ongoing	Flow: Submerged, indeterminate	Previous Rainfall (hrs): 72+
Illicit Discharge Potential: Potential		Inspector: JCW		
Submerged: Fully		Depth (in): 20		
Sampling Results		Notes Floating gross solids (litter) in manhole.		
Sample Location: Pool	Floatables: None	Condition Assessment Graffiti: None Erosion: None Deposition: None in. Damage: None		
Total Chlorine: 0 ppm	Odor: Faint			
Free Chlorine: 0 ppm	Turbidity: None			
Ammonia: 1 ppm	Color: None			
pH: 7.69 units	Gross Solids: Slight			
Temperature 70 °F	Vegetation: None			
Conductivity: 352 µS/cm	Benthic Growth: Slight			
Detergents: 0 mg/L	Stains: None			
	Non-illicit: None
