IDDE Ongoing Screening Summary Report

2021 Inspection Year

City of Oshkosh

Westwood

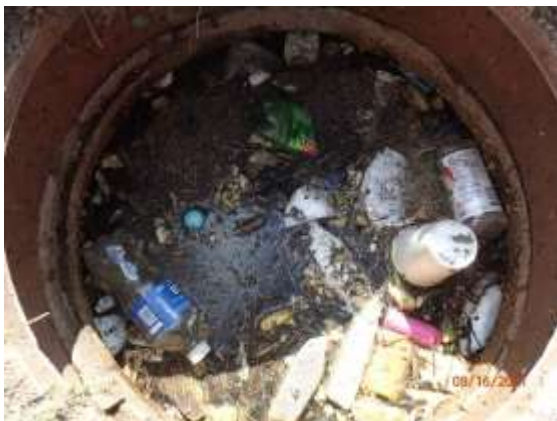
During the 2021 ongoing screening program, 16 upstream manholes contained significant (moderate or severe) amounts of floatable debris (gross solids), including plastic bottles, foam packaging, and other solid waste, and were classified as potential illicit discharges. This effect was most pronounced at manholes upstream of a fully submerged outfall, where the storm sewer pipes within the manhole were also fully submerged. In these cases, any floatable debris traveling along the top of the storm sewer pipe will enter the manhole and will remain trapped on the surface of the manhole pool, as they are not able to escape through the submerged outlet pipe. In these cases, the submerged manhole acts as a trap for much of the floatable debris.

Figure 11 – Floating gross solids in manhole 05-14 US1

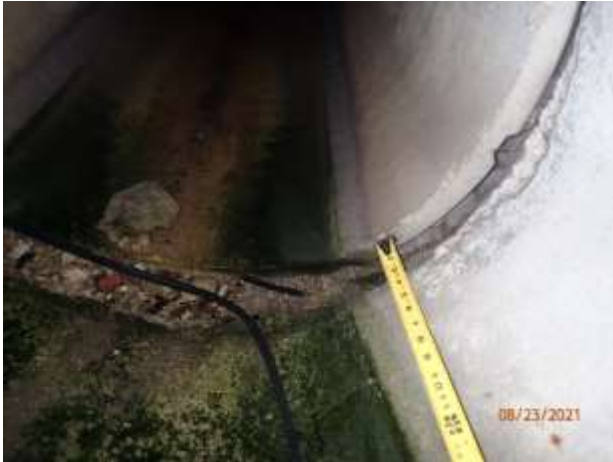
Figure 20 – Displaced apron at outfall 13-1673

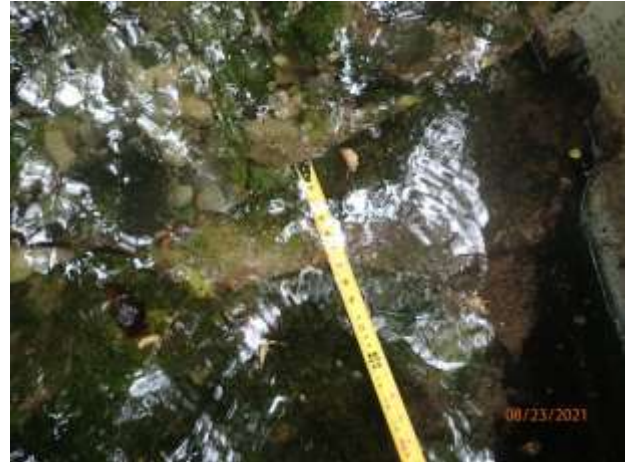
Figure 21 – Concrete spalling at outfall 13-1673

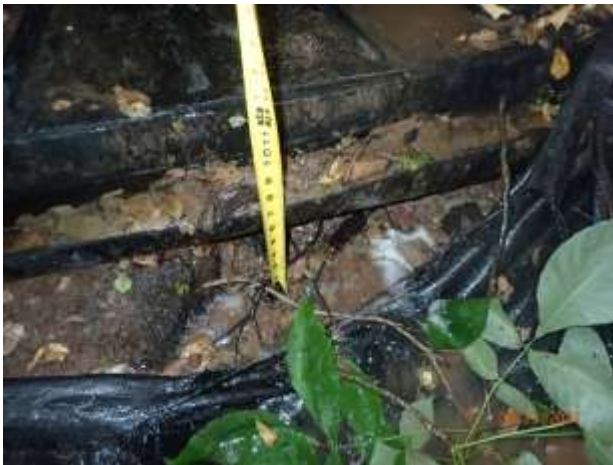
Figure 22 – Undercut apron at outfall 13-3130

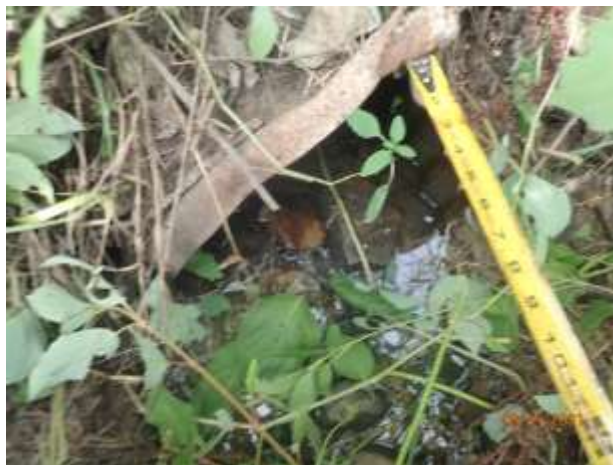
Figure 27 – Corrosion and crushing at outfall 15-1217

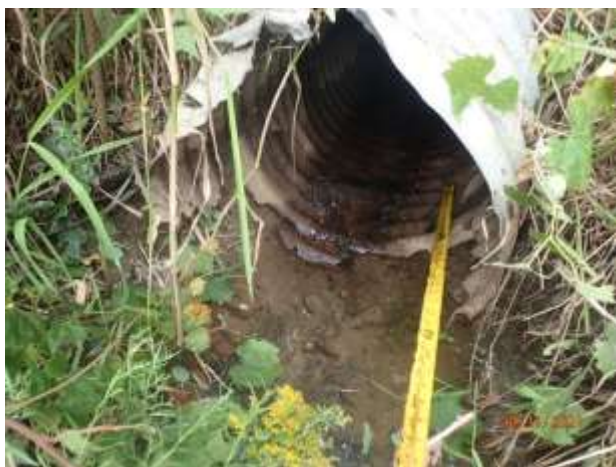
Figure 28 – Corrosion and crushing at outfall 15-1219

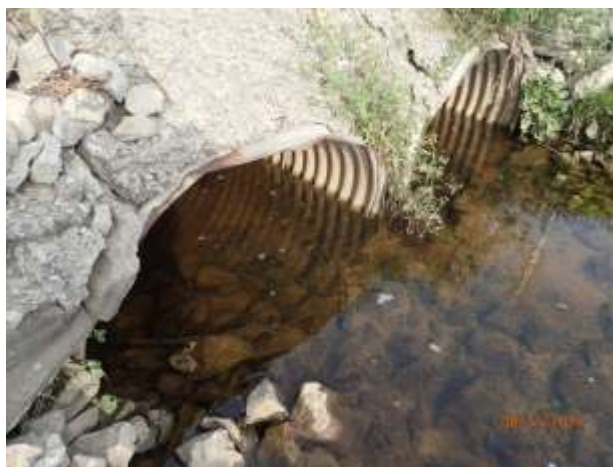
Figure 29 – Corrosion at outfall Wash41_03
