IDDE Ongoing Screening Summary Report

2022 Inspection Year

City of Oshkosh

Westwood

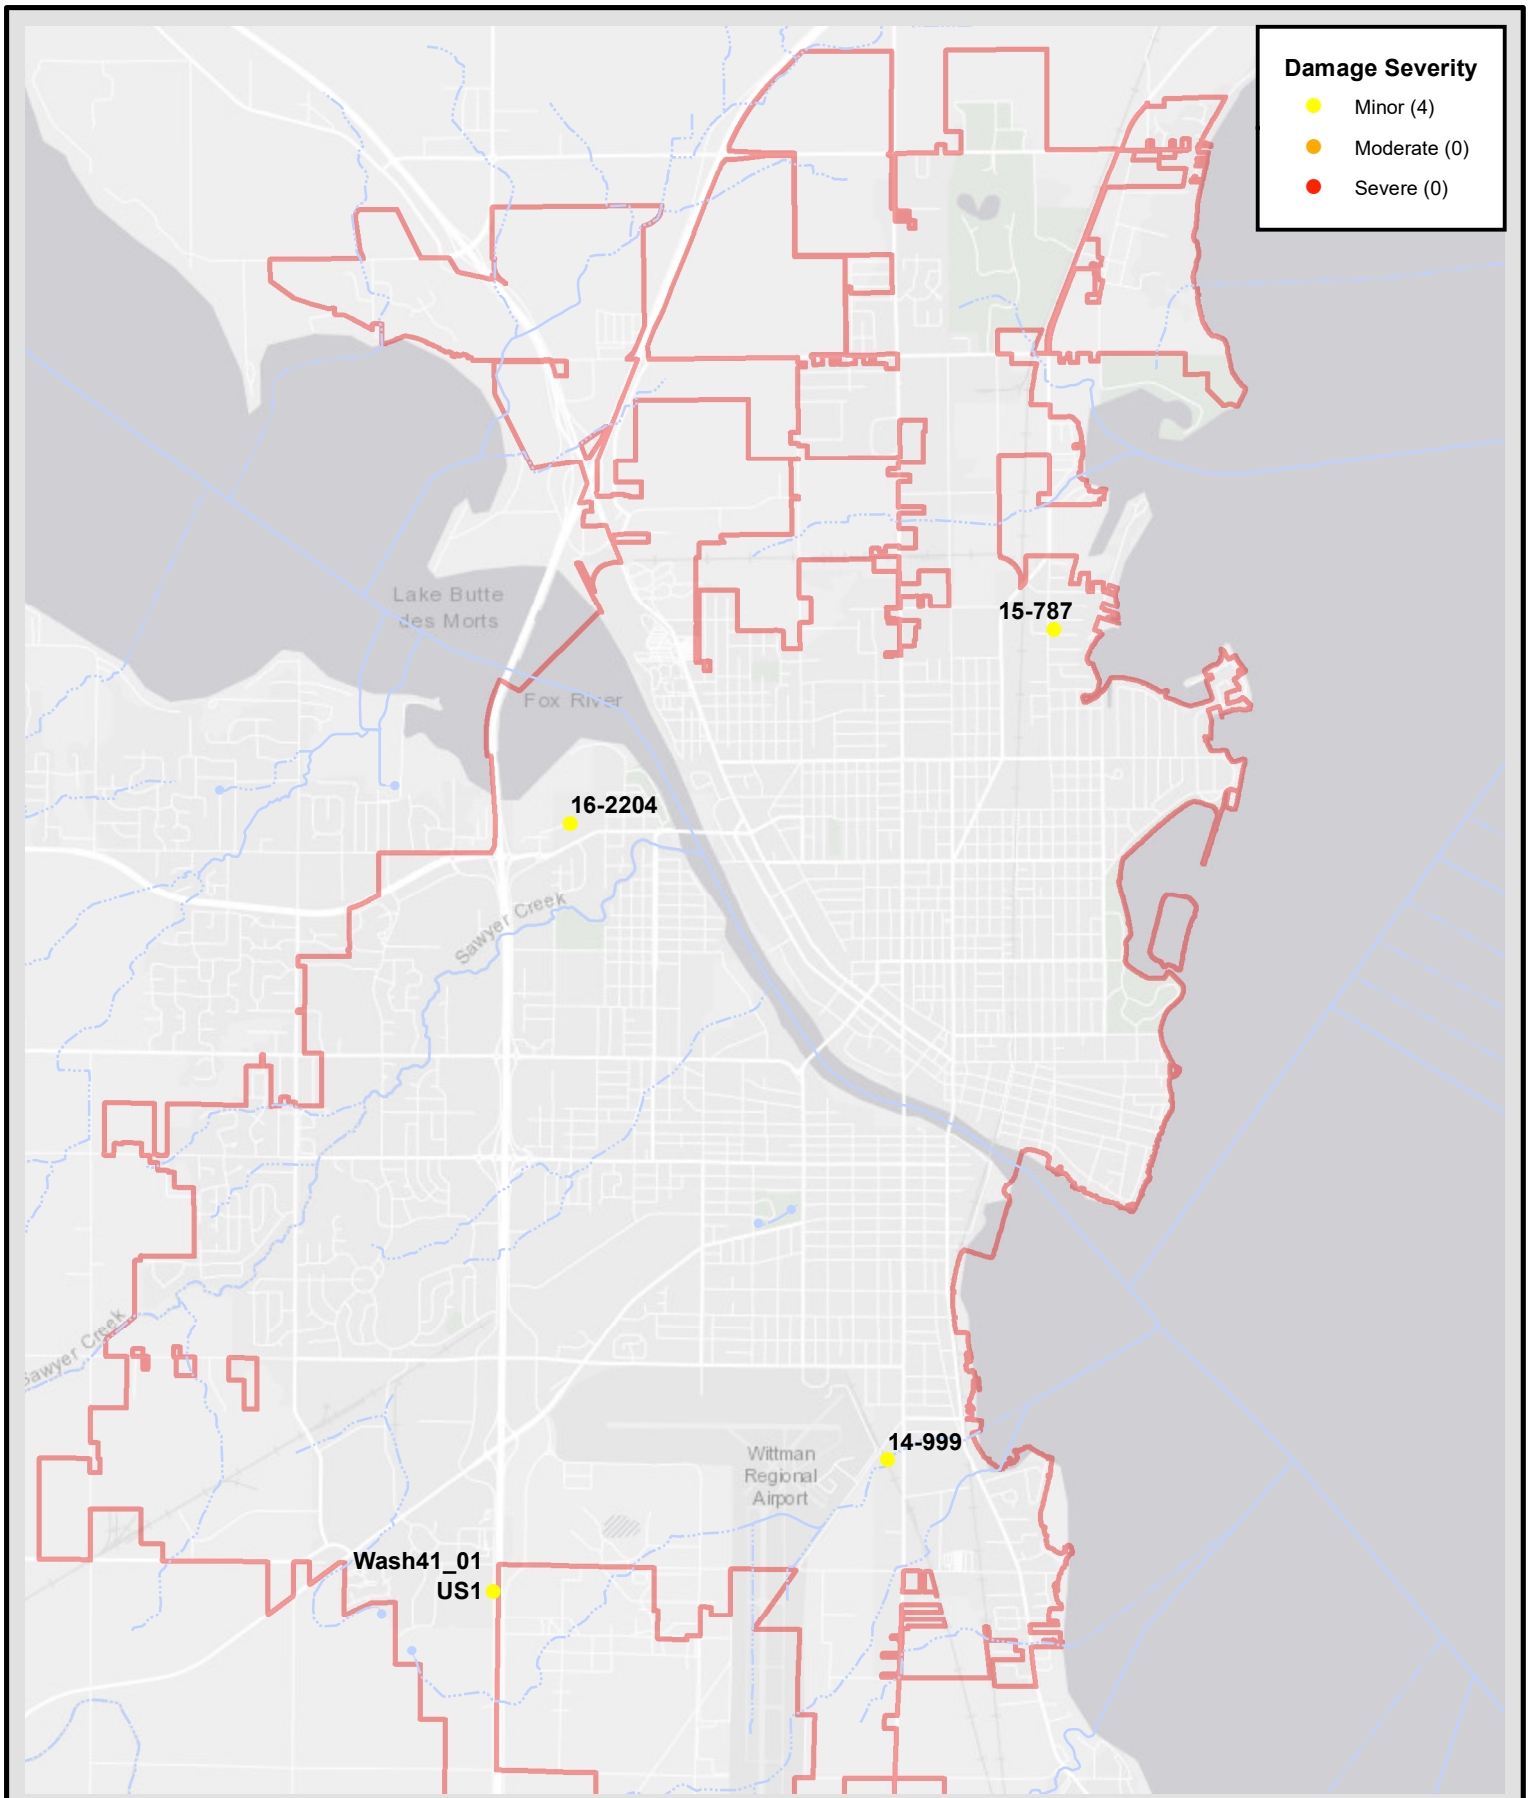
The ongoing screening identified four outfalls with some degree of visible damage and seven outfalls with deposition. None of the outfalls screened in 2022 had reported erosion or graffiti. While none of these posed an immediate danger, the City will likely want to address these issues as part of the regular storm sewer system maintenance. Appendix C contains lists, maps, and photos of outfalls with non-illicit discharge concerns.
