IDDE Ongoing Screening Summary Report

2024 Inspection Year

City of Oshkosh

Westwood

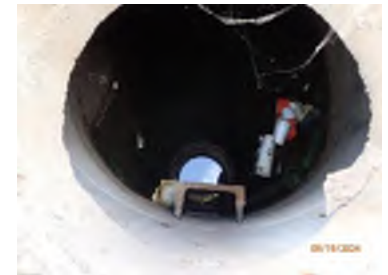
o20240919142416.JPG

Notes: Sample collected from submerged pool in manhole. Follow-up to spring petroleum sheen complaint. No petroleum observed.

Gross Solids: Slight ☒ Litter ☐ Veg. Debris ☐ Sediment ☐ OtherVegetation: None ☐ Inhibited ☐ ExcessiveBenthic Growth: None ☐ Green ☐ BrownStains: None ☐ Flow Line ☐ Oil ☐ Rust Stains☐ Paint ☐ OtherNon-illicit: None ☐ Natural Sheen ☐ Natural Suds/Foam

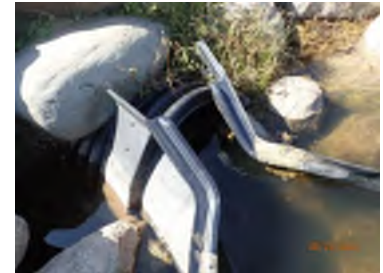
o20240822150844.JPG

Damage: Minor ☐ Displacement ☐ Undercut ☐ Crushed☐ Corrosion ☒ Cracks/Structural Damage

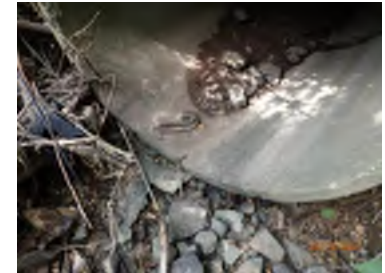
o20240910130638.JPG

Damage: Minor ☒ Displacement ☐ Undercut ☐ Crushed☐ Corrosion ☒ Cracks/Structural Damage
