# Initial Screening Summary Report

Illicit Discharge Detection and Elimination Program

City of Oshkosh

May 18, 2010

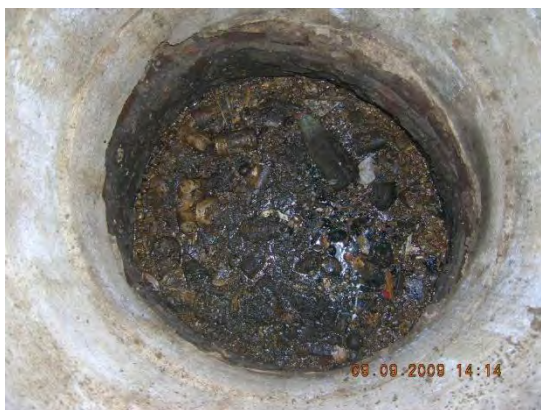
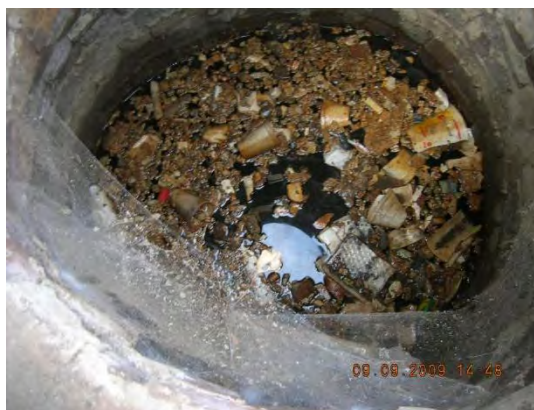
**Figure 12 - Floatables in upstream manholes 03-81 US1 and US2 (with diesel fuel and grease)**

While some may not consider solid waste as a true illicit discharge, it does meet the definition of an illicit discharge, since it is a substance present in the discharge that is not comprised entirely of stormwater. In most cases, there will be one or more access points which allow the debris to enter the MS4. Because of this, the presence of significant floatable debris in upstream manholes caused the illicit discharge potential of the outfall to be raised to “suspect.” In outfall 03-38, the presence of diesel fuel and grease, along with the floatable debris, caused the status to be raised to “obvious.”

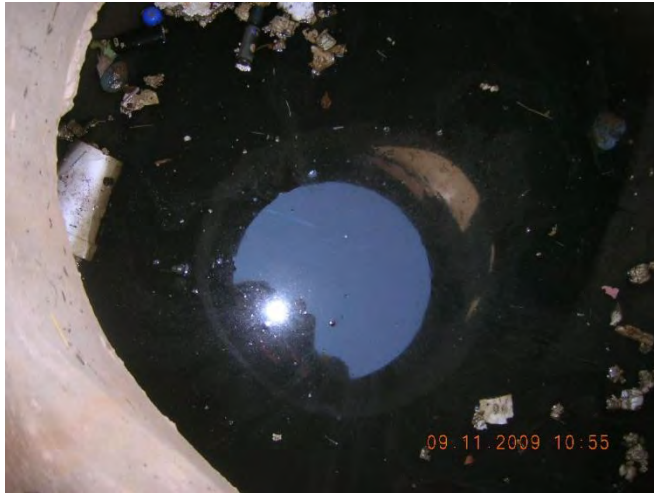
The upstream manhole for outfall 09-101c was located in the center of W. 6<sup>th</sup> Avenue. During the inspection, a slight sheen was observed on the pool in the submerged manhole. Because the sheen was very faint, and because there was no observed flow in the pool, the sheen was most likely a result of street runoff from W. 6<sup>th</sup> Avenue. No immediate action was required at this time, but this manhole should be observed during the first year of the ongoing screening program to verify that this is not an ongoing discharge. If an oil sheen is still present, the manhole and surrounding storm sewer should be cleaned with a vacuum truck to remove any residual contamination, and re-inspected to determine if there is an active source of oil contamination.

**Figure 13 - Oil sheen in upstream manhole 09-101c US1**

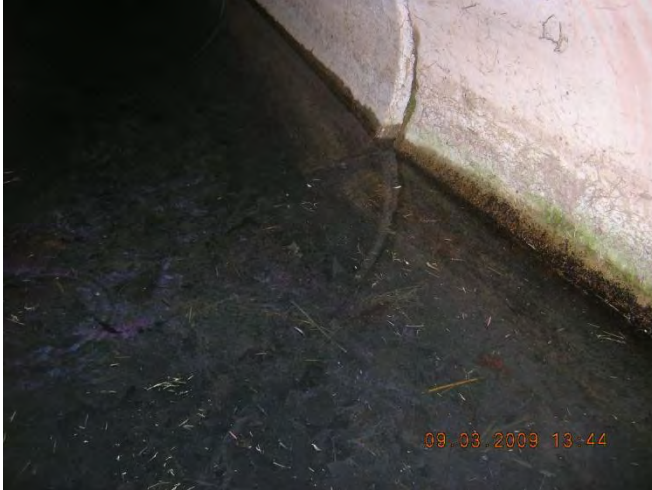
Outfall 13-3099 is located on Pheasant Creek Drive, and drains into a stormwater pond located within a residential area. The drainage area is entirely residential. There was a small sheen located in the pool downstream from the outfall. The pond has significant amounts of cattails and other vegetation, so natural sheens could be expected. However, the sheen did not appear to break up when stirred, so it was suspected to be an oil sheen. Because of the land use in the area, along with the relatively small amount of observed sheen, the likely source was runoff from the residential streets. No immediate action was required at this time, but this manhole should be observed during the first year of the ongoing screening program to verify that this is not an ongoing discharge. If an oil sheen is still present, the upstream manhole and surrounding storm sewer should be cleaned with a vacuum truck to remove any residual contamination, and re-inspected to determine if there is an active source of oil contamination.

**Figure 14 - Oil sheen in outfall 13-3099**

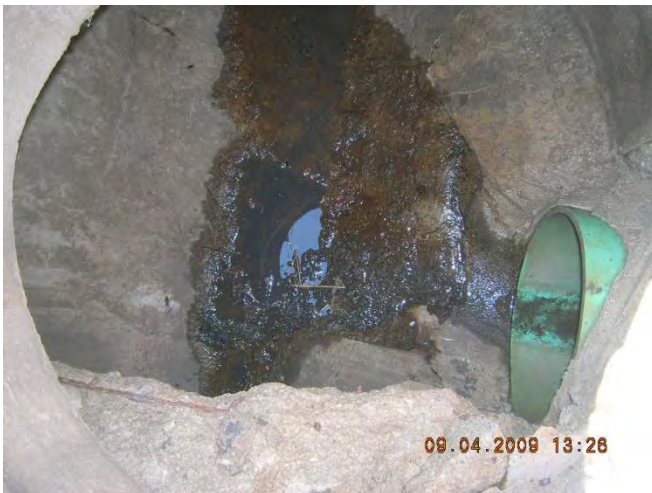
The upstream manhole for outfall 14-595 is located at the end of W. 33<sup>rd</sup> Avenue. During the inspection, there was no flow in the catch basin, but the bottom of the catch basin was wet. There was a slight oil sheen on the water in the pool. No obvious discharges were observed at the time of the inspection. However, this catch basin is located in an industrial area, with an Oshkosh Corporation facility to the north and another manufacturing facility to the south. No immediate action was required at this time, but this manhole should be observed during the first year of the ongoing screening program to verify that this is not an ongoing discharge.

**Figure 15 - Oil sheen in upstream manhole 14-595 US1**

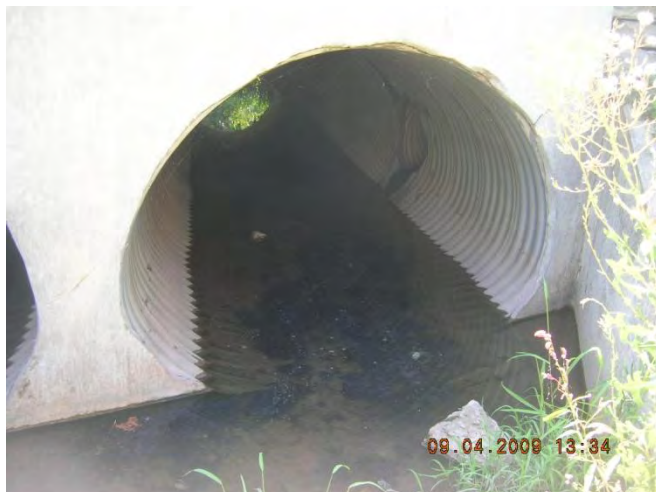
Outfall 14-676 consists of a 30-inch corrugated metal pipe (CMP) that discharges into a corrugated metal pipe arch culvert crossing W. Waukau Avenue, just west of Oregon Street. During the inspection, the pool in the box culvert contained a noticeable amount of suds. No suds were observed in the stream upstream of the outfall. While some suds and bubbles can typically occur when the flow from an outfall drops into the receiving channel, these bubbles are typically short-lived, and located only in the area of the outfall. Because these bubbles persisted downstream, an illicit discharge was suspected.

**Figure 16 - Suds in receiving stream for outfall 14-676**

It is recommended that this outfall be reinspected during the first year of the ongoing screening program to determine if this is an ongoing problem. If suds are observed again at that time, or as a result of a complaint, additional samples should be collected and analyzed. In addition, because this could be an intermittent discharge from washing operations upstream, alternate test methods, such as optical brightener traps at the outfall, may be considered.

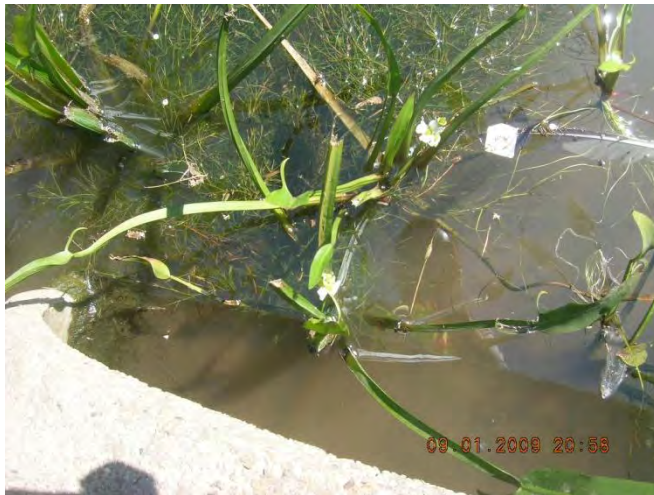
Because the outfall was partially-submerged, the upstream manhole in N. Main Street was sampled. This manhole was also submerged, so a sample was collected from the pool in the manhole. No sheen was observed in the upstream manhole. An additional sample was collected from the surface of the outfall pool, including some of the sheen material.

**Figure 17 – Milky sheen in flow for outfall 15-1095**

It is recommended that this outfall be reinspected during the first year of the ongoing screening program. If this sheen is still present at that time, additional analytical tests may be required to identify any chemicals present in the sheen, along with potential sources.

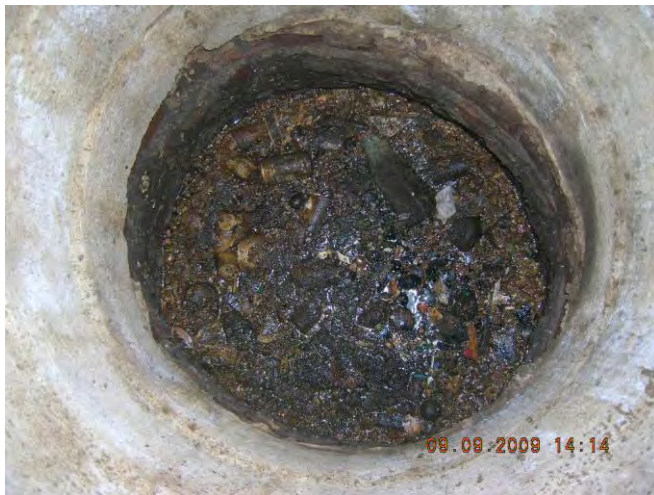
**Figure 21 – Floatable debris and grease in upstream manhole 03-81 US1**

A sample was collected from upstream manhole 03-81 US1. The sample had a grayish-black color, and had a strong odor of diesel fuel. The sampling equipment and container were coated in grease from penetrating the floatable debris. None of the typical sampling parameters tested positive. Because of the obvious odor of diesel fuel and appearance of grease, no additional VOC or oil/grease tests were run. The railroad track ballast in the area showed no signs of stains or other leaks, so a railroad spill seemed unlikely.

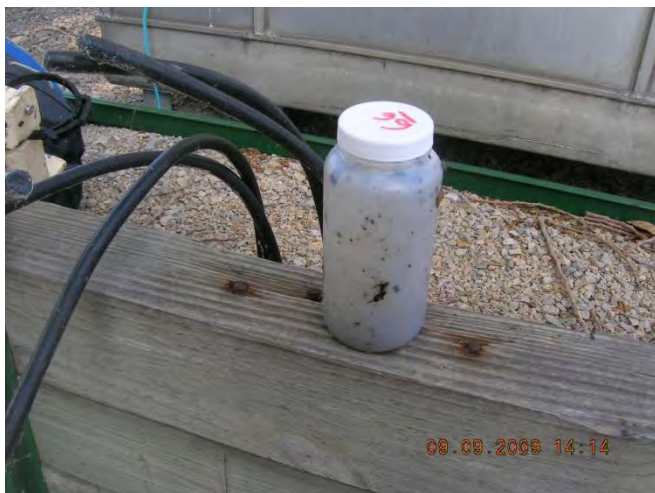
**Figure 22 – Sample container from upstream manhole 03-81 US1**

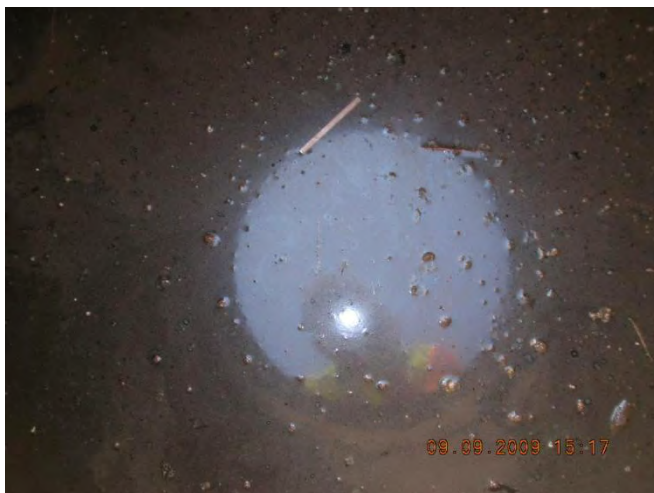
Additional upstream manholes were sampled along E. 10<sup>th</sup> Avenue. The manholes on 10<sup>th</sup> Avenue did not have the floatable debris or the diesel odor. However, they did have a reddish-brown tint to the submerged pool, and showed a slight oil sheen. The property on the south side of 10<sup>th</sup> Avenue is a steel fabrication facility, and the property on the north side is a metal salvage facility. Both could be potential sources of oil and grease.

**Figure 24 – Oil sheen in upstream manhole 03-81 US4**

The City and OMNNI believe that the illicit discharge evidence for this outfall was not caused by one significant event. Rather, it was likely caused by a gradual buildup of diesel fuel and oil/grease over many years, which became trapped in the downstream manholes. Upon discovering the problem, the City vacuumed the upstream manholes. A follow-up inspection of manhole 03-81 US1 revealed that the manhole was still full-submerged, but the sample collected from the pool did not have a detectable odor.

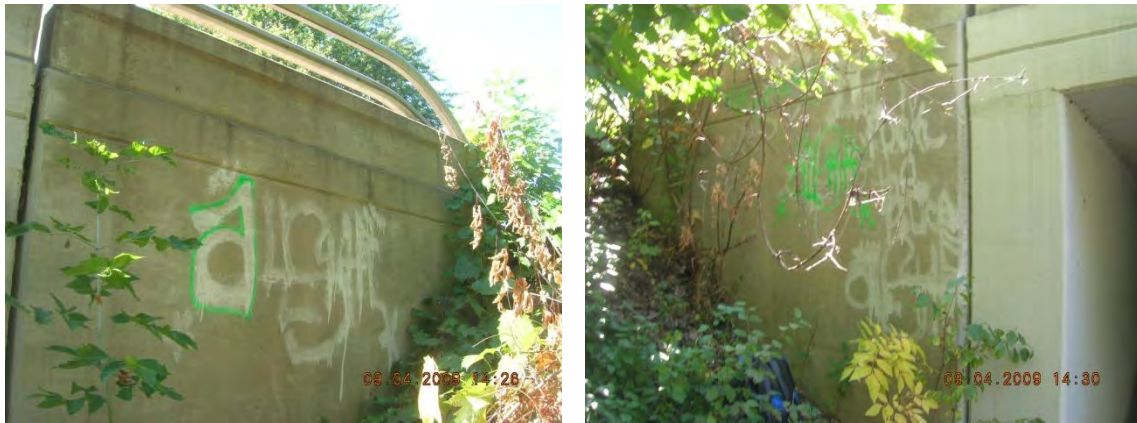
Graffiti was identified at three of the major outfalls. Two of the outfalls (14-659 and 14-660) were located on the east side of the Oregon Street bridge, south of 25<sup>th</sup> Avenue.

Figure 25 - Outfall 14-659 and 14-660 graffiti

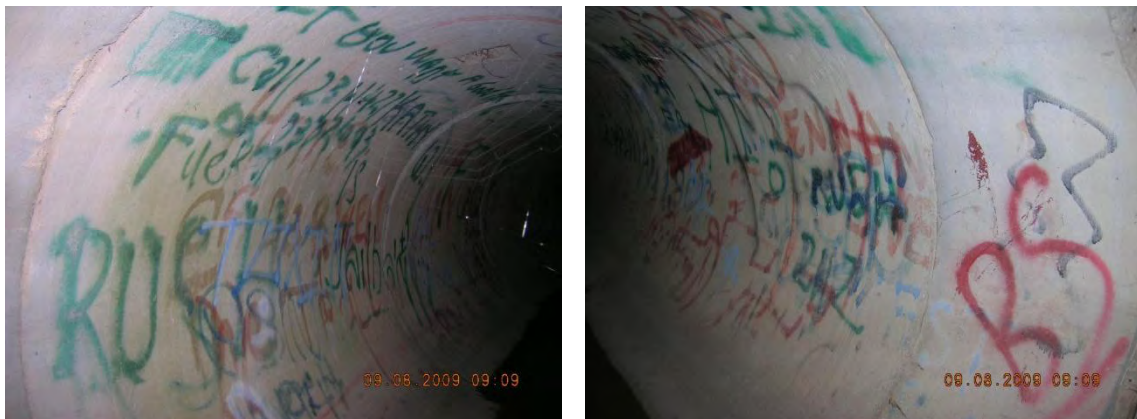
The other graffiti was observed under the N. Washburn Street bridge, south of Linway Court, at outfall 16-646.

Figure 26 - Outfall 16-646 graffiti

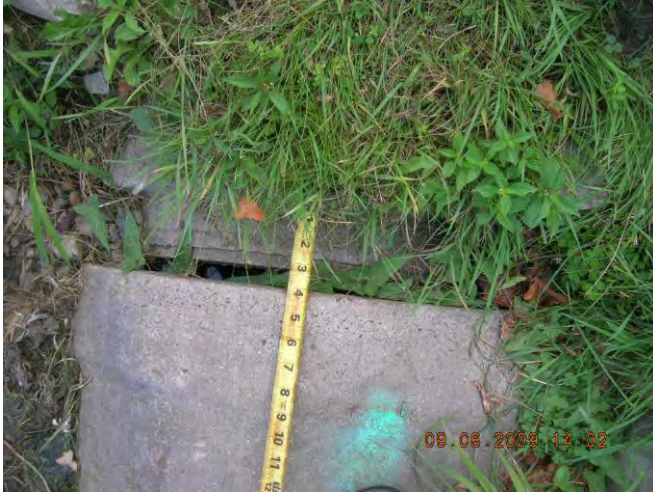
Eight outfalls showed signs of damage that may require attention in the near future. Several concrete pipes had dislocated end pipe sections (11-244 and 14-999) or aprons (13-1554, 14-659 and 14-660). Several corrugated metal pipes had ends that were crushed, with holes or tears at the end of the pipe (15-1067, 15-1217 and 15-1219). The damage is shown in the photos below.

**Figure 27 - Outfall 11-244 displaced pipe section**

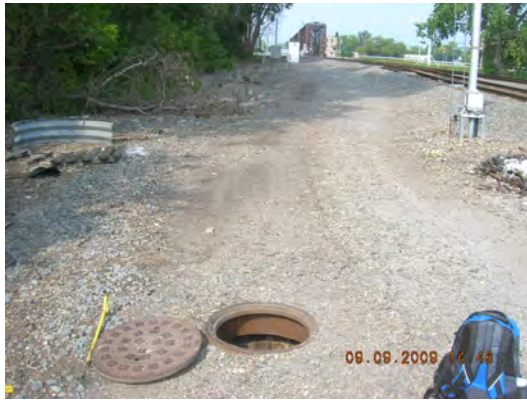
DSCN6750.JPG

Notes: Floatables with oil stains. Slight petroleum odor.

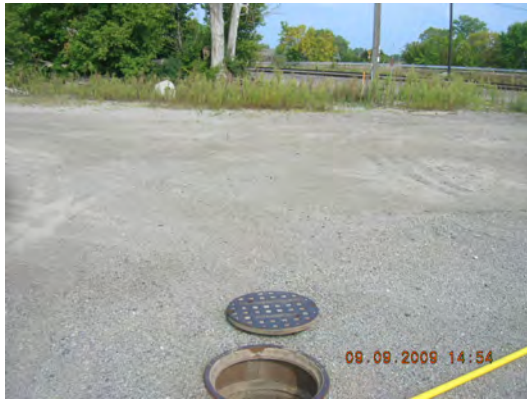
DSCN6753.JPG

Notes: Rust colored floatables and sheen on surface. Slight odor.
