Ongoing Screening Summary Report 2010 Inspection Year

Illicit Discharge Detection and Elimination Program

City of Oshkosh

OMNNI Project No. N2029B10

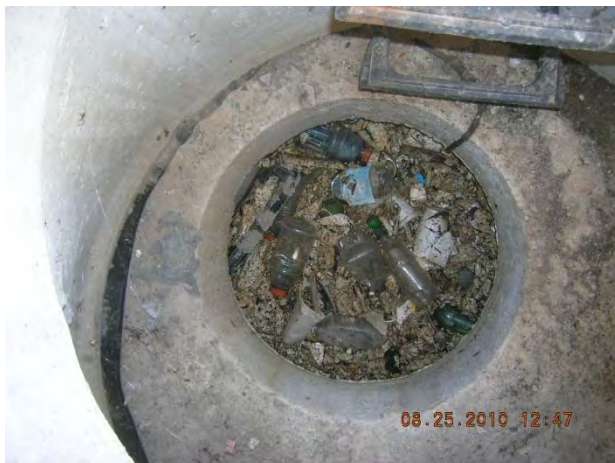
Figure 28 – Severe floatables in manhole 01-520 US1

While some may not consider solid waste as a true illicit discharge, it does meet the definition of an illicit discharge, since it is a substance present in the discharge that is not comprised entirely of stormwater. In most cases, there will be one or more access points which allow the debris to enter the MS4. Because of this, the presence of significant floatable debris in upstream manholes caused the illicit discharge potential of the outfall to be raised to “potential.”

It is recommended that the outfalls with significant floatable debris be reinspected during the 2011 ongoing screening program. These manholes should be cleaned several months prior to the next outfall screening. By doing this, it will be possible to determine if the debris is from a prior discharge, or if the problem is ongoing. If it is determined that it is an ongoing problem, upstream inlets, especially those located near dumpsters or other solid waste storage areas, should be closely examined in an attempt to locate the source of the discharge. These areas could then be targeted for public education campaigns.

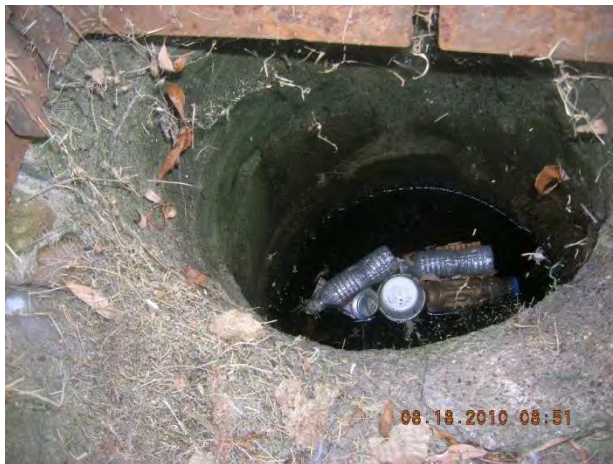
In all cases, the sheen was isolated to small patch on the surface of the pooled water, and was likely caused by trace amounts of oil from street runoff. The inlets with the oil sheen are shown in the photos below.

Figure 29 – Slight oil sheen in curb inlet 03-381 US1

Because the oil is in such limited quantities in each inlet, it is unlikely to identify an actual source of the discharge other than general street or parking lot runoff. If larger oil sheens are observed in the future, then additional screening may be warranted.

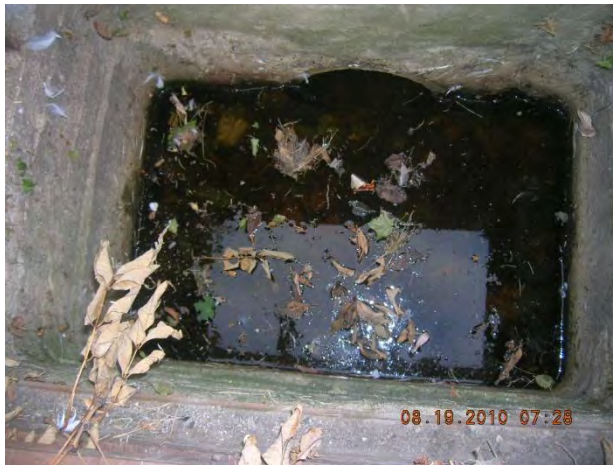
Figure 31 – Slight oil sheen in curb inlet 16-119 US1

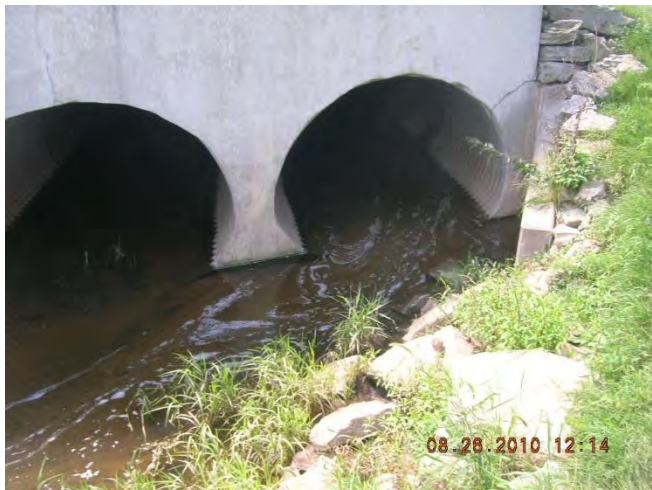
Outfall 14-676 consists of a 30-inch corrugated metal pipe (CMP) that discharges into a corrugated metal pipe arch culvert crossing W. Waukau Avenue, just west of Oregon Street. During the inspection, the pool in the culvert contained a noticeable amount of suds. No suds were observed in the stream upstream of the outfall. While some suds and bubbles can typically occur when the flow from an outfall drops into the receiving channel, these bubbles are typically short-lived, and located only in the area of the outfall. Because these bubbles persisted downstream, an illicit discharge was suspected.

Figure 32 - Suds in receiving stream for outfall 14-676

This outfall was exhibiting similar characteristics during the initial screening of the major outfalls on September 4, 2009. At that time, it was recommended that the outfall be rescreened in 2010

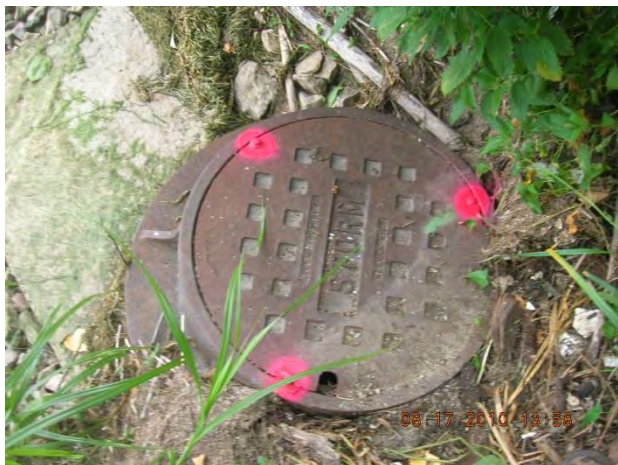
Figure 33 – Rusted/broken bolts at upstream manhole 03-173 US1 (moderate damage)

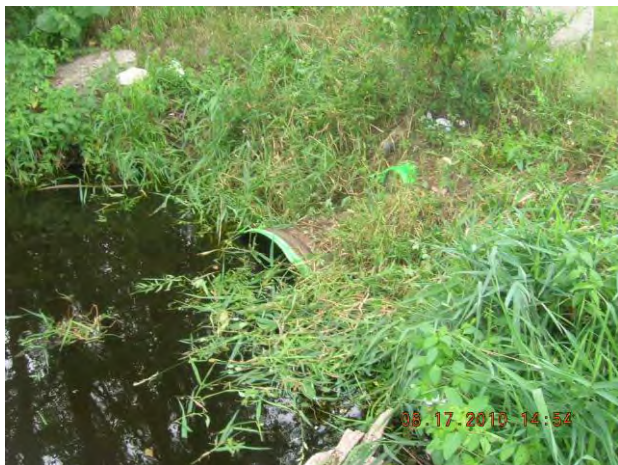
Figure 34 – Minor corrosion at outfall 03-293 (minor damage)

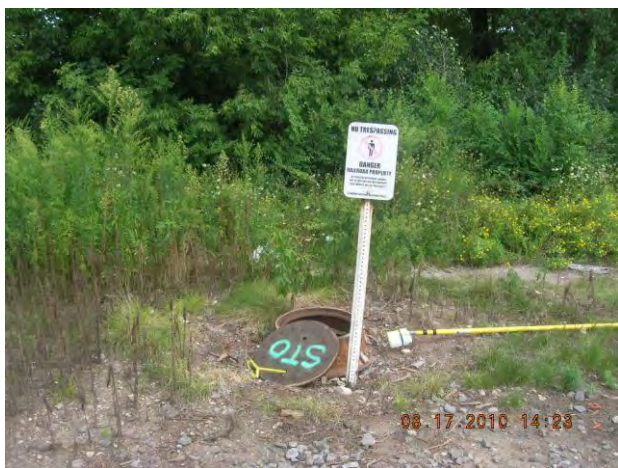
Figure 35 – Damaged rings at upstream manhole 03-306 US1 (minor damage)

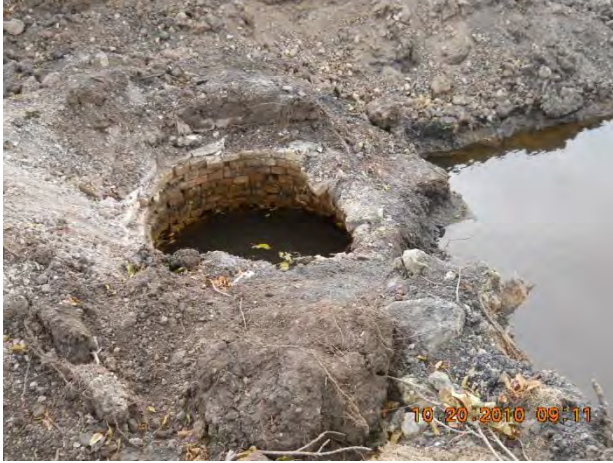
Eight outfalls showed signs of damage that may require attention in the near future. Most of the damage consisted of relatively minor defects, such as corrosion, damaged concrete, broken castings, or stuck manhole lids. The manhole at 08-100 US1 was in the area being reconstructed for the convention center, and had been partially removed. Because the storm sewer will likely be rerouted as part of the project, no repairs would be necessary at that manhole.

Figure 36 – Upstream manhole 08-100 US1 removed during reconstruction (major damage)

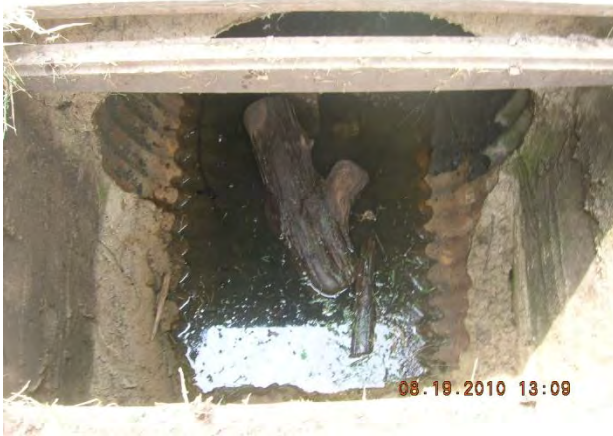
Figure 37 – Debris inside upstream catchbasin 12-890 US1 (minor damage)

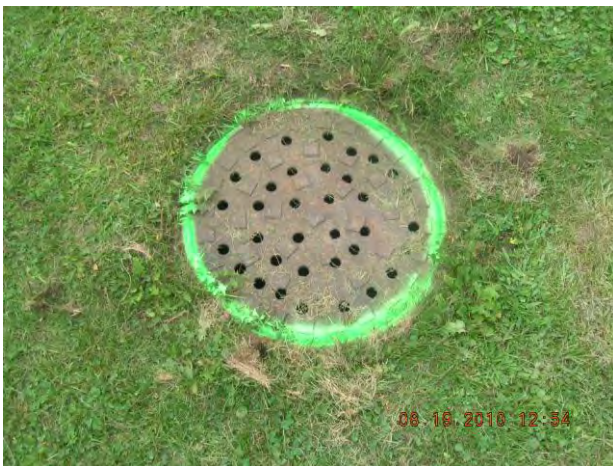
Figure 38 – Stuck lid at upstream manhole 12-972 US1

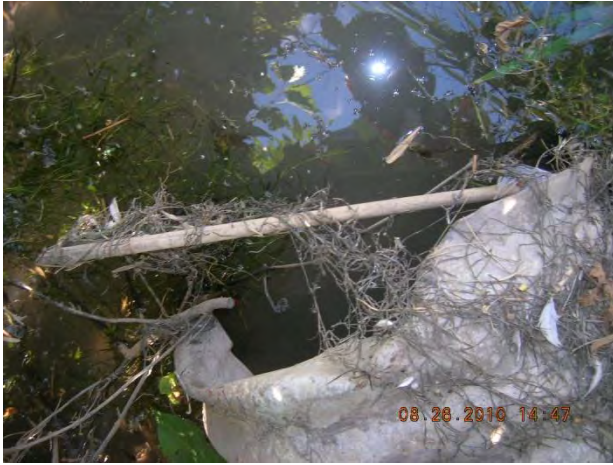
Figure 39 – Corrosion and crushed CMP at outfall 15-1093 (minor damage)

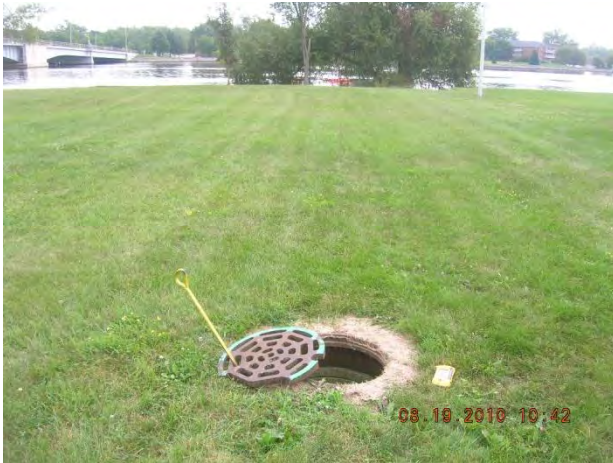
Figure 40 – Broken grate at upstream catchbasin 16-873 US1 (minor damage)

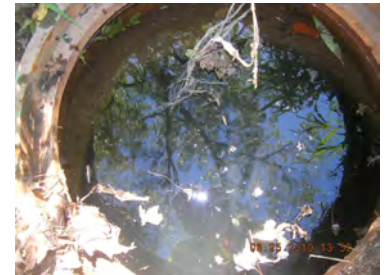
o20100825135010.JPG

Graffiti: None
Erosion: None
Deposition: Moderate Depth (in): 4
Damage: None ☐ Displacement ☐ Undercut ☐ Crushed
☐ Corrosion ☐ Concrete Damage
