Existing Conditions

2.0 EXISTING CONDITIONS

2.1 SHORELINE DESCRIPTIONS

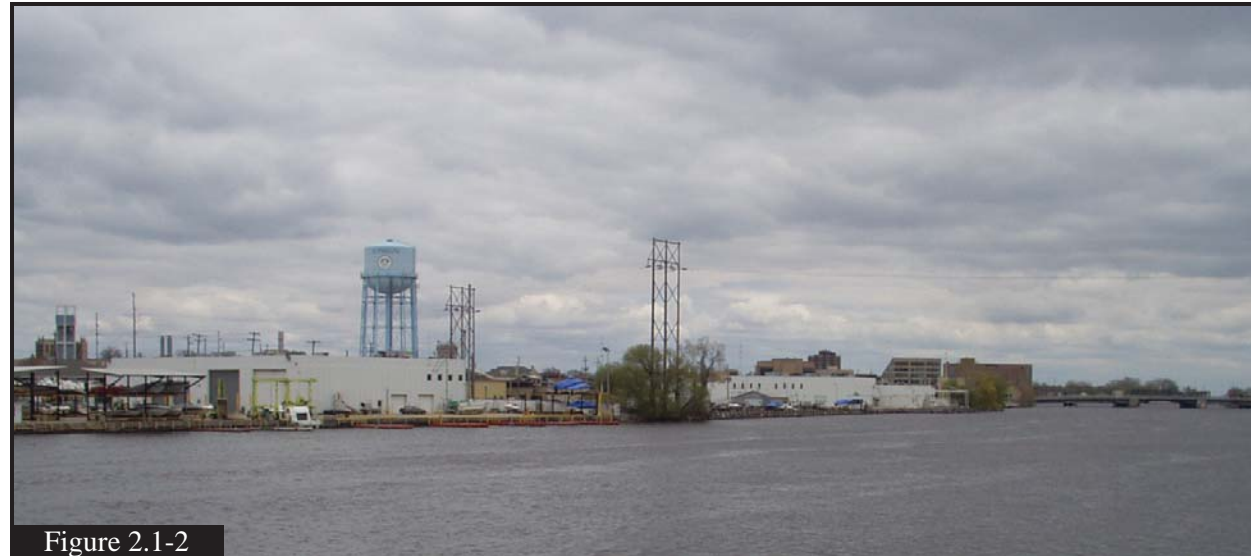
Figure 2.1-2

- Variety of retaining wall types. Marion Road (Figure 2.1-2).
- Cantilevered concrete platform over water steel pile supports. City Center Area (Figure 2.1-3).
- Cantilevered concrete seawall on steel pile supports. City Center Area (Figure 2.1-4).
- Steel sheet pile with concrete boardwalk and concrete bollards; suspended fixed wooden deck. Hotel (Figure 2.1-5).
- Wood pile and wood retaining wall with concrete walk. Riverside Park (Figure 2.1-6).
- Steel sheet pile with cap plate and horizontal wood bumpers. Riverside Park (Figure 2.1-7).

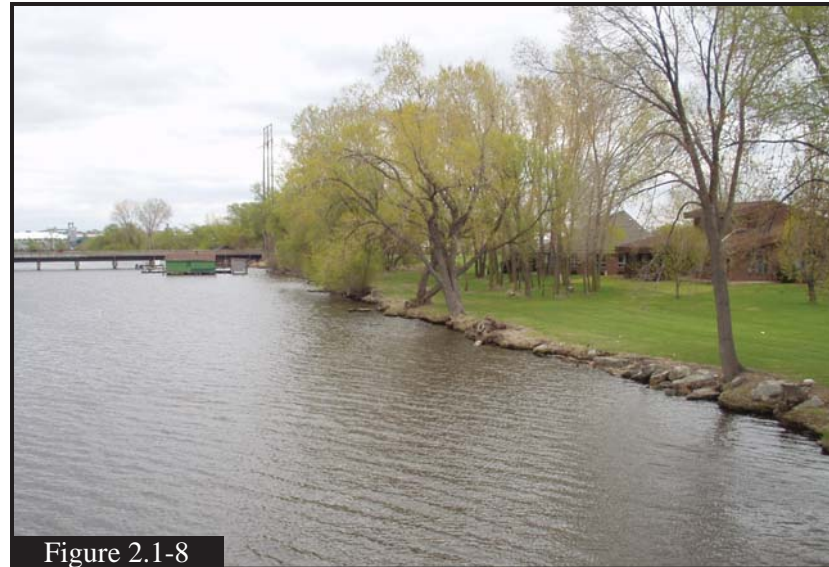
Figure 2.1-8

- Vegetated and rock rip-rap shoreline. William A. Steiger Park (Figure 2.1-8).
- Damaged wood piles; retaining wall. Jeld-Wen (Figure 2.1-9).
- Wood pile and wood retaining wall. South Shore Central (Figure 2.1-10).
- Marine with fixed wood finger docks. South Shore Central (Figure 2.1-11).
- Rip-rap shoreline with informal concrete cap (unformed). South Shore East (Figure 2.1-12).
- Vegetated; rock rip-rap shoreline mix. Pioneer Resort (Figure 2.1-13).
- Foreground broken concrete; background cast-in-place concrete retaining wall. Pioneer Resort (Figure 2.1-14).
- Broken concrete 'rip-rap' shoreline. Pioneer Resort (Figure 2.1-15).
- Wood pile seawall. Pioneer Resort (Figure 2.1-16).

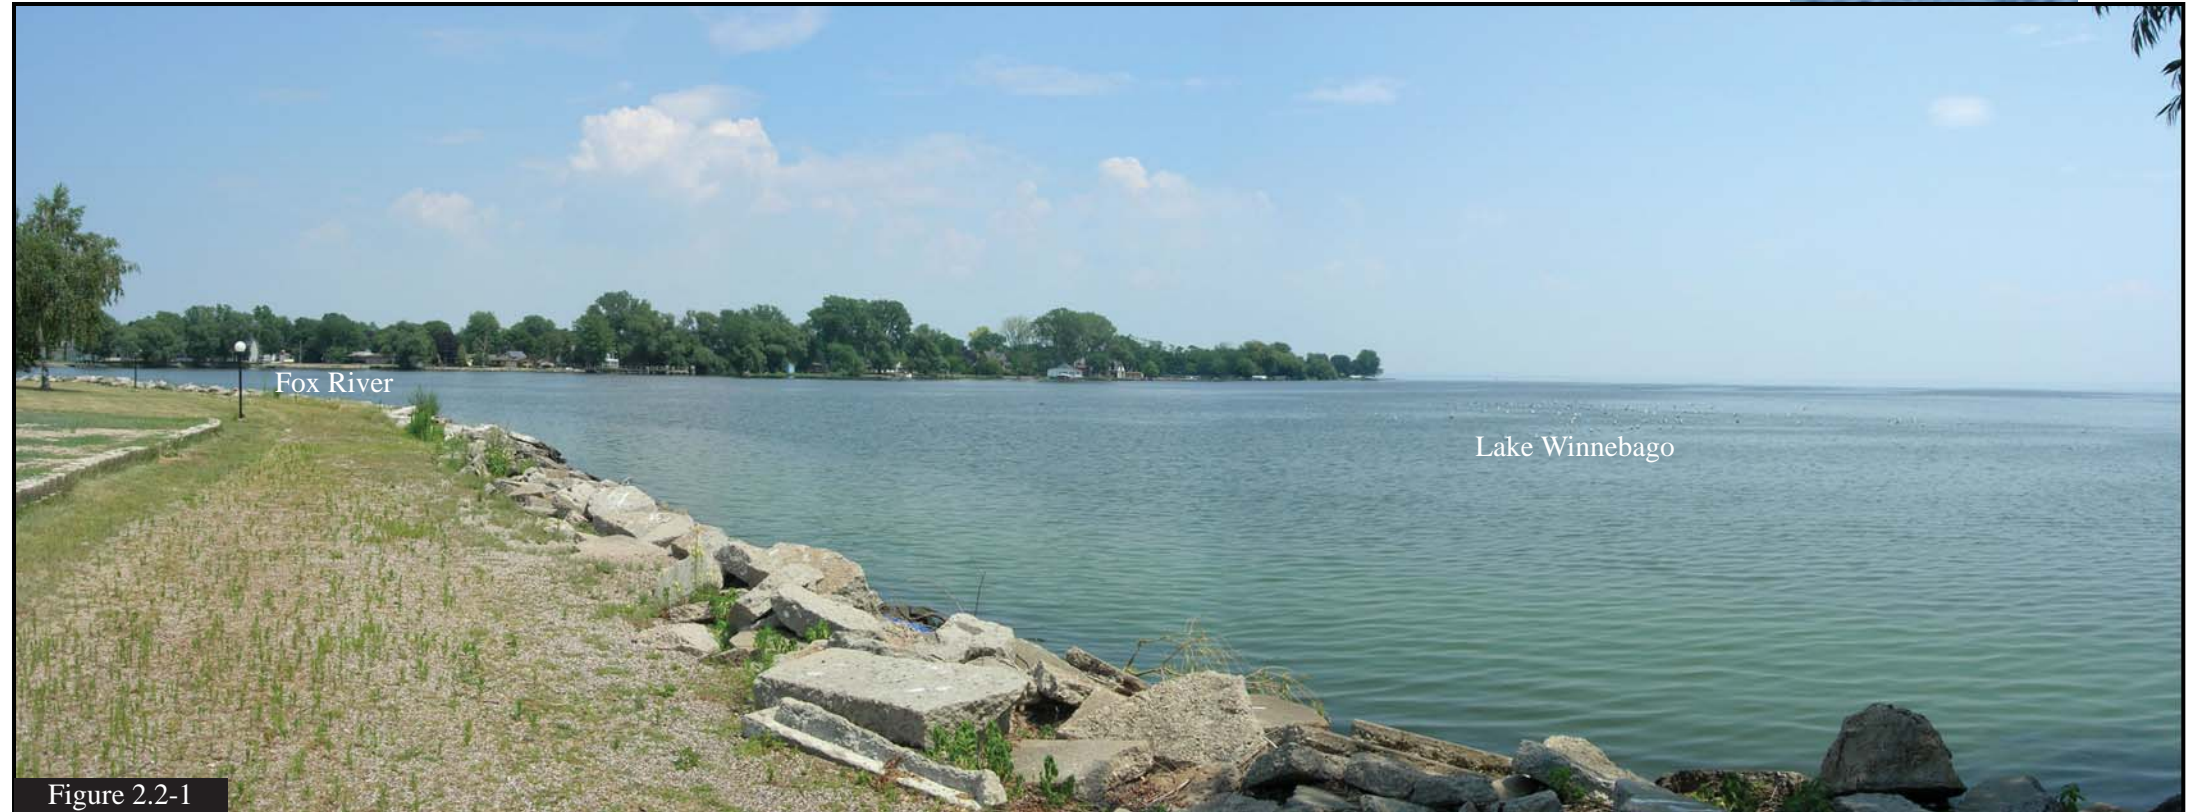
Figure 2.2-1

- Seasonal changes in river elevation range from 1.68' to 3.0' (based on Menasha Dam gage).
- Storm driven waves need to be included in design. Generally waves are reduced as distance from Lake Winnebago increases (Figure 2.2-1).
- River ice floating downstream needs to be included in design if docks remain in water over winter.
- River flow, generally less than 2 knots but continual source of wave action, must be included in anchorage design (Figure 2.2-2).
