Clearwells	Inspection Findings					
May – June:	Conduct physical inspections of empty Clearwells					
	Install groundwater monitoring wells near Clearwells					
June – July:	Prepare and submit to WDNR Clearwell inspection reports					
	Develop Clearwells repair strategy					
	Sample groundwater and analyze for contaminants regulated under the Safe Drinking Water Act (SDWA)					
August:	Review findings with WDNR					
	Review project with Common Council					
3		©Jacobs 2020				
3

Clearwells Inspection Findings

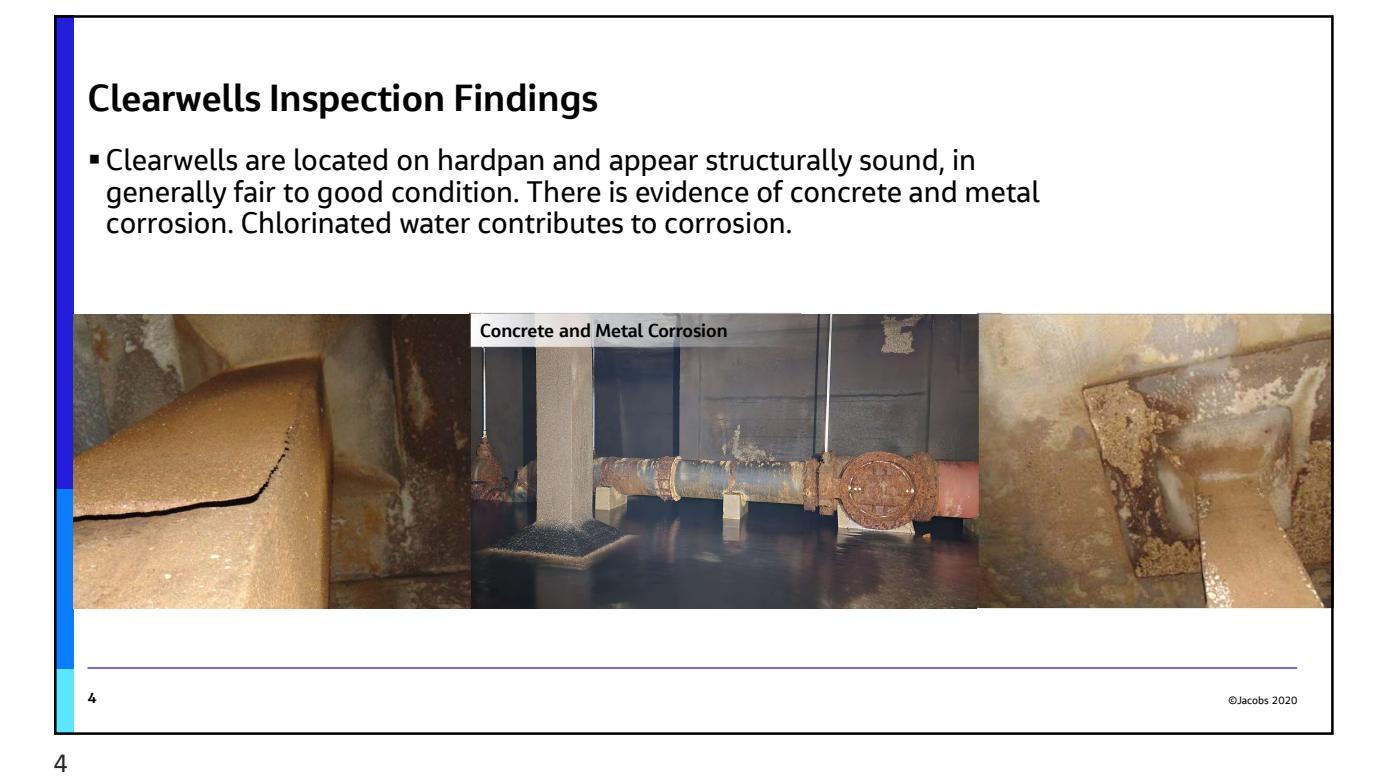
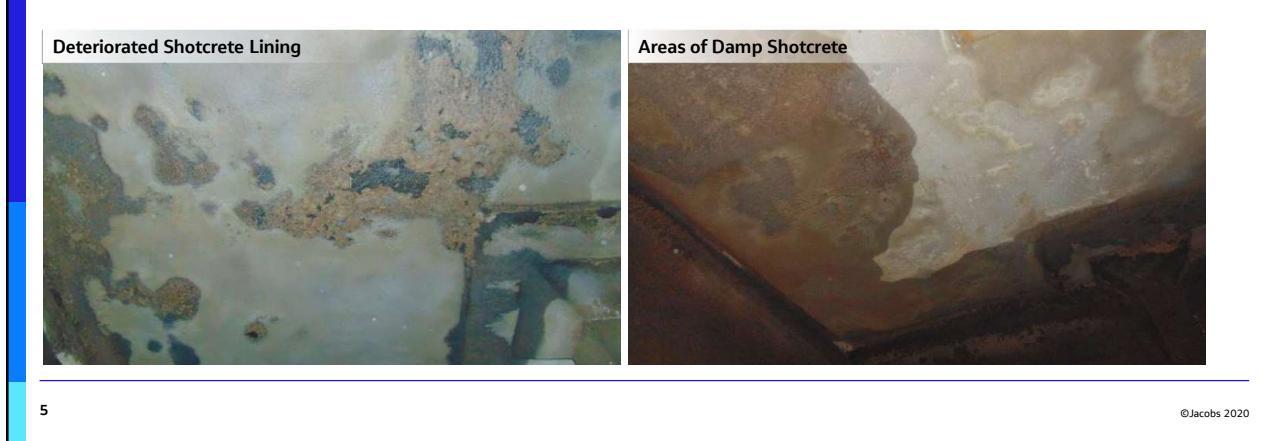
- Previously installed shotcrete lining is in poor condition.
- Remaining shotcrete is damp in locations and potentially masking cracks. Complete removal of shotcrete is needed to expose, map, and measure unsealed concrete cracks.

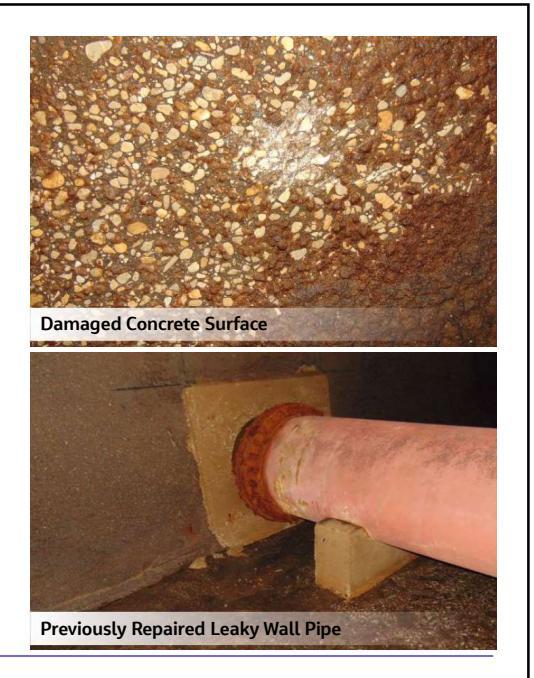
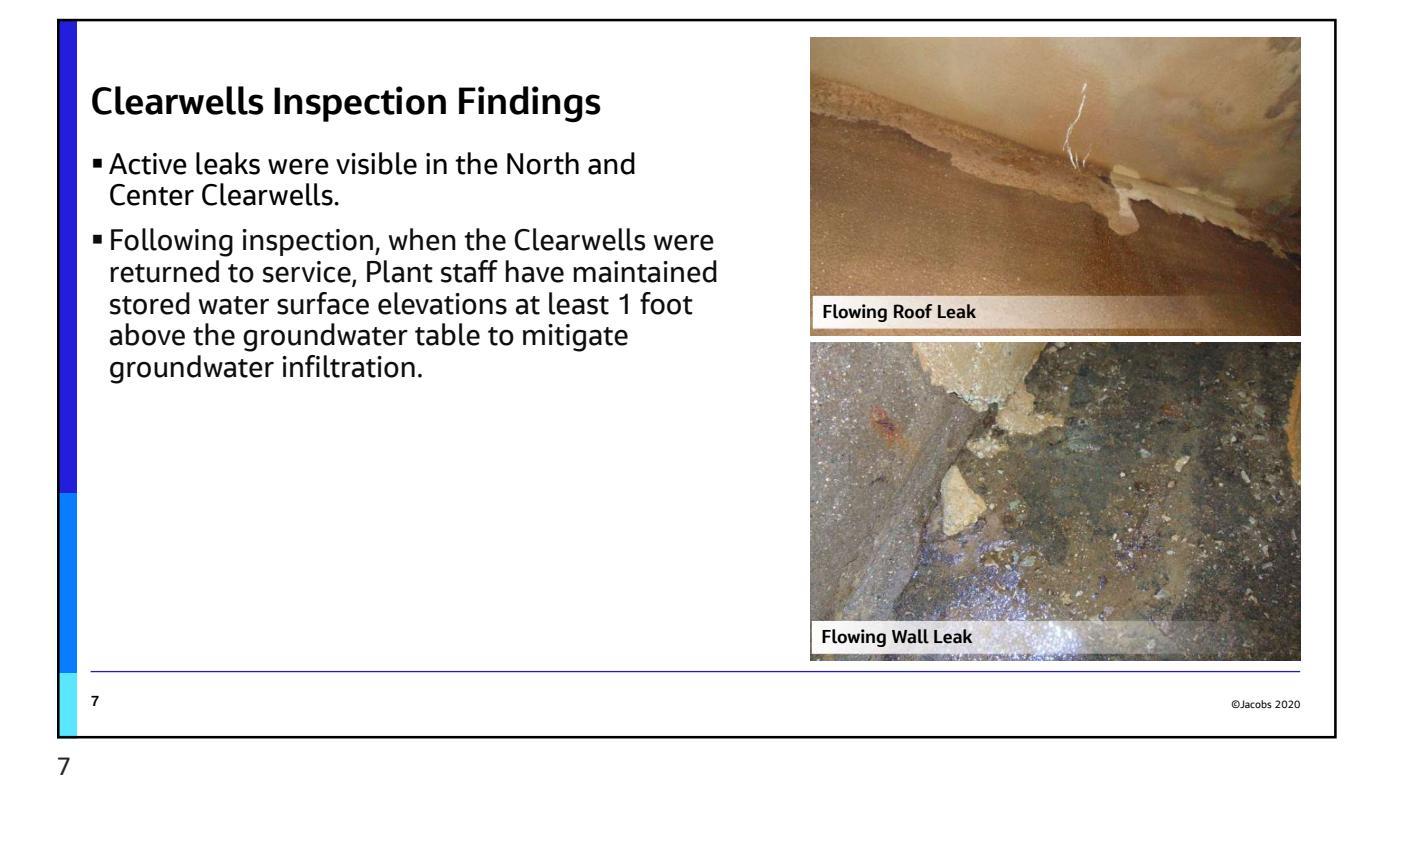
- Some concrete surfaces are spongey, a common effect after exposure to chlorinated water for many years. Removing the top ½-inch of interior surfaces by blast cleaning prior to applying new corrosion resistant lining is needed.
- Moisture or leaking around pipes at wall penetrations is evident and pipe wall sleeves require replacement.
