Ongoing Screening Summary Report 2012 Inspection Year

Illicit Discharge Detection and Elimination Program

City of Oshkosh

March 25, 2013

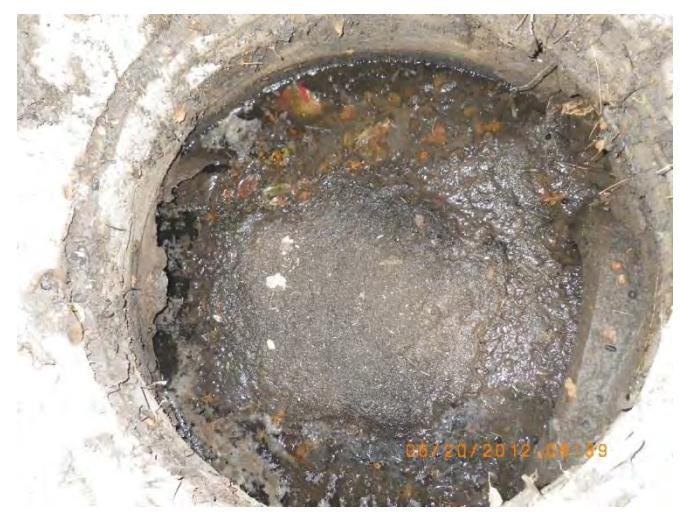
Figure 16 - Upstream manhole 02-322 US1 (6/20/2012)

The outfall and upstream manhole was rescreened as part of the gross solids pre-screening on June 20, 2012. The upstream manhole still had significant debris and sediment, and had a strong sewer odor. The sample from the manhole pool had an ammonia concentration greater than 6 ppm (the upper limit of the test strips).

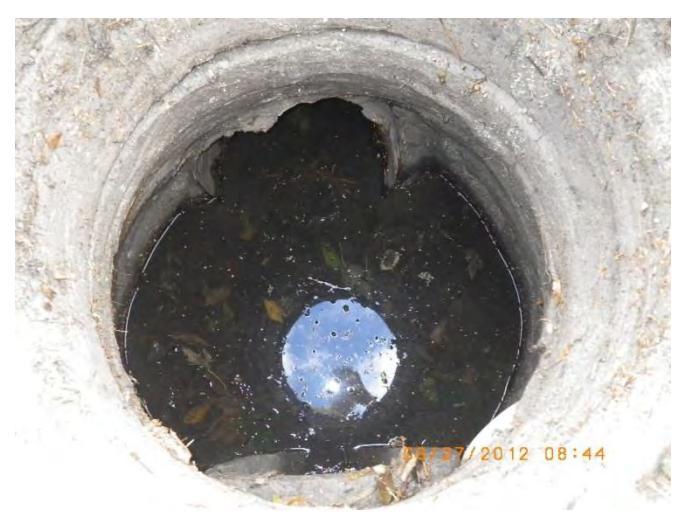
Figure 17 - Upstream manhole 02-322 US1 (9/27/2012)

The manhole was rescreened on September 27, 2012. It appeared that the amount of gross solids in the manhole had been reduced, although there was still a moderate amount of debris present. The sewer odor was still easily detected, and the sample from the manhole pool had an ammonia concentration of 3 ppm.

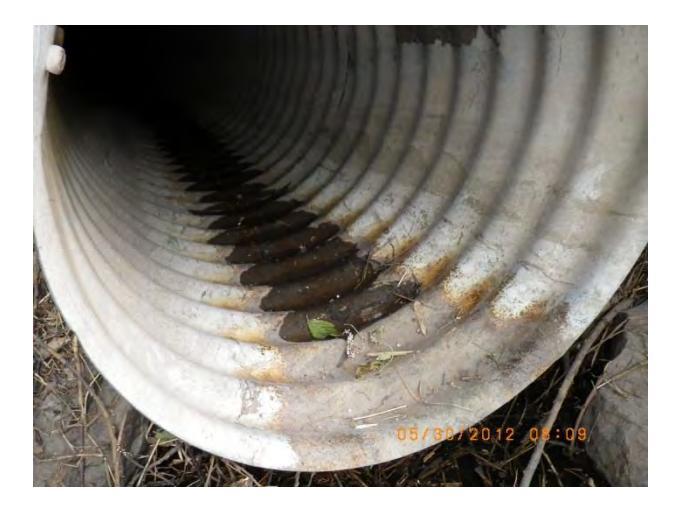
Figure 52 - Outfall 16-629 corroded pipe (minor damage)

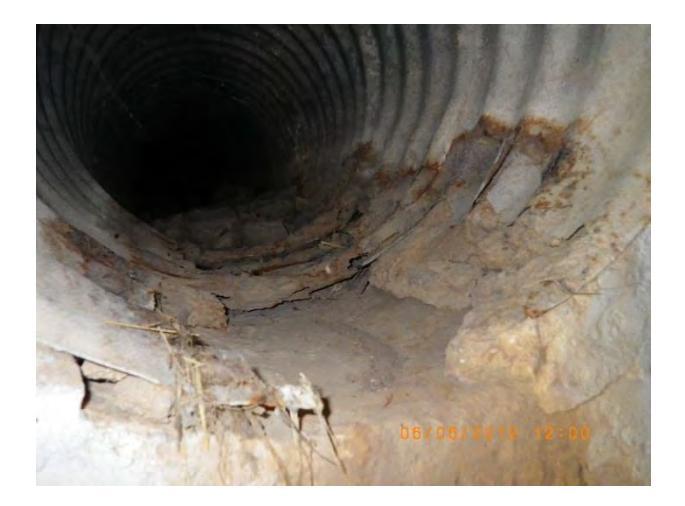
Figure 54 - Outfall 16-830 corroded pipe and damaged concrete(minor damage)

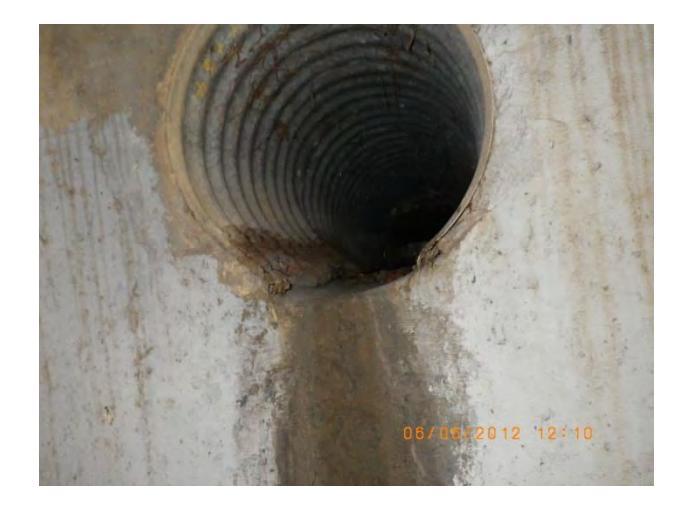
Figure 53 - Outfall 16-826 corroded pipe and damaged concrete (moderate damage)
