Ongoing Screening Summary Report 2014 Inspection Year

Illicit Discharge Detection and Elimination Program

City of Oshkosh

February 23, 2015

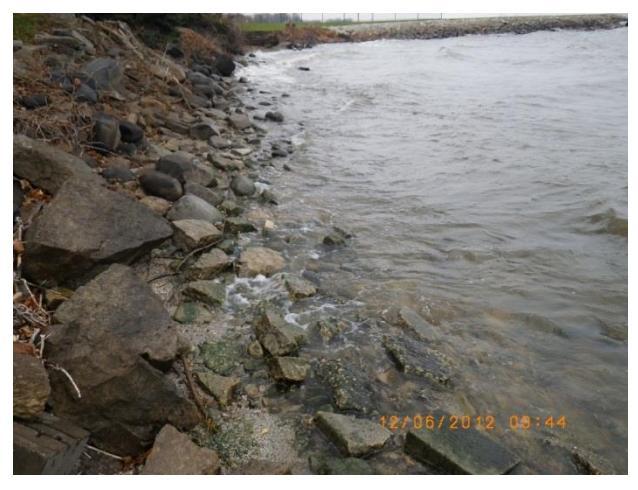
Figure 14 – Suds along shoreline north of outfall 02-184 (2012)

The suds observed on December 6 were consistent with the appearance of the suds that can be formed by natural surfactants in surface water. However, the sample that was collected from the pool in the upstream manhole had a detergent concentration of 0.2 mg/L, and an ammonia concentration of 3-6 ppm. These chemical indicators suggest that sanitary sewage may be present in the storm sewer, which could be causing the suds in the lake.

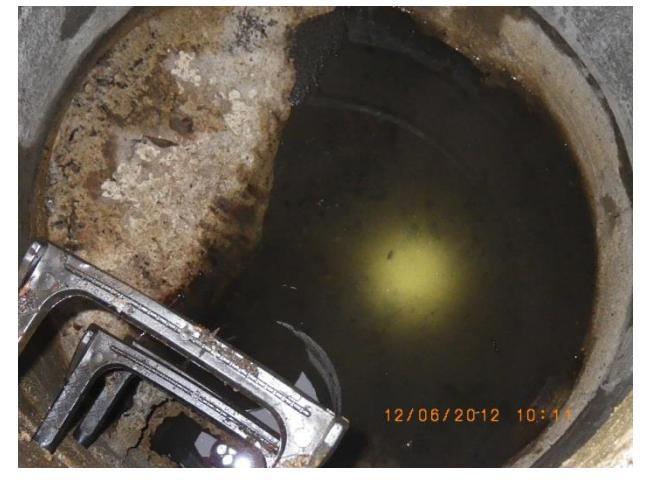
Figure 15 – Pool in upstream manhole 02-184 US1 (2012)

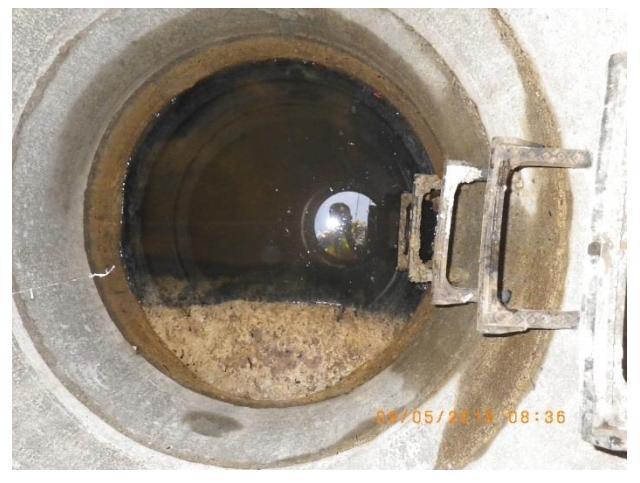
The outfall and upstream manhole were re-screened on September 5, 2013. At that time, a strong sewer odor was present in the upstream manhole. In addition, the sample had an ammonia concentration in excess of 6 ppm, and a detergent concentration of 1.3 mg/L. Both of these concentrations were higher than the 2012 screening. An update was provided to the Illicit Discharge Coordinator on September 6, 2013.

Figure 16 – Pool in upstream manhole 02-184 US1 (2013)

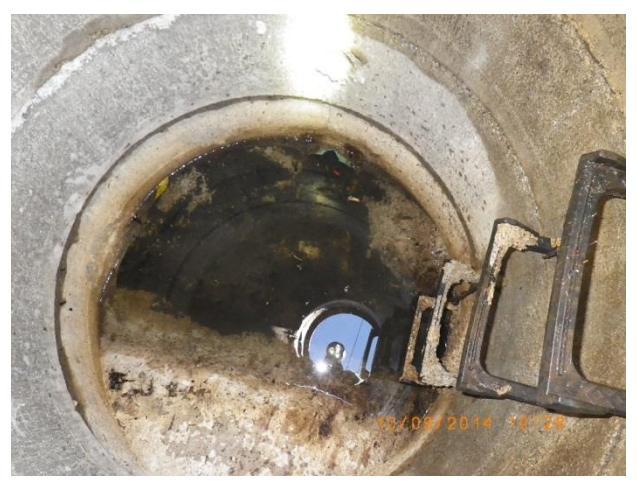
Because of the potential illicit discharges in prior years, the outfall was included in the 2014 screening program. During the 2014 screening, it was noted that the manhole appeared to be cleaner, with less sludge at the bottom. The sewage odor that was detected in previous years was not detected.

Figure 17 – Pool in upstream manhole 02-184 US1 (2014)

However, the stormwater sample collected from the manhole pool had an ammonia concentration of 3 ppm, and a detergent concentration of 0.7 mg/L. While these concentrations are approximately half of the 2013 concentrations, they are still significant.

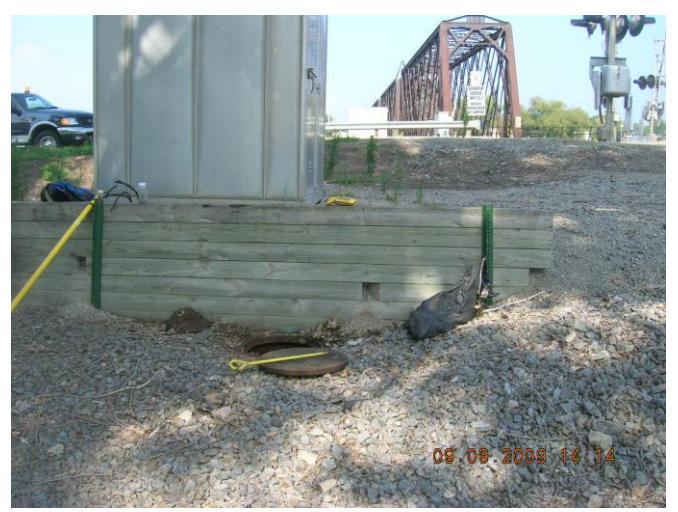
The outfall was first screened in 2009. The first upstream manhole was located on the south side of Pioneer Drive, behind the railroad control shed. When the manhole was opened, a strong smell of diesel fuel was detected inside the manhole. The manhole was also submerged, and had a significant amount of floatable debris, which appeared to be coated with oil and grease.

Figure 18 – Upstream manhole 03-81 US1 (2009)

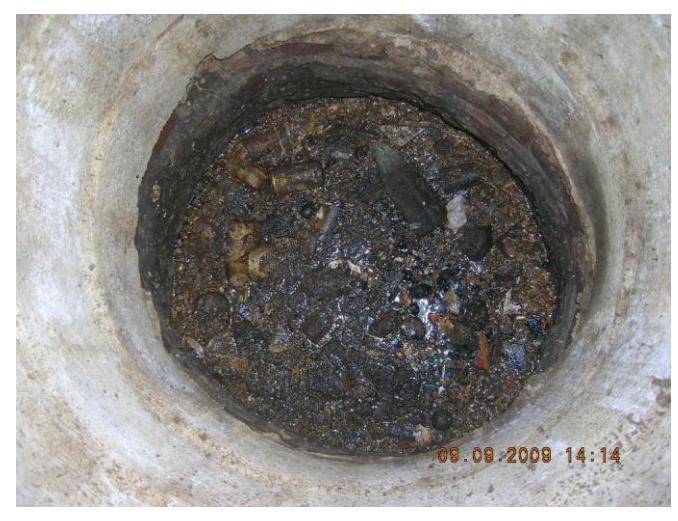
Figure 19 – Floatable debris and grease in upstream manhole 03-81 US1 (2009)

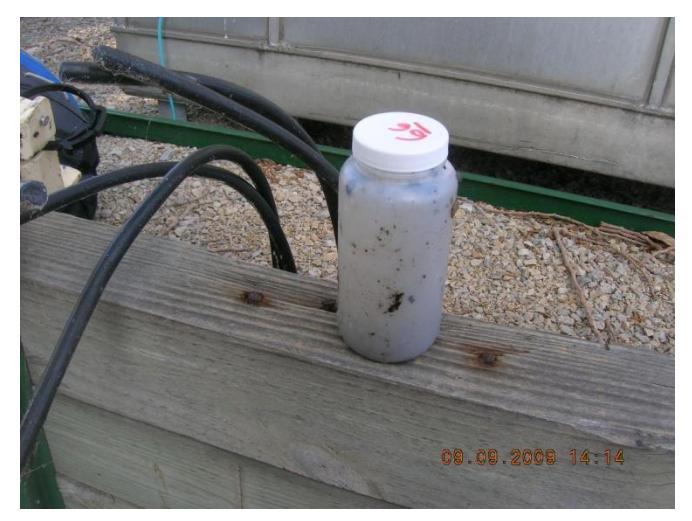
A sample was collected from upstream manhole 03-81 US1. The sample had a grayish-black color, and had a strong odor of diesel fuel. The sampling equipment and container were coated in grease from penetrating the floatable debris. None of the typical sampling parameters tested

positive. Because of the obvious odor of diesel fuel and appearance of grease, no additional VOC or oil/grease tests were run. The railroad track ballast in the area showed no signs of stains or other leaks, so a railroad spill seemed unlikely.

Figure 20 – Sample container from upstream manhole 03-81 US1 (2009)

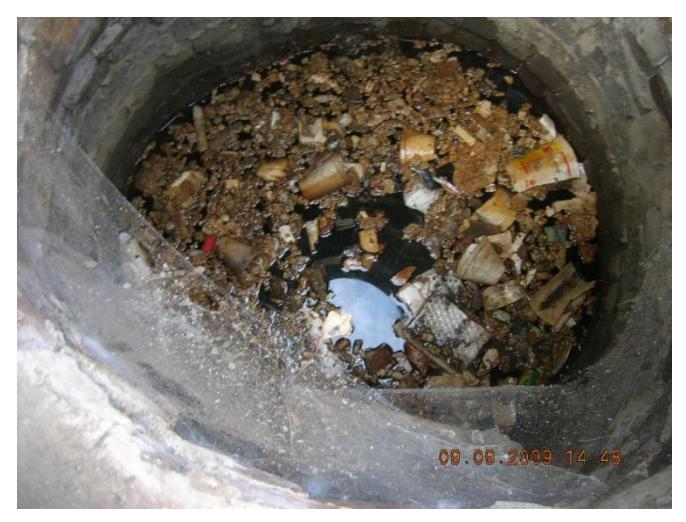
After receiving authorization from the City to use the contingency funds set aside for the project, additional upstream manholes were screened in an attempt to determine the extent of the contamination and the possible source. The first upstream manhole could not be located, as it was buried under the ballast in the railroad right-of-way. The second upstream manhole was located, also in the railroad right-of-way. This manhole (03-81 US2) also had oil-covered floatables, but the diesel odor was not as significant as in 03-81 US1.

Figure 21 – Floatable debris in upstream manhole 03-81 US2 (2009)

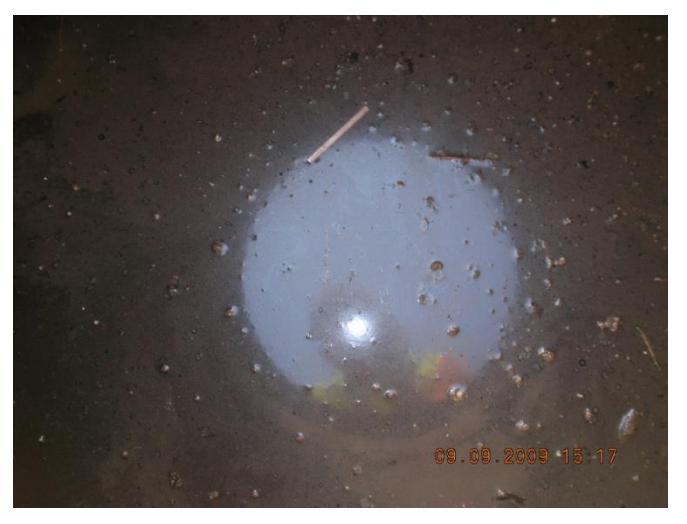
Additional upstream manholes were sampled along E. 10th Avenue. The manholes on 10th Avenue did not have the floatable debris or the diesel odor. However, they did have a reddishbrown tint to the submerged pool, and showed a slight oil sheen. The property on the south side of 10th Avenue is a steel fabrication facility, and the property on the north side is a metal salvage facility. Both could be potential sources of oil and grease.

Figure 22 – Oil sheen in upstream manhole 03-81 US4 (2009)

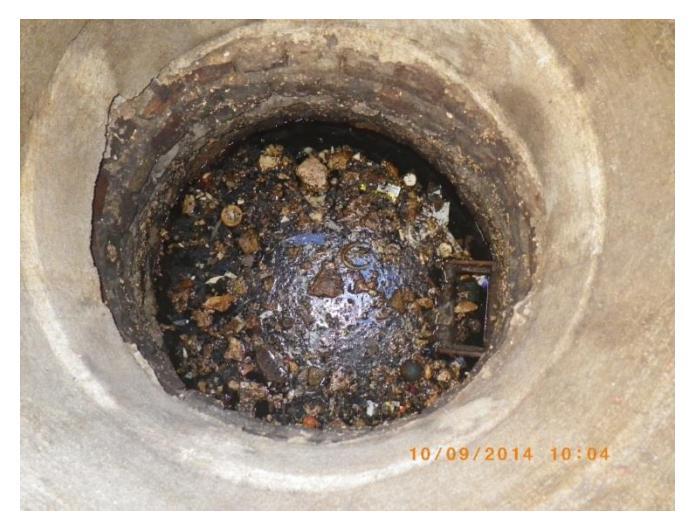
The outfall was screened on October 9, 2014 as part of the 2014 ongoing screening program due to the past illicit discharge. During this inspection, the manhole once again had moderate floatable debris, a visible petroleum sheen on the water and debris, and a faint petroleum odor. The stormwater sample collected from the manhole also contained an ammonia concentration of 0.5 ppm. The Illicit Discharge Coordinator was contacted on October 9 and notified of the reappearance of the petroleum.

Figure 23 – Oil sheen and debris in manhole 03-81 US1 (2014)

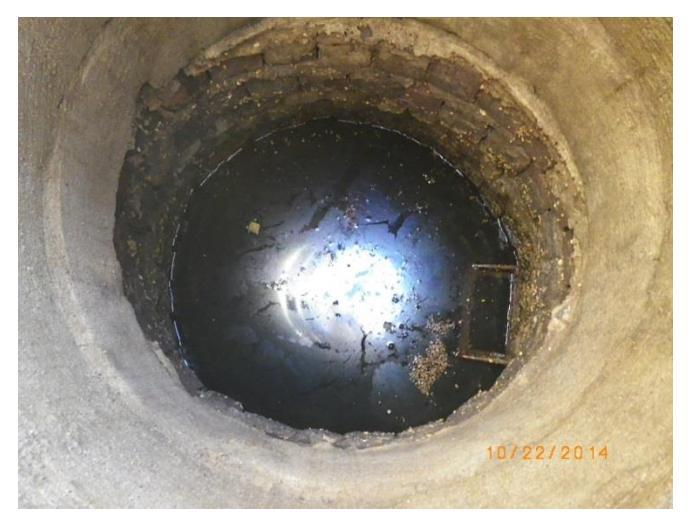
The City vacuumed the debris from the manhole on October 9. The manhole was rescreened on October 22, 2014. There was no debris present in the manhole, but the petroleum sheen and odor was still present.

Figure 24 – Oil sheen and debris in manhole 03-81 US1 after vacuuming (2014)

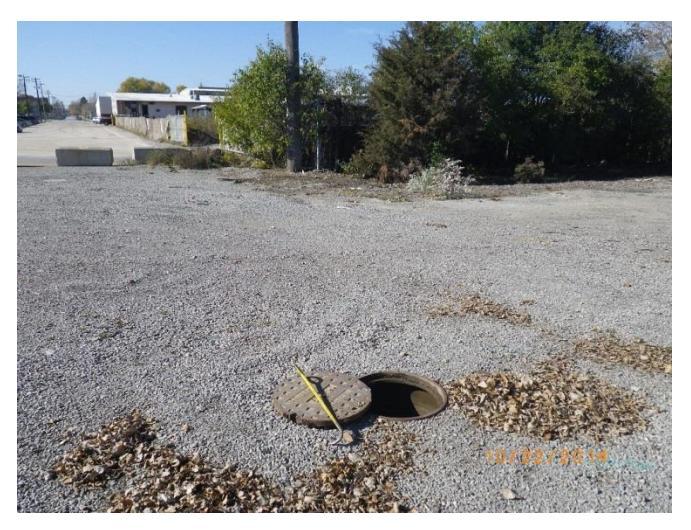
Based on the 2009 tracking, the suspected source(s) came from E 10th Avenue. The manhole at the east end of E 10th Avenue was opened for a visual inspection. There was a small submerged pool in this manhole, and a slight petroleum sheen and odor were detected. There were also some darker stains above the flowline of the manhole, possibly from petroleum.

Figure 25 – Upstream manhole 03-81 US4 (2014)

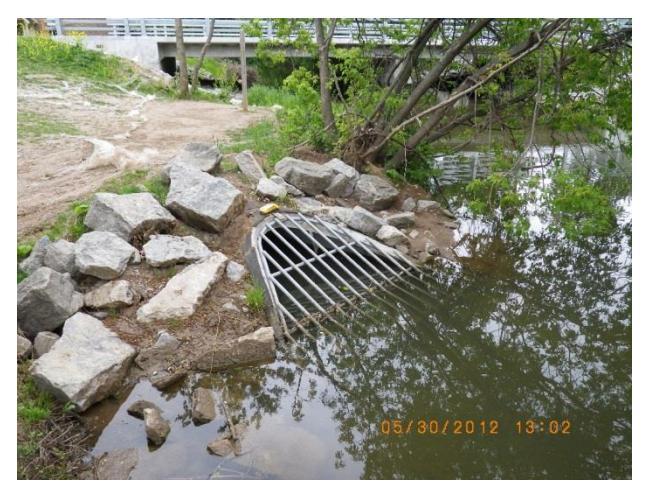
Outfall 16-1508 consists of a 54-inch reinforced concrete pipe that discharges to Sawyer Creek from the south. The outfall is located approximately 60 feet east of the Westfield Street bridge. The outfall was previously named 16-487 before it was reconstructed in 2011.

Figure 27 – Outfall 16-1508 (5/30/2012)

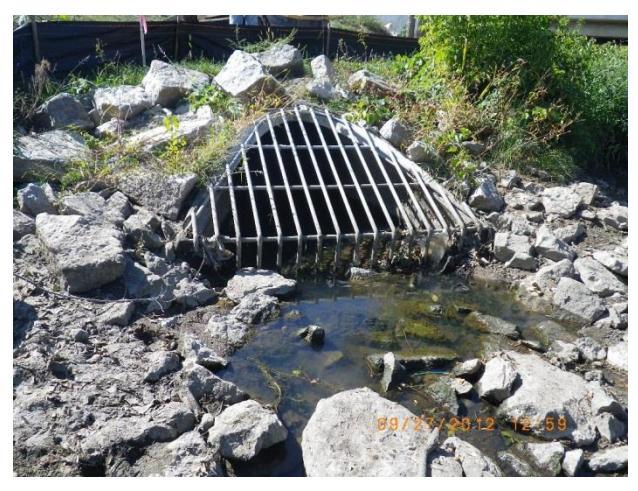
The outfall was rescreened on September 27, 2012. At that time, the Sawyer Creek stream channel was under construction. The outfall was still partially submerged, and a sample was collected from the upstream manhole.

Figure 28 – Outfall 16-1508 (9/27/2012)

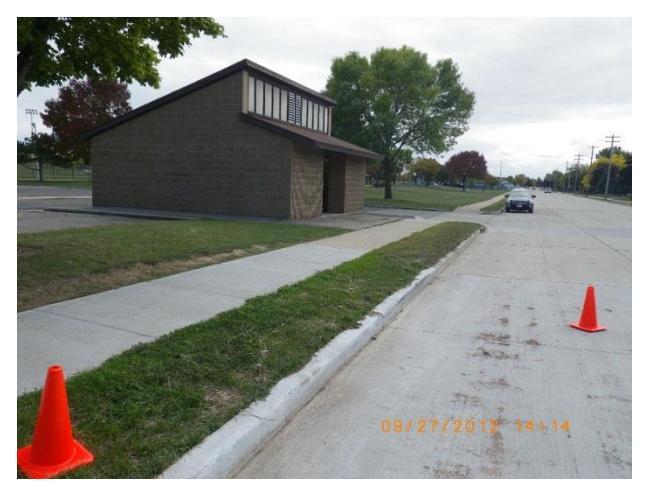
The land use in this area consists of multifamily residential property on the west side of Westfield Street, and Red Arrow Park on the east side of the street. A building housing the restrooms for the park is located immediately to the east of this segment. Based on the elevated ammonia levels in the segment adjacent to the park restroom building, this was identified as a potential source. Additionally, Red Arrow Park is a former landfill site, and infiltration of groundwater from the site could be another potential source.

Figure 29 – Park restroom building upstream of 16-1504 (2013)

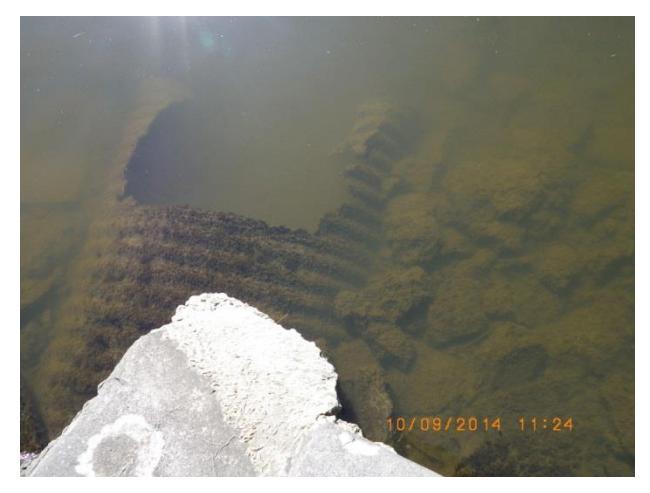
Figure 30 – Corroded metal pipe at outfall 08-284 (minor damage)

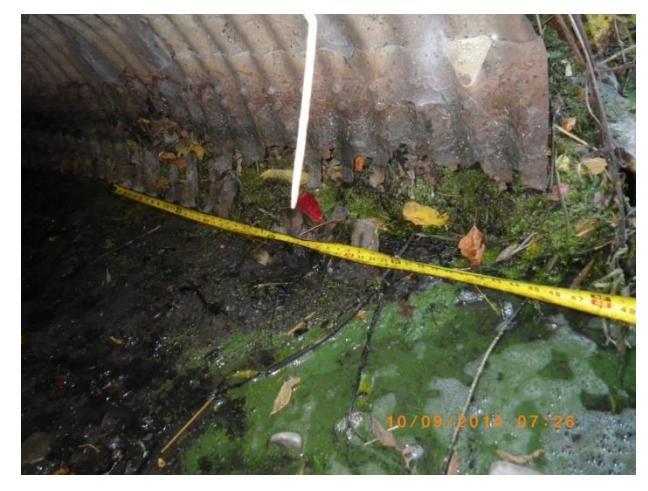
Figure 31 – Corroded metal pipe at outfall 12-890 (moderate damage)

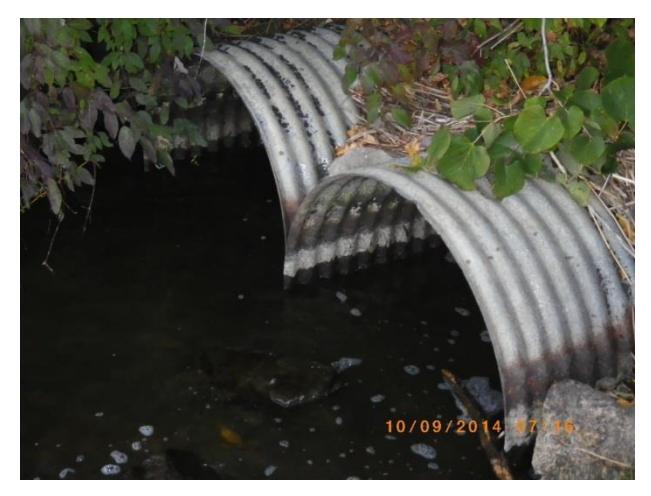
Figure 32 – Corroded metal pipe at outfall 12-890x (minor damage)

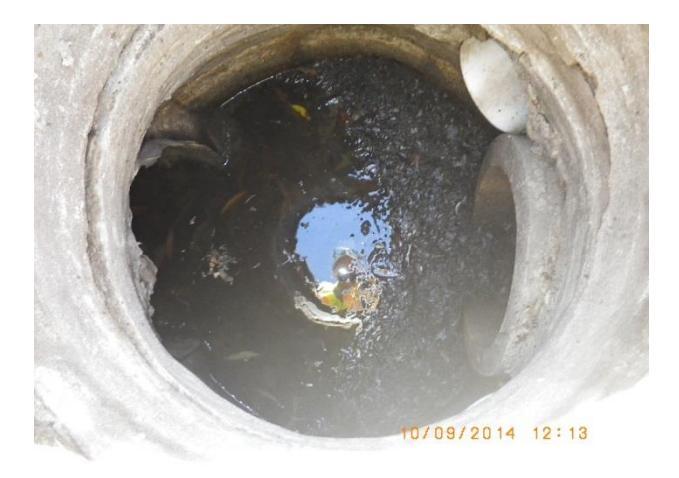
Figure 33 – Minor deposition in manhole 02-322 US1

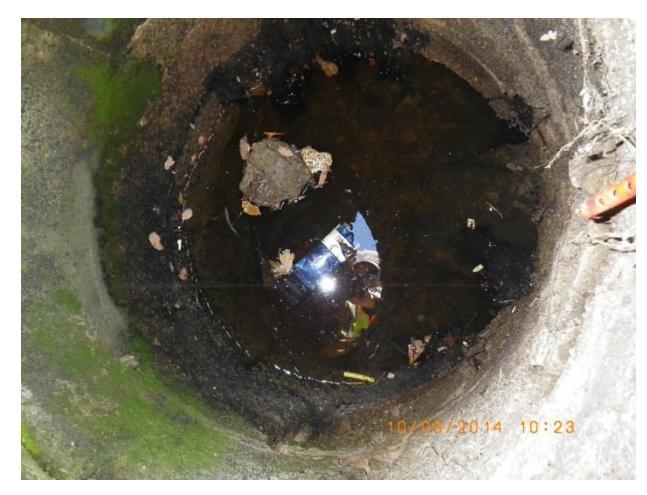
Figure 35 – Minor deposition in manhole 03-381 US1

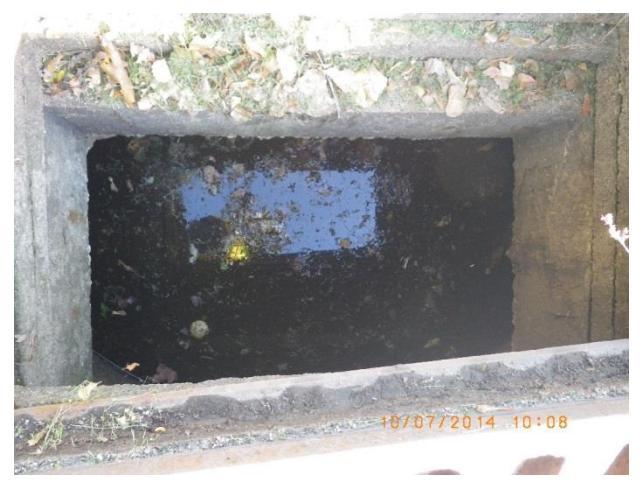
Figure 37 – Moderate deposition in inlet 06-1694 US1

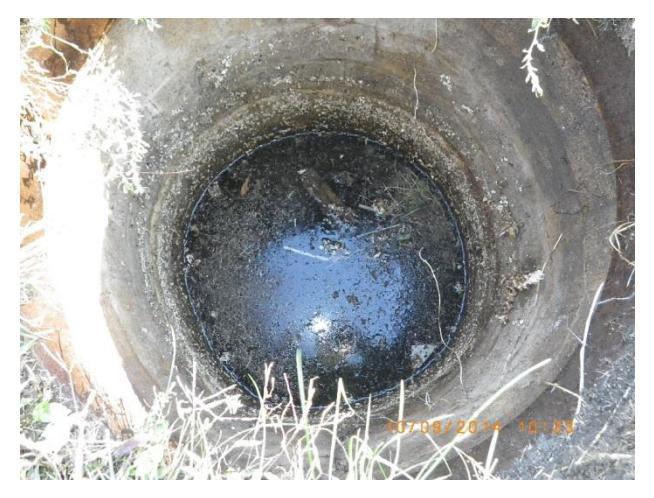
Figure 34 – Minor deposition in manhole 03-35 US1

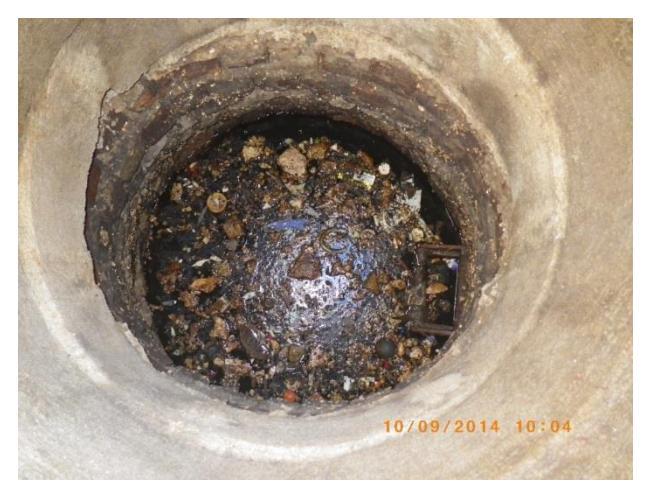
Figure 36 – Minor deposition in manhole 03-81 US1

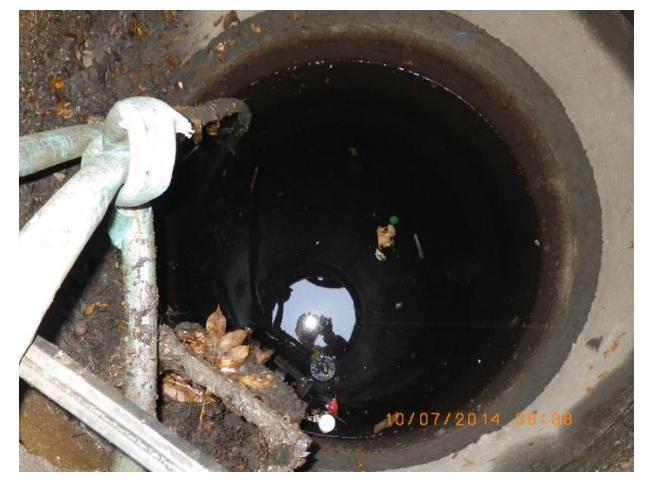
Figure 38 – Minor deposition in manhole 06-221 US1

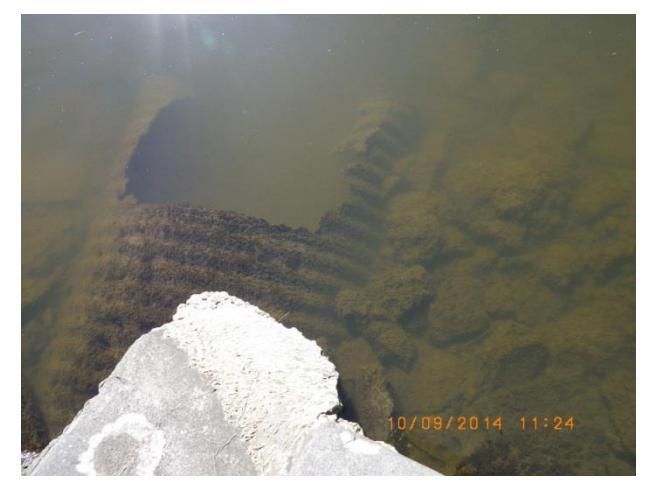
Figure 39 – Minor deposition at outfall 08-284

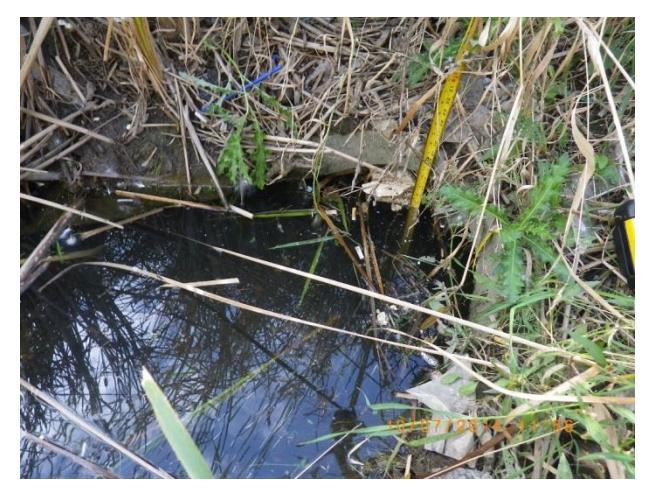
Figure 41 – Moderate deposition at outfall 13-1758

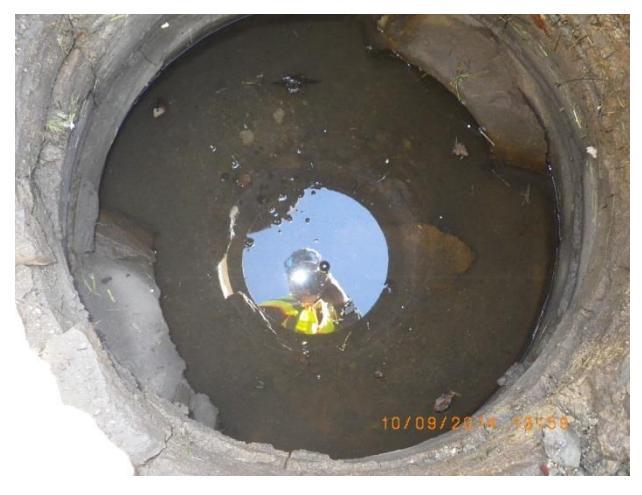
Figure 43 – Moderate deposition in manhole 15-1093 US1

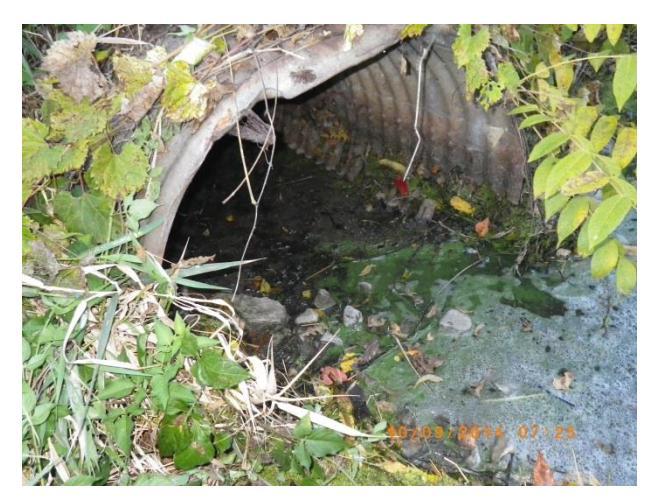
Figure 40 – Minor deposition at outfall 12-890

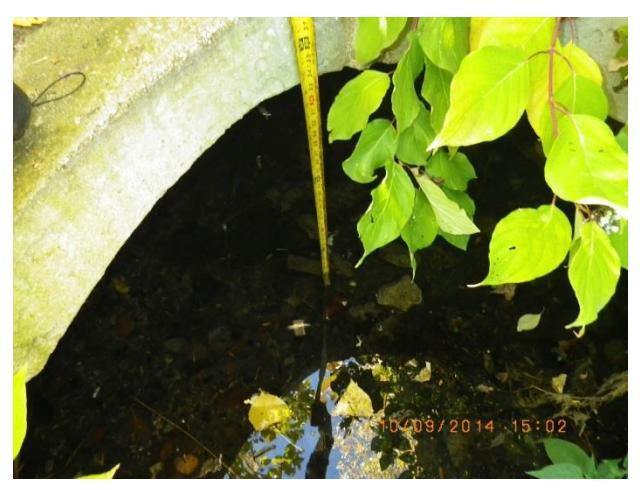
Figure 42 – Minor deposition at outfall 13-3099

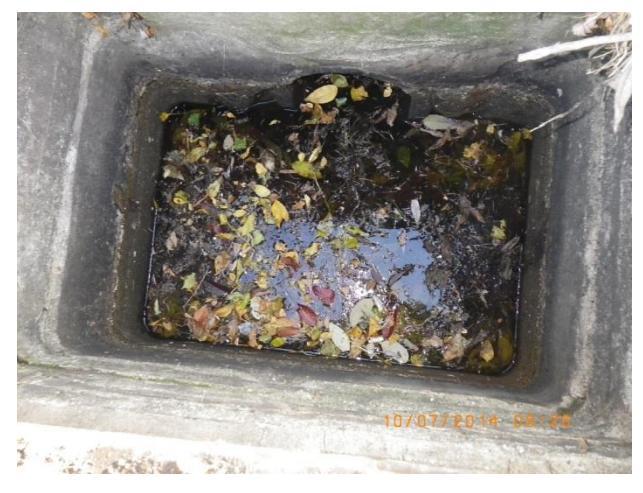
Figure 44 – Minor deposition in inlet 16-119 US1

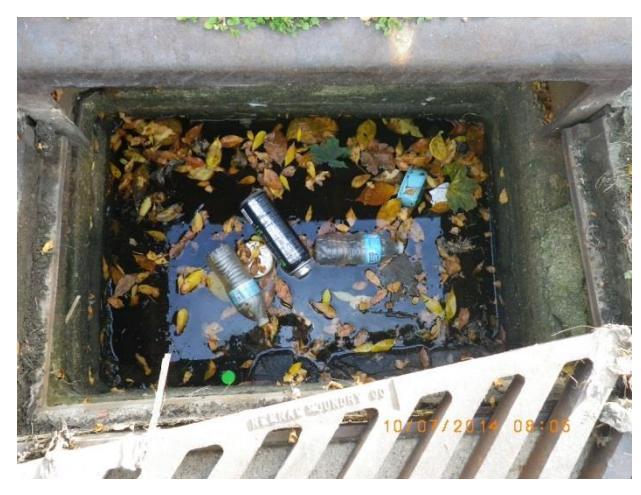
Figure 45 – Minor deposition in inlet 16-142 US1

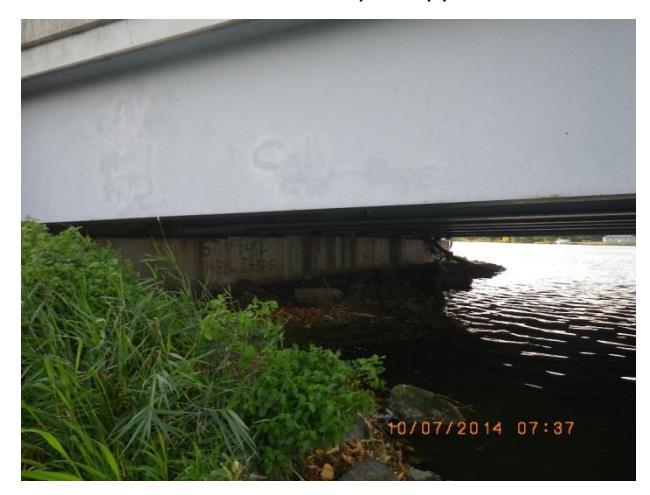
Figure 46 – Graffiti near outfall 12-569
