# Submittal of Annual Reports and Other Compliance Documents for Municipal Separate Storm Sewer System (MS4) Permits

**Project Name:** 2023 Annual Report

**Municipality:** Oshkosh, City

**Permit Number:** S050075

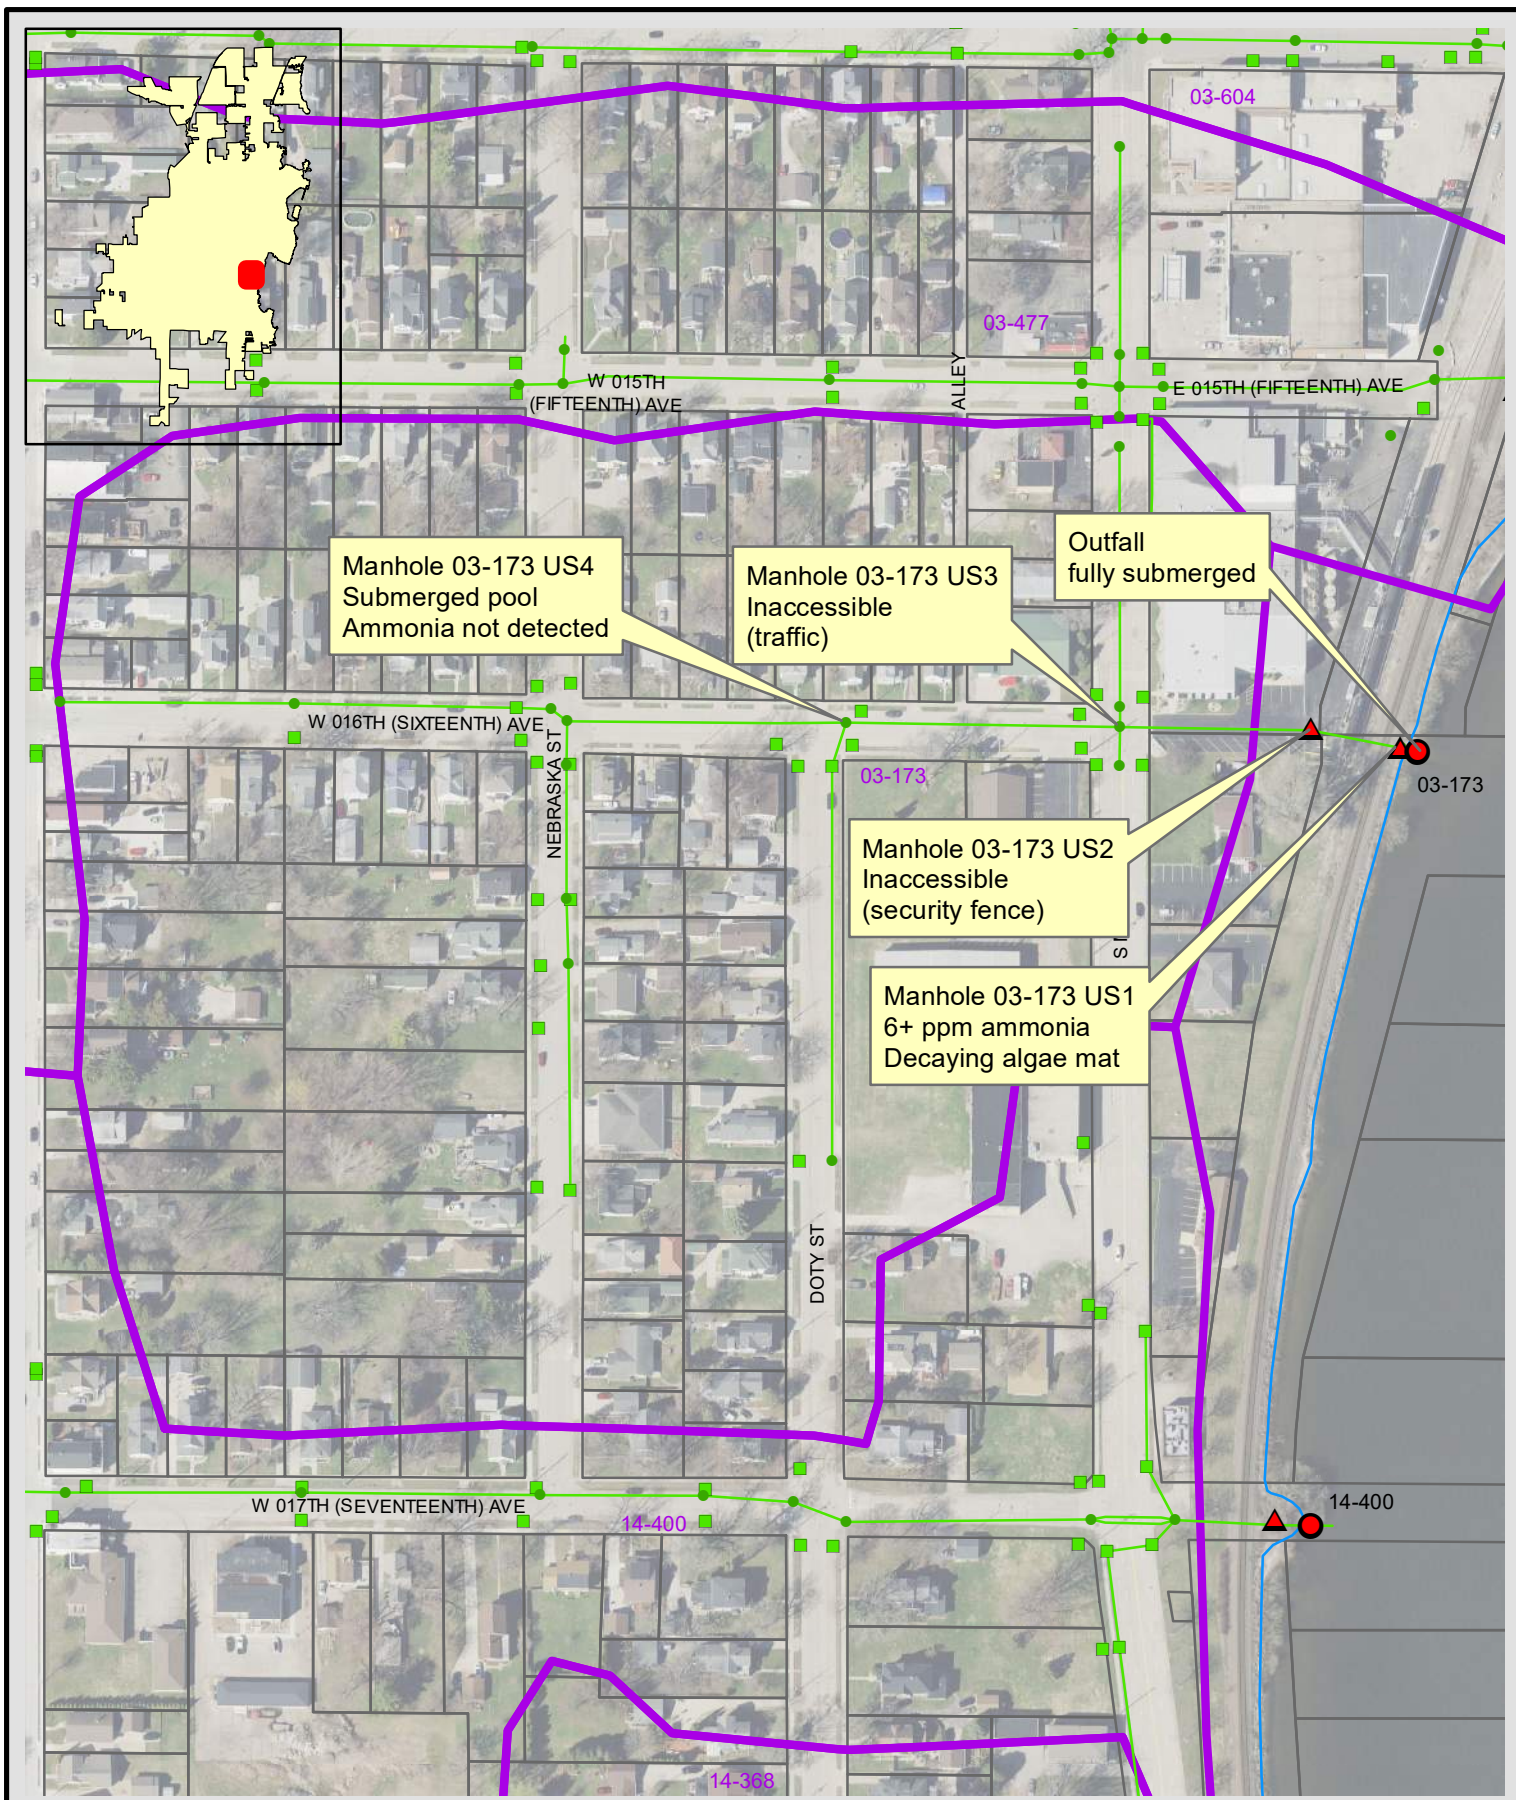
<b>2023 IDDE ONGOING SCREENING</b> <b>AREA MAP - OUTFALL 03-173</b> <b>(7/19/2023 SCREENING)</b>		Project Manager: Project Engineer: Drawn By: JCW Checked By:	SCALE: 1" = 200' PROJECT NO. <b>R3000958.00</b>
		CITY OF OSHKOSH, WINNEBAGO COUNTY, WISCONSIN		Date: 1/23/2024	FIGURE NO. <b>B-2</b>

The algae mat had been removed from the shoreline manhole. Based on these findings, it appears that the elevated ammonia in the manhole sample was likely from the accumulation of decaying algae, and not an upstream illicit discharge. This outfall is already classified as a Priority Outfall, so it will be automatically screened in 2024. If ammonia or other indicators are detected at that time, additional tracking could be completed.

I was able to screen 26 outfalls on Monday, and the only other outfall with a potential issue was 03-173 (Blended Waxes). The upstream manhole that is located immediately adjacent to the shoreline had several inches of decaying algae at the top of the submerged pool. The ammonia concentration of the pool sample was > 6 ppm, likely as a result of the decaying algae. I will take an additional sample upstream of Main Street, outside of the reach of the algae, to verify that there is not an ammonia source coming from upstream.

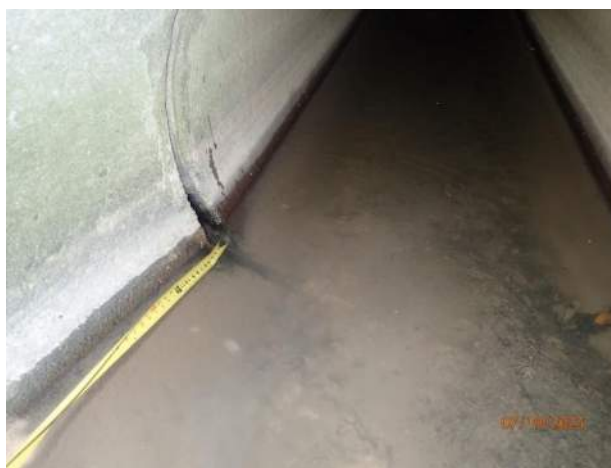
**Figure 2 – Outfall 06-1136**

Outfall	Severity	Description
06-2798	Minor	Apron undercut 4"
06-1136	Minor	3" joint displacement
06-478	Minor	3" joint displacement/deterioration
13-2332	Minor	2" joint displacement
13-3774	Minor	2" joint displacement
14-999	Minor	3" joint displacement, downed trees at end of pipe
15-3339	Minor	Debris (log) on apron
16-2092	Minor	3" joint displacement

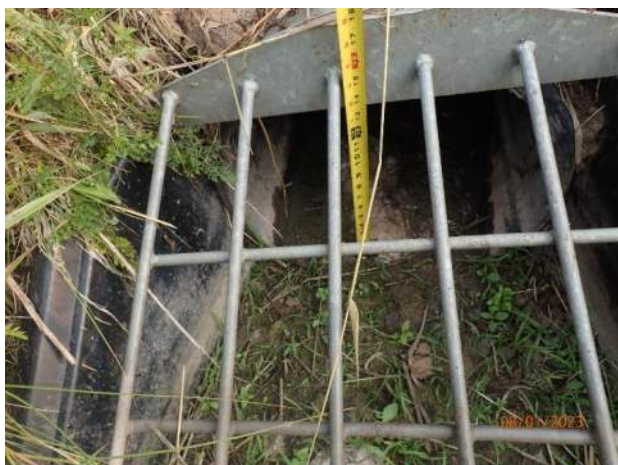
Figure 27 – Outfall 15-311a

15-311a	Minor	1" sediment inside pipe and on apron
16-1205	Minor	2" sediment inside pipe and on apron
16-660	Minor	1" sediment inside pipe and on apron
16-995	Moderate	15" sediment immediate downstream of outfall creating berm

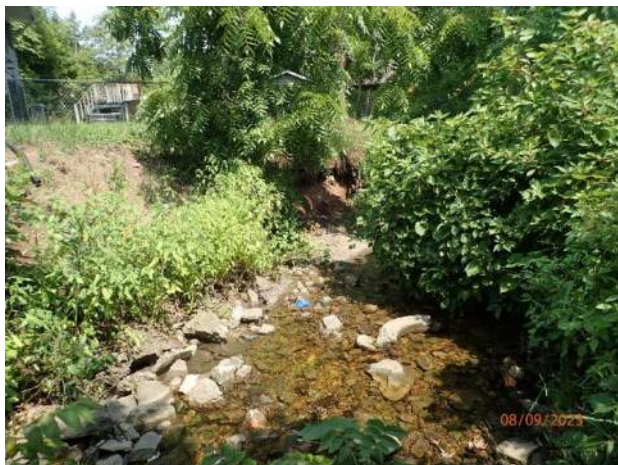
Outfall	Severity	Description
13-471	Moderate	Downstream channel erosion
13-2332	Moderate	Downstream channel erosion

Figure 31 – Channel erosion downstream of outfall 13-471

Two of the outfalls showed signs of erosion at the end of the outfall pipe or channel. Most outfalls with minor erosion could be repaired with minor landscaping repairs. Those outfalls with moderate or severe erosion may need additional structural reinforcement, such as turf reinforcement mat or riprap.

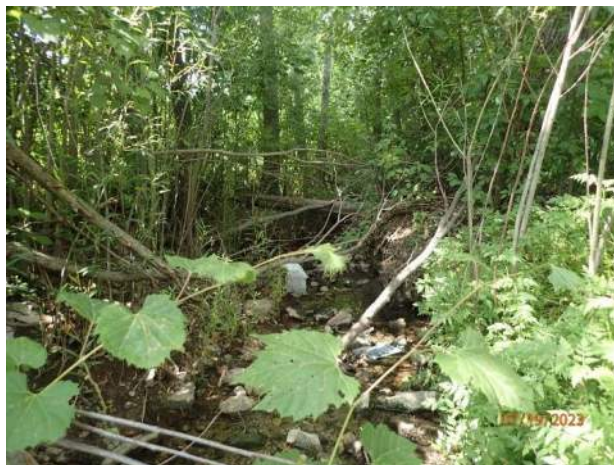
Figure 32 – Channel erosion downstream of outfall 13-2332

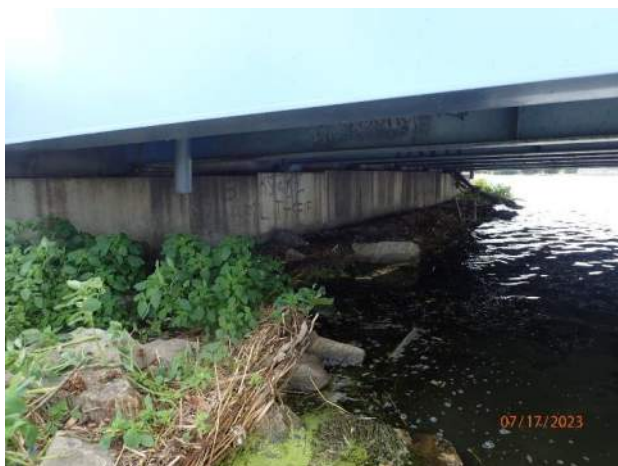
Outfall	Severity	Description
12-569	Moderate	Graffiti on bridge abutment near outfall
16-2092	Moderate	Graffiti on bridge abutment near outfall

Figure 33 – Abutment near outfall 12-569

Graffiti was observed in or around two outfalls. The graffiti was not severe but should probably be monitored to make sure that it does not become more severe.

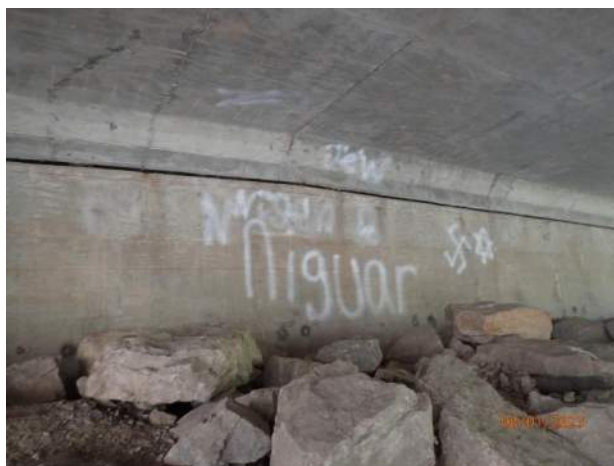
Figure 34 – Abutment near outfall 16-2092

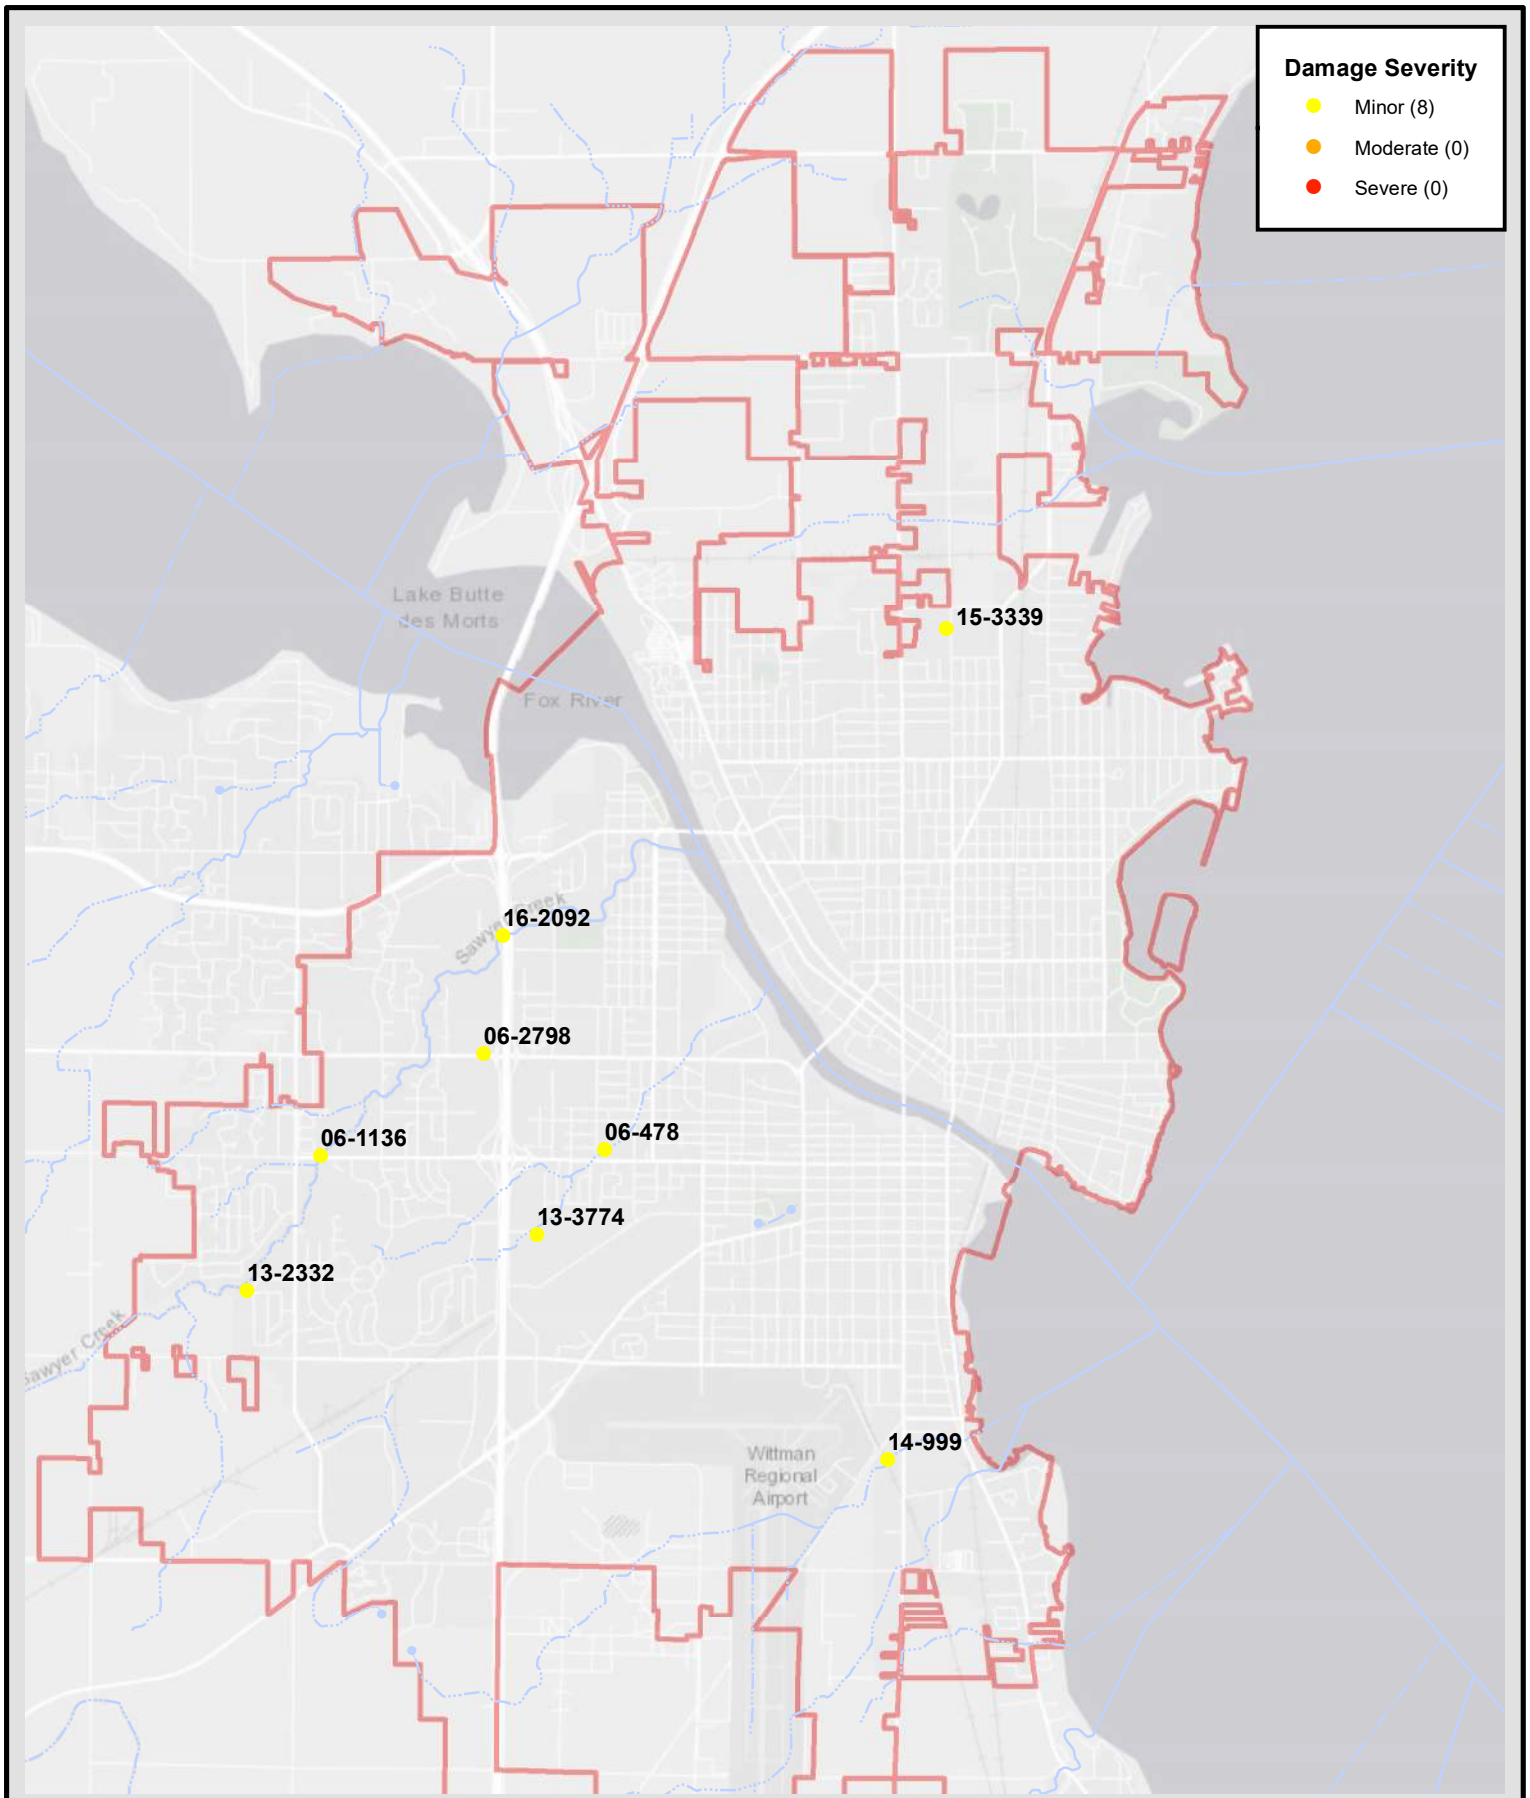
Eight outfalls showed signs of damage that may require attention in the near future. Observed damage included pipe joint displacement, damaged pipes and aprons, and corrosion.

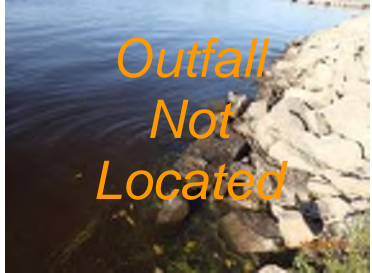
<p style="text-align: center;">o20191008081446.JPG</p> <p style="text-align: center; font-size: 1.5em; font-weight: bold;">2019</p>																																									
Submerged: Fully		Depth (in):		Outfall fully submerged - screened upstream at 01-520 US1. Floating gross solids (litter) in manhole.																																											
<b>Sampling Results</b> <table border="1" style="width:100%; border-collapse: collapse;"> <tr><td colspan="2">Sample Location:</td></tr> <tr><td>Total Chlorine:</td><td>-- ppm</td></tr> <tr><td>Free Chlorine:</td><td>-- ppm</td></tr> <tr><td>Ammonia:</td><td>-- ppm</td></tr> <tr><td>pH:</td><td>-- units</td></tr> <tr><td>Temperature:</td><td>-- ° F</td></tr> <tr><td>Conductivity:</td><td>-- µS/cm</td></tr> <tr><td>Detergents:</td><td>-- mg/L</td></tr> </table>		Sample Location:		Total Chlorine:	-- ppm			Free Chlorine:	-- ppm	Ammonia:	-- ppm	pH:	-- units	Temperature:	-- ° F	Conductivity:	-- µS/cm	Detergents:	-- mg/L	<table border="1" style="width:100%; border-collapse: collapse;"> <tr><td>Floatables:</td><td>None</td></tr> <tr><td>Odor:</td><td>None</td></tr> <tr><td>Turbidity:</td><td>None</td></tr> <tr><td>Color:</td><td>None</td></tr> <tr><td>Gross Solids:</td><td>None</td></tr> <tr><td>Vegetation:</td><td>None</td></tr> <tr><td>Benthic Growth:</td><td>None</td></tr> <tr><td>Stains:</td><td>None</td></tr> <tr><td>Non-illicit:</td><td>None</td></tr> </table>		Floatables:	None	Odor:	None	Turbidity:	None	Color:	None	Gross Solids:	None	Vegetation:	None	Benthic Growth:	None	Stains:	None	Non-illicit:	None	<b>Condition Assessment</b> <table border="1" style="width:100%; border-collapse: collapse;"> <tr><td>Graffiti:</td><td>None</td></tr> <tr><td>Erosion:</td><td>None</td></tr> <tr><td>Deposition:</td><td>None in.</td></tr> <tr><td>Damage:</td><td>None</td></tr> </table>		Graffiti:	None	Erosion:	None	Deposition:	None in.

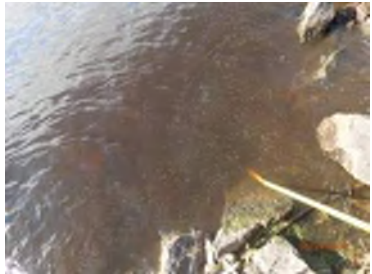
<p style="text-align: center;">o20181024110412.JPG</p> <p style="text-align: center; font-size: 1.5em; font-weight: bold;">2018</p>																																									
Submerged: Fully		Depth (in):		Outfall fully submerged - screened upstream at 01-520 US1. Floating gross solids (litter) in manhole.																																											
<b>Sampling Results</b> <table border="1" style="width:100%; border-collapse: collapse;"> <tr><td colspan="2">Sample Location:</td></tr> <tr><td>Total Chlorine:</td><td>-- ppm</td></tr> <tr><td>Free Chlorine:</td><td>-- ppm</td></tr> <tr><td>Ammonia:</td><td>-- ppm</td></tr> <tr><td>pH:</td><td>-- units</td></tr> <tr><td>Temperature:</td><td>-- ° F</td></tr> <tr><td>Conductivity:</td><td>-- µS/cm</td></tr> <tr><td>Detergents:</td><td>-- mg/L</td></tr> </table>		Sample Location:		Total Chlorine:	-- ppm			Free Chlorine:	-- ppm	Ammonia:	-- ppm	pH:	-- units	Temperature:	-- ° F	Conductivity:	-- µS/cm	Detergents:	-- mg/L	<table border="1" style="width:100%; border-collapse: collapse;"> <tr><td>Floatables:</td><td>None</td></tr> <tr><td>Odor:</td><td>None</td></tr> <tr><td>Turbidity:</td><td>None</td></tr> <tr><td>Color:</td><td>None</td></tr> <tr><td>Gross Solids:</td><td>None</td></tr> <tr><td>Vegetation:</td><td>None</td></tr> <tr><td>Benthic Growth:</td><td>None</td></tr> <tr><td>Stains:</td><td>None</td></tr> <tr><td>Non-illicit:</td><td>None</td></tr> </table>		Floatables:	None	Odor:	None	Turbidity:	None	Color:	None	Gross Solids:	None	Vegetation:	None	Benthic Growth:	None	Stains:	None	Non-illicit:	None	<b>Condition Assessment</b> <table border="1" style="width:100%; border-collapse: collapse;"> <tr><td>Graffiti:</td><td>None</td></tr> <tr><td>Erosion:</td><td>None</td></tr> <tr><td>Deposition:</td><td>None in.</td></tr> <tr><td>Damage:</td><td>None</td></tr> </table>		Graffiti:	None	Erosion:	None	Deposition:	None in.

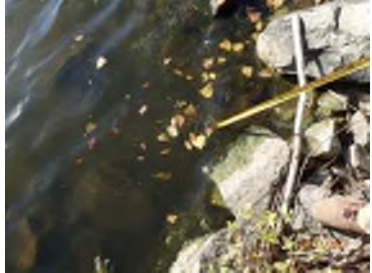
<p style="text-align: center;">o20171017151448.JPG</p> <p style="text-align: center; font-size: 1.5em; font-weight: bold;">2017</p>																																									
Submerged: Fully		Depth (in): 39		Outfall fully submerged - screened upstream at 01-520 US1. Floating gross solids (litter) in manhole.																																											
<b>Sampling Results</b> <table border="1" style="width:100%; border-collapse: collapse;"> <tr><td colspan="2">Sample Location:</td></tr> <tr><td>Total Chlorine:</td><td>-- ppm</td></tr> <tr><td>Free Chlorine:</td><td>-- ppm</td></tr> <tr><td>Ammonia:</td><td>-- ppm</td></tr> <tr><td>pH:</td><td>-- units</td></tr> <tr><td>Temperature:</td><td>-- ° F</td></tr> <tr><td>Conductivity:</td><td>-- µS/cm</td></tr> <tr><td>Detergents:</td><td>-- mg/L</td></tr> </table>		Sample Location:		Total Chlorine:	-- ppm			Free Chlorine:	-- ppm	Ammonia:	-- ppm	pH:	-- units	Temperature:	-- ° F	Conductivity:	-- µS/cm	Detergents:	-- mg/L	<table border="1" style="width:100%; border-collapse: collapse;"> <tr><td>Floatables:</td><td>None</td></tr> <tr><td>Odor:</td><td>None</td></tr> <tr><td>Turbidity:</td><td>None</td></tr> <tr><td>Color:</td><td>None</td></tr> <tr><td>Gross Solids:</td><td>None</td></tr> <tr><td>Vegetation:</td><td>None</td></tr> <tr><td>Benthic Growth:</td><td>None</td></tr> <tr><td>Stains:</td><td>None</td></tr> <tr><td>Non-illicit:</td><td>None</td></tr> </table>		Floatables:	None	Odor:	None	Turbidity:	None	Color:	None	Gross Solids:	None	Vegetation:	None	Benthic Growth:	None	Stains:	None	Non-illicit:	None	<b>Condition Assessment</b> <table border="1" style="width:100%; border-collapse: collapse;"> <tr><td>Graffiti:</td><td>None</td></tr> <tr><td>Erosion:</td><td>None</td></tr> <tr><td>Deposition:</td><td>None in.</td></tr> <tr><td>Damage:</td><td>None</td></tr> </table>		Graffiti:	None	Erosion:	None	Deposition:	None in.

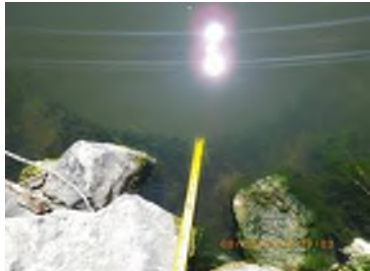
<p style="text-align: center;">o20130905120336.JPG</p> <p style="text-align: center; font-size: 1.5em; font-weight: bold;">2013</p>																																									
Submerged: Fully		Depth (in): 49		Outfall fully submerged. Outfall screened upstream at 01-520 US1. 2012 screening follow-up. Gross solids in upstream mh.																																											
<b>Sampling Results</b> <table border="1" style="width:100%; border-collapse: collapse;"> <tr><td>Sample Location:</td><td></td></tr> <tr><td>Total Chlorine:</td><td>-- ppm</td></tr> <tr><td>Free Chlorine:</td><td>-- ppm</td></tr> <tr><td>Ammonia:</td><td>-- ppm</td></tr> <tr><td>pH:</td><td>-- units</td></tr> <tr><td>Temperature:</td><td>-- °F</td></tr> <tr><td>Conductivity:</td><td>-- µS/cm</td></tr> <tr><td>Detergents:</td><td>-- mg/L</td></tr> </table>		Sample Location:		Total Chlorine:	-- ppm			Free Chlorine:	-- ppm	Ammonia:	-- ppm	pH:	-- units	Temperature:	-- °F	Conductivity:	-- µS/cm	Detergents:	-- mg/L	<table border="1" style="width:100%; border-collapse: collapse;"> <tr><td>Floatables:</td><td>None</td></tr> <tr><td>Odor:</td><td>None</td></tr> <tr><td>Turbidity:</td><td>None</td></tr> <tr><td>Color:</td><td>None</td></tr> <tr><td>Gross Solids:</td><td>None</td></tr> <tr><td>Vegetation:</td><td>None</td></tr> <tr><td>Benthic Growth:</td><td>Moderate</td></tr> <tr><td>Stains:</td><td>None</td></tr> <tr><td>Non-illicit:</td><td>None</td></tr> </table>		Floatables:	None	Odor:	None	Turbidity:	None	Color:	None	Gross Solids:	None	Vegetation:	None	Benthic Growth:	Moderate	Stains:	None	Non-illicit:	None	<b>Condition Assessment</b> <table border="1" style="width:100%; border-collapse: collapse;"> <tr><td>Graffiti:</td><td>None</td></tr> <tr><td>Erosion:</td><td>None</td></tr> <tr><td>Deposition:</td><td>None in.</td></tr> <tr><td>Damage:</td><td>None</td></tr> </table>		Graffiti:	None	Erosion:	None	Deposition:	None in.

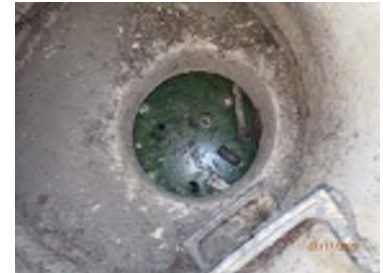
o20230717083818.JPG

☐ Petrol. Sheen ☐ Suds ☐ Sewage ☐ Algae ☐ Other☐ Petroleum ☐ Musty ☐ Sewage ☐ Chlorine ☐ Other☐ VOC/Solvent ☐ Fishy ☐ Sulfur ☐ Fragrant☒ Litter ☐ Veg. Debris ☐ Sediment ☐ Other☐ Inhibited ☐ Excessive☐ Green ☐ Brown☐ Flow Line ☐ Oil ☐ Rust Stains☐ Paint ☐ Other☐ Natural Sheen ☐ Natural Suds/Foam

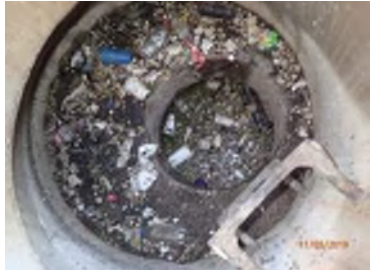
o20191105110322.JPG <div style="text-align: right; font-weight: bold; font-size: 1.2em;">2019</div>

<b>Inspection Date:</b> 11/5/2019 11:05:04 AM		<b>Type:</b> Repeat	<b>Flow:</b> Submerged, indeterminate	<b>Previous Rainfall (hrs):</b> 48-72
<b>Illicit Discharge Potential:</b> Potential		<b>Inspector:</b> JCW		
Submerged: Partially		Depth (in): 67		
<b>Sampling Results</b>		<b>Notes</b> Detergent detection follow-up. Limited screening conducted.		
Sample Location: Pool	Floatables:			
Total Chlorine: -- ppm	Odor:	None		
Free Chlorine: -- ppm	Turbidity:	None		
Ammonia: -- ppm	Color:	None		
pH: -- units	Gross Solids:	Severe		
Temperature -- °F	Vegetation:	None		
Conductivity: -- µS/cm	Benthic Growth:	None		
Detergents: 0 mg/L	Stains:	None		
	Non-illicit:	None		
		<b>Condition Assessment</b> Graffiti: None Erosion: None Deposition: None in. Damage: None

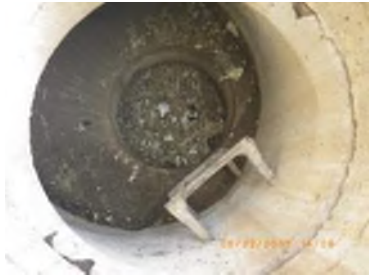
o20150922130946.JPG  
**2015**

<b>Inspection Date:</b> 9/22/2015 2:08:37 PM		<b>Type:</b> Ongoing	<b>Flow:</b> Submerged, indeterminate	<b>Previous Rainfall (hrs):</b> 72+
<b>Illicit Discharge Potential:</b> <b>Potential</b>		<b>Inspector:</b> JCW	<b>Notes</b>	
Submerged: Fully		Depth (in): 70	Floating gross solids (litter) in manhole.	
<b>Sampling Results</b>		<b>Floatables:</b> None	<b>Condition Assessment</b> Graffiti: None Erosion: None Deposition: None in. Damage: None	
Sample Location: Pool	<b>Odor:</b> None			
Total Chlorine: 0 ppm	<b>Turbidity:</b> None			
Free Chlorine: 0 ppm	<b>Color:</b> None			
Ammonia: 0 ppm	<b>Gross Solids:</b> Severe			
pH: 8.1 units	<b>Vegetation:</b> None			
Temperature 76 °F	<b>Benthic Growth:</b> None			
Conductivity: 917 µS/cm	<b>Stains:</b> None			
Detergents: 0 mg/L	<b>Non-illicit:</b> None

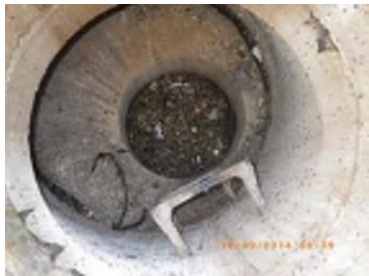
o20141009073910.JPG  
**2014**

<b>Inspection Date:</b> 10/9/2014 8:42:09 AM		<b>Type:</b> Ongoing	<b>Flow:</b> Submerged, indeterminate	<b>Previous Rainfall (hrs):</b> 72+
<b>Illicit Discharge Potential:</b> <b>Potential</b>		<b>Inspector:</b> JCW	<b>Notes</b>	
Submerged: Fully		Depth (in): 64	Floating gross solids (litter) inside manhole.	
<b>Sampling Results</b>		<b>Floatables:</b> None	<b>Condition Assessment</b> Graffiti: None Erosion: None Deposition: None in. Damage: None	
Sample Location: Pool	<b>Odor:</b> Faint			
Total Chlorine: 0 ppm	<b>Turbidity:</b> None			
Free Chlorine: 0 ppm	<b>Color:</b> None			
Ammonia: 0 ppm	<b>Gross Solids:</b> Severe			
pH: 7.84 units	<b>Vegetation:</b> None			
Temperature 57 °F	<b>Benthic Growth:</b> Slight			
Conductivity: 1318 µS/cm	<b>Stains:</b> None			
Detergents: 0 mg/L	<b>Non-illicit:</b> None

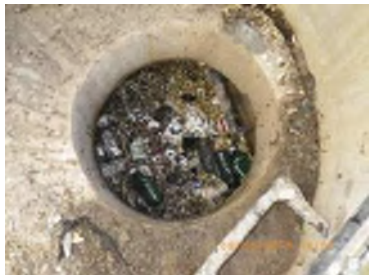
o20130905120924.JPG  
**2013**

<b>Inspection Date:</b> 9/5/2013 1:02:45 PM		<b>Type:</b> Ongoing	<b>Flow:</b> Submerged, indeterminate	<b>Previous Rainfall (hrs):</b> 72+
<b>Illicit Discharge Potential:</b> <b>Potential</b>		<b>Inspector:</b> JCW	<b>Notes</b>	
Submerged: Fully		Depth (in): 69	2012 screening follow-up. Significant gross solids in manhole - similar to previous years.	
<b>Sampling Results</b>		<b>Floatables:</b> None	<b>Condition Assessment</b> Graffiti: None Erosion: None Deposition: None in. Damage: None	
Sample Location: Pool	<b>Odor:</b> None			
Total Chlorine: 0 ppm	<b>Turbidity:</b> None			
Free Chlorine: 0 ppm	<b>Color:</b> None			
Ammonia: 0 ppm	<b>Gross Solids:</b> Severe			
pH: 8.51 units	<b>Vegetation:</b> None			
Temperature 76 °F	<b>Benthic Growth:</b> None			
Conductivity: 424 µS/cm	<b>Stains:</b> None			
Detergents: 0 mg/L	<b>Non-illicit:</b> None

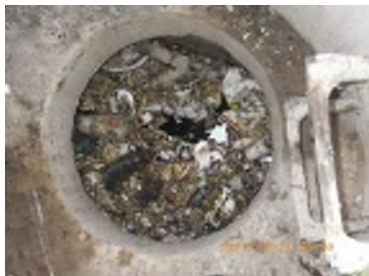
o20120927085918.JPG  
**2012**

<b>Inspection Date:</b> 9/27/2012 9:57:25 AM		<b>Type:</b> Ongoing	<b>Flow:</b> Submerged, indeterminate	<b>Previous Rainfall (hrs):</b> 72+
<b>Illicit Discharge Potential:</b> <b>Potential</b>		<b>Inspector:</b> JCW	<b>Notes</b>	
Submerged: Fully		Depth (in): 69	2011 gross solids follow-up.	
<b>Sampling Results</b>		<b>Floatables:</b> None	<b>Condition Assessment</b> Graffiti: None Erosion: None Deposition: None in. Damage: None	
Sample Location: Pool	<b>Odor:</b> None			
Total Chlorine: 0 ppm	<b>Turbidity:</b> None			
Free Chlorine: 0 ppm	<b>Color:</b> None			
Ammonia: 0.5 ppm	<b>Gross Solids:</b> Severe			
pH: 7.77 units	<b>Vegetation:</b> None			
Temperature 60 °F	<b>Benthic Growth:</b> None			
Conductivity: 542 µS/cm	<b>Stains:</b> Slight			
Detergents: 0 mg/L	<b>Non-illicit:</b> None

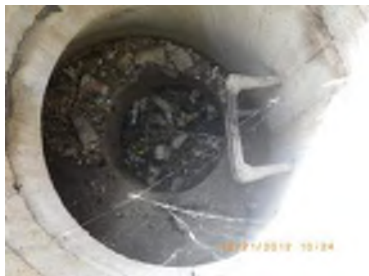
o20120621092424.JPG

<b>Inspection Date:</b> 6/21/2012 10:34:01 AM		<b>Type:</b> Other	<b>Flow:</b> Submerged, indeterminate	<b>Previous Rainfall (hrs):</b> 0-24
<b>Illicit Discharge Potential:</b> <b>Potential</b>		<b>Inspector:</b> JCW	<b>Notes</b>	
Submerged: Fully		Depth (in): 70	Gross solids pre-screening.	
<b>Sampling Results</b>		<b>Condition Assessment</b>		
Sample Location:	Floatables:	None		
Total Chlorine: -- ppm	Odor:	None		
Free Chlorine: -- ppm	Turbidity:	None		
Ammonia: -- ppm	Color:	None		
pH: -- units	Gross Solids:	Severe		
Temperature -- °F	Vegetation:	None		
Conductivity: -- µS/cm	Benthic Growth:	None		
Detergents: -- mg/L	Stains:	Moderate		
	Non-illicit:	None		
		Graffiti: None		
		Erosion: None		
		Deposition: None in.		
		Damage: None

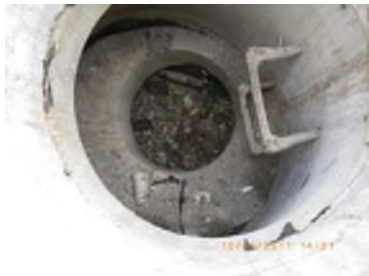
o20111011142110.JPG

<b>Inspection Date:</b> 10/11/2011 2:24:37 PM		<b>Type:</b> Ongoing	<b>Flow:</b> Submerged, indeterminate	<b>Previous Rainfall (hrs):</b> 72+
<b>Illicit Discharge Potential:</b> <b>Potential</b>		<b>Inspector:</b> JCW	<b>Notes</b>	
Submerged: Fully		Depth (in): 64	2010 screening follow-up. Floatable debris still present.	
<b>Sampling Results</b>		<b>Condition Assessment</b>		
Sample Location: Pool	Floatables:	None		
Total Chlorine: 0 ppm	Odor:	None		
Free Chlorine: 0 ppm	Turbidity:	None		
Ammonia: 0 ppm	Color:	None		
pH: 8.49 units	Gross Solids:	Severe		
Temperature 71 °F	Vegetation:	None		
Conductivity: -- µS/cm	Benthic Growth:	None		
Detergents: -- mg/L	Stains:	None		
	Non-illicit:	None		
		Graffiti: None		
		Erosion: None		
		Deposition: None 0 in.		
		Damage: None

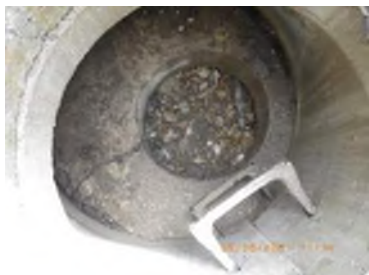
o20110526111400.JPG

<b>Inspection Date:</b> 5/26/2011 11:13:00 AM		<b>Type:</b> Other	<b>Flow:</b> Submerged, indeterminate	<b>Previous Rainfall (hrs):</b> 72+
<b>Illicit Discharge Potential:</b> <b>Potential</b>		<b>Inspector:</b> JCW	<b>Notes</b>	
Submerged: Fully		Depth (in):	Limited screening conducted to check for floatable debris.	
<b>Sampling Results</b>		<b>Condition Assessment</b>		
Sample Location:	Floatables:	None		
Total Chlorine: -- ppm	Odor:			
Free Chlorine: -- ppm	Turbidity:			
Ammonia: -- ppm	Color:			
pH: -- units	Gross Solids:	Severe		
Temperature -- °F	Vegetation:			
Conductivity: -- µS/cm	Benthic Growth:			
Detergents: -- mg/L	Stains:			
	Non-illicit:	None		
		Graffiti: None		
		Erosion: None		
		Deposition: None 0 in.		
		Damage: None

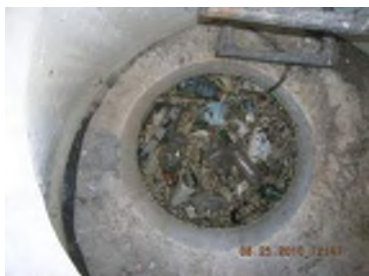
o20100825124708.JPG

<b>Inspection Date:</b> 8/25/2010 12:53:35 PM		<b>Type:</b> Ongoing	<b>Flow:</b> Submerged, indeterminate	<b>Previous Rainfall (hrs):</b> 72+
<b>Illicit Discharge Potential:</b> <b>Potential</b>		<b>Inspector:</b> JCW	<b>Notes</b>	
Submerged: Fully		Depth (in): 72	Significant floatable debris in manhole.	
<b>Sampling Results</b>		<b>Condition Assessment</b>		
Sample Location: Pool	Floatables:	None		
Total Chlorine: 0 ppm	Odor:	None		
Free Chlorine: 0 ppm	Turbidity:	None		
Ammonia: 0 ppm	Color:	Faint in bottle		
pH: 8.18 units	Gross Solids:	Severe		
Temperature 73 °F	Vegetation:	None		
Conductivity: -- µS/cm	Benthic Growth:	None		
Detergents: 0 mg/L	Stains:	None		
	Non-illicit:	None		
		Graffiti: None		
		Erosion: None		
		Deposition: None 0 in.		
		Damage: None

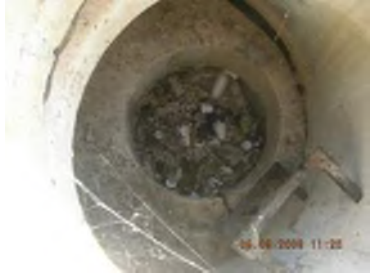
<b>Inspection Date:</b> 9/9/2009		<b>Type:</b> Initial		<b>Flow:</b> Submerged, indeterminate		<b>Previous Rainfall (hrs):</b> 72+	
<b>Illicit Discharge Potential:</b> Potential		Inspector: JCW		<b>Notes</b> Abnormal detergent analysis result (bubbles). Significant floatables in manhole. Brown color.

Osh09_DSCN6718.JPG	
Submerged: Fully		Depth (in): 61					
<b>Sampling Results</b>		Floatables: None Odor: None Turbidity: None Color: Clearly visible in bottl Gross Solids: Severe Vegetation: None Benthic Growth: None Stains: None Non-illicit: None		<b>Condition Assessment</b> Graffiti: None Erosion: None Deposition: None 0 in. Damage: None			
Sample Location: Pool Total Chlorine: 0 ppm Free Chlorine: 0 ppm Ammonia: -- ppm pH: 8.6 units Temperature: 78 °F Conductivity: -- µS/cm Detergents: 0 mg/L						<b>2009</b>

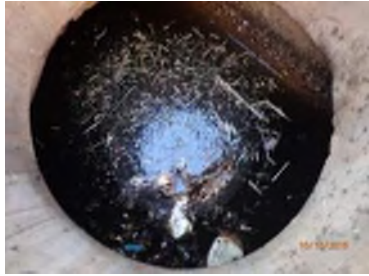
o20161010161634.JPG <div style="text-align: center; font-size: 24pt; font-weight: bold;">2016</div>
			<b>Condition Assessment</b> Graffiti: None Erosion: None Deposition: None in. Damage: None

<b>Inspection Date:</b> 10/10/2016 4:18:29 PM		<b>Type:</b> Ongoing	<b>Flow:</b> Submerged, indeterminate	<b>Previous Rainfall (hrs):</b> 72+
<b>Illicit Discharge Potential:</b> Potential		<b>Inspector:</b> JCW		
Submerged: Fully		Depth (in): 59		
<b>Sampling Results</b> Sample Location: Pool Total Chlorine: 0 ppm Free Chlorine: 0 ppm Ammonia: 0 ppm pH: 8.37 units Temperature: 68 °F Conductivity: 369 µS/cm Detergents: 0 mg/L		Floatables: None Odor: None Turbidity: None Color: Faint in bottle Gross Solids: Slight Vegetation: None Benthic Growth: None Stains: None Non-illicit: Slight	<b>Notes</b> Potential illicit discharge due to gross solids.

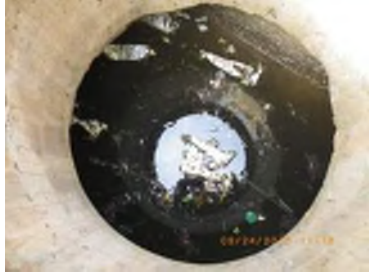
o20150924101848.JPG <div style="text-align: center; font-size: 24pt; font-weight: bold;">2015</div>
			<b>Condition Assessment</b> Graffiti: None Erosion: None Deposition: None in. Damage: None

<b>Inspection Date:</b> 9/24/2015 11:20:01 AM		<b>Type:</b> Ongoing	<b>Flow:</b> Submerged, indeterminate	<b>Previous Rainfall (hrs):</b> 72+
<b>Illicit Discharge Potential:</b> Potential		<b>Inspector:</b> JCW		
Submerged: Fully		Depth (in): 66		
<b>Sampling Results</b> Sample Location: Pool Total Chlorine: 0 ppm Free Chlorine: 0 ppm Ammonia: 0 ppm pH: 7.61 units Temperature: 71 °F Conductivity: 481 µS/cm Detergents: 0 mg/L		Floatables: None Odor: None Turbidity: None Color: None Gross Solids: Moderate Vegetation: None Benthic Growth: None Stains: None Non-illicit: Slight	<b>Notes</b> Floating gross solids (litter) in manhole.

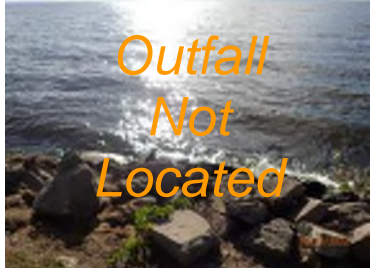
o20220923084544.JPG <b>2022</b>
			<b>Condition Assessment</b> Graffiti: None Erosion: None Deposition: None in. Damage: None

<b>Inspection Date:</b> 9/23/2022 8:46:00 AM		<b>Type:</b> Ongoing	<b>Flow:</b> Submerged (not located)	<b>Previous Rainfall (hrs):</b> 72+
<b>Illicit Discharge Potential:</b> Unlikely		<b>Inspector:</b> EJK		
<b>Submerged:</b> Fully		<b>Depth (in):</b>		
<b>Sampling Results</b> Sample Location: _____ Total Chlorine: -- ppm Free Chlorine: -- ppm Ammonia: -- ppm pH: -- units Temperature: -- °F Conductivity: -- µS/cm Detergents: -- mg/L		Floatables: None Odor: None Turbidity: None Color: None Gross Solids: None Vegetation: None Benthic Growth: None Stains: None Non-illicit: None	<b>Notes</b> Outfall fully submerged and not located - screened upstream at 02-309 US1.

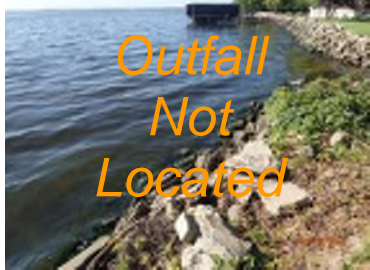
o20210816091538.JPG <b>2021</b>
			<b>Condition Assessment</b> Graffiti: None Erosion: None Deposition: None in. Damage: None

<b>Inspection Date:</b> 8/16/2021 9:16:09 AM		<b>Type:</b> Ongoing	<b>Flow:</b> Submerged (not located)	<b>Previous Rainfall (hrs):</b> 72+
<b>Illicit Discharge Potential:</b> Unlikely		<b>Inspector:</b> JCW		
<b>Submerged:</b> Fully		<b>Depth (in):</b>		
<b>Sampling Results</b> Sample Location: _____ Total Chlorine: -- ppm Free Chlorine: -- ppm Ammonia: -- ppm pH: -- units Temperature: -- °F Conductivity: -- µS/cm Detergents: -- mg/L		Floatables: None Odor: None Turbidity: None Color: None Gross Solids: None Vegetation: None Benthic Growth: None Stains: None Non-illicit: None	<b>Notes</b> Outfall fully submerged and not located - screened upstream at 02-309 US1.

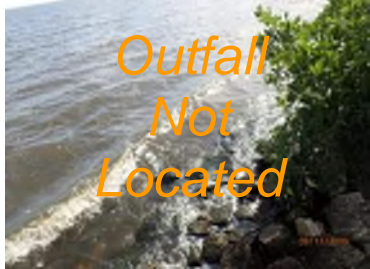
o20190917132548.JPG <b>2019</b>
			<b>Condition Assessment</b> Graffiti: None Erosion: None Deposition: None in. Damage: None

<b>Inspection Date:</b> 9/17/2019 2:26:03 PM		<b>Type:</b> Ongoing	<b>Flow:</b> Submerged (not located)	<b>Previous Rainfall (hrs):</b> 48-72
<b>Illicit Discharge Potential:</b> Unlikely		<b>Inspector:</b> JCW		
<b>Submerged:</b> Fully		<b>Depth (in):</b>		
<b>Sampling Results</b> Sample Location: _____ Total Chlorine: -- ppm Free Chlorine: -- ppm Ammonia: -- ppm pH: -- units Temperature: -- °F Conductivity: -- µS/cm Detergents: -- mg/L		Floatables: None Odor: None Turbidity: None Color: None Gross Solids: None Vegetation: None Benthic Growth: None Stains: None Non-illicit: None	<b>Notes</b> Outfall fully submerged and not located - screened upstream at 02-309 US1.

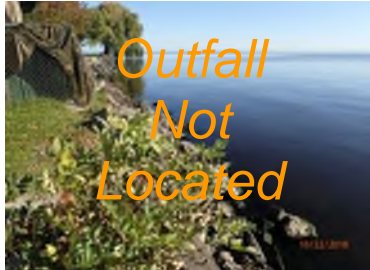
o20181022102328.JPG <b>2018</b>
			<b>Condition Assessment</b> Graffiti: None Erosion: None Deposition: None in. Damage: None

<b>Inspection Date:</b> 10/22/2018 10:23:45 AM		<b>Type:</b> Ongoing	<b>Flow:</b> Submerged (not located)	<b>Previous Rainfall (hrs):</b> 48-72
<b>Illicit Discharge Potential:</b> Potential		<b>Inspector:</b> JCW		
<b>Submerged:</b> Fully		<b>Depth (in):</b>		
<b>Sampling Results</b> Sample Location: _____ Total Chlorine: -- ppm Free Chlorine: -- ppm Ammonia: -- ppm pH: -- units Temperature: -- °F Conductivity: -- µS/cm Detergents: -- mg/L		Floatables: None Odor: None Turbidity: None Color: None Gross Solids: None Vegetation: None Benthic Growth: None Stains: None Non-illicit: None	<b>Notes</b> Outfall fully submerged and not located - screened upstream at 02-309 US1. Floating gross solids (litter) in manhole.

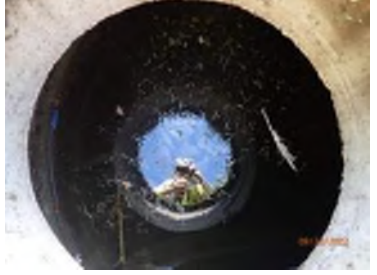
o20220923084658.JPG <div style="text-align: center; font-size: 24pt; font-weight: bold;">2022</div>
			<b>Condition Assessment</b> Graffiti: None Erosion: None Deposition: None in. Damage: None

<b>Inspection Date:</b> 9/23/2022 8:48:00 AM		<b>Type:</b> Ongoing	<b>Flow:</b> Submerged, indeterminate	<b>Previous Rainfall (hrs):</b> 72+
<b>Illicit Discharge Potential:</b> Unlikely		<b>Inspector:</b> EJK		
Submerged: Partially		Depth (in): 29		
<b>Sampling Results</b> Sample Location: Pool Total Chlorine: 0 ppm Free Chlorine: 0 ppm Ammonia: 0 ppm pH: 7.79 units Temperature: 62 °F Conductivity: 774 µS/cm Detergents: 0 mg/L		Floatables: Slight Odor: None Turbidity: None Color: None Gross Solids: None Vegetation: None Benthic Growth: Slight Stains: None Non-illicit: None	<b>Notes</b> Sample collected from submerged pool in manhole.

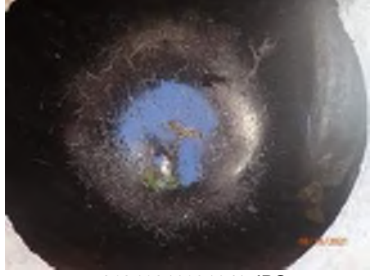
o20210816091646.JPG <div style="text-align: center; font-size: 24pt; font-weight: bold;">2021</div>
			<b>Condition Assessment</b> Graffiti: None Erosion: None Deposition: None in. Damage: None

<b>Inspection Date:</b> 8/16/2021 9:18:55 AM		<b>Type:</b> Ongoing	<b>Flow:</b> Submerged, indeterminate	<b>Previous Rainfall (hrs):</b> 72+
<b>Illicit Discharge Potential:</b> Unlikely		<b>Inspector:</b> JCW		
Submerged: Partially		Depth (in): 34		
<b>Sampling Results</b> Sample Location: Pool Total Chlorine: 0 ppm Free Chlorine: 0 ppm Ammonia: 0 ppm pH: 7.53 units Temperature: 72 °F Conductivity: 493 µS/cm Detergents: 0 mg/L		Floatables: None Odor: None Turbidity: None Color: None Gross Solids: None Vegetation: None Benthic Growth: Slight Stains: None Non-illicit: None	<b>Notes</b> Sample collected from submerged pool in manhole.

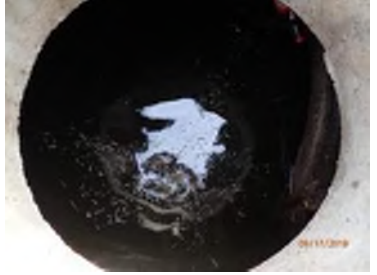
o20190917132614.JPG <div style="text-align: center; font-size: 24pt; font-weight: bold;">2019</div>
			<b>Condition Assessment</b> Graffiti: None Erosion: None Deposition: None in. Damage: None

<b>Inspection Date:</b> 9/17/2019 2:28:11 PM		<b>Type:</b> Ongoing	<b>Flow:</b> Submerged, indeterminate	<b>Previous Rainfall (hrs):</b> 48-72
<b>Illicit Discharge Potential:</b> Unlikely		<b>Inspector:</b> JCW		
Submerged: Fully		Depth (in): 32		
<b>Sampling Results</b> Sample Location: Pool Total Chlorine: 0 ppm Free Chlorine: 0 ppm Ammonia: 0 ppm pH: 8.22 units Temperature: 75 °F Conductivity: 465 µS/cm Detergents: 0 mg/L		Floatables: None Odor: None Turbidity: None Color: None Gross Solids: None Vegetation: None Benthic Growth: Slight Stains: None Non-illicit: None	<b>Notes</b> Sample collected from submerged pool in manhole.

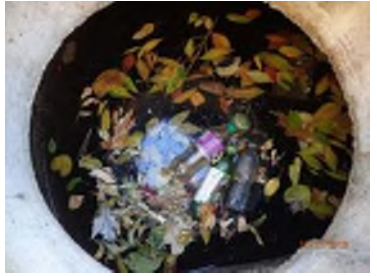
o20181022102412.JPG <div style="text-align: center; font-size: 24pt; font-weight: bold;">2018</div>
			<b>Condition Assessment</b> Graffiti: None Erosion: None Deposition: None in. Damage: None

<b>Inspection Date:</b> 10/22/2018 10:26:35 AM		<b>Type:</b> Ongoing	<b>Flow:</b> Submerged, indeterminate	<b>Previous Rainfall (hrs):</b> 48-72
<b>Illicit Discharge Potential:</b> Potential		<b>Inspector:</b> JCW		
Submerged: Fully		Depth (in): 34		
<b>Sampling Results</b> Sample Location: Pool Total Chlorine: 0 ppm Free Chlorine: 0 ppm Ammonia: 0 ppm pH: 7.46 units Temperature: 58 °F Conductivity: 498 µS/cm Detergents: 0 mg/L		Floatables: None Odor: None Turbidity: None Color: None Gross Solids: Moderate Vegetation: None Benthic Growth: Slight Stains: None Non-illicit: None	<b>Notes</b> Sample collected from submerged pool in manhole. Floating gross solids (litter) in manhole.

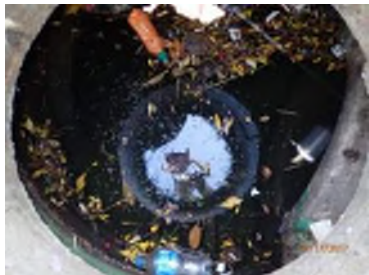
o20171017134106.JPG  
**2017**

<b>Inspection Date:</b> 10/17/2017 1:45:07 PM		<b>Type:</b> Ongoing	<b>Flow:</b> Submerged, indeterminate	<b>Previous Rainfall (hrs):</b> 48-72
<b>Illicit Discharge Potential:</b> <b>Potential</b>		<b>Inspector:</b> JCW	<b>Notes</b>	
Submerged: Fully		Depth (in): 31	Sample collected from submerged pool in manhole. Floating gross solids (litter) in manhole.	
<b>Sampling Results</b>		<b>Floatables:</b> None	<b>Condition Assessment</b> Graffiti: None Erosion: None Deposition: None in. Damage: None	
Sample Location: Pool	Odor: None			
Total Chlorine: 0 ppm	Turbidity: None			
Free Chlorine: 0 ppm	Color: None			
Ammonia: 0 ppm	Gross Solids: Moderate			
pH: 7.74 units	Vegetation: None			
Temperature 69 °F	Benthic Growth: Moderate			
Conductivity: 644 µS/cm	Stains: None			
Detergents: 0 mg/L	Non-illicit: None

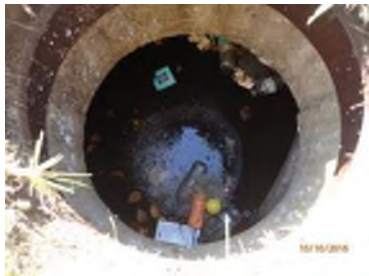
o20161010103236.JPG  
**2016**

<b>Inspection Date:</b> 10/10/2016 10:35:02 AM		<b>Type:</b> Ongoing	<b>Flow:</b> Submerged, indeterminate	<b>Previous Rainfall (hrs):</b> 72+
<b>Illicit Discharge Potential:</b> <b>Potential</b>		<b>Inspector:</b> JCW	<b>Notes</b>	
Submerged: Fully		Depth (in): 28	Potential illicit discharge due to gross solids.	
<b>Sampling Results</b>		<b>Floatables:</b> None	<b>Condition Assessment</b> Graffiti: None Erosion: None Deposition: None in. Damage: None	
Sample Location: Pool	Odor: None			
Total Chlorine: 0 ppm	Turbidity: None			
Free Chlorine: 0 ppm	Color: None			
Ammonia: 0 ppm	Gross Solids: Moderate			
pH: 7.54 units	Vegetation: None			
Temperature 64 °F	Benthic Growth: None			
Conductivity: 592 µS/cm	Stains: None			
Detergents: 0 mg/L	Non-illicit: None

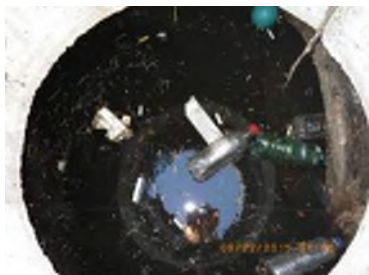
o20150922065636.JPG  
**2015**

<b>Inspection Date:</b> 9/22/2015 7:50:50 AM		<b>Type:</b> Ongoing	<b>Flow:</b> Submerged, indeterminate	<b>Previous Rainfall (hrs):</b> 72+
<b>Illicit Discharge Potential:</b> <b>Potential</b>		<b>Inspector:</b> JCW	<b>Notes</b>	
Submerged: Fully		Depth (in): 28	Floating gross solids (litter) in manhole.	
<b>Sampling Results</b>		<b>Floatables:</b> None	<b>Condition Assessment</b> Graffiti: None Erosion: None Deposition: None in. Damage: None	
Sample Location: Pool	Odor: None			
Total Chlorine: 0 ppm	Turbidity: None			
Free Chlorine: 0 ppm	Color: None			
Ammonia: 0 ppm	Gross Solids: Slight			
pH: 7.74 units	Vegetation: None			
Temperature 66 °F	Benthic Growth: Slight			
Conductivity: 853 µS/cm	Stains: Slight			
Detergents: 0 mg/L	Non-illicit: None

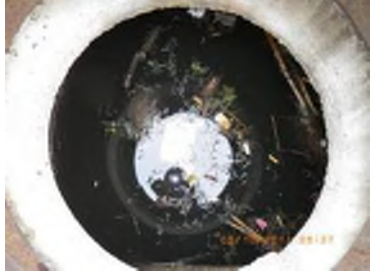
<p>o20110510082708.JPG</p> <p style="font-size: 24pt; font-weight: bold;">2011</p>

<b>Inspection Date:</b> 5/10/2011 8:27:00 AM		<b>Type:</b> Other	<b>Flow:</b> Submerged, indeterminate	<b>Previous Rainfall (hrs):</b> 0-24
<b>Illicit Discharge Potential:</b> Potential		<b>Inspector:</b> JCW		<b>Notes</b> Limited screening conducted for upstream manhole prescreening.
Submerged: Fully		Depth (in):		
<b>Sampling Results</b> Sample Location:		Floatables: None		
Total Chlorine: -- ppm Free Chlorine: -- ppm Ammonia: -- ppm pH: -- units Temperature: -- °F Conductivity: -- µS/cm Detergents: -- mg/L		Odor: Turbidity: Color: Gross Solids: Slight Vegetation: Benthic Growth: Stains: Non-illicit: None		
		<b>Condition Assessment</b> Graffiti: None Erosion: None Deposition: None 0 in. Damage: None

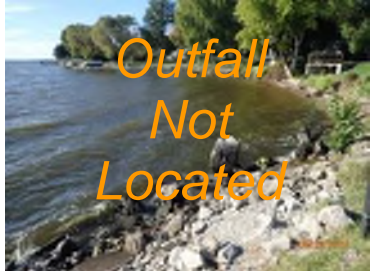
o20220923090838.JPG

<b>Inspection Date:</b> 9/23/2022 9:09:00 AM		<b>Type:</b> Ongoing	<b>Flow:</b> Submerged (not located)	<b>Previous Rainfall (hrs):</b> 72+
<b>Illicit Discharge Potential:</b> Potential		<b>Inspector:</b> EJK	<b>Notes</b>	
Submerged: Fully		Depth (in):	Outfall fully submerged and not located - screened upstream at 02-357 US1. Floating gross solids (litter) in upstream manhole.	
<b>Sampling Results</b>		Floatables:	<b>Condition Assessment</b>	
Sample Location:		Odor:		
Total Chlorine: -- ppm		Turbidity:	Graffiti: None Erosion: None Deposition: None in. Damage: None	
Free Chlorine: -- ppm		Color:		
Ammonia: -- ppm		Gross Solids:		
pH: -- units		Vegetation:		
Temperature -- °F		Benthic Growth:		
Conductivity: -- µS/cm		Stains:		
Detergents: -- mg/L		Non-illicit:

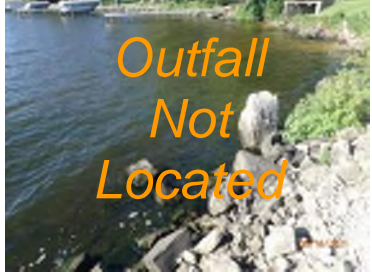
o20210816085746.JPG

<b>Inspection Date:</b> 8/16/2021 8:57:00 AM		<b>Type:</b> Ongoing	<b>Flow:</b> Submerged (not located)	<b>Previous Rainfall (hrs):</b> 72+
<b>Illicit Discharge Potential:</b> Potential		<b>Inspector:</b> JCW	<b>Notes</b>	
Submerged: Fully		Depth (in):	Outfall fully submerged and not located - screened upstream at 02-357 US1. Floating gross solids (litter) in upstream manhole.	
<b>Sampling Results</b>		Floatables:	<b>Condition Assessment</b>	
Sample Location:		Odor:		
Total Chlorine: -- ppm		Turbidity:	Graffiti: None Erosion: None Deposition: None in. Damage: None	
Free Chlorine: -- ppm		Color:		
Ammonia: -- ppm		Gross Solids:		
pH: -- units		Vegetation:		
Temperature -- °F		Benthic Growth:		
Conductivity: -- µS/cm		Stains:		
Detergents: -- mg/L		Non-illicit:

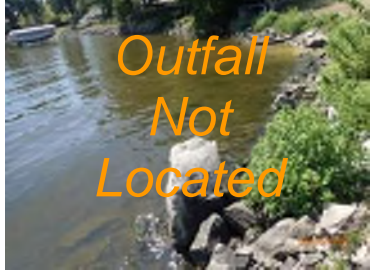
o20200820130304.JPG

<b>Inspection Date:</b> 8/20/2020 1:04:00 PM		<b>Type:</b> Ongoing	<b>Flow:</b> Submerged (not located)	<b>Previous Rainfall (hrs):</b> 72+
<b>Illicit Discharge Potential:</b> Potential		<b>Inspector:</b> JCW	<b>Notes</b>	
Submerged: Fully		Depth (in):	Outfall fully submerged and not located - screened upstream at 02-357 US1. Floating gross solids (litter) in upstream manhole.	
<b>Sampling Results</b>		Floatables:	<b>Condition Assessment</b>	
Sample Location:		Odor:		
Total Chlorine: -- ppm		Turbidity:	Graffiti: None Erosion: None Deposition: None in. Damage: None	
Free Chlorine: -- ppm		Color:		
Ammonia: -- ppm		Gross Solids:		
pH: -- units		Vegetation:		
Temperature -- °F		Benthic Growth:		
Conductivity: -- µS/cm		Stains:		
Detergents: -- mg/L		Non-illicit:

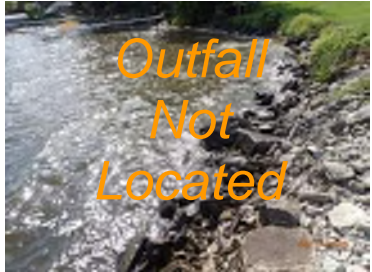
o20190917131538.JPG

<b>Inspection Date:</b> 9/17/2019 2:15:46 PM		<b>Type:</b> Ongoing	<b>Flow:</b> Submerged (not located)	<b>Previous Rainfall (hrs):</b> 48-72
<b>Illicit Discharge Potential:</b> Potential		<b>Inspector:</b> JCW	<b>Notes</b>	
Submerged: Fully		Depth (in):	Outfall fully submerged and not located - screened upstream at 02-357 US1. Floating gross solids (litter) in manhole.	
<b>Sampling Results</b>		Floatables:	<b>Condition Assessment</b>	
Sample Location:		Odor:		
Total Chlorine: -- ppm		Turbidity:	Graffiti: None Erosion: None Deposition: None in. Damage: None	
Free Chlorine: -- ppm		Color:		
Ammonia: -- ppm		Gross Solids:		
pH: -- units		Vegetation:		
Temperature -- °F		Benthic Growth:		
Conductivity: -- µS/cm		Stains:		
Detergents: -- mg/L		Non-illicit:

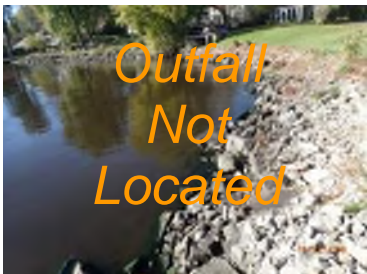
<b>Inspection Date:</b> 10/22/2018 10:13:07 AM		<b>Type:</b> Ongoing		<b>Flow:</b> Submerged (not located)		<b>Previous Rainfall (hrs):</b> 48-72	
<b>Illicit Discharge Potential:</b> Potential		<b>Inspector:</b> JCW		<b>Notes</b>

Submerged: Fully		Depth (in):		Outfall fully submerged and not located - screened upstream at 02-357 US1. Floating gross solids (litter) in manhole.			
<b>Sampling Results</b>		<b>Floatables:</b>		<b>Condition Assessment</b>			
Sample Location:		None		Graffiti:		None	
Total Chlorine: -- ppm		Odor:		Erosion:		None	
Free Chlorine: -- ppm		Turbidity:		Deposition:		None in.	
Ammonia: -- ppm		Color:		Damage:		None	
pH: -- units		Gross Solids:					
Temperature: -- °F		Vegetation:					
Conductivity: -- µS/cm		Benthic Growth:					
Detergents: -- mg/L		Stains:					
		Non-illicit:

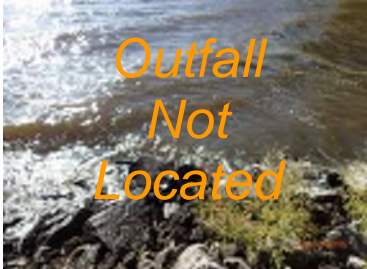
<b>Inspection Date:</b> 10/10/2016 10:53:43 AM		<b>Type:</b> Ongoing		<b>Flow:</b> Submerged (not located)		<b>Previous Rainfall (hrs):</b> 72+	
<b>Illicit Discharge Potential:</b> Potential		<b>Inspector:</b> JCW		<b>Notes</b>

<p>o20161010105240.JPG</p> <p><b>2016</b></p>	
Submerged: Fully		Depth (in):		Outfall fully submerged and not located - screened upstream at 02-357 US1.			
<b>Sampling Results</b>				<b>Condition Assessment</b>			
Sample Location:		Floatables:	None	Graffiti:	None		
Total Chlorine: -- ppm		Odor:	None	Erosion:	None		
Free Chlorine: -- ppm		Turbidity:	None	Deposition:	None	in.	
Ammonia: -- ppm		Color:	None	Damage:	None		
pH: -- units		Gross Solids:	None				
Temperature -- °F		Vegetation:	None				
Conductivity: -- µS/cm		Benthic Growth:	None				
Detergents: -- mg/L		Stains:	None				
		Non-illicit:	None

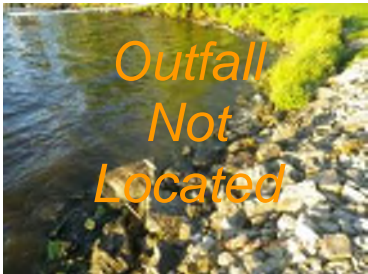
<p>o20150922061856.JPG</p> <p><b>2015</b></p>

<b>Inspection Date:</b> 9/22/2015 7:14:30 AM		<b>Type:</b> Ongoing	<b>Flow:</b> Submerged (not located)	<b>Previous Rainfall (hrs):</b> 72+
<b>Illicit Discharge Potential:</b> Potential		<b>Inspector:</b> JCW		
<b>Submerged:</b> Fully		<b>Depth (in):</b>		
<b>Sampling Results</b>		<b>Notes</b> Outfall fully submerged and not located - screened upstream at 02-357 US1.		
Sample Location:	Floatables:	None		
Total Chlorine: -- ppm	Odor:	None		
Free Chlorine: -- ppm	Turbidity:	None		
Ammonia: -- ppm	Color:	None		
pH: -- units	Gross Solids:	None		
Temperature -- °F	Vegetation:	None		
Conductivity: -- µS/cm	Benthic Growth:	None		
Detergents: -- mg/L	Stains:	None		
	Non-illicit:	None		
		<b>Condition Assessment</b> Graffiti: None Erosion: None Deposition: None in. Damage: None

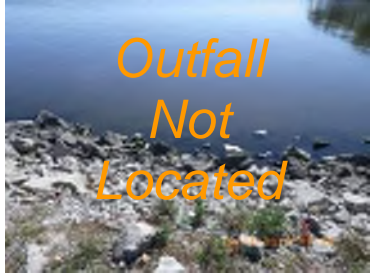
o20141009113806.JPG

<b>Inspection Date:</b> 10/9/2014 12:37:08 PM		<b>Type:</b> Ongoing	<b>Flow:</b> Submerged (not located)	<b>Previous Rainfall (hrs):</b> 72+
<b>Illicit Discharge Potential:</b> <b>Potential</b>		<b>Inspector:</b> JCW	<b>Notes</b>	
Submerged: Fully		Depth (in):	Outfall fully submerged and not located - screened upstream at 02-357 US1.	
<b>Sampling Results</b>		Floatables:	<b>Condition Assessment</b> Graffiti: None Erosion: None Deposition: None in. Damage: None	
Sample Location:		Odor:		
Total Chlorine: -- ppm	Turbidity:			
Free Chlorine: -- ppm	Color:			
Ammonia: -- ppm	Gross Solids:			
pH: -- units	Vegetation:			
Temperature -- °F	Benthic Growth:			
Conductivity: -- µS/cm	Stains:			
Detergents: -- mg/L	Non-illicit:

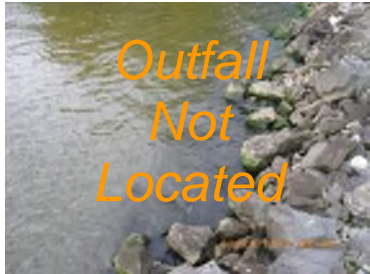
o20120927073330.JPG

<b>Inspection Date:</b> 9/27/2012 8:29:10 AM		<b>Type:</b> Ongoing	<b>Flow:</b> Submerged (not located)	<b>Previous Rainfall (hrs):</b> 72+
<b>Illicit Discharge Potential:</b> <b>Unlikely</b>		<b>Inspector:</b> JCW	<b>Notes</b>	
Submerged: Fully		Depth (in):	Outfall fully submerged; screened upstream at 02-357 US1.	
<b>Sampling Results</b>		Floatables:	<b>Condition Assessment</b> Graffiti: None Erosion: None Deposition: None in. Damage: None	
Sample Location:		Odor:		
Total Chlorine: -- ppm	Turbidity:			
Free Chlorine: -- ppm	Color:			
Ammonia: -- ppm	Gross Solids:			
pH: -- units	Vegetation:			
Temperature -- °F	Benthic Growth:			
Conductivity: -- µS/cm	Stains:			
Detergents: -- mg/L	Non-illicit:

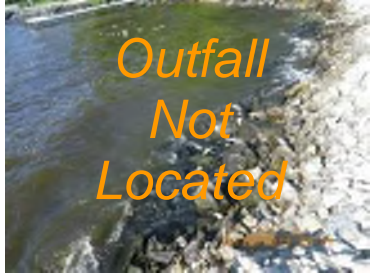
o20120620070830.JPG

<b>Inspection Date:</b> 6/20/2012 8:05:53 AM		<b>Type:</b> Other	<b>Flow:</b> Submerged (not located)	<b>Previous Rainfall (hrs):</b> 24-48
<b>Illicit Discharge Potential:</b> <b>Unlikely</b>		<b>Inspector:</b> JCW	<b>Notes</b>	
Submerged: Fully		Depth (in):	Gross solids pre-screening. Outfall fully submerged; screened upstream at 02-357 US1.	
<b>Sampling Results</b>		Floatables:	<b>Condition Assessment</b> Graffiti: None Erosion: None Deposition: None in. Damage: None	
Sample Location:		Odor:		
Total Chlorine: -- ppm	Turbidity:			
Free Chlorine: -- ppm	Color:			
Ammonia: -- ppm	Gross Solids:			
pH: -- units	Vegetation:			
Temperature -- °F	Benthic Growth:			
Conductivity: -- µS/cm	Stains:			
Detergents: -- mg/L	Non-illicit:
