# Submittal of Annual Reports and Other Compliance Documents for Municipal Separate Storm Sewer System (MS4) Permits

**Project Name:** 2023 Annual Report

**Municipality:** Oshkosh, City

**Permit Number:** S050075

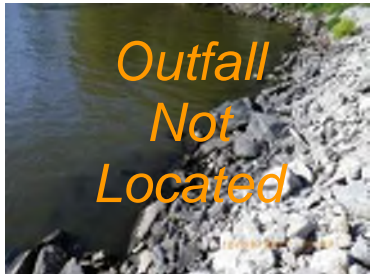
o20111003102714.JPG

<b>Inspection Date:</b> 10/3/2011 10:26:14 AM		<b>Type:</b> Ongoing	<b>Flow:</b> Submerged (not located)	<b>Previous Rainfall (hrs):</b> 72+
<b>Illicit Discharge Potential:</b> <b>Potential</b>		<b>Inspector:</b> JCW	<b>Notes</b>	
Submerged: Fully		Depth (in):	Outfall fully submerged and not physically located. Outfall screened upstream at 02-357 US1.	
<b>Sampling Results</b>		Floatables:	<b>Condition Assessment</b> Graffiti: None Erosion: None Deposition: None 0 in. Damage: None	
Sample Location:		Odor:		
Total Chlorine: -- ppm	Turbidity:			
Free Chlorine: -- ppm	Color:			
Ammonia: -- ppm	Gross Solids:			
pH: -- units	Vegetation:			
Temperature -- °F	Benthic Growth:			
Conductivity: -- µS/cm	Stains:			
Detergents: -- mg/L	Non-illicit:

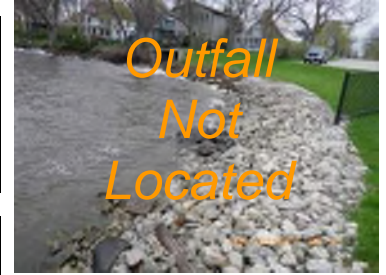
o20110510085116.JPG

<b>Inspection Date:</b> 5/10/2011 8:51:00 AM		<b>Type:</b> Other	<b>Flow:</b> Submerged (not located)	<b>Previous Rainfall (hrs):</b> 0-24
<b>Illicit Discharge Potential:</b> Potential		<b>Inspector:</b> JCW		<b>Notes</b> Outfall fully submerged and not physically located. Outfall screened upstream at 02-357 US1.
Submerged: Fully		Depth (in):		
<b>Sampling Results</b> Sample Location: Total Chlorine: -- ppm Free Chlorine: -- ppm Ammonia: -- ppm pH: -- units Temperature: -- °F Conductivity: -- µS/cm Detergents: -- mg/L		Floatables: Odor: Turbidity: Color: Gross Solids: Vegetation: Benthic Growth: Stains: Non-illicit: None		<b>Condition Assessment</b> Graffiti: None Erosion: None Deposition: None 0 in. Damage: None

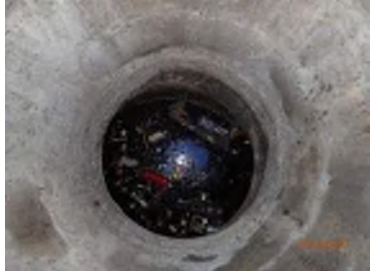
o20220923091028.JPG

<b>Inspection Date:</b> 9/23/2022 9:10:00 AM		<b>Type:</b> Ongoing	<b>Flow:</b> Submerged, indeterminate	<b>Previous Rainfall (hrs):</b> 72+
<b>Illicit Discharge Potential:</b> Potential		<b>Inspector:</b> EJK		
Submerged: Partially		Depth (in): 41		
<b>Sampling Results</b>		<b>Notes</b> Sample collected from submerged pool in manhole. Floating gross solids (litter) in upstream manhole.		
Sample Location: Pool	Floatables: Slight	<b>Condition Assessment</b> Graffiti: None Erosion: None Deposition: None in. Damage: None		
Total Chlorine: 0 ppm	Odor: None			
Free Chlorine: 0 ppm	Turbidity: None			
Ammonia: 0 ppm	Color: None			
pH: 7.8 units	Gross Solids: Moderate			
Temperature 64 °F	Vegetation: None			
Conductivity: 570 µS/cm	Benthic Growth: None			
Detergents: 0 mg/L	Stains: None			
	Non-illicit: None

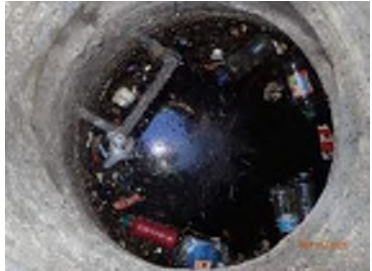
o20210816085830.JPG

<b>Inspection Date:</b> 8/16/2021 9:01:46 AM		<b>Type:</b> Ongoing	<b>Flow:</b> Submerged, indeterminate	<b>Previous Rainfall (hrs):</b> 72+
<b>Illicit Discharge Potential:</b> Potential		<b>Inspector:</b> JCW		
Submerged: Fully		Depth (in): 44		
<b>Sampling Results</b>		<b>Notes</b> Sample collected from submerged pool in manhole. Floating gross solids (litter) in manhole.		
Sample Location: Pool	Floatables: None	<b>Condition Assessment</b> Graffiti: None Erosion: None Deposition: None in. Damage: None		
Total Chlorine: 0 ppm	Odor: None			
Free Chlorine: 0 ppm	Turbidity: None			
Ammonia: 0 ppm	Color: None			
pH: 7.59 units	Gross Solids: Moderate			
Temperature 73 °F	Vegetation: None			
Conductivity: 392 µS/cm	Benthic Growth: None			
Detergents: 0 mg/L	Stains: None			
	Non-illicit: None

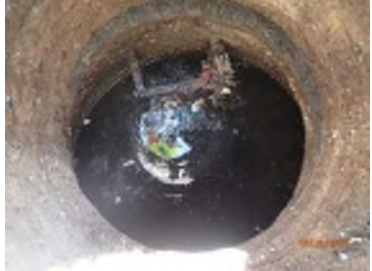
o20200820130342.JPG

<b>Inspection Date:</b> 8/20/2020 1:06:54 PM		<b>Type:</b> Ongoing	<b>Flow:</b> Submerged, indeterminate	<b>Previous Rainfall (hrs):</b> 72+
<b>Illicit Discharge Potential:</b> Potential		<b>Inspector:</b> JCW		
Submerged: Fully		Depth (in): 42		
<b>Sampling Results</b>		<b>Notes</b> Sample collected from submerged pool in manhole. Floating gross solids (litter) in manhole.		
Sample Location: Pool	Floatables: None	<b>Condition Assessment</b> Graffiti: None Erosion: None Deposition: None in. Damage: None		
Total Chlorine: 0 ppm	Odor: None			
Free Chlorine: 0 ppm	Turbidity: None			
Ammonia: 0 ppm	Color: None			
pH: 8.83 units	Gross Solids: Moderate			
Temperature 83 °F	Vegetation: None			
Conductivity: 404 µS/cm	Benthic Growth: None			
Detergents: 0 mg/L	Stains: None			
	Non-illicit: None

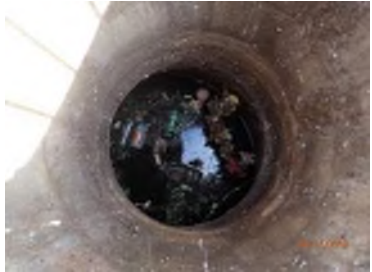
o20190917131642.JPG

<b>Inspection Date:</b> 9/17/2019 2:18:49 PM		<b>Type:</b> Ongoing	<b>Flow:</b> Submerged, indeterminate	<b>Previous Rainfall (hrs):</b> 48-72
<b>Illicit Discharge Potential:</b> Potential		<b>Inspector:</b> JCW		
Submerged: Fully		Depth (in): 42		
<b>Sampling Results</b>		<b>Notes</b> Sample collected from submerged pool in manhole. Floating gross solids (litter) in manhole.		
Sample Location: Pool	Floatables: None	<b>Condition Assessment</b> Graffiti: None Erosion: None Deposition: None in. Damage: None		
Total Chlorine: 0 ppm	Odor: None			
Free Chlorine: 0 ppm	Turbidity: None			
Ammonia: 0 ppm	Color: None			
pH: 8.03 units	Gross Solids: Moderate			
Temperature 76 °F	Vegetation: None			
Conductivity: 404 µS/cm	Benthic Growth: None			
Detergents: 0 mg/L	Stains: None			
	Non-illicit: None

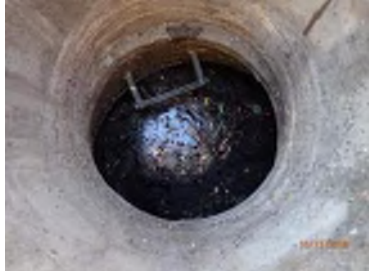
o20181022101258.JPG

<b>Inspection Date:</b> 10/22/2018 10:15:43 AM		<b>Type:</b> Ongoing	<b>Flow:</b> Submerged, indeterminate	<b>Previous Rainfall (hrs):</b> 48-72
<b>Illicit Discharge Potential:</b> <b>Potential</b>		<b>Inspector:</b> JCW	<b>Notes</b>	
Submerged: Fully		Depth (in): 43	Sample collected from submerged pool in manhole. Floating gross solids (litter) in manhole.	
<b>Sampling Results</b>		<b>Floatables:</b> None	<b>Condition Assessment</b>	
Sample Location: Pool		<b>Odor:</b> None	Graffiti: None	
Total Chlorine: 0 ppm		<b>Turbidity:</b> None	Erosion: None	
Free Chlorine: 0 ppm		<b>Color:</b> None	Deposition: None in.	
Ammonia: 0 ppm		<b>Gross Solids:</b> Slight	Damage: None	
pH: 7.17 units		<b>Vegetation:</b> None		
Temperature 60 °F		<b>Benthic Growth:</b> None		
Conductivity: 506 µS/cm		<b>Stains:</b> None		
Detergents: 0 mg/L		<b>Non-illicit:</b> None

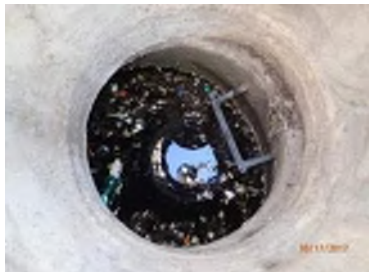
o20171017133104.JPG

<b>Inspection Date:</b> 10/17/2017 1:35:20 PM		<b>Type:</b> Ongoing	<b>Flow:</b> Submerged, indeterminate	<b>Previous Rainfall (hrs):</b> 48-72
<b>Illicit Discharge Potential:</b> <b>Potential</b>		<b>Inspector:</b> JCW	<b>Notes</b>	
Submerged: Fully		Depth (in): 39	Sample collected from submerged pool in manhole. Floating gross solids (litter) in manhole.	
<b>Sampling Results</b>		<b>Floatables:</b> None	<b>Condition Assessment</b>	
Sample Location: Pool		<b>Odor:</b> None	Graffiti: None	
Total Chlorine: 0 ppm		<b>Turbidity:</b> None	Erosion: None	
Free Chlorine: 0 ppm		<b>Color:</b> None	Deposition: None in.	
Ammonia: 0 ppm		<b>Gross Solids:</b> Moderate	Damage: None	
pH: 7.57 units		<b>Vegetation:</b> None		
Temperature 67 °F		<b>Benthic Growth:</b> None		
Conductivity: 537 µS/cm		<b>Stains:</b> None		
Detergents: 0 mg/L		<b>Non-illicit:</b> None

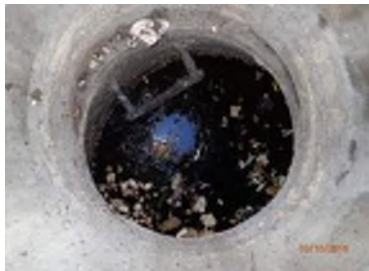
o20161010105436.JPG

<b>Inspection Date:</b> 10/10/2016 10:57:04 AM		<b>Type:</b> Ongoing	<b>Flow:</b> Submerged, indeterminate	<b>Previous Rainfall (hrs):</b> 72+
<b>Illicit Discharge Potential:</b> <b>Potential</b>		<b>Inspector:</b> JCW	<b>Notes</b>	
Submerged: Fully		Depth (in): 37	Potential illicit discharge due to gross solids.	
<b>Sampling Results</b>		<b>Floatables:</b> None	<b>Condition Assessment</b>	
Sample Location: Pool		<b>Odor:</b> None	Graffiti: None	
Total Chlorine: 0 ppm		<b>Turbidity:</b> None	Erosion: None	
Free Chlorine: 0 ppm		<b>Color:</b> None	Deposition: None in.	
Ammonia: 0 ppm		<b>Gross Solids:</b> Moderate	Damage: None	
pH: 7.54 units		<b>Vegetation:</b> None		
Temperature 65 °F		<b>Benthic Growth:</b> None		
Conductivity: 654 µS/cm		<b>Stains:</b> None		
Detergents: 0 mg/L		<b>Non-illicit:</b> None

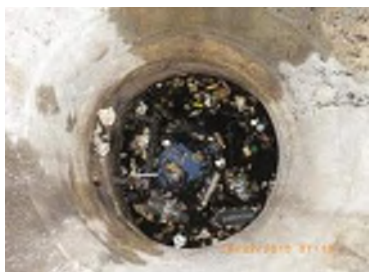
o20150922061944.JPG

<b>Inspection Date:</b> 9/22/2015 7:15:12 AM		<b>Type:</b> Ongoing	<b>Flow:</b> Submerged, indeterminate	<b>Previous Rainfall (hrs):</b> 72+
<b>Illicit Discharge Potential:</b> <b>Potential</b>		<b>Inspector:</b> JCW	<b>Notes</b>	
Submerged: Fully		Depth (in): 39	Floating gross solids (litter) in manhole.	
<b>Sampling Results</b>		<b>Floatables:</b> None	<b>Condition Assessment</b>	
Sample Location: Pool		<b>Odor:</b> None	Graffiti: None	
Total Chlorine: 0 ppm		<b>Turbidity:</b> None	Erosion: None	
Free Chlorine: 0 ppm		<b>Color:</b> None	Deposition: None in.	
Ammonia: 0 ppm		<b>Gross Solids:</b> Moderate	Damage: None	
pH: 7.84 units		<b>Vegetation:</b> None		
Temperature 65 °F		<b>Benthic Growth:</b> None		
Conductivity: 459 µS/cm		<b>Stains:</b> None		
Detergents: 0 mg/L		<b>Non-illicit:</b> None

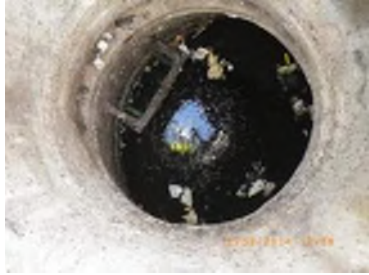
o20141009113842.JPG  
**2014**

<b>Inspection Date:</b> 10/9/2014 12:40:37 PM		<b>Type:</b> Ongoing	<b>Flow:</b> Submerged, indeterminate	<b>Previous Rainfall (hrs):</b> 72+
<b>Illicit Discharge Potential:</b> <b>Potential</b>		<b>Inspector:</b> JCW	<b>Notes</b>	
Submerged: Fully		Depth (in): 35	Floating gross solids (litter) in manhole.	
<b>Sampling Results</b>		<b>Condition Assessment</b>		
Sample Location: Pool	Floatables: None	Graffiti: None	Erosion: None	in.
Total Chlorine: 0 ppm	Odor: None	Deposition: None	Damage: None	
Free Chlorine: 0 ppm	Turbidity: None			
Ammonia: 0 ppm	Color: None			
pH: 7.58 units	Gross Solids: Moderate			
Temperature 62 °F	Vegetation: None			
Conductivity: 707 µS/cm	Benthic Growth: None			
Detergents: 0 mg/L	Stains: None			
	Non-illicit: None

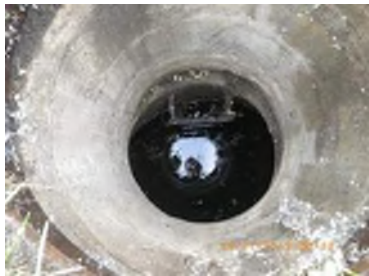
o20120927073352.JPG  
**2012**

<b>Inspection Date:</b> 9/27/2012 8:31:15 AM		<b>Type:</b> Ongoing	<b>Flow:</b> Submerged, indeterminate	<b>Previous Rainfall (hrs):</b> 72+
<b>Illicit Discharge Potential:</b> <b>Unlikely</b>		<b>Inspector:</b> JCW	<b>Notes</b>	
Submerged: Fully		Depth (in): 36	2011 gross solids follow-up.	
<b>Sampling Results</b>		<b>Condition Assessment</b>		
Sample Location: Pool	Floatables: None	Graffiti: None	Erosion: None	in.
Total Chlorine: 0 ppm	Odor: None	Deposition: None	Damage: None	
Free Chlorine: 0 ppm	Turbidity: None			
Ammonia: 0 ppm	Color: None			
pH: 7.73 units	Gross Solids: Slight			
Temperature 60 °F	Vegetation: None			
Conductivity: 518 µS/cm	Benthic Growth: None			
Detergents: 0 mg/L	Stains: None			
	Non-illicit: None

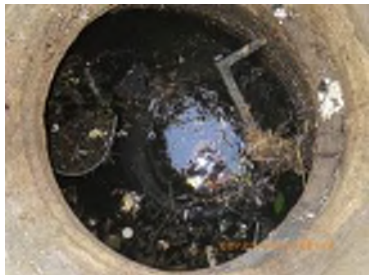
o20120620070908.JPG  
**2012**

<b>Inspection Date:</b> 6/20/2012 8:08:37 AM		<b>Type:</b> Other	<b>Flow:</b> Submerged, indeterminate	<b>Previous Rainfall (hrs):</b> 24-48
<b>Illicit Discharge Potential:</b> <b>Unlikely</b>		<b>Inspector:</b> JCW	<b>Notes</b>	
Submerged: Fully		Depth (in): 43	Gross solids pre-screening.	
<b>Sampling Results</b>		<b>Condition Assessment</b>		
Sample Location: Pool	Floatables: None	Graffiti: None	Erosion: None	in.
Total Chlorine: -- ppm	Odor: None	Deposition: None	Damage: None	
Free Chlorine: -- ppm	Turbidity: None			
Ammonia: -- ppm	Color: None			
pH: -- units	Gross Solids: Moderate			
Temperature -- °F	Vegetation: None			
Conductivity: -- µS/cm	Benthic Growth: Slight			
Detergents: -- mg/L	Stains: None			
	Non-illicit: None

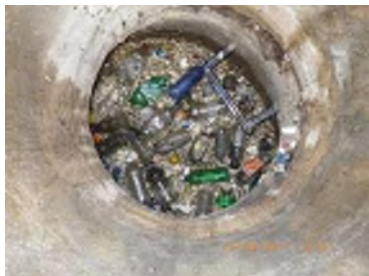
o20111003103104.JPG  
**2011**

<b>Inspection Date:</b> 10/3/2011 10:30:08 AM		<b>Type:</b> Ongoing	<b>Flow:</b> Submerged, indeterminate	<b>Previous Rainfall (hrs):</b> 72+
<b>Illicit Discharge Potential:</b> <b>Potential</b>		<b>Inspector:</b> JCW	<b>Notes</b>	
Submerged: Fully		Depth (in): 39	Significant floatable debris in manhole.	
<b>Sampling Results</b>		<b>Condition Assessment</b>		
Sample Location: Pool	Floatables: None	Graffiti: None	Erosion: None	0 in.
Total Chlorine: 0 ppm	Odor: None	Deposition: None	Damage: None	
Free Chlorine: 0 ppm	Turbidity: None			
Ammonia: 0 ppm	Color: None			
pH: 7.1 units	Gross Solids: Severe			
Temperature 61 °F	Vegetation: None			
Conductivity: -- µS/cm	Benthic Growth: None			
Detergents: 0 mg/L	Stains: None			
	Non-illicit: None

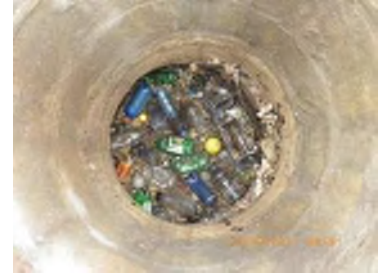
o20110510085154.JPG

<b>Inspection Date:</b> 5/10/2011 8:51:00 AM		<b>Type:</b> Other	<b>Flow:</b> Submerged, indeterminate	<b>Previous Rainfall (hrs):</b> 0-24
<b>Illicit Discharge Potential:</b> Potential		<b>Inspector:</b> JCW		<b>Notes</b> Limited screening conducted for upstream manhole prescreening.
Submerged: Fully		Depth (in):		
<b>Sampling Results</b> Sample Location: Total Chlorine: -- ppm Free Chlorine: -- ppm Ammonia: -- ppm pH: -- units Temperature: -- °F Conductivity: -- µS/cm Detergents: -- mg/L		Floatables: None Odor: Turbidity: Color: Gross Solids: Severe Vegetation: Benthic Growth: Stains: Non-illicit: None		<b>Condition Assessment</b> Graffiti: None Erosion: None Deposition: None 0 in. Damage: None

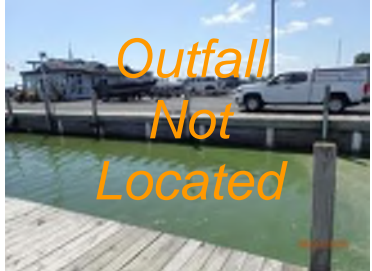
o20220822115730.JPG <div style="text-align: center; font-size: 24pt; font-weight: bold;">2022</div>

<b>Inspection Date:</b> 8/22/2022 12:04:00 PM		<b>Type:</b> Ongoing	<b>Flow:</b> Submerged (not located)	<b>Previous Rainfall (hrs):</b> 72+
<b>Illicit Discharge Potential:</b> <b>Potential</b>		<b>Inspector:</b> EJK		
Submerged: Fully		Depth (in):		
<b>Sampling Results</b> Sample Location: _____ Total Chlorine: -- ppm Free Chlorine: -- ppm Ammonia: -- ppm pH: -- units Temperature: -- °F Conductivity: -- µS/cm Detergents: -- mg/L		Floatables: None Odor: None Turbidity: None Color: None Gross Solids: None Vegetation: None Benthic Growth: None Stains: None Non-illicit: None		
		<b>Notes</b> Outfall fully submerged and not located - screened upstream at 03-119 US1. Detergent in upstream manhole.		
		<b>Condition Assessment</b> Graffiti: None Erosion: None Deposition: None in. Damage: None

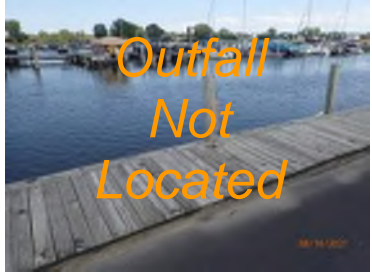
o20210816131918.JPG <div style="text-align: center; font-size: 24pt; font-weight: bold;">2021</div>

<b>Inspection Date:</b> 8/16/2021 1:21:13 PM		<b>Type:</b> Ongoing	<b>Flow:</b> Submerged (not located)	<b>Previous Rainfall (hrs):</b> 72+
<b>Illicit Discharge Potential:</b> <b>Unlikely</b>		<b>Inspector:</b> JCW		
Submerged: Fully		Depth (in):		
<b>Sampling Results</b> Sample Location: _____ Total Chlorine: -- ppm Free Chlorine: -- ppm Ammonia: -- ppm pH: -- units Temperature: -- °F Conductivity: -- µS/cm Detergents: -- mg/L		Floatables: None Odor: None Turbidity: None Color: None Gross Solids: None Vegetation: None Benthic Growth: None Stains: None Non-illicit: None		
		<b>Notes</b> Outfall fully submerged and not located - screened upstream at 03-119 US1.		
		<b>Condition Assessment</b> Graffiti: None Erosion: None Deposition: None in. Damage: None

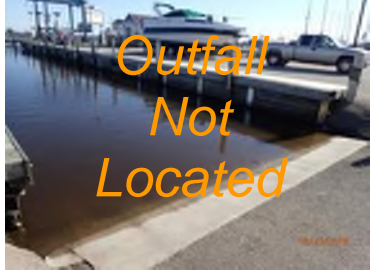
o20181022140104.JPG <div style="text-align: center; font-size: 24pt; font-weight: bold;">2018</div>

<b>Inspection Date:</b> 10/22/2018 2:02:38 PM		<b>Type:</b> Ongoing	<b>Flow:</b> Submerged (not located)	<b>Previous Rainfall (hrs):</b> 48-72
<b>Illicit Discharge Potential:</b> <b>Unlikely</b>		<b>Inspector:</b> JCW		
Submerged: Fully		Depth (in):		
<b>Sampling Results</b> Sample Location: _____ Total Chlorine: -- ppm Free Chlorine: -- ppm Ammonia: -- ppm pH: -- units Temperature: -- °F Conductivity: -- µS/cm Detergents: -- mg/L		Floatables: None Odor: None Turbidity: None Color: None Gross Solids: None Vegetation: None Benthic Growth: None Stains: None Non-illicit: None		
		<b>Notes</b> Outfall fully submerged and not located - screened upstream at 03-119 US1.		
		<b>Condition Assessment</b> Graffiti: None Erosion: None Deposition: None in. Damage: None

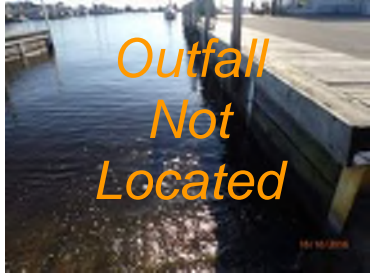
o20161010084558.JPG

<b>Inspection Date:</b> 10/10/2016 8:46:57 AM		<b>Type:</b> Ongoing	<b>Flow:</b> Submerged (not located)	<b>Previous Rainfall (hrs):</b> 72+
<b>Illicit Discharge Potential:</b> Unlikely		<b>Inspector:</b> JCW		
Submerged: Fully		Depth (in):		
<b>Sampling Results</b>		<b>Notes</b>		
Sample Location:	Floatables:	<div style="border: 1px solid black; padding: 5px;"> <p>Outfall fully submerged and not located - screened upstream at 03-119 US1.</p> </div>		
Total Chlorine: -- ppm	Odor:			
Free Chlorine: -- ppm	Turbidity:			
Ammonia: -- ppm	Color:			
pH: -- units	Gross Solids:			
Temperature -- °F	Vegetation:			
Conductivity: -- µS/cm	Benthic Growth:			
Detergents: -- mg/L	Stains:			
	Non-illicit:	<div style="border: 1px solid black; padding: 5px;"> <p><b>Condition Assessment</b></p> <p>Graffiti: None</p> <p>Erosion: None</p> <p>Deposition: None in.</p> <p>Damage: None</p> </div>

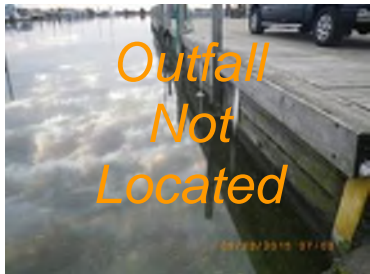
o20150923060350.JPG

<b>Inspection Date:</b> 9/23/2015 7:00:50 AM		<b>Type:</b> Ongoing	<b>Flow:</b> Submerged (not located)	<b>Previous Rainfall (hrs):</b> 72+
<b>Illicit Discharge Potential:</b> Unlikely		<b>Inspector:</b> JCW		
Submerged: Fully		Depth (in):		
<b>Sampling Results</b>		<b>Notes</b>		
Sample Location:	Floatables:	<div style="border: 1px solid black; padding: 5px;"> <p>Outfall fully submerged and not located - screened at 03-119 US1.</p> </div>		
Total Chlorine: -- ppm	Odor:			
Free Chlorine: -- ppm	Turbidity:			
Ammonia: -- ppm	Color:			
pH: -- units	Gross Solids:			
Temperature -- °F	Vegetation:			
Conductivity: -- µS/cm	Benthic Growth:			
Detergents: -- mg/L	Stains:			
	Non-illicit:	<div style="border: 1px solid black; padding: 5px;"> <p><b>Condition Assessment</b></p> <p>Graffiti: None</p> <p>Erosion: None</p> <p>Deposition: None in.</p> <p>Damage: None</p> </div>

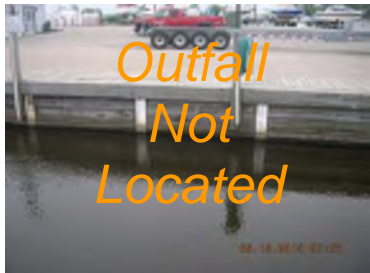
o20100818072558.JPG

<b>Inspection Date:</b> 8/18/2010 7:32:47 AM		<b>Type:</b> Ongoing	<b>Flow:</b> Submerged (not located)	<b>Previous Rainfall (hrs):</b> 72+
<b>Illicit Discharge Potential:</b> Unlikely		<b>Inspector:</b> JCW		
Submerged: Fully		Depth (in):		
<b>Sampling Results</b>		<b>Notes</b>		
Sample Location:	Floatables:	<div style="border: 1px solid black; padding: 5px;"> <p>Outfall fully submerged and not physically located. Outfall screened upstream at 03-119 US1.</p> </div>		
Total Chlorine: -- ppm	Odor:			
Free Chlorine: -- ppm	Turbidity:			
Ammonia: -- ppm	Color:			
pH: -- units	Gross Solids:			
Temperature -- °F	Vegetation:			
Conductivity: -- µS/cm	Benthic Growth:			
Detergents: -- mg/L	Stains:			
	Non-illicit:	<div style="border: 1px solid black; padding: 5px;"> <p><b>Condition Assessment</b></p> <p>Graffiti: None</p> <p>Erosion: None</p> <p>Deposition: None 0 in.</p> <p>Damage: None</p> </div>

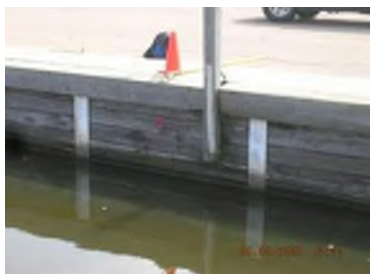
Osh09\_DSCN6741.JPG

<b>Inspection Date:</b> 9/9/2009		<b>Type:</b> Initial	<b>Flow:</b> Submerged, indeterminate	<b>Previous Rainfall (hrs):</b> 72+
<b>Illicit Discharge Potential:</b> Unlikely		<b>Inspector:</b> JCW		
Submerged: Fully		Depth (in):		
<b>Sampling Results</b>		<b>Notes</b>		
Sample Location:	Floatables:	<div style="border: 1px solid black; padding: 5px;"> <p></p> </div>		
Total Chlorine: -- ppm	Odor:			
Free Chlorine: -- ppm	Turbidity:			
Ammonia: -- ppm	Color:			
pH: -- units	Gross Solids:			
Temperature -- °F	Vegetation:			
Conductivity: -- µS/cm	Benthic Growth:			
Detergents: -- mg/L	Stains:			
	Non-illicit:	<div style="border: 1px solid black; padding: 5px;"> <p><b>Condition Assessment</b></p> <p>Graffiti: None</p> <p>Erosion: None</p> <p>Deposition: None in.</p> <p>Damage: None</p> </div>

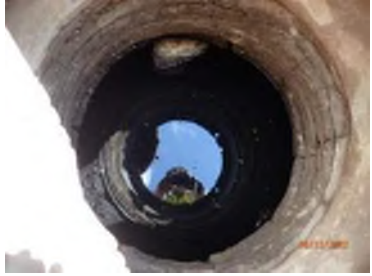
o20220822120016.JPG <b>2022</b>

Sample Location:	Pool																																					
Total Chlorine:	0 ppm																																					
Free Chlorine:	0 ppm																																					
Ammonia:	0 ppm																																					
pH:	6.89 units																																					
Temperature:	75 °F																																					
Conductivity:	312 µS/cm																																					
Detergents:	0.2 mg/L																																					
Floatables:	None																																					
Odor:	None																																					
Turbidity:	None																																					
Color:	None																																					
Gross Solids:	Slight																																					
Vegetation:	None																																					
Benthic Growth:	None																																					
Stains:	None																																					
Non-illicit:	None

<div style="display: flex;"> <div style="flex: 1;"> <p><b>Notes</b></p> <p>Sample collected from submerged pool in manhole. Detergent detected in sample.</p> </div> <div style="flex: 1;"> <p><b>Condition Assessment</b></p> <table border="1" style="width:100%; border-collapse: collapse;"> <tr><td>Graffiti:</td><td>None</td></tr> <tr><td>Erosion:</td><td>None</td></tr> <tr><td>Deposition:</td><td>None in.</td></tr> <tr><td>Damage:</td><td>None</td></tr> </table> </div> </div>			Graffiti:	None	Erosion:	None	Deposition:	None in.	Damage:	None																										
Graffiti:	None																																					
Erosion:	None																																					
Deposition:	None in.																																					
Damage:	None

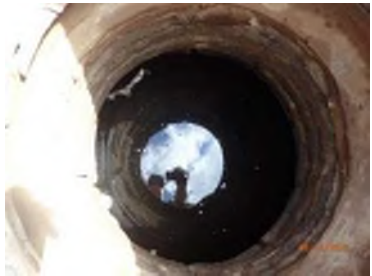
o20210816132344.JPG <b>2021</b>

<b>Inspection Date:</b> 8/16/2021 1:26:50 PM		<b>Type:</b> Ongoing	<b>Flow:</b> Submerged, indeterminate	<b>Previous Rainfall (hrs):</b> 72+																																		
<b>Illicit Discharge Potential:</b> Unlikely		<b>Inspector:</b> JCW																																				
Submerged: Fully		Depth (in): 34																																				
<b>Sampling Results</b>		<div style="display: flex;"> <div style="flex: 1;"> <table border="1" style="width:100%; border-collapse: collapse;"> <tr><td>Sample Location:</td><td>Pool</td></tr> <tr><td>Total Chlorine:</td><td>0 ppm</td></tr> <tr><td>Free Chlorine:</td><td>0 ppm</td></tr> <tr><td>Ammonia:</td><td>0 ppm</td></tr> <tr><td>pH:</td><td>7.41 units</td></tr> <tr><td>Temperature:</td><td>79 °F</td></tr> <tr><td>Conductivity:</td><td>372 µS/cm</td></tr> <tr><td>Detergents:</td><td>0 mg/L</td></tr> </table> </div> <div style="flex: 1;"> <table border="1" style="width:100%; border-collapse: collapse;"> <tr><td>Floatables:</td><td>None</td></tr> <tr><td>Odor:</td><td>None</td></tr> <tr><td>Turbidity:</td><td>None</td></tr> <tr><td>Color:</td><td>None</td></tr> <tr><td>Gross Solids:</td><td>None</td></tr> <tr><td>Vegetation:</td><td>None</td></tr> <tr><td>Benthic Growth:</td><td>None</td></tr> <tr><td>Stains:</td><td>None</td></tr> <tr><td>Non-illicit:</td><td>None</td></tr> </table> </div> </div>			Sample Location:	Pool	Total Chlorine:	0 ppm	Free Chlorine:	0 ppm	Ammonia:	0 ppm	pH:	7.41 units	Temperature:	79 °F	Conductivity:	372 µS/cm	Detergents:	0 mg/L	Floatables:	None	Odor:	None	Turbidity:	None	Color:	None	Gross Solids:	None	Vegetation:	None	Benthic Growth:	None	Stains:	None	Non-illicit:	None

<div style="display: flex;"> <div style="flex: 1;"> <p><b>Notes</b></p> <p>Sample collected from submerged pool in manhole.</p> </div> <div style="flex: 1;"> <p><b>Condition Assessment</b></p> <table border="1" style="width:100%; border-collapse: collapse;"> <tr><td>Graffiti:</td><td>None</td></tr> <tr><td>Erosion:</td><td>None</td></tr> <tr><td>Deposition:</td><td>None in.</td></tr> <tr><td>Damage:</td><td>None</td></tr> </table> </div> </div>			Graffiti:	None	Erosion:	None	Deposition:	None in.	Damage:	None																										
Graffiti:	None																																					
Erosion:	None																																					
Deposition:	None in.																																					
Damage:	None

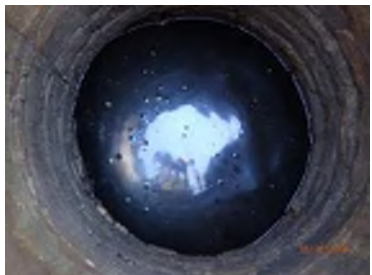
o20181022140340.JPG <b>2018</b>

<b>Inspection Date:</b> 10/22/2018 2:06:18 PM		<b>Type:</b> Ongoing	<b>Flow:</b> Submerged, indeterminate	<b>Previous Rainfall (hrs):</b> 48-72																																		
<b>Illicit Discharge Potential:</b> Unlikely		<b>Inspector:</b> JCW																																				
Submerged: Partially		Depth (in): 32																																				
<b>Sampling Results</b>		<div style="display: flex;"> <div style="flex: 1;"> <table border="1" style="width:100%; border-collapse: collapse;"> <tr><td>Sample Location:</td><td>Pool</td></tr> <tr><td>Total Chlorine:</td><td>0 ppm</td></tr> <tr><td>Free Chlorine:</td><td>0 ppm</td></tr> <tr><td>Ammonia:</td><td>0.5 ppm</td></tr> <tr><td>pH:</td><td>6.72 units</td></tr> <tr><td>Temperature:</td><td>60 °F</td></tr> <tr><td>Conductivity:</td><td>773 µS/cm</td></tr> <tr><td>Detergents:</td><td>0 mg/L</td></tr> </table> </div> <div style="flex: 1;"> <table border="1" style="width:100%; border-collapse: collapse;"> <tr><td>Floatables:</td><td>None</td></tr> <tr><td>Odor:</td><td>None</td></tr> <tr><td>Turbidity:</td><td>None</td></tr> <tr><td>Color:</td><td>None</td></tr> <tr><td>Gross Solids:</td><td>None</td></tr> <tr><td>Vegetation:</td><td>None</td></tr> <tr><td>Benthic Growth:</td><td>None</td></tr> <tr><td>Stains:</td><td>None</td></tr> <tr><td>Non-illicit:</td><td>Moderate</td></tr> </table> </div> </div>			Sample Location:	Pool	Total Chlorine:	0 ppm	Free Chlorine:	0 ppm	Ammonia:	0.5 ppm	pH:	6.72 units	Temperature:	60 °F	Conductivity:	773 µS/cm	Detergents:	0 mg/L	Floatables:	None	Odor:	None	Turbidity:	None	Color:	None	Gross Solids:	None	Vegetation:	None	Benthic Growth:	None	Stains:	None	Non-illicit:	Moderate

<div style="display: flex;"> <div style="flex: 1;"> <p><b>Notes</b></p> <p>Sample collected from submerged pool in manhole.</p> </div> <div style="flex: 1;"> <p><b>Condition Assessment</b></p> <table border="1" style="width:100%; border-collapse: collapse;"> <tr><td>Graffiti:</td><td>None</td></tr> <tr><td>Erosion:</td><td>None</td></tr> <tr><td>Deposition:</td><td>None in.</td></tr> <tr><td>Damage:</td><td>None</td></tr> </table> </div> </div>			Graffiti:	None	Erosion:	None	Deposition:	None in.	Damage:	None																										
Graffiti:	None																																					
Erosion:	None																																					
Deposition:	None in.																																					
Damage:	None

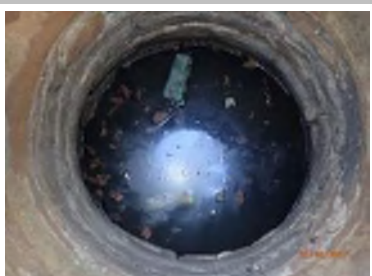
o20171018144002.JPG <b>2017</b>

<b>Inspection Date:</b> 10/18/2017 2:45:31 PM		<b>Type:</b> Ongoing	<b>Flow:</b> Submerged, indeterminate	<b>Previous Rainfall (hrs):</b> 72+																																		
<b>Illicit Discharge Potential:</b> Unlikely		<b>Inspector:</b> JCW																																				
Submerged: Fully		Depth (in): 27																																				
<b>Sampling Results</b>		<div style="display: flex;"> <div style="flex: 1;"> <table border="1" style="width:100%; border-collapse: collapse;"> <tr><td>Sample Location:</td><td>Pool</td></tr> <tr><td>Total Chlorine:</td><td>0 ppm</td></tr> <tr><td>Free Chlorine:</td><td>0 ppm</td></tr> <tr><td>Ammonia:</td><td>0 ppm</td></tr> <tr><td>pH:</td><td>7.18 units</td></tr> <tr><td>Temperature:</td><td>67 °F</td></tr> <tr><td>Conductivity:</td><td>774 µS/cm</td></tr> <tr><td>Detergents:</td><td>0 mg/L</td></tr> </table> </div> <div style="flex: 1;"> <table border="1" style="width:100%; border-collapse: collapse;"> <tr><td>Floatables:</td><td>None</td></tr> <tr><td>Odor:</td><td>None</td></tr> <tr><td>Turbidity:</td><td>None</td></tr> <tr><td>Color:</td><td>None</td></tr> <tr><td>Gross Solids:</td><td>Slight</td></tr> <tr><td>Vegetation:</td><td>None</td></tr> <tr><td>Benthic Growth:</td><td>None</td></tr> <tr><td>Stains:</td><td>None</td></tr> <tr><td>Non-illicit:</td><td>None</td></tr> </table> </div> </div>			Sample Location:	Pool	Total Chlorine:	0 ppm	Free Chlorine:	0 ppm	Ammonia:	0 ppm	pH:	7.18 units	Temperature:	67 °F	Conductivity:	774 µS/cm	Detergents:	0 mg/L	Floatables:	None	Odor:	None	Turbidity:	None	Color:	None	Gross Solids:	Slight	Vegetation:	None	Benthic Growth:	None	Stains:	None	Non-illicit:	None

<div style="display: flex;"> <div style="flex: 1;"> <p><b>Notes</b></p> <p>Sample collected from submerged pool in manhole.</p> </div> <div style="flex: 1;"> <p><b>Condition Assessment</b></p> <table border="1" style="width:100%; border-collapse: collapse;"> <tr><td>Graffiti:</td><td>None</td></tr> <tr><td>Erosion:</td><td>None</td></tr> <tr><td>Deposition:</td><td>None in.</td></tr> <tr><td>Damage:</td><td>None</td></tr> </table> </div> </div>			Graffiti:	None	Erosion:	None	Deposition:	None in.	Damage:	None																										
Graffiti:	None																																					
Erosion:	None																																					
Deposition:	None in.																																					
Damage:	None

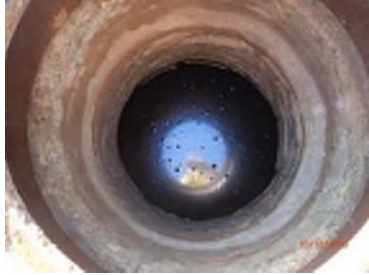
<b>Inspection Date:</b> 10/10/2016 8:50:36 AM		<b>Type:</b> Ongoing	<b>Flow:</b> Submerged, indeterminate	<b>Previous Rainfall (hrs):</b> 72+	
<b>Illicit Discharge Potential:</b> Unlikely		<b>Inspector:</b> JCW	<b>Notes</b>		
Submerged: Fully		Depth (in): 25

o20161010084816.JPG <div style="text-align: center; font-size: 24pt; font-weight: bold;">2016</div>		
<b>Sampling Results</b>					
Sample Location:	Pool	Floatables:			None
Total Chlorine:	0 ppm	Odor:			None
Free Chlorine:	0 ppm	Turbidity:			Slight cloudiness
Ammonia:	0 ppm	Color:			None
pH:	6.98 units	Gross Solids:			None
Temperature	63 °F	Vegetation:			None
Conductivity:	781 µS/cm	Benthic Growth:			None
Detergents:	0 mg/L	Stains:			None
		Non-illicit:	Slight		
			<b>Condition Assessment</b> Graffiti: None Erosion: None Deposition: None in. Damage: None

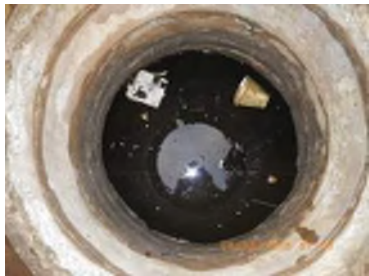
<b>Inspection Date:</b> 9/23/2015 7:05:01 AM		<b>Type:</b> Ongoing	<b>Flow:</b> Submerged, indeterminate	<b>Previous Rainfall (hrs):</b> 72+	
<b>Illicit Discharge Potential:</b> Unlikely		<b>Inspector:</b> JCW	<b>Notes</b>		
Submerged: Fully		Depth (in): 29

o20150923060646.JPG <div style="text-align: center; font-size: 24pt; font-weight: bold;">2015</div>		
<b>Sampling Results</b>					
Sample Location:	Pool	Floatables:			None
Total Chlorine:	0 ppm	Odor:			None
Free Chlorine:	0 ppm	Turbidity:			None
Ammonia:	0 ppm	Color:			None
pH:	7.44 units	Gross Solids:			Slight
Temperature	69 °F	Vegetation:			None
Conductivity:	516 µS/cm	Benthic Growth:			Moderate
Detergents:	0 mg/L	Stains:			None
		Non-illicit:	None		
			<b>Condition Assessment</b> Graffiti: None Erosion: None Deposition: None in. Damage: None

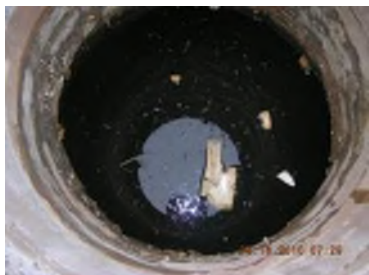
<b>Inspection Date:</b> 8/18/2010 7:36:59 AM		<b>Type:</b> Ongoing	<b>Flow:</b> Submerged, indeterminate	<b>Previous Rainfall (hrs):</b> 72+	
<b>Illicit Discharge Potential:</b> Unlikely		<b>Inspector:</b> JCW	<b>Notes</b>		
Submerged: Fully		Depth (in): 29

o20100818072942.JPG <div style="text-align: center; font-size: 24pt; font-weight: bold;">2010</div>		
<b>Sampling Results</b>					
Sample Location:	Pool	Floatables:			Slight
Total Chlorine:	0 ppm	Odor:			Faint
Free Chlorine:	0 ppm	Turbidity:			None
Ammonia:	0.5 ppm	Color:			Faint in bottle
pH:	7.06 units	Gross Solids:			Slight
Temperature	71 °F	Vegetation:			None
Conductivity:	-- µS/cm	Benthic Growth:			None
Detergents:	0 mg/L	Stains:			None
		Non-illicit:	Slight		
			<b>Condition Assessment</b> Graffiti: None Erosion: None Deposition: None 0 in. Damage: None

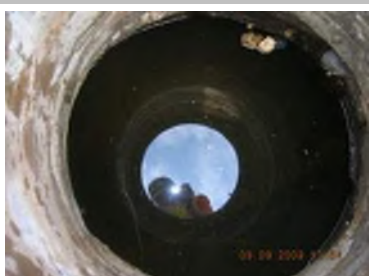
<b>Inspection Date:</b> 9/9/2009		<b>Type:</b> Initial	<b>Flow:</b> Submerged, indeterminate	<b>Previous Rainfall (hrs):</b> 72+	
<b>Illicit Discharge Potential:</b> Unlikely		<b>Inspector:</b> JCW	<b>Notes</b>		
Submerged: Fully		Depth (in): 27

Osh09_DSCN6743.JPG <div style="text-align: center; font-size: 24pt; font-weight: bold;">2009</div>		
<b>Sampling Results</b>					
Sample Location:	Pool	Floatables:			None
Total Chlorine:	0 ppm	Odor:			None
Free Chlorine:	0 ppm	Turbidity:			None
Ammonia:	-- ppm	Color:			None
pH:	7.87 units	Gross Solids:			None
Temperature	76 °F	Vegetation:			None
Conductivity:	-- µS/cm	Benthic Growth:			None
Detergents:	0 mg/L	Stains:			None
		Non-illicit:	None		
			<b>Condition Assessment</b> Graffiti: None Erosion: None Deposition: None 0 in. Damage: None

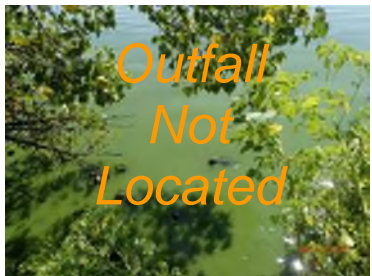
<b>Inspection Date:</b> 8/22/2022 11:05:00 AM		<b>Type:</b> Ongoing	<b>Flow:</b> Submerged (not located)	<b>Previous Rainfall (hrs):</b> 72+
<b>Illicit Discharge Potential:</b> Potential		<b>Inspector:</b> EJK	<b>Notes</b>	
Submerged: Fully		Depth (in):	Outfall fully submerged and not located - screened upstream at 03-173 US1. Dense algae obstructing view. Floating gross solids in upstream manhole.	
<b>Sampling Results</b>		Floatables:	<div style="text-align: center; font-size: 2em; color: orange; font-weight: bold;">Outfall Not Located</div>

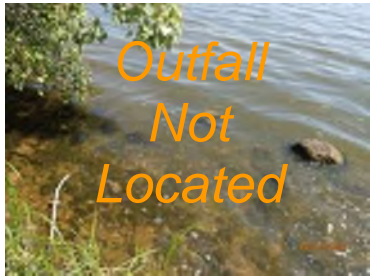
<b>Inspection Date:</b> 8/16/2021 1:06:56 PM		<b>Type:</b> Ongoing	<b>Flow:</b> Submerged (not located)	<b>Previous Rainfall (hrs):</b> 72+
<b>Illicit Discharge Potential:</b> Potential		<b>Inspector:</b> JCW	<b>Notes</b>	
Submerged: Fully		Depth (in):	Outfall fully submerged and not located - screened upstream at 03-173 US1. Floating gross solids (litter) in upstream manhole.	
<b>Sampling Results</b>		Floatables:	<div style="text-align: center; font-size: 2em; color: orange; font-weight: bold;">Outfall Not Located</div>

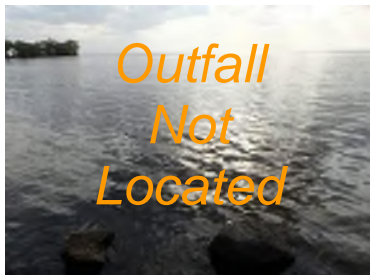
<b>Inspection Date:</b> 9/24/2020 8:57:20 AM		<b>Type:</b> Ongoing	<b>Flow:</b> Submerged (not located)	<b>Previous Rainfall (hrs):</b> 72+
<b>Illicit Discharge Potential:</b> Potential		<b>Inspector:</b> QAL	<b>Notes</b>	
Submerged: Fully		Depth (in):	Outfall fully submerged and not located - screened upstream at 03-173 US1. Floating gross solids (litter) in upstream manhole.	
<b>Sampling Results</b>		Floatables:	<div style="text-align: center; font-size: 2em; color: orange; font-weight: bold;">Outfall Not Located</div>

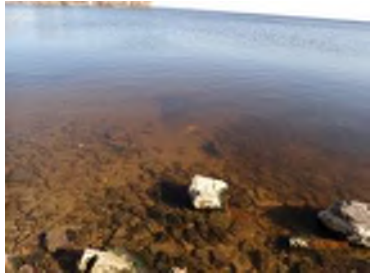
<b>Inspection Date:</b> 11/5/2019 1:14:00 PM		<b>Type:</b> Repeat	<b>Flow:</b> Submerged, indeterminate	<b>Previous Rainfall (hrs):</b> 48-72
<b>Illicit Discharge Potential:</b> Potential		<b>Inspector:</b> JCW	<b>Notes</b>	
Submerged: Fully		Depth (in):	Outfall fully submerged - screened upstream at 03-173 US1. Follow-up inspection for sampling - limited screening conducted.	
<b>Sampling Results</b>		Floatables:	<div style="text-align: center; font-size: 2em; color: orange; font-weight: bold;">Outfall Not Located</div>

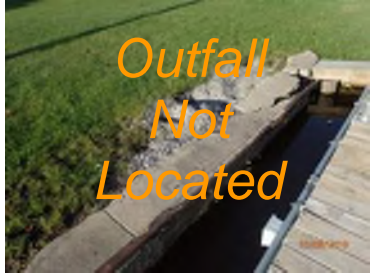
o20191008073428.jpg

<b>Inspection Date:</b> 10/8/2019 8:34:00 AM		<b>Type:</b> Repeat	<b>Flow:</b> Submerged (not located)	<b>Previous Rainfall (hrs):</b> 48-72
<b>Illicit Discharge Potential:</b> Potential		<b>Inspector:</b> JCW		
Submerged: Fully		Depth (in):		
<b>Sampling Results</b>		<b>Notes</b> Outfall fully submerged and not located - screened upstream at 03-22 US1. Follow-up inspection for sampling - limited screening conducted.		
Sample Location:	Floatables:	None		
Total Chlorine: -- ppm	Odor:	None		
Free Chlorine: -- ppm	Turbidity:	None		
Ammonia: -- ppm	Color:	None		
pH: -- units	Gross Solids:	None		
Temperature -- °F	Vegetation:	None		
Conductivity: -- µS/cm	Benthic Growth:	None		
Detergents: -- mg/L	Stains:	None		
	Non-illicit:	None		
		<b>Condition Assessment</b> Graffiti: None Erosion: None Deposition: None in. Damage: None

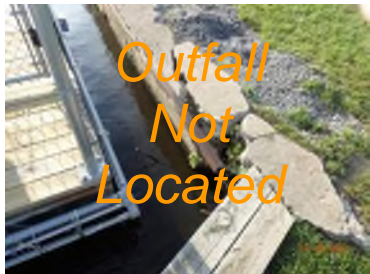
o20190918071544.JPG

<b>Inspection Date:</b> 9/18/2019 8:16:51 AM		<b>Type:</b> Ongoing	<b>Flow:</b> Submerged (not located)	<b>Previous Rainfall (hrs):</b> 72+
<b>Illicit Discharge Potential:</b> Potential		<b>Inspector:</b> JCW		
Submerged: Fully		Depth (in):		
<b>Sampling Results</b>		<b>Notes</b> Outfall fully submerged and not located - screened upstream at 03-22 US1. Floating gross solids (litter) and detergent in manhole.		
Sample Location:	Floatables:	None		
Total Chlorine: -- ppm	Odor:	None		
Free Chlorine: -- ppm	Turbidity:	None		
Ammonia: -- ppm	Color:	None		
pH: -- units	Gross Solids:	None		
Temperature -- °F	Vegetation:	None		
Conductivity: -- µS/cm	Benthic Growth:	None		
Detergents: -- mg/L	Stains:	None		
	Non-illicit:	None		
		<b>Condition Assessment</b> Graffiti: None Erosion: None Deposition: None in. Damage: None

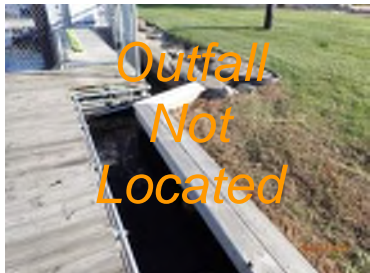
o20181022155222.JPG

<b>Inspection Date:</b> 10/22/2018 3:53:56 PM		<b>Type:</b> Ongoing	<b>Flow:</b> Submerged (not located)	<b>Previous Rainfall (hrs):</b> 48-72
<b>Illicit Discharge Potential:</b> Potential		<b>Inspector:</b> JCW		
Submerged: Fully		Depth (in):		
<b>Sampling Results</b>		<b>Notes</b> Outfall fully submerged and not located - screened upstream at 03-22 US1. Floating gross solids (litter) in manhole.		
Sample Location:	Floatables:	None		
Total Chlorine: -- ppm	Odor:	None		
Free Chlorine: -- ppm	Turbidity:	None		
Ammonia: -- ppm	Color:	None		
pH: -- units	Gross Solids:	None		
Temperature -- °F	Vegetation:	None		
Conductivity: -- µS/cm	Benthic Growth:	None		
Detergents: -- mg/L	Stains:	None		
	Non-illicit:	None		
		<b>Condition Assessment</b> Graffiti: None Erosion: None Deposition: None in. Damage: None

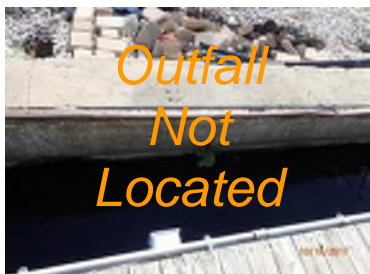
o20171018151946.JPG

<b>Inspection Date:</b> 10/18/2017 3:22:08 PM		<b>Type:</b> Ongoing	<b>Flow:</b> Submerged (not located)	<b>Previous Rainfall (hrs):</b> 72+
<b>Illicit Discharge Potential:</b> Potential		<b>Inspector:</b> JCW		
Submerged: Fully		Depth (in):		
<b>Sampling Results</b>		<b>Notes</b> Outfall fully submerged and not located - screened upstream at 03-22 US1. Floating gross solids (litter) in manhole.		
Sample Location:	Floatables:	None		
Total Chlorine: -- ppm	Odor:	None		
Free Chlorine: -- ppm	Turbidity:	None		
Ammonia: -- ppm	Color:	None		
pH: -- units	Gross Solids:	None		
Temperature -- °F	Vegetation:	None		
Conductivity: -- µS/cm	Benthic Growth:	None		
Detergents: -- mg/L	Stains:	None		
	Non-illicit:	None		
		<b>Condition Assessment</b> Graffiti: None Erosion: None Deposition: None in. Damage: None

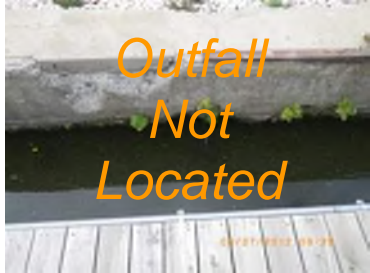
o20120927082846.JPG

<b>Inspection Date:</b> 9/27/2012 9:26:54 AM		<b>Type:</b> Ongoing	<b>Flow:</b> Submerged (not located)	<b>Previous Rainfall (hrs):</b> 72+
<b>Illicit Discharge Potential:</b> Potential		<b>Inspector:</b> JCW	<b>Notes</b>	
Submerged: Fully		Depth (in):	Outfall fully submerged; screened upstream at 03-22 US1.	
<b>Sampling Results</b>		Floatables:	<b>Condition Assessment</b> Graffiti: None Erosion: None Deposition: None in. Damage: None	
Sample Location:		Odor:		
Total Chlorine: -- ppm		Turbidity:		
Free Chlorine: -- ppm		Color:		
Ammonia: -- ppm		Gross Solids:		
pH: -- units		Vegetation:		
Temperature -- °F		Benthic Growth:		
Conductivity: -- µS/cm		Stains:		
Detergents: -- mg/L		Non-illicit:

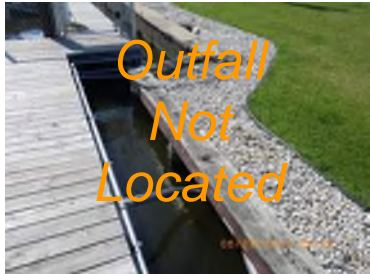
o20120620082248.JPG

<b>Inspection Date:</b> 6/20/2012 9:22:09 AM		<b>Type:</b> Other	<b>Flow:</b> Submerged (not located)	<b>Previous Rainfall (hrs):</b> 24-48
<b>Illicit Discharge Potential:</b> Potential		<b>Inspector:</b> JCW	<b>Notes</b>	
Submerged: Fully		Depth (in):	Gross solids pre-screening.	
<b>Sampling Results</b>		Floatables:	<b>Condition Assessment</b> Graffiti: None Erosion: None Deposition: None in. Damage: None	
Sample Location:		Odor:		
Total Chlorine: -- ppm		Turbidity:		
Free Chlorine: -- ppm		Color:		
Ammonia: -- ppm		Gross Solids:		
pH: -- units		Vegetation:		
Temperature -- °F		Benthic Growth:		
Conductivity: -- µS/cm		Stains:		
Detergents: -- mg/L		Non-illicit:

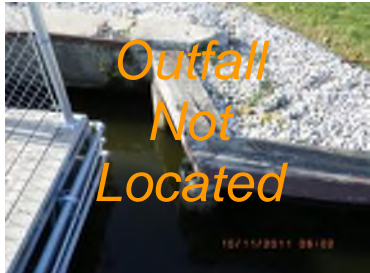
o20111011090250.JPG

<b>Inspection Date:</b> 10/11/2011 9:03:10 AM		<b>Type:</b> Ongoing	<b>Flow:</b> Submerged (not located)	<b>Previous Rainfall (hrs):</b> 72+
<b>Illicit Discharge Potential:</b> Potential		<b>Inspector:</b> JCW	<b>Notes</b>	
Submerged: Fully		Depth (in):	2010 screening follow-up. Outfall fully submerged and not physically located. Outfall screened upstream at 03-22 US1.	
<b>Sampling Results</b>		Floatables:	<b>Condition Assessment</b> Graffiti: None Erosion: None Deposition: None 0 in. Damage: None	
Sample Location:		Odor:		
Total Chlorine: -- ppm		Turbidity:		
Free Chlorine: -- ppm		Color:		
Ammonia: -- ppm		Gross Solids:		
pH: -- units		Vegetation:		
Temperature -- °F		Benthic Growth:		
Conductivity: -- µS/cm		Stains:		
Detergents: -- mg/L		Non-illicit:

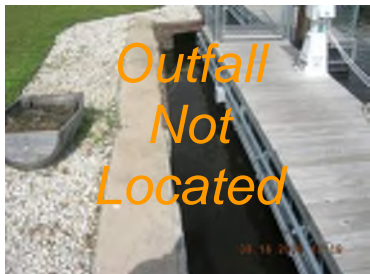
o20100818101918.JPG

<b>Inspection Date:</b> 8/18/2010 10:26:01 AM		<b>Type:</b> Ongoing	<b>Flow:</b> Submerged (not located)	<b>Previous Rainfall (hrs):</b> 72+
<b>Illicit Discharge Potential:</b> Potential		<b>Inspector:</b> JCW	<b>Notes</b>	
Submerged: Fully		Depth (in):	Outfall fully submerged and not physically located. Outfall screened upstream at 03-22 US1.	
<b>Sampling Results</b>		Floatables:	<b>Condition Assessment</b> Graffiti: None Erosion: None Deposition: None 0 in. Damage: None	
Sample Location:		Odor:		
Total Chlorine: -- ppm		Turbidity:		
Free Chlorine: -- ppm		Color:		
Ammonia: -- ppm		Gross Solids:		
pH: -- units		Vegetation:		
Temperature -- °F		Benthic Growth:		
Conductivity: -- µS/cm		Stains:		
Detergents: -- mg/L		Non-illicit:

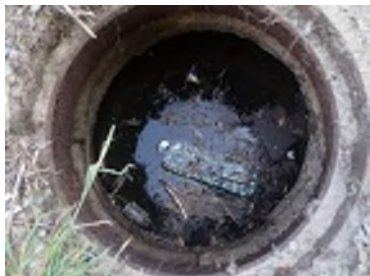
<b>Inspection Date:</b> 8/24/2022 10:31:00 AM		<b>Type:</b> Ongoing	<b>Flow:</b> Submerged, indeterminate	<b>Previous Rainfall (hrs):</b> 72+
<b>Illicit Discharge Potential:</b> Potential		<b>Inspector:</b> EJK		
Submerged: Fully		Depth (in):		
<b>Sampling Results</b>		<b>Notes</b> Sample collected from submerged pool in manhole. Floating gross solids (litter) in manhole.		
Sample Location: Pool	Floatables: None	<b>Condition Assessment</b> Graffiti: None Erosion: None Deposition: None in. Damage: None		
Total Chlorine: 0 ppm	Odor: None			
Free Chlorine: 0 ppm	Turbidity: None			
Ammonia: 0 ppm	Color: None			
pH: 8.54 units	Gross Solids: Moderate			
Temperature 77 °F	Vegetation: None			
Conductivity: 395 µS/cm	Benthic Growth: None			
Detergents: 0 mg/L	Stains: None			
	Non-illicit: None

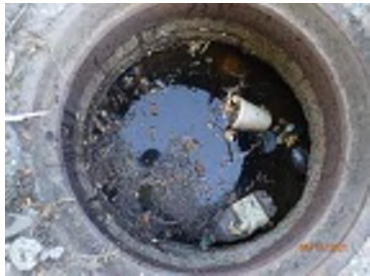
<b>Inspection Date:</b> 8/16/2021 10:36:24 AM		<b>Type:</b> Ongoing	<b>Flow:</b> Submerged, indeterminate	<b>Previous Rainfall (hrs):</b> 72+
<b>Illicit Discharge Potential:</b> Potential		<b>Inspector:</b> JCW		
Submerged: Fully		Depth (in): 49		
<b>Sampling Results</b>		<b>Notes</b> Sample collected from submerged pool in manhole. Floating gross solids (litter) in manhole.		
Sample Location: Pool	Floatables: None	<b>Condition Assessment</b> Graffiti: None Erosion: None Deposition: None in. Damage: None		
Total Chlorine: 0 ppm	Odor: Faint			
Free Chlorine: 0 ppm	Turbidity: None			
Ammonia: 0 ppm	Color: None			
pH: 7.74 units	Gross Solids: Moderate			
Temperature 76 °F	Vegetation: None			
Conductivity: 322 µS/cm	Benthic Growth: None			
Detergents: 0 mg/L	Stains: None			
	Non-illicit: None

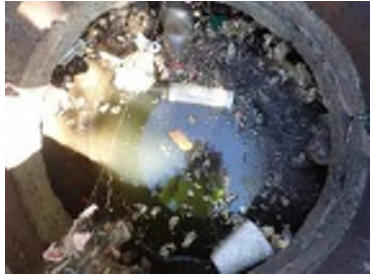
<b>Inspection Date:</b> 8/19/2020 2:04:58 PM		<b>Type:</b> Ongoing	<b>Flow:</b> Submerged, indeterminate	<b>Previous Rainfall (hrs):</b> 72+
<b>Illicit Discharge Potential:</b> Potential		<b>Inspector:</b> JCW		
Submerged: Fully		Depth (in): 47		
<b>Sampling Results</b>		<b>Notes</b> Sample collected from submerged pool in manhole. Floating gross solids (litter) in manhole. Elevated pH seemed widespread in river.		
Sample Location: Pool	Floatables: None	<b>Condition Assessment</b> Graffiti: None Erosion: None Deposition: None in. Damage: None		
Total Chlorine: 0 ppm	Odor: None			
Free Chlorine: 0 ppm	Turbidity: None			
Ammonia: 0 ppm	Color: None			
pH: 9.13 units	Gross Solids: Severe			
Temperature 84 °F	Vegetation: None			
Conductivity: 338 µS/cm	Benthic Growth: None			
Detergents: 0 mg/L	Stains: None			
	Non-illicit: None

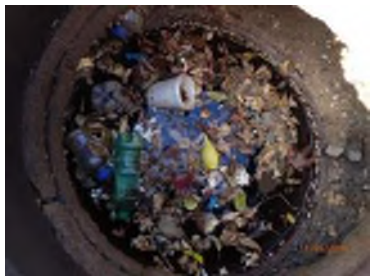
<b>Inspection Date:</b> 11/5/2019 11:28:50 AM		<b>Type:</b> Repeat	<b>Flow:</b> Submerged, indeterminate	<b>Previous Rainfall (hrs):</b> 48-72
<b>Illicit Discharge Potential:</b> Potential		<b>Inspector:</b> JCW		
Submerged: Partially		Depth (in): 47		
<b>Sampling Results</b>		<b>Notes</b> Follow-up inspection for sampling - limited screening conducted. Floating gross solids (litter) in manhole.		
Sample Location: Pool	Floatables: None	<b>Condition Assessment</b> Graffiti: None Erosion: None Deposition: None in. Damage: None		
Total Chlorine: -- ppm	Odor: None			
Free Chlorine: -- ppm	Turbidity: None			
Ammonia: -- ppm	Color: None			
pH: -- units	Gross Solids: Severe			
Temperature -- °F	Vegetation: None			
Conductivity: -- µS/cm	Benthic Growth: None			
Detergents: 0 mg/L	Stains: None			
	Non-illicit: None

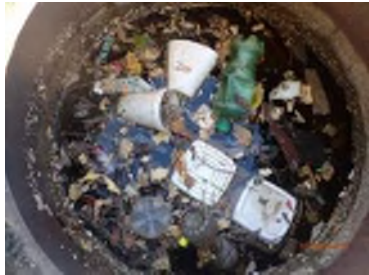
o20191008073520.jpg <div style="text-align: center; font-weight: bold; font-size: 1.2em;">2019</div>

<b>Inspection Date:</b> 10/8/2019 8:35:00 AM		<b>Type:</b> Repeat	<b>Flow:</b> Submerged, indeterminate	<b>Previous Rainfall (hrs):</b> 48-72																																										
<b>Illicit Discharge Potential:</b> <b>Potential</b>		<b>Inspector:</b> JCW	<b>Notes</b>																																											
Submerged: Partially      Depth (in): 47			Follow-up inspection for sampling - limited screening conducted. Floating gross solids (litter) in manhole.																																											
<b>Sampling Results</b> <table border="1" style="width:100%; border-collapse: collapse;"> <tr> <td>Sample Location:</td> <td>Pool</td> </tr> <tr> <td>Total Chlorine:</td> <td>0 ppm</td> </tr> <tr> <td>Free Chlorine:</td> <td>0 ppm</td> </tr> <tr> <td>Ammonia:</td> <td>0 ppm</td> </tr> <tr> <td>pH:</td> <td>7.58 units</td> </tr> <tr> <td>Temperature:</td> <td>56 °F</td> </tr> <tr> <td>Conductivity:</td> <td>381 µS/cm</td> </tr> <tr> <td>Detergents:</td> <td>1.2 mg/L</td> </tr> </table>		Sample Location:	Pool	Total Chlorine:	0 ppm	Free Chlorine:	0 ppm	Ammonia:	0 ppm	pH:	7.58 units	Temperature:	56 °F	Conductivity:	381 µS/cm	Detergents:	1.2 mg/L	<table border="1" style="width:100%; border-collapse: collapse;"> <tr> <td>Floatables:</td> <td>None</td> </tr> <tr> <td>Odor:</td> <td>None</td> </tr> <tr> <td>Turbidity:</td> <td>None</td> </tr> <tr> <td>Color:</td> <td>None</td> </tr> <tr> <td>Gross Solids:</td> <td>Severe</td> </tr> <tr> <td>Vegetation:</td> <td>None</td> </tr> <tr> <td>Benthic Growth:</td> <td>None</td> </tr> <tr> <td>Stains:</td> <td>None</td> </tr> <tr> <td>Non-illicit:</td> <td>None</td> </tr> </table>	Floatables:	None	Odor:	None	Turbidity:	None	Color:	None	Gross Solids:	Severe	Vegetation:	None	Benthic Growth:	None	Stains:	None	Non-illicit:	None	<b>Condition Assessment</b> <table border="1" style="width:100%; border-collapse: collapse;"> <tr> <td>Graffiti:</td> <td>None</td> </tr> <tr> <td>Erosion:</td> <td>None</td> </tr> <tr> <td>Deposition:</td> <td>None in.</td> </tr> <tr> <td>Damage:</td> <td>None</td> </tr> </table>		Graffiti:	None	Erosion:	None	Deposition:	None in.	Damage:	None

Sample Location:	Pool																																													
Total Chlorine:	0 ppm																																													
Free Chlorine:	0 ppm																																													
Ammonia:	0 ppm																																													
pH:	7.58 units																																													
Temperature:	56 °F																																													
Conductivity:	381 µS/cm																																													
Detergents:	1.2 mg/L																																													
Floatables:	None																																													
Odor:	None																																													
Turbidity:	None																																													
Color:	None																																													
Gross Solids:	Severe																																													
Vegetation:	None																																													
Benthic Growth:	None

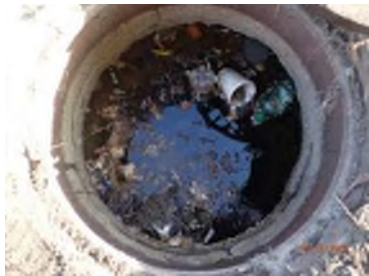
o20190918071726.JPG <div style="text-align: center; font-weight: bold; font-size: 1.2em;">2019</div>

<b>Inspection Date:</b> 9/18/2019 8:19:32 AM		<b>Type:</b> Ongoing	<b>Flow:</b> Submerged, indeterminate	<b>Previous Rainfall (hrs):</b> 72+																																										
<b>Illicit Discharge Potential:</b> <b>Potential</b>		<b>Inspector:</b> JCW	<b>Notes</b>																																											
Submerged: Fully      Depth (in): 49			Sample collected from submerged pool in manhole. Floating gross solids (litter) and detergent in manhole.																																											
<b>Sampling Results</b> <table border="1" style="width:100%; border-collapse: collapse;"> <tr> <td>Sample Location:</td> <td>Pool</td> </tr> <tr> <td>Total Chlorine:</td> <td>0 ppm</td> </tr> <tr> <td>Free Chlorine:</td> <td>0 ppm</td> </tr> <tr> <td>Ammonia:</td> <td>0 ppm</td> </tr> <tr> <td>pH:</td> <td>8.64 units</td> </tr> <tr> <td>Temperature:</td> <td>71 °F</td> </tr> <tr> <td>Conductivity:</td> <td>372 µS/cm</td> </tr> <tr> <td>Detergents:</td> <td>1 mg/L</td> </tr> </table>		Sample Location:	Pool	Total Chlorine:	0 ppm	Free Chlorine:	0 ppm	Ammonia:	0 ppm	pH:	8.64 units	Temperature:	71 °F	Conductivity:	372 µS/cm	Detergents:	1 mg/L	<table border="1" style="width:100%; border-collapse: collapse;"> <tr> <td>Floatables:</td> <td>None</td> </tr> <tr> <td>Odor:</td> <td>None</td> </tr> <tr> <td>Turbidity:</td> <td>None</td> </tr> <tr> <td>Color:</td> <td>None</td> </tr> <tr> <td>Gross Solids:</td> <td>Moderate</td> </tr> <tr> <td>Vegetation:</td> <td>None</td> </tr> <tr> <td>Benthic Growth:</td> <td>None</td> </tr> <tr> <td>Stains:</td> <td>None</td> </tr> <tr> <td>Non-illicit:</td> <td>None</td> </tr> </table>	Floatables:	None	Odor:	None	Turbidity:	None	Color:	None	Gross Solids:	Moderate	Vegetation:	None	Benthic Growth:	None	Stains:	None	Non-illicit:	None	<b>Condition Assessment</b> <table border="1" style="width:100%; border-collapse: collapse;"> <tr> <td>Graffiti:</td> <td>None</td> </tr> <tr> <td>Erosion:</td> <td>None</td> </tr> <tr> <td>Deposition:</td> <td>None in.</td> </tr> <tr> <td>Damage:</td> <td>None</td> </tr> </table>		Graffiti:	None	Erosion:	None	Deposition:	None in.	Damage:	None

Sample Location:	Pool																																													
Total Chlorine:	0 ppm																																													
Free Chlorine:	0 ppm																																													
Ammonia:	0 ppm																																													
pH:	8.64 units																																													
Temperature:	71 °F																																													
Conductivity:	372 µS/cm																																													
Detergents:	1 mg/L																																													
Floatables:	None																																													
Odor:	None																																													
Turbidity:	None																																													
Color:	None																																													
Gross Solids:	Moderate																																													
Vegetation:	None																																													
Benthic Growth:	None

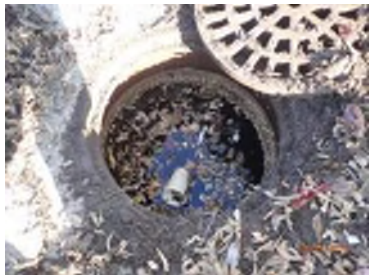
o20181022155408.JPG <div style="text-align: center; font-weight: bold; font-size: 1.2em;">2018</div>

<b>Inspection Date:</b> 10/22/2018 3:58:28 PM		<b>Type:</b> Ongoing	<b>Flow:</b> Submerged, indeterminate	<b>Previous Rainfall (hrs):</b> 48-72																																										
<b>Illicit Discharge Potential:</b> <b>Potential</b>		<b>Inspector:</b> JCW	<b>Notes</b>																																											
Submerged: Fully      Depth (in): 49			Sample collected from submerged pool in manhole. Floating gross solids (litter) in manhole.																																											
<b>Sampling Results</b> <table border="1" style="width:100%; border-collapse: collapse;"> <tr> <td>Sample Location:</td> <td>Pool</td> </tr> <tr> <td>Total Chlorine:</td> <td>0 ppm</td> </tr> <tr> <td>Free Chlorine:</td> <td>0 ppm</td> </tr> <tr> <td>Ammonia:</td> <td>0 ppm</td> </tr> <tr> <td>pH:</td> <td>7.68 units</td> </tr> <tr> <td>Temperature:</td> <td>55 °F</td> </tr> <tr> <td>Conductivity:</td> <td>355 µS/cm</td> </tr> <tr> <td>Detergents:</td> <td>0 mg/L</td> </tr> </table>		Sample Location:	Pool	Total Chlorine:	0 ppm	Free Chlorine:	0 ppm	Ammonia:	0 ppm	pH:	7.68 units	Temperature:	55 °F	Conductivity:	355 µS/cm	Detergents:	0 mg/L	<table border="1" style="width:100%; border-collapse: collapse;"> <tr> <td>Floatables:</td> <td>None</td> </tr> <tr> <td>Odor:</td> <td>None</td> </tr> <tr> <td>Turbidity:</td> <td>None</td> </tr> <tr> <td>Color:</td> <td>None</td> </tr> <tr> <td>Gross Solids:</td> <td>Moderate</td> </tr> <tr> <td>Vegetation:</td> <td>None</td> </tr> <tr> <td>Benthic Growth:</td> <td>None</td> </tr> <tr> <td>Stains:</td> <td>None</td> </tr> <tr> <td>Non-illicit:</td> <td>None</td> </tr> </table>	Floatables:	None	Odor:	None	Turbidity:	None	Color:	None	Gross Solids:	Moderate	Vegetation:	None	Benthic Growth:	None	Stains:	None	Non-illicit:	None	<b>Condition Assessment</b> <table border="1" style="width:100%; border-collapse: collapse;"> <tr> <td>Graffiti:</td> <td>None</td> </tr> <tr> <td>Erosion:</td> <td>None</td> </tr> <tr> <td>Deposition:</td> <td>None in.</td> </tr> <tr> <td>Damage:</td> <td>None</td> </tr> </table>		Graffiti:	None	Erosion:	None	Deposition:	None in.	Damage:	None

Sample Location:	Pool																																													
Total Chlorine:	0 ppm																																													
Free Chlorine:	0 ppm																																													
Ammonia:	0 ppm																																													
pH:	7.68 units																																													
Temperature:	55 °F																																													
Conductivity:	355 µS/cm																																													
Detergents:	0 mg/L																																													
Floatables:	None																																													
Odor:	None																																													
Turbidity:	None																																													
Color:	None																																													
Gross Solids:	Moderate																																													
Vegetation:	None																																													
Benthic Growth:	None

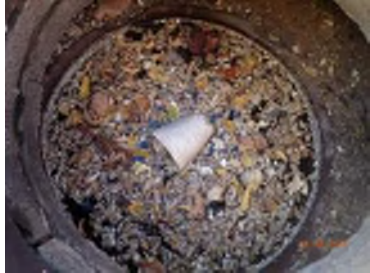
<p style="text-align: center;">o20161018160430.JPG</p> <p style="text-align: center; font-size: 24pt; font-weight: bold;">2016</p>																																									
Submerged: Fully		Depth (in): 44		Potential illicit discharge due to gross solids.																																											
<b>Sampling Results</b> <table border="1" style="width:100%; border-collapse: collapse;"> <tr><td colspan="2">Sample Location: Pool</td></tr> <tr><td>Total Chlorine:</td><td>0 ppm</td></tr> <tr><td>Free Chlorine:</td><td>0 ppm</td></tr> <tr><td>Ammonia:</td><td>0 ppm</td></tr> <tr><td>pH:</td><td>8.15 units</td></tr> <tr><td>Temperature:</td><td>66 °F</td></tr> <tr><td>Conductivity:</td><td>403 µS/cm</td></tr> <tr><td>Detergents:</td><td>0 mg/L</td></tr> </table>		Sample Location: Pool		Total Chlorine:	0 ppm			Free Chlorine:	0 ppm	Ammonia:	0 ppm	pH:	8.15 units	Temperature:	66 °F	Conductivity:	403 µS/cm	Detergents:	0 mg/L	<table border="1" style="width:100%; border-collapse: collapse;"> <tr><td>Floatables:</td><td>None</td></tr> <tr><td>Odor:</td><td>None</td></tr> <tr><td>Turbidity:</td><td>None</td></tr> <tr><td>Color:</td><td>Faint in bottle</td></tr> <tr><td>Gross Solids:</td><td>Severe</td></tr> <tr><td>Vegetation:</td><td>None</td></tr> <tr><td>Benthic Growth:</td><td>None</td></tr> <tr><td>Stains:</td><td>None</td></tr> <tr><td>Non-illicit:</td><td>None</td></tr> </table>		Floatables:	None	Odor:	None	Turbidity:	None	Color:	Faint in bottle	Gross Solids:	Severe	Vegetation:	None	Benthic Growth:	None	Stains:	None	Non-illicit:	None	<b>Condition Assessment</b> <table border="1" style="width:100%; border-collapse: collapse;"> <tr><td>Graffiti:</td><td>None</td></tr> <tr><td>Erosion:</td><td>None</td></tr> <tr><td>Deposition:</td><td>None in.</td></tr> <tr><td>Damage:</td><td>None</td></tr> </table>		Graffiti:	None	Erosion:	None	Deposition:	None in.

Sample Location: Pool																																															
Total Chlorine:	0 ppm																																														
Free Chlorine:	0 ppm																																														
Ammonia:	0 ppm																																														
pH:	8.15 units																																														
Temperature:	66 °F																																														
Conductivity:	403 µS/cm																																														
Detergents:	0 mg/L																																														
Floatables:	None																																														
Odor:	None																																														
Turbidity:	None																																														
Color:	Faint in bottle																																														
Gross Solids:	Severe																																														
Vegetation:	None																																														
Benthic Growth:	None

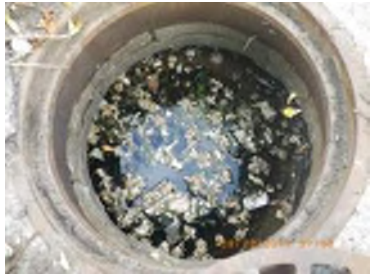
<p style="text-align: center;">o20150923065324.JPG</p> <p style="text-align: center; font-size: 24pt; font-weight: bold;">2015</p>																																									
Submerged: Fully		Depth (in): 46		Floating gross solids (litter) in manhole.																																											
<b>Sampling Results</b> <table border="1" style="width:100%; border-collapse: collapse;"> <tr><td colspan="2">Sample Location: Pool</td></tr> <tr><td>Total Chlorine:</td><td>0 ppm</td></tr> <tr><td>Free Chlorine:</td><td>0 ppm</td></tr> <tr><td>Ammonia:</td><td>0 ppm</td></tr> <tr><td>pH:</td><td>8.44 units</td></tr> <tr><td>Temperature:</td><td>70 °F</td></tr> <tr><td>Conductivity:</td><td>354 µS/cm</td></tr> <tr><td>Detergents:</td><td>0 mg/L</td></tr> </table>		Sample Location: Pool		Total Chlorine:	0 ppm			Free Chlorine:	0 ppm	Ammonia:	0 ppm	pH:	8.44 units	Temperature:	70 °F	Conductivity:	354 µS/cm	Detergents:	0 mg/L	<table border="1" style="width:100%; border-collapse: collapse;"> <tr><td>Floatables:</td><td>None</td></tr> <tr><td>Odor:</td><td>None</td></tr> <tr><td>Turbidity:</td><td>None</td></tr> <tr><td>Color:</td><td>None</td></tr> <tr><td>Gross Solids:</td><td>Moderate</td></tr> <tr><td>Vegetation:</td><td>None</td></tr> <tr><td>Benthic Growth:</td><td>None</td></tr> <tr><td>Stains:</td><td>None</td></tr> <tr><td>Non-illicit:</td><td>None</td></tr> </table>		Floatables:	None	Odor:	None	Turbidity:	None	Color:	None	Gross Solids:	Moderate	Vegetation:	None	Benthic Growth:	None	Stains:	None	Non-illicit:	None	<b>Condition Assessment</b> <table border="1" style="width:100%; border-collapse: collapse;"> <tr><td>Graffiti:</td><td>None</td></tr> <tr><td>Erosion:</td><td>None</td></tr> <tr><td>Deposition:</td><td>None in.</td></tr> <tr><td>Damage:</td><td>None</td></tr> </table>		Graffiti:	None	Erosion:	None	Deposition:	None in.

Sample Location: Pool																																															
Total Chlorine:	0 ppm																																														
Free Chlorine:	0 ppm																																														
Ammonia:	0 ppm																																														
pH:	8.44 units																																														
Temperature:	70 °F																																														
Conductivity:	354 µS/cm																																														
Detergents:	0 mg/L																																														
Floatables:	None																																														
Odor:	None																																														
Turbidity:	None																																														
Color:	None																																														
Gross Solids:	Moderate																																														
Vegetation:	None																																														
Benthic Growth:	None
