# Submittal of Annual Reports and Other Compliance Documents for Municipal Separate Storm Sewer System (MS4) Permits

**Project Name:** 2023 Annual Report

**Municipality:** Oshkosh, City

**Permit Number:** S050075

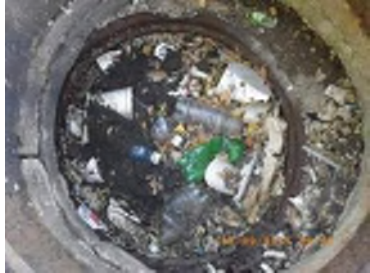
<p style="text-align: center;">o20141009085040.JPG</p> <p style="text-align: center; font-size: 24pt; font-weight: bold;">2014</p>																																									
Submerged: Fully		Depth (in): 40		Floatable litter in catchbasin.																																											
<b>Sampling Results</b> <table border="1" style="width:100%; border-collapse: collapse;"> <tr><td colspan="2">Sample Location: Pool</td></tr> <tr><td>Total Chlorine:</td><td>0 ppm</td></tr> <tr><td>Free Chlorine:</td><td>0 ppm</td></tr> <tr><td>Ammonia:</td><td>0 ppm</td></tr> <tr><td>pH:</td><td>7.79 units</td></tr> <tr><td>Temperature:</td><td>57 °F</td></tr> <tr><td>Conductivity:</td><td>442 µS/cm</td></tr> <tr><td>Detergents:</td><td>0 mg/L</td></tr> </table>		Sample Location: Pool		Total Chlorine:	0 ppm			Free Chlorine:	0 ppm	Ammonia:	0 ppm	pH:	7.79 units	Temperature:	57 °F	Conductivity:	442 µS/cm	Detergents:	0 mg/L	<table border="1" style="width:100%; border-collapse: collapse;"> <tr><td>Floatables:</td><td>None</td></tr> <tr><td>Odor:</td><td>None</td></tr> <tr><td>Turbidity:</td><td>None</td></tr> <tr><td>Color:</td><td>Faint in bottle</td></tr> <tr><td>Gross Solids:</td><td>Severe</td></tr> <tr><td>Vegetation:</td><td>None</td></tr> <tr><td>Benthic Growth:</td><td>None</td></tr> <tr><td>Stains:</td><td>None</td></tr> <tr><td>Non-illicit:</td><td>None</td></tr> </table>		Floatables:	None	Odor:	None	Turbidity:	None	Color:	Faint in bottle	Gross Solids:	Severe	Vegetation:	None	Benthic Growth:	None	Stains:	None	Non-illicit:	None	<b>Condition Assessment</b> <table border="1" style="width:100%; border-collapse: collapse;"> <tr><td>Graffiti:</td><td>None</td></tr> <tr><td>Erosion:</td><td>None</td></tr> <tr><td>Deposition:</td><td>None in.</td></tr> <tr><td>Damage:</td><td>None</td></tr> </table>		Graffiti:	None	Erosion:	None	Deposition:	None in.

Sample Location: Pool																																															
Total Chlorine:	0 ppm																																														
Free Chlorine:	0 ppm																																														
Ammonia:	0 ppm																																														
pH:	7.79 units																																														
Temperature:	57 °F																																														
Conductivity:	442 µS/cm																																														
Detergents:	0 mg/L																																														
Floatables:	None																																														
Odor:	None																																														
Turbidity:	None																																														
Color:	Faint in bottle																																														
Gross Solids:	Severe																																														
Vegetation:	None																																														
Benthic Growth:	None

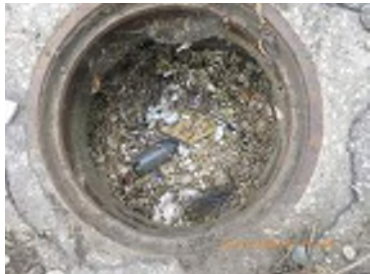
<p style="text-align: center;">o20130731114610.JPG</p> <p style="text-align: center; font-size: 24pt; font-weight: bold;">2013</p>																																									
Submerged: Fully		Depth (in): 44		2012 screening follow-up. Significant gross solids - similar to previous years.																																											
<b>Sampling Results</b> <table border="1" style="width:100%; border-collapse: collapse;"> <tr><td colspan="2">Sample Location: Pool</td></tr> <tr><td>Total Chlorine:</td><td>0 ppm</td></tr> <tr><td>Free Chlorine:</td><td>0 ppm</td></tr> <tr><td>Ammonia:</td><td>0 ppm</td></tr> <tr><td>pH:</td><td>7.95 units</td></tr> <tr><td>Temperature:</td><td>76 °F</td></tr> <tr><td>Conductivity:</td><td>450 µS/cm</td></tr> <tr><td>Detergents:</td><td>0 mg/L</td></tr> </table>		Sample Location: Pool		Total Chlorine:	0 ppm			Free Chlorine:	0 ppm	Ammonia:	0 ppm	pH:	7.95 units	Temperature:	76 °F	Conductivity:	450 µS/cm	Detergents:	0 mg/L	<table border="1" style="width:100%; border-collapse: collapse;"> <tr><td>Floatables:</td><td>None</td></tr> <tr><td>Odor:</td><td>Faint</td></tr> <tr><td>Turbidity:</td><td>None</td></tr> <tr><td>Color:</td><td>Faint in bottle</td></tr> <tr><td>Gross Solids:</td><td>Severe</td></tr> <tr><td>Vegetation:</td><td>None</td></tr> <tr><td>Benthic Growth:</td><td>None</td></tr> <tr><td>Stains:</td><td>None</td></tr> <tr><td>Non-illicit:</td><td>None</td></tr> </table>		Floatables:	None	Odor:	Faint	Turbidity:	None	Color:	Faint in bottle	Gross Solids:	Severe	Vegetation:	None	Benthic Growth:	None	Stains:	None	Non-illicit:	None	<b>Condition Assessment</b> <table border="1" style="width:100%; border-collapse: collapse;"> <tr><td>Graffiti:</td><td>None</td></tr> <tr><td>Erosion:</td><td>None</td></tr> <tr><td>Deposition:</td><td>None in.</td></tr> <tr><td>Damage:</td><td>None</td></tr> </table>		Graffiti:	None	Erosion:	None	Deposition:	None in.

Sample Location: Pool																																															
Total Chlorine:	0 ppm																																														
Free Chlorine:	0 ppm																																														
Ammonia:	0 ppm																																														
pH:	7.95 units																																														
Temperature:	76 °F																																														
Conductivity:	450 µS/cm																																														
Detergents:	0 mg/L																																														
Floatables:	None																																														
Odor:	Faint																																														
Turbidity:	None																																														
Color:	Faint in bottle																																														
Gross Solids:	Severe																																														
Vegetation:	None																																														
Benthic Growth:	None

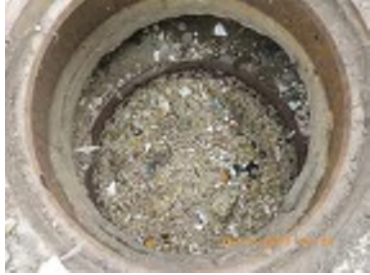
o20120927082922.JPG  
**2012**

<b>Inspection Date:</b> 9/27/2012 9:27:45 AM		<b>Type:</b> Ongoing	<b>Flow:</b> Submerged, indeterminate	<b>Previous Rainfall (hrs):</b> 72+
<b>Illicit Discharge Potential:</b> <b>Potential</b>		<b>Inspector:</b> JCW	<b>Notes</b>	
Submerged: Fully		Depth (in): 39	2011 gross solids follow-up.	
<b>Sampling Results</b>		<b>Condition Assessment</b>		
Sample Location: Pool	Floatables: None	Graffiti: None Erosion: None Deposition: None in. Damage: None		
Total Chlorine: 0 ppm	Odor: None			
Free Chlorine: 0 ppm	Turbidity: None			
Ammonia: 0 ppm	Color: None			
pH: 8.32 units	Gross Solids: Severe			
Temperature 59 °F	Vegetation: None			
Conductivity: 398 µS/cm	Benthic Growth: None			
Detergents: 0 mg/L	Stains: None			
	Non-illicit: None

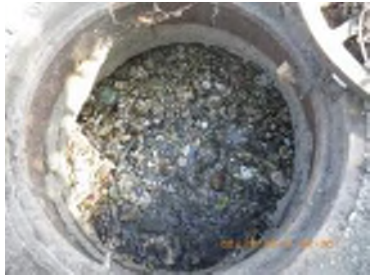
o20120620082508.JPG  
**2012**

<b>Inspection Date:</b> 6/20/2012 9:24:19 AM		<b>Type:</b> Other	<b>Flow:</b> Submerged, indeterminate	<b>Previous Rainfall (hrs):</b> 24-48
<b>Illicit Discharge Potential:</b> <b>Potential</b>		<b>Inspector:</b> JCW	<b>Notes</b>	
Submerged: Fully		Depth (in): 46	Gross solids pre-screening.	
<b>Sampling Results</b>		<b>Condition Assessment</b>		
Sample Location:	Floatables: None	Graffiti: None Erosion: None Deposition: None in. Damage: None		
Total Chlorine: -- ppm	Odor: None			
Free Chlorine: -- ppm	Turbidity: None			
Ammonia: -- ppm	Color: None			
pH: -- units	Gross Solids: Severe			
Temperature -- °F	Vegetation: None			
Conductivity: -- µS/cm	Benthic Growth: None			
Detergents: -- mg/L	Stains: None			
	Non-illicit: None

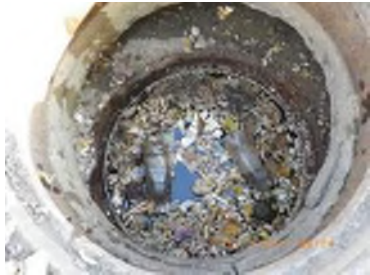
o20111011090446.JPG  
**2011**

<b>Inspection Date:</b> 10/11/2011 9:05:50 AM		<b>Type:</b> Ongoing	<b>Flow:</b> Submerged, indeterminate	<b>Previous Rainfall (hrs):</b> 72+
<b>Illicit Discharge Potential:</b> <b>Potential</b>		<b>Inspector:</b> JCW	<b>Notes</b>	
Submerged: Fully		Depth (in): 37	2010 screening follow-up. No significant change in volume of floatable debris.	
<b>Sampling Results</b>		<b>Condition Assessment</b>		
Sample Location: Pool	Floatables: None	Graffiti: None Erosion: None Deposition: None 0 in. Damage: None		
Total Chlorine: 0 ppm	Odor: None			
Free Chlorine: 0 ppm	Turbidity: None			
Ammonia: 0 ppm	Color: None			
pH: 8.13 units	Gross Solids: Moderate			
Temperature 70 °F	Vegetation: None			
Conductivity: -- µS/cm	Benthic Growth: None			
Detergents: -- mg/L	Stains: None			
	Non-illicit: None

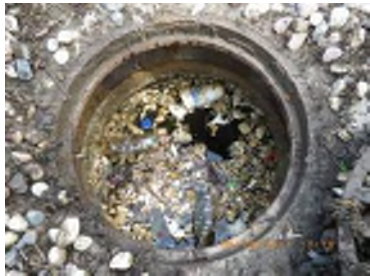
o20110526111930.JPG  
**2011**

<b>Inspection Date:</b> 5/26/2011 11:19:00 AM		<b>Type:</b> Other	<b>Flow:</b> Submerged, indeterminate	<b>Previous Rainfall (hrs):</b> 72+
<b>Illicit Discharge Potential:</b> <b>Potential</b>		<b>Inspector:</b> JCW	<b>Notes</b>	
Submerged: Fully		Depth (in):	Limited screening conducted to check for floatable debris.	
<b>Sampling Results</b>		<b>Condition Assessment</b>		
Sample Location:	Floatables: None	Graffiti: None Erosion: None Deposition: None 0 in. Damage: None		
Total Chlorine: -- ppm	Odor:			
Free Chlorine: -- ppm	Turbidity:			
Ammonia: -- ppm	Color:			
pH: -- units	Gross Solids: Moderate			
Temperature -- °F	Vegetation:			
Conductivity: -- µS/cm	Benthic Growth:			
Detergents: -- mg/L	Stains:			
	Non-illicit: None

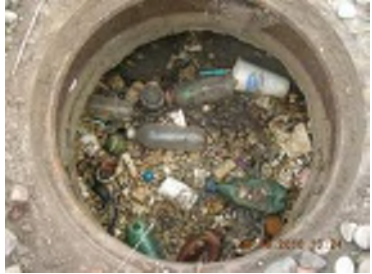
o20100818102410.JPG

<b>Inspection Date:</b> 8/18/2010 10:29:59 AM		<b>Type:</b> Ongoing	<b>Flow:</b> Submerged, indeterminate	<b>Previous Rainfall (hrs):</b> 72+
<b>Illicit Discharge Potential:</b> <b>Potential</b>		<b>Inspector:</b> JCW	<b>Notes</b>	
Submerged: Fully		Depth (in): 44	Severe floatable debris in catchbasin.	
<b>Sampling Results</b>		<b>Condition Assessment</b>		
Sample Location: Pool	Floatables: None	Graffiti: None Erosion: None Deposition: None 0 in. Damage: None		
Total Chlorine: 0 ppm	Odor: None			
Free Chlorine: 0 ppm	Turbidity: None			
Ammonia: 0 ppm	Color: Faint in bottle			
pH: 7.38 units	Gross Solids: Severe			
Temperature 76 °F	Vegetation: None			
Conductivity: -- µS/cm	Benthic Growth: None			
Detergents: 0 mg/L	Stains: None			
	Non-illicit: None

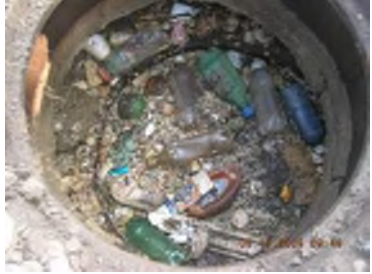
Osh09\_DSCN6768.JPG

<b>Inspection Date:</b> 9/10/2009		<b>Type:</b> Initial	<b>Flow:</b> Submerged, indeterminate	<b>Previous Rainfall (hrs):</b> 72+
<b>Illicit Discharge Potential:</b> <b>Potential</b>		<b>Inspector:</b> JCW	<b>Notes</b>	
Submerged: Fully		Depth (in): 44	Abnormal detergent analysis result (bubbles). Significant floatables in manhole.	
<b>Sampling Results</b>		<b>Condition Assessment</b>		
Sample Location: Pool	Floatables: None	Graffiti: None Erosion: None Deposition: None 0 in. Damage: None		
Total Chlorine: 0 ppm	Odor: None			
Free Chlorine: 0 ppm	Turbidity: None			
Ammonia: -- ppm	Color: None			
pH: 8.3 units	Gross Solids: Severe			
Temperature 75 °F	Vegetation: None			
Conductivity: -- µS/cm	Benthic Growth: None			
Detergents: 0 mg/L	Stains: None			
	Non-illicit: None

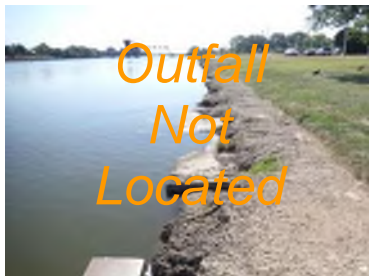
o20220824101500.JPG <b>2022</b>

<b>Inspection Date:</b> 8/24/2022 10:18:00 AM		<b>Type:</b> Ongoing	<b>Flow:</b> Submerged (not located)	<b>Previous Rainfall (hrs):</b> 72+
<b>Illicit Discharge Potential:</b> Potential		<b>Inspector:</b> EJK		
Submerged: Fully		Depth (in):		
<b>Sampling Results</b> Sample Location: _____ Total Chlorine: -- ppm Free Chlorine: -- ppm Ammonia: -- ppm pH: -- units Temperature: -- °F Conductivity: -- µS/cm Detergents: -- mg/L		Floatables: None Odor: None Turbidity: None Color: None Gross Solids: None Vegetation: None Benthic Growth: None Stains: None Non-illicit: None	<b>Notes</b> Outfall fully submerged and not located - screened upstream at 03-35 US1. Floating gross solids (litter) in upstream manhole.  <b>Condition Assessment</b> Graffiti: None Erosion: None Deposition: None in. Damage: None

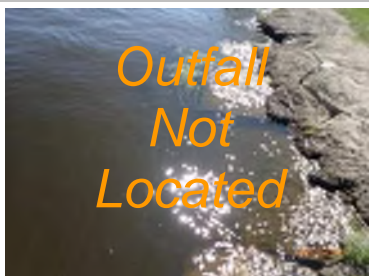
o20210816104428.JPG <b>2021</b>

<b>Inspection Date:</b> 8/16/2021 10:47:35 AM		<b>Type:</b> Ongoing	<b>Flow:</b> Submerged (not located)	<b>Previous Rainfall (hrs):</b> 72+
<b>Illicit Discharge Potential:</b> Potential		<b>Inspector:</b> JCW		
Submerged: Fully		Depth (in):		
<b>Sampling Results</b> Sample Location: _____ Total Chlorine: -- ppm Free Chlorine: -- ppm Ammonia: -- ppm pH: -- units Temperature: -- °F Conductivity: -- µS/cm Detergents: -- mg/L		Floatables: None Odor: None Turbidity: None Color: None Gross Solids: None Vegetation: None Benthic Growth: None Stains: None Non-illicit: None	<b>Notes</b> Outfall fully submerged and not located - screened upstream at 03-35 US1. Floating gross solids (litter) in upstream manhole.  <b>Condition Assessment</b> Graffiti: None Erosion: None Deposition: None in. Damage: None

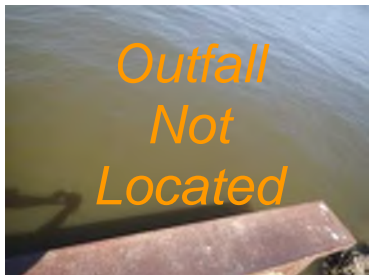
o20200819143634.JPG <b>2020</b>

<b>Inspection Date:</b> 8/19/2020 2:40:57 PM		<b>Type:</b> Ongoing	<b>Flow:</b> Submerged (not located)	<b>Previous Rainfall (hrs):</b> 72+
<b>Illicit Discharge Potential:</b> Potential		<b>Inspector:</b> JCW		
Submerged: Fully		Depth (in):		
<b>Sampling Results</b> Sample Location: _____ Total Chlorine: -- ppm Free Chlorine: -- ppm Ammonia: -- ppm pH: -- units Temperature: -- °F Conductivity: -- µS/cm Detergents: -- mg/L		Floatables: None Odor: None Turbidity: None Color: None Gross Solids: None Vegetation: None Benthic Growth: None Stains: None Non-illicit: None	<b>Notes</b> Outfall fully submerged and not located - screened upstream at 03-35 US1. Floating gross solids (litter) in upstream manhole.  <b>Condition Assessment</b> Graffiti: None Erosion: None Deposition: None in. Damage: None

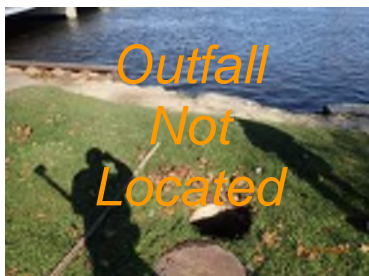
o20191105114512.JPG <b>2019</b>

<b>Inspection Date:</b> 11/5/2019 11:44:00 AM		<b>Type:</b> Repeat	<b>Flow:</b> Submerged (not located)	<b>Previous Rainfall (hrs):</b> 48-72
<b>Illicit Discharge Potential:</b> Potential		<b>Inspector:</b> JCW		
Submerged: Fully		Depth (in):		
<b>Sampling Results</b> Sample Location: _____ Total Chlorine: -- ppm Free Chlorine: -- ppm Ammonia: -- ppm pH: -- units Temperature: -- °F Conductivity: -- µS/cm Detergents: -- mg/L		Floatables: None Odor: None Turbidity: None Color: None Gross Solids: None Vegetation: None Benthic Growth: None Stains: None Non-illicit: None	<b>Notes</b> Follow-up inspection for sampling - limited screening conducted. Floating gross solids (litter) and detergent in manhole.  <b>Condition Assessment</b> Graffiti: None Erosion: None Deposition: None in. Damage: None

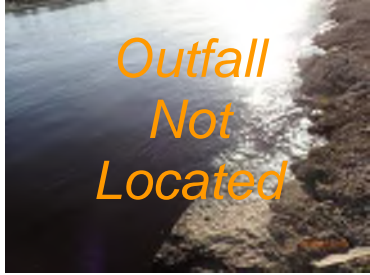
<p style="text-align: center; color: orange; font-size: 1.5em; font-weight: bold;">Outfall Not Located</p> <p style="text-align: center; font-size: 0.8em;">o20191008072714.JPG</p> <p style="text-align: center; font-size: 1.2em; font-weight: bold;">2019</p>																																									
Submerged: Fully		Depth (in):		Detergent detection follow-up. Limited screening conducted beyond sampling.																																											
<b>Sampling Results</b> <table border="1" style="width:100%; border-collapse: collapse;"> <tr><td colspan="2">Sample Location:</td></tr> <tr><td>Total Chlorine:</td><td>-- ppm</td></tr> <tr><td>Free Chlorine:</td><td>-- ppm</td></tr> <tr><td>Ammonia:</td><td>-- ppm</td></tr> <tr><td>pH:</td><td>-- units</td></tr> <tr><td>Temperature:</td><td>-- ° F</td></tr> <tr><td>Conductivity:</td><td>-- µS/cm</td></tr> <tr><td>Detergents:</td><td>-- mg/L</td></tr> </table>		Sample Location:		Total Chlorine:	-- ppm			Free Chlorine:	-- ppm	Ammonia:	-- ppm	pH:	-- units	Temperature:	-- ° F	Conductivity:	-- µS/cm	Detergents:	-- mg/L	<table border="1" style="width:100%; border-collapse: collapse;"> <tr><td>Floatables:</td><td>None</td></tr> <tr><td>Odor:</td><td>None</td></tr> <tr><td>Turbidity:</td><td>None</td></tr> <tr><td>Color:</td><td>None</td></tr> <tr><td>Gross Solids:</td><td>None</td></tr> <tr><td>Vegetation:</td><td>None</td></tr> <tr><td>Benthic Growth:</td><td>None</td></tr> <tr><td>Stains:</td><td>None</td></tr> <tr><td>Non-illicit:</td><td>None</td></tr> </table>		Floatables:	None	Odor:	None	Turbidity:	None	Color:	None	Gross Solids:	None	Vegetation:	None	Benthic Growth:	None	Stains:	None	Non-illicit:	None	<b>Condition Assessment</b> <table border="1" style="width:100%; border-collapse: collapse;"> <tr><td>Graffiti:</td><td>None</td></tr> <tr><td>Erosion:</td><td>None</td></tr> <tr><td>Deposition:</td><td>None in.</td></tr> <tr><td>Damage:</td><td>None</td></tr> </table>		Graffiti:	None	Erosion:	None	Deposition:	None in.

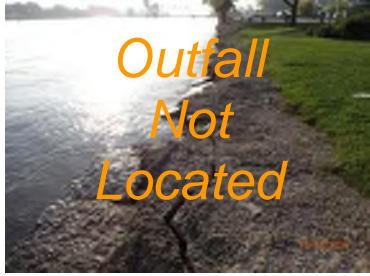
<p style="text-align: center; color: orange; font-size: 1.5em; font-weight: bold;">Outfall Not Located</p> <p style="text-align: center; font-size: 0.8em;">o20190918070310.JPG</p> <p style="text-align: center; font-size: 1.2em; font-weight: bold;">2019</p>																																									
Submerged: Fully		Depth (in):		Outfall fully submerged and not located - screened upstream at 03-35 US1. Floating gross solids (litter) and detergent in manhole.																																											
<b>Sampling Results</b> <table border="1" style="width:100%; border-collapse: collapse;"> <tr><td colspan="2">Sample Location:</td></tr> <tr><td>Total Chlorine:</td><td>-- ppm</td></tr> <tr><td>Free Chlorine:</td><td>-- ppm</td></tr> <tr><td>Ammonia:</td><td>-- ppm</td></tr> <tr><td>pH:</td><td>-- units</td></tr> <tr><td>Temperature:</td><td>-- ° F</td></tr> <tr><td>Conductivity:</td><td>-- µS/cm</td></tr> <tr><td>Detergents:</td><td>-- mg/L</td></tr> </table>		Sample Location:		Total Chlorine:	-- ppm			Free Chlorine:	-- ppm	Ammonia:	-- ppm	pH:	-- units	Temperature:	-- ° F	Conductivity:	-- µS/cm	Detergents:	-- mg/L	<table border="1" style="width:100%; border-collapse: collapse;"> <tr><td>Floatables:</td><td>None</td></tr> <tr><td>Odor:</td><td>None</td></tr> <tr><td>Turbidity:</td><td>None</td></tr> <tr><td>Color:</td><td>None</td></tr> <tr><td>Gross Solids:</td><td>None</td></tr> <tr><td>Vegetation:</td><td>None</td></tr> <tr><td>Benthic Growth:</td><td>None</td></tr> <tr><td>Stains:</td><td>None</td></tr> <tr><td>Non-illicit:</td><td>None</td></tr> </table>		Floatables:	None	Odor:	None	Turbidity:	None	Color:	None	Gross Solids:	None	Vegetation:	None	Benthic Growth:	None	Stains:	None	Non-illicit:	None	<b>Condition Assessment</b> <table border="1" style="width:100%; border-collapse: collapse;"> <tr><td>Graffiti:</td><td>None</td></tr> <tr><td>Erosion:</td><td>None</td></tr> <tr><td>Deposition:</td><td>None in.</td></tr> <tr><td>Damage:</td><td>None</td></tr> </table>		Graffiti:	None	Erosion:	None	Deposition:	None in.

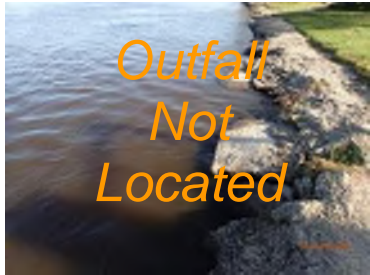
<p style="text-align: center; color: orange; font-size: 1.5em; font-weight: bold;">Outfall Not Located</p> <p style="text-align: center; font-size: 0.8em;">o20181022152608.JPG</p> <p style="text-align: center; font-size: 1.2em; font-weight: bold;">2018</p>																																									
Submerged: Fully		Depth (in):		Outfall fully submerged and not located - screened upstream at 03-35 US1. Floating gross solids (litter) in manhole.																																											
<b>Sampling Results</b> <table border="1" style="width:100%; border-collapse: collapse;"> <tr><td colspan="2">Sample Location:</td></tr> <tr><td>Total Chlorine:</td><td>-- ppm</td></tr> <tr><td>Free Chlorine:</td><td>-- ppm</td></tr> <tr><td>Ammonia:</td><td>-- ppm</td></tr> <tr><td>pH:</td><td>-- units</td></tr> <tr><td>Temperature:</td><td>-- ° F</td></tr> <tr><td>Conductivity:</td><td>-- µS/cm</td></tr> <tr><td>Detergents:</td><td>-- mg/L</td></tr> </table>		Sample Location:		Total Chlorine:	-- ppm			Free Chlorine:	-- ppm	Ammonia:	-- ppm	pH:	-- units	Temperature:	-- ° F	Conductivity:	-- µS/cm	Detergents:	-- mg/L	<table border="1" style="width:100%; border-collapse: collapse;"> <tr><td>Floatables:</td><td>None</td></tr> <tr><td>Odor:</td><td>None</td></tr> <tr><td>Turbidity:</td><td>None</td></tr> <tr><td>Color:</td><td>None</td></tr> <tr><td>Gross Solids:</td><td>None</td></tr> <tr><td>Vegetation:</td><td>None</td></tr> <tr><td>Benthic Growth:</td><td>None</td></tr> <tr><td>Stains:</td><td>None</td></tr> <tr><td>Non-illicit:</td><td>None</td></tr> </table>		Floatables:	None	Odor:	None	Turbidity:	None	Color:	None	Gross Solids:	None	Vegetation:	None	Benthic Growth:	None	Stains:	None	Non-illicit:	None	<b>Condition Assessment</b> <table border="1" style="width:100%; border-collapse: collapse;"> <tr><td>Graffiti:</td><td>None</td></tr> <tr><td>Erosion:</td><td>None</td></tr> <tr><td>Deposition:</td><td>None in.</td></tr> <tr><td>Damage:</td><td>None</td></tr> </table>		Graffiti:	None	Erosion:	None	Deposition:	None in.

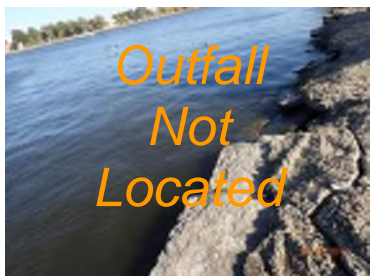
<p style="text-align: center; color: orange; font-size: 1.5em; font-weight: bold;">Outfall Not Located</p> <p style="text-align: center; font-size: 0.8em;">o20171018150844.JPG</p> <p style="text-align: center; font-size: 1.2em; font-weight: bold;">2017</p>																																									
Submerged: Fully		Depth (in):		Outfall fully submerged and not located - screened upstream at 03-35 US1. Floating gross solids (litter) in manhole.																																											
<b>Sampling Results</b> <table border="1" style="width:100%; border-collapse: collapse;"> <tr><td colspan="2">Sample Location:</td></tr> <tr><td>Total Chlorine:</td><td>-- ppm</td></tr> <tr><td>Free Chlorine:</td><td>-- ppm</td></tr> <tr><td>Ammonia:</td><td>-- ppm</td></tr> <tr><td>pH:</td><td>-- units</td></tr> <tr><td>Temperature:</td><td>-- ° F</td></tr> <tr><td>Conductivity:</td><td>-- µS/cm</td></tr> <tr><td>Detergents:</td><td>-- mg/L</td></tr> </table>		Sample Location:		Total Chlorine:	-- ppm			Free Chlorine:	-- ppm	Ammonia:	-- ppm	pH:	-- units	Temperature:	-- ° F	Conductivity:	-- µS/cm	Detergents:	-- mg/L	<table border="1" style="width:100%; border-collapse: collapse;"> <tr><td>Floatables:</td><td>None</td></tr> <tr><td>Odor:</td><td>None</td></tr> <tr><td>Turbidity:</td><td>None</td></tr> <tr><td>Color:</td><td>None</td></tr> <tr><td>Gross Solids:</td><td>None</td></tr> <tr><td>Vegetation:</td><td>None</td></tr> <tr><td>Benthic Growth:</td><td>None</td></tr> <tr><td>Stains:</td><td>None</td></tr> <tr><td>Non-illicit:</td><td>None</td></tr> </table>		Floatables:	None	Odor:	None	Turbidity:	None	Color:	None	Gross Solids:	None	Vegetation:	None	Benthic Growth:	None	Stains:	None	Non-illicit:	None	<b>Condition Assessment</b> <table border="1" style="width:100%; border-collapse: collapse;"> <tr><td>Graffiti:</td><td>None</td></tr> <tr><td>Erosion:</td><td>None</td></tr> <tr><td>Deposition:</td><td>None in.</td></tr> <tr><td>Damage:</td><td>None</td></tr> </table>		Graffiti:	None	Erosion:	None	Deposition:	None in.

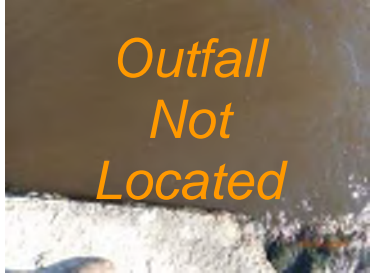
<p style="text-align: center;">o20161010094930.JPG</p> <p style="text-align: center; font-size: 1.2em; font-weight: bold;">2016</p>	
Submerged: Fully		Depth (in):		Outfall fully submerged and not located - screened upstream at 03-35 US1.			
<b>Sampling Results</b>				<b>Condition Assessment</b>			
Sample Location:		Floatables:	None	Graziti:		None	in.
Total Chlorine: -- ppm		Odor:	None	Erosion:		None	
Free Chlorine: -- ppm		Turbidity:	None	Deposition:		None	
Ammonia: -- ppm		Color:	None	Damage:		None	
pH: -- units		Gross Solids:	None				
Temperature -- °F		Vegetation:	None				
Conductivity: -- µS/cm		Benthic Growth:	None				
Detergents: -- mg/L		Stains:	None				
		Non-illicit:	None

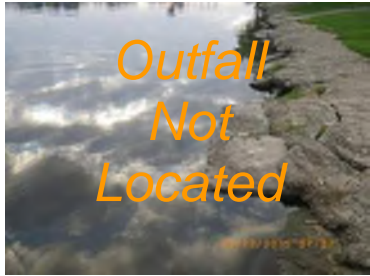
<p style="text-align: center;">o20150923063720.JPG</p> <p style="text-align: center; font-size: 1.2em; font-weight: bold;">2015</p>	
Submerged: Fully		Depth (in):		Outfall fully submerged and not located - screened at 03-35 US1.			
<b>Sampling Results</b>				<b>Condition Assessment</b>			
Sample Location:		Floatables:	None	Graziti:		None	in.
Total Chlorine: -- ppm		Odor:	None	Erosion:		None	
Free Chlorine: -- ppm		Turbidity:	None	Deposition:		None	
Ammonia: -- ppm		Color:	None	Damage:		None	
pH: -- units		Gross Solids:	None				
Temperature -- °F		Vegetation:	None				
Conductivity: -- µS/cm		Benthic Growth:	None				
Detergents: -- mg/L		Stains:	None				
		Non-illicit:	None

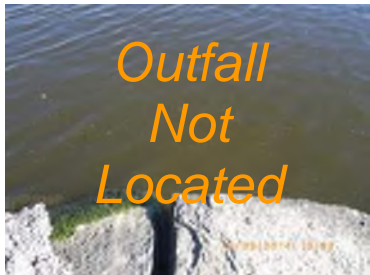
<p style="text-align: center;">o20141009093222.JPG</p> <p style="text-align: center; font-size: 1.2em; font-weight: bold;">2014</p>	
Submerged: Fully		Depth (in):		Outfall fully submerged and not located - screened upstream at 03-35 US1			
<b>Sampling Results</b>				<b>Condition Assessment</b>			
Sample Location:		Floatables:	None	Graziti:		None	in.
Total Chlorine: -- ppm		Odor:	None	Erosion:		None	
Free Chlorine: -- ppm		Turbidity:	None	Deposition:		None	
Ammonia: -- ppm		Color:	None	Damage:		None	
pH: -- units		Gross Solids:	None				
Temperature -- °F		Vegetation:	None				
Conductivity: -- µS/cm		Benthic Growth:	None				
Detergents: -- mg/L		Stains:	None				
		Non-illicit:	None

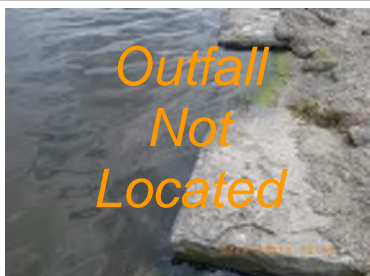
<p style="text-align: center;">o20130731113304.JPG</p> <p style="text-align: center; font-size: 1.2em; font-weight: bold;">2013</p>	
Submerged: Fully		Depth (in):		2012 screening follow-up. Outfall not located. Outfall screened upstream at 03-35 US1. Gross solids in upstrem mh.			
<b>Sampling Results</b>				<b>Condition Assessment</b>			
Sample Location:		Floatables:	None	Graziti:		None	in.
Total Chlorine: -- ppm		Odor:	None	Erosion:		None	
Free Chlorine: -- ppm		Turbidity:	None	Deposition:		None	
Ammonia: -- ppm		Color:	None	Damage:		None	
pH: -- units		Gross Solids:	None				
Temperature -- °F		Vegetation:	None				
Conductivity: -- µS/cm		Benthic Growth:	None				
Detergents: -- mg/L		Stains:	None

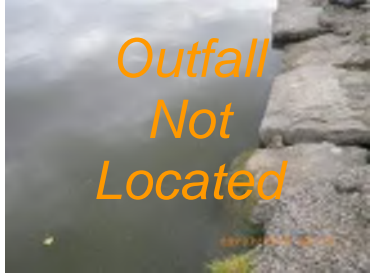
o20120927081506.JPG

<b>Inspection Date:</b> 9/27/2012 9:13:17 AM		<b>Type:</b> Ongoing	<b>Flow:</b> Submerged (not located)	<b>Previous Rainfall (hrs):</b> 72+
<b>Illicit Discharge Potential:</b> <b>Potential</b>		<b>Inspector:</b> JCW	<b>Notes</b>	
Submerged: Fully		Depth (in):	Outfall fully submerged; screened upstream at 03-35 US1.	
<b>Sampling Results</b>		Floatables:	<b>Condition Assessment</b> Graffiti: None Erosion: None Deposition: None in. Damage: None	
Sample Location:		Odor:		
Total Chlorine: -- ppm		Turbidity:		
Free Chlorine: -- ppm		Color:		
Ammonia: -- ppm		Gross Solids:		
pH: -- units		Vegetation:		
Temperature -- °F		Benthic Growth:		
Conductivity: -- µS/cm		Stains:		
Detergents: -- mg/L		Non-illicit:

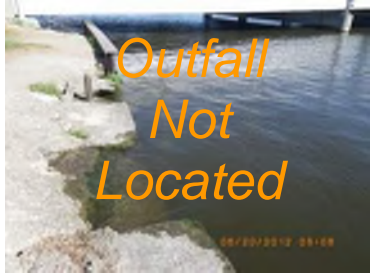
o20120620080844.JPG

<b>Inspection Date:</b> 6/20/2012 9:06:10 AM		<b>Type:</b> Other	<b>Flow:</b> Submerged (not located)	<b>Previous Rainfall (hrs):</b> 24-48
<b>Illicit Discharge Potential:</b> <b>Potential</b>		<b>Inspector:</b> JCW	<b>Notes</b>	
Submerged: Fully		Depth (in):	Gross solids pre-screening.	
<b>Sampling Results</b>		Floatables:	<b>Condition Assessment</b> Graffiti: None Erosion: None Deposition: None in. Damage: None	
Sample Location:		Odor:		
Total Chlorine: -- ppm		Turbidity:		
Free Chlorine: -- ppm		Color:		
Ammonia: -- ppm		Gross Solids:		
pH: -- units		Vegetation:		
Temperature -- °F		Benthic Growth:		
Conductivity: -- µS/cm		Stains:		
Detergents: -- mg/L		Non-illicit:

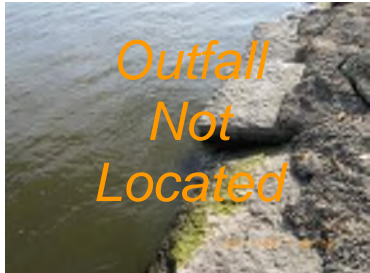
o20111011093254.JPG

<b>Inspection Date:</b> 10/11/2011 9:36:03 AM		<b>Type:</b> Ongoing	<b>Flow:</b> Submerged (not located)	<b>Previous Rainfall (hrs):</b> 72+
<b>Illicit Discharge Potential:</b> <b>Potential</b>		<b>Inspector:</b> JCW	<b>Notes</b>	
Submerged: Fully		Depth (in):	2010 screening follow-up. Outfall fully submerged and not physically located. Outfall screened upstream at 03-35 US1.	
<b>Sampling Results</b>		Floatables:	<b>Condition Assessment</b> Graffiti: None Erosion: None Deposition: None 0 in. Damage: None	
Sample Location:		Odor:		
Total Chlorine: -- ppm		Turbidity:		
Free Chlorine: -- ppm		Color:		
Ammonia: -- ppm		Gross Solids:		
pH: -- units		Vegetation:		
Temperature -- °F		Benthic Growth:		
Conductivity: -- µS/cm		Stains:		
Detergents: -- mg/L		Non-illicit:

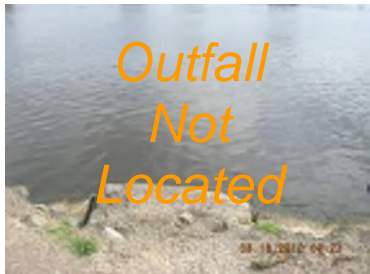
o20100818092204.JPG

<b>Inspection Date:</b> 8/18/2010 9:27:46 AM		<b>Type:</b> Ongoing	<b>Flow:</b> Submerged (not located)	<b>Previous Rainfall (hrs):</b> 72+
<b>Illicit Discharge Potential:</b> <b>Potential</b>		<b>Inspector:</b> JCW	<b>Notes</b>	
Submerged: Fully		Depth (in):	Outfall fully submerged and not physically located. Outfall screened upstream at 03-35 US1.	
<b>Sampling Results</b>		Floatables:	<b>Condition Assessment</b> Graffiti: None Erosion: None Deposition: None 0 in. Damage: None	
Sample Location:		Odor:		
Total Chlorine: -- ppm		Turbidity:		
Free Chlorine: -- ppm		Color:		
Ammonia: -- ppm		Gross Solids:		
pH: -- units		Vegetation:		
Temperature -- °F		Benthic Growth:		
Conductivity: -- µS/cm		Stains:		
Detergents: -- mg/L		Non-illicit:

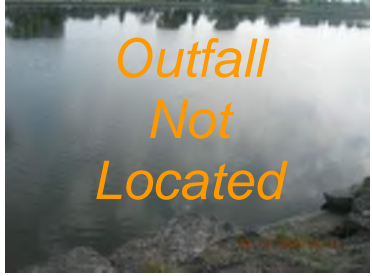
<p>Osh09_DSCN6761.JPG</p> <p><b>2009</b></p>	
Submerged: Fully		Depth (in):		Outfall fully submerged and not physically located. Outfall screened upstream at 03-35 US1.			
<b>Sampling Results</b>		Floatables:		None		<b>Condition Assessment</b> Graffiti: None Erosion: None Deposition: None 0 in. Damage: None	
Sample Location:		Odor:		None			
Total Chlorine: -- ppm		Turbidity:		None			
Free Chlorine: -- ppm		Color:		None			
Ammonia: -- ppm		Gross Solids:		None			
pH: -- units		Vegetation:		None			
Temperature -- °F		Benthic Growth:		None			
Conductivity: -- µS/cm		Stains:		None			
Detergents: -- mg/L		Non-illicit:		None

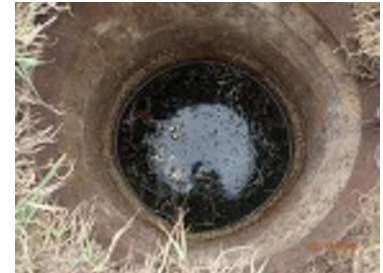
o20230717134952.JPG

Sample Location:	Pool																																					
Total Chlorine:	0 ppm																																					
Free Chlorine:	0 ppm																																					
Ammonia:	0 ppm																																					
pH:	8.1 units																																					
Temperature:	77 °F																																					
Conductivity:	593 µS/cm																																					
Detergents:	0 mg/L																																					
Floatables:	None																																					
Odor:	None																																					
Turbidity:	None																																					
Color:	None																																					
Gross Solids:	Moderate																																					
Vegetation:	None																																					
Benthic Growth:	None																																					
Stains:	None																																					
Non-illicit:	None

<div style="display: flex;"> <div style="flex: 1;"> <p><b>Notes</b></p> <p>Sample collected from submerged pool in manhole. Floating gross solids (litter) in manhole.</p> </div> <div style="flex: 1;"> <p><b>Condition Assessment</b></p> <table border="1" style="width:100%; border-collapse: collapse;"> <tr><td>Graffiti:</td><td>None</td></tr> <tr><td>Erosion:</td><td>None</td></tr> <tr><td>Deposition:</td><td>None in.</td></tr> <tr><td>Damage:</td><td>None</td></tr> </table> </div> </div>			Graffiti:	None	Erosion:	None	Deposition:	None in.	Damage:	None																										
Graffiti:	None																																					
Erosion:	None																																					
Deposition:	None in.																																					
Damage:	None

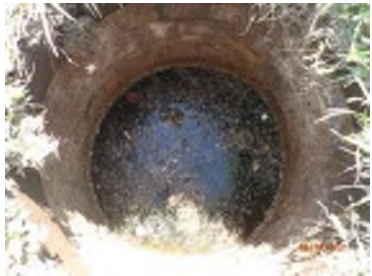
o20210816104502.JPG <b>2021</b>

<b>Inspection Date:</b> 8/16/2021 10:48:38 AM		<b>Type:</b> Ongoing	<b>Flow:</b> Submerged, indeterminate	<b>Previous Rainfall (hrs):</b> 72+																																		
<b>Illicit Discharge Potential:</b> Potential		<b>Inspector:</b> JCW																																				
Submerged: Fully		Depth (in): 39																																				
<b>Sampling Results</b>		<div style="display: flex;"> <div style="flex: 1;"> <table border="1" style="width:100%; border-collapse: collapse;"> <tr><td>Sample Location:</td><td>Pool</td></tr> <tr><td>Total Chlorine:</td><td>0 ppm</td></tr> <tr><td>Free Chlorine:</td><td>0 ppm</td></tr> <tr><td>Ammonia:</td><td>0 ppm</td></tr> <tr><td>pH:</td><td>7.76 units</td></tr> <tr><td>Temperature:</td><td>77 °F</td></tr> <tr><td>Conductivity:</td><td>349 µS/cm</td></tr> <tr><td>Detergents:</td><td>0 mg/L</td></tr> </table> </div> <div style="flex: 1;"> <table border="1" style="width:100%; border-collapse: collapse;"> <tr><td>Floatables:</td><td>None</td></tr> <tr><td>Odor:</td><td>None</td></tr> <tr><td>Turbidity:</td><td>None</td></tr> <tr><td>Color:</td><td>None</td></tr> <tr><td>Gross Solids:</td><td>Moderate</td></tr> <tr><td>Vegetation:</td><td>None</td></tr> <tr><td>Benthic Growth:</td><td>None</td></tr> <tr><td>Stains:</td><td>None</td></tr> <tr><td>Non-illicit:</td><td>None</td></tr> </table> </div> </div>			Sample Location:	Pool	Total Chlorine:	0 ppm	Free Chlorine:	0 ppm	Ammonia:	0 ppm	pH:	7.76 units	Temperature:	77 °F	Conductivity:	349 µS/cm	Detergents:	0 mg/L	Floatables:	None	Odor:	None	Turbidity:	None	Color:	None	Gross Solids:	Moderate	Vegetation:	None	Benthic Growth:	None	Stains:	None	Non-illicit:	None

<div style="display: flex;"> <div style="flex: 1;"> <p><b>Notes</b></p> <p>Sample collected from submerged pool in manhole. Floating gross solids (litter) in manhole.</p> </div> <div style="flex: 1;"> <p><b>Condition Assessment</b></p> <table border="1" style="width:100%; border-collapse: collapse;"> <tr><td>Graffiti:</td><td>None</td></tr> <tr><td>Erosion:</td><td>None</td></tr> <tr><td>Deposition:</td><td>None in.</td></tr> <tr><td>Damage:</td><td>None</td></tr> </table> </div> </div>			Graffiti:	None	Erosion:	None	Deposition:	None in.	Damage:	None																										
Graffiti:	None																																					
Erosion:	None																																					
Deposition:	None in.																																					
Damage:	None

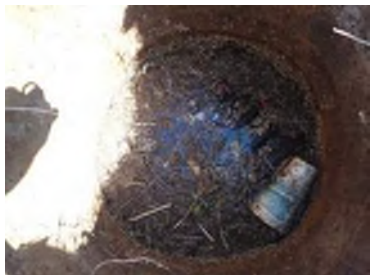
o20200819143804.JPG <b>2020</b>

<b>Inspection Date:</b> 8/19/2020 2:41:48 PM		<b>Type:</b> Ongoing	<b>Flow:</b> Submerged, indeterminate	<b>Previous Rainfall (hrs):</b> 72+																																		
<b>Illicit Discharge Potential:</b> Potential		<b>Inspector:</b> JCW																																				
Submerged: Fully		Depth (in): 36																																				
<b>Sampling Results</b>		<div style="display: flex;"> <div style="flex: 1;"> <table border="1" style="width:100%; border-collapse: collapse;"> <tr><td>Sample Location:</td><td>Pool</td></tr> <tr><td>Total Chlorine:</td><td>0 ppm</td></tr> <tr><td>Free Chlorine:</td><td>0 ppm</td></tr> <tr><td>Ammonia:</td><td>0.5 ppm</td></tr> <tr><td>pH:</td><td>8.44 units</td></tr> <tr><td>Temperature:</td><td>85 °F</td></tr> <tr><td>Conductivity:</td><td>346 µS/cm</td></tr> <tr><td>Detergents:</td><td>0 mg/L</td></tr> </table> </div> <div style="flex: 1;"> <table border="1" style="width:100%; border-collapse: collapse;"> <tr><td>Floatables:</td><td>None</td></tr> <tr><td>Odor:</td><td>None</td></tr> <tr><td>Turbidity:</td><td>None</td></tr> <tr><td>Color:</td><td>None</td></tr> <tr><td>Gross Solids:</td><td>Severe</td></tr> <tr><td>Vegetation:</td><td>None</td></tr> <tr><td>Benthic Growth:</td><td>None</td></tr> <tr><td>Stains:</td><td>None</td></tr> <tr><td>Non-illicit:</td><td>None</td></tr> </table> </div> </div>			Sample Location:	Pool	Total Chlorine:	0 ppm	Free Chlorine:	0 ppm	Ammonia:	0.5 ppm	pH:	8.44 units	Temperature:	85 °F	Conductivity:	346 µS/cm	Detergents:	0 mg/L	Floatables:	None	Odor:	None	Turbidity:	None	Color:	None	Gross Solids:	Severe	Vegetation:	None	Benthic Growth:	None	Stains:	None	Non-illicit:	None

<div style="display: flex;"> <div style="flex: 1;"> <p><b>Notes</b></p> <p>Sample collected from submerged pool in manhole. Floating gross solids (litter) in manhole. Slightly elevated ammonia.</p> </div> <div style="flex: 1;"> <p><b>Condition Assessment</b></p> <table border="1" style="width:100%; border-collapse: collapse;"> <tr><td>Graffiti:</td><td>None</td></tr> <tr><td>Erosion:</td><td>None</td></tr> <tr><td>Deposition:</td><td>None in.</td></tr> <tr><td>Damage:</td><td>None</td></tr> </table> </div> </div>			Graffiti:	None	Erosion:	None	Deposition:	None in.	Damage:	None																										
Graffiti:	None																																					
Erosion:	None																																					
Deposition:	None in.																																					
Damage:	None

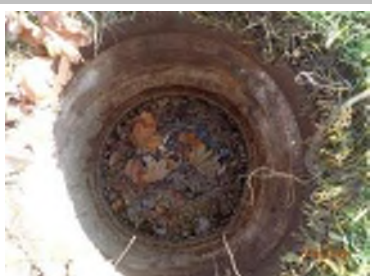
o20191105114518.JPG <b>2019</b>

<b>Inspection Date:</b> 11/5/2019 11:45:22 AM		<b>Type:</b> Repeat	<b>Flow:</b> Submerged, indeterminate	<b>Previous Rainfall (hrs):</b> 48-72																																		
<b>Illicit Discharge Potential:</b> Potential		<b>Inspector:</b> JCW																																				
Submerged: Partially		Depth (in): 30																																				
<b>Sampling Results</b>		<div style="display: flex;"> <div style="flex: 1;"> <table border="1" style="width:100%; border-collapse: collapse;"> <tr><td>Sample Location:</td><td>Pool</td></tr> <tr><td>Total Chlorine:</td><td>-- ppm</td></tr> <tr><td>Free Chlorine:</td><td>-- ppm</td></tr> <tr><td>Ammonia:</td><td>-- ppm</td></tr> <tr><td>pH:</td><td>-- units</td></tr> <tr><td>Temperature:</td><td>-- °F</td></tr> <tr><td>Conductivity:</td><td>-- µS/cm</td></tr> <tr><td>Detergents:</td><td>0 mg/L</td></tr> </table> </div> <div style="flex: 1;"> <table border="1" style="width:100%; border-collapse: collapse;"> <tr><td>Floatables:</td><td>None</td></tr> <tr><td>Odor:</td><td>None</td></tr> <tr><td>Turbidity:</td><td>None</td></tr> <tr><td>Color:</td><td>None</td></tr> <tr><td>Gross Solids:</td><td>Severe</td></tr> <tr><td>Vegetation:</td><td>None</td></tr> <tr><td>Benthic Growth:</td><td>None</td></tr> <tr><td>Stains:</td><td>None</td></tr> <tr><td>Non-illicit:</td><td>None</td></tr> </table> </div> </div>			Sample Location:	Pool	Total Chlorine:	-- ppm	Free Chlorine:	-- ppm	Ammonia:	-- ppm	pH:	-- units	Temperature:	-- °F	Conductivity:	-- µS/cm	Detergents:	0 mg/L	Floatables:	None	Odor:	None	Turbidity:	None	Color:	None	Gross Solids:	Severe	Vegetation:	None	Benthic Growth:	None	Stains:	None	Non-illicit:	None

<div style="display: flex;"> <div style="flex: 1;"> <p><b>Notes</b></p> <p>Detergent detection follow-up. Limited screening conducted. Floating gross solids (litter) and detergent in manhole.</p> </div> <div style="flex: 1;"> <p><b>Condition Assessment</b></p> <table border="1" style="width:100%; border-collapse: collapse;"> <tr><td>Graffiti:</td><td>None</td></tr> <tr><td>Erosion:</td><td>None</td></tr> <tr><td>Deposition:</td><td>None in.</td></tr> <tr><td>Damage:</td><td>None</td></tr> </table> </div> </div>			Graffiti:	None	Erosion:	None	Deposition:	None in.	Damage:	None																										
Graffiti:	None																																					
Erosion:	None																																					
Deposition:	None in.																																					
Damage:	None

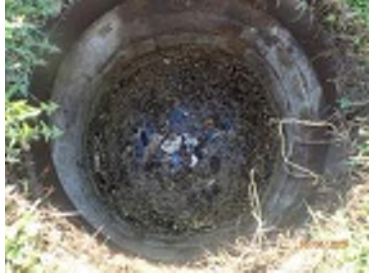
o20191008072724.JPG

<b>Inspection Date:</b> 10/8/2019 8:30:16 AM		<b>Type:</b> Repeat	<b>Flow:</b> Submerged, indeterminate	<b>Previous Rainfall (hrs):</b> 48-72
<b>Illicit Discharge Potential:</b> <b>Potential</b>		<b>Inspector:</b> JCW	<b>Notes</b>	
Submerged: Partially      Depth (in): 42			Detergent detection follow-up. Limited screening conducted beyond sampling.	
<b>Sampling Results</b>		<b>Floatables:</b> None	<b>Condition Assessment</b>	
Sample Location: Pool		<b>Odor:</b> None	<b>Graffiti:</b> None	
Total Chlorine: 0 ppm		<b>Turbidity:</b> None	<b>Erosion:</b> None	
Free Chlorine: 0 ppm		<b>Color:</b> None	<b>Deposition:</b> None in.	
Ammonia: 0 ppm		<b>Gross Solids:</b> Severe	<b>Damage:</b> None	
pH: 7.68 units		<b>Vegetation:</b> None		
Temperature 55 °F		<b>Benthic Growth:</b> None		
Conductivity: 415 µS/cm		<b>Stains:</b> None		
Detergents: 1.3 mg/L		<b>Non-illicit:</b> None

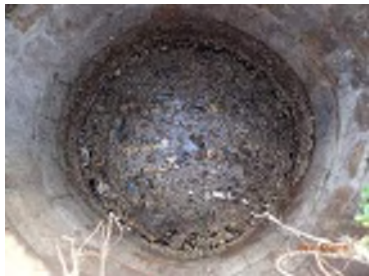
o20190918070320.JPG

<b>Inspection Date:</b> 9/18/2019 8:06:15 AM		<b>Type:</b> Ongoing	<b>Flow:</b> Submerged, indeterminate	<b>Previous Rainfall (hrs):</b> 72+
<b>Illicit Discharge Potential:</b> <b>Potential</b>		<b>Inspector:</b> JCW	<b>Notes</b>	
Submerged: Fully      Depth (in): 38			Sample collected from submerged pool in manhole. Floating gross solids (litter) and detergent in manhole.	
<b>Sampling Results</b>		<b>Floatables:</b> None	<b>Condition Assessment</b>	
Sample Location: Pool		<b>Odor:</b> None	<b>Graffiti:</b> None	
Total Chlorine: 0 ppm		<b>Turbidity:</b> None	<b>Erosion:</b> None	
Free Chlorine: 0 ppm		<b>Color:</b> None	<b>Deposition:</b> None in.	
Ammonia: 0 ppm		<b>Gross Solids:</b> Severe	<b>Damage:</b> None	
pH: 8.47 units		<b>Vegetation:</b> None		
Temperature 70 °F		<b>Benthic Growth:</b> None		
Conductivity: 389 µS/cm		<b>Stains:</b> None		
Detergents: 1.3 mg/L		<b>Non-illicit:</b> None

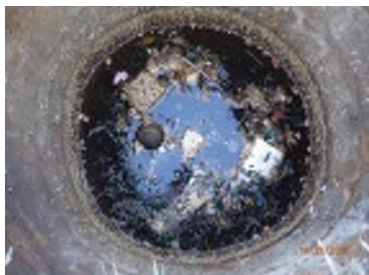
o20181022152746.JPG

<b>Inspection Date:</b> 10/22/2018 3:30:12 PM		<b>Type:</b> Ongoing	<b>Flow:</b> Submerged, indeterminate	<b>Previous Rainfall (hrs):</b> 48-72
<b>Illicit Discharge Potential:</b> <b>Potential</b>		<b>Inspector:</b> JCW	<b>Notes</b>	
Submerged: Fully      Depth (in): 41			Sample collected from submerged pool in manhole. Floating gross solids (litter) in manhole.	
<b>Sampling Results</b>		<b>Floatables:</b> None	<b>Condition Assessment</b>	
Sample Location: Pool		<b>Odor:</b> None	<b>Graffiti:</b> None	
Total Chlorine: 0 ppm		<b>Turbidity:</b> None	<b>Erosion:</b> None	
Free Chlorine: 0 ppm		<b>Color:</b> None	<b>Deposition:</b> None in.	
Ammonia: 0 ppm		<b>Gross Solids:</b> Moderate	<b>Damage:</b> None	
pH: 7.81 units		<b>Vegetation:</b> None		
Temperature 56 °F		<b>Benthic Growth:</b> None		
Conductivity: 338 µS/cm		<b>Stains:</b> None		
Detergents: 0 mg/L		<b>Non-illicit:</b> None

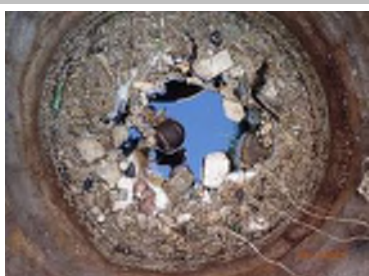
o20171018151012.JPG

<b>Inspection Date:</b> 10/18/2017 3:16:37 PM		<b>Type:</b> Ongoing	<b>Flow:</b> Submerged, indeterminate	<b>Previous Rainfall (hrs):</b> 72+
<b>Illicit Discharge Potential:</b> <b>Potential</b>		<b>Inspector:</b> JCW	<b>Notes</b>	
Submerged: Fully      Depth (in): 35			Sample collected from submerged pool in manhole. Floating gross solids (litter) in manhole.	
<b>Sampling Results</b>		<b>Floatables:</b> None	<b>Condition Assessment</b>	
Sample Location: Pool		<b>Odor:</b> None	<b>Graffiti:</b> None	
Total Chlorine: 0 ppm		<b>Turbidity:</b> None	<b>Erosion:</b> None	
Free Chlorine: 0 ppm		<b>Color:</b> None	<b>Deposition:</b> None in.	
Ammonia: 0 ppm		<b>Gross Solids:</b> Severe	<b>Damage:</b> None	
pH: 7.94 units		<b>Vegetation:</b> None		
Temperature 66 °F		<b>Benthic Growth:</b> None		
Conductivity: 554 µS/cm		<b>Stains:</b> None		
Detergents: 0 mg/L		<b>Non-illicit:</b> None

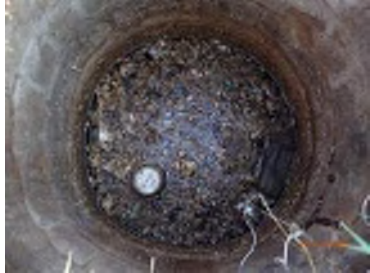
<p style="text-align: center;">o20161010094958.JPG</p> <p style="text-align: center; font-size: 1.5em; font-weight: bold;">2016</p>	
Submerged: Fully		Depth (in): 32		Potential illicit discharge due to gross solids.			
<b>Sampling Results</b> Sample Location: Pool Total Chlorine: 0 ppm Free Chlorine: 0 ppm Ammonia: 0 ppm pH: 7.54 units Temperature: 63 °F Conductivity: 391 µS/cm Detergents: 0 mg/L		Floatables: None Odor: Faint Turbidity: None Color: None Gross Solids: Moderate Vegetation: None Benthic Growth: None Stains: None Non-illicit: None		<b>Condition Assessment</b> Graffiti: None Erosion: None Deposition: None in. Damage: None

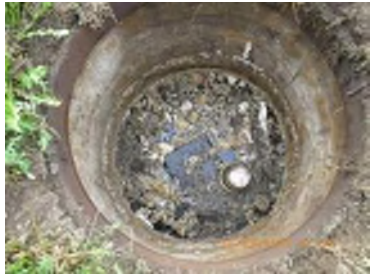
<p style="text-align: center;">o20150923063950.JPG</p> <p style="text-align: center; font-size: 1.5em; font-weight: bold;">2015</p>	
Submerged: Fully		Depth (in): 30		Floating gross solids (litter) in manhole.			
<b>Sampling Results</b> Sample Location: Pool Total Chlorine: 0 ppm Free Chlorine: 0 ppm Ammonia: 0 ppm pH: 8.64 units Temperature: 69 °F Conductivity: 359 µS/cm Detergents: 0 mg/L		Floatables: None Odor: None Turbidity: None Color: Faint in bottle Gross Solids: Moderate Vegetation: None Benthic Growth: None Stains: None Non-illicit: None		<b>Condition Assessment</b> Graffiti: None Erosion: None Deposition: Minor 1 in. Damage: None

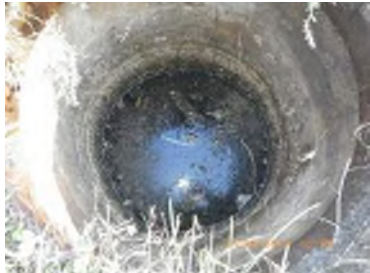
<p style="text-align: center;">o20141009093356.JPG</p> <p style="text-align: center; font-size: 1.5em; font-weight: bold;">2014</p>	
Submerged: Fully		Depth (in): 32		Vegetative debris in photo from opening lid.			
<b>Sampling Results</b> Sample Location: Pool Total Chlorine: 0 ppm Free Chlorine: 0 ppm Ammonia: 0 ppm pH: 7.86 units Temperature: 58 °F Conductivity: 476 µS/cm Detergents: 0 mg/L		Floatables: None Odor: None Turbidity: None Color: Faint in bottle Gross Solids: Slight Vegetation: None Benthic Growth: None Stains: None Non-illicit: None		<b>Condition Assessment</b> Graffiti: None Erosion: None Deposition: Minor 1 in. Damage: None

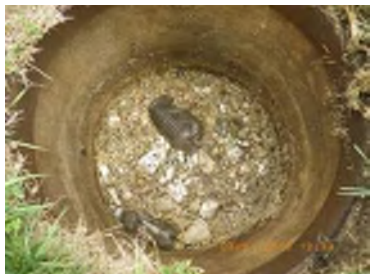
<b>Inspection Date:</b> 7/31/2013 12:31:00 PM		<b>Type:</b> Ongoing		<b>Flow:</b> Submerged, indeterminate		<b>Previous Rainfall (hrs):</b> 72+	
<b>Illicit Discharge Potential:</b> Potential		<b>Inspector:</b> JCW		<b>Notes</b>

<p style="text-align: center;">o20130731113346.JPG</p> <p style="text-align: center; font-size: 1.5em; font-weight: bold;">2013</p>	
Submerged: Fully		Depth (in): 33		2012 screening follow-up. Significant gross solids. Similar to previous years.			
<b>Sampling Results</b> Sample Location: Pool Total Chlorine: 0 ppm Free Chlorine: 0 ppm Ammonia: 0 ppm pH: 8.47 units Temperature: 75 °F Conductivity: 425 µS/cm Detergents: 0 mg/L		Floatables: None Odor: None Turbidity: None Color: Faint in bottle Gross Solids: Severe Vegetation: None Benthic Growth: None Stains: Moderate Non-illicit: None		<b>Condition Assessment</b> Graffiti: None Erosion: None Deposition: None in. Damage: None

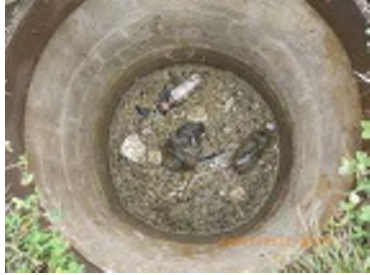
o20120927081522.JPG																																	
<b>2012</b>

<b>Inspection Date:</b> 9/27/2012 9:13:54 AM		<b>Type:</b> Ongoing		<b>Flow:</b> Submerged, indeterminate		<b>Previous Rainfall (hrs):</b> 72+																											
<b>Illicit Discharge Potential:</b> Potential		<b>Inspector:</b> JCW		<b>Notes</b> 2011 gross solids follow-up.

Submerged: Fully		Depth (in): 31																															
<b>Sampling Results</b>		<table border="1" style="width:100%; border-collapse: collapse;"> <tr><td>Floatables:</td><td>None</td></tr> <tr><td>Odor:</td><td>None</td></tr> <tr><td>Turbidity:</td><td>None</td></tr> <tr><td>Color:</td><td>None</td></tr> <tr><td>Gross Solids:</td><td>Severe</td></tr> <tr><td>Vegetation:</td><td>None</td></tr> <tr><td>Benthic Growth:</td><td>None</td></tr> <tr><td>Stains:</td><td>Slight</td></tr> <tr><td>Non-illicit:</td><td>None</td></tr> </table>		Floatables:	None	Odor:	None	Turbidity:	None	Color:	None	Gross Solids:	Severe	Vegetation:	None	Benthic Growth:	None	Stains:	Slight	Non-illicit:	None	<b>Condition Assessment</b>		<table border="1" style="width:100%; border-collapse: collapse;"> <tr><td>Graffiti:</td><td>None</td></tr> <tr><td>Erosion:</td><td>None</td></tr> <tr><td>Deposition:</td><td>Minor 3 in.</td></tr> <tr><td>Damage:</td><td>None</td></tr> </table>		Graffiti:	None	Erosion:	None	Deposition:	Minor 3 in.	Damage:	None

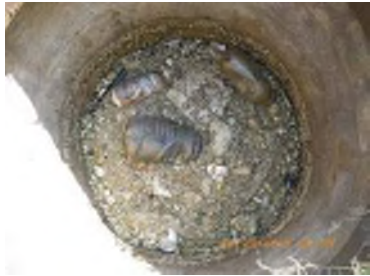
o20120620080918.JPG																																	
<b>2012</b>

<b>Inspection Date:</b> 6/20/2012 9:08:12 AM		<b>Type:</b> Other		<b>Flow:</b> Submerged, indeterminate		<b>Previous Rainfall (hrs):</b> 24-48																											
<b>Illicit Discharge Potential:</b> Potential		<b>Inspector:</b> JCW		<b>Notes</b> Gross solids pre-screening.

Submerged: Fully		Depth (in): 39																															
<b>Sampling Results</b>		<table border="1" style="width:100%; border-collapse: collapse;"> <tr><td>Floatables:</td><td>None</td></tr> <tr><td>Odor:</td><td>None</td></tr> <tr><td>Turbidity:</td><td>None</td></tr> <tr><td>Color:</td><td>None</td></tr> <tr><td>Gross Solids:</td><td>Severe</td></tr> <tr><td>Vegetation:</td><td>None</td></tr> <tr><td>Benthic Growth:</td><td>None</td></tr> <tr><td>Stains:</td><td>None</td></tr> <tr><td>Non-illicit:</td><td>None</td></tr> </table>		Floatables:	None	Odor:	None	Turbidity:	None	Color:	None	Gross Solids:	Severe	Vegetation:	None	Benthic Growth:	None	Stains:	None	Non-illicit:	None	<b>Condition Assessment</b>		<table border="1" style="width:100%; border-collapse: collapse;"> <tr><td>Graffiti:</td><td>None</td></tr> <tr><td>Erosion:</td><td>None</td></tr> <tr><td>Deposition:</td><td>None in.</td></tr> <tr><td>Damage:</td><td>None</td></tr> </table>		Graffiti:	None	Erosion:	None	Deposition:	None in.	Damage:	None

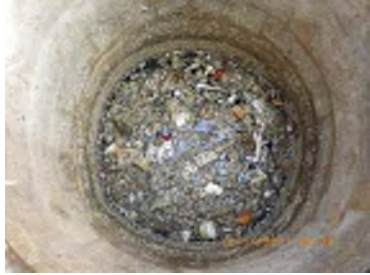
o20111011092832.JPG																																	
<b>2011</b>

<b>Inspection Date:</b> 10/11/2011 9:29:50 AM		<b>Type:</b> Ongoing		<b>Flow:</b> Submerged, indeterminate		<b>Previous Rainfall (hrs):</b> 72+																											
<b>Illicit Discharge Potential:</b> Potential		<b>Inspector:</b> JCW		<b>Notes</b> 2010 screening follow-up. Floatable debris still present. Slight petroleum sheen.

Submerged: Fully		Depth (in): 19																															
<b>Sampling Results</b>		<table border="1" style="width:100%; border-collapse: collapse;"> <tr><td>Floatables:</td><td>Severe</td></tr> <tr><td>Odor:</td><td>None</td></tr> <tr><td>Turbidity:</td><td>None</td></tr> <tr><td>Color:</td><td>None</td></tr> <tr><td>Gross Solids:</td><td>Severe</td></tr> <tr><td>Vegetation:</td><td>None</td></tr> <tr><td>Benthic Growth:</td><td>None</td></tr> <tr><td>Stains:</td><td>None</td></tr> <tr><td>Non-illicit:</td><td>None</td></tr> </table>		Floatables:	Severe	Odor:	None	Turbidity:	None	Color:	None	Gross Solids:	Severe	Vegetation:	None	Benthic Growth:	None	Stains:	None	Non-illicit:	None	<b>Condition Assessment</b>		<table border="1" style="width:100%; border-collapse: collapse;"> <tr><td>Graffiti:</td><td>None</td></tr> <tr><td>Erosion:</td><td>None</td></tr> <tr><td>Deposition:</td><td>None 0 in.</td></tr> <tr><td>Damage:</td><td>None</td></tr> </table>		Graffiti:	None	Erosion:	None	Deposition:	None 0 in.	Damage:	None

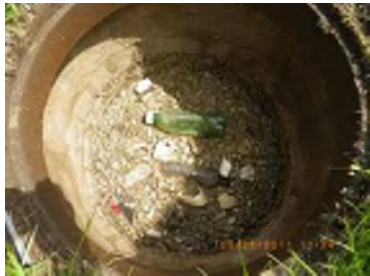
o20110526112400.JPG																																	
<b>2011</b>

<b>Inspection Date:</b> 5/26/2011 11:23:00 AM		<b>Type:</b> Other		<b>Flow:</b> Submerged, indeterminate		<b>Previous Rainfall (hrs):</b> 72+																											
<b>Illicit Discharge Potential:</b> Potential		<b>Inspector:</b> JCW		<b>Notes</b> Limited screening conducted to check for floatable debris.

Submerged: Fully		Depth (in):																															
<b>Sampling Results</b>		<table border="1" style="width:100%; border-collapse: collapse;"> <tr><td>Floatables:</td><td>None</td></tr> <tr><td>Odor:</td><td></td></tr> <tr><td>Turbidity:</td><td></td></tr> <tr><td>Color:</td><td></td></tr> <tr><td>Gross Solids:</td><td>Severe</td></tr> <tr><td>Vegetation:</td><td></td></tr> <tr><td>Benthic Growth:</td><td></td></tr> <tr><td>Stains:</td><td></td></tr> <tr><td>Non-illicit:</td><td>None</td></tr> </table>		Floatables:	None	Odor:		Turbidity:		Color:		Gross Solids:	Severe	Vegetation:		Benthic Growth:		Stains:		Non-illicit:	None	<b>Condition Assessment</b>		<table border="1" style="width:100%; border-collapse: collapse;"> <tr><td>Graffiti:</td><td>None</td></tr> <tr><td>Erosion:</td><td>None</td></tr> <tr><td>Deposition:</td><td>None 0 in.</td></tr> <tr><td>Damage:</td><td>None</td></tr> </table>		Graffiti:	None	Erosion:	None	Deposition:	None 0 in.	Damage:	None

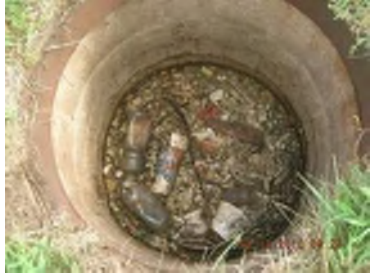
<b>Inspection Date:</b> 8/18/2010 9:32:06 AM		<b>Type:</b> Ongoing	<b>Flow:</b> Submerged, indeterminate	<b>Previous Rainfall (hrs):</b> 72+
<b>Illicit Discharge Potential:</b> <b>Potential</b>		<b>Inspector:</b> JCW	<b>Notes</b> Severe floatable debris in catchbasin.	
Submerged: Fully		Depth (in): 34

o20100818092304.JPG <div style="text-align: center; font-size: 24pt; font-weight: bold;">2010</div>	
<b>Sampling Results</b> Sample Location: Pool Total Chlorine: 0 ppm Free Chlorine: 0 ppm Ammonia: 0.5 ppm pH: 7.46 units Temperature: 73 °F Conductivity: -- µS/cm Detergents: 0 mg/L		Floatables: None Odor: Faint Turbidity: None Color: Faint in bottle Gross Solids: Severe Vegetation: None Benthic Growth: None Stains: None Non-illicit: None		
			<b>Condition Assessment</b> Graffiti: None Erosion: None Deposition: None 0 in. Damage: None

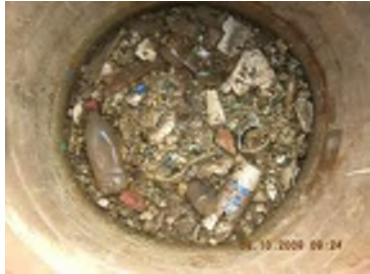
<b>Inspection Date:</b> 9/10/2009		<b>Type:</b> Initial	<b>Flow:</b> Submerged, indeterminate	<b>Previous Rainfall (hrs):</b> 72+
<b>Illicit Discharge Potential:</b> <b>Potential</b>		<b>Inspector:</b> JCW	<b>Notes</b> Abnormal detergent analysis result (bubbles). Significant floatables in manhole.	
Submerged: Fully		Depth (in): 33

Osh09_DSCN6763.JPG <div style="text-align: center; font-size: 24pt; font-weight: bold;">2009</div>	
<b>Sampling Results</b> Sample Location: Pool Total Chlorine: 0 ppm Free Chlorine: 0 ppm Ammonia: -- ppm pH: 8.23 units Temperature: 73 °F Conductivity: -- µS/cm Detergents: 0 mg/L		Floatables: None Odor: None Turbidity: None Color: None Gross Solids: Severe Vegetation: None Benthic Growth: None Stains: None Non-illicit: None		
			<b>Condition Assessment</b> Graffiti: None Erosion: None Deposition: None 0 in. Damage: None

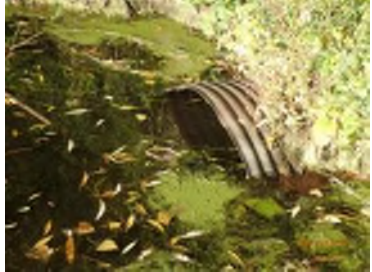
o20161010083458.JPG <div style="text-align: center; font-size: 24pt; font-weight: bold;">2016</div>

<b>Inspection Date:</b> 10/10/2016 8:37:23 AM		<b>Type:</b> Ongoing	<b>Flow:</b> Submerged, indeterminate	<b>Previous Rainfall (hrs):</b> 72+
<b>Illicit Discharge Potential:</b> Unlikely		<b>Inspector:</b> JCW		
Submerged: Partially		Depth (in): 31		
<b>Sampling Results</b> Sample Location: _____ Total Chlorine: -- ppm Free Chlorine: -- ppm Ammonia: -- ppm pH: -- units Temperature: -- °F Conductivity: -- µS/cm Detergents: -- mg/L		Floatables: None Odor: None Turbidity: None Color: None Gross Solids: None Vegetation: None Benthic Growth: None Stains: None Non-illicit: None	<b>Notes</b> Outfall partially submerged - screened upstream at 03-293 US1.  <b>Condition Assessment</b> Graffiti: None Erosion: None Deposition: None in. Damage: Minor

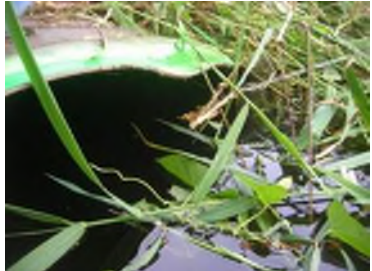
o20100817145430.JPG <div style="text-align: center; font-size: 24pt; font-weight: bold;">2010</div>

<b>Inspection Date:</b> 8/17/2010 3:02:36 PM		<b>Type:</b> Ongoing	<b>Flow:</b> Submerged, indeterminate	<b>Previous Rainfall (hrs):</b> 72+
<b>Illicit Discharge Potential:</b> Unlikely		<b>Inspector:</b> JCW		
Submerged: Partially		Depth (in): 38		
<b>Sampling Results</b> Sample Location: _____ Total Chlorine: -- ppm Free Chlorine: -- ppm Ammonia: -- ppm pH: -- units Temperature: -- °F Conductivity: -- µS/cm Detergents: -- mg/L		Floatables: None Odor: None Turbidity: None Color: None Gross Solids: None Vegetation: None Benthic Growth: None Stains: None Non-illicit: None	<b>Notes</b> Outfall partially submerged. Outfall screened upstream at 03-293 US1.  <b>Condition Assessment</b> Graffiti: None Erosion: None Deposition: None 0 in. Damage: Minor

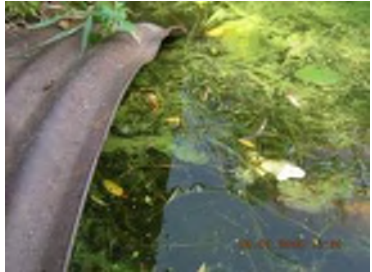
Osh09_DSCN6736.JPG <div style="text-align: center; font-size: 24pt; font-weight: bold;">2009</div>

<b>Inspection Date:</b> 9/9/2009		<b>Type:</b> Initial	<b>Flow:</b> Submerged, indeterminate	<b>Previous Rainfall (hrs):</b> 72+
<b>Illicit Discharge Potential:</b> Potential		<b>Inspector:</b> JCW		
Submerged: Partially		Depth (in): 32		
<b>Sampling Results</b> Sample Location: _____ Total Chlorine: -- ppm Free Chlorine: -- ppm Ammonia: -- ppm pH: -- units Temperature: -- °F Conductivity: -- µS/cm Detergents: -- mg/L		Floatables: None Odor: None Turbidity: None Color: None Gross Solids: None Vegetation: None Benthic Growth: Slight Stains: None Non-illicit: None	<b>Notes</b> Outfall partially submerged. Outfall screened upstream at 03-293 US1.  <b>Condition Assessment</b> Graffiti: None Erosion: None Deposition: None 0 in. Damage: Minor

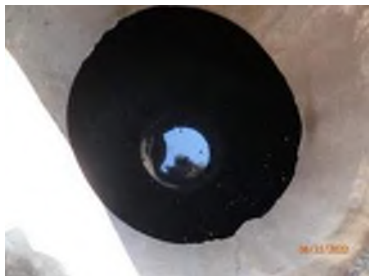
o20220822111818.JPG <div style="text-align: center; font-size: 24pt; font-weight: bold;">2022</div>

<div style="display: flex;"> <div style="flex: 1;"> <p><b>Notes</b></p> <p>Sample collected from submerged pool in manhole. Elevated ammonia in sample.</p> </div> <div style="flex: 1;"> <p><b>Condition Assessment</b></p> <table border="1" style="width:100%; border-collapse: collapse;"> <tr><td>Graffiti:</td><td>None</td></tr> <tr><td>Erosion:</td><td>None</td></tr> <tr><td>Deposition:</td><td>None in.</td></tr> <tr><td>Damage:</td><td>None</td></tr> </table> </div> </div>			Graffiti:	None	Erosion:	None	Deposition:	None in.	Damage:	None																										
Graffiti:	None																																					
Erosion:	None																																					
Deposition:	None in.																																					
Damage:	None

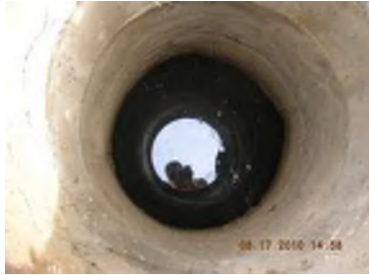
o20100817145804.JPG <div style="text-align: center; font-size: 24pt; font-weight: bold;">2010</div>

Sample Location:	Pool																																					
Total Chlorine:	0 ppm																																					
Free Chlorine:	0 ppm																																					
Ammonia:	0 ppm																																					
pH:	7.39 units																																					
Temperature:	76 °F																																					
Conductivity:	-- µS/cm																																					
Detergents:	0 mg/L																																					
Floatables:	Slight																																					
Odor:	None																																					
Turbidity:	None																																					
Color:	None																																					
Gross Solids:	None																																					
Vegetation:	None																																					
Benthic Growth:	None																																					
Stains:	None																																					
Non-illicit:	Slight

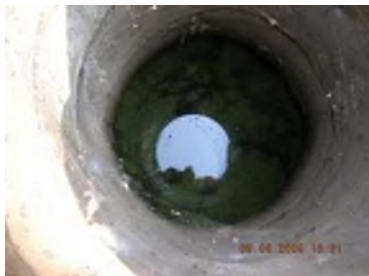
Osh09_DSCN6739.JPG <div style="text-align: center; font-size: 24pt; font-weight: bold;">2009</div>

<div style="display: flex;"> <div style="flex: 1;"> <p><b>Notes</b></p> <p>Abnormal detergent analysis result (bubbles)</p> </div> <div style="flex: 1;"> <p><b>Condition Assessment</b></p> <table border="1" style="width:100%; border-collapse: collapse;"> <tr><td>Graffiti:</td><td>None</td></tr> <tr><td>Erosion:</td><td>None</td></tr> <tr><td>Deposition:</td><td>None 0 in.</td></tr> <tr><td>Damage:</td><td>None</td></tr> </table> </div> </div>			Graffiti:	None	Erosion:	None	Deposition:	None 0 in.	Damage:	None																										
Graffiti:	None																																					
Erosion:	None																																					
Deposition:	None 0 in.																																					
Damage:	None

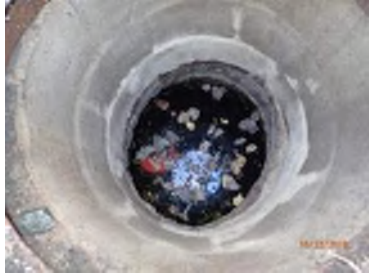
<b>Inspection Date:</b> 10/22/2018 3:18:57 PM		<b>Type:</b> Ongoing	<b>Flow:</b> Submerged, indeterminate	<b>Previous Rainfall (hrs):</b> 48-72
<b>Illicit Discharge Potential:</b> <b>Potential</b>		<b>Inspector:</b> JCW	<b>Notes</b>	
Submerged: Fully		Depth (in): 57	Floating gross solids (litter) in manhole.	
<b>Sampling Results</b>		<b>Condition Assessment</b>		
Sample Location: Pool	Floatables: None	Graffiti: None

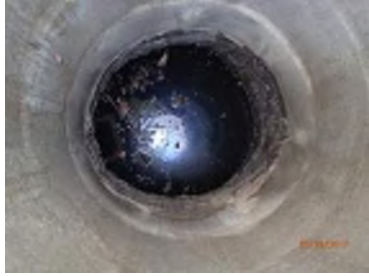
<b>Inspection Date:</b> 10/18/2017 2:55:07 PM		<b>Type:</b> Ongoing	<b>Flow:</b> Submerged, indeterminate	<b>Previous Rainfall (hrs):</b> 72+
<b>Illicit Discharge Potential:</b> <b>Potential</b>		<b>Inspector:</b> JCW	<b>Notes</b>	
Submerged: Fully		Depth (in): 50	Elevated ammonia and detergent in sample from manhole pool. Slight sheen observed on surface.	
<b>Sampling Results</b>		<b>Condition Assessment</b>		
Sample Location: Pool	Floatables: Moderate	Graffiti: None

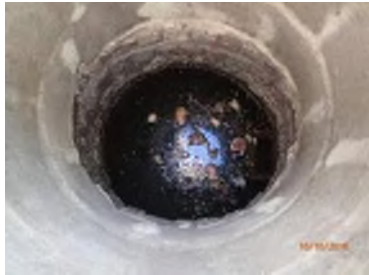
<b>Inspection Date:</b> 10/10/2016 9:04:32 AM		<b>Type:</b> Ongoing	<b>Flow:</b> Submerged, indeterminate	<b>Previous Rainfall (hrs):</b> 72+
<b>Illicit Discharge Potential:</b> <b>Potential</b>		<b>Inspector:</b> JCW	<b>Notes</b>	
Submerged: Fully		Depth (in): 46	Potential illicit discharge due to gross solids and petroleum odor and sheen and elevated ammonia.	
<b>Sampling Results</b>		<b>Condition Assessment</b>		
Sample Location: Pool	Floatables: Moderate	Graffiti: None
