# Submittal of Annual Reports and Other Compliance Documents for Municipal Separate Storm Sewer System (MS4) Permits

**Project Name:** 2023 Annual Report

**Municipality:** Oshkosh, City

**Permit Number:** S050075

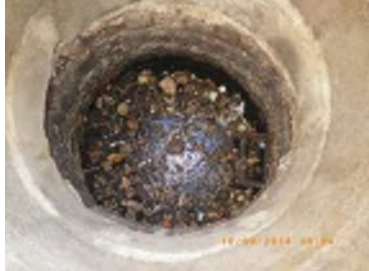
<p style="text-align: center;">o20141009090404.JPG</p> <p style="text-align: center; font-size: 1.5em; font-weight: bold;">2014</p>																																			
Submerged: Fully		Depth (in): 44																																					
<b>Sampling Results</b>

<b>Inspection Date:</b> 10/9/2014 10:07:49 AM		<b>Type:</b> Ongoing	<b>Flow:</b> Submerged, indeterminate	<b>Previous Rainfall (hrs):</b> 72+																																			
<b>Illicit Discharge Potential:</b> Obvious		<b>Inspector:</b> JCW

Sample Location:	Pool		Floatables:	Moderate	Total Chlorine:	0 ppm	Odor:	Faint	Free Chlorine:	0 ppm	Turbidity:	None	Ammonia:	0.5 ppm	Color:	None	pH:	7.58 units	Gross Solids:	Severe	Temperature	58 °F	Vegetation:	None	Conductivity:	679 µS/cm	Benthic Growth:	None	Detergents:	0 mg/L	Stains:	None			Non-illicit:	None	<b>Notes</b> Petroleum odor and sheen on surface.
Sample Location:	Pool	Floatables:	Moderate																																				
Total Chlorine:	0 ppm	Odor:	Faint																																				
Free Chlorine:	0 ppm	Turbidity:	None																																				
Ammonia:	0.5 ppm	Color:	None																																				
pH:	7.58 units	Gross Solids:	Severe																																				
Temperature	58 °F	Vegetation:	None																																				
Conductivity:	679 µS/cm	Benthic Growth:	None																																				
Detergents:	0 mg/L	Stains:	None																																				
		Non-illicit:	None																																				
		<b>Condition Assessment</b> Graffiti: None Erosion: None Deposition: Minor 2 in. Damage: None

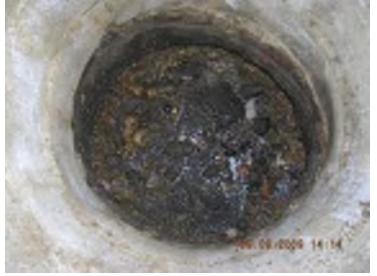
<b>Inspection Date:</b> 9/9/2009		<b>Type:</b> Initial		<b>Flow:</b> Submerged, indeterminate		<b>Previous Rainfall (hrs):</b> 72+	
<b>Illicit Discharge Potential:</b> Obvious		Inspector: JCW		<b>Notes</b> Diesel/oil odor, sheen on surface. Floatables with grease. Brown/gray color.

Submerged: Fully		Depth (in): 44					
<b>Sampling Results</b> Sample Location: Pool Total Chlorine: 0 ppm Free Chlorine: 0 ppm Ammonia: -- ppm pH: 6.98 units Temperature: 73 °F Conductivity: -- µS/cm Detergents: 0 mg/L		Floatables: Severe Odor: Easily detected Turbidity: None Color: Faint in bottle Gross Solids: Severe Vegetation: None Benthic Growth: None Stains: None Non-illicit: None		<b>Condition Assessment</b> Graffiti: None Erosion: None Deposition: None 0 in. Damage: None		Osh09_DSCN6747.JPG <b>2009</b>

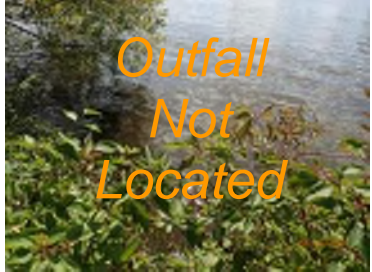
<p style="text-align: center;">o20210816151250.JPG</p> <p style="text-align: center; font-size: 1.2em; font-weight: bold;">2021</p>	
Submerged: Fully		Depth (in):		Outfall fully submerged and not located - screened upstream at 05-14 US1. Floating gross solids (litter) in upstream manhole.			
<b>Sampling Results</b> Sample Location: _____ Total Chlorine: -- ppm Free Chlorine: -- ppm Ammonia: -- ppm pH: -- units Temperature -- ° F Conductivity: -- µS/cm Detergents: -- mg/L		Floatables: None Odor: None Turbidity: None Color: None Gross Solids: None Vegetation: None Benthic Growth: None Stains: None Non-illicit: None		<b>Condition Assessment</b> Graffiti: None Erosion: None Deposition: None in. Damage: None

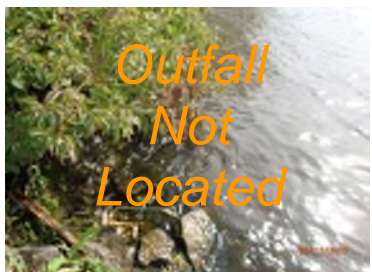
<p style="text-align: center;">o20190918134402.JPG</p> <p style="text-align: center; font-size: 1.2em; font-weight: bold;">2019</p>	
Submerged: Fully		Depth (in):		Outfall fully submerged and not located - screened upstream at 05-14 US1. Floating gross solids (litter) in manhole.			
<b>Sampling Results</b> Sample Location: _____ Total Chlorine: -- ppm Free Chlorine: -- ppm Ammonia: -- ppm pH: -- units Temperature -- ° F Conductivity: -- µS/cm Detergents: -- mg/L		Floatables: None Odor: None Turbidity: None Color: None Gross Solids: None Vegetation: None Benthic Growth: None Stains: None Non-illicit: None		<b>Condition Assessment</b> Graffiti: None Erosion: None Deposition: None in. Damage: None

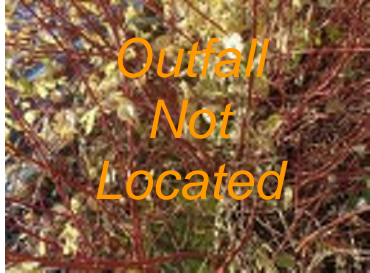
<p style="text-align: center;">o20181022170942.JPG</p> <p style="text-align: center; font-size: 1.2em; font-weight: bold;">2018</p>																																									
Submerged: Fully		Depth (in):		Outfall fully submerged and not located - screened upstream at 05-14 US1. Floating gross solids (litter) in manhole.																																											
<b>Sampling Results</b> <table border="1" style="width:100%; border-collapse: collapse;"> <tr><td>Sample Location:</td><td></td></tr> <tr><td>Total Chlorine:</td><td>-- ppm</td></tr> <tr><td>Free Chlorine:</td><td>-- ppm</td></tr> <tr><td>Ammonia:</td><td>-- ppm</td></tr> <tr><td>pH:</td><td>-- units</td></tr> <tr><td>Temperature:</td><td>-- ° F</td></tr> <tr><td>Conductivity:</td><td>-- µS/cm</td></tr> <tr><td>Detergents:</td><td>-- mg/L</td></tr> </table>		Sample Location:		Total Chlorine:	-- ppm			Free Chlorine:	-- ppm	Ammonia:	-- ppm	pH:	-- units	Temperature:	-- ° F	Conductivity:	-- µS/cm	Detergents:	-- mg/L	<table border="1" style="width:100%; border-collapse: collapse;"> <tr><td>Floatables:</td><td>None</td></tr> <tr><td>Odor:</td><td>None</td></tr> <tr><td>Turbidity:</td><td>None</td></tr> <tr><td>Color:</td><td>None</td></tr> <tr><td>Gross Solids:</td><td>None</td></tr> <tr><td>Vegetation:</td><td>None</td></tr> <tr><td>Benthic Growth:</td><td>None</td></tr> <tr><td>Stains:</td><td>None</td></tr> <tr><td>Non-illicit:</td><td>None</td></tr> </table>		Floatables:	None	Odor:	None	Turbidity:	None	Color:	None	Gross Solids:	None	Vegetation:	None	Benthic Growth:	None	Stains:	None	Non-illicit:	None	<b>Condition Assessment</b> <table border="1" style="width:100%; border-collapse: collapse;"> <tr><td>Graffiti:</td><td>None</td></tr> <tr><td>Erosion:</td><td>None</td></tr> <tr><td>Deposition:</td><td>None in.</td></tr> <tr><td>Damage:</td><td>None</td></tr> </table>		Graffiti:	None	Erosion:	None	Deposition:	None in.

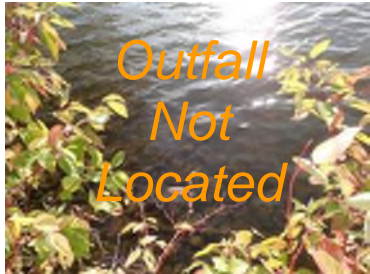
<p style="text-align: center;">o20171017155038.JPG</p> <p style="text-align: center; font-size: 1.2em; font-weight: bold;">2017</p>																																									
Submerged: Fully		Depth (in):		Outfall fully submerged and not located - screened upstream at 05-14 US1. Floating gross solids (litter) in manhole.																																											
<b>Sampling Results</b> <table border="1" style="width:100%; border-collapse: collapse;"> <tr><td>Sample Location:</td><td></td></tr> <tr><td>Total Chlorine:</td><td>-- ppm</td></tr> <tr><td>Free Chlorine:</td><td>-- ppm</td></tr> <tr><td>Ammonia:</td><td>-- ppm</td></tr> <tr><td>pH:</td><td>-- units</td></tr> <tr><td>Temperature:</td><td>-- ° F</td></tr> <tr><td>Conductivity:</td><td>-- µS/cm</td></tr> <tr><td>Detergents:</td><td>-- mg/L</td></tr> </table>		Sample Location:		Total Chlorine:	-- ppm			Free Chlorine:	-- ppm	Ammonia:	-- ppm	pH:	-- units	Temperature:	-- ° F	Conductivity:	-- µS/cm	Detergents:	-- mg/L	<table border="1" style="width:100%; border-collapse: collapse;"> <tr><td>Floatables:</td><td>None</td></tr> <tr><td>Odor:</td><td>None</td></tr> <tr><td>Turbidity:</td><td>None</td></tr> <tr><td>Color:</td><td>None</td></tr> <tr><td>Gross Solids:</td><td>None</td></tr> <tr><td>Vegetation:</td><td>None</td></tr> <tr><td>Benthic Growth:</td><td>None</td></tr> <tr><td>Stains:</td><td>None</td></tr> <tr><td>Non-illicit:</td><td>None</td></tr> </table>		Floatables:	None	Odor:	None	Turbidity:	None	Color:	None	Gross Solids:	None	Vegetation:	None	Benthic Growth:	None	Stains:	None	Non-illicit:	None	<b>Condition Assessment</b> <table border="1" style="width:100%; border-collapse: collapse;"> <tr><td>Graffiti:</td><td>None</td></tr> <tr><td>Erosion:</td><td>None</td></tr> <tr><td>Deposition:</td><td>None in.</td></tr> <tr><td>Damage:</td><td>None</td></tr> </table>		Graffiti:	None	Erosion:	None	Deposition:	None in.

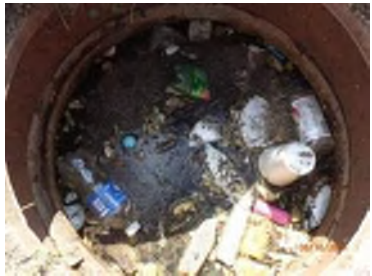
The outfalls with potential or obvious illicit discharges are summarized below:

<b>Notes</b> Sample collected from submerged pool in manhole. Floating gross solids (litter) in manhole.																																				
		<b>Condition Assessment</b> <table border="1" style="width:100%; border-collapse: collapse;"> <tr><td>Graffiti:</td><td>None</td></tr> <tr><td>Erosion:</td><td>None</td></tr> <tr><td>Deposition:</td><td>None in.</td></tr> <tr><td>Damage:</td><td>None</td></tr> </table>			Graffiti:	None	Erosion:	None	Deposition:	None in.	Damage:	None																										
Graffiti:	None																																					
Erosion:	None																																					
Deposition:	None in.																																					
Damage:	None

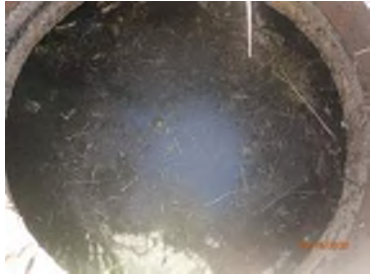
o20200819154014.JPG <div style="text-align: center; font-size: 24pt; font-weight: bold;">2020</div>

<b>Notes</b> Sample collected from submerged pool in manhole. Floating gross solids (litter) in manhole.																																				
		<b>Condition Assessment</b> <table border="1" style="width:100%; border-collapse: collapse;"> <tr><td>Graffiti:</td><td>None</td></tr> <tr><td>Erosion:</td><td>None</td></tr> <tr><td>Deposition:</td><td>None in.</td></tr> <tr><td>Damage:</td><td>None</td></tr> </table>			Graffiti:	None	Erosion:	None	Deposition:	None in.	Damage:	None																										
Graffiti:	None																																					
Erosion:	None																																					
Deposition:	None in.																																					
Damage:	None

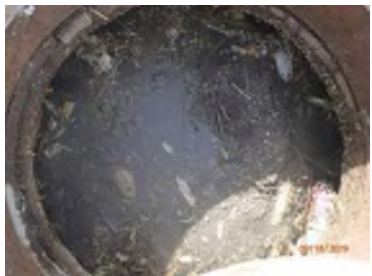
o20190918134540.JPG <div style="text-align: center; font-size: 24pt; font-weight: bold;">2019</div>

<b>Notes</b> Sample collected from submerged pool in manhole. Floating gross solids (litter) in manhole.																																				
		<b>Condition Assessment</b> <table border="1" style="width:100%; border-collapse: collapse;"> <tr><td>Graffiti:</td><td>None</td></tr> <tr><td>Erosion:</td><td>None</td></tr> <tr><td>Deposition:</td><td>None in.</td></tr> <tr><td>Damage:</td><td>None</td></tr> </table>			Graffiti:	None	Erosion:	None	Deposition:	None in.	Damage:	None																										
Graffiti:	None																																					
Erosion:	None																																					
Deposition:	None in.																																					
Damage:	None

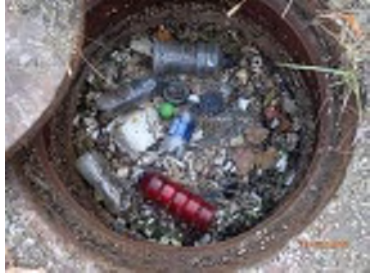
o20181022171308.JPG

<b>Inspection Date:</b> 10/22/2018 5:15:36 PM		<b>Type:</b> Ongoing	<b>Flow:</b> Submerged, indeterminate	<b>Previous Rainfall (hrs):</b> 48-72
<b>Illicit Discharge Potential:</b> <b>Potential</b>		<b>Inspector:</b> JCW	<b>Notes</b>	
Submerged: Fully		Depth (in): 47	Sample collected from submerged pool in manhole. Floating gross solids (litter) in manhole.	
<b>Sampling Results</b>		<b>Floatables:</b> None	<b>Condition Assessment</b>	
Sample Location:	Pool	<b>Odor:</b> None	Gross Solids: Severe	
Total Chlorine:	0 ppm	<b>Turbidity:</b> Cloudy	Vegetation: None	
Free Chlorine:	0 ppm	<b>Color:</b> None	Benthic Growth: None	
Ammonia:	0 ppm	<b>Gross Solids:</b> Severe	Stains: None	
pH:	7.59 units	<b>Vegetation:</b> None	Non-illicit: None	
Temperature:	56 °F	<b>Benthic Growth:</b> None	<b>Graffiti:</b> None	
Conductivity:	361 µS/cm	<b>Stains:</b> None	<b>Erosion:</b> None	
Detergents:	0 mg/L	<b>Non-illicit:</b> None	<b>Deposition:</b> None in.

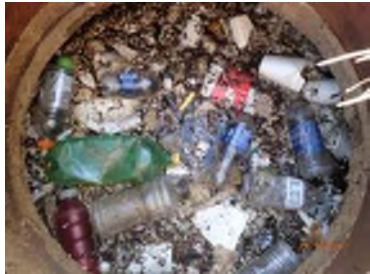
o20171017155256.JPG

<b>Inspection Date:</b> 10/17/2017 3:58:36 PM		<b>Type:</b> Ongoing	<b>Flow:</b> Submerged, indeterminate	<b>Previous Rainfall (hrs):</b> 48-72
<b>Illicit Discharge Potential:</b> <b>Potential</b>		<b>Inspector:</b> JCW	<b>Notes</b>	
Submerged: Fully		Depth (in): 40	Sample collected from submerged pool in manhole. Floating gross solids (litter) in manhole.	
<b>Sampling Results</b>		<b>Floatables:</b> None	<b>Condition Assessment</b>	
Sample Location:	Pool	<b>Odor:</b> None	Gross Solids: Severe	
Total Chlorine:	0 ppm	<b>Turbidity:</b> None	Vegetation: None	
Free Chlorine:	0 ppm	<b>Color:</b> None	Benthic Growth: None	
Ammonia:	0 ppm	<b>Gross Solids:</b> Severe	Stains: None	
pH:	7.93 units	<b>Vegetation:</b> None	Non-illicit: None	
Temperature:	66 °F	<b>Benthic Growth:</b> None	<b>Graffiti:</b> None	
Conductivity:	886 µS/cm	<b>Stains:</b> None	<b>Erosion:</b> None	
Detergents:	0 mg/L	<b>Non-illicit:</b> None	<b>Deposition:</b> None in.

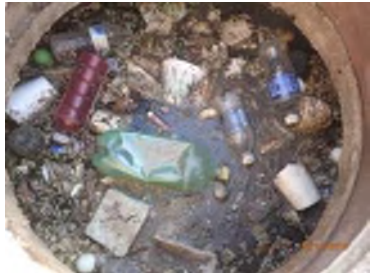
o20161010154428.JPG

<b>Inspection Date:</b> 10/10/2016 3:46:48 PM		<b>Type:</b> Ongoing	<b>Flow:</b> Submerged, indeterminate	<b>Previous Rainfall (hrs):</b> 72+
<b>Illicit Discharge Potential:</b> <b>Potential</b>		<b>Inspector:</b> JCW	<b>Notes</b>	
Submerged: Fully		Depth (in): 41	Potential illicit discharge due to gross solids.	
<b>Sampling Results</b>		<b>Floatables:</b> None	<b>Condition Assessment</b>	
Sample Location:	Pool	<b>Odor:</b> None	Gross Solids: Severe	
Total Chlorine:	0 ppm	<b>Turbidity:</b> None	Vegetation: None	
Free Chlorine:	0 ppm	<b>Color:</b> None	Benthic Growth: None	
Ammonia:	0 ppm	<b>Gross Solids:</b> Severe	Stains: None	
pH:	7.69 units	<b>Vegetation:</b> None	Non-illicit: None	
Temperature:	70 °F	<b>Benthic Growth:</b> None	<b>Graffiti:</b> None	
Conductivity:	660 µS/cm	<b>Stains:</b> None	<b>Erosion:</b> None	
Detergents:	0 mg/L	<b>Non-illicit:</b> None	<b>Deposition:</b> None in.	
			<b>Damage:</b> None

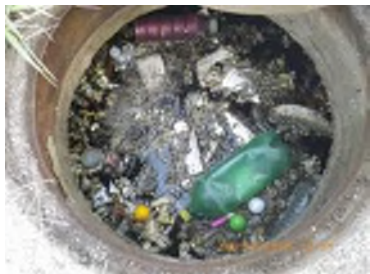
o20150924093714.JPG

<b>Inspection Date:</b> 9/24/2015 10:36:18 AM		<b>Type:</b> Ongoing	<b>Flow:</b> Submerged, indeterminate	<b>Previous Rainfall (hrs):</b> 72+
<b>Illicit Discharge Potential:</b> <b>Potential</b>		<b>Inspector:</b> JCW	<b>Notes</b>	
Submerged: Fully		Depth (in): 44	Floating gross solids (litter) in manhole.	
<b>Sampling Results</b>		<b>Floatables:</b> None	<b>Condition Assessment</b>	
Sample Location:	Pool	<b>Odor:</b> None	Gross Solids: Severe	
Total Chlorine:	0 ppm	<b>Turbidity:</b> None	Vegetation: None	
Free Chlorine:	0 ppm	<b>Color:</b> None	Benthic Growth: None	
Ammonia:	0 ppm	<b>Gross Solids:</b> Severe	Stains: None	
pH:	7.98 units	<b>Vegetation:</b> None	Non-illicit: None	
Temperature:	70 °F	<b>Benthic Growth:</b> None	<b>Graffiti:</b> None	
Conductivity:	424 µS/cm	<b>Stains:</b> None	<b>Erosion:</b> None	
Detergents:	0 mg/L	<b>Non-illicit:</b> None	<b>Deposition:</b> None in.	
			<b>Damage:</b> None

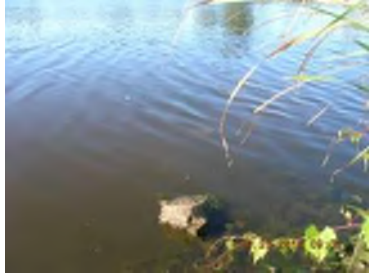
<b>Inspection Date:</b> 8/26/2010 9:11:00 AM		<b>Type:</b> Ongoing		<b>Flow:</b> Submerged, indeterminate		<b>Previous Rainfall (hrs):</b> 72+	
<b>Illicit Discharge Potential:</b> Unlikely		<b>Inspector:</b> JCW		<b>Notes</b> Fully submerged. Only vegetation in water is at end of pipe. Outfall screened upstream at 05-155 US1.

o20100826090214.JPG	
Submerged: Fully		Depth (in):					
<b>Sampling Results</b> Sample Location: _____ Total Chlorine: -- ppm Free Chlorine: -- ppm Ammonia: -- ppm pH: -- units Temperature -- °F Conductivity: -- µS/cm Detergents: -- mg/L		Floatables: None Odor: None Turbidity: None Color: None Gross Solids: None Vegetation: Slight Benthic Growth: None Stains: None Non-illicit: None		<b>Condition Assessment</b> Graffiti: None Erosion: None Deposition: None 0 in. Damage: None		<h1 style="margin: 0;">2010</h1>

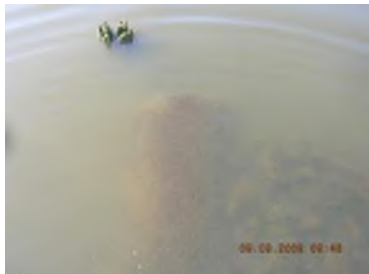
<b>Inspection Date:</b> 9/9/2009		<b>Type:</b> Initial		<b>Flow:</b> Submerged, indeterminate		<b>Previous Rainfall (hrs):</b> 72+	
<b>Illicit Discharge Potential:</b> Unlikely		<b>Inspector:</b> JCW		<b>Notes</b> Outfall fully submerged. Incorrectly screened upstream at water valve manhole.

Osh09_DSCN6691.JPG	
Submerged: Fully		Depth (in): 27					
<b>Sampling Results</b> Sample Location: _____ Total Chlorine: -- ppm Free Chlorine: -- ppm Ammonia: -- ppm pH: -- units Temperature -- °F Conductivity: -- µS/cm Detergents: -- mg/L		Floatables: None Odor: None Turbidity: None Color: None Gross Solids: None Vegetation: None Benthic Growth: None Stains: None Non-illicit: None		<b>Condition Assessment</b> Graffiti: None Erosion: None Deposition: None 0 in. Damage: None		<h1 style="margin: 0;">2009</h1>

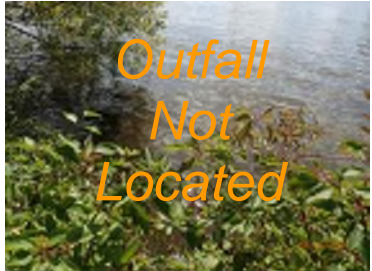
<b>Inspection Date:</b> 8/16/2021 3:20:05 PM		<b>Type:</b> Ongoing		<b>Flow:</b> Submerged (not located)		<b>Previous Rainfall (hrs):</b> 72+	
<b>Illicit Discharge Potential:</b> Unlikely		<b>Inspector:</b> JCW		<b>Notes</b> Outfall fully submerged and not located - screened upstream at 05-241 US1.

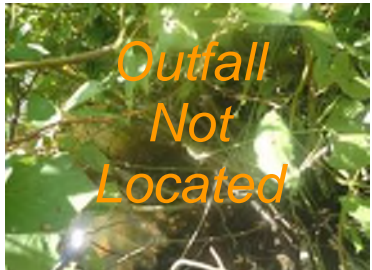
<b>Inspection Date:</b> 8/19/2020 3:45:30 PM		<b>Type:</b> Ongoing		<b>Flow:</b> Submerged (not located)		<b>Previous Rainfall (hrs):</b> 72+	
<b>Illicit Discharge Potential:</b> Unlikely		<b>Inspector:</b> JCW		<b>Notes</b> Outfall fully submerged and not located - screened upstream at 05-241 US1.

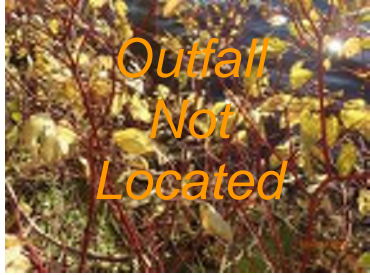
<b>Inspection Date:</b> 10/22/2018 5:11:27 PM		<b>Type:</b> Ongoing	<b>Flow:</b> Submerged (not located)	<b>Previous Rainfall (hrs):</b> 48-72
<b>Illicit Discharge Potential:</b> <b>Unlikely</b>		<b>Inspector:</b> JCW	<b>Notes</b>	
Submerged: Fully		Depth (in):	Outfall fully submerged and not located - screened upstream at 05-241 US1.	
<b>Sampling Results</b>		Floatables:	<div style="text-align: center;">

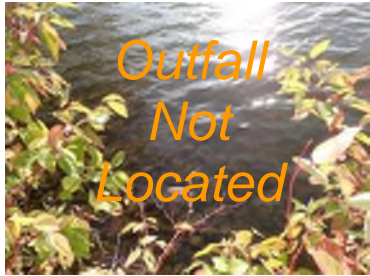
<b>Inspection Date:</b> 10/17/2017 3:57:59 PM		<b>Type:</b> Ongoing	<b>Flow:</b> Submerged (not located)	<b>Previous Rainfall (hrs):</b> 48-72
<b>Illicit Discharge Potential:</b> <b>Potential</b>		<b>Inspector:</b> JCW	<b>Notes</b>	
Submerged: Fully		Depth (in):	Outfall fully submerged and not located - screened upstream at 05-241 US1. Detergent detected in upstream manhole.	
<b>Sampling Results</b>		Floatables:	<div style="text-align: center;">

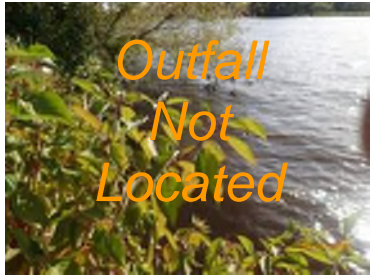
<b>Inspection Date:</b> 10/10/2016 3:43:52 PM		<b>Type:</b> Ongoing	<b>Flow:</b> Submerged (not located)	<b>Previous Rainfall (hrs):</b> 72+
<b>Illicit Discharge Potential:</b> <b>Unlikely</b>		<b>Inspector:</b> JCW	<b>Notes</b>	
Submerged: Fully		Depth (in):	Outfall fully submerged and not located - screened upstream at 05-241 US1.	
<b>Sampling Results</b>		Floatables:	<div style="text-align: center;">

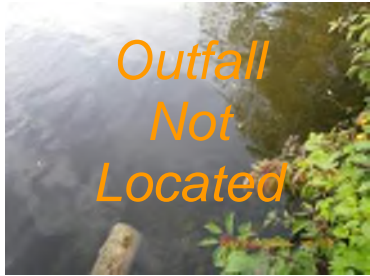
<b>Inspection Date:</b> 9/24/2015 10:23:00 AM		<b>Type:</b> Ongoing	<b>Flow:</b> Submerged (not located)	<b>Previous Rainfall (hrs):</b> 72+
<b>Illicit Discharge Potential:</b> <b>Unlikely</b>		<b>Inspector:</b> JCW	<b>Notes</b>	
Submerged: Fully		Depth (in):	Outfall fully submerged and not located - screened at 05-241 US1.	
<b>Sampling Results</b>		Floatables:	<div style="text-align: center;">

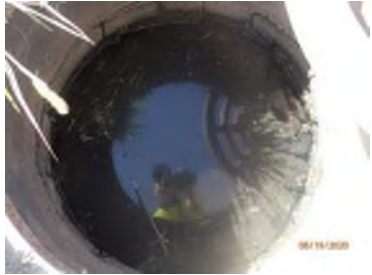
o20200819154302.JPG <div style="text-align: center; font-size: 24pt; font-weight: bold;">2020</div>

<b>Inspection Date:</b> 8/19/2020 3:46:25 PM		<b>Type:</b> Ongoing	<b>Flow:</b> Submerged, indeterminate	<b>Previous Rainfall (hrs):</b> 72+																																		
<b>Illicit Discharge Potential:</b> Unlikely		<b>Inspector:</b> JCW																																				
Submerged: Fully		Depth (in): 20																																				
<b>Sampling Results</b> <table border="1" style="width:100%; border-collapse: collapse;"> <tr><td>Sample Location:</td><td>Pool</td></tr> <tr><td>Total Chlorine:</td><td>0 ppm</td></tr> <tr><td>Free Chlorine:</td><td>0 ppm</td></tr> <tr><td>Ammonia:</td><td>0 ppm</td></tr> <tr><td>pH:</td><td>9.22 units</td></tr> <tr><td>Temperature:</td><td>84 °F</td></tr> <tr><td>Conductivity:</td><td>351 µS/cm</td></tr> <tr><td>Detergents:</td><td>0 mg/L</td></tr> </table>		Sample Location:	Pool	Total Chlorine:	0 ppm	Free Chlorine:	0 ppm	Ammonia:	0 ppm	pH:	9.22 units	Temperature:	84 °F	Conductivity:	351 µS/cm	Detergents:	0 mg/L	<table border="1" style="width:100%; border-collapse: collapse;"> <tr><td>Floatables:</td><td>None</td></tr> <tr><td>Odor:</td><td>None</td></tr> <tr><td>Turbidity:</td><td>None</td></tr> <tr><td>Color:</td><td>None</td></tr> <tr><td>Gross Solids:</td><td>None</td></tr> <tr><td>Vegetation:</td><td>None</td></tr> <tr><td>Benthic Growth:</td><td>None</td></tr> <tr><td>Stains:</td><td>None</td></tr> <tr><td>Non-illicit:</td><td>None</td></tr> </table>			Floatables:	None	Odor:	None	Turbidity:	None	Color:	None	Gross Solids:	None	Vegetation:	None	Benthic Growth:	None	Stains:	None	Non-illicit:	None

<b>Notes</b> Sample collected from submerged pool in manhole. Elevated pH seemed widespread in river.																																				
		<b>Condition Assessment</b> <table border="1" style="width:100%; border-collapse: collapse;"> <tr><td>Graffiti:</td><td>None</td></tr> <tr><td>Erosion:</td><td>None</td></tr> <tr><td>Deposition:</td><td>None in.</td></tr> <tr><td>Damage:</td><td>None</td></tr> </table>			Graffiti:	None	Erosion:	None	Deposition:	None in.	Damage:	None																										
Graffiti:	None																																					
Erosion:	None																																					
Deposition:	None in.																																					
Damage:	None

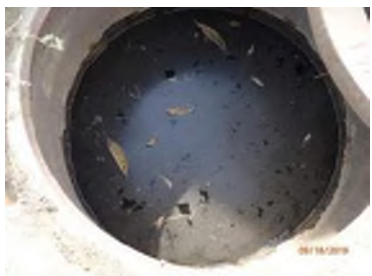
o20190918135010.JPG <div style="text-align: center; font-size: 24pt; font-weight: bold;">2019</div>

<b>Inspection Date:</b> 9/18/2019 2:53:05 PM		<b>Type:</b> Ongoing	<b>Flow:</b> Submerged, indeterminate	<b>Previous Rainfall (hrs):</b> 72+																																		
<b>Illicit Discharge Potential:</b> Unlikely		<b>Inspector:</b> JCW																																				
Submerged: Fully		Depth (in): 22																																				
<b>Sampling Results</b> <table border="1" style="width:100%; border-collapse: collapse;"> <tr><td>Sample Location:</td><td>Pool</td></tr> <tr><td>Total Chlorine:</td><td>0 ppm</td></tr> <tr><td>Free Chlorine:</td><td>0 ppm</td></tr> <tr><td>Ammonia:</td><td>0.5 ppm</td></tr> <tr><td>pH:</td><td>7.49 units</td></tr> <tr><td>Temperature:</td><td>78 °F</td></tr> <tr><td>Conductivity:</td><td>564 µS/cm</td></tr> <tr><td>Detergents:</td><td>0 mg/L</td></tr> </table>		Sample Location:	Pool	Total Chlorine:	0 ppm	Free Chlorine:	0 ppm	Ammonia:	0.5 ppm	pH:	7.49 units	Temperature:	78 °F	Conductivity:	564 µS/cm	Detergents:	0 mg/L	<table border="1" style="width:100%; border-collapse: collapse;"> <tr><td>Floatables:</td><td>None</td></tr> <tr><td>Odor:</td><td>None</td></tr> <tr><td>Turbidity:</td><td>None</td></tr> <tr><td>Color:</td><td>None</td></tr> <tr><td>Gross Solids:</td><td>None</td></tr> <tr><td>Vegetation:</td><td>None</td></tr> <tr><td>Benthic Growth:</td><td>None</td></tr> <tr><td>Stains:</td><td>None</td></tr> <tr><td>Non-illicit:</td><td>None</td></tr> </table>			Floatables:	None	Odor:	None	Turbidity:	None	Color:	None	Gross Solids:	None	Vegetation:	None	Benthic Growth:	None	Stains:	None	Non-illicit:	None

<b>Notes</b> Sample collected from submerged pool in manhole. Ammonia below action limit.																																				
		<b>Condition Assessment</b> <table border="1" style="width:100%; border-collapse: collapse;"> <tr><td>Graffiti:</td><td>None</td></tr> <tr><td>Erosion:</td><td>None</td></tr> <tr><td>Deposition:</td><td>None in.</td></tr> <tr><td>Damage:</td><td>None</td></tr> </table>			Graffiti:	None	Erosion:	None	Deposition:	None in.	Damage:	None																										
Graffiti:	None																																					
Erosion:	None																																					
Deposition:	None in.																																					
Damage:	None

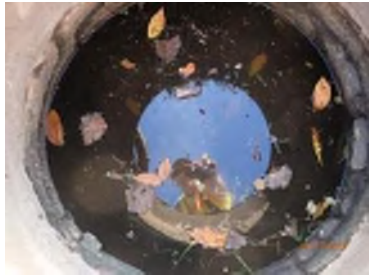
<p style="text-align: center;">o20171017155840.JPG</p> <p style="text-align: center; font-size: 24pt; font-weight: bold;">2017</p>

<b>Inspection Date:</b> 10/10/2016 3:50:18 PM		<b>Type:</b> Ongoing	<b>Flow:</b> Submerged, indeterminate	<b>Previous Rainfall (hrs):</b> 72+																																				
<b>Illicit Discharge Potential:</b> <b>Unlikely</b>		<b>Inspector:</b> JCW	<b>Notes</b>																																					
Submerged: Fully		Depth (in): 17																																						
<table border="1" style="width:100%; border-collapse: collapse;"> <tr> <td colspan="2"><b>Sampling Results</b></td> <td><b>Floatables:</b></td> <td>None</td> </tr> <tr> <td>Sample Location:</td> <td>Pool</td> <td><b>Odor:</b></td> <td>None</td> </tr> <tr> <td>Total Chlorine:</td> <td>0 ppm</td> <td><b>Turbidity:</b></td> <td>None</td> </tr> <tr> <td>Free Chlorine:</td> <td>0 ppm</td> <td><b>Color:</b></td> <td>None</td> </tr> <tr> <td>Ammonia:</td> <td>0 ppm</td> <td><b>Gross Solids:</b></td> <td>Moderate</td> </tr> <tr> <td>pH:</td> <td>7.59 units</td> <td><b>Vegetation:</b></td> <td>None</td> </tr> <tr> <td>Temperature</td> <td>69 °F</td> <td><b>Benthic Growth:</b></td> <td>None</td> </tr> <tr> <td>Conductivity:</td> <td>1551 µS/cm</td> <td><b>Stains:</b></td> <td>None</td> </tr> <tr> <td>Detergents:</td> <td>0 mg/L</td> <td><b>Non-illicit:</b></td> <td>Slight</td> </tr> </table>					<b>Sampling Results</b>		<b>Floatables:</b>	None	Sample Location:	Pool	<b>Odor:</b>	None	Total Chlorine:	0 ppm	<b>Turbidity:</b>	None	Free Chlorine:	0 ppm	<b>Color:</b>	None	Ammonia:	0 ppm	<b>Gross Solids:</b>	Moderate	pH:	7.59 units	<b>Vegetation:</b>	None	Temperature	69 °F	<b>Benthic Growth:</b>	None	Conductivity:	1551 µS/cm	<b>Stains:</b>	None	Detergents:	0 mg/L	<b>Non-illicit:</b>	Slight

<b>Sampling Results</b>		<b>Floatables:</b>	None																																					
Sample Location:	Pool	<b>Odor:</b>	None																																					
Total Chlorine:	0 ppm	<b>Turbidity:</b>	None																																					
Free Chlorine:	0 ppm	<b>Color:</b>	None																																					
Ammonia:	0 ppm	<b>Gross Solids:</b>	Moderate																																					
pH:	7.59 units	<b>Vegetation:</b>	None																																					
Temperature	69 °F	<b>Benthic Growth:</b>	None																																					
Conductivity:	1551 µS/cm	<b>Stains:</b>	None																																					
Detergents:	0 mg/L	<b>Non-illicit:</b>	Slight																																					
<table border="1" style="width:100%; border-collapse: collapse;"> <tr> <td colspan="2"><b>Condition Assessment</b></td> </tr> <tr> <td>Graffiti:</td> <td>None</td> </tr> <tr> <td>Erosion:</td> <td>None</td> </tr> <tr> <td>Deposition:</td> <td>None in.</td> </tr> <tr> <td>Damage:</td> <td>None</td> </tr> </table>					<b>Condition Assessment</b>		Graffiti:	None	Erosion:	None	Deposition:	None in.	Damage:	None

<b>Condition Assessment</b>																																								
Graffiti:	None																																							
Erosion:	None																																							
Deposition:	None in.																																							
Damage:	None

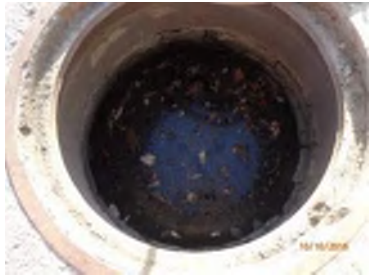
<p style="text-align: center;">o20161010154822.JPG</p> <p style="text-align: center; font-size: 24pt; font-weight: bold;">2016</p>

<b>Inspection Date:</b> 9/24/2015 10:27:12 AM		<b>Type:</b> Ongoing	<b>Flow:</b> Submerged, indeterminate	<b>Previous Rainfall (hrs):</b> 72+																																				
<b>Illicit Discharge Potential:</b> <b>Unlikely</b>		<b>Inspector:</b> JCW	<b>Notes</b>																																					
Submerged: Fully		Depth (in): 18																																						
<table border="1" style="width:100%; border-collapse: collapse;"> <tr> <td colspan="2"><b>Sampling Results</b></td> <td><b>Floatables:</b></td> <td>None</td> </tr> <tr> <td>Sample Location:</td> <td>Pool</td> <td><b>Odor:</b></td> <td>None</td> </tr> <tr> <td>Total Chlorine:</td> <td>0 ppm</td> <td><b>Turbidity:</b></td> <td>None</td> </tr> <tr> <td>Free Chlorine:</td> <td>0 ppm</td> <td><b>Color:</b></td> <td>None</td> </tr> <tr> <td>Ammonia:</td> <td>0 ppm</td> <td><b>Gross Solids:</b></td> <td>None</td> </tr> <tr> <td>pH:</td> <td>7.43 units</td> <td><b>Vegetation:</b></td> <td>None</td> </tr> <tr> <td>Temperature</td> <td>71 °F</td> <td><b>Benthic Growth:</b></td> <td>Moderate</td> </tr> <tr> <td>Conductivity:</td> <td>474 µS/cm</td> <td><b>Stains:</b></td> <td>None</td> </tr> <tr> <td>Detergents:</td> <td>0 mg/L</td> <td><b>Non-illicit:</b></td> <td>None</td> </tr> </table>					<b>Sampling Results</b>		<b>Floatables:</b>	None	Sample Location:	Pool	<b>Odor:</b>	None	Total Chlorine:	0 ppm	<b>Turbidity:</b>	None	Free Chlorine:	0 ppm	<b>Color:</b>	None	Ammonia:	0 ppm	<b>Gross Solids:</b>	None	pH:	7.43 units	<b>Vegetation:</b>	None	Temperature	71 °F	<b>Benthic Growth:</b>	Moderate	Conductivity:	474 µS/cm	<b>Stains:</b>	None	Detergents:	0 mg/L	<b>Non-illicit:</b>	None

<b>Sampling Results</b>		<b>Floatables:</b>	None																																					
Sample Location:	Pool	<b>Odor:</b>	None																																					
Total Chlorine:	0 ppm	<b>Turbidity:</b>	None																																					
Free Chlorine:	0 ppm	<b>Color:</b>	None																																					
Ammonia:	0 ppm	<b>Gross Solids:</b>	None																																					
pH:	7.43 units	<b>Vegetation:</b>	None																																					
Temperature	71 °F	<b>Benthic Growth:</b>	Moderate																																					
Conductivity:	474 µS/cm	<b>Stains:</b>	None																																					
Detergents:	0 mg/L	<b>Non-illicit:</b>	None																																					
<table border="1" style="width:100%; border-collapse: collapse;"> <tr> <td colspan="2"><b>Condition Assessment</b></td> </tr> <tr> <td>Graffiti:</td> <td>None</td> </tr> <tr> <td>Erosion:</td> <td>None</td> </tr> <tr> <td>Deposition:</td> <td>None in.</td> </tr> <tr> <td>Damage:</td> <td>None</td> </tr> </table>					<b>Condition Assessment</b>		Graffiti:	None	Erosion:	None	Deposition:	None in.	Damage:	None

<b>Condition Assessment</b>																																								
Graffiti:	None																																							
Erosion:	None																																							
Deposition:	None in.																																							
Damage:	None

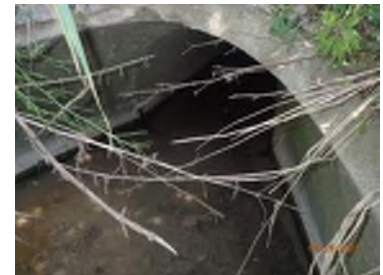
o20230719143332.JPG

Stains: Slight

☐ Petrol. Sheen ☐ Suds ☐ Sewage ☐ Algae ☐ Other☐ Petroleum ☐ Musty ☐ Sewage ☐ Chlorine ☐ Other☐ VOC/Solvent ☐ Fishy ☐ Sulfur ☐ Fragrant☐ Litter ☐ Veg. Debris ☐ Sediment ☐ Other☐ Inhibited ☐ Excessive☒ Green ☐ Brown☒ Flow Line ☐ Oil ☐ Rust Stains☐ Paint ☐ Other☐ Natural Sheen ☐ Natural Suds/Foam

Damage: Minor ☒ Displacement ☐ Undercut ☐ Crushed☐ Corrosion ☐ Cracks/Structural Damage

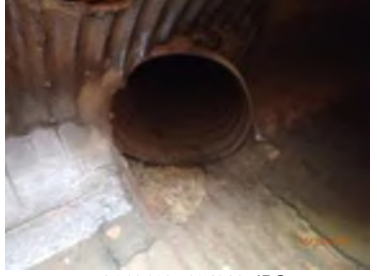
<p>o20181025104932.JPG</p> <p><b>2018</b></p>

<b>Inspection Date:</b> 10/25/2018 10:49:47 AM		<b>Type:</b> Ongoing	<b>Flow:</b> Submerged, indeterminate	<b>Previous Rainfall (hrs):</b> 72+
<b>Illicit Discharge Potential:</b> Unlikely		<b>Inspector:</b> JCW		
Submerged: Partially		Depth (in): 4		
<b>Sampling Results</b>				
Sample Location: Pool		Floatables: None		
Total Chlorine: 0 ppm		Odor: None		
Free Chlorine: 0 ppm		Turbidity: None		
Ammonia: 0 ppm		Color: None		
pH: 8.34 units		Gross Solids: None		
Temperature 53 °F		Vegetation: None		
Conductivity: 1239 µS/cm		Benthic Growth: None		
Detergents: 0 mg/L		Stains: None		
		Non-illicit: None		
<b>Notes</b>				
Sample collected from submerged pool in manhole.				
<b>Condition Assessment</b>				
Graffiti: None				
Erosion: None				
Deposition: None in.				
Damage: None

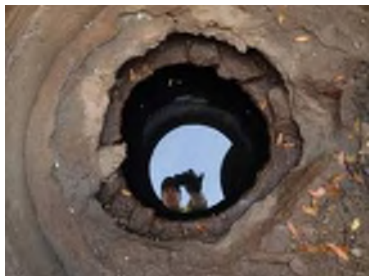
o20181025134812.JPG <div style="text-align: center; font-size: 24pt; font-weight: bold;">2018</div>

Floatables:	None	Odor:	None	Turbidity:	None	Color:	None	Gross Solids:	None	Vegetation:	None	Benthic Growth:	None	Stains:	None	Non-illicit:	None
Floatables:	None																					
Odor:	None																					
Turbidity:	None																					
Color:	None																					
Gross Solids:	None																					
Vegetation:	None																					
Benthic Growth:	None																					
Stains:	None																					
Non-illicit:	None																					
		<b>Notes</b> Sample collected from submerged pool in manhole.																				
		<b>Condition Assessment</b> Graffiti: None Erosion: None Deposition: None in. Damage: None

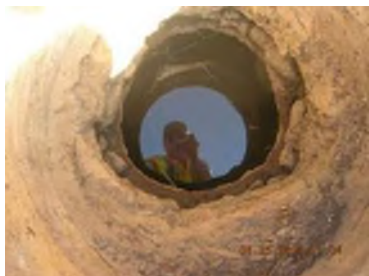
o20100825110424.JPG <div style="text-align: center; font-size: 24pt; font-weight: bold;">2010</div>

<b>Inspection Date:</b> 8/25/2010 11:14:23 AM		<b>Type:</b> Ongoing	<b>Flow:</b> Submerged, indeterminate	<b>Previous Rainfall (hrs):</b> 72+																		
<b>Illicit Discharge Potential:</b> Unlikely		<b>Inspector:</b> JCW																				
Submerged: Fully		Depth (in): 19																				
<b>Sampling Results</b> Sample Location: Pool Total Chlorine: 0 ppm Free Chlorine: 0 ppm Ammonia: 0 ppm pH: 7.31 units Temperature: 71 °F Conductivity: -- µS/cm Detergents: 0 mg/L

Floatables:	None	Odor:	None	Turbidity:	None	Color:	None	Gross Solids:	None	Vegetation:	None	Benthic Growth:	Slight	Stains:	Slight	Non-illicit:	None
Floatables:	None																					
Odor:	None																					
Turbidity:	None																					
Color:	None																					
Gross Solids:	None																					
Vegetation:	None																					
Benthic Growth:	Slight																					
Stains:	Slight																					
Non-illicit:	None																					
		<b>Notes</b>																				
		<b>Condition Assessment</b> Graffiti: None Erosion: None Deposition: None 0 in. Damage: None

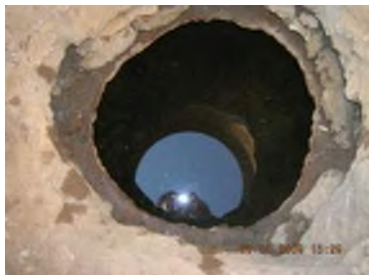
Osh09_DSCN6819.JPG <div style="text-align: center; font-size: 24pt; font-weight: bold;">2009</div>

<b>Inspection Date:</b> 9/10/2009		<b>Type:</b> Initial	<b>Flow:</b> Submerged, slight flow	<b>Previous Rainfall (hrs):</b> 72+																		
<b>Illicit Discharge Potential:</b> Unlikely		<b>Inspector:</b> JCW																				
Submerged: Fully		Depth (in): 13																				
<b>Sampling Results</b> Sample Location: Pool Total Chlorine: 0 ppm Free Chlorine: 0 ppm Ammonia: -- ppm pH: 7.2 units Temperature: 75 °F Conductivity: -- µS/cm Detergents: 0 mg/L

Floatables:	None	Odor:	None	Turbidity:	None	Color:	None	Gross Solids:	None	Vegetation:	None	Benthic Growth:	None	Stains:	None	Non-illicit:	None
Floatables:	None																					
Odor:	None																					
Turbidity:	None																					
Color:	None																					
Gross Solids:	None																					
Vegetation:	None																					
Benthic Growth:	None																					
Stains:	None																					
Non-illicit:	None																					
		<b>Notes</b>																				
		<b>Condition Assessment</b> Graffiti: None Erosion: None Deposition: None 0 in. Damage: None

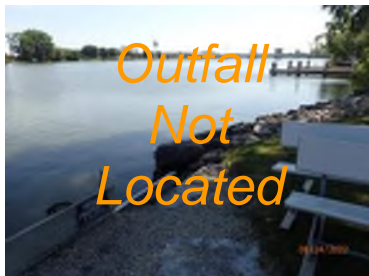
<b>Inspection Date:</b> 8/24/2022 11:40:00 AM		<b>Type:</b> Ongoing		<b>Flow:</b> Submerged (not located)		<b>Previous Rainfall (hrs):</b> 72+	
<b>Illicit Discharge Potential:</b> Unlikely		<b>Inspector:</b> EJK		<b>Notes</b> Outfall fully submerged and not located - submerged upstream at 06-1709 US1.

o20220824113640.JPG	
Submerged: Fully		Depth (in):					
<b>Sampling Results</b> Sample Location: _____ Total Chlorine: -- ppm Free Chlorine: -- ppm Ammonia: -- ppm pH: -- units Temperature: -- °F Conductivity: -- µS/cm Detergents: -- mg/L		Floatables: None Odor: None Turbidity: None Color: None Gross Solids: None Vegetation: None Benthic Growth: None Stains: None Non-illicit: None		<b>Condition Assessment</b> Graffiti: None Erosion: None Deposition: None in. Damage: None			
<b>2022</b>

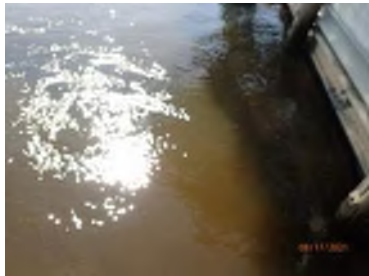
<b>Inspection Date:</b> 8/17/2021 10:43:57 AM		<b>Type:</b> Ongoing		<b>Flow:</b> Submerged, significant flow		<b>Previous Rainfall (hrs):</b> 72+	
<b>Illicit Discharge Potential:</b> Potential		<b>Inspector:</b> JCW		<b>Notes</b> Outfall fully submerged and not located - screened upstream at 06-1709 US1. Detergent detected in upstream manhole.

o20210817104212.JPG	
Submerged: Fully		Depth (in):					
<b>Sampling Results</b> Sample Location: _____ Total Chlorine: -- ppm Free Chlorine: -- ppm Ammonia: -- ppm pH: -- units Temperature: -- °F Conductivity: -- µS/cm Detergents: -- mg/L		Floatables: None Odor: None Turbidity: None Color: None Gross Solids: None Vegetation: None Benthic Growth: None Stains: None Non-illicit: None		<b>Condition Assessment</b> Graffiti: None Erosion: None Deposition: None in. Damage: None			
<b>2021</b>

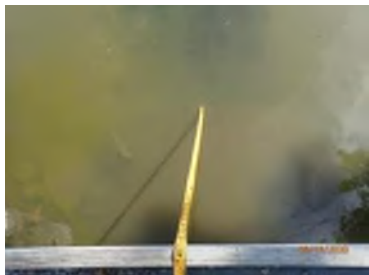
<b>Inspection Date:</b> 8/19/2020 10:22:53 AM		<b>Type:</b> Ongoing		<b>Flow:</b> Submerged, significant flow		<b>Previous Rainfall (hrs):</b> 72+	
<b>Illicit Discharge Potential:</b> Unlikely		<b>Inspector:</b> JCW		<b>Notes</b> Outfall fully submerged - screened upstream at 06-253 US1.

o20200819102052.JPG	
Submerged: Fully		Depth (in): 38					
<b>Sampling Results</b> Sample Location: _____ Total Chlorine: -- ppm Free Chlorine: -- ppm Ammonia: -- ppm pH: -- units Temperature: -- °F Conductivity: -- µS/cm Detergents: -- mg/L		Floatables: None Odor: None Turbidity: None Color: None Gross Solids: None Vegetation: None Benthic Growth: None Stains: None Non-illicit: None		<b>Condition Assessment</b> Graffiti: None Erosion: None Deposition: None in. Damage: None			
<b>2020</b>

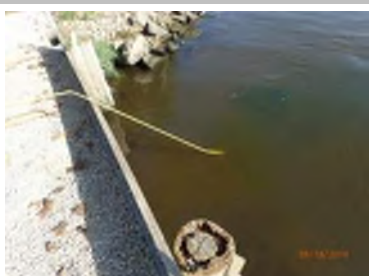
<b>Inspection Date:</b> 9/18/2019 9:25:08 AM		<b>Type:</b> Ongoing		<b>Flow:</b> Submerged, significant flow		<b>Previous Rainfall (hrs):</b> 72+	
<b>Illicit Discharge Potential:</b> Unlikely		<b>Inspector:</b> JCW		<b>Notes</b> Outfall fully submerged, significant flow causing surface disturbance. Screened upstream at 06-253 US1.

o20190918082324.JPG	
Submerged: Fully		Depth (in):					
<b>Sampling Results</b> Sample Location: _____ Total Chlorine: -- ppm Free Chlorine: -- ppm Ammonia: -- ppm pH: -- units Temperature: -- °F Conductivity: -- µS/cm Detergents: -- mg/L		Floatables: None Odor: None Turbidity: None Color: None Gross Solids: None Vegetation: None Benthic Growth: None Stains: None Non-illicit: None		<b>Condition Assessment</b> Graffiti: None Erosion: None Deposition: None in. Damage: None			
<b>2019</b>

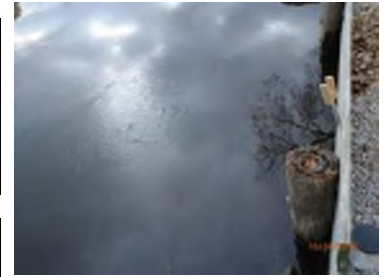
o20181024072834.JPG

<b>Inspection Date:</b> 10/24/2018 7:29:02 AM		<b>Type:</b> Ongoing	<b>Flow:</b> Submerged, significant flow	<b>Previous Rainfall (hrs):</b> 72+
<b>Illicit Discharge Potential:</b> <b>Potential</b>		<b>Inspector:</b> JCW	<b>Notes</b>	
Submerged: Fully		Depth (in):	Outfall fully submerged, significant flow causing surface disturbance. Screened upstream at 06-253 US1. Elevated ammonia and conductivity in manhole.	
<b>Sampling Results</b>		<b>Floatables:</b>	<b>Condition Assessment</b>	
Sample Location:		<b>Odor:</b>	Graffiti: None Erosion: None Deposition: None in. Damage: None	
Total Chlorine: -- ppm		<b>Turbidity:</b>		
Free Chlorine: -- ppm		<b>Color:</b>		
Ammonia: -- ppm		<b>Gross Solids:</b>		
pH: -- units		<b>Vegetation:</b>		
Temperature -- °F		<b>Benthic Growth:</b>		
Conductivity: -- µS/cm		<b>Stains:</b>		
Detergents: -- mg/L		<b>Non-illicit:</b>

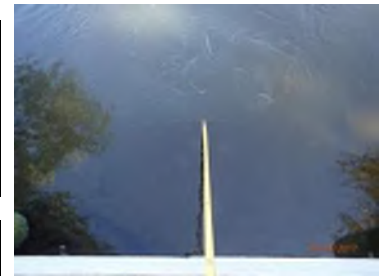
o20171019131334.JPG

<b>Inspection Date:</b> 10/19/2017 1:14:17 PM		<b>Type:</b> Ongoing	<b>Flow:</b> Submerged, significant flow	<b>Previous Rainfall (hrs):</b> 72+
<b>Illicit Discharge Potential:</b> <b>Potential</b>		<b>Inspector:</b> JCW	<b>Notes</b>	
Submerged: Fully		Depth (in):	Outfall fully submerged with significant flow causing surface disturbance. Screened upstream at 06-253 US1. Elevated ammonia in manhole.	
<b>Sampling Results</b>		<b>Floatables:</b>	<b>Condition Assessment</b>	
Sample Location:		<b>Odor:</b>	Graffiti: None Erosion: None Deposition: None in. Damage: None	
Total Chlorine: -- ppm		<b>Turbidity:</b>		
Free Chlorine: -- ppm		<b>Color:</b>		
Ammonia: -- ppm		<b>Gross Solids:</b>		
pH: -- units		<b>Vegetation:</b>		
Temperature -- °F		<b>Benthic Growth:</b>		
Conductivity: -- µS/cm		<b>Stains:</b>		
Detergents: -- mg/L		<b>Non-illicit:</b>

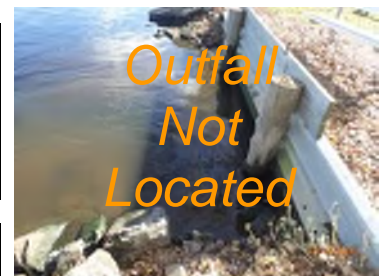
o20161018135746.JPG

<b>Inspection Date:</b> 10/18/2016 1:59:02 PM		<b>Type:</b> Ongoing	<b>Flow:</b> Submerged (not located)	<b>Previous Rainfall (hrs):</b> 72+
<b>Illicit Discharge Potential:</b> <b>Unlikely</b>		<b>Inspector:</b> JCW	<b>Notes</b>	
Submerged: Fully		Depth (in):	Outfall fully submerged and not located - screened upstream at 06-253 US1.	
<b>Sampling Results</b>		<b>Floatables:</b>	<b>Condition Assessment</b>	
Sample Location:		<b>Odor:</b>	Graffiti: None Erosion: None Deposition: None in. Damage: None	
Total Chlorine: -- ppm		<b>Turbidity:</b>		
Free Chlorine: -- ppm		<b>Color:</b>		
Ammonia: -- ppm		<b>Gross Solids:</b>		
pH: -- units		<b>Vegetation:</b>		
Temperature -- °F		<b>Benthic Growth:</b>		
Conductivity: -- µS/cm		<b>Stains:</b>		
Detergents: -- mg/L		<b>Non-illicit:</b>

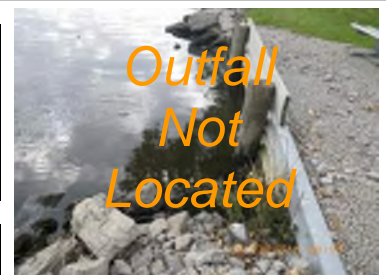
o20150923082910.JPG

<b>Inspection Date:</b> 9/23/2015 9:26:08 AM		<b>Type:</b> Ongoing	<b>Flow:</b> Submerged (not located)	<b>Previous Rainfall (hrs):</b> 72+
<b>Illicit Discharge Potential:</b> <b>Unlikely</b>		<b>Inspector:</b> JCW	<b>Notes</b>	
Submerged: Fully		Depth (in):	Outfall fully submerged and not located - screened at 06-253 US1.	
<b>Sampling Results</b>		<b>Floatables:</b>	<b>Condition Assessment</b>	
Sample Location:		<b>Odor:</b>	Graffiti: None Erosion: None Deposition: None in. Damage: None	
Total Chlorine: -- ppm		<b>Turbidity:</b>		
Free Chlorine: -- ppm		<b>Color:</b>		
Ammonia: -- ppm		<b>Gross Solids:</b>		
pH: -- units		<b>Vegetation:</b>		
Temperature -- °F		<b>Benthic Growth:</b>		
Conductivity: -- µS/cm		<b>Stains:</b>		
Detergents: -- mg/L		<b>Non-illicit:</b>

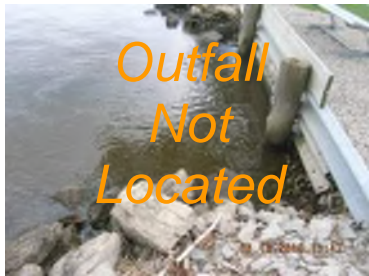
o20100818134248.JPG <div style="text-align: center; font-size: 24pt; font-weight: bold;">2010</div>

<b>Inspection Date:</b> 8/18/2010 1:51:34 PM		<b>Type:</b> Ongoing	<b>Flow:</b> Submerged (not located)	<b>Previous Rainfall (hrs):</b> 72+
<b>Illicit Discharge Potential:</b> Unlikely		<b>Inspector:</b> JCW		
Submerged: Fully		Depth (in):		
<b>Sampling Results</b> Sample Location: _____ Total Chlorine: -- ppm Free Chlorine: -- ppm Ammonia: -- ppm pH: -- units Temperature: -- °F Conductivity: -- µS/cm Detergents: -- mg/L		Floatables: None Odor: None Turbidity: None Color: None Gross Solids: None Vegetation: None Benthic Growth: None Stains: None Non-illicit: None		
		<b>Notes</b> Outfall fully submerged and not physically located. Outfall screened upstream at 06-263 US1.		
		<b>Condition Assessment</b> Graffiti: None Erosion: None Deposition: None 0 in. Damage: None

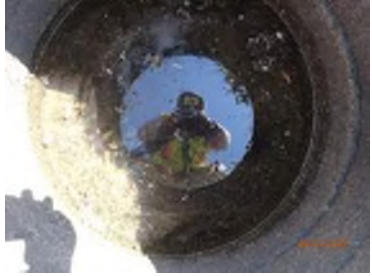
<b>Inspection Date:</b> 8/24/2022 11:41:00 AM		<b>Type:</b> Ongoing	<b>Flow:</b> Submerged, slight flow	<b>Previous Rainfall (hrs):</b> 72+
<b>Illicit Discharge Potential:</b> Unlikely		<b>Inspector:</b> EJK		
Submerged: Fully		Depth (in):		
<b>Sampling Results</b> Sample Location: Flow Total Chlorine: 0 ppm Free Chlorine: 0 ppm Ammonia: 0 ppm pH: 7.71 units Temperature: 76 °F Conductivity: 1250 µS/cm Detergents: 0 mg/L		Floatables: None Odor: None Turbidity: None Color: None Gross Solids: Slight Vegetation: None Benthic Growth: Moderate Stains: None Non-illicit: None		
		<b>Notes</b> Sample collected from submerged flow in catchbasin.		
		<b>Condition Assessment</b> Graffiti: None Erosion: None Deposition: None in. Damage: None

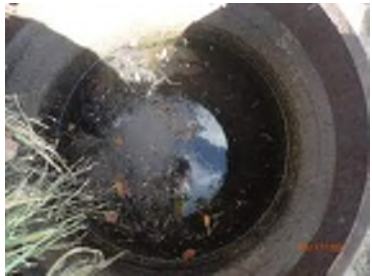
<b>Inspection Date:</b> 8/17/2021 10:51:45 AM		<b>Type:</b> Ongoing	<b>Flow:</b> Submerged, significant flow	<b>Previous Rainfall (hrs):</b> 72+
<b>Illicit Discharge Potential:</b> Potential		<b>Inspector:</b> JCW		
Submerged: Fully		Depth (in): 48		
<b>Sampling Results</b> Sample Location: Flow Total Chlorine: 0 ppm Free Chlorine: 0 ppm Ammonia: 0 ppm pH: 7.08 units Temperature: 80 °F Conductivity: 1154 µS/cm Detergents: 0.4 mg/L		Floatables: None Odor: None Turbidity: None Color: None Gross Solids: None Vegetation: None Benthic Growth: Moderate Stains: None Non-illicit: None		
		<b>Notes</b> Sample collected from flow in catchbasin. Detergent detected in sample.		
		<b>Condition Assessment</b> Graffiti: None Erosion: None Deposition: None in. Damage: None

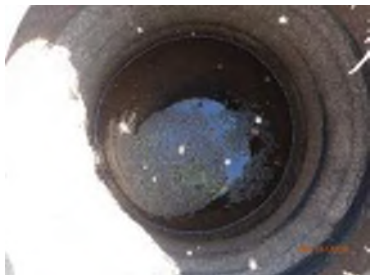
<b>Inspection Date:</b> 8/19/2020 10:28:37 AM		<b>Type:</b> Ongoing	<b>Flow:</b> Submerged, significant flow	<b>Previous Rainfall (hrs):</b> 72+
<b>Illicit Discharge Potential:</b> Unlikely		<b>Inspector:</b> JCW		
Submerged: Fully		Depth (in): 42		
<b>Sampling Results</b> Sample Location: Flow Total Chlorine: 0 ppm Free Chlorine: 0 ppm Ammonia: 0 ppm pH: 6.92 units Temperature: 76 °F Conductivity: 1320 µS/cm Detergents: 0 mg/L		Floatables: None Odor: None Turbidity: None Color: None Gross Solids: None Vegetation: None Benthic Growth: Moderate Stains: None Non-illicit: None		
		<b>Notes</b> Sample collected from submerged flow in manhole.		
		<b>Condition Assessment</b> Graffiti: None Erosion: None Deposition: None in. Damage: None

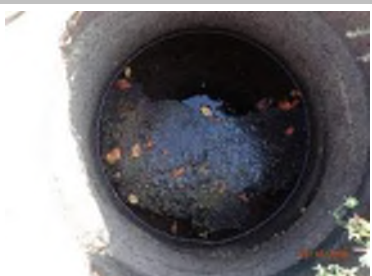
<b>Inspection Date:</b> 9/18/2019 9:48:09 AM		<b>Type:</b> Ongoing	<b>Flow:</b> Submerged, slight flow	<b>Previous Rainfall (hrs):</b> 72+
<b>Illicit Discharge Potential:</b> Unlikely		<b>Inspector:</b> JCW		
Submerged: Fully		Depth (in): 45		
<b>Sampling Results</b> Sample Location: Pool Total Chlorine: 0 ppm Free Chlorine: 0 ppm Ammonia: 0 ppm pH: 7.38 units Temperature: 71 °F Conductivity: 1261 µS/cm Detergents: 0 mg/L		Floatables: None Odor: None Turbidity: None Color: None Gross Solids: Slight Vegetation: None Benthic Growth: None Stains: None Non-illicit: None		
		<b>Notes</b> Sample collected from submerged flow in manhole. Floating gross solids (litter) in manhole.		
		<b>Condition Assessment</b> Graffiti: None Erosion: None Deposition: None in. Damage: None

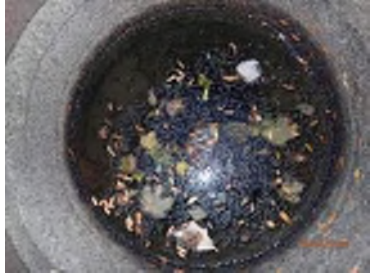
<b>Inspection Date:</b> 10/24/2018 7:21:30 AM		<b>Type:</b> Ongoing		<b>Flow:</b> Submerged, indeterminate		<b>Previous Rainfall (hrs):</b> 72+	
<b>Illicit Discharge Potential:</b> <b>Potential</b>		<b>Inspector:</b> JCW		<b>Notes</b>

<p style="text-align: center;">o20181024071720.JPG</p> <p style="text-align: center; font-size: 24pt; font-weight: bold;">2018</p>	
Submerged: Fully		Depth (in): 46		Sample collected from submerged flow in manhole. Elevated ammonia and conductivity in sample.			
<b>Sampling Results</b>							
Sample Location: Pool		Floatables: None		<b>Condition Assessment</b>		Graffiti: None Erosion: None Deposition: None in. Damage: None	
Total Chlorine: 0 ppm		Odor: None					
Free Chlorine: 0 ppm		Turbidity: None					
Ammonia: 3 ppm		Color: None					
pH: 7.27 units		Gross Solids: Slight					
Temperature 52 °F		Vegetation: None					
Conductivity: 2280 µS/cm		Benthic Growth: None

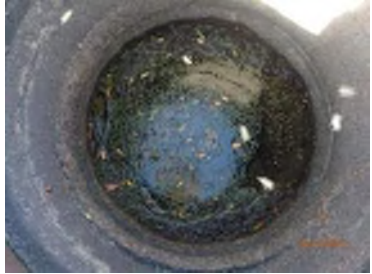
<b>Inspection Date:</b> 10/19/2017 1:19:57 PM		<b>Type:</b> Ongoing		<b>Flow:</b> Submerged, slight flow		<b>Previous Rainfall (hrs):</b> 72+	
<b>Illicit Discharge Potential:</b> <b>Potential</b>		<b>Inspector:</b> JCW		<b>Notes</b>

<p style="text-align: center;">o20171019131708.JPG</p> <p style="text-align: center; font-size: 24pt; font-weight: bold;">2017</p>	
Submerged: Fully		Depth (in): 40		Sample collected from submerged flow in manhole. Elevated ammonia.			
<b>Sampling Results</b>							
Sample Location: Flow		Floatables: None		<b>Condition Assessment</b>		Graffiti: None Erosion: None Deposition: None in. Damage: None	
Total Chlorine: 0 ppm		Odor: None					
Free Chlorine: 0 ppm		Turbidity: None					
Ammonia: 3 ppm		Color: None					
pH: 7.15 units		Gross Solids: None					
Temperature 68 °F		Vegetation: None					
Conductivity: 1990 µS/cm		Benthic Growth: None					
Detergents: 0 mg/L		Stains: None

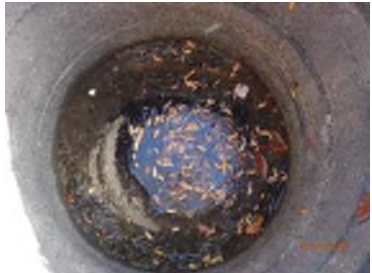
<p style="text-align: center;">o20161018140148.JPG</p> <p style="text-align: center; font-size: 24pt; font-weight: bold;">2016</p>	
Submerged: Fully		Depth (in): 40		Strong current; significant flies in manhole.			
<b>Sampling Results</b>							
Sample Location: Flow		Floatables: None		<b>Condition Assessment</b>		Graffiti: None Erosion: None Deposition: None in. Damage: None	
Total Chlorine: 0 ppm		Odor: Faint					
Free Chlorine: 0 ppm		Turbidity: None					
Ammonia: 0 ppm		Color: None					
pH: 7.01 units		Gross Solids: None					
Temperature 70 °F		Vegetation: None					
Conductivity: 1228 µS/cm		Benthic Growth: None					
Detergents: 0 mg/L		Stains: None					
		Non-illicit: None

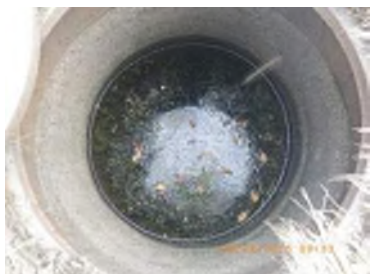
<p style="text-align: center;">o20150923083310.JPG</p> <p style="text-align: center; font-size: 24pt; font-weight: bold;">2015</p>	
Submerged: Fully		Depth (in): 42		Significant current detected in pool. Many flies emerging from water.			
<b>Sampling Results</b>							
Sample Location: Pool		Floatables: None		<b>Condition Assessment</b>		Graffiti: None Erosion: None Deposition: None in. Damage: None	
Total Chlorine: 0 ppm		Odor: None					
Free Chlorine: 0 ppm		Turbidity: None					
Ammonia: 0 ppm		Color: None					
pH: 7.53 units		Gross Solids: Slight					
Temperature 70 °F		Vegetation: None					
Conductivity: 1220 µS/cm		Benthic Growth: Slight					
Detergents: 0 mg/L		Stains: None

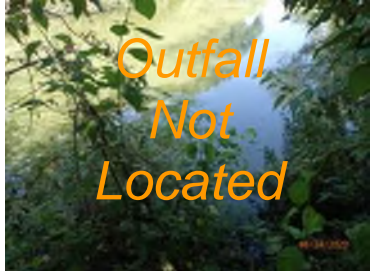
o20220824121214.JPG

<b>Inspection Date:</b> 8/24/2022 12:15:00 PM		<b>Type:</b> Ongoing	<b>Flow:</b> Submerged (not located)	<b>Previous Rainfall (hrs):</b> 72+
<b>Illicit Discharge Potential:</b> Unlikely		<b>Inspector:</b> EJK	<b>Notes</b>	
Submerged: Fully		Depth (in):	Outfall fully submerged and not located - screened upstream at 06-221 US1.	
<b>Sampling Results</b>		Floatables:	<b>Condition Assessment</b> Graffiti: None Erosion: None Deposition: None in. Damage: None	
Sample Location:		Odor:		
Total Chlorine: -- ppm		Turbidity:		
Free Chlorine: -- ppm		Color:		
Ammonia: -- ppm		Gross Solids:		
pH: -- units		Vegetation:		
Temperature -- ° F		Benthic Growth:		
Conductivity: -- µS/cm		Stains:		
Detergents: -- mg/L		Non-illicit:

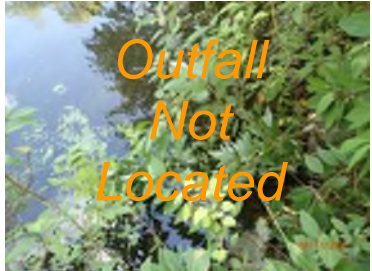
o20210817103222.JPG

<b>Inspection Date:</b> 8/17/2021 10:33:51 AM		<b>Type:</b> Ongoing	<b>Flow:</b> Submerged (not located)	<b>Previous Rainfall (hrs):</b> 72+
<b>Illicit Discharge Potential:</b> Unlikely		<b>Inspector:</b> JCW	<b>Notes</b>	
Submerged: Fully		Depth (in):	Outfall fully submerged and not located - screened upstream at 06-221 US1.	
<b>Sampling Results</b>		Floatables:	<b>Condition Assessment</b> Graffiti: None Erosion: None Deposition: None in. Damage: None	
Sample Location:		Odor:		
Total Chlorine: -- ppm		Turbidity:		
Free Chlorine: -- ppm		Color:		
Ammonia: -- ppm		Gross Solids:		
pH: -- units		Vegetation:		
Temperature -- ° F		Benthic Growth:		
Conductivity: -- µS/cm		Stains:		
Detergents: -- mg/L		Non-illicit:

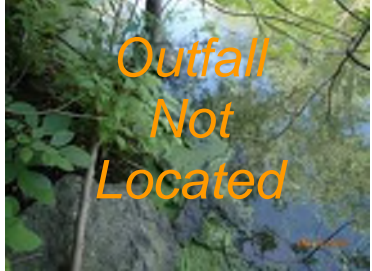
o20200819101038.JPG

<b>Inspection Date:</b> 8/19/2020 10:10:00 AM		<b>Type:</b> Ongoing	<b>Flow:</b> Submerged (not located)	<b>Previous Rainfall (hrs):</b> 72+
<b>Illicit Discharge Potential:</b> Unlikely		<b>Inspector:</b> JCW	<b>Notes</b>	
Submerged: Fully		Depth (in):	Outfall fully submerged and not located - screened upstream at 06-221 US1.	
<b>Sampling Results</b>		Floatables:	<b>Condition Assessment</b> Graffiti: None Erosion: None Deposition: None in. Damage: None	
Sample Location:		Odor:		
Total Chlorine: -- ppm		Turbidity:		
Free Chlorine: -- ppm		Color:		
Ammonia: -- ppm		Gross Solids:		
pH: -- units		Vegetation:		
Temperature -- ° F		Benthic Growth:		
Conductivity: -- µS/cm		Stains:		
Detergents: -- mg/L		Non-illicit:

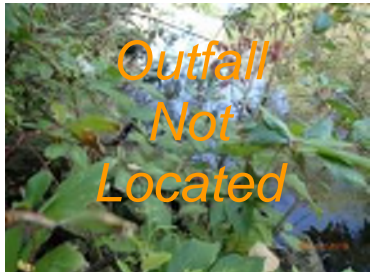
o20190918083642.JPG

<b>Inspection Date:</b> 9/18/2019 9:37:57 AM		<b>Type:</b> Ongoing	<b>Flow:</b> Submerged (not located)	<b>Previous Rainfall (hrs):</b> 72+
<b>Illicit Discharge Potential:</b> Unlikely		<b>Inspector:</b> JCW	<b>Notes</b>	
Submerged: Fully		Depth (in):	Outfall fully submerged and not located - screened upstream at 06-221 US1. Floating gross solids (litter) in manhole.	
<b>Sampling Results</b>		Floatables:	<b>Condition Assessment</b> Graffiti: None Erosion: None Deposition: None in. Damage: None	
Sample Location:		Odor:		
Total Chlorine: -- ppm		Turbidity:		
Free Chlorine: -- ppm		Color:		
Ammonia: -- ppm		Gross Solids:		
pH: -- units		Vegetation:		
Temperature -- ° F		Benthic Growth:		
Conductivity: -- µS/cm		Stains:		
Detergents: -- mg/L		Non-illicit:

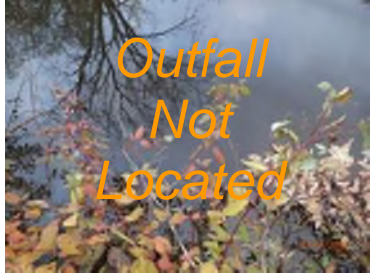
o20181024074402.JPG

<b>Inspection Date:</b> 10/24/2018 7:45:30 AM		<b>Type:</b> Ongoing	<b>Flow:</b> Submerged (not located)	<b>Previous Rainfall (hrs):</b> 72+
<b>Illicit Discharge Potential:</b> <b>Potential</b>		<b>Inspector:</b> JCW	<b>Notes</b>	
Submerged: Fully		Depth (in):	Outfall fully submerged and not located - screened upstream at 06-221 US1. Floating gross solids (litter) in manhole.	
<b>Sampling Results</b>		Floatables:	<b>Condition Assessment</b> Graffiti: None Erosion: None Deposition: None in. Damage: None	
Sample Location:		Odor:		
Total Chlorine: -- ppm		Turbidity:		
Free Chlorine: -- ppm		Color:		
Ammonia: -- ppm		Gross Solids:		
pH: -- units		Vegetation:		
Temperature -- °F		Benthic Growth:		
Conductivity: -- µS/cm		Stains:		
Detergents: -- mg/L		Non-illicit:

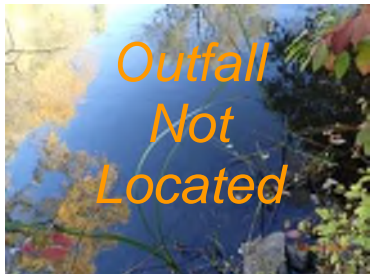
o20171018105502.JPG

<b>Inspection Date:</b> 10/18/2017 10:56:45 AM		<b>Type:</b> Ongoing	<b>Flow:</b> Submerged (not located)	<b>Previous Rainfall (hrs):</b> 72+
<b>Illicit Discharge Potential:</b> <b>Potential</b>		<b>Inspector:</b> JCW	<b>Notes</b>	
Submerged: Fully		Depth (in):	Outfall fully submerged and not located - screened upstream at 06-221 US1. Floating gross solids (litter) in manhole.	
<b>Sampling Results</b>		Floatables:	<b>Condition Assessment</b> Graffiti: None Erosion: None Deposition: None in. Damage: None	
Sample Location:		Odor:		
Total Chlorine: -- ppm		Turbidity:		
Free Chlorine: -- ppm		Color:		
Ammonia: -- ppm		Gross Solids:		
pH: -- units		Vegetation:		
Temperature -- °F		Benthic Growth:		
Conductivity: -- µS/cm		Stains:		
Detergents: -- mg/L		Non-illicit:

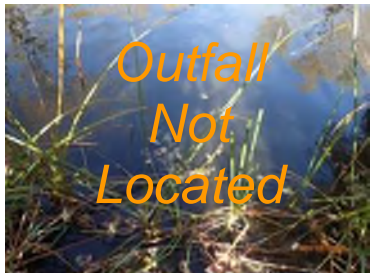
o20161018133940.JPG

<b>Inspection Date:</b> 10/18/2016 1:40:09 PM		<b>Type:</b> Ongoing	<b>Flow:</b> Submerged (not located)	<b>Previous Rainfall (hrs):</b> 72+
<b>Illicit Discharge Potential:</b> <b>Potential</b>		<b>Inspector:</b> JCW	<b>Notes</b>	
Submerged: Fully		Depth (in):	Outfall fully submerged and not located - screened upstream at 06-221 US1.	
<b>Sampling Results</b>		Floatables:	<b>Condition Assessment</b> Graffiti: None Erosion: None Deposition: None in. Damage: None	
Sample Location:		Odor:		
Total Chlorine: -- ppm		Turbidity:		
Free Chlorine: -- ppm		Color:		
Ammonia: -- ppm		Gross Solids:		
pH: -- units		Vegetation:		
Temperature -- °F		Benthic Growth:		
Conductivity: -- µS/cm		Stains:		
Detergents: -- mg/L		Non-illicit:

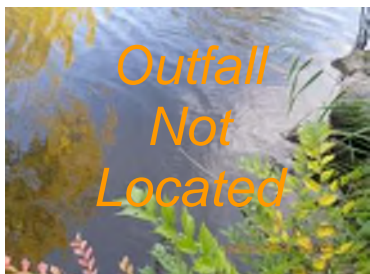
o20141007083652.JPG

<b>Inspection Date:</b> 10/7/2014 9:37:56 AM		<b>Type:</b> Ongoing	<b>Flow:</b> Submerged (not located)	<b>Previous Rainfall (hrs):</b> 48-72
<b>Illicit Discharge Potential:</b> <b>Unlikely</b>		<b>Inspector:</b> JCW	<b>Notes</b>	
Submerged: Fully		Depth (in):	Outfall partially submerged and not located - screened upstream at 06-221 US1.	
<b>Sampling Results</b>		Floatables:	<b>Condition Assessment</b> Graffiti: None Erosion: None Deposition: None in. Damage: None	
Sample Location:		Odor:		
Total Chlorine: -- ppm		Turbidity:		
Free Chlorine: -- ppm		Color:		
Ammonia: -- ppm		Gross Solids:		
pH: -- units		Vegetation:		
Temperature -- °F		Benthic Growth:		
Conductivity: -- µS/cm		Stains:		
Detergents: -- mg/L		Non-illicit:

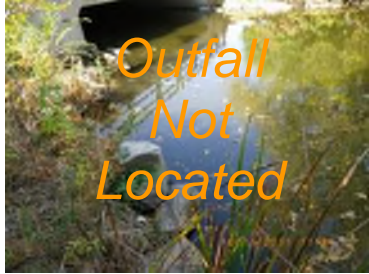
o20111011113446.JPG

<b>Inspection Date:</b> 10/11/2011 11:34:32 AM		<b>Type:</b> Ongoing	<b>Flow:</b> Submerged (not located)	<b>Previous Rainfall (hrs):</b> 72+
<b>Illicit Discharge Potential:</b> <b>Potential</b>		<b>Inspector:</b> JCW	<b>Notes</b>	
Submerged: Fully      Depth (in):			2010 screening follow-up. Outfall fully submerged and not physically located. Outfall screened upstream at 06-221 US1.	
<b>Sampling Results</b>			<b>Condition Assessment</b>	
Sample Location:	Floatables:	None	Graffiti: None	
Total Chlorine: -- ppm	Odor:	None	Erosion: None	
Free Chlorine: -- ppm	Turbidity:	None	Deposition: None      0 in.	
Ammonia: -- ppm	Color:	None	Damage: None	
pH: -- units	Gross Solids:	None		
Temperature -- °F	Vegetation:	None		
Conductivity: -- µS/cm	Benthic Growth:	None		
Detergents: -- mg/L	Stains:	None		
	Non-illicit:	None

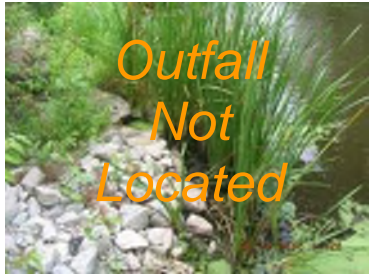
o20100818142820.JPG

<b>Inspection Date:</b> 8/18/2010 2:38:53 PM		<b>Type:</b> Ongoing	<b>Flow:</b> Submerged (not located)	<b>Previous Rainfall (hrs):</b> 72+
<b>Illicit Discharge Potential:</b> <b>Potential</b>		<b>Inspector:</b> JCW	<b>Notes</b>	
Submerged: Fully      Depth (in):			Outfall fully submerged and not physically located. Outfall screened upstream at 06-221 US1.	
<b>Sampling Results</b>			<b>Condition Assessment</b>	
Sample Location:	Floatables:	None	Graffiti: None	
Total Chlorine: -- ppm	Odor:	None	Erosion: None	
Free Chlorine: -- ppm	Turbidity:	None	Deposition: None      0 in.	
Ammonia: -- ppm	Color:	None	Damage: None	
pH: -- units	Gross Solids:	None		
Temperature -- °F	Vegetation:	None		
Conductivity: -- µS/cm	Benthic Growth:	None		
Detergents: -- mg/L	Stains:	None		
	Non-illicit:	None

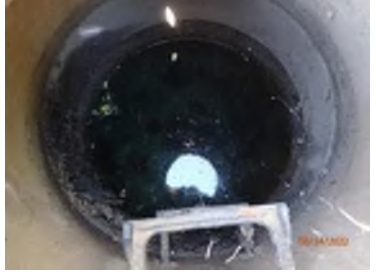
o20220824121332.JPG <div style="text-align: center; font-size: 24pt; font-weight: bold;">2022</div>

<b>Inspection Date:</b> 8/24/2022 12:16:00 PM		<b>Type:</b> Ongoing	<b>Flow:</b> Submerged, indeterminate	<b>Previous Rainfall (hrs):</b> 72+
<b>Illicit Discharge Potential:</b> Unlikely		<b>Inspector:</b> EJK		
Submerged: Fully		Depth (in):		
<b>Sampling Results</b> Sample Location: Pool Total Chlorine: 0 ppm Free Chlorine: 0 ppm Ammonia: 0 ppm pH: 6.77 units Temperature: 81 °F Conductivity: 281 µS/cm Detergents: 0 mg/L		Floatables: None Odor: None Turbidity: None Color: None Gross Solids: Slight Vegetation: None Benthic Growth: Slight Stains: None Non-illicit: None		
		<b>Notes</b> Sample collected from submerged pool in manhole.		
		<b>Condition Assessment</b> Graffiti: None Erosion: None Deposition: None in. Damage: None
