# Submittal of Annual Reports and Other Compliance Documents for Municipal Separate Storm Sewer System (MS4) Permits

**Project Name:** 2023 Annual Report

**Municipality:** Oshkosh, City

**Permit Number:** S050075

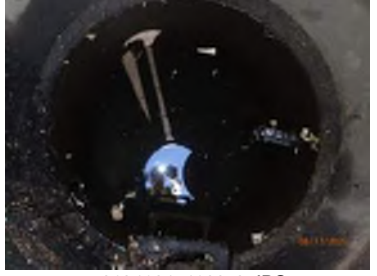
o20210817103352.JPG <div style="text-align: center; font-size: 24pt; font-weight: bold;">2021</div>

<b>Inspection Date:</b> 8/17/2021 10:34:25 AM		<b>Type:</b> Ongoing	<b>Flow:</b> Submerged, indeterminate	<b>Previous Rainfall (hrs):</b> 72+
<b>Illicit Discharge Potential:</b> Unlikely		<b>Inspector:</b> JCW		
Submerged: Fully		Depth (in): 41		
<b>Sampling Results</b> Sample Location: Pool Total Chlorine: 0 ppm Free Chlorine: 0 ppm Ammonia: 0 ppm pH: 7.34 units Temperature: 81 °F Conductivity: 258 µS/cm Detergents: 0 mg/L		Floatables: None Odor: None Turbidity: None Color: None Gross Solids: Slight Vegetation: None Benthic Growth: None Stains: None Non-illicit: None		
		<b>Notes</b> Sample collected from submerged pool in manhole.		
		<b>Condition Assessment</b> Graffiti: None Erosion: None Deposition: None in. Damage: None

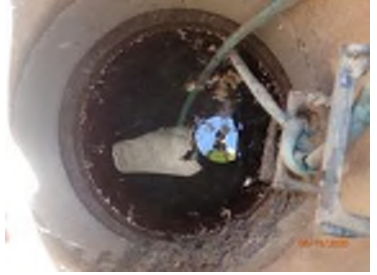
o20200819101208.JPG <div style="text-align: center; font-size: 24pt; font-weight: bold;">2020</div>

<b>Inspection Date:</b> 8/19/2020 10:14:42 AM		<b>Type:</b> Ongoing	<b>Flow:</b> Submerged, indeterminate	<b>Previous Rainfall (hrs):</b> 72+
<b>Illicit Discharge Potential:</b> Unlikely		<b>Inspector:</b> JCW		
Submerged: Fully		Depth (in): 37		
<b>Sampling Results</b> Sample Location: Pool Total Chlorine: 0 ppm Free Chlorine: 0 ppm Ammonia: 0 ppm pH: 7.18 units Temperature: 78 °F Conductivity: 265 µS/cm Detergents: 0 mg/L		Floatables: None Odor: None Turbidity: None Color: None Gross Solids: Slight Vegetation: None Benthic Growth: None Stains: None Non-illicit: None		
		<b>Notes</b> Sample collected from submerged pool in manhole.		
		<b>Condition Assessment</b> Graffiti: None Erosion: None Deposition: None in. Damage: None

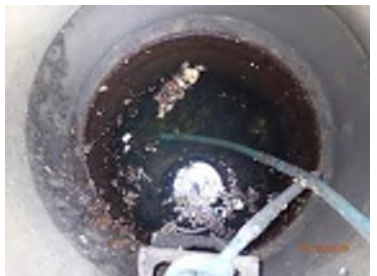
o20190918083752.JPG <div style="text-align: center; font-size: 24pt; font-weight: bold;">2019</div>

<b>Inspection Date:</b> 9/18/2019 9:40:11 AM		<b>Type:</b> Ongoing	<b>Flow:</b> Submerged, indeterminate	<b>Previous Rainfall (hrs):</b> 72+
<b>Illicit Discharge Potential:</b> Unlikely		<b>Inspector:</b> JCW		
Submerged: Fully		Depth (in): 39		
<b>Sampling Results</b> Sample Location: Pool Total Chlorine: 0 ppm Free Chlorine: 0 ppm Ammonia: 0 ppm pH: 7.43 units Temperature: 71 °F Conductivity: 170 µS/cm Detergents: 0 mg/L		Floatables: None Odor: None Turbidity: None Color: None Gross Solids: Slight Vegetation: None Benthic Growth: None Stains: None Non-illicit: None		
		<b>Notes</b> Sample collected from submerged pool in manhole. Floating gross solids (litter) in manhole.		
		<b>Condition Assessment</b> Graffiti: None Erosion: None Deposition: None in. Damage: None

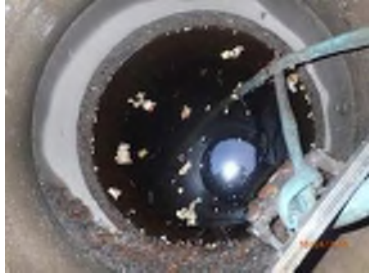
o20181024074456.JPG

<b>Inspection Date:</b> 10/24/2018 7:47:19 AM		<b>Type:</b> Ongoing	<b>Flow:</b> Submerged, indeterminate	<b>Previous Rainfall (hrs):</b> 72+
<b>Illicit Discharge Potential:</b> <b>Potential</b>		<b>Inspector:</b> JCW	<b>Notes</b>	
Submerged: Fully		Depth (in): 40	Sample collected from submerged pool in manhole. Floating gross solids (litter) in manhole.	
<b>Sampling Results</b>		<b>Floatables:</b> None	<b>Condition Assessment</b> Graffiti: None Erosion: None Deposition: None in. Damage: None	
Sample Location: Pool	<b>Odor:</b> None			
Total Chlorine: 0 ppm	<b>Turbidity:</b> None			
Free Chlorine: 0 ppm	<b>Color:</b> None			
Ammonia: 0 ppm	<b>Gross Solids:</b> Slight			
pH: 7.59 units	<b>Vegetation:</b> None			
Temperature 52 °F	<b>Benthic Growth:</b> None			
Conductivity: 575 µS/cm	<b>Stains:</b> None			
Detergents: 0 mg/L	<b>Non-illicit:</b> None

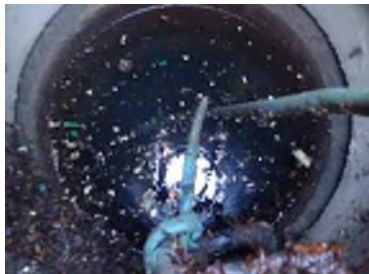
o20171018105550.JPG

<b>Inspection Date:</b> 10/18/2017 11:00:06 AM		<b>Type:</b> Ongoing	<b>Flow:</b> Submerged, indeterminate	<b>Previous Rainfall (hrs):</b> 72+
<b>Illicit Discharge Potential:</b> <b>Potential</b>		<b>Inspector:</b> JCW	<b>Notes</b>	
Submerged: Fully		Depth (in): 32	Sample collected from submerged pool in manhole. Floating gross solids (litter) in manhole.	
<b>Sampling Results</b>		<b>Floatables:</b> None	<b>Condition Assessment</b> Graffiti: None Erosion: None Deposition: None in. Damage: None	
Sample Location: Pool	<b>Odor:</b> None			
Total Chlorine: 0 ppm	<b>Turbidity:</b> None			
Free Chlorine: 0 ppm	<b>Color:</b> None			
Ammonia: 0 ppm	<b>Gross Solids:</b> Moderate			
pH: 7.24 units	<b>Vegetation:</b> None			
Temperature 66 °F	<b>Benthic Growth:</b> None			
Conductivity: 379 µS/cm	<b>Stains:</b> None			
Detergents: 0 mg/L	<b>Non-illicit:</b> None

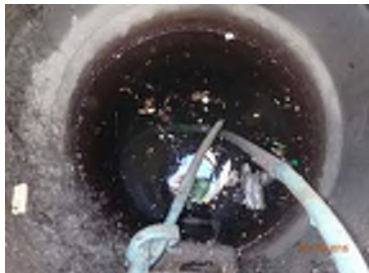
o20161018134038.JPG

<b>Inspection Date:</b> 10/18/2016 1:43:57 PM		<b>Type:</b> Ongoing	<b>Flow:</b> Submerged, indeterminate	<b>Previous Rainfall (hrs):</b> 72+
<b>Illicit Discharge Potential:</b> <b>Potential</b>		<b>Inspector:</b> JCW	<b>Notes</b>	
Submerged: Fully		Depth (in): 35	Casting displaced 2". Potential illicit discharge due to gross solids.	
<b>Sampling Results</b>		<b>Floatables:</b> None	<b>Condition Assessment</b> Graffiti: None Erosion: None Deposition: None in. Damage: Minor	
Sample Location: Pool	<b>Odor:</b> None			
Total Chlorine: 0 ppm	<b>Turbidity:</b> None			
Free Chlorine: 0 ppm	<b>Color:</b> None			
Ammonia: 0 ppm	<b>Gross Solids:</b> Moderate			
pH: 7.06 units	<b>Vegetation:</b> None			
Temperature 68 °F	<b>Benthic Growth:</b> None			
Conductivity: 460 µS/cm	<b>Stains:</b> None			
Detergents: 0 mg/L	<b>Non-illicit:</b> None

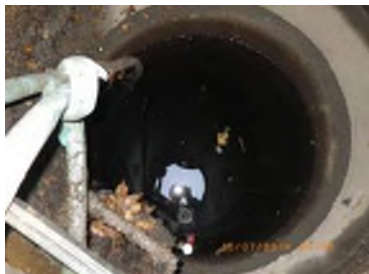
o20141007083848.JPG

<b>Inspection Date:</b> 10/7/2014 9:38:38 AM		<b>Type:</b> Ongoing	<b>Flow:</b> Submerged, indeterminate	<b>Previous Rainfall (hrs):</b> 48-72
<b>Illicit Discharge Potential:</b> <b>Unlikely</b>		<b>Inspector:</b> JCW	<b>Notes</b>	
Submerged: Fully		Depth (in): 32		
<b>Sampling Results</b>		<b>Floatables:</b> None	<b>Condition Assessment</b> Graffiti: None Erosion: None Deposition: Minor 3 in. Damage: None	
Sample Location: Pool	<b>Odor:</b> None			
Total Chlorine: 0 ppm	<b>Turbidity:</b> None			
Free Chlorine: 0 ppm	<b>Color:</b> None			
Ammonia: 0 ppm	<b>Gross Solids:</b> Slight			
pH: 7.78 units	<b>Vegetation:</b> None			
Temperature -- °F	<b>Benthic Growth:</b> None			
Conductivity: 351 µS/cm	<b>Stains:</b> None			
Detergents: 0 mg/L	<b>Non-illicit:</b> None

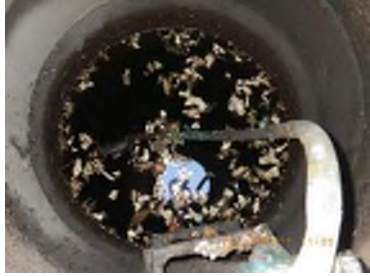
o20111011113522.JPG  
**2011**

<b>Inspection Date:</b> 10/11/2011 11:37:34 AM		<b>Type:</b> Ongoing	<b>Flow:</b> Submerged, indeterminate	<b>Previous Rainfall (hrs):</b> 72+
<b>Illicit Discharge Potential:</b> <b>Potential</b>		<b>Inspector:</b> JCW	<b>Notes</b>	
Submerged: Fully		Depth (in): 32	2010 screening follow-up. Floatable debris still present.	
<b>Sampling Results</b>		<b>Condition Assessment</b>		
Sample Location: Pool	Floatables: None	Graffiti: None Erosion: None Deposition: None 0 in. Damage: None		
Total Chlorine: 0 ppm	Odor: None			
Free Chlorine: 0 ppm	Turbidity: None			
Ammonia: 0 ppm	Color: None			
pH: 7.5 units	Gross Solids: Moderate			
Temperature 71 °F	Vegetation: None			
Conductivity: -- µS/cm	Benthic Growth: None			
Detergents: -- mg/L	Stains: None			
	Non-illicit: None

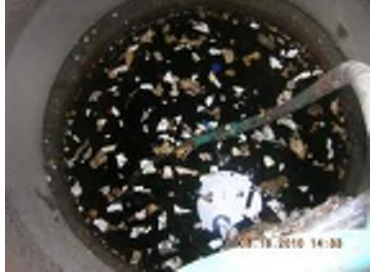
o20100818143354.JPG  
**2010**

<b>Inspection Date:</b> 8/18/2010 2:43:51 PM		<b>Type:</b> Ongoing	<b>Flow:</b> Submerged, indeterminate	<b>Previous Rainfall (hrs):</b> 72+
<b>Illicit Discharge Potential:</b> <b>Potential</b>		<b>Inspector:</b> JCW	<b>Notes</b>	
Submerged: Fully		Depth (in): 36	Torn paper and other floatable debris in manhole.	
<b>Sampling Results</b>		<b>Condition Assessment</b>		
Sample Location: Pool	Floatables: None	Graffiti: None Erosion: None Deposition: None 0 in. Damage: None		
Total Chlorine: 0 ppm	Odor: None			
Free Chlorine: 0 ppm	Turbidity: None			
Ammonia: 0 ppm	Color: None			
pH: 7.21 units	Gross Solids: Moderate			
Temperature 79 °F	Vegetation: None			
Conductivity: -- µS/cm	Benthic Growth: None			
Detergents: 0 mg/L	Stains: None			
	Non-illicit: None

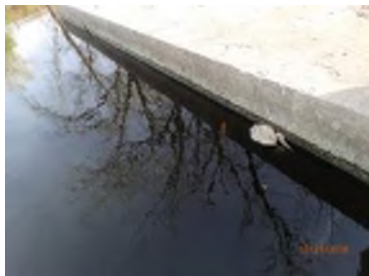
o20181025135726.JPG <div style="text-align: center; font-size: 24pt; font-weight: bold;">2018</div>

<b>Inspection Date:</b> 10/25/2018 1:59:21 PM		<b>Type:</b> Ongoing	<b>Flow:</b> Submerged, indeterminate	<b>Previous Rainfall (hrs):</b> 72+
<b>Illicit Discharge Potential:</b> Unlikely		<b>Inspector:</b> JCW		
Submerged: Fully		Depth (in): 60		
<b>Sampling Results</b> Sample Location: Total Chlorine: -- ppm Free Chlorine: -- ppm Ammonia: -- ppm pH: -- units Temperature -- ° F Conductivity: -- µS/cm Detergents: -- mg/L		Floatables: None Odor: None Turbidity: None Color: None Gross Solids: None Vegetation: None Benthic Growth: None Stains: None Non-illicit: None	<b>Notes</b> Outfall fully submerged - screened upstream at 06-2241 US1.  <b>Condition Assessment</b> Graffiti: None Erosion: None Deposition: None in. Damage: None

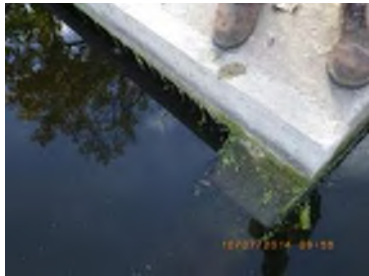
o20141007085606.JPG <div style="text-align: center; font-size: 24pt; font-weight: bold;">2014</div>

<b>Inspection Date:</b> 10/7/2014 9:58:05 AM		<b>Type:</b> Ongoing	<b>Flow:</b> Submerged, indeterminate	<b>Previous Rainfall (hrs):</b> 48-72
<b>Illicit Discharge Potential:</b> Unlikely		<b>Inspector:</b> JCW		
Submerged: Partially		Depth (in): 46		
<b>Sampling Results</b> Sample Location: Total Chlorine: -- ppm Free Chlorine: -- ppm Ammonia: -- ppm pH: -- units Temperature -- ° F Conductivity: -- µS/cm Detergents: -- mg/L		Floatables: None Odor: None Turbidity: None Color: None Gross Solids: None Vegetation: None Benthic Growth: Moderate Stains: None Non-illicit: None	<b>Notes</b> Outfall partially submerged - screened upstream at 06-2241 US1.  <b>Condition Assessment</b> Graffiti: None Erosion: None Deposition: None in. Damage: None

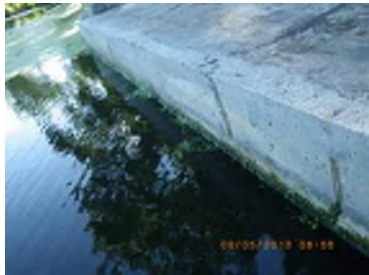
o20130905075650.JPG <div style="text-align: center; font-size: 24pt; font-weight: bold;">2013</div>

<b>Inspection Date:</b> 9/5/2013 8:49:36 AM		<b>Type:</b> Ongoing	<b>Flow:</b> Submerged, indeterminate	<b>Previous Rainfall (hrs):</b> 72+
<b>Illicit Discharge Potential:</b> Unlikely		<b>Inspector:</b> JCW		
Submerged: Fully		Depth (in): 44		
<b>Sampling Results</b> Sample Location: Total Chlorine: -- ppm Free Chlorine: -- ppm Ammonia: -- ppm pH: -- units Temperature -- ° F Conductivity: -- µS/cm Detergents: -- mg/L		Floatables: None Odor: None Turbidity: None Color: None Gross Solids: None Vegetation: None Benthic Growth: Severe Stains: None Non-illicit: None	<b>Notes</b> 2012 screening follow-up. Outfall fully submerged. Outfall screened upstream at 06-2241 US1.  <b>Condition Assessment</b> Graffiti: None Erosion: None Deposition: None in. Damage: None

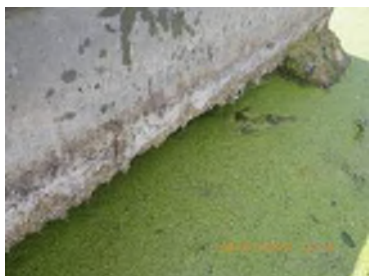
o20120927111938.JPG <div style="text-align: center; font-size: 24pt; font-weight: bold;">2012</div>

<b>Inspection Date:</b> 9/27/2012 12:15:16 PM		<b>Type:</b> Repeat	<b>Flow:</b> Submerged, indeterminate	<b>Previous Rainfall (hrs):</b> 72+
<b>Illicit Discharge Potential:</b> Unlikely		<b>Inspector:</b> JCW		
Submerged: Partially		Depth (in): 36		
<b>Sampling Results</b> Sample Location: Total Chlorine: -- ppm Free Chlorine: -- ppm Ammonia: -- ppm pH: -- units Temperature -- ° F Conductivity: -- µS/cm Detergents: -- mg/L		Floatables: None Odor: None Turbidity: None Color: None Gross Solids: None Vegetation: None Benthic Growth: None Stains: None Non-illicit: None	<b>Notes</b> Outfall partially submerged; screened upstream at 06-2241.  <b>Condition Assessment</b> Graffiti: None Erosion: None Deposition: None in. Damage: None

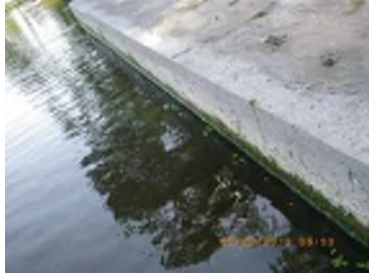
o20120620085346.JPG

<b>Inspection Date:</b> 6/20/2012 9:50:33 AM		<b>Type:</b> Ongoing	<b>Flow:</b> Submerged, indeterminate	<b>Previous Rainfall (hrs):</b> 24-48
<b>Illicit Discharge Potential:</b> <b>Potential</b>		<b>Inspector:</b> JCW	<b>Notes</b>	
Submerged: Fully		Depth (in): 45	Outfall partially submerged; screened upstream at 06-2241 US1.	
<b>Sampling Results</b>		<b>Condition Assessment</b>		
Sample Location:	Floatables:	None		
Total Chlorine: -- ppm	Odor:	None		
Free Chlorine: -- ppm	Turbidity:	None		
Ammonia: -- ppm	Color:	None		
pH: -- units	Gross Solids:	None		
Temperature -- °F	Vegetation:	None		
Conductivity: -- µS/cm	Benthic Growth:	Moderate		
Detergents: -- mg/L	Stains:	None		
	Non-illicit:	None		
		Graffiti: None Erosion: None Deposition: None in. Damage: None

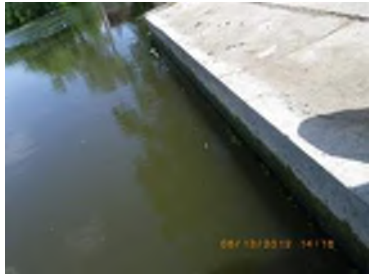
o20120613131558.JPG

<b>Inspection Date:</b> 6/13/2012 2:13:03 PM		<b>Type:</b> Other	<b>Flow:</b> Submerged, indeterminate	<b>Previous Rainfall (hrs):</b> 72+
<b>Illicit Discharge Potential:</b> <b>Potential</b>		<b>Inspector:</b> JCW	<b>Notes</b>	
Submerged: Fully		Depth (in): 45	Gross solids pre-screening.	
<b>Sampling Results</b>		<b>Condition Assessment</b>		
Sample Location:	Floatables:	None		
Total Chlorine: -- ppm	Odor:	None		
Free Chlorine: -- ppm	Turbidity:	None		
Ammonia: -- ppm	Color:	None		
pH: -- units	Gross Solids:	None		
Temperature -- °F	Vegetation:	None		
Conductivity: -- µS/cm	Benthic Growth:	None		
Detergents: -- mg/L	Stains:	None		
	Non-illicit:	None		
		Graffiti: None Erosion: None Deposition: None in. Damage: None

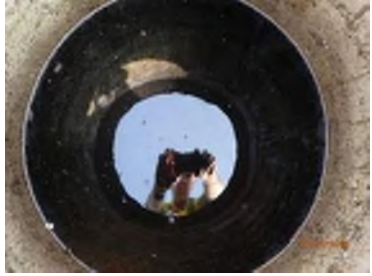
o20181025135914.JPG <div style="text-align: center; font-size: 24pt; font-weight: bold;">2018</div>

Floatables:	None	Odor:	None	Turbidity:	None	Color:	None	Gross Solids:	None	Vegetation:	None	Benthic Growth:	None	Stains:	None	Non-illicit:	None
Floatables:	None																					
Odor:	None																					
Turbidity:	None																					
Color:	None																					
Gross Solids:	None																					
Vegetation:	None																					
Benthic Growth:	None																					
Stains:	None																					
Non-illicit:	None																					
		<b>Notes</b> Sample collected from submerged pool in manhole.																				
		<b>Condition Assessment</b> Graffiti: None Erosion: None Deposition: None in. Damage: None

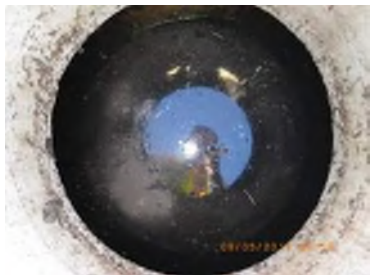
o20130905075900.JPG <div style="text-align: center; font-size: 24pt; font-weight: bold;">2013</div>

Floatables:	None	Odor:	None	Turbidity:	None	Color:	None	Gross Solids:	None	Vegetation:	None	Benthic Growth:	Slight	Stains:	None	Non-illicit:	Slight
Floatables:	None																					
Odor:	None																					
Turbidity:	None																					
Color:	None																					
Gross Solids:	None																					
Vegetation:	None																					
Benthic Growth:	Slight																					
Stains:	None																					
Non-illicit:	Slight																					
		<b>Notes</b> 2012 screening follow-up.																				
		<b>Condition Assessment</b> Graffiti: None Erosion: None Deposition: None in. Damage: None

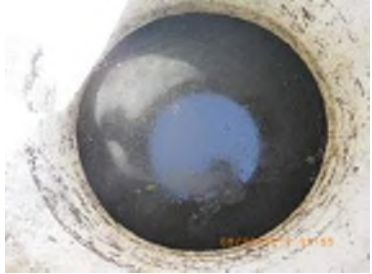
<b>Inspection Date:</b> 6/20/2012 9:54:44 AM		<b>Type:</b> Ongoing	<b>Flow:</b> Submerged, indeterminate	<b>Previous Rainfall (hrs):</b> 24-48	
<b>Illicit Discharge Potential:</b> <b>Potential</b>		<b>Inspector:</b> JCW	<b>Notes</b>		
Submerged: Fully		Depth (in): 60

<p style="text-align: center;">o20120620085526.JPG</p> <p style="text-align: center; font-size: 1.5em; font-weight: bold;">2012</p>		
<b>Sampling Results</b>					
Sample Location:	Pool	Floatables:			None
Total Chlorine:	0 ppm	Odor:			None
Free Chlorine:	0 ppm	Turbidity:			None
Ammonia:	0.5 ppm	Color:			None
pH:	7.77 units	Gross Solids:			None
Temperature	81 °F	Vegetation:			None
Conductivity:	632 µS/cm	Benthic Growth:			Slight
Detergents:	0 mg/L	Stains:			None
		Non-illicit:	None		
			<b>Condition Assessment</b> Graffiti: None Erosion: None Deposition: None in. Damage: None

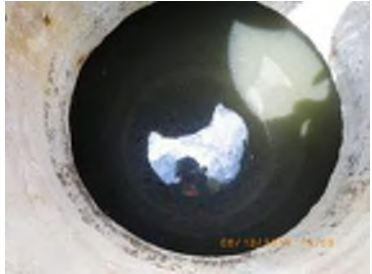
<b>Inspection Date:</b> 6/13/2012 2:06:46 PM		<b>Type:</b> Other	<b>Flow:</b> Submerged, indeterminate	<b>Previous Rainfall (hrs):</b> 72+	
<b>Illicit Discharge Potential:</b> <b>Potential</b>		<b>Inspector:</b> JCW	<b>Notes</b>		
Submerged: Fully		Depth (in): 52

<p style="text-align: center;">o20120613130900.JPG</p> <p style="text-align: center; font-size: 1.5em; font-weight: bold;">2012</p>		
<b>Sampling Results</b>					
Sample Location:	Pool	Floatables:			None
Total Chlorine:	0 ppm	Odor:			Faint
Free Chlorine:	0 ppm	Turbidity:			None
Ammonia:	3 ppm	Color:			None
pH:	7.76 units	Gross Solids:			None
Temperature	75 °F	Vegetation:			None
Conductivity:	1034 µS/cm	Benthic Growth:			None
Detergents:	0 mg/L	Stains:			None
		Non-illicit:	Slight		
			<b>Condition Assessment</b> Graffiti: None Erosion: None Deposition: None in. Damage: None

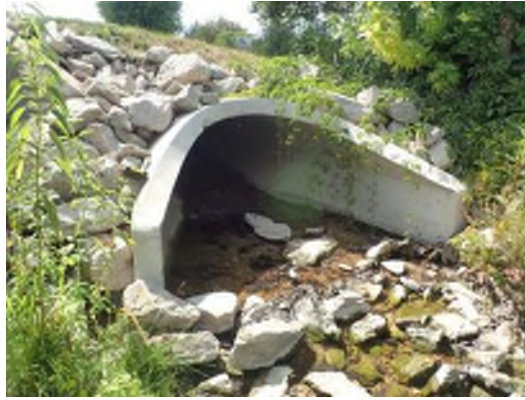
o20230719142840.JPG

Storm sewer from W. 9th Ave discharges to stream from west. Replaces outfall 06-1132 (2021).

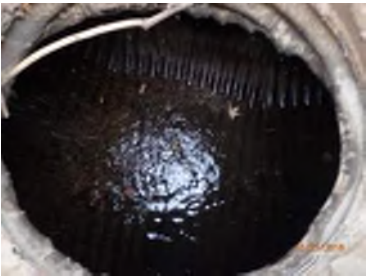
o20181025100244.JPG <div style="text-align: center; font-size: 24pt; font-weight: bold;">2018</div>

<div style="display: flex;"> <div style="flex: 1;"> <p><b>Notes</b></p> <p>Sample collected from submerged pool in manhole. Detergent detected in sample.</p> </div> <div style="flex: 1;"> <p><b>Condition Assessment</b></p> <table border="1" style="width:100%; border-collapse: collapse;"> <tr><td>Graffiti:</td><td>None</td></tr> <tr><td>Erosion:</td><td>None</td></tr> <tr><td>Deposition:</td><td>None in.</td></tr> <tr><td>Damage:</td><td>None</td></tr> </table> </div> </div>			Graffiti:	None	Erosion:	None	Deposition:	None in.	Damage:	None																										
Graffiti:	None																																					
Erosion:	None																																					
Deposition:	None in.																																					
Damage:	None

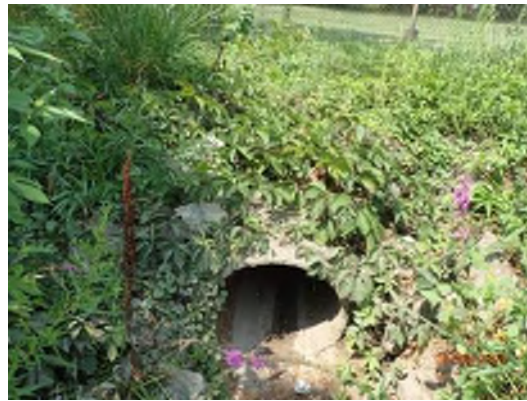
o20230809114056.JPG

Notes: Pipe dry at time of inspection. 3" joint displacement/deterioration.

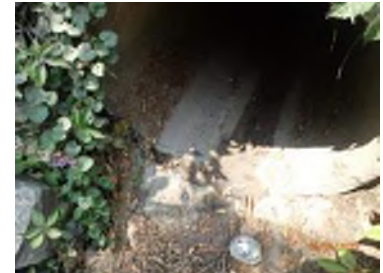
o20230809114110.JPG

Damage: Minor ☐ Displacement ☐ Undercut ☐ Crushed☐ Corrosion ☒ Cracks/Structural Damage

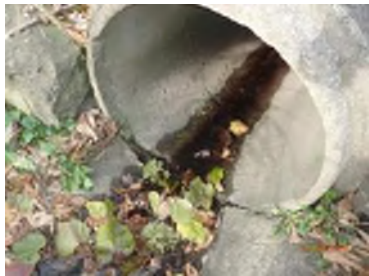
o20181025094334.JPG <div style="text-align: center; font-size: 24pt; font-weight: bold;">2018</div>
		<b>Condition Assessment</b> Graffiti: None Erosion: None Deposition: None in. Damage: Minor

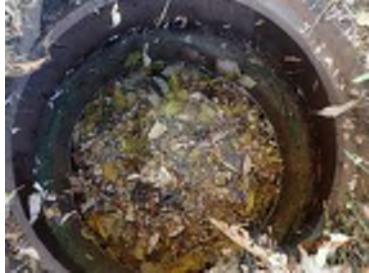
<p style="text-align: center;">o20181022163150.JPG</p> <p style="text-align: center; font-size: 1.5em; font-weight: bold;">2018</p>	
Submerged: Fully		Depth (in): 44		Sample collected from submerged pool in manhole. Floating gross solids (litter) in manhole.			
<b>Sampling Results</b>		<b>Floatables:</b> None <b>Odor:</b> None <b>Turbidity:</b> None <b>Color:</b> None <b>Gross Solids:</b> Moderate <b>Vegetation:</b> None <b>Benthic Growth:</b> Slight <b>Stains:</b> None <b>Non-illicit:</b> None		<b>Condition Assessment</b> <b>Graffiti:</b> None <b>Erosion:</b> None <b>Deposition:</b> None in. <b>Damage:</b> None			
<b>Sample Location:</b> Pool <b>Total Chlorine:</b> 0 ppm <b>Free Chlorine:</b> 0 ppm <b>Ammonia:</b> 0 ppm <b>pH:</b> 7.77 units <b>Temperature:</b> 54 °F <b>Conductivity:</b> 348 µS/cm <b>Detergents:</b> 0 mg/L

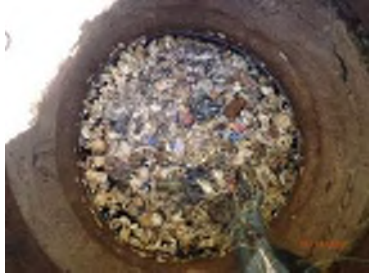
<p style="text-align: center;">o20171018112938.JPG</p> <p style="text-align: center; font-size: 1.5em; font-weight: bold;">2017</p>	
Submerged: Fully		Depth (in): 40		Sample collected from submerged pool in manhole. Floating gross solids (litter) in manhole.			
<b>Sampling Results</b>		<b>Floatables:</b> None <b>Odor:</b> None <b>Turbidity:</b> None <b>Color:</b> None <b>Gross Solids:</b> Severe <b>Vegetation:</b> None <b>Benthic Growth:</b> None <b>Stains:</b> None <b>Non-illicit:</b> None		<b>Condition Assessment</b> <b>Graffiti:</b> None <b>Erosion:</b> None <b>Deposition:</b> None in. <b>Damage:</b> None			
<b>Sample Location:</b> Pool <b>Total Chlorine:</b> 0 ppm <b>Free Chlorine:</b> 0 ppm <b>Ammonia:</b> 0 ppm <b>pH:</b> 8.39 units <b>Temperature:</b> 65 °F <b>Conductivity:</b> 403 µS/cm <b>Detergents:</b> 0 mg/L

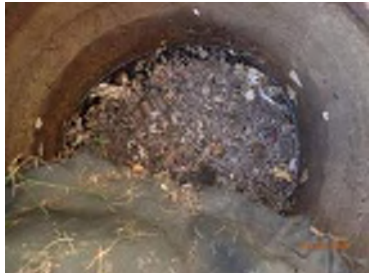
<p style="text-align: center;">o20161018145924.JPG</p> <p style="text-align: center; font-size: 1.5em; font-weight: bold;">2016</p>	
Submerged: Fully		Depth (in):		Potential illicit discharge due to gross solids.			
<b>Sampling Results</b>		<b>Floatables:</b> None <b>Odor:</b> None <b>Turbidity:</b> None <b>Color:</b> None <b>Gross Solids:</b> Moderate <b>Vegetation:</b> None <b>Benthic Growth:</b> None <b>Stains:</b> None <b>Non-illicit:</b> None		<b>Condition Assessment</b> <b>Graffiti:</b> None <b>Erosion:</b> None <b>Deposition:</b> None 0 in. <b>Damage:</b> None			
<b>Sample Location:</b> Pool <b>Total Chlorine:</b> 0 ppm <b>Free Chlorine:</b> 0 ppm <b>Ammonia:</b> 0 ppm <b>pH:</b> 8.02 units <b>Temperature:</b> 67 °F <b>Conductivity:</b> 418 µS/cm <b>Detergents:</b> 0 mg/L

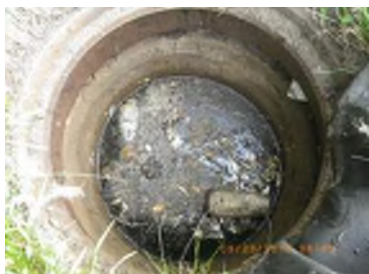
<p style="text-align: center;">o20150923074542.JPG</p> <p style="text-align: center; font-size: 1.5em; font-weight: bold;">2015</p>	
Submerged: Fully		Depth (in): 44		Floating gross solids (litter) in manhole.			
<b>Sampling Results</b>		<b>Floatables:</b> None <b>Odor:</b> None <b>Turbidity:</b> None <b>Color:</b> None <b>Gross Solids:</b> Moderate <b>Vegetation:</b> None <b>Benthic Growth:</b> None <b>Stains:</b> None <b>Non-illicit:</b> None		<b>Condition Assessment</b> <b>Graffiti:</b> None <b>Erosion:</b> None <b>Deposition:</b> None in. <b>Damage:</b> None			
<b>Sample Location:</b> Pool <b>Total Chlorine:</b> 0 ppm <b>Free Chlorine:</b> 0 ppm <b>Ammonia:</b> 0 ppm <b>pH:</b> 8.74 units <b>Temperature:</b> 70 °F <b>Conductivity:</b> 351 µS/cm <b>Detergents:</b> 0 mg/L

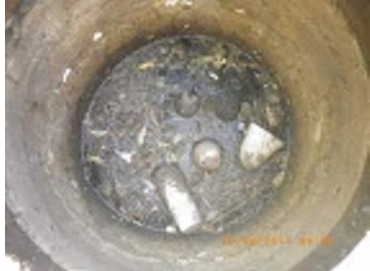
o20141009083526.JPG

<b>Inspection Date:</b> 10/9/2014 9:37:13 AM		<b>Type:</b> Ongoing	<b>Flow:</b> Submerged, indeterminate	<b>Previous Rainfall (hrs):</b> 72+
<b>Illicit Discharge Potential:</b> <b>Potential</b>		<b>Inspector:</b> JCW	<b>Notes</b>	
Submerged: Fully		Depth (in): 35	Floating gross solids (litter) in manhole. Filter fabric installed in inlet.	
<b>Sampling Results</b>		<b>Condition Assessment</b>		
Sample Location: Pool	Floatables: None	Graffiti: None	Erosion: None	in.
Total Chlorine: 0 ppm	Odor: None	Deposition: None	Damage: None	
Free Chlorine: 0 ppm	Turbidity: Slight cloudiness			
Ammonia: 0 ppm	Color: None			
pH: 7.82 units	Gross Solids: Severe			
Temperature 56 °F	Vegetation: None			
Conductivity: 471 µS/cm	Benthic Growth: Slight			
Detergents: 0 mg/L	Stains: None			
	Non-illicit: None

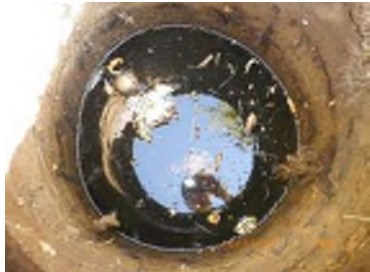
o20111011110824.JPG

<b>Inspection Date:</b> 10/11/2011 11:09:29 AM		<b>Type:</b> Ongoing	<b>Flow:</b> Submerged, indeterminate	<b>Previous Rainfall (hrs):</b> 72+
<b>Illicit Discharge Potential:</b> <b>Unlikely</b>		<b>Inspector:</b> JCW	<b>Notes</b>	
Submerged: Fully		Depth (in): 35	2010 screening follow-up. Floatable debris significantly reduced.	
<b>Sampling Results</b>		<b>Condition Assessment</b>		
Sample Location: Pool	Floatables: None	Graffiti: None	Erosion: None	0 in.
Total Chlorine: 0 ppm	Odor: None	Deposition: None	Damage: None	
Free Chlorine: 0 ppm	Turbidity: None			
Ammonia: 0 ppm	Color: None			
pH: 8.13 units	Gross Solids: Moderate			
Temperature 70 °F	Vegetation: None			
Conductivity: -- µS/cm	Benthic Growth: None			
Detergents: -- mg/L	Stains: None			
	Non-illicit: None

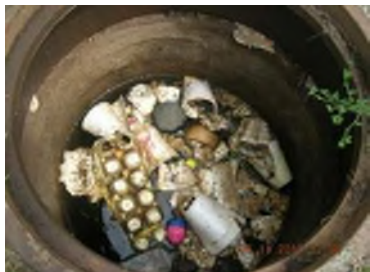
o20100818125018.JPG

<b>Inspection Date:</b> 8/18/2010 1:00:07 PM		<b>Type:</b> Ongoing	<b>Flow:</b> Submerged, indeterminate	<b>Previous Rainfall (hrs):</b> 72+
<b>Illicit Discharge Potential:</b> <b>Potential</b>		<b>Inspector:</b> JCW	<b>Notes</b>	
Submerged: Fully		Depth (in): 41	Significant floatable debris in manhole.	
<b>Sampling Results</b>		<b>Condition Assessment</b>		
Sample Location: Pool	Floatables: None	Graffiti: None	Erosion: None	0 in.
Total Chlorine: 0 ppm	Odor: None	Deposition: None	Damage: None	
Free Chlorine: 0 ppm	Turbidity: Slight cloudiness			
Ammonia: 0 ppm	Color: Faint in bottle			
pH: 7.98 units	Gross Solids: Severe			
Temperature 76 °F	Vegetation: None			
Conductivity: -- µS/cm	Benthic Growth: None			
Detergents: 0 mg/L	Stains: None			
	Non-illicit: None

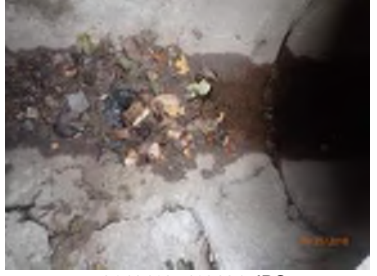
Sample Location:																																		
Total Chlorine:	-- ppm																																	
Free Chlorine:	-- ppm																																	
Ammonia:	-- ppm																																	
pH:	-- units																																	
Temperature:	-- °F																																	
Conductivity:	-- µS/cm																																	
Detergents:	-- mg/L																																	
<b>Notes</b>																																		
Flowline wet, but no collectable flow at time of inspection.																																		
<b>Condition Assessment</b>																																		
Graffiti:	None																																	
Erosion:	None																																	
Deposition:	None in.																																	
Damage:	None

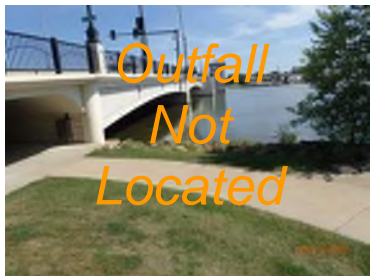
<b>Inspection Date:</b> 8/24/2022 11:01:00 AM		<b>Type:</b> Ongoing	<b>Flow:</b> Submerged (not located)	<b>Previous Rainfall (hrs):</b> 72+
<b>Illicit Discharge Potential:</b> Unlikely		<b>Inspector:</b> EJK		
<b>Submerged:</b> Fully		<b>Depth (in):</b>		
<b>Sampling Results</b> Sample Location: _____ Total Chlorine: -- ppm Free Chlorine: -- ppm Ammonia: -- ppm pH: -- units Temperature: -- °F Conductivity: -- µS/cm Detergents: -- mg/L		Floatables: None Odor: None Turbidity: None Color: None Gross Solids: None Vegetation: None Benthic Growth: None Stains: None Non-illicit: None	<b>Notes</b> Outfall fully submerged and not located - screened upstream at 06-810 US1.

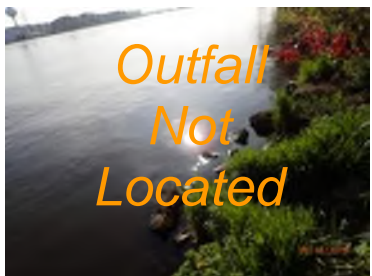
<b>Inspection Date:</b> 9/18/2019 9:09:25 AM		<b>Type:</b> Ongoing	<b>Flow:</b> Submerged (not located)	<b>Previous Rainfall (hrs):</b> 72+
<b>Illicit Discharge Potential:</b> Potential		<b>Inspector:</b> JCW		
<b>Submerged:</b> Fully		<b>Depth (in):</b>		
<b>Sampling Results</b> Sample Location: _____ Total Chlorine: -- ppm Free Chlorine: -- ppm Ammonia: -- ppm pH: -- units Temperature: -- °F Conductivity: -- µS/cm Detergents: -- mg/L		Floatables: None Odor: None Turbidity: None Color: None Gross Solids: None Vegetation: None Benthic Growth: None Stains: None Non-illicit: None	<b>Notes</b> Outfall fully submerged and not located - screened upstream at 06-810 US1. Floating gross solids (litter) in manhole.

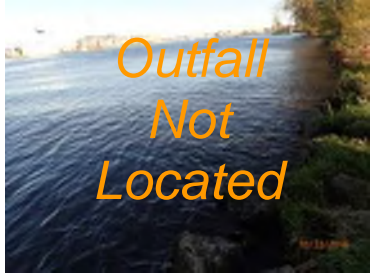
<b>Inspection Date:</b> 10/22/2018 4:42:27 PM		<b>Type:</b> Ongoing	<b>Flow:</b> Submerged (not located)	<b>Previous Rainfall (hrs):</b> 48-72
<b>Illicit Discharge Potential:</b> <b>Potential</b>		<b>Inspector:</b> JCW		<b>Notes</b> Outfall fully submerged and not located - screened upstream at 06-810 US1. Floating gross solids (litter) in manhole.
Submerged: Fully      Depth (in):				
<b>Sampling Results</b> Sample Location: _____ Total Chlorine: -- ppm Free Chlorine: -- ppm Ammonia: -- ppm pH: -- units Temperature -- ° F Conductivity: -- µS/cm Detergents: -- mg/L		Floatables: None Odor: None Turbidity: None Color: None Gross Solids: None Vegetation: None Benthic Growth: None Stains: None Non-illicit: None	<b>Condition Assessment</b> Graffiti: None Erosion: None Deposition: None in. Damage: None

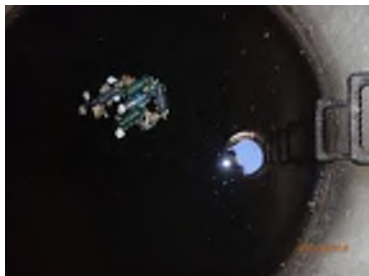
o20190918080922.JPG <div style="text-align: right; font-size: 24pt; font-weight: bold;">2019</div>

<b>Inspection Date:</b> 10/22/2018 4:45:48 PM		<b>Type:</b> Ongoing	<b>Flow:</b> Submerged, indeterminate	<b>Previous Rainfall (hrs):</b> 48-72
<b>Illicit Discharge Potential:</b> <b>Potential</b>		<b>Inspector:</b> JCW	<b>Notes</b>	
Submerged: Fully		Depth (in): 58	Sample collected from submerged pool in manhole. Floating gross solids (litter) in manhole.	
<b>Sampling Results</b>		<b>Floatables:</b> None	<b>Condition Assessment</b> Graffiti: None Erosion: None Deposition: None in. Damage: None	
Sample Location: Pool	<b>Odor:</b> None			
Total Chlorine: 0 ppm	<b>Turbidity:</b> None			
Free Chlorine: 0 ppm	<b>Color:</b> None			
Ammonia: 0 ppm	<b>Gross Solids:</b> Slight			
pH: 7.7 units	<b>Vegetation:</b> None			
Temperature 55 °F	<b>Benthic Growth:</b> None			
Conductivity: 370 µS/cm	<b>Stains:</b> None			
Detergents: 0 mg/L	<b>Non-illicit:</b> None

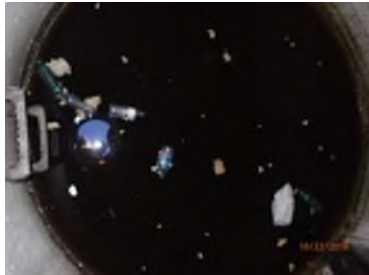
o20181022164226.JPG  
**2018**

<b>Inspection Date:</b> 10/18/2017 11:23:20 AM		<b>Type:</b> Ongoing	<b>Flow:</b> Submerged, indeterminate	<b>Previous Rainfall (hrs):</b> 72+
<b>Illicit Discharge Potential:</b> <b>Unlikely</b>		<b>Inspector:</b> JCW	<b>Notes</b>	
Submerged: Fully		Depth (in): 50	Sample collected from submerged pool in manhole.	
<b>Sampling Results</b>		<b>Floatables:</b> None	<b>Condition Assessment</b> Graffiti: None Erosion: None Deposition: None in. Damage: None	
Sample Location: Pool	<b>Odor:</b> None			
Total Chlorine: 0 ppm	<b>Turbidity:</b> None			
Free Chlorine: 0 ppm	<b>Color:</b> None			
Ammonia: 0 ppm	<b>Gross Solids:</b> Slight			
pH: 7.85 units	<b>Vegetation:</b> None			
Temperature 65 °F	<b>Benthic Growth:</b> Moderate			
Conductivity: 174 µS/cm	<b>Stains:</b> None			
Detergents: 0 mg/L	<b>Non-illicit:</b> None

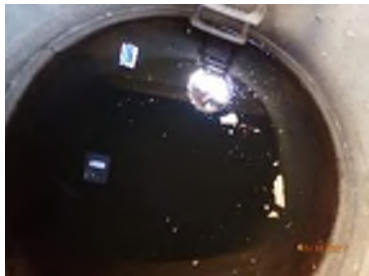
o20171018111612.JPG  
**2017**

<b>Inspection Date:</b> 10/18/2016 2:47:47 PM		<b>Type:</b> Ongoing	<b>Flow:</b> Submerged, indeterminate	<b>Previous Rainfall (hrs):</b> 72+
<b>Illicit Discharge Potential:</b> <b>Unlikely</b>		<b>Inspector:</b> JCW	<b>Notes</b>	
Submerged: Fully		Depth (in): 52		
<b>Sampling Results</b>		<b>Floatables:</b> None	<b>Condition Assessment</b> Graffiti: None Erosion: None Deposition: None in. Damage: None	
Sample Location: Pool	<b>Odor:</b> None			
Total Chlorine: 0 ppm	<b>Turbidity:</b> None			
Free Chlorine: 0 ppm	<b>Color:</b> None			
Ammonia: 0 ppm	<b>Gross Solids:</b> None			
pH: 7.93 units	<b>Vegetation:</b> None			
Temperature 67 °F	<b>Benthic Growth:</b> Slight			
Conductivity: 400 µS/cm	<b>Stains:</b> None			
Detergents: 0 mg/L	<b>Non-illicit:</b> None

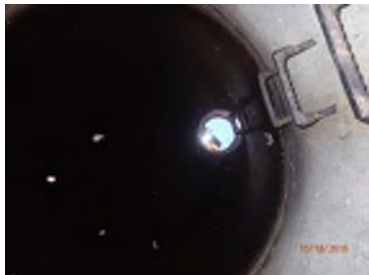
o20161018144430.JPG  
**2016**

<b>Inspection Date:</b> 9/23/2015 9:13:00 AM		<b>Type:</b> Ongoing	<b>Flow:</b> Submerged, indeterminate	<b>Previous Rainfall (hrs):</b> 72+
<b>Illicit Discharge Potential:</b> <b>Unlikely</b>		<b>Inspector:</b> JCW	<b>Notes</b>	
Submerged: Fully		Depth (in): 57		
<b>Sampling Results</b>		<b>Floatables:</b> None	<b>Condition Assessment</b> Graffiti: None Erosion: None Deposition: None in. Damage: None	
Sample Location: Pool	<b>Odor:</b> None			
Total Chlorine: 0 ppm	<b>Turbidity:</b> None			
Free Chlorine: 0 ppm	<b>Color:</b> None			
Ammonia: 0 ppm	<b>Gross Solids:</b> None			
pH: 8.39 units	<b>Vegetation:</b> None			
Temperature 70 °F	<b>Benthic Growth:</b> Slight			
Conductivity: 372 µS/cm	<b>Stains:</b> None			
Detergents: 0 mg/L	<b>Non-illicit:</b> None

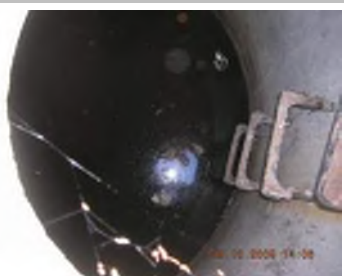
<p style="text-align: center;">Osh09_DSCN6801.JPG</p> <p style="text-align: center; font-size: 24pt; font-weight: bold;">2009</p>

<b>Inspection Date:</b> 9/10/2009		<b>Type:</b> Initial	<b>Flow:</b> Submerged, indeterminate	<b>Previous Rainfall (hrs):</b> 72+																	
<b>Illicit Discharge Potential:</b> <b>Potential</b>		<b>Inspector:</b> JCW	<div style="border: 1px solid black; height: 80px; width: 100%;"></div> <b>Notes</b> Abnormal detergent analysis result (bubbles)																		
Submerged: Partially      Depth (in): 6																					
<b>Sampling Results</b>

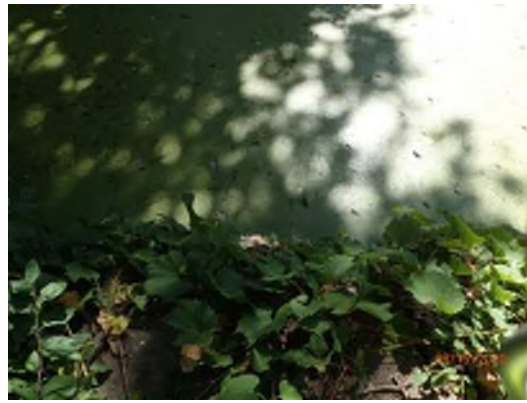
o20200819105032.JPG

Storm sewer from Josslyn St discharges to stream from west. Exits wall approx 9' north of fence.

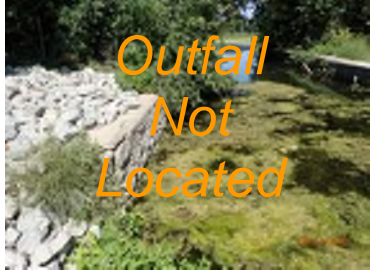
<b>Inspection Date:</b> 8/24/2022 1:58:00 PM		<b>Type:</b> Ongoing	<b>Flow:</b> Submerged (not located)	<b>Previous Rainfall (hrs):</b> 72+
<b>Illicit Discharge Potential:</b> Unlikely		<b>Inspector:</b> EJK		
Submerged: Fully		Depth (in):		
<b>Sampling Results</b> Sample Location: _____ Total Chlorine: -- ppm Free Chlorine: -- ppm Ammonia: -- ppm pH: -- units Temperature: -- °F Conductivity: -- µS/cm Detergents: -- mg/L		Floatables: None Odor: None Turbidity: None Color: None Gross Solids: None Vegetation: None Benthic Growth: None Stains: None Non-illicit: None	<b>Notes</b> Outfall fully submerged and not located - screened upstream at 06-829 US1.

o20220824135212.JPG <div style="text-align: center; font-weight: bold; font-size: 1.2em;">2022</div>
			<b>Condition Assessment</b> Graffiti: None Erosion: None Deposition: None in. Damage: None

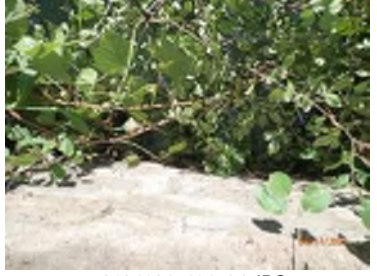
<b>Inspection Date:</b> 8/17/2021 10:19:04 AM		<b>Type:</b> Ongoing	<b>Flow:</b> Submerged, indeterminate	<b>Previous Rainfall (hrs):</b> 72+
<b>Illicit Discharge Potential:</b> Unlikely		<b>Inspector:</b> JCW		
Submerged: Fully		Depth (in): 43		
<b>Sampling Results</b> Sample Location: _____ Total Chlorine: -- ppm Free Chlorine: -- ppm Ammonia: -- ppm pH: -- units Temperature: -- °F Conductivity: -- µS/cm Detergents: -- mg/L		Floatables: None Odor: None Turbidity: None Color: None Gross Solids: None Vegetation: None Benthic Growth: None Stains: None Non-illicit: None	<b>Notes</b> Outfall fully submerged and not located - screened upstream at 06-829 US1.

o20210817101734.JPG <div style="text-align: center; font-weight: bold; font-size: 1.2em;">2021</div>
			<b>Condition Assessment</b> Graffiti: None Erosion: None Deposition: None in. Damage: None

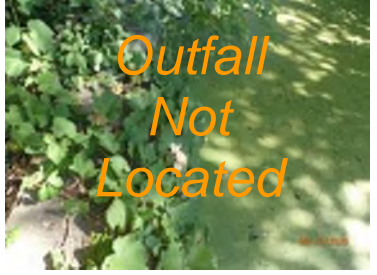
<b>Inspection Date:</b> 8/19/2020 10:50:40 AM		<b>Type:</b> Ongoing	<b>Flow:</b> Submerged (not located)	<b>Previous Rainfall (hrs):</b> 72+
<b>Illicit Discharge Potential:</b> Unlikely		<b>Inspector:</b> JCW		
Submerged: Fully		Depth (in):		
<b>Sampling Results</b> Sample Location: _____ Total Chlorine: -- ppm Free Chlorine: -- ppm Ammonia: -- ppm pH: -- units Temperature: -- °F Conductivity: -- µS/cm Detergents: -- mg/L		Floatables: None Odor: None Turbidity: None Color: None Gross Solids: None Vegetation: None Benthic Growth: None Stains: None Non-illicit: None	<b>Notes</b> Outfall fully submerged and not located - screened upstream at 06-829 US1.

o20200819105038.JPG <div style="text-align: center; font-weight: bold; font-size: 1.2em;">2020</div>
			<b>Condition Assessment</b> Graffiti: None Erosion: None Deposition: None in. Damage: None

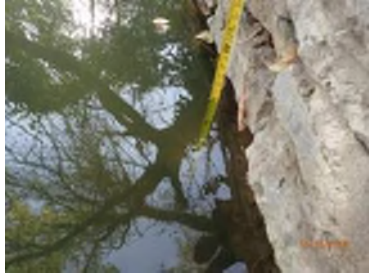
<p style="text-align: center;">o20181025133432.JPG</p> <p style="text-align: center; font-size: 24pt; font-weight: bold;">2018</p>																									
Submerged: Fully		Depth (in):		Outfall fully submerged - screened upstream at 06-829 US1. Floating gross solids (litter) in manhole.																											
<b>Sampling Results</b>		<table border="1" style="width:100%; border-collapse: collapse;"> <tr><td>Floatables:</td><td>None</td></tr> <tr><td>Odor:</td><td>None</td></tr> <tr><td>Turbidity:</td><td>None</td></tr> <tr><td>Color:</td><td>None</td></tr> <tr><td>Gross Solids:</td><td>None</td></tr> <tr><td>Vegetation:</td><td>None</td></tr> <tr><td>Benthic Growth:</td><td>None</td></tr> <tr><td>Stains:</td><td>None</td></tr> <tr><td>Non-illicit:</td><td>None</td></tr> </table>		Floatables:	None	Odor:	None	Turbidity:	None	Color:	None	Gross Solids:	None	Vegetation:	None	Benthic Growth:	None	Stains:	None	Non-illicit:	None	<b>Condition Assessment</b> <table border="1" style="width:100%; border-collapse: collapse;"> <tr><td>Graffiti:</td><td>None</td></tr> <tr><td>Erosion:</td><td>None</td></tr> <tr><td>Deposition:</td><td>None in.</td></tr> <tr><td>Damage:</td><td>None</td></tr> </table>		Graffiti:	None	Erosion:	None	Deposition:	None in.	Damage:	None

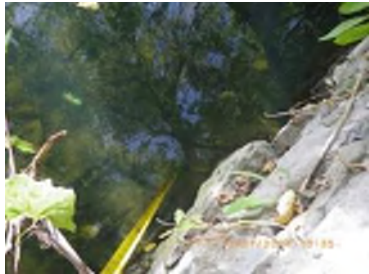
<p style="text-align: center;">o20141007093522.JPG</p> <p style="text-align: center; font-size: 24pt; font-weight: bold;">2014</p>																									
Submerged: Fully		Depth (in): 42		Outfall fully submerged - screened upstream at 06-829 US1. Manhole lid in water near end of pipe.																											
<b>Sampling Results</b>		<table border="1" style="width:100%; border-collapse: collapse;"> <tr><td>Floatables:</td><td>None</td></tr> <tr><td>Odor:</td><td>None</td></tr> <tr><td>Turbidity:</td><td>None</td></tr> <tr><td>Color:</td><td>None</td></tr> <tr><td>Gross Solids:</td><td>None</td></tr> <tr><td>Vegetation:</td><td>None</td></tr> <tr><td>Benthic Growth:</td><td>Slight</td></tr> <tr><td>Stains:</td><td>None</td></tr> <tr><td>Non-illicit:</td><td>None</td></tr> </table>		Floatables:	None	Odor:	None	Turbidity:	None	Color:	None	Gross Solids:	None	Vegetation:	None	Benthic Growth:	Slight	Stains:	None	Non-illicit:	None	<b>Condition Assessment</b> <table border="1" style="width:100%; border-collapse: collapse;"> <tr><td>Graffiti:</td><td>None</td></tr> <tr><td>Erosion:</td><td>None</td></tr> <tr><td>Deposition:</td><td>None in.</td></tr> <tr><td>Damage:</td><td>None</td></tr> </table>		Graffiti:	None	Erosion:	None	Deposition:	None in.	Damage:	None

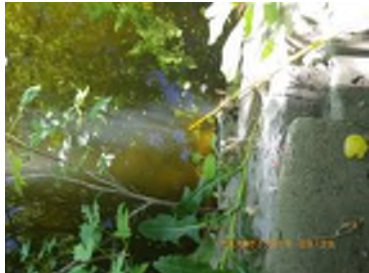
<p style="text-align: center;">o20130905082920.JPG</p> <p style="text-align: center; font-size: 24pt; font-weight: bold;">2013</p>																									
Submerged: Fully		Depth (in): 45		2012 screening follow-up. Outfall fully submerged. Outfall screened upstream at 06-829 US1. Gross solids in upstream mh.																											
<b>Sampling Results</b>		<table border="1" style="width:100%; border-collapse: collapse;"> <tr><td>Floatables:</td><td>None</td></tr> <tr><td>Odor:</td><td>None</td></tr> <tr><td>Turbidity:</td><td>None</td></tr> <tr><td>Color:</td><td>None</td></tr> <tr><td>Gross Solids:</td><td>None</td></tr> <tr><td>Vegetation:</td><td>None</td></tr> <tr><td>Benthic Growth:</td><td>None</td></tr> <tr><td>Stains:</td><td>None</td></tr> <tr><td>Non-illicit:</td><td>None</td></tr> </table>		Floatables:	None	Odor:	None	Turbidity:	None	Color:	None	Gross Solids:	None	Vegetation:	None	Benthic Growth:	None	Stains:	None	Non-illicit:	None	<b>Condition Assessment</b> <table border="1" style="width:100%; border-collapse: collapse;"> <tr><td>Graffiti:</td><td>None</td></tr> <tr><td>Erosion:</td><td>None</td></tr> <tr><td>Deposition:</td><td>None in.</td></tr> <tr><td>Damage:</td><td>None</td></tr> </table>		Graffiti:	None	Erosion:	None	Deposition:	None in.	Damage:	None

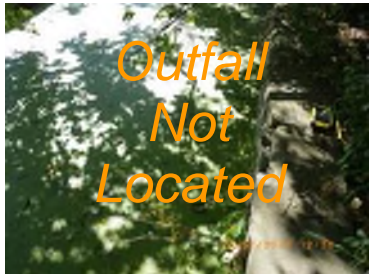
<p style="text-align: center;">o20120927113654.JPG</p> <p style="text-align: center; font-size: 24pt; font-weight: bold;">2012</p>																									
Submerged: Fully		Depth (in):		Outfall fully submerged; screened upstream at 06-829 US1.																											
<b>Sampling Results</b>		<table border="1" style="width:100%; border-collapse: collapse;"> <tr><td>Floatables:</td><td>None</td></tr> <tr><td>Odor:</td><td>None</td></tr> <tr><td>Turbidity:</td><td>None</td></tr> <tr><td>Color:</td><td>None</td></tr> <tr><td>Gross Solids:</td><td>None</td></tr> <tr><td>Vegetation:</td><td>None</td></tr> <tr><td>Benthic Growth:</td><td>None</td></tr> <tr><td>Stains:</td><td>None</td></tr> <tr><td>Non-illicit:</td><td>None</td></tr> </table>		Floatables:	None	Odor:	None	Turbidity:	None	Color:	None	Gross Solids:	None	Vegetation:	None	Benthic Growth:	None	Stains:	None	Non-illicit:	None	<b>Condition Assessment</b> <table border="1" style="width:100%; border-collapse: collapse;"> <tr><td>Graffiti:</td><td>None</td></tr> <tr><td>Erosion:</td><td>None</td></tr> <tr><td>Deposition:</td><td>None in.</td></tr> <tr><td>Damage:</td><td>None</td></tr> </table>		Graffiti:	None	Erosion:	None	Deposition:	None in.	Damage:	None

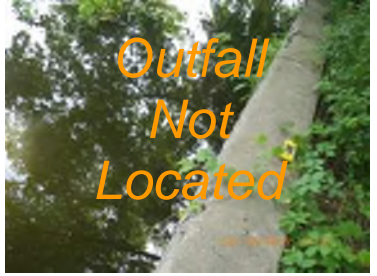
<p>o20120613132730.JPG</p> <p><b>2012</b></p>

<b>Inspection Date:</b> 6/13/2012 2:26:38 PM		<b>Type:</b> Other	<b>Flow:</b> Submerged (not located)	<b>Previous Rainfall (hrs):</b> 72+
<b>Illicit Discharge Potential:</b> Potential		<b>Inspector:</b> JCW		<b>Notes</b> Gross solids pre-screening.
Submerged: Fully		Depth (in):		
<b>Sampling Results</b> Sample Location:		Floatables:	None	
Total Chlorine: -- ppm		Odor:	None	
Free Chlorine: -- ppm		Turbidity:	None	
Ammonia: -- ppm		Color:	None	
pH: -- units		Gross Solids:	None	
Temperature -- °F		Vegetation:	None	
Conductivity: -- µS/cm		Benthic Growth:	None	
Detergents: -- mg/L		Stains:	None	
		Non-illicit:	None	
		<b>Condition Assessment</b> Graffiti: None Erosion: None Deposition: None in. Damage: None

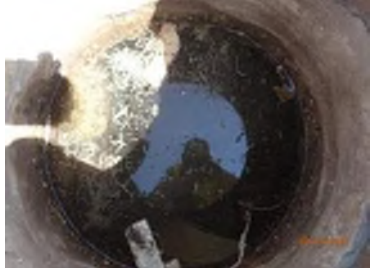
o20220824135512.JPG <div style="text-align: center; font-size: 24pt; font-weight: bold;">2022</div>

<b>Notes</b> Sample collected from submerged pool in manhole.																																				
		<b>Condition Assessment</b> <table border="1" style="width:100%; border-collapse: collapse;"> <tr><td>Graffiti:</td><td>None</td></tr> <tr><td>Erosion:</td><td>None</td></tr> <tr><td>Deposition:</td><td>None in.</td></tr> <tr><td>Damage:</td><td>None</td></tr> </table>			Graffiti:	None	Erosion:	None	Deposition:	None in.	Damage:	None																										
Graffiti:	None																																					
Erosion:	None																																					
Deposition:	None in.																																					
Damage:	None

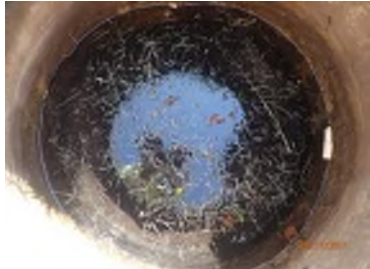
o20210817102130.JPG <div style="text-align: center; font-size: 24pt; font-weight: bold;">2021</div>

<b>Notes</b> Sample collected from submerged pool in manhole.																																				
		<b>Condition Assessment</b> <table border="1" style="width:100%; border-collapse: collapse;"> <tr><td>Graffiti:</td><td>None</td></tr> <tr><td>Erosion:</td><td>None</td></tr> <tr><td>Deposition:</td><td>None in.</td></tr> <tr><td>Damage:</td><td>None</td></tr> </table>			Graffiti:	None	Erosion:	None	Deposition:	None in.	Damage:	None																										
Graffiti:	None																																					
Erosion:	None																																					
Deposition:	None in.																																					
Damage:	None

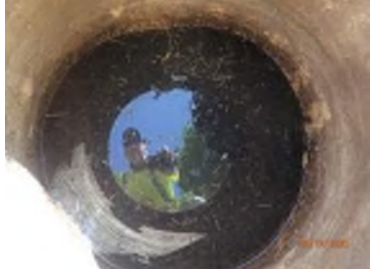
o20200819105348.JPG <div style="text-align: center; font-size: 24pt; font-weight: bold;">2020</div>

<b>Inspection Date:</b> 8/19/2020 10:56:12 AM		<b>Type:</b> Ongoing	<b>Flow:</b> Submerged, indeterminate	<b>Previous Rainfall (hrs):</b> 72+																																		
<b>Illicit Discharge Potential:</b> Unlikely		<b>Inspector:</b> JCW																																				
Submerged: Fully		Depth (in): 35																																				
<b>Sampling Results</b> <table border="1" style="width:100%; border-collapse: collapse;"> <tr><td>Sample Location:</td><td>Pool</td></tr> <tr><td>Total Chlorine:</td><td>0 ppm</td></tr> <tr><td>Free Chlorine:</td><td>0 ppm</td></tr> <tr><td>Ammonia:</td><td>0 ppm</td></tr> <tr><td>pH:</td><td>7.57 units</td></tr> <tr><td>Temperature:</td><td>80 °F</td></tr> <tr><td>Conductivity:</td><td>1508 µS/cm</td></tr> <tr><td>Detergents:</td><td>0 mg/L</td></tr> </table>		Sample Location:	Pool	Total Chlorine:	0 ppm	Free Chlorine:	0 ppm	Ammonia:	0 ppm	pH:	7.57 units	Temperature:	80 °F	Conductivity:	1508 µS/cm	Detergents:	0 mg/L	<table border="1" style="width:100%; border-collapse: collapse;"> <tr><td>Floatables:</td><td>None</td></tr> <tr><td>Odor:</td><td>None</td></tr> <tr><td>Turbidity:</td><td>None</td></tr> <tr><td>Color:</td><td>None</td></tr> <tr><td>Gross Solids:</td><td>None</td></tr> <tr><td>Vegetation:</td><td>None</td></tr> <tr><td>Benthic Growth:</td><td>None</td></tr> <tr><td>Stains:</td><td>None</td></tr> <tr><td>Non-illicit:</td><td>None</td></tr> </table>			Floatables:	None	Odor:	None	Turbidity:	None	Color:	None	Gross Solids:	None	Vegetation:	None	Benthic Growth:	None	Stains:	None	Non-illicit:	None

<b>Notes</b> Sample collected from submerged pool in manhole.																																				
		<b>Condition Assessment</b> <table border="1" style="width:100%; border-collapse: collapse;"> <tr><td>Graffiti:</td><td>None</td></tr> <tr><td>Erosion:</td><td>None</td></tr> <tr><td>Deposition:</td><td>None in.</td></tr> <tr><td>Damage:</td><td>None</td></tr> </table>			Graffiti:	None	Erosion:	None	Deposition:	None in.	Damage:	None																										
Graffiti:	None																																					
Erosion:	None																																					
Deposition:	None in.																																					
Damage:	None

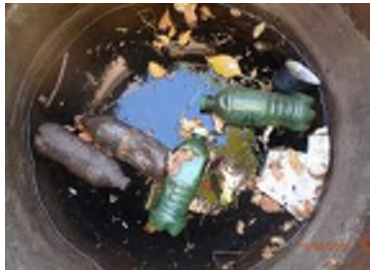
o20191008151850.JPG <div style="text-align: center; font-size: 24pt; font-weight: bold;">2019</div>

<b>Inspection Date:</b> 10/8/2019 4:19:45 PM		<b>Type:</b> Ongoing	<b>Flow:</b> Submerged, indeterminate	<b>Previous Rainfall (hrs):</b> 48-72																																		
<b>Illicit Discharge Potential:</b> Potential		<b>Inspector:</b> JCW																																				
Submerged: Fully		Depth (in): 42																																				
<b>Sampling Results</b> <table border="1" style="width:100%; border-collapse: collapse;"> <tr><td>Sample Location:</td><td>Pool</td></tr> <tr><td>Total Chlorine:</td><td>0 ppm</td></tr> <tr><td>Free Chlorine:</td><td>0 ppm</td></tr> <tr><td>Ammonia:</td><td>0 ppm</td></tr> <tr><td>pH:</td><td>7.47 units</td></tr> <tr><td>Temperature:</td><td>64 °F</td></tr> <tr><td>Conductivity:</td><td>1533 µS/cm</td></tr> <tr><td>Detergents:</td><td>0 mg/L</td></tr> </table>		Sample Location:	Pool	Total Chlorine:	0 ppm	Free Chlorine:	0 ppm	Ammonia:	0 ppm	pH:	7.47 units	Temperature:	64 °F	Conductivity:	1533 µS/cm	Detergents:	0 mg/L	<table border="1" style="width:100%; border-collapse: collapse;"> <tr><td>Floatables:</td><td>None</td></tr> <tr><td>Odor:</td><td>None</td></tr> <tr><td>Turbidity:</td><td>None</td></tr> <tr><td>Color:</td><td>None</td></tr> <tr><td>Gross Solids:</td><td>Moderate</td></tr> <tr><td>Vegetation:</td><td>None</td></tr> <tr><td>Benthic Growth:</td><td>None</td></tr> <tr><td>Stains:</td><td>None</td></tr> <tr><td>Non-illicit:</td><td>None</td></tr> </table>			Floatables:	None	Odor:	None	Turbidity:	None	Color:	None	Gross Solids:	Moderate	Vegetation:	None	Benthic Growth:	None	Stains:	None	Non-illicit:	None

<b>Notes</b> Sample collected from submerged pool in manhole. Floating gross solids (litter) in manhole.																																				
		<b>Condition Assessment</b> <table border="1" style="width:100%; border-collapse: collapse;"> <tr><td>Graffiti:</td><td>None</td></tr> <tr><td>Erosion:</td><td>None</td></tr> <tr><td>Deposition:</td><td>None in.</td></tr> <tr><td>Damage:</td><td>None</td></tr> </table>			Graffiti:	None	Erosion:	None	Deposition:	None in.	Damage:	None																										
Graffiti:	None																																					
Erosion:	None																																					
Deposition:	None in.																																					
Damage:	None

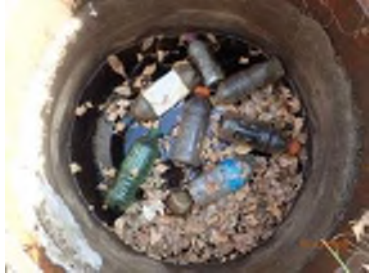
o20181025133814.JPG

<b>Inspection Date:</b> 10/25/2018 1:40:19 PM		<b>Type:</b> Ongoing	<b>Flow:</b> Submerged, indeterminate	<b>Previous Rainfall (hrs):</b> 72+
<b>Illicit Discharge Potential:</b> <b>Potential</b>		<b>Inspector:</b> JCW	<b>Notes</b>	
Submerged: Fully		Depth (in): 39	Sample collected from submerged pool in manhole. Floating gross solids (litter) in manhole.	
<b>Sampling Results</b>		<b>Floatables:</b> None	<b>Condition Assessment</b> Graffiti: None Erosion: None Deposition: None in. Damage: None	
Sample Location: Pool	<b>Odor:</b> None			
Total Chlorine: 0 ppm	<b>Turbidity:</b> None			
Free Chlorine: 0 ppm	<b>Color:</b> None			
Ammonia: 0 ppm	<b>Gross Solids:</b> Moderate			
pH: 7.64 units	<b>Vegetation:</b> None			
Temperature 58 °F	<b>Benthic Growth:</b> Slight			
Conductivity: 1550 µS/cm	<b>Stains:</b> None			
Detergents: 0 mg/L	<b>Non-illicit:</b> None

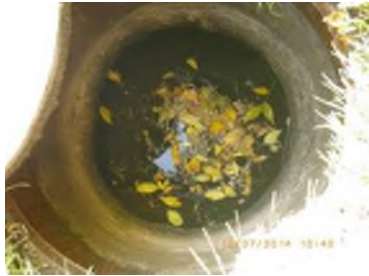
o20141007094030.JPG

<b>Inspection Date:</b> 10/7/2014 10:41:53 AM		<b>Type:</b> Ongoing	<b>Flow:</b> Submerged, indeterminate	<b>Previous Rainfall (hrs):</b> 48-72
<b>Illicit Discharge Potential:</b> <b>Unlikely</b>		<b>Inspector:</b> JCW	<b>Notes</b>	
Submerged: Fully		Depth (in): 30	Vegetative debris from opening lid.	
<b>Sampling Results</b>		<b>Floatables:</b> None	<b>Condition Assessment</b> Graffiti: None Erosion: None Deposition: None in. Damage: None	
Sample Location: Pool	<b>Odor:</b> None			
Total Chlorine: 0 ppm	<b>Turbidity:</b> None			
Free Chlorine: 0 ppm	<b>Color:</b> None			
Ammonia: 0 ppm	<b>Gross Solids:</b> None			
pH: 7.82 units	<b>Vegetation:</b> None			
Temperature -- °F	<b>Benthic Growth:</b> Slight			
Conductivity: 1715 µS/cm	<b>Stains:</b> None			
Detergents: 0 mg/L	<b>Non-illicit:</b> None

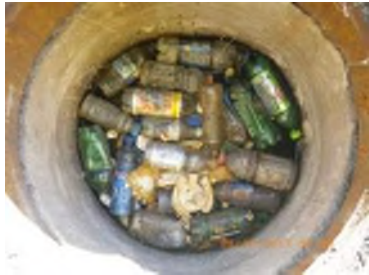
o20130905082002.JPG

<b>Inspection Date:</b> 9/5/2013 9:16:05 AM		<b>Type:</b> Ongoing	<b>Flow:</b> Submerged, indeterminate	<b>Previous Rainfall (hrs):</b> 72+
<b>Illicit Discharge Potential:</b> <b>Potential</b>		<b>Inspector:</b> JCW	<b>Notes</b>	
Submerged: Fully		Depth (in): 35	2012 screening follow-up. Significant gross solids in manhole - similar to previous years.	
<b>Sampling Results</b>		<b>Floatables:</b> None	<b>Condition Assessment</b> Graffiti: None Erosion: None Deposition: None in. Damage: None	
Sample Location: Pool	<b>Odor:</b> None			
Total Chlorine: 0 ppm	<b>Turbidity:</b> None			
Free Chlorine: 0 ppm	<b>Color:</b> None			
Ammonia: 0 ppm	<b>Gross Solids:</b> Severe			
pH: 7.7 units	<b>Vegetation:</b> None			
Temperature 71 °F	<b>Benthic Growth:</b> None			
Conductivity: 1666 µS/cm	<b>Stains:</b> Slight			
Detergents: 0 mg/L	<b>Non-illicit:</b> None

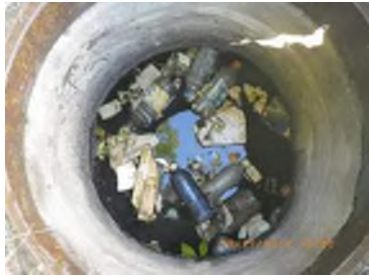
o20120927113044.JPG

<b>Inspection Date:</b> 9/27/2012 12:28:37 PM		<b>Type:</b> Ongoing	<b>Flow:</b> Submerged, indeterminate	<b>Previous Rainfall (hrs):</b> 72+
<b>Illicit Discharge Potential:</b> <b>Potential</b>		<b>Inspector:</b> JCW	<b>Notes</b>	
Submerged: Fully		Depth (in): 30		
<b>Sampling Results</b>		<b>Floatables:</b> None	<b>Condition Assessment</b> Graffiti: None Erosion: None Deposition: None in. Damage: None	
Sample Location: Pool	<b>Odor:</b> None			
Total Chlorine: 0 ppm	<b>Turbidity:</b> None			
Free Chlorine: 0 ppm	<b>Color:</b> None			
Ammonia: 0 ppm	<b>Gross Solids:</b> Moderate			
pH: 7.72 units	<b>Vegetation:</b> None			
Temperature 64 °F	<b>Benthic Growth:</b> None			
Conductivity: 1583 µS/cm	<b>Stains:</b> Slight			
Detergents: 0 mg/L	<b>Non-illicit:</b> None

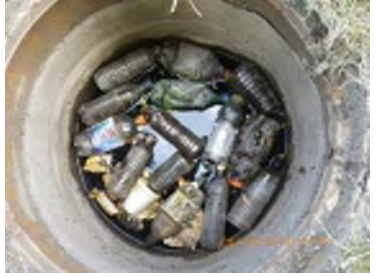
<p>o20120613133100.JPG</p> <p><b>2012</b></p>

<b>Inspection Date:</b> 6/13/2012 2:30:25 PM		<b>Type:</b> Other	<b>Flow:</b> Submerged, indeterminate	<b>Previous Rainfall (hrs):</b> 72+																										
<b>Illicit Discharge Potential:</b> Potential		<b>Inspector:</b> JCW		<b>Notes</b> Gross solids pre-screening. Bottles in manhole.																										
Submerged: Fully		Depth (in): 37																												
<b>Sampling Results</b>		<table border="1"> <tr><td>Floatables:</td><td>None</td></tr> <tr><td>Odor:</td><td>None</td></tr> <tr><td>Turbidity:</td><td>None</td></tr> <tr><td>Color:</td><td>None</td></tr> <tr><td>Gross Solids:</td><td>Severe</td></tr> <tr><td>Vegetation:</td><td>None</td></tr> <tr><td>Benthic Growth:</td><td>Slight</td></tr> <tr><td>Stains:</td><td>None</td></tr> <tr><td>Non-illicit:</td><td>None</td></tr> </table>		Floatables:	None	Odor:	None	Turbidity:	None	Color:	None	Gross Solids:	Severe	Vegetation:	None	Benthic Growth:	Slight	Stains:	None	Non-illicit:	None	<b>Condition Assessment</b> <table border="1"> <tr><td>Graffiti:</td><td>None</td></tr> <tr><td>Erosion:</td><td>None</td></tr> <tr><td>Deposition:</td><td>None</td></tr> <tr><td>Damage:</td><td>None</td></tr> </table>	Graffiti:	None	Erosion:	None	Deposition:	None	Damage:	None

Floatables:	None																													
Odor:	None																													
Turbidity:	None																													
Color:	None																													
Gross Solids:	Severe																													
Vegetation:	None																													
Benthic Growth:	Slight																													
Stains:	None																													
Non-illicit:	None																													
Graffiti:	None																													
Erosion:	None																													
Deposition:	None																													
Damage:	None																													
<table border="1"> <tr><td>Sample Location:</td><td>Pool</td></tr> <tr><td>Total Chlorine:</td><td>0 ppm</td></tr> <tr><td>Free Chlorine:</td><td>0 ppm</td></tr> <tr><td>Ammonia:</td><td>0 ppm</td></tr> <tr><td>pH:</td><td>7.58 units</td></tr> <tr><td>Temperature:</td><td>70 °F</td></tr> <tr><td>Conductivity:</td><td>1765 µS/cm</td></tr> <tr><td>Detergents:</td><td>0 mg/L</td></tr> </table>		Sample Location:	Pool	Total Chlorine:	0 ppm	Free Chlorine:	0 ppm	Ammonia:	0 ppm	pH:	7.58 units	Temperature:	70 °F	Conductivity:	1765 µS/cm	Detergents:	0 mg/L

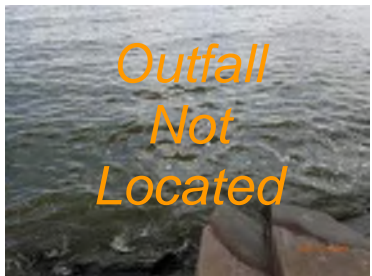
o20220916131014.JPG <b>2022</b>

<b>Inspection Date:</b> 9/16/2022 1:11:00 PM		<b>Type:</b> Ongoing	<b>Flow:</b> Submerged (not located)	<b>Previous Rainfall (hrs):</b> 72+
<b>Illicit Discharge Potential:</b> Potential		<b>Inspector:</b> EJK		
Submerged: Fully		Depth (in):		
<b>Sampling Results</b> Sample Location: _____ Total Chlorine: -- ppm Free Chlorine: -- ppm Ammonia: -- ppm pH: -- units Temperature: -- °F Conductivity: -- µS/cm Detergents: -- mg/L		Floatables: None Odor: None Turbidity: None Color: None Gross Solids: None Vegetation: None Benthic Growth: None Stains: None Non-illicit: None	<b>Notes</b> Outfall partially submerged - screened upstream at 08-284 US1. Floating gross solids (litter) in upstream manhole.  <b>Condition Assessment</b> Graffiti: None Erosion: None Deposition: None in. Damage: None

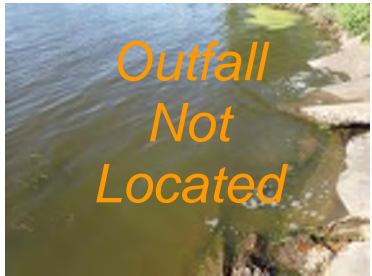
o20210816095056.JPG <b>2021</b>

<b>Inspection Date:</b> 8/16/2021 9:52:24 AM		<b>Type:</b> Ongoing	<b>Flow:</b> Submerged (not located)	<b>Previous Rainfall (hrs):</b> 72+
<b>Illicit Discharge Potential:</b> Potential		<b>Inspector:</b> JCW		
Submerged: Fully		Depth (in):		
<b>Sampling Results</b> Sample Location: _____ Total Chlorine: -- ppm Free Chlorine: -- ppm Ammonia: -- ppm pH: -- units Temperature: -- °F Conductivity: -- µS/cm Detergents: -- mg/L		Floatables: None Odor: None Turbidity: None Color: None Gross Solids: None Vegetation: None Benthic Growth: None Stains: None Non-illicit: None	<b>Notes</b> Outfall partially submerged - screened upstream at 08-284 US1. Floating gross solids (litter) in upstream manhole.  <b>Condition Assessment</b> Graffiti: None Erosion: None Deposition: None in. Damage: None

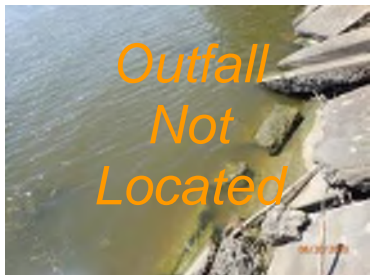
o20200820125142.JPG <b>2020</b>

<b>Inspection Date:</b> 8/20/2020 12:51:42 PM		<b>Type:</b> Ongoing	<b>Flow:</b> Submerged (not located)	<b>Previous Rainfall (hrs):</b> 72+
<b>Illicit Discharge Potential:</b> Potential		<b>Inspector:</b> JCW		
Submerged: Fully		Depth (in):		
<b>Sampling Results</b> Sample Location: _____ Total Chlorine: -- ppm Free Chlorine: -- ppm Ammonia: -- ppm pH: -- units Temperature: -- °F Conductivity: -- µS/cm Detergents: -- mg/L		Floatables: None Odor: None Turbidity: None Color: None Gross Solids: None Vegetation: None Benthic Growth: None Stains: None Non-illicit: None	<b>Notes</b> Outfall fully submerged and not located - screened upstream at 08-284 US1. Floating gross solids (litter) in upstream manhole.  <b>Condition Assessment</b> Graffiti: None Erosion: None Deposition: None in. Damage: None

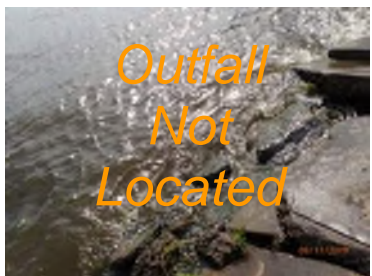
o20190917133750.JPG <b>2019</b>

<b>Inspection Date:</b> 9/17/2019 2:38:06 PM		<b>Type:</b> Ongoing	<b>Flow:</b> Submerged (not located)	<b>Previous Rainfall (hrs):</b> 48-72
<b>Illicit Discharge Potential:</b> Potential		<b>Inspector:</b> JCW		
Submerged: Fully		Depth (in):		
<b>Sampling Results</b> Sample Location: _____ Total Chlorine: -- ppm Free Chlorine: -- ppm Ammonia: -- ppm pH: -- units Temperature: -- °F Conductivity: -- µS/cm Detergents: -- mg/L		Floatables: None Odor: None Turbidity: None Color: None Gross Solids: None Vegetation: None Benthic Growth: None Stains: None Non-illicit: None	<b>Notes</b> Outfall fully submerged and not located - screened upstream at 08-284 US1. Floating gross solids (litter) in manhole.  <b>Condition Assessment</b> Graffiti: None Erosion: None Deposition: None in. Damage: None
