# Submittal of Annual Reports and Other Compliance Documents for Municipal Separate Storm Sewer System (MS4) Permits

**Project Name:** 2023 Annual Report

**Municipality:** Oshkosh, City

**Permit Number:** S050075

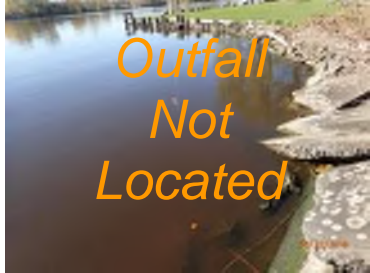
o20181022105100.JPG

<b>Inspection Date:</b> 10/22/2018 10:51:14 AM		<b>Type:</b> Ongoing	<b>Flow:</b> Submerged (not located)	<b>Previous Rainfall (hrs):</b> 48-72
<b>Illicit Discharge Potential:</b> <b>Potential</b>		<b>Inspector:</b> JCW	<b>Notes</b>	
Submerged: Fully		Depth (in):	Outfall fully submerged and not located - screened upstream at 08-284 US1. Floating gross solids (litter) in manhole.	
<b>Sampling Results</b>		Floatables:	<b>Condition Assessment</b> Graffiti: None Erosion: None Deposition: None in. Damage: None	
Sample Location:		Odor:		
Total Chlorine: -- ppm		Turbidity:		
Free Chlorine: -- ppm		Color:		
Ammonia: -- ppm		Gross Solids:		
pH: -- units		Vegetation:		
Temperature -- °F		Benthic Growth:		
Conductivity: -- µS/cm		Stains:		
Detergents: -- mg/L		Non-illicit:

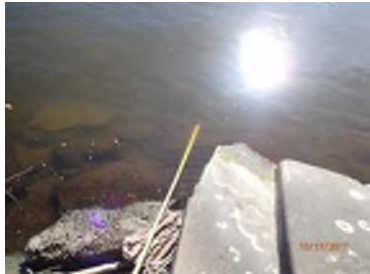
o20171017135302.JPG

<b>Inspection Date:</b> 10/17/2017 1:56:02 PM		<b>Type:</b> Ongoing	<b>Flow:</b> Submerged, indeterminate	<b>Previous Rainfall (hrs):</b> 48-72
<b>Illicit Discharge Potential:</b> <b>Potential</b>		<b>Inspector:</b> JCW	<b>Notes</b>	
Submerged: Fully		Depth (in): 36	Outfall fully submerged with approx 9" of water over crown of pipe - screened upstream at 08-284 US1. Floating gross solids (litter) in manhole.	
<b>Sampling Results</b>		Floatables:	<b>Condition Assessment</b> Graffiti: None Erosion: None Deposition: None in. Damage: None	
Sample Location:		Odor:		
Total Chlorine: -- ppm		Turbidity:		
Free Chlorine: -- ppm		Color:		
Ammonia: -- ppm		Gross Solids:		
pH: -- units		Vegetation:		
Temperature -- °F		Benthic Growth:		
Conductivity: -- µS/cm		Stains:		
Detergents: -- mg/L		Non-illicit:

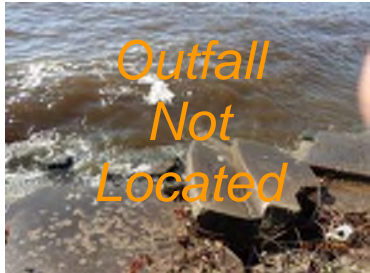
o20161010101832.JPG

<b>Inspection Date:</b> 10/10/2016 10:18:48 AM		<b>Type:</b> Ongoing	<b>Flow:</b> Submerged (not located)	<b>Previous Rainfall (hrs):</b> 72+
<b>Illicit Discharge Potential:</b> <b>Potential</b>		<b>Inspector:</b> JCW	<b>Notes</b>	
Submerged: Fully		Depth (in):	Outfall fully submerged and not located - screened upstream at 08-284 US1.	
<b>Sampling Results</b>		Floatables:	<b>Condition Assessment</b> Graffiti: None Erosion: None Deposition: None in. Damage: None	
Sample Location:		Odor:		
Total Chlorine: -- ppm		Turbidity:		
Free Chlorine: -- ppm		Color:		
Ammonia: -- ppm		Gross Solids:		
pH: -- units		Vegetation:		
Temperature -- °F		Benthic Growth:		
Conductivity: -- µS/cm		Stains:		
Detergents: -- mg/L		Non-illicit:

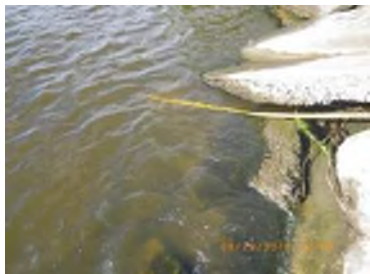
o20150922090932.JPG

<b>Inspection Date:</b> 9/22/2015 10:04:59 AM		<b>Type:</b> Ongoing	<b>Flow:</b> Submerged, indeterminate	<b>Previous Rainfall (hrs):</b> 72+
<b>Illicit Discharge Potential:</b> <b>Potential</b>		<b>Inspector:</b> JCW	<b>Notes</b>	
Submerged: Fully		Depth (in): 30	Outfall fully submerged - screened at 08-284 US1.	
<b>Sampling Results</b>		Floatables:	<b>Condition Assessment</b> Graffiti: None Erosion: None Deposition: None in. Damage: None	
Sample Location:		Odor:		
Total Chlorine: -- ppm		Turbidity:		
Free Chlorine: -- ppm		Color:		
Ammonia: -- ppm		Gross Solids:		
pH: -- units		Vegetation:		
Temperature -- °F		Benthic Growth:		
Conductivity: -- µS/cm		Stains:		
Detergents: -- mg/L		Non-illicit:

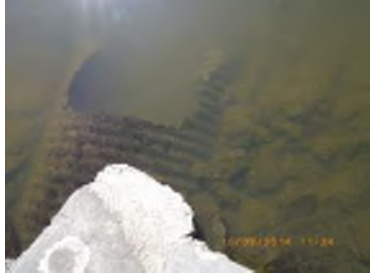
o20141009102400.JPG

<b>Inspection Date:</b> 10/9/2014 11:24:44 AM		<b>Type:</b> Ongoing	<b>Flow:</b> Submerged, indeterminate	<b>Previous Rainfall (hrs):</b> 72+
<b>Illicit Discharge Potential:</b> <b>Potential</b>		<b>Inspector:</b> JCW	<b>Notes</b>	
Submerged: Fully		Depth (in): 29	Outfall fully submerged - screened upstream at 08-284 US1.	
<b>Sampling Results</b>		<b>Condition Assessment</b>		
Sample Location:	Floatables:	None		
Total Chlorine: -- ppm	Odor:	None		
Free Chlorine: -- ppm	Turbidity:	None		
Ammonia: -- ppm	Color:	None		
pH: -- units	Gross Solids:	None		
Temperature -- °F	Vegetation:	None		
Conductivity: -- µS/cm	Benthic Growth:	None		
Detergents: -- mg/L	Stains:	None		
	Non-illicit:	None		
		Graffiti:	None	
		Erosion:	None	
		Deposition:	Minor	3 in.
		Damage:	Minor

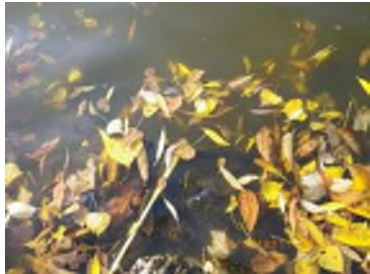
o20111011083728.JPG

<b>Inspection Date:</b> 10/11/2011 8:37:04 AM		<b>Type:</b> Ongoing	<b>Flow:</b> Submerged, indeterminate	<b>Previous Rainfall (hrs):</b> 72+
<b>Illicit Discharge Potential:</b> <b>Unlikely</b>		<b>Inspector:</b> JCW	<b>Notes</b>	
Submerged: Fully		Depth (in): 25	2010 screening follow-up. Outfall fully submerged. Outfall screened upstream at 08-284 US1.	
<b>Sampling Results</b>		<b>Condition Assessment</b>		
Sample Location:	Floatables:	None		
Total Chlorine: -- ppm	Odor:	None		
Free Chlorine: -- ppm	Turbidity:	None		
Ammonia: -- ppm	Color:	None		
pH: -- units	Gross Solids:	None		
Temperature -- °F	Vegetation:	None		
Conductivity: -- µS/cm	Benthic Growth:	None		
Detergents: -- mg/L	Stains:	None		
	Non-illicit:	None		
		Graffiti:	None	
		Erosion:	None	
		Deposition:	None	0 in.
		Damage:	None

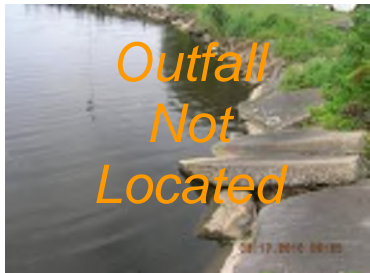
o20100817093554.JPG

<b>Inspection Date:</b> 8/17/2010 9:35:00 AM		<b>Type:</b> Ongoing	<b>Flow:</b> Submerged (not located)	<b>Previous Rainfall (hrs):</b> 72+
<b>Illicit Discharge Potential:</b> <b>Potential</b>		<b>Inspector:</b> JCW	<b>Notes</b>	
Submerged: Fully		Depth (in):	Outfall fully submerged and not physically located. Outfall screened upstream at 08-284 US1.	
<b>Sampling Results</b>		<b>Condition Assessment</b>		
Sample Location:	Floatables:	None		
Total Chlorine: -- ppm	Odor:	None		
Free Chlorine: -- ppm	Turbidity:	None		
Ammonia: -- ppm	Color:	None		
pH: -- units	Gross Solids:	None		
Temperature -- °F	Vegetation:	None		
Conductivity: -- µS/cm	Benthic Growth:	None		
Detergents: -- mg/L	Stains:	None		
	Non-illicit:	None		
		Graffiti:	None	
		Erosion:	None	
		Deposition:	None	0 in.
		Damage:	None

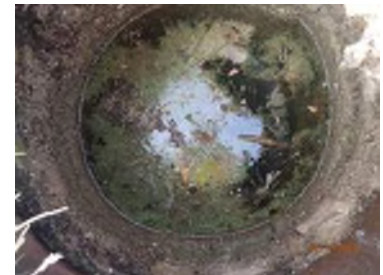
o20230717075704.JPG

☐ Petrol. Sheen ☐ Suds ☐ Sewage ☒ Algae ☐ Other☐ Petroleum ☐ Musty ☐ Sewage ☐ Chlorine ☐ Other☐ VOC/Solvent ☐ Fishy ☐ Sulfur ☐ Fragrant☒ Litter ☐ Veg. Debris ☐ Sediment ☐ Other☐ Inhibited ☐ Excessive☐ Green ☐ Brown☐ Flow Line ☐ Oil ☐ Rust Stains☐ Paint ☐ Other☐ Natural Sheen ☐ Natural Suds/Foam

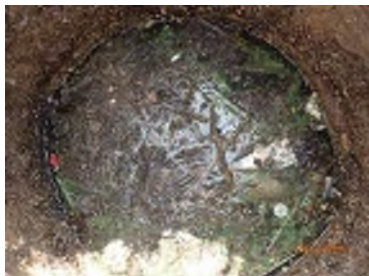
o20220916131222.JPG  
**2022**

<b>Inspection Date:</b> 9/16/2022 1:13:00 PM		<b>Type:</b> Ongoing	<b>Flow:</b> Submerged, indeterminate	<b>Previous Rainfall (hrs):</b> 72+
<b>Illicit Discharge Potential:</b> Potential		<b>Inspector:</b> EJK		
Submerged: Partially		Depth (in): 34		
<b>Sampling Results</b>		<b>Notes</b>		
Sample Location: Pool	Floatables: None	Sample collected from submerged pool in manhole. Floating gross solids (litter) in manhole.		
Total Chlorine: 0 ppm	Odor: None			
Free Chlorine: 0 ppm	Turbidity: None	<b>Condition Assessment</b>		
Ammonia: 0 ppm	Color: None			
pH: 7.24 units	Gross Solids: Moderate	Graffiti: None	in.	
Temperature 75 °F	Vegetation: None	Erosion: None		
Conductivity: 364 µS/cm	Benthic Growth: Slight	Deposition: None		
Detergents: 0 mg/L	Stains: None	Damage: None		
	Non-illicit: Slight

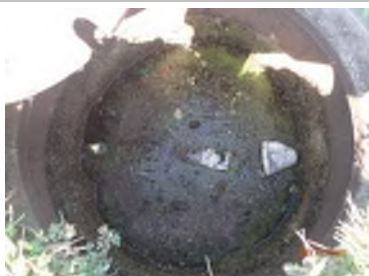
o20210816095220.JPG  
**2021**

<b>Inspection Date:</b> 8/16/2021 9:55:45 AM		<b>Type:</b> Ongoing	<b>Flow:</b> Submerged, indeterminate	<b>Previous Rainfall (hrs):</b> 72+
<b>Illicit Discharge Potential:</b> Potential		<b>Inspector:</b> JCW		
Submerged: Fully		Depth (in): 36		
<b>Sampling Results</b>		<b>Notes</b>		
Sample Location: Pool	Floatables: None	Sample collected from submerged pool in manhole. Floating gross solids (litter) in manhole.		
Total Chlorine: 0 ppm	Odor: None			
Free Chlorine: 0 ppm	Turbidity: None	<b>Condition Assessment</b>		
Ammonia: 0 ppm	Color: None			
pH: 7.14 units	Gross Solids: Severe	Graffiti: None	in.	
Temperature 77 °F	Vegetation: None	Erosion: None		
Conductivity: 328 µS/cm	Benthic Growth: None	Deposition: None		
Detergents: 0 mg/L	Stains: None	Damage: None		
	Non-illicit: None

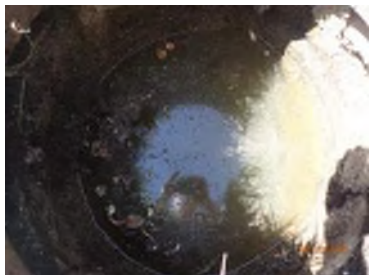
o20200820125256.JPG  
**2020**

<b>Inspection Date:</b> 8/20/2020 12:55:02 PM		<b>Type:</b> Ongoing	<b>Flow:</b> Submerged, indeterminate	<b>Previous Rainfall (hrs):</b> 72+
<b>Illicit Discharge Potential:</b> Potential		<b>Inspector:</b> JCW		
Submerged: Fully		Depth (in): 33		
<b>Sampling Results</b>		<b>Notes</b>		
Sample Location: Pool	Floatables: None	Sample collected from submerged pool in manhole. Floating gross solids (litter) in manhole. Elevated pH seemed widespread in river.		
Total Chlorine: 0 ppm	Odor: None			
Free Chlorine: 0 ppm	Turbidity: None	<b>Condition Assessment</b>		
Ammonia: 0 ppm	Color: None			
pH: 9.23 units	Gross Solids: Moderate	Graffiti: None	in.	
Temperature 82 °F	Vegetation: None	Erosion: None		
Conductivity: 320 µS/cm	Benthic Growth: Moderate	Deposition: None		
Detergents: 0 mg/L	Stains: None	Damage: None		
	Non-illicit: None

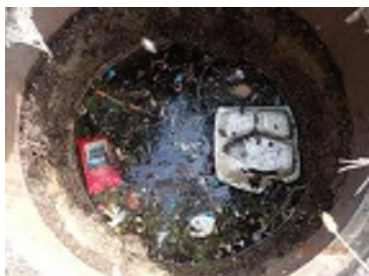
o20190917133856.JPG  
**2019**

<b>Inspection Date:</b> 9/17/2019 2:41:09 PM		<b>Type:</b> Ongoing	<b>Flow:</b> Submerged, indeterminate	<b>Previous Rainfall (hrs):</b> 48-72
<b>Illicit Discharge Potential:</b> Potential		<b>Inspector:</b> JCW		
Submerged: Fully		Depth (in): 34		
<b>Sampling Results</b>		<b>Notes</b>		
Sample Location: Pool	Floatables: None	Sample collected from submerged pool in outfall. Syringe and other floating gross solids (litter) in manhole.		
Total Chlorine: 0 ppm	Odor: None			
Free Chlorine: 0 ppm	Turbidity: None	<b>Condition Assessment</b>		
Ammonia: 0 ppm	Color: None			
pH: 8.79 units	Gross Solids: Severe	Graffiti: None	in.	
Temperature 76 °F	Vegetation: None	Erosion: None		
Conductivity: 341 µS/cm	Benthic Growth: None	Deposition: None		
Detergents: 0 mg/L	Stains: None	Damage: None		
	Non-illicit: None

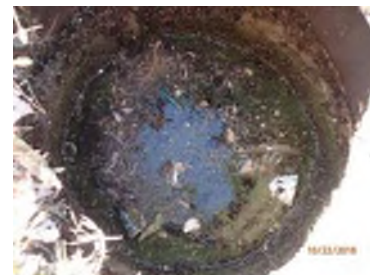
o20181022105156.JPG

<b>Inspection Date:</b> 10/22/2018 10:54:41 AM		<b>Type:</b> Ongoing	<b>Flow:</b> Submerged, indeterminate	<b>Previous Rainfall (hrs):</b> 48-72
<b>Illicit Discharge Potential:</b> <b>Potential</b>		<b>Inspector:</b> JCW		
Submerged: Fully		Depth (in): 34		
<b>Sampling Results</b>		<b>Notes</b>		
Sample Location: Pool	Floatables: None	Sample collected from submerged pool in outfall. Floating gross solids (litter) in manhole.		
Total Chlorine: 0 ppm	Odor: None			
Free Chlorine: 0 ppm	Turbidity: None			
Ammonia: 0 ppm	Color: Faint in bottle			
pH: 7.5 units	Gross Solids: Moderate			
Temperature 54 °F	Vegetation: None			
Conductivity: 314 µS/cm	Benthic Growth: Moderate			
Detergents: 0 mg/L	Stains: None			
	Non-illicit: None	<b>Condition Assessment</b>		
		Graffiti: None		
		Erosion: None		
		Deposition: None in.		
		Damage: None

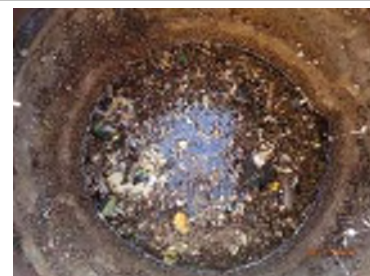
o20171017135518.JPG

<b>Inspection Date:</b> 10/17/2017 1:59:35 PM		<b>Type:</b> Ongoing	<b>Flow:</b> Submerged, indeterminate	<b>Previous Rainfall (hrs):</b> 48-72
<b>Illicit Discharge Potential:</b> <b>Potential</b>		<b>Inspector:</b> JCW		
Submerged: Fully		Depth (in): 30		
<b>Sampling Results</b>		<b>Notes</b>		
Sample Location: Pool	Floatables: None	Sample collected from submerged pool in outfall. Floating gross solids (litter) in manhole.		
Total Chlorine: 0 ppm	Odor: None			
Free Chlorine: 0 ppm	Turbidity: None			
Ammonia: 0 ppm	Color: None			
pH: 8.67 units	Gross Solids: Moderate			
Temperature 66 °F	Vegetation: None			
Conductivity: 352 µS/cm	Benthic Growth: None			
Detergents: 0 mg/L	Stains: None			
	Non-illicit: None	<b>Condition Assessment</b>		
		Graffiti: None		
		Erosion: None		
		Deposition: None in.		
		Damage: None

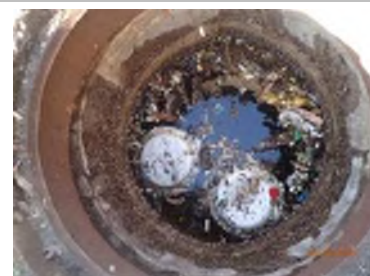
o20161010101916.JPG

<b>Inspection Date:</b> 10/10/2016 10:21:35 AM		<b>Type:</b> Ongoing	<b>Flow:</b> Submerged, indeterminate	<b>Previous Rainfall (hrs):</b> 72+
<b>Illicit Discharge Potential:</b> <b>Potential</b>		<b>Inspector:</b> JCW		
Submerged: Fully		Depth (in): 32		
<b>Sampling Results</b>		<b>Notes</b>		
Sample Location: Pool	Floatables: None	Potential illicit discharge due to gross solids.		
Total Chlorine: 0 ppm	Odor: None			
Free Chlorine: 0 ppm	Turbidity: None			
Ammonia: 0 ppm	Color: Clearly visible in bottl			
pH: 8.15 units	Gross Solids: Moderate			
Temperature 63 °F	Vegetation: None			
Conductivity: 369 µS/cm	Benthic Growth: None			
Detergents: 0 mg/L	Stains: None			
	Non-illicit: None	<b>Condition Assessment</b>		
		Graffiti: None		
		Erosion: None		
		Deposition: None in.		
		Damage: None

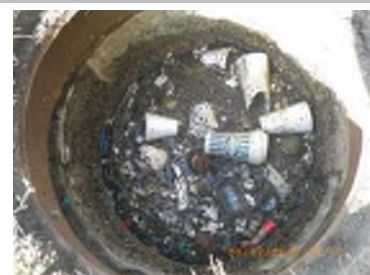
o20150922091040.JPG

<b>Inspection Date:</b> 9/22/2015 10:09:39 AM		<b>Type:</b> Ongoing	<b>Flow:</b> Submerged, indeterminate	<b>Previous Rainfall (hrs):</b> 72+
<b>Illicit Discharge Potential:</b> <b>Potential</b>		<b>Inspector:</b> JCW		
Submerged: Fully		Depth (in): 34		
<b>Sampling Results</b>		<b>Notes</b>		
Sample Location: Pool	Floatables: None	Floating gross solids (litter) in manhole.		
Total Chlorine: 0 ppm	Odor: None			
Free Chlorine: 0 ppm	Turbidity: None			
Ammonia: 0 ppm	Color: None			
pH: 8.8 units	Gross Solids: Severe			
Temperature 70 °F	Vegetation: None			
Conductivity: 335 µS/cm	Benthic Growth: None			
Detergents: 0 mg/L	Stains: None			
	Non-illicit: None	<b>Condition Assessment</b>		
		Graffiti: None		
		Erosion: None		
		Deposition: None in.		
		Damage: None

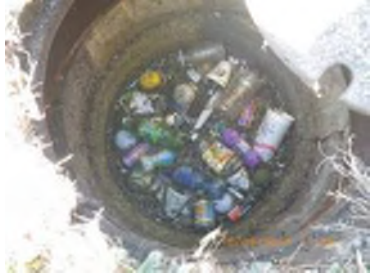
o20141009102622.JPG  
**2014**

<b>Inspection Date:</b> 10/9/2014 11:28:19 AM		<b>Type:</b> Ongoing	<b>Flow:</b> Submerged, indeterminate	<b>Previous Rainfall (hrs):</b> 72+
<b>Illicit Discharge Potential:</b> <b>Potential</b>		<b>Inspector:</b> JCW	<b>Notes</b>	
Submerged: Fully		Depth (in): 29	Floating gross solids (litter) in manhole.	
<b>Sampling Results</b>		<b>Floatables:</b> None	<b>Condition Assessment</b> Graffiti: None Erosion: None Deposition: None in. Damage: None	
Sample Location: Pool	<b>Odor:</b> None			
Total Chlorine: 0 ppm	<b>Turbidity:</b> None			
Free Chlorine: 0 ppm	<b>Color:</b> Faint in bottle			
Ammonia: 0 ppm	<b>Gross Solids:</b> Severe			
pH: 8.34 units	<b>Vegetation:</b> None			
Temperature 57 °F	<b>Benthic Growth:</b> None			
Conductivity: 400 µS/cm	<b>Stains:</b> None			
Detergents: 0 mg/L	<b>Non-illicit:</b> None

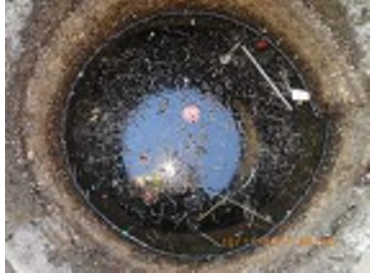
o20111011084038.JPG  
**2011**

<b>Inspection Date:</b> 10/11/2011 8:41:22 AM		<b>Type:</b> Ongoing	<b>Flow:</b> Submerged, indeterminate	<b>Previous Rainfall (hrs):</b> 72+
<b>Illicit Discharge Potential:</b> <b>Unlikely</b>		<b>Inspector:</b> JCW	<b>Notes</b>	
Submerged: Fully		Depth (in): 18	2010 screening follow-up. Floatable debris significantly reduced.	
<b>Sampling Results</b>		<b>Floatables:</b> None	<b>Condition Assessment</b> Graffiti: None Erosion: None Deposition: None 0 in. Damage: None	
Sample Location: Pool	<b>Odor:</b> None			
Total Chlorine: 0 ppm	<b>Turbidity:</b> None			
Free Chlorine: 0 ppm	<b>Color:</b> None			
Ammonia: 0 ppm	<b>Gross Solids:</b> Slight			
pH: 8.11 units	<b>Vegetation:</b> None			
Temperature 72 °F	<b>Benthic Growth:</b> None			
Conductivity: -- µS/cm	<b>Stains:</b> None			
Detergents: -- mg/L	<b>Non-illicit:</b> None

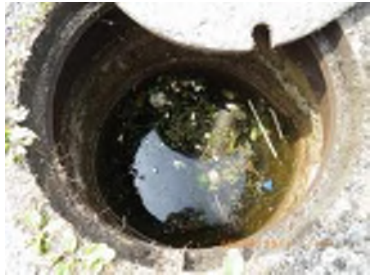
o20110526110156.JPG  
**2011**

<b>Inspection Date:</b> 5/26/2011 11:01:00 AM		<b>Type:</b> Other	<b>Flow:</b> Submerged, indeterminate	<b>Previous Rainfall (hrs):</b> 72+
<b>Illicit Discharge Potential:</b> <b>Potential</b>		<b>Inspector:</b> JCW	<b>Notes</b>	
Submerged: Fully		Depth (in):	Limited screening conducted to check for floatable debris.	
<b>Sampling Results</b>		<b>Floatables:</b> None	<b>Condition Assessment</b> Graffiti: None Erosion: None Deposition: None 0 in. Damage: None	
Sample Location:	<b>Odor:</b>			
Total Chlorine: -- ppm	<b>Turbidity:</b>			
Free Chlorine: -- ppm	<b>Color:</b>			
Ammonia: -- ppm	<b>Gross Solids:</b> Moderate			
pH: -- units	<b>Vegetation:</b>			
Temperature -- °F	<b>Benthic Growth:</b>			
Conductivity: -- µS/cm	<b>Stains:</b>			
Detergents: -- mg/L	<b>Non-illicit:</b> None

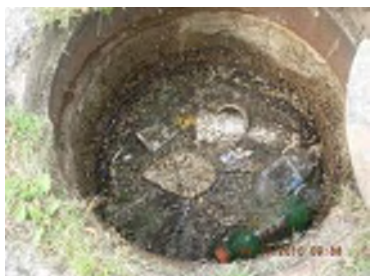
o20100817093838.JPG  
**2010**

<b>Inspection Date:</b> 8/17/2010 9:47:15 AM		<b>Type:</b> Ongoing	<b>Flow:</b> Submerged, indeterminate	<b>Previous Rainfall (hrs):</b> 72+
<b>Illicit Discharge Potential:</b> <b>Potential</b>		<b>Inspector:</b> JCW	<b>Notes</b>	
Submerged: Fully		Depth (in): 31	Significant floatable debris in manhole.	
<b>Sampling Results</b>		<b>Floatables:</b> None	<b>Condition Assessment</b> Graffiti: None Erosion: None Deposition: None 0 in. Damage: None	
Sample Location: Pool	<b>Odor:</b> None			
Total Chlorine: 0 ppm	<b>Turbidity:</b> None			
Free Chlorine: 0 ppm	<b>Color:</b> Faint in bottle			
Ammonia: 0 ppm	<b>Gross Solids:</b> Severe			
pH: 7.64 units	<b>Vegetation:</b> None			
Temperature 74 °F	<b>Benthic Growth:</b> None			
Conductivity: -- µS/cm	<b>Stains:</b> None			
Detergents: 0 mg/L	<b>Non-illicit:</b> None

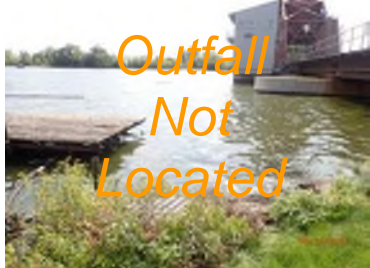
o20220916132138.JPG <b>2022</b>

<b>Inspection Date:</b> 9/16/2022 1:22:00 PM		<b>Type:</b> Ongoing	<b>Flow:</b> Submerged (not located)	<b>Previous Rainfall (hrs):</b> 72+
<b>Illicit Discharge Potential:</b> Potential		<b>Inspector:</b> EJK		
Submerged: Fully		Depth (in):		
<b>Sampling Results</b> Sample Location: _____ Total Chlorine: -- ppm Free Chlorine: -- ppm Ammonia: -- ppm pH: -- units Temperature: -- °F Conductivity: -- µS/cm Detergents: -- mg/L		Floatables: None Odor: None Turbidity: None Color: None Gross Solids: None Vegetation: None Benthic Growth: None Stains: None Non-illicit: None	<b>Notes</b> Outfall fully submerged and not located - screened upstream at 08-347 US1. Detergent in upstream manhole.  <b>Condition Assessment</b> Graffiti: None Erosion: None Deposition: None in. Damage: None

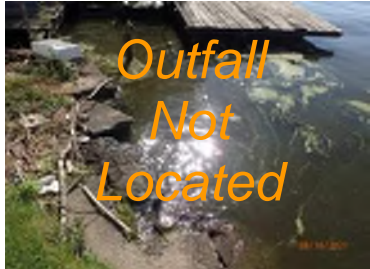
o20210816100046.JPG <b>2021</b>

<b>Inspection Date:</b> 8/16/2021 10:01:15 AM		<b>Type:</b> Ongoing	<b>Flow:</b> Submerged (not located)	<b>Previous Rainfall (hrs):</b> 72+
<b>Illicit Discharge Potential:</b> Unlikely		<b>Inspector:</b> JCW		
Submerged: Fully		Depth (in):		
<b>Sampling Results</b> Sample Location: _____ Total Chlorine: -- ppm Free Chlorine: -- ppm Ammonia: -- ppm pH: -- units Temperature: -- °F Conductivity: -- µS/cm Detergents: -- mg/L		Floatables: None Odor: None Turbidity: None Color: None Gross Solids: None Vegetation: None Benthic Growth: None Stains: None Non-illicit: None	<b>Notes</b> Outfall fully submerged and not located - screened upstream at 08-347 US1.  <b>Condition Assessment</b> Graffiti: None Erosion: None Deposition: None in. Damage: None

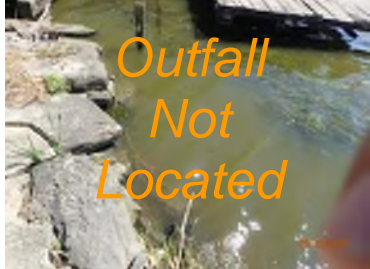
o20200820124230.JPG <b>2020</b>

<b>Inspection Date:</b> 8/20/2020 12:42:50 PM		<b>Type:</b> Ongoing	<b>Flow:</b> Submerged (not located)	<b>Previous Rainfall (hrs):</b> 72+
<b>Illicit Discharge Potential:</b> Potential		<b>Inspector:</b> JCW		
Submerged: Fully		Depth (in):		
<b>Sampling Results</b> Sample Location: _____ Total Chlorine: -- ppm Free Chlorine: -- ppm Ammonia: -- ppm pH: -- units Temperature: -- °F Conductivity: -- µS/cm Detergents: -- mg/L		Floatables: None Odor: None Turbidity: None Color: None Gross Solids: None Vegetation: None Benthic Growth: None Stains: None Non-illicit: None	<b>Notes</b> Outfall fully submerged and not located - screened upstream at 08-347 US1. Floating gross solids (litter) in upstream manhole.  <b>Condition Assessment</b> Graffiti: None Erosion: None Deposition: None in. Damage: None

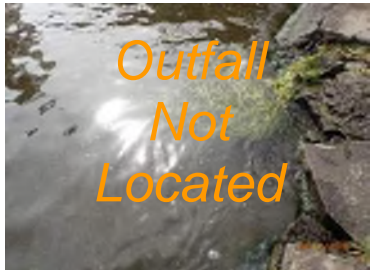
o20190917134640.JPG <b>2019</b>

<b>Inspection Date:</b> 9/17/2019 2:47:00 PM		<b>Type:</b> Ongoing	<b>Flow:</b> Submerged (not located)	<b>Previous Rainfall (hrs):</b> 48-72
<b>Illicit Discharge Potential:</b> Unlikely		<b>Inspector:</b> JCW		
Submerged: Fully		Depth (in):		
<b>Sampling Results</b> Sample Location: _____ Total Chlorine: -- ppm Free Chlorine: -- ppm Ammonia: -- ppm pH: -- units Temperature: -- °F Conductivity: -- µS/cm Detergents: -- mg/L		Floatables: None Odor: None Turbidity: None Color: None Gross Solids: None Vegetation: None Benthic Growth: None Stains: None Non-illicit: None	<b>Notes</b> Outfall fully submerged and not located - screened upstream at 08-347 US1.  <b>Condition Assessment</b> Graffiti: None Erosion: None Deposition: None in. Damage: None

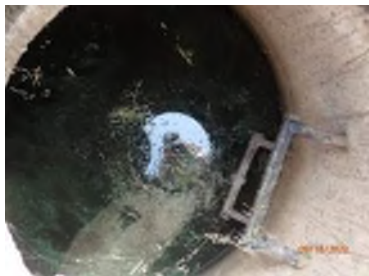
o20220916132530.JPG <div style="text-align: center; font-size: 24pt; font-weight: bold;">2022</div>

<b>Inspection Date:</b> 9/16/2022 1:27:00 PM		<b>Type:</b> Ongoing	<b>Flow:</b> Submerged, indeterminate	<b>Previous Rainfall (hrs):</b> 72+
<b>Illicit Discharge Potential:</b> Potential		<b>Inspector:</b> EJK		
Submerged: Partially		Depth (in): 48		
<b>Sampling Results</b>		<b>Notes</b> Sample collected from submerged pool in manhole. Detergent detected in sample.		
Sample Location: Pool Total Chlorine: 0 ppm Free Chlorine: 0 ppm Ammonia: 0 ppm pH: 7.51 units Temperature: 74 °F Conductivity: 922 µS/cm Detergents: 0.4 mg/L		<b>Condition Assessment</b> Graffiti: None Erosion: None Deposition: None in. Damage: None		
Floatables: Slight Odor: None Turbidity: None Color: None Gross Solids: None Vegetation: None Benthic Growth: None Stains: None Non-illicit: None

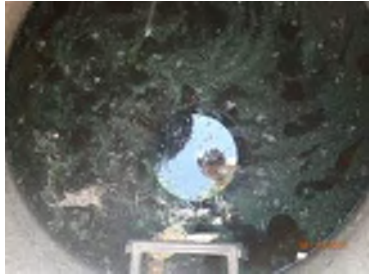
o20210816100142.JPG <div style="text-align: center; font-size: 24pt; font-weight: bold;">2021</div>

<b>Inspection Date:</b> 8/16/2021 10:04:55 AM		<b>Type:</b> Ongoing	<b>Flow:</b> Submerged, indeterminate	<b>Previous Rainfall (hrs):</b> 72+
<b>Illicit Discharge Potential:</b> Unlikely		<b>Inspector:</b> JCW		
Submerged: Fully		Depth (in): 51		
<b>Sampling Results</b>		<b>Notes</b> Sample collected from submerged pool in manhole.		
Sample Location: Pool Total Chlorine: 0 ppm Free Chlorine: 0 ppm Ammonia: 0 ppm pH: 7.84 units Temperature: 76 °F Conductivity: 318 µS/cm Detergents: 0 mg/L		<b>Condition Assessment</b> Graffiti: None Erosion: None Deposition: None in. Damage: None		
Floatables: None Odor: None Turbidity: None Color: None Gross Solids: Slight Vegetation: None Benthic Growth: None Stains: None Non-illicit: None

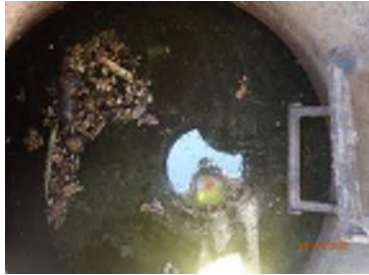
o20200820124306.JPG <div style="text-align: center; font-size: 24pt; font-weight: bold;">2020</div>

<b>Inspection Date:</b> 8/20/2020 12:45:49 PM		<b>Type:</b> Ongoing	<b>Flow:</b> Submerged, indeterminate	<b>Previous Rainfall (hrs):</b> 72+
<b>Illicit Discharge Potential:</b> Potential		<b>Inspector:</b> JCW		
Submerged: Fully		Depth (in): 48		
<b>Sampling Results</b>		<b>Notes</b> Sample collected from submerged pool in manhole. Floating gross solids (litter) in manhole.		
Sample Location: Pool Total Chlorine: 0 ppm Free Chlorine: 0 ppm Ammonia: 0 ppm pH: 8.95 units Temperature: 82 °F Conductivity: 340 µS/cm Detergents: 0 mg/L		<b>Condition Assessment</b> Graffiti: None Erosion: None Deposition: None in. Damage: None		
Floatables: None Odor: None Turbidity: None Color: None Gross Solids: Moderate Vegetation: None Benthic Growth: None Stains: None Non-illicit: None

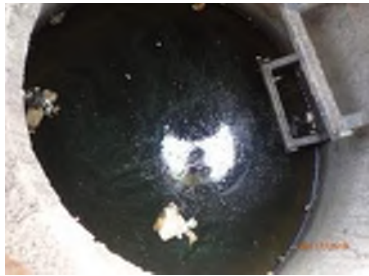
o20190917134722.JPG <div style="text-align: center; font-size: 24pt; font-weight: bold;">2019</div>

<b>Inspection Date:</b> 9/17/2019 2:49:27 PM		<b>Type:</b> Ongoing	<b>Flow:</b> Submerged, indeterminate	<b>Previous Rainfall (hrs):</b> 48-72
<b>Illicit Discharge Potential:</b> Unlikely		<b>Inspector:</b> JCW		
Submerged: Fully		Depth (in): 50		
<b>Sampling Results</b>		<b>Notes</b> Sample collected from submerged pool in manhole.		
Sample Location: Pool Total Chlorine: 0 ppm Free Chlorine: 0 ppm Ammonia: 0 ppm pH: 8.56 units Temperature: 75 °F Conductivity: 356 µS/cm Detergents: 0 mg/L		<b>Condition Assessment</b> Graffiti: None Erosion: None Deposition: None in. Damage: None		
Floatables: None Odor: None Turbidity: None Color: None Gross Solids: Slight Vegetation: None Benthic Growth: None Stains: None Non-illicit: None

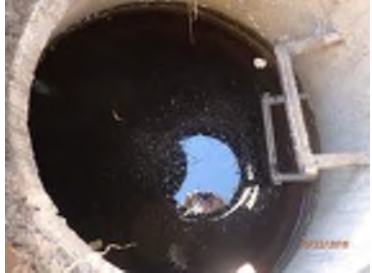
o20181022110036.JPG

<b>Inspection Date:</b> 10/22/2018 11:02:59 AM		<b>Type:</b> Ongoing	<b>Flow:</b> Submerged, indeterminate	<b>Previous Rainfall (hrs):</b> 48-72
<b>Illicit Discharge Potential:</b> <b>Potential</b>		<b>Inspector:</b> JCW	<b>Notes</b>	
Submerged: Fully		Depth (in): 53	Sample collected from submerged pool in manhole. Floating gross solids (litter) in manhole.	
<b>Sampling Results</b>		<b>Floatables:</b> None	<b>Condition Assessment</b> Graffiti: None Erosion: None Deposition: None in. Damage: None	
Sample Location: Pool	<b>Odor:</b> None			
Total Chlorine: 0 ppm	<b>Turbidity:</b> None			
Free Chlorine: 0 ppm	<b>Color:</b> Faint in bottle			
Ammonia: 0 ppm	<b>Gross Solids:</b> Slight			
pH: 7.49 units	<b>Vegetation:</b> None			
Temperature 55 °F	<b>Benthic Growth:</b> Slight			
Conductivity: 321 µS/cm	<b>Stains:</b> None			
Detergents: 0 mg/L	<b>Non-illicit:</b> None

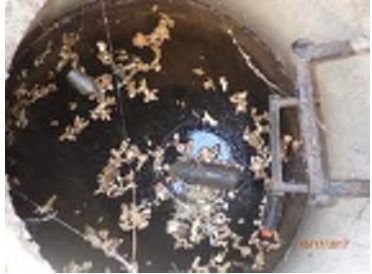
o20171017140304.JPG

<b>Inspection Date:</b> 10/17/2017 2:07:18 PM		<b>Type:</b> Ongoing	<b>Flow:</b> Submerged, indeterminate	<b>Previous Rainfall (hrs):</b> 48-72
<b>Illicit Discharge Potential:</b> <b>Potential</b>		<b>Inspector:</b> JCW	<b>Notes</b>	
Submerged: Fully		Depth (in): 46	Sample collected from submerged pool in manhole. Floating gross solids (litter) in manhole.	
<b>Sampling Results</b>		<b>Floatables:</b> None	<b>Condition Assessment</b> Graffiti: None Erosion: None Deposition: None in. Damage: None	
Sample Location: Pool	<b>Odor:</b> None			
Total Chlorine: 0 ppm	<b>Turbidity:</b> None			
Free Chlorine: 0 ppm	<b>Color:</b> None			
Ammonia: 0 ppm	<b>Gross Solids:</b> Moderate			
pH: 8.29 units	<b>Vegetation:</b> None			
Temperature 66 °F	<b>Benthic Growth:</b> None			
Conductivity: 346 µS/cm	<b>Stains:</b> None			
Detergents: 0 mg/L	<b>Non-illicit:</b> None

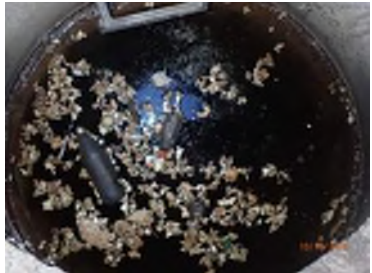
o20161018170248.JPG

<b>Inspection Date:</b> 10/18/2016 5:02:56 PM		<b>Type:</b> Ongoing	<b>Flow:</b> Submerged, indeterminate	<b>Previous Rainfall (hrs):</b> 72+
<b>Illicit Discharge Potential:</b> <b>Potential</b>		<b>Inspector:</b> JCW	<b>Notes</b>	
Submerged: Partially		Depth (in): 46	Potential illicit discharge due to gross solids.	
<b>Sampling Results</b>		<b>Floatables:</b> None	<b>Condition Assessment</b> Graffiti: None Erosion: None Deposition: None in. Damage: None	
Sample Location: Pool	<b>Odor:</b> None			
Total Chlorine: 0 ppm	<b>Turbidity:</b> None			
Free Chlorine: 0 ppm	<b>Color:</b> Faint in bottle			
Ammonia: 0 ppm	<b>Gross Solids:</b> Severe			
pH: 8.18 units	<b>Vegetation:</b> None			
Temperature 66 °F	<b>Benthic Growth:</b> None			
Conductivity: 361 µS/cm	<b>Stains:</b> None			
Detergents: 0 mg/L	<b>Non-illicit:</b> None

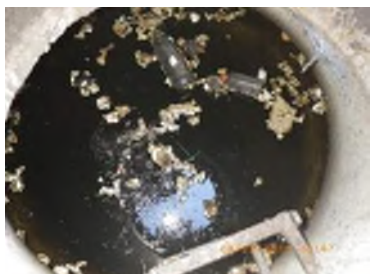
o20150922094746.JPG

<b>Inspection Date:</b> 9/22/2015 10:46:05 AM		<b>Type:</b> Ongoing	<b>Flow:</b> Submerged, indeterminate	<b>Previous Rainfall (hrs):</b> 72+
<b>Illicit Discharge Potential:</b> <b>Potential</b>		<b>Inspector:</b> JCW	<b>Notes</b>	
Submerged: Fully		Depth (in): 48	Floating gross solids (litter) in manhole.	
<b>Sampling Results</b>		<b>Floatables:</b> None	<b>Condition Assessment</b> Graffiti: None Erosion: None Deposition: None in. Damage: None	
Sample Location: Pool	<b>Odor:</b> None			
Total Chlorine: 0 ppm	<b>Turbidity:</b> None			
Free Chlorine: 0 ppm	<b>Color:</b> None			
Ammonia: 0 ppm	<b>Gross Solids:</b> Moderate			
pH: 8.33 units	<b>Vegetation:</b> None			
Temperature 73 °F	<b>Benthic Growth:</b> None			
Conductivity: 352 µS/cm	<b>Stains:</b> None			
Detergents: 0 mg/L	<b>Non-illicit:</b> None

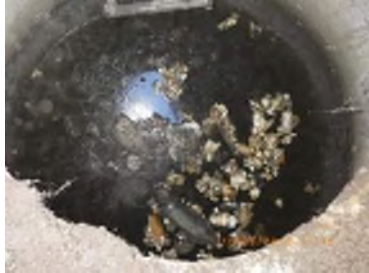
o20141009101552.JPG

<b>Inspection Date:</b> 10/9/2014 11:17:38 AM		<b>Type:</b> Ongoing	<b>Flow:</b> Submerged, indeterminate	<b>Previous Rainfall (hrs):</b> 72+
<b>Illicit Discharge Potential:</b> <b>Potential</b>		<b>Inspector:</b> JCW	<b>Notes</b>	
Submerged: Fully		Depth (in): 43	Floating gross solids (litter) in manhole.	
<b>Sampling Results</b>		<b>Condition Assessment</b>		
Sample Location: Pool	Floatables: None	Graffiti: None	Erosion: None	in.
Total Chlorine: 0 ppm	Odor: None	Deposition: None	Damage: None	
Free Chlorine: 0 ppm	Turbidity: None			
Ammonia: 0 ppm	Color: None			
pH: 7.67 units	Gross Solids: Moderate			
Temperature 59 °F	Vegetation: None			
Conductivity: 422 µS/cm	Benthic Growth: None			
Detergents: 0 mg/L	Stains: None			
	Non-illicit: None

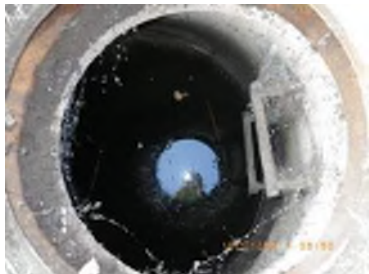
o20111011085018.JPG

<b>Inspection Date:</b> 10/11/2011 8:51:38 AM		<b>Type:</b> Ongoing	<b>Flow:</b> Submerged, indeterminate	<b>Previous Rainfall (hrs):</b> 72+
<b>Illicit Discharge Potential:</b> <b>Unlikely</b>		<b>Inspector:</b> JCW	<b>Notes</b>	
Submerged: Fully		Depth (in): 43	2010 screening follow-up. Floatable debris significantly reduced.	
<b>Sampling Results</b>		<b>Condition Assessment</b>		
Sample Location: Pool	Floatables: None	Graffiti: None	Erosion: None	0 in.
Total Chlorine: 0 ppm	Odor: None	Deposition: None	Damage: None	
Free Chlorine: 0 ppm	Turbidity: None			
Ammonia: 0 ppm	Color: Faint in bottle			
pH: 7.87 units	Gross Solids: Slight			
Temperature 71 °F	Vegetation: None			
Conductivity: -- µS/cm	Benthic Growth: None			
Detergents: -- mg/L	Stains: None			
	Non-illicit: None

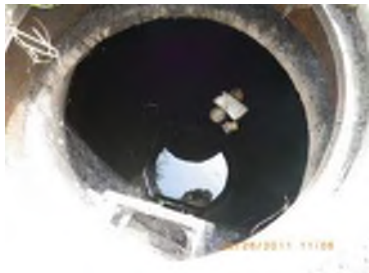
o20110526110604.JPG

<b>Inspection Date:</b> 5/26/2011 11:05:00 AM		<b>Type:</b> Other	<b>Flow:</b> Submerged, indeterminate	<b>Previous Rainfall (hrs):</b> 72+
<b>Illicit Discharge Potential:</b> <b>Unlikely</b>		<b>Inspector:</b> JCW	<b>Notes</b>	
Submerged: Fully		Depth (in):	Limited screening conducted to check for floatable debris.	
<b>Sampling Results</b>		<b>Condition Assessment</b>		
Sample Location: --	Floatables: None	Graffiti: None	Erosion: None	0 in.
Total Chlorine: -- ppm	Odor: --	Deposition: None	Damage: None	
Free Chlorine: -- ppm	Turbidity: --			
Ammonia: -- ppm	Color: --			
pH: -- units	Gross Solids: Slight			
Temperature -- °F	Vegetation: --			
Conductivity: -- µS/cm	Benthic Growth: --			
Detergents: -- mg/L	Stains: --			
	Non-illicit: None

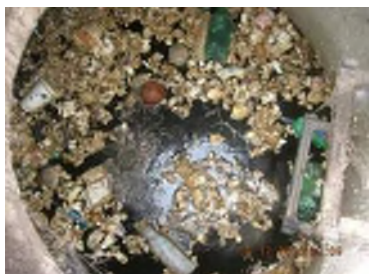
o20100817100950.JPG

<b>Inspection Date:</b> 8/17/2010 10:17:46 AM		<b>Type:</b> Ongoing	<b>Flow:</b> Submerged, indeterminate	<b>Previous Rainfall (hrs):</b> 72+
<b>Illicit Discharge Potential:</b> <b>Potential</b>		<b>Inspector:</b> JCW	<b>Notes</b>	
Submerged: Fully		Depth (in): 48	Significant floatable debris in manhole.	
<b>Sampling Results</b>		<b>Condition Assessment</b>		
Sample Location: Pool	Floatables: None	Graffiti: None	Erosion: None	0 in.
Total Chlorine: 0 ppm	Odor: None	Deposition: None	Damage: None	
Free Chlorine: 0 ppm	Turbidity: None			
Ammonia: 0 ppm	Color: None			
pH: 7.71 units	Gross Solids: Severe			
Temperature 74 °F	Vegetation: None			
Conductivity: -- µS/cm	Benthic Growth: None			
Detergents: 0 mg/L	Stains: None			
	Non-illicit: None

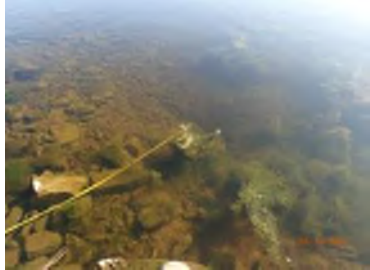
<p style="text-align: center;">o20210816080850.JPG</p> <p style="text-align: center; font-size: 1.5em; font-weight: bold;">2021</p>	
Submerged: Fully		Depth (in):		Outfall partially submerged - screened upstream at 11-177 US1. Floating gross solids (litter) in upstream manhole.			
<b>Sampling Results</b> Sample Location: _____ Total Chlorine: -- ppm Free Chlorine: -- ppm Ammonia: -- ppm pH: -- units Temperature -- ° F Conductivity: -- µS/cm Detergents: -- mg/L		Floatables: None Odor: None Turbidity: None Color: None Gross Solids: None Vegetation: None Benthic Growth: None Stains: None Non-illicit: None		<b>Condition Assessment</b> Graffiti: None Erosion: None Deposition: None in. Damage: None

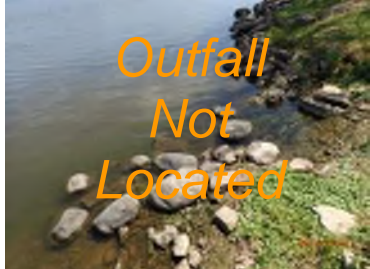
<p style="text-align: center;">o20200820135154.JPG</p> <p style="text-align: center; font-size: 1.5em; font-weight: bold;">2020</p>	
Submerged: Fully		Depth (in):		Outfall fully submerged and not located - screened upstream at 11-177 US1. Floating gross solids (litter) in upstream manhole.			
<b>Sampling Results</b> Sample Location: _____ Total Chlorine: -- ppm Free Chlorine: -- ppm Ammonia: -- ppm pH: -- units Temperature -- ° F Conductivity: -- µS/cm Detergents: -- mg/L		Floatables: None Odor: None Turbidity: None Color: None Gross Solids: None Vegetation: None Benthic Growth: None Stains: None Non-illicit: None		<b>Condition Assessment</b> Graffiti: None Erosion: None Deposition: None in. Damage: None

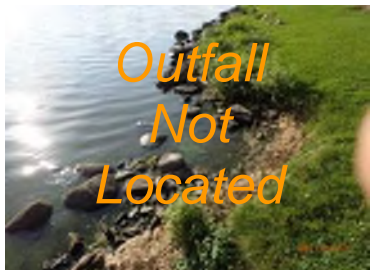
<p style="text-align: center;">o20190917075538.JPG</p> <p style="text-align: center; font-size: 1.5em; font-weight: bold;">2019</p>	
Submerged: Fully		Depth (in):		Outfall fully submerged and not physically located. Outfall screened upstream at 11-177 US1. Floating gross solids (litter) in manhole.			
<b>Sampling Results</b> Sample Location: _____ Total Chlorine: -- ppm Free Chlorine: -- ppm Ammonia: -- ppm pH: -- units Temperature -- ° F Conductivity: -- µS/cm Detergents: -- mg/L		Floatables: None Odor: None Turbidity: None Color: None Gross Solids: None Vegetation: None Benthic Growth: None Stains: None Non-illicit: None		<b>Condition Assessment</b> Graffiti: None Erosion: None Deposition: None in. Damage: None

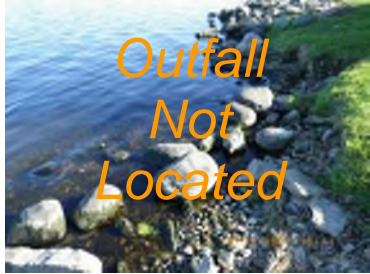
o20111003161156.JPG <div style="text-align: center; font-weight: bold; font-size: 1.2em;">2011</div>

<b>Inspection Date:</b> 10/3/2011 4:12:24 PM		<b>Type:</b> Ongoing	<b>Flow:</b> Submerged (not located)	<b>Previous Rainfall (hrs):</b> 72+
<b>Illicit Discharge Potential:</b> Unlikely		<b>Inspector:</b> JCW		
Submerged: Fully		Depth (in):		
<b>Sampling Results</b> Sample Location: _____ Total Chlorine: -- ppm Free Chlorine: -- ppm Ammonia: -- ppm pH: -- units Temperature -- °F Conductivity: -- µS/cm Detergents: -- mg/L		Floatables: None Odor: None Turbidity: None Color: None Gross Solids: None Vegetation: None Benthic Growth: None Stains: None Non-illicit: None		
		<b>Notes</b> Outfall fully submerged and not physically located. Outfall screened upstream at 11-177 US1.		
		<b>Condition Assessment</b> Graffiti: None Erosion: None Deposition: None 0 in. Damage: None

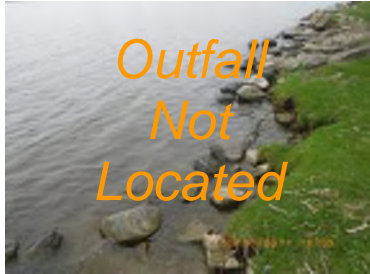
o20110510120530.JPG <div style="text-align: center; font-weight: bold; font-size: 1.2em;">2011</div>

<b>Inspection Date:</b> 5/10/2011 12:05:00 PM		<b>Type:</b> Other	<b>Flow:</b> Submerged (not located)	<b>Previous Rainfall (hrs):</b> 0-24
<b>Illicit Discharge Potential:</b> Potential		<b>Inspector:</b> JCW		
Submerged: Fully		Depth (in):		
<b>Sampling Results</b> Sample Location: _____ Total Chlorine: -- ppm Free Chlorine: -- ppm Ammonia: -- ppm pH: -- units Temperature -- °F Conductivity: -- µS/cm Detergents: -- mg/L		Floatables: _____ Odor: _____ Turbidity: _____ Color: _____ Gross Solids: _____ Vegetation: _____ Benthic Growth: _____ Stains: _____ Non-illicit: None		
		<b>Notes</b> Outfall fully submerged and not physically located. Outfall screened upstream at 11-177 US1.		
		<b>Condition Assessment</b> Graffiti: None Erosion: None Deposition: None 0 in. Damage: None

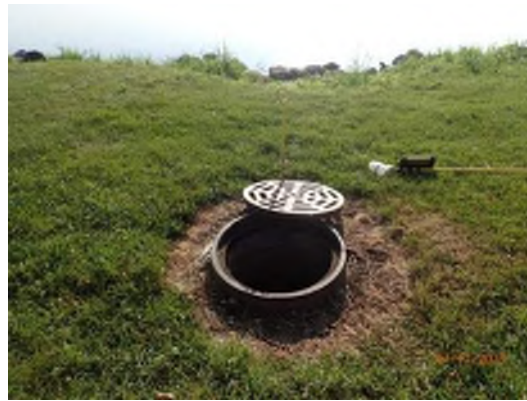
o20230717063856.JPG

Upstream catchbasin located approx 45 ft WSW of outfall 11-177. Intermediate area consists of open space.

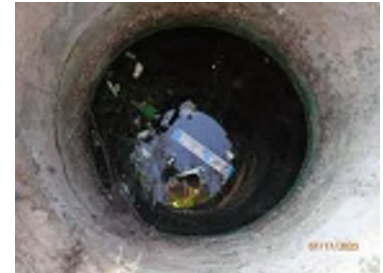
o20230717063904.JPG

☐ Petrol. Sheen ☐ Suds ☐ Sewage ☐ Algae ☐ Other☐ Petroleum ☐ Musty ☐ Sewage ☐ Chlorine ☐ Other☐ VOC/Solvent ☐ Fishy ☐ Sulfur ☐ Fragrant☒ Litter ☐ Veg. Debris ☐ Sediment ☐ Other☐ Inhibited ☐ Excessive☒ Green ☐ Brown☐ Flow Line ☐ Oil ☐ Rust Stains☐ Paint ☐ Other☐ Natural Sheen ☐ Natural Suds/Foam

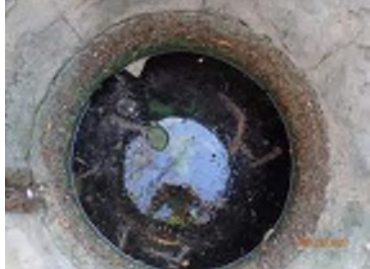
o20220923101908.JPG <div style="text-align: right; font-weight: bold; font-size: 1.2em;">2022</div>

<b>Inspection Date:</b> 9/23/2022 10:21:00 AM		<b>Type:</b> Ongoing	<b>Flow:</b> Submerged, indeterminate	<b>Previous Rainfall (hrs):</b> 72+
<b>Illicit Discharge Potential:</b> Unlikely		<b>Inspector:</b> EJK		
Submerged: Partially		Depth (in): 45		
<b>Sampling Results</b>		<b>Notes</b> Sample collected from submerged pool in manhole.		
Sample Location: Pool	Floatables:	Slight		
Total Chlorine: 0 ppm	Odor:	None		
Free Chlorine: 0 ppm	Turbidity:	None		
Ammonia: 0 ppm	Color:	None		
pH: 7.88 units	Gross Solids:	Slight		
Temperature 67 °F	Vegetation:	None		
Conductivity: 409 µS/cm	Benthic Growth:	None		
Detergents: 0 mg/L	Stains:	None		
	Non-illicit:	None		
		<b>Condition Assessment</b> Graffiti: None Erosion: None Deposition: None in. Damage: None

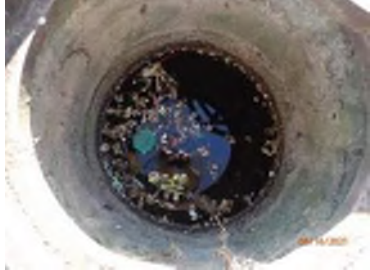
o20210816081106.JPG <div style="text-align: right; font-weight: bold; font-size: 1.2em;">2021</div>

<b>Inspection Date:</b> 8/16/2021 8:13:29 AM		<b>Type:</b> Ongoing	<b>Flow:</b> Submerged, indeterminate	<b>Previous Rainfall (hrs):</b> 72+
<b>Illicit Discharge Potential:</b> Potential		<b>Inspector:</b> JCW		
Submerged: Fully		Depth (in): 48		
<b>Sampling Results</b>		<b>Notes</b> Sample collected from submerged pool in manhole. Floating gross solids (litter) in manhole.		
Sample Location: Pool	Floatables:	None		
Total Chlorine: 0 ppm	Odor:	None		
Free Chlorine: 0 ppm	Turbidity:	None		
Ammonia: 0 ppm	Color:	None		
pH: 8.11 units	Gross Solids:	Moderate		
Temperature 73 °F	Vegetation:	None		
Conductivity: 372 µS/cm	Benthic Growth:	Slight		
Detergents: 0 mg/L	Stains:	None		
	Non-illicit:	None		
		<b>Condition Assessment</b> Graffiti: None Erosion: None Deposition: None in. Damage: None

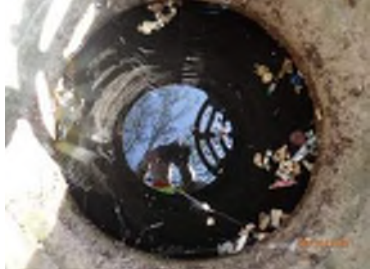
o20200820135226.JPG <div style="text-align: right; font-weight: bold; font-size: 1.2em;">2020</div>

<b>Inspection Date:</b> 8/20/2020 1:55:38 PM		<b>Type:</b> Ongoing	<b>Flow:</b> Submerged, indeterminate	<b>Previous Rainfall (hrs):</b> 72+
<b>Illicit Discharge Potential:</b> Potential		<b>Inspector:</b> JCW		
Submerged: Fully		Depth (in): 45		
<b>Sampling Results</b>		<b>Notes</b> Sample collected from submerged pool in manhole. Floating gross solids (litter) in manhole.		
Sample Location: Pool	Floatables:	None		
Total Chlorine: 0 ppm	Odor:	None		
Free Chlorine: 0 ppm	Turbidity:	None		
Ammonia: 0 ppm	Color:	None		
pH: 8.85 units	Gross Solids:	Moderate		
Temperature 85 °F	Vegetation:	None		
Conductivity: 342 µS/cm	Benthic Growth:	None		
Detergents: 0 mg/L	Stains:	None		
	Non-illicit:	None		
		<b>Condition Assessment</b> Graffiti: None Erosion: None Deposition: None in. Damage: None

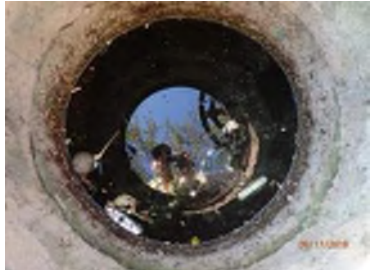
o20190917075612.JPG <div style="text-align: right; font-weight: bold; font-size: 1.2em;">2019</div>

<b>Inspection Date:</b> 9/17/2019 8:58:14 AM		<b>Type:</b> Ongoing	<b>Flow:</b> Submerged, indeterminate	<b>Previous Rainfall (hrs):</b> 48-72
<b>Illicit Discharge Potential:</b> Potential		<b>Inspector:</b> JCW		
Submerged: Fully		Depth (in): 47		
<b>Sampling Results</b>		<b>Notes</b> Sample collected from submerged pool in manhole. Floating gross solids (litter) in manhole.		
Sample Location: Pool	Floatables:	None		
Total Chlorine: 0 ppm	Odor:	None		
Free Chlorine: 0 ppm	Turbidity:	None		
Ammonia: 0 ppm	Color:	None		
pH: 8.13 units	Gross Solids:	Moderate		
Temperature 72 °F	Vegetation:	None		
Conductivity: 316 µS/cm	Benthic Growth:	Slight		
Detergents: 0 mg/L	Stains:	None		
	Non-illicit:	None		
		<b>Condition Assessment</b> Graffiti: None Erosion: None Deposition: None in. Damage: None

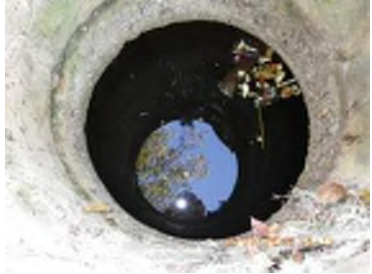
<b>Inspection Date:</b> 10/3/2011 4:15:48 PM		<b>Type:</b> Ongoing	<b>Flow:</b> Submerged, indeterminate	<b>Previous Rainfall (hrs):</b> 72+	
<b>Illicit Discharge Potential:</b> Unlikely		<b>Inspector:</b> JCW	<b>Notes</b>		
Submerged: Fully		Depth (in): 42

o20111003161244.JPG <b>2011</b>		
<b>Sampling Results</b>					
Sample Location:	Pool	Floatables:			None
Total Chlorine:	0 ppm	Odor:			None
Free Chlorine:	0 ppm	Turbidity:			None
Ammonia:	0 ppm	Color:			None
pH:	8.03 units	Gross Solids:			None
Temperature	68 °F	Vegetation:			None
Conductivity:	-- µS/cm	Benthic Growth:			None
Detergents:	0 mg/L	Stains:			None
		Non-illicit:	None		
			<b>Condition Assessment</b> Graffiti: None Erosion: None Deposition: None 0 in. Damage: None

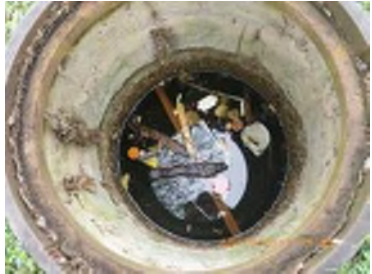
<b>Inspection Date:</b> 5/10/2011 12:03:00 PM		<b>Type:</b> Other	<b>Flow:</b> Submerged, indeterminate	<b>Previous Rainfall (hrs):</b> 0-24	
<b>Illicit Discharge Potential:</b> Potential		<b>Inspector:</b> JCW	<b>Notes</b>		
Submerged: Fully		Depth (in):

o20110510120546.JPG <b>2011</b>		
<b>Sampling Results</b>					
Sample Location:		Floatables:			None
Total Chlorine:	-- ppm	Odor:			
Free Chlorine:	-- ppm	Turbidity:			
Ammonia:	-- ppm	Color:			
pH:	-- units	Gross Solids:			Moderate
Temperature	-- °F	Vegetation:			
Conductivity:	-- µS/cm	Benthic Growth:			
Detergents:	-- mg/L	Stains:			
		Non-illicit:	None		
			<b>Condition Assessment</b> Graffiti: None Erosion: None Deposition: None 0 in. Damage: None

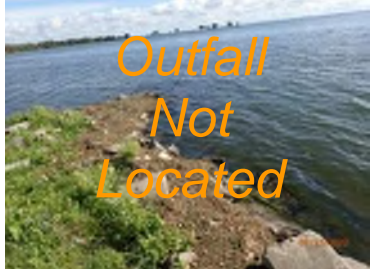
o20220923105534.JPG

<b>Inspection Date:</b> 9/23/2022 10:56:00 AM		<b>Type:</b> Ongoing	<b>Flow:</b> Submerged (not located)	<b>Previous Rainfall (hrs):</b> 72+
<b>Illicit Discharge Potential:</b> Potential		<b>Inspector:</b> EJK	<b>Notes</b>	
Submerged: Fully		Depth (in):	Outfall fully submerged and not located - screened upstream at 11-376 US1. Floating gross solids (litter) in upstream manhole.	
<b>Sampling Results</b>		Floatables:	<b>Condition Assessment</b>	
Sample Location:		Odor:	Graffiti: None Erosion: None Deposition: None in. Damage: None	
Total Chlorine: -- ppm		Turbidity:		
Free Chlorine: -- ppm		Color:		
Ammonia: -- ppm		Gross Solids:		
pH: -- units		Vegetation:		
Temperature -- °F		Benthic Growth:		
Conductivity: -- µS/cm		Stains:		
Detergents: -- mg/L		Non-illicit:

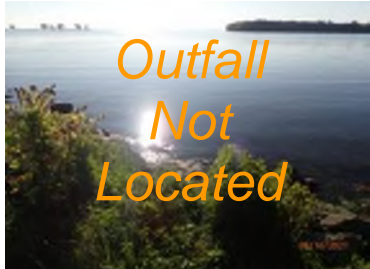
o20210816075628.JPG

<b>Inspection Date:</b> 8/16/2021 7:57:45 AM		<b>Type:</b> Ongoing	<b>Flow:</b> Submerged (not located)	<b>Previous Rainfall (hrs):</b> 72+
<b>Illicit Discharge Potential:</b> Potential		<b>Inspector:</b> JCW	<b>Notes</b>	
Submerged: Fully		Depth (in):	Outfall fully submerged and not located - screened upstream at 11-376 US1. Floating gross solids (litter) in upstream manhole.	
<b>Sampling Results</b>		Floatables:	<b>Condition Assessment</b>	
Sample Location:		Odor:	Graffiti: None Erosion: None Deposition: None in. Damage: None	
Total Chlorine: -- ppm		Turbidity:		
Free Chlorine: -- ppm		Color:		
Ammonia: -- ppm		Gross Solids:		
pH: -- units		Vegetation:		
Temperature -- °F		Benthic Growth:		
Conductivity: -- µS/cm		Stains:		
Detergents: -- mg/L		Non-illicit:

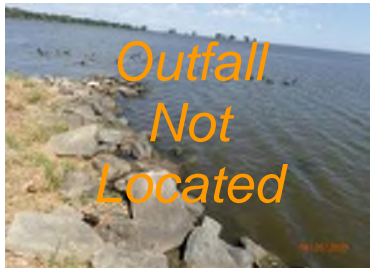
o20200820140432.JPG

<b>Inspection Date:</b> 8/20/2020 2:10:06 PM		<b>Type:</b> Ongoing	<b>Flow:</b> Submerged (not located)	<b>Previous Rainfall (hrs):</b> 72+
<b>Illicit Discharge Potential:</b> Potential		<b>Inspector:</b> JCW	<b>Notes</b>	
Submerged: Fully		Depth (in):	Outfall fully submerged and not located - screened upstream at 11-376 US1. Floating gross solids (litter) in upstream manhole.	
<b>Sampling Results</b>		Floatables:	<b>Condition Assessment</b>	
Sample Location:		Odor:	Graffiti: None Erosion: None Deposition: None in. Damage: None	
Total Chlorine: -- ppm		Turbidity:		
Free Chlorine: -- ppm		Color:		
Ammonia: -- ppm		Gross Solids:		
pH: -- units		Vegetation:		
Temperature -- °F		Benthic Growth:		
Conductivity: -- µS/cm		Stains:		
Detergents: -- mg/L		Non-illicit:

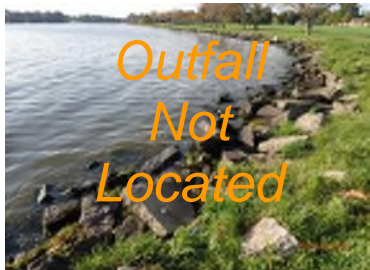
o20190917074332.JPG

<b>Inspection Date:</b> 9/17/2019 8:43:35 AM		<b>Type:</b> Ongoing	<b>Flow:</b> Submerged (not located)	<b>Previous Rainfall (hrs):</b> 48-72
<b>Illicit Discharge Potential:</b> Potential		<b>Inspector:</b> JCW	<b>Notes</b>	
Submerged: Fully		Depth (in):	Outfall fully submerged and not located - screened upstream at 11-376 US1. Floating gross solids (litter) in manhole.	
<b>Sampling Results</b>		Floatables:	<b>Condition Assessment</b>	
Sample Location:		Odor:	Graffiti: None Erosion: None Deposition: None in. Damage: None	
Total Chlorine: -- ppm		Turbidity:		
Free Chlorine: -- ppm		Color:		
Ammonia: -- ppm		Gross Solids:		
pH: -- units		Vegetation:		
Temperature -- °F		Benthic Growth:		
Conductivity: -- µS/cm		Stains:		
Detergents: -- mg/L		Non-illicit:

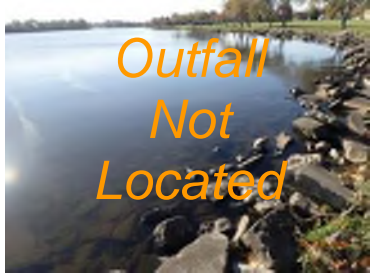
<b>Inspection Date:</b> 10/22/2018 9:42:07 AM		<b>Type:</b> Ongoing		<b>Flow:</b> Submerged (not located)		<b>Previous Rainfall (hrs):</b> 48-72	
<b>Illicit Discharge Potential:</b> Potential		<b>Inspector:</b> JCW		<b>Notes</b>

<p style="text-align: center;">o20181022094126.JPG</p> <p style="text-align: center; font-size: 1.2em;"><b>2018</b></p>	
Submerged: Fully		Depth (in):		Outfall fully submerged and not located - screened upstream at 11-376 US1. Floating gross solids (litter) in manhole.			
<b>Sampling Results</b>							
Sample Location:		Floatables:	None	<b>Condition Assessment</b>		Graffiti: None Erosion: None Deposition: None in. Damage: None	
Total Chlorine: -- ppm		Odor:	None				
Free Chlorine: -- ppm		Turbidity:	None				
Ammonia: -- ppm		Color:	None				
pH: -- units		Gross Solids:	None				
Temperature -- °F		Vegetation:	None				
Conductivity: -- µS/cm		Benthic Growth:	None				
Detergents: -- mg/L		Stains:	None

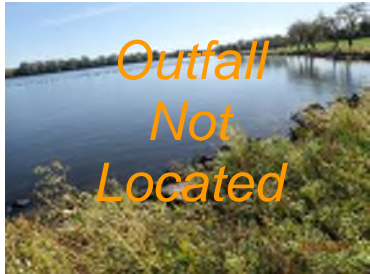
<b>Inspection Date:</b> 10/17/2017 1:03:56 PM		<b>Type:</b> Ongoing		<b>Flow:</b> Submerged (not located)		<b>Previous Rainfall (hrs):</b> 48-72	
<b>Illicit Discharge Potential:</b> Potential		<b>Inspector:</b> JCW		<b>Notes</b>

<p style="text-align: center;">o20171017130204.JPG</p> <p style="text-align: center; font-size: 1.2em;"><b>2017</b></p>	
Submerged: Fully		Depth (in):		Outfall fully submerged and not located - screened upstream at 11-376 US1. Floating gross solids (litter) in manhole.			
<b>Sampling Results</b>							
Sample Location:		Floatables:	None	<b>Condition Assessment</b>		Graffiti: None Erosion: None Deposition: None in. Damage: None	
Total Chlorine: -- ppm		Odor:	None				
Free Chlorine: -- ppm		Turbidity:	None				
Ammonia: -- ppm		Color:	None				
pH: -- units		Gross Solids:	None				
Temperature -- °F		Vegetation:	None				
Conductivity: -- µS/cm		Benthic Growth:	None				
Detergents: -- mg/L		Stains:	None

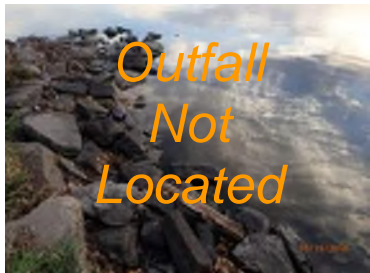
<b>Inspection Date:</b> 10/19/2016 7:43:58 AM		<b>Type:</b> Ongoing		<b>Flow:</b> Submerged (not located)		<b>Previous Rainfall (hrs):</b> 72+	
<b>Illicit Discharge Potential:</b> Potential		<b>Inspector:</b> JCW		<b>Notes</b>

<p style="text-align: center;">o20161019074246.JPG</p> <p style="text-align: center; font-size: 1.2em;"><b>2016</b></p>	
Submerged: Fully		Depth (in):		Outfall fully submerged and not located - screened upstream at 11-376 US1.			
<b>Sampling Results</b>							
Sample Location:		Floatables:	None	<b>Condition Assessment</b>		Graffiti: None Erosion: None Deposition: None in. Damage: None	
Total Chlorine: -- ppm		Odor:	None				
Free Chlorine: -- ppm		Turbidity:	None				
Ammonia: -- ppm		Color:	None				
pH: -- units		Gross Solids:	None				
Temperature -- °F		Vegetation:	None				
Conductivity: -- µS/cm		Benthic Growth:	None				
Detergents: -- mg/L		Stains:	None				
		Non-illicit:	None

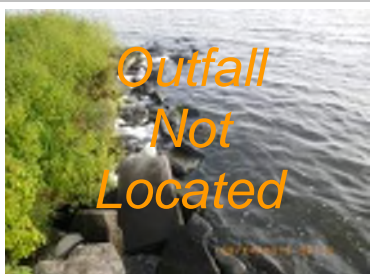
<b>Inspection Date:</b> 9/24/2015 9:06:24 AM		<b>Type:</b> Ongoing		<b>Flow:</b> Submerged (not located)		<b>Previous Rainfall (hrs):</b> 72+	
<b>Illicit Discharge Potential:</b> Potential		<b>Inspector:</b> JCW		<b>Notes</b>

<p style="text-align: center;">o20150924081044.JPG</p> <p style="text-align: center; font-size: 1.2em;"><b>2015</b></p>	
Submerged: Fully		Depth (in):		Outfall fully submerged and not located - screened at 11-376 US1.			
<b>Sampling Results</b>							
Sample Location:		Floatables:	None	<b>Condition Assessment</b>		Graffiti: None Erosion: None Deposition: None in. Damage: None	
Total Chlorine: -- ppm		Odor:	None				
Free Chlorine: -- ppm		Turbidity:	None				
Ammonia: -- ppm		Color:	None				
pH: -- units		Gross Solids:	None				
Temperature -- °F		Vegetation:	None				
Conductivity: -- µS/cm		Benthic Growth:	None				
Detergents: -- mg/L		Stains:	None				
		Non-illicit:	Moderate

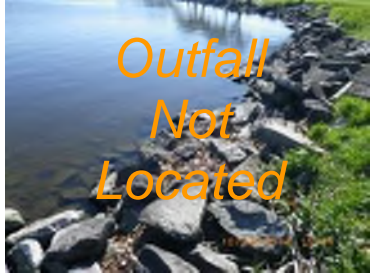
o20141009123438.JPG

<b>Inspection Date:</b> 10/9/2014 1:35:21 PM		<b>Type:</b> Ongoing	<b>Flow:</b> Submerged (not located)	<b>Previous Rainfall (hrs):</b> 72+
<b>Illicit Discharge Potential:</b> <b>Potential</b>		<b>Inspector:</b> JCW	<b>Notes</b>	
Submerged: Fully		Depth (in):	Outfall fully submerged and not located - screened upstream at 11-376 US1.	
<b>Sampling Results</b>		Floatables:	<b>Condition Assessment</b> Graffiti: None Erosion: None Deposition: None in. Damage: None	
Sample Location:		Odor:		
Total Chlorine: -- ppm		Turbidity:		
Free Chlorine: -- ppm		Color:		
Ammonia: -- ppm		Gross Solids:		
pH: -- units		Vegetation:		
Temperature -- °F		Benthic Growth:		
Conductivity: -- µS/cm		Stains:		
Detergents: -- mg/L		Non-illicit:

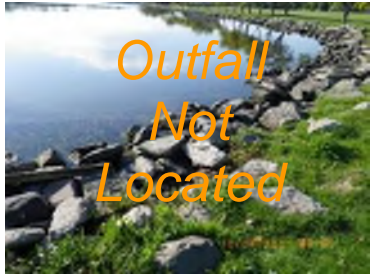
o20111004092048.JPG

<b>Inspection Date:</b> 10/4/2011 9:20:16 AM		<b>Type:</b> Ongoing	<b>Flow:</b> Submerged (not located)	<b>Previous Rainfall (hrs):</b> 72+
<b>Illicit Discharge Potential:</b> <b>Unlikely</b>		<b>Inspector:</b> JCW	<b>Notes</b>	
Submerged: Fully		Depth (in):	Outfall fully submerged and not physically located. Outfall screened upstream at 11-376 US1.	
<b>Sampling Results</b>		Floatables:	<b>Condition Assessment</b> Graffiti: None Erosion: None Deposition: None 0 in. Damage: None	
Sample Location:		Odor:		
Total Chlorine: -- ppm		Turbidity:		
Free Chlorine: -- ppm		Color:		
Ammonia: -- ppm		Gross Solids:		
pH: -- units		Vegetation:		
Temperature -- °F		Benthic Growth:		
Conductivity: -- µS/cm		Stains:		
Detergents: -- mg/L		Non-illicit:

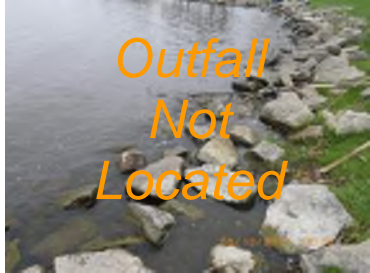
o20110510122252.JPG

<b>Inspection Date:</b> 5/10/2011 12:22:00 PM		<b>Type:</b> Other	<b>Flow:</b> Submerged (not located)	<b>Previous Rainfall (hrs):</b> 0-24
<b>Illicit Discharge Potential:</b> <b>Potential</b>		<b>Inspector:</b> JCW	<b>Notes</b>	
Submerged: Fully		Depth (in):	Outfall fully submerged and not physically located. Outfall screened upstream at 11-376 US1.	
<b>Sampling Results</b>		Floatables:	<b>Condition Assessment</b> Graffiti: None Erosion: None Deposition: None 0 in. Damage: None	
Sample Location:		Odor:		
Total Chlorine: -- ppm		Turbidity:		
Free Chlorine: -- ppm		Color:		
Ammonia: -- ppm		Gross Solids:		
pH: -- units		Vegetation:		
Temperature -- °F		Benthic Growth:		
Conductivity: -- µS/cm		Stains:		
Detergents: -- mg/L		Non-illicit:

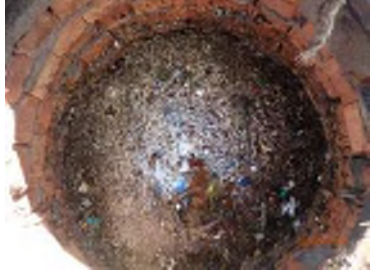
Inspection Date: 9/23/2022 10:57:00 AM		Type: Ongoing	Flow: Submerged, indeterminate	Previous Rainfall (hrs): 72+
<b>Illicit Discharge Potential: Potential</b> Submerged: Partially      Depth (in): 80		Inspector: EJK	Notes

o20220923105710.JPG <b>2022</b>
<b>Sampling Results</b> Sample Location: Pool Total Chlorine: 0 ppm Free Chlorine: 0 ppm Ammonia: 0.25 ppm pH: 7.16 units Temperature: 70 °F Conductivity: 648 µS/cm Detergents: 0 mg/L		Floatables: None Odor: None Turbidity: None Color: None Gross Solids: Moderate Vegetation: None Benthic Growth: None Stains: None Non-illicit: None	Sample collected from submerged pool in manhole. Floating gross solids approx 5" thick. Slightly elevated ammonia.  <b>Condition Assessment</b> Graffiti: None Erosion: None Deposition: None in. Damage: None	
<b>Inspection Date: 8/16/2021 8:01:10 AM</b>		Type: Ongoing	Flow: Submerged, indeterminate	Previous Rainfall (hrs): 72+

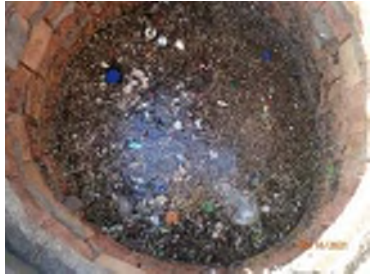
o20210816075758.JPG <b>2021</b>
<b>Sampling Results</b> Sample Location: Pool Total Chlorine: 0 ppm Free Chlorine: 0 ppm Ammonia: 0 ppm pH: 7.67 units Temperature: 72 °F Conductivity: 572 µS/cm Detergents: 0 mg/L		Floatables: None Odor: None Turbidity: None Color: None Gross Solids: Severe Vegetation: None Benthic Growth: None Stains: None Non-illicit: None	Sample collected from submerged pool in manhole. Floating gross solids (litter) in manhole.  <b>Condition Assessment</b> Graffiti: None Erosion: None Deposition: None in. Damage: None	
<b>Inspection Date: 8/20/2020 2:10:47 PM</b>		Type: Ongoing	Flow: Submerged, indeterminate	Previous Rainfall (hrs): 72+
<b>Illicit Discharge Potential: Potential</b> Submerged: Fully      Depth (in): 81		Inspector: JCW	Notes

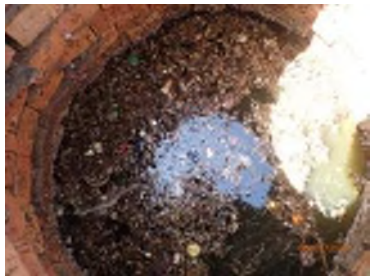
o20200820140542.JPG <b>2020</b>

<b>Sampling Results</b> Sample Location: Pool Total Chlorine: 0 ppm Free Chlorine: 0 ppm Ammonia: 0 ppm pH: 8.64 units Temperature: 84 °F Conductivity: 382 µS/cm Detergents: 0 mg/L		Floatables: None Odor: None Turbidity: None Color: None Gross Solids: Moderate Vegetation: None Benthic Growth: Moderate Stains: None Non-illicit: None	Sample collected from submerged pool in manhole. Floating gross solids (litter) in manhole.  <b>Condition Assessment</b> Graffiti: None Erosion: None Deposition: None in. Damage: None	
<b>Inspection Date: 9/17/2019 8:47:01 AM</b>		Type: Ongoing	Flow: Submerged, indeterminate	Previous Rainfall (hrs): 48-72
<b>Illicit Discharge Potential: Potential</b> Submerged: Fully      Depth (in): 82		Inspector: JCW	Notes

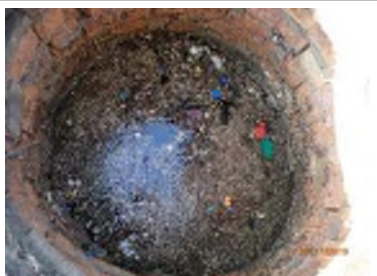
o20190917074432.JPG <b>2019</b>
<b>Sampling Results</b> Sample Location: Pool Total Chlorine: 0 ppm Free Chlorine: 0 ppm Ammonia: 0 ppm pH: 7.94 units Temperature: 71 °F Conductivity: 439 µS/cm Detergents: 0 mg/L		Floatables: None Odor: None Turbidity: None Color: None Gross Solids: Moderate Vegetation: None Benthic Growth: None Stains: None Non-illicit: None	Sample collected from submerged pool in manhole. Floating gross solids (litter) in manhole.  <b>Condition Assessment</b> Graffiti: None Erosion: None Deposition: None in. Damage: None

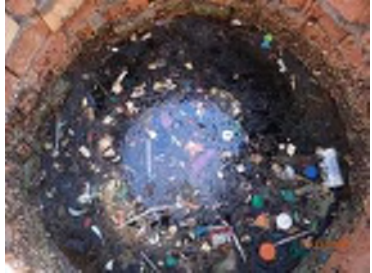
<b>Inspection Date:</b> 10/22/2018 9:45:12 AM		<b>Type:</b> Ongoing		<b>Flow:</b> Submerged, indeterminate		<b>Previous Rainfall (hrs):</b> 48-72	
<b>Illicit Discharge Potential:</b> <b>Potential</b>		<b>Inspector:</b> JCW		<b>Notes</b>

<p style="text-align: center;">o20181022094232.JPG</p> <p style="text-align: center; font-size: 24pt; font-weight: bold;">2018</p>	
Submerged: Fully		Depth (in): 82		Sample collected from submerged pool in manhole. Floating gross solids (litter) in manhole.			
<b>Sampling Results</b>				<b>Condition Assessment</b>			
Sample Location: Pool		Floatables: None		Graffiti: None			
Total Chlorine: 0 ppm		Odor: None		Erosion: None			
Free Chlorine: 0 ppm		Turbidity: None		Deposition: None in.			
Ammonia: 0 ppm		Color: None		Damage: None			
pH: 7.52 units		Gross Solids: Moderate					
Temperature 55 °F		Vegetation: None					
Conductivity: 575 µS/cm		Benthic Growth: None

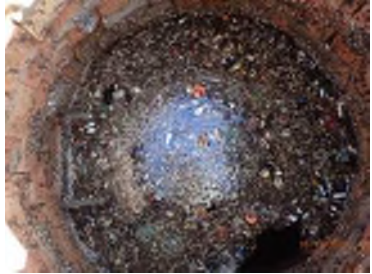
<b>Inspection Date:</b> 10/17/2017 1:07:06 PM		<b>Type:</b> Ongoing		<b>Flow:</b> Submerged, indeterminate		<b>Previous Rainfall (hrs):</b> 48-72	
<b>Illicit Discharge Potential:</b> <b>Potential</b>		<b>Inspector:</b> JCW		<b>Notes</b>

<p style="text-align: center;">o20171017130258.JPG</p> <p style="text-align: center; font-size: 24pt; font-weight: bold;">2017</p>	
Submerged: Fully		Depth (in): 79		Sample collected from submerged pool in manhole. Floating gross solids (litter) in manhole.			
<b>Sampling Results</b>				<b>Condition Assessment</b>			
Sample Location: Pool		Floatables: None		Graffiti: None			
Total Chlorine: 0 ppm		Odor: None		Erosion: None			
Free Chlorine: 0 ppm		Turbidity: None		Deposition: None in.			
Ammonia: 0 ppm		Color: None		Damage: None			
pH: 7.62 units		Gross Solids: Moderate					
Temperature 67 °F		Vegetation: None					
Conductivity: 829 µS/cm		Benthic Growth: None
