# Submittal of Annual Reports and Other Compliance Documents for Municipal Separate Storm Sewer System (MS4) Permits

**Project Name:** 2023 Annual Report

**Municipality:** Oshkosh, City

**Permit Number:** S050075

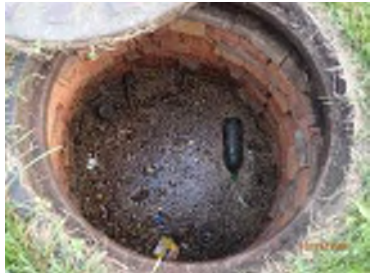
<b>Inspection Date:</b> 10/19/2016 7:46:56 AM		<b>Type:</b> Ongoing		<b>Flow:</b> Submerged, indeterminate		<b>Previous Rainfall (hrs):</b> 72+	
<b>Illicit Discharge Potential:</b> <b>Potential</b>		<b>Inspector:</b> JCW		<b>Notes</b>

<p style="text-align: center;">o20161019074410.JPG</p> <p style="text-align: center; font-size: 24pt; font-weight: bold;">2016</p>	
Submerged: Fully		Depth (in): 79		Potential illicit discharge due to gross solids.			
<b>Sampling Results</b>				<b>Condition Assessment</b>			
Sample Location: Pool		Floatables: None		Graffiti: None			
Total Chlorine: 0 ppm		Odor: Faint		Erosion: None			
Free Chlorine: 0 ppm		Turbidity: None		Deposition: None in.			
Ammonia: 0 ppm		Color: Faint in bottle		Damage: None			
pH: 7.89 units		Gross Solids: Severe					
Temperature 58 °F		Vegetation: None					
Conductivity: 357 µS/cm		Benthic Growth: None					
Detergents: 0 mg/L		Stains: None

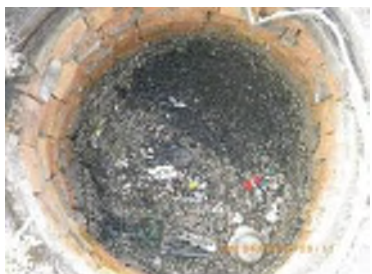
<b>Inspection Date:</b> 9/24/2015 9:10:22 AM		<b>Type:</b> Ongoing		<b>Flow:</b> Submerged, indeterminate		<b>Previous Rainfall (hrs):</b> 72+	
<b>Illicit Discharge Potential:</b> <b>Potential</b>		<b>Inspector:</b> JCW		<b>Notes</b>

<p style="text-align: center;">o20150924081150.JPG</p> <p style="text-align: center; font-size: 24pt; font-weight: bold;">2015</p>	
Submerged: Fully		Depth (in): 81		Floating gross solids (litter) in manhole.			
<b>Sampling Results</b>				<b>Condition Assessment</b>			
Sample Location: Pool		Floatables: None		Graffiti: None			
Total Chlorine: 0 ppm		Odor: Faint		Erosion: None			
Free Chlorine: 0 ppm		Turbidity: None		Deposition: None in.			
Ammonia: 0 ppm		Color: None		Damage: None			
pH: 7.88 units		Gross Solids: Severe					
Temperature 68 °F		Vegetation: None					
Conductivity: 397 µS/cm		Benthic Growth: None					
Detergents: 0 mg/L		Stains: None					
		Non-illicit: None

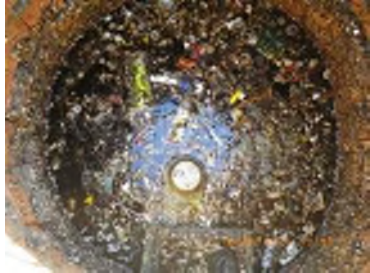
o20141009123616.JPG  
**2014**

<b>Inspection Date:</b> 10/9/2014 1:36:18 PM		<b>Type:</b> Ongoing	<b>Flow:</b> Submerged, indeterminate	<b>Previous Rainfall (hrs):</b> 72+
<b>Illicit Discharge Potential:</b> <b>Potential</b>		<b>Inspector:</b> JCW	<b>Notes</b>	
Submerged: Fully		Depth (in): 74	Floating gross solids (litter) in manhole.	
<b>Sampling Results</b>		<b>Floatables:</b> None	<b>Condition Assessment</b> Graffiti: None Erosion: None Deposition: None in. Damage: None	
Sample Location: Pool	<b>Odor:</b> None			
Total Chlorine: 0 ppm	<b>Turbidity:</b> None			
Free Chlorine: 0 ppm	<b>Color:</b> Faint in bottle			
Ammonia: 0 ppm	<b>Gross Solids:</b> Severe			
pH: 7.76 units	<b>Vegetation:</b> None			
Temperature 59 °F	<b>Benthic Growth:</b> None			
Conductivity: 381 µS/cm	<b>Stains:</b> None			
Detergents: 0 mg/L	<b>Non-illicit:</b> None

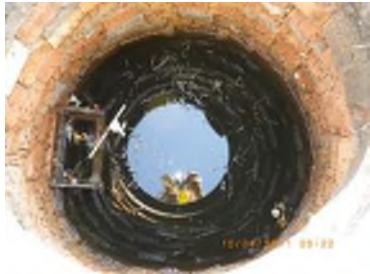
o20111004092208.JPG  
**2011**

<b>Inspection Date:</b> 10/4/2011 9:23:47 AM		<b>Type:</b> Ongoing	<b>Flow:</b> Submerged, indeterminate	<b>Previous Rainfall (hrs):</b> 72+
<b>Illicit Discharge Potential:</b> <b>Unlikely</b>		<b>Inspector:</b> JCW	<b>Notes</b>	
Submerged: Fully		Depth (in): 79		
<b>Sampling Results</b>		<b>Floatables:</b> None	<b>Condition Assessment</b> Graffiti: None Erosion: None Deposition: None 0 in. Damage: None	
Sample Location: Pool	<b>Odor:</b> None			
Total Chlorine: 0 ppm	<b>Turbidity:</b> None			
Free Chlorine: 0 ppm	<b>Color:</b> None			
Ammonia: 0 ppm	<b>Gross Solids:</b> Slight			
pH: 7.76 units	<b>Vegetation:</b> None			
Temperature 62 °F	<b>Benthic Growth:</b> None			
Conductivity: -- µS/cm	<b>Stains:</b> None			
Detergents: 0 mg/L	<b>Non-illicit:</b> None

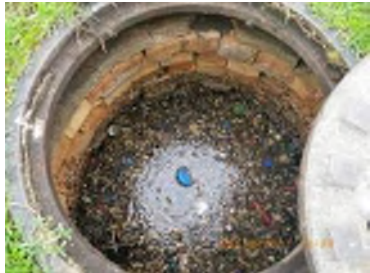
o20110510122336.JPG  
**2011**

<b>Inspection Date:</b> 5/10/2011 12:23:00 PM		<b>Type:</b> Other	<b>Flow:</b> Submerged, indeterminate	<b>Previous Rainfall (hrs):</b> 0-24
<b>Illicit Discharge Potential:</b> <b>Potential</b>		<b>Inspector:</b> JCW	<b>Notes</b>	
Submerged: Fully		Depth (in):	Limited screening conducted for upstream manhole prescreening.	
<b>Sampling Results</b>		<b>Floatables:</b> None	<b>Condition Assessment</b> Graffiti: None Erosion: None Deposition: None 0 in. Damage: None	
Sample Location:	<b>Odor:</b>			
Total Chlorine: -- ppm	<b>Turbidity:</b>			
Free Chlorine: -- ppm	<b>Color:</b>			
Ammonia: -- ppm	<b>Gross Solids:</b> Severe			
pH: -- units	<b>Vegetation:</b>			
Temperature -- °F	<b>Benthic Growth:</b>			
Conductivity: -- µS/cm	<b>Stains:</b>			
Detergents: -- mg/L	<b>Non-illicit:</b> None

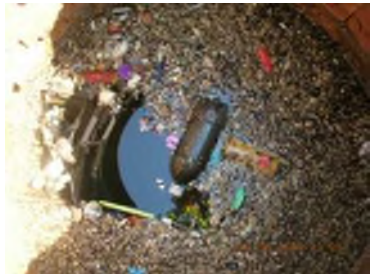
Osh09\_DSCN6622.JPG  
**2009**

<b>Inspection Date:</b> 9/8/2009		<b>Type:</b> Initial	<b>Flow:</b> Submerged, indeterminate	<b>Previous Rainfall (hrs):</b> 72+
<b>Illicit Discharge Potential:</b> <b>Potential</b>		<b>Inspector:</b> JCW	<b>Notes</b>	
Submerged: Fully		Depth (in): 81	Abnormal detergent analysis result (bubbles). Significant floating debris in manhole.	
<b>Sampling Results</b>		<b>Floatables:</b> None	<b>Condition Assessment</b> Graffiti: None Erosion: None Deposition: None 0 in. Damage: None	
Sample Location: Pool	<b>Odor:</b>			
Total Chlorine: 0 ppm	<b>Turbidity:</b>			
Free Chlorine: 0 ppm	<b>Color:</b>			
Ammonia: -- ppm	<b>Gross Solids:</b> Severe			
pH: 7.82 units	<b>Vegetation:</b>			
Temperature 76 °F	<b>Benthic Growth:</b>			
Conductivity: -- µS/cm	<b>Stains:</b>			
Detergents: 0 mg/L	<b>Non-illicit:</b> None

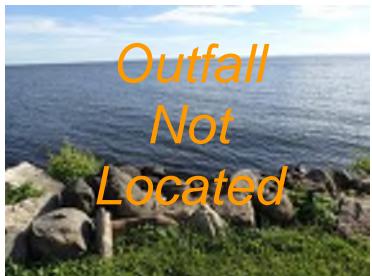
o20220923092250.JPG

<b>Inspection Date:</b> 9/23/2022 9:24:00 AM		<b>Type:</b> Ongoing	<b>Flow:</b> Submerged (not located)	<b>Previous Rainfall (hrs):</b> 72+
<b>Illicit Discharge Potential:</b> Potential		<b>Inspector:</b> EJK	<b>Notes</b>	
Submerged: Fully		Depth (in):	Outfall fully submerged and not located - screened upstream at 11-512 US1. Floating gross solids (litter) in upstream manhole.	
<b>Sampling Results</b>		Floatables:	<b>Condition Assessment</b>	
Sample Location:		Odor:		
Total Chlorine: -- ppm		Turbidity:	Graffiti: None Erosion: None Deposition: None in. Damage: None	
Free Chlorine: -- ppm		Color:		
Ammonia: -- ppm		Gross Solids:		
pH: -- units		Vegetation:		
Temperature -- °F		Benthic Growth:		
Conductivity: -- µS/cm		Stains:		
Detergents: -- mg/L		Non-illicit:

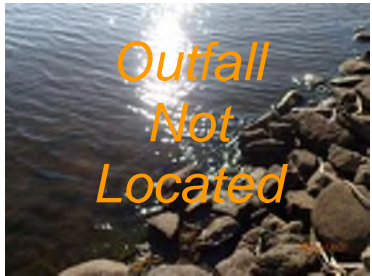
o20210816083746.JPG

<b>Inspection Date:</b> 8/16/2021 8:42:01 AM		<b>Type:</b> Ongoing	<b>Flow:</b> Submerged (not located)	<b>Previous Rainfall (hrs):</b> 72+
<b>Illicit Discharge Potential:</b> Potential		<b>Inspector:</b> JCW	<b>Notes</b>	
Submerged: Fully		Depth (in):	Outfall fully submerged and not located - screened upstream at 11-512 US1. Floating gross solids (litter) in upstream manhole.	
<b>Sampling Results</b>		Floatables:	<b>Condition Assessment</b>	
Sample Location:		Odor:		
Total Chlorine: -- ppm		Turbidity:	Graffiti: None Erosion: None Deposition: None in. Damage: None	
Free Chlorine: -- ppm		Color:		
Ammonia: -- ppm		Gross Solids:		
pH: -- units		Vegetation:		
Temperature -- °F		Benthic Growth:		
Conductivity: -- µS/cm		Stains:		
Detergents: -- mg/L		Non-illicit:

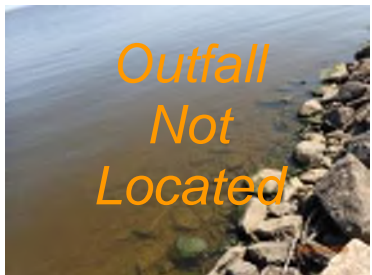
o20200820131742.JPG

<b>Inspection Date:</b> 8/20/2020 1:20:27 PM		<b>Type:</b> Ongoing	<b>Flow:</b> Submerged (not located)	<b>Previous Rainfall (hrs):</b> 72+
<b>Illicit Discharge Potential:</b> Potential		<b>Inspector:</b> JCW	<b>Notes</b>	
Submerged: Fully		Depth (in):	Outfall fully submerged and not located - screened upstream at 11-512 US1. Floating gross solids (litter) in upstream manhole.	
<b>Sampling Results</b>		Floatables:	<b>Condition Assessment</b>	
Sample Location:		Odor:		
Total Chlorine: -- ppm		Turbidity:	Graffiti: None Erosion: None Deposition: None in. Damage: None	
Free Chlorine: -- ppm		Color:		
Ammonia: -- ppm		Gross Solids:		
pH: -- units		Vegetation:		
Temperature -- °F		Benthic Growth:		
Conductivity: -- µS/cm		Stains:		
Detergents: -- mg/L		Non-illicit:

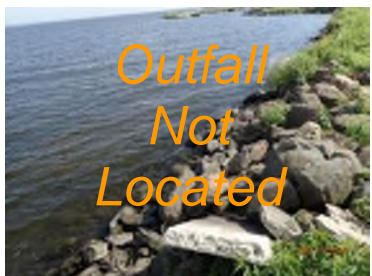
o20190917130514.JPG

<b>Inspection Date:</b> 9/17/2019 2:05:48 PM		<b>Type:</b> Ongoing	<b>Flow:</b> Submerged (not located)	<b>Previous Rainfall (hrs):</b> 48-72
<b>Illicit Discharge Potential:</b> Potential		<b>Inspector:</b> JCW	<b>Notes</b>	
Submerged: Fully		Depth (in):	Outfall fully submerged and not located - screened upstream at 11-512 US1. Floating gross solids (litter) in manhole.	
<b>Sampling Results</b>		Floatables:	<b>Condition Assessment</b>	
Sample Location:		Odor:		
Total Chlorine: -- ppm		Turbidity:	Graffiti: None Erosion: None Deposition: None in. Damage: None	
Free Chlorine: -- ppm		Color:		
Ammonia: -- ppm		Gross Solids:		
pH: -- units		Vegetation:		
Temperature -- °F		Benthic Growth:		
Conductivity: -- µS/cm		Stains:		
Detergents: -- mg/L		Non-illicit:

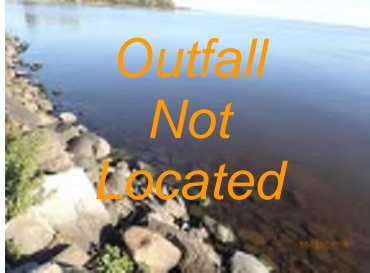
o20181022095658.JPG

<b>Inspection Date:</b> 10/22/2018 9:59:38 AM		<b>Type:</b> Ongoing	<b>Flow:</b> Submerged (not located)	<b>Previous Rainfall (hrs):</b> 48-72
<b>Illicit Discharge Potential:</b> <b>Potential</b>		<b>Inspector:</b> JCW	<b>Notes</b>	
Submerged: Fully		Depth (in):	Outfall fully submerged and not located - screened upstream at 11-512 US1. Floating gross solids (litter) in manhole.	
<b>Sampling Results</b>		Floatables:	<b>Condition Assessment</b> Graffiti: None Erosion: None Deposition: None in. Damage: None	
Sample Location:		Odor:		
Total Chlorine: -- ppm		Turbidity:		
Free Chlorine: -- ppm		Color:		
Ammonia: -- ppm		Gross Solids:		
pH: -- units		Vegetation:		
Temperature -- °F		Benthic Growth:		
Conductivity: -- µS/cm		Stains:		
Detergents: -- mg/L		Non-illicit:

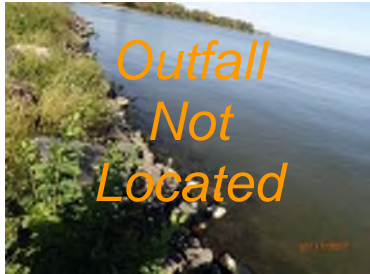
o20171017131910.JPG

<b>Inspection Date:</b> 10/17/2017 1:20:48 PM		<b>Type:</b> Ongoing	<b>Flow:</b> Submerged (not located)	<b>Previous Rainfall (hrs):</b> 48-72
<b>Illicit Discharge Potential:</b> <b>Potential</b>		<b>Inspector:</b> JCW	<b>Notes</b>	
Submerged: Fully		Depth (in):	Outfall fully submerged and not located - screened upstream at 11-512 US1. Floating gross solids (litter) in manhole.	
<b>Sampling Results</b>		Floatables:	<b>Condition Assessment</b> Graffiti: None Erosion: None Deposition: None in. Damage: None	
Sample Location:		Odor:		
Total Chlorine: -- ppm		Turbidity:		
Free Chlorine: -- ppm		Color:		
Ammonia: -- ppm		Gross Solids:		
pH: -- units		Vegetation:		
Temperature -- °F		Benthic Growth:		
Conductivity: -- µS/cm		Stains:		
Detergents: -- mg/L		Non-illicit:

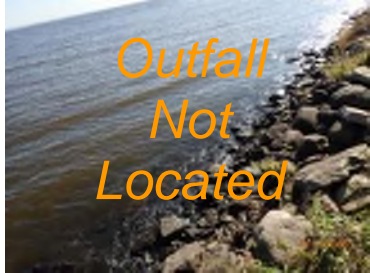
o20161010110406.JPG

<b>Inspection Date:</b> 10/10/2016 11:04:16 AM		<b>Type:</b> Ongoing	<b>Flow:</b> Submerged (not located)	<b>Previous Rainfall (hrs):</b> 72+
<b>Illicit Discharge Potential:</b> <b>Potential</b>		<b>Inspector:</b> JCW	<b>Notes</b>	
Submerged: Fully		Depth (in):	Outfall fully submerged and not located - screened upstream at 11-512 US1.	
<b>Sampling Results</b>		Floatables:	<b>Condition Assessment</b> Graffiti: None Erosion: None Deposition: None in. Damage: None	
Sample Location:		Odor:		
Total Chlorine: -- ppm		Turbidity:		
Free Chlorine: -- ppm		Color:		
Ammonia: -- ppm		Gross Solids:		
pH: -- units		Vegetation:		
Temperature -- °F		Benthic Growth:		
Conductivity: -- µS/cm		Stains:		
Detergents: -- mg/L		Non-illicit:

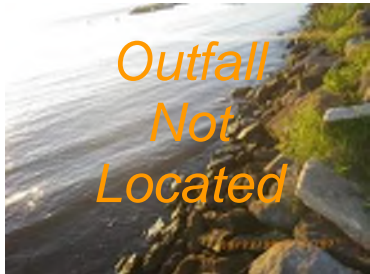
o20150922060708.JPG

<b>Inspection Date:</b> 9/22/2015 7:03:32 AM		<b>Type:</b> Ongoing	<b>Flow:</b> Submerged (not located)	<b>Previous Rainfall (hrs):</b> 72+
<b>Illicit Discharge Potential:</b> <b>Potential</b>		<b>Inspector:</b> JCW	<b>Notes</b>	
Submerged: Fully		Depth (in):	Outfall fully submerged and not located - screened upstream at 11-512 US1.	
<b>Sampling Results</b>		Floatables:	<b>Condition Assessment</b> Graffiti: None Erosion: None Deposition: None in. Damage: None	
Sample Location:		Odor:		
Total Chlorine: -- ppm		Turbidity:		
Free Chlorine: -- ppm		Color:		
Ammonia: -- ppm		Gross Solids:		
pH: -- units		Vegetation:		
Temperature -- °F		Benthic Growth:		
Conductivity: -- µS/cm		Stains:		
Detergents: -- mg/L		Non-illicit:

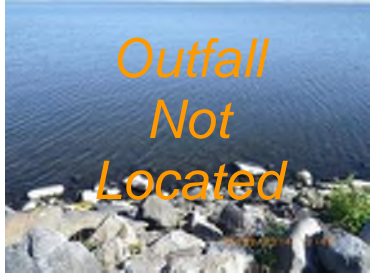
o20141009114820.JPG

<b>Inspection Date:</b> 10/9/2014 12:48:49 PM		<b>Type:</b> Ongoing	<b>Flow:</b> Submerged (not located)	<b>Previous Rainfall (hrs):</b> 72+
<b>Illicit Discharge Potential:</b> <b>Potential</b>		<b>Inspector:</b> JCW	<b>Notes</b>	
Submerged: Fully		Depth (in):	Outfall fully submerged and not located - screened upstream at 11-512 US1.	
<b>Sampling Results</b>		Floatables:	<b>Condition Assessment</b> Graffiti: None Erosion: None Deposition: None in. Damage: None	
Sample Location:		Odor:		
Total Chlorine: -- ppm		Turbidity:		
Free Chlorine: -- ppm		Color:		
Ammonia: -- ppm		Gross Solids:		
pH: -- units		Vegetation:		
Temperature -- °F		Benthic Growth:		
Conductivity: -- µS/cm		Stains:		
Detergents: -- mg/L		Non-illicit:

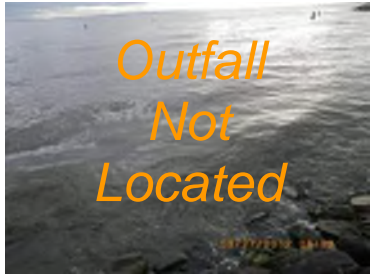
o20120927072324.JPG

<b>Inspection Date:</b> 9/27/2012 8:21:03 AM		<b>Type:</b> Ongoing	<b>Flow:</b> Submerged (not located)	<b>Previous Rainfall (hrs):</b> 72+
<b>Illicit Discharge Potential:</b> <b>Unlikely</b>		<b>Inspector:</b> JCW	<b>Notes</b>	
Submerged: Fully		Depth (in):	Outfall fully submerged; screened upstream at 11-512 US1.	
<b>Sampling Results</b>		Floatables:	<b>Condition Assessment</b> Graffiti: None Erosion: None Deposition: None in. Damage: None	
Sample Location:		Odor:		
Total Chlorine: -- ppm		Turbidity:		
Free Chlorine: -- ppm		Color:		
Ammonia: -- ppm		Gross Solids:		
pH: -- units		Vegetation:		
Temperature -- °F		Benthic Growth:		
Conductivity: -- µS/cm		Stains:		
Detergents: -- mg/L		Non-illicit:

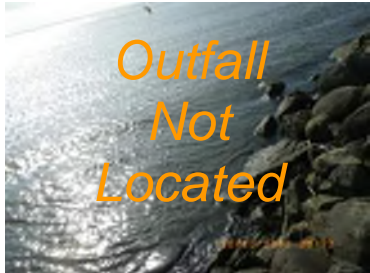
o20120620072350.JPG

<b>Inspection Date:</b> 6/20/2012 8:23:31 AM		<b>Type:</b> Other	<b>Flow:</b> Submerged (not located)	<b>Previous Rainfall (hrs):</b> 24-48
<b>Illicit Discharge Potential:</b> <b>Potential</b>		<b>Inspector:</b> JCW	<b>Notes</b>	
Submerged: Fully		Depth (in):	Gross solids pre-screening	
<b>Sampling Results</b>		Floatables:	<b>Condition Assessment</b> Graffiti: None Erosion: None Deposition: None in. Damage: None	
Sample Location:		Odor:		
Total Chlorine: -- ppm		Turbidity:		
Free Chlorine: -- ppm		Color:		
Ammonia: -- ppm		Gross Solids:		
pH: -- units		Vegetation:		
Temperature -- °F		Benthic Growth:		
Conductivity: -- µS/cm		Stains:		
Detergents: -- mg/L		Non-illicit:

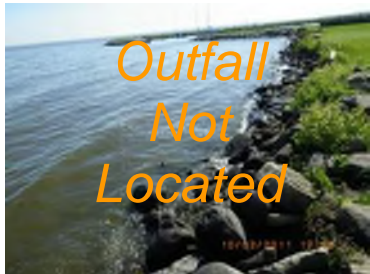
o20111003121010.JPG

<b>Inspection Date:</b> 10/3/2011 12:09:11 PM		<b>Type:</b> Ongoing	<b>Flow:</b> Submerged (not located)	<b>Previous Rainfall (hrs):</b> 72+
<b>Illicit Discharge Potential:</b> <b>Potential</b>		<b>Inspector:</b> JCW	<b>Notes</b>	
Submerged: Fully		Depth (in):	Outfall fully submerged and not physically located. Outfall screened upstream at 11-512 US1.	
<b>Sampling Results</b>		Floatables:	<b>Condition Assessment</b> Graffiti: None Erosion: None Deposition: None 0 in. Damage: None	
Sample Location:		Odor:		
Total Chlorine: -- ppm		Turbidity:		
Free Chlorine: -- ppm		Color:		
Ammonia: -- ppm		Gross Solids:		
pH: -- units		Vegetation:		
Temperature -- °F		Benthic Growth:		
Conductivity: -- µS/cm		Stains:		
Detergents: -- mg/L		Non-illicit:

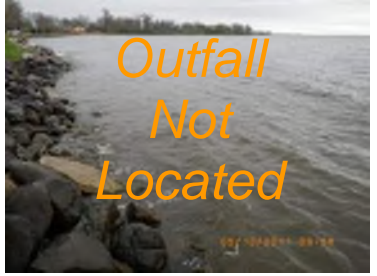
o20110510090810.JPG

<b>Inspection Date:</b> 5/10/2011 9:08:00 AM		<b>Type:</b> Other	<b>Flow:</b> Submerged (not located)	<b>Previous Rainfall (hrs):</b> 0-24
<b>Illicit Discharge Potential:</b> Potential		<b>Inspector:</b> JCW		
Submerged: Fully		Depth (in):		
<b>Sampling Results</b> Sample Location: Total Chlorine: -- ppm Free Chlorine: -- ppm Ammonia: -- ppm pH: -- units Temperature: -- °F Conductivity: -- µS/cm Detergents: -- mg/L		Floatables: Odor: Turbidity: Color: Gross Solids: Vegetation: Benthic Growth: Stains: Non-illicit: None		
		<b>Notes</b> Outfall fully submerged and not physically located. Outfall screened upstream at 11-512 US1.		
		<b>Condition Assessment</b> Graffiti: None Erosion: None Deposition: None 0 in. Damage: None

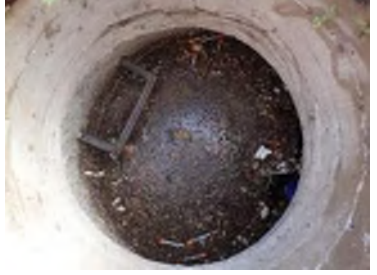
Inspection Date: 9/23/2022 9:26:00 AM		Type: Ongoing	Flow: Submerged, indeterminate	Previous Rainfall (hrs): 72+
<b>Illicit Discharge Potential: Potential</b> Submerged: Partially      Depth (in): 36		Inspector: EJK	Notes

o20220923092448.JPG <b>2022</b>
<b>Sampling Results</b> Sample Location: Pool Total Chlorine: 0 ppm Free Chlorine: 0 ppm Ammonia: 0 ppm pH: 7.84 units Temperature: 66 °F Conductivity: 460 µS/cm Detergents: 0 mg/L		Floatables: None Odor: None Turbidity: None Color: None Gross Solids: Moderate Vegetation: None Benthic Growth: None Stains: None Non-illicit: None	Sample collected from submerged pool in manhole. Floating gross solids (litter) in upstream manhole.  <b>Condition Assessment</b> Graffiti: None Erosion: None Deposition: None in. Damage: None	
<b>Inspection Date: 8/16/2021 8:42:51 AM</b>		Type: Ongoing	Flow: Submerged, indeterminate	Previous Rainfall (hrs): 72+
<b>Illicit Discharge Potential: Potential</b> Submerged: Fully      Depth (in): 41		Inspector: JCW	Notes

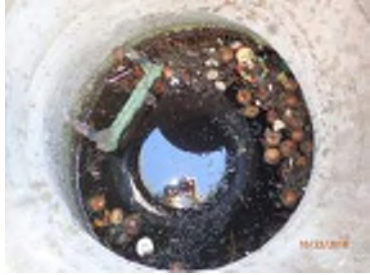
<b>Inspection Date:</b> 10/22/2018 10:00:30 AM		<b>Type:</b> Ongoing		<b>Flow:</b> Submerged, indeterminate		<b>Previous Rainfall (hrs):</b> 48-72	
<b>Illicit Discharge Potential:</b> <b>Potential</b>		<b>Inspector:</b> JCW		<b>Notes</b>

<p style="text-align: center;">o20181022100114.JPG</p> <p style="text-align: center; font-size: 24pt; font-weight: bold;">2018</p>	
Submerged: Fully		Depth (in): 42		Sample collected from submerged pool in manhole. Floating gross solids (litter) in manhole.			
<b>Sampling Results</b> Sample Location: Pool Total Chlorine: 0 ppm Free Chlorine: 0 ppm Ammonia: 0 ppm pH: 7.35 units Temperature: 57 °F Conductivity: 470 µS/cm Detergents: 0 mg/L		Floatables: None Odor: None Turbidity: None Color: None Gross Solids: Moderate Vegetation: None Benthic Growth: Slight Stains: None Non-illicit: None		<b>Condition Assessment</b> Graffiti: None Erosion: None Deposition: None in. Damage: None

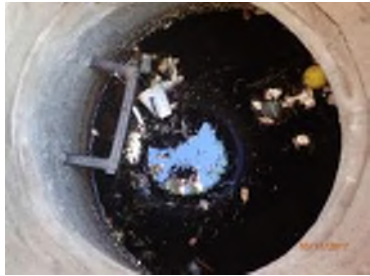
<b>Inspection Date:</b> 10/17/2017 1:23:39 PM		<b>Type:</b> Ongoing		<b>Flow:</b> Submerged, indeterminate		<b>Previous Rainfall (hrs):</b> 48-72	
<b>Illicit Discharge Potential:</b> <b>Potential</b>		<b>Inspector:</b> JCW		<b>Notes</b>

<p style="text-align: center;">o20171017131930.JPG</p> <p style="text-align: center; font-size: 24pt; font-weight: bold;">2017</p>	
Submerged: Fully		Depth (in): 35		Sample collected from submerged pool in manhole. Floating gross solids (litter) in manhole.			
<b>Sampling Results</b> Sample Location: Pool Total Chlorine: 0 ppm Free Chlorine: 0 ppm Ammonia: 0 ppm pH: 7.47 units Temperature: 67 °F Conductivity: 581 µS/cm Detergents: 0 mg/L		Floatables: None Odor: None Turbidity: None Color: None Gross Solids: Moderate Vegetation: None Benthic Growth: None Stains: None Non-illicit: None		<b>Condition Assessment</b> Graffiti: None Erosion: None Deposition: None in. Damage: None

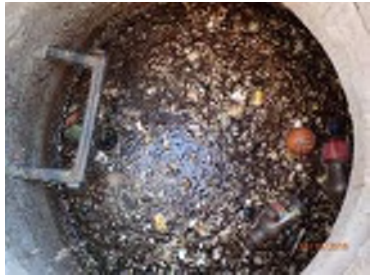
<b>Inspection Date:</b> 10/10/2016 11:07:16 AM		<b>Type:</b> Ongoing		<b>Flow:</b> Submerged, indeterminate		<b>Previous Rainfall (hrs):</b> 72+	
<b>Illicit Discharge Potential:</b> <b>Potential</b>		<b>Inspector:</b> JCW		<b>Notes</b>

<p style="text-align: center;">o20161010110444.JPG</p> <p style="text-align: center; font-size: 24pt; font-weight: bold;">2016</p>	
Submerged: Fully		Depth (in): 35		Potential illicit discharge due to gross solids.			
<b>Sampling Results</b> Sample Location: Pool Total Chlorine: 0 ppm Free Chlorine: 0 ppm Ammonia: 0 ppm pH: 7.63 units Temperature: 65 °F Conductivity: 514 µS/cm Detergents: 0 mg/L		Floatables: None Odor: None Turbidity: None Color: None Gross Solids: Severe Vegetation: None Benthic Growth: None Stains: None Non-illicit: None		<b>Condition Assessment</b> Graffiti: None Erosion: None Deposition: None in. Damage: None

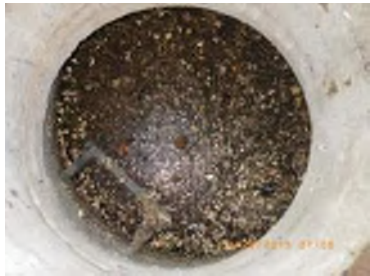
<b>Inspection Date:</b> 9/22/2015 7:04:46 AM		<b>Type:</b> Ongoing		<b>Flow:</b> Submerged, indeterminate		<b>Previous Rainfall (hrs):</b> 72+	
<b>Illicit Discharge Potential:</b> <b>Potential</b>		<b>Inspector:</b> JCW		<b>Notes</b>

<p style="text-align: center;">o20150922060832.JPG</p> <p style="text-align: center; font-size: 24pt; font-weight: bold;">2015</p>	
Submerged: Fully		Depth (in): 37		Floating gross solids (litter) in manhole.			
<b>Sampling Results</b> Sample Location: Pool Total Chlorine: 0 ppm Free Chlorine: 0 ppm Ammonia: 0 ppm pH: 7.93 units Temperature: 65 °F Conductivity: 1055 µS/cm Detergents: 0 mg/L		Floatables: None Odor: None Turbidity: None Color: None Gross Solids: Moderate Vegetation: None Benthic Growth: None Stains: None Non-illicit: None		<b>Condition Assessment</b> Graffiti: None Erosion: None Deposition: None in. Damage: None

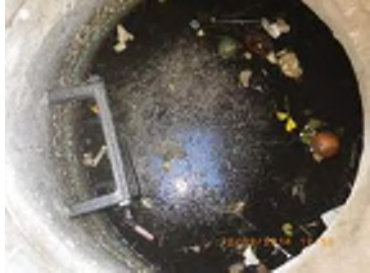
o20141009115024.JPG

<b>Inspection Date:</b> 10/9/2014 12:52:08 PM		<b>Type:</b> Ongoing	<b>Flow:</b> Submerged, indeterminate	<b>Previous Rainfall (hrs):</b> 72+
<b>Illicit Discharge Potential:</b> <b>Potential</b>		<b>Inspector:</b> JCW	<b>Notes</b>	
Submerged: Fully		Depth (in): 39	Floating gross solids (litter) in manhole.	
<b>Sampling Results</b>		<b>Condition Assessment</b>		
Sample Location: Pool	Floatables: None	Graffiti: None	Erosion: None	in.
Total Chlorine: 0 ppm	Odor: None	Deposition: None	Damage: None	
Free Chlorine: 0 ppm	Turbidity: Slight cloudiness			
Ammonia: 0 ppm	Color: None			
pH: 7.57 units	Gross Solids: Moderate			
Temperature 62 °F	Vegetation: None			
Conductivity: 548 µS/cm	Benthic Growth: Slight			
Detergents: 0 mg/L	Stains: None			
	Non-illicit: None

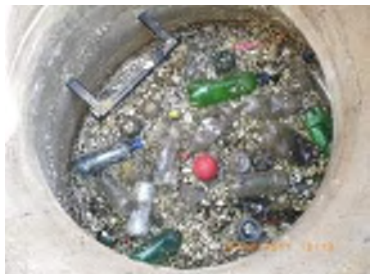
o20111003121302.JPG

<b>Inspection Date:</b> 10/3/2011 12:13:00 PM		<b>Type:</b> Ongoing	<b>Flow:</b> Submerged, indeterminate	<b>Previous Rainfall (hrs):</b> 72+
<b>Illicit Discharge Potential:</b> <b>Potential</b>		<b>Inspector:</b> JCW	<b>Notes</b>	
Submerged: Fully		Depth (in): 36	Significant floatable debris in manhole.	
<b>Sampling Results</b>		<b>Condition Assessment</b>		
Sample Location: Pool	Floatables: None	Graffiti: None	Erosion: None	0 in.
Total Chlorine: 0 ppm	Odor: None	Deposition: None	Damage: None	
Free Chlorine: 0 ppm	Turbidity: None			
Ammonia: 0 ppm	Color: None			
pH: 7.39 units	Gross Solids: Severe			
Temperature 67 °F	Vegetation: None			
Conductivity: -- µS/cm	Benthic Growth: None			
Detergents: 0 mg/L	Stains: None			
	Non-illicit: None

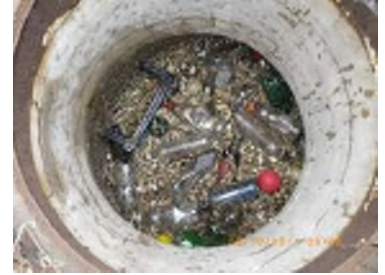
o20110510090830.JPG

<b>Inspection Date:</b> 5/10/2011 9:08:00 AM		<b>Type:</b> Other	<b>Flow:</b> Submerged, indeterminate	<b>Previous Rainfall (hrs):</b> 0-24
<b>Illicit Discharge Potential:</b> Potential		<b>Inspector:</b> JCW	<b>Notes</b> Limited screening conducted for upstream manhole prescreening.	
Submerged: Fully		Depth (in):	<b>Condition Assessment</b> Graffiti: None Erosion: None Deposition: None 0 in. Damage: None	
<b>Sampling Results</b> Sample Location: Total Chlorine: -- ppm Free Chlorine: -- ppm Ammonia: -- ppm pH: -- units Temperature: -- °F Conductivity: -- µS/cm Detergents: -- mg/L		Floatables: None Odor: Turbidity: Color: Gross Solids: Severe Vegetation: Benthic Growth: Stains: Non-illicit: None

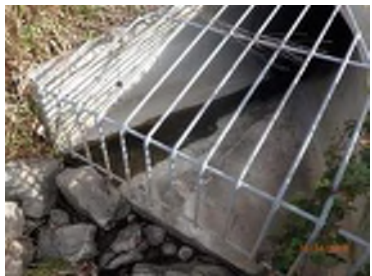
<b>Inspection Date:</b> 10/24/2018 10:34:16 AM		<b>Type:</b> Ongoing	<b>Flow:</b> Trickle	<b>Previous Rainfall (hrs):</b> 72+
<b>Illicit Discharge Potential:</b> Potential		<b>Inspector:</b> JCW		
Submerged: None		Depth (in):		
<b>Sampling Results</b> Sample Location: Flow Total Chlorine: 0 ppm Free Chlorine: 0 ppm Ammonia: 0 ppm pH: 9.04 units Temperature: 50 °F Conductivity: 792 µS/cm Detergents: 0 mg/L		Floatables: None Odor: None Turbidity: None Color: None Gross Solids: None Vegetation: None Benthic Growth: Moderate Stains: Slight Non-illicit: None	<b>Notes</b> Elevated pH in sample from trickle flow. No flow in upstream curb inlet at time of inspection.

o20181024103144.JPG <div style="text-align: center; font-size: 24pt; font-weight: bold;">2018</div>
			<b>Condition Assessment</b> Graffiti: None Erosion: None Deposition: None in. Damage: None

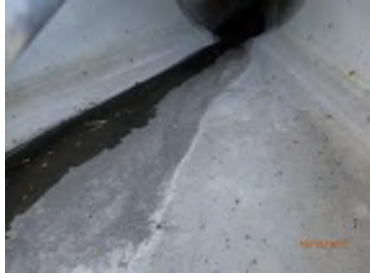
o20171018093128.JPG  
**2017**

<b>Inspection Date:</b> 10/18/2017 9:40:26 AM		<b>Type:</b> Ongoing	<b>Flow:</b> Trickle	<b>Previous Rainfall (hrs):</b> 72+	
<b>Illicit Discharge Potential:</b> <b>Potential</b>		<b>Inspector:</b> JCW	<b>Notes</b>		
Submerged: None		Depth (in):	Elevated pH in sample from trickle flow. No flow in upstream curb inlet at time of inspection.		
<b>Sampling Results</b>		Floatables:	<b>Condition Assessment</b> Graffiti: None Erosion: None Deposition: None in. Damage: None		
Sample Location:	Flow	Odor:			None
Total Chlorine:	0 ppm	Turbidity:			None
Free Chlorine:	0 ppm	Color:			None
Ammonia:	0 ppm	Gross Solids:			None
pH:	9.23 units	Vegetation:			None
Temperature	65 °F	Benthic Growth:			None
Conductivity:	1563 µS/cm	Stains:			
Detergents:	0 mg/L	Non-illicit:			None

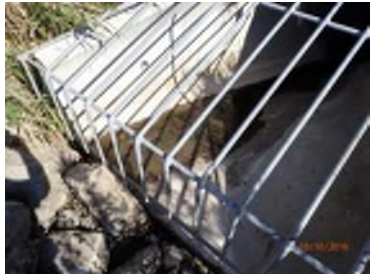
o20161010122036.JPG  
**2016**

<b>Inspection Date:</b> 10/10/2016 12:26:38 PM		<b>Type:</b> Ongoing	<b>Flow:</b> Trickle	<b>Previous Rainfall (hrs):</b> 72+	
<b>Illicit Discharge Potential:</b> <b>Potential</b>		<b>Inspector:</b> JCW	<b>Notes</b>		
Submerged: None		Depth (in):	Elevated pH, but not as high as 2015 screening. Possible residual in upstream pipe.		
<b>Sampling Results</b>		Floatables:	<b>Condition Assessment</b> Graffiti: None Erosion: None Deposition: None in. Damage: None		
Sample Location:	Flow	Odor:			None
Total Chlorine:	0 ppm	Turbidity:			None
Free Chlorine:	0 ppm	Color:			None
Ammonia:	0 ppm	Gross Solids:			None
pH:	9.45 units	Vegetation:			None
Temperature	64 °F	Benthic Growth:			Moderate
Conductivity:	880 µS/cm	Stains:			Slight
Detergents:	0 mg/L	Non-illicit:			None

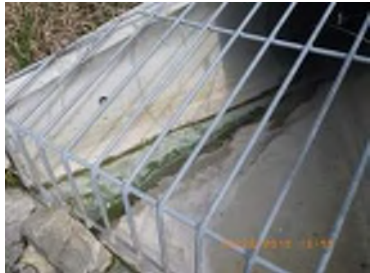
o20150923115508.JPG  
**2015**

<b>Inspection Date:</b> 9/23/2015 12:56:15 PM		<b>Type:</b> Ongoing	<b>Flow:</b> Trickle	<b>Previous Rainfall (hrs):</b> 72+	
<b>Illicit Discharge Potential:</b> <b>Obvious</b>		<b>Inspector:</b> JCW	<b>Notes</b>		
Submerged: None		Depth (in):	White silty discharge. Chlorine patches turned yellow (not on scale). Elevated pH and conductivity.		
<b>Sampling Results</b>		Floatables:	<b>Condition Assessment</b> Graffiti: None Erosion: None Deposition: None in. Damage: None		
Sample Location:	Flow	Odor:			None
Total Chlorine:	-- ppm	Turbidity:			None
Free Chlorine:	-- ppm	Color:			None
Ammonia:	1 ppm	Gross Solids:			Slight
pH:	11.66 units	Vegetation:			None
Temperature	73 °F	Benthic Growth:			Moderate
Conductivity:	2470 µS/cm	Stains:			Moderate
Detergents:	0 mg/L	Non-illicit:			None

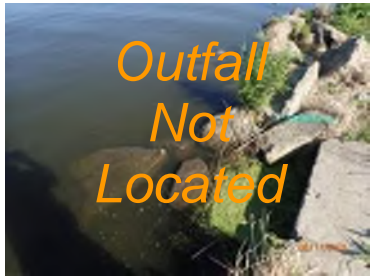
o20210817091208.JPG <div style="text-align: center; font-weight: bold; font-size: 1.2em;">2021</div>

Floatables:	None	Odor:	None	Turbidity:	None	Color:	None	Gross Solids:	None	Vegetation:	None	Benthic Growth:	None	Stains:	None	Non-illicit:	None
Floatables:	None																					
Odor:	None																					
Turbidity:	None																					
Color:	None																					
Gross Solids:	None																					
Vegetation:	None																					
Benthic Growth:	None																					
Stains:	None																					
Non-illicit:	None																					
		<b>Notes</b> Outfall fully submerged and not located - screened upstream at 12-569 US1. Graffiti on nearby bridge abutment.																				
		<b>Condition Assessment</b> Graffiti: Moderate Erosion: None Deposition: None in. Damage: None

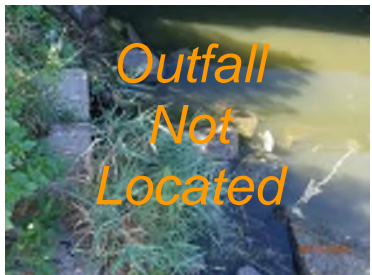
o20200819084114.JPG <div style="text-align: center; font-weight: bold; font-size: 1.2em;">2020</div>

Floatables:	None	Odor:	None	Turbidity:	None	Color:	None	Gross Solids:	None	Vegetation:	None	Benthic Growth:	None	Stains:	None	Non-illicit:	None
Floatables:	None																					
Odor:	None																					
Turbidity:	None																					
Color:	None																					
Gross Solids:	None																					
Vegetation:	None																					
Benthic Growth:	None																					
Stains:	None																					
Non-illicit:	None																					
		<b>Notes</b> Outfall fully submerged and not physically located - screened upstream at 12-569 US1. Graffiti on bridge abutment.																				
		<b>Condition Assessment</b> Graffiti: Moderate Erosion: None Deposition: None in. Damage: None

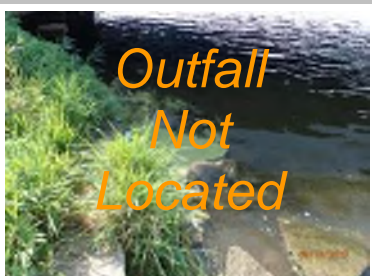
o20190918101816.JPG <div style="text-align: center; font-weight: bold; font-size: 1.2em;">2019</div>

Floatables:	None	Odor:	None	Turbidity:	None	Color:	None	Gross Solids:	None	Vegetation:	None	Benthic Growth:	None	Stains:	None	Non-illicit:	None
Floatables:	None																					
Odor:	None																					
Turbidity:	None																					
Color:	None																					
Gross Solids:	None																					
Vegetation:	None																					
Benthic Growth:	None																					
Stains:	None																					
Non-illicit:	None																					
		<b>Notes</b> Outfall fully submerged and not located - screened upstream at 12-569 US1. Graffiti on nearby bridge abutment. Floating gross solids (litter) in MH.																				
		<b>Condition Assessment</b> Graffiti: Moderate Erosion: None Deposition: None in. Damage: None

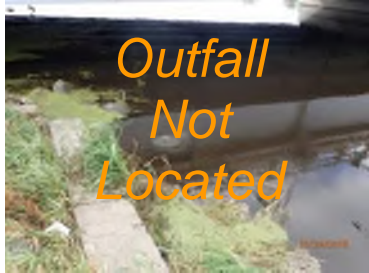
<p style="text-align: center;">o20181024092154.JPG</p> <p style="text-align: center; font-size: 1.2em; font-weight: bold;">2018</p>	
Submerged: Fully		Depth (in):		Outfall fully submerged and not located - screened upstream at 12-569 US1. Graffiti on nearby bridge abutment. Floating gross solids (litter) in MH.			
<b>Sampling Results</b> Sample Location: Total Chlorine: -- ppm Free Chlorine: -- ppm Ammonia: -- ppm pH: -- units Temperature -- °F Conductivity: -- µS/cm Detergents: -- mg/L		Floatables: None Odor: None Turbidity: None Color: None Gross Solids: None Vegetation: None Benthic Growth: None Stains: None Non-illicit: None		<b>Condition Assessment</b> Graffiti: Moderate Erosion: None Deposition: None in. Damage: None

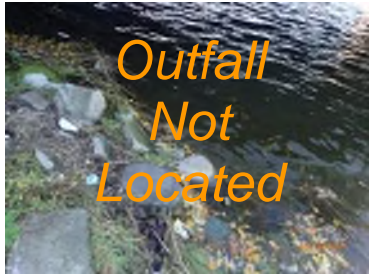
<p style="text-align: center;">o20171018101412.JPG</p> <p style="text-align: center; font-size: 1.2em; font-weight: bold;">2017</p>	
Submerged: Fully		Depth (in):		Outfall fully submerged and not located - screened upstream at 12-569 US1. Graffiti on nearby bridge abutment. Floating gross solids (litter) in MH.			
<b>Sampling Results</b> Sample Location: Total Chlorine: -- ppm Free Chlorine: -- ppm Ammonia: -- ppm pH: -- units Temperature -- °F Conductivity: -- µS/cm Detergents: -- mg/L		Floatables: None Odor: None Turbidity: None Color: None Gross Solids: None Vegetation: None Benthic Growth: None Stains: None Non-illicit: None		<b>Condition Assessment</b> Graffiti: Minor Erosion: None Deposition: None in. Damage: None

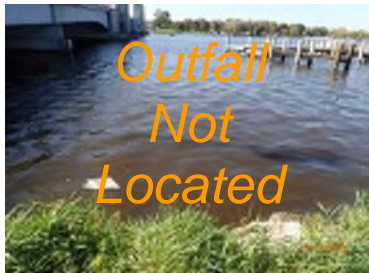
<p style="text-align: center;">o20161010132600.JPG</p> <p style="text-align: center; font-size: 1.2em; font-weight: bold;">2016</p>	
Submerged: Fully		Depth (in):		Graffiti on east bridge abutment. Outfall fully submerged and not located - screened upstream at 12-569 US1.			
<b>Sampling Results</b> Sample Location: Total Chlorine: -- ppm Free Chlorine: -- ppm Ammonia: -- ppm pH: -- units Temperature -- °F Conductivity: -- µS/cm Detergents: -- mg/L		Floatables: None Odor: None Turbidity: None Color: None Gross Solids: None Vegetation: None Benthic Growth: None Stains: None Non-illicit: None		<b>Condition Assessment</b> Graffiti: Minor Erosion: None Deposition: None in. Damage: None

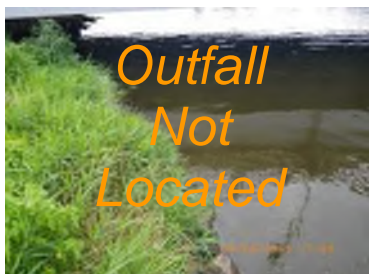
<p style="text-align: center;">o20150923100828.JPG</p> <p style="text-align: center; font-size: 1.2em; font-weight: bold;">2015</p>	
Submerged: Fully		Depth (in):		Outfall fully submerged and not located - screened at 12-569 US1.			
<b>Sampling Results</b> Sample Location: Total Chlorine: -- ppm Free Chlorine: -- ppm Ammonia: -- ppm pH: -- units Temperature -- °F Conductivity: -- µS/cm Detergents: -- mg/L		Floatables: None Odor: None Turbidity: None Color: None Gross Solids: None Vegetation: None Benthic Growth: None Stains: None Non-illicit: None		<b>Condition Assessment</b> Graffiti: Moderate Erosion: None Deposition: None in. Damage: None

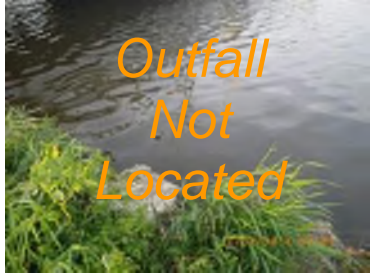
o20141007063712.JPG <div style="text-align: center; font-size: 24pt; font-weight: bold;">2014</div>

<b>Inspection Date:</b> 10/7/2014 7:38:26 AM		<b>Type:</b> Ongoing	<b>Flow:</b> Submerged (not located)	<b>Previous Rainfall (hrs):</b> 48-72
<b>Illicit Discharge Potential:</b> <b>Potential</b>		<b>Inspector:</b> JCW		
Submerged: Fully		Depth (in):		
<b>Sampling Results</b> Sample Location: _____ Total Chlorine: -- ppm Free Chlorine: -- ppm Ammonia: -- ppm pH: -- units Temperature: -- °F Conductivity: -- µS/cm Detergents: -- mg/L		Floatables: None Odor: None Turbidity: None Color: None Gross Solids: None Vegetation: None Benthic Growth: None Stains: None Non-illicit: None	<b>Notes</b> Outfall fully submerged and not located - screened upstream at 12-569 US1. Graffiti on east abutment.  <b>Condition Assessment</b> Graffiti: Moderate Erosion: None Deposition: None in. Damage: None

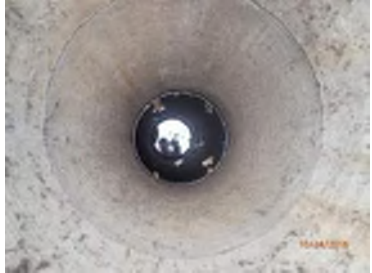
<b>Inspection Date:</b> 10/24/2018 9:25:23 AM		<b>Type:</b> Ongoing		<b>Flow:</b> Submerged, indeterminate		<b>Previous Rainfall (hrs):</b> 72+	
<b>Illicit Discharge Potential:</b> Potential		<b>Inspector:</b> JCW		<b>Notes</b> Sample collected from submerged pool in manhole. Floating gross solids (litter) in manhole.

o20181024092322.JPG	
Submerged: Fully		Depth (in): 44					
<b>Sampling Results</b> Sample Location: Pool Total Chlorine: 0 ppm Free Chlorine: 0 ppm Ammonia: 0 ppm pH: 7.4 units Temperature: 52 °F Conductivity: 714 µS/cm Detergents: 0 mg/L		Floatables: None Odor: None Turbidity: None Color: None Gross Solids: Slight Vegetation: None Benthic Growth: None Stains: None Non-illicit: None		<b>Condition Assessment</b> Graffiti: None Erosion: None Deposition: None in. Damage: None			
<b>2018</b>

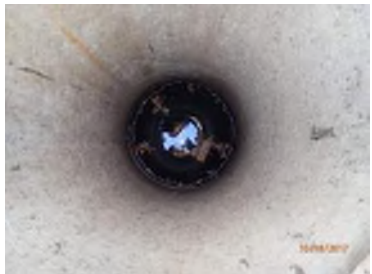
<b>Inspection Date:</b> 10/18/2017 10:20:25 AM		<b>Type:</b> Ongoing		<b>Flow:</b> Submerged, indeterminate		<b>Previous Rainfall (hrs):</b> 72+	
<b>Illicit Discharge Potential:</b> Potential		<b>Inspector:</b> JCW		<b>Notes</b> Sample collected from submerged pool in manhole. Floating gross solids (litter) in manhole.

o20171018101542.JPG	
Submerged: Fully		Depth (in): 39					
<b>Sampling Results</b> Sample Location: Pool Total Chlorine: 0 ppm Free Chlorine: 0 ppm Ammonia: 0 ppm pH: 7.44 units Temperature: 65 °F Conductivity: 1118 µS/cm Detergents: 0 mg/L		Floatables: None Odor: None Turbidity: None Color: None Gross Solids: Moderate Vegetation: None Benthic Growth: None Stains: None Non-illicit: None		<b>Condition Assessment</b> Graffiti: None Erosion: None Deposition: None in. Damage: None			
<b>2017</b>

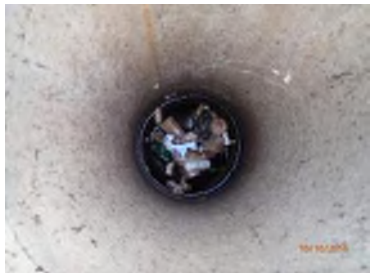
<b>Inspection Date:</b> 10/10/2016 1:30:04 PM		<b>Type:</b> Ongoing		<b>Flow:</b> Submerged, indeterminate		<b>Previous Rainfall (hrs):</b> 72+	
<b>Illicit Discharge Potential:</b> Potential		<b>Inspector:</b> JCW		<b>Notes</b> Potential illicit discharge due to gross solids.

o20161010132718.JPG	
Submerged: Fully		Depth (in): 38					
<b>Sampling Results</b> Sample Location: Pool Total Chlorine: 0 ppm Free Chlorine: 0 ppm Ammonia: 0 ppm pH: 7.41 units Temperature: 69 °F Conductivity: 616 µS/cm Detergents: 0 mg/L		Floatables: None Odor: None Turbidity: Slight cloudiness Color: Clearly visible in bottl Gross Solids: Moderate Vegetation: None Benthic Growth: None Stains: None Non-illicit: None		<b>Condition Assessment</b> Graffiti: None Erosion: None Deposition: None in. Damage: None			
<b>2016</b>

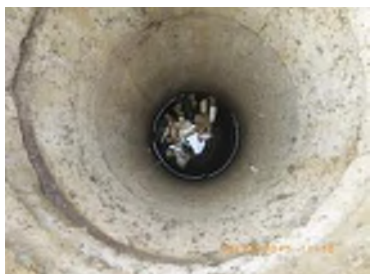
<b>Inspection Date:</b> 9/23/2015 11:06:51 AM		<b>Type:</b> Ongoing		<b>Flow:</b> Submerged, indeterminate		<b>Previous Rainfall (hrs):</b> 72+	
<b>Illicit Discharge Potential:</b> Potential		<b>Inspector:</b> JCW		<b>Notes</b> Floating gross solids (litter) in manhole.

o20150923101026.JPG	
Submerged: Fully		Depth (in): 40					
<b>Sampling Results</b> Sample Location: Pool Total Chlorine: 0 ppm Free Chlorine: 0 ppm Ammonia: 0 ppm pH: 7.5 units Temperature: 76 °F Conductivity: 441 µS/cm Detergents: 0 mg/L		Floatables: None Odor: None Turbidity: None Color: None Gross Solids: Moderate Vegetation: None Benthic Growth: Slight Stains: None Non-illicit: None		<b>Condition Assessment</b> Graffiti: None Erosion: None Deposition: None in. Damage: None			
<b>2015</b>

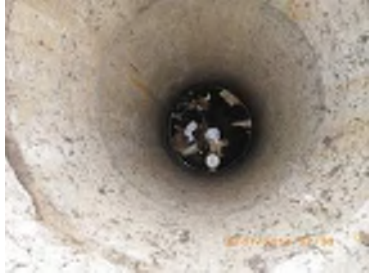
o20141007063948.JPG  
**2014**

<b>Inspection Date:</b> 10/7/2014 7:39:34 AM		<b>Type:</b> Ongoing	<b>Flow:</b> Submerged, indeterminate	<b>Previous Rainfall (hrs):</b> 48-72
<b>Illicit Discharge Potential:</b> <b>Potential</b>		<b>Inspector:</b> JCW	<b>Notes</b>	
Submerged: Fully		Depth (in): 34	Floating gross solids (litter) in manhole.	
<b>Sampling Results</b>		<b>Condition Assessment</b>		
Sample Location: Pool	Floatables: None	Graffiti: None	Erosion: None	in.
Total Chlorine: 0 ppm	Odor: None	Deposition: None	Damage: None	
Free Chlorine: 0 ppm	Turbidity: None			
Ammonia: 0 ppm	Color: None			
pH: 7.66 units	Gross Solids: Moderate			
Temperature 59 °F	Vegetation: None			
Conductivity: 771 µS/cm	Benthic Growth: None			
Detergents: 0 mg/L	Stains: None			
	Non-illicit: None

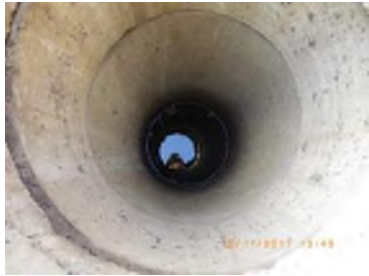
<b>Inspection Date:</b> 10/11/2011 1:51:24 PM		<b>Type:</b> Ongoing	<b>Flow:</b> Submerged, indeterminate	<b>Previous Rainfall (hrs):</b> 72+
<b>Illicit Discharge Potential:</b> <b>Unlikely</b>		<b>Inspector:</b> JCW	<b>Notes</b>	
Submerged: Fully		Depth (in): 32	2010 screening follow-up. Floatable debris significantly reduced.	
<b>Sampling Results</b>		<b>Condition Assessment</b>		
Sample Location: Pool	Floatables: None	Graffiti: None	Erosion: None	0 in.
Total Chlorine: 0 ppm	Odor: None	Deposition: None	Damage: None	
Free Chlorine: 0 ppm	Turbidity: None			
Ammonia: 0 ppm	Color: None			
pH: 8.63 units	Gross Solids: None			
Temperature 73 °F	Vegetation: None			
Conductivity: -- µS/cm	Benthic Growth: None			
Detergents: -- mg/L	Stains: None			
	Non-illicit: None

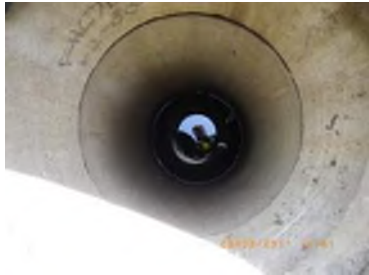
<b>Inspection Date:</b> 5/26/2011 2:40:00 PM		<b>Type:</b> Other	<b>Flow:</b> Submerged, indeterminate	<b>Previous Rainfall (hrs):</b> 72+
<b>Illicit Discharge Potential:</b> <b>Unlikely</b>		<b>Inspector:</b> JCW	<b>Notes</b>	
Submerged: Fully		Depth (in):	Limited screening conducted to check for floatable debris.	
<b>Sampling Results</b>		<b>Condition Assessment</b>		
Sample Location: --	Floatables: None	Graffiti: None	Erosion: None	0 in.
Total Chlorine: -- ppm	Odor: --	Deposition: None	Damage: None	
Free Chlorine: -- ppm	Turbidity: --			
Ammonia: -- ppm	Color: --			
pH: -- units	Gross Solids: None			
Temperature -- °F	Vegetation: --			
Conductivity: -- µS/cm	Benthic Growth: --			
Detergents: -- mg/L	Stains: --			
	Non-illicit: None

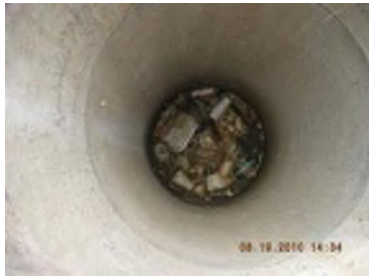
<b>Inspection Date:</b> 8/19/2010 2:41:43 PM		<b>Type:</b> Ongoing	<b>Flow:</b> Submerged, indeterminate	<b>Previous Rainfall (hrs):</b> 72+
<b>Illicit Discharge Potential:</b> <b>Potential</b>		<b>Inspector:</b> JCW	<b>Notes</b>	
Submerged: Fully		Depth (in): 38	Severe floatable debris	
<b>Sampling Results</b>		<b>Condition Assessment</b>		
Sample Location: Pool	Floatables: None	Graffiti: None	Erosion: None	0 in.
Total Chlorine: 0 ppm	Odor: None	Deposition: None	Damage: None	
Free Chlorine: 0 ppm	Turbidity: None			
Ammonia: 0 ppm	Color: Faint in bottle			
pH: 7.59 units	Gross Solids: Severe			
Temperature 79 °F	Vegetation: None			
Conductivity: -- µS/cm	Benthic Growth: None			
Detergents: 0 mg/L	Stains: Slight			
	Non-illicit: None

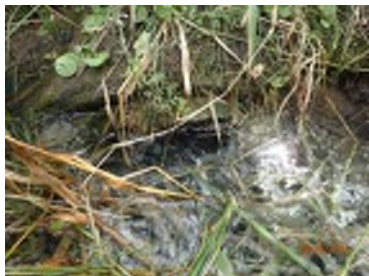
<b>Inspection Date:</b> 8/18/2022 2:17:00 PM		<b>Type:</b> Ongoing	<b>Flow:</b> Submerged, slight flow	<b>Previous Rainfall (hrs):</b> 72+
<b>Illicit Discharge Potential:</b> Obvious		<b>Inspector:</b> EJK		
Submerged: Fully		Depth (in): 6		
<b>Sampling Results</b> Sample Location: Flow Total Chlorine: 0 ppm Free Chlorine: 0 ppm Ammonia: 3 ppm pH: 7.15 units Temperature: 80 °F Conductivity: 1805 µS/cm Detergents: 0 mg/L		Floatables: None Odor: Easily detected Turbidity: None Color: None Gross Solids: None Vegetation: None Benthic Growth: Severe Stains: None Non-illicit: None		
		<b>Notes</b> Sample collected from submerged flow at end of pipe. Elevated ammonia. Tracking revealed sanitary cross connection.		
		<b>Condition Assessment</b> Graffiti: None Erosion: None Deposition: Moderate 18 in. Damage: None

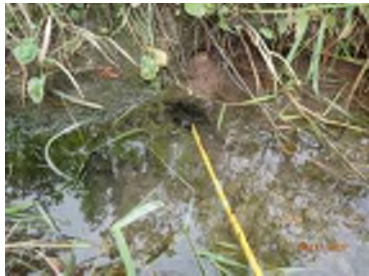
<b>Inspection Date:</b> 8/31/2021 7:49:46 AM		<b>Type:</b> Ongoing	<b>Flow:</b> Submerged, significant flow	<b>Previous Rainfall (hrs):</b> 48-72
<b>Illicit Discharge Potential:</b> Unlikely		<b>Inspector:</b> JCW		
Submerged: Fully		Depth (in):		
<b>Sampling Results</b> Sample Location: Flow Total Chlorine: 0 ppm Free Chlorine: 0 ppm Ammonia: 0 ppm pH: 6.98 units Temperature: 71 °F Conductivity: 1980 µS/cm Detergents: 0 mg/L		Floatables: None Odor: None Turbidity: None Color: None Gross Solids: None Vegetation: None Benthic Growth: Moderate Stains: None Non-illicit: None		
		<b>Notes</b> Sample collected from concentrated flow immediately downstream of pipe.		
		<b>Condition Assessment</b> Graffiti: None Erosion: None Deposition: Moderate 16 in. Damage: None

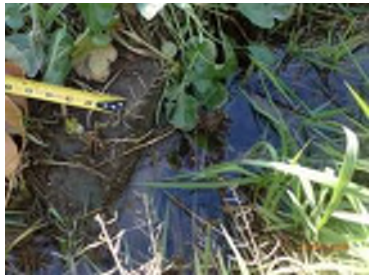
<b>Inspection Date:</b> 10/24/2018 3:06:28 PM		<b>Type:</b> Ongoing	<b>Flow:</b> Submerged, slight flow	<b>Previous Rainfall (hrs):</b> 72+
<b>Illicit Discharge Potential:</b> Unlikely		<b>Inspector:</b> JCW		
Submerged: Fully		Depth (in): 24		
<b>Sampling Results</b> Sample Location: -- Total Chlorine: -- ppm Free Chlorine: -- ppm Ammonia: -- ppm pH: -- units Temperature: -- °F Conductivity: -- µS/cm Detergents: -- mg/L		Floatables: None Odor: None Turbidity: None Color: None Gross Solids: None Vegetation: None Benthic Growth: None Stains: None Non-illicit: None		
		<b>Notes</b> Outfall partially submerged - screened upstream at 13-1098 US1.		
		<b>Condition Assessment</b> Graffiti: None Erosion: None Deposition: None in. Damage: None

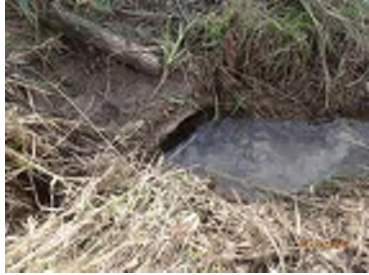
<b>Condition Assessment</b>																																								
<b>Graffiti:</b>	None																																							
<b>Erosion:</b>	None																																							
<b>Deposition:</b>	Severe 16 in.																																							
<b>Damage:</b>	None

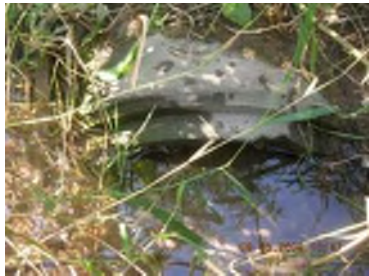
<b>Condition Assessment</b>																																								
<b>Graffiti:</b>	None																																							
<b>Erosion:</b>	None																																							
<b>Deposition:</b>	18 in.																																							
<b>Damage:</b>	None

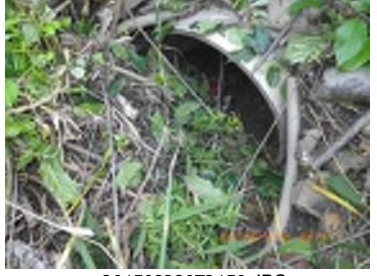
<b>Notes</b> Flowline damp, but no flow at time of inspection. Sediment level with crown of pipe.																																				
		<b>Condition Assessment</b> <table border="1" style="width: 100%; border-collapse: collapse;"> <tr> <td>Graffiti:</td> <td>None</td> </tr> <tr> <td>Erosion:</td> <td>None</td> </tr> <tr> <td>Deposition:</td> <td>Severe 18 in.</td> </tr> <tr> <td>Damage:</td> <td>None</td> </tr> </table>			Graffiti:	None	Erosion:	None	Deposition:	Severe 18 in.	Damage:	None																										
Graffiti:	None																																					
Erosion:	None																																					
Deposition:	Severe 18 in.																																					
Damage:	None

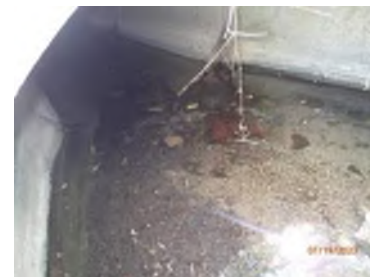
Stains: Severe

☐ Petrol. Sheen ☐ Suds ☐ Sewage ☐ Algae ☐ Other☐ Petroleum ☐ Musty ☐ Sewage ☐ Chlorine ☐ Other☐ VOC/Solvent ☐ Fishy ☐ Sulfur ☐ Fragrant☒ Litter ☐ Veg. Debris ☐ Sediment ☐ Other☐ Inhibited ☐ Excessive☒ Green ☐ Brown☒ Flow Line ☐ Oil ☐ Rust Stains☐ Paint ☐ Other☐ Natural Sheen ☐ Natural Suds/Foam

Damage: Minor ☒ Displacement ☐ Undercut ☐ Crushed☐ Corrosion ☐ Cracks/Structural Damage

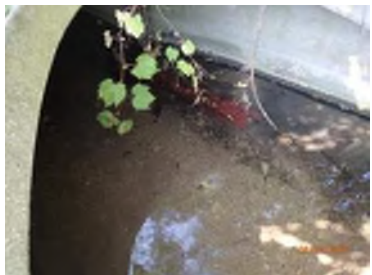
<b>Inspection Date:</b> 8/20/2020 10:49:39 AM		<b>Type:</b> Ongoing	<b>Flow:</b> Submerged, slight flow	<b>Previous Rainfall (hrs):</b> 72+
<b>Illicit Discharge Potential:</b> Unlikely		<b>Inspector:</b> JCW		
Submerged: Partially		Depth (in): 3		
<b>Sampling Results</b> Sample Location: Flow Total Chlorine: 0 ppm Free Chlorine: 0 ppm Ammonia: 0 ppm pH: 8.18 units Temperature: 76 °F Conductivity: 1219 µS/cm Detergents: 0 mg/L		Floatables: None Odor: None Turbidity: None Color: None Gross Solids: None Vegetation: None Benthic Growth: Moderate Stains: Slight Non-illicit: None	<b>Notes</b> Sample collected from concentrated flow immediately downstream from outfall.

o20200820104754.JPG <div style="text-align: center; font-size: 24pt; font-weight: bold;">2020</div>
			<b>Condition Assessment</b> Graffiti: None Erosion: None Deposition: None in. Damage: None

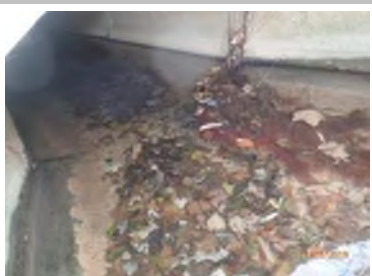
<b>Inspection Date:</b> 11/5/2019 2:05:00 PM		<b>Type:</b> Repeat	<b>Flow:</b> Submerged, indeterminate	<b>Previous Rainfall (hrs):</b> 48-72
<b>Illicit Discharge Potential:</b> Potential		<b>Inspector:</b> JCW		
Submerged: Partially		Depth (in): 19		
<b>Sampling Results</b> Sample Location: Total Chlorine: -- ppm Free Chlorine: -- ppm Ammonia: -- ppm pH: -- units Temperature: -- °F Conductivity: -- µS/cm Detergents: -- mg/L		Floatables: None Odor: None Turbidity: None Color: None Gross Solids: None Vegetation: None Benthic Growth: Slight Stains: None Non-illicit: Slight	<b>Notes</b> Outfall partially submerged - screened upstream at 13-2332 US1. Follow-up inspection for sampling - limited screening conducted.

o20191105140404.JPG <div style="text-align: center; font-size: 24pt; font-weight: bold;">2019</div>
			<b>Condition Assessment</b> Graffiti: None Erosion: None Deposition: None in. Damage: None

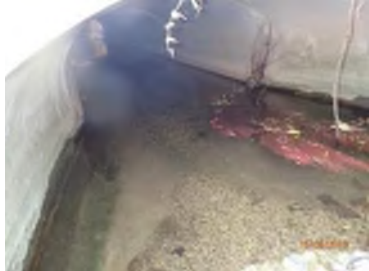
o20191008140758.jpg

<b>Inspection Date:</b> 10/8/2019 3:09:23 PM		<b>Type:</b> Ongoing	<b>Flow:</b> Submerged, indeterminate	<b>Previous Rainfall (hrs):</b> 48-72
<b>Illicit Discharge Potential:</b> <b>Potential</b>		<b>Inspector:</b> JCW	<b>Notes</b>	
Submerged: Partially      Depth (in): 19			Outfall partially submerged - screened upstream at 13-2332 US1. Detergent detected in upstream manhole.	
<b>Sampling Results</b>			<b>Condition Assessment</b>	
Sample Location:	Floatables:	None	Graffiti:	None
Total Chlorine: -- ppm	Odor:	None	Erosion:	None
Free Chlorine: -- ppm	Turbidity:	None	Deposition:	None in.
Ammonia: -- ppm	Color:	None	Damage:	None
pH: -- units	Gross Solids:	None		
Temperature -- °F	Vegetation:	None		
Conductivity: -- µS/cm	Benthic Growth:	Slight		
Detergents: -- mg/L	Stains:	None		
	Non-illicit:	Slight

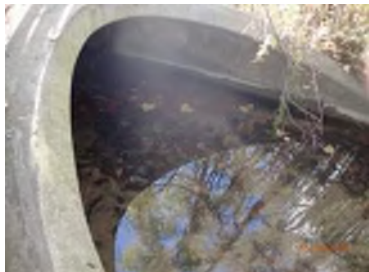
o20181024151710.JPG

<b>Inspection Date:</b> 10/24/2018 3:19:11 PM		<b>Type:</b> Ongoing	<b>Flow:</b> Submerged, slight flow	<b>Previous Rainfall (hrs):</b> 72+
<b>Illicit Discharge Potential:</b> <b>Potential</b>		<b>Inspector:</b> JCW	<b>Notes</b>	
Submerged: Partially      Depth (in): 11			Outfall partially submerged - screened upstream at 13-2332 US1. Detergent detected in upstream manhole.	
<b>Sampling Results</b>			<b>Condition Assessment</b>	
Sample Location:	Floatables:	None	Graffiti:	None
Total Chlorine: -- ppm	Odor:	Faint	Erosion:	None
Free Chlorine: -- ppm	Turbidity:	None	Deposition:	None in.
Ammonia: -- ppm	Color:	None	Damage:	None
pH: -- units	Gross Solids:	Moderate		
Temperature -- °F	Vegetation:	None		
Conductivity: -- µS/cm	Benthic Growth:	Slight		
Detergents: -- mg/L	Stains:	Moderate		
	Non-illicit:	None

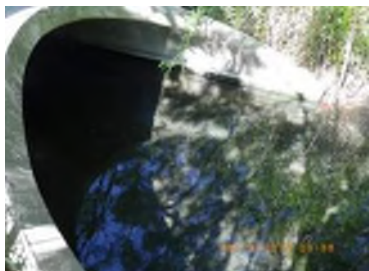
o20120612083850.JPG

<b>Inspection Date:</b> 6/12/2012 9:35:59 AM		<b>Type:</b> Ongoing	<b>Flow:</b> Submerged, slight flow	<b>Previous Rainfall (hrs):</b> 72+
<b>Illicit Discharge Potential:</b> <b>Unlikely</b>		<b>Inspector:</b> JCW	<b>Notes</b>	
Submerged: Partially      Depth (in): 14			Outfall partially submerged; screened upstream at 13-2332 US1.	
<b>Sampling Results</b>			<b>Condition Assessment</b>	
Sample Location:	Floatables:	None	Graffiti:	None
Total Chlorine: -- ppm	Odor:	None	Erosion:	None
Free Chlorine: -- ppm	Turbidity:	None	Deposition:	None in.
Ammonia: -- ppm	Color:	None	Damage:	None
pH: -- units	Gross Solids:	Slight		
Temperature -- °F	Vegetation:	None		
Conductivity: -- µS/cm	Benthic Growth:	Moderate		
Detergents: -- mg/L	Stains:	None		
	Non-illicit:	None

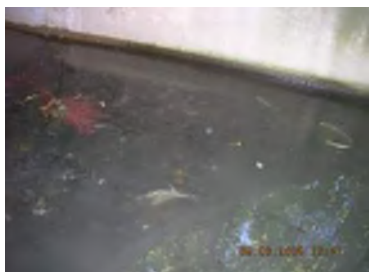
Osh09\_DSCN6437.JPG

<b>Inspection Date:</b> 9/3/2009		<b>Type:</b> Initial	<b>Flow:</b> Submerged, slight flow	<b>Previous Rainfall (hrs):</b> 72+
<b>Illicit Discharge Potential:</b> <b>Unlikely</b>		<b>Inspector:</b> JCW	<b>Notes</b>	
Submerged: Partially      Depth (in): 15				
<b>Sampling Results</b>			<b>Condition Assessment</b>	
Sample Location:	Floatables:	None	Graffiti:	None
Total Chlorine: -- ppm	Odor:	Faint	Erosion:	None
Free Chlorine: -- ppm	Turbidity:	None	Deposition:	8 in.
Ammonia: -- ppm	Color:	None	Damage:	None
pH: -- units	Gross Solids:	None		
Temperature -- °F	Vegetation:			
Conductivity: -- µS/cm	Benthic Growth:	Slight		
Detergents: -- mg/L	Stains:			
	Non-illicit:	None

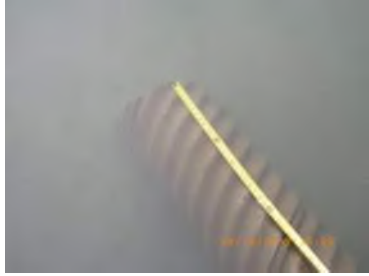
<b>Inspection Date:</b> 6/13/2012 9:59:36 AM		<b>Type:</b> Other	<b>Flow:</b> Submerged, indeterminate	<b>Previous Rainfall (hrs):</b> 72+
<b>Illicit Discharge Potential:</b> Potential		<b>Inspector:</b> JCW		
Submerged: Fully		Depth (in): 14		
<b>Sampling Results</b> Sample Location: Total Chlorine: -- ppm Free Chlorine: -- ppm Ammonia: -- ppm pH: -- units Temperature: -- °F Conductivity: -- µS/cm Detergents: -- mg/L		Floatables: None Odor: None Turbidity: None Color: None Gross Solids: None Vegetation: None Benthic Growth: None Stains: None Non-illicit: None	<b>Notes</b> Gross solids pre-screen. Outfall fully submerged; screened upstream at 13-3427 US1.  <b>Condition Assessment</b> Graffiti: None Erosion: None Deposition: None in. Damage: None

o20120613090224.JPG <b>2012</b>

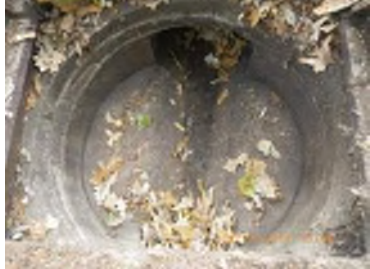
<b>Inspection Date:</b> 9/27/2012 10:41:20 AM		<b>Type:</b> Ongoing	<b>Flow:</b> None	<b>Previous Rainfall (hrs):</b> 72+
<b>Illicit Discharge Potential:</b> Unlikely		<b>Inspector:</b> JCW		
<b>Submerged:</b> None		<b>Depth (in):</b>		
<b>Sampling Results</b> Sample Location: _____ Total Chlorine: -- ppm Free Chlorine: -- ppm Ammonia: -- ppm pH: -- units Temperature: -- °F Conductivity: -- µS/cm Detergents: -- mg/L		Floatables: None Odor: None Turbidity: None Color: None Gross Solids: None Vegetation: None Benthic Growth: None Stains: None Non-illicit: None	<b>Notes</b> Inlet dry at time of inspection.  <b>Condition Assessment</b> Graffiti: None Erosion: None Deposition: None in. Damage: None

o20120927094518.JPG <div style="text-align: center; font-size: 24pt; font-weight: bold;">2012</div>

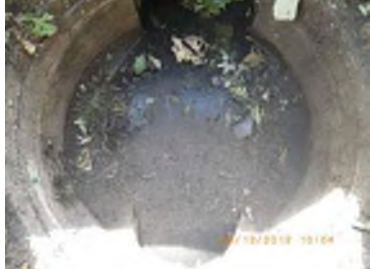
<b>Inspection Date:</b> 6/13/2012 10:02:18 AM		<b>Type:</b> Other	<b>Flow:</b> Submerged, indeterminate	<b>Previous Rainfall (hrs):</b> 72+
<b>Illicit Discharge Potential:</b> Potential		<b>Inspector:</b> JCW		
<b>Submerged:</b> Partially		<b>Depth (in):</b> 5		
<b>Sampling Results</b> Sample Location: Pool Total Chlorine: 0 ppm Free Chlorine: 0 ppm Ammonia: 1 ppm pH: 7.3 units Temperature: 74 °F Conductivity: 1429 µS/cm Detergents: 0 mg/L		Floatables: None Odor: None Turbidity: Cloudy Color: None Gross Solids: Moderate Vegetation: None Benthic Growth: None Stains: None Non-illicit: None	<b>Notes</b> Gross solids pre-screen.  <b>Condition Assessment</b> Graffiti: None Erosion: None Deposition: Moderate 2 in. Damage: None

o20120613090436.JPG <div style="text-align: center; font-size: 24pt; font-weight: bold;">2012</div>

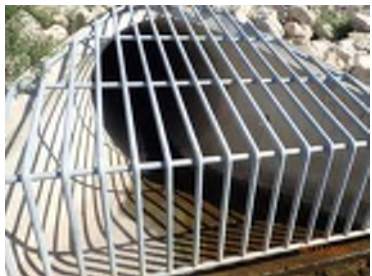
<b>Inspection Date:</b> 8/22/2022 9:46:00 AM		<b>Type:</b> Ongoing	<b>Flow:</b> Trickle	<b>Previous Rainfall (hrs):</b> 72+
<b>Illicit Discharge Potential:</b> Unlikely		<b>Inspector:</b> EJK		
<b>Submerged:</b> None		<b>Depth (in):</b>		
<b>Sampling Results</b> Sample Location: Flow Total Chlorine: 0 ppm Free Chlorine: 0 ppm Ammonia: 0 ppm pH: 7.64 units Temperature: 70 °F Conductivity: 162 µS/cm Detergents: 0 mg/L		Floatables: None Odor: None Turbidity: None Color: None Gross Solids: None Vegetation: None Benthic Growth: Slight Stains: Slight Non-illicit: None	<b>Notes</b> Sample collected from pipe flow.  <b>Condition Assessment</b> Graffiti: None Erosion: None Deposition: None in. Damage: None

o20220822094500.JPG <div style="text-align: center; font-size: 24pt; font-weight: bold;">2022</div>

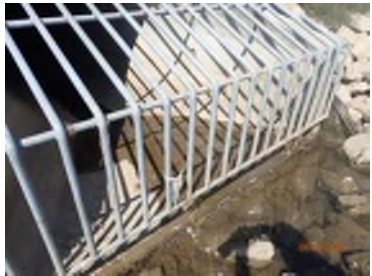
<b>Inspection Date:</b> 8/23/2021 2:58:26 PM		<b>Type:</b> Ongoing	<b>Flow:</b> Trickle	<b>Previous Rainfall (hrs):</b> 72+
<b>Illicit Discharge Potential:</b> Unlikely		<b>Inspector:</b> JCW		
<b>Submerged:</b> None		<b>Depth (in):</b>		
<b>Sampling Results</b> Sample Location: Flow Total Chlorine: 0 ppm Free Chlorine: 0 ppm Ammonia: 0 ppm pH: 7.31 units Temperature: 82 °F Conductivity: 1720 µS/cm Detergents: 0 mg/L		Floatables: None Odor: None Turbidity: None Color: None Gross Solids: None Vegetation: None Benthic Growth: Slight Stains: Slight Non-illicit: Slight	<b>Notes</b> Sample collected from pipe flow.  <b>Condition Assessment</b> Graffiti: None Erosion: None Deposition: None in. Damage: None

o20210823145642.JPG <div style="text-align: center; font-size: 24pt; font-weight: bold;">2021</div>

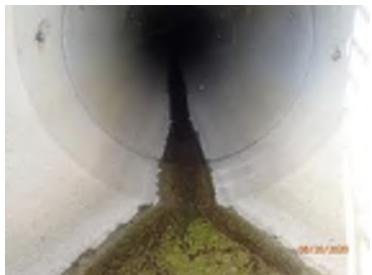
<b>Inspection Date:</b> 8/20/2020 4:09:06 PM		<b>Type:</b> Ongoing	<b>Flow:</b> Trickle	<b>Previous Rainfall (hrs):</b> 72+
<b>Illicit Discharge Potential:</b> Unlikely		<b>Inspector:</b> JCW		
<b>Submerged:</b> None		<b>Depth (in):</b>		
<b>Sampling Results</b> Sample Location: Flow Total Chlorine: 0 ppm Free Chlorine: 0 ppm Ammonia: 0 ppm pH: 7.91 units Temperature: 79 °F Conductivity: 1889 µS/cm Detergents: 0 mg/L		Floatables: Moderate Odor: None Turbidity: None Color: None Gross Solids: None Vegetation: None Benthic Growth: Moderate Stains: Slight Non-illicit: None	<b>Notes</b> Sample collected from pipe flow.  <b>Condition Assessment</b> Graffiti: None Erosion: None Deposition: None in. Damage: None

o20200820160626.JPG <div style="text-align: center; font-size: 24pt; font-weight: bold;">2020</div>

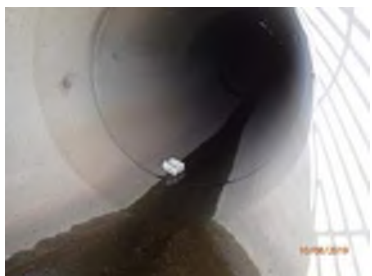
<b>Inspection Date:</b> 10/8/2019 4:01:14 PM		<b>Type:</b> Ongoing	<b>Flow:</b> Moderate	<b>Previous Rainfall (hrs):</b> 48-72
<b>Illicit Discharge Potential:</b> Potential		<b>Inspector:</b> JCW		
<b>Submerged:</b> None		<b>Depth (in):</b>		
<b>Sampling Results</b> Sample Location: Flow Total Chlorine: 0 ppm Free Chlorine: 0 ppm Ammonia: 0 ppm pH: 7.66 units Temperature: 65 °F Conductivity: 2470 µS/cm Detergents: 0 mg/L		Floatables: None Odor: None Turbidity: None Color: None Gross Solids: None Vegetation: None Benthic Growth: Moderate Stains: None Non-illicit: None	<b>Notes</b> Sample collected from submerged flow at end of pipe. Elevated conductivity.  <b>Condition Assessment</b> Graffiti: None Erosion: None Deposition: None in. Damage: None

o20191008145924.JPG <div style="text-align: center; font-size: 24pt; font-weight: bold;">2019</div>
