# Submittal of Annual Reports and Other Compliance Documents for Municipal Separate Storm Sewer System (MS4) Permits

**Project Name:** 2023 Annual Report

**Municipality:** Oshkosh, City

**Permit Number:** S050075

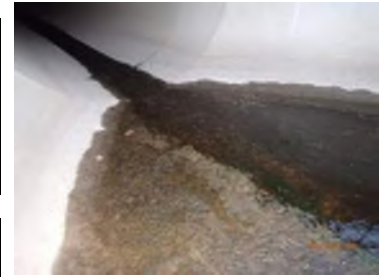
o20181025072226.JPG

<b>Inspection Date:</b> 10/26/2018 12:50:27 PM		<b>Type:</b> Repeat	<b>Flow:</b> Trickle	<b>Previous Rainfall (hrs):</b> 72+	
<b>Illicit Discharge Potential:</b> <b>Potential</b>		<b>Inspector:</b> KMK	<b>Notes</b>		
Submerged: None		Depth (in):	Detergent detection follow-up. Limited screening conducted beyond sampling.		
<b>Sampling Results</b>		Floatables:	<b>Condition Assessment</b> Graffiti: None Erosion: None Deposition: None in. Damage: None		
Sample Location:	Flow	Odor:			None
Total Chlorine:	0 ppm	Turbidity:			None
Free Chlorine:	0 ppm	Color:			None
Ammonia:	0 ppm	Gross Solids:			None
pH:	7.91 units	Vegetation:			None
Temperature	56 °F	Benthic Growth:			None
Conductivity:	1745 µS/cm	Stains:			Slight
Detergents:	0.85 mg/L	Non-illicit:			None

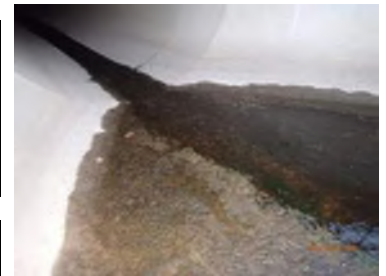
o20181025072226.JPG

<b>Inspection Date:</b> 10/25/2018 7:24:13 AM		<b>Type:</b> Ongoing	<b>Flow:</b> Trickle	<b>Previous Rainfall (hrs):</b> 72+	
<b>Illicit Discharge Potential:</b> <b>Potential</b>		<b>Inspector:</b> JCW	<b>Notes</b>		
Submerged: None		Depth (in):	Sample collected from submerged flow at end of pipe. Detergent detected.		
<b>Sampling Results</b>		Floatables:	<b>Condition Assessment</b> Graffiti: None Erosion: None Deposition: None in. Damage: None		
Sample Location:	Flow	Odor:			None
Total Chlorine:	0 ppm	Turbidity:			None
Free Chlorine:	0 ppm	Color:			None
Ammonia:	0 ppm	Gross Solids:			None
pH:	7.94 units	Vegetation:			None
Temperature	49 °F	Benthic Growth:			Moderate
Conductivity:	1865 µS/cm	Stains:			Slight
Detergents:	0.45 mg/L	Non-illicit:			None

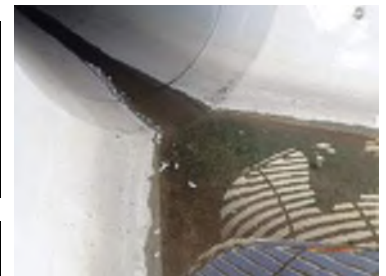
o20171018161638.JPG

<b>Inspection Date:</b> 10/18/2017 4:20:44 PM		<b>Type:</b> Ongoing	<b>Flow:</b> Submerged, slight flow	<b>Previous Rainfall (hrs):</b> 72+	
<b>Illicit Discharge Potential:</b> <b>Unlikely</b>		<b>Inspector:</b> JCW	<b>Notes</b>		
Submerged: Partially		Depth (in): 1	Sample collected from submerged flow at end of pipe.		
<b>Sampling Results</b>		Floatables:	<b>Condition Assessment</b> Graffiti: None Erosion: None Deposition: None in. Damage: None		
Sample Location:	Flow	Odor:			None
Total Chlorine:	0 ppm	Turbidity:			None
Free Chlorine:	0 ppm	Color:			None
Ammonia:	0 ppm	Gross Solids:			None
pH:	7.88 units	Vegetation:			None
Temperature	67 °F	Benthic Growth:			Moderate
Conductivity:	1262 µS/cm	Stains:			Slight
Detergents:	0 mg/L	Non-illicit:			None

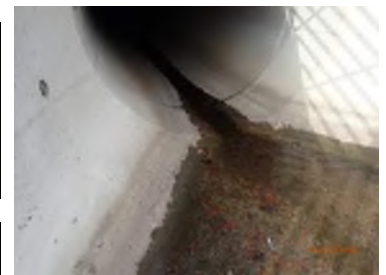
o20161019151808.JPG

<b>Inspection Date:</b> 10/19/2016 3:20:01 PM		<b>Type:</b> Ongoing	<b>Flow:</b> Trickle	<b>Previous Rainfall (hrs):</b> 72+	
<b>Illicit Discharge Potential:</b> <b>Unlikely</b>		<b>Inspector:</b> JCW	<b>Notes</b>		
Submerged: None		Depth (in):			
<b>Sampling Results</b>		Floatables:	<b>Condition Assessment</b> Graffiti: None Erosion: None Deposition: None in. Damage: None		
Sample Location:	Flow	Odor:			None
Total Chlorine:	0 ppm	Turbidity:			None
Free Chlorine:	0 ppm	Color:			None
Ammonia:	0 ppm	Gross Solids:			Slight
pH:	8.07 units	Vegetation:			None
Temperature	66 °F	Benthic Growth:			Moderate
Conductivity:	1396 µS/cm	Stains:			Slight
Detergents:	0 mg/L	Non-illicit:			None

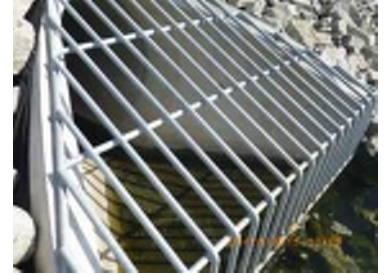
o20150928090940.JPG

Sample Location: Flow	Floatables: Slight																					
Total Chlorine: 0 ppm	Odor: None																					
Free Chlorine: 0 ppm	Turbidity: None																					
Ammonia: 0 ppm	Color: None																					
pH: 8.07 units	Gross Solids: None																					
Temperature: 70 °F	Vegetation: None																					
Conductivity: 455 µS/cm	Benthic Growth: Moderate																					
Detergents: 0 mg/L	Stains: Slight																					
	Non-illicit: None																					
		<b>Condition Assessment</b> <table border="1" style="width: 100%; border-collapse: collapse;"> <tr> <td style="width: 50%;">Graffiti: None</td> <td style="width: 50%;"></td> </tr> <tr> <td>Erosion: None</td> <td></td> </tr> <tr> <td>Deposition: None</td> <td>in.</td> </tr> <tr> <td>Damage: None</td> <td></td> </tr> </table>			Graffiti: None		Erosion: None		Deposition: None	in.	Damage: None											
Graffiti: None

Erosion: None																						
Deposition: None	in.																					
Damage: None

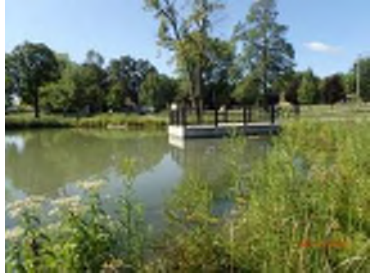
<b>Inspection Date:</b> 8/22/2022 10:20:00 AM		<b>Type:</b> Ongoing	<b>Flow:</b> Submerged, indeterminate	<b>Previous Rainfall (hrs):</b> 72+
<b>Illicit Discharge Potential:</b> Unlikely		<b>Inspector:</b> EJK		
Submerged: Fully		Depth (in):		
<b>Sampling Results</b> Sample Location: _____ Total Chlorine: -- ppm Free Chlorine: -- ppm Ammonia: -- ppm pH: -- units Temperature: -- °F Conductivity: -- µS/cm Detergents: -- mg/L		Floatables: None Odor: None Turbidity: None Color: None Gross Solids: None Vegetation: None Benthic Growth: None Stains: None Non-illicit: None		
		<b>Notes</b> Outfall fully submerged - screened upstream at 13-4012 US1.		
		<b>Condition Assessment</b> Graffiti: None Erosion: None Deposition: None in. Damage: None

o20220822101316.JPG <div style="text-align: center; font-size: 24pt; font-weight: bold;">2022</div>

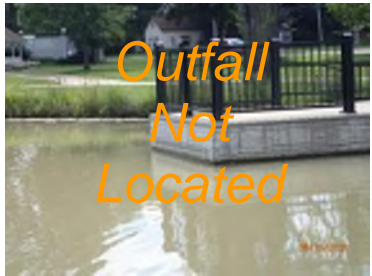
<b>Inspection Date:</b> 8/16/2021 1:47:39 PM		<b>Type:</b> Ongoing	<b>Flow:</b> Submerged (not located)	<b>Previous Rainfall (hrs):</b> 72+
<b>Illicit Discharge Potential:</b> Unlikely		<b>Inspector:</b> JCW		
Submerged: Fully		Depth (in):		
<b>Sampling Results</b> Sample Location: _____ Total Chlorine: -- ppm Free Chlorine: -- ppm Ammonia: -- ppm pH: -- units Temperature: -- °F Conductivity: -- µS/cm Detergents: -- mg/L		Floatables: None Odor: None Turbidity: None Color: None Gross Solids: None Vegetation: None Benthic Growth: None Stains: None Non-illicit: None		
		<b>Notes</b> Outfall fully submerged and not located - screened upstream at 13-4012 US1.		
		<b>Condition Assessment</b> Graffiti: None Erosion: None Deposition: None in. Damage: None

o20210816134612.JPG <div style="text-align: center; font-size: 24pt; font-weight: bold;">2021</div>

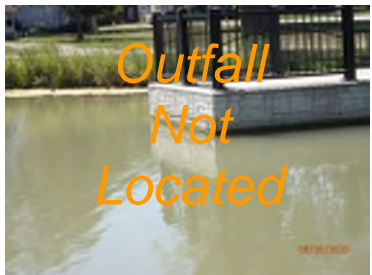
o20200820122132.JPG <div style="text-align: center; font-size: 24pt; font-weight: bold;">2020</div>

<b>Inspection Date:</b> 8/20/2020 12:23:12 PM		<b>Type:</b> Ongoing	<b>Flow:</b> Submerged (not located)	<b>Previous Rainfall (hrs):</b> 72+
<b>Illicit Discharge Potential:</b> Unlikely		<b>Inspector:</b> JCW		
Submerged: Fully		Depth (in):		
<b>Sampling Results</b> Sample Location: _____ Total Chlorine: -- ppm Free Chlorine: -- ppm Ammonia: -- ppm pH: -- units Temperature: -- °F Conductivity: -- µS/cm Detergents: -- mg/L		Floatables: None Odor: None Turbidity: None Color: None Gross Solids: None Vegetation: None Benthic Growth: None Stains: None Non-illicit: None		
		<b>Notes</b> Outfall fully submerged and not located - screened upstream at 13-2957 US1.		
		<b>Condition Assessment</b> Graffiti: None Erosion: None Deposition: None in. Damage: None

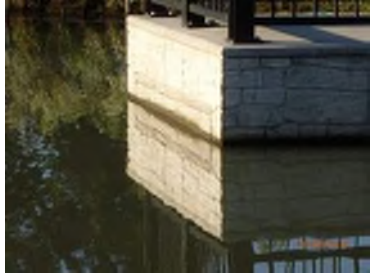
o20191008071216.JPG

<b>Inspection Date:</b> 10/8/2019 8:14:46 AM		<b>Type:</b> Repeat	<b>Flow:</b> Submerged, indeterminate	<b>Previous Rainfall (hrs):</b> 48-72
<b>Illicit Discharge Potential:</b> Unlikely		<b>Inspector:</b> JCW	<b>Notes</b>	
<b>Submerged:</b> Fully		<b>Depth (in):</b>	Detergent detection follow-up. Limited screening conducted beyond sampling. No detergent in follow-up sample.	
<b>Sampling Results</b>		<b>Floatables:</b>	<b>Condition Assessment</b>	
Sample Location:		None	Graffiti: None	
Total Chlorine: -- ppm		Odor: None	Erosion: None	
Free Chlorine: -- ppm		Turbidity: None	Deposition: None in.	
Ammonia: -- ppm		Color: None	Damage: None	
pH: -- units		Gross Solids: None		
Temperature -- °F		Vegetation: None		
Conductivity: -- µS/cm		Benthic Growth: None		
Detergents: -- mg/L		Stains: None		
		Non-illicit: None

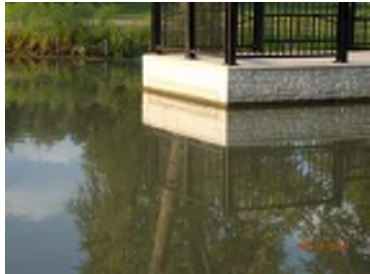
o20190918063134.JPG

<b>Inspection Date:</b> 9/18/2019 7:32:53 AM		<b>Type:</b> Ongoing	<b>Flow:</b> Submerged, indeterminate	<b>Previous Rainfall (hrs):</b> 72+
<b>Illicit Discharge Potential:</b> Potential		<b>Inspector:</b> JCW	<b>Notes</b>	
<b>Submerged:</b> Fully		<b>Depth (in):</b>	Outfall inaccessible - screened upstream at 13-2957 US1a. Detergent in upstream manhole.	
<b>Sampling Results</b>		<b>Floatables:</b>	<b>Condition Assessment</b>	
Sample Location:		None	Graffiti: None	
Total Chlorine: -- ppm		Odor: None	Erosion: None	
Free Chlorine: -- ppm		Turbidity: None	Deposition: None in.	
Ammonia: -- ppm		Color: None	Damage: None	
pH: -- units		Gross Solids: None		
Temperature -- °F		Vegetation: None		
Conductivity: -- µS/cm		Benthic Growth: None		
Detergents: -- mg/L		Stains: None		
		Non-illicit: None

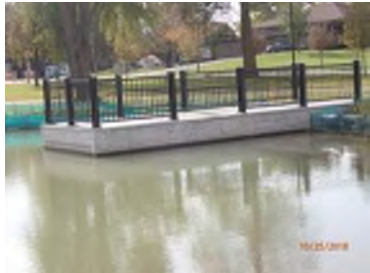
o20181025131742.JPG

<b>Inspection Date:</b> 10/25/2018 1:17:00 PM		<b>Type:</b> Ongoing	<b>Flow:</b> Submerged, indeterminate	<b>Previous Rainfall (hrs):</b> 72+
<b>Illicit Discharge Potential:</b> Unlikely		<b>Inspector:</b> JCW	<b>Notes</b>	
<b>Submerged:</b> Partially		<b>Depth (in):</b>	Outfall inaccessible - screened upstream at 13-2957 US1a.	
<b>Sampling Results</b>		<b>Floatables:</b>	<b>Condition Assessment</b>	
Sample Location:		None	Graffiti: None	
Total Chlorine: -- ppm		Odor: None	Erosion: None	
Free Chlorine: -- ppm		Turbidity: None	Deposition: None in.	
Ammonia: -- ppm		Color: None	Damage: None	
pH: -- units		Gross Solids: None		
Temperature -- °F		Vegetation: None		
Conductivity: -- µS/cm		Benthic Growth: None		
Detergents: -- mg/L		Stains: None		
		Non-illicit: None

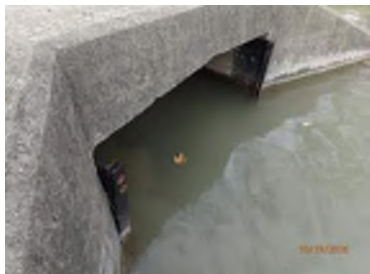
o20161019134018.JPG

<b>Inspection Date:</b> 10/19/2016 1:42:21 PM		<b>Type:</b> Ongoing	<b>Flow:</b> Submerged, indeterminate	<b>Previous Rainfall (hrs):</b> 72+
<b>Illicit Discharge Potential:</b> Unlikely		<b>Inspector:</b> JCW	<b>Notes</b>	
<b>Submerged:</b> Partially		<b>Depth (in):</b> 19	Outfall partially submerged - screened upstream at 13-2957 US1.	
<b>Sampling Results</b>		<b>Floatables:</b>	<b>Condition Assessment</b>	
Sample Location:		None	Graffiti: None	
Total Chlorine: -- ppm		Odor: None	Erosion: None	
Free Chlorine: -- ppm		Turbidity: Cloudy	Deposition: None in.	
Ammonia: -- ppm		Color: None	Damage: None	
pH: -- units		Gross Solids: None		
Temperature -- °F		Vegetation: None		
Conductivity: -- µS/cm		Benthic Growth: Moderate		
Detergents: -- mg/L		Stains: Moderate		
		Non-illicit: None

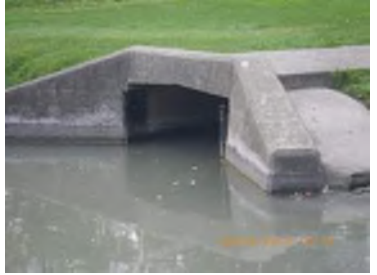
o20150924121536.JPG <div style="text-align: center; font-size: 1.5em; font-weight: bold;">2015</div>

<b>Inspection Date:</b> 9/24/2015 1:12:45 PM		<b>Type:</b> Ongoing	<b>Flow:</b> Submerged, indeterminate	<b>Previous Rainfall (hrs):</b> 72+																																		
<b>Illicit Discharge Potential:</b> Unlikely		<b>Inspector:</b> JCW	<b>Notes</b> Outfall partially submerged - screened at 13-2957 US1.																																			
<b>Submerged:</b> Partially <b>Depth (in):</b> 17																																						
<b>Sampling Results</b> <table border="1" style="width:100%; border-collapse: collapse;"> <tr> <td style="width:50%;">Sample Location:</td> <td style="width:50%;">Floatables:</td> <td>None</td> </tr> <tr> <td>Total Chlorine: -- ppm</td> <td>Odor:</td> <td>None</td> </tr> <tr> <td>Free Chlorine: -- ppm</td> <td>Turbidity:</td> <td>Cloudy</td> </tr> <tr> <td>Ammonia: -- ppm</td> <td>Color:</td> <td>None</td> </tr> <tr> <td>pH: -- units</td> <td>Gross Solids:</td> <td>None</td> </tr> <tr> <td>Temperature -- °F</td> <td>Vegetation:</td> <td>None</td> </tr> <tr> <td>Conductivity: -- µS/cm</td> <td>Benthic Growth:</td> <td>Moderate</td> </tr> <tr> <td>Detergents: -- mg/L</td> <td>Stains:</td> <td>None</td> </tr> <tr> <td></td> <td>Non-illicit:</td> <td>None</td> </tr> </table>		Sample Location:	Floatables:	None	Total Chlorine: -- ppm	Odor:	None	Free Chlorine: -- ppm	Turbidity:	Cloudy	Ammonia: -- ppm	Color:	None	pH: -- units	Gross Solids:	None	Temperature -- °F	Vegetation:	None	Conductivity: -- µS/cm	Benthic Growth:	Moderate	Detergents: -- mg/L	Stains:	None		Non-illicit:	None	<b>Condition Assessment</b> <table border="1" style="width:100%; border-collapse: collapse;"> <tr> <td style="width:50%;">Graffiti:</td> <td style="width:50%;">None</td> </tr> <tr> <td>Erosion:</td> <td>None</td> </tr> <tr> <td>Deposition:</td> <td>None in.</td> </tr> <tr> <td>Damage:</td> <td>None</td> </tr> </table>		Graffiti:	None	Erosion:	None	Deposition:	None in.	Damage:	None

Sample Location:	Floatables:	None																																				
Total Chlorine: -- ppm	Odor:	None																																				
Free Chlorine: -- ppm	Turbidity:	Cloudy																																				
Ammonia: -- ppm	Color:	None																																				
pH: -- units	Gross Solids:	None																																				
Temperature -- °F	Vegetation:	None																																				
Conductivity: -- µS/cm	Benthic Growth:	Moderate																																				
Detergents: -- mg/L	Stains:	None																																				
	Non-illicit:	None																																				
Graffiti:	None																																					
Erosion:	None																																					
Deposition:	None in.																																					
Damage:	None

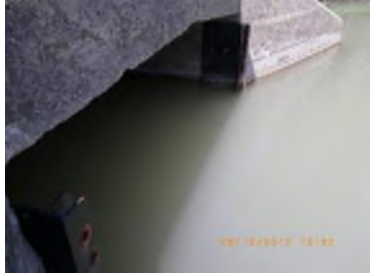
o20120612123258.JPG <div style="text-align: center; font-size: 1.5em; font-weight: bold;">2012</div>

<b>Inspection Date:</b> 6/12/2012 1:30:43 PM		<b>Type:</b> Ongoing	<b>Flow:</b> Submerged, indeterminate	<b>Previous Rainfall (hrs):</b> 72+																																		
<b>Illicit Discharge Potential:</b> Unlikely		<b>Inspector:</b> JCW	<b>Notes</b> Outfall partially submerged; screened upstream at 13-2957 US1.																																			
<b>Submerged:</b> Partially <b>Depth (in):</b> 21																																						
<b>Sampling Results</b> <table border="1" style="width:100%; border-collapse: collapse;"> <tr> <td style="width:50%;">Sample Location:</td> <td style="width:50%;">Floatables:</td> <td>None</td> </tr> <tr> <td>Total Chlorine: -- ppm</td> <td>Odor:</td> <td>None</td> </tr> <tr> <td>Free Chlorine: -- ppm</td> <td>Turbidity:</td> <td>None</td> </tr> <tr> <td>Ammonia: -- ppm</td> <td>Color:</td> <td>None</td> </tr> <tr> <td>pH: -- units</td> <td>Gross Solids:</td> <td>None</td> </tr> <tr> <td>Temperature -- °F</td> <td>Vegetation:</td> <td>None</td> </tr> <tr> <td>Conductivity: -- µS/cm</td> <td>Benthic Growth:</td> <td>Moderate</td> </tr> <tr> <td>Detergents: -- mg/L</td> <td>Stains:</td> <td>Moderate</td> </tr> <tr> <td></td> <td>Non-illicit:</td> <td>None</td> </tr> </table>		Sample Location:	Floatables:	None	Total Chlorine: -- ppm	Odor:	None	Free Chlorine: -- ppm	Turbidity:	None	Ammonia: -- ppm	Color:	None	pH: -- units	Gross Solids:	None	Temperature -- °F	Vegetation:	None	Conductivity: -- µS/cm	Benthic Growth:	Moderate	Detergents: -- mg/L	Stains:	Moderate		Non-illicit:	None	<b>Condition Assessment</b> <table border="1" style="width:100%; border-collapse: collapse;"> <tr> <td style="width:50%;">Graffiti:</td> <td style="width:50%;">Minor</td> </tr> <tr> <td>Erosion:</td> <td>None</td> </tr> <tr> <td>Deposition:</td> <td>None in.</td> </tr> <tr> <td>Damage:</td> <td>None</td> </tr> </table>		Graffiti:	Minor	Erosion:	None	Deposition:	None in.	Damage:	None

Sample Location:	Floatables:	None																																				
Total Chlorine: -- ppm	Odor:	None																																				
Free Chlorine: -- ppm	Turbidity:	None																																				
Ammonia: -- ppm	Color:	None																																				
pH: -- units	Gross Solids:	None																																				
Temperature -- °F	Vegetation:	None																																				
Conductivity: -- µS/cm	Benthic Growth:	Moderate																																				
Detergents: -- mg/L	Stains:	Moderate																																				
	Non-illicit:	None																																				
Graffiti:	Minor																																					
Erosion:	None																																					
Deposition:	None in.																																					
Damage:	None

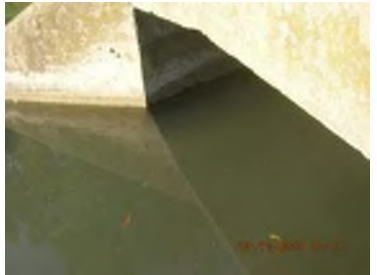
Osh09_DSCN6483.JPG <div style="text-align: center; font-size: 1.5em; font-weight: bold;">2009</div>

<b>Inspection Date:</b> 9/4/2009		<b>Type:</b> Initial	<b>Flow:</b> Submerged, slight flow	<b>Previous Rainfall (hrs):</b> 72+																																		
<b>Illicit Discharge Potential:</b> Unlikely		<b>Inspector:</b> JCW	<b>Notes</b> 																																			
<b>Submerged:</b> None <b>Depth (in):</b> 16																																						
<b>Sampling Results</b> <table border="1" style="width:100%; border-collapse: collapse;"> <tr> <td style="width:50%;">Sample Location:</td> <td style="width:50%;">Floatables:</td> <td>None</td> </tr> <tr> <td>Total Chlorine: -- ppm</td> <td>Odor:</td> <td>None</td> </tr> <tr> <td>Free Chlorine: -- ppm</td> <td>Turbidity:</td> <td>None</td> </tr> <tr> <td>Ammonia: -- ppm</td> <td>Color:</td> <td>None</td> </tr> <tr> <td>pH: -- units</td> <td>Gross Solids:</td> <td>None</td> </tr> <tr> <td>Temperature -- °F</td> <td>Vegetation:</td> <td></td> </tr> <tr> <td>Conductivity: -- µS/cm</td> <td>Benthic Growth:</td> <td>Slight</td> </tr> <tr> <td>Detergents: -- mg/L</td> <td>Stains:</td> <td></td> </tr> <tr> <td></td> <td>Non-illicit:</td> <td>None</td> </tr> </table>		Sample Location:	Floatables:	None	Total Chlorine: -- ppm	Odor:	None	Free Chlorine: -- ppm	Turbidity:	None	Ammonia: -- ppm	Color:	None	pH: -- units	Gross Solids:	None	Temperature -- °F	Vegetation:		Conductivity: -- µS/cm	Benthic Growth:	Slight	Detergents: -- mg/L	Stains:			Non-illicit:	None	<b>Condition Assessment</b> <table border="1" style="width:100%; border-collapse: collapse;"> <tr> <td style="width:50%;">Graffiti:</td> <td style="width:50%;">None</td> </tr> <tr> <td>Erosion:</td> <td>None</td> </tr> <tr> <td>Deposition:</td> <td>None 0 in.</td> </tr> <tr> <td>Damage:</td> <td>None</td> </tr> </table>		Graffiti:	None	Erosion:	None	Deposition:	None 0 in.	Damage:	None

Sample Location:	Floatables:	None																																				
Total Chlorine: -- ppm	Odor:	None																																				
Free Chlorine: -- ppm	Turbidity:	None																																				
Ammonia: -- ppm	Color:	None																																				
pH: -- units	Gross Solids:	None																																				
Temperature -- °F	Vegetation:																																					
Conductivity: -- µS/cm	Benthic Growth:	Slight																																				
Detergents: -- mg/L	Stains:																																					
	Non-illicit:	None																																				
Graffiti:	None																																					
Erosion:	None																																					
Deposition:	None 0 in.																																					
Damage:	None

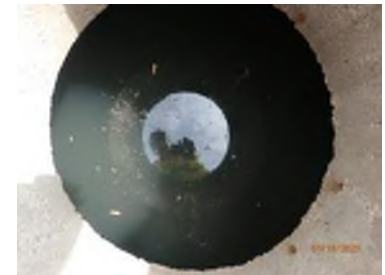
o20230719110556.JPG

**Inspection Date:** 7/19/2023 12:22:45 PM**Inspector:** JCW**Inspection Type:** Ongoing**Previous Rainfall (hrs):** 72+**Flow Description:** Submerged, indeterminate

Damage: None ☐ Displacement ☐ Undercut ☐ Crushed☐ Corrosion ☐ Cracks/Structural Damage

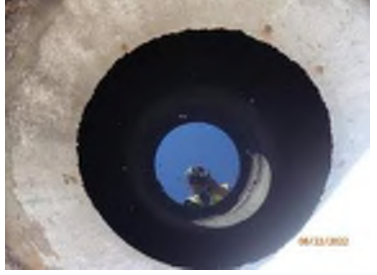
Inspection Date: 8/22/2022 10:21:00 AM		Type: Ongoing	Flow: Submerged, indeterminate	Previous Rainfall (hrs): 72+
<b>Illicit Discharge Potential: Unlikely</b> Submerged: Fully      Depth (in):		Inspector: EJK	Notes

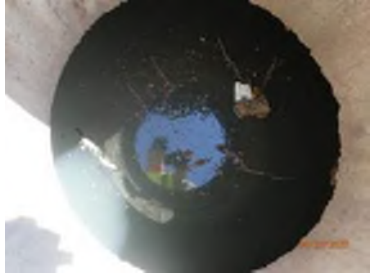
<b>Sampling Results</b> Sample Location: Pool Total Chlorine: 0 ppm Free Chlorine: 0 ppm Ammonia: 0 ppm pH: 7.4 units Temperature: 77 °F Conductivity: 1233 µS/cm Detergents: 0 mg/L		Floatables: None Odor: None Turbidity: Slight cloudiness Color: None Gross Solids: None Vegetation: None Benthic Growth: None Stains: None Non-illicit: None	Sample collected from submerged pool in manhole.  <b>Condition Assessment</b> Graffiti: None Erosion: None Deposition: None in. Damage: None	
<b>Inspection Date: 8/20/2020 12:29:26 PM</b>		Type: Ongoing	Flow: Submerged, indeterminate	Previous Rainfall (hrs): 72+
<b>Illicit Discharge Potential: Unlikely</b> Submerged: Fully      Depth (in): 57		Inspector: JCW	Notes

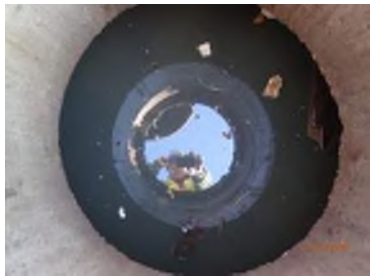
<b>Inspection Date: 11/5/2019 1:33:38 PM</b>		Type: Repeat	Flow: Submerged, indeterminate	Previous Rainfall (hrs): 48-72
<b>Illicit Discharge Potential: Potential</b> Submerged: Partially      Depth (in): 71		Inspector: JCW	Notes

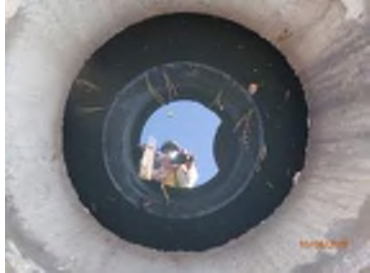
o20191008071514.JPG

<b>Inspection Date:</b> 10/8/2019 8:16:29 AM		<b>Type:</b> Repeat	<b>Flow:</b> Submerged, indeterminate	<b>Previous Rainfall (hrs):</b> 48-72
<b>Illicit Discharge Potential:</b> Unlikely		<b>Inspector:</b> JCW	<b>Notes</b>	
Submerged: Partially		Depth (in): 72	Detergent detection follow-up. Limited screening conducted beyond sampling. No detergent in follow-up sample.	
<b>Sampling Results</b>		<b>Floatables:</b>	<b>Condition Assessment</b>	
Sample Location: Flow		Odor: None	Graffiti: None	
Total Chlorine: 0 ppm		Turbidity: None	Erosion: None	
Free Chlorine: 0 ppm		Color: None	Deposition: None in.	
Ammonia: 0 ppm		Gross Solids: Slight	Damage: None	
pH: 7.65 units		Vegetation: None		
Temperature 55 °F		Benthic Growth: None		
Conductivity: 1354 µS/cm		Stains: None		
Detergents: 0 mg/L		Non-illicit: None

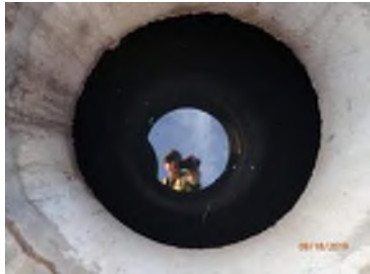
o20190918063424.JPG

<b>Inspection Date:</b> 9/18/2019 7:36:33 AM		<b>Type:</b> Ongoing	<b>Flow:</b> Submerged, indeterminate	<b>Previous Rainfall (hrs):</b> 72+
<b>Illicit Discharge Potential:</b> Potential		<b>Inspector:</b> JCW	<b>Notes</b>	
Submerged: Fully		Depth (in): 71	Sample collected from submerged pool in manhole. Detergent detected in sample.	
<b>Sampling Results</b>		<b>Floatables:</b>	<b>Condition Assessment</b>	
Sample Location: Pool		Odor: None	Graffiti: None	
Total Chlorine: 0 ppm		Turbidity: None	Erosion: None	
Free Chlorine: 0 ppm		Color: None	Deposition: None in.	
Ammonia: 0 ppm		Gross Solids: None	Damage: None	
pH: 7.9 units		Vegetation: None		
Temperature 70 °F		Benthic Growth: None		
Conductivity: 1265 µS/cm		Stains: None		
Detergents: 0.75 mg/L		Non-illicit: None

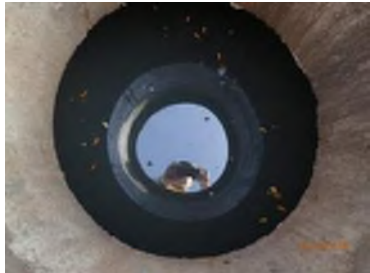
o20181025131952.JPG

<b>Inspection Date:</b> 10/25/2018 1:21:51 PM		<b>Type:</b> Ongoing	<b>Flow:</b> Submerged, indeterminate	<b>Previous Rainfall (hrs):</b> 72+
<b>Illicit Discharge Potential:</b> Unlikely		<b>Inspector:</b> JCW	<b>Notes</b>	
Submerged: Fully		Depth (in): 72	Sample collected from submerged pool in manhole.	
<b>Sampling Results</b>		<b>Floatables:</b>	<b>Condition Assessment</b>	
Sample Location: Pool		Odor: None	Graffiti: None	
Total Chlorine: 0 ppm		Turbidity: None	Erosion: None	
Free Chlorine: 0 ppm		Color: None	Deposition: None in.	
Ammonia: 0 ppm		Gross Solids: None	Damage: None	
pH: 7.81 units		Vegetation: None		
Temperature 56 °F		Benthic Growth: None		
Conductivity: 1178 µS/cm		Stains: None		
Detergents: 0 mg/L		Non-illicit: None

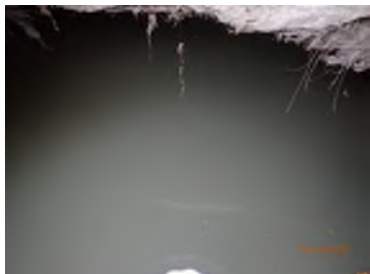
o20161019134250\_1.JPG

<b>Inspection Date:</b> 10/19/2016 1:45:38 PM		<b>Type:</b> Ongoing	<b>Flow:</b> Submerged, slight flow	<b>Previous Rainfall (hrs):</b> 72+
<b>Illicit Discharge Potential:</b> Unlikely		<b>Inspector:</b> JCW	<b>Notes</b>	
Submerged: Partially		Depth (in): 22	Screened at old location (13-2957 US1).	
<b>Sampling Results</b>		<b>Floatables:</b>	<b>Condition Assessment</b>	
Sample Location: Flow		Odor: None	Graffiti: None	
Total Chlorine: 0 ppm		Turbidity: Slight cloudiness	Erosion: None	
Free Chlorine: 0 ppm		Color: None	Deposition: None in.	
Ammonia: 0 ppm		Gross Solids: None	Damage: None	
pH: 7.98 units		Vegetation: None		
Temperature 65 °F		Benthic Growth: None		
Conductivity: 1234 µS/cm		Stains: None		
Detergents: 0 mg/L		Non-illicit: None

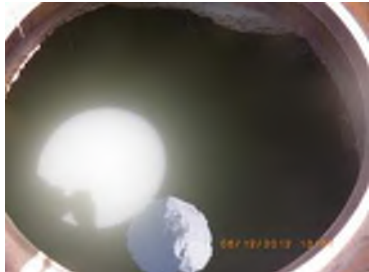
o20120612123728.JPG <b>2012</b>

<b>Inspection Date:</b> 6/12/2012 1:36:29 PM		<b>Type:</b> Ongoing	<b>Flow:</b> Submerged, indeterminate	<b>Previous Rainfall (hrs):</b> 72+
<b>Illicit Discharge Potential:</b> Unlikely		<b>Inspector:</b> JCW		
Submerged: Partially		Depth (in): 23		
<b>Sampling Results</b> Sample Location: Pool Total Chlorine: 0 ppm Free Chlorine: 0 ppm Ammonia: 0 ppm pH: 8.35 units Temperature: 71 °F Conductivity: 1336 µS/cm Detergents: 0 mg/L		Floatables: None Odor: None Turbidity: Slight cloudiness Color: None Gross Solids: None Vegetation: None Benthic Growth: None Stains: None Non-illicit: None	<b>Notes</b> Screened at old location (13-2957 US1).  <b>Condition Assessment</b> Graffiti: None Erosion: None Deposition: None in. Damage: None

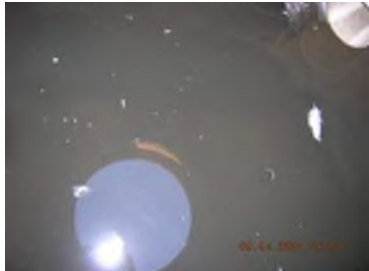
Osh09_DSCN6486.JPG <b>2009</b>

<b>Inspection Date:</b> 9/4/2009		<b>Type:</b> Initial	<b>Flow:</b> Submerged, slight flow	<b>Previous Rainfall (hrs):</b> 72+
<b>Illicit Discharge Potential:</b> Unlikely		<b>Inspector:</b> JCW		
Submerged: Fully		Depth (in):		
<b>Sampling Results</b> Sample Location: Pool Total Chlorine: 0 ppm Free Chlorine: 0 ppm Ammonia: -- ppm pH: 8.1 units Temperature: 66 °F Conductivity: -- µS/cm Detergents: 0 mg/L		Floatables: None Odor: None Turbidity: None Color: None Gross Solids: None Vegetation: Benthic Growth: Stains: Non-illicit: None	<b>Notes</b> Screened at old location (13-2957 US1).  <b>Condition Assessment</b> Graffiti: None Erosion: None Deposition: None 0 in. Damage: None

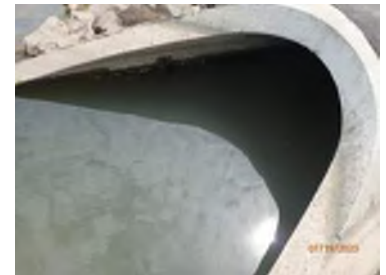
o20230719113004.JPG

Stains: Moderate

☐ Petrol. Sheen ☐ Suds ☐ Sewage ☐ Algae ☐ Other☐ Petroleum ☐ Musty ☐ Sewage ☐ Chlorine ☐ Other☐ VOC/Solvent ☐ Fishy ☐ Sulfur ☐ Fragrant☐ Litter ☐ Veg. Debris ☐ Sediment ☐ Other☐ Inhibited ☐ Excessive☒ Green ☐ Brown☒ Flow Line ☐ Oil ☐ Rust Stains☐ Paint ☐ Other☐ Natural Sheen ☐ Natural Suds/Foam

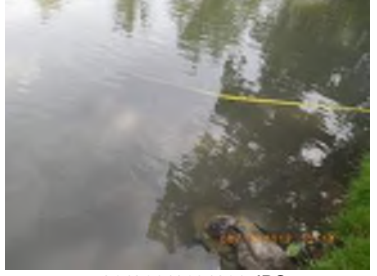
<p>o20120613091306.JPG</p> <p><b>2012</b></p>

Sample Location:																																		
Total Chlorine:	-- ppm																																	
Free Chlorine:	-- ppm																																	
Ammonia:	-- ppm																																	
pH:	-- units																																	
Temperature:	-- °F																																	
Conductivity:	-- µS/cm																																	
Detergents:	-- mg/L																																	
<b>Notes</b>																																		
Outfall pipes fully submerged; screened upstream at 13-819 US1.																																		
<b>Condition Assessment</b>																																		
Graffiti:	None																																	
Erosion:	None																																	
Deposition:	None in.																																	
Damage:	None

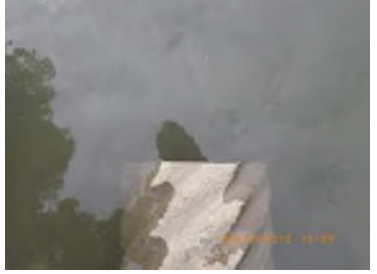
o20120927093556.JPG <div style="text-align: center; font-size: 24pt; font-weight: bold;">2012</div>

<b>Inspection Date:</b> 9/27/2012 10:31:48 AM		<b>Type:</b> Ongoing	<b>Flow:</b> Submerged, indeterminate	<b>Previous Rainfall (hrs):</b> 72+
<b>Illicit Discharge Potential:</b> Unlikely		<b>Inspector:</b> JCW		
Submerged: Partially		Depth (in): 11		
<b>Sampling Results</b> Sample Location: Total Chlorine: -- ppm Free Chlorine: -- ppm Ammonia: -- ppm pH: -- units Temperature: -- °F Conductivity: -- µS/cm Detergents: -- mg/L		Floatables: None Odor: None Turbidity: None Color: None Gross Solids: None Vegetation: None Benthic Growth: None Stains: None Non-illicit: None	<b>Notes</b>        <b>Condition Assessment</b> Graffiti: None Erosion: None Deposition: None in. Damage: None

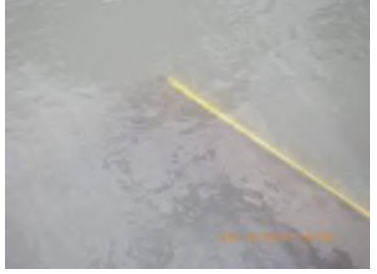
o20120612120442.JPG <div style="text-align: center; font-size: 24pt; font-weight: bold;">2012</div>

<b>Inspection Date:</b> 6/12/2012 1:04:23 PM		<b>Type:</b> Other	<b>Flow:</b> Submerged, indeterminate	<b>Previous Rainfall (hrs):</b> 72+
<b>Illicit Discharge Potential:</b> Unlikely		<b>Inspector:</b> JCW		
Submerged: Fully		Depth (in): 13		
<b>Sampling Results</b> Sample Location: Total Chlorine: -- ppm Free Chlorine: -- ppm Ammonia: -- ppm pH: -- units Temperature: -- °F Conductivity: -- µS/cm Detergents: -- mg/L		Floatables: None Odor: None Turbidity: None Color: None Gross Solids: None Vegetation: None Benthic Growth: None Stains: None Non-illicit: None	<b>Notes</b> Gross solids pre-screening. Outfall fully submerged; screened upstream at 13-3431 US1.

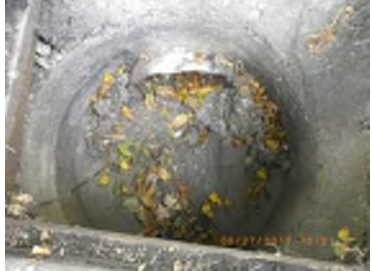
o20120927093152.JPG <div style="text-align: center; font-size: 24pt; font-weight: bold;">2012</div>

<b>Inspection Date:</b> 9/27/2012 10:29:26 AM		<b>Type:</b> Ongoing	<b>Flow:</b> None	<b>Previous Rainfall (hrs):</b> 72+
<b>Illicit Discharge Potential:</b> Unlikely		<b>Inspector:</b> JCW		
<b>Submerged:</b> None		<b>Depth (in):</b>		
<b>Sampling Results</b> Sample Location: --- Total Chlorine: -- ppm Free Chlorine: -- ppm Ammonia: -- ppm pH: -- units Temperature: -- °F Conductivity: -- µS/cm Detergents: -- mg/L		Floatables: None Odor: None Turbidity: None Color: None Gross Solids: None Vegetation: None Benthic Growth: None Stains: None Non-illicit: None		
		<b>Notes</b> Dry. Old concrete washout at pipe outlet.		
		<b>Condition Assessment</b> Graffiti: None Erosion: None Deposition: None in. Damage: None

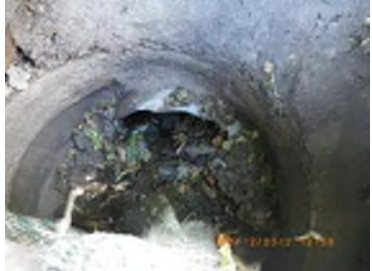
o20120612115904.JPG <div style="text-align: center; font-size: 24pt; font-weight: bold;">2012</div>

<b>Inspection Date:</b> 6/12/2012 12:56:45 PM		<b>Type:</b> Other	<b>Flow:</b> Submerged, indeterminate	<b>Previous Rainfall (hrs):</b> 72+
<b>Illicit Discharge Potential:</b> Potential		<b>Inspector:</b> JCW		
<b>Submerged:</b> Partially		<b>Depth (in):</b> 2		
<b>Sampling Results</b> Sample Location: Pool Total Chlorine: 0 ppm Free Chlorine: 0 ppm Ammonia: 0 ppm pH: 7.86 units Temperature: 72 °F Conductivity: 1372 µS/cm Detergents: 0 mg/L		Floatables: None Odor: Easily detected Turbidity: None Color: None Gross Solids: Moderate Vegetation: None Benthic Growth: None Stains: None Non-illicit: None		
		<b>Notes</b> Pre-screening for gross solids.		
		<b>Condition Assessment</b> Graffiti: None Erosion: None Deposition: Minor 2 in. Damage: None

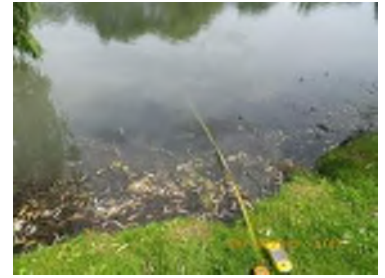
o20120613092740.JPG

<b>Inspection Date:</b> 6/13/2012 10:24:40 AM		<b>Type:</b> Ongoing	<b>Flow:</b> Submerged, indeterminate	<b>Previous Rainfall (hrs):</b> 72+
<b>Illicit Discharge Potential:</b> Unlikely		<b>Inspector:</b> JCW		
<b>Submerged:</b> Fully		<b>Depth (in):</b>		
<b>Sampling Results</b>		<b>Notes</b>		
Sample Location:		Tops of pipes missing or cut off. Outfall pipes fully submerged; screened upstream at 13-95 US1.		
Total Chlorine:	-- ppm	Floatables:	None	
Free Chlorine:	-- ppm	Odor:	None	
Ammonia:	-- ppm	Turbidity:	None	
pH:	-- units	Color:	None	
Temperature	-- °F	Gross Solids:	None	
Conductivity:	-- µS/cm	Vegetation:	None	
Detergents:	-- mg/L	Benthic Growth:	None	
		Stains:	None	
		Non-illicit:	None	
		<b>Condition Assessment</b>		
		Graffiti:	None	
		Erosion:	None	
		Deposition:	None in.	
		Damage:	Moderate

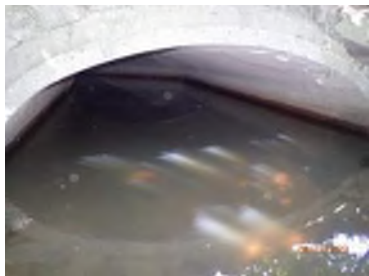
o20220822095708.JPG <div style="text-align: right; font-weight: bold; font-size: 1.2em;">2022</div>

Floatables:	None	Odor:	None	Turbidity:	None	Color:	None	Gross Solids:	None	Vegetation:	None	Benthic Growth:	None	Stains:	Slight	Non-illicit:	Slight
Floatables:	None																					
Odor:	None																					
Turbidity:	None																					
Color:	None																					
Gross Solids:	None																					
Vegetation:	None																					
Benthic Growth:	None																					
Stains:	Slight																					
Non-illicit:	Slight																					
		<b>Notes</b> Sample collected from submerged flow at end of pipe. Detergent and slightly elevated ammonia in sample.																				
		<b>Condition Assessment</b> Graffiti: None Erosion: None Deposition: None in. Damage: None

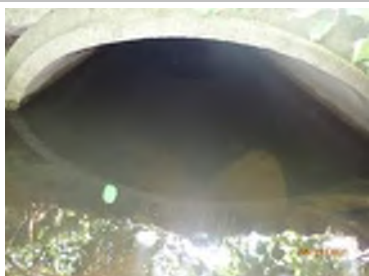
o20210823151038.JPG <div style="text-align: right; font-weight: bold; font-size: 1.2em;">2021</div>

Floatables:	None	Odor:	None	Turbidity:	None	Color:	None	Gross Solids:	Slight	Vegetation:	None	Benthic Growth:	None	Stains:	None	Non-illicit:	None
Floatables:	None																					
Odor:	None																					
Turbidity:	None																					
Color:	None																					
Gross Solids:	Slight																					
Vegetation:	None																					
Benthic Growth:	None																					
Stains:	None																					
Non-illicit:	None																					
		<b>Notes</b> Severe channel erosion downstream of pipe. Sample collected from submerged flow. Detergent detected in sample.																				
		<b>Condition Assessment</b> Graffiti: None Erosion: Severe Deposition: None in. Damage: None

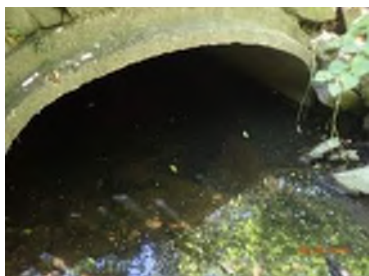
o20200820121004.JPG <div style="text-align: right; font-weight: bold; font-size: 1.2em;">2020</div>

Floatables:	Moderate	Odor:	None	Turbidity:	None	Color:	None	Gross Solids:	None	Vegetation:	None	Benthic Growth:	Moderate	Stains:	None	Non-illicit:	None
Floatables:	Moderate																					
Odor:	None																					
Turbidity:	None																					
Color:	None																					
Gross Solids:	None																					
Vegetation:	None																					
Benthic Growth:	Moderate																					
Stains:	None																					
Non-illicit:	None																					
		<b>Notes</b> No flow appears to be leaving pool at end of outfall. Sample collected from pool -detergent detected.																				
		<b>Condition Assessment</b> Graffiti: None Erosion: Moderate Deposition: Moderate 12 in. Damage: None

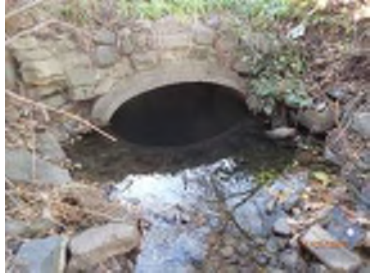
o20191105142746.JPG  
**2019**

<b>Inspection Date:</b> 11/5/2019 2:27:14 PM		<b>Type:</b> Repeat	<b>Flow:</b> Submerged, indeterminate	<b>Previous Rainfall (hrs):</b> 48-72
<b>Illicit Discharge Potential:</b> <b>Potential</b>		<b>Inspector:</b> JCW	<b>Notes</b>	
Submerged: Partially      Depth (in): 20			Follow-up inspection for sampling - limited screening conducted. pH in normal range; detergent detected.	
<b>Sampling Results</b>		<b>Floatables:</b> None	<b>Condition Assessment</b> Graffiti: None Erosion: None Deposition: None in. Damage: None	
Sample Location: Pool	<b>Odor:</b> None			
Total Chlorine: -- ppm	<b>Turbidity:</b> None			
Free Chlorine: -- ppm	<b>Color:</b> None			
Ammonia: -- ppm	<b>Gross Solids:</b> None			
pH: 8.18 units	<b>Vegetation:</b> None			
Temperature 45 °F	<b>Benthic Growth:</b> None			
Conductivity: 680 µS/cm	<b>Stains:</b> None			
Detergents: 0.8 mg/L	<b>Non-illicit:</b> None

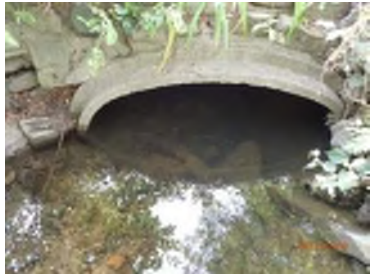
o20190918141444.JPG  
**2019**

<b>Inspection Date:</b> 9/18/2019 3:16:56 PM		<b>Type:</b> Ongoing	<b>Flow:</b> Submerged, slight flow	<b>Previous Rainfall (hrs):</b> 72+
<b>Illicit Discharge Potential:</b> <b>Potential</b>		<b>Inspector:</b> JCW	<b>Notes</b>	
Submerged: Partially      Depth (in): 20			Downstream bank erosion. Sample collected from submerged flow in pipe. High pH detected.	
<b>Sampling Results</b>		<b>Floatables:</b> None	<b>Condition Assessment</b> Graffiti: None Erosion: Severe Deposition: None in. Damage: None	
Sample Location: Flow	<b>Odor:</b> None			
Total Chlorine: 0 ppm	<b>Turbidity:</b> None			
Free Chlorine: 0 ppm	<b>Color:</b> None			
Ammonia: 0 ppm	<b>Gross Solids:</b> None			
pH: 9.27 units	<b>Vegetation:</b> None			
Temperature 77 °F	<b>Benthic Growth:</b> Moderate			
Conductivity: 368 µS/cm	<b>Stains:</b> Slight			
Detergents: 0 mg/L	<b>Non-illicit:</b> None

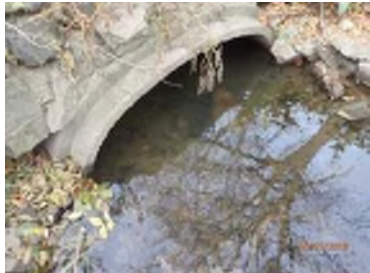
o20181025093132.JPG  
**2018**

<b>Inspection Date:</b> 10/26/2018 1:26:25 PM		<b>Type:</b> Repeat	<b>Flow:</b> Submerged, significant flow	<b>Previous Rainfall (hrs):</b> 72+
<b>Illicit Discharge Potential:</b> <b>Potential</b>		<b>Inspector:</b> KMK	<b>Notes</b>	
Submerged: Partially      Depth (in): 26			Detergent detection follow-up. Limited screening conducted beyond sampling.	
<b>Sampling Results</b>		<b>Floatables:</b> None	<b>Condition Assessment</b> Graffiti: None Erosion: None Deposition: None in. Damage: None	
Sample Location: Flow	<b>Odor:</b> None			
Total Chlorine: 0 ppm	<b>Turbidity:</b> None			
Free Chlorine: 0 ppm	<b>Color:</b> None			
Ammonia: 0 ppm	<b>Gross Solids:</b> Slight			
pH: 8.18 units	<b>Vegetation:</b> None			
Temperature 54 °F	<b>Benthic Growth:</b> Slight			
Conductivity: 1183 µS/cm	<b>Stains:</b> None			
Detergents: 0.4 mg/L	<b>Non-illicit:</b> None

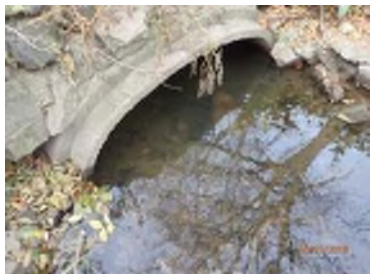
o20181025093132.JPG  
**2018**

<b>Inspection Date:</b> 10/25/2018 9:33:47 AM		<b>Type:</b> Ongoing	<b>Flow:</b> Submerged, significant flow	<b>Previous Rainfall (hrs):</b> 72+
<b>Illicit Discharge Potential:</b> <b>Potential</b>		<b>Inspector:</b> JCW	<b>Notes</b>	
Submerged: Partially      Depth (in): 26			Downstream bank erosion. Sample collected from submerged flow in pipe. Detergent detected.	
<b>Sampling Results</b>		<b>Floatables:</b> None	<b>Condition Assessment</b> Graffiti: None Erosion: Moderate Deposition: None in. Damage: None	
Sample Location: Flow	<b>Odor:</b> None			
Total Chlorine: 0 ppm	<b>Turbidity:</b> None			
Free Chlorine: 0 ppm	<b>Color:</b> None			
Ammonia: 0 ppm	<b>Gross Solids:</b> Slight			
pH: 8.16 units	<b>Vegetation:</b> None			
Temperature 51 °F	<b>Benthic Growth:</b> Moderate			
Conductivity: 1209 µS/cm	<b>Stains:</b> None			
Detergents: 0.5 mg/L	<b>Non-illicit:</b> None

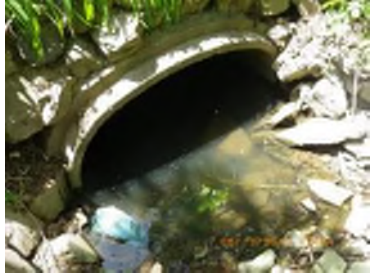
<p>o20120613115412.JPG</p> <p><b>2012</b></p>

<div style="border: 1px solid black; padding: 5px; min-height: 100px;"> <b>Notes</b>            No flow leaving pool on apron. Downstream channel dry. Sample collected from apron pool.         </div>		<div style="border: 1px solid black; padding: 5px; min-height: 100px;"> <b>Condition Assessment</b>            Graffiti: None            Erosion: None            Deposition: None in.            Damage: None         </div>

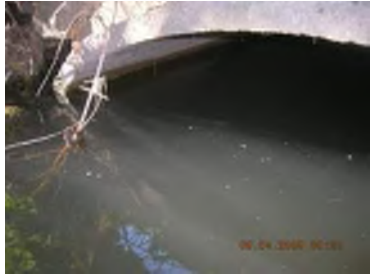
<p>Osh09_DSCN6503.JPG</p> <p><b>2009</b></p>

<div style="border: 1px solid black; padding: 5px; min-height: 100px;"> <b>Notes</b> </div>		<div style="border: 1px solid black; padding: 5px; min-height: 100px;"> <b>Condition Assessment</b>            Graffiti: None            Erosion: None            Deposition: None 0 in.            Damage: None         </div>

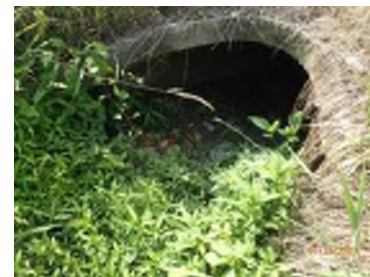
Floatables: Slight

Damage: None

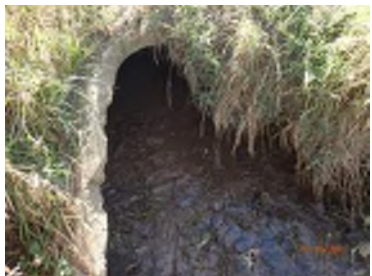
o20171018140212.JPG <div style="text-align: center; font-size: 24pt; font-weight: bold;">2017</div>

<b>Inspection Date:</b> 10/18/2017 2:05:41 PM		<b>Type:</b> Ongoing	<b>Flow:</b> Submerged, slight flow	<b>Previous Rainfall (hrs):</b> 72+
<b>Illicit Discharge Potential:</b> Unlikely		<b>Inspector:</b> JCW		
Submerged: Partially		Depth (in): 2		
<b>Sampling Results</b> Sample Location: Pool Total Chlorine: 0 ppm Free Chlorine: 0 ppm Ammonia: 0 ppm pH: 7.61 units Temperature: 68 °F Conductivity: 341 µS/cm Detergents: 0 mg/L		Floatables: None Odor: None Turbidity: None Color: None Gross Solids: None Vegetation: None Benthic Growth: None Stains: None Non-illicit: None		
		<b>Notes</b> Sample collected from submerged flow at end of pipe.		
		<b>Condition Assessment</b> Graffiti: None Erosion: None Deposition: Minor 2 in. Damage: None

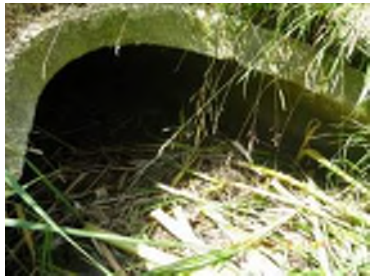
o20130717104110.JPG <div style="text-align: center; font-size: 24pt; font-weight: bold;">2013</div>

<b>Inspection Date:</b> 7/17/2013 11:41:00 AM		<b>Type:</b> Ongoing	<b>Flow:</b> None	<b>Previous Rainfall (hrs):</b> 72+
<b>Illicit Discharge Potential:</b> Unlikely		<b>Inspector:</b> JCW		
Submerged: None		Depth (in):		
<b>Sampling Results</b> Sample Location: Total Chlorine: -- ppm Free Chlorine: -- ppm Ammonia: -- ppm pH: -- units Temperature: -- °F Conductivity: -- µS/cm Detergents: -- mg/L		Floatables: None Odor: None Turbidity: None Color: None Gross Solids: Slight Vegetation: None Benthic Growth: Slight Stains: Slight Non-illicit: None		
		<b>Notes</b> Apron sediment wet, but no collectable flow at time of inspection.		
		<b>Condition Assessment</b> Graffiti: None Erosion: None Deposition: Minor 5 in. Damage: None

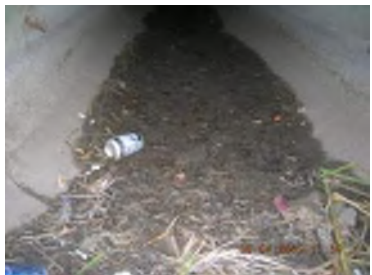
Osh09_DSCN6525.JPG <div style="text-align: center; font-size: 24pt; font-weight: bold;">2009</div>

<b>Inspection Date:</b> 9/4/2009		<b>Type:</b> Initial	<b>Flow:</b> None	<b>Previous Rainfall (hrs):</b> 72+
<b>Illicit Discharge Potential:</b> Unlikely		<b>Inspector:</b> JCW		
Submerged: None		Depth (in): 0		
<b>Sampling Results</b> Sample Location: Total Chlorine: -- ppm Free Chlorine: -- ppm Ammonia: -- ppm pH: -- units Temperature: -- °F Conductivity: -- µS/cm Detergents: -- mg/L		Floatables: Odor: Turbidity: Color: Gross Solids: Vegetation: Benthic Growth: Stains: Non-illicit: None		
		<b>Notes</b> Garbage inside pipe.		
		<b>Condition Assessment</b> Graffiti: None Erosion: None Deposition: 1 in. Damage: None

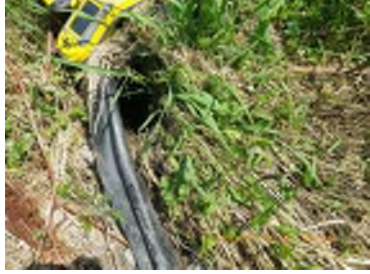
<p>o20130717095634.JPG</p> <p><b>2013</b></p>

Sample Location:																																		
Total Chlorine:	-- ppm																																	
Free Chlorine:	-- ppm																																	
Ammonia:	-- ppm																																	
pH:	-- units																																	
Temperature:	-- °F																																	
Conductivity:	-- µS/cm																																	
Detergents:	-- mg/L																																	
<b>Notes</b>																																		
Apron blocked with dirt and grass. Pipe dry at time of inspection.																																		
<b>Condition Assessment</b>																																		
Graffiti:	None																																	
Erosion:	None																																	
Deposition:	Severe 12 in.																																	
Damage:	None

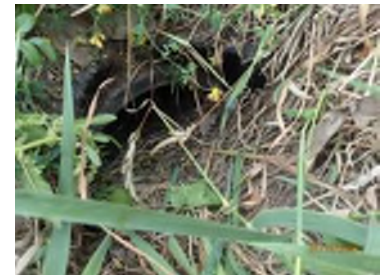
o20230719073250.JPG

Deposition: Severe Depth (in): 7

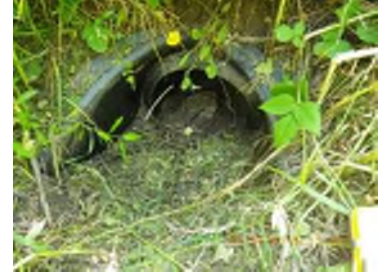
o20130717101438.JPG

Floatables:	None	Odor:	None	Turbidity:	None	Color:	None	Gross Solids:	Slight	Vegetation:	None	Benthic Growth:	None	Stains:	None	Non-illicit:	None
Floatables:	None																					
Odor:	None																					
Turbidity:	None																					
Color:	None																					
Gross Solids:	Slight																					
Vegetation:	None																					
Benthic Growth:	None																					
Stains:	None																					
Non-illicit:	None																					
		<b>Condition Assessment</b> Graffiti: None Erosion: None Deposition: Minor 2 in. Damage: None

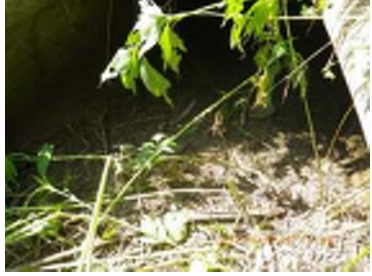
<p>o20130717100914.JPG</p> <p><b>2013</b></p>

Floatables:	None	Odor:	None	Turbidity:	None	Color:	None	Gross Solids:	Slight	Vegetation:	None	Benthic Growth:	Slight	Stains:	Slight	Non-illicit:	None
Floatables:	None																					
Odor:	None																					
Turbidity:	None																					
Color:	None																					
Gross Solids:	Slight																					
Vegetation:	None																					
Benthic Growth:	Slight																					
Stains:	Slight																					
Non-illicit:	None																					
		<b>Condition Assessment</b> Graffiti: None Erosion: None Deposition: None in. Damage: None

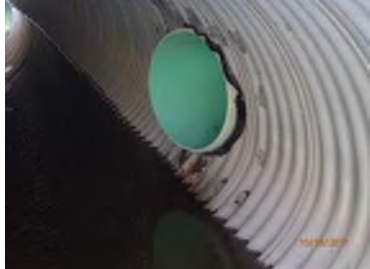
o20171018132244.JPG <div style="text-align: center; font-size: 24pt; font-weight: bold;">2017</div>

<b>Inspection Date:</b> 10/18/2017 1:25:59 PM		<b>Type:</b> Ongoing	<b>Flow:</b> None	<b>Previous Rainfall (hrs):</b> 72+
<b>Illicit Discharge Potential:</b> Unlikely		<b>Inspector:</b> JCW		
<b>Submerged:</b> None		<b>Depth (in):</b>		
<b>Sampling Results</b> Sample Location: _____ Total Chlorine: -- ppm Free Chlorine: -- ppm Ammonia: -- ppm pH: -- units Temperature: -- °F Conductivity: -- µS/cm Detergents: -- mg/L		Floatables: None Odor: None Turbidity: None Color: None Gross Solids: None Vegetation: None Benthic Growth: None Stains: None Non-illicit: None	<b>Notes</b> Pipe dry at time of inspection.  <b>Condition Assessment</b> Graffiti: None Erosion: None Deposition: None in. Damage: None

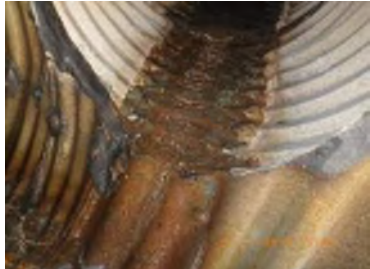
o20130717120006.JPG <div style="text-align: center; font-size: 24pt; font-weight: bold;">2013</div>

<b>Inspection Date:</b> 7/17/2013 12:56:41 PM		<b>Type:</b> Ongoing	<b>Flow:</b> Moderate	<b>Previous Rainfall (hrs):</b> 72+
<b>Illicit Discharge Potential:</b> Unlikely		<b>Inspector:</b> JCW		
<b>Submerged:</b> None		<b>Depth (in):</b>		
<b>Sampling Results</b> Sample Location: Flow Total Chlorine: 0 ppm Free Chlorine: 0 ppm Ammonia: 0.5 ppm pH: 8.11 units Temperature: 72 °F Conductivity: 947 µS/cm Detergents: 0 mg/L		Floatables: None Odor: None Turbidity: None Color: None Gross Solids: None Vegetation: None Benthic Growth: None Stains: Moderate Non-illicit: Slight	<b>Notes</b> Fine light color silt settled on culvert and rocks at base of outfall.  <b>Condition Assessment</b> Graffiti: None Erosion: None Deposition: None in. Damage: Moderate

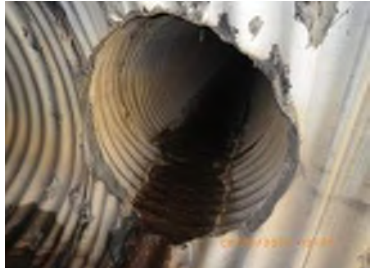
o20120620112732.JPG <div style="text-align: center; font-size: 24pt; font-weight: bold;">2012</div>

<b>Inspection Date:</b> 6/20/2012 12:29:02 PM		<b>Type:</b> Ongoing	<b>Flow:</b> None	<b>Previous Rainfall (hrs):</b> 24-48
<b>Illicit Discharge Potential:</b> Unlikely		<b>Inspector:</b> JCW		
<b>Submerged:</b> None		<b>Depth (in):</b>		
<b>Sampling Results</b> Sample Location: _____ Total Chlorine: -- ppm Free Chlorine: -- ppm Ammonia: -- ppm pH: -- units Temperature: -- °F Conductivity: -- µS/cm Detergents: -- mg/L		Floatables: None Odor: None Turbidity: None Color: None Gross Solids: None Vegetation: None Benthic Growth: None Stains: Slight Non-illicit: None	<b>Notes</b> 2011 suds (natural) follow-up. Pipe wet but no flow at outfall.  <b>Condition Assessment</b> Graffiti: None Erosion: None Deposition: None in. Damage: Minor

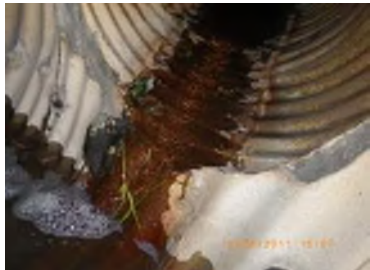
o20111006150702.JPG <div style="text-align: center; font-size: 24pt; font-weight: bold;">2011</div>

<b>Inspection Date:</b> 10/6/2011 3:04:00 PM		<b>Type:</b> Ongoing	<b>Flow:</b> Moderate	<b>Previous Rainfall (hrs):</b> 72+
<b>Illicit Discharge Potential:</b> Potential		<b>Inspector:</b> JCW		
<b>Submerged:</b> None		<b>Depth (in):</b>		
<b>Sampling Results</b> Sample Location: _____ Total Chlorine: -- ppm Free Chlorine: -- ppm Ammonia: -- ppm pH: -- units Temperature: -- °F Conductivity: -- µS/cm Detergents: -- mg/L		Floatables: Moderate Odor: None Turbidity: None Color: None Gross Solids: None Vegetation: None Benthic Growth: None Stains: Moderate Non-illicit: None	<b>Notes</b> Persistent suds still present in mixing zone and downstream.  <b>Condition Assessment</b> Graffiti: None Erosion: None Deposition: None 0 in. Damage: Moderate

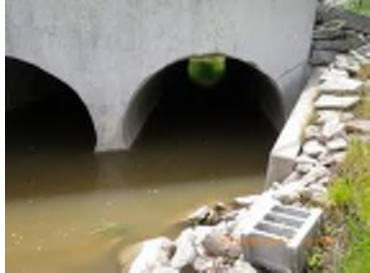
o20110526124526.JPG <b>2011</b>

<b>Inspection Date:</b> 5/26/2011 12:58:00 PM		<b>Type:</b> Other	<b>Flow:</b> Submerged, indeterminate	<b>Previous Rainfall (hrs):</b> 72+
<b>Illicit Discharge Potential:</b> Potential		<b>Inspector:</b> JCW		<b>Notes</b> Limited screening conducted to check for suds. Slight suds - all coming from upstream of culvert.
Submerged: Partially      Depth (in): 2				
<b>Sampling Results</b> Sample Location:      Floatables: None Total Chlorine: -- ppm      Odor: None Free Chlorine: -- ppm      Turbidity: None Ammonia: -- ppm      Color: None pH: -- units      Gross Solids: None Temperature -- °F      Vegetation: None Conductivity: -- µS/cm      Benthic Growth: None Detergents: -- mg/L      Stains: None Non-illicit: None		<b>Condition Assessment</b> Graffiti: None Erosion: None Deposition: None      0 in. Damage: None

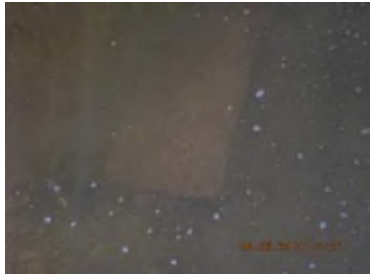
o20100826123758.JPG <b>2010</b>

<b>Inspection Date:</b> 8/26/2010 1:00:18 PM		<b>Type:</b> Other	<b>Flow:</b> Moderate	<b>Previous Rainfall (hrs):</b> 72+
<b>Illicit Discharge Potential:</b> Potential		<b>Inspector:</b> JCW		<b>Notes</b> Sample consists of sheen skimmed from surface of downstream pool.
Submerged: None      Depth (in):				
<b>Sampling Results</b> Sample Location: Pool      Floatables: Moderate Total Chlorine: 0 ppm      Odor: None Free Chlorine: 0 ppm      Turbidity: None Ammonia: 0 ppm      Color: None pH: 8.52 units      Gross Solids: None Temperature 76 °F      Vegetation: None Conductivity: -- µS/cm      Benthic Growth: None Detergents: 0 mg/L      Stains: Moderate Non-illicit: None		<b>Condition Assessment</b> Graffiti: None Erosion: None Deposition: None      0 in. Damage: None

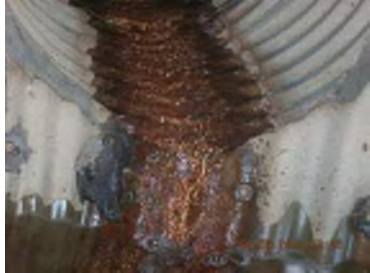
o20100826123658.JPG <b>2010</b>

<b>Inspection Date:</b> 8/26/2010 12:58:18 PM		<b>Type:</b> Ongoing	<b>Flow:</b> Moderate	<b>Previous Rainfall (hrs):</b> 72+
<b>Illicit Discharge Potential:</b> Potential		<b>Inspector:</b> JCW		<b>Notes</b> Persistent suds and gel-like sheen downstream
Submerged: None      Depth (in):				
<b>Sampling Results</b> Sample Location: Flow      Floatables: Moderate Total Chlorine: 0 ppm      Odor: None Free Chlorine: 0 ppm      Turbidity: None Ammonia: 0 ppm      Color: None pH: 8.3 units      Gross Solids: None Temperature 78 °F      Vegetation: None Conductivity: -- µS/cm      Benthic Growth: None Detergents: 0 mg/L      Stains: Moderate Non-illicit: None		<b>Condition Assessment</b> Graffiti: None Erosion: None Deposition: None      0 in. Damage: Moderate

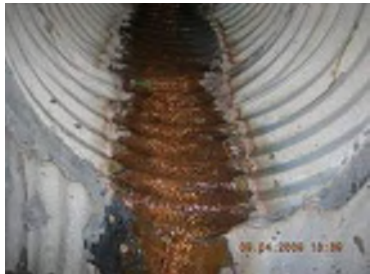
Osh09_DSCN6538.JPG <b>2009</b>

<b>Inspection Date:</b> 9/4/2009		<b>Type:</b> Initial	<b>Flow:</b> Moderate	<b>Previous Rainfall (hrs):</b> 72+
<b>Illicit Discharge Potential:</b> Potential		<b>Inspector:</b> JCW		<b>Notes</b> Sample 09090411 collected from pool (suds). No detergent detected.
Submerged: None      Depth (in): 0				
<b>Sampling Results</b> Sample Location: Flow      Floatables: Moderate Total Chlorine: 0 ppm      Odor: None Free Chlorine: 0 ppm      Turbidity: None Ammonia: -- ppm      Color: None pH: 8.32 units      Gross Solids: None Temperature 78 °F      Vegetation: None Conductivity: -- µS/cm      Benthic Growth: None Detergents: 0 mg/L      Stains: Moderate Non-illicit: None		<b>Condition Assessment</b> Graffiti: None Erosion: None Deposition: None      0 in. Damage: Minor

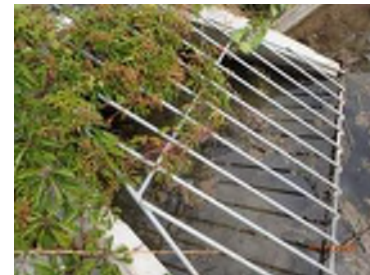
o20230719092308.JPG

Stains: Moderate

☐ Petrol. Sheen ☐ Suds ☐ Sewage ☐ Algae ☐ Other☐ Petroleum ☐ Musty ☐ Sewage ☐ Chlorine ☐ Other☐ VOC/Solvent ☐ Fishy ☐ Sulfur ☐ Fragrant☐ Litter ☐ Veg. Debris ☐ Sediment ☐ Other☐ Inhibited ☐ Excessive☒ Green ☒ Brown☒ Flow Line ☐ Oil ☐ Rust Stains☐ Paint ☐ Other☐ Natural Sheen ☐ Natural Suds/Foam

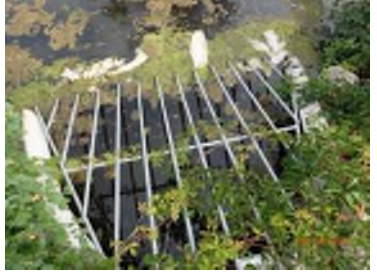
o20220818145708.JPG <div style="text-align: center; font-size: 24pt; font-weight: bold;">2022</div>

Sample Location:	Flow																																					
Total Chlorine:	0 ppm																																					
Free Chlorine:	0 ppm																																					
Ammonia:	0 ppm																																					
pH:	5.8 units																																					
Temperature:	81 °F																																					
Conductivity:	1358 µS/cm																																					
Detergents:	0 mg/L																																					
Floatables:	Moderate																																					
Odor:	None																																					
Turbidity:	None																																					
Color:	None																																					
Gross Solids:	Slight																																					
Vegetation:	None																																					
Benthic Growth:	None																																					
Stains:	Slight																																					
Non-illicit:	None

<b>Notes</b> Sample collected from submerged flow at end of pipe. Low pH reading due to probe malfunction. Retested 7.3.																																				
		<b>Condition Assessment</b> <table border="1" style="width: 100%; border-collapse: collapse;"> <tr> <td>Graffiti:</td> <td>None</td> </tr> <tr> <td>Erosion:</td> <td>None</td> </tr> <tr> <td>Deposition:</td> <td>None in.</td> </tr> <tr> <td>Damage:</td> <td>None</td> </tr> </table>			Graffiti:	None	Erosion:	None	Deposition:	None in.	Damage:	None																										
Graffiti:	None																																					
Erosion:	None																																					
Deposition:	None in.																																					
Damage:	None

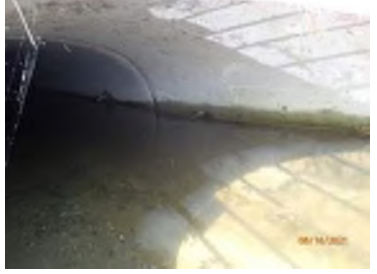
o20210816123040.JPG <div style="text-align: center; font-size: 24pt; font-weight: bold;">2021</div>

<b>Inspection Date:</b> 8/16/2021 12:35:00 PM		<b>Type:</b> Ongoing	<b>Flow:</b> Submerged, slight flow	<b>Previous Rainfall (hrs):</b> 72+																																		
<b>Illicit Discharge Potential:</b> Unlikely		<b>Inspector:</b> JCW																																				
Submerged: Partially		Depth (in): 17																																				
<b>Sampling Results</b> <table border="1" style="width: 100%; border-collapse: collapse;"> <tr> <td>Sample Location:</td> <td>Flow</td> </tr> <tr> <td>Total Chlorine:</td> <td>0 ppm</td> </tr> <tr> <td>Free Chlorine:</td> <td>0 ppm</td> </tr> <tr> <td>Ammonia:</td> <td>0 ppm</td> </tr> <tr> <td>pH:</td> <td>7.37 units</td> </tr> <tr> <td>Temperature:</td> <td>78 °F</td> </tr> <tr> <td>Conductivity:</td> <td>991 µS/cm</td> </tr> <tr> <td>Detergents:</td> <td>0 mg/L</td> </tr> </table>		Sample Location:	Flow	Total Chlorine:	0 ppm	Free Chlorine:	0 ppm	Ammonia:	0 ppm	pH:	7.37 units	Temperature:	78 °F	Conductivity:	991 µS/cm	Detergents:	0 mg/L	<table border="1" style="width: 100%; border-collapse: collapse;"> <tr> <td>Floatables:</td> <td>None</td> </tr> <tr> <td>Odor:</td> <td>None</td> </tr> <tr> <td>Turbidity:</td> <td>None</td> </tr> <tr> <td>Color:</td> <td>None</td> </tr> <tr> <td>Gross Solids:</td> <td>None</td> </tr> <tr> <td>Vegetation:</td> <td>None</td> </tr> <tr> <td>Benthic Growth:</td> <td>Moderate</td> </tr> <tr> <td>Stains:</td> <td>None</td> </tr> <tr> <td>Non-illicit:</td> <td>None</td> </tr> </table>			Floatables:	None	Odor:	None	Turbidity:	None	Color:	None	Gross Solids:	None	Vegetation:	None	Benthic Growth:	Moderate	Stains:	None	Non-illicit:	None

<b>Notes</b> New HECP. Sample collected from submerged flow in pipe.																																				
		<b>Condition Assessment</b> <table border="1" style="width: 100%; border-collapse: collapse;"> <tr> <td>Graffiti:</td> <td>None</td> </tr> <tr> <td>Erosion:</td> <td>None</td> </tr> <tr> <td>Deposition:</td> <td>None in.</td> </tr> <tr> <td>Damage:</td> <td>None</td> </tr> </table>			Graffiti:	None	Erosion:	None	Deposition:	None in.	Damage:	None																										
Graffiti:	None																																					
Erosion:	None																																					
Deposition:	None in.																																					
Damage:	None

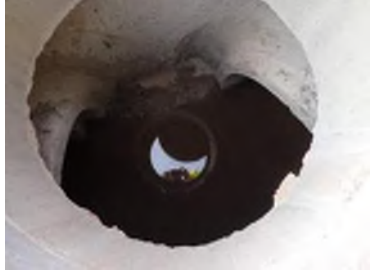
<p>o20200924092200.JPG</p> <p><b>2020</b></p>	
Submerged: Partially      Depth (in): 9				Sample collected from submerged pool in manhole.			
<b>Sampling Results</b>				<b>Condition Assessment</b>			
Sample Location: Pool		Floatables: None		Graffiti: None			
Total Chlorine: 0 ppm		Odor: None		Erosion: None			
Free Chlorine: 0 ppm		Turbidity: None		Deposition: None in.			
Ammonia: 0 ppm		Color: None		Damage: None			
pH: 7.81 units		Gross Solids: None					
Temperature 66 °F		Vegetation: None					
Conductivity: 1112 µS/cm		Benthic Growth: None					
Detergents: 0 mg/L		Stains: None					
		Non-illicit: None

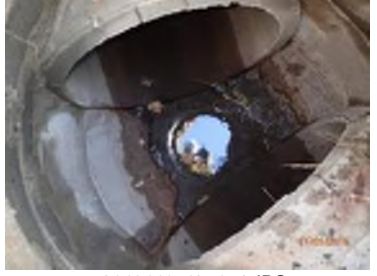
<p>o20191105125154.JPG</p> <p><b>2019</b></p>	
Submerged: Partially      Depth (in): 3				Follow-up inspection for sampling - limited screening conducted. Detergent detected.			
<b>Sampling Results</b>				<b>Condition Assessment</b>			
Sample Location: Flow		Floatables: None		Graffiti: None			
Total Chlorine: -- ppm		Odor: None		Erosion: None			
Free Chlorine: -- ppm		Turbidity: None		Deposition: None in.			
Ammonia: -- ppm		Color: None		Damage: None			
pH: -- units		Gross Solids: None					
Temperature -- °F		Vegetation: None					
Conductivity: -- µS/cm		Benthic Growth: None					
Detergents: 0.6 mg/L		Stains: None					
		Non-illicit: None

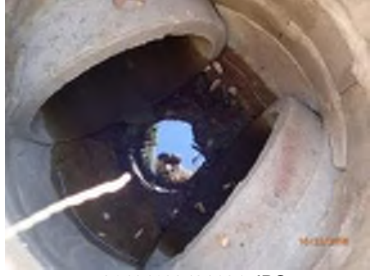
<p>o20181022123926.JPG</p> <p><b>2018</b></p>	
Submerged: Partially      Depth (in): 9				Sample collected from submerged pool in manhole.			
<b>Sampling Results</b>				<b>Condition Assessment</b>			
Sample Location: Pool		Floatables: None		Graffiti: None			
Total Chlorine: 0 ppm		Odor: None		Erosion: None			
Free Chlorine: 0 ppm		Turbidity: None		Deposition: None in.			
Ammonia: 0 ppm		Color: None		Damage: None			
pH: 7.03 units		Gross Solids: None					
Temperature 58 °F		Vegetation: None					
Conductivity: 1580 µS/cm		Benthic Growth: Slight					
Detergents: 0 mg/L		Stains: None					
		Non-illicit: None
