# Submittal of Annual Reports and Other Compliance Documents for Municipal Separate Storm Sewer System (MS4) Permits

**Project Name:** 2023 Annual Report

**Municipality:** Oshkosh, City

**Permit Number:** S050075

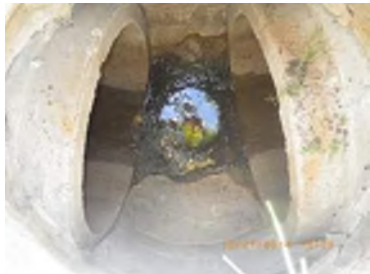
<p style="text-align: center;">o20141007120930.JPG</p> <p style="text-align: center; font-size: 24pt; font-weight: bold;">2014</p>	
Submerged: Partially		Depth (in): 2		No flow at 14-582 US7 (Hydrite lateral).			
<b>Sampling Results</b>				<b>Condition Assessment</b>			
Sample Location: Pool		Floatables: None		Graffiti: None			
Total Chlorine: 0 ppm		Odor: None		Erosion: None			
Free Chlorine: 0 ppm		Turbidity: None		Deposition: None in.			
Ammonia: 0 ppm		Color: None		Damage: None			
pH: 7.73 units		Gross Solids: None					
Temperature -- °F		Vegetation: None					
Conductivity: 1481 µS/cm		Benthic Growth: None					
Detergents: 0 mg/L		Stains: Slight					
		Non-illicit: None

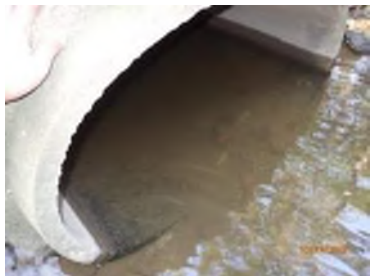
<b>Inspection Date:</b> 10/19/2017 12:32:13 PM		<b>Type:</b> Ongoing	<b>Flow:</b> Submerged, indeterminate	<b>Previous Rainfall (hrs):</b> 72+
<b>Illicit Discharge Potential:</b> Unlikely		<b>Inspector:</b> JCW		
Submerged: Partially		Depth (in): 8		
<b>Sampling Results</b> Sample Location: Flow Total Chlorine: 0 ppm Free Chlorine: 0 ppm Ammonia: 0 ppm pH: 7.71 units Temperature: 62 °F Conductivity: 629 µS/cm Detergents: 0 mg/L		Floatables: None Odor: None Turbidity: None Color: None Gross Solids: None Vegetation: None Benthic Growth: Moderate Stains: Slight Non-illicit: None	<b>Notes</b> Upstream location inside locked fence surrounding detention basin. Sample collected from submerged pool at end of pipe.

o20171019123026.JPG <div style="text-align: center; font-size: 24pt; font-weight: bold;">2017</div>
		<b>Condition Assessment</b> Graffiti: None Erosion: None Deposition: None in. Damage: None

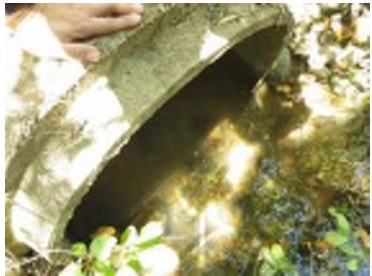
<b>Inspection Date:</b> 10/7/2014 12:52:01 PM		<b>Type:</b> Ongoing	<b>Flow:</b> Submerged, indeterminate	<b>Previous Rainfall (hrs):</b> 48-72
<b>Illicit Discharge Potential:</b> Unlikely		<b>Inspector:</b> JCW		
Submerged: Partially		Depth (in): 6		
<b>Sampling Results</b> Sample Location: Total Chlorine: -- ppm Free Chlorine: -- ppm Ammonia: -- ppm pH: -- units Temperature: -- °F Conductivity: -- µS/cm Detergents: -- mg/L		Floatables: None Odor: None Turbidity: None Color: None Gross Solids: None Vegetation: None Benthic Growth: Slight Stains: Slight Non-illicit: None	<b>Notes</b> Outfall partially submerged - screened upstream at 14-595 US1.

o20141007115328.JPG <div style="text-align: center; font-size: 24pt; font-weight: bold;">2014</div>
		<b>Condition Assessment</b> Graffiti: None Erosion: None Deposition: None in. Damage: None

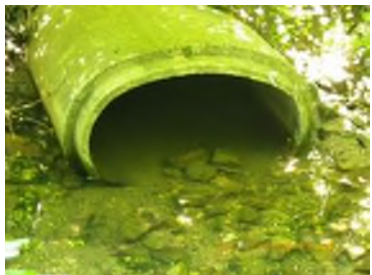
<b>Inspection Date:</b> 7/17/2013 11:58:51 AM		<b>Type:</b> Ongoing	<b>Flow:</b> Submerged, indeterminate	<b>Previous Rainfall (hrs):</b> 72+
<b>Illicit Discharge Potential:</b> Unlikely		<b>Inspector:</b> JCW		
Submerged: Partially		Depth (in): 5		
<b>Sampling Results</b> Sample Location: Total Chlorine: -- ppm Free Chlorine: -- ppm Ammonia: -- ppm pH: -- units Temperature: -- °F Conductivity: -- µS/cm Detergents: -- mg/L		Floatables: None Odor: None Turbidity: None Color: None Gross Solids: None Vegetation: None Benthic Growth: Slight Stains: Moderate Non-illicit: None	<b>Notes</b> Outfall partially submerged. Outfall screened upstream at 14-595 US3.

o20130717110248.JPG <div style="text-align: center; font-size: 24pt; font-weight: bold;">2013</div>
		<b>Condition Assessment</b> Graffiti: None Erosion: None Deposition: None in. Damage: None

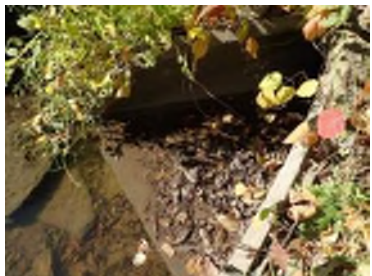
<b>Inspection Date:</b> 10/18/2017 1:32:37 PM		<b>Type:</b> Ongoing	<b>Flow:</b> Submerged, no flow	<b>Previous Rainfall (hrs):</b> 72+
<b>Illicit Discharge Potential:</b> Unlikely		<b>Inspector:</b> JCW		
Submerged: Partially		Depth (in): 0.5		
<b>Sampling Results</b> Sample Location: _____ Total Chlorine: -- ppm Free Chlorine: -- ppm Ammonia: -- ppm pH: -- units Temperature -- ° F Conductivity: -- µS/cm Detergents: -- mg/L		Floatables: None Odor: None Turbidity: None Color: None Gross Solids: None Vegetation: None Benthic Growth: Slight Stains: None Non-illicit: None	<b>Notes</b> Pipe was dry approx 10 ft from end of pipe - no sample collected (from stream). Apron displaced 4".

o20171018132924.JPG <div style="text-align: center; font-size: 24pt; font-weight: bold;">2017</div>
			<b>Condition Assessment</b> Graffiti: None Erosion: None Deposition: None in. Damage: Minor

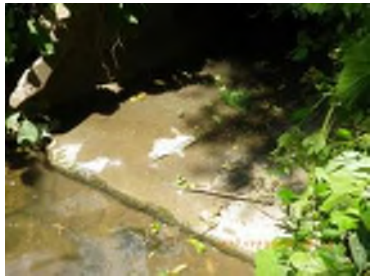
<b>Inspection Date:</b> 7/17/2013 1:12:46 PM		<b>Type:</b> Ongoing	<b>Flow:</b> None	<b>Previous Rainfall (hrs):</b> 72+
<b>Illicit Discharge Potential:</b> Unlikely		<b>Inspector:</b> JCW		
Submerged: None		Depth (in):		
<b>Sampling Results</b> Sample Location: _____ Total Chlorine: -- ppm Free Chlorine: -- ppm Ammonia: -- ppm pH: -- units Temperature -- ° F Conductivity: -- µS/cm Detergents: -- mg/L		Floatables: None Odor: None Turbidity: None Color: None Gross Solids: Slight Vegetation: None Benthic Growth: Slight Stains: Slight Non-illicit: None	<b>Notes</b> Pipe wet, but no flow leaving apron. Apron displaced 4".

o20130717121624.JPG <div style="text-align: center; font-size: 24pt; font-weight: bold;">2013</div>
			<b>Condition Assessment</b> Graffiti: None Erosion: None Deposition: None in. Damage: Minor

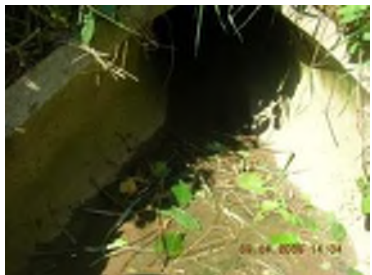
<b>Inspection Date:</b> 9/4/2009		<b>Type:</b> Initial	<b>Flow:</b> None	<b>Previous Rainfall (hrs):</b> 72+
<b>Illicit Discharge Potential:</b> Unlikely		<b>Inspector:</b> JCW		
Submerged: None		Depth (in): 0		
<b>Sampling Results</b> Sample Location: _____ Total Chlorine: -- ppm Free Chlorine: -- ppm Ammonia: -- ppm pH: -- units Temperature -- ° F Conductivity: -- µS/cm Detergents: -- mg/L		Floatables: _____ Odor: _____ Turbidity: _____ Color: _____ Gross Solids: _____ Vegetation: _____ Benthic Growth: _____ Stains: _____ Non-illicit: None	<b>Notes</b> Wet, no flow.

Osh09_DSCN6547.JPG <div style="text-align: center; font-size: 24pt; font-weight: bold;">2009</div>
			<b>Condition Assessment</b> Graffiti: None Erosion: None Deposition: None 0 in. Damage: Minor

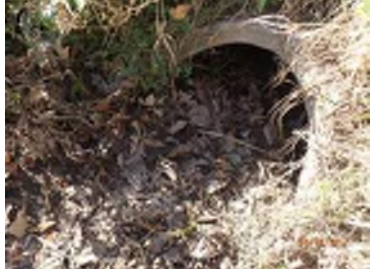
<b>Inspection Date:</b> 10/18/2017 2:02:42 PM		<b>Type:</b> Ongoing	<b>Flow:</b> None	<b>Previous Rainfall (hrs):</b> 72+
<b>Illicit Discharge Potential:</b> Unlikely		<b>Inspector:</b> JCW		
Submerged: None		Depth (in):		
<b>Sampling Results</b> Sample Location: Total Chlorine: -- ppm Free Chlorine: -- ppm Ammonia: -- ppm pH: -- units Temperature -- ° F Conductivity: -- µS/cm Detergents: -- mg/L		Floatables: None Odor: None Turbidity: None Color: None Gross Solids: None Vegetation: None Benthic Growth: None Stains: None Non-illicit: None		
		<b>Notes</b> Sediment in pipe wet, but no collectable flow at time of inspection.		
		<b>Condition Assessment</b> Graffiti: None Erosion: None Deposition: Moderate 3 in. Damage: None

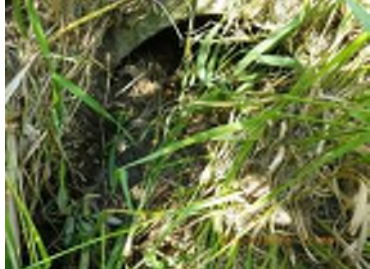
o20130717103632.JPG <div style="text-align: center; font-size: 24pt; font-weight: bold;">2013</div>

<b>Inspection Date:</b> 7/17/2013 11:32:29 AM		<b>Type:</b> Ongoing	<b>Flow:</b> None	<b>Previous Rainfall (hrs):</b> 72+
<b>Illicit Discharge Potential:</b> Unlikely		<b>Inspector:</b> JCW		
Submerged: None		Depth (in):		
<b>Sampling Results</b> Sample Location: Total Chlorine: -- ppm Free Chlorine: -- ppm Ammonia: -- ppm pH: -- units Temperature -- ° F Conductivity: -- µS/cm Detergents: -- mg/L		Floatables: None Odor: None Turbidity: None Color: None Gross Solids: Slight Vegetation: None Benthic Growth: Slight Stains: Slight Non-illicit: None		
		<b>Notes</b> Apron sediment wet, but no collectable flow at time of inspection.		
		<b>Condition Assessment</b> Graffiti: None Erosion: None Deposition: Moderate 4 in. Damage: None

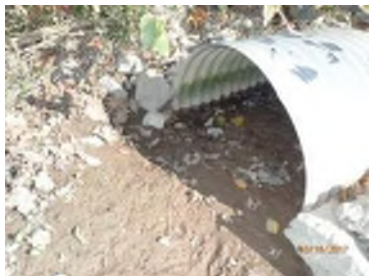
o20171018131222.JPG <div style="text-align: right; font-size: 24pt; font-weight: bold;">2017</div>

<b>Inspection Date:</b> 10/18/2017 1:15:47 PM		<b>Type:</b> Ongoing	<b>Flow:</b> None	<b>Previous Rainfall (hrs):</b> 72+
<b>Illicit Discharge Potential:</b> Unlikely		<b>Inspector:</b> JCW		
Submerged: None		Depth (in):		
<b>Sampling Results</b> Sample Location: Total Chlorine: -- ppm Free Chlorine: -- ppm Ammonia: -- ppm pH: -- units Temperature -- ° F Conductivity: -- µS/cm Detergents: -- mg/L		Floatables: None Odor: None Turbidity: None Color: None Gross Solids: None Vegetation: None Benthic Growth: Slight Stains: None Non-illicit: None		
		<b>Notes</b> Sediment inside pipe wet, but no collectable flow at time of inspection.		
		<b>Condition Assessment</b> Graffiti: None Erosion: None Deposition: Moderate 11 in. Damage: None

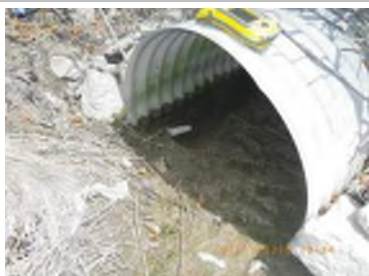
o20130717123414.JPG <div style="text-align: right; font-size: 24pt; font-weight: bold;">2013</div>

<b>Inspection Date:</b> 7/17/2013 1:30:26 PM		<b>Type:</b> Ongoing	<b>Flow:</b> None	<b>Previous Rainfall (hrs):</b> 72+
<b>Illicit Discharge Potential:</b> Unlikely		<b>Inspector:</b> JCW		
Submerged: None		Depth (in):		
<b>Sampling Results</b> Sample Location: Total Chlorine: -- ppm Free Chlorine: -- ppm Ammonia: -- ppm pH: -- units Temperature -- ° F Conductivity: -- µS/cm Detergents: -- mg/L		Floatables: None Odor: None Turbidity: None Color: None Gross Solids: None Vegetation: None Benthic Growth: Slight Stains: Slight Non-illicit: None		
		<b>Notes</b> Sediment wet, but no collectable flow at time of inspection.		
		<b>Condition Assessment</b> Graffiti: None Erosion: None Deposition: Moderate 10 in. Damage: None

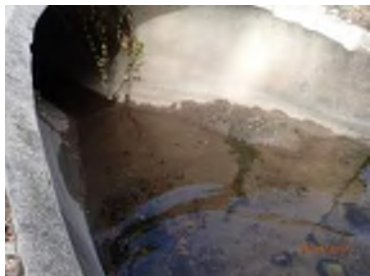
o20171019120120.JPG <div style="text-align: center; font-size: 24pt; font-weight: bold;">2017</div>

<b>Inspection Date:</b> 10/19/2017 12:02:52 PM		<b>Type:</b> Ongoing	<b>Flow:</b> Submerged, indeterminate	<b>Previous Rainfall (hrs):</b> 72+
<b>Illicit Discharge Potential:</b> Unlikely		<b>Inspector:</b> JCW		
Submerged: Partially		Depth (in): 1		
<b>Sampling Results</b> Sample Location: Total Chlorine: 0 ppm Free Chlorine: 0 ppm Ammonia: 0 ppm pH: 7.48 units Temperature: 61 °F Conductivity: 740 µS/cm Detergents: 0 mg/L		Floatables: None Odor: None Turbidity: None Color: None Gross Solids: None Vegetation: None Benthic Growth: Slight Stains: Slight Non-illicit: None		
		<b>Notes</b> Upstream inlet dry - sample collected from submerged pool at end of pipe. 4" joint displacement.		
		<b>Condition Assessment</b> Graffiti: None Erosion: None Deposition: None in. Damage: Moderate

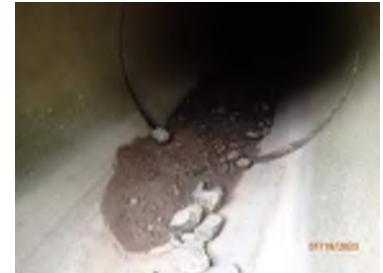
o20230719095626.JPG

Deposition: Minor Depth (in): 1

Damage: Minor ☒ Displacement ☐ Undercut ☐ Crushed☐ Corrosion ☐ Cracks/Structural Damage

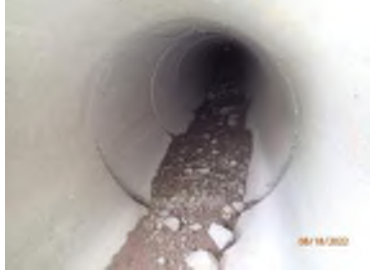
<b>Inspection Date:</b> 8/18/2022 3:24:00 PM		<b>Type:</b> Ongoing		<b>Flow:</b> None		<b>Previous Rainfall (hrs):</b> 72+	
<b>Illicit Discharge Potential:</b> Unlikely		<b>Inspector:</b> EJK		<b>Notes</b> Pipe dry at time of inspection. Dry sediment inside pipe. 3" joint displacement.

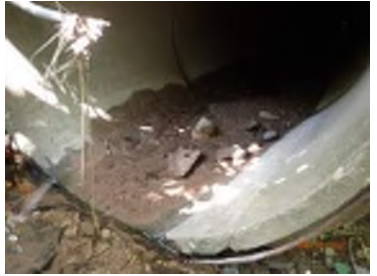
<b>Inspection Date:</b> 8/16/2021 12:54:23 PM		<b>Type:</b> Ongoing		<b>Flow:</b> None		<b>Previous Rainfall (hrs):</b> 72+	
<b>Illicit Discharge Potential:</b> Unlikely		<b>Inspector:</b> JCW		<b>Notes</b> Pipe wet, but no collectable flow at time of inspection. 3" joint displacement. Downed trees blocking stream channel.

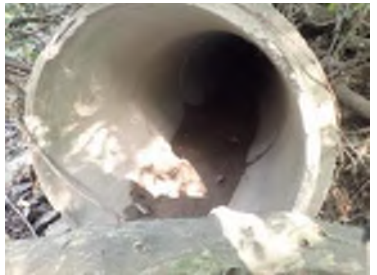
<b>Inspection Date:</b> 9/24/2020 9:32:24 AM		<b>Type:</b> Ongoing		<b>Flow:</b> None		<b>Previous Rainfall (hrs):</b> 72+	
<b>Illicit Discharge Potential:</b> Unlikely		<b>Inspector:</b> QAL		<b>Notes</b> Sediment damp, but no flow at time of inspection. 4" joint displacement.

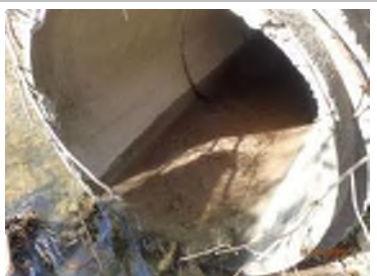
<b>Inspection Date:</b> 11/5/2019 12:33:00 PM		<b>Type:</b> Repeat		<b>Flow:</b> Submerged, significant flow		<b>Previous Rainfall (hrs):</b> 48-72	
<b>Illicit Discharge Potential:</b> Unlikely		<b>Inspector:</b> JCW		<b>Notes</b> Follow-up inspection for sampling - limited screening conducted. No detergent in follow-up sample.

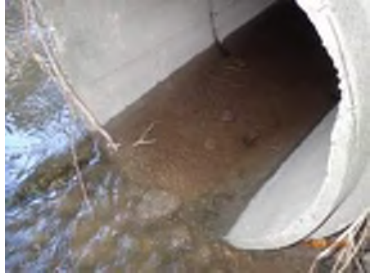
o20191008064438.JPG <div style="text-align: center; font-size: 24pt; font-weight: bold;">2019</div>

<b>Inspection Date:</b> 10/8/2019 7:44:51 AM		<b>Type:</b> Ongoing	<b>Flow:</b> Submerged, significant flow	<b>Previous Rainfall (hrs):</b> 48-72
<b>Illicit Discharge Potential:</b> <b>Potential</b>		<b>Inspector:</b> JCW	<b>Notes</b>	
Submerged: Partially      Depth (in): 5			Sample collected from submerged flow at end of pipe. 2" joint displacement. Detergent detected.	
<b>Sampling Results</b> Sample Location: Flow Total Chlorine: 0 ppm Free Chlorine: 0 ppm Ammonia: 0 ppm pH: 7.85 units Temperature: 51 °F Conductivity: 741 µS/cm Detergents: 1 mg/L		Floatables: None Odor: None Turbidity: None Color: None Gross Solids: None Vegetation: None Benthic Growth: Slight Stains: None Non-illicit: None	<b>Condition Assessment</b> Graffiti: None Erosion: None Deposition: Minor      1 in. Damage: Minor

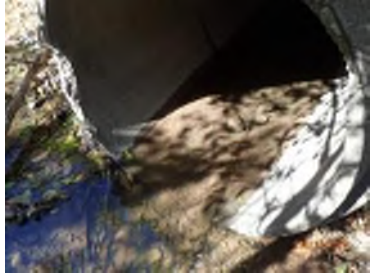
o20181022130156.JPG <div style="text-align: center; font-size: 24pt; font-weight: bold;">2018</div>

<b>Inspection Date:</b> 10/22/2018 1:04:11 PM		<b>Type:</b> Ongoing	<b>Flow:</b> Submerged, slight flow	<b>Previous Rainfall (hrs):</b> 48-72
<b>Illicit Discharge Potential:</b> <b>Unlikely</b>		<b>Inspector:</b> JCW	<b>Notes</b>	
Submerged: Partially      Depth (in): 3			Sample collected from submerged flow at end of pipe. 4" joint displacement.	
<b>Sampling Results</b> Sample Location: Flow Total Chlorine: 0 ppm Free Chlorine: 0 ppm Ammonia: 0 ppm pH: 7.62 units Temperature: 57 °F Conductivity: 811 µS/cm Detergents: 0 mg/L		Floatables: None Odor: None Turbidity: None Color: None Gross Solids: None Vegetation: None Benthic Growth: None Stains: None Non-illicit: None	<b>Condition Assessment</b> Graffiti: None Erosion: None Deposition: Minor      1 in. Damage: Moderate

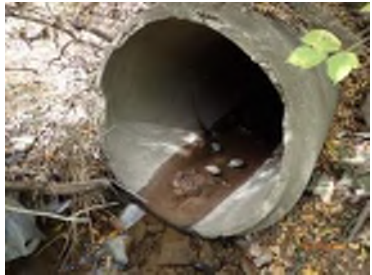
o20171019115316.JPG <div style="text-align: center; font-size: 24pt; font-weight: bold;">2017</div>

<b>Inspection Date:</b> 10/19/2017 11:55:23 AM		<b>Type:</b> Ongoing	<b>Flow:</b> Submerged, indeterminate	<b>Previous Rainfall (hrs):</b> 72+
<b>Illicit Discharge Potential:</b> <b>Unlikely</b>		<b>Inspector:</b> JCW	<b>Notes</b>	
Submerged: Partially      Depth (in): 2			Upstream manhole dry - sample collected from submerged pool at end of pipe. 3" joint displacement and damaged concrete.	
<b>Sampling Results</b> Sample Location: Flow Total Chlorine: 0 ppm Free Chlorine: 0 ppm Ammonia: 0 ppm pH: 8.1 units Temperature: 62 °F Conductivity: 725 µS/cm Detergents: 0 mg/L		Floatables: None Odor: None Turbidity: None Color: None Gross Solids: None Vegetation: None Benthic Growth: Slight Stains: None Non-illicit: None	<b>Condition Assessment</b> Graffiti: None Erosion: None Deposition: None      in. Damage: Moderate

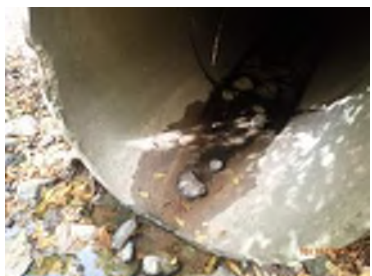
o20161019130908.JPG <div style="text-align: center; font-size: 24pt; font-weight: bold;">2016</div>

<b>Inspection Date:</b> 10/19/2016 1:11:20 PM		<b>Type:</b> Ongoing	<b>Flow:</b> Trickle	<b>Previous Rainfall (hrs):</b> 72+
<b>Illicit Discharge Potential:</b> <b>Unlikely</b>		<b>Inspector:</b> JCW	<b>Notes</b>	
Submerged: None      Depth (in):			Last pipe segment displaced 4" at joint.	
<b>Sampling Results</b> Sample Location: Flow Total Chlorine: 0 ppm Free Chlorine: 0 ppm Ammonia: 0 ppm pH: 8.24 units Temperature: 65 °F Conductivity: 765 µS/cm Detergents: 0 mg/L		Floatables: None Odor: None Turbidity: None Color: Faint in bottle Gross Solids: None Vegetation: None Benthic Growth: Slight Stains: None Non-illicit: None	<b>Condition Assessment</b> Graffiti: None Erosion: None Deposition: None      in. Damage: Minor

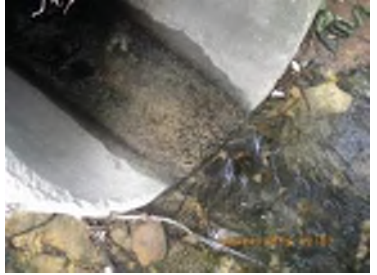
<b>Inspection Date:</b> 9/24/2015 12:55:30 PM		<b>Type:</b> Ongoing		<b>Flow:</b> Moderate		<b>Previous Rainfall (hrs):</b> 72+																																											
<b>Illicit Discharge Potential:</b> Unlikely		<b>Inspector:</b> JCW		<b>Notes</b> 4" joint displacement.

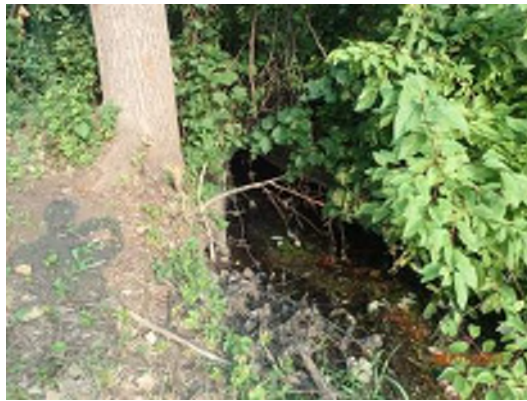
o20230801070036.JPG

Storm sewer discharges to Winnebago County Community Park from west.

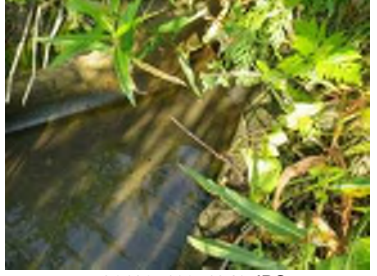
o20130716071846.JPG

<p>Apron wet, but no collectable flow from pipe at time of inspection.</p>	
Submerged: None		Depth (in):		<b>Condition Assessment</b> Graffiti: None Erosion: None Deposition: None in. Damage: None			
<b>Sampling Results</b> Sample Location: Total Chlorine: -- ppm Free Chlorine: -- ppm Ammonia: -- ppm pH: -- units Temperature: -- °F Conductivity: -- µS/cm Detergents: -- mg/L		Floatables: None Odor: None Turbidity: None Color: None Gross Solids: None Vegetation: None Benthic Growth: Slight Stains: None Non-illicit: None

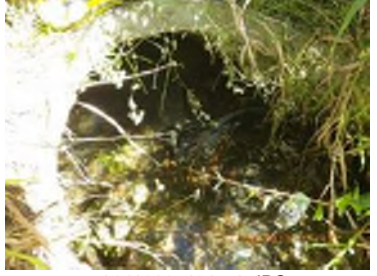
<p>o20130905101552.JPG</p> <p><b>2013</b></p>	
Submerged: Partially		Depth (in): 5		Outfall partially submerged. Outfall screened upstream at 15-2297 US1.			
<b>Sampling Results</b>				<b>Condition Assessment</b>			
Sample Location:		Floatables:	None	Graffiti:		None	in.
Total Chlorine: -- ppm		Odor:	None	Erosion:		None	
Free Chlorine: -- ppm		Turbidity:	None	Deposition:		None	
Ammonia: -- ppm		Color:	None	Damage:		None	
pH: -- units		Gross Solids:	Slight				
Temperature -- °F		Vegetation:	None				
Conductivity: -- µS/cm		Benthic Growth:	Slight				
Detergents: -- mg/L		Stains:	Slight				
		Non-illicit:	None

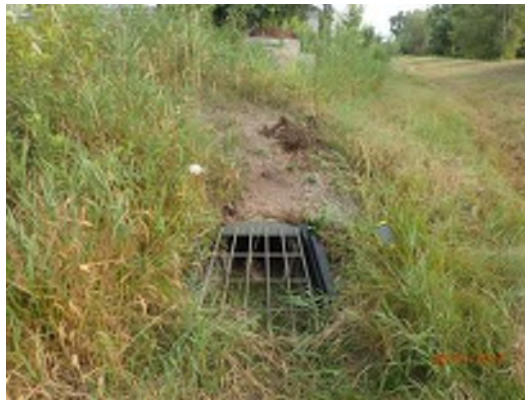
o20230801064108.JPG

Outlet structure from detention basin discharges to north end of swale.

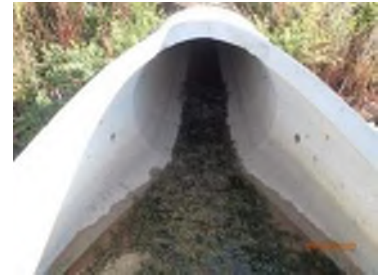
o20220930093620.JPG

<b>Inspection Date:</b> 9/30/2022 9:37:00 AM		<b>Type:</b> Ongoing	<b>Flow:</b> Submerged, indeterminate	<b>Previous Rainfall (hrs):</b> 72+
<b>Illicit Discharge Potential:</b> Potential		<b>Inspector:</b> EJK		
Submerged: Partially		Depth (in): 2		
<b>Sampling Results</b>		<b>Notes</b> Outfall partially submerged - screened upstream at 15-3339 US1. Abnormal detergent result from upstream manhole.		
Sample Location:	Floatables:	None		
Total Chlorine: -- ppm	Odor:	None		
Free Chlorine: -- ppm	Turbidity:	None		
Ammonia: -- ppm	Color:	None		
pH: -- units	Gross Solids:	None		
Temperature -- °F	Vegetation:	None		
Conductivity: -- µS/cm	Benthic Growth:	Severe		
Detergents: -- mg/L	Stains:	Slight		
	Non-illicit:	None		
		<b>Condition Assessment</b> Graffiti: None Erosion: None Deposition: None in. Damage: None

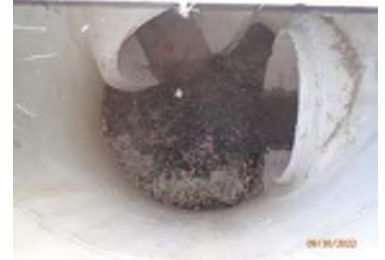
o20220930094256.JPG

<b>Inspection Date:</b> 9/30/2022 9:42:00 AM		<b>Type:</b> Ongoing	<b>Flow:</b> Submerged, indeterminate	<b>Previous Rainfall (hrs):</b> 72+
<b>Illicit Discharge Potential:</b> Potential		<b>Inspector:</b> EJK		
Submerged: Partially		Depth (in): 1		
<b>Sampling Results</b>				
Sample Location:	Pool	Floatables:	None	
Total Chlorine:	0 ppm	Odor:	None	
Free Chlorine:	0 ppm	Turbidity:	None	
Ammonia:	0 ppm	Color:	None	
pH:	7.52 units	Gross Solids:	Moderate	
Temperature:	59 °F	Vegetation:	None	
Conductivity:	1428 µS/cm	Benthic Growth:	Slight	
Detergents:	-1 mg/L	Stains:	Slight	
		Non-illicit:	None	
<b>Notes</b>				
Sample collected from submerged pool in manhole. Abnormal detergent test result.				
<b>Condition Assessment</b>				
Graffiti:	None	Erosion:	None	
Deposition:	None	Damage:	None	in.

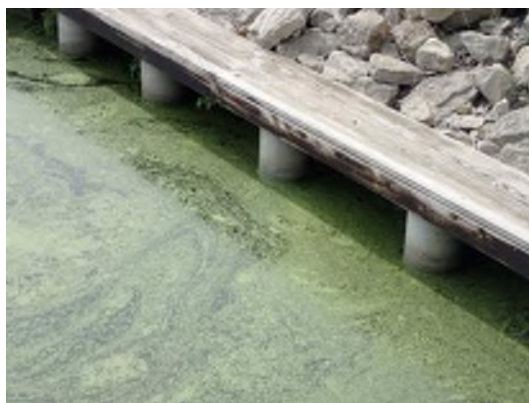
o20230809093412.JPG

N Sawyer St storm sewer discharges to river from south. Outfall fully submerged and not physically located. GPS coordinates approximate. Pipe info from MS4 map. (Formerly 16-533.)

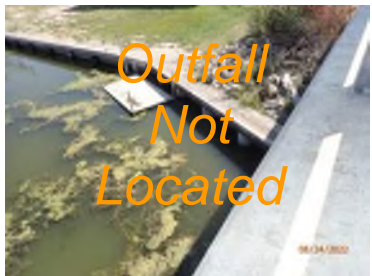
<b>Inspection Date:</b> 8/24/2022 2:29:00 PM		<b>Type:</b> Ongoing	<b>Flow:</b> Submerged (not located)	<b>Previous Rainfall (hrs):</b> 72+
<b>Illicit Discharge Potential:</b> Unlikely		<b>Inspector:</b> EJK		
Submerged: Fully		Depth (in):		
<b>Sampling Results</b> Sample Location: _____ Total Chlorine: -- ppm Free Chlorine: -- ppm Ammonia: -- ppm pH: -- units Temperature: -- °F Conductivity: -- µS/cm Detergents: -- mg/L		Floatables: None Odor: None Turbidity: None Color: None Gross Solids: None Vegetation: None Benthic Growth: None Stains: None Non-illicit: None	<b>Notes</b> Outfall fully submerged and not located - screened upstream at 16-1178 US1.

o20220824142120.JPG <div style="text-align: center; font-weight: bold; font-size: 1.2em;">2022</div>
		<b>Condition Assessment</b> Graffiti: None Erosion: None Deposition: None in. Damage: None

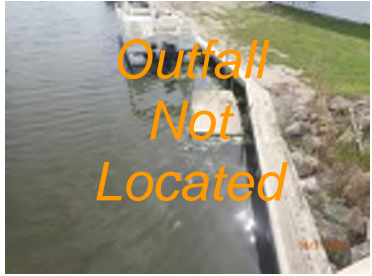
<b>Inspection Date:</b> 8/31/2021 11:09:30 AM		<b>Type:</b> Ongoing	<b>Flow:</b> Submerged (not located)	<b>Previous Rainfall (hrs):</b> 48-72
<b>Illicit Discharge Potential:</b> Potential		<b>Inspector:</b> JCW		
Submerged: Fully		Depth (in):		
<b>Sampling Results</b> Sample Location: _____ Total Chlorine: -- ppm Free Chlorine: -- ppm Ammonia: -- ppm pH: -- units Temperature: -- °F Conductivity: -- µS/cm Detergents: -- mg/L		Floatables: None Odor: None Turbidity: None Color: None Gross Solids: None Vegetation: None Benthic Growth: None Stains: None Non-illicit: None	<b>Notes</b> Outfall partially submerged - screened upstream at 16-1178 US1. Floating gross solids (litter) in upstream manhole.

o20210831110724.JPG <div style="text-align: center; font-weight: bold; font-size: 1.2em;">2021</div>
		<b>Condition Assessment</b> Graffiti: None Erosion: None Deposition: None in. Damage: None

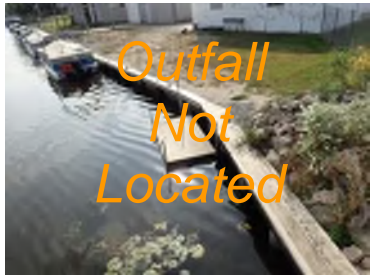
<b>Inspection Date:</b> 9/24/2020 9:53:07 AM		<b>Type:</b> Ongoing	<b>Flow:</b> Submerged (not located)	<b>Previous Rainfall (hrs):</b> 72+
<b>Illicit Discharge Potential:</b> Potential		<b>Inspector:</b> QAL		
Submerged: Fully		Depth (in):		
<b>Sampling Results</b> Sample Location: _____ Total Chlorine: -- ppm Free Chlorine: -- ppm Ammonia: -- ppm pH: -- units Temperature: -- °F Conductivity: -- µS/cm Detergents: -- mg/L		Floatables: None Odor: None Turbidity: None Color: None Gross Solids: None Vegetation: None Benthic Growth: None Stains: None Non-illicit: None	<b>Notes</b> Outfall fully submerged and not located - screened upstream at 16-533 US1. Floating gross solids (litter) in upstream manhole.

o20200924095628.JPG <div style="text-align: center; font-weight: bold; font-size: 1.2em;">2020</div>
		<b>Condition Assessment</b> Graffiti: None Erosion: None Deposition: None in. Damage: None

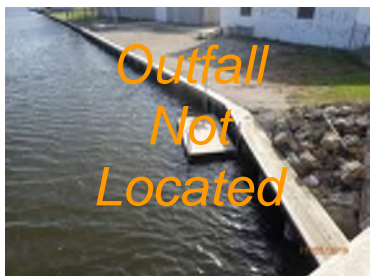
<b>Inspection Date:</b> 11/5/2019 9:36:00 AM		<b>Type:</b> Repeat	<b>Flow:</b> Submerged (not located)	<b>Previous Rainfall (hrs):</b> 48-72
<b>Illicit Discharge Potential:</b> Unlikely		<b>Inspector:</b> JCW		
Submerged: Fully		Depth (in):		
<b>Sampling Results</b> Sample Location: _____ Total Chlorine: -- ppm Free Chlorine: -- ppm Ammonia: -- ppm pH: -- units Temperature: -- °F Conductivity: -- µS/cm Detergents: -- mg/L		Floatables: None Odor: None Turbidity: None Color: None Gross Solids: None Vegetation: None Benthic Growth: None Stains: None Non-illicit: None	<b>Notes</b> Outfall fully submerged and not located - screened upstream at 16-533 US1. Follow-up inspection for sampling - limited screening conducted.

o20191105093616.JPG <div style="text-align: center; font-weight: bold; font-size: 1.2em;">2019</div>
		<b>Condition Assessment</b> Graffiti: None Erosion: None Deposition: None in. Damage: None

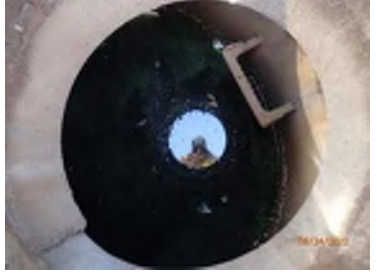
Inspection Date: 8/24/2022 2:30:00 PM		Type: Ongoing	Flow: Submerged, indeterminate	Previous Rainfall (hrs): 72+
<b>Illicit Discharge Potential: Unlikely</b> Submerged: Fully      Depth (in):		Inspector: EJK	Notes

o20220824142446.JPG <b>2022</b>
<b>Sampling Results</b> Sample Location: Pool Total Chlorine: 0 ppm Free Chlorine: 0 ppm Ammonia: 0 ppm pH: 7.64 units Temperature: 81 °F Conductivity: 354 µS/cm Detergents: 0 mg/L		Floatables: None Odor: None Turbidity: None Color: None Gross Solids: Slight Vegetation: None Benthic Growth: None Stains: None Non-illicit: None	Sample collected from submerged pool in manhole.  <b>Condition Assessment</b> Graffiti: None Erosion: None Deposition: None in. Damage: None	
<b>Inspection Date: 8/31/2021 11:17:57 AM</b> <b>Illicit Discharge Potential: Potential</b> Submerged: Fully      Depth (in): 40		Type: Ongoing	Flow: Submerged, indeterminate	Previous Rainfall (hrs): 48-72

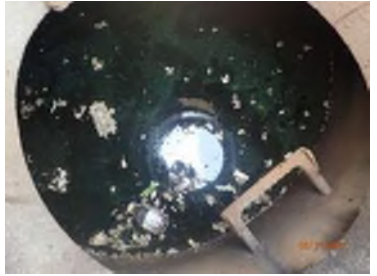
<b>Sampling Results</b> Sample Location: Pool Total Chlorine: 0 ppm Free Chlorine: 0 ppm Ammonia: 0 ppm pH: 7.29 units Temperature: 78 °F Conductivity: 389 µS/cm Detergents: 0 mg/L		Inspector: JCW	Notes

o20210831111218.JPG <b>2021</b>
Floatables: None Odor: None Turbidity: None Color: None Gross Solids: Moderate Vegetation: None Benthic Growth: None Stains: None Non-illicit: None		Sample collected from submerged pool in manhole. Floating gross solids (litter) in manhole.  <b>Condition Assessment</b> Graffiti: None Erosion: None Deposition: None in. Damage: None		
<b>Inspection Date: 9/24/2020 10:01:33 AM</b> <b>Illicit Discharge Potential: Potential</b> Submerged: Fully      Depth (in): 33		Type: Ongoing	Flow: Submerged, indeterminate	Previous Rainfall (hrs): 72+
<b>Sampling Results</b> Sample Location: Pool Total Chlorine: 0 ppm Free Chlorine: 0 ppm Ammonia: 0 ppm pH: 8.8 units Temperature: 68 °F Conductivity: 433 µS/cm Detergents: 0 mg/L		Inspector: QAL	Notes

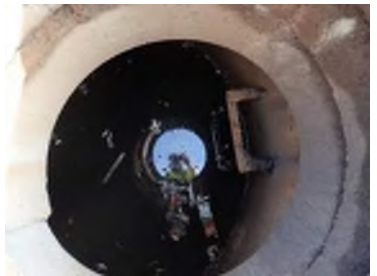
o20200924100816.JPG <b>2020</b>

Floatables: None Odor: None Turbidity: None Color: None Gross Solids: Moderate Vegetation: None Benthic Growth: None Stains: None Non-illicit: None		Sample collected from submerged pool in manhole. Floating gross solids (litter) in manhole.  <b>Condition Assessment</b> Graffiti: None Erosion: None Deposition: None in. Damage: None		
<b>Inspection Date: 11/5/2019 9:37:43 AM</b> <b>Illicit Discharge Potential: Unlikely</b> Submerged: Partially      Depth (in): 38		Type: Repeat	Flow: Submerged, indeterminate	Previous Rainfall (hrs): 48-72
<b>Sampling Results</b> Sample Location: Pool Total Chlorine: -- ppm Free Chlorine: -- ppm Ammonia: -- ppm pH: -- units Temperature: -- °F Conductivity: -- µS/cm Detergents: 0 mg/L		Inspector: JCW	Notes

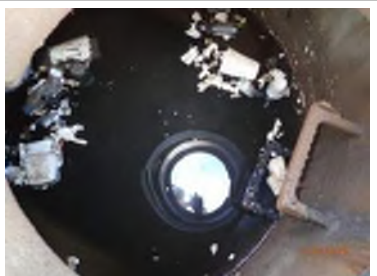
o20191105093642.JPG <b>2019</b>
Floatables: None Odor: None Turbidity: None Color: None Gross Solids: None Vegetation: None Benthic Growth: None Stains: None Non-illicit: None		Follow-up inspection for sampling - limited screening conducted.  <b>Condition Assessment</b> Graffiti: None Erosion: None Deposition: None in. Damage: None

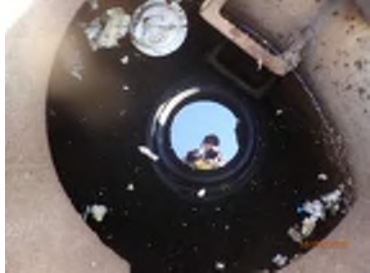
o20191008123830.JPG <div style="font-size: 24pt; font-weight: bold;">2019</div>

<b>Inspection Date:</b> 10/8/2019 1:38:32 PM		<b>Type:</b> Ongoing	<b>Flow:</b> Submerged, indeterminate	<b>Previous Rainfall (hrs):</b> 48-72
<b>Illicit Discharge Potential:</b> <b>Potential</b>		<b>Inspector:</b> JCW		<b>Notes</b> Sample collected from submerged pool in manhole. Floating gross solids (litter) in manhole. Detergent detected in sample.
Submerged: Partially      Depth (in): 38				
<b>Sampling Results</b> Sample Location: Pool Total Chlorine: 0 ppm Free Chlorine: 0 ppm Ammonia: 0 ppm pH: 7.34 units Temperature: 66 °F Conductivity: 449 µS/cm Detergents: 0.5 mg/L		Floatables: None Odor: None Turbidity: None Color: None Gross Solids: Moderate Vegetation: None Benthic Growth: None Stains: None Non-illicit: None	<b>Condition Assessment</b> Graffiti: None Erosion: None Deposition: None in. Damage: None

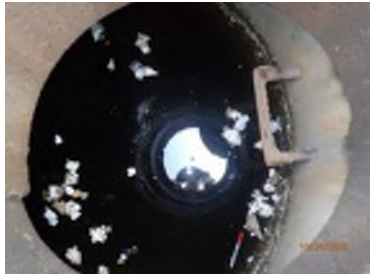
o20181024084850.JPG <div style="font-size: 24pt; font-weight: bold;">2018</div>

<b>Inspection Date:</b> 10/24/2018 8:51:52 AM		<b>Type:</b> Ongoing	<b>Flow:</b> Submerged, indeterminate	<b>Previous Rainfall (hrs):</b> 72+
<b>Illicit Discharge Potential:</b> <b>Potential</b>		<b>Inspector:</b> JCW		<b>Notes</b> Sample collected from submerged pool in manhole. Floating gross solids (litter) in manhole.
Submerged: Partially      Depth (in): 46				
<b>Sampling Results</b> Sample Location: Pool Total Chlorine: 0 ppm Free Chlorine: 0 ppm Ammonia: 0 ppm pH: 7.75 units Temperature: 48 °F Conductivity: 485 µS/cm Detergents: 0 mg/L		Floatables: None Odor: None Turbidity: None Color: None Gross Solids: Slight Vegetation: None Benthic Growth: None Stains: None Non-illicit: None	<b>Condition Assessment</b> Graffiti: None Erosion: None Deposition: None in. Damage: None

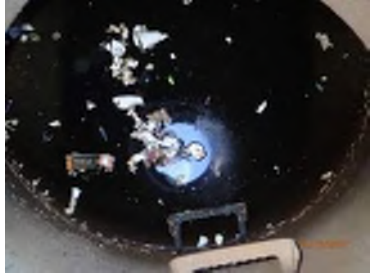
o20171019133054.JPG <div style="font-size: 24pt; font-weight: bold;">2017</div>

<b>Inspection Date:</b> 10/19/2017 1:34:48 PM		<b>Type:</b> Ongoing	<b>Flow:</b> Submerged, indeterminate	<b>Previous Rainfall (hrs):</b> 72+
<b>Illicit Discharge Potential:</b> <b>Unlikely</b>		<b>Inspector:</b> JCW		<b>Notes</b> Sample collected from submerged pool in manhole.
Submerged: Fully      Depth (in):				
<b>Sampling Results</b> Sample Location: Pool Total Chlorine: 0 ppm Free Chlorine: 0 ppm Ammonia: 0 ppm pH: 7.89 units Temperature: 66 °F Conductivity: 668 µS/cm Detergents: 0 mg/L		Floatables: Slight Odor: None Turbidity: None Color: None Gross Solids: Slight Vegetation: None Benthic Growth: None Stains: None Non-illicit: None	<b>Condition Assessment</b> Graffiti: None Erosion: None Deposition: None in. Damage: None

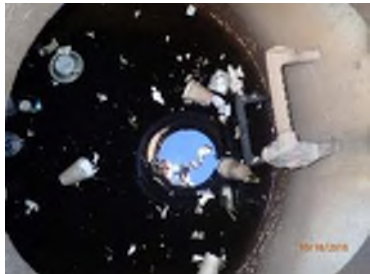
o20161018092516.JPG <div style="font-size: 24pt; font-weight: bold;">2016</div>

<b>Inspection Date:</b> 10/18/2016 9:29:17 AM		<b>Type:</b> Ongoing	<b>Flow:</b> Submerged, indeterminate	<b>Previous Rainfall (hrs):</b> 72+
<b>Illicit Discharge Potential:</b> <b>Potential</b>		<b>Inspector:</b> JCW		<b>Notes</b> Potential illicit discharge due to gross solids.
Submerged: Fully      Depth (in): 40				
<b>Sampling Results</b> Sample Location: Pool Total Chlorine: 0 ppm Free Chlorine: 0 ppm Ammonia: 0 ppm pH: 7.94 units Temperature: 63 °F Conductivity: 482 µS/cm Detergents: 0 mg/L		Floatables: None Odor: None Turbidity: None Color: None Gross Solids: Moderate Vegetation: None Benthic Growth: None Stains: None Non-illicit: None	<b>Condition Assessment</b> Graffiti: None Erosion: None Deposition: None in. Damage: None

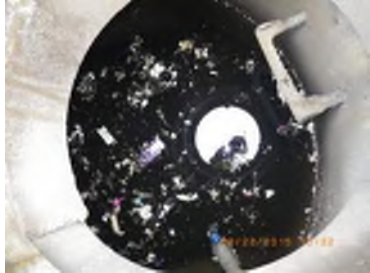
o20150923093204.JPG

<b>Inspection Date:</b> 9/23/2015 10:32:59 AM		<b>Type:</b> Ongoing	<b>Flow:</b> Submerged, indeterminate	<b>Previous Rainfall (hrs):</b> 72+
<b>Illicit Discharge Potential:</b> <b>Potential</b>		<b>Inspector:</b> JCW	<b>Notes</b>	
Submerged: Fully		Depth (in): 36	Floating gross solids (litter) - including syringe - in manhole.	
<b>Sampling Results</b>		<b>Floatables:</b> None	<b>Condition Assessment</b>	
Sample Location: Pool		<b>Odor:</b> None	<b>Graffiti:</b> None	
Total Chlorine: 0 ppm		<b>Turbidity:</b> None	<b>Erosion:</b> None	
Free Chlorine: 0 ppm		<b>Color:</b> None	<b>Deposition:</b> None in.	
Ammonia: 0 ppm		<b>Gross Solids:</b> Moderate	<b>Damage:</b> None	
pH: 7.95 units		<b>Vegetation:</b> None		
Temperature 71 °F		<b>Benthic Growth:</b> Slight		
Conductivity: 363 µS/cm		<b>Stains:</b> None		
Detergents: 0 mg/L		<b>Non-illicit:</b> None

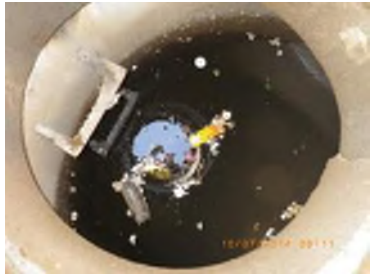
o20141007081140.JPG

<b>Inspection Date:</b> 10/7/2014 9:13:45 AM		<b>Type:</b> Ongoing	<b>Flow:</b> Submerged, indeterminate	<b>Previous Rainfall (hrs):</b> 48-72
<b>Illicit Discharge Potential:</b> <b>Potential</b>		<b>Inspector:</b> JCW	<b>Notes</b>	
Submerged: Fully		Depth (in): 34	Floating gross solids (litter) in manhole.	
<b>Sampling Results</b>		<b>Floatables:</b> None	<b>Condition Assessment</b>	
Sample Location: Pool		<b>Odor:</b> None	<b>Graffiti:</b> None	
Total Chlorine: 0 ppm		<b>Turbidity:</b> None	<b>Erosion:</b> None	
Free Chlorine: 0 ppm		<b>Color:</b> None	<b>Deposition:</b> None in.	
Ammonia: 0 ppm		<b>Gross Solids:</b> Moderate	<b>Damage:</b> None	
pH: 7.67 units		<b>Vegetation:</b> None		
Temperature -- °F		<b>Benthic Growth:</b> None		
Conductivity: 474 µS/cm		<b>Stains:</b> None		
Detergents: 0 mg/L		<b>Non-illicit:</b> None

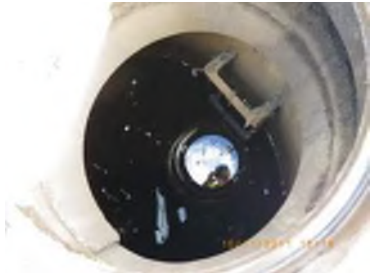
o20111011121924.JPG

<b>Inspection Date:</b> 10/11/2011 12:22:21 PM		<b>Type:</b> Ongoing	<b>Flow:</b> Submerged, indeterminate	<b>Previous Rainfall (hrs):</b> 72+
<b>Illicit Discharge Potential:</b> <b>Unlikely</b>		<b>Inspector:</b> JCW	<b>Notes</b>	
Submerged: Fully		Depth (in): 16	2010 screening follow-up. Floatable debris significantly reduced.	
<b>Sampling Results</b>		<b>Floatables:</b> None	<b>Condition Assessment</b>	
Sample Location: Pool		<b>Odor:</b> None	<b>Graffiti:</b> None	
Total Chlorine: 0 ppm		<b>Turbidity:</b> None	<b>Erosion:</b> None	
Free Chlorine: 0 ppm		<b>Color:</b> None	<b>Deposition:</b> None 0 in.	
Ammonia: 0 ppm		<b>Gross Solids:</b> Moderate	<b>Damage:</b> None	
pH: 7.9 units		<b>Vegetation:</b> None		
Temperature 70 °F		<b>Benthic Growth:</b> None		
Conductivity: -- µS/cm		<b>Stains:</b> None		
Detergents: -- mg/L		<b>Non-illicit:</b> None

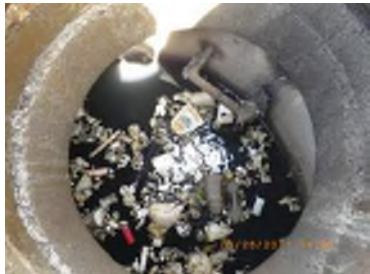
o20110526143524.JPG

<b>Inspection Date:</b> 5/26/2011 2:35:00 PM		<b>Type:</b> Other	<b>Flow:</b> Submerged, indeterminate	<b>Previous Rainfall (hrs):</b> 72+
<b>Illicit Discharge Potential:</b> <b>Potential</b>		<b>Inspector:</b> JCW	<b>Notes</b>	
Submerged: Fully		Depth (in):	Limited screening conducted to check for floatable debris.	
<b>Sampling Results</b>		<b>Floatables:</b> None	<b>Condition Assessment</b>	
Sample Location:		<b>Odor:</b>	<b>Graffiti:</b> None	
Total Chlorine: -- ppm		<b>Turbidity:</b>	<b>Erosion:</b> None	
Free Chlorine: -- ppm		<b>Color:</b>	<b>Deposition:</b> None 0 in.	
Ammonia: -- ppm		<b>Gross Solids:</b> Moderate	<b>Damage:</b> None	
pH: -- units		<b>Vegetation:</b>		
Temperature -- °F		<b>Benthic Growth:</b>		
Conductivity: -- µS/cm		<b>Stains:</b>		
Detergents: -- mg/L		<b>Non-illicit:</b> None

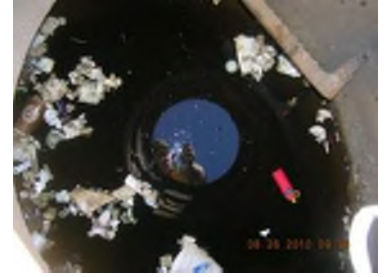
o20100826095640.JPG

<b>Inspection Date:</b> 8/26/2010 10:01:38 AM		<b>Type:</b> Ongoing	<b>Flow:</b> Submerged, indeterminate	<b>Previous Rainfall (hrs):</b> 72+
<b>Illicit Discharge Potential:</b> Potential		<b>Inspector:</b> JCW	<b>Notes</b>	
Submerged: Fully		Depth (in): 36	Floatable debris in manhole.	
<b>Sampling Results</b>				
Sample Location:	Pool	Floatables:	None	
Total Chlorine:	0 ppm	Odor:	None	
Free Chlorine:	0 ppm	Turbidity:	None	
Ammonia:	0 ppm	Color:	Faint in bottle	
pH:	7.23 units	Gross Solids:	Moderate	
Temperature	76 °F	Vegetation:	None	
Conductivity:	-- µS/cm	Benthic Growth:	Slight	
Detergents:	0 mg/L	Stains:	None	
		Non-illicit:	None	
		<b>Condition Assessment</b>		
		Graffiti:	None	
		Erosion:	None	
		Deposition:	None 0 in.	
		Damage:	None

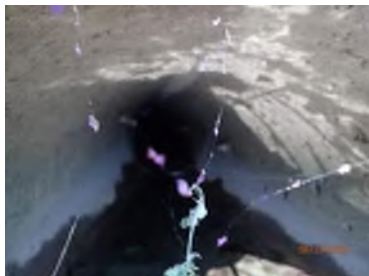
o20220823152424.JPG <div style="text-align: center; font-size: 24pt; font-weight: bold;">2022</div>

<b>Inspection Date:</b> 8/23/2022 3:25:00 PM		<b>Type:</b> Ongoing	<b>Flow:</b> Submerged, no flow	<b>Previous Rainfall (hrs):</b> 72+
<b>Illicit Discharge Potential:</b> Potential		<b>Inspector:</b> EJK		
Submerged: Partially		Depth (in): 2		
<b>Sampling Results</b> Sample Location: Pool Total Chlorine: 0 ppm Free Chlorine: 0 ppm Ammonia: 0 ppm pH: 8.55 units Temperature: 82 °F Conductivity: 835 µS/cm Detergents: 2.5 mg/L		Floatables: None Odor: Easily detected Turbidity: None Color: None Gross Solids: None Vegetation: None Benthic Growth: Severe Stains: Slight Non-illicit: Slight	<b>Notes</b> No flow escaping upstream curb inlet. Sample collected from outfall pool. Detergent in pond, possibly from car wash.  <b>Condition Assessment</b> Graffiti: None Erosion: None Deposition: None in. Damage: None

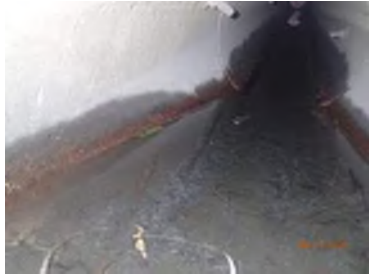
o20210817073912.JPG <div style="text-align: center; font-size: 24pt; font-weight: bold;">2021</div>

<b>Inspection Date:</b> 8/17/2021 7:41:43 AM		<b>Type:</b> Ongoing	<b>Flow:</b> Submerged, indeterminate	<b>Previous Rainfall (hrs):</b> 72+
<b>Illicit Discharge Potential:</b> Potential		<b>Inspector:</b> JCW		
Submerged: Partially		Depth (in): 3		
<b>Sampling Results</b> Sample Location: Pool Total Chlorine: 0 ppm Free Chlorine: 0 ppm Ammonia: 0 ppm pH: 7.4 units Temperature: 72 °F Conductivity: 2580 µS/cm Detergents: 0.6 mg/L		Floatables: None Odor: None Turbidity: None Color: None Gross Solids: None Vegetation: None Benthic Growth: Slight Stains: Slight Non-illicit: Slight	<b>Notes</b> Outfall partially submerged. Traffic prevented screening of upstream inlet. Pond sample from end of pipe had detergent and elevated conductivity.  <b>Condition Assessment</b> Graffiti: None Erosion: None Deposition: None in. Damage: None

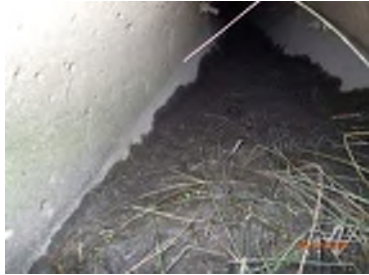
o20200820085150.JPG <div style="text-align: center; font-size: 24pt; font-weight: bold;">2020</div>

<b>Inspection Date:</b> 8/20/2020 8:54:14 AM		<b>Type:</b> Ongoing	<b>Flow:</b> None	<b>Previous Rainfall (hrs):</b> 72+
<b>Illicit Discharge Potential:</b> Unlikely		<b>Inspector:</b> JCW		
Submerged: None		Depth (in):		
<b>Sampling Results</b> Sample Location: Total Chlorine: -- ppm Free Chlorine: -- ppm Ammonia: -- ppm pH: -- units Temperature: -- °F Conductivity: -- µS/cm Detergents: -- mg/L		Floatables: None Odor: None Turbidity: None Color: None Gross Solids: None Vegetation: None Benthic Growth: Slight Stains: None Non-illicit: None	<b>Notes</b> Sediment wet, but no flow at time of inspection. No flow entering pipe at upstream curb inlet.  <b>Condition Assessment</b> Graffiti: None Erosion: None Deposition: Minor 1 in. Damage: None

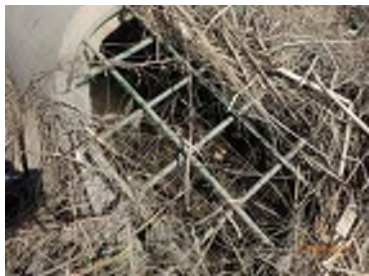
o20191008130940.JPG <div style="text-align: center; font-size: 24pt; font-weight: bold;">2019</div>

<b>Inspection Date:</b> 10/8/2019 2:11:11 PM		<b>Type:</b> Ongoing	<b>Flow:</b> Submerged, indeterminate	<b>Previous Rainfall (hrs):</b> 48-72
<b>Illicit Discharge Potential:</b> Potential		<b>Inspector:</b> JCW		
Submerged: Partially		Depth (in): 5		
<b>Sampling Results</b> Sample Location: Total Chlorine: -- ppm Free Chlorine: -- ppm Ammonia: -- ppm pH: -- units Temperature: -- °F Conductivity: -- µS/cm Detergents: -- mg/L		Floatables: None Odor: None Turbidity: None Color: None Gross Solids: Slight Vegetation: None Benthic Growth: Slight Stains: None Non-illicit: None	<b>Notes</b> Outfall partially submerged - screened upstream at 16-1205 US1. Detergent detected in upstream manhole.  <b>Condition Assessment</b> Graffiti: None Erosion: None Deposition: Minor 2 in. Damage: None

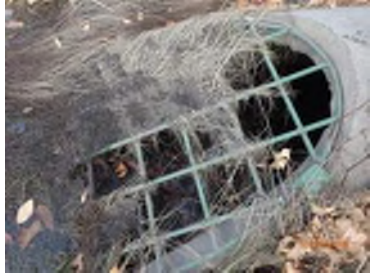
o20181025083538.JPG

<b>Inspection Date:</b> 10/25/2018 8:41:00 AM		<b>Type:</b> Ongoing	<b>Flow:</b> Submerged, indeterminate	<b>Previous Rainfall (hrs):</b> 72+
<b>Illicit Discharge Potential:</b> <b>Potential</b>		<b>Inspector:</b> JCW	<b>Notes</b>	
Submerged: Partially      Depth (in): 5			Outfall partially submerged - screened upstream at 16-1205 US1. Detergent detected in upstream manhole.	
<b>Sampling Results</b>			<b>Condition Assessment</b>	
Sample Location:	Floatables:	None	Graffiti: None Erosion: None Deposition: Minor      2 in. Damage: None	
Total Chlorine: -- ppm	Odor:	None		
Free Chlorine: -- ppm	Turbidity:	None		
Ammonia: -- ppm	Color:	None		
pH: -- units	Gross Solids:	Slight		
Temperature -- ° F	Vegetation:	None		
Conductivity: -- µS/cm	Benthic Growth:	None		
Detergents: -- mg/L	Stains:	None		
	Non-illicit:	None

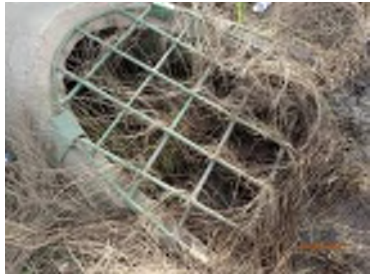
o20171003090114.JPG

<b>Inspection Date:</b> 10/3/2017 9:04:39 AM		<b>Type:</b> Ongoing	<b>Flow:</b> Submerged, indeterminate	<b>Previous Rainfall (hrs):</b> 72+
<b>Illicit Discharge Potential:</b> <b>Unlikely</b>		<b>Inspector:</b> JCW	<b>Notes</b>	
Submerged: Partially      Depth (in): 1			Outfall partially submerged - screened upstream at 16-1205 US1.	
<b>Sampling Results</b>			<b>Condition Assessment</b>	
Sample Location:	Floatables:	None	Graffiti: None Erosion: None Deposition: Minor      1 in. Damage: None	
Total Chlorine: -- ppm	Odor:	None		
Free Chlorine: -- ppm	Turbidity:	None		
Ammonia: -- ppm	Color:	None		
pH: -- units	Gross Solids:	Slight		
Temperature -- ° F	Vegetation:	None		
Conductivity: -- µS/cm	Benthic Growth:	None		
Detergents: -- mg/L	Stains:	None		
	Non-illicit:	None

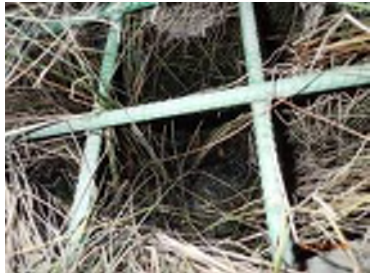
o20161018070408.JPG

<b>Inspection Date:</b> 10/18/2016 7:06:22 AM		<b>Type:</b> Ongoing	<b>Flow:</b> Submerged, indeterminate	<b>Previous Rainfall (hrs):</b> 72+
<b>Illicit Discharge Potential:</b> <b>Unlikely</b>		<b>Inspector:</b> JCW	<b>Notes</b>	
Submerged: Partially      Depth (in): 2			Outfall partially submerged - screened upstream at 16-1205 US1.	
<b>Sampling Results</b>			<b>Condition Assessment</b>	
Sample Location:	Floatables:	None	Graffiti: None Erosion: None Deposition: None      in. Damage: None	
Total Chlorine: -- ppm	Odor:	None		
Free Chlorine: -- ppm	Turbidity:	None		
Ammonia: -- ppm	Color:	None		
pH: -- units	Gross Solids:	None		
Temperature -- ° F	Vegetation:	None		
Conductivity: -- µS/cm	Benthic Growth:	Slight		
Detergents: -- mg/L	Stains:	None		
	Non-illicit:	None

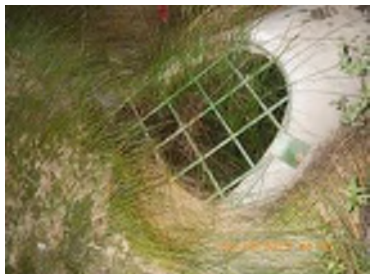
o20150928053734.JPG

<b>Inspection Date:</b> 9/28/2015 6:36:00 AM		<b>Type:</b> Ongoing	<b>Flow:</b> Submerged, indeterminate	<b>Previous Rainfall (hrs):</b> 72+
<b>Illicit Discharge Potential:</b> <b>Unlikely</b>		<b>Inspector:</b> JCW	<b>Notes</b>	
Submerged: Partially      Depth (in): 3			Outfall partially submerged - screened at 16-1205 US1.	
<b>Sampling Results</b>			<b>Condition Assessment</b>	
Sample Location:	Floatables:	None	Graffiti: None Erosion: None Deposition: None      in. Damage: None	
Total Chlorine: -- ppm	Odor:	None		
Free Chlorine: -- ppm	Turbidity:	None		
Ammonia: -- ppm	Color:	None		
pH: -- units	Gross Solids:	None		
Temperature -- ° F	Vegetation:	None		
Conductivity: -- µS/cm	Benthic Growth:	Slight		
Detergents: -- mg/L	Stains:	Slight		
	Non-illicit:	None

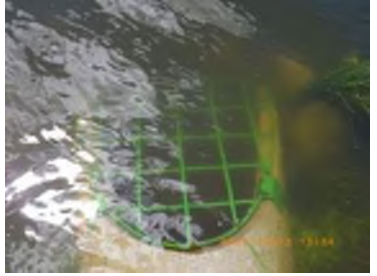
<p>o20120621113440.JPG</p> <p><b>2012</b></p>

<b>Inspection Date:</b> 6/21/2012 12:32:35 PM		<b>Type:</b> Ongoing	<b>Flow:</b> Submerged, indeterminate	<b>Previous Rainfall (hrs):</b> 0-24
<b>Illicit Discharge Potential:</b> Unlikely		<b>Inspector:</b> JCW		
Submerged: Fully		Depth (in): 21		
<b>Sampling Results</b> Sample Location: Total Chlorine: -- ppm Free Chlorine: -- ppm Ammonia: -- ppm pH: -- units Temperature: -- °F Conductivity: -- µS/cm Detergents: -- mg/L		Floatables: None Odor: None Turbidity: None Color: None Gross Solids: None Vegetation: None Benthic Growth: None Stains: None Non-illicit: None		
		<b>Notes</b> Outfall fully submerged; screened upstream at 16-1205 US1.		
		<b>Condition Assessment</b> Graffiti: None Erosion: None Deposition: None in. Damage: None

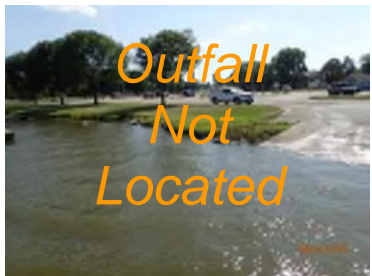
<b>Inspection Date:</b> 8/24/2022 3:03:00 PM		<b>Type:</b> Ongoing		<b>Flow:</b> Submerged (not located)		<b>Previous Rainfall (hrs):</b> 72+	
<b>Illicit Discharge Potential:</b> Unlikely		<b>Inspector:</b> EJK		<b>Notes</b> Outfall fully submerged and not located - screened upstream at 16-201 US1.

o20220824145704.JPG	
Submerged: Fully		Depth (in):					
<b>Sampling Results</b> Sample Location: _____ Total Chlorine: -- ppm Free Chlorine: -- ppm Ammonia: -- ppm pH: -- units Temperature: -- °F Conductivity: -- µS/cm Detergents: -- mg/L		Floatables: None Odor: None Turbidity: None Color: None Gross Solids: None Vegetation: None Benthic Growth: None Stains: None Non-illicit: None		<b>Condition Assessment</b> Graffiti: None Erosion: None Deposition: None in. Damage: None		<b>2022</b>

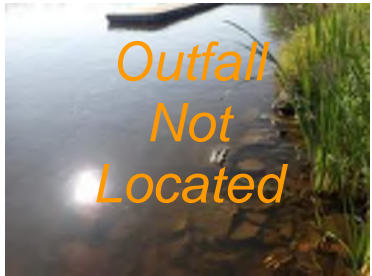
<b>Inspection Date:</b> 8/17/2021 9:30:31 AM		<b>Type:</b> Ongoing		<b>Flow:</b> Submerged (not located)		<b>Previous Rainfall (hrs):</b> 72+	
<b>Illicit Discharge Potential:</b> Unlikely		<b>Inspector:</b> JCW		<b>Notes</b> Outfall fully submerged and not located - screened upstream at 16-201 US1.

o20210817092902.JPG	
Submerged: Fully		Depth (in):					
<b>Sampling Results</b> Sample Location: _____ Total Chlorine: -- ppm Free Chlorine: -- ppm Ammonia: -- ppm pH: -- units Temperature: -- °F Conductivity: -- µS/cm Detergents: -- mg/L		Floatables: None Odor: None Turbidity: None Color: None Gross Solids: None Vegetation: None Benthic Growth: None Stains: None Non-illicit: None		<b>Condition Assessment</b> Graffiti: None Erosion: None Deposition: None in. Damage: None		<b>2021</b>

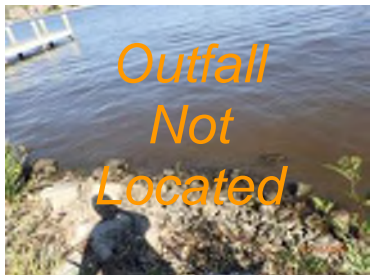
<b>Inspection Date:</b> 10/10/2016 1:47:19 PM		<b>Type:</b> Ongoing		<b>Flow:</b> Submerged (not located)		<b>Previous Rainfall (hrs):</b> 72+	
<b>Illicit Discharge Potential:</b> Potential		<b>Inspector:</b> JCW		<b>Notes</b> Outfall fully submerged and not located - screened upstream at 16-201 US1.

o20161010134624.JPG	
Submerged: Fully		Depth (in):					
<b>Sampling Results</b> Sample Location: _____ Total Chlorine: -- ppm Free Chlorine: -- ppm Ammonia: -- ppm pH: -- units Temperature: -- °F Conductivity: -- µS/cm Detergents: -- mg/L		Floatables: None Odor: None Turbidity: None Color: None Gross Solids: None Vegetation: None Benthic Growth: None Stains: None Non-illicit: None		<b>Condition Assessment</b> Graffiti: None Erosion: None Deposition: None in. Damage: None		<b>2016</b>

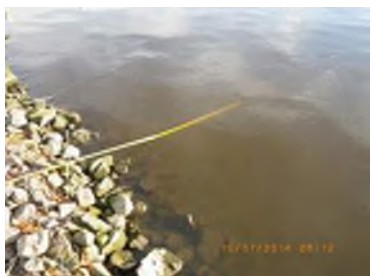
<b>Inspection Date:</b> 10/7/2014 8:11:23 AM		<b>Type:</b> Ongoing		<b>Flow:</b> Submerged, indeterminate		<b>Previous Rainfall (hrs):</b> 48-72	
<b>Illicit Discharge Potential:</b> Unlikely		<b>Inspector:</b> JCW		<b>Notes</b> Outfall fully submerged - screened upstream at 16-201 US1.

o20141007071204.JPG	
Submerged: Fully		Depth (in): 28					
<b>Sampling Results</b> Sample Location: _____ Total Chlorine: -- ppm Free Chlorine: -- ppm Ammonia: -- ppm pH: -- units Temperature: -- °F Conductivity: -- µS/cm Detergents: -- mg/L		Floatables: None Odor: None Turbidity: None Color: None Gross Solids: None Vegetation: None Benthic Growth: None Stains: None Non-illicit: None		<b>Condition Assessment</b> Graffiti: None Erosion: None Deposition: None in. Damage: None		<b>2014</b>

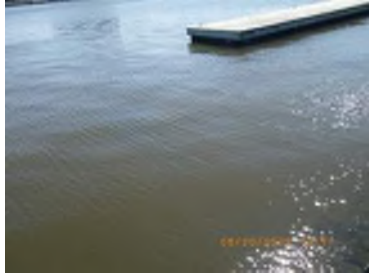
<b>Inspection Date:</b> 6/20/2012 10:55:37 AM		<b>Type:</b> Ongoing		<b>Flow:</b> Submerged, indeterminate		<b>Previous Rainfall (hrs):</b> 24-48	
<b>Illicit Discharge Potential:</b> <b>Unlikely</b>		<b>Inspector:</b> JCW		<b>Notes</b> Outfall fully submerged; screened upstream at 16-201 US1.

o20120620095704.JPG	
Submerged: Fully		Depth (in):					
<b>Sampling Results</b> Sample Location: Total Chlorine: -- ppm Free Chlorine: -- ppm Ammonia: -- ppm pH: -- units Temperature: -- °F Conductivity: -- µS/cm Detergents: -- mg/L		Floatables: None Odor: None Turbidity: None Color: None Gross Solids: None Vegetation: None Benthic Growth: None Stains: None Non-illicit: None		<b>Condition Assessment</b> Graffiti: None Erosion: None Deposition: None in. Damage: None		<div style="text-align: center; font-size: 24pt; font-weight: bold;">2012</div>

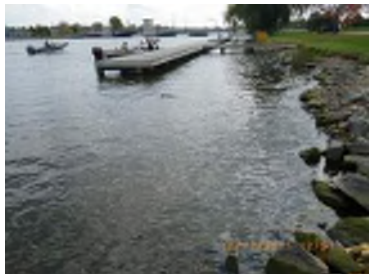
<b>Inspection Date:</b> 10/11/2011 12:51:01 PM		<b>Type:</b> Ongoing		<b>Flow:</b> Submerged, indeterminate		<b>Previous Rainfall (hrs):</b> 72+	
<b>Illicit Discharge Potential:</b> <b>Potential</b>		<b>Inspector:</b> JCW		<b>Notes</b> 2010 screening follow-up. Outfall partially submerged. Outfall screened upstream at 16-201 US1.

o20111011125132.JPG	
Submerged: Partially		Depth (in):					
<b>Sampling Results</b> Sample Location: Total Chlorine: -- ppm Free Chlorine: -- ppm Ammonia: -- ppm pH: -- units Temperature: -- °F Conductivity: -- µS/cm Detergents: -- mg/L		Floatables: None Odor: None Turbidity: None Color: None Gross Solids: None Vegetation: None Benthic Growth: None Stains: None Non-illicit: None		<b>Condition Assessment</b> Graffiti: None Erosion: None Deposition: None 0 in. Damage: None		<div style="text-align: center; font-size: 24pt; font-weight: bold;">2011</div>

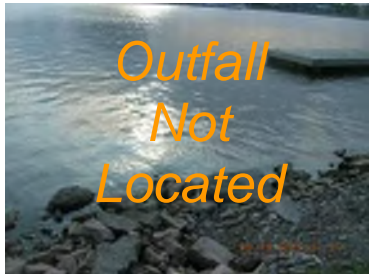
<b>Inspection Date:</b> 8/19/2010 7:49:43 AM		<b>Type:</b> Ongoing		<b>Flow:</b> Submerged (not located)		<b>Previous Rainfall (hrs):</b> 72+	
<b>Illicit Discharge Potential:</b> <b>Potential</b>		<b>Inspector:</b> JCW		<b>Notes</b> Outfall fully submerged and not physically located. Outfall screened upstream at 16-201 US1.

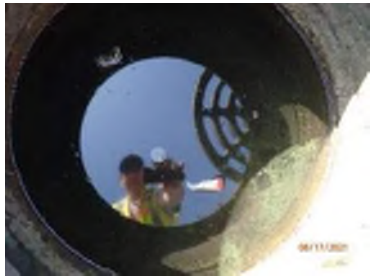
o20210817093056.JPG <b>2021</b>
Floatables: Moderate Odor: Easily detected Turbidity: None Color: None Gross Solids: Slight Vegetation: None Benthic Growth: Moderate Stains: None Non-illicit: None		Sample collected from submerged pool in manhole.  <b>Condition Assessment</b> Graffiti: None Erosion: None Deposition: None in. Damage: None		
<b>Inspection Date: 10/10/2016 1:50:41 PM</b> <b>Illicit Discharge Potential: Potential</b> Submerged: Fully      Depth (in): 24		Type: Ongoing	Flow: Submerged, indeterminate	Previous Rainfall (hrs): 72+
<b>Sampling Results</b> Sample Location: Pool Total Chlorine: 0 ppm Free Chlorine: 0 ppm Ammonia: 0 ppm pH: 7.22 units Temperature: 69 °F Conductivity: 429 µS/cm Detergents: 0 mg/L		Inspector: JCW	Notes

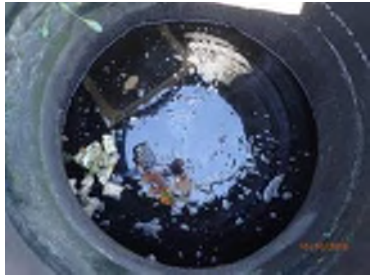
o20161010134816.JPG <b>2016</b>

Floatables: Slight Odor: Faint Turbidity: None Color: Faint in bottle Gross Solids: Moderate Vegetation: None Benthic Growth: None Stains: None Non-illicit: None		Potential illicit discharge due to gross solids.  <b>Condition Assessment</b> Graffiti: None Erosion: None Deposition: None in. Damage: None		
<b>Inspection Date: 10/7/2014 8:16:37 AM</b> <b>Illicit Discharge Potential: Unlikely</b> Submerged: Fully      Depth (in): 22		Type: Ongoing	Flow: Submerged, indeterminate	Previous Rainfall (hrs): 48-72
<b>Sampling Results</b> Sample Location: Pool Total Chlorine: 0 ppm Free Chlorine: 0 ppm Ammonia: 0 ppm pH: 7.42 units Temperature: -- °F Conductivity: 429 µS/cm Detergents: 0 mg/L		Inspector: JCW	Notes

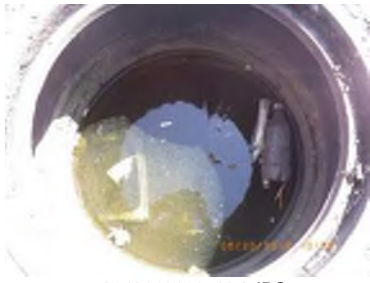
o20120620095824.JPG

<b>Inspection Date:</b> 6/20/2012 10:56:06 AM		<b>Type:</b> Ongoing	<b>Flow:</b> Submerged, indeterminate	<b>Previous Rainfall (hrs):</b> 24-48
<b>Illicit Discharge Potential:</b> Unlikely		<b>Inspector:</b> JCW	<b>Notes</b>	
Submerged: Fully		Depth (in): 29	2011 gross solids follow-up. Visual screening only.	
<b>Sampling Results</b>		<b>Condition Assessment</b>		
Sample Location:	Floatables:	None		
Total Chlorine: -- ppm	Odor:	None		
Free Chlorine: -- ppm	Turbidity:	None		
Ammonia: -- ppm	Color:	None		
pH: -- units	Gross Solids:	Slight		
Temperature -- °F	Vegetation:	None		
Conductivity: -- µS/cm	Benthic Growth:	Slight		
Detergents: -- mg/L	Stains:	None		
	Non-illicit:	None		
		Graffiti:	None	
		Erosion:	None	
		Deposition:	None in.	
		Damage:	None

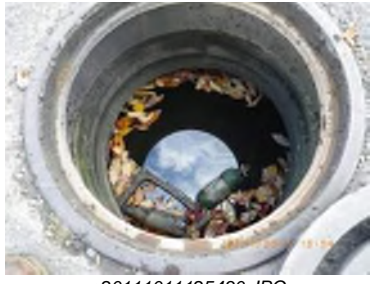
o20111011125430.JPG

<b>Inspection Date:</b> 10/11/2011 12:54:49 PM		<b>Type:</b> Ongoing	<b>Flow:</b> Submerged, indeterminate	<b>Previous Rainfall (hrs):</b> 72+
<b>Illicit Discharge Potential:</b> Potential		<b>Inspector:</b> JCW	<b>Notes</b>	
Submerged: Fully		Depth (in): 22	2010 screening follow-up. Floatable debris still present. Slight petroleum sheen.	
<b>Sampling Results</b>		<b>Condition Assessment</b>		
Sample Location: Pool	Floatables:	Slight		
Total Chlorine: 0 ppm	Odor:	None		
Free Chlorine: 0 ppm	Turbidity:	None		
Ammonia: 0 ppm	Color:	None		
pH: 8.44 units	Gross Solids:	Slight		
Temperature 71 °F	Vegetation:	None		
Conductivity: -- µS/cm	Benthic Growth:	None		
Detergents: -- mg/L	Stains:	None		
	Non-illicit:	None		
		Graffiti:	None	
		Erosion:	None	
		Deposition:	None 0 in.	
		Damage:	None

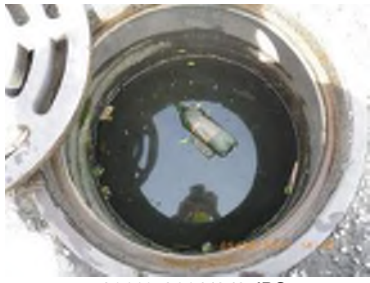
o20110526144848.JPG

<b>Inspection Date:</b> 5/26/2011 2:48:00 PM		<b>Type:</b> Other	<b>Flow:</b> Submerged, indeterminate	<b>Previous Rainfall (hrs):</b> 72+
<b>Illicit Discharge Potential:</b> Unlikely		<b>Inspector:</b> JCW	<b>Notes</b>	
Submerged: Fully		Depth (in):	Limited screening conducted to check for floatable debris.	
<b>Sampling Results</b>		<b>Condition Assessment</b>		
Sample Location:	Floatables:	Slight		
Total Chlorine: -- ppm	Odor:			
Free Chlorine: -- ppm	Turbidity:			
Ammonia: -- ppm	Color:			
pH: -- units	Gross Solids:	Slight		
Temperature -- °F	Vegetation:			
Conductivity: -- µS/cm	Benthic Growth:			
Detergents: -- mg/L	Stains:			
	Non-illicit:	None		
		Graffiti:	None	
		Erosion:	None	
		Deposition:	None 0 in.	
		Damage:	None

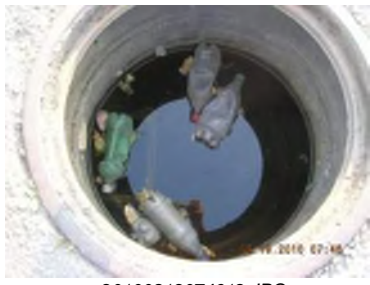
o20100819074612.JPG

<b>Inspection Date:</b> 8/19/2010 7:54:51 AM		<b>Type:</b> Ongoing	<b>Flow:</b> Submerged, indeterminate	<b>Previous Rainfall (hrs):</b> 72+
<b>Illicit Discharge Potential:</b> Potential		<b>Inspector:</b> JCW	<b>Notes</b>	
Submerged: Fully		Depth (in): 29	Moderate floatable debris in catchbasin.	
<b>Sampling Results</b>		<b>Condition Assessment</b>		
Sample Location: Pool	Floatables:	None		
Total Chlorine: 0 ppm	Odor:	None		
Free Chlorine: 0 ppm	Turbidity:	Slight cloudiness		
Ammonia: 0 ppm	Color:	Faint in bottle		
pH: 7.57 units	Gross Solids:	Moderate		
Temperature 74 °F	Vegetation:	None		
Conductivity: -- µS/cm	Benthic Growth:	Slight		
Detergents: 0 mg/L	Stains:	None		
	Non-illicit:	None		
		Graffiti:	None	
		Erosion:	None	
		Deposition:	None 0 in.	
		Damage:	None

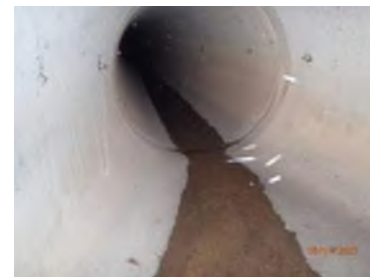
o20230801101852.JPG

Damage: Minor ☒ Displacement ☐ Undercut ☐ Crushed☐ Corrosion ☐ Cracks/Structural Damage
