# Submittal of Annual Reports and Other Compliance Documents for Municipal Separate Storm Sewer System (MS4) Permits

**Project Name:** 2023 Annual Report

**Municipality:** Oshkosh, City

**Permit Number:** S050075

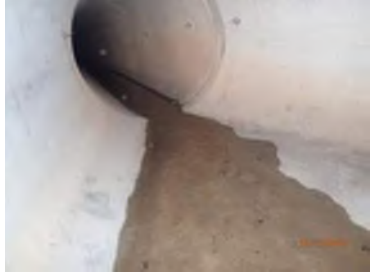
<b>Inspection Date:</b> 10/17/2017 10:14:25 AM		<b>Type:</b> Ongoing	<b>Flow:</b> Trickle	<b>Previous Rainfall (hrs):</b> 48-72
<b>Illicit Discharge Potential:</b> Unlikely		<b>Inspector:</b> JCW		
<b>Submerged:</b> None		<b>Depth (in):</b>		
<b>Sampling Results</b> Sample Location: Flow Total Chlorine: 0 ppm Free Chlorine: 0 ppm Ammonia: 0 ppm pH: 8.7 units Temperature: 65 °F Conductivity: 1919 µS/cm Detergents: 0 mg/L		Floatables: None Odor: None Turbidity: None Color: None Gross Solids: Slight Vegetation: None Benthic Growth: None Stains: None Non-illicit: None	<b>Notes</b> Sample collected from pipe flow. Loose grate.

o20171017100542.JPG <div style="font-size: 24pt; font-weight: bold; text-align: center;">2017</div>
		<b>Condition Assessment</b> Graffiti: None Erosion: None Deposition: None in. Damage: Minor

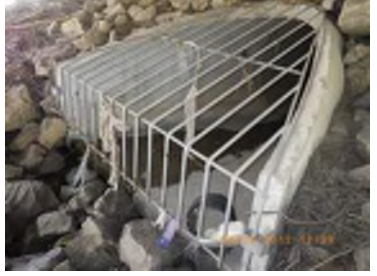
<b>Inspection Date:</b> 6/6/2012 12:26:31 PM		<b>Type:</b> Ongoing	<b>Flow:</b> None	<b>Previous Rainfall (hrs):</b> 72+
<b>Illicit Discharge Potential:</b> Unlikely		<b>Inspector:</b> JCW		
<b>Submerged:</b> None		<b>Depth (in):</b>		
<b>Sampling Results</b> Sample Location: -- Total Chlorine: -- ppm Free Chlorine: -- ppm Ammonia: -- ppm pH: -- units Temperature: -- °F Conductivity: -- µS/cm Detergents: -- mg/L		Floatables: None Odor: None Turbidity: None Color: None Gross Solids: Slight Vegetation: None Benthic Growth: None Stains: None Non-illicit: None	<b>Notes</b> Wet but no flow. Minor litter, likely from construction.

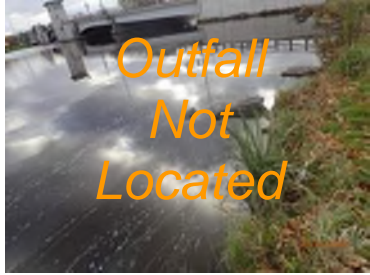
<p style="text-align: center;">o20181024090620.JPG</p> <p style="text-align: center; font-size: 1.2em; font-weight: bold;">2018</p>																																									
Submerged: Fully		Depth (in):		Outfall fully submerged and not located - screened upstream at 16-594 US1. Floating gross solids (litter) in manhole.																																											
<b>Sampling Results</b> <table border="1" style="width:100%; border-collapse: collapse;"> <tr><td colspan="2">Sample Location:</td></tr> <tr><td>Total Chlorine:</td><td>-- ppm</td></tr> <tr><td>Free Chlorine:</td><td>-- ppm</td></tr> <tr><td>Ammonia:</td><td>-- ppm</td></tr> <tr><td>pH:</td><td>-- units</td></tr> <tr><td>Temperature:</td><td>-- ° F</td></tr> <tr><td>Conductivity:</td><td>-- µS/cm</td></tr> <tr><td>Detergents:</td><td>-- mg/L</td></tr> </table>		Sample Location:		Total Chlorine:	-- ppm			Free Chlorine:	-- ppm	Ammonia:	-- ppm	pH:	-- units	Temperature:	-- ° F	Conductivity:	-- µS/cm	Detergents:	-- mg/L	<table border="1" style="width:100%; border-collapse: collapse;"> <tr><td>Floatables:</td><td>None</td></tr> <tr><td>Odor:</td><td>None</td></tr> <tr><td>Turbidity:</td><td>None</td></tr> <tr><td>Color:</td><td>None</td></tr> <tr><td>Gross Solids:</td><td>None</td></tr> <tr><td>Vegetation:</td><td>None</td></tr> <tr><td>Benthic Growth:</td><td>None</td></tr> <tr><td>Stains:</td><td>None</td></tr> <tr><td>Non-illicit:</td><td>None</td></tr> </table>		Floatables:	None	Odor:	None	Turbidity:	None	Color:	None	Gross Solids:	None	Vegetation:	None	Benthic Growth:	None	Stains:	None	Non-illicit:	None	<b>Condition Assessment</b> <table border="1" style="width:100%; border-collapse: collapse;"> <tr><td>Graffiti:</td><td>None</td></tr> <tr><td>Erosion:</td><td>None</td></tr> <tr><td>Deposition:</td><td>None in.</td></tr> <tr><td>Damage:</td><td>None</td></tr> </table>		Graffiti:	None	Erosion:	None	Deposition:	None in.

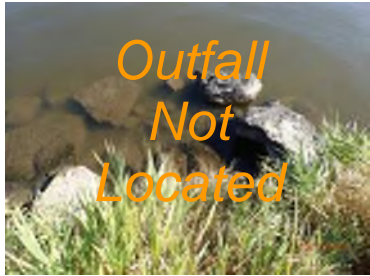
<p style="text-align: center;">o20171017112242.JPG</p> <p style="text-align: center; font-size: 1.2em; font-weight: bold;">2017</p>																																									
Submerged: Fully		Depth (in):		Outfall fully submerged and not located - screened upstream at 16-594 US1. Floating gross solids (litter) in manhole.																																											
<b>Sampling Results</b> <table border="1" style="width:100%; border-collapse: collapse;"> <tr><td colspan="2">Sample Location:</td></tr> <tr><td>Total Chlorine:</td><td>-- ppm</td></tr> <tr><td>Free Chlorine:</td><td>-- ppm</td></tr> <tr><td>Ammonia:</td><td>-- ppm</td></tr> <tr><td>pH:</td><td>-- units</td></tr> <tr><td>Temperature:</td><td>-- ° F</td></tr> <tr><td>Conductivity:</td><td>-- µS/cm</td></tr> <tr><td>Detergents:</td><td>-- mg/L</td></tr> </table>		Sample Location:		Total Chlorine:	-- ppm			Free Chlorine:	-- ppm	Ammonia:	-- ppm	pH:	-- units	Temperature:	-- ° F	Conductivity:	-- µS/cm	Detergents:	-- mg/L	<table border="1" style="width:100%; border-collapse: collapse;"> <tr><td>Floatables:</td><td>None</td></tr> <tr><td>Odor:</td><td>None</td></tr> <tr><td>Turbidity:</td><td>None</td></tr> <tr><td>Color:</td><td>None</td></tr> <tr><td>Gross Solids:</td><td>None</td></tr> <tr><td>Vegetation:</td><td>None</td></tr> <tr><td>Benthic Growth:</td><td>None</td></tr> <tr><td>Stains:</td><td>None</td></tr> <tr><td>Non-illicit:</td><td>None</td></tr> </table>		Floatables:	None	Odor:	None	Turbidity:	None	Color:	None	Gross Solids:	None	Vegetation:	None	Benthic Growth:	None	Stains:	None	Non-illicit:	None	<b>Condition Assessment</b> <table border="1" style="width:100%; border-collapse: collapse;"> <tr><td>Graffiti:</td><td>None</td></tr> <tr><td>Erosion:</td><td>None</td></tr> <tr><td>Deposition:</td><td>None in.</td></tr> <tr><td>Damage:</td><td>None</td></tr> </table>		Graffiti:	None	Erosion:	None	Deposition:	None in.

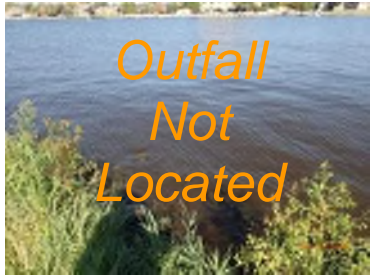
<p style="text-align: center;">o20161010140356.JPG</p> <p style="text-align: center; font-size: 1.2em; font-weight: bold;">2016</p>																																									
Submerged: Fully		Depth (in):		Outfall fully submerged and not located -screened upstream at 16-594 US1.																																											
<b>Sampling Results</b> <table border="1" style="width:100%; border-collapse: collapse;"> <tr><td colspan="2">Sample Location:</td></tr> <tr><td>Total Chlorine:</td><td>-- ppm</td></tr> <tr><td>Free Chlorine:</td><td>-- ppm</td></tr> <tr><td>Ammonia:</td><td>-- ppm</td></tr> <tr><td>pH:</td><td>-- units</td></tr> <tr><td>Temperature:</td><td>-- ° F</td></tr> <tr><td>Conductivity:</td><td>-- µS/cm</td></tr> <tr><td>Detergents:</td><td>-- mg/L</td></tr> </table>		Sample Location:		Total Chlorine:	-- ppm			Free Chlorine:	-- ppm	Ammonia:	-- ppm	pH:	-- units	Temperature:	-- ° F	Conductivity:	-- µS/cm	Detergents:	-- mg/L	<table border="1" style="width:100%; border-collapse: collapse;"> <tr><td>Floatables:</td><td>None</td></tr> <tr><td>Odor:</td><td>None</td></tr> <tr><td>Turbidity:</td><td>None</td></tr> <tr><td>Color:</td><td>None</td></tr> <tr><td>Gross Solids:</td><td>None</td></tr> <tr><td>Vegetation:</td><td>None</td></tr> <tr><td>Benthic Growth:</td><td>None</td></tr> <tr><td>Stains:</td><td>None</td></tr> <tr><td>Non-illicit:</td><td>None</td></tr> </table>		Floatables:	None	Odor:	None	Turbidity:	None	Color:	None	Gross Solids:	None	Vegetation:	None	Benthic Growth:	None	Stains:	None	Non-illicit:	None	<b>Condition Assessment</b> <table border="1" style="width:100%; border-collapse: collapse;"> <tr><td>Graffiti:</td><td>None</td></tr> <tr><td>Erosion:</td><td>None</td></tr> <tr><td>Deposition:</td><td>None in.</td></tr> <tr><td>Damage:</td><td>None</td></tr> </table>		Graffiti:	None	Erosion:	None	Deposition:	None in.

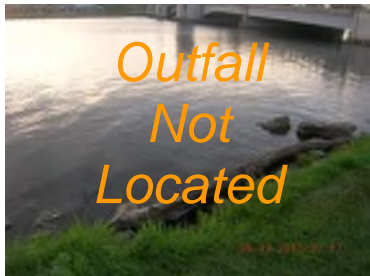
<p style="text-align: center;">o20100819071708.JPG</p> <p style="text-align: center; font-size: 1.2em; font-weight: bold;">2010</p>																																									
Submerged: Fully		Depth (in):		Outfall fully submerged and not physically located. Outfall screened upstream at 16-594 US1.																																											
<b>Sampling Results</b> <table border="1" style="width:100%; border-collapse: collapse;"> <tr><td colspan="2">Sample Location:</td></tr> <tr><td>Total Chlorine:</td><td>-- ppm</td></tr> <tr><td>Free Chlorine:</td><td>-- ppm</td></tr> <tr><td>Ammonia:</td><td>-- ppm</td></tr> <tr><td>pH:</td><td>-- units</td></tr> <tr><td>Temperature:</td><td>-- ° F</td></tr> <tr><td>Conductivity:</td><td>-- µS/cm</td></tr> <tr><td>Detergents:</td><td>-- mg/L</td></tr> </table>		Sample Location:		Total Chlorine:	-- ppm			Free Chlorine:	-- ppm	Ammonia:	-- ppm	pH:	-- units	Temperature:	-- ° F	Conductivity:	-- µS/cm	Detergents:	-- mg/L	<table border="1" style="width:100%; border-collapse: collapse;"> <tr><td>Floatables:</td><td>None</td></tr> <tr><td>Odor:</td><td>None</td></tr> <tr><td>Turbidity:</td><td>None</td></tr> <tr><td>Color:</td><td>None</td></tr> <tr><td>Gross Solids:</td><td>None</td></tr> <tr><td>Vegetation:</td><td>None</td></tr> <tr><td>Benthic Growth:</td><td>None</td></tr> <tr><td>Stains:</td><td>None</td></tr> <tr><td>Non-illicit:</td><td>None</td></tr> </table>		Floatables:	None	Odor:	None	Turbidity:	None	Color:	None	Gross Solids:	None	Vegetation:	None	Benthic Growth:	None	Stains:	None	Non-illicit:	None	<b>Condition Assessment</b> <table border="1" style="width:100%; border-collapse: collapse;"> <tr><td>Graffiti:</td><td>None</td></tr> <tr><td>Erosion:</td><td>None</td></tr> <tr><td>Deposition:</td><td>None 0 in.</td></tr> <tr><td>Damage:</td><td>None</td></tr> </table>		Graffiti:	None	Erosion:	None	Deposition:	None 0 in.

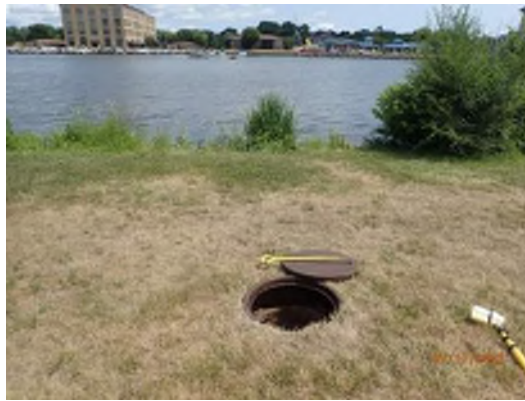
o20230717111156.JPG

Upstream manhole located approx 60 ft WSW of outfall 16-594. Intermediate area consists of open space in park.

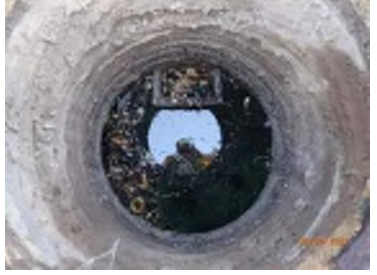
Inspection Date: 8/24/2022 2:53:00 PM		Type: Ongoing	Flow: Submerged, indeterminate	Previous Rainfall (hrs): 72+
<b>Illicit Discharge Potential: Potential</b> Submerged: Fully      Depth (in):		Inspector: EJK	Notes

o20220824144754.JPG <b>2022</b>
<b>Sampling Results</b> Sample Location: Pool Total Chlorine: 0 ppm Free Chlorine: 0 ppm Ammonia: 0 ppm pH: 8.12 units Temperature: 79 °F Conductivity: 336 µS/cm Detergents: 0 mg/L		Floatables: None Odor: None Turbidity: None Color: None Gross Solids: Moderate Vegetation: None Benthic Growth: None Stains: None Non-illicit: None	Condition Assessment Graffiti: None Erosion: None Deposition: None in. Damage: None	
<b>Inspection Date: 8/17/2021 9:42:48 AM</b>		Type: Ongoing	Flow: Submerged, indeterminate	Previous Rainfall (hrs): 72+
<b>Illicit Discharge Potential: Potential</b> Submerged: Fully      Depth (in): 59		Inspector: JCW	Notes

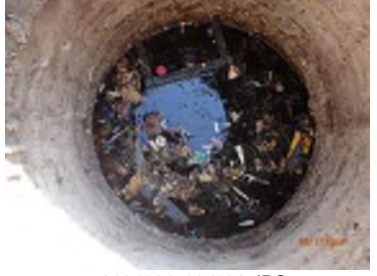
o20210817094028.JPG <b>2021</b>

<b>Sampling Results</b> Sample Location: Pool Total Chlorine: 0 ppm Free Chlorine: 0 ppm Ammonia: 0 ppm pH: 7.66 units Temperature: 79 °F Conductivity: 205 µS/cm Detergents: 0 mg/L		Floatables: None Odor: None Turbidity: None Color: None Gross Solids: Moderate Vegetation: None Benthic Growth: None Stains: None Non-illicit: None	Condition Assessment Graffiti: None Erosion: None Deposition: None in. Damage: None	
<b>Inspection Date: 8/19/2020 9:06:48 AM</b>		Type: Ongoing	Flow: Submerged, indeterminate	Previous Rainfall (hrs): 72+
<b>Illicit Discharge Potential: Potential</b> Submerged: Fully      Depth (in): 57		Inspector: JCW	Notes

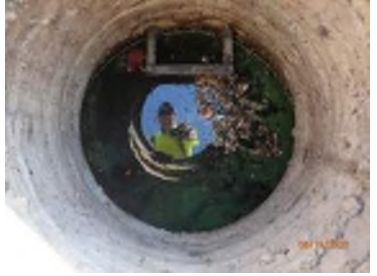
o20200819090422.JPG <b>2020</b>
<b>Sampling Results</b> Sample Location: Pool Total Chlorine: 0 ppm Free Chlorine: 0 ppm Ammonia: 0 ppm pH: 8.9 units Temperature: 75 °F Conductivity: 339 µS/cm Detergents: 0 mg/L		Floatables: None Odor: None Turbidity: None Color: None Gross Solids: Moderate Vegetation: None Benthic Growth: None Stains: None Non-illicit: None	Condition Assessment Graffiti: None Erosion: None Deposition: None in. Damage: None

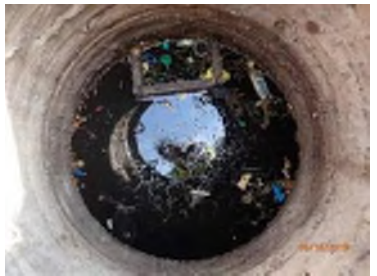
<b>Inspection Date: 9/18/2019 11:07:43 AM</b>		Type: Ongoing	Flow: Submerged, indeterminate	Previous Rainfall (hrs): 72+
<b>Illicit Discharge Potential: Potential</b> Submerged: Fully      Depth (in): 56		Inspector: JCW	Notes

o20190918100526.JPG <b>2019</b>
<b>Sampling Results</b> Sample Location: Pool Total Chlorine: 0 ppm Free Chlorine: 0 ppm Ammonia: 0 ppm pH: 8.27 units Temperature: 74 °F Conductivity: 367 µS/cm Detergents: 0 mg/L		Floatables: None Odor: None Turbidity: None Color: None Gross Solids: Moderate Vegetation: None Benthic Growth: None Stains: None Non-illicit: None	Condition Assessment Graffiti: None Erosion: None Deposition: None in. Damage: None

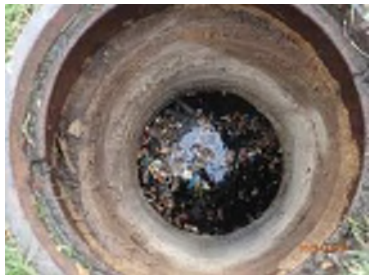
o20181024090720.JPG  
**2018**

<b>Inspection Date:</b> 10/24/2018 9:08:57 AM		<b>Type:</b> Ongoing	<b>Flow:</b> Submerged, indeterminate	<b>Previous Rainfall (hrs):</b> 72+
<b>Illicit Discharge Potential:</b> <b>Potential</b>		<b>Inspector:</b> JCW	<b>Notes</b>	
Submerged: Fully		Depth (in): 57	Sample collected from submerged pool in manhole. Floating gross solids (litter) in manhole.	
<b>Sampling Results</b>		<b>Floatables:</b> None	<b>Condition Assessment</b> Graffiti: None Erosion: None Deposition: None in. Damage: None	
Sample Location: Pool	Odor: None			
Total Chlorine: 0 ppm	Turbidity: None			
Free Chlorine: 0 ppm	Color: None			
Ammonia: 0 ppm	Gross Solids: Moderate			
pH: 7.35 units	Vegetation: None			
Temperature 50 °F	Benthic Growth: None			
Conductivity: 456 µS/cm	Stains: None			
Detergents: 0 mg/L	Non-illicit: None

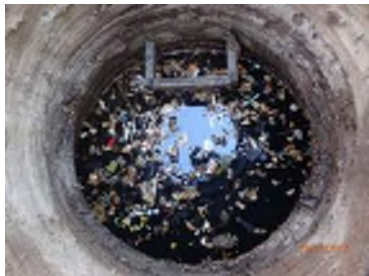
o20171017112318.JPG  
**2017**

<b>Inspection Date:</b> 10/17/2017 11:27:30 AM		<b>Type:</b> Ongoing	<b>Flow:</b> Submerged, indeterminate	<b>Previous Rainfall (hrs):</b> 48-72
<b>Illicit Discharge Potential:</b> <b>Potential</b>		<b>Inspector:</b> JCW	<b>Notes</b>	
Submerged: Fully		Depth (in): 51	Sample collected from submerged pool in manhole. Floating gross solids (litter) in manhole.	
<b>Sampling Results</b>		<b>Floatables:</b> None	<b>Condition Assessment</b> Graffiti: None Erosion: None Deposition: None in. Damage: None	
Sample Location: Pool	Odor: None			
Total Chlorine: 0 ppm	Turbidity: None			
Free Chlorine: 0 ppm	Color: None			
Ammonia: 0 ppm	Gross Solids: Moderate			
pH: 6.98 units	Vegetation: None			
Temperature 68 °F	Benthic Growth: None			
Conductivity: 741 µS/cm	Stains: None			
Detergents: 0 mg/L	Non-illicit: None

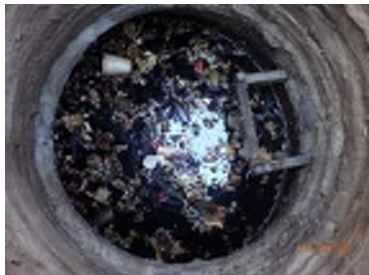
o20161010140454.JPG  
**2016**

<b>Inspection Date:</b> 10/10/2016 2:07:20 PM		<b>Type:</b> Ongoing	<b>Flow:</b> Submerged, indeterminate	<b>Previous Rainfall (hrs):</b> 72+
<b>Illicit Discharge Potential:</b> <b>Potential</b>		<b>Inspector:</b> JCW	<b>Notes</b>	
Submerged: Fully		Depth (in): 51	Potential illicit discharge due to gross solids.	
<b>Sampling Results</b>		<b>Floatables:</b> Slight	<b>Condition Assessment</b> Graffiti: None Erosion: None Deposition: None in. Damage: None	
Sample Location: Pool	Odor: Easily detected			
Total Chlorine: 0 ppm	Turbidity: None			
Free Chlorine: 0 ppm	Color: None			
Ammonia: 0.25 ppm	Gross Solids: Moderate			
pH: 7.17 units	Vegetation: None			
Temperature 71 °F	Benthic Growth: None			
Conductivity: 831 µS/cm	Stains: None			
Detergents: 0 mg/L	Non-illicit: None

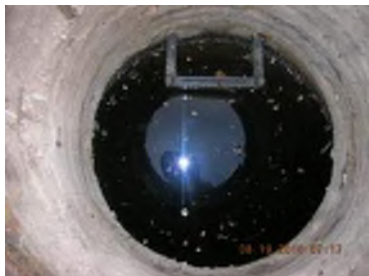
o20100819071738.JPG  
**2010**

<b>Inspection Date:</b> 8/19/2010 7:26:35 AM		<b>Type:</b> Ongoing	<b>Flow:</b> Submerged, indeterminate	<b>Previous Rainfall (hrs):</b> 72+
<b>Illicit Discharge Potential:</b> <b>Unlikely</b>		<b>Inspector:</b> JCW	<b>Notes</b>	
Submerged: Fully		Depth (in): 51	2 small oil drops, likely from Oshkosh Ave runoff.	
<b>Sampling Results</b>		<b>Floatables:</b> Slight	<b>Condition Assessment</b> Graffiti: None Erosion: None Deposition: None 0 in. Damage: None	
Sample Location: Pool	Odor: None			
Total Chlorine: 0 ppm	Turbidity: None			
Free Chlorine: 0 ppm	Color: Faint in bottle			
Ammonia: 0 ppm	Gross Solids: Slight			
pH: 7.44 units	Vegetation: None			
Temperature 75 °F	Benthic Growth: None			
Conductivity: -- µS/cm	Stains: None			
Detergents: 0 mg/L	Non-illicit: None

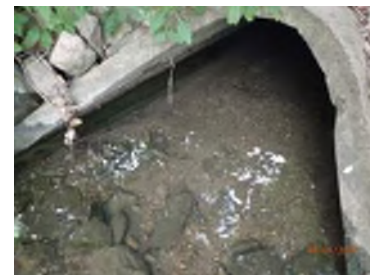
o20230801093700.JPG

Stains: Slight

☐ Petrol. Sheen ☐ Suds ☐ Sewage ☐ Algae ☐ Other☐ Petroleum ☐ Musty ☐ Sewage ☐ Chlorine ☐ Other☐ VOC/Solvent ☐ Fishy ☐ Sulfur ☐ Fragrant☐ Litter ☐ Veg. Debris ☐ Sediment ☐ Other☐ Inhibited ☐ Excessive☒ Green ☐ Brown☒ Flow Line ☐ Oil ☐ Rust Stains☐ Paint ☐ Other☐ Natural Sheen ☐ Natural Suds/Foam

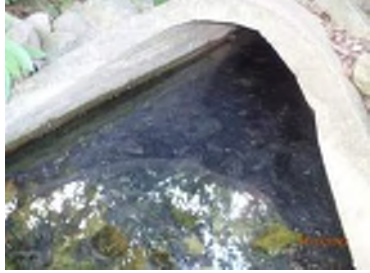
o20220823145452.JPG <div style="text-align: center; font-size: 24pt; font-weight: bold;">2022</div>

<b>Inspection Date:</b> 8/23/2022 2:57:00 PM		<b>Type:</b> Ongoing	<b>Flow:</b> Submerged, slight flow	<b>Previous Rainfall (hrs):</b> 72+
<b>Illicit Discharge Potential:</b> Unlikely		<b>Inspector:</b> EJK		
Submerged: Partially		Depth (in): 10		
<b>Sampling Results</b> Sample Location: Flow Total Chlorine: 0 ppm Free Chlorine: 0 ppm Ammonia: 0 ppm pH: 6.81 units Temperature: 73 °F Conductivity: 1058 µS/cm Detergents: 0 mg/L		Floatables: None Odor: None Turbidity: None Color: None Gross Solids: None Vegetation: None Benthic Growth: Slight Stains: Slight Non-illicit: None	<b>Notes</b> Sample collected from submerged flow inside pipe.  <b>Condition Assessment</b> Graffiti: None Erosion: None Deposition: None in. Damage: None

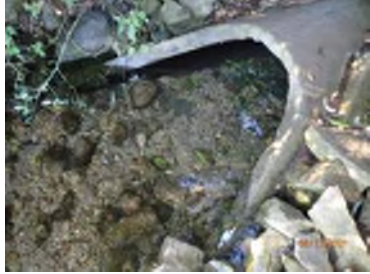
o20210817082858.JPG <div style="text-align: center; font-size: 24pt; font-weight: bold;">2021</div>

<b>Inspection Date:</b> 8/17/2021 8:31:17 AM		<b>Type:</b> Ongoing	<b>Flow:</b> Submerged, indeterminate	<b>Previous Rainfall (hrs):</b> 72+
<b>Illicit Discharge Potential:</b> Unlikely		<b>Inspector:</b> JCW		
Submerged: Partially		Depth (in): 14		
<b>Sampling Results</b> Sample Location: -- Total Chlorine: -- ppm Free Chlorine: -- ppm Ammonia: -- ppm pH: -- units Temperature: -- °F Conductivity: -- µS/cm Detergents: -- mg/L		Floatables: None Odor: None Turbidity: None Color: None Gross Solids: None Vegetation: None Benthic Growth: Moderate Stains: None Non-illicit: None	<b>Notes</b> Outfall partially submerged - screened upstream at 16-660 US1. Neighbor reported occasional sewage odor and suds at outfall.  <b>Condition Assessment</b> Graffiti: None Erosion: None Deposition: Minor 1 in. Damage: None

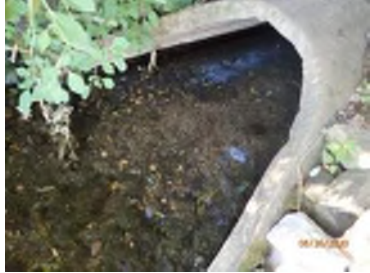
o20200820081850.JPG <div style="text-align: center; font-size: 24pt; font-weight: bold;">2020</div>

<b>Inspection Date:</b> 8/20/2020 8:20:53 AM		<b>Type:</b> Ongoing	<b>Flow:</b> Submerged, indeterminate	<b>Previous Rainfall (hrs):</b> 72+
<b>Illicit Discharge Potential:</b> Unlikely		<b>Inspector:</b> JCW		
Submerged: Partially		Depth (in): 9		
<b>Sampling Results</b> Sample Location: -- Total Chlorine: -- ppm Free Chlorine: -- ppm Ammonia: -- ppm pH: -- units Temperature: -- °F Conductivity: -- µS/cm Detergents: -- mg/L		Floatables: None Odor: None Turbidity: None Color: None Gross Solids: None Vegetation: None Benthic Growth: Severe Stains: Slight Non-illicit: None	<b>Notes</b> Outfall partially submerged - screened upstream at 16-660 US1.  <b>Condition Assessment</b> Graffiti: None Erosion: None Deposition: Minor 1 in. Damage: None

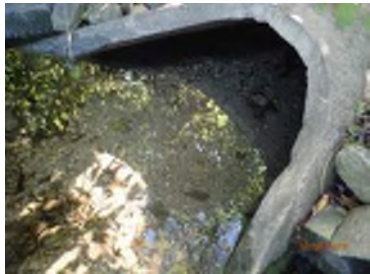
o20191008134040.JPG <div style="text-align: center; font-size: 24pt; font-weight: bold;">2019</div>

<b>Inspection Date:</b> 10/8/2019 2:42:09 PM		<b>Type:</b> Ongoing	<b>Flow:</b> Submerged, indeterminate	<b>Previous Rainfall (hrs):</b> 48-72
<b>Illicit Discharge Potential:</b> Potential		<b>Inspector:</b> JCW		
Submerged: Partially		Depth (in): 16		
<b>Sampling Results</b> Sample Location: -- Total Chlorine: -- ppm Free Chlorine: -- ppm Ammonia: -- ppm pH: -- units Temperature: -- °F Conductivity: -- µS/cm Detergents: -- mg/L		Floatables: None Odor: None Turbidity: None Color: None Gross Solids: None Vegetation: None Benthic Growth: Slight Stains: None Non-illicit: None	<b>Notes</b> Outfall partially submerged - screened upstream at 16-660 US1. Detergent detected in sample.  <b>Condition Assessment</b> Graffiti: None Erosion: None Deposition: Minor 3 in. Damage: None

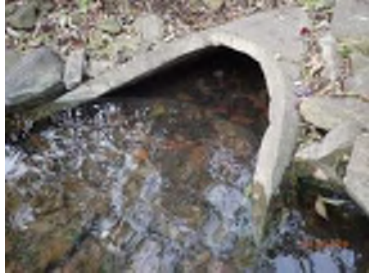
<b>Inspection Date:</b> 10/25/2018 8:13:23 AM		<b>Type:</b> Ongoing		<b>Flow:</b> Submerged, indeterminate		<b>Previous Rainfall (hrs):</b> 72+	
<b>Illicit Discharge Potential:</b> Potential		<b>Inspector:</b> JCW		<b>Notes</b>

<p style="text-align: center;">o20181025081252.JPG</p> <p style="text-align: center; font-size: 1.5em; font-weight: bold;">2018</p>	
Submerged: Partially      Depth (in): 14				Outfall partially submerged - screened upstream at 16-660 US1. Detergent detected in sample.			
<b>Sampling Results</b>				<b>Condition Assessment</b>			
Sample Location:		Floatables:	None	Graffiti:		None	
Total Chlorine: -- ppm		Odor:	None	Erosion:		None	
Free Chlorine: -- ppm		Turbidity:	None	Deposition:		None	in.
Ammonia: -- ppm		Color:	None	Damage:		None	
pH: -- units		Gross Solids:	Slight				
Temperature -- °F		Vegetation:	None				
Conductivity: -- µS/cm		Benthic Growth:	Moderate				
Detergents: -- mg/L		Stains:	Moderate

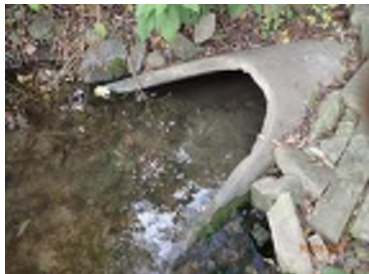
<b>Inspection Date:</b> 10/3/2017 11:03:37 AM		<b>Type:</b> Ongoing		<b>Flow:</b> Submerged, indeterminate		<b>Previous Rainfall (hrs):</b> 72+	
<b>Illicit Discharge Potential:</b> Potential		<b>Inspector:</b> JCW		<b>Notes</b>

<p style="text-align: center;">o20171003110156.JPG</p> <p style="text-align: center; font-size: 1.5em; font-weight: bold;">2017</p>	
Submerged: Partially      Depth (in): 12				Outfall partially submerged - screened upstream at 16-660 US1. Detergent detected in sample.			
<b>Sampling Results</b>				<b>Condition Assessment</b>			
Sample Location:		Floatables:	None	Graffiti:		None	
Total Chlorine: -- ppm		Odor:	None	Erosion:		None	
Free Chlorine: -- ppm		Turbidity:	None	Deposition:		None	in.
Ammonia: -- ppm		Color:	None	Damage:		None	
pH: -- units		Gross Solids:	None				
Temperature -- °F		Vegetation:	None				
Conductivity: -- µS/cm		Benthic Growth:	Moderate				
Detergents: -- mg/L		Stains:	Moderate

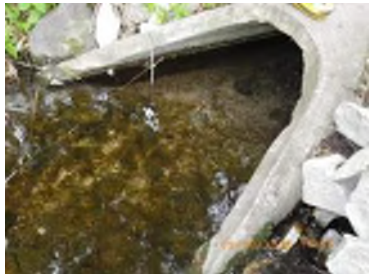
<b>Inspection Date:</b> 5/30/2012 10:59:58 AM		<b>Type:</b> Ongoing		<b>Flow:</b> Submerged, indeterminate		<b>Previous Rainfall (hrs):</b> 72+	
<b>Illicit Discharge Potential:</b> Unlikely		<b>Inspector:</b> JCW		<b>Notes</b>

<p style="text-align: center;">o20120530100048.JPG</p> <p style="text-align: center; font-size: 1.5em; font-weight: bold;">2012</p>	
Submerged: Partially      Depth (in): 10				Outfall partially submerged. Outfall screened upstream at 16-660.			
<b>Sampling Results</b>				<b>Condition Assessment</b>			
Sample Location:		Floatables:	None	Graffiti:		None	
Total Chlorine: -- ppm		Odor:	None	Erosion:		None	
Free Chlorine: -- ppm		Turbidity:	None	Deposition:		Minor	1 in.
Ammonia: -- ppm		Color:	None	Damage:		None	
pH: -- units		Gross Solids:	Slight				
Temperature -- °F		Vegetation:	None				
Conductivity: -- µS/cm		Benthic Growth:	Moderate				
Detergents: -- mg/L		Stains:	Slight

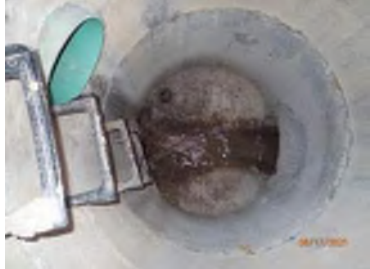
<b>Inspection Date:</b> 8/17/2021 8:24:19 AM		<b>Type:</b> Ongoing	<b>Flow:</b> Moderate	<b>Previous Rainfall (hrs):</b> 72+
<b>Illicit Discharge Potential:</b> Unlikely		<b>Inspector:</b> JCW		
<b>Submerged:</b> None		<b>Depth (in):</b>		
<b>Sampling Results</b> Sample Location: Pool Total Chlorine: 0 ppm Free Chlorine: 0 ppm Ammonia: 0 ppm pH: 7.53 units Temperature: 73 °F Conductivity: 918 µS/cm Detergents: 0 mg/L		Floatables: None Odor: None Turbidity: None Color: None Gross Solids: None Vegetation: None Benthic Growth: None Stains: None Non-illicit: None	<b>Notes</b> Sample collected from flow in manhole.

o20210817082014.JPG <div style="text-align: center; font-size: 24pt; font-weight: bold;">2021</div>
		<b>Condition Assessment</b> Graffiti: None Erosion: None Deposition: None in. Damage: None

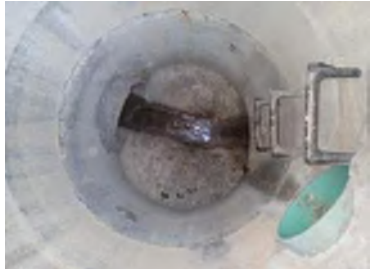
<b>Inspection Date:</b> 8/20/2020 8:24:59 AM		<b>Type:</b> Ongoing	<b>Flow:</b> None	<b>Previous Rainfall (hrs):</b> 72+
<b>Illicit Discharge Potential:</b> Unlikely		<b>Inspector:</b> JCW		
<b>Submerged:</b> None		<b>Depth (in):</b>		
<b>Sampling Results</b> Sample Location: -- Total Chlorine: -- ppm Free Chlorine: -- ppm Ammonia: -- ppm pH: -- units Temperature: -- °F Conductivity: -- µS/cm Detergents: -- mg/L		Floatables: None Odor: None Turbidity: None Color: None Gross Solids: None Vegetation: None Benthic Growth: None Stains: None Non-illicit: None	<b>Notes</b> Flowline damp, but no collectable flow at time of inspection.

o20200820082306.JPG <div style="text-align: center; font-size: 24pt; font-weight: bold;">2020</div>
		<b>Condition Assessment</b> Graffiti: None Erosion: None Deposition: None in. Damage: None

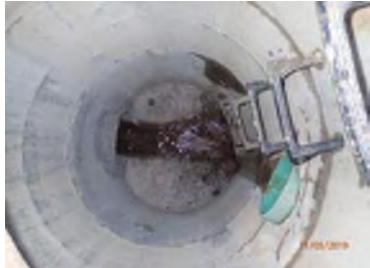
<b>Inspection Date:</b> 11/5/2019 2:41:00 PM		<b>Type:</b> Repeat	<b>Flow:</b> Moderate	<b>Previous Rainfall (hrs):</b> 48-72
<b>Illicit Discharge Potential:</b> Potential		<b>Inspector:</b> JCW		
<b>Submerged:</b> None		<b>Depth (in):</b>		
<b>Sampling Results</b> Sample Location: Flow Total Chlorine: -- ppm Free Chlorine: -- ppm Ammonia: -- ppm pH: -- units Temperature: -- °F Conductivity: -- µS/cm Detergents: 0.9 mg/L		Floatables: None Odor: None Turbidity: None Color: None Gross Solids: None Vegetation: None Benthic Growth: None Stains: None Non-illicit: None	<b>Notes</b> Follow-up inspection for sampling - limited screening conducted.

o20191105144026.JPG <div style="text-align: center; font-size: 24pt; font-weight: bold;">2019</div>
		<b>Condition Assessment</b> Graffiti: None Erosion: None Deposition: None in. Damage: None

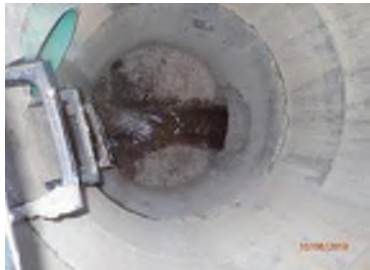
<b>Inspection Date:</b> 10/8/2019 2:44:41 PM		<b>Type:</b> Ongoing	<b>Flow:</b> Moderate	<b>Previous Rainfall (hrs):</b> 48-72
<b>Illicit Discharge Potential:</b> Potential		<b>Inspector:</b> JCW		
<b>Submerged:</b> None		<b>Depth (in):</b>		
<b>Sampling Results</b> Sample Location: Flow Total Chlorine: 0 ppm Free Chlorine: 0 ppm Ammonia: 0 ppm pH: 7.68 units Temperature: 65 °F Conductivity: 943 µS/cm Detergents: 0.5 mg/L		Floatables: None Odor: None Turbidity: None Color: None Gross Solids: None Vegetation: None Benthic Growth: None Stains: None Non-illicit: None	<b>Notes</b> Sample collected from flow in manhole. Detergent detected in sample.

o20191008134416.JPG <div style="text-align: center; font-size: 24pt; font-weight: bold;">2019</div>
		<b>Condition Assessment</b> Graffiti: None Erosion: None Deposition: None in. Damage: None

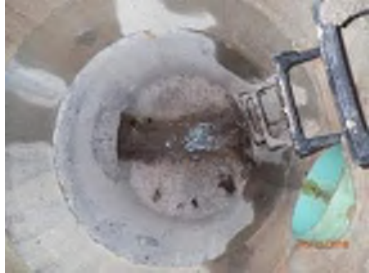
o20181025081632.JPG  
**2018**

<b>Inspection Date:</b> 10/26/2018 12:20:38 PM		<b>Type:</b> Repeat	<b>Flow:</b> Trickle	<b>Previous Rainfall (hrs):</b> 72+	
<b>Illicit Discharge Potential:</b> <b>Potential</b>		<b>Inspector:</b> KMK	<b>Notes</b>		
Submerged: None		Depth (in):	Detergent detection follow-up. Limited screening conducted beyond sampling.		
<b>Sampling Results</b>		Floatables:	<b>Condition Assessment</b> Graffiti: None Erosion: None Deposition: None in. Damage: None		
Sample Location:	Flow	Odor:			None
Total Chlorine:	0 ppm	Turbidity:			None
Free Chlorine:	0 ppm	Color:			None
Ammonia:	0 ppm	Gross Solids:			None
pH:	7.83 units	Vegetation:			None
Temperature	56 °F	Benthic Growth:			None
Conductivity:	1063 µS/cm	Stains:			None
Detergents:	0.7 mg/L	Non-illicit:			None

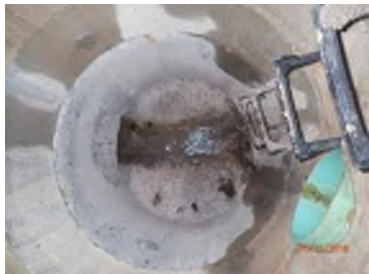
o20181025081632.JPG  
**2018**

<b>Inspection Date:</b> 10/25/2018 8:16:19 AM		<b>Type:</b> Ongoing	<b>Flow:</b> Trickle	<b>Previous Rainfall (hrs):</b> 72+	
<b>Illicit Discharge Potential:</b> <b>Potential</b>		<b>Inspector:</b> JCW	<b>Notes</b>		
Submerged: None		Depth (in):	Sample collected from flow in manhole. Detergent detected in sample.		
<b>Sampling Results</b>		Floatables:	<b>Condition Assessment</b> Graffiti: None Erosion: None Deposition: None in. Damage: None		
Sample Location:	Flow	Odor:			None
Total Chlorine:	0 ppm	Turbidity:			None
Free Chlorine:	0 ppm	Color:			None
Ammonia:	0 ppm	Gross Solids:			None
pH:	7.9 units	Vegetation:			None
Temperature	52 °F	Benthic Growth:			None
Conductivity:	1037 µS/cm	Stains:			None
Detergents:	0.35 mg/L	Non-illicit:			None

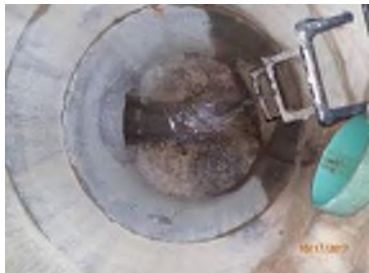
o20171017085628.JPG  
**2017**

<b>Inspection Date:</b> 10/17/2017 9:02:21 AM		<b>Type:</b> Repeat	<b>Flow:</b> Moderate	<b>Previous Rainfall (hrs):</b> 48-72	
<b>Illicit Discharge Potential:</b> <b>Unlikely</b>		<b>Inspector:</b> JCW	<b>Notes</b>		
Submerged: None		Depth (in):	Repeat inspection due to detergent. No detergent detected in manhole sample.		
<b>Sampling Results</b>		Floatables:	<b>Condition Assessment</b> Graffiti: None Erosion: None Deposition: None in. Damage: None		
Sample Location:	Flow	Odor:			None
Total Chlorine:	0 ppm	Turbidity:			None
Free Chlorine:	0 ppm	Color:			None
Ammonia:	0 ppm	Gross Solids:			None
pH:	7.78 units	Vegetation:			None
Temperature	61 °F	Benthic Growth:			Slight
Conductivity:	926 µS/cm	Stains:			None
Detergents:	0 mg/L	Non-illicit:			None

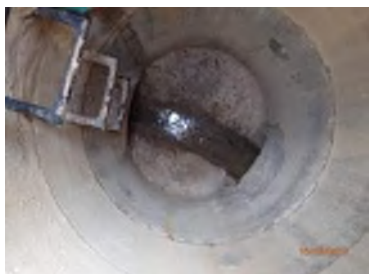
o20171003110702.JPG  
**2017**

<b>Inspection Date:</b> 10/3/2017 11:12:57 AM		<b>Type:</b> Ongoing	<b>Flow:</b> Trickle	<b>Previous Rainfall (hrs):</b> 72+	
<b>Illicit Discharge Potential:</b> <b>Potential</b>		<b>Inspector:</b> JCW	<b>Notes</b>		
Submerged: None		Depth (in):	Sample collected from flow in manhole. Detergent detected in sample.		
<b>Sampling Results</b>		Floatables:	<b>Condition Assessment</b> Graffiti: None Erosion: None Deposition: None in. Damage: None		
Sample Location:	Flow	Odor:			None
Total Chlorine:	0 ppm	Turbidity:			None
Free Chlorine:	0 ppm	Color:			None
Ammonia:	0 ppm	Gross Solids:			None
pH:	8.26 units	Vegetation:			None
Temperature	76 °F	Benthic Growth:			None
Conductivity:	845 µS/cm	Stains:			None
Detergents:	0.55 mg/L	Non-illicit:			None

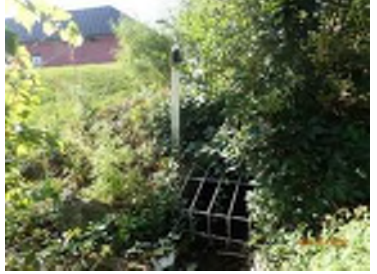
<b>Inspection Date:</b> 9/16/2022 9:45:00 AM		<b>Type:</b> Ongoing	<b>Flow:</b> Trickle	<b>Previous Rainfall (hrs):</b> 72+
<b>Illicit Discharge Potential:</b> Potential		<b>Inspector:</b> EJK		
Submerged: None		Depth (in):		
<b>Sampling Results</b> Sample Location: Flow Total Chlorine: 0 ppm Free Chlorine: 0 ppm Ammonia: 0 ppm pH: 7.99 units Temperature: 70 °F Conductivity: 2310 µS/cm Detergents: 0 mg/L		Floatables: None Odor: None Turbidity: None Color: None Gross Solids: Slight Vegetation: None Benthic Growth: Moderate Stains: Slight Non-illicit: None	<b>Notes</b> Sample collected from pipe flow. Elevated conductivity in sample. Tracked upstream without finding source.

o20220916094346.JPG <div style="text-align: center; font-size: 24pt; font-weight: bold;">2022</div>
			<b>Condition Assessment</b> Graffiti: None Erosion: None Deposition: None in. Damage: None

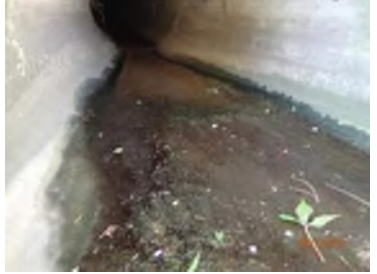
<b>Inspection Date:</b> 8/17/2021 8:47:50 AM		<b>Type:</b> Ongoing	<b>Flow:</b> Trickle	<b>Previous Rainfall (hrs):</b> 72+
<b>Illicit Discharge Potential:</b> Potential		<b>Inspector:</b> JCW		
Submerged: None		Depth (in):		
<b>Sampling Results</b> Sample Location: Flow Total Chlorine: 0 ppm Free Chlorine: 0 ppm Ammonia: 0 ppm pH: 8.14 units Temperature: 76 °F Conductivity: 1990 µS/cm Detergents: 0.65 mg/L		Floatables: None Odor: None Turbidity: None Color: None Gross Solids: Slight Vegetation: None Benthic Growth: Severe Stains: Moderate Non-illicit: None	<b>Notes</b> Sample collected from pipe flow. Detergent detected in sample.

o20210817084532.JPG <div style="text-align: center; font-size: 24pt; font-weight: bold;">2021</div>
			<b>Condition Assessment</b> Graffiti: None Erosion: None Deposition: None in. Damage: None

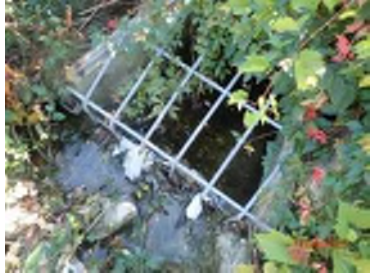
o20191008125814.JPG  
**2019**

<b>Inspection Date:</b> 10/8/2019 1:59:59 PM		<b>Type:</b> Ongoing	<b>Flow:</b> Trickle	<b>Previous Rainfall (hrs):</b> 48-72
<b>Illicit Discharge Potential:</b> <b>Potential</b>		<b>Inspector:</b> JCW	<b>Notes</b>	
Submerged: None		Depth (in):	Sample collected from pipe flow. Detergent and elevated conductivity in sample.	
<b>Sampling Results</b>		<b>Floatables:</b>	<b>Condition Assessment</b>	
Sample Location: Flow		<b>Odor:</b>	Graffiti: None	
Total Chlorine: 0 ppm		<b>Turbidity:</b>	Erosion: None	
Free Chlorine: 0 ppm		<b>Color:</b>	Deposition: None in.	
Ammonia: 0 ppm		<b>Gross Solids:</b>	Damage: None	
pH: 8.09 units		<b>Vegetation:</b>		
Temperature 66 °F		<b>Benthic Growth:</b>		
Conductivity: 2640 µS/cm		<b>Stains:</b>		
Detergents: 0.5 mg/L		<b>Non-illicit:</b>

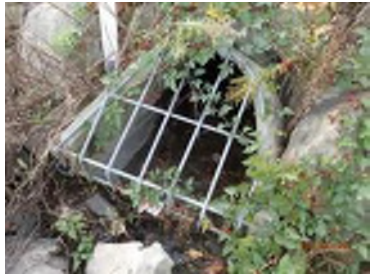
o20181025085152.JPG  
**2018**

<b>Inspection Date:</b> 10/26/2018 1:46:37 PM		<b>Type:</b> Repeat	<b>Flow:</b> Trickle	<b>Previous Rainfall (hrs):</b> 72+
<b>Illicit Discharge Potential:</b> <b>Potential</b>		<b>Inspector:</b> KMK	<b>Notes</b>	
Submerged: None		Depth (in):	Detergent detection follow-up. Limited screening conducted beyond sampling.	
<b>Sampling Results</b>		<b>Floatables:</b>	<b>Condition Assessment</b>	
Sample Location: Flow		<b>Odor:</b>	Graffiti: None	
Total Chlorine: 0 ppm		<b>Turbidity:</b>	Erosion: None	
Free Chlorine: 0 ppm		<b>Color:</b>	Deposition: None in.	
Ammonia: 0 ppm		<b>Gross Solids:</b>	Damage: None	
pH: 8.19 units		<b>Vegetation:</b>		
Temperature 56 °F		<b>Benthic Growth:</b>		
Conductivity: 3550 µS/cm		<b>Stains:</b>		
Detergents: 0.5 mg/L		<b>Non-illicit:</b>

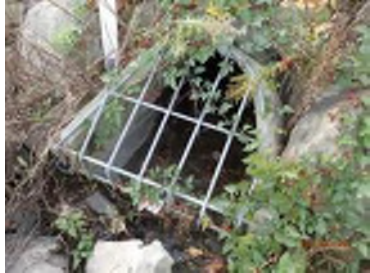
o20181025085152.JPG  
**2018**

<b>Inspection Date:</b> 10/25/2018 8:55:36 AM		<b>Type:</b> Ongoing	<b>Flow:</b> Trickle	<b>Previous Rainfall (hrs):</b> 72+
<b>Illicit Discharge Potential:</b> <b>Potential</b>		<b>Inspector:</b> JCW	<b>Notes</b>	
Submerged: None		Depth (in):	Sample collected from pipe flow. Detergent and elevated conductivity in sample.	
<b>Sampling Results</b>		<b>Floatables:</b>	<b>Condition Assessment</b>	
Sample Location: Flow		<b>Odor:</b>	Graffiti: None	
Total Chlorine: 0 ppm		<b>Turbidity:</b>	Erosion: None	
Free Chlorine: 0 ppm		<b>Color:</b>	Deposition: None in.	
Ammonia: 0 ppm		<b>Gross Solids:</b>	Damage: None	
pH: 8.22 units		<b>Vegetation:</b>		
Temperature 52 °F		<b>Benthic Growth:</b>		
Conductivity: 3300 µS/cm		<b>Stains:</b>		
Detergents: 0.45 mg/L		<b>Non-illicit:</b>

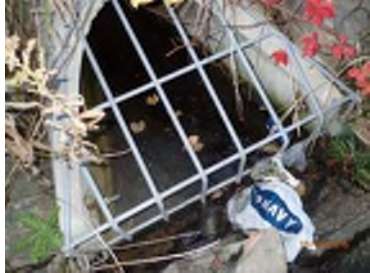
o20161018071712.JPG  
**2016**

<b>Inspection Date:</b> 10/18/2016 7:21:24 AM		<b>Type:</b> Ongoing	<b>Flow:</b> Trickle	<b>Previous Rainfall (hrs):</b> 72+
<b>Illicit Discharge Potential:</b> Unlikely		<b>Inspector:</b> JCW		
<b>Submerged:</b> None		<b>Depth (in):</b>		
<b>Sampling Results</b>		<b>Notes</b>		
Sample Location: Flow		Elevated conductivity, but no other parameters out of range.		
Total Chlorine:	0 ppm	Floatables:	None	
Free Chlorine:	0 ppm	Odor:	Faint	
Ammonia:	0 ppm	Turbidity:	None	
pH:	8.29 units	Color:	None	
Temperature:	64 °F	Gross Solids:	Slight	
Conductivity:	3880 µS/cm	Vegetation:	None	
Detergents:	0 mg/L	Benthic Growth:	Moderate	
		Stains:	None	
		Non-illicit:	None	
		<b>Condition Assessment</b>		
		Graffiti:	None	
		Erosion:	None	
		Deposition:	None	in.
		Damage:	None

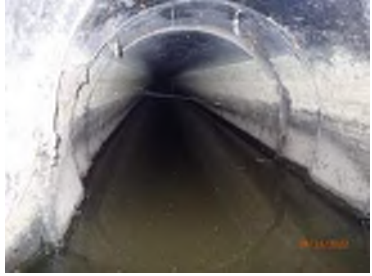
<b>Inspection Date:</b> 8/23/2022 3:14:00 PM		<b>Type:</b> Ongoing	<b>Flow:</b> Submerged, no flow	<b>Previous Rainfall (hrs):</b> 72+
<b>Illicit Discharge Potential:</b> Potential		<b>Inspector:</b> EJK		
Submerged: Partially		Depth (in): 10		
<b>Sampling Results</b> Sample Location: Pool Total Chlorine: 0 ppm Free Chlorine: 0 ppm Ammonia: 0 ppm pH: 7.46 units Temperature: 73 °F Conductivity: 325 µS/cm Detergents: 3.5 mg/L		Floatables: None Odor: None Turbidity: None Color: None Gross Solids: None Vegetation: None Benthic Growth: None Stains: Slight Non-illicit: None	<b>Notes</b> No flow leaving apron. Sample collected from apron pool. Detergent detected in sample.

o20220823151212.JPG <div style="text-align: center; font-size: 24pt; font-weight: bold;">2022</div>
		<b>Condition Assessment</b> Graffiti: None Erosion: None Deposition: None in. Damage: None

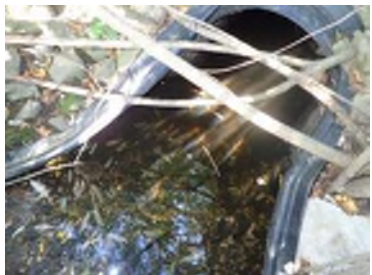
<b>Inspection Date:</b> 8/20/2020 8:35:17 AM		<b>Type:</b> Ongoing	<b>Flow:</b> Submerged, indeterminate	<b>Previous Rainfall (hrs):</b> 72+
<b>Illicit Discharge Potential:</b> Unlikely		<b>Inspector:</b> JCW		
Submerged: Partially		Depth (in): 8		
<b>Sampling Results</b> Sample Location: -- Total Chlorine: -- ppm Free Chlorine: -- ppm Ammonia: -- ppm pH: -- units Temperature: -- °F Conductivity: -- µS/cm Detergents: -- mg/L		Floatables: None Odor: None Turbidity: None Color: None Gross Solids: None Vegetation: None Benthic Growth: None Stains: None Non-illicit: None	<b>Notes</b> 10 inch berm of roots blocking flow from apron. Outfall partially submerged - screened upstream at 16-995 US1.

o20200820083238.JPG <div style="text-align: center; font-size: 24pt; font-weight: bold;">2020</div>
		<b>Condition Assessment</b> Graffiti: None Erosion: None Deposition: None in. Damage: None

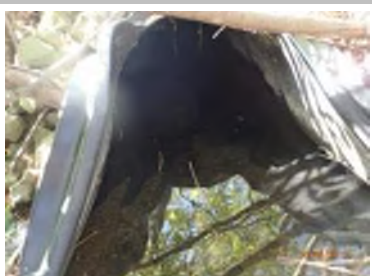
<b>Inspection Date:</b> 10/8/2019 2:29:54 PM		<b>Type:</b> Ongoing	<b>Flow:</b> Submerged, indeterminate	<b>Previous Rainfall (hrs):</b> 48-72
<b>Illicit Discharge Potential:</b> Potential		<b>Inspector:</b> JCW		
Submerged: Partially		Depth (in): 18		
<b>Sampling Results</b> Sample Location: -- Total Chlorine: -- ppm Free Chlorine: -- ppm Ammonia: -- ppm pH: -- units Temperature: -- °F Conductivity: -- µS/cm Detergents: -- mg/L		Floatables: None Odor: None Turbidity: None Color: None Gross Solids: None Vegetation: None Benthic Growth: Slight Stains: None Non-illicit: None	<b>Notes</b> Outfall partially submerged - screened upstream at 16-995 US1. Detergent detected in sample.

o20191008132854.JPG <div style="text-align: center; font-size: 24pt; font-weight: bold;">2019</div>
		<b>Condition Assessment</b> Graffiti: None Erosion: None Deposition: None in. Damage: None

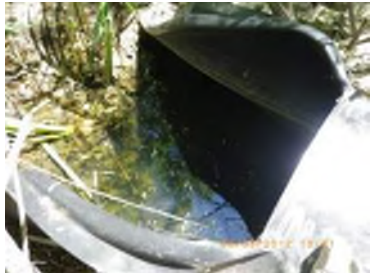
o20120606122140.JPG

<b>Inspection Date:</b> 6/6/2012 1:21:40 PM		<b>Type:</b> Ongoing	<b>Flow:</b> Submerged, indeterminate	<b>Previous Rainfall (hrs):</b> 72+
<b>Illicit Discharge Potential:</b> Unlikely		<b>Inspector:</b> JCW	<b>Notes</b>	
Submerged: Partially      Depth (in): 9			No flow leaving pool at end of outfall. Deposition in swale downstream. Screened upstream at 16-995 US1.	
<b>Sampling Results</b>			<b>Condition Assessment</b>	
Sample Location:	Floatables:	None	Graffiti: None Erosion: None Deposition: Moderate      8 in. Damage: None	
Total Chlorine: -- ppm	Odor:	None		
Free Chlorine: -- ppm	Turbidity:	None		
Ammonia: -- ppm	Color:	None		
pH: -- units	Gross Solids:	Slight		
Temperature -- °F	Vegetation:	None		
Conductivity: -- µS/cm	Benthic Growth:	Slight		
Detergents: -- mg/L	Stains:	Slight		
	Non-illicit:	None

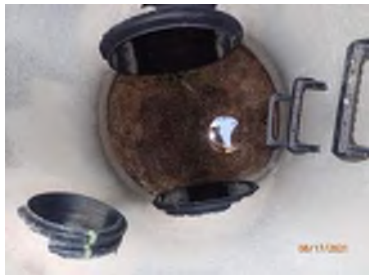
o20210817080912.JPG <b>2021</b>
<b>Sampling Results</b> Sample Location: Pool Total Chlorine: 0 ppm Free Chlorine: 0 ppm Ammonia: 0 ppm pH: 7.53 units Temperature: 72 °F Conductivity: 801 µS/cm Detergents: 0 mg/L		Floatables: None Odor: None Turbidity: None Color: None Gross Solids: None Vegetation: None Benthic Growth: None Stains: None Non-illicit: None	Sample collected from submerged pool in manhole.  <b>Condition Assessment</b> Graffiti: None Erosion: None Deposition: None in. Damage: None	
<b>Inspection Date: 8/20/2020 8:38:07 AM</b>		Type: Ongoing	Flow: None	Previous Rainfall (hrs): 72+
<b>Illicit Discharge Potential: Unlikely</b> Submerged: None      Depth (in):		Inspector: JCW	Notes

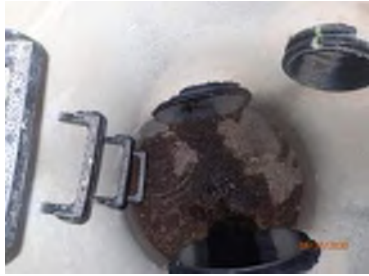
o20200820083626.JPG <b>2020</b>

<b>Sampling Results</b> Sample Location: -- Total Chlorine: -- ppm Free Chlorine: -- ppm Ammonia: -- ppm pH: -- units Temperature: -- °F Conductivity: -- µS/cm Detergents: -- mg/L		Floatables: None Odor: None Turbidity: None Color: None Gross Solids: None Vegetation: None Benthic Growth: None Stains: None Non-illicit: None	Flowline damp, but no collectable flow at time of inspection.  <b>Condition Assessment</b> Graffiti: None Erosion: None Deposition: None in. Damage: None	
<b>Inspection Date: 11/5/2019 3:00:59 PM</b>		Type: Repeat	Flow: Submerged, indeterminate	Previous Rainfall (hrs): 48-72
<b>Illicit Discharge Potential: Potential</b> Submerged: Partially      Depth (in): 8		Inspector: JCW	Notes

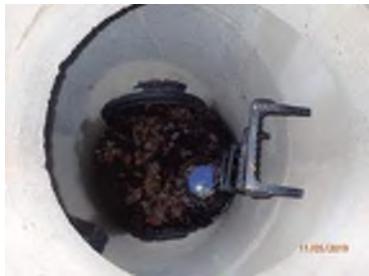
o20191105145942.JPG <b>2019</b>
<b>Sampling Results</b> Sample Location: Pool Total Chlorine: -- ppm Free Chlorine: -- ppm Ammonia: -- ppm pH: -- units Temperature: -- °F Conductivity: -- µS/cm Detergents: 1.3 mg/L		Floatables: None Odor: None Turbidity: None Color: None Gross Solids: None Vegetation: None Benthic Growth: None Stains: None Non-illicit: None	Follow-up inspection for sampling - limited screening conducted.  <b>Condition Assessment</b> Graffiti: None Erosion: None Deposition: None in. Damage: None

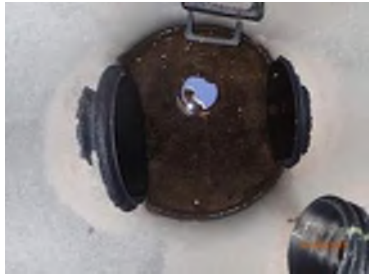
o20191008133058.JPG <b>2019</b>
<b>Sampling Results</b> Sample Location: Pool Total Chlorine: 0 ppm Free Chlorine: 0 ppm Ammonia: 0 ppm pH: 7.45 units Temperature: 65 °F Conductivity: 731 µS/cm Detergents: 1 mg/L		Floatables: None Odor: None Turbidity: None Color: None Gross Solids: None Vegetation: None Benthic Growth: None Stains: None Non-illicit: None	Sample collected from submerged pool in outfall. Detergent detected in sample.  <b>Condition Assessment</b> Graffiti: None Erosion: None Deposition: None in. Damage: None

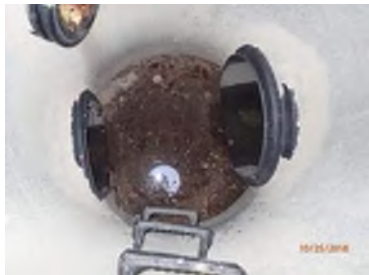
o20181025082910.JPG <div style="text-align: center; font-size: 24pt; font-weight: bold;">2018</div>

<b>Inspection Date:</b> 10/25/2018 8:28:36 AM		<b>Type:</b> Ongoing	<b>Flow:</b> Submerged, indeterminate	<b>Previous Rainfall (hrs):</b> 72+
<b>Illicit Discharge Potential:</b> Potential		<b>Inspector:</b> JCW		
Submerged: Partially		Depth (in): 2		
<b>Sampling Results</b> Sample Location: Pool Total Chlorine: 0 ppm Free Chlorine: 0 ppm Ammonia: 0 ppm pH: 7.86 units Temperature: 50 °F Conductivity: 1011 µS/cm Detergents: 0.4 mg/L		Floatables: None Odor: None Turbidity: None Color: None Gross Solids: Slight Vegetation: None Benthic Growth: None Stains: None Non-illicit: None		
		<b>Notes</b> Sample collected from submerged pool in outfall. Detergent detected in sample.		
		<b>Condition Assessment</b> Graffiti: None Erosion: None Deposition: None in. Damage: None

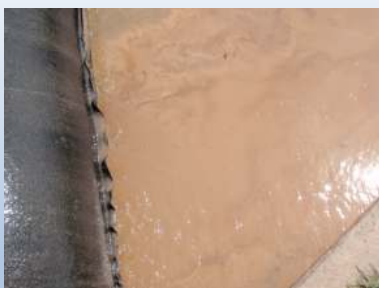
IF YOUR DISCHARGE LOOKS LIKE THIS, MORE IS REQUIRED

Consider this your first warning for the project.

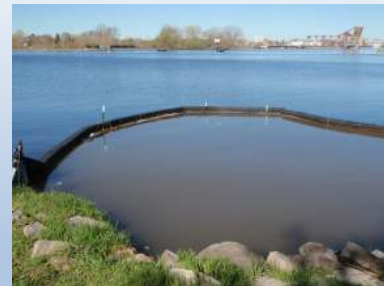
TURBIDITY BARRIER  
MUST EXTEND FULLY TO  
SHORELINE

- Must be installed before any work takes place in a waterway.
  - Make sure your barrier is designed for the flows or wave action the water body has
    - Lake Winnebago is different than Fox River
  - The barrier must be securely staked to prevent floating back to shore
  - The barrier must be secured to the waterway bottom to prevent sediment from escaping
  - The barrier must extend from the shore edges completely around working area
  - Must be left in place for 24 hours after work in the waterway is complete

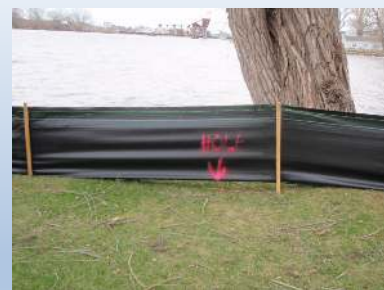
NO TRENCH, STAKES ON THE WRONG SIDE, AND A BIG HOLE

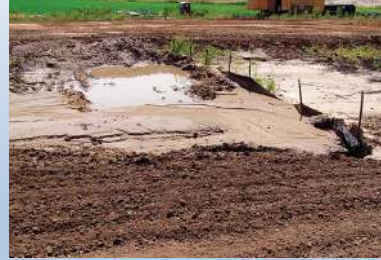
IF SEDIMENT ACCULULATES TO HALF THE FENCE HEIGHT  
CLEAN IMMEDIATELY

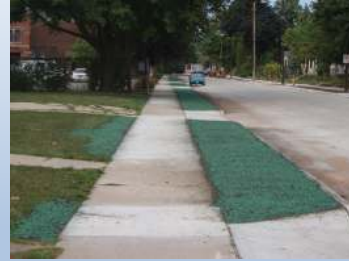
TAKE CARE TO ENSURE HYDRO MULCH IS ONLY SPRAYED OVER EXPOSED SOILS. MULCH SPRAYED ANYWHERE ELSE SHALL BE CLEANED UP AT CONTRACTORS EXPENSE

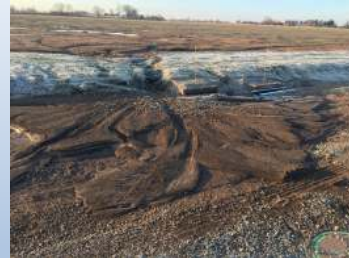
GIVE YOURSELF ENOUGH TIME TO ESTABLISH VEGETATION BEFORE WINTER. EROSION MAT ALONE WILL NOT PREVENT SEDIMENT TRANSPORTATION.

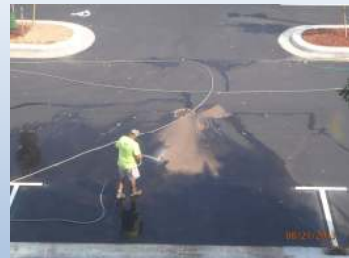
NOT APPROVED! THIS WAS DONE IN THE CITY HALL PARKING LOT!
