IDDE Ongoing Screening Summary Report

2023 Inspection Year

Westwood

City of Oshkosh

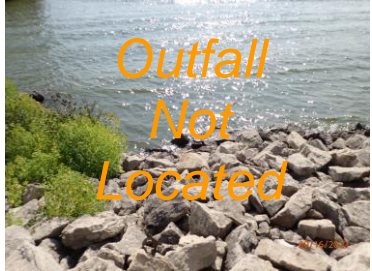
o20220916133918.JPG 2022

Inspection Date: 9/16/2022 1:40:00 PM		Type: Ongoing	Flow: Submerged (not located)	Previous Rainfall (hrs): 72+
Illicit Discharge Potential: Unlikely		Inspector: EJK		
Submerged: Fully		Depth (in):		
Sampling Results Sample Location: _____ Total Chlorine: -- ppm Free Chlorine: -- ppm Ammonia: -- ppm pH: -- units Temperature -- ° F Conductivity: -- µS/cm Detergents: -- mg/L		Floatables: None Odor: None Turbidity: None Color: None Gross Solids: None Vegetation: None Benthic Growth: None Stains: None Non-illicit: None	Notes Outfall fully submerged and not located - screened upstream at 01-520 US1. Condition Assessment Graffiti: None Erosion: None Deposition: None in. Damage: None

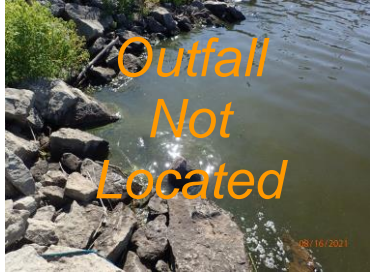
o20210816101510.JPG 2021

Inspection Date: 8/16/2021 10:15:00 AM		Type: Ongoing	Flow: Submerged (not located)	Previous Rainfall (hrs): 72+
Illicit Discharge Potential: Potential		Inspector: JCW		
Submerged: Fully		Depth (in):		
Sampling Results Sample Location: _____ Total Chlorine: -- ppm Free Chlorine: -- ppm Ammonia: -- ppm pH: -- units Temperature -- ° F Conductivity: -- µS/cm Detergents: -- mg/L		Floatables: None Odor: None Turbidity: None Color: None Gross Solids: None Vegetation: None Benthic Growth: None Stains: None Non-illicit: None	Notes Outfall fully submerged and not located - screened upstream at 01-520 US1. Floating gross solids (litter) in upstream manhole. Condition Assessment Graffiti: None Erosion: None Deposition: None in. Damage: None

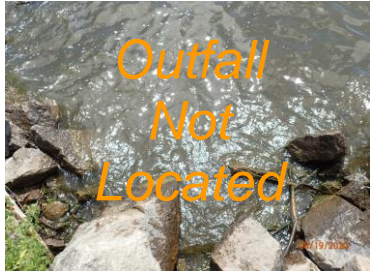
o20200819131544.JPG 2020

Inspection Date: 8/19/2020 1:19:20 PM		Type: Ongoing	Flow: Submerged (not located)	Previous Rainfall (hrs): 72+
Illicit Discharge Potential: Potential		Inspector: JCW		
Submerged: Fully		Depth (in):		
Sampling Results Sample Location: _____ Total Chlorine: -- ppm Free Chlorine: -- ppm Ammonia: -- ppm pH: -- units Temperature -- ° F Conductivity: -- µS/cm Detergents: -- mg/L		Floatables: None Odor: None Turbidity: None Color: None Gross Solids: None Vegetation: None Benthic Growth: None Stains: None Non-illicit: None	Notes Outfall fully submerged and not located - screened upstream at 01-520 US1. Floating gross solids (litter) in upstream manhole. Condition Assessment Graffiti: None Erosion: None Deposition: None in. Damage: None

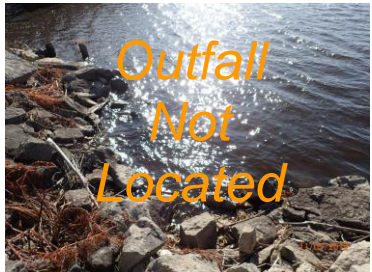
o20191105110258.JPG 2019

Inspection Date: 11/5/2019 11:04:00 AM		Type: Repeat	Flow: Submerged (not located)	Previous Rainfall (hrs): 48-72
Illicit Discharge Potential: Potential		Inspector: JCW		
Submerged: Fully		Depth (in):		
Sampling Results Sample Location: _____ Total Chlorine: -- ppm Free Chlorine: -- ppm Ammonia: -- ppm pH: -- units Temperature -- ° F Conductivity: -- µS/cm Detergents: -- mg/L		Floatables: None Odor: None Turbidity: None Color: None Gross Solids: None Vegetation: None Benthic Growth: None Stains: None Non-illicit: None	Notes Outfall fully submerged - screened upstream at 01-520 US1. Follow-up inspection for sampling - limited screening conducted. Condition Assessment Graffiti: None Erosion: None Deposition: None in. Damage: None

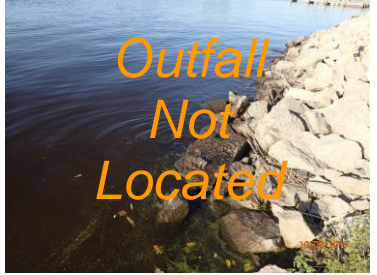
Inspection Date: 10/8/2019 9:16:36 AM		Type: Ongoing	Flow: Submerged (not located)	Previous Rainfall (hrs): 48-72
Illicit Discharge Potential: Potential		Inspector: JCW	Notes	
Submerged: Fully		Depth (in):	Outfall fully submerged - screened upstream at 01-520 US1. Floating gross solids (litter) in manhole.	
Sampling Results		Floatables:	<div style="text-align: center;">

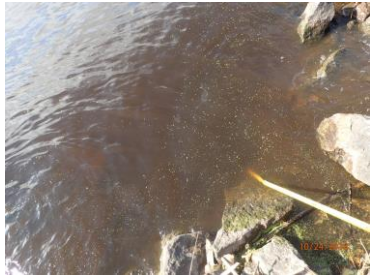
Inspection Date: 10/24/2018 11:06:05 AM		Type: Ongoing	Flow: Submerged, indeterminate	Previous Rainfall (hrs): 72+
Illicit Discharge Potential: Potential		Inspector: JCW	Notes	
Submerged: Fully		Depth (in):	Outfall fully submerged - screened upstream at 01-520 US1. Floating gross solids (litter) in manhole.	
Sampling Results		Floatables:	<div style="text-align: center;">

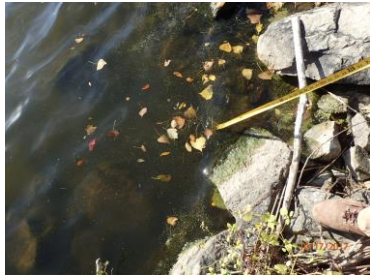
Inspection Date: 10/17/2017 3:18:17 PM		Type: Ongoing	Flow: Submerged, indeterminate	Previous Rainfall (hrs): 48-72
Illicit Discharge Potential: Potential		Inspector: JCW	Notes	
Submerged: Fully		Depth (in): 39	Outfall fully submerged - screened upstream at 01-520 US1. Floating gross solids (litter) in manhole.	
Sampling Results		Floatables:	<div style="text-align: center;">

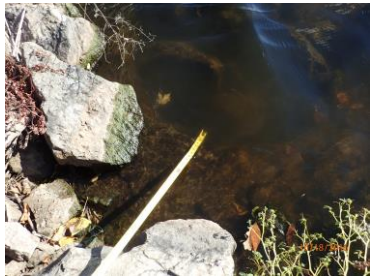
Inspection Date: 10/18/2016 3:38:45 PM		Type: Ongoing	Flow: Submerged, indeterminate	Previous Rainfall (hrs): 72+
Illicit Discharge Potential: Potential		Inspector: JCW	Notes	
Submerged: Fully		Depth (in): 33	Outfall fully submerged - screened upstream at 01-520 US1.	
Sampling Results		Floatables:	<div style="text-align: center;">

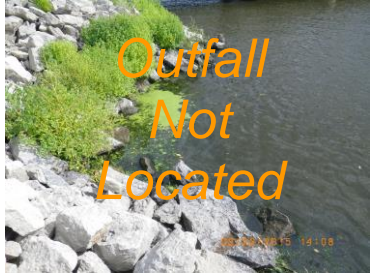
o20150922130830.JPG

Inspection Date: 9/22/2015 2:05:49 PM		Type: Ongoing	Flow: Submerged (not located)	Previous Rainfall (hrs): 72+
Illicit Discharge Potential: Potential		Inspector: JCW	Notes	
Submerged: Fully		Depth (in):	Outfall fully submerged and not located during this screening - screened at 01-520 US1.	
Sampling Results		Floatables:	Condition Assessment Graffiti: None Erosion: None Deposition: None in. Damage: None	
Sample Location:	Odor:	None		
Total Chlorine: -- ppm	Turbidity:	None		
Free Chlorine: -- ppm	Color:	None		
Ammonia: -- ppm	Gross Solids:	None		
pH: -- units	Vegetation:	None		
Temperature -- °F	Benthic Growth:	None		
Conductivity: -- µS/cm	Stains:	None		
Detergents: -- mg/L	Non-illicit:	None

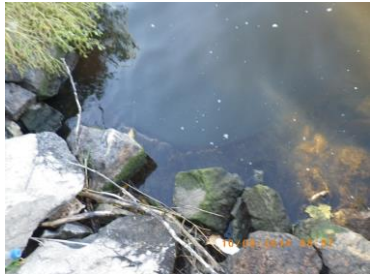
o20141009073704.JPG

Inspection Date: 10/9/2014 8:38:02 AM		Type: Ongoing	Flow: Submerged, indeterminate	Previous Rainfall (hrs): 72+
Illicit Discharge Potential: Potential		Inspector: JCW	Notes	
Submerged: Fully		Depth (in): 56	Outfall fully submerged - screened upstream at 01-520 US1.	
Sampling Results		Floatables:	Condition Assessment Graffiti: None Erosion: None Deposition: None in. Damage: None	
Sample Location:	Odor:	None		
Total Chlorine: -- ppm	Turbidity:	None		
Free Chlorine: -- ppm	Color:	None		
Ammonia: -- ppm	Gross Solids:	None		
pH: -- units	Vegetation:	None		
Temperature -- °F	Benthic Growth:	Moderate		
Conductivity: -- µS/cm	Stains:	None		
Detergents: -- mg/L	Non-illicit:	None

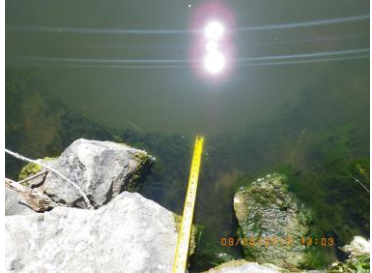
o20130905120336.JPG

Inspection Date: 9/5/2013 12:59:39 PM		Type: Ongoing	Flow: Submerged, indeterminate	Previous Rainfall (hrs): 72+
Illicit Discharge Potential: Potential		Inspector: JCW	Notes	
Submerged: Fully		Depth (in): 49	Outfall fully submerged. Outfall screened upstream at 01-520 US1. 2012 screening follow-up. Gross solids in upstream mh.	
Sampling Results		Floatables:	Condition Assessment Graffiti: None Erosion: None Deposition: None in. Damage: None	
Sample Location:	Odor:	None		
Total Chlorine: -- ppm	Turbidity:	None		
Free Chlorine: -- ppm	Color:	None		
Ammonia: -- ppm	Gross Solids:	None		
pH: -- units	Vegetation:	None		
Temperature -- °F	Benthic Growth:	Moderate		
Conductivity: -- µS/cm	Stains:	None		
Detergents: -- mg/L	Non-illicit:	None

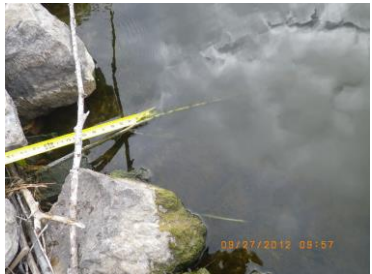
o20120927085734.JPG

Inspection Date: 9/27/2012 9:53:44 AM		Type: Ongoing	Flow: Submerged, indeterminate	Previous Rainfall (hrs): 72+
Illicit Discharge Potential: Potential		Inspector: JCW	Notes	
Submerged: Fully		Depth (in): 40	Outfall fully submerged; screened upstream at 01-520 US1.	
Sampling Results		Floatables:	Condition Assessment Graffiti: None Erosion: None Deposition: None in. Damage: None	
Sample Location:	Odor:	None		
Total Chlorine: -- ppm	Turbidity:	None		
Free Chlorine: -- ppm	Color:	None		
Ammonia: -- ppm	Gross Solids:	None		
pH: -- units	Vegetation:	None		
Temperature -- °F	Benthic Growth:	None		
Conductivity: -- µS/cm	Stains:	None		
Detergents: -- mg/L	Non-illicit:	None

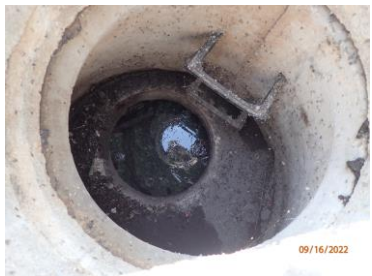
o20220916134136.JPG <div style="text-align: right; font-size: 24pt; font-weight: bold;">2022</div>

Inspection Date: 9/16/2022 1:44:00 PM		Type: Ongoing	Flow: Submerged, indeterminate	Previous Rainfall (hrs): 72+
Illicit Discharge Potential: Unlikely		Inspector: EJK		
Submerged: Partially		Depth (in): 66		
Sampling Results		Notes Sample collected from submerged pool in manhole.		
Sample Location: Pool	Floatables:	Slight		
Total Chlorine: 0 ppm	Odor:	None		
Free Chlorine: 0 ppm	Turbidity:	None		
Ammonia: 0 ppm	Color:	None		
pH: 7.61 units	Gross Solids:	Slight		
Temperature 74 °F	Vegetation:	None		
Conductivity: 472 µS/cm	Benthic Growth:	None		
Detergents: 0 mg/L	Stains:	None		
	Non-illicit:	None		
		Condition Assessment Graffiti: None Erosion: None Deposition: None in. Damage: None

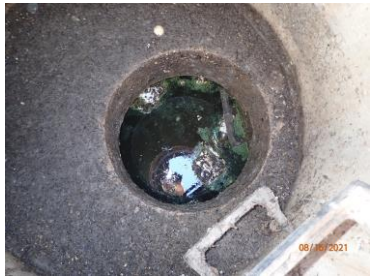
o20210816101558.JPG <div style="text-align: right; font-size: 24pt; font-weight: bold;">2021</div>

Inspection Date: 8/16/2021 10:19:15 AM		Type: Ongoing	Flow: Submerged, indeterminate	Previous Rainfall (hrs): 72+
Illicit Discharge Potential: Potential		Inspector: JCW		
Submerged: Fully		Depth (in): 71		
Sampling Results		Notes Sample collected from submerged pool in manhole. Floating gross solids (litter) in manhole.		
Sample Location: Pool	Floatables:	None		
Total Chlorine: 0 ppm	Odor:	None		
Free Chlorine: 0 ppm	Turbidity:	None		
Ammonia: 0 ppm	Color:	None		
pH: 7.57 units	Gross Solids:	Moderate		
Temperature 76 °F	Vegetation:	None		
Conductivity: 844 µS/cm	Benthic Growth:	None		
Detergents: 0 mg/L	Stains:	None		
	Non-illicit:	None		
		Condition Assessment Graffiti: None Erosion: None Deposition: None in. Damage: None

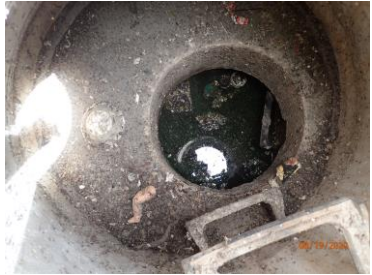
o20200819131610.JPG <div style="text-align: right; font-size: 24pt; font-weight: bold;">2020</div>

Inspection Date: 8/19/2020 1:20:07 PM		Type: Ongoing	Flow: Submerged, indeterminate	Previous Rainfall (hrs): 72+
Illicit Discharge Potential: Potential		Inspector: JCW		
Submerged: Fully		Depth (in): 68		
Sampling Results		Notes Sample collected from submerged pool in manhole. Floating gross solids (litter) in manhole. Elevated pH seemed widespread in river.		
Sample Location: Pool	Floatables:	None		
Total Chlorine: 0 ppm	Odor:	None		
Free Chlorine: 0 ppm	Turbidity:	None		
Ammonia: 0 ppm	Color:	None		
pH: 9.11 units	Gross Solids:	Severe		
Temperature 85 °F	Vegetation:	None		
Conductivity: 372 µS/cm	Benthic Growth:	None		
Detergents: 0 mg/L	Stains:	None		
	Non-illicit:	None		
		Condition Assessment Graffiti: None Erosion: None Deposition: None in. Damage: None

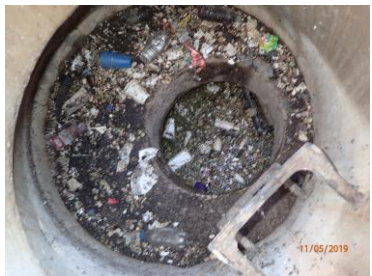
o20191105110322.JPG <div style="text-align: right; font-size: 24pt; font-weight: bold;">2019</div>

Inspection Date: 10/8/2019 9:18:01 AM		Type: Ongoing	Flow: Submerged, indeterminate	Previous Rainfall (hrs): 48-72
Illicit Discharge Potential: Potential		Inspector: JCW	Notes	
Submerged: Partially Depth (in): 73			Sample collected from submerged pool in manhole. Floating gross solids (litter) in manhole. Detergent detected.	
Sampling Results		Floatables: None	Condition Assessment Graffiti: None Erosion: None Deposition: None in. Damage: None	
Sample Location: Pool		Odor: None		
Total Chlorine: 0 ppm		Turbidity: None		
Free Chlorine: 0 ppm		Color: None		
Ammonia: 0 ppm		Gross Solids: Severe		
pH: 7.28 units		Vegetation: None		
Temperature 61 °F		Benthic Growth: None		
Conductivity: 381 µS/cm		Stains: None		
Detergents: 0.9 mg/L		Non-illicit: None

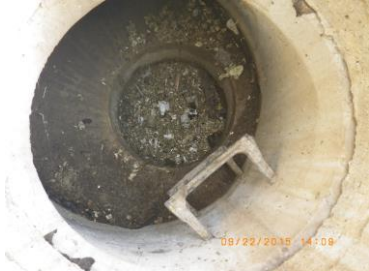
020150922130946.JPG

Inspection Date: 9/22/2015 2:08:37 PM		Type: Ongoing	Flow: Submerged, indeterminate	Previous Rainfall (hrs): 72+
Illicit Discharge Potential: Potential		Inspector: JCW	Notes	
Submerged: Fully		Depth (in): 70	Floating gross solids (litter) in manhole.	
Sampling Results		Floatables: None	Condition Assessment Graffiti: None Erosion: None Deposition: None in. Damage: None	
Sample Location: Pool	Odor: None			
Total Chlorine: 0 ppm	Turbidity: None			
Free Chlorine: 0 ppm	Color: None			
Ammonia: 0 ppm	Gross Solids: Severe			
pH: 8.1 units	Vegetation: None			
Temperature 76 °F	Benthic Growth: None			
Conductivity: 917 µS/cm	Stains: None			
Detergents: 0 mg/L	Non-illicit: None

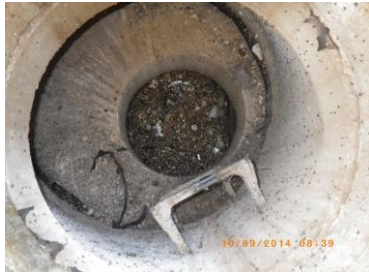
020141009073910.JPG

Inspection Date: 10/9/2014 8:42:09 AM		Type: Ongoing	Flow: Submerged, indeterminate	Previous Rainfall (hrs): 72+
Illicit Discharge Potential: Potential		Inspector: JCW	Notes	
Submerged: Fully		Depth (in): 64	Floating gross solids (litter) inside manhole.	
Sampling Results		Floatables: None	Condition Assessment Graffiti: None Erosion: None Deposition: None in. Damage: None	
Sample Location: Pool	Odor: Faint			
Total Chlorine: 0 ppm	Turbidity: None			
Free Chlorine: 0 ppm	Color: None			
Ammonia: 0 ppm	Gross Solids: Severe			
pH: 7.84 units	Vegetation: None			
Temperature 57 °F	Benthic Growth: Slight			
Conductivity: 1318 µS/cm	Stains: None			
Detergents: 0 mg/L	Non-illicit: None

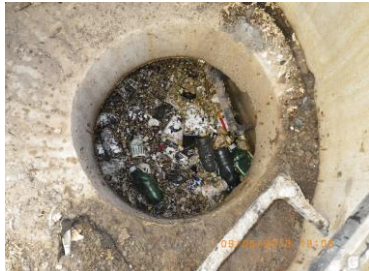
020130905120924.JPG

Inspection Date: 9/5/2013 1:02:45 PM		Type: Ongoing	Flow: Submerged, indeterminate	Previous Rainfall (hrs): 72+
Illicit Discharge Potential: Potential		Inspector: JCW	Notes	
Submerged: Fully		Depth (in): 69	2012 screening follow-up. Significant gross solids in manhole - similar to previous years.	
Sampling Results		Floatables: None	Condition Assessment Graffiti: None Erosion: None Deposition: None in. Damage: None	
Sample Location: Pool	Odor: None			
Total Chlorine: 0 ppm	Turbidity: None			
Free Chlorine: 0 ppm	Color: None			
Ammonia: 0 ppm	Gross Solids: Severe			
pH: 8.51 units	Vegetation: None			
Temperature 76 °F	Benthic Growth: None			
Conductivity: 424 µS/cm	Stains: None			
Detergents: 0 mg/L	Non-illicit: None

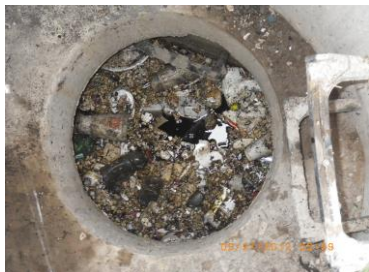
020120927085918.JPG

Inspection Date: 9/27/2012 9:57:25 AM		Type: Ongoing	Flow: Submerged, indeterminate	Previous Rainfall (hrs): 72+
Illicit Discharge Potential: Potential		Inspector: JCW	Notes	
Submerged: Fully		Depth (in): 69	2011 gross solids follow-up.	
Sampling Results		Floatables: None	Condition Assessment Graffiti: None Erosion: None Deposition: None in. Damage: None	
Sample Location: Pool	Odor: None			
Total Chlorine: 0 ppm	Turbidity: None			
Free Chlorine: 0 ppm	Color: None			
Ammonia: 0.5 ppm	Gross Solids: Severe			
pH: 7.77 units	Vegetation: None			
Temperature 60 °F	Benthic Growth: None			
Conductivity: 542 µS/cm	Stains: Slight			
Detergents: 0 mg/L	Non-illicit: None

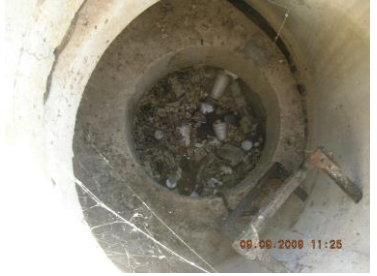
Inspection Date: 9/9/2009		Type: Initial		Flow: Submerged, indeterminate		Previous Rainfall (hrs): 72+	
Illicit Discharge Potential: Potential		Inspector: JCW		Notes Abnormal detergent analysis result (bubbles). Significant floatables in manhole. Brown color.

Osh09_DSCN6718.JPG	
Submerged: Fully		Depth (in): 61					
Sampling Results		Floatables: None Odor: None Turbidity: None Color: Clearly visible in bottl Gross Solids: Severe Vegetation: None Benthic Growth: None Stains: None Non-illicit: None		Condition Assessment Graffiti: None Erosion: None Deposition: None 0 in. Damage: None			
Sample Location: Pool Total Chlorine: 0 ppm Free Chlorine: 0 ppm Ammonia: -- ppm pH: 8.6 units Temperature: 78 °F Conductivity: -- µS/cm Detergents: 0 mg/L						2009

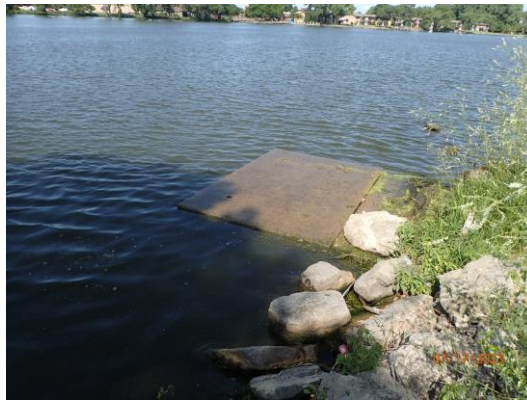
o20230717085750.JPG

Storm sewer from Pearl Ave discharges to river from east. Replaces outfall 01-329 (2011).

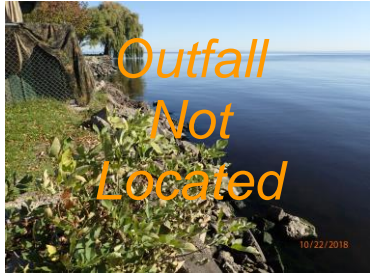
Inspection Date: 10/22/2018 10:23:45 AM		Type: Ongoing	Flow: Submerged (not located)	Previous Rainfall (hrs): 48-72
Illicit Discharge Potential: Potential		Inspector: JCW		
Submerged: Fully		Depth (in):		
Sampling Results Sample Location: _____ Total Chlorine: -- ppm Free Chlorine: -- ppm Ammonia: -- ppm pH: -- units Temperature: -- °F Conductivity: -- µS/cm Detergents: -- mg/L		Floatables: None Odor: None Turbidity: None Color: None Gross Solids: None Vegetation: None Benthic Growth: None Stains: None Non-illicit: None	Notes Outfall fully submerged and not located - screened upstream at 02-309 US1. Floating gross solids (litter) in manhole.

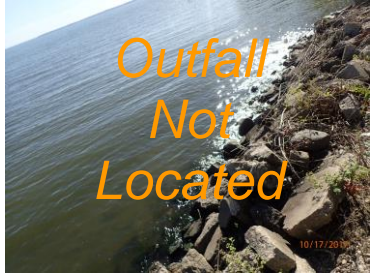
o20171017133948.JPG

Inspection Date: 10/17/2017 1:41:46 PM		Type: Ongoing	Flow: Submerged (not located)	Previous Rainfall (hrs): 48-72
Illicit Discharge Potential: Potential		Inspector: JCW	Notes	
Submerged: Fully		Depth (in):	Outfall fully submerged and not located - screened upstream at 02-309 US1. Floating gross solids (litter) in manhole.	
Sampling Results		Floatables:	Condition Assessment Graffiti: None Erosion: None Deposition: None in. Damage: None	
Sample Location:		Odor:		
Total Chlorine: -- ppm		Turbidity:		
Free Chlorine: -- ppm		Color:		
Ammonia: -- ppm		Gross Solids:		
pH: -- units		Vegetation:		
Temperature -- °F		Benthic Growth:		
Conductivity: -- µS/cm		Stains:		
Detergents: -- mg/L		Non-illicit:

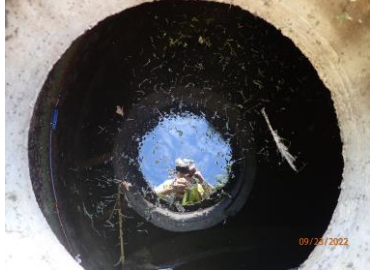
o20220923084658.JPG <div style="text-align: right; font-size: 24pt; font-weight: bold;">2022</div>

Inspection Date: 9/23/2022 8:48:00 AM		Type: Ongoing	Flow: Submerged, indeterminate	Previous Rainfall (hrs): 72+
Illicit Discharge Potential: Unlikely		Inspector: EJK		
Submerged: Partially		Depth (in): 29		
Sampling Results		Notes Sample collected from submerged pool in manhole.		
Sample Location: Pool	Floatables:	Slight		
Total Chlorine: 0 ppm	Odor:	None		
Free Chlorine: 0 ppm	Turbidity:	None		
Ammonia: 0 ppm	Color:	None		
pH: 7.79 units	Gross Solids:	None		
Temperature 62 °F	Vegetation:	None		
Conductivity: 774 µS/cm	Benthic Growth:	Slight		
Detergents: 0 mg/L	Stains:	None		
	Non-illicit:	None		
		Condition Assessment Graffiti: None Erosion: None Deposition: None in. Damage: None

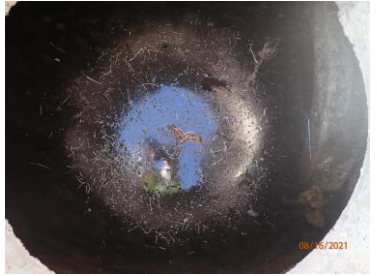
o20210816091646.JPG <div style="text-align: right; font-size: 24pt; font-weight: bold;">2021</div>

Inspection Date: 8/16/2021 9:18:55 AM		Type: Ongoing	Flow: Submerged, indeterminate	Previous Rainfall (hrs): 72+
Illicit Discharge Potential: Unlikely		Inspector: JCW		
Submerged: Partially		Depth (in): 34		
Sampling Results		Notes Sample collected from submerged pool in manhole.		
Sample Location: Pool	Floatables:	None		
Total Chlorine: 0 ppm	Odor:	None		
Free Chlorine: 0 ppm	Turbidity:	None		
Ammonia: 0 ppm	Color:	None		
pH: 7.53 units	Gross Solids:	None		
Temperature 72 °F	Vegetation:	None		
Conductivity: 493 µS/cm	Benthic Growth:	Slight		
Detergents: 0 mg/L	Stains:	None		
	Non-illicit:	None		
		Condition Assessment Graffiti: None Erosion: None Deposition: None in. Damage: None

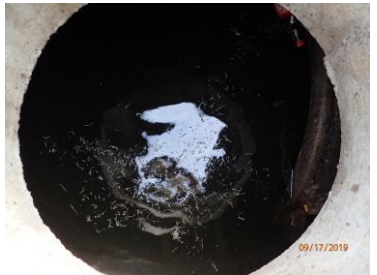
o20190917132614.JPG <div style="text-align: right; font-size: 24pt; font-weight: bold;">2019</div>

Inspection Date: 9/17/2019 2:28:11 PM		Type: Ongoing	Flow: Submerged, indeterminate	Previous Rainfall (hrs): 48-72
Illicit Discharge Potential: Unlikely		Inspector: JCW		
Submerged: Fully		Depth (in): 32		
Sampling Results		Notes Sample collected from submerged pool in manhole.		
Sample Location: Pool	Floatables:	None		
Total Chlorine: 0 ppm	Odor:	None		
Free Chlorine: 0 ppm	Turbidity:	None		
Ammonia: 0 ppm	Color:	None		
pH: 8.22 units	Gross Solids:	None		
Temperature 75 °F	Vegetation:	None		
Conductivity: 465 µS/cm	Benthic Growth:	Slight		
Detergents: 0 mg/L	Stains:	None		
	Non-illicit:	None		
		Condition Assessment Graffiti: None Erosion: None Deposition: None in. Damage: None

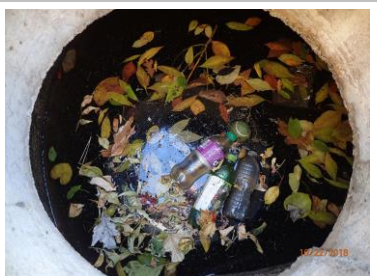
o20181022102412.JPG <div style="text-align: right; font-size: 24pt; font-weight: bold;">2018</div>

Inspection Date: 10/22/2018 10:26:35 AM		Type: Ongoing	Flow: Submerged, indeterminate	Previous Rainfall (hrs): 48-72
Illicit Discharge Potential: Potential		Inspector: JCW		
Submerged: Fully		Depth (in): 34		
Sampling Results		Notes Sample collected from submerged pool in manhole. Floating gross solids (litter) in manhole.		
Sample Location: Pool	Floatables:	None		
Total Chlorine: 0 ppm	Odor:	None		
Free Chlorine: 0 ppm	Turbidity:	None		
Ammonia: 0 ppm	Color:	None		
pH: 7.46 units	Gross Solids:	Moderate		
Temperature 58 °F	Vegetation:	None		
Conductivity: 498 µS/cm	Benthic Growth:	Slight		
Detergents: 0 mg/L	Stains:	None		
	Non-illicit:	None		
		Condition Assessment Graffiti: None Erosion: None Deposition: None in. Damage: None

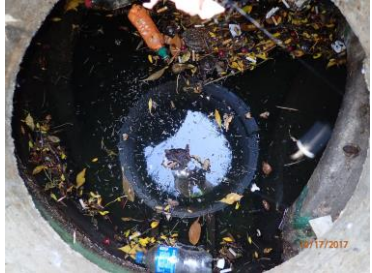
o20171017134106.JPG

Inspection Date: 10/17/2017 1:45:07 PM		Type: Ongoing	Flow: Submerged, indeterminate	Previous Rainfall (hrs): 48-72
Illicit Discharge Potential: Potential		Inspector: JCW	Notes	
Submerged: Fully		Depth (in): 31	Sample collected from submerged pool in manhole. Floating gross solids (litter) in manhole.	
Sampling Results		Floatables: None	Condition Assessment	
Sample Location:	Pool	Odor: None	Graffiti: None Erosion: None Deposition: None in. Damage: None	
Total Chlorine:	0 ppm	Turbidity: None		
Free Chlorine:	0 ppm	Color: None		
Ammonia:	0 ppm	Gross Solids: Moderate		
pH:	7.74 units	Vegetation: None		
Temperature	69 °F	Benthic Growth: Moderate		
Conductivity:	644 µS/cm	Stains: None		
Detergents:	0 mg/L	Non-illicit: None

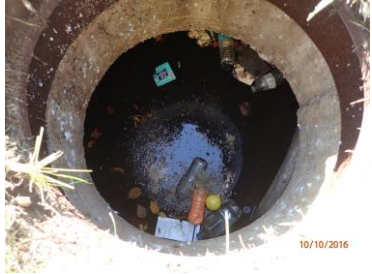
o20161010103236.JPG

Inspection Date: 10/10/2016 10:35:02 AM		Type: Ongoing	Flow: Submerged, indeterminate	Previous Rainfall (hrs): 72+
Illicit Discharge Potential: Potential		Inspector: JCW	Notes	
Submerged: Fully		Depth (in): 28	Potential illicit discharge due to gross solids.	
Sampling Results		Floatables: None	Condition Assessment	
Sample Location:	Pool	Odor: None	Graffiti: None Erosion: None Deposition: None in. Damage: None	
Total Chlorine:	0 ppm	Turbidity: None		
Free Chlorine:	0 ppm	Color: None		
Ammonia:	0 ppm	Gross Solids: Moderate		
pH:	7.54 units	Vegetation: None		
Temperature	64 °F	Benthic Growth: None		
Conductivity:	592 µS/cm	Stains: None		
Detergents:	0 mg/L	Non-illicit: None

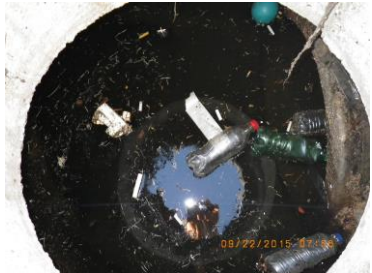
o20150922065636.JPG

Inspection Date: 9/22/2015 7:50:50 AM		Type: Ongoing	Flow: Submerged, indeterminate	Previous Rainfall (hrs): 72+
Illicit Discharge Potential: Potential		Inspector: JCW	Notes	
Submerged: Fully		Depth (in): 28	Floating gross solids (litter) in manhole.	
Sampling Results		Floatables: None	Condition Assessment	
Sample Location:	Pool	Odor: None	Graffiti: None Erosion: None Deposition: None in. Damage: None	
Total Chlorine:	0 ppm	Turbidity: None		
Free Chlorine:	0 ppm	Color: None		
Ammonia:	0 ppm	Gross Solids: Slight		
pH:	7.74 units	Vegetation: None		
Temperature	66 °F	Benthic Growth: Slight		
Conductivity:	853 µS/cm	Stains: Slight		
Detergents:	0 mg/L	Non-illicit: None

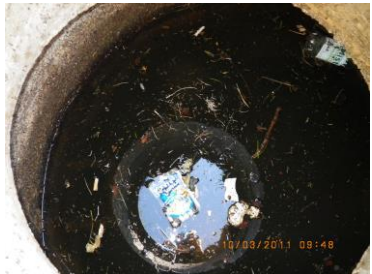
o20111003094830.JPG

Inspection Date: 10/3/2011 9:47:42 AM		Type: Ongoing	Flow: Submerged, indeterminate	Previous Rainfall (hrs): 72+
Illicit Discharge Potential: Unlikely		Inspector: JCW	Notes	
Submerged: Fully		Depth (in): 32		
Sampling Results		Floatables: None	Condition Assessment	
Sample Location:	Pool	Odor: Faint	Graffiti: None Erosion: None Deposition: None 0 in. Damage: None	
Total Chlorine:	0 ppm	Turbidity: None		
Free Chlorine:	0 ppm	Color: None		
Ammonia:	0 ppm	Gross Solids: Slight		
pH:	7.71 units	Vegetation: None		
Temperature	60 °F	Benthic Growth: None		
Conductivity:	-- µS/cm	Stains: None		
Detergents:	0 mg/L	Non-illicit: None

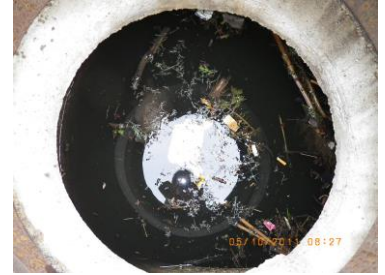
o20110510082708.JPG

Inspection Date: 5/10/2011 8:27:00 AM		Type: Other	Flow: Submerged, indeterminate	Previous Rainfall (hrs): 0-24
Illicit Discharge Potential: Potential		Inspector: JCW	Notes Limited screening conducted for upstream manhole prescreening.	
Submerged: Fully Depth (in):				
Sampling Results Sample Location: _____ Total Chlorine: -- ppm Free Chlorine: -- ppm Ammonia: -- ppm pH: -- units Temperature -- °F Conductivity: -- µS/cm Detergents: -- mg/L		Floatables: None Odor: _____ Turbidity: _____ Color: _____ Gross Solids: Slight Vegetation: _____ Benthic Growth: _____ Stains: _____ Non-illicit: None	Condition Assessment Graffiti: None Erosion: None Deposition: None 0 in. Damage: None

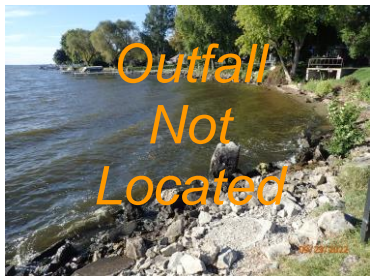
Inspection Date: 9/23/2022 9:09:00 AM		Type: Ongoing	Flow: Submerged (not located)	Previous Rainfall (hrs): 72+
Illicit Discharge Potential: Potential		Inspector: EJK	Notes	
Submerged: Fully		Depth (in):	Outfall fully submerged and not located - screened upstream at 02-357 US1. Floating gross solids (litter) in upstream manhole.	
Sampling Results		Floatables:	<div style="text-align: center;">

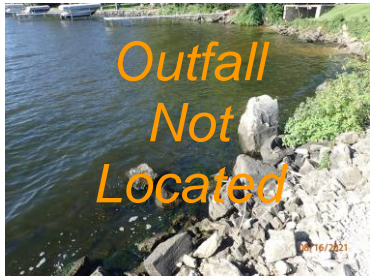
Inspection Date: 8/16/2021 8:57:00 AM		Type: Ongoing	Flow: Submerged (not located)	Previous Rainfall (hrs): 72+
Illicit Discharge Potential: Potential		Inspector: JCW	Notes	
Submerged: Fully		Depth (in):	Outfall fully submerged and not located - screened upstream at 02-357 US1. Floating gross solids (litter) in upstream manhole.	
Sampling Results		Floatables:	<div style="text-align: center;">

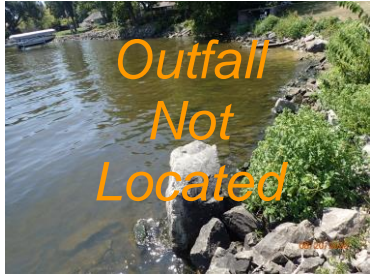
Inspection Date: 8/20/2020 1:04:00 PM		Type: Ongoing	Flow: Submerged (not located)	Previous Rainfall (hrs): 72+
Illicit Discharge Potential: Potential		Inspector: JCW	Notes	
Submerged: Fully		Depth (in):	Outfall fully submerged and not located - screened upstream at 02-357 US1. Floating gross solids (litter) in upstream manhole.	
Sampling Results		Floatables:	<div style="text-align: center;">

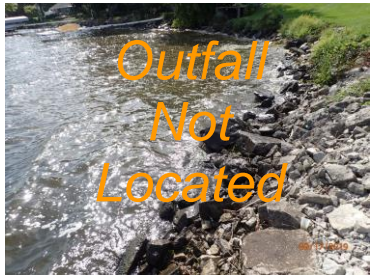
Inspection Date: 9/17/2019 2:15:46 PM		Type: Ongoing	Flow: Submerged (not located)	Previous Rainfall (hrs): 48-72
Illicit Discharge Potential: Potential		Inspector: JCW	Notes	
Submerged: Fully		Depth (in):	Outfall fully submerged and not located - screened upstream at 02-357 US1. Floating gross solids (litter) in manhole.	
Sampling Results		Floatables:	<div style="text-align: center;">

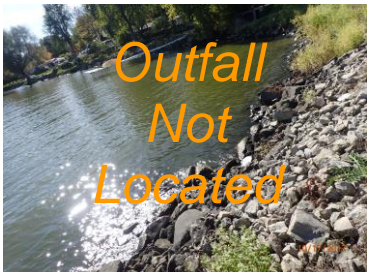
Inspection Date: 10/17/2017 1:32:28 PM		Type: Ongoing	Flow: Submerged (not located)	Previous Rainfall (hrs): 48-72
Illicit Discharge Potential: Potential		Inspector: JCW		
Submerged: Fully		Depth (in):		
Sampling Results Sample Location: Total Chlorine: -- ppm Free Chlorine: -- ppm Ammonia: -- ppm pH: -- units Temperature: -- °F Conductivity: -- µS/cm Detergents: -- mg/L		Floatables: None Odor: None Turbidity: None Color: None Gross Solids: None Vegetation: None Benthic Growth: None Stains: None Non-illicit: None	Notes Outfall fully submerged and not located - screened upstream at 02-357 US1. Floating gross solids (litter) in manhole.

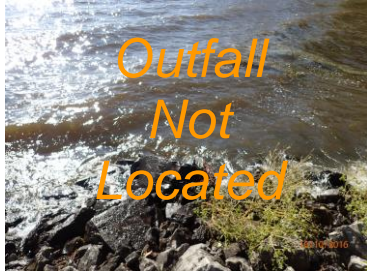
Inspection Date: 10/10/2016 10:53:43 AM		Type: Ongoing	Flow: Submerged (not located)	Previous Rainfall (hrs): 72+
Illicit Discharge Potential: Potential		Inspector: JCW		
Submerged: Fully		Depth (in):		
Sampling Results Sample Location: Total Chlorine: -- ppm Free Chlorine: -- ppm Ammonia: -- ppm pH: -- units Temperature: -- °F Conductivity: -- µS/cm Detergents: -- mg/L		Floatables: None Odor: None Turbidity: None Color: None Gross Solids: None Vegetation: None Benthic Growth: None Stains: None Non-illicit: None	Notes Outfall fully submerged and not located - screened upstream at 02-357 US1.

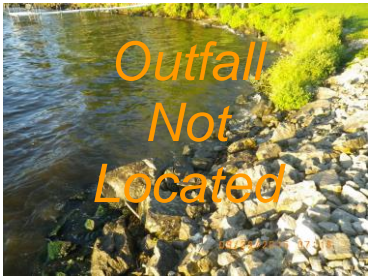
<p>o20150922061856.JPG</p> <p>2015</p>

Inspection Date: 9/22/2015 7:14:30 AM		Type: Ongoing	Flow: Submerged (not located)	Previous Rainfall (hrs): 72+
Illicit Discharge Potential: Potential		Inspector: JCW		
Submerged: Fully		Depth (in):		
Sampling Results		Notes Outfall fully submerged and not located - screened upstream at 02-357 US1.		
Sample Location: Total Chlorine: -- ppm Free Chlorine: -- ppm Ammonia: -- ppm pH: -- units Temperature: -- °F Conductivity: -- µS/cm Detergents: -- mg/L		Condition Assessment Graffiti: None Erosion: None Deposition: None in. Damage: None		
Floatables: None Odor: None Turbidity: None Color: None Gross Solids: None Vegetation: None Benthic Growth: None Stains: None Non-illicit: None

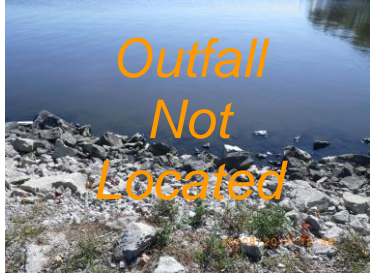
o20141009113806.JPG

Inspection Date: 10/9/2014 12:37:08 PM		Type: Ongoing	Flow: Submerged (not located)	Previous Rainfall (hrs): 72+
Illicit Discharge Potential: Potential		Inspector: JCW	Notes	
Submerged: Fully Depth (in):			Outfall fully submerged and not located - screened upstream at 02-357 US1.	
Sampling Results			Condition Assessment	
Sample Location:	Floatables:	None	Graffiti: None Erosion: None Deposition: None in. Damage: None	
Total Chlorine: -- ppm	Odor:	None		
Free Chlorine: -- ppm	Turbidity:	None		
Ammonia: -- ppm	Color:	None		
pH: -- units	Gross Solids:	None		
Temperature -- °F	Vegetation:	None		
Conductivity: -- µS/cm	Benthic Growth:	None		
Detergents: -- mg/L	Stains:	None		
	Non-illicit:	None

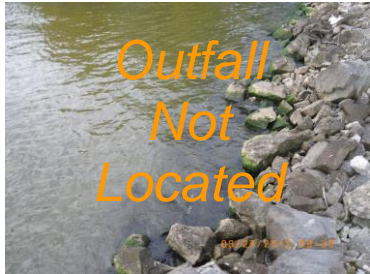
o20120927073330.JPG

Inspection Date: 9/27/2012 8:29:10 AM		Type: Ongoing	Flow: Submerged (not located)	Previous Rainfall (hrs): 72+
Illicit Discharge Potential: Unlikely		Inspector: JCW	Notes	
Submerged: Fully Depth (in):			Outfall fully submerged; screened upstream at 02-357 US1.	
Sampling Results			Condition Assessment	
Sample Location:	Floatables:	None	Graffiti: None Erosion: None Deposition: None in. Damage: None	
Total Chlorine: -- ppm	Odor:	None		
Free Chlorine: -- ppm	Turbidity:	None		
Ammonia: -- ppm	Color:	None		
pH: -- units	Gross Solids:	None		
Temperature -- °F	Vegetation:	None		
Conductivity: -- µS/cm	Benthic Growth:	None		
Detergents: -- mg/L	Stains:	None		
	Non-illicit:	None

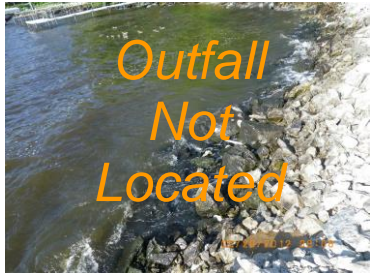
o20120620070830.JPG

Inspection Date: 6/20/2012 8:05:53 AM		Type: Other	Flow: Submerged (not located)	Previous Rainfall (hrs): 24-48
Illicit Discharge Potential: Unlikely		Inspector: JCW	Notes	
Submerged: Fully Depth (in):			Gross solids pre-screening. Outfall fully submerged; screened upstream at 02-357 US1.	
Sampling Results			Condition Assessment	
Sample Location:	Floatables:	None	Graffiti: None Erosion: None Deposition: None in. Damage: None	
Total Chlorine: -- ppm	Odor:	None		
Free Chlorine: -- ppm	Turbidity:	None		
Ammonia: -- ppm	Color:	None		
pH: -- units	Gross Solids:	None		
Temperature -- °F	Vegetation:	None		
Conductivity: -- µS/cm	Benthic Growth:	None		
Detergents: -- mg/L	Stains:	None		
	Non-illicit:	None

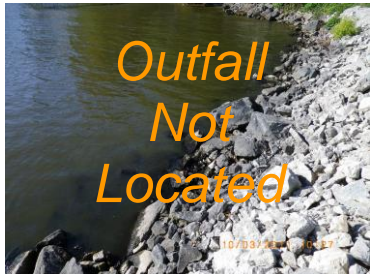
o20111003102714.JPG

Inspection Date: 10/3/2011 10:26:14 AM		Type: Ongoing	Flow: Submerged (not located)	Previous Rainfall (hrs): 72+
Illicit Discharge Potential: Potential		Inspector: JCW	Notes	
Submerged: Fully Depth (in):			Outfall fully submerged and not physically located. Outfall screened upstream at 02-357 US1.	
Sampling Results			Condition Assessment	
Sample Location:	Floatables:	None	Graffiti: None Erosion: None Deposition: None 0 in. Damage: None	
Total Chlorine: -- ppm	Odor:	None		
Free Chlorine: -- ppm	Turbidity:	None		
Ammonia: -- ppm	Color:	None		
pH: -- units	Gross Solids:	None		
Temperature -- °F	Vegetation:	None		
Conductivity: -- µS/cm	Benthic Growth:	None		
Detergents: -- mg/L	Stains:	None		
	Non-illicit:	None

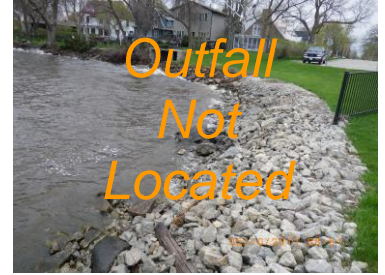
o20110510085116.JPG

Inspection Date: 5/10/2011 8:51:00 AM		Type: Other	Flow: Submerged (not located)	Previous Rainfall (hrs): 0-24
Illicit Discharge Potential: Potential		Inspector: JCW		Notes Outfall fully submerged and not physically located. Outfall screened upstream at 02-357 US1.
Submerged: Fully		Depth (in):		
Sampling Results Sample Location: Total Chlorine: -- ppm Free Chlorine: -- ppm Ammonia: -- ppm pH: -- units Temperature: -- °F Conductivity: -- µS/cm Detergents: -- mg/L		Floatables: Odor: Turbidity: Color: Gross Solids: Vegetation: Benthic Growth: Stains: Non-illicit: None		Condition Assessment Graffiti: None Erosion: None Deposition: None 0 in. Damage: None

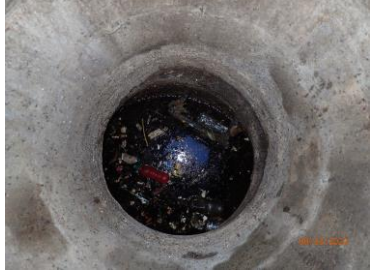
Inspection Date: 9/23/2022 9:10:00 AM		Type: Ongoing	Flow: Submerged, indeterminate	Previous Rainfall (hrs): 72+
Illicit Discharge Potential: Potential Submerged: Partially Depth (in): 41		Inspector: EJK	Notes

o20220923091028.JPG 2022
Sampling Results Sample Location: Pool Total Chlorine: 0 ppm Free Chlorine: 0 ppm Ammonia: 0 ppm pH: 7.8 units Temperature: 64 °F Conductivity: 570 µS/cm Detergents: 0 mg/L		Floatables: Slight Odor: None Turbidity: None Color: None Gross Solids: Moderate Vegetation: None Benthic Growth: None Stains: None Non-illicit: None	Sample collected from submerged pool in manhole. Floating gross solids (litter) in upstream manhole. Condition Assessment Graffiti: None Erosion: None Deposition: None in. Damage: None	
Inspection Date: 8/16/2021 9:01:46 AM		Type: Ongoing	Flow: Submerged, indeterminate	Previous Rainfall (hrs): 72+
Illicit Discharge Potential: Potential Submerged: Fully Depth (in): 44		Inspector: JCW	Notes

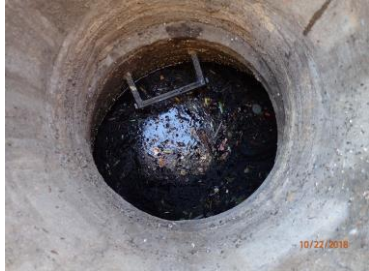
o20181022101258.JPG

Inspection Date: 10/22/2018 10:15:43 AM		Type: Ongoing	Flow: Submerged, indeterminate	Previous Rainfall (hrs): 48-72
Illicit Discharge Potential: Potential		Inspector: JCW	Notes	
Submerged: Fully		Depth (in): 43	Sample collected from submerged pool in manhole. Floating gross solids (litter) in manhole.	
Sampling Results		Floatables: None	Condition Assessment	
Sample Location: Pool		Odor: None	Graffiti: None	
Total Chlorine: 0 ppm		Turbidity: None	Erosion: None	
Free Chlorine: 0 ppm		Color: None	Deposition: None in.	
Ammonia: 0 ppm		Gross Solids: Slight	Damage: None	
pH: 7.17 units		Vegetation: None		
Temperature 60 °F		Benthic Growth: None		
Conductivity: 506 µS/cm		Stains: None		
Detergents: 0 mg/L		Non-illicit: None

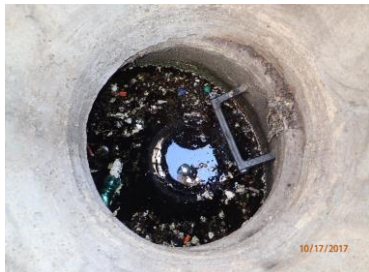
o20171017133104.JPG

Inspection Date: 10/17/2017 1:35:20 PM		Type: Ongoing	Flow: Submerged, indeterminate	Previous Rainfall (hrs): 48-72
Illicit Discharge Potential: Potential		Inspector: JCW	Notes	
Submerged: Fully		Depth (in): 39	Sample collected from submerged pool in manhole. Floating gross solids (litter) in manhole.	
Sampling Results		Floatables: None	Condition Assessment	
Sample Location: Pool		Odor: None	Graffiti: None	
Total Chlorine: 0 ppm		Turbidity: None	Erosion: None	
Free Chlorine: 0 ppm		Color: None	Deposition: None in.	
Ammonia: 0 ppm		Gross Solids: Moderate	Damage: None	
pH: 7.57 units		Vegetation: None		
Temperature 67 °F		Benthic Growth: None		
Conductivity: 537 µS/cm		Stains: None		
Detergents: 0 mg/L		Non-illicit: None

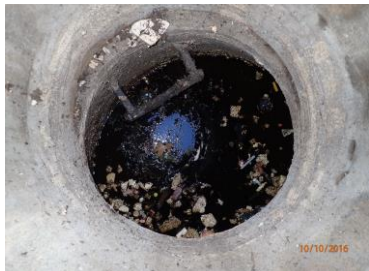
o20161010105436.JPG

Inspection Date: 10/10/2016 10:57:04 AM		Type: Ongoing	Flow: Submerged, indeterminate	Previous Rainfall (hrs): 72+
Illicit Discharge Potential: Potential		Inspector: JCW	Notes	
Submerged: Fully		Depth (in): 37	Potential illicit discharge due to gross solids.	
Sampling Results		Floatables: None	Condition Assessment	
Sample Location: Pool		Odor: None	Graffiti: None	
Total Chlorine: 0 ppm		Turbidity: None	Erosion: None	
Free Chlorine: 0 ppm		Color: None	Deposition: None in.	
Ammonia: 0 ppm		Gross Solids: Moderate	Damage: None	
pH: 7.54 units		Vegetation: None		
Temperature 65 °F		Benthic Growth: None		
Conductivity: 654 µS/cm		Stains: None		
Detergents: 0 mg/L		Non-illicit: None

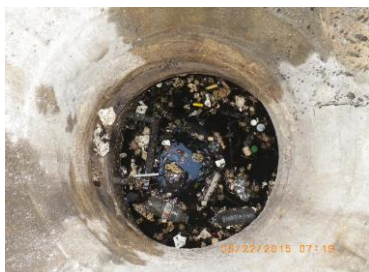
o20150922061944.JPG

Inspection Date: 9/22/2015 7:15:12 AM		Type: Ongoing	Flow: Submerged, indeterminate	Previous Rainfall (hrs): 72+
Illicit Discharge Potential: Potential		Inspector: JCW	Notes	
Submerged: Fully		Depth (in): 39	Floating gross solids (litter) in manhole.	
Sampling Results		Floatables: None	Condition Assessment	
Sample Location: Pool		Odor: None	Graffiti: None	
Total Chlorine: 0 ppm		Turbidity: None	Erosion: None	
Free Chlorine: 0 ppm		Color: None	Deposition: None in.	
Ammonia: 0 ppm		Gross Solids: Moderate	Damage: None	
pH: 7.84 units		Vegetation: None		
Temperature 65 °F		Benthic Growth: None		
Conductivity: 459 µS/cm		Stains: None		
Detergents: 0 mg/L		Non-illicit: None

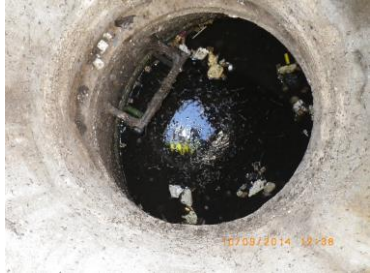
o20141009113842.JPG

Inspection Date: 10/9/2014 12:40:37 PM		Type: Ongoing	Flow: Submerged, indeterminate	Previous Rainfall (hrs): 72+
Illicit Discharge Potential: Potential		Inspector: JCW	Notes	
Submerged: Fully		Depth (in): 35	Floating gross solids (litter) in manhole.	
Sampling Results		Condition Assessment		
Sample Location: Pool	Floatables: None	Graffiti: None	Erosion: None	in.
Total Chlorine: 0 ppm	Odor: None	Deposition: None	Damage: None	
Free Chlorine: 0 ppm	Turbidity: None			
Ammonia: 0 ppm	Color: None			
pH: 7.58 units	Gross Solids: Moderate			
Temperature 62 °F	Vegetation: None			
Conductivity: 707 µS/cm	Benthic Growth: None			
Detergents: 0 mg/L	Stains: None			
	Non-illicit: None

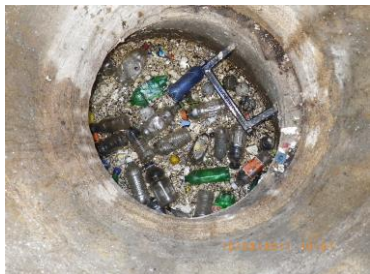
o20111003103104.JPG

Inspection Date: 10/3/2011 10:30:08 AM		Type: Ongoing	Flow: Submerged, indeterminate	Previous Rainfall (hrs): 72+
Illicit Discharge Potential: Potential		Inspector: JCW	Notes	
Submerged: Fully		Depth (in): 39	Significant floatable debris in manhole.	
Sampling Results		Condition Assessment		
Sample Location: Pool	Floatables: None	Graffiti: None	Erosion: None	0 in.
Total Chlorine: 0 ppm	Odor: None	Deposition: None	Damage: None	
Free Chlorine: 0 ppm	Turbidity: None			
Ammonia: 0 ppm	Color: None			
pH: 7.1 units	Gross Solids: Severe			
Temperature 61 °F	Vegetation: None			
Conductivity: -- µS/cm	Benthic Growth: None			
Detergents: 0 mg/L	Stains: None			
	Non-illicit: None

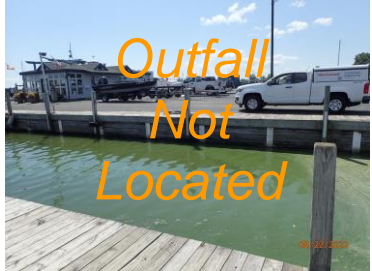
o20220822115730.JPG <div style="text-align: center; font-size: 24pt; font-weight: bold;">2022</div>
		Condition Assessment Graffiti: None Erosion: None Deposition: None in. Damage: None

Inspection Date: 8/22/2022 12:04:00 PM		Type: Ongoing	Flow: Submerged (not located)	Previous Rainfall (hrs): 72+
Illicit Discharge Potential: Potential		Inspector: EJK		
Submerged: Fully		Depth (in):		
Sampling Results Sample Location: _____ Total Chlorine: -- ppm Free Chlorine: -- ppm Ammonia: -- ppm pH: -- units Temperature: -- °F Conductivity: -- µS/cm Detergents: -- mg/L		Floatables: None Odor: None Turbidity: None Color: None Gross Solids: None Vegetation: None Benthic Growth: None Stains: None Non-illicit: None	Notes Outfall fully submerged and not located - screened upstream at 03-119 US1. Detergent in upstream manhole.

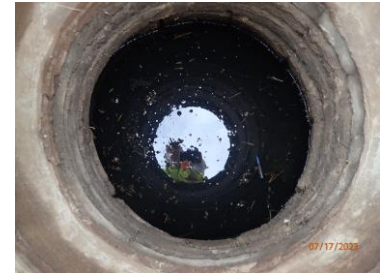
o20230717132712.JPG

☐ Petrol. Sheen ☐ Suds ☐ Sewage ☐ Algae ☐ Other☐ Petroleum ☐ Musty ☐ Sewage ☐ Chlorine ☐ Other☐ VOC/Solvent ☐ Fishy ☐ Sulfur ☐ Fragrant☒ Litter ☒ Veg. Debris ☐ Sediment ☐ Other☐ Inhibited ☐ Excessive☐ Green ☐ Brown☐ Flow Line ☐ Oil ☐ Rust Stains☐ Paint ☐ Other☐ Natural Sheen ☐ Natural Suds/Foam

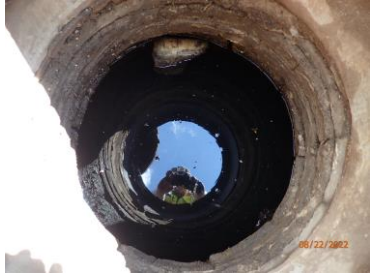
<p style="text-align: center;">o20220822120016.JPG</p> <p style="text-align: center; font-size: 24pt; font-weight: bold;">2022</p>

Sample Location:	Pool																																					
Total Chlorine:	0 ppm																																					
Free Chlorine:	0 ppm																																					
Ammonia:	0 ppm																																					
pH:	6.89 units																																					
Temperature:	75 °F																																					
Conductivity:	312 µS/cm																																					
Detergents:	0.2 mg/L																																					
Floatables:	None																																					
Odor:	None																																					
Turbidity:	None																																					
Color:	None																																					
Gross Solids:	Slight																																					
Vegetation:	None																																					
Benthic Growth:	None																																					
Stains:	None																																					
Non-illicit:	None

<div style="display: flex;"> <div style="flex: 1;"> <p>Notes</p> <p>Sample collected from submerged pool in manhole. Detergent detected in sample.</p> </div> <div style="flex: 1;"> <p>Condition Assessment</p> <table border="1" style="width:100%; border-collapse: collapse;"> <tr><td>Graffiti:</td><td>None</td></tr> <tr><td>Erosion:</td><td>None</td></tr> <tr><td>Deposition:</td><td>None in.</td></tr> <tr><td>Damage:</td><td>None</td></tr> </table> </div> </div>			Graffiti:	None	Erosion:	None	Deposition:	None in.	Damage:	None																										
Graffiti:	None																																					
Erosion:	None																																					
Deposition:	None in.																																					
Damage:	None

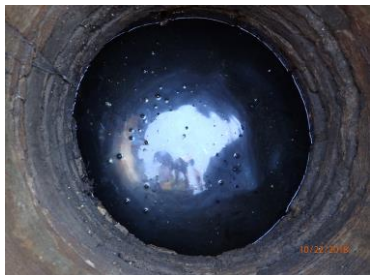
Due to the lack of any incoming flow, it was assumed that the pooled water in the pipe was backed up from the receiving water at the outfall. No additional tracking was able to be conducted.

Outfall 14-996 discharges to a stream inside the Oshkosh Truck test track on the southeast side of Hughes Street. It is surrounded by a security fence and inaccessible. There were several vehicles on the track during the screening.

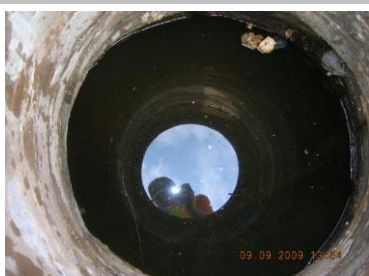
Water of the State

Major Outfall

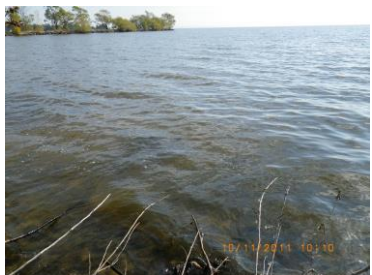
Inspection Date: 10/11/2011 2:19:37 PM		Type: Ongoing	Flow: Submerged, indeterminate	Previous Rainfall (hrs): 72+
Illicit Discharge Potential: Potential		Inspector: JCW		
Submerged: Fully		Depth (in):		
Sampling Results		Notes		
Sample Location:	Floatables:	None		
Total Chlorine: -- ppm	Odor:	None		
Free Chlorine: -- ppm	Turbidity:	None		
Ammonia: -- ppm	Color:	None		
pH: -- units	Gross Solids:	None		
Temperature -- °F	Vegetation:	None		
Conductivity: -- µS/cm	Benthic Growth:	None		
Detergents: -- mg/L	Stains:	None		
	Non-illicit:	None		
		Condition Assessment		
		Graffiti:	None	
		Erosion:	None	
		Deposition:	None	0 in.
		Damage:	None

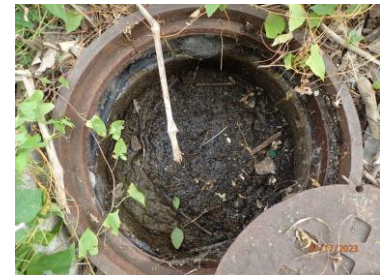
Notes: Sample collected from submerged pool in manhole. Floating gross solids (litter) in manhole.

Depth (in): 65

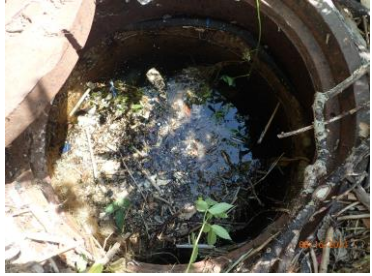
Sample ID: 230717-11

Sampling Results

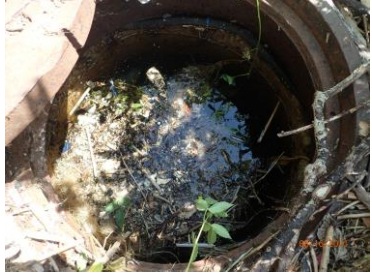
pH (field): 8.79 units

Time Collected: 09:38

Free Chlorine (field): 0 ppm

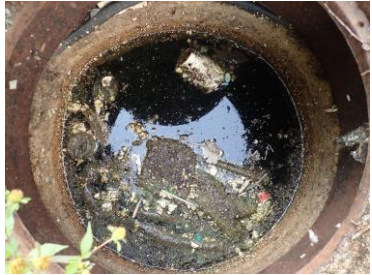
o20200924090226.JPG <div style="text-align: center; font-size: 24pt; font-weight: bold;">2020</div>

<div style="display: flex;"> <div style="flex: 1;"> <p>Notes</p> <p>Sample collected from submerged pool in manhole. Floating gross solids (litter) in manhole.</p> </div> <div style="flex: 1;"> <p>Condition Assessment</p> <table border="1" style="width:100%; border-collapse: collapse;"> <tr><td>Graffiti:</td><td>None</td></tr> <tr><td>Erosion:</td><td>None</td></tr> <tr><td>Deposition:</td><td>None in.</td></tr> <tr><td>Damage:</td><td>None</td></tr> </table> </div> </div>			Graffiti:	None	Erosion:	None	Deposition:	None in.	Damage:	None																										
Graffiti:	None																																					
Erosion:	None																																					
Deposition:	None in.																																					
Damage:	None

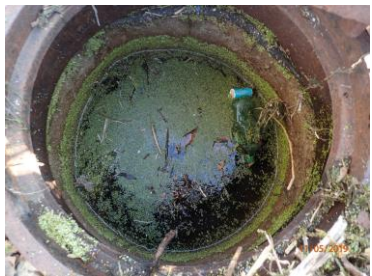
o20191105131426.JPG <div style="text-align: center; font-size: 24pt; font-weight: bold;">2019</div>

Inspection Date: 11/5/2019 1:15:28 PM		Type: Repeat	Flow: Submerged, indeterminate	Previous Rainfall (hrs): 48-72																																		
Illicit Discharge Potential: Potential		Inspector: JCW																																				
Submerged: Partially		Depth (in): 32																																				
Sampling Results		<div style="display: flex;"> <div style="flex: 1;"> <table border="1" style="width:100%; border-collapse: collapse;"> <tr><td>Sample Location:</td><td>Pool</td></tr> <tr><td>Total Chlorine:</td><td>-- ppm</td></tr> <tr><td>Free Chlorine:</td><td>-- ppm</td></tr> <tr><td>Ammonia:</td><td>-- ppm</td></tr> <tr><td>pH:</td><td>-- units</td></tr> <tr><td>Temperature:</td><td>-- °F</td></tr> <tr><td>Conductivity:</td><td>-- µS/cm</td></tr> <tr><td>Detergents:</td><td>0 mg/L</td></tr> </table> </div> <div style="flex: 1;"> <table border="1" style="width:100%; border-collapse: collapse;"> <tr><td>Floatables:</td><td>None</td></tr> <tr><td>Odor:</td><td>None</td></tr> <tr><td>Turbidity:</td><td>None</td></tr> <tr><td>Color:</td><td>None</td></tr> <tr><td>Gross Solids:</td><td>None</td></tr> <tr><td>Vegetation:</td><td>None</td></tr> <tr><td>Benthic Growth:</td><td>None</td></tr> <tr><td>Stains:</td><td>None</td></tr> <tr><td>Non-illicit:</td><td>None</td></tr> </table> </div> </div>			Sample Location:	Pool	Total Chlorine:	-- ppm	Free Chlorine:	-- ppm	Ammonia:	-- ppm	pH:	-- units	Temperature:	-- °F	Conductivity:	-- µS/cm	Detergents:	0 mg/L	Floatables:	None	Odor:	None	Turbidity:	None	Color:	None	Gross Solids:	None	Vegetation:	None	Benthic Growth:	None	Stains:	None	Non-illicit:	None

<div style="display: flex;"> <div style="flex: 1;"> <p>Notes</p> <p>Detergent detection follow-up. Limited screening conducted.</p> </div> <div style="flex: 1;"> <p>Condition Assessment</p> <table border="1" style="width:100%; border-collapse: collapse;"> <tr><td>Graffiti:</td><td>None</td></tr> <tr><td>Erosion:</td><td>None</td></tr> <tr><td>Deposition:</td><td>None in.</td></tr> <tr><td>Damage:</td><td>None</td></tr> </table> </div> </div>			Graffiti:	None	Erosion:	None	Deposition:	None in.	Damage:	None																										
Graffiti:	None																																					
Erosion:	None																																					
Deposition:	None in.																																					
Damage:	None

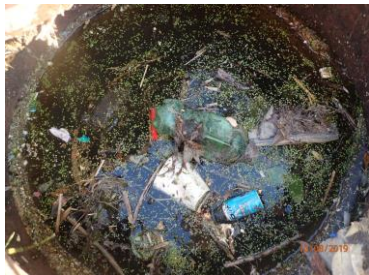
o20191008070022.JPG

Inspection Date: 10/8/2019 8:01:54 AM		Type: Ongoing	Flow: Submerged, indeterminate	Previous Rainfall (hrs): 48-72
Illicit Discharge Potential: Potential		Inspector: JCW	Notes	
Submerged: Partially Depth (in): 38			Manhole 03-173 US2 inaccessible (behind locked gate). Floating gross solids (litter) in manhole. Detergent detected.	
Sampling Results		Floatables: Moderate	Condition Assessment	
Sample Location: Pool		Odor: None	Graffiti: None	
Total Chlorine: 0 ppm		Turbidity: None	Erosion: None	
Free Chlorine: 0 ppm		Color: None	Deposition: Minor 4 in.	
Ammonia: 0 ppm		Gross Solids: Moderate	Damage: None	
pH: 7.64 units		Vegetation: None		
Temperature 53 °F		Benthic Growth: Slight		
Conductivity: 592 µS/cm		Stains: None		
Detergents: 1 mg/L		Non-illicit: None

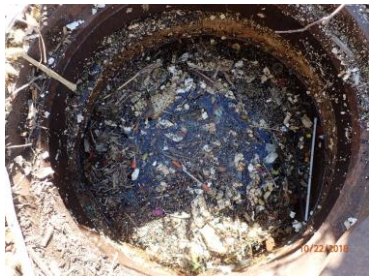
o20181022132154.JPG

Inspection Date: 10/22/2018 1:24:38 PM		Type: Ongoing	Flow: Submerged, indeterminate	Previous Rainfall (hrs): 48-72
Illicit Discharge Potential: Potential		Inspector: JCW	Notes	
Submerged: Fully Depth (in): 40			Manhole 03-173 US2 inaccessible (behind locked gate). Floating gross solids (litter) in manhole, including 2 syringes.	
Sampling Results		Floatables: None	Condition Assessment	
Sample Location: Pool		Odor: None	Graffiti: None	
Total Chlorine: 0 ppm		Turbidity: None	Erosion: None	
Free Chlorine: 0 ppm		Color: None	Deposition: None in.	
Ammonia: 0 ppm		Gross Solids: Moderate	Damage: None	
pH: 7.18 units		Vegetation: None		
Temperature 59 °F		Benthic Growth: None		
Conductivity: 1229 µS/cm		Stains: None		
Detergents: 0 mg/L		Non-illicit: None

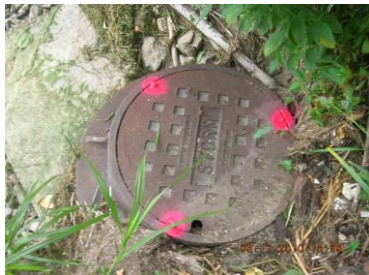
o20100817135854.JPG

Inspection Date: 8/17/2010 2:07:11 PM		Type: Ongoing	Flow: Submerged, indeterminate	Previous Rainfall (hrs): 72+
Illicit Discharge Potential: Potential		Inspector: JCW	Notes	
Submerged: Fully Depth (in):			Lid bolts rusted tight - could not access. Screened upstream at 03-173 US2.	
Sampling Results		Floatables: None	Condition Assessment	
Sample Location:		Odor: None	Graffiti: None	
Total Chlorine: -- ppm		Turbidity: None	Erosion: None	
Free Chlorine: -- ppm		Color: None	Deposition: None 0 in.	
Ammonia: -- ppm		Gross Solids: None	Damage: Moderate	
pH: -- units		Vegetation: None		
Temperature -- °F		Benthic Growth: None		
Conductivity: -- µS/cm		Stains: None		
Detergents: -- mg/L		Non-illicit: None

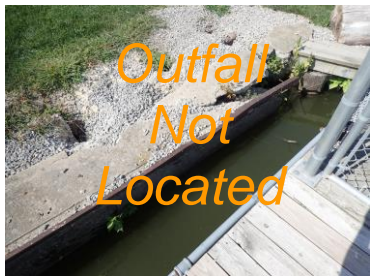
o20220824102800.JPG 2022

Inspection Date: 8/24/2022 10:30:00 AM		Type: Ongoing	Flow: Submerged (not located)	Previous Rainfall (hrs): 72+
Illicit Discharge Potential: Potential		Inspector: EJK	Notes	
Submerged: Fully		Depth (in):	Outfall fully submerged and not located - screened upstream at 03-22 US1. Floating gross solids (litter) in upstream manhole.	
Sampling Results Sample Location: _____ Total Chlorine: -- ppm Free Chlorine: -- ppm Ammonia: -- ppm pH: -- units Temperature -- ° F Conductivity: -- µS/cm Detergents: -- mg/L		Floatables: None Odor: None Turbidity: None Color: None Gross Solids: None Vegetation: None Benthic Growth: None Stains: None Non-illicit: None	Condition Assessment Graffiti: None Erosion: None Deposition: None in. Damage: None

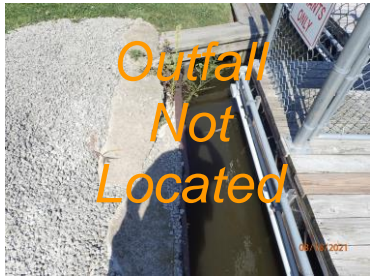
o20210816103158.JPG 2021

Inspection Date: 8/16/2021 10:33:32 AM		Type: Ongoing	Flow: Submerged (not located)	Previous Rainfall (hrs): 72+
Illicit Discharge Potential: Potential		Inspector: JCW	Notes	
Submerged: Fully		Depth (in):	Outfall partially submerged - screened upstream at 03-22 US1. Floating gross solids (litter) in upstream manhole.	
Sampling Results Sample Location: _____ Total Chlorine: -- ppm Free Chlorine: -- ppm Ammonia: -- ppm pH: -- units Temperature -- ° F Conductivity: -- µS/cm Detergents: -- mg/L		Floatables: None Odor: None Turbidity: None Color: None Gross Solids: None Vegetation: None Benthic Growth: None Stains: None Non-illicit: None	Condition Assessment Graffiti: None Erosion: None Deposition: None in. Damage: None

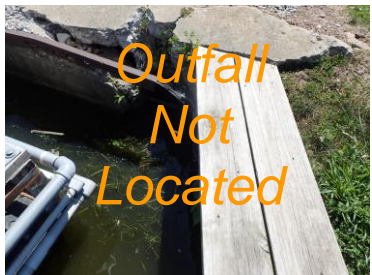
o20200819140018.JPG 2020

Inspection Date: 8/19/2020 2:03:43 PM		Type: Ongoing	Flow: Submerged (not located)	Previous Rainfall (hrs): 72+
Illicit Discharge Potential: Potential		Inspector: JCW	Notes	
Submerged: Fully		Depth (in):	Outfall fully submerged and not located - screened upstream at 03-22 US1. Floating gross solids (litter) in upstream manhole.	
Sampling Results Sample Location: _____ Total Chlorine: -- ppm Free Chlorine: -- ppm Ammonia: -- ppm pH: -- units Temperature -- ° F Conductivity: -- µS/cm Detergents: -- mg/L		Floatables: None Odor: None Turbidity: None Color: None Gross Solids: None Vegetation: None Benthic Growth: None Stains: None Non-illicit: None	Condition Assessment Graffiti: None Erosion: None Deposition: None in. Damage: None

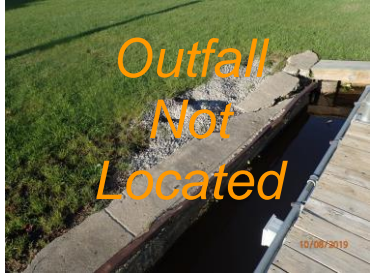
o20191008073428.jpg

Inspection Date: 10/8/2019 8:34:00 AM		Type: Repeat	Flow: Submerged (not located)	Previous Rainfall (hrs): 48-72
Illicit Discharge Potential: Potential		Inspector: JCW	Notes	
Submerged: Fully		Depth (in):	Outfall fully submerged and not located - screened upstream at 03-22 US1. Follow-up inspection for sampling - limited screening conducted.	
Sampling Results		Floatables:	Condition Assessment Graffiti: None Erosion: None Deposition: None in. Damage: None	
Sample Location:		Odor:		
Total Chlorine: -- ppm	Turbidity:			
Free Chlorine: -- ppm	Color:			
Ammonia: -- ppm	Gross Solids:			
pH: -- units	Vegetation:			
Temperature -- °F	Benthic Growth:			
Conductivity: -- µS/cm	Stains:			
Detergents: -- mg/L	Non-illicit:

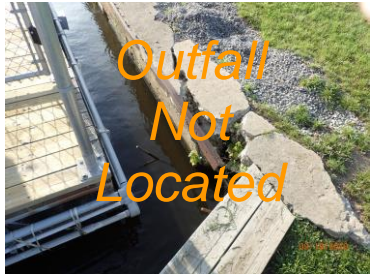
o20190918071544.JPG

Inspection Date: 9/18/2019 8:16:51 AM		Type: Ongoing	Flow: Submerged (not located)	Previous Rainfall (hrs): 72+
Illicit Discharge Potential: Potential		Inspector: JCW	Notes	
Submerged: Fully		Depth (in):	Outfall fully submerged and not located - screened upstream at 03-22 US1. Floating gross solids (litter) and detergent in manhole.	
Sampling Results		Floatables:	Condition Assessment Graffiti: None Erosion: None Deposition: None in. Damage: None	
Sample Location:		Odor:		
Total Chlorine: -- ppm	Turbidity:			
Free Chlorine: -- ppm	Color:			
Ammonia: -- ppm	Gross Solids:			
pH: -- units	Vegetation:			
Temperature -- °F	Benthic Growth:			
Conductivity: -- µS/cm	Stains:			
Detergents: -- mg/L	Non-illicit:

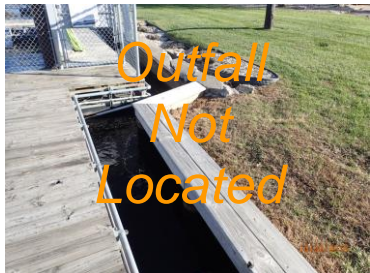
o20181022155222.JPG

Inspection Date: 10/22/2018 3:53:56 PM		Type: Ongoing	Flow: Submerged (not located)	Previous Rainfall (hrs): 48-72
Illicit Discharge Potential: Potential		Inspector: JCW	Notes	
Submerged: Fully		Depth (in):	Outfall fully submerged and not located - screened upstream at 03-22 US1. Floating gross solids (litter) in manhole.	
Sampling Results		Floatables:	Condition Assessment Graffiti: None Erosion: None Deposition: None in. Damage: None	
Sample Location:		Odor:		
Total Chlorine: -- ppm	Turbidity:			
Free Chlorine: -- ppm	Color:			
Ammonia: -- ppm	Gross Solids:			
pH: -- units	Vegetation:			
Temperature -- °F	Benthic Growth:			
Conductivity: -- µS/cm	Stains:			
Detergents: -- mg/L	Non-illicit:

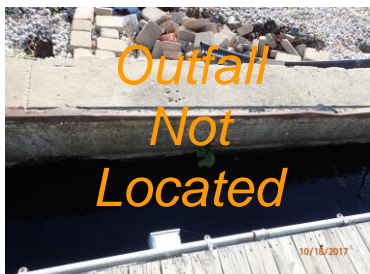
o20171018151946.JPG

Inspection Date: 10/18/2017 3:22:08 PM		Type: Ongoing	Flow: Submerged (not located)	Previous Rainfall (hrs): 72+
Illicit Discharge Potential: Potential		Inspector: JCW	Notes	
Submerged: Fully		Depth (in):	Outfall fully submerged and not located - screened upstream at 03-22 US1. Floating gross solids (litter) in manhole.	
Sampling Results		Floatables:	Condition Assessment Graffiti: None Erosion: None Deposition: None in. Damage: None	
Sample Location:		Odor:		
Total Chlorine: -- ppm	Turbidity:			
Free Chlorine: -- ppm	Color:			
Ammonia: -- ppm	Gross Solids:			
pH: -- units	Vegetation:			
Temperature -- °F	Benthic Growth:			
Conductivity: -- µS/cm	Stains:			
Detergents: -- mg/L	Non-illicit:
