IDDE Ongoing Screening Summary Report

2023 Inspection Year

Westwood

City of Oshkosh

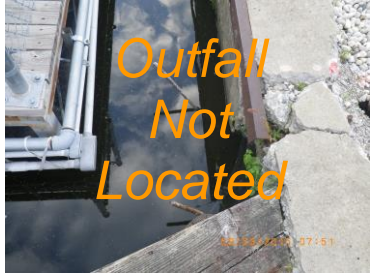
Sample Location:	Floatables:		None	Total Chlorine: -- ppm	Odor:	None	Free Chlorine: -- ppm	Turbidity:	None	Ammonia: -- ppm	Color:	None	pH: -- units	Gross Solids:	None	Temperature -- °F	Vegetation:	None	Conductivity: -- µS/cm	Benthic Growth:	None	Detergents: -- mg/L	Stains:	None		Non-illicit:	None	Notes Significant sinking above suspected pipe. Outfall not located - screened at 03-22 US1.
Sample Location:	Floatables:	None																												
Total Chlorine: -- ppm	Odor:	None																												
Free Chlorine: -- ppm	Turbidity:	None																												
Ammonia: -- ppm	Color:	None																												
pH: -- units	Gross Solids:	None																												
Temperature -- °F	Vegetation:	None																												
Conductivity: -- µS/cm	Benthic Growth:	None																												
Detergents: -- mg/L	Stains:	None																												
	Non-illicit:	None																												
		Condition Assessment Graffiti: None Erosion: None Deposition: None in. Damage: Severe

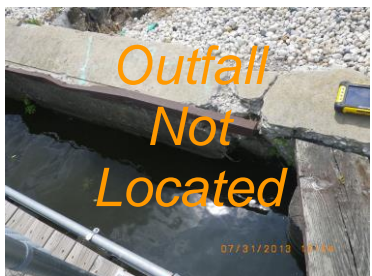
Sample Location:	Floatables:		None	Total Chlorine: -- ppm	Odor:	None	Free Chlorine: -- ppm	Turbidity:	None	Ammonia: -- ppm	Color:	None	pH: -- units	Gross Solids:	None	Temperature -- °F	Vegetation:	None	Conductivity: -- µS/cm	Benthic Growth:	None	Detergents: -- mg/L	Stains:	None		Non-illicit:	None	Notes 2012 screening follow-up. Outfall not located. Outfall screened upstream at 03-22 US1. Gross solids in upstream mh.
Sample Location:	Floatables:	None																												
Total Chlorine: -- ppm	Odor:	None																												
Free Chlorine: -- ppm	Turbidity:	None																												
Ammonia: -- ppm	Color:	None																												
pH: -- units	Gross Solids:	None																												
Temperature -- °F	Vegetation:	None																												
Conductivity: -- µS/cm	Benthic Growth:	None																												
Detergents: -- mg/L	Stains:	None																												
	Non-illicit:	None																												
		Condition Assessment Graffiti: None Erosion: None Deposition: None in. Damage: None

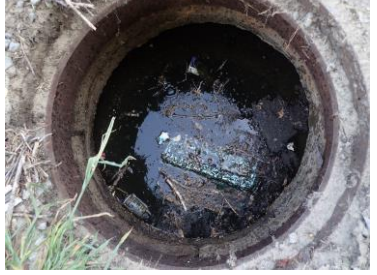
o20220824102900.JPG 2022
Sampling Results Sample Location: Pool Total Chlorine: 0 ppm Free Chlorine: 0 ppm Ammonia: 0 ppm pH: 8.54 units Temperature: 77 °F Conductivity: 395 µS/cm Detergents: 0 mg/L		Floatables: None Odor: None Turbidity: None Color: None Gross Solids: Moderate Vegetation: None Benthic Growth: None Stains: None Non-illicit: None	Sample collected from submerged pool in manhole. Floating gross solids (litter) in manhole. Condition Assessment Graffiti: None Erosion: None Deposition: None in. Damage: None	
Inspection Date: 8/16/2021 10:36:24 AM		Type: Ongoing	Flow: Submerged, indeterminate	Previous Rainfall (hrs): 72+
Illicit Discharge Potential: Potential Submerged: Fully Depth (in): 49		Inspector: JCW	Notes

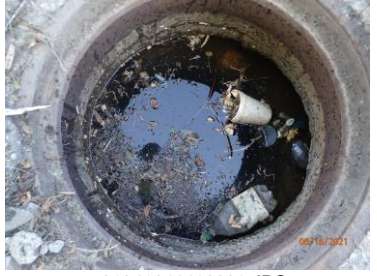
o20210816103330.JPG 2021

Sampling Results Sample Location: Pool Total Chlorine: 0 ppm Free Chlorine: 0 ppm Ammonia: 0 ppm pH: 7.74 units Temperature: 76 °F Conductivity: 322 µS/cm Detergents: 0 mg/L		Floatables: None Odor: Faint Turbidity: None Color: None Gross Solids: Moderate Vegetation: None Benthic Growth: None Stains: None Non-illicit: None	Sample collected from submerged pool in manhole. Floating gross solids (litter) in manhole. Condition Assessment Graffiti: None Erosion: None Deposition: None in. Damage: None	
Inspection Date: 8/19/2020 2:04:58 PM		Type: Ongoing	Flow: Submerged, indeterminate	Previous Rainfall (hrs): 72+
Illicit Discharge Potential: Potential Submerged: Fully Depth (in): 47		Inspector: JCW	Notes

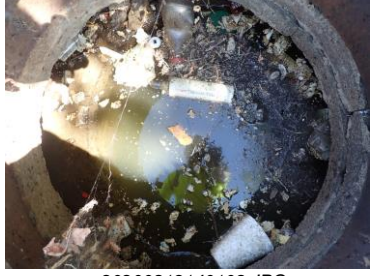
o20200819140108.JPG 2020
Sampling Results Sample Location: Pool Total Chlorine: 0 ppm Free Chlorine: 0 ppm Ammonia: 0 ppm pH: 9.13 units Temperature: 84 °F Conductivity: 338 µS/cm Detergents: 0 mg/L		Floatables: None Odor: None Turbidity: None Color: None Gross Solids: Severe Vegetation: None Benthic Growth: None Stains: None Non-illicit: None	Sample collected from submerged pool in manhole. Floating gross solids (litter) in manhole. Elevated pH seemed widespread in river. Condition Assessment Graffiti: None Erosion: None Deposition: None in. Damage: None

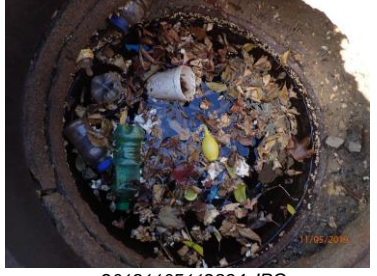
o20191105112834.JPG 2019
Sampling Results Sample Location: Pool Total Chlorine: -- ppm Free Chlorine: -- ppm Ammonia: -- ppm pH: -- units Temperature: -- °F Conductivity: -- µS/cm Detergents: 0 mg/L		Floatables: None Odor: None Turbidity: None Color: None Gross Solids: Severe Vegetation: None Benthic Growth: None Stains: None Non-illicit: None	Follow-up inspection for sampling - limited screening conducted. Floating gross solids (litter) in manhole. Condition Assessment Graffiti: None Erosion: None Deposition: None in. Damage: None

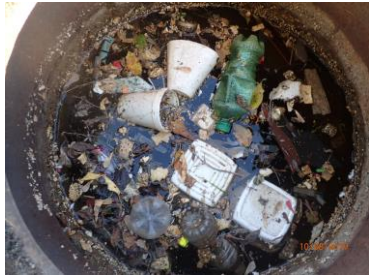
o20191008073520.jpg <div style="font-size: 24pt; font-weight: bold;">2019</div>

Inspection Date: 10/8/2019 8:35:00 AM		Type: Repeat	Flow: Submerged, indeterminate	Previous Rainfall (hrs): 48-72
Illicit Discharge Potential: Potential		Inspector: JCW		Notes Follow-up inspection for sampling - limited screening conducted. Floating gross solids (litter) in manhole.
Submerged: Partially Depth (in): 47				
Sampling Results Sample Location: Pool Total Chlorine: 0 ppm Free Chlorine: 0 ppm Ammonia: 0 ppm pH: 7.58 units Temperature: 56 °F Conductivity: 381 µS/cm Detergents: 1.2 mg/L		Floatables: None Odor: None Turbidity: None Color: None Gross Solids: Severe Vegetation: None Benthic Growth: None Stains: None Non-illicit: None	Condition Assessment Graffiti: None Erosion: None Deposition: None in. Damage: None

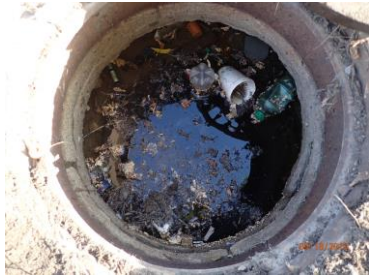
o20190918071726.JPG <div style="font-size: 24pt; font-weight: bold;">2019</div>

Inspection Date: 9/18/2019 8:19:32 AM		Type: Ongoing	Flow: Submerged, indeterminate	Previous Rainfall (hrs): 72+
Illicit Discharge Potential: Potential		Inspector: JCW		Notes Sample collected from submerged pool in manhole. Floating gross solids (litter) and detergent in manhole.
Submerged: Fully Depth (in): 49				
Sampling Results Sample Location: Pool Total Chlorine: 0 ppm Free Chlorine: 0 ppm Ammonia: 0 ppm pH: 8.64 units Temperature: 71 °F Conductivity: 372 µS/cm Detergents: 1 mg/L		Floatables: None Odor: None Turbidity: None Color: None Gross Solids: Moderate Vegetation: None Benthic Growth: None Stains: None Non-illicit: None	Condition Assessment Graffiti: None Erosion: None Deposition: None in. Damage: None

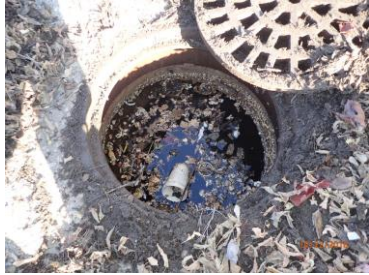
o20181022155408.JPG <div style="font-size: 24pt; font-weight: bold;">2018</div>

Inspection Date: 10/22/2018 3:58:28 PM		Type: Ongoing	Flow: Submerged, indeterminate	Previous Rainfall (hrs): 48-72
Illicit Discharge Potential: Potential		Inspector: JCW		Notes Sample collected from submerged pool in manhole. Floating gross solids (litter) in manhole.
Submerged: Fully Depth (in): 49				
Sampling Results Sample Location: Pool Total Chlorine: 0 ppm Free Chlorine: 0 ppm Ammonia: 0 ppm pH: 7.68 units Temperature: 55 °F Conductivity: 355 µS/cm Detergents: 0 mg/L		Floatables: None Odor: None Turbidity: None Color: None Gross Solids: Moderate Vegetation: None Benthic Growth: None Stains: None Non-illicit: None	Condition Assessment Graffiti: None Erosion: None Deposition: None in. Damage: None

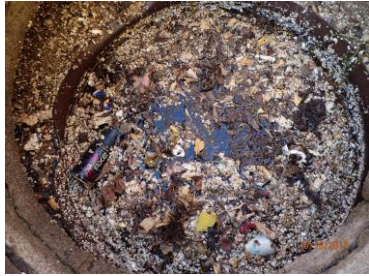
o20171018152158.JPG <div style="font-size: 24pt; font-weight: bold;">2017</div>

Inspection Date: 10/18/2017 3:25:56 PM		Type: Ongoing	Flow: Submerged, indeterminate	Previous Rainfall (hrs): 72+
Illicit Discharge Potential: Potential		Inspector: JCW		Notes Sample collected from submerged pool in manhole. Floating gross solids (litter) in manhole.
Submerged: Fully Depth (in): 44				
Sampling Results Sample Location: Pool Total Chlorine: 0 ppm Free Chlorine: 0 ppm Ammonia: 0 ppm pH: 8.32 units Temperature: 66 °F Conductivity: 422 µS/cm Detergents: 0 mg/L		Floatables: None Odor: None Turbidity: None Color: None Gross Solids: Moderate Vegetation: None Benthic Growth: None Stains: None Non-illicit: None	Condition Assessment Graffiti: None Erosion: None Deposition: None in. Damage: None

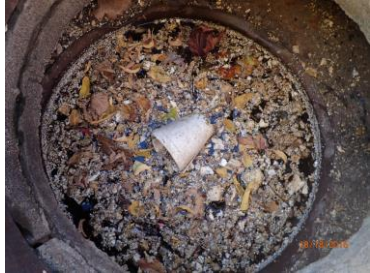
o20161018160430.JPG

Inspection Date: 10/18/2016 4:06:54 PM		Type: Ongoing	Flow: Submerged, indeterminate	Previous Rainfall (hrs): 72+
Illicit Discharge Potential: Potential		Inspector: JCW	Notes	
Submerged: Fully		Depth (in): 44	Potential illicit discharge due to gross solids.	
Sampling Results		Floatables: None	Condition Assessment Graffiti: None Erosion: None Deposition: None in. Damage: None	
Sample Location: Pool	Odor: None			
Total Chlorine: 0 ppm	Turbidity: None			
Free Chlorine: 0 ppm	Color: Faint in bottle			
Ammonia: 0 ppm	Gross Solids: Severe			
pH: 8.15 units	Vegetation: None			
Temperature 66 °F	Benthic Growth: None			
Conductivity: 403 µS/cm	Stains: None			
Detergents: 0 mg/L	Non-illicit: None

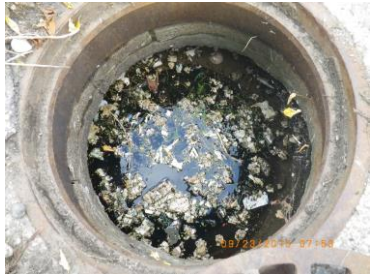
o20150923065324.JPG

Inspection Date: 9/23/2015 7:51:33 AM		Type: Ongoing	Flow: Submerged, indeterminate	Previous Rainfall (hrs): 72+
Illicit Discharge Potential: Potential		Inspector: JCW	Notes	
Submerged: Fully		Depth (in): 46	Floating gross solids (litter) in manhole.	
Sampling Results		Floatables: None	Condition Assessment Graffiti: None Erosion: None Deposition: None in. Damage: None	
Sample Location: Pool	Odor: None			
Total Chlorine: 0 ppm	Turbidity: None			
Free Chlorine: 0 ppm	Color: None			
Ammonia: 0 ppm	Gross Solids: Moderate			
pH: 8.44 units	Vegetation: None			
Temperature 70 °F	Benthic Growth: None			
Conductivity: 354 µS/cm	Stains: None			
Detergents: 0 mg/L	Non-illicit: None

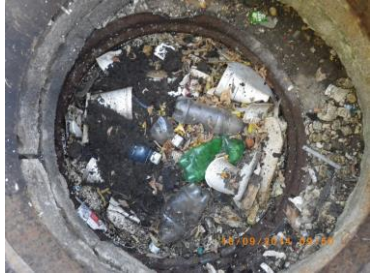
o20141009085040.JPG

Inspection Date: 10/9/2014 9:52:24 AM		Type: Ongoing	Flow: Submerged, indeterminate	Previous Rainfall (hrs): 72+
Illicit Discharge Potential: Potential		Inspector: JCW	Notes	
Submerged: Fully		Depth (in): 40	Floatable litter in catchbasin.	
Sampling Results		Floatables: None	Condition Assessment Graffiti: None Erosion: None Deposition: None in. Damage: None	
Sample Location: Pool	Odor: None			
Total Chlorine: 0 ppm	Turbidity: None			
Free Chlorine: 0 ppm	Color: Faint in bottle			
Ammonia: 0 ppm	Gross Solids: Severe			
pH: 7.79 units	Vegetation: None			
Temperature 57 °F	Benthic Growth: None			
Conductivity: 442 µS/cm	Stains: None			
Detergents: 0 mg/L	Non-illicit: None

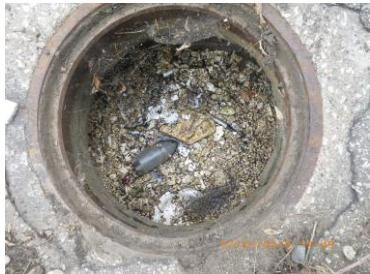
o20130731114610.JPG

Inspection Date: 7/31/2013 12:42:35 PM		Type: Ongoing	Flow: Submerged, indeterminate	Previous Rainfall (hrs): 72+
Illicit Discharge Potential: Potential		Inspector: JCW	Notes	
Submerged: Fully		Depth (in): 44	2012 screening follow-up. Significant gross solids - similar to previous years.	
Sampling Results		Floatables: None	Condition Assessment Graffiti: None Erosion: None Deposition: None in. Damage: None	
Sample Location: Pool	Odor: Faint			
Total Chlorine: 0 ppm	Turbidity: None			
Free Chlorine: 0 ppm	Color: Faint in bottle			
Ammonia: 0 ppm	Gross Solids: Severe			
pH: 7.95 units	Vegetation: None			
Temperature 76 °F	Benthic Growth: None			
Conductivity: 450 µS/cm	Stains: None			
Detergents: 0 mg/L	Non-illicit: None

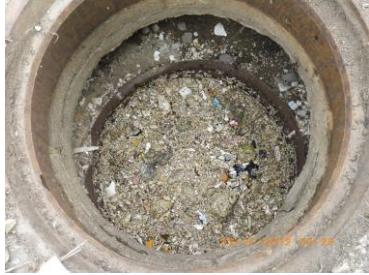
o20120927082922.JPG

Inspection Date: 9/27/2012 9:27:45 AM		Type: Ongoing	Flow: Submerged, indeterminate	Previous Rainfall (hrs): 72+
Illicit Discharge Potential: Potential		Inspector: JCW	Notes	
Submerged: Fully		Depth (in): 39	2011 gross solids follow-up.	
Sampling Results				
Sample Location:	Pool	Floatables:	None	
Total Chlorine:	0 ppm	Odor:	None	
Free Chlorine:	0 ppm	Turbidity:	None	
Ammonia:	0 ppm	Color:	None	
pH:	8.32 units	Gross Solids:	Severe	
Temperature	59 °F	Vegetation:	None	
Conductivity:	398 µS/cm	Benthic Growth:	None	
Detergents:	0 mg/L	Stains:	None	
		Non-illicit:	None	
			Condition Assessment	
			Graffiti:	None
			Erosion:	None
			Deposition:	None in.
			Damage:	None

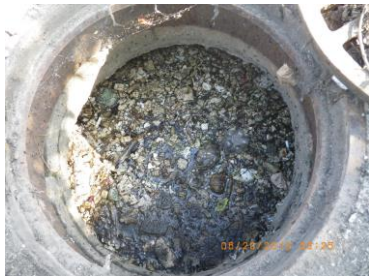
o20120620082508.JPG

Inspection Date: 6/20/2012 9:24:19 AM		Type: Other	Flow: Submerged, indeterminate	Previous Rainfall (hrs): 24-48
Illicit Discharge Potential: Potential		Inspector: JCW	Notes	
Submerged: Fully		Depth (in): 46	Gross solids pre-screening.	
Sampling Results				
Sample Location:		Floatables:	None	
Total Chlorine:	-- ppm	Odor:	None	
Free Chlorine:	-- ppm	Turbidity:	None	
Ammonia:	-- ppm	Color:	None	
pH:	-- units	Gross Solids:	Severe	
Temperature	-- °F	Vegetation:	None	
Conductivity:	-- µS/cm	Benthic Growth:	None	
Detergents:	-- mg/L	Stains:	None	
		Non-illicit:	None	
			Condition Assessment	
			Graffiti:	None
			Erosion:	None
			Deposition:	None in.
			Damage:	None

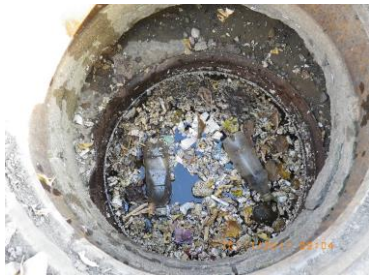
o20111011090446.JPG

Inspection Date: 10/11/2011 9:05:50 AM		Type: Ongoing	Flow: Submerged, indeterminate	Previous Rainfall (hrs): 72+
Illicit Discharge Potential: Potential		Inspector: JCW	Notes	
Submerged: Fully		Depth (in): 37	2010 screening follow-up. No significant change in volume of floatable debris.	
Sampling Results				
Sample Location:	Pool	Floatables:	None	
Total Chlorine:	0 ppm	Odor:	None	
Free Chlorine:	0 ppm	Turbidity:	None	
Ammonia:	0 ppm	Color:	None	
pH:	8.13 units	Gross Solids:	Moderate	
Temperature	70 °F	Vegetation:	None	
Conductivity:	-- µS/cm	Benthic Growth:	None	
Detergents:	-- mg/L	Stains:	None	
		Non-illicit:	None	
			Condition Assessment	
			Graffiti:	None
			Erosion:	None
			Deposition:	None 0 in.
			Damage:	None

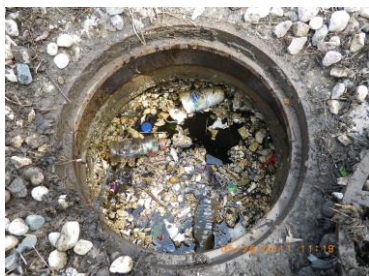
o20110526111930.JPG

Inspection Date: 5/26/2011 11:19:00 AM		Type: Other	Flow: Submerged, indeterminate	Previous Rainfall (hrs): 72+
Illicit Discharge Potential: Potential		Inspector: JCW	Notes	
Submerged: Fully		Depth (in):	Limited screening conducted to check for floatable debris.	
Sampling Results				
Sample Location:		Floatables:	None	
Total Chlorine:	-- ppm	Odor:		
Free Chlorine:	-- ppm	Turbidity:		
Ammonia:	-- ppm	Color:		
pH:	-- units	Gross Solids:	Moderate	
Temperature	-- °F	Vegetation:		
Conductivity:	-- µS/cm	Benthic Growth:		
Detergents:	-- mg/L	Stains:		
		Non-illicit:	None	
			Condition Assessment	
			Graffiti:	None
			Erosion:	None
			Deposition:	None 0 in.
			Damage:	None

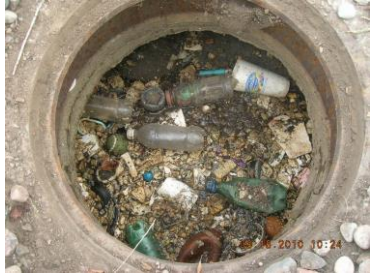
o20100818102410.JPG

Inspection Date: 8/18/2010 10:29:59 AM		Type: Ongoing	Flow: Submerged, indeterminate	Previous Rainfall (hrs): 72+
Illicit Discharge Potential: Potential		Inspector: JCW	Notes	
Submerged: Fully		Depth (in): 44	Severe floatable debris in catchbasin.	
Sampling Results		Condition Assessment		
Sample Location:	Pool	Floatables:	None	
Total Chlorine:	0 ppm	Odor:	None	
Free Chlorine:	0 ppm	Turbidity:	None	
Ammonia:	0 ppm	Color:	Faint in bottle	
pH:	7.38 units	Gross Solids:	Severe	
Temperature	76 °F	Vegetation:	None	
Conductivity:	-- µS/cm	Benthic Growth:	None	
Detergents:	0 mg/L	Stains:	None	
		Non-illicit:	None	
		Graffiti:	None	
		Erosion:	None	
		Deposition:	None 0 in.	
		Damage:	None

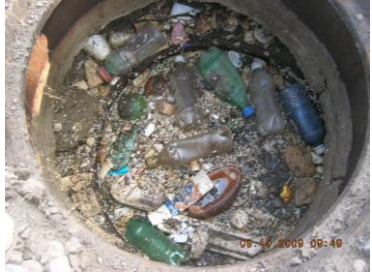
Osh09_DSCN6768.JPG

Inspection Date: 9/10/2009		Type: Initial	Flow: Submerged, indeterminate	Previous Rainfall (hrs): 72+
Illicit Discharge Potential: Potential		Inspector: JCW	Notes	
Submerged: Fully		Depth (in): 44	Abnormal detergent analysis result (bubbles). Significant floatables in manhole.	
Sampling Results		Condition Assessment		
Sample Location:	Pool	Floatables:	None	
Total Chlorine:	0 ppm	Odor:	None	
Free Chlorine:	0 ppm	Turbidity:	None	
Ammonia:	-- ppm	Color:	None	
pH:	8.3 units	Gross Solids:	Severe	
Temperature	75 °F	Vegetation:	None	
Conductivity:	-- µS/cm	Benthic Growth:	None	
Detergents:	0 mg/L	Stains:	None	
		Non-illicit:	None	
		Graffiti:	None	
		Erosion:	None	
		Deposition:	None 0 in.	
		Damage:	None

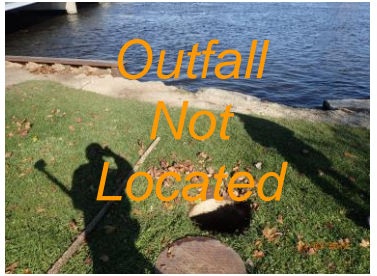
o20191105114512.JPG 2019
Sampling Results Sample Location: _____ Total Chlorine: -- ppm Free Chlorine: -- ppm Ammonia: -- ppm pH: -- units Temperature: -- °F Conductivity: -- µS/cm Detergents: -- mg/L		Floatables: None Odor: None Turbidity: None Color: None Gross Solids: None Vegetation: None Benthic Growth: None Stains: None Non-illicit: None	Follow-up inspection for sampling - limited screening conducted. Floating gross solids (litter) and detergent in manhole. Condition Assessment Graffiti: None Erosion: None Deposition: None in. Damage: None

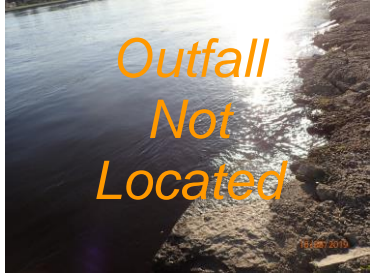
o20191008072714.JPG

Inspection Date: 10/8/2019 8:29:12 AM		Type: Repeat	Flow: Submerged (not located)	Previous Rainfall (hrs): 48-72
Illicit Discharge Potential: Potential		Inspector: JCW	Notes	
Submerged: Fully		Depth (in):	Detergent detection follow-up. Limited screening conducted beyond sampling.	
Sampling Results		Floatables:	Condition Assessment Graffiti: None Erosion: None Deposition: None in. Damage: None	
Sample Location:		Odor:		
Total Chlorine: -- ppm		Turbidity:		
Free Chlorine: -- ppm		Color:		
Ammonia: -- ppm		Gross Solids:		
pH: -- units		Vegetation:		
Temperature -- °F		Benthic Growth:		
Conductivity: -- µS/cm		Stains:		
Detergents: -- mg/L		Non-illicit:

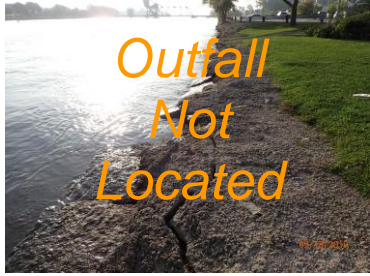
o20190918070310.JPG

Inspection Date: 9/18/2019 8:05:22 AM		Type: Ongoing	Flow: Submerged (not located)	Previous Rainfall (hrs): 72+
Illicit Discharge Potential: Potential		Inspector: JCW	Notes	
Submerged: Fully		Depth (in):	Outfall fully submerged and not located - screened upstream at 03-35 US1. Floating gross solids (litter) and detergent in manhole.	
Sampling Results		Floatables:	Condition Assessment Graffiti: None Erosion: None Deposition: None in. Damage: None	
Sample Location:		Odor:		
Total Chlorine: -- ppm		Turbidity:		
Free Chlorine: -- ppm		Color:		
Ammonia: -- ppm		Gross Solids:		
pH: -- units		Vegetation:		
Temperature -- °F		Benthic Growth:		
Conductivity: -- µS/cm		Stains:		
Detergents: -- mg/L		Non-illicit:

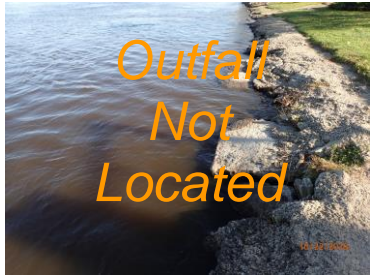
o20181022152608.JPG

Inspection Date: 10/22/2018 3:27:47 PM		Type: Ongoing	Flow: Submerged (not located)	Previous Rainfall (hrs): 48-72
Illicit Discharge Potential: Potential		Inspector: JCW	Notes	
Submerged: Fully		Depth (in):	Outfall fully submerged and not located - screened upstream at 03-35 US1. Floating gross solids (litter) in manhole.	
Sampling Results		Floatables:	Condition Assessment Graffiti: None Erosion: None Deposition: None in. Damage: None	
Sample Location:		Odor:		
Total Chlorine: -- ppm		Turbidity:		
Free Chlorine: -- ppm		Color:		
Ammonia: -- ppm		Gross Solids:		
pH: -- units		Vegetation:		
Temperature -- °F		Benthic Growth:		
Conductivity: -- µS/cm		Stains:		
Detergents: -- mg/L		Non-illicit:

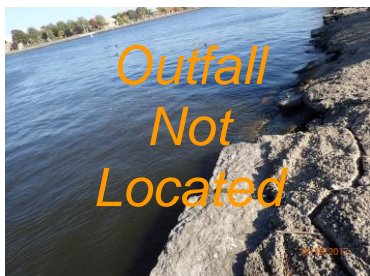
o20171018150844.JPG

Inspection Date: 10/18/2017 3:15:43 PM		Type: Ongoing	Flow: Submerged (not located)	Previous Rainfall (hrs): 72+
Illicit Discharge Potential: Potential		Inspector: JCW	Notes	
Submerged: Fully		Depth (in):	Outfall fully submerged and not located - screened upstream at 03-35 US1. Floating gross solids (litter) in manhole.	
Sampling Results		Floatables:	Condition Assessment Graffiti: None Erosion: None Deposition: None in. Damage: None	
Sample Location:		Odor:		
Total Chlorine: -- ppm		Turbidity:		
Free Chlorine: -- ppm		Color:		
Ammonia: -- ppm		Gross Solids:		
pH: -- units		Vegetation:		
Temperature -- °F		Benthic Growth:		
Conductivity: -- µS/cm		Stains:		
Detergents: -- mg/L		Non-illicit:

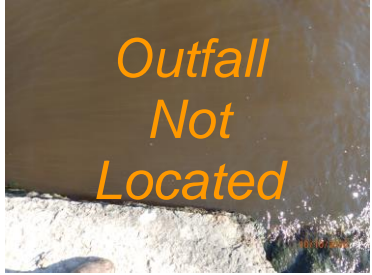
o20161010094930.JPG

Inspection Date: 10/10/2016 9:52:05 AM		Type: Ongoing	Flow: Submerged (not located)	Previous Rainfall (hrs): 72+
Illicit Discharge Potential: Potential		Inspector: JCW	Notes	
Submerged: Fully		Depth (in):	Outfall fully submerged and not located - screened upstream at 03-35 US1.	
Sampling Results		Floatables:	Condition Assessment Graffiti: None Erosion: None Deposition: None in. Damage: None	
Sample Location:		Odor:		
Total Chlorine: -- ppm		Turbidity:		
Free Chlorine: -- ppm		Color:		
Ammonia: -- ppm		Gross Solids:		
pH: -- units		Vegetation:		
Temperature -- °F		Benthic Growth:		
Conductivity: -- µS/cm		Stains:		
Detergents: -- mg/L		Non-illicit:

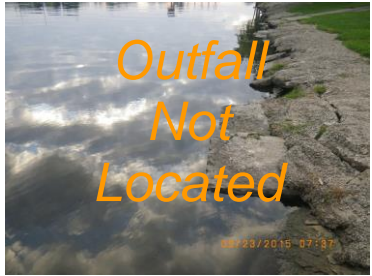
o20150923063720.JPG

Inspection Date: 9/23/2015 7:34:32 AM		Type: Ongoing	Flow: Submerged (not located)	Previous Rainfall (hrs): 72+
Illicit Discharge Potential: Potential		Inspector: JCW	Notes	
Submerged: Fully		Depth (in):	Outfall fully submerged and not located - screened at 03-35 US1.	
Sampling Results		Floatables:	Condition Assessment Graffiti: None Erosion: None Deposition: None in. Damage: None	
Sample Location:		Odor:		
Total Chlorine: -- ppm		Turbidity:		
Free Chlorine: -- ppm		Color:		
Ammonia: -- ppm		Gross Solids:		
pH: -- units		Vegetation:		
Temperature -- °F		Benthic Growth:		
Conductivity: -- µS/cm		Stains:		
Detergents: -- mg/L		Non-illicit:

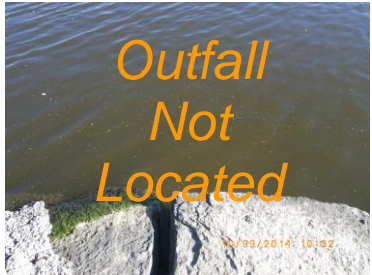
o20141009093222.JPG

Inspection Date: 10/9/2014 10:33:07 AM		Type: Ongoing	Flow: Submerged (not located)	Previous Rainfall (hrs): 72+
Illicit Discharge Potential: Unlikely		Inspector: JCW	Notes	
Submerged: Fully		Depth (in):	Outfall fully submerged and not located - screened upstream at 03-35 US1	
Sampling Results		Floatables:	Condition Assessment Graffiti: None Erosion: None Deposition: None in. Damage: None	
Sample Location:		Odor:		
Total Chlorine: -- ppm		Turbidity:		
Free Chlorine: -- ppm		Color:		
Ammonia: -- ppm		Gross Solids:		
pH: -- units		Vegetation:		
Temperature -- °F		Benthic Growth:		
Conductivity: -- µS/cm		Stains:		
Detergents: -- mg/L		Non-illicit:

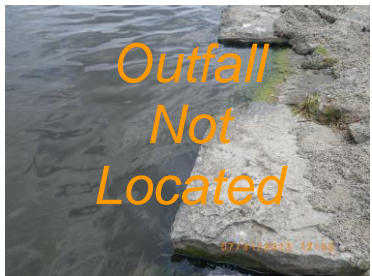
o20130731113304.JPG

Inspection Date: 7/31/2013 12:30:28 PM		Type: Ongoing	Flow: Submerged (not located)	Previous Rainfall (hrs): 72+
Illicit Discharge Potential: Potential		Inspector: JCW	Notes	
Submerged: Fully		Depth (in):	2012 screening follow-up. Outfall not located. Outfall screened upstream at 03-35 US1. Gross solids in upstream mh.	
Sampling Results		Floatables:	Condition Assessment Graffiti: None Erosion: None Deposition: None in. Damage: None	
Sample Location:		Odor:		
Total Chlorine: -- ppm		Turbidity:		
Free Chlorine: -- ppm		Color:		
Ammonia: -- ppm		Gross Solids:		
pH: -- units		Vegetation:		
Temperature -- °F		Benthic Growth:		
Conductivity: -- µS/cm		Stains:		
Detergents: -- mg/L		Non-illicit:

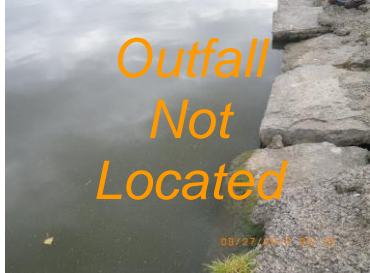
o20120927081506.JPG

Inspection Date: 9/27/2012 9:13:17 AM		Type: Ongoing	Flow: Submerged (not located)	Previous Rainfall (hrs): 72+
Illicit Discharge Potential: Potential		Inspector: JCW	Notes	
Submerged: Fully		Depth (in):	Outfall fully submerged; screened upstream at 03-35 US1.	
Sampling Results		Floatables:	Condition Assessment Graffiti: None Erosion: None Deposition: None in. Damage: None	
Sample Location:		Odor:		
Total Chlorine: -- ppm		Turbidity:		
Free Chlorine: -- ppm		Color:		
Ammonia: -- ppm		Gross Solids:		
pH: -- units		Vegetation:		
Temperature -- °F		Benthic Growth:		
Conductivity: -- µS/cm		Stains:		
Detergents: -- mg/L		Non-illicit:

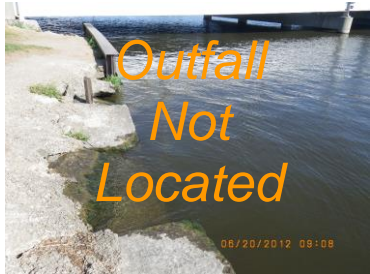
o20120620080844.JPG

Inspection Date: 6/20/2012 9:06:10 AM		Type: Other	Flow: Submerged (not located)	Previous Rainfall (hrs): 24-48
Illicit Discharge Potential: Potential		Inspector: JCW	Notes	
Submerged: Fully		Depth (in):	Gross solids pre-screening.	
Sampling Results		Floatables:	Condition Assessment Graffiti: None Erosion: None Deposition: None in. Damage: None	
Sample Location:		Odor:		
Total Chlorine: -- ppm		Turbidity:		
Free Chlorine: -- ppm		Color:		
Ammonia: -- ppm		Gross Solids:		
pH: -- units		Vegetation:		
Temperature -- °F		Benthic Growth:		
Conductivity: -- µS/cm		Stains:		
Detergents: -- mg/L		Non-illicit:

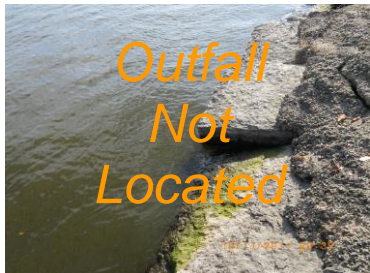
o20111011093254.JPG

Inspection Date: 10/11/2011 9:36:03 AM		Type: Ongoing	Flow: Submerged (not located)	Previous Rainfall (hrs): 72+
Illicit Discharge Potential: Potential		Inspector: JCW	Notes	
Submerged: Fully		Depth (in):	2010 screening follow-up. Outfall fully submerged and not physically located. Outfall screened upstream at 03-35 US1.	
Sampling Results		Floatables:	Condition Assessment Graffiti: None Erosion: None Deposition: None 0 in. Damage: None	
Sample Location:		Odor:		
Total Chlorine: -- ppm		Turbidity:		
Free Chlorine: -- ppm		Color:		
Ammonia: -- ppm		Gross Solids:		
pH: -- units		Vegetation:		
Temperature -- °F		Benthic Growth:		
Conductivity: -- µS/cm		Stains:		
Detergents: -- mg/L		Non-illicit:

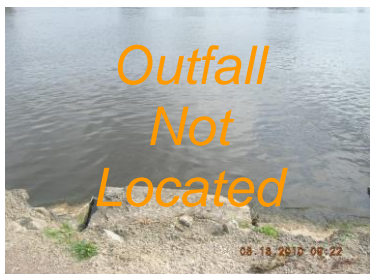
o20100818092204.JPG

Inspection Date: 8/18/2010 9:27:46 AM		Type: Ongoing	Flow: Submerged (not located)	Previous Rainfall (hrs): 72+
Illicit Discharge Potential: Potential		Inspector: JCW	Notes	
Submerged: Fully		Depth (in):	Outfall fully submerged and not physically located. Outfall screened upstream at 03-35 US1.	
Sampling Results		Floatables:	Condition Assessment Graffiti: None Erosion: None Deposition: None 0 in. Damage: None	
Sample Location:		Odor:		
Total Chlorine: -- ppm		Turbidity:		
Free Chlorine: -- ppm		Color:		
Ammonia: -- ppm		Gross Solids:		
pH: -- units		Vegetation:		
Temperature -- °F		Benthic Growth:		
Conductivity: -- µS/cm		Stains:		
Detergents: -- mg/L		Non-illicit:

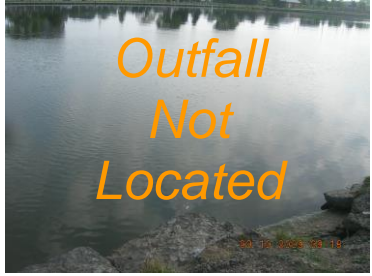
<p>Osh09_DSCN6761.JPG</p> <p>2009</p>	
Submerged: Fully		Depth (in):		Outfall fully submerged and not physically located. Outfall screened upstream at 03-35 US1.			
Sampling Results		Floatables:		None		Condition Assessment Graffiti: None Erosion: None Deposition: None 0 in. Damage: None	
Sample Location:		Odor:		None			
Total Chlorine: -- ppm		Turbidity:		None			
Free Chlorine: -- ppm		Color:		None			
Ammonia: -- ppm		Gross Solids:		None			
pH: -- units		Vegetation:		None			
Temperature -- °F		Benthic Growth:		None			
Conductivity: -- µS/cm		Stains:		None			
Detergents: -- mg/L		Non-illicit:		None

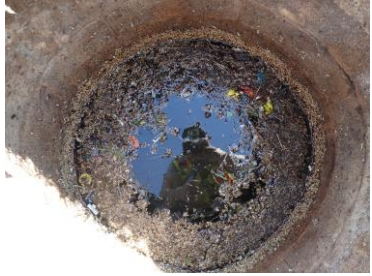
o20220824101600.JPG
2022

Inspection Date: 8/24/2022 10:19:00 AM		Type: Ongoing	Flow: Submerged, indeterminate	Previous Rainfall (hrs): 72+
Illicit Discharge Potential: Potential		Inspector: EJK		
Submerged: Fully		Depth (in):		
Sampling Results		Notes Sample collected from submerged pool in manhole. Floating gross solids (litter) in manhole.		
Sample Location: Pool	Floatables: None	Condition Assessment Graffiti: None Erosion: None Deposition: None in. Damage: None		
Total Chlorine: 0 ppm	Odor: None			
Free Chlorine: 0 ppm	Turbidity: None			
Ammonia: 0 ppm	Color: None			
pH: 8.1 units	Gross Solids: Moderate			
Temperature 77 °F	Vegetation: None			
Conductivity: 593 µS/cm	Benthic Growth: None			
Detergents: 0 mg/L	Stains: None			
	Non-illicit: None

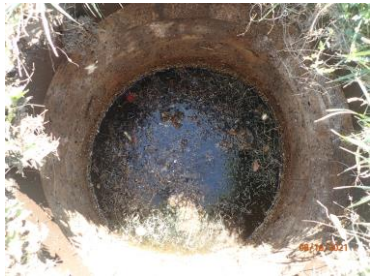
o20210816104502.JPG
2021

Inspection Date: 8/16/2021 10:48:38 AM		Type: Ongoing	Flow: Submerged, indeterminate	Previous Rainfall (hrs): 72+
Illicit Discharge Potential: Potential		Inspector: JCW		
Submerged: Fully		Depth (in): 39		
Sampling Results		Notes Sample collected from submerged pool in manhole. Floating gross solids (litter) in manhole.		
Sample Location: Pool	Floatables: None	Condition Assessment Graffiti: None Erosion: None Deposition: None in. Damage: None		
Total Chlorine: 0 ppm	Odor: None			
Free Chlorine: 0 ppm	Turbidity: None			
Ammonia: 0 ppm	Color: None			
pH: 7.76 units	Gross Solids: Moderate			
Temperature 77 °F	Vegetation: None			
Conductivity: 349 µS/cm	Benthic Growth: None			
Detergents: 0 mg/L	Stains: None			
	Non-illicit: None

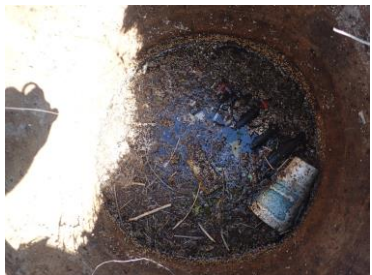
o20200819143804.JPG
2020

Inspection Date: 8/19/2020 2:41:48 PM		Type: Ongoing	Flow: Submerged, indeterminate	Previous Rainfall (hrs): 72+
Illicit Discharge Potential: Potential		Inspector: JCW		
Submerged: Fully		Depth (in): 36		
Sampling Results		Notes Sample collected from submerged pool in manhole. Floating gross solids (litter) in manhole. Slightly elevated ammonia.		
Sample Location: Pool	Floatables: None	Condition Assessment Graffiti: None Erosion: None Deposition: None in. Damage: None		
Total Chlorine: 0 ppm	Odor: None			
Free Chlorine: 0 ppm	Turbidity: None			
Ammonia: 0.5 ppm	Color: None			
pH: 8.44 units	Gross Solids: Severe			
Temperature 85 °F	Vegetation: None			
Conductivity: 346 µS/cm	Benthic Growth: None			
Detergents: 0 mg/L	Stains: None			
	Non-illicit: None

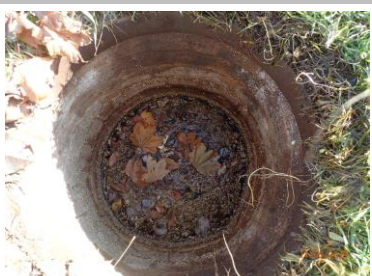
o20191105114518.JPG
2019

Inspection Date: 11/5/2019 11:45:22 AM		Type: Repeat	Flow: Submerged, indeterminate	Previous Rainfall (hrs): 48-72
Illicit Discharge Potential: Potential		Inspector: JCW		
Submerged: Partially		Depth (in): 30		
Sampling Results		Notes Detergent detection follow-up. Limited screening conducted. Floating gross solids (litter) and detergent in manhole.		
Sample Location: Pool	Floatables: None	Condition Assessment Graffiti: None Erosion: None Deposition: None in. Damage: None		
Total Chlorine: -- ppm	Odor: None			
Free Chlorine: -- ppm	Turbidity: None			
Ammonia: -- ppm	Color: None			
pH: -- units	Gross Solids: Severe			
Temperature -- °F	Vegetation: None			
Conductivity: -- µS/cm	Benthic Growth: None			
Detergents: 0 mg/L	Stains: None			
	Non-illicit: None

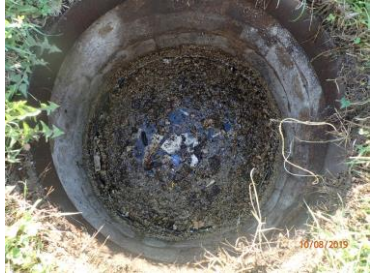
o20191008072724.JPG 2019

Inspection Date: 10/8/2019 8:30:16 AM		Type: Repeat	Flow: Submerged, indeterminate	Previous Rainfall (hrs): 48-72
Illicit Discharge Potential: Potential		Inspector: JCW		
Submerged: Partially		Depth (in): 42		
<div style="display: flex; justify-content: space-between;"> <div style="width: 45%;"> <p>Sampling Results</p> <p>Sample Location: Pool</p> <p>Total Chlorine: 0 ppm</p> <p>Free Chlorine: 0 ppm</p> <p>Ammonia: 0 ppm</p> <p>pH: 7.68 units</p> <p>Temperature: 55 °F</p> <p>Conductivity: 415 µS/cm</p> <p>Detergents: 1.3 mg/L</p> </div> <div style="width: 45%;"> <p>Floatables: None</p> <p>Odor: None</p> <p>Turbidity: None</p> <p>Color: None</p> <p>Gross Solids: Severe</p> <p>Vegetation: None</p> <p>Benthic Growth: None</p> <p>Stains: None</p> <p>Non-illicit: None</p> </div> </div>				
		<p>Notes</p> <p>Detergent detection follow-up. Limited screening conducted beyond sampling.</p>		
		<p>Condition Assessment</p> <p>Graffiti: None</p> <p>Erosion: None</p> <p>Deposition: None in.</p> <p>Damage: None</p>

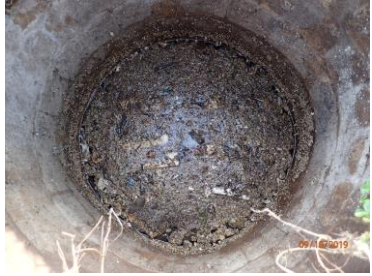
o20190918070320.JPG 2019

Inspection Date: 9/18/2019 8:06:15 AM		Type: Ongoing	Flow: Submerged, indeterminate	Previous Rainfall (hrs): 72+
Illicit Discharge Potential: Potential		Inspector: JCW		
Submerged: Fully		Depth (in): 38		
<div style="display: flex; justify-content: space-between;"> <div style="width: 45%;"> <p>Sampling Results</p> <p>Sample Location: Pool</p> <p>Total Chlorine: 0 ppm</p> <p>Free Chlorine: 0 ppm</p> <p>Ammonia: 0 ppm</p> <p>pH: 8.47 units</p> <p>Temperature: 70 °F</p> <p>Conductivity: 389 µS/cm</p> <p>Detergents: 1.3 mg/L</p> </div> <div style="width: 45%;"> <p>Floatables: None</p> <p>Odor: None</p> <p>Turbidity: None</p> <p>Color: None</p> <p>Gross Solids: Severe</p> <p>Vegetation: None</p> <p>Benthic Growth: None</p> <p>Stains: None</p> <p>Non-illicit: None</p> </div> </div>				
		<p>Notes</p> <p>Sample collected from submerged pool in manhole. Floating gross solids (litter) and detergent in manhole.</p>

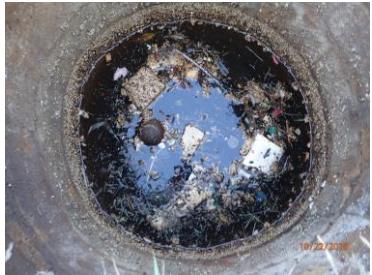
o20181022152746.JPG 2018

Inspection Date: 10/22/2018 3:30:12 PM		Type: Ongoing	Flow: Submerged, indeterminate	Previous Rainfall (hrs): 48-72
Illicit Discharge Potential: Potential		Inspector: JCW		
Submerged: Fully		Depth (in): 41		
<div style="display: flex; justify-content: space-between;"> <div style="width: 45%;"> <p>Sampling Results</p> <p>Sample Location: Pool</p> <p>Total Chlorine: 0 ppm</p> <p>Free Chlorine: 0 ppm</p> <p>Ammonia: 0 ppm</p> <p>pH: 7.81 units</p> <p>Temperature: 56 °F</p> <p>Conductivity: 338 µS/cm</p> <p>Detergents: 0 mg/L</p> </div> <div style="width: 45%;"> <p>Floatables: None</p> <p>Odor: None</p> <p>Turbidity: None</p> <p>Color: None</p> <p>Gross Solids: Moderate</p> <p>Vegetation: None</p> <p>Benthic Growth: None</p> <p>Stains: None</p> <p>Non-illicit: None</p> </div> </div>				
		<p>Notes</p> <p>Sample collected from submerged pool in manhole. Floating gross solids (litter) in manhole.</p>

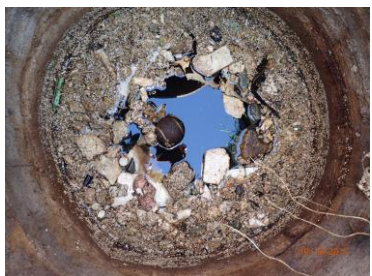
o20171018151012.JPG 2017

Inspection Date: 10/18/2017 3:16:37 PM		Type: Ongoing	Flow: Submerged, indeterminate	Previous Rainfall (hrs): 72+
Illicit Discharge Potential: Potential		Inspector: JCW		
Submerged: Fully		Depth (in): 35		
<div style="display: flex; justify-content: space-between;"> <div style="width: 45%;"> <p>Sampling Results</p> <p>Sample Location: Pool</p> <p>Total Chlorine: 0 ppm</p> <p>Free Chlorine: 0 ppm</p> <p>Ammonia: 0 ppm</p> <p>pH: 7.94 units</p> <p>Temperature: 66 °F</p> <p>Conductivity: 554 µS/cm</p> <p>Detergents: 0 mg/L</p> </div> <div style="width: 45%;"> <p>Floatables: None</p> <p>Odor: None</p> <p>Turbidity: None</p> <p>Color: None</p> <p>Gross Solids: Severe</p> <p>Vegetation: None</p> <p>Benthic Growth: None</p> <p>Stains: None</p> <p>Non-illicit: None</p> </div> </div>				
		<p>Notes</p> <p>Sample collected from submerged pool in manhole. Floating gross solids (litter) in manhole.</p>

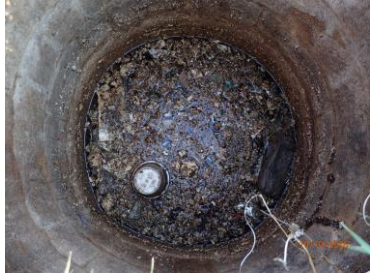
<p style="text-align: center;">o20161010094958.JPG</p> <p style="text-align: center; font-size: 24pt; font-weight: bold;">2016</p>																																									
Submerged: Fully		Depth (in): 32		Potential illicit discharge due to gross solids.																																											
Sampling Results <table border="1" style="width:100%; border-collapse: collapse;"> <tr><td>Sample Location:</td><td>Pool</td></tr> <tr><td>Total Chlorine:</td><td>0 ppm</td></tr> <tr><td>Free Chlorine:</td><td>0 ppm</td></tr> <tr><td>Ammonia:</td><td>0 ppm</td></tr> <tr><td>pH:</td><td>7.54 units</td></tr> <tr><td>Temperature:</td><td>63 °F</td></tr> <tr><td>Conductivity:</td><td>391 µS/cm</td></tr> <tr><td>Detergents:</td><td>0 mg/L</td></tr> </table>		Sample Location:	Pool	Total Chlorine:	0 ppm			Free Chlorine:	0 ppm	Ammonia:	0 ppm	pH:	7.54 units	Temperature:	63 °F	Conductivity:	391 µS/cm	Detergents:	0 mg/L	<table border="1" style="width:100%; border-collapse: collapse;"> <tr><td>Floatables:</td><td>None</td></tr> <tr><td>Odor:</td><td>Faint</td></tr> <tr><td>Turbidity:</td><td>None</td></tr> <tr><td>Color:</td><td>None</td></tr> <tr><td>Gross Solids:</td><td>Moderate</td></tr> <tr><td>Vegetation:</td><td>None</td></tr> <tr><td>Benthic Growth:</td><td>None</td></tr> <tr><td>Stains:</td><td>None</td></tr> <tr><td>Non-illicit:</td><td>None</td></tr> </table>		Floatables:	None	Odor:	Faint	Turbidity:	None	Color:	None	Gross Solids:	Moderate	Vegetation:	None	Benthic Growth:	None	Stains:	None	Non-illicit:	None	Condition Assessment <table border="1" style="width:100%; border-collapse: collapse;"> <tr><td>Graffiti:</td><td>None</td></tr> <tr><td>Erosion:</td><td>None</td></tr> <tr><td>Deposition:</td><td>None in.</td></tr> <tr><td>Damage:</td><td>None</td></tr> </table>		Graffiti:	None	Erosion:	None	Deposition:	None in.

Sample Location:	Pool																																														
Total Chlorine:	0 ppm																																														
Free Chlorine:	0 ppm																																														
Ammonia:	0 ppm																																														
pH:	7.54 units																																														
Temperature:	63 °F																																														
Conductivity:	391 µS/cm																																														
Detergents:	0 mg/L																																														
Floatables:	None																																														
Odor:	Faint																																														
Turbidity:	None																																														
Color:	None																																														
Gross Solids:	Moderate																																														
Vegetation:	None																																														
Benthic Growth:	None

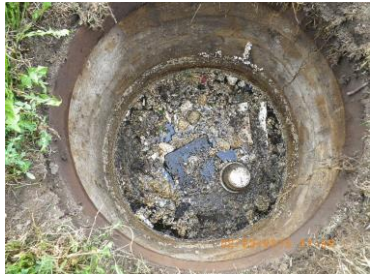
<p style="text-align: center;">o20150923063950.JPG</p> <p style="text-align: center; font-size: 24pt; font-weight: bold;">2015</p>																																									
Submerged: Fully		Depth (in): 30		Floating gross solids (litter) in manhole.																																											
Sampling Results <table border="1" style="width:100%; border-collapse: collapse;"> <tr><td>Sample Location:</td><td>Pool</td></tr> <tr><td>Total Chlorine:</td><td>0 ppm</td></tr> <tr><td>Free Chlorine:</td><td>0 ppm</td></tr> <tr><td>Ammonia:</td><td>0 ppm</td></tr> <tr><td>pH:</td><td>8.64 units</td></tr> <tr><td>Temperature:</td><td>69 °F</td></tr> <tr><td>Conductivity:</td><td>359 µS/cm</td></tr> <tr><td>Detergents:</td><td>0 mg/L</td></tr> </table>		Sample Location:	Pool	Total Chlorine:	0 ppm			Free Chlorine:	0 ppm	Ammonia:	0 ppm	pH:	8.64 units	Temperature:	69 °F	Conductivity:	359 µS/cm	Detergents:	0 mg/L	<table border="1" style="width:100%; border-collapse: collapse;"> <tr><td>Floatables:</td><td>None</td></tr> <tr><td>Odor:</td><td>None</td></tr> <tr><td>Turbidity:</td><td>None</td></tr> <tr><td>Color:</td><td>Faint in bottle</td></tr> <tr><td>Gross Solids:</td><td>Moderate</td></tr> <tr><td>Vegetation:</td><td>None</td></tr> <tr><td>Benthic Growth:</td><td>None</td></tr> <tr><td>Stains:</td><td>None</td></tr> <tr><td>Non-illicit:</td><td>None</td></tr> </table>		Floatables:	None	Odor:	None	Turbidity:	None	Color:	Faint in bottle	Gross Solids:	Moderate	Vegetation:	None	Benthic Growth:	None	Stains:	None	Non-illicit:	None	Condition Assessment <table border="1" style="width:100%; border-collapse: collapse;"> <tr><td>Graffiti:</td><td>None</td></tr> <tr><td>Erosion:</td><td>None</td></tr> <tr><td>Deposition:</td><td>Minor 1 in.</td></tr> <tr><td>Damage:</td><td>None</td></tr> </table>		Graffiti:	None	Erosion:	None	Deposition:	Minor 1 in.

Sample Location:	Pool																																														
Total Chlorine:	0 ppm																																														
Free Chlorine:	0 ppm																																														
Ammonia:	0 ppm																																														
pH:	8.64 units																																														
Temperature:	69 °F																																														
Conductivity:	359 µS/cm																																														
Detergents:	0 mg/L																																														
Floatables:	None																																														
Odor:	None																																														
Turbidity:	None																																														
Color:	Faint in bottle																																														
Gross Solids:	Moderate																																														
Vegetation:	None																																														
Benthic Growth:	None

Stains:	None																																														
Non-illicit:	None																																														
Graffiti:	None																																														
Erosion:	None																																														
Deposition:	Minor 1 in.																																														
Damage:	None

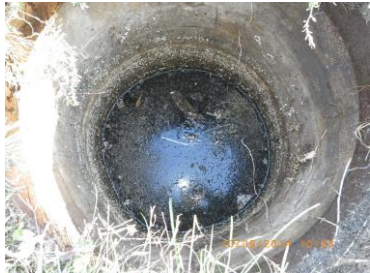
<p style="text-align: center;">o20141009093356.JPG</p> <p style="text-align: center; font-size: 24pt; font-weight: bold;">2014</p>																																									
Submerged: Fully		Depth (in): 32		Vegetative debris in photo from opening lid.																																											
Sampling Results <table border="1" style="width:100%; border-collapse: collapse;"> <tr><td>Sample Location:</td><td>Pool</td></tr> <tr><td>Total Chlorine:</td><td>0 ppm</td></tr> <tr><td>Free Chlorine:</td><td>0 ppm</td></tr> <tr><td>Ammonia:</td><td>0 ppm</td></tr> <tr><td>pH:</td><td>7.86 units</td></tr> <tr><td>Temperature:</td><td>58 °F</td></tr> <tr><td>Conductivity:</td><td>476 µS/cm</td></tr> <tr><td>Detergents:</td><td>0 mg/L</td></tr> </table>		Sample Location:	Pool	Total Chlorine:	0 ppm			Free Chlorine:	0 ppm	Ammonia:	0 ppm	pH:	7.86 units	Temperature:	58 °F	Conductivity:	476 µS/cm	Detergents:	0 mg/L	<table border="1" style="width:100%; border-collapse: collapse;"> <tr><td>Floatables:</td><td>None</td></tr> <tr><td>Odor:</td><td>None</td></tr> <tr><td>Turbidity:</td><td>None</td></tr> <tr><td>Color:</td><td>Faint in bottle</td></tr> <tr><td>Gross Solids:</td><td>Slight</td></tr> <tr><td>Vegetation:</td><td>None</td></tr> <tr><td>Benthic Growth:</td><td>None</td></tr> <tr><td>Stains:</td><td>None</td></tr> <tr><td>Non-illicit:</td><td>None</td></tr> </table>		Floatables:	None	Odor:	None	Turbidity:	None	Color:	Faint in bottle	Gross Solids:	Slight	Vegetation:	None	Benthic Growth:	None	Stains:	None	Non-illicit:	None	Condition Assessment <table border="1" style="width:100%; border-collapse: collapse;"> <tr><td>Graffiti:</td><td>None</td></tr> <tr><td>Erosion:</td><td>None</td></tr> <tr><td>Deposition:</td><td>Minor 1 in.</td></tr> <tr><td>Damage:</td><td>None</td></tr> </table>		Graffiti:	None	Erosion:	None	Deposition:	Minor 1 in.

Sample Location:	Pool																																														
Total Chlorine:	0 ppm																																														
Free Chlorine:	0 ppm																																														
Ammonia:	0 ppm																																														
pH:	7.86 units																																														
Temperature:	58 °F																																														
Conductivity:	476 µS/cm																																														
Detergents:	0 mg/L																																														
Floatables:	None																																														
Odor:	None																																														
Turbidity:	None																																														
Color:	Faint in bottle																																														
Gross Solids:	Slight																																														
Vegetation:	None																																														
Benthic Growth:	None

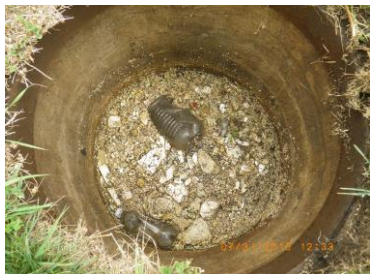
<p style="text-align: center;">o20130731113346.JPG</p> <p style="text-align: center; font-size: 24pt; font-weight: bold;">2013</p>																																									
Submerged: Fully		Depth (in): 33		2012 screening follow-up. Significant gross solids. Similar to previous years.																																											
Sampling Results <table border="1" style="width:100%; border-collapse: collapse;"> <tr><td>Sample Location:</td><td>Pool</td></tr> <tr><td>Total Chlorine:</td><td>0 ppm</td></tr> <tr><td>Free Chlorine:</td><td>0 ppm</td></tr> <tr><td>Ammonia:</td><td>0 ppm</td></tr> <tr><td>pH:</td><td>8.47 units</td></tr> <tr><td>Temperature:</td><td>75 °F</td></tr> <tr><td>Conductivity:</td><td>425 µS/cm</td></tr> <tr><td>Detergents:</td><td>0 mg/L</td></tr> </table>		Sample Location:	Pool	Total Chlorine:	0 ppm			Free Chlorine:	0 ppm	Ammonia:	0 ppm	pH:	8.47 units	Temperature:	75 °F	Conductivity:	425 µS/cm	Detergents:	0 mg/L	<table border="1" style="width:100%; border-collapse: collapse;"> <tr><td>Floatables:</td><td>None</td></tr> <tr><td>Odor:</td><td>None</td></tr> <tr><td>Turbidity:</td><td>None</td></tr> <tr><td>Color:</td><td>Faint in bottle</td></tr> <tr><td>Gross Solids:</td><td>Severe</td></tr> <tr><td>Vegetation:</td><td>None</td></tr> <tr><td>Benthic Growth:</td><td>None</td></tr> <tr><td>Stains:</td><td>Moderate</td></tr> <tr><td>Non-illicit:</td><td>None</td></tr> </table>		Floatables:	None	Odor:	None	Turbidity:	None	Color:	Faint in bottle	Gross Solids:	Severe	Vegetation:	None	Benthic Growth:	None	Stains:	Moderate	Non-illicit:	None	Condition Assessment <table border="1" style="width:100%; border-collapse: collapse;"> <tr><td>Graffiti:</td><td>None</td></tr> <tr><td>Erosion:</td><td>None</td></tr> <tr><td>Deposition:</td><td>None in.</td></tr> <tr><td>Damage:</td><td>None</td></tr> </table>		Graffiti:	None	Erosion:	None	Deposition:	None in.

Sample Location:	Pool																																														
Total Chlorine:	0 ppm																																														
Free Chlorine:	0 ppm																																														
Ammonia:	0 ppm																																														
pH:	8.47 units																																														
Temperature:	75 °F																																														
Conductivity:	425 µS/cm																																														
Detergents:	0 mg/L																																														
Floatables:	None																																														
Odor:	None																																														
Turbidity:	None																																														
Color:	Faint in bottle																																														
Gross Solids:	Severe																																														
Vegetation:	None																																														
Benthic Growth:	None

Stains:	Moderate																																														
Non-illicit:	None																																														
Graffiti:	None																																														
Erosion:	None																																														
Deposition:	None in.																																														
Damage:	None

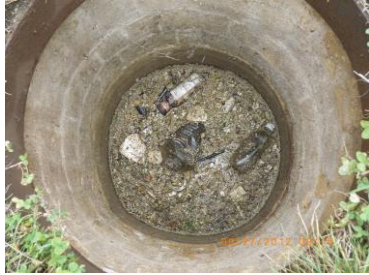
o20120927081522.JPG
2012

Inspection Date: 9/27/2012 9:13:54 AM		Type: Ongoing	Flow: Submerged, indeterminate	Previous Rainfall (hrs): 72+
Illicit Discharge Potential: Potential		Inspector: JCW	Notes	
Submerged: Fully		Depth (in): 31	2011 gross solids follow-up.	
Sampling Results		Condition Assessment		
Sample Location: Pool	Floatables: None	Graffiti: None Erosion: None Deposition: Minor 3 in. Damage: None		
Total Chlorine: 0 ppm	Odor: None			
Free Chlorine: 0 ppm	Turbidity: None			
Ammonia: 0 ppm	Color: None			
pH: 8.42 units	Gross Solids: Severe			
Temperature 59 °F	Vegetation: None			
Conductivity: 723 µS/cm	Benthic Growth: None			
Detergents: 0 mg/L	Stains: Slight			
	Non-illicit: None

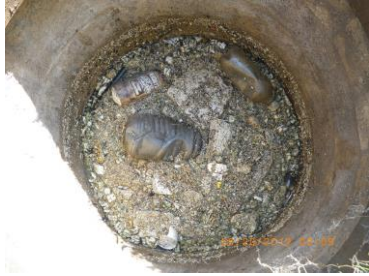
o20120620080918.JPG
2012

Inspection Date: 6/20/2012 9:08:12 AM		Type: Other	Flow: Submerged, indeterminate	Previous Rainfall (hrs): 24-48
Illicit Discharge Potential: Potential		Inspector: JCW	Notes	
Submerged: Fully		Depth (in): 39	Gross solids pre-screening.	
Sampling Results		Condition Assessment		
Sample Location:	Floatables: None	Graffiti: None Erosion: None Deposition: None in. Damage: None		
Total Chlorine: -- ppm	Odor: None			
Free Chlorine: -- ppm	Turbidity: None			
Ammonia: -- ppm	Color: None			
pH: -- units	Gross Solids: Severe			
Temperature -- °F	Vegetation: None			
Conductivity: -- µS/cm	Benthic Growth: None			
Detergents: -- mg/L	Stains: None			
	Non-illicit: None

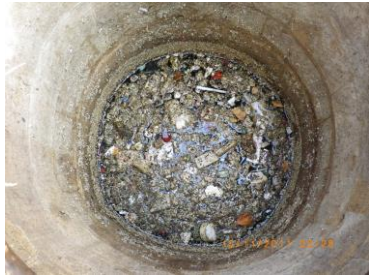
o20111011092832.JPG
2011

Inspection Date: 10/11/2011 9:29:50 AM		Type: Ongoing	Flow: Submerged, indeterminate	Previous Rainfall (hrs): 72+
Illicit Discharge Potential: Potential		Inspector: JCW	Notes	
Submerged: Fully		Depth (in): 19	2010 screening follow-up. Floatable debris still present. Slight petroleum sheen.	
Sampling Results		Condition Assessment		
Sample Location: Pool	Floatables: Severe	Graffiti: None Erosion: None Deposition: None 0 in. Damage: None		
Total Chlorine: 0 ppm	Odor: None			
Free Chlorine: 0 ppm	Turbidity: None			
Ammonia: 0 ppm	Color: None			
pH: 8.01 units	Gross Solids: Severe			
Temperature 71 °F	Vegetation: None			
Conductivity: -- µS/cm	Benthic Growth: None			
Detergents: -- mg/L	Stains: None			
	Non-illicit: None

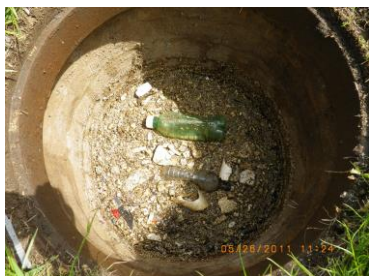
o20110526112400.JPG
2011

Inspection Date: 5/26/2011 11:23:00 AM		Type: Other	Flow: Submerged, indeterminate	Previous Rainfall (hrs): 72+
Illicit Discharge Potential: Potential		Inspector: JCW	Notes	
Submerged: Fully		Depth (in):	Limited screening conducted to check for floatable debris.	
Sampling Results		Condition Assessment		
Sample Location:	Floatables: None	Graffiti: None Erosion: None Deposition: None 0 in. Damage: None		
Total Chlorine: -- ppm	Odor:			
Free Chlorine: -- ppm	Turbidity:			
Ammonia: -- ppm	Color:			
pH: -- units	Gross Solids: Severe			
Temperature -- °F	Vegetation:			
Conductivity: -- µS/cm	Benthic Growth:			
Detergents: -- mg/L	Stains:			
	Non-illicit: None

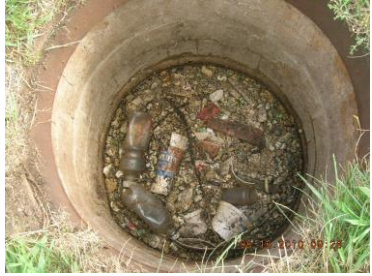
Inspection Date: 8/18/2010 9:32:06 AM		Type: Ongoing	Flow: Submerged, indeterminate	Previous Rainfall (hrs): 72+																																											
Illicit Discharge Potential: Potential		Inspector: JCW	Notes Severe floatable debris in catchbasin.																																												
Submerged: Fully		Depth (in): 34

<small>o20100818092304.JPG</small> <div style="font-size: 24pt; font-weight: bold; text-align: center;">2010</div>																																												
Sampling Results <table border="1" style="width:100%; border-collapse: collapse;"> <tr> <td>Sample Location:</td> <td>Pool</td> <td>Floatables:</td> <td>None</td> </tr> <tr> <td>Total Chlorine:</td> <td>0 ppm</td> <td>Odor:</td> <td>Faint</td> </tr> <tr> <td>Free Chlorine:</td> <td>0 ppm</td> <td>Turbidity:</td> <td>None</td> </tr> <tr> <td>Ammonia:</td> <td>0.5 ppm</td> <td>Color:</td> <td>Faint in bottle</td> </tr> <tr> <td>pH:</td> <td>7.46 units</td> <td>Gross Solids:</td> <td>Severe</td> </tr> <tr> <td>Temperature</td> <td>73 °F</td> <td>Vegetation:</td> <td>None</td> </tr> <tr> <td>Conductivity:</td> <td>-- µS/cm</td> <td>Benthic Growth:</td> <td>None</td> </tr> <tr> <td>Detergents:</td> <td>0 mg/L</td> <td>Stains:</td> <td>None</td> </tr> <tr> <td></td> <td></td> <td>Non-illicit:</td> <td>None</td> </tr> </table>		Sample Location:			Pool	Floatables:	None	Total Chlorine:	0 ppm	Odor:	Faint	Free Chlorine:	0 ppm	Turbidity:	None	Ammonia:	0.5 ppm	Color:	Faint in bottle	pH:	7.46 units	Gross Solids:	Severe	Temperature	73 °F	Vegetation:	None	Conductivity:	-- µS/cm	Benthic Growth:	None	Detergents:	0 mg/L	Stains:	None			Non-illicit:	None	Condition Assessment <table border="1" style="width:100%; border-collapse: collapse;"> <tr> <td>Graffiti:</td> <td>None</td> </tr> <tr> <td>Erosion:</td> <td>None</td> </tr> <tr> <td>Deposition:</td> <td>None</td> </tr> <tr> <td>Damage:</td> <td>None</td> </tr> </table>		Graffiti:	None	Erosion:	None	Deposition:	None

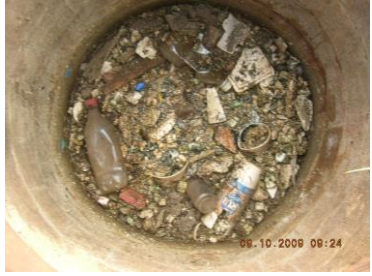
Inspection Date: 9/10/2009		Type: Initial	Flow: Submerged, indeterminate	Previous Rainfall (hrs): 72+																																											
Illicit Discharge Potential: Potential		Inspector: JCW	Notes Abnormal detergent analysis result (bubbles). Significant floatables in manhole.																																												
Submerged: Fully		Depth (in): 33

<small>Osh09_DSCN6763.JPG</small> <div style="font-size: 24pt; font-weight: bold; text-align: center;">2009</div>																																												
Sampling Results <table border="1" style="width:100%; border-collapse: collapse;"> <tr> <td>Sample Location:</td> <td>Pool</td> <td>Floatables:</td> <td>None</td> </tr> <tr> <td>Total Chlorine:</td> <td>0 ppm</td> <td>Odor:</td> <td>None</td> </tr> <tr> <td>Free Chlorine:</td> <td>0 ppm</td> <td>Turbidity:</td> <td>None</td> </tr> <tr> <td>Ammonia:</td> <td>-- ppm</td> <td>Color:</td> <td>None</td> </tr> <tr> <td>pH:</td> <td>8.23 units</td> <td>Gross Solids:</td> <td>Severe</td> </tr> <tr> <td>Temperature</td> <td>73 °F</td> <td>Vegetation:</td> <td>None</td> </tr> <tr> <td>Conductivity:</td> <td>-- µS/cm</td> <td>Benthic Growth:</td> <td>None</td> </tr> <tr> <td>Detergents:</td> <td>0 mg/L</td> <td>Stains:</td> <td>None</td> </tr> <tr> <td></td> <td></td> <td>Non-illicit:</td> <td>None</td> </tr> </table>		Sample Location:			Pool	Floatables:	None	Total Chlorine:	0 ppm	Odor:	None	Free Chlorine:	0 ppm	Turbidity:	None	Ammonia:	-- ppm	Color:	None	pH:	8.23 units	Gross Solids:	Severe	Temperature	73 °F	Vegetation:	None	Conductivity:	-- µS/cm	Benthic Growth:	None	Detergents:	0 mg/L	Stains:	None			Non-illicit:	None	Condition Assessment <table border="1" style="width:100%; border-collapse: collapse;"> <tr> <td>Graffiti:</td> <td>None</td> </tr> <tr> <td>Erosion:</td> <td>None</td> </tr> <tr> <td>Deposition:</td> <td>None</td> </tr> <tr> <td>Damage:</td> <td>None</td> </tr> </table>		Graffiti:	None	Erosion:	None	Deposition:	None

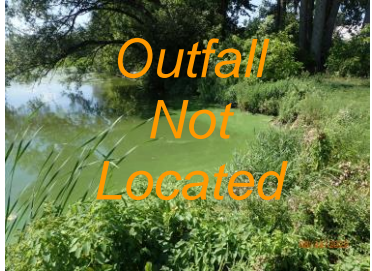
o20220822111642.JPG <div style="text-align: center; font-size: 24pt; font-weight: bold;">2022</div>

Inspection Date: 8/22/2022 11:21:00 AM		Type: Ongoing	Flow: Submerged (not located)	Previous Rainfall (hrs): 72+
Illicit Discharge Potential: Potential		Inspector: EJK		
Submerged: Fully		Depth (in):		
Sampling Results Sample Location: _____ Total Chlorine: -- ppm Free Chlorine: -- ppm Ammonia: -- ppm pH: -- units Temperature: -- °F Conductivity: -- µS/cm Detergents: -- mg/L		Floatables: Moderate Odor: None Turbidity: None Color: None Gross Solids: None Vegetation: None Benthic Growth: None Stains: None Non-illicit: None	Notes Outfall fully submerged and not located - screened upstream at 03-604 US1. Dense algae obstructing view. Ammonia in upstream manhole. Condition Assessment Graffiti: None Erosion: None Deposition: None in. Damage: None

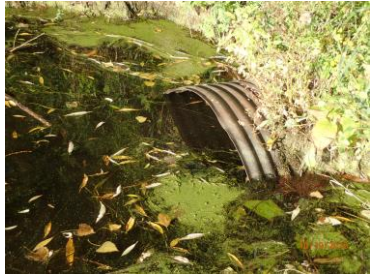
o20161010083458.JPG <div style="text-align: center; font-size: 24pt; font-weight: bold;">2016</div>

Inspection Date: 10/10/2016 8:37:23 AM		Type: Ongoing	Flow: Submerged, indeterminate	Previous Rainfall (hrs): 72+
Illicit Discharge Potential: Unlikely		Inspector: JCW		
Submerged: Partially		Depth (in): 31		
Sampling Results Sample Location: _____ Total Chlorine: -- ppm Free Chlorine: -- ppm Ammonia: -- ppm pH: -- units Temperature: -- °F Conductivity: -- µS/cm Detergents: -- mg/L		Floatables: None Odor: None Turbidity: None Color: None Gross Solids: None Vegetation: None Benthic Growth: None Stains: None Non-illicit: None	Notes Outfall partially submerged - screened upstream at 03-293 US1. Condition Assessment Graffiti: None Erosion: None Deposition: None in. Damage: Minor

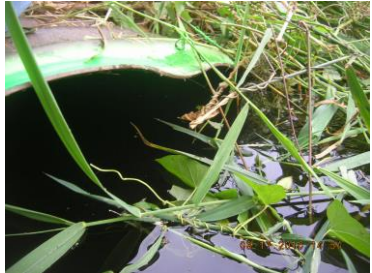
o20100817145430.JPG <div style="text-align: center; font-size: 24pt; font-weight: bold;">2010</div>

Inspection Date: 8/17/2010 3:02:36 PM		Type: Ongoing	Flow: Submerged, indeterminate	Previous Rainfall (hrs): 72+
Illicit Discharge Potential: Unlikely		Inspector: JCW		
Submerged: Partially		Depth (in): 38		
Sampling Results Sample Location: _____ Total Chlorine: -- ppm Free Chlorine: -- ppm Ammonia: -- ppm pH: -- units Temperature: -- °F Conductivity: -- µS/cm Detergents: -- mg/L		Floatables: None Odor: None Turbidity: None Color: None Gross Solids: None Vegetation: None Benthic Growth: None Stains: None Non-illicit: None	Notes Outfall partially submerged. Outfall screened upstream at 03-293 US1. Condition Assessment Graffiti: None Erosion: None Deposition: None 0 in. Damage: Minor

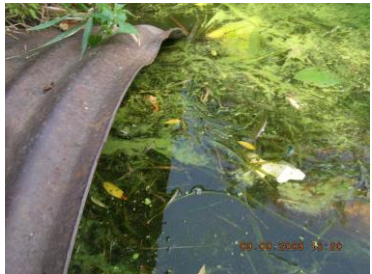
Osh09_DSCN6736.JPG <div style="text-align: center; font-size: 24pt; font-weight: bold;">2009</div>

Inspection Date: 9/9/2009		Type: Initial	Flow: Submerged, indeterminate	Previous Rainfall (hrs): 72+
Illicit Discharge Potential: Potential		Inspector: JCW		
Submerged: Partially		Depth (in): 32		
Sampling Results Sample Location: _____ Total Chlorine: -- ppm Free Chlorine: -- ppm Ammonia: -- ppm pH: -- units Temperature: -- °F Conductivity: -- µS/cm Detergents: -- mg/L		Floatables: None Odor: None Turbidity: None Color: None Gross Solids: None Vegetation: None Benthic Growth: Slight Stains: None Non-illicit: None	Notes Outfall partially submerged. Outfall screened upstream at 03-293 US1. Condition Assessment Graffiti: None Erosion: None Deposition: None 0 in. Damage: Minor

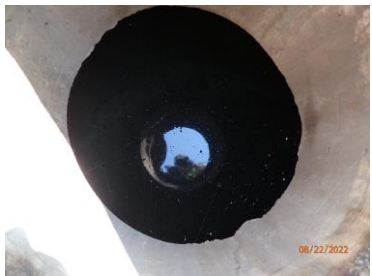
o20220822111818.JPG <div style="text-align: center; font-size: 24pt; font-weight: bold;">2022</div>

Inspection Date: 8/22/2022 11:22:00 AM		Type: Ongoing	Flow: Submerged, indeterminate	Previous Rainfall (hrs): 72+
Illicit Discharge Potential: Potential		Inspector: EJK		
Submerged: Fully		Depth (in):		
Sampling Results Sample Location: Pool Total Chlorine: 0 ppm Free Chlorine: 0 ppm Ammonia: 1 ppm pH: 8.67 units Temperature: 75 °F Conductivity: 428 µS/cm Detergents: 0 mg/L		Floatables: None Odor: None Turbidity: None Color: None Gross Solids: None Vegetation: None Benthic Growth: None Stains: None Non-illicit: None		
		Notes Sample collected from submerged pool in manhole. Elevated ammonia in sample.		
		Condition Assessment Graffiti: None Erosion: None Deposition: None in. Damage: None

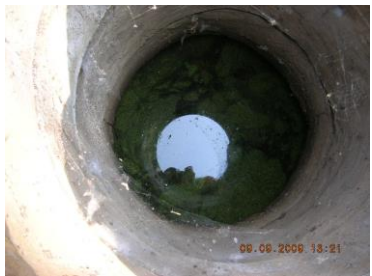
Osh09_DSCN6739.JPG <div style="text-align: center; font-size: 24pt; font-weight: bold;">2009</div>

Inspection Date: 9/9/2009		Type: Initial	Flow: Submerged, indeterminate	Previous Rainfall (hrs): 72+
Illicit Discharge Potential: Potential		Inspector: JCW		
Submerged: Partially		Depth (in):		
Sampling Results Sample Location: Pool Total Chlorine: 0 ppm Free Chlorine: 0 ppm Ammonia: -- ppm pH: 7.82 units Temperature: 78 °F Conductivity: -- µS/cm Detergents: 0 mg/L		Floatables: None Odor: None Turbidity: None Color: None Gross Solids: None Vegetation: None Benthic Growth: None Stains: None Non-illicit: None		
		Notes Abnormal detergent analysis result (bubbles)		
		Condition Assessment Graffiti: None Erosion: None Deposition: None 0 in. Damage: None

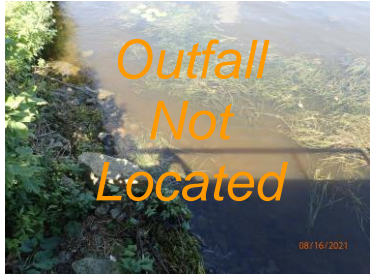
<div style="font-size: 1.2em; font-weight: bold; color: black;">o20210816110756.JPG</div> <div style="font-size: 1.5em; font-weight: bold; color: black;">2021</div>

Inspection Date: 8/16/2021 11:09:51 AM		Type: Ongoing	Flow: Submerged (not located)	Previous Rainfall (hrs): 72+
Illicit Discharge Potential: Potential		Inspector: JCW		
Submerged: Fully		Depth (in):		
Sampling Results Sample Location: _____ Total Chlorine: -- ppm Free Chlorine: -- ppm Ammonia: -- ppm pH: -- units Temperature -- ° F Conductivity: -- µS/cm Detergents: -- mg/L		Floatables: None Odor: None Turbidity: None Color: None Gross Solids: None Vegetation: None Benthic Growth: None Stains: None Non-illicit: None	Notes Outfall fully submerged and not located - screened upstream at 03-81 US1. Floating gross solids (litter) in upstream manhole. Condition Assessment Graffiti: None Erosion: None Deposition: None in. Damage: None
