IDDE Ongoing Screening Summary Report

2023 Inspection Year

Westwood

City of Oshkosh

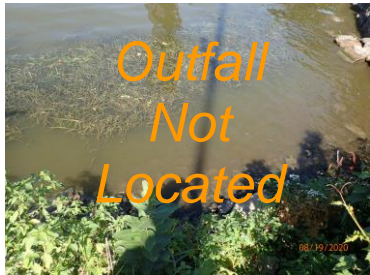
<div style="font-size: 1.2em; font-weight: bold; color: black;">o20200819141442.JPG</div> <div style="font-size: 1.5em; font-weight: bold; color: black;">2020</div>

Inspection Date: 8/19/2020 2:16:29 PM		Type: Ongoing	Flow: Submerged (not located)	Previous Rainfall (hrs): 72+
Illicit Discharge Potential: Potential		Inspector: JCW		
Submerged: Fully		Depth (in):		
Sampling Results Sample Location: _____ Total Chlorine: -- ppm Free Chlorine: -- ppm Ammonia: -- ppm pH: -- units Temperature -- ° F Conductivity: -- µS/cm Detergents: -- mg/L		Floatables: None Odor: None Turbidity: None Color: None Gross Solids: None Vegetation: None Benthic Growth: None Stains: None Non-illicit: None	Notes Outfall fully submerged and not located - screened upstream at 03-81 US1. Floating gross solids (litter) in upstream manhole. Condition Assessment Graffiti: None Erosion: None Deposition: None in. Damage: None

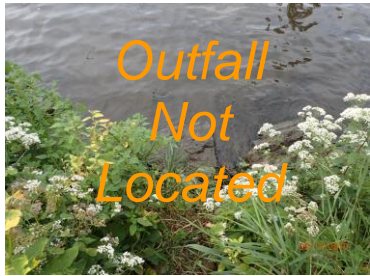
<div style="font-size: 1.2em; font-weight: bold; color: black;">o20190917135900.JPG</div> <div style="font-size: 1.5em; font-weight: bold; color: black;">2019</div>

Inspection Date: 9/17/2019 3:00:32 PM		Type: Ongoing	Flow: Submerged (not located)	Previous Rainfall (hrs): 48-72
Illicit Discharge Potential: Potential		Inspector: JCW		
Submerged: Fully		Depth (in):		
Sampling Results Sample Location: _____ Total Chlorine: -- ppm Free Chlorine: -- ppm Ammonia: -- ppm pH: -- units Temperature -- ° F Conductivity: -- µS/cm Detergents: -- mg/L		Floatables: None Odor: None Turbidity: None Color: None Gross Solids: None Vegetation: None Benthic Growth: None Stains: None Non-illicit: None	Notes Outfall fully submerged and not located - screened upstream at 03-81 US1. Floating gross solids (litter) in manhole. Condition Assessment Graffiti: None Erosion: None Deposition: None in. Damage: None

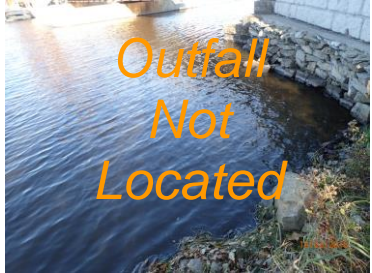
o20181022151216.JPG

Inspection Date: 10/22/2018 3:13:39 PM		Type: Ongoing	Flow: Submerged (not located)	Previous Rainfall (hrs): 48-72
Illicit Discharge Potential: Potential		Inspector: JCW	Notes	
Submerged: Fully		Depth (in):	Outfall fully submerged and not located - screened upstream at 03-81 US1. Floating gross solids (litter) in manhole.	
Sampling Results		Floatables:	Condition Assessment Graffiti: None Erosion: None Deposition: None in. Damage: None	
Sample Location:		Odor:		
Total Chlorine: -- ppm		Turbidity:		
Free Chlorine: -- ppm		Color:		
Ammonia: -- ppm		Gross Solids:		
pH: -- units		Vegetation:		
Temperature -- °F		Benthic Growth:		
Conductivity: -- µS/cm		Stains:		
Detergents: -- mg/L		Non-illicit:

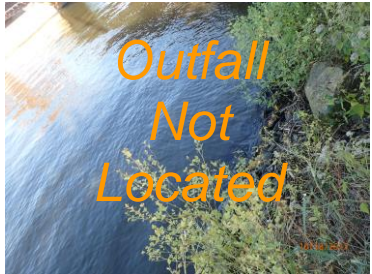
o20171018144750.JPG

Inspection Date: 10/18/2017 2:50:50 PM		Type: Ongoing	Flow: Submerged (not located)	Previous Rainfall (hrs): 72+
Illicit Discharge Potential: Potential		Inspector: JCW	Notes	
Submerged: Fully		Depth (in):	Outfall fully submerged and not located - screened upstream at 03-81 US1. Ammonia, detergent and sheen in upstream manhole.	
Sampling Results		Floatables:	Condition Assessment Graffiti: None Erosion: None Deposition: None in. Damage: None	
Sample Location:		Odor:		
Total Chlorine: -- ppm		Turbidity:		
Free Chlorine: -- ppm		Color:		
Ammonia: -- ppm		Gross Solids:		
pH: -- units		Vegetation:		
Temperature -- °F		Benthic Growth:		
Conductivity: -- µS/cm		Stains:		
Detergents: -- mg/L		Non-illicit:

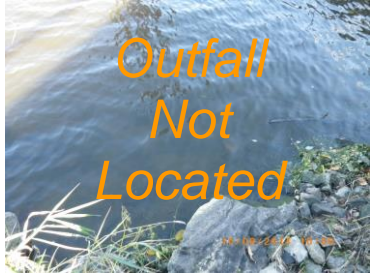
o20141009090032.JPG

Inspection Date: 10/9/2014 10:00:10 AM		Type: Ongoing	Flow: Submerged (not located)	Previous Rainfall (hrs): 72+
Illicit Discharge Potential: Obvious		Inspector: JCW		
Submerged: Fully		Depth (in):		
Sampling Results		Notes		
Sample Location:		Outfall fully submerged and not located - screened upstream at 03-81 US1.		
Total Chlorine: -- ppm	Floatables: None	Condition Assessment Graffiti: None Erosion: None Deposition: None in. Damage: None		
Free Chlorine: -- ppm	Odor: None			
Ammonia: -- ppm	Turbidity: None			
pH: -- units	Color: None			
Temperature -- °F	Gross Solids: None			
Conductivity: -- µS/cm	Vegetation: None			
Detergents: -- mg/L	Benthic Growth: None			
	Stains: None			
	Non-illicit: None

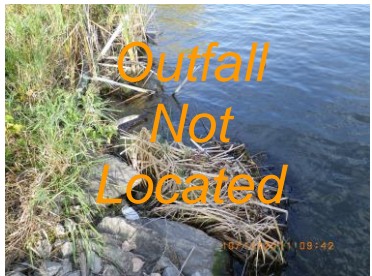
o20111011094236.JPG

Inspection Date: 10/11/2011 9:42:33 AM		Type: Ongoing	Flow: Submerged (not located)	Previous Rainfall (hrs): 72+
Illicit Discharge Potential: Unlikely		Inspector: JCW		
Submerged: Fully		Depth (in):		
Sampling Results		Notes		
Sample Location:		2010 screening follow-up. Outfall fully submerged and not physically located. Outfall screened upstream at 03-81 US1.		
Total Chlorine: -- ppm	Floatables: None	Condition Assessment Graffiti: None Erosion: None Deposition: None 0 in. Damage: None		
Free Chlorine: -- ppm	Odor: None			
Ammonia: -- ppm	Turbidity: None			
pH: -- units	Color: None			
Temperature -- °F	Gross Solids: None			
Conductivity: -- µS/cm	Vegetation: None			
Detergents: -- mg/L	Benthic Growth: None			
	Stains: None			
	Non-illicit: None

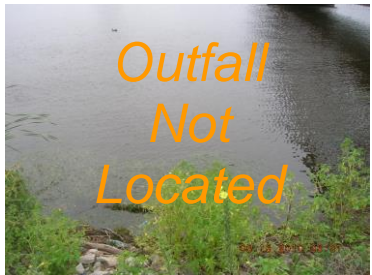
o20100818083116.JPG

Inspection Date: 8/18/2010 8:38:23 AM		Type: Ongoing	Flow: Submerged (not located)	Previous Rainfall (hrs): 72+
Illicit Discharge Potential: Potential		Inspector: JCW		
Submerged: Fully		Depth (in):		
Sampling Results		Notes		
Sample Location:		Outfall fully submerged and not physically located. Outfall screened upstream at 03-81 US1.		
Total Chlorine: -- ppm	Floatables: None	Condition Assessment Graffiti: None Erosion: None Deposition: None 0 in. Damage: None		
Free Chlorine: -- ppm	Odor: None			
Ammonia: -- ppm	Turbidity: None			
pH: -- units	Color: None			
Temperature -- °F	Gross Solids: None			
Conductivity: -- µS/cm	Vegetation: None			
Detergents: -- mg/L	Benthic Growth: None			
	Stains: None			
	Non-illicit: None

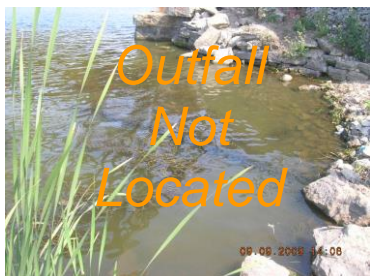
Osh09_DSCN6745.JPG

Inspection Date: 9/9/2009		Type: Initial	Flow: Submerged (not located)	Previous Rainfall (hrs): 72+
Illicit Discharge Potential: Obvious		Inspector: JCW		
Submerged: Fully		Depth (in):		
Sampling Results		Notes		
Sample Location:		Outfall fully submerged and not physically located. Outfall screened upstream at 03-81 US1.		
Total Chlorine: -- ppm	Floatables: None	Condition Assessment Graffiti: None Erosion: None Deposition: None 0 in. Damage: None		
Free Chlorine: -- ppm	Odor: None			
Ammonia: -- ppm	Turbidity: None			
pH: -- units	Color: None			
Temperature -- °F	Gross Solids: None			
Conductivity: -- µS/cm	Vegetation: None			
Detergents: -- mg/L	Benthic Growth: None			
	Stains: None			
	Non-illicit: None

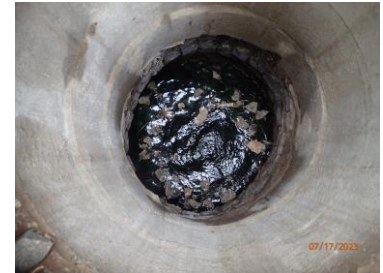
o20230717133924.JPG

Notes: Sample collected from submerged pool in manhole. Replacement lid too large for casting.

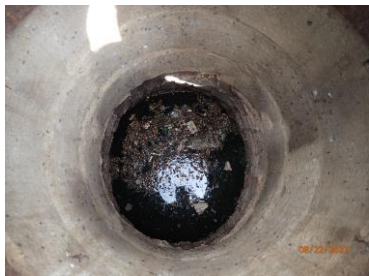
o20220822135248.JPG

Inspection Date: 8/22/2022 1:55:00 PM		Type: Ongoing	Flow: Submerged, indeterminate	Previous Rainfall (hrs): 72+
Illicit Discharge Potential: Potential		Inspector: EJK		
Submerged: Fully		Depth (in):		
Sampling Results		Notes Sample collected from submerged pool in manhole. Floating gross solids (litter) in manhole.		
Sample Location: Pool	Floatables: None	Condition Assessment Graffiti: None Erosion: None Deposition: None in. Damage: None		
Total Chlorine: 0 ppm	Odor: None			
Free Chlorine: 0 ppm	Turbidity: None			
Ammonia: 0 ppm	Color: None			
pH: 8.43 units	Gross Solids: Moderate			
Temperature 75 °F	Vegetation: None			
Conductivity: 345 µS/cm	Benthic Growth: None			
Detergents: 0 mg/L	Stains: None			
	Non-illicit: None

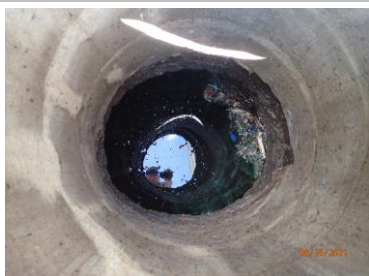
o20210816111026.JPG

Inspection Date: 8/16/2021 11:13:37 AM		Type: Ongoing	Flow: Submerged, indeterminate	Previous Rainfall (hrs): 72+
Illicit Discharge Potential: Potential		Inspector: JCW		
Submerged: Fully		Depth (in): 56		
Sampling Results		Notes Sample collected from submerged pool in manhole. Floating gross solids (litter) in manhole.		
Sample Location: Pool	Floatables: None	Condition Assessment Graffiti: None Erosion: None Deposition: None in. Damage: None		
Total Chlorine: 0 ppm	Odor: None			
Free Chlorine: 0 ppm	Turbidity: None			
Ammonia: 0 ppm	Color: None			
pH: 7.56 units	Gross Solids: Moderate			
Temperature 77 °F	Vegetation: None			
Conductivity: 317 µS/cm	Benthic Growth: None			
Detergents: 0 mg/L	Stains: None			
	Non-illicit: None

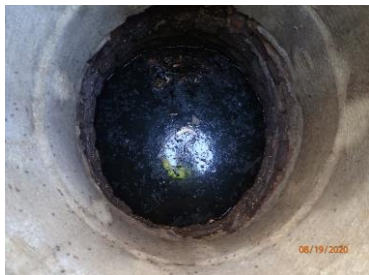
o20200819141648.JPG

Inspection Date: 8/19/2020 2:19:30 PM		Type: Ongoing	Flow: Submerged, indeterminate	Previous Rainfall (hrs): 72+
Illicit Discharge Potential: Potential		Inspector: JCW		
Submerged: Fully		Depth (in): 50		
Sampling Results		Notes Sample collected from submerged pool in manhole. Floating gross solids (litter) in manhole. Elevated pH seemed widespread in river.		
Sample Location: Pool	Floatables: None	Condition Assessment Graffiti: None Erosion: None Deposition: None in. Damage: None		
Total Chlorine: 0 ppm	Odor: None			
Free Chlorine: 0 ppm	Turbidity: None			
Ammonia: 0 ppm	Color: Faint in bottle			
pH: 9.09 units	Gross Solids: Moderate			
Temperature 84 °F	Vegetation: None			
Conductivity: 327 µS/cm	Benthic Growth: None			
Detergents: 0 mg/L	Stains: None			
	Non-illicit: None

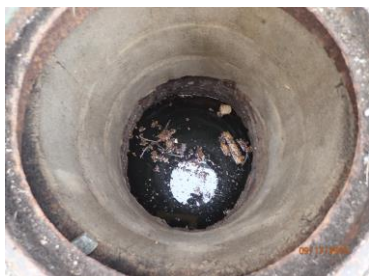
o20190917140134.JPG

Inspection Date: 9/17/2019 3:03:50 PM		Type: Ongoing	Flow: Submerged, indeterminate	Previous Rainfall (hrs): 48-72
Illicit Discharge Potential: Potential		Inspector: JCW		
Submerged: Fully		Depth (in): 52		
Sampling Results		Notes Sample collected from submerged pool in manhole. Floating gross solids (litter) in manhole.		
Sample Location: Pool	Floatables: None	Condition Assessment Graffiti: None Erosion: None Deposition: None in. Damage: None		
Total Chlorine: 0 ppm	Odor: None			
Free Chlorine: 0 ppm	Turbidity: None			
Ammonia: 0 ppm	Color: None			
pH: 8.07 units	Gross Solids: Moderate			
Temperature 75 °F	Vegetation: None			
Conductivity: 399 µS/cm	Benthic Growth: None			
Detergents: 0 mg/L	Stains: None			
	Non-illicit: None

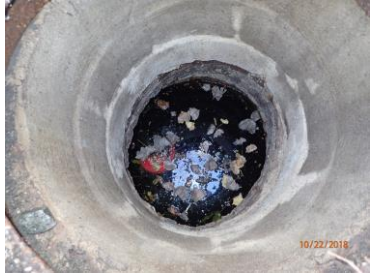
Inspection Date: 10/22/2018 3:18:57 PM		Type: Ongoing	Flow: Submerged, indeterminate	Previous Rainfall (hrs): 48-72
Illicit Discharge Potential: Potential		Inspector: JCW	Notes	
Submerged: Fully		Depth (in): 57	Floating gross solids (litter) in manhole.	
Sampling Results		Condition Assessment		
Sample Location: Pool	Floatables: None	Graffiti: None

o20181022151626.JPG 2018	
Total Chlorine: 0 ppm	Odor: None	Erosion: None		
Free Chlorine: 0 ppm	Turbidity: None	Deposition: None		
Ammonia: 0 ppm	Color: None	Damage: None		
pH: 7.62 units	Gross Solids: Moderate			
Temperature 57 °F	Vegetation: None			
Conductivity: 357 µS/cm	Benthic Growth: None			
Detergents: 0 mg/L	Stains: None			
	Non-illicit: None

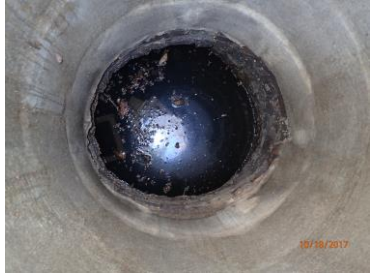
Inspection Date: 10/18/2017 2:55:07 PM		Type: Ongoing	Flow: Submerged, indeterminate	Previous Rainfall (hrs): 72+
Illicit Discharge Potential: Potential		Inspector: JCW	Notes	
Submerged: Fully		Depth (in): 50	Elevated ammonia and detergent in sample from manhole pool. Slight sheen observed on surface.	
Sampling Results		Condition Assessment		
Sample Location: Pool	Floatables: Moderate	Graffiti: None

o20171018145016.JPG 2017	
Total Chlorine: 0 ppm	Odor: None	Erosion: None		
Free Chlorine: 0 ppm	Turbidity: None	Deposition: None		
Ammonia: 1 ppm	Color: Faint in bottle	Damage: None		
pH: 7.22 units	Gross Solids: Slight			
Temperature 66 °F	Vegetation: None			
Conductivity: 1020 µS/cm	Benthic Growth: None			
Detergents: 0.8 mg/L	Stains: None			
	Non-illicit: None

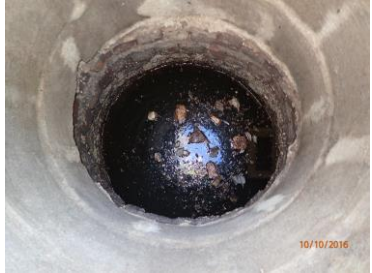
Inspection Date: 10/10/2016 9:04:32 AM		Type: Ongoing	Flow: Submerged, indeterminate	Previous Rainfall (hrs): 72+
Illicit Discharge Potential: Potential		Inspector: JCW	Notes	
Submerged: Fully		Depth (in): 46	Potential illicit discharge due to gross solids and petroleum odor and sheen and elevated ammonia.	
Sampling Results		Condition Assessment		
Sample Location: Pool	Floatables: Moderate	Graffiti: None

o20161010090136.JPG 2016	
Total Chlorine: 0 ppm	Odor: Faint	Erosion: None		
Free Chlorine: 0 ppm	Turbidity: None	Deposition: None		
Ammonia: 1 ppm	Color: Faint in bottle	Damage: None		
pH: 7.41 units	Gross Solids: Slight			
Temperature 63 °F	Vegetation: None			
Conductivity: 565 µS/cm	Benthic Growth: None			
Detergents: 0 mg/L	Stains: None			
	Non-illicit: None

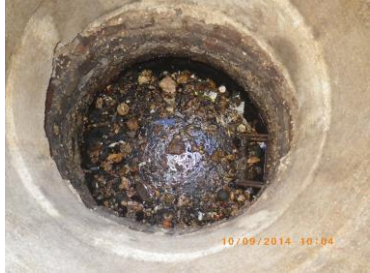
o20141009090404.JPG

Inspection Date: 10/9/2014 10:07:49 AM		Type: Ongoing	Flow: Submerged, indeterminate	Previous Rainfall (hrs): 72+
Illicit Discharge Potential: Obvious		Inspector: JCW	Notes	
Submerged: Fully		Depth (in): 44	Petroleum odor and sheen on surface.	
Sampling Results		Floatables: Moderate	Condition Assessment	
Sample Location: Pool		Odor: Faint	Graffiti: None	
Total Chlorine: 0 ppm		Turbidity: None	Erosion: None	
Free Chlorine: 0 ppm		Color: None	Deposition: Minor 2 in.	
Ammonia: 0.5 ppm		Gross Solids: Severe	Damage: None	
pH: 7.58 units		Vegetation: None		
Temperature 58 °F		Benthic Growth: None		
Conductivity: 679 µS/cm		Stains: None		
Detergents: 0 mg/L		Non-illicit: None

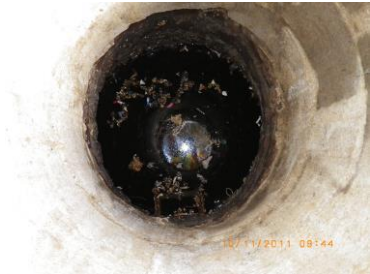
o20111011094434.JPG

Inspection Date: 10/11/2011 9:46:04 AM		Type: Ongoing	Flow: Submerged, indeterminate	Previous Rainfall (hrs): 72+
Illicit Discharge Potential: Unlikely		Inspector: JCW	Notes	
Submerged: Fully		Depth (in): 38	2010 screening follow-up. Floatable debris significantly reduced.	
Sampling Results		Floatables: None	Condition Assessment	
Sample Location: Pool		Odor: None	Graffiti: None	
Total Chlorine: 0 ppm		Turbidity: None	Erosion: None	
Free Chlorine: 0 ppm		Color: None	Deposition: None 0 in.	
Ammonia: 0.25 ppm		Gross Solids: Slight	Damage: None	
pH: 7.68 units		Vegetation: None		
Temperature 71 °F		Benthic Growth: None		
Conductivity: -- µS/cm		Stains: None		
Detergents: -- mg/L		Non-illicit: None

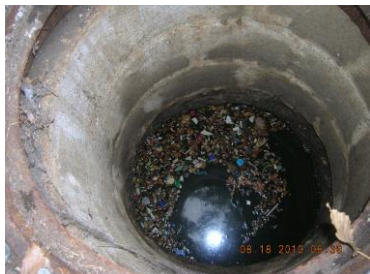
o20100818083958.JPG

Inspection Date: 8/18/2010 8:43:09 AM		Type: Ongoing	Flow: Submerged, indeterminate	Previous Rainfall (hrs): 72+
Illicit Discharge Potential: Potential		Inspector: JCW	Notes	
Submerged: Fully		Depth (in): 47	Petroleum odor likely from residual petroleum in pipes after 2009 jetting.	
Sampling Results		Floatables: None	Condition Assessment	
Sample Location: Pool		Odor: Faint	Graffiti: None	
Total Chlorine: 0 ppm		Turbidity: None	Erosion: None	
Free Chlorine: 0 ppm		Color: None	Deposition: None 0 in.	
Ammonia: 0 ppm		Gross Solids: Moderate	Damage: None	
pH: 6.63 units		Vegetation: None		
Temperature 71 °F		Benthic Growth: None		
Conductivity: -- µS/cm		Stains: Moderate		
Detergents: 0 mg/L		Non-illicit: None

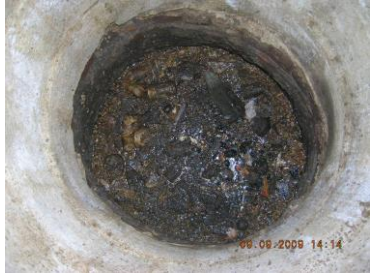
Inspection Date: 9/9/2009		Type: Initial		Flow: Submerged, indeterminate		Previous Rainfall (hrs): 72+	
Illicit Discharge Potential: Obvious		Inspector: JCW		Notes Diesel/oil odor, sheen on surface. Floatables with grease. Brown/gray color.

Osh09_DSCN6747.JPG	
Submerged: Fully		Depth (in): 44					
Sampling Results Sample Location: Pool Total Chlorine: 0 ppm Free Chlorine: 0 ppm Ammonia: -- ppm pH: 6.98 units Temperature: 73 °F Conductivity: -- µS/cm Detergents: 0 mg/L		Floatables: Severe Odor: Easily detected Turbidity: None Color: Faint in bottle Gross Solids: Severe Vegetation: None Benthic Growth: None Stains: None Non-illicit: None		Condition Assessment Graffiti: None Erosion: None Deposition: None 0 in. Damage: None		2009

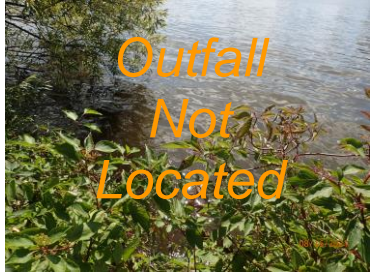
Inspection Date: 8/16/2021 3:16:07 PM		Type: Ongoing	Flow: Submerged (not located)	Previous Rainfall (hrs): 72+
Illicit Discharge Potential: Potential		Inspector: JCW		
Submerged: Fully		Depth (in):		
Sampling Results Sample Location: _____ Total Chlorine: -- ppm Free Chlorine: -- ppm Ammonia: -- ppm pH: -- units Temperature: -- °F Conductivity: -- µS/cm Detergents: -- mg/L		Floatables: None Odor: None Turbidity: None Color: None Gross Solids: None Vegetation: None Benthic Growth: None Stains: None Non-illicit: None	Notes Outfall fully submerged and not located - screened upstream at 05-14 US1. Floating gross solids (litter) in upstream manhole.

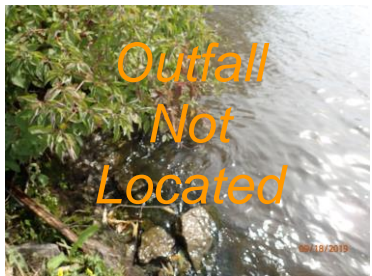
Inspection Date: 9/18/2019 2:47:43 PM		Type: Ongoing	Flow: Submerged (not located)	Previous Rainfall (hrs): 72+
Illicit Discharge Potential: Potential		Inspector: JCW		
Submerged: Fully		Depth (in):		
Sampling Results Sample Location: _____ Total Chlorine: -- ppm Free Chlorine: -- ppm Ammonia: -- ppm pH: -- units Temperature: -- °F Conductivity: -- µS/cm Detergents: -- mg/L		Floatables: None Odor: None Turbidity: None Color: None Gross Solids: None Vegetation: None Benthic Growth: None Stains: None Non-illicit: None	Notes Outfall fully submerged and not located - screened upstream at 05-14 US1. Floating gross solids (litter) in manhole.

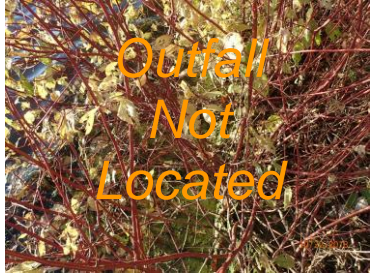
o20181022170942.JPG

Inspection Date: 10/22/2018 5:09:36 PM		Type: Ongoing	Flow: Submerged (not located)	Previous Rainfall (hrs): 48-72
Illicit Discharge Potential: Potential		Inspector: JCW	Notes	
Submerged: Fully		Depth (in):	Outfall fully submerged and not located - screened upstream at 05-14 US1. Floating gross solids (litter) in manhole.	
Sampling Results		Floatables:	Condition Assessment Graffiti: None Erosion: None Deposition: None in. Damage: None	
Sample Location:		Odor:		
Total Chlorine: -- ppm		Turbidity:		
Free Chlorine: -- ppm		Color:		
Ammonia: -- ppm		Gross Solids:		
pH: -- units		Vegetation:		
Temperature -- °F		Benthic Growth:		
Conductivity: -- µS/cm		Stains:		
Detergents: -- mg/L		Non-illicit:

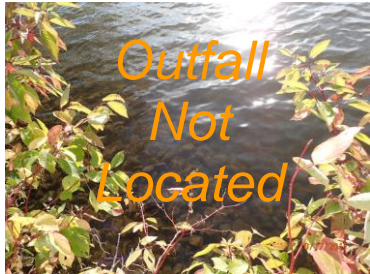
o20171017155038.JPG

Inspection Date: 10/17/2017 3:57:26 PM		Type: Ongoing	Flow: Submerged (not located)	Previous Rainfall (hrs): 48-72
Illicit Discharge Potential: Potential		Inspector: JCW	Notes	
Submerged: Fully		Depth (in):	Outfall fully submerged and not located - screened upstream at 05-14 US1. Floating gross solids (litter) in manhole.	
Sampling Results		Floatables:	Condition Assessment Graffiti: None Erosion: None Deposition: None in. Damage: None	
Sample Location:		Odor:		
Total Chlorine: -- ppm		Turbidity:		
Free Chlorine: -- ppm		Color:		
Ammonia: -- ppm		Gross Solids:		
pH: -- units		Vegetation:		
Temperature -- °F		Benthic Growth:		
Conductivity: -- µS/cm		Stains:		
Detergents: -- mg/L		Non-illicit:

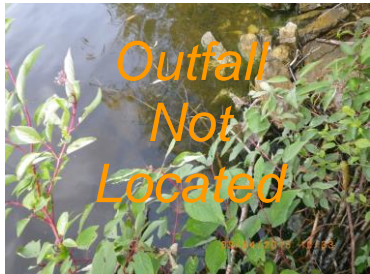
o20150924093340.JPG

Inspection Date: 9/24/2015 10:30:54 AM		Type: Ongoing	Flow: Submerged (not located)	Previous Rainfall (hrs): 72+
Illicit Discharge Potential: Potential		Inspector: JCW	Notes	
Submerged: Fully		Depth (in):	Outfall fully submerged and not located - screened at 05-14 US1.	
Sampling Results		Floatables:	Condition Assessment Graffiti: None Erosion: None Deposition: None in. Damage: None	
Sample Location:		Odor:		
Total Chlorine: -- ppm		Turbidity:		
Free Chlorine: -- ppm		Color:		
Ammonia: -- ppm		Gross Solids:		
pH: -- units		Vegetation:		
Temperature -- °F		Benthic Growth:		
Conductivity: -- µS/cm		Stains:		
Detergents: -- mg/L		Non-illicit:

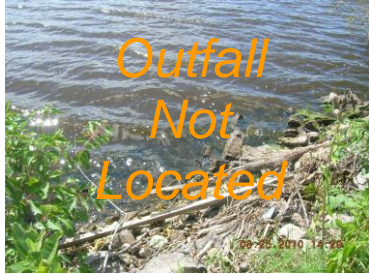
o20100825142900.JPG

Inspection Date: 8/25/2010 2:37:24 PM		Type: Ongoing	Flow: Submerged (not located)	Previous Rainfall (hrs): 72+
Illicit Discharge Potential: Unlikely		Inspector: JCW	Notes	
Submerged: Fully		Depth (in):	Outfall fully submerged and not physically located. Outfall screened upstream at 05-14 US2.	
Sampling Results		Floatables:	Condition Assessment	
Sample Location:		Odor:	Graffiti: None Erosion: None Deposition: None 0 in. Damage: None	
Total Chlorine: -- ppm		Turbidity:		
Free Chlorine: -- ppm		Color:		
Ammonia: -- ppm		Gross Solids:		
pH: -- units		Vegetation:		
Temperature -- °F		Benthic Growth:		
Conductivity: -- µS/cm		Stains:		
Detergents: -- mg/L		Non-illicit:

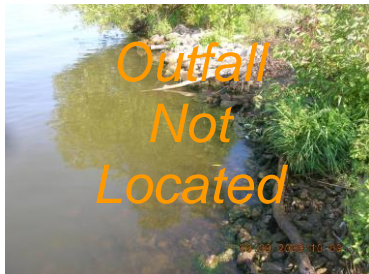
Osh09_DSCN6696.JPG

Inspection Date: 9/9/2009		Type: Initial	Flow: Submerged (not located)	Previous Rainfall (hrs): 72+
Illicit Discharge Potential: Potential		Inspector: JCW	Notes	
Submerged: Fully		Depth (in):	Outfall fully submerged and not physically located. Outfall screened upstream at 05-14 US2.	
Sampling Results		Floatables:	Condition Assessment	
Sample Location:		Odor:	Graffiti: None Erosion: None Deposition: None 0 in. Damage: None	
Total Chlorine: -- ppm		Turbidity:		
Free Chlorine: -- ppm		Color:		
Ammonia: -- ppm		Gross Solids:		
pH: -- units		Vegetation:		
Temperature -- °F		Benthic Growth:		
Conductivity: -- µS/cm		Stains:		
Detergents: -- mg/L		Non-illicit:

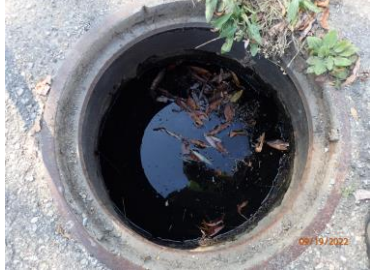
o20220919141718.JPG <div style="text-align: center; font-size: 24pt; font-weight: bold;">2022</div>

Sample Location:	Pool																																					
Total Chlorine:	0 ppm																																					
Free Chlorine:	0 ppm																																					
Ammonia:	0 ppm																																					
pH:	7.58 units																																					
Temperature:	73 °F																																					
Conductivity:	672 µS/cm																																					
Detergents:	0 mg/L																																					
Floatables:	None																																					
Odor:	None																																					
Turbidity:	None																																					
Color:	None																																					
Gross Solids:	Slight																																					
Vegetation:	None																																					
Benthic Growth:	Slight																																					
Stains:	None																																					
Non-illicit:	Slight

Notes Sample collected from submerged pool in manhole.																																				
		Condition Assessment <table border="1" style="width:100%; border-collapse: collapse;"> <tr><td>Graffiti:</td><td>None</td></tr> <tr><td>Erosion:</td><td>None</td></tr> <tr><td>Deposition:</td><td>None in.</td></tr> <tr><td>Damage:</td><td>None</td></tr> </table>			Graffiti:	None	Erosion:	None	Deposition:	None in.	Damage:	None																										
Graffiti:	None																																					
Erosion:	None																																					
Deposition:	None in.																																					
Damage:	None

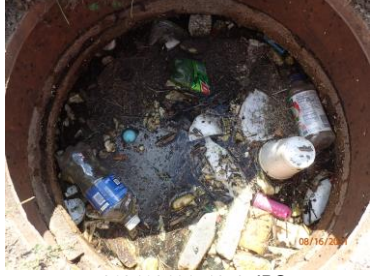
o20210816151352.JPG <div style="text-align: center; font-size: 24pt; font-weight: bold;">2021</div>

Inspection Date: 8/16/2021 3:16:49 PM		Type: Ongoing	Flow: Submerged, indeterminate	Previous Rainfall (hrs): 72+																																		
Illicit Discharge Potential: Potential		Inspector: JCW																																				
Submerged: Fully		Depth (in): 46																																				
Sampling Results <table border="1" style="width:100%; border-collapse: collapse;"> <tr><td>Sample Location:</td><td>Pool</td></tr> <tr><td>Total Chlorine:</td><td>0 ppm</td></tr> <tr><td>Free Chlorine:</td><td>0 ppm</td></tr> <tr><td>Ammonia:</td><td>0 ppm</td></tr> <tr><td>pH:</td><td>8 units</td></tr> <tr><td>Temperature:</td><td>85 °F</td></tr> <tr><td>Conductivity:</td><td>367 µS/cm</td></tr> <tr><td>Detergents:</td><td>0 mg/L</td></tr> </table>		Sample Location:	Pool	Total Chlorine:	0 ppm	Free Chlorine:	0 ppm	Ammonia:	0 ppm	pH:	8 units	Temperature:	85 °F	Conductivity:	367 µS/cm	Detergents:	0 mg/L	<table border="1" style="width:100%; border-collapse: collapse;"> <tr><td>Floatables:</td><td>None</td></tr> <tr><td>Odor:</td><td>None</td></tr> <tr><td>Turbidity:</td><td>None</td></tr> <tr><td>Color:</td><td>None</td></tr> <tr><td>Gross Solids:</td><td>Severe</td></tr> <tr><td>Vegetation:</td><td>None</td></tr> <tr><td>Benthic Growth:</td><td>None</td></tr> <tr><td>Stains:</td><td>None</td></tr> <tr><td>Non-illicit:</td><td>None</td></tr> </table>			Floatables:	None	Odor:	None	Turbidity:	None	Color:	None	Gross Solids:	Severe	Vegetation:	None	Benthic Growth:	None	Stains:	None	Non-illicit:	None

Notes Sample collected from submerged pool in manhole. Floating gross solids (litter) in manhole.																																				
		Condition Assessment <table border="1" style="width:100%; border-collapse: collapse;"> <tr><td>Graffiti:</td><td>None</td></tr> <tr><td>Erosion:</td><td>None</td></tr> <tr><td>Deposition:</td><td>None in.</td></tr> <tr><td>Damage:</td><td>None</td></tr> </table>			Graffiti:	None	Erosion:	None	Deposition:	None in.	Damage:	None																										
Graffiti:	None																																					
Erosion:	None																																					
Deposition:	None in.																																					
Damage:	None

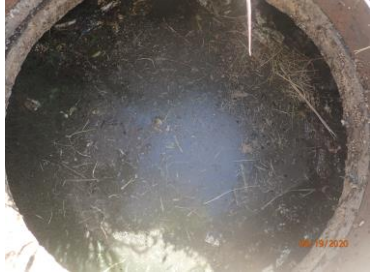
o20200819154014.JPG <div style="text-align: center; font-size: 24pt; font-weight: bold;">2020</div>

Inspection Date: 8/19/2020 3:39:59 PM		Type: Ongoing	Flow: Submerged, indeterminate	Previous Rainfall (hrs): 72+																																		
Illicit Discharge Potential: Unlikely		Inspector: JCW																																				
Submerged: Fully		Depth (in): 43																																				
Sampling Results <table border="1" style="width:100%; border-collapse: collapse;"> <tr><td>Sample Location:</td><td>Pool</td></tr> <tr><td>Total Chlorine:</td><td>0 ppm</td></tr> <tr><td>Free Chlorine:</td><td>0 ppm</td></tr> <tr><td>Ammonia:</td><td>0 ppm</td></tr> <tr><td>pH:</td><td>7.94 units</td></tr> <tr><td>Temperature:</td><td>87 °F</td></tr> <tr><td>Conductivity:</td><td>1577 µS/cm</td></tr> <tr><td>Detergents:</td><td>0 mg/L</td></tr> </table>		Sample Location:	Pool	Total Chlorine:	0 ppm	Free Chlorine:	0 ppm	Ammonia:	0 ppm	pH:	7.94 units	Temperature:	87 °F	Conductivity:	1577 µS/cm	Detergents:	0 mg/L	<table border="1" style="width:100%; border-collapse: collapse;"> <tr><td>Floatables:</td><td>None</td></tr> <tr><td>Odor:</td><td>None</td></tr> <tr><td>Turbidity:</td><td>None</td></tr> <tr><td>Color:</td><td>None</td></tr> <tr><td>Gross Solids:</td><td>Slight</td></tr> <tr><td>Vegetation:</td><td>None</td></tr> <tr><td>Benthic Growth:</td><td>None</td></tr> <tr><td>Stains:</td><td>None</td></tr> <tr><td>Non-illicit:</td><td>None</td></tr> </table>			Floatables:	None	Odor:	None	Turbidity:	None	Color:	None	Gross Solids:	Slight	Vegetation:	None	Benthic Growth:	None	Stains:	None	Non-illicit:	None

Notes Sample collected from submerged pool in manhole. Floating gross solids (litter) in manhole.																																				
		Condition Assessment <table border="1" style="width:100%; border-collapse: collapse;"> <tr><td>Graffiti:</td><td>None</td></tr> <tr><td>Erosion:</td><td>None</td></tr> <tr><td>Deposition:</td><td>None in.</td></tr> <tr><td>Damage:</td><td>None</td></tr> </table>			Graffiti:	None	Erosion:	None	Deposition:	None in.	Damage:	None																										
Graffiti:	None																																					
Erosion:	None																																					
Deposition:	None in.																																					
Damage:	None

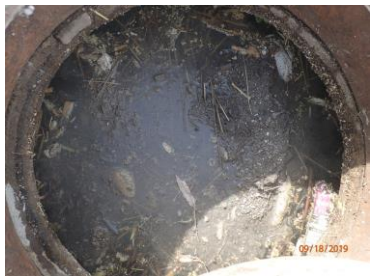
o20190918134540.JPG <div style="text-align: center; font-size: 24pt; font-weight: bold;">2019</div>

Inspection Date: 9/18/2019 2:48:24 PM		Type: Ongoing	Flow: Submerged, indeterminate	Previous Rainfall (hrs): 72+																																		
Illicit Discharge Potential: Potential		Inspector: JCW																																				
Submerged: Partially		Depth (in): 45																																				
Sampling Results <table border="1" style="width:100%; border-collapse: collapse;"> <tr><td>Sample Location:</td><td>Pool</td></tr> <tr><td>Total Chlorine:</td><td>0 ppm</td></tr> <tr><td>Free Chlorine:</td><td>0 ppm</td></tr> <tr><td>Ammonia:</td><td>0 ppm</td></tr> <tr><td>pH:</td><td>8.9 units</td></tr> <tr><td>Temperature:</td><td>78 °F</td></tr> <tr><td>Conductivity:</td><td>383 µS/cm</td></tr> <tr><td>Detergents:</td><td>0 mg/L</td></tr> </table>		Sample Location:	Pool	Total Chlorine:	0 ppm	Free Chlorine:	0 ppm	Ammonia:	0 ppm	pH:	8.9 units	Temperature:	78 °F	Conductivity:	383 µS/cm	Detergents:	0 mg/L	<table border="1" style="width:100%; border-collapse: collapse;"> <tr><td>Floatables:</td><td>None</td></tr> <tr><td>Odor:</td><td>None</td></tr> <tr><td>Turbidity:</td><td>None</td></tr> <tr><td>Color:</td><td>None</td></tr> <tr><td>Gross Solids:</td><td>Moderate</td></tr> <tr><td>Vegetation:</td><td>None</td></tr> <tr><td>Benthic Growth:</td><td>None</td></tr> <tr><td>Stains:</td><td>None</td></tr> <tr><td>Non-illicit:</td><td>None</td></tr> </table>			Floatables:	None	Odor:	None	Turbidity:	None	Color:	None	Gross Solids:	Moderate	Vegetation:	None	Benthic Growth:	None	Stains:	None	Non-illicit:	None

Notes Sample collected from submerged pool in manhole. Floating gross solids (litter) in manhole.																																				
		Condition Assessment <table border="1" style="width:100%; border-collapse: collapse;"> <tr><td>Graffiti:</td><td>None</td></tr> <tr><td>Erosion:</td><td>None</td></tr> <tr><td>Deposition:</td><td>None in.</td></tr> <tr><td>Damage:</td><td>None</td></tr> </table>			Graffiti:	None	Erosion:	None	Deposition:	None in.	Damage:	None																										
Graffiti:	None																																					
Erosion:	None																																					
Deposition:	None in.																																					
Damage:	None

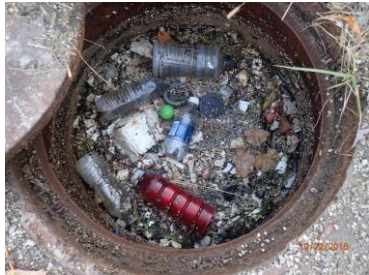
o20181022171308.JPG

Inspection Date: 10/22/2018 5:15:36 PM		Type: Ongoing	Flow: Submerged, indeterminate	Previous Rainfall (hrs): 48-72
Illicit Discharge Potential: Potential		Inspector: JCW	Notes	
Submerged: Fully		Depth (in): 47	Sample collected from submerged pool in manhole. Floating gross solids (litter) in manhole.	
Sampling Results		Floatables: None	Condition Assessment	
Sample Location: Pool		Odor: None	Graffiti: None	
Total Chlorine: 0 ppm		Turbidity: Cloudy	Erosion: None	
Free Chlorine: 0 ppm		Color: None	Deposition: None in.	
Ammonia: 0 ppm		Gross Solids: Severe	Damage: None	
pH: 7.59 units		Vegetation: None		
Temperature 56 °F		Benthic Growth: None		
Conductivity: 361 µS/cm		Stains: None		
Detergents: 0 mg/L		Non-illicit: None

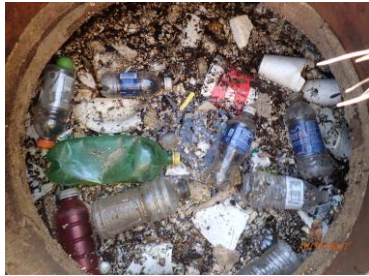
o20171017155256.JPG

Inspection Date: 10/17/2017 3:58:36 PM		Type: Ongoing	Flow: Submerged, indeterminate	Previous Rainfall (hrs): 48-72
Illicit Discharge Potential: Potential		Inspector: JCW	Notes	
Submerged: Fully		Depth (in): 40	Sample collected from submerged pool in manhole. Floating gross solids (litter) in manhole.	
Sampling Results		Floatables: None	Condition Assessment	
Sample Location: Pool		Odor: None	Graffiti: None	
Total Chlorine: 0 ppm		Turbidity: None	Erosion: None	
Free Chlorine: 0 ppm		Color: None	Deposition: None in.	
Ammonia: 0 ppm		Gross Solids: Severe	Damage: None	
pH: 7.93 units		Vegetation: None		
Temperature 66 °F		Benthic Growth: None		
Conductivity: 886 µS/cm		Stains: None		
Detergents: 0 mg/L		Non-illicit: None

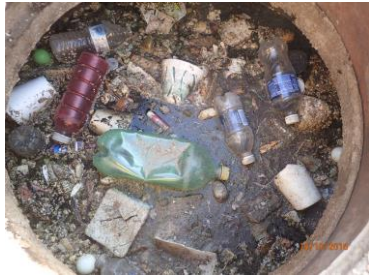
o20161010154428.JPG

Inspection Date: 10/10/2016 3:46:48 PM		Type: Ongoing	Flow: Submerged, indeterminate	Previous Rainfall (hrs): 72+
Illicit Discharge Potential: Potential		Inspector: JCW	Notes	
Submerged: Fully		Depth (in): 41	Potential illicit discharge due to gross solids.	
Sampling Results		Floatables: None	Condition Assessment	
Sample Location: Pool		Odor: None	Graffiti: None	
Total Chlorine: 0 ppm		Turbidity: None	Erosion: None	
Free Chlorine: 0 ppm		Color: None	Deposition: None in.	
Ammonia: 0 ppm		Gross Solids: Severe	Damage: None	
pH: 7.69 units		Vegetation: None		
Temperature 70 °F		Benthic Growth: None		
Conductivity: 660 µS/cm		Stains: None		
Detergents: 0 mg/L		Non-illicit: None

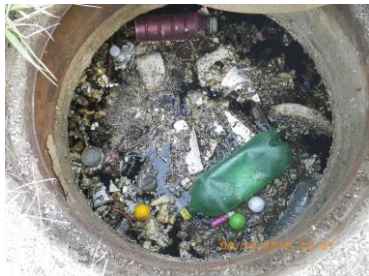
o20150924093714.JPG

Inspection Date: 9/24/2015 10:36:18 AM		Type: Ongoing	Flow: Submerged, indeterminate	Previous Rainfall (hrs): 72+
Illicit Discharge Potential: Potential		Inspector: JCW	Notes	
Submerged: Fully		Depth (in): 44	Floating gross solids (litter) in manhole.	
Sampling Results		Floatables: None	Condition Assessment	
Sample Location: Pool		Odor: None	Graffiti: None	
Total Chlorine: 0 ppm		Turbidity: None	Erosion: None	
Free Chlorine: 0 ppm		Color: None	Deposition: None in.	
Ammonia: 0 ppm		Gross Solids: Severe	Damage: None	
pH: 7.98 units		Vegetation: None		
Temperature 70 °F		Benthic Growth: None		
Conductivity: 424 µS/cm		Stains: None		
Detergents: 0 mg/L		Non-illicit: None

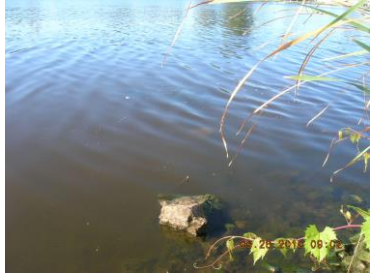
Inspection Date: 8/26/2010 9:11:00 AM		Type: Ongoing		Flow: Submerged, indeterminate		Previous Rainfall (hrs): 72+	
Illicit Discharge Potential: Unlikely		Inspector: JCW		Notes Fully submerged. Only vegetation in water is at end of pipe. Outfall screened upstream at 05-155 US1.

o20100826090214.JPG	
Submerged: Fully		Depth (in):					
Sampling Results Sample Location: _____ Total Chlorine: -- ppm Free Chlorine: -- ppm Ammonia: -- ppm pH: -- units Temperature -- °F Conductivity: -- µS/cm Detergents: -- mg/L		Floatables: None Odor: None Turbidity: None Color: None Gross Solids: None Vegetation: Slight Benthic Growth: None Stains: None Non-illicit: None		Condition Assessment Graffiti: None Erosion: None Deposition: None 0 in. Damage: None			
2010

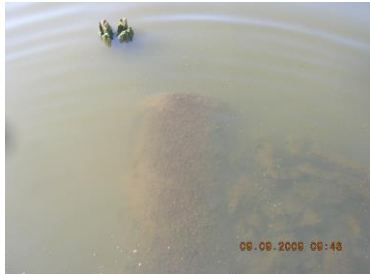
Inspection Date: 9/9/2009		Type: Initial		Flow: Submerged, indeterminate		Previous Rainfall (hrs): 72+	
Illicit Discharge Potential: Unlikely		Inspector: JCW		Notes Outfall fully submerged. Incorrectly screened upstream at water valve manhole.

Osh09_DSCN6691.JPG	
Submerged: Fully		Depth (in): 27					
Sampling Results Sample Location: _____ Total Chlorine: -- ppm Free Chlorine: -- ppm Ammonia: -- ppm pH: -- units Temperature -- °F Conductivity: -- µS/cm Detergents: -- mg/L		Floatables: None Odor: None Turbidity: None Color: None Gross Solids: None Vegetation: None Benthic Growth: None Stains: None Non-illicit: None		Condition Assessment Graffiti: None Erosion: None Deposition: None 0 in. Damage: None			
2009

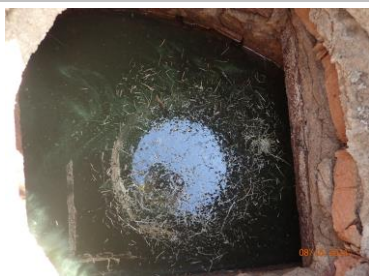
<p style="text-align: center;">o20210816150616.JPG</p> <p style="text-align: center; font-size: 24pt; font-weight: bold;">2021</p>

Sample Location:	Pool																																					
Total Chlorine:	0 ppm																																					
Free Chlorine:	0 ppm																																					
Ammonia:	0 ppm																																					
pH:	8.06 units																																					
Temperature:	84 °F																																					
Conductivity:	412 µS/cm																																					
Detergents:	0 mg/L																																					
Floatables:	None																																					
Odor:	None																																					
Turbidity:	None																																					
Color:	None																																					
Gross Solids:	None																																					
Vegetation:	None																																					
Benthic Growth:	None																																					
Stains:	None																																					
Non-illicit:	None

<div style="display: flex;"> <div style="flex: 1;"> <p>Notes</p> <p>Sample collected from submerged pool in manhole.</p> </div> <div style="flex: 1;"> <p>Condition Assessment</p> <p>Graffiti: None</p> <p>Erosion: None</p> <p>Deposition: None in.</p> <p>Damage: None</p> </div> </div>

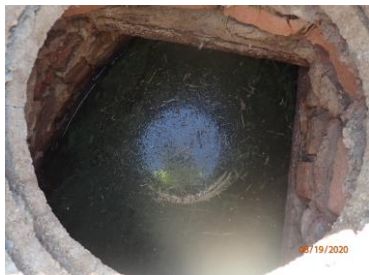
<p style="text-align: center;">o20200819160058.JPG</p> <p style="text-align: center; font-size: 24pt; font-weight: bold;">2020</p>

Sample Location:	Pool																																					
Total Chlorine:	0 ppm																																					
Free Chlorine:	0 ppm																																					
Ammonia:	0 ppm																																					
pH:	8.96 units																																					
Temperature:	87 °F																																					
Conductivity:	417 µS/cm																																					
Detergents:	0 mg/L																																					
Floatables:	None																																					
Odor:	None																																					
Turbidity:	None																																					
Color:	None																																					
Gross Solids:	None																																					
Vegetation:	None																																					
Benthic Growth:	None																																					
Stains:	None																																					
Non-illicit:	None

<div style="display: flex;"> <div style="flex: 1;"> <p>Notes</p> <p>Sample collected from submerged pool in manhole.</p> </div> <div style="flex: 1;"> <p>Condition Assessment</p> <p>Graffiti: None</p> <p>Erosion: None</p> <p>Deposition: None in.</p> <p>Damage: None</p> </div> </div>

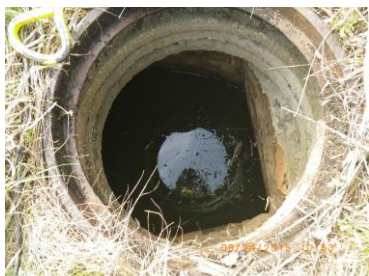
<p style="text-align: center;">o20150924095342.JPG</p> <p style="text-align: center; font-size: 24pt; font-weight: bold;">2015</p>

Sample Location:	Pool																																					
Total Chlorine:	0 ppm																																					
Free Chlorine:	0 ppm																																					
Ammonia:	0 ppm																																					
pH:	7.51 units																																					
Temperature:	70 °F																																					
Conductivity:	744 µS/cm																																					
Detergents:	0 mg/L																																					
Floatables:	None																																					
Odor:	None																																					
Turbidity:	None																																					
Color:	Faint in bottle																																					
Gross Solids:	None																																					
Vegetation:	None																																					
Benthic Growth:	None																																					
Stains:	None																																					
Non-illicit:	None

<div style="display: flex;"> <div style="flex: 1;"> <p>Notes</p> </div> <div style="flex: 1;"> <p>Condition Assessment</p> <p>Graffiti: None</p> <p>Erosion: None</p> <p>Deposition: None in.</p> <p>Damage: None</p> </div> </div>

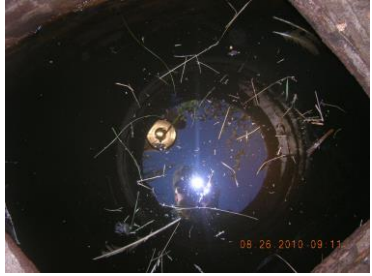
<p style="text-align: center; font-size: small;">o20100826091148.JPG</p> <p style="text-align: center; font-size: large; font-weight: bold;">2010</p>

Sample Location: Pool	Floatables: None																													
Total Chlorine: 0 ppm	Odor: None																													
Free Chlorine: 0 ppm	Turbidity: None																													
Ammonia: 0 ppm	Color: Faint in bottle																													
pH: 7.87 units	Gross Solids: None																													
Temperature: 76 °F	Vegetation: None																													
Conductivity: -- µS/cm	Benthic Growth: Slight																													
Detergents: 0 mg/L	Stains: None																													
	Non-illicit: None																													
Graffiti: None																														
Erosion: None																														
Deposition: None	0 in.																													
Damage: None

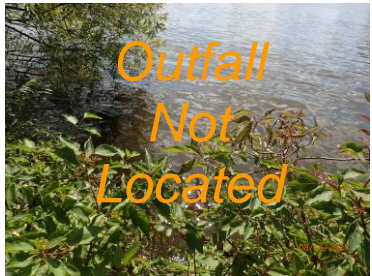
<p style="text-align: center;">o20210816151250.JPG</p> <p style="text-align: center; font-size: 1.2em; font-weight: bold;">2021</p>																																									
Submerged: Fully		Depth (in):		Outfall fully submerged and not located - screened upstream at 05-241 US1.																																											
Sampling Results <table border="1" style="width:100%; border-collapse: collapse;"> <tr><td>Sample Location:</td><td></td></tr> <tr><td>Total Chlorine:</td><td>-- ppm</td></tr> <tr><td>Free Chlorine:</td><td>-- ppm</td></tr> <tr><td>Ammonia:</td><td>-- ppm</td></tr> <tr><td>pH:</td><td>-- units</td></tr> <tr><td>Temperature:</td><td>-- ° F</td></tr> <tr><td>Conductivity:</td><td>-- µS/cm</td></tr> <tr><td>Detergents:</td><td>-- mg/L</td></tr> </table>		Sample Location:		Total Chlorine:	-- ppm			Free Chlorine:	-- ppm	Ammonia:	-- ppm	pH:	-- units	Temperature:	-- ° F	Conductivity:	-- µS/cm	Detergents:	-- mg/L	<table border="1" style="width:100%; border-collapse: collapse;"> <tr><td>Floatables:</td><td>None</td></tr> <tr><td>Odor:</td><td>None</td></tr> <tr><td>Turbidity:</td><td>None</td></tr> <tr><td>Color:</td><td>None</td></tr> <tr><td>Gross Solids:</td><td>None</td></tr> <tr><td>Vegetation:</td><td>None</td></tr> <tr><td>Benthic Growth:</td><td>None</td></tr> <tr><td>Stains:</td><td>None</td></tr> <tr><td>Non-illicit:</td><td>None</td></tr> </table>		Floatables:	None	Odor:	None	Turbidity:	None	Color:	None	Gross Solids:	None	Vegetation:	None	Benthic Growth:	None	Stains:	None	Non-illicit:	None	Condition Assessment <table border="1" style="width:100%; border-collapse: collapse;"> <tr><td>Graffiti:</td><td>None</td></tr> <tr><td>Erosion:</td><td>None</td></tr> <tr><td>Deposition:</td><td>None in.</td></tr> <tr><td>Damage:</td><td>None</td></tr> </table>		Graffiti:	None	Erosion:	None	Deposition:	None in.

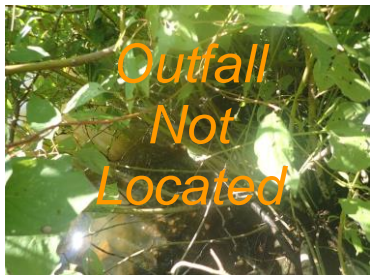
<p style="text-align: center;">o20200819153632.JPG</p> <p style="text-align: center; font-size: 1.2em; font-weight: bold;">2020</p>																																									
Submerged: Fully		Depth (in):		Outfall fully submerged and not located - screened upstream at 05-241 US1.																																											
Sampling Results <table border="1" style="width:100%; border-collapse: collapse;"> <tr><td>Sample Location:</td><td></td></tr> <tr><td>Total Chlorine:</td><td>-- ppm</td></tr> <tr><td>Free Chlorine:</td><td>-- ppm</td></tr> <tr><td>Ammonia:</td><td>-- ppm</td></tr> <tr><td>pH:</td><td>-- units</td></tr> <tr><td>Temperature:</td><td>-- ° F</td></tr> <tr><td>Conductivity:</td><td>-- µS/cm</td></tr> <tr><td>Detergents:</td><td>-- mg/L</td></tr> </table>		Sample Location:		Total Chlorine:	-- ppm			Free Chlorine:	-- ppm	Ammonia:	-- ppm	pH:	-- units	Temperature:	-- ° F	Conductivity:	-- µS/cm	Detergents:	-- mg/L	<table border="1" style="width:100%; border-collapse: collapse;"> <tr><td>Floatables:</td><td>None</td></tr> <tr><td>Odor:</td><td>None</td></tr> <tr><td>Turbidity:</td><td>None</td></tr> <tr><td>Color:</td><td>None</td></tr> <tr><td>Gross Solids:</td><td>None</td></tr> <tr><td>Vegetation:</td><td>None</td></tr> <tr><td>Benthic Growth:</td><td>None</td></tr> <tr><td>Stains:</td><td>None</td></tr> <tr><td>Non-illicit:</td><td>None</td></tr> </table>		Floatables:	None	Odor:	None	Turbidity:	None	Color:	None	Gross Solids:	None	Vegetation:	None	Benthic Growth:	None	Stains:	None	Non-illicit:	None	Condition Assessment <table border="1" style="width:100%; border-collapse: collapse;"> <tr><td>Graffiti:</td><td>None</td></tr> <tr><td>Erosion:</td><td>None</td></tr> <tr><td>Deposition:</td><td>None in.</td></tr> <tr><td>Damage:</td><td>None</td></tr> </table>		Graffiti:	None	Erosion:	None	Deposition:	None in.

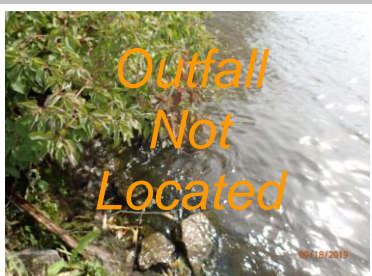
<p style="text-align: center;">o20190918134402.JPG</p> <p style="text-align: center; font-size: 1.2em; font-weight: bold;">2019</p>																																									
Submerged: Fully		Depth (in):		Outfall fully submerged and not located - screened upstream at 05-241 US1.																																											
Sampling Results <table border="1" style="width:100%; border-collapse: collapse;"> <tr><td>Sample Location:</td><td></td></tr> <tr><td>Total Chlorine:</td><td>-- ppm</td></tr> <tr><td>Free Chlorine:</td><td>-- ppm</td></tr> <tr><td>Ammonia:</td><td>-- ppm</td></tr> <tr><td>pH:</td><td>-- units</td></tr> <tr><td>Temperature:</td><td>-- ° F</td></tr> <tr><td>Conductivity:</td><td>-- µS/cm</td></tr> <tr><td>Detergents:</td><td>-- mg/L</td></tr> </table>		Sample Location:		Total Chlorine:	-- ppm			Free Chlorine:	-- ppm	Ammonia:	-- ppm	pH:	-- units	Temperature:	-- ° F	Conductivity:	-- µS/cm	Detergents:	-- mg/L	<table border="1" style="width:100%; border-collapse: collapse;"> <tr><td>Floatables:</td><td>None</td></tr> <tr><td>Odor:</td><td>None</td></tr> <tr><td>Turbidity:</td><td>None</td></tr> <tr><td>Color:</td><td>None</td></tr> <tr><td>Gross Solids:</td><td>None</td></tr> <tr><td>Vegetation:</td><td>None</td></tr> <tr><td>Benthic Growth:</td><td>None</td></tr> <tr><td>Stains:</td><td>None</td></tr> <tr><td>Non-illicit:</td><td>None</td></tr> </table>		Floatables:	None	Odor:	None	Turbidity:	None	Color:	None	Gross Solids:	None	Vegetation:	None	Benthic Growth:	None	Stains:	None	Non-illicit:	None	Condition Assessment <table border="1" style="width:100%; border-collapse: collapse;"> <tr><td>Graffiti:</td><td>None</td></tr> <tr><td>Erosion:</td><td>None</td></tr> <tr><td>Deposition:</td><td>None in.</td></tr> <tr><td>Damage:</td><td>None</td></tr> </table>		Graffiti:	None	Erosion:	None	Deposition:	None in.

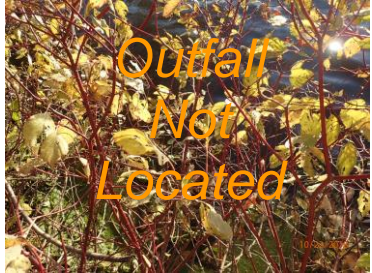
o20181022170952.JPG

Inspection Date: 10/22/2018 5:11:27 PM		Type: Ongoing	Flow: Submerged (not located)	Previous Rainfall (hrs): 48-72
Illicit Discharge Potential: Unlikely		Inspector: JCW	Notes	
Submerged: Fully		Depth (in):	Outfall fully submerged and not located - screened upstream at 05-241 US1.	
Sampling Results		Floatables:	<div style="border: 1px solid black; padding: 5px;"> Condition Assessment Graffiti: None Erosion: None Deposition: None in. Damage: None </div>	
Sample Location:	Odor:	None		
Total Chlorine: -- ppm	Turbidity:	None		
Free Chlorine: -- ppm	Color:	None		
Ammonia: -- ppm	Gross Solids:	None		
pH: -- units	Vegetation:	None		
Temperature -- °F	Benthic Growth:	None		
Conductivity: -- µS/cm	Stains:	None		
Detergents: -- mg/L	Non-illicit:	None

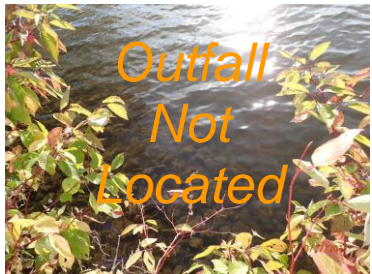
o20171017155038.JPG

Inspection Date: 10/17/2017 3:57:59 PM		Type: Ongoing	Flow: Submerged (not located)	Previous Rainfall (hrs): 48-72
Illicit Discharge Potential: Potential		Inspector: JCW	Notes	
Submerged: Fully		Depth (in):	Outfall fully submerged and not located - screened upstream at 05-241 US1. Detergent detected in upstream manhole.	
Sampling Results		Floatables:	<div style="border: 1px solid black; padding: 5px;"> Condition Assessment Graffiti: None Erosion: None Deposition: None in. Damage: None </div>	
Sample Location:	Odor:	None		
Total Chlorine: -- ppm	Turbidity:	None		
Free Chlorine: -- ppm	Color:	None		
Ammonia: -- ppm	Gross Solids:	None		
pH: -- units	Vegetation:	None		
Temperature -- °F	Benthic Growth:	None		
Conductivity: -- µS/cm	Stains:	None		
Detergents: -- mg/L	Non-illicit:	None

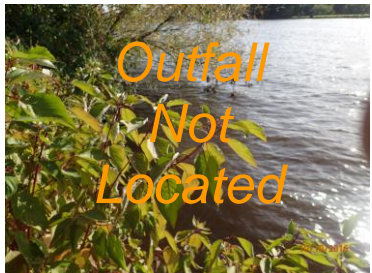
o20161010154050.JPG

Inspection Date: 10/10/2016 3:43:52 PM		Type: Ongoing	Flow: Submerged (not located)	Previous Rainfall (hrs): 72+
Illicit Discharge Potential: Unlikely		Inspector: JCW	Notes	
Submerged: Fully		Depth (in):	Outfall fully submerged and not located - screened upstream at 05-241 US1.	
Sampling Results		Floatables:	<div style="border: 1px solid black; padding: 5px;"> Condition Assessment Graffiti: None Erosion: None Deposition: None in. Damage: None </div>	
Sample Location:	Odor:	None		
Total Chlorine: -- ppm	Turbidity:	None		
Free Chlorine: -- ppm	Color:	None		
Ammonia: -- ppm	Gross Solids:	None		
pH: -- units	Vegetation:	None		
Temperature -- °F	Benthic Growth:	None		
Conductivity: -- µS/cm	Stains:	None		
Detergents: -- mg/L	Non-illicit:	None

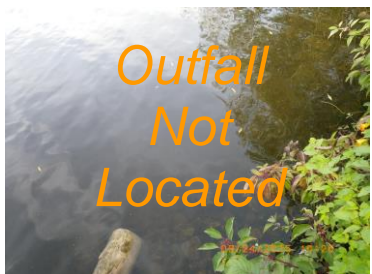
o20150924092602.JPG

Inspection Date: 9/24/2015 10:23:00 AM		Type: Ongoing	Flow: Submerged (not located)	Previous Rainfall (hrs): 72+
Illicit Discharge Potential: Unlikely		Inspector: JCW	Notes	
Submerged: Fully		Depth (in):	Outfall fully submerged and not located - screened at 05-241 US1.	
Sampling Results		Floatables:	<div style="border: 1px solid black; padding: 5px;"> Condition Assessment Graffiti: None Erosion: None Deposition: None in. Damage: None </div>	
Sample Location:	Odor:	None		
Total Chlorine: -- ppm	Turbidity:	None		
Free Chlorine: -- ppm	Color:	None		
Ammonia: -- ppm	Gross Solids:	None		
pH: -- units	Vegetation:	None		
Temperature -- °F	Benthic Growth:	None		
Conductivity: -- µS/cm	Stains:	None		
Detergents: -- mg/L	Non-illicit:	None

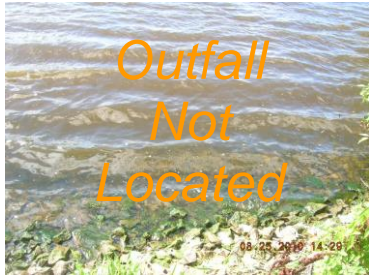
Inspection Date: 8/25/2010 2:39:56 PM		Type: Ongoing		Flow: Submerged (not located)		Previous Rainfall (hrs): 72+	
Illicit Discharge Potential: Unlikely		Inspector: JCW		Notes Outfall fully submerged and not physically located. Outfall screened upstream at 05-241 US2.

o20100825142910.JPG	
Submerged: Fully		Depth (in):					
Sampling Results Sample Location:		Floatables: None Odor: None Turbidity: None Color: None Gross Solids: None Vegetation: None Benthic Growth: None Stains: None Non-illicit: None		Condition Assessment Graffiti: None Erosion: None Deposition: None 0 in. Damage: None			
Total Chlorine: -- ppm Free Chlorine: -- ppm Ammonia: -- ppm pH: -- units Temperature: -- °F Conductivity: -- µS/cm Detergents: -- mg/L						2010

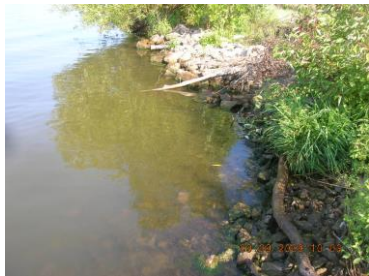
Inspection Date: 9/9/2009		Type: Initial		Flow: Submerged, indeterminate		Previous Rainfall (hrs): 72+	
Illicit Discharge Potential: Potential		Inspector: JCW		Notes

Osh09_DSCN6696.JPG	
Submerged: Fully		Depth (in):					
Sampling Results Sample Location:		Floatables: None Odor: None Turbidity: None Color: None Gross Solids: None Vegetation: None Benthic Growth: None Stains: None Non-illicit: None		Condition Assessment Graffiti: None Erosion: None Deposition: None 0 in. Damage: None			
Total Chlorine: -- ppm Free Chlorine: -- ppm Ammonia: -- ppm pH: -- units Temperature: -- °F Conductivity: -- µS/cm Detergents: -- mg/L						2009

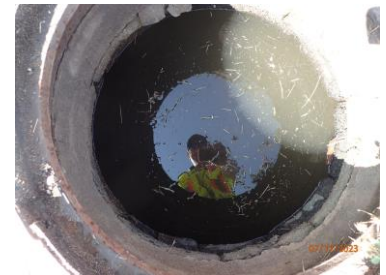
o20230717092010.JPG

Sample Location:	Pool																																					
Total Chlorine:	0 ppm																																					
Free Chlorine:	0 ppm																																					
Ammonia:	0 ppm																																					
pH:	7.69 units																																					
Temperature:	73 °F																																					
Conductivity:	629 µS/cm																																					
Detergents:	0 mg/L																																					
Floatables:	None																																					
Odor:	None																																					
Turbidity:	None																																					
Color:	None																																					
Gross Solids:	Slight																																					
Vegetation:	None																																					
Benthic Growth:	Slight																																					
Stains:	None																																					
Non-illicit:	None

Notes Sample collected from submerged pool in manhole.																																				
		Condition Assessment <table border="1" style="width:100%; border-collapse: collapse;"> <tr><td>Graffiti:</td><td>None</td></tr> <tr><td>Erosion:</td><td>None</td></tr> <tr><td>Deposition:</td><td>None in.</td></tr> <tr><td>Damage:</td><td>None</td></tr> </table>			Graffiti:	None	Erosion:	None	Deposition:	None in.	Damage:	None																										
Graffiti:	None																																					
Erosion:	None																																					
Deposition:	None in.																																					
Damage:	None

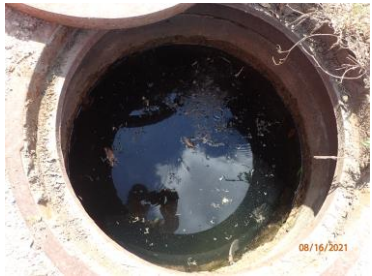
o20210816152000.JPG <div style="text-align: center; font-size: 24pt; font-weight: bold;">2021</div>

Sample Location:	Pool																																					
Total Chlorine:	0 ppm																																					
Free Chlorine:	0 ppm																																					
Ammonia:	0 ppm																																					
pH:	7.31 units																																					
Temperature:	84 °F																																					
Conductivity:	1336 µS/cm																																					
Detergents:	0 mg/L																																					
Floatables:	None																																					
Odor:	None																																					
Turbidity:	None																																					
Color:	None																																					
Gross Solids:	None																																					
Vegetation:	None																																					
Benthic Growth:	Slight																																					
Stains:	None																																					
Non-illicit:	None

Notes Sample collected from submerged pool in manhole.																																				
		Condition Assessment <table border="1" style="width:100%; border-collapse: collapse;"> <tr><td>Graffiti:</td><td>None</td></tr> <tr><td>Erosion:</td><td>None</td></tr> <tr><td>Deposition:</td><td>None in.</td></tr> <tr><td>Damage:</td><td>None</td></tr> </table>			Graffiti:	None	Erosion:	None	Deposition:	None in.	Damage:	None																										
Graffiti:	None																																					
Erosion:	None																																					
Deposition:	None in.																																					
Damage:	None

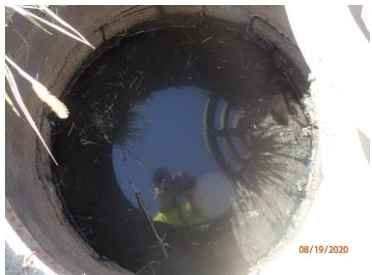
o20200819154302.JPG <div style="text-align: center; font-size: 24pt; font-weight: bold;">2020</div>

Sample Location:	Pool																																					
Total Chlorine:	0 ppm																																					
Free Chlorine:	0 ppm																																					
Ammonia:	0 ppm																																					
pH:	9.22 units																																					
Temperature:	84 °F																																					
Conductivity:	351 µS/cm																																					
Detergents:	0 mg/L																																					
Floatables:	None																																					
Odor:	None																																					
Turbidity:	None																																					
Color:	None																																					
Gross Solids:	None																																					
Vegetation:	None																																					
Benthic Growth:	None																																					
Stains:	None																																					
Non-illicit:	None

Notes Sample collected from submerged pool in manhole. Elevated pH seemed widespread in river.																																				
		Condition Assessment <table border="1" style="width:100%; border-collapse: collapse;"> <tr><td>Graffiti:</td><td>None</td></tr> <tr><td>Erosion:</td><td>None</td></tr> <tr><td>Deposition:</td><td>None in.</td></tr> <tr><td>Damage:</td><td>None</td></tr> </table>			Graffiti:	None	Erosion:	None	Deposition:	None in.	Damage:	None																										
Graffiti:	None																																					
Erosion:	None																																					
Deposition:	None in.																																					
Damage:	None

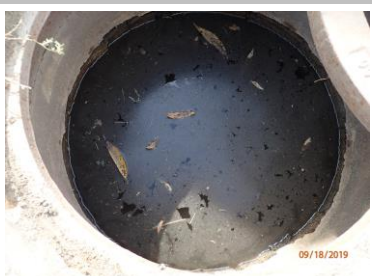
o20190918135010.JPG <div style="text-align: center; font-size: 24pt; font-weight: bold;">2019</div>

Notes Sample collected from submerged pool in manhole. Ammonia below action limit.																																				
		Condition Assessment <table border="1" style="width:100%; border-collapse: collapse;"> <tr><td>Graffiti:</td><td>None</td></tr> <tr><td>Erosion:</td><td>None</td></tr> <tr><td>Deposition:</td><td>None in.</td></tr> <tr><td>Damage:</td><td>None</td></tr> </table>			Graffiti:	None	Erosion:	None	Deposition:	None in.	Damage:	None																										
Graffiti:	None																																					
Erosion:	None																																					
Deposition:	None in.																																					
Damage:	None

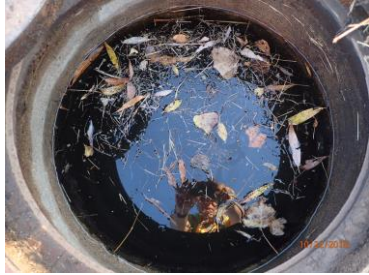
<p style="text-align: center;">o20181022171816.JPG</p> <p style="text-align: center; font-size: 24pt; font-weight: bold;">2018</p>

Inspection Date: 10/22/2018 5:20:26 PM		Type: Ongoing	Flow: Submerged, indeterminate	Previous Rainfall (hrs): 48-72																																				
Illicit Discharge Potential: Unlikely		Inspector: JCW	Notes																																					
Submerged: Fully		Depth (in): 23	Sample collected from submerged pool in manhole.																																					
<table border="1" style="width:100%; border-collapse: collapse;"> <tr> <td colspan="2">Sampling Results</td> <td>Floatables:</td> <td>None</td> </tr> <tr> <td>Sample Location:</td> <td>Pool</td> <td>Odor:</td> <td>None</td> </tr> <tr> <td>Total Chlorine:</td> <td>0 ppm</td> <td>Turbidity:</td> <td>None</td> </tr> <tr> <td>Free Chlorine:</td> <td>0 ppm</td> <td>Color:</td> <td>None</td> </tr> <tr> <td>Ammonia:</td> <td>0 ppm</td> <td>Gross Solids:</td> <td>None</td> </tr> <tr> <td>pH:</td> <td>7.55 units</td> <td>Vegetation:</td> <td>None</td> </tr> <tr> <td>Temperature</td> <td>55 °F</td> <td>Benthic Growth:</td> <td>None</td> </tr> <tr> <td>Conductivity:</td> <td>410 µS/cm</td> <td>Stains:</td> <td>None</td> </tr> <tr> <td>Detergents:</td> <td>0 mg/L</td> <td>Non-illicit:</td> <td>None</td> </tr> </table>					Sampling Results		Floatables:	None	Sample Location:	Pool	Odor:	None	Total Chlorine:	0 ppm	Turbidity:	None	Free Chlorine:	0 ppm	Color:	None	Ammonia:	0 ppm	Gross Solids:	None	pH:	7.55 units	Vegetation:	None	Temperature	55 °F	Benthic Growth:	None	Conductivity:	410 µS/cm	Stains:	None	Detergents:	0 mg/L	Non-illicit:	None

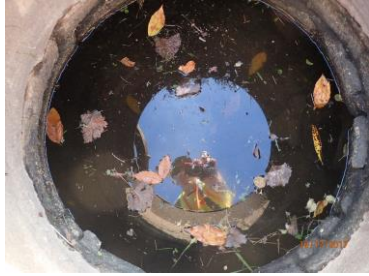
<p style="text-align: center;">o20171017155840.JPG</p> <p style="text-align: center; font-size: 24pt; font-weight: bold;">2017</p>

Inspection Date: 10/17/2017 4:02:57 PM		Type: Ongoing	Flow: Submerged, indeterminate	Previous Rainfall (hrs): 48-72																																				
Illicit Discharge Potential: Potential		Inspector: JCW	Notes																																					
Submerged: Fully		Depth (in): 16	Detergent detected in sample collected from submerged pool in manhole.																																					
<table border="1" style="width:100%; border-collapse: collapse;"> <tr> <td colspan="2">Sampling Results</td> <td>Floatables:</td> <td>None</td> </tr> <tr> <td>Sample Location:</td> <td>Pool</td> <td>Odor:</td> <td>None</td> </tr> <tr> <td>Total Chlorine:</td> <td>0 ppm</td> <td>Turbidity:</td> <td>None</td> </tr> <tr> <td>Free Chlorine:</td> <td>0 ppm</td> <td>Color:</td> <td>None</td> </tr> <tr> <td>Ammonia:</td> <td>0 ppm</td> <td>Gross Solids:</td> <td>None</td> </tr> <tr> <td>pH:</td> <td>7.4 units</td> <td>Vegetation:</td> <td>None</td> </tr> <tr> <td>Temperature</td> <td>65 °F</td> <td>Benthic Growth:</td> <td>None</td> </tr> <tr> <td>Conductivity:</td> <td>244 µS/cm</td> <td>Stains:</td> <td>None</td> </tr> <tr> <td>Detergents:</td> <td>1 mg/L</td> <td>Non-illicit:</td> <td>None</td> </tr> </table>					Sampling Results		Floatables:	None	Sample Location:	Pool	Odor:	None	Total Chlorine:	0 ppm	Turbidity:	None	Free Chlorine:	0 ppm	Color:	None	Ammonia:	0 ppm	Gross Solids:	None	pH:	7.4 units	Vegetation:	None	Temperature	65 °F	Benthic Growth:	None	Conductivity:	244 µS/cm	Stains:	None	Detergents:	1 mg/L	Non-illicit:	None
