IDDE Ongoing Screening Summary Report

2023 Inspection Year

Westwood

City of Oshkosh

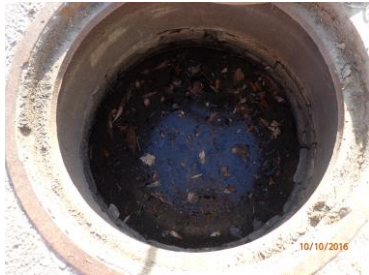
<p style="text-align: center;">o20161010154822.JPG</p> <p style="text-align: center; font-size: 24pt; font-weight: bold;">2016</p>

Inspection Date: 10/10/2016 3:50:18 PM		Type: Ongoing	Flow: Submerged, indeterminate	Previous Rainfall (hrs): 72+																																				
Illicit Discharge Potential: Unlikely		Inspector: JCW	Notes																																					
Submerged: Fully		Depth (in): 17																																						
<table border="1" style="width:100%; border-collapse: collapse;"> <tr> <td colspan="2">Sampling Results</td> <td>Floatables:</td> <td>None</td> </tr> <tr> <td>Sample Location:</td> <td>Pool</td> <td>Odor:</td> <td>None</td> </tr> <tr> <td>Total Chlorine:</td> <td>0 ppm</td> <td>Turbidity:</td> <td>None</td> </tr> <tr> <td>Free Chlorine:</td> <td>0 ppm</td> <td>Color:</td> <td>None</td> </tr> <tr> <td>Ammonia:</td> <td>0 ppm</td> <td>Gross Solids:</td> <td>Moderate</td> </tr> <tr> <td>pH:</td> <td>7.59 units</td> <td>Vegetation:</td> <td>None</td> </tr> <tr> <td>Temperature</td> <td>69 °F</td> <td>Benthic Growth:</td> <td>None</td> </tr> <tr> <td>Conductivity:</td> <td>1551 µS/cm</td> <td>Stains:</td> <td>None</td> </tr> <tr> <td>Detergents:</td> <td>0 mg/L</td> <td>Non-illicit:</td> <td>Slight</td> </tr> </table>					Sampling Results		Floatables:	None	Sample Location:	Pool	Odor:	None	Total Chlorine:	0 ppm	Turbidity:	None	Free Chlorine:	0 ppm	Color:	None	Ammonia:	0 ppm	Gross Solids:	Moderate	pH:	7.59 units	Vegetation:	None	Temperature	69 °F	Benthic Growth:	None	Conductivity:	1551 µS/cm	Stains:	None	Detergents:	0 mg/L	Non-illicit:	Slight

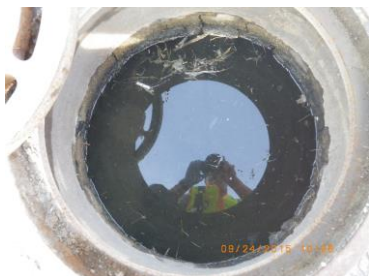
<p style="text-align: center;">o20150924092818.JPG</p> <p style="text-align: center; font-size: 24pt; font-weight: bold;">2015</p>

Inspection Date: 9/24/2015 10:27:12 AM		Type: Ongoing	Flow: Submerged, indeterminate	Previous Rainfall (hrs): 72+																																				
Illicit Discharge Potential: Unlikely		Inspector: JCW	Notes																																					
Submerged: Fully		Depth (in): 18																																						
<table border="1" style="width:100%; border-collapse: collapse;"> <tr> <td colspan="2">Sampling Results</td> <td>Floatables:</td> <td>None</td> </tr> <tr> <td>Sample Location:</td> <td>Pool</td> <td>Odor:</td> <td>None</td> </tr> <tr> <td>Total Chlorine:</td> <td>0 ppm</td> <td>Turbidity:</td> <td>None</td> </tr> <tr> <td>Free Chlorine:</td> <td>0 ppm</td> <td>Color:</td> <td>None</td> </tr> <tr> <td>Ammonia:</td> <td>0 ppm</td> <td>Gross Solids:</td> <td>None</td> </tr> <tr> <td>pH:</td> <td>7.43 units</td> <td>Vegetation:</td> <td>None</td> </tr> <tr> <td>Temperature</td> <td>71 °F</td> <td>Benthic Growth:</td> <td>Moderate</td> </tr> <tr> <td>Conductivity:</td> <td>474 µS/cm</td> <td>Stains:</td> <td>None</td> </tr> <tr> <td>Detergents:</td> <td>0 mg/L</td> <td>Non-illicit:</td> <td>None</td> </tr> </table>					Sampling Results		Floatables:	None	Sample Location:	Pool	Odor:	None	Total Chlorine:	0 ppm	Turbidity:	None	Free Chlorine:	0 ppm	Color:	None	Ammonia:	0 ppm	Gross Solids:	None	pH:	7.43 units	Vegetation:	None	Temperature	71 °F	Benthic Growth:	Moderate	Conductivity:	474 µS/cm	Stains:	None	Detergents:	0 mg/L	Non-illicit:	None

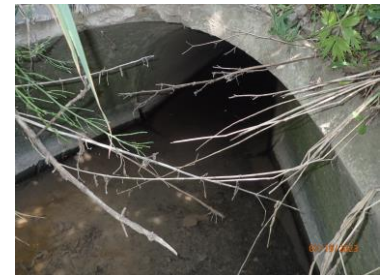
o20230719143332.JPG

Damage: Minor ☒ Displacement ☐ Undercut ☐ Crushed☐ Corrosion ☐ Cracks/Structural Damage

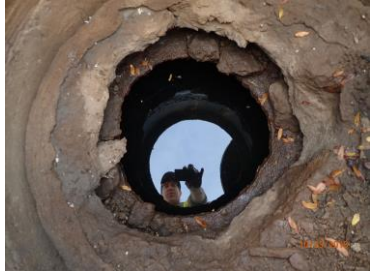
o20181025134812.JPG <div style="text-align: center; font-size: 24pt; font-weight: bold;">2018</div>

Inspection Date: 10/25/2018 1:50:14 PM		Type: Ongoing	Flow: Submerged, indeterminate	Previous Rainfall (hrs): 72+
Illicit Discharge Potential: Unlikely		Inspector: JCW		
Submerged: Fully		Depth (in): 19		
Sampling Results Sample Location: Pool Total Chlorine: 0 ppm Free Chlorine: 0 ppm Ammonia: 0 ppm pH: 7.3 units Temperature: 58 °F Conductivity: 1119 µS/cm Detergents: 0 mg/L		Floatables: None Odor: None Turbidity: None Color: None Gross Solids: None Vegetation: None Benthic Growth: None Stains: None Non-illicit: None		
		Notes Sample collected from submerged pool in manhole.		
		Condition Assessment Graffiti: None Erosion: None Deposition: None in. Damage: None

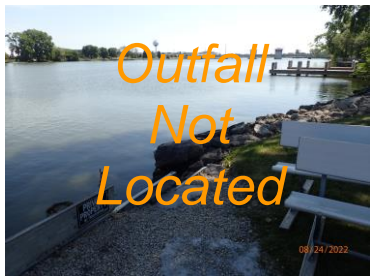
o20220824113640.JPG <div style="text-align: center; font-size: 24pt; font-weight: bold;">2022</div>

Inspection Date: 8/24/2022 11:40:00 AM		Type: Ongoing	Flow: Submerged (not located)	Previous Rainfall (hrs): 72+
Illicit Discharge Potential: Unlikely		Inspector: EJK		
Submerged: Fully		Depth (in):		
Sampling Results Sample Location: _____ Total Chlorine: -- ppm Free Chlorine: -- ppm Ammonia: -- ppm pH: -- units Temperature: -- °F Conductivity: -- µS/cm Detergents: -- mg/L		Floatables: None Odor: None Turbidity: None Color: None Gross Solids: None Vegetation: None Benthic Growth: None Stains: None Non-illicit: None		
		Notes Outfall fully submerged and not located - submerged upstream at 06-1709 US1.		
		Condition Assessment Graffiti: None Erosion: None Deposition: None in. Damage: None

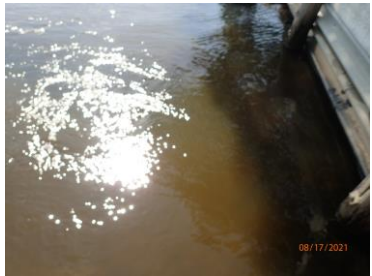
o20210817104212.JPG <div style="text-align: center; font-size: 24pt; font-weight: bold;">2021</div>

Inspection Date: 8/17/2021 10:43:57 AM		Type: Ongoing	Flow: Submerged, significant flow	Previous Rainfall (hrs): 72+
Illicit Discharge Potential: Potential		Inspector: JCW		
Submerged: Fully		Depth (in):		
Sampling Results Sample Location: _____ Total Chlorine: -- ppm Free Chlorine: -- ppm Ammonia: -- ppm pH: -- units Temperature: -- °F Conductivity: -- µS/cm Detergents: -- mg/L		Floatables: None Odor: None Turbidity: None Color: None Gross Solids: None Vegetation: None Benthic Growth: None Stains: None Non-illicit: None		
		Notes Outfall fully submerged and not located - screened upstream at 06-1709 US1. Detergent detected in upstream manhole.		
		Condition Assessment Graffiti: None Erosion: None Deposition: None in. Damage: None

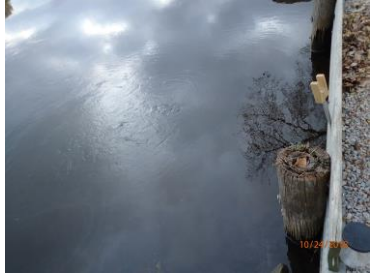
<p style="text-align: center;">o20181024072834.JPG</p> <p style="text-align: center; font-size: 24pt; font-weight: bold;">2018</p>	
Submerged: Fully		Depth (in):		Outfall fully submerged, significant flow causing surface disturbance. Screened upstream at 06-253 US1. Elevated ammonia and conductivity in manhole.			
Sampling Results		Floatables:		Condition Assessment			
Sample Location:		None		Graffiti: None			
Total Chlorine: -- ppm		Odor: None		Erosion: None			
Free Chlorine: -- ppm		Turbidity: None		Deposition: None in.			
Ammonia: -- ppm		Color: None		Damage: None			
pH: -- units		Gross Solids: None					
Temperature -- °F		Vegetation: None					
Conductivity: -- µS/cm		Benthic Growth: None					
Detergents: -- mg/L		Stains: None

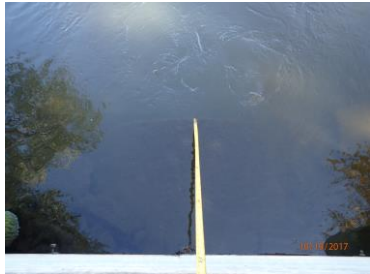
<p style="text-align: center;">o20171019131334.JPG</p> <p style="text-align: center; font-size: 24pt; font-weight: bold;">2017</p>	
Submerged: Fully		Depth (in):		Outfall fully submerged with significant flow causing surface disturbance. Screened upstream at 06-253 US1. Elevated ammonia in manhole.			
Sampling Results		Floatables:		Condition Assessment			
Sample Location:		None		Graffiti: None			
Total Chlorine: -- ppm		Odor: None		Erosion: None			
Free Chlorine: -- ppm		Turbidity: None		Deposition: None in.			
Ammonia: -- ppm		Color: None		Damage: None			
pH: -- units		Gross Solids: None					
Temperature -- °F		Vegetation: None					
Conductivity: -- µS/cm		Benthic Growth: None					
Detergents: -- mg/L		Stains: None

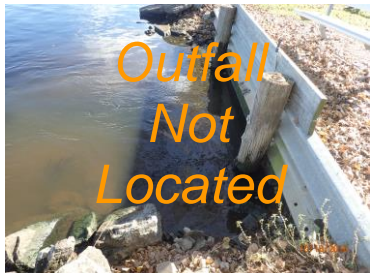
Inspection Date: 10/18/2016 1:59:02 PM		Type: Ongoing		Flow: Submerged (not located)		Previous Rainfall (hrs): 72+	
Illicit Discharge Potential: Unlikely		Inspector: JCW		Notes

<p style="text-align: center;">o20161018135746.JPG</p> <p style="text-align: center; font-size: 24pt; font-weight: bold;">2016</p>	
Submerged: Fully		Depth (in):		Outfall fully submerged and not located - screened upstream at 06-253 US1.			
Sampling Results		Floatables:		Condition Assessment			
Sample Location:		None		Graffiti: None			
Total Chlorine: -- ppm		Odor: None		Erosion: None			
Free Chlorine: -- ppm		Turbidity: None		Deposition: None in.			
Ammonia: -- ppm		Color: None		Damage: None			
pH: -- units		Gross Solids: None					
Temperature -- °F		Vegetation: None					
Conductivity: -- µS/cm		Benthic Growth: None					
Detergents: -- mg/L		Stains: None					
		Non-illicit: None

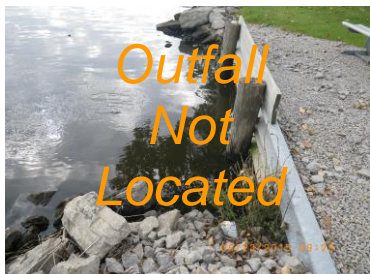
Inspection Date: 9/23/2015 9:26:08 AM		Type: Ongoing		Flow: Submerged (not located)		Previous Rainfall (hrs): 72+	
Illicit Discharge Potential: Unlikely		Inspector: JCW		Notes

<p style="text-align: center;">o20150923082910.JPG</p> <p style="text-align: center; font-size: 24pt; font-weight: bold;">2015</p>	
Submerged: Fully		Depth (in):		Outfall fully submerged and not located - screened at 06-253 US1.			
Sampling Results		Floatables:		Condition Assessment			
Sample Location:		None		Graffiti: None			
Total Chlorine: -- ppm		Odor: None		Erosion: None			
Free Chlorine: -- ppm		Turbidity: None		Deposition: None in.			
Ammonia: -- ppm		Color: None		Damage: None			
pH: -- units		Gross Solids: None					
Temperature -- °F		Vegetation: None					
Conductivity: -- µS/cm		Benthic Growth: None					
Detergents: -- mg/L		Stains: None					
		Non-illicit: None

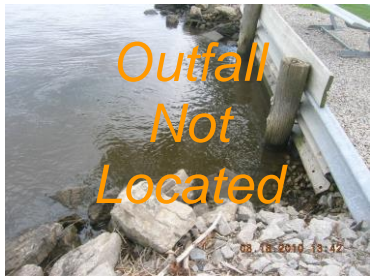
o20100818134248.JPG

Inspection Date: 8/18/2010 1:51:34 PM		Type: Ongoing	Flow: Submerged (not located)	Previous Rainfall (hrs): 72+
Illicit Discharge Potential: Unlikely		Inspector: JCW	Notes	
Submerged: Fully		Depth (in):	Outfall fully submerged and not physically located. Outfall screened upstream at 06-263 US1.	
Sampling Results			Condition Assessment Graffiti: None Erosion: None Deposition: None 0 in. Damage: None	
Sample Location: Floatables: None Total Chlorine: -- ppm Odor: None Free Chlorine: -- ppm Turbidity: None Ammonia: -- ppm Color: None pH: -- units Gross Solids: None Temperature -- °F Vegetation: None Conductivity: -- µS/cm Benthic Growth: None Detergents: -- mg/L Stains: None Non-illicit: None

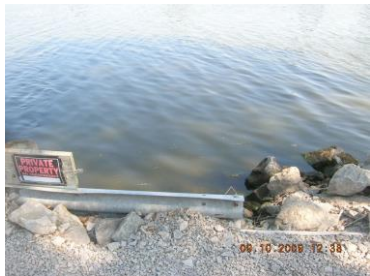
Osh09_DSCN6785.JPG

Inspection Date: 9/10/2009		Type: Initial	Flow: Submerged, indeterminate	Previous Rainfall (hrs): 72+
Illicit Discharge Potential: Unlikely		Inspector: JCW	Notes	
Submerged: Fully		Depth (in):		
Sampling Results			Condition Assessment Graffiti: None Erosion: None Deposition: None 0 in. Damage: None	
Sample Location: Floatables: None Total Chlorine: -- ppm Odor: None Free Chlorine: -- ppm Turbidity: None Ammonia: -- ppm Color: None pH: -- units Gross Solids: None Temperature -- °F Vegetation: None Conductivity: -- µS/cm Benthic Growth: None Detergents: -- mg/L Stains: None Non-illicit: None

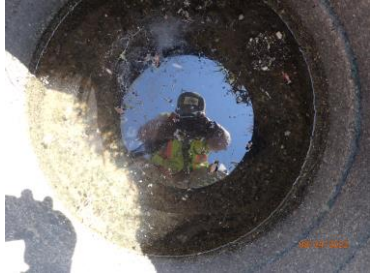
o20220824113850.JPG <div style="text-align: right; font-size: 24pt; font-weight: bold;">2022</div>

Inspection Date: 8/24/2022 11:41:00 AM		Type: Ongoing	Flow: Submerged, slight flow	Previous Rainfall (hrs): 72+
Illicit Discharge Potential: Unlikely		Inspector: EJK		
Submerged: Fully		Depth (in):		
Sampling Results Sample Location: Flow Total Chlorine: 0 ppm Free Chlorine: 0 ppm Ammonia: 0 ppm pH: 7.71 units Temperature: 76 °F Conductivity: 1250 µS/cm Detergents: 0 mg/L		Floatables: None Odor: None Turbidity: None Color: None Gross Solids: Slight Vegetation: None Benthic Growth: Moderate Stains: None Non-illicit: None		
		Notes Sample collected from submerged flow in catchbasin.		
		Condition Assessment Graffiti: None Erosion: None Deposition: None in. Damage: None

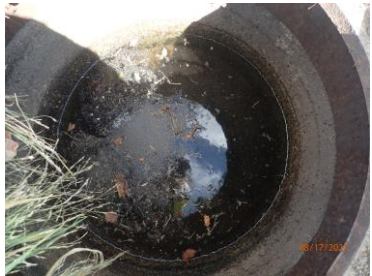
o20210817104756.JPG <div style="text-align: right; font-size: 24pt; font-weight: bold;">2021</div>

Inspection Date: 8/17/2021 10:51:45 AM		Type: Ongoing	Flow: Submerged, significant flow	Previous Rainfall (hrs): 72+
Illicit Discharge Potential: Potential		Inspector: JCW		
Submerged: Fully		Depth (in): 48		
Sampling Results Sample Location: Flow Total Chlorine: 0 ppm Free Chlorine: 0 ppm Ammonia: 0 ppm pH: 7.08 units Temperature: 80 °F Conductivity: 1154 µS/cm Detergents: 0.4 mg/L		Floatables: None Odor: None Turbidity: None Color: None Gross Solids: None Vegetation: None Benthic Growth: Moderate Stains: None Non-illicit: None		
		Notes Sample collected from flow in catchbasin. Detergent detected in sample.		
		Condition Assessment Graffiti: None Erosion: None Deposition: None in. Damage: None

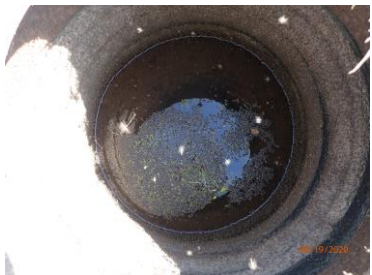
o20200819102530.JPG <div style="text-align: right; font-size: 24pt; font-weight: bold;">2020</div>

Inspection Date: 8/19/2020 10:28:37 AM		Type: Ongoing	Flow: Submerged, significant flow	Previous Rainfall (hrs): 72+
Illicit Discharge Potential: Unlikely		Inspector: JCW		
Submerged: Fully		Depth (in): 42		
Sampling Results Sample Location: Flow Total Chlorine: 0 ppm Free Chlorine: 0 ppm Ammonia: 0 ppm pH: 6.92 units Temperature: 76 °F Conductivity: 1320 µS/cm Detergents: 0 mg/L		Floatables: None Odor: None Turbidity: None Color: None Gross Solids: None Vegetation: None Benthic Growth: Moderate Stains: None Non-illicit: None		
		Notes Sample collected from submerged flow in manhole.		
		Condition Assessment Graffiti: None Erosion: None Deposition: None in. Damage: None

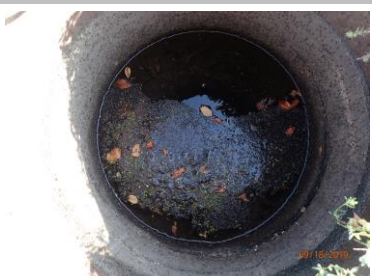
o20190918084446.JPG <div style="text-align: right; font-size: 24pt; font-weight: bold;">2019</div>

Inspection Date: 9/18/2019 9:48:09 AM		Type: Ongoing	Flow: Submerged, slight flow	Previous Rainfall (hrs): 72+
Illicit Discharge Potential: Unlikely		Inspector: JCW		
Submerged: Fully		Depth (in): 45		
Sampling Results Sample Location: Pool Total Chlorine: 0 ppm Free Chlorine: 0 ppm Ammonia: 0 ppm pH: 7.38 units Temperature: 71 °F Conductivity: 1261 µS/cm Detergents: 0 mg/L		Floatables: None Odor: None Turbidity: None Color: None Gross Solids: Slight Vegetation: None Benthic Growth: None Stains: None Non-illicit: None		
		Notes Sample collected from submerged flow in manhole. Floating gross solids (litter) in manhole.		
		Condition Assessment Graffiti: None Erosion: None Deposition: None in. Damage: None

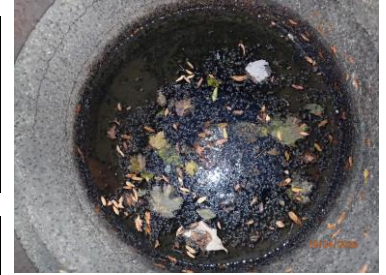
o20181024071720.JPG

Inspection Date: 10/24/2018 7:21:30 AM		Type: Ongoing	Flow: Submerged, indeterminate	Previous Rainfall (hrs): 72+
Illicit Discharge Potential: Potential		Inspector: JCW	Notes	
Submerged: Fully		Depth (in): 46	Sample collected from submerged flow in manhole. Elevated ammonia and conductivity in sample.	
Sampling Results		Floatables: None	Condition Assessment Graffiti: None Erosion: None Deposition: None in. Damage: None	
Sample Location: Pool	Odor: None	Turbidity: None		
Total Chlorine: 0 ppm	Color: None	Gross Solids: Slight		
Free Chlorine: 0 ppm	Vegetation: None	Benthic Growth: None		
Ammonia: 3 ppm	Stains: None	Non-illicit: None		
pH: 7.27 units				
Temperature: 52 °F				
Conductivity: 2280 µS/cm				
Detergents: 0 mg/L

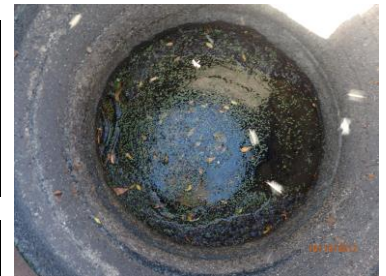
o20171019131708.JPG

Inspection Date: 10/19/2017 1:19:57 PM		Type: Ongoing	Flow: Submerged, slight flow	Previous Rainfall (hrs): 72+
Illicit Discharge Potential: Potential		Inspector: JCW	Notes	
Submerged: Fully		Depth (in): 40	Sample collected from submerged flow in manhole. Elevated ammonia.	
Sampling Results		Floatables: None	Condition Assessment Graffiti: None Erosion: None Deposition: None in. Damage: None	
Sample Location: Flow	Odor: None	Turbidity: None		
Total Chlorine: 0 ppm	Color: None	Gross Solids: None		
Free Chlorine: 0 ppm	Vegetation: None	Benthic Growth: None		
Ammonia: 3 ppm	Stains: None	Non-illicit: None		
pH: 7.15 units				
Temperature: 68 °F				
Conductivity: 1990 µS/cm				
Detergents: 0 mg/L

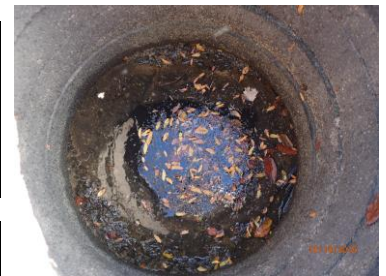
o20161018140148.JPG

Inspection Date: 10/18/2016 2:03:25 PM		Type: Ongoing	Flow: Submerged, significant flow	Previous Rainfall (hrs): 72+
Illicit Discharge Potential: Unlikely		Inspector: JCW	Notes	
Submerged: Fully		Depth (in): 40	Strong current; significant flies in manhole.	
Sampling Results		Floatables: None	Condition Assessment Graffiti: None Erosion: None Deposition: None in. Damage: None	
Sample Location: Flow	Odor: Faint	Turbidity: None		
Total Chlorine: 0 ppm	Color: None	Gross Solids: None		
Free Chlorine: 0 ppm	Vegetation: None	Benthic Growth: None		
Ammonia: 0 ppm	Stains: None	Non-illicit: None		
pH: 7.01 units				
Temperature: 70 °F				
Conductivity: 1228 µS/cm				
Detergents: 0 mg/L

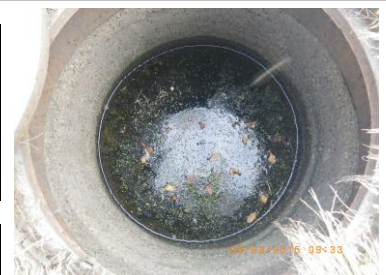
o20150923083310.JPG

Inspection Date: 9/23/2015 9:31:39 AM		Type: Ongoing	Flow: Submerged, significant flow	Previous Rainfall (hrs): 72+
Illicit Discharge Potential: Unlikely		Inspector: JCW	Notes	
Submerged: Fully		Depth (in): 42	Significant current detected in pool. Many flies emerging from water.	
Sampling Results		Floatables: None	Condition Assessment Graffiti: None Erosion: None Deposition: None in. Damage: None	
Sample Location: Pool	Odor: None	Turbidity: None		
Total Chlorine: 0 ppm	Color: None	Gross Solids: Slight		
Free Chlorine: 0 ppm	Vegetation: None	Benthic Growth: Slight		
Ammonia: 0 ppm	Stains: None	Non-illicit: None		
pH: 7.53 units				
Temperature: 70 °F				
Conductivity: 1220 µS/cm				
Detergents: 0 mg/L

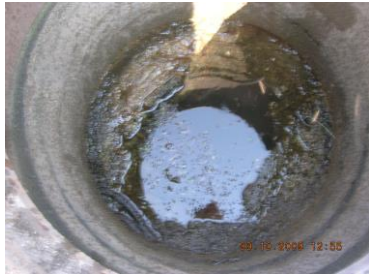
<p style="text-align: center;">Osh09_DSCN6791.JPG</p> <p style="text-align: center; font-size: 24pt; font-weight: bold;">2009</p>

Inspection Date: 9/10/2009		Type: Initial	Flow: Submerged, slight flow	Previous Rainfall (hrs): 72+																																			
Illicit Discharge Potential: Unlikely		Inspector: JCW	<div style="border: 1px solid black; height: 80px; width: 100%;"></div> Notes River fly swarm inside manhole.																																				
Submerged: Fully Depth (in): 38																																							
Sampling Results

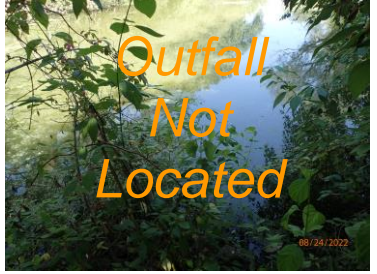
Inspection Date: 8/24/2022 12:15:00 PM		Type: Ongoing	Flow: Submerged (not located)	Previous Rainfall (hrs): 72+
Illicit Discharge Potential: Unlikely		Inspector: EJK		
Submerged: Fully		Depth (in):		
Sampling Results Sample Location: _____ Total Chlorine: -- ppm Free Chlorine: -- ppm Ammonia: -- ppm pH: -- units Temperature: -- °F Conductivity: -- µS/cm Detergents: -- mg/L		Floatables: Slight Odor: None Turbidity: None Color: None Gross Solids: None Vegetation: None Benthic Growth: None Stains: None Non-illicit: None	Notes Outfall fully submerged and not located - screened upstream at 06-221 US1.

o20220824121214.JPG <div style="text-align: center; font-weight: bold; font-size: 1.2em;">2022</div>
		Condition Assessment Graffiti: None Erosion: None Deposition: None in. Damage: None

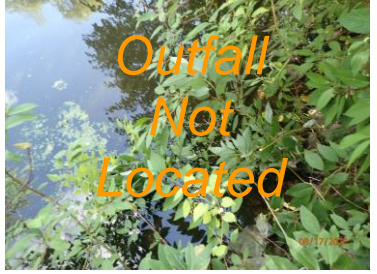
Inspection Date: 8/17/2021 10:33:51 AM		Type: Ongoing	Flow: Submerged (not located)	Previous Rainfall (hrs): 72+
Illicit Discharge Potential: Unlikely		Inspector: JCW		
Submerged: Fully		Depth (in):		
Sampling Results Sample Location: _____ Total Chlorine: -- ppm Free Chlorine: -- ppm Ammonia: -- ppm pH: -- units Temperature: -- °F Conductivity: -- µS/cm Detergents: -- mg/L		Floatables: None Odor: None Turbidity: None Color: None Gross Solids: None Vegetation: None Benthic Growth: None Stains: None Non-illicit: None	Notes Outfall fully submerged and not located - screened upstream at 06-221 US1.

o20210817103222.JPG <div style="text-align: center; font-weight: bold; font-size: 1.2em;">2021</div>
		Condition Assessment Graffiti: None Erosion: None Deposition: None in. Damage: None

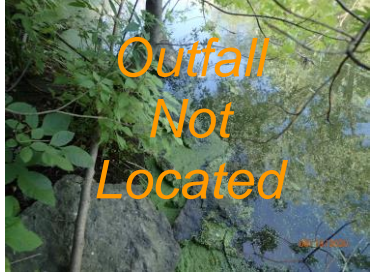
Inspection Date: 8/19/2020 10:10:00 AM		Type: Ongoing	Flow: Submerged (not located)	Previous Rainfall (hrs): 72+
Illicit Discharge Potential: Unlikely		Inspector: JCW		
Submerged: Fully		Depth (in):		
Sampling Results Sample Location: _____ Total Chlorine: -- ppm Free Chlorine: -- ppm Ammonia: -- ppm pH: -- units Temperature: -- °F Conductivity: -- µS/cm Detergents: -- mg/L		Floatables: None Odor: None Turbidity: None Color: None Gross Solids: None Vegetation: None Benthic Growth: None Stains: None Non-illicit: None	Notes Outfall fully submerged and not located - screened upstream at 06-221 US1.

o20200819101038.JPG <div style="text-align: center; font-weight: bold; font-size: 1.2em;">2020</div>
		Condition Assessment Graffiti: None Erosion: None Deposition: None in. Damage: None

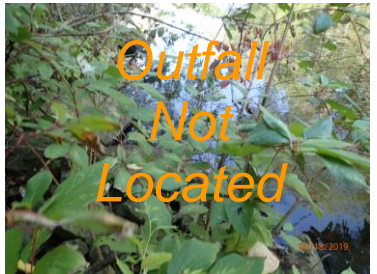
Inspection Date: 9/18/2019 9:37:57 AM		Type: Ongoing	Flow: Submerged (not located)	Previous Rainfall (hrs): 72+
Illicit Discharge Potential: Unlikely		Inspector: JCW		
Submerged: Fully		Depth (in):		
Sampling Results Sample Location: _____ Total Chlorine: -- ppm Free Chlorine: -- ppm Ammonia: -- ppm pH: -- units Temperature: -- °F Conductivity: -- µS/cm Detergents: -- mg/L		Floatables: None Odor: None Turbidity: None Color: None Gross Solids: None Vegetation: None Benthic Growth: None Stains: None Non-illicit: None	Notes Outfall fully submerged and not located - screened upstream at 06-221 US1. Floating gross solids (litter) in manhole.

o20190918083642.JPG <div style="text-align: center; font-weight: bold; font-size: 1.2em;">2019</div>
		Condition Assessment Graffiti: None Erosion: None Deposition: None in. Damage: None

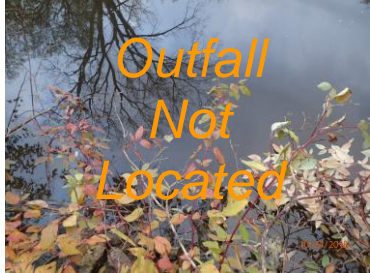
o20181024074402.JPG

Inspection Date: 10/24/2018 7:45:30 AM		Type: Ongoing	Flow: Submerged (not located)	Previous Rainfall (hrs): 72+
Illicit Discharge Potential: Potential		Inspector: JCW	Notes	
Submerged: Fully		Depth (in):	Outfall fully submerged and not located - screened upstream at 06-221 US1. Floating gross solids (litter) in manhole.	
Sampling Results		Floatables:	Condition Assessment Graffiti: None Erosion: None Deposition: None in. Damage: None	
Sample Location:		Odor:		
Total Chlorine: -- ppm		Turbidity:		
Free Chlorine: -- ppm		Color:		
Ammonia: -- ppm		Gross Solids:		
pH: -- units		Vegetation:		
Temperature -- °F		Benthic Growth:		
Conductivity: -- µS/cm		Stains:		
Detergents: -- mg/L		Non-illicit:

Outfall Not Located

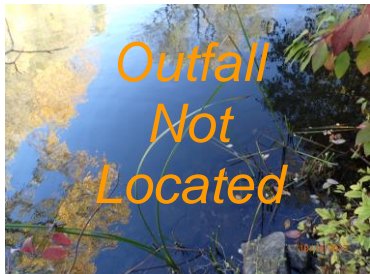
o20171018105502.JPG

Inspection Date: 10/18/2017 10:56:45 AM		Type: Ongoing	Flow: Submerged (not located)	Previous Rainfall (hrs): 72+
Illicit Discharge Potential: Potential		Inspector: JCW	Notes	
Submerged: Fully		Depth (in):	Outfall fully submerged and not located - screened upstream at 06-221 US1. Floating gross solids (litter) in manhole.	
Sampling Results		Floatables:	Condition Assessment Graffiti: None Erosion: None Deposition: None in. Damage: None	
Sample Location:		Odor:		
Total Chlorine: -- ppm		Turbidity:		
Free Chlorine: -- ppm		Color:		
Ammonia: -- ppm		Gross Solids:		
pH: -- units		Vegetation:		
Temperature -- °F		Benthic Growth:		
Conductivity: -- µS/cm		Stains:		
Detergents: -- mg/L		Non-illicit:

Outfall Not Located

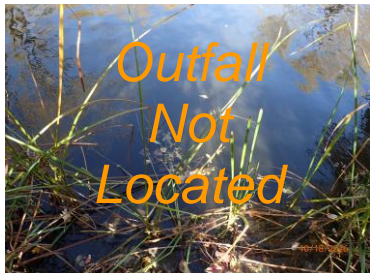
o20161018133940.JPG

Inspection Date: 10/18/2016 1:40:09 PM		Type: Ongoing	Flow: Submerged (not located)	Previous Rainfall (hrs): 72+
Illicit Discharge Potential: Potential		Inspector: JCW	Notes	
Submerged: Fully		Depth (in):	Outfall fully submerged and not located - screened upstream at 06-221 US1.	
Sampling Results		Floatables:	Condition Assessment Graffiti: None Erosion: None Deposition: None in. Damage: None	
Sample Location:		Odor:		
Total Chlorine: -- ppm		Turbidity:		
Free Chlorine: -- ppm		Color:		
Ammonia: -- ppm		Gross Solids:		
pH: -- units		Vegetation:		
Temperature -- °F		Benthic Growth:		
Conductivity: -- µS/cm		Stains:		
Detergents: -- mg/L		Non-illicit:

Outfall Not Located

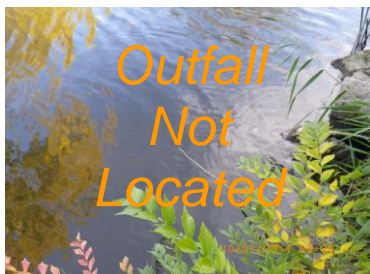
o20141007083652.JPG

Inspection Date: 10/7/2014 9:37:56 AM		Type: Ongoing	Flow: Submerged (not located)	Previous Rainfall (hrs): 48-72
Illicit Discharge Potential: Unlikely		Inspector: JCW	Notes	
Submerged: Fully		Depth (in):	Outfall partially submerged and not located - screened upstream at 06-221 US1.	
Sampling Results		Floatables:	Condition Assessment Graffiti: None Erosion: None Deposition: None in. Damage: None	
Sample Location:		Odor:		
Total Chlorine: -- ppm		Turbidity:		
Free Chlorine: -- ppm		Color:		
Ammonia: -- ppm		Gross Solids:		
pH: -- units		Vegetation:		
Temperature -- °F		Benthic Growth:		
Conductivity: -- µS/cm		Stains:		
Detergents: -- mg/L		Non-illicit:

Outfall Not Located

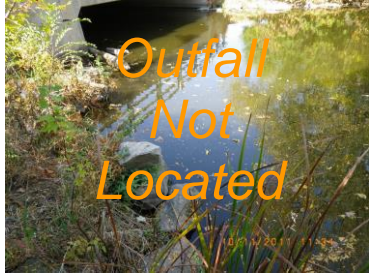
o20111011113446.JPG

Inspection Date: 10/11/2011 11:34:32 AM		Type: Ongoing	Flow: Submerged (not located)	Previous Rainfall (hrs): 72+
Illicit Discharge Potential: Potential		Inspector: JCW	Notes	
Submerged: Fully		Depth (in):	2010 screening follow-up. Outfall fully submerged and not physically located. Outfall screened upstream at 06-221 US1.	
Sampling Results		Floatables:	Condition Assessment Graffiti: None Erosion: None Deposition: None 0 in. Damage: None	
Sample Location:		Odor:		
Total Chlorine: -- ppm	Turbidity:			
Free Chlorine: -- ppm	Color:			
Ammonia: -- ppm	Gross Solids:			
pH: -- units	Vegetation:			
Temperature -- °F	Benthic Growth:			
Conductivity: -- µS/cm	Stains:			
Detergents: -- mg/L	Non-illicit:

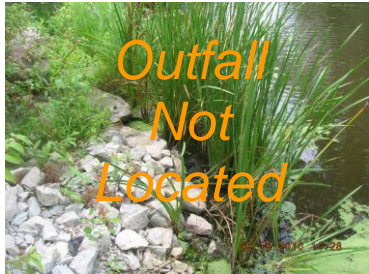
o20100818142820.JPG

Inspection Date: 8/18/2010 2:38:53 PM		Type: Ongoing	Flow: Submerged (not located)	Previous Rainfall (hrs): 72+
Illicit Discharge Potential: Potential		Inspector: JCW	Notes	
Submerged: Fully		Depth (in):	Outfall fully submerged and not physically located. Outfall screened upstream at 06-221 US1.	
Sampling Results		Floatables:	Condition Assessment Graffiti: None Erosion: None Deposition: None 0 in. Damage: None	
Sample Location:		Odor:		
Total Chlorine: -- ppm	Turbidity:			
Free Chlorine: -- ppm	Color:			
Ammonia: -- ppm	Gross Solids:			
pH: -- units	Vegetation:			
Temperature -- °F	Benthic Growth:			
Conductivity: -- µS/cm	Stains:			
Detergents: -- mg/L	Non-illicit:

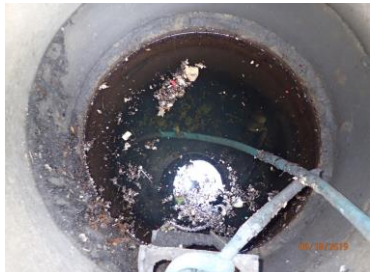
<p style="text-align: center;">o20190918083752.JPG</p> <p style="text-align: center; font-size: 24pt; font-weight: bold;">2019</p>

<div style="display: flex;"> <div style="flex: 1;"> <p>Notes</p> <p>Sample collected from submerged pool in manhole. Floating gross solids (litter) in manhole.</p> </div> <div style="flex: 1;"> <p>Condition Assessment</p> <p>Graffiti: None</p> <p>Erosion: None</p> <p>Deposition: None in.</p> <p>Damage: None</p> </div> </div>

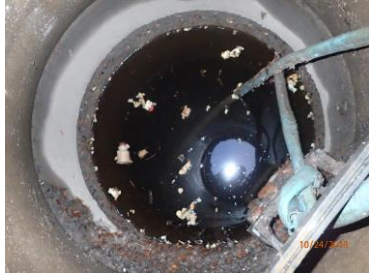
o20181024074456.JPG

Inspection Date: 10/24/2018 7:47:19 AM		Type: Ongoing	Flow: Submerged, indeterminate	Previous Rainfall (hrs): 72+
Illicit Discharge Potential: Potential		Inspector: JCW	Notes	
Submerged: Fully		Depth (in): 40	Sample collected from submerged pool in manhole. Floating gross solids (litter) in manhole.	
Sampling Results		Floatables: None	Condition Assessment Graffiti: None Erosion: None Deposition: None in. Damage: None	
Sample Location: Pool	Odor: None	Turbidity: None		
Total Chlorine: 0 ppm	Color: None	Gross Solids: Slight		
Free Chlorine: 0 ppm	Vegetation: None	Benthic Growth: None		
Ammonia: 0 ppm	Stains: None	Non-illicit: None		
pH: 7.59 units				
Temperature 52 °F				
Conductivity: 575 µS/cm				
Detergents: 0 mg/L

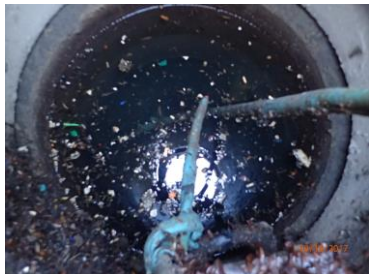
o20171018105550.JPG

Inspection Date: 10/18/2017 11:00:06 AM		Type: Ongoing	Flow: Submerged, indeterminate	Previous Rainfall (hrs): 72+
Illicit Discharge Potential: Potential		Inspector: JCW	Notes	
Submerged: Fully		Depth (in): 32	Sample collected from submerged pool in manhole. Floating gross solids (litter) in manhole.	
Sampling Results		Floatables: None	Condition Assessment Graffiti: None Erosion: None Deposition: None in. Damage: None	
Sample Location: Pool	Odor: None	Turbidity: None		
Total Chlorine: 0 ppm	Color: None	Gross Solids: Moderate		
Free Chlorine: 0 ppm	Vegetation: None	Benthic Growth: None		
Ammonia: 0 ppm	Stains: None	Non-illicit: None		
pH: 7.24 units				
Temperature 66 °F				
Conductivity: 379 µS/cm				
Detergents: 0 mg/L

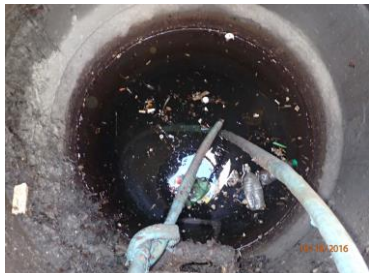
o20161018134038.JPG

Inspection Date: 10/18/2016 1:43:57 PM		Type: Ongoing	Flow: Submerged, indeterminate	Previous Rainfall (hrs): 72+
Illicit Discharge Potential: Potential		Inspector: JCW	Notes	
Submerged: Fully		Depth (in): 35	Casting displaced 2". Potential illicit discharge due to gross solids.	
Sampling Results		Floatables: None	Condition Assessment Graffiti: None Erosion: None Deposition: None in. Damage: Minor	
Sample Location: Pool	Odor: None	Turbidity: None		
Total Chlorine: 0 ppm	Color: None	Gross Solids: Moderate		
Free Chlorine: 0 ppm	Vegetation: None	Benthic Growth: None		
Ammonia: 0 ppm	Stains: None	Non-illicit: None		
pH: 7.06 units				
Temperature 68 °F				
Conductivity: 460 µS/cm				
Detergents: 0 mg/L

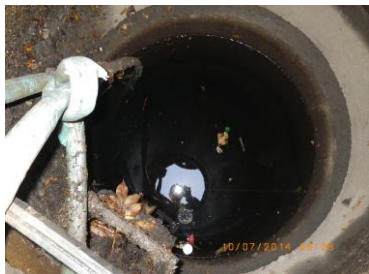
o20141007083848.JPG

Inspection Date: 10/7/2014 9:38:38 AM		Type: Ongoing	Flow: Submerged, indeterminate	Previous Rainfall (hrs): 48-72
Illicit Discharge Potential: Unlikely		Inspector: JCW	Notes	
Submerged: Fully		Depth (in): 32		
Sampling Results		Floatables: None	Condition Assessment Graffiti: None Erosion: None Deposition: Minor 3 in. Damage: None	
Sample Location: Pool	Odor: None	Turbidity: None		
Total Chlorine: 0 ppm	Color: None	Gross Solids: Slight		
Free Chlorine: 0 ppm	Vegetation: None	Benthic Growth: None		
Ammonia: 0 ppm	Stains: None	Non-illicit: None		
pH: 7.78 units				
Temperature -- °F				
Conductivity: 351 µS/cm				
Detergents: 0 mg/L

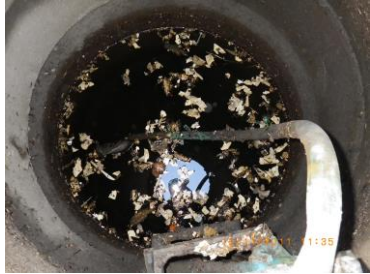
o20111011113522.JPG

Inspection Date: 10/11/2011 11:37:34 AM		Type: Ongoing	Flow: Submerged, indeterminate	Previous Rainfall (hrs): 72+																																		
Illicit Discharge Potential: Potential		Inspector: JCW	Notes																																			
Submerged: Fully		Depth (in): 32	2010 screening follow-up. Floatable debris still present.																																			
Sampling Results		Condition Assessment																																				
<table border="1" style="width:100%; border-collapse: collapse;"> <tr><td>Sample Location:</td><td>Pool</td></tr> <tr><td>Total Chlorine:</td><td>0 ppm</td></tr> <tr><td>Free Chlorine:</td><td>0 ppm</td></tr> <tr><td>Ammonia:</td><td>0 ppm</td></tr> <tr><td>pH:</td><td>7.5 units</td></tr> <tr><td>Temperature:</td><td>71 °F</td></tr> <tr><td>Conductivity:</td><td>-- µS/cm</td></tr> <tr><td>Detergents:</td><td>-- mg/L</td></tr> </table>		Sample Location:	Pool	Total Chlorine:	0 ppm	Free Chlorine:	0 ppm	Ammonia:	0 ppm	pH:	7.5 units	Temperature:	71 °F	Conductivity:	-- µS/cm	Detergents:	-- mg/L	<table border="1" style="width:100%; border-collapse: collapse;"> <tr><td>Floatables:</td><td>None</td></tr> <tr><td>Odor:</td><td>None</td></tr> <tr><td>Turbidity:</td><td>None</td></tr> <tr><td>Color:</td><td>None</td></tr> <tr><td>Gross Solids:</td><td>Moderate</td></tr> <tr><td>Vegetation:</td><td>None</td></tr> <tr><td>Benthic Growth:</td><td>None</td></tr> <tr><td>Stains:</td><td>None</td></tr> <tr><td>Non-illicit:</td><td>None</td></tr> </table>			Floatables:	None	Odor:	None	Turbidity:	None	Color:	None	Gross Solids:	Moderate	Vegetation:	None	Benthic Growth:	None	Stains:	None	Non-illicit:	None

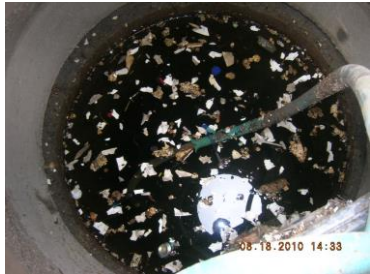
o20100818143354.JPG

Inspection Date: 8/18/2010 2:43:51 PM		Type: Ongoing	Flow: Submerged, indeterminate	Previous Rainfall (hrs): 72+																																		
Illicit Discharge Potential: Potential		Inspector: JCW	Notes																																			
Submerged: Fully		Depth (in): 36	Torn paper and other floatable debris in manhole.																																			
Sampling Results		Condition Assessment																																				
<table border="1" style="width:100%; border-collapse: collapse;"> <tr><td>Sample Location:</td><td>Pool</td></tr> <tr><td>Total Chlorine:</td><td>0 ppm</td></tr> <tr><td>Free Chlorine:</td><td>0 ppm</td></tr> <tr><td>Ammonia:</td><td>0 ppm</td></tr> <tr><td>pH:</td><td>7.21 units</td></tr> <tr><td>Temperature:</td><td>79 °F</td></tr> <tr><td>Conductivity:</td><td>-- µS/cm</td></tr> <tr><td>Detergents:</td><td>0 mg/L</td></tr> </table>		Sample Location:	Pool	Total Chlorine:	0 ppm	Free Chlorine:	0 ppm	Ammonia:	0 ppm	pH:	7.21 units	Temperature:	79 °F	Conductivity:	-- µS/cm	Detergents:	0 mg/L	<table border="1" style="width:100%; border-collapse: collapse;"> <tr><td>Floatables:</td><td>None</td></tr> <tr><td>Odor:</td><td>None</td></tr> <tr><td>Turbidity:</td><td>None</td></tr> <tr><td>Color:</td><td>None</td></tr> <tr><td>Gross Solids:</td><td>Moderate</td></tr> <tr><td>Vegetation:</td><td>None</td></tr> <tr><td>Benthic Growth:</td><td>None</td></tr> <tr><td>Stains:</td><td>None</td></tr> <tr><td>Non-illicit:</td><td>None</td></tr> </table>			Floatables:	None	Odor:	None	Turbidity:	None	Color:	None	Gross Solids:	Moderate	Vegetation:	None	Benthic Growth:	None	Stains:	None	Non-illicit:	None

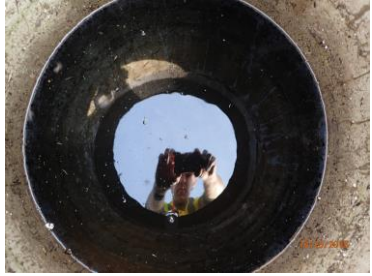
Inspection Date: 10/25/2018 2:01:17 PM		Type: Ongoing	Flow: Submerged, indeterminate	Previous Rainfall (hrs): 72+
Illicit Discharge Potential: Unlikely		Inspector: JCW		
Submerged: Fully		Depth (in): 58		
Sampling Results Sample Location: Pool Total Chlorine: 0 ppm Free Chlorine: 0 ppm Ammonia: 0 ppm pH: 7.81 units Temperature: 55 °F Conductivity: 1013 µS/cm Detergents: 0 mg/L		Floatables: None Odor: None Turbidity: None Color: None Gross Solids: None Vegetation: None Benthic Growth: None Stains: None Non-illicit: None	Notes Sample collected from submerged pool in manhole.

o20181025135914.JPG <div style="text-align: center; font-size: 24pt; font-weight: bold;">2018</div>
			Condition Assessment Graffiti: None Erosion: None Deposition: None in. Damage: None

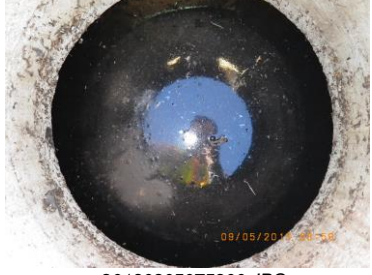
Inspection Date: 9/5/2013 8:55:27 AM		Type: Ongoing	Flow: Submerged, indeterminate	Previous Rainfall (hrs): 72+
Illicit Discharge Potential: Unlikely		Inspector: JCW		
Submerged: Fully		Depth (in): 58		
Sampling Results Sample Location: Pool Total Chlorine: 0 ppm Free Chlorine: 0 ppm Ammonia: 0 ppm pH: 7.34 units Temperature: 69 °F Conductivity: 438 µS/cm Detergents: 0 mg/L		Floatables: None Odor: None Turbidity: None Color: None Gross Solids: None Vegetation: None Benthic Growth: Slight Stains: None Non-illicit: Slight	Notes 2012 screening follow-up.

o20130905075900.JPG <div style="text-align: center; font-size: 24pt; font-weight: bold;">2013</div>
			Condition Assessment Graffiti: None Erosion: None Deposition: None in. Damage: None

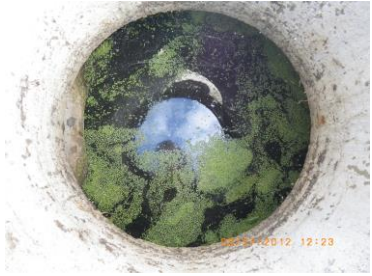
Inspection Date: 9/27/2012 12:18:11 PM		Type: Repeat	Flow: Submerged, indeterminate	Previous Rainfall (hrs): 72+
Illicit Discharge Potential: Unlikely		Inspector: JCW		
Submerged: Fully		Depth (in): 54		
Sampling Results Sample Location: Pool Total Chlorine: 0 ppm Free Chlorine: 0 ppm Ammonia: 0 ppm pH: 7.85 units Temperature: 63 °F Conductivity: 497 µS/cm Detergents: 0 mg/L		Floatables: None Odor: None Turbidity: None Color: None Gross Solids: None Vegetation: None Benthic Growth: None Stains: None Non-illicit: Slight	Notes Ammonia follow-up. Duckweed in manhole.

o20120927112310.JPG <div style="text-align: center; font-size: 24pt; font-weight: bold;">2012</div>
			Condition Assessment Graffiti: None Erosion: None Deposition: None in. Damage: None

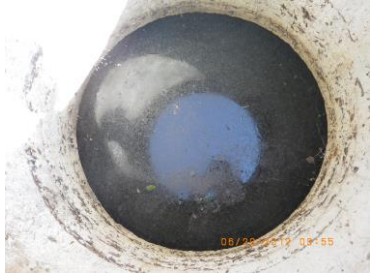
Inspection Date: 6/20/2012 9:54:44 AM		Type: Ongoing	Flow: Submerged, indeterminate	Previous Rainfall (hrs): 24-48	
Illicit Discharge Potential: Potential		Inspector: JCW	Notes		
Submerged: Fully		Depth (in): 60

<p style="text-align: center;">o20120620085526.JPG</p> <p style="text-align: center; font-size: 24pt; font-weight: bold;">2012</p>		
Sampling Results					
Sample Location:	Pool	Floatables:			None
Total Chlorine:	0 ppm	Odor:			None
Free Chlorine:	0 ppm	Turbidity:			None
Ammonia:	0.5 ppm	Color:			None
pH:	7.77 units	Gross Solids:			None
Temperature	81 °F	Vegetation:			None
Conductivity:	632 µS/cm	Benthic Growth:			Slight
Detergents:	0 mg/L	Stains:			None
		Non-illicit:	None		
			Condition Assessment Graffiti: None Erosion: None Deposition: None in. Damage: None

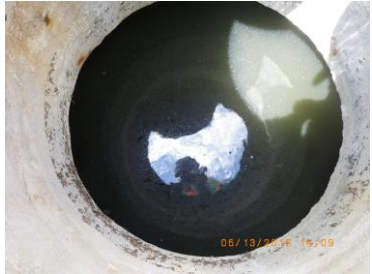
Inspection Date: 6/13/2012 2:06:46 PM		Type: Other	Flow: Submerged, indeterminate	Previous Rainfall (hrs): 72+	
Illicit Discharge Potential: Potential		Inspector: JCW	Notes		
Submerged: Fully		Depth (in): 52

<p style="text-align: center;">o20120613130900.JPG</p> <p style="text-align: center; font-size: 24pt; font-weight: bold;">2012</p>		
Sampling Results					
Sample Location:	Pool	Floatables:			None
Total Chlorine:	0 ppm	Odor:			Faint
Free Chlorine:	0 ppm	Turbidity:			None
Ammonia:	3 ppm	Color:			None
pH:	7.76 units	Gross Solids:			None
Temperature	75 °F	Vegetation:			None
Conductivity:	1034 µS/cm	Benthic Growth:			None
Detergents:	0 mg/L	Stains:			None
		Non-illicit:	Slight		
			Condition Assessment Graffiti: None Erosion: None Deposition: None in. Damage: None

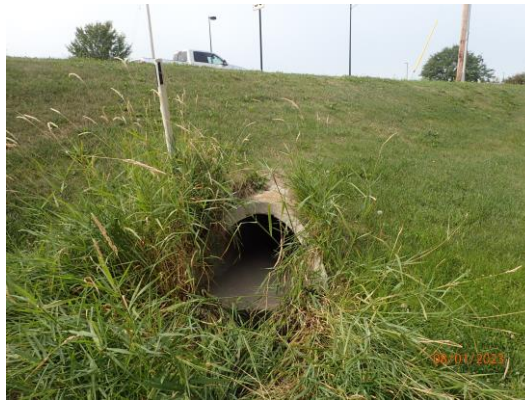
o20230801095908.JPG

☐ Petrol. Sheen ☐ Suds ☐ Sewage ☐ Algae ☐ Other☐ Petroleum ☐ Musty ☐ Sewage ☐ Chlorine ☐ Other☐ VOC/Solvent ☐ Fishy ☐ Sulfur ☐ Fragrant☐ Litter ☐ Veg. Debris ☐ Sediment ☐ Other☐ Inhibited ☐ Excessive☒ Green ☐ Brown☐ Flow Line ☐ Oil ☐ Rust Stains☐ Paint ☐ Other☐ Natural Sheen ☐ Natural Suds/Foam

Damage: Minor ☐ Displacement ☒ Undercut ☐ Crushed☐ Corrosion ☐ Cracks/Structural Damage

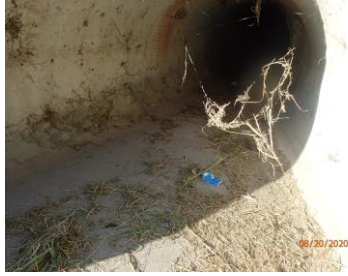
Inspection Date: 8/20/2020 8:06:39 AM		Type: Ongoing	Flow: None	Previous Rainfall (hrs): 72+
Illicit Discharge Potential: Unlikely		Inspector: JCW		
Submerged: None		Depth (in):		
Sampling Results				
Sample Location:		Floatables:	None	
Total Chlorine: -- ppm		Odor:	None	
Free Chlorine: -- ppm		Turbidity:	None	
Ammonia: -- ppm		Color:	None	
pH: -- units		Gross Solids:	Slight	
Temperature -- °F		Vegetation:	None	
Conductivity: -- µS/cm		Benthic Growth:	None	
Detergents: -- mg/L		Stains:	None	
		Non-illicit:	None	
		Notes Pipe dry at time of inspection. Erosion downstream of outfall.		
		Condition Assessment Graffiti: None Erosion: Moderate Deposition: None in. Damage: None

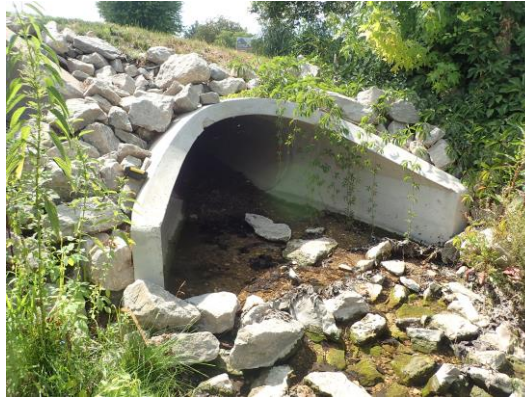
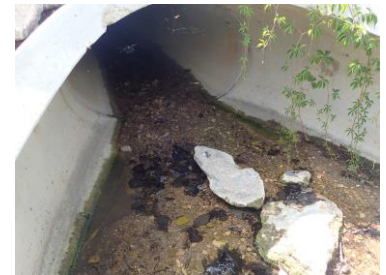
o20230719142840.JPG

Storm sewer from W. 9th Ave discharges to stream from west. Replaces outfall 06-1132 (2021).

Stains: Slight

☐ Petrol. Sheen ☐ Suds ☐ Sewage ☐ Algae ☐ Other☐ Petroleum ☐ Musty ☐ Sewage ☐ Chlorine ☐ Other☐ VOC/Solvent ☐ Fishy ☐ Sulfur ☐ Fragrant☐ Litter ☒ Veg. Debris ☐ Sediment ☐ Other☐ Inhibited ☐ Excessive☒ Green ☒ Brown☒ Flow Line ☐ Oil ☐ Rust Stains☐ Paint ☐ Other☐ Natural Sheen ☐ Natural Suds/Foam

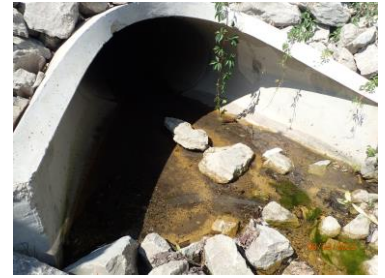
Inspection Date: 8/23/2022 12:12:00 PM		Type: Ongoing	Flow: Submerged, slight flow	Previous Rainfall (hrs): 72+
Illicit Discharge Potential: Potential		Inspector: EJK		
Submerged: Partially		Depth (in): 3		
Sampling Results				
Sample Location: Flow		Floatables:	None	
Total Chlorine: 0 ppm		Odor:	Easily detected	
Free Chlorine: 0 ppm		Turbidity:	None	
Ammonia: 0 ppm		Color:	None	
pH: 8.12 units		Gross Solids:	None	
Temperature 74 °F		Vegetation:	None	
Conductivity: 433 µS/cm		Benthic Growth:	Moderate	
Detergents: 1 mg/L		Stains:	Slight	
		Non-illicit:	None	
Notes				
Sample collected from submerged flow at end of pipe. Detergent detected in sample.				
Condition Assessment				
Graffiti:		None		
Erosion:		None		
Deposition:		None in.		
Damage:		None

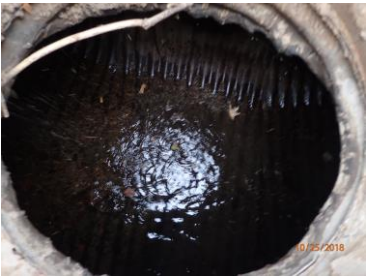
Inspection Date: 10/26/2018 1:18:04 PM		Type: Repeat	Flow: Submerged, slight flow	Previous Rainfall (hrs): 72+
Illicit Discharge Potential: Potential		Inspector: KMK		
Submerged: Partially		Depth (in): 2		
Sampling Results Sample Location: Flow Total Chlorine: 0 ppm Free Chlorine: 0 ppm Ammonia: 0 ppm pH: 8.25 units Temperature: 55 °F Conductivity: 1080 µS/cm Detergents: 0.3 mg/L		Floatables: None Odor: None Turbidity: None Color: None Gross Solids: None Vegetation: None Benthic Growth: None Stains: None Non-illicit: None		
		Notes Detergent detection follow-up. Limited screening conducted beyond sampling.		
		Condition Assessment Graffiti: None Erosion: None Deposition: None in. Damage: None

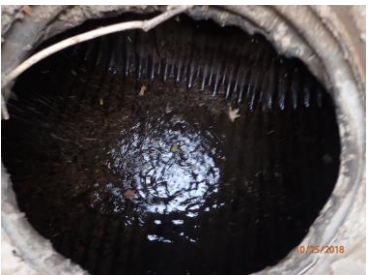
Inspection Date: 10/25/2018 10:02:44 AM		Type: Ongoing	Flow: Submerged, slight flow	Previous Rainfall (hrs): 72+
Illicit Discharge Potential: Potential		Inspector: JCW		
Submerged: Partially		Depth (in): 2		
Sampling Results Sample Location: Flow Total Chlorine: 0 ppm Free Chlorine: 0 ppm Ammonia: 0 ppm pH: 8.15 units Temperature: 52 °F Conductivity: 1289 µS/cm Detergents: 0.5 mg/L		Floatables: None Odor: None Turbidity: None Color: None Gross Solids: None Vegetation: None Benthic Growth: None Stains: None Non-illicit: None		
		Notes Sample collected from submerged pool in manhole. Detergent detected in sample.		
		Condition Assessment Graffiti: None Erosion: None Deposition: None in. Damage: None

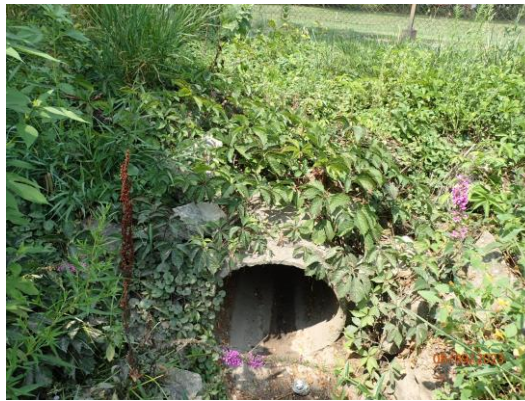
o20230809114056.JPG

Notes: Pipe dry at time of inspection. 3" joint displacement/deterioration.

☐ Petrol. Sheen ☐ Suds ☐ Sewage ☐ Algae ☐ Other☐ Petroleum ☐ Musty ☐ Sewage ☐ Chlorine ☐ Other☐ VOC/Solvent ☐ Fishy ☐ Sulfur ☐ Fragrant☒ Litter ☒ Veg. Debris ☐ Sediment ☐ Other☐ Inhibited ☐ Excessive☐ Green ☐ Brown☐ Flow Line ☐ Oil ☐ Rust Stains☐ Paint ☐ Other☐ Natural Sheen ☐ Natural Suds/Foam

Damage: Minor ☐ Displacement ☐ Undercut ☐ Crushed☐ Corrosion ☒ Cracks/Structural Damage

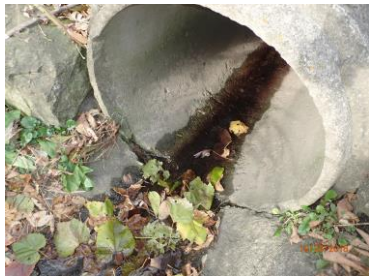
Inspection Date: 10/25/2018 9:45:38 AM		Type: Ongoing	Flow: Trickle	Previous Rainfall (hrs): 72+
Illicit Discharge Potential: Unlikely		Inspector: JCW		
Submerged: None		Depth (in):		
Sampling Results Sample Location: Flow Total Chlorine: 0 ppm Free Chlorine: 0 ppm Ammonia: 0 ppm pH: 7.81 units Temperature: 52 °F Conductivity: 851 µS/cm Detergents: 0 mg/L		Floatables: None Odor: None Turbidity: None Color: None Gross Solids: None Vegetation: None Benthic Growth: Slight Stains: None Non-illicit: None		
		Notes Sample collected from pipe flow.		
		Condition Assessment Graffiti: None Erosion: None Deposition: None in. Damage: Minor

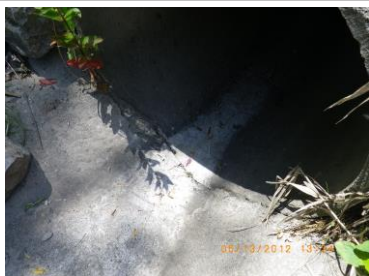
Inspection Date: 6/13/2012 1:23:15 PM		Type: Ongoing	Flow: None	Previous Rainfall (hrs): 72+
Illicit Discharge Potential: Unlikely		Inspector: JCW		
Submerged: None		Depth (in):		
Sampling Results Sample Location: -- Total Chlorine: -- ppm Free Chlorine: -- ppm Ammonia: -- ppm pH: -- units Temperature: -- °F Conductivity: -- µS/cm Detergents: -- mg/L		Floatables: None Odor: None Turbidity: None Color: None Gross Solids: None Vegetation: None Benthic Growth: None Stains: Moderate Non-illicit: None		
		Notes Pipe and downstream channel dry.		
		Condition Assessment Graffiti: None Erosion: None Deposition: None in. Damage: None

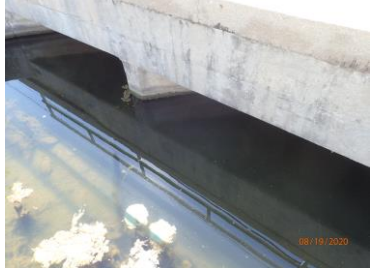
Sample Location:	Flow																																					
Total Chlorine:	0 ppm																																					
Free Chlorine:	0 ppm																																					
Ammonia:	0 ppm																																					
pH:	7.89 units																																					
Temperature:	78 °F																																					
Conductivity:	1371 µS/cm																																					
Detergents:	0 mg/L																																					
Floatables:	None																																					
Odor:	None																																					
Turbidity:	None																																					
Color:	None																																					
Gross Solids:	None																																					
Vegetation:	None																																					
Benthic Growth:	Moderate																																					
Stains:	Slight																																					
Non-illicit:	None

Notes Sample collected from submerged flow leaving culvert.																																				
		Condition Assessment <table border="1" style="width:100%; border-collapse: collapse;"> <tr><td>Graffiti:</td><td>None</td></tr> <tr><td>Erosion:</td><td>None</td></tr> <tr><td>Deposition:</td><td>None in.</td></tr> <tr><td>Damage:</td><td>None</td></tr> </table>			Graffiti:	None	Erosion:	None	Deposition:	None in.	Damage:	None																										
Graffiti:	None																																					
Erosion:	None																																					
Deposition:	None in.																																					
Damage:	None

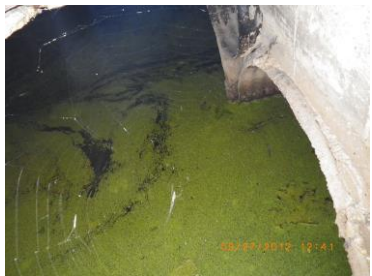
o20191105110322.JPG <div style="text-align: right; font-size: 24pt; font-weight: bold;">2019</div>

Inspection Date: 11/5/2019 11:05:04 AM		Type: Repeat	Flow: Submerged, indeterminate	Previous Rainfall (hrs): 48-72
Illicit Discharge Potential: Potential		Inspector: JCW		
Submerged: Partially		Depth (in): 67		
Sampling Results		Notes Detergent detection follow-up. Limited screening conducted.		
Sample Location: Pool	Floatables:			
Total Chlorine: -- ppm	Odor:	None		
Free Chlorine: -- ppm	Turbidity:	None		
Ammonia: -- ppm	Color:	None		
pH: -- units	Gross Solids:	Severe		
Temperature -- °F	Vegetation:	None		
Conductivity: -- µS/cm	Benthic Growth:	None		
Detergents: 0 mg/L	Stains:	None		
	Non-illicit:	None		
		Condition Assessment Graffiti: None Erosion: None Deposition: None in. Damage: None

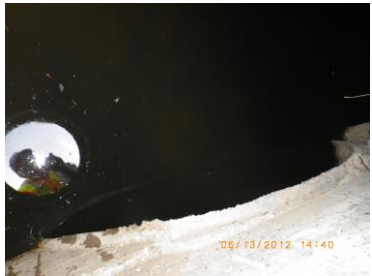
Inspection Date: 10/8/2019 9:18:01 AM		Type: Ongoing	Flow: Submerged, indeterminate	Previous Rainfall (hrs): 48-72
Illicit Discharge Potential: Potential		Inspector: JCW	Notes	
Submerged: Partially Depth (in): 73			Sample collected from submerged pool in manhole. Floating gross solids (litter) in manhole. Detergent detected.	
Sampling Results		Floatables: None	Condition Assessment Graffiti: None Erosion: None Deposition: None in. Damage: None	
Sample Location: Pool		Odor: None		
Total Chlorine: 0 ppm		Turbidity: None		
Free Chlorine: 0 ppm		Color: None		
Ammonia: 0 ppm		Gross Solids: Severe		
pH: 7.28 units		Vegetation: None		
Temperature 61 °F		Benthic Growth: None		
Conductivity: 381 µS/cm		Stains: None		
Detergents: 0.9 mg/L		Non-illicit: None

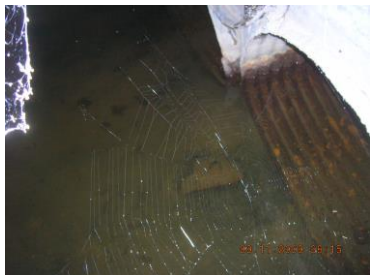
Inspection Date: 10/18/2016 3:42:40 PM		Type: Ongoing	Flow: Submerged, indeterminate	Previous Rainfall (hrs): 72+
Illicit Discharge Potential: Potential		Inspector: JCW	Notes	
Submerged: Fully Depth (in): 67			Potential illicit discharge due to gross solids.	
Sampling Results		Floatables: None	Condition Assessment Graffiti: None Erosion: None Deposition: None in. Damage: None	
Sample Location: Pool		Odor: None		
Total Chlorine: 0 ppm		Turbidity: None		
Free Chlorine: 0 ppm		Color: Faint in bottle		
Ammonia: 0 ppm		Gross Solids: Severe		
pH: 8.16 units		Vegetation: None		
Temperature 66 °F		Benthic Growth: None		
Conductivity: 531 µS/cm		Stains: None		
Detergents: 0 mg/L		Non-illicit: None

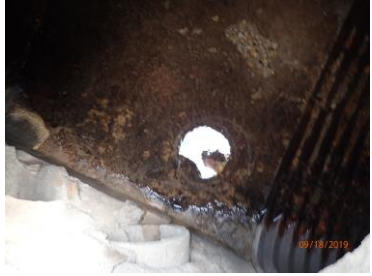
o20230717085802.JPG

Damage: None ☐ Displacement ☐ Undercut ☐ Crushed☐ Corrosion ☐ Cracks/Structural Damage

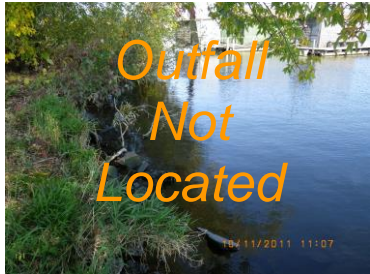
Height/Depth (in): 24

Dimensions

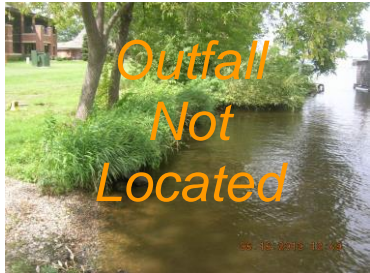
☒ Not Physically Located

Mapping Precison:

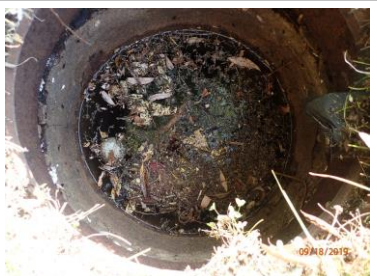
o20190918074352.JPG 2019
Sampling Results Sample Location: Pool Total Chlorine: 0 ppm Free Chlorine: 0 ppm Ammonia: 0 ppm pH: 8.4 units Temperature: 70 °F Conductivity: 391 µS/cm Detergents: 0 mg/L		Floatables: None Odor: None Turbidity: None Color: None Gross Solids: Moderate Vegetation: None Benthic Growth: None Stains: None Non-illicit: None	Sample collected from submerged pool in manhole. Floating gross solids (litter) in manhole. Condition Assessment Graffiti: None Erosion: None Deposition: None in. Damage: None

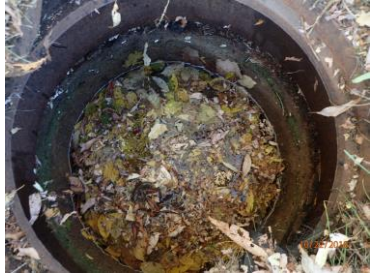
<p style="text-align: center;">o20181022163150.JPG</p> <p style="text-align: center; font-size: 24pt; font-weight: bold;">2018</p>	
Submerged: Fully		Depth (in): 44		Sample collected from submerged pool in manhole. Floating gross solids (litter) in manhole.			
Sampling Results		Floatables: None Odor: None Turbidity: None Color: None Gross Solids: Moderate Vegetation: None Benthic Growth: Slight Stains: None Non-illicit: None		Condition Assessment Graffiti: None Erosion: None Deposition: None in. Damage: None			
Sample Location: Pool Total Chlorine: 0 ppm Free Chlorine: 0 ppm Ammonia: 0 ppm pH: 7.77 units Temperature: 54 °F Conductivity: 348 µS/cm Detergents: 0 mg/L

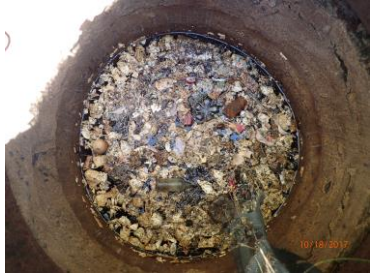
<p style="text-align: center;">o20171018112938.JPG</p> <p style="text-align: center; font-size: 24pt; font-weight: bold;">2017</p>	
Submerged: Fully		Depth (in): 40		Sample collected from submerged pool in manhole. Floating gross solids (litter) in manhole.			
Sampling Results		Floatables: None Odor: None Turbidity: None Color: None Gross Solids: Severe Vegetation: None Benthic Growth: None Stains: None Non-illicit: None		Condition Assessment Graffiti: None Erosion: None Deposition: None in. Damage: None			
Sample Location: Pool Total Chlorine: 0 ppm Free Chlorine: 0 ppm Ammonia: 0 ppm pH: 8.39 units Temperature: 65 °F Conductivity: 403 µS/cm Detergents: 0 mg/L

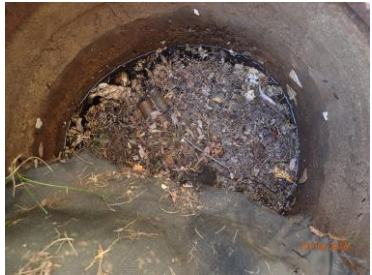
<p style="text-align: center;">o20161018145924.JPG</p> <p style="text-align: center; font-size: 24pt; font-weight: bold;">2016</p>	
Submerged: Fully		Depth (in):		Potential illicit discharge due to gross solids.			
Sampling Results		Floatables: None Odor: None Turbidity: None Color: None Gross Solids: Moderate Vegetation: None Benthic Growth: None Stains: None Non-illicit: None		Condition Assessment Graffiti: None Erosion: None Deposition: None 0 in. Damage: None			
Sample Location: Pool Total Chlorine: 0 ppm Free Chlorine: 0 ppm Ammonia: 0 ppm pH: 8.02 units Temperature: 67 °F Conductivity: 418 µS/cm Detergents: 0 mg/L

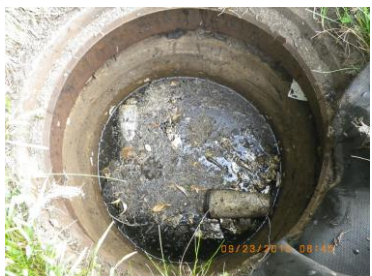
<p style="text-align: center;">o20150923074542.JPG</p> <p style="text-align: center; font-size: 24pt; font-weight: bold;">2015</p>	
Submerged: Fully		Depth (in): 44		Floating gross solids (litter) in manhole.			
Sampling Results		Floatables: None Odor: None Turbidity: None Color: None Gross Solids: Moderate Vegetation: None Benthic Growth: None Stains: None Non-illicit: None		Condition Assessment Graffiti: None Erosion: None Deposition: None in. Damage: None			
Sample Location: Pool Total Chlorine: 0 ppm Free Chlorine: 0 ppm Ammonia: 0 ppm pH: 8.74 units Temperature: 70 °F Conductivity: 351 µS/cm Detergents: 0 mg/L

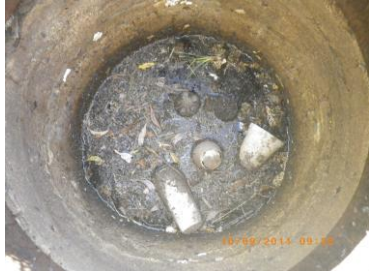
o20141009083526.JPG

Inspection Date: 10/9/2014 9:37:13 AM		Type: Ongoing	Flow: Submerged, indeterminate	Previous Rainfall (hrs): 72+
Illicit Discharge Potential: Potential		Inspector: JCW	Notes	
Submerged: Fully		Depth (in): 35	Floating gross solids (litter) in manhole. Filter fabric installed in inlet.	
Sampling Results		Floatables: None	Condition Assessment	
Sample Location: Pool		Odor: None	Graffiti: None	
Total Chlorine: 0 ppm		Turbidity: Slight cloudiness	Erosion: None	
Free Chlorine: 0 ppm		Color: None	Deposition: None in.	
Ammonia: 0 ppm		Gross Solids: Severe	Damage: None	
pH: 7.82 units		Vegetation: None		
Temperature 56 °F		Benthic Growth: Slight		
Conductivity: 471 µS/cm		Stains: None		
Detergents: 0 mg/L		Non-illicit: None

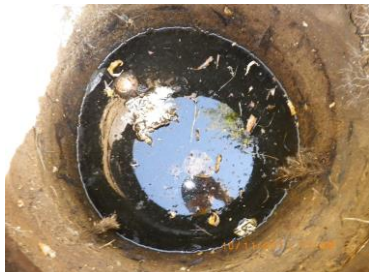
o20111011110824.JPG

Inspection Date: 10/11/2011 11:09:29 AM		Type: Ongoing	Flow: Submerged, indeterminate	Previous Rainfall (hrs): 72+
Illicit Discharge Potential: Unlikely		Inspector: JCW	Notes	
Submerged: Fully		Depth (in): 35	2010 screening follow-up. Floatable debris significantly reduced.	
Sampling Results		Floatables: None	Condition Assessment	
Sample Location: Pool		Odor: None	Graffiti: None	
Total Chlorine: 0 ppm		Turbidity: None	Erosion: None	
Free Chlorine: 0 ppm		Color: None	Deposition: None 0 in.	
Ammonia: 0 ppm		Gross Solids: Moderate	Damage: None	
pH: 8.13 units		Vegetation: None		
Temperature 70 °F		Benthic Growth: None		
Conductivity: -- µS/cm		Stains: None		
Detergents: -- mg/L		Non-illicit: None

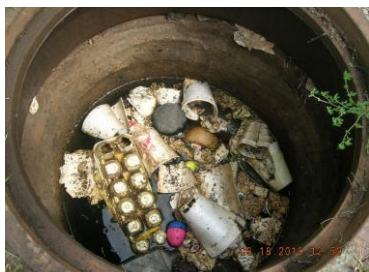
o20100818125018.JPG

Inspection Date: 8/18/2010 1:00:07 PM		Type: Ongoing	Flow: Submerged, indeterminate	Previous Rainfall (hrs): 72+
Illicit Discharge Potential: Potential		Inspector: JCW	Notes	
Submerged: Fully		Depth (in): 41	Significant floatable debris in manhole.	
Sampling Results		Floatables: None	Condition Assessment	
Sample Location: Pool		Odor: None	Graffiti: None	
Total Chlorine: 0 ppm		Turbidity: Slight cloudiness	Erosion: None	
Free Chlorine: 0 ppm		Color: Faint in bottle	Deposition: None 0 in.	
Ammonia: 0 ppm		Gross Solids: Severe	Damage: None	
pH: 7.98 units		Vegetation: None		
Temperature 76 °F		Benthic Growth: None		
Conductivity: -- µS/cm		Stains: None		
Detergents: 0 mg/L		Non-illicit: None

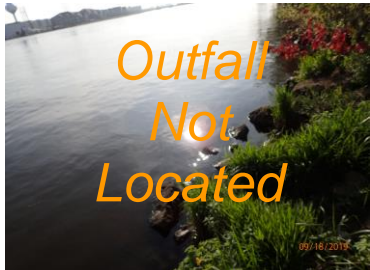
Inspection Date: 9/18/2019 9:09:25 AM		Type: Ongoing		Flow: Submerged (not located)		Previous Rainfall (hrs): 72+	
Illicit Discharge Potential: Potential		Inspector: JCW		Notes Outfall fully submerged and not located - screened upstream at 06-810 US1. Floating gross solids (litter) in manhole.

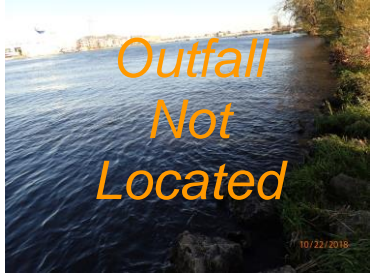
<p style="text-align: center;">o20181022164110.JPG</p> <p style="text-align: center; font-size: 24pt; font-weight: bold;">2018</p>

Notes Outfall fully submerged and not located - screened upstream at 06-810 US1. Floating gross solids (litter) in manhole.																																				
		Condition Assessment <table border="1" style="width:100%; border-collapse: collapse;"> <tr><td>Graffiti:</td><td>None</td></tr> <tr><td>Erosion:</td><td>None</td></tr> <tr><td>Deposition:</td><td>None in.</td></tr> <tr><td>Damage:</td><td>None</td></tr> </table>			Graffiti:	None	Erosion:	None	Deposition:	None in.	Damage:	None																										
Graffiti:	None																																					
Erosion:	None																																					
Deposition:	None in.																																					
Damage:	None
