IDDE Ongoing Screening Summary Report

2023 Inspection Year

Westwood

City of Oshkosh

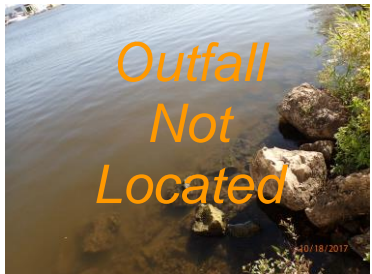
<p style="text-align: center;">o20171018111512.JPG</p> <p style="text-align: center; font-size: 24pt; font-weight: bold;">2017</p>

Notes Outfall fully submerged and not located - screened upstream at 06-810 US1.																																				
		Condition Assessment <table border="1" style="width:100%; border-collapse: collapse;"> <tr><td>Graffiti:</td><td>None</td></tr> <tr><td>Erosion:</td><td>None</td></tr> <tr><td>Deposition:</td><td>None in.</td></tr> <tr><td>Damage:</td><td>None</td></tr> </table>			Graffiti:	None	Erosion:	None	Deposition:	None in.	Damage:	None																										
Graffiti:	None																																					
Erosion:	None																																					
Deposition:	None in.																																					
Damage:	None

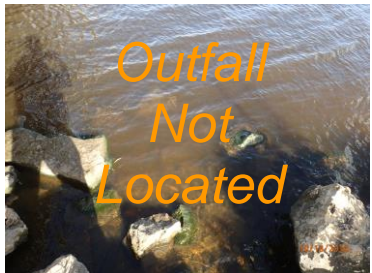
<p style="text-align: center;">o20161018144322.JPG</p> <p style="text-align: center; font-size: 24pt; font-weight: bold;">2016</p>

Notes Outfall fully submerged and not located - screened upstream at 06-810 US1.																																				
		Condition Assessment <table border="1" style="width:100%; border-collapse: collapse;"> <tr><td>Graffiti:</td><td>None</td></tr> <tr><td>Erosion:</td><td>None</td></tr> <tr><td>Deposition:</td><td>None in.</td></tr> <tr><td>Damage:</td><td>None</td></tr> </table>			Graffiti:	None	Erosion:	None	Deposition:	None in.	Damage:	None																										
Graffiti:	None																																					
Erosion:	None																																					
Deposition:	None in.																																					
Damage:	None

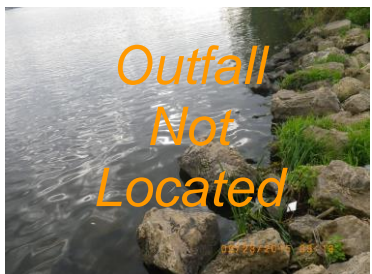
<p style="text-align: center;">o20150923081344.JPG</p> <p style="text-align: center; font-size: 24pt; font-weight: bold;">2015</p>

Notes Outfall fully submerged and not located - screened at 06-810 US1.																																				
		Condition Assessment <table border="1" style="width:100%; border-collapse: collapse;"> <tr><td>Graffiti:</td><td>None</td></tr> <tr><td>Erosion:</td><td>None</td></tr> <tr><td>Deposition:</td><td>None in.</td></tr> <tr><td>Damage:</td><td>None</td></tr> </table>			Graffiti:	None	Erosion:	None	Deposition:	None in.	Damage:	None																										
Graffiti:	None																																					
Erosion:	None																																					
Deposition:	None in.																																					
Damage:	None

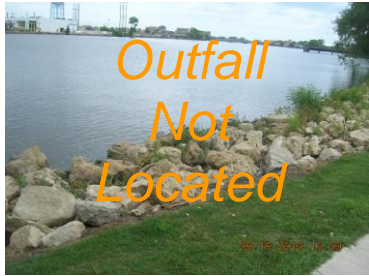
o20100818130938.JPG

Inspection Date: 8/18/2010 1:15:26 PM		Type: Ongoing	Flow: Submerged (not located)	Previous Rainfall (hrs): 72+
Illicit Discharge Potential: Unlikely		Inspector: JCW	Notes	
Submerged: Fully		Depth (in):	Outfall fully submerged and not physically located. Outfall screened upstream at 06-810 US1.	
Sampling Results			Condition Assessment	
Sample Location:		Floatables:	Graffiti: None	
Total Chlorine: -- ppm		Odor:	Erosion: None	
Free Chlorine: -- ppm		Turbidity:	Deposition: None 0 in.	
Ammonia: -- ppm		Color:	Damage: None	
pH: -- units		Gross Solids:		
Temperature -- °F		Vegetation:		
Conductivity: -- µS/cm		Benthic Growth:		
Detergents: -- mg/L		Stains:		
		Non-illicit:

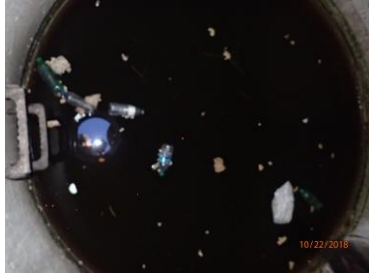
o20181022164226.JPG

Inspection Date: 10/22/2018 4:45:48 PM		Type: Ongoing	Flow: Submerged, indeterminate	Previous Rainfall (hrs): 48-72
Illicit Discharge Potential: Potential		Inspector: JCW	Notes	
Submerged: Fully		Depth (in): 58	Sample collected from submerged pool in manhole. Floating gross solids (litter) in manhole.	
Sampling Results		Condition Assessment		
Sample Location: Pool	Floatables: None	Graffiti: None Erosion: None Deposition: None in. Damage: None		
Total Chlorine: 0 ppm	Odor: None			
Free Chlorine: 0 ppm	Turbidity: None			
Ammonia: 0 ppm	Color: None			
pH: 7.7 units	Gross Solids: Slight			
Temperature 55 °F	Vegetation: None			
Conductivity: 370 µS/cm	Benthic Growth: None			
Detergents: 0 mg/L	Stains: None			
	Non-illicit: None

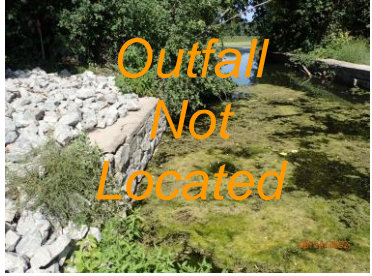
<p style="text-align: center;">o20220824135212.JPG</p> <p style="text-align: center; font-size: 1.5em; font-weight: bold;">2022</p>	
Submerged: Fully		Depth (in):		Outfall fully submerged and not located - screened upstream at 06-829 US1.			
Sampling Results Sample Location: _____ Total Chlorine: -- ppm Free Chlorine: -- ppm Ammonia: -- ppm pH: -- units Temperature -- ° F Conductivity: -- µS/cm Detergents: -- mg/L		Floatables: None Odor: None Turbidity: None Color: None Gross Solids: None Vegetation: None Benthic Growth: None Stains: None Non-illicit: None		Condition Assessment Graffiti: None Erosion: None Deposition: None in. Damage: None

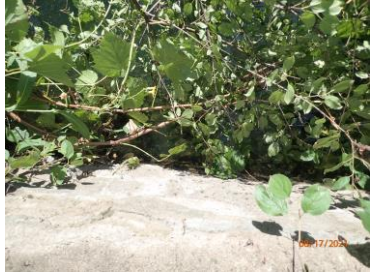
<p style="text-align: center;">o20210817101734.JPG</p> <p style="text-align: center; font-size: 1.5em; font-weight: bold;">2021</p>	
Submerged: Fully		Depth (in): 43		Outfall fully submerged and not located - screened upstream at 06-829 US1.			
Sampling Results Sample Location: _____ Total Chlorine: -- ppm Free Chlorine: -- ppm Ammonia: -- ppm pH: -- units Temperature -- ° F Conductivity: -- µS/cm Detergents: -- mg/L		Floatables: None Odor: None Turbidity: None Color: None Gross Solids: None Vegetation: None Benthic Growth: None Stains: None Non-illicit: None		Condition Assessment Graffiti: None Erosion: None Deposition: None in. Damage: None

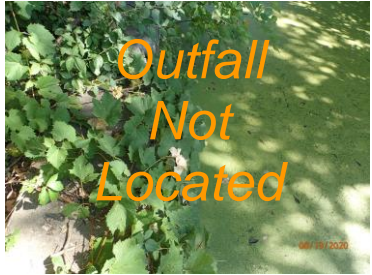
<p style="text-align: center;">o20200819105038.JPG</p> <p style="text-align: center; font-size: 1.5em; font-weight: bold;">2020</p>	
Submerged: Fully		Depth (in):		Outfall fully submerged and not located - screened upstream at 06-829 US1.			
Sampling Results Sample Location: _____ Total Chlorine: -- ppm Free Chlorine: -- ppm Ammonia: -- ppm pH: -- units Temperature -- ° F Conductivity: -- µS/cm Detergents: -- mg/L		Floatables: None Odor: None Turbidity: None Color: None Gross Solids: None Vegetation: None Benthic Growth: None Stains: None Non-illicit: None		Condition Assessment Graffiti: None Erosion: None Deposition: None in. Damage: None

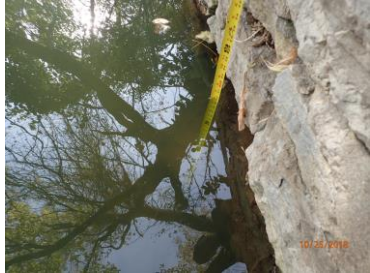
<p style="text-align: right; font-size: small;">10/25/2018</p> <p style="text-align: center;">o20181025133432.JPG</p> <p style="text-align: center; font-size: large; font-weight: bold;">2018</p>	
Submerged: Fully		Depth (in):		Outfall fully submerged - screened upstream at 06-829 US1. Floating gross solids (litter) in manhole.			
Sampling Results				Condition Assessment			
Sample Location:		Floatables:		Graftiti:		None	
Total Chlorine: -- ppm		Odor:		Erosion:		None	
Free Chlorine: -- ppm		Turbidity:		Deposition:		None in.	
Ammonia: -- ppm		Color:		Damage:		None	
pH: -- units		Gross Solids:					
Temperature -- °F		Vegetation:					
Conductivity: -- µS/cm		Benthic Growth:					
Detergents: -- mg/L		Stains:					
		Non-illicit:

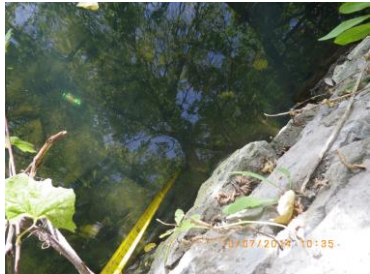
<p style="text-align: right; font-size: small;">10/07/2014 10:35</p> <p style="text-align: center;">o20141007093522.JPG</p> <p style="text-align: center; font-size: large; font-weight: bold;">2014</p>	
Submerged: Fully		Depth (in): 42		Outfall fully submerged - screened upstream at 06-829 US1. Manhole lid in water near end of pipe.			
Sampling Results				Condition Assessment			
Sample Location:		Floatables:		Graftiti:		None	
Total Chlorine: -- ppm		Odor:		Erosion:		None	
Free Chlorine: -- ppm		Turbidity:		Deposition:		None in.	
Ammonia: -- ppm		Color:		Damage:		None	
pH: -- units		Gross Solids:					
Temperature -- °F		Vegetation:					
Conductivity: -- µS/cm		Benthic Growth:					
Detergents: -- mg/L		Stains:					
		Non-illicit:

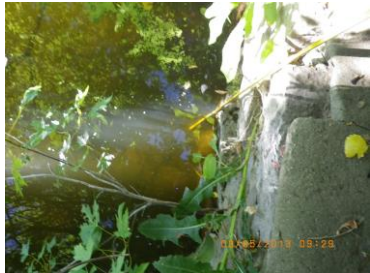
<p style="text-align: right; font-size: small;">11/05/2013 09:28</p> <p style="text-align: center;">o20130905082920.JPG</p> <p style="text-align: center; font-size: large; font-weight: bold;">2013</p>	
Submerged: Fully		Depth (in): 45		2012 screening follow-up. Outfall fully submerged. Outfall screened upstream at 06-829 US1. Gross solids in upstream mh.			
Sampling Results				Condition Assessment			
Sample Location:		Floatables:		Graftiti:		None	
Total Chlorine: -- ppm		Odor:		Erosion:		None	
Free Chlorine: -- ppm		Turbidity:		Deposition:		None in.	
Ammonia: -- ppm		Color:		Damage:		None	
pH: -- units		Gross Solids:					
Temperature -- °F		Vegetation:					
Conductivity: -- µS/cm		Benthic Growth:					
Detergents: -- mg/L		Stains:

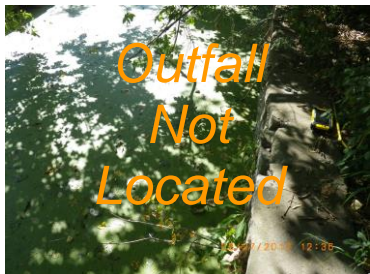
<p style="text-align: right; font-size: small;">10/27/2012 12:35</p> <p style="text-align: center;">o20120927113654.JPG</p> <p style="text-align: center; font-size: large; font-weight: bold;">2012</p>	
Submerged: Fully		Depth (in):		Outfall fully submerged; screened upstream at 06-829 US1.			
Sampling Results				Condition Assessment			
Sample Location:		Floatables:		Graftiti:		None	
Total Chlorine: -- ppm		Odor:		Erosion:		None	
Free Chlorine: -- ppm		Turbidity:		Deposition:		None in.	
Ammonia: -- ppm		Color:		Damage:		None	
pH: -- units		Gross Solids:					
Temperature -- °F		Vegetation:					
Conductivity: -- µS/cm		Benthic Growth:					
Detergents: -- mg/L		Stains:					
		Non-illicit:

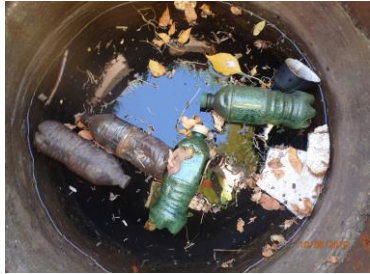
<p style="text-align: center;">o20191008151850.JPG</p> <p style="text-align: center; font-size: 24pt; font-weight: bold;">2019</p>

<div style="display: flex;"> <div style="flex: 1;"> <p>Notes</p> <p>Sample collected from submerged pool in manhole. Floating gross solids (litter) in manhole.</p> </div> <div style="flex: 1;"> <p>Condition Assessment</p> <p>Graffiti: None</p> <p>Erosion: None</p> <p>Deposition: None in.</p> <p>Damage: None</p> </div> </div>

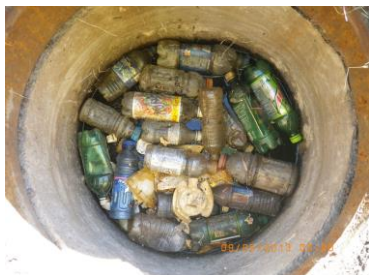
o20130905082002.JPG
2013

Inspection Date: 9/5/2013 9:16:05 AM		Type: Ongoing	Flow: Submerged, indeterminate	Previous Rainfall (hrs): 72+
Illicit Discharge Potential: Potential		Inspector: JCW	Notes	
Submerged: Fully		Depth (in): 35	2012 screening follow-up. Significant gross solids in manhole - similar to previous years.	
Sampling Results		Floatables: None	Condition Assessment Graffiti: None Erosion: None Deposition: None in. Damage: None	
Sample Location: Pool	Odor: None			
Total Chlorine: 0 ppm	Turbidity: None			
Free Chlorine: 0 ppm	Color: None			
Ammonia: 0 ppm	Gross Solids: Severe			
pH: 7.7 units	Vegetation: None			
Temperature 71 °F	Benthic Growth: None			
Conductivity: 1666 µS/cm	Stains: Slight			
Detergents: 0 mg/L	Non-illicit: None

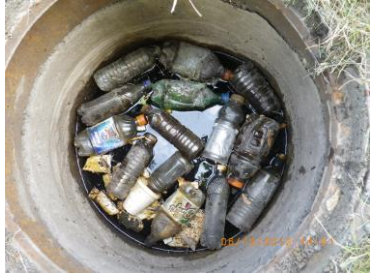
o20120613133100.JPG

Inspection Date: 6/13/2012 2:30:25 PM		Type: Other	Flow: Submerged, indeterminate	Previous Rainfall (hrs): 72+																									
Illicit Discharge Potential: Potential		Inspector: JCW	Notes Gross solids pre-screening. Bottles in manhole.																										
Submerged: Fully Depth (in): 37																													
Sampling Results <table style="width: 100%;"> <tr> <td style="width: 50%;">Sample Location: Pool</td> <td style="width: 50%;">Floatables: None</td> </tr> <tr> <td>Total Chlorine: 0 ppm</td> <td>Odor: None</td> </tr> <tr> <td>Free Chlorine: 0 ppm</td> <td>Turbidity: None</td> </tr> <tr> <td>Ammonia: 0 ppm</td> <td>Color: None</td> </tr> <tr> <td>pH: 7.58 units</td> <td>Gross Solids: Severe</td> </tr> <tr> <td>Temperature: 70 °F</td> <td>Vegetation: None</td> </tr> <tr> <td>Conductivity: 1765 µS/cm</td> <td>Benthic Growth: Slight</td> </tr> <tr> <td>Detergents: 0 mg/L</td> <td>Stains: None</td> </tr> <tr> <td></td> <td>Non-illicit: None</td> </tr> </table>		Sample Location: Pool	Floatables: None	Total Chlorine: 0 ppm	Odor: None	Free Chlorine: 0 ppm	Turbidity: None	Ammonia: 0 ppm	Color: None	pH: 7.58 units	Gross Solids: Severe	Temperature: 70 °F	Vegetation: None	Conductivity: 1765 µS/cm	Benthic Growth: Slight	Detergents: 0 mg/L	Stains: None		Non-illicit: None	Condition Assessment <table style="width: 100%;"> <tr> <td>Graffiti:</td> <td>None</td> </tr> <tr> <td>Erosion:</td> <td>None</td> </tr> <tr> <td>Deposition:</td> <td>None in.</td> </tr> <tr> <td>Damage:</td> <td>None</td> </tr> </table>		Graffiti:	None	Erosion:	None	Deposition:	None in.	Damage:	None

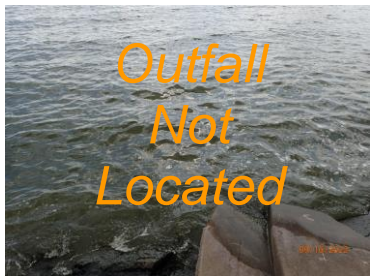
Inspection Date: 9/16/2022 1:11:00 PM		Type: Ongoing	Flow: Submerged (not located)	Previous Rainfall (hrs): 72+
Illicit Discharge Potential: Potential		Inspector: EJK		
Submerged: Fully		Depth (in):		
Sampling Results Sample Location: _____ Total Chlorine: -- ppm Free Chlorine: -- ppm Ammonia: -- ppm pH: -- units Temperature: -- °F Conductivity: -- µS/cm Detergents: -- mg/L		Floatables: None Odor: None Turbidity: None Color: None Gross Solids: None Vegetation: None Benthic Growth: None Stains: None Non-illicit: None	Notes Outfall partially submerged - screened upstream at 08-284 US1. Floating gross solids (litter) in upstream manhole.

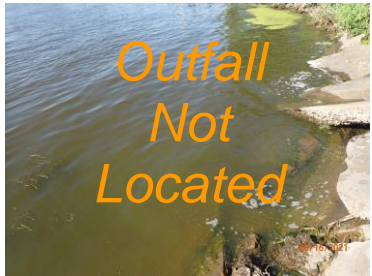
o20210816095056.JPG <div style="text-align: center; font-weight: bold; font-size: 1.2em;">2021</div>
		Condition Assessment Graffiti: None Erosion: None Deposition: None in. Damage: None

Inspection Date: 8/16/2021 9:52:24 AM		Type: Ongoing	Flow: Submerged (not located)	Previous Rainfall (hrs): 72+
Illicit Discharge Potential: Potential		Inspector: JCW		
Submerged: Fully		Depth (in):		
Sampling Results Sample Location: _____ Total Chlorine: -- ppm Free Chlorine: -- ppm Ammonia: -- ppm pH: -- units Temperature: -- °F Conductivity: -- µS/cm Detergents: -- mg/L		Floatables: None Odor: None Turbidity: None Color: None Gross Solids: None Vegetation: None Benthic Growth: None Stains: None Non-illicit: None	Notes Outfall partially submerged - screened upstream at 08-284 US1. Floating gross solids (litter) in upstream manhole.

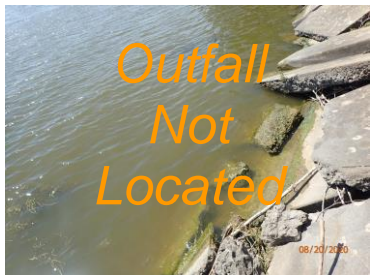
o20200820125142.JPG <div style="text-align: center; font-weight: bold; font-size: 1.2em;">2020</div>
		Condition Assessment Graffiti: None Erosion: None Deposition: None in. Damage: None

Inspection Date: 8/20/2020 12:51:42 PM		Type: Ongoing	Flow: Submerged (not located)	Previous Rainfall (hrs): 72+
Illicit Discharge Potential: Potential		Inspector: JCW		
Submerged: Fully		Depth (in):		
Sampling Results Sample Location: _____ Total Chlorine: -- ppm Free Chlorine: -- ppm Ammonia: -- ppm pH: -- units Temperature: -- °F Conductivity: -- µS/cm Detergents: -- mg/L		Floatables: None Odor: None Turbidity: None Color: None Gross Solids: None Vegetation: None Benthic Growth: None Stains: None Non-illicit: None	Notes Outfall fully submerged and not located - screened upstream at 08-284 US1. Floating gross solids (litter) in upstream manhole.

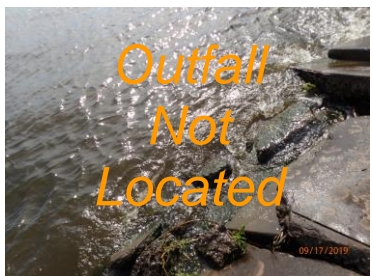
o20190917133750.JPG <div style="text-align: center; font-weight: bold; font-size: 1.2em;">2019</div>
		Condition Assessment Graffiti: None Erosion: None Deposition: None in. Damage: None

Inspection Date: 9/17/2019 2:38:06 PM		Type: Ongoing	Flow: Submerged (not located)	Previous Rainfall (hrs): 48-72
Illicit Discharge Potential: Potential		Inspector: JCW		
Submerged: Fully		Depth (in):		
Sampling Results Sample Location: _____ Total Chlorine: -- ppm Free Chlorine: -- ppm Ammonia: -- ppm pH: -- units Temperature: -- °F Conductivity: -- µS/cm Detergents: -- mg/L		Floatables: None Odor: None Turbidity: None Color: None Gross Solids: None Vegetation: None Benthic Growth: None Stains: None Non-illicit: None	Notes Outfall fully submerged and not located - screened upstream at 08-284 US1. Floating gross solids (litter) in manhole.

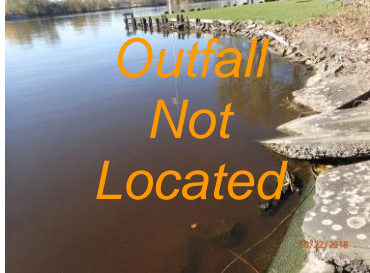
o20181022105100.JPG

Inspection Date: 10/22/2018 10:51:14 AM		Type: Ongoing	Flow: Submerged (not located)	Previous Rainfall (hrs): 48-72
Illicit Discharge Potential: Potential		Inspector: JCW	Notes	
Submerged: Fully		Depth (in):	Outfall fully submerged and not located - screened upstream at 08-284 US1. Floating gross solids (litter) in manhole.	
Sampling Results		Floatables:	Condition Assessment Graffiti: None Erosion: None Deposition: None in. Damage: None	
Sample Location:		Odor:		
Total Chlorine: -- ppm		Turbidity:		
Free Chlorine: -- ppm		Color:		
Ammonia: -- ppm		Gross Solids:		
pH: -- units		Vegetation:		
Temperature -- °F		Benthic Growth:		
Conductivity: -- µS/cm		Stains:		
Detergents: -- mg/L		Non-illicit:

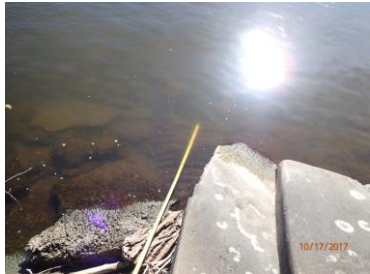
o20171017135302.JPG

Inspection Date: 10/17/2017 1:56:02 PM		Type: Ongoing	Flow: Submerged, indeterminate	Previous Rainfall (hrs): 48-72
Illicit Discharge Potential: Potential		Inspector: JCW	Notes	
Submerged: Fully		Depth (in): 36	Outfall fully submerged with approx 9" of water over crown of pipe - screened upstream at 08-284 US1. Floating gross solids (litter) in manhole.	
Sampling Results		Floatables:	Condition Assessment Graffiti: None Erosion: None Deposition: None in. Damage: None	
Sample Location:		Odor:		
Total Chlorine: -- ppm		Turbidity:		
Free Chlorine: -- ppm		Color:		
Ammonia: -- ppm		Gross Solids:		
pH: -- units		Vegetation:		
Temperature -- °F		Benthic Growth:		
Conductivity: -- µS/cm		Stains:		
Detergents: -- mg/L		Non-illicit:

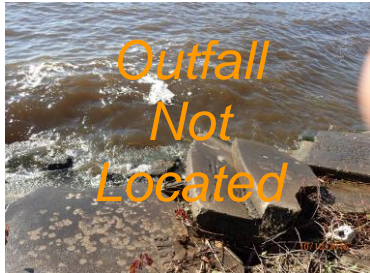
o20161010101832.JPG

Inspection Date: 10/10/2016 10:18:48 AM		Type: Ongoing	Flow: Submerged (not located)	Previous Rainfall (hrs): 72+
Illicit Discharge Potential: Potential		Inspector: JCW	Notes	
Submerged: Fully		Depth (in):	Outfall fully submerged and not located - screened upstream at 08-284 US1.	
Sampling Results		Floatables:	Condition Assessment Graffiti: None Erosion: None Deposition: None in. Damage: None	
Sample Location:		Odor:		
Total Chlorine: -- ppm		Turbidity:		
Free Chlorine: -- ppm		Color:		
Ammonia: -- ppm		Gross Solids:		
pH: -- units		Vegetation:		
Temperature -- °F		Benthic Growth:		
Conductivity: -- µS/cm		Stains:		
Detergents: -- mg/L		Non-illicit:

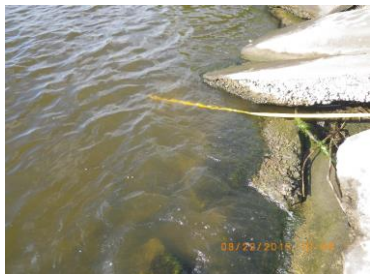
o20150922090932.JPG

Inspection Date: 9/22/2015 10:04:59 AM		Type: Ongoing	Flow: Submerged, indeterminate	Previous Rainfall (hrs): 72+
Illicit Discharge Potential: Potential		Inspector: JCW	Notes	
Submerged: Fully		Depth (in): 30	Outfall fully submerged - screened at 08-284 US1.	
Sampling Results		Floatables:	Condition Assessment Graffiti: None Erosion: None Deposition: None in. Damage: None	
Sample Location:		Odor:		
Total Chlorine: -- ppm		Turbidity:		
Free Chlorine: -- ppm		Color:		
Ammonia: -- ppm		Gross Solids:		
pH: -- units		Vegetation:		
Temperature -- °F		Benthic Growth:		
Conductivity: -- µS/cm		Stains:		
Detergents: -- mg/L		Non-illicit:

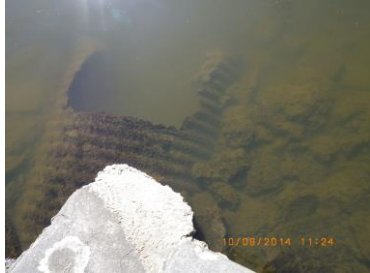
o20141009102400.JPG

Inspection Date: 10/9/2014 11:24:44 AM		Type: Ongoing	Flow: Submerged, indeterminate	Previous Rainfall (hrs): 72+
Illicit Discharge Potential: Potential		Inspector: JCW	Notes	
Submerged: Fully		Depth (in): 29	Outfall fully submerged - screened upstream at 08-284 US1.	
Sampling Results		Condition Assessment		
Sample Location:	Floatables:	None		
Total Chlorine: -- ppm	Odor:	None		
Free Chlorine: -- ppm	Turbidity:	None		
Ammonia: -- ppm	Color:	None		
pH: -- units	Gross Solids:	None		
Temperature -- °F	Vegetation:	None		
Conductivity: -- µS/cm	Benthic Growth:	None		
Detergents: -- mg/L	Stains:	None		
	Non-illicit:	None		
		Graffiti:	None	
		Erosion:	None	
		Deposition:	Minor	3 in.
		Damage:	Minor

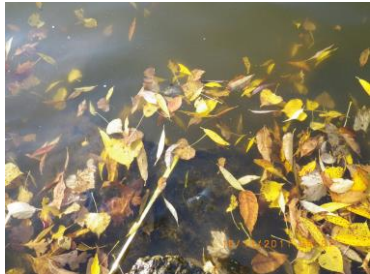
o20111011083728.JPG

Inspection Date: 10/11/2011 8:37:04 AM		Type: Ongoing	Flow: Submerged, indeterminate	Previous Rainfall (hrs): 72+
Illicit Discharge Potential: Unlikely		Inspector: JCW	Notes	
Submerged: Fully		Depth (in): 25	2010 screening follow-up. Outfall fully submerged. Outfall screened upstream at 08-284 US1.	
Sampling Results		Condition Assessment		
Sample Location:	Floatables:	None		
Total Chlorine: -- ppm	Odor:	None		
Free Chlorine: -- ppm	Turbidity:	None		
Ammonia: -- ppm	Color:	None		
pH: -- units	Gross Solids:	None		
Temperature -- °F	Vegetation:	None		
Conductivity: -- µS/cm	Benthic Growth:	None		
Detergents: -- mg/L	Stains:	None		
	Non-illicit:	None		
		Graffiti:	None	
		Erosion:	None	
		Deposition:	None	0 in.
		Damage:	None

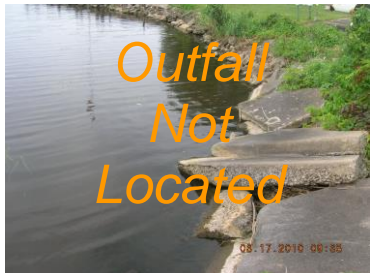
o20100817093554.JPG

Inspection Date: 8/17/2010 9:35:00 AM		Type: Ongoing	Flow: Submerged (not located)	Previous Rainfall (hrs): 72+
Illicit Discharge Potential: Potential		Inspector: JCW	Notes	
Submerged: Fully		Depth (in):	Outfall fully submerged and not physically located. Outfall screened upstream at 08-284 US1.	
Sampling Results		Condition Assessment		
Sample Location:	Floatables:	None		
Total Chlorine: -- ppm	Odor:	None		
Free Chlorine: -- ppm	Turbidity:	None		
Ammonia: -- ppm	Color:	None		
pH: -- units	Gross Solids:	None		
Temperature -- °F	Vegetation:	None		
Conductivity: -- µS/cm	Benthic Growth:	None		
Detergents: -- mg/L	Stains:	None		
	Non-illicit:	None		
		Graffiti:	None	
		Erosion:	None	
		Deposition:	None	0 in.
		Damage:	None

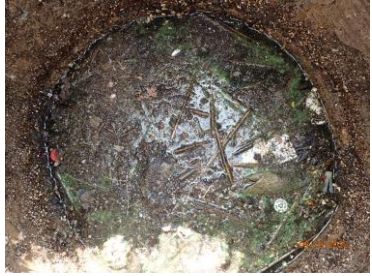
o20220916131222.JPG
2022

Inspection Date: 9/16/2022 1:13:00 PM		Type: Ongoing	Flow: Submerged, indeterminate	Previous Rainfall (hrs): 72+
Illicit Discharge Potential: Potential		Inspector: EJK		
Submerged: Partially		Depth (in): 34		
Sampling Results		Notes Sample collected from submerged pool in manhole. Floating gross solids (litter) in manhole.		
Sample Location: Pool	Floatables: None	Condition Assessment Graffiti: None Erosion: None Deposition: None in. Damage: None		
Total Chlorine: 0 ppm	Odor: None			
Free Chlorine: 0 ppm	Turbidity: None			
Ammonia: 0 ppm	Color: None			
pH: 7.24 units	Gross Solids: Moderate			
Temperature 75 °F	Vegetation: None			
Conductivity: 364 µS/cm	Benthic Growth: Slight			
Detergents: 0 mg/L	Stains: None			
	Non-illicit: Slight

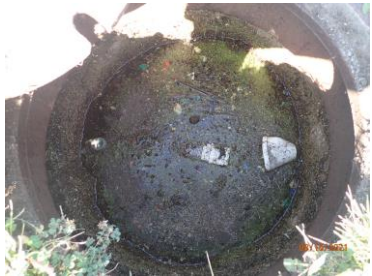
o20210816095220.JPG
2021

Inspection Date: 8/16/2021 9:55:45 AM		Type: Ongoing	Flow: Submerged, indeterminate	Previous Rainfall (hrs): 72+
Illicit Discharge Potential: Potential		Inspector: JCW		
Submerged: Fully		Depth (in): 36		
Sampling Results		Notes Sample collected from submerged pool in manhole. Floating gross solids (litter) in manhole.		
Sample Location: Pool	Floatables: None	Condition Assessment Graffiti: None Erosion: None Deposition: None in. Damage: None		
Total Chlorine: 0 ppm	Odor: None			
Free Chlorine: 0 ppm	Turbidity: None			
Ammonia: 0 ppm	Color: None			
pH: 7.14 units	Gross Solids: Severe			
Temperature 77 °F	Vegetation: None			
Conductivity: 328 µS/cm	Benthic Growth: None			
Detergents: 0 mg/L	Stains: None			
	Non-illicit: None

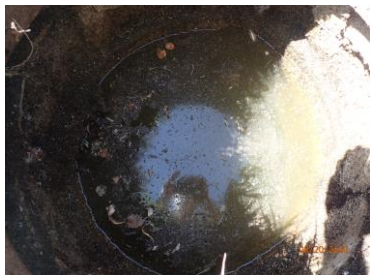
o20200820125256.JPG
2020

Inspection Date: 8/20/2020 12:55:02 PM		Type: Ongoing	Flow: Submerged, indeterminate	Previous Rainfall (hrs): 72+
Illicit Discharge Potential: Potential		Inspector: JCW		
Submerged: Fully		Depth (in): 33		
Sampling Results		Notes Sample collected from submerged pool in manhole. Floating gross solids (litter) in manhole. Elevated pH seemed widespread in river.		
Sample Location: Pool	Floatables: None	Condition Assessment Graffiti: None Erosion: None Deposition: None in. Damage: None		
Total Chlorine: 0 ppm	Odor: None			
Free Chlorine: 0 ppm	Turbidity: None			
Ammonia: 0 ppm	Color: None			
pH: 9.23 units	Gross Solids: Moderate			
Temperature 82 °F	Vegetation: None			
Conductivity: 320 µS/cm	Benthic Growth: Moderate			
Detergents: 0 mg/L	Stains: None			
	Non-illicit: None

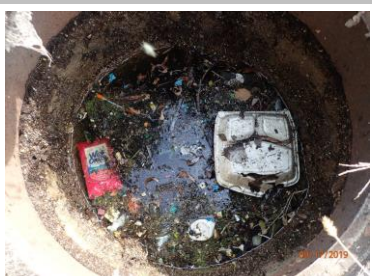
o20190917133856.JPG
2019

Inspection Date: 9/17/2019 2:41:09 PM		Type: Ongoing	Flow: Submerged, indeterminate	Previous Rainfall (hrs): 48-72
Illicit Discharge Potential: Potential		Inspector: JCW		
Submerged: Fully		Depth (in): 34		
Sampling Results		Notes Sample collected from submerged pool in outfall. Syringe and other floating gross solids (litter) in manhole.		
Sample Location: Pool	Floatables: None	Condition Assessment Graffiti: None Erosion: None Deposition: None in. Damage: None		
Total Chlorine: 0 ppm	Odor: None			
Free Chlorine: 0 ppm	Turbidity: None			
Ammonia: 0 ppm	Color: None			
pH: 8.79 units	Gross Solids: Severe			
Temperature 76 °F	Vegetation: None			
Conductivity: 341 µS/cm	Benthic Growth: None			
Detergents: 0 mg/L	Stains: None			
	Non-illicit: None

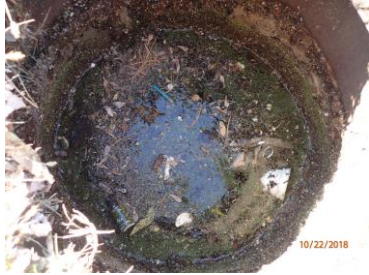
o20181022105156.JPG

Inspection Date: 10/22/2018 10:54:41 AM		Type: Ongoing	Flow: Submerged, indeterminate	Previous Rainfall (hrs): 48-72
Illicit Discharge Potential: Potential		Inspector: JCW	Notes	
Submerged: Fully		Depth (in): 34	Sample collected from submerged pool in outfall. Floating gross solids (litter) in manhole.	
Sampling Results		Floatables: None	Condition Assessment Graffiti: None Erosion: None Deposition: None in. Damage: None	
Sample Location: Pool	Odor: None			
Total Chlorine: 0 ppm	Turbidity: None			
Free Chlorine: 0 ppm	Color: Faint in bottle			
Ammonia: 0 ppm	Gross Solids: Moderate			
pH: 7.5 units	Vegetation: None			
Temperature 54 °F	Benthic Growth: Moderate			
Conductivity: 314 µS/cm	Stains: None			
Detergents: 0 mg/L	Non-illicit: None

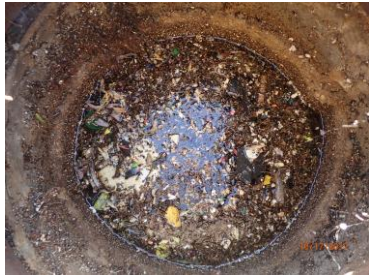
o20171017135518.JPG

Inspection Date: 10/17/2017 1:59:35 PM		Type: Ongoing	Flow: Submerged, indeterminate	Previous Rainfall (hrs): 48-72
Illicit Discharge Potential: Potential		Inspector: JCW	Notes	
Submerged: Fully		Depth (in): 30	Sample collected from submerged pool in outfall. Floating gross solids (litter) in manhole.	
Sampling Results		Floatables: None	Condition Assessment Graffiti: None Erosion: None Deposition: None in. Damage: None	
Sample Location: Pool	Odor: None			
Total Chlorine: 0 ppm	Turbidity: None			
Free Chlorine: 0 ppm	Color: None			
Ammonia: 0 ppm	Gross Solids: Moderate			
pH: 8.67 units	Vegetation: None			
Temperature 66 °F	Benthic Growth: None			
Conductivity: 352 µS/cm	Stains: None			
Detergents: 0 mg/L	Non-illicit: None

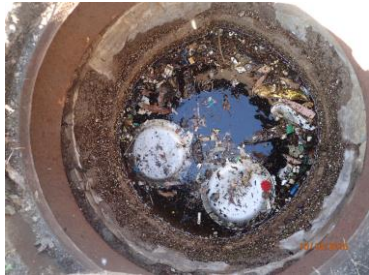
o20161010101916.JPG

Inspection Date: 10/10/2016 10:21:35 AM		Type: Ongoing	Flow: Submerged, indeterminate	Previous Rainfall (hrs): 72+
Illicit Discharge Potential: Potential		Inspector: JCW	Notes	
Submerged: Fully		Depth (in): 32	Potential illicit discharge due to gross solids.	
Sampling Results		Floatables: None	Condition Assessment Graffiti: None Erosion: None Deposition: None in. Damage: None	
Sample Location: Pool	Odor: None			
Total Chlorine: 0 ppm	Turbidity: None			
Free Chlorine: 0 ppm	Color: Clearly visible in bottl			
Ammonia: 0 ppm	Gross Solids: Moderate			
pH: 8.15 units	Vegetation: None			
Temperature 63 °F	Benthic Growth: None			
Conductivity: 369 µS/cm	Stains: None			
Detergents: 0 mg/L	Non-illicit: None

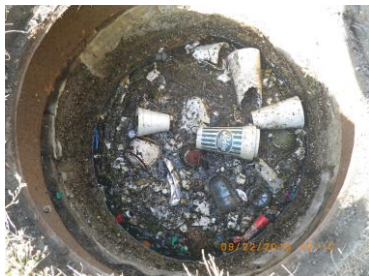
o20150922091040.JPG

Inspection Date: 9/22/2015 10:09:39 AM		Type: Ongoing	Flow: Submerged, indeterminate	Previous Rainfall (hrs): 72+
Illicit Discharge Potential: Potential		Inspector: JCW	Notes	
Submerged: Fully		Depth (in): 34	Floating gross solids (litter) in manhole.	
Sampling Results		Floatables: None	Condition Assessment Graffiti: None Erosion: None Deposition: None in. Damage: None	
Sample Location: Pool	Odor: None			
Total Chlorine: 0 ppm	Turbidity: None			
Free Chlorine: 0 ppm	Color: None			
Ammonia: 0 ppm	Gross Solids: Severe			
pH: 8.8 units	Vegetation: None			
Temperature 70 °F	Benthic Growth: None			
Conductivity: 335 µS/cm	Stains: None			
Detergents: 0 mg/L	Non-illicit: None

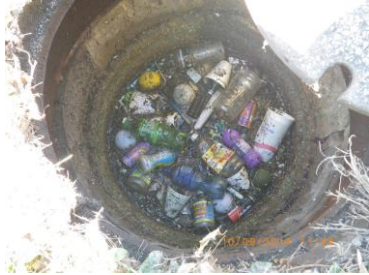
o20141009102622.JPG

Inspection Date: 10/9/2014 11:28:19 AM		Type: Ongoing	Flow: Submerged, indeterminate	Previous Rainfall (hrs): 72+
Illicit Discharge Potential: Potential		Inspector: JCW	Notes	
Submerged: Fully		Depth (in): 29	Floating gross solids (litter) in manhole.	
Sampling Results		Condition Assessment		
Sample Location: Pool	Floatables: None	Graffiti: None	Erosion: None	in.
Total Chlorine: 0 ppm	Odor: None	Deposition: None	Damage: None	
Free Chlorine: 0 ppm	Turbidity: None			
Ammonia: 0 ppm	Color: Faint in bottle			
pH: 8.34 units	Gross Solids: Severe			
Temperature 57 °F	Vegetation: None			
Conductivity: 400 µS/cm	Benthic Growth: None			
Detergents: 0 mg/L	Stains: None			
	Non-illicit: None

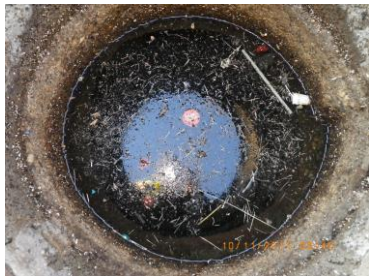
o20111011084038.JPG

Inspection Date: 10/11/2011 8:41:22 AM		Type: Ongoing	Flow: Submerged, indeterminate	Previous Rainfall (hrs): 72+
Illicit Discharge Potential: Unlikely		Inspector: JCW	Notes	
Submerged: Fully		Depth (in): 18	2010 screening follow-up. Floatable debris significantly reduced.	
Sampling Results		Condition Assessment		
Sample Location: Pool	Floatables: None	Graffiti: None	Erosion: None	0 in.
Total Chlorine: 0 ppm	Odor: None	Deposition: None	Damage: None	
Free Chlorine: 0 ppm	Turbidity: None			
Ammonia: 0 ppm	Color: None			
pH: 8.11 units	Gross Solids: Slight			
Temperature 72 °F	Vegetation: None			
Conductivity: -- µS/cm	Benthic Growth: None			
Detergents: -- mg/L	Stains: None			
	Non-illicit: None

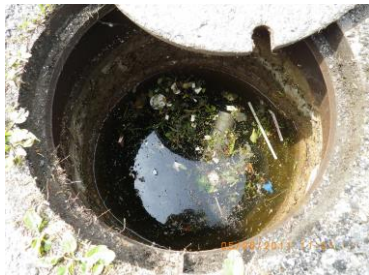
o20110526110156.JPG

Inspection Date: 5/26/2011 11:01:00 AM		Type: Other	Flow: Submerged, indeterminate	Previous Rainfall (hrs): 72+
Illicit Discharge Potential: Potential		Inspector: JCW	Notes	
Submerged: Fully		Depth (in):	Limited screening conducted to check for floatable debris.	
Sampling Results		Condition Assessment		
Sample Location: --	Floatables: None	Graffiti: None	Erosion: None	0 in.
Total Chlorine: -- ppm	Odor: --	Deposition: None	Damage: None	
Free Chlorine: -- ppm	Turbidity: --			
Ammonia: -- ppm	Color: --			
pH: -- units	Gross Solids: Moderate			
Temperature -- °F	Vegetation: --			
Conductivity: -- µS/cm	Benthic Growth: --			
Detergents: -- mg/L	Stains: --			
	Non-illicit: None

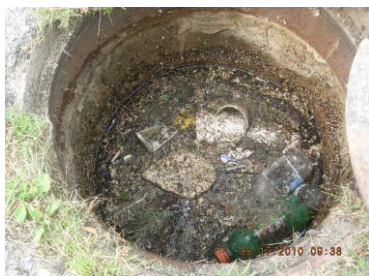
o20100817093838.JPG

Inspection Date: 8/17/2010 9:47:15 AM		Type: Ongoing	Flow: Submerged, indeterminate	Previous Rainfall (hrs): 72+
Illicit Discharge Potential: Potential		Inspector: JCW	Notes	
Submerged: Fully		Depth (in): 31	Significant floatable debris in manhole.	
Sampling Results		Condition Assessment		
Sample Location: Pool	Floatables: None	Graffiti: None	Erosion: None	0 in.
Total Chlorine: 0 ppm	Odor: None	Deposition: None	Damage: None	
Free Chlorine: 0 ppm	Turbidity: None			
Ammonia: 0 ppm	Color: Faint in bottle			
pH: 7.64 units	Gross Solids: Severe			
Temperature 74 °F	Vegetation: None			
Conductivity: -- µS/cm	Benthic Growth: None			
Detergents: 0 mg/L	Stains: None			
	Non-illicit: None

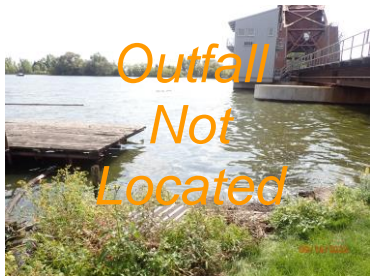
o20220916132138.JPG <div style="text-align: center; font-size: 24pt; font-weight: bold;">2022</div>

Inspection Date: 9/16/2022 1:22:00 PM		Type: Ongoing	Flow: Submerged (not located)	Previous Rainfall (hrs): 72+
Illicit Discharge Potential: Potential		Inspector: EJK		
Submerged: Fully		Depth (in):		
Sampling Results Sample Location: _____ Total Chlorine: -- ppm Free Chlorine: -- ppm Ammonia: -- ppm pH: -- units Temperature: -- °F Conductivity: -- µS/cm Detergents: -- mg/L		Floatables: None Odor: None Turbidity: None Color: None Gross Solids: None Vegetation: None Benthic Growth: None Stains: None Non-illicit: None		
		Notes Outfall fully submerged and not located - screened upstream at 08-347 US1. Detergent in upstream manhole.		
		Condition Assessment Graffiti: None Erosion: None Deposition: None in. Damage: None

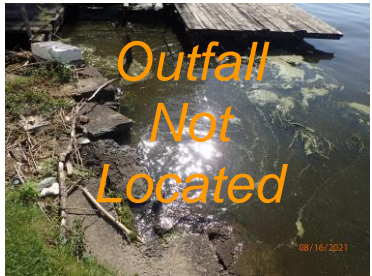
o20210816100046.JPG <div style="text-align: center; font-size: 24pt; font-weight: bold;">2021</div>

Inspection Date: 8/16/2021 10:01:15 AM		Type: Ongoing	Flow: Submerged (not located)	Previous Rainfall (hrs): 72+
Illicit Discharge Potential: Unlikely		Inspector: JCW		
Submerged: Fully		Depth (in):		
Sampling Results Sample Location: _____ Total Chlorine: -- ppm Free Chlorine: -- ppm Ammonia: -- ppm pH: -- units Temperature: -- °F Conductivity: -- µS/cm Detergents: -- mg/L		Floatables: None Odor: None Turbidity: None Color: None Gross Solids: None Vegetation: None Benthic Growth: None Stains: None Non-illicit: None		
		Notes Outfall fully submerged and not located - screened upstream at 08-347 US1.		
		Condition Assessment Graffiti: None Erosion: None Deposition: None in. Damage: None

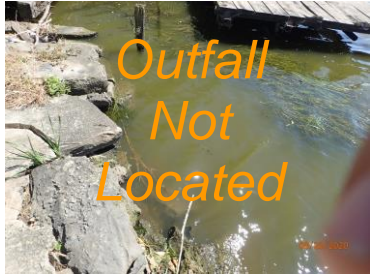
o20200820124230.JPG <div style="text-align: center; font-size: 24pt; font-weight: bold;">2020</div>

Inspection Date: 8/20/2020 12:42:50 PM		Type: Ongoing	Flow: Submerged (not located)	Previous Rainfall (hrs): 72+
Illicit Discharge Potential: Potential		Inspector: JCW		
Submerged: Fully		Depth (in):		
Sampling Results Sample Location: _____ Total Chlorine: -- ppm Free Chlorine: -- ppm Ammonia: -- ppm pH: -- units Temperature: -- °F Conductivity: -- µS/cm Detergents: -- mg/L		Floatables: None Odor: None Turbidity: None Color: None Gross Solids: None Vegetation: None Benthic Growth: None Stains: None Non-illicit: None		
		Notes Outfall fully submerged and not located - screened upstream at 08-347 US1. Floating gross solids (litter) in upstream manhole.		
		Condition Assessment Graffiti: None Erosion: None Deposition: None in. Damage: None

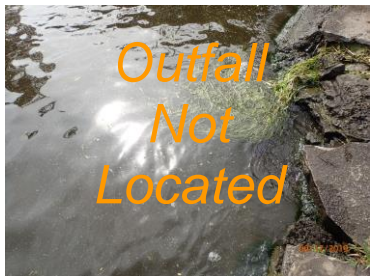
o20190917134640.JPG <div style="text-align: center; font-size: 24pt; font-weight: bold;">2019</div>

Inspection Date: 9/17/2019 2:47:00 PM		Type: Ongoing	Flow: Submerged (not located)	Previous Rainfall (hrs): 48-72
Illicit Discharge Potential: Unlikely		Inspector: JCW		
Submerged: Fully		Depth (in):		
Sampling Results Sample Location: _____ Total Chlorine: -- ppm Free Chlorine: -- ppm Ammonia: -- ppm pH: -- units Temperature: -- °F Conductivity: -- µS/cm Detergents: -- mg/L		Floatables: None Odor: None Turbidity: None Color: None Gross Solids: None Vegetation: None Benthic Growth: None Stains: None Non-illicit: None		
		Notes Outfall fully submerged and not located - screened upstream at 08-347 US1.		
		Condition Assessment Graffiti: None Erosion: None Deposition: None in. Damage: None

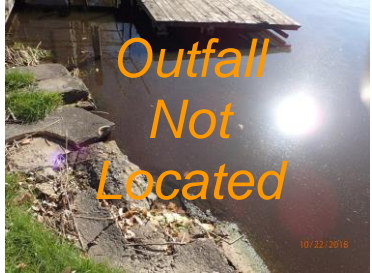
o20181022105820.JPG

Inspection Date: 10/22/2018 10:59:46 AM		Type: Ongoing	Flow: Submerged (not located)	Previous Rainfall (hrs): 48-72
Illicit Discharge Potential: Potential		Inspector: JCW	Notes	
Submerged: Fully		Depth (in):	Outfall fully submerged and not located - screened upstream at 08-347 US1. Floating gross solids (litter) in manhole.	
Sampling Results		Floatables:	Condition Assessment Graffiti: None Erosion: None Deposition: None in. Damage: None	
Sample Location:		Odor:		
Total Chlorine: -- ppm		Turbidity:		
Free Chlorine: -- ppm		Color:		
Ammonia: -- ppm		Gross Solids:		
pH: -- units		Vegetation:		
Temperature -- °F		Benthic Growth:		
Conductivity: -- µS/cm		Stains:		
Detergents: -- mg/L		Non-illicit:

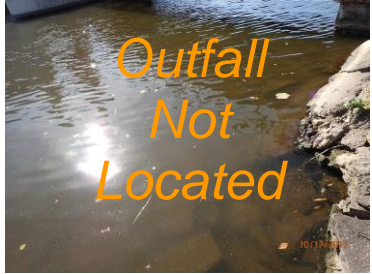
o20171017140150.JPG

Inspection Date: 10/17/2017 2:04:43 PM		Type: Ongoing	Flow: Submerged (not located)	Previous Rainfall (hrs): 48-72
Illicit Discharge Potential: Potential		Inspector: JCW	Notes	
Submerged: Fully		Depth (in):	Outfall fully submerged and not located - screened upstream at 08-347 US1. Floating gross solids (litter) in manhole.	
Sampling Results		Floatables:	Condition Assessment Graffiti: None Erosion: None Deposition: None in. Damage: None	
Sample Location:		Odor:		
Total Chlorine: -- ppm		Turbidity:		
Free Chlorine: -- ppm		Color:		
Ammonia: -- ppm		Gross Solids:		
pH: -- units		Vegetation:		
Temperature -- °F		Benthic Growth:		
Conductivity: -- µS/cm		Stains:		
Detergents: -- mg/L		Non-illicit:

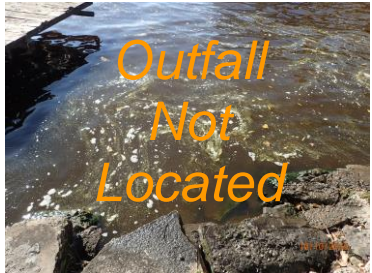
o20161010101244.JPG

Inspection Date: 10/10/2016 10:13:44 AM		Type: Ongoing	Flow: Submerged (not located)	Previous Rainfall (hrs): 72+
Illicit Discharge Potential: Potential		Inspector: JCW	Notes	
Submerged: Fully		Depth (in):	Outfall fully submerged and not located - screened upstream at 08-347 US1.	
Sampling Results		Floatables:	Condition Assessment Graffiti: None Erosion: None Deposition: None in. Damage: None	
Sample Location:		Odor:		
Total Chlorine: -- ppm		Turbidity:		
Free Chlorine: -- ppm		Color:		
Ammonia: -- ppm		Gross Solids:		
pH: -- units		Vegetation:		
Temperature -- °F		Benthic Growth:		
Conductivity: -- µS/cm		Stains:		
Detergents: -- mg/L		Non-illicit:

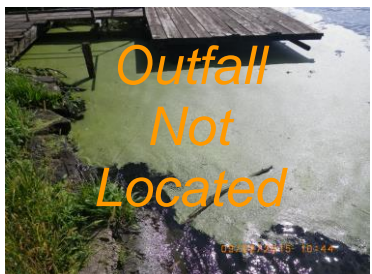
o20150922094458.JPG

Inspection Date: 9/22/2015 10:41:14 AM		Type: Ongoing	Flow: Submerged (not located)	Previous Rainfall (hrs): 72+
Illicit Discharge Potential: Potential		Inspector: JCW	Notes	
Submerged: Fully		Depth (in):	Outfall fully submerged and not located - screened at 08-347 US1.	
Sampling Results		Floatables:	Condition Assessment Graffiti: None Erosion: None Deposition: None in. Damage: None	
Sample Location:		Odor:		
Total Chlorine: -- ppm		Turbidity:		
Free Chlorine: -- ppm		Color:		
Ammonia: -- ppm		Gross Solids:		
pH: -- units		Vegetation:		
Temperature -- °F		Benthic Growth:		
Conductivity: -- µS/cm		Stains:		
Detergents: -- mg/L		Non-illicit:

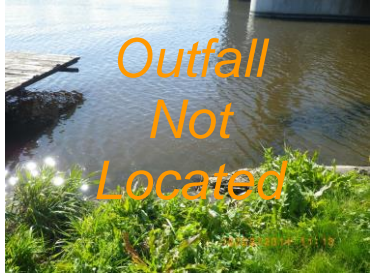
o20141009101330.JPG

Inspection Date: 10/9/2014 11:13:09 AM		Type: Ongoing	Flow: Submerged (not located)	Previous Rainfall (hrs): 72+
Illicit Discharge Potential: Potential		Inspector: JCW	Notes	
Submerged: Fully		Depth (in):	Outfall fully submerged and not located - screened upstream at 08-347 US1.	
Sampling Results		Floatables:	Condition Assessment Graffiti: None Erosion: None Deposition: None in. Damage: None	
Sample Location:		Odor:		
Total Chlorine: -- ppm		Turbidity:		
Free Chlorine: -- ppm		Color:		
Ammonia: -- ppm		Gross Solids:		
pH: -- units		Vegetation:		
Temperature -- °F		Benthic Growth:		
Conductivity: -- µS/cm		Stains:		
Detergents: -- mg/L		Non-illicit:

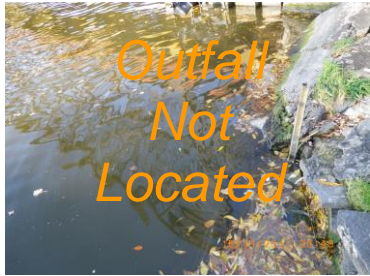
o20111011084904.JPG

Inspection Date: 10/11/2011 8:48:34 AM		Type: Ongoing	Flow: Submerged (not located)	Previous Rainfall (hrs): 72+
Illicit Discharge Potential: Unlikely		Inspector: JCW	Notes	
Submerged: Fully		Depth (in):	2010 screening follow-up. Outfall fully submerged and not physically located. Outfall screened upstream at 08-347 US1.	
Sampling Results		Floatables:	Condition Assessment Graffiti: None Erosion: None Deposition: None 0 in. Damage: None	
Sample Location:		Odor:		
Total Chlorine: -- ppm		Turbidity:		
Free Chlorine: -- ppm		Color:		
Ammonia: -- ppm		Gross Solids:		
pH: -- units		Vegetation:		
Temperature -- °F		Benthic Growth:		
Conductivity: -- µS/cm		Stains:		
Detergents: -- mg/L		Non-illicit:

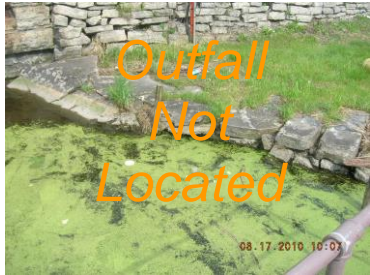
o20100817100702.JPG

Inspection Date: 8/17/2010 10:13:00 AM		Type: Ongoing	Flow: Submerged (not located)	Previous Rainfall (hrs): 72+
Illicit Discharge Potential: Potential		Inspector: JCW	Notes	
Submerged: Fully		Depth (in):	Outfall fully submerged and not physically located. Outfall screened upstream at 08-347 US1.	
Sampling Results		Floatables:	Condition Assessment Graffiti: None Erosion: None Deposition: None 0 in. Damage: None	
Sample Location:		Odor:		
Total Chlorine: -- ppm		Turbidity:		
Free Chlorine: -- ppm		Color:		
Ammonia: -- ppm		Gross Solids:		
pH: -- units		Vegetation:		
Temperature -- °F		Benthic Growth:		
Conductivity: -- µS/cm		Stains:		
Detergents: -- mg/L		Non-illicit:

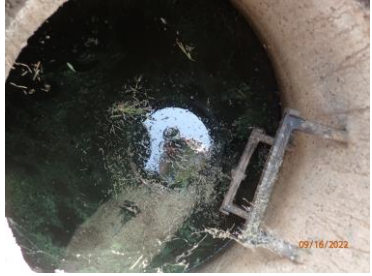
o20220916132530.JPG <div style="text-align: right; font-size: 24pt; font-weight: bold;">2022</div>

Inspection Date: 9/16/2022 1:27:00 PM		Type: Ongoing	Flow: Submerged, indeterminate	Previous Rainfall (hrs): 72+
Illicit Discharge Potential: Potential		Inspector: EJK		
Submerged: Partially		Depth (in): 48		
Sampling Results		Notes Sample collected from submerged pool in manhole. Detergent detected in sample.		
Sample Location: Pool	Floatables:	Slight		
Total Chlorine: 0 ppm	Odor:	None		
Free Chlorine: 0 ppm	Turbidity:	None		
Ammonia: 0 ppm	Color:	None		
pH: 7.51 units	Gross Solids:	None		
Temperature 74 °F	Vegetation:	None		
Conductivity: 922 µS/cm	Benthic Growth:	None		
Detergents: 0.4 mg/L	Stains:	None		
	Non-illicit:	None		
		Condition Assessment Graffiti: None Erosion: None Deposition: None in. Damage: None

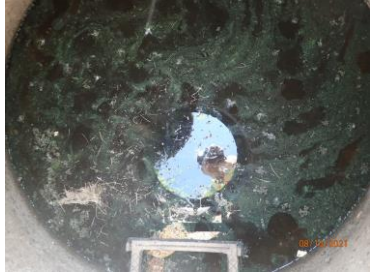
o20210816100142.JPG <div style="text-align: right; font-size: 24pt; font-weight: bold;">2021</div>

Inspection Date: 8/16/2021 10:04:55 AM		Type: Ongoing	Flow: Submerged, indeterminate	Previous Rainfall (hrs): 72+
Illicit Discharge Potential: Unlikely		Inspector: JCW		
Submerged: Fully		Depth (in): 51		
Sampling Results		Notes Sample collected from submerged pool in manhole.		
Sample Location: Pool	Floatables:	None		
Total Chlorine: 0 ppm	Odor:	None		
Free Chlorine: 0 ppm	Turbidity:	None		
Ammonia: 0 ppm	Color:	None		
pH: 7.84 units	Gross Solids:	Slight		
Temperature 76 °F	Vegetation:	None		
Conductivity: 318 µS/cm	Benthic Growth:	None		
Detergents: 0 mg/L	Stains:	None		
	Non-illicit:	None		
		Condition Assessment Graffiti: None Erosion: None Deposition: None in. Damage: None

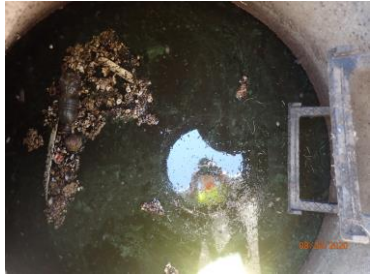
o20200820124306.JPG <div style="text-align: right; font-size: 24pt; font-weight: bold;">2020</div>

Inspection Date: 8/20/2020 12:45:49 PM		Type: Ongoing	Flow: Submerged, indeterminate	Previous Rainfall (hrs): 72+
Illicit Discharge Potential: Potential		Inspector: JCW		
Submerged: Fully		Depth (in): 48		
Sampling Results		Notes Sample collected from submerged pool in manhole. Floating gross solids (litter) in manhole.		
Sample Location: Pool	Floatables:	None		
Total Chlorine: 0 ppm	Odor:	None		
Free Chlorine: 0 ppm	Turbidity:	None		
Ammonia: 0 ppm	Color:	None		
pH: 8.95 units	Gross Solids:	Moderate		
Temperature 82 °F	Vegetation:	None		
Conductivity: 340 µS/cm	Benthic Growth:	None		
Detergents: 0 mg/L	Stains:	None		
	Non-illicit:	None		
		Condition Assessment Graffiti: None Erosion: None Deposition: None in. Damage: None

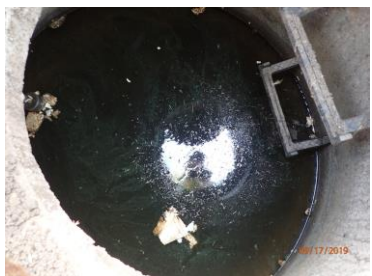
o20190917134722.JPG <div style="text-align: right; font-size: 24pt; font-weight: bold;">2019</div>

Inspection Date: 9/17/2019 2:49:27 PM		Type: Ongoing	Flow: Submerged, indeterminate	Previous Rainfall (hrs): 48-72
Illicit Discharge Potential: Unlikely		Inspector: JCW		
Submerged: Fully		Depth (in): 50		
Sampling Results		Notes Sample collected from submerged pool in manhole.		
Sample Location: Pool	Floatables:	None		
Total Chlorine: 0 ppm	Odor:	None		
Free Chlorine: 0 ppm	Turbidity:	None		
Ammonia: 0 ppm	Color:	None		
pH: 8.56 units	Gross Solids:	Slight		
Temperature 75 °F	Vegetation:	None		
Conductivity: 356 µS/cm	Benthic Growth:	None		
Detergents: 0 mg/L	Stains:	None		
	Non-illicit:	None		
		Condition Assessment Graffiti: None Erosion: None Deposition: None in. Damage: None

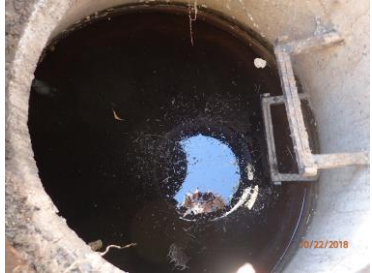
o20181022110036.JPG

Inspection Date: 10/22/2018 11:02:59 AM		Type: Ongoing	Flow: Submerged, indeterminate	Previous Rainfall (hrs): 48-72
Illicit Discharge Potential: Potential		Inspector: JCW	Notes	
Submerged: Fully		Depth (in): 53	Sample collected from submerged pool in manhole. Floating gross solids (litter) in manhole.	
Sampling Results		Floatables: None	Condition Assessment Graffiti: None Erosion: None Deposition: None in. Damage: None	
Sample Location: Pool	Odor: None			
Total Chlorine: 0 ppm	Turbidity: None			
Free Chlorine: 0 ppm	Color: Faint in bottle			
Ammonia: 0 ppm	Gross Solids: Slight			
pH: 7.49 units	Vegetation: None			
Temperature 55 °F	Benthic Growth: Slight			
Conductivity: 321 µS/cm	Stains: None			
Detergents: 0 mg/L	Non-illicit: None

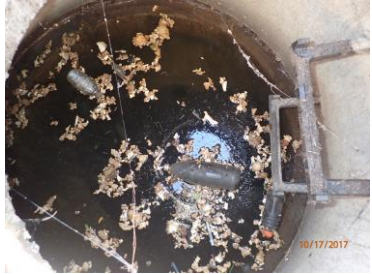
o20171017140304.JPG

Inspection Date: 10/17/2017 2:07:18 PM		Type: Ongoing	Flow: Submerged, indeterminate	Previous Rainfall (hrs): 48-72
Illicit Discharge Potential: Potential		Inspector: JCW	Notes	
Submerged: Fully		Depth (in): 46	Sample collected from submerged pool in manhole. Floating gross solids (litter) in manhole.	
Sampling Results		Floatables: None	Condition Assessment Graffiti: None Erosion: None Deposition: None in. Damage: None	
Sample Location: Pool	Odor: None			
Total Chlorine: 0 ppm	Turbidity: None			
Free Chlorine: 0 ppm	Color: None			
Ammonia: 0 ppm	Gross Solids: Moderate			
pH: 8.29 units	Vegetation: None			
Temperature 66 °F	Benthic Growth: None			
Conductivity: 346 µS/cm	Stains: None			
Detergents: 0 mg/L	Non-illicit: None

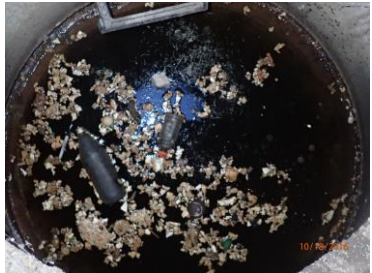
o20161018170248.JPG

Inspection Date: 10/18/2016 5:02:56 PM		Type: Ongoing	Flow: Submerged, indeterminate	Previous Rainfall (hrs): 72+
Illicit Discharge Potential: Potential		Inspector: JCW	Notes	
Submerged: Partially		Depth (in): 46	Potential illicit discharge due to gross solids.	
Sampling Results		Floatables: None	Condition Assessment Graffiti: None Erosion: None Deposition: None in. Damage: None	
Sample Location: Pool	Odor: None			
Total Chlorine: 0 ppm	Turbidity: None			
Free Chlorine: 0 ppm	Color: Faint in bottle			
Ammonia: 0 ppm	Gross Solids: Severe			
pH: 8.18 units	Vegetation: None			
Temperature 66 °F	Benthic Growth: None			
Conductivity: 361 µS/cm	Stains: None			
Detergents: 0 mg/L	Non-illicit: None

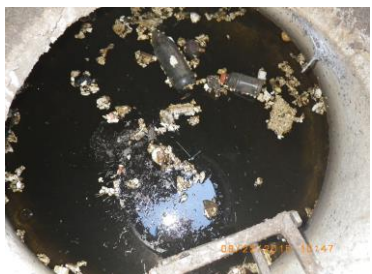
o20150922094746.JPG

Inspection Date: 9/22/2015 10:46:05 AM		Type: Ongoing	Flow: Submerged, indeterminate	Previous Rainfall (hrs): 72+
Illicit Discharge Potential: Potential		Inspector: JCW	Notes	
Submerged: Fully		Depth (in): 48	Floating gross solids (litter) in manhole.	
Sampling Results		Floatables: None	Condition Assessment Graffiti: None Erosion: None Deposition: None in. Damage: None	
Sample Location: Pool	Odor: None			
Total Chlorine: 0 ppm	Turbidity: None			
Free Chlorine: 0 ppm	Color: None			
Ammonia: 0 ppm	Gross Solids: Moderate			
pH: 8.33 units	Vegetation: None			
Temperature 73 °F	Benthic Growth: None			
Conductivity: 352 µS/cm	Stains: None			
Detergents: 0 mg/L	Non-illicit: None

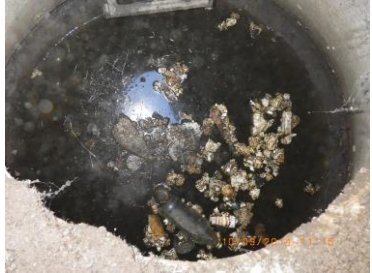
o20141009101552.JPG

Inspection Date: 10/9/2014 11:17:38 AM		Type: Ongoing	Flow: Submerged, indeterminate	Previous Rainfall (hrs): 72+
Illicit Discharge Potential: Potential		Inspector: JCW	Notes	
Submerged: Fully		Depth (in): 43	Floating gross solids (litter) in manhole.	
Sampling Results				
Sample Location:	Pool	Floatables:	None	
Total Chlorine:	0 ppm	Odor:	None	
Free Chlorine:	0 ppm	Turbidity:	None	
Ammonia:	0 ppm	Color:	None	
pH:	7.67 units	Gross Solids:	Moderate	
Temperature	59 °F	Vegetation:	None	
Conductivity:	422 µS/cm	Benthic Growth:	None	
Detergents:	0 mg/L	Stains:	None	
		Non-illicit:	None	
			Condition Assessment	
			Graffiti:	None
			Erosion:	None
			Deposition:	None in.
			Damage:	None

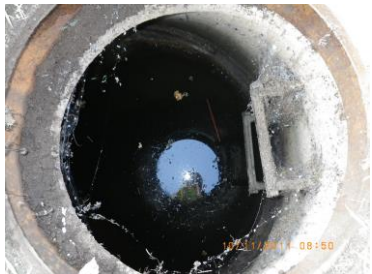
o20111011085018.JPG

Inspection Date: 10/11/2011 8:51:38 AM		Type: Ongoing	Flow: Submerged, indeterminate	Previous Rainfall (hrs): 72+
Illicit Discharge Potential: Unlikely		Inspector: JCW	Notes	
Submerged: Fully		Depth (in): 43	2010 screening follow-up. Floatable debris significantly reduced.	
Sampling Results				
Sample Location:	Pool	Floatables:	None	
Total Chlorine:	0 ppm	Odor:	None	
Free Chlorine:	0 ppm	Turbidity:	None	
Ammonia:	0 ppm	Color:	Faint in bottle	
pH:	7.87 units	Gross Solids:	Slight	
Temperature	71 °F	Vegetation:	None	
Conductivity:	-- µS/cm	Benthic Growth:	None	
Detergents:	-- mg/L	Stains:	None	
		Non-illicit:	None	
			Condition Assessment	
			Graffiti:	None
			Erosion:	None
			Deposition:	None 0 in.
			Damage:	None

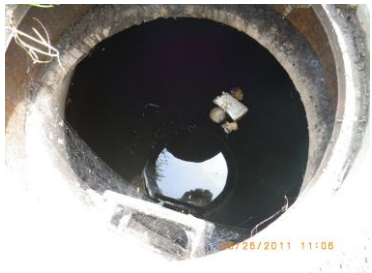
o20110526110604.JPG

Inspection Date: 5/26/2011 11:05:00 AM		Type: Other	Flow: Submerged, indeterminate	Previous Rainfall (hrs): 72+
Illicit Discharge Potential: Unlikely		Inspector: JCW	Notes	
Submerged: Fully		Depth (in):	Limited screening conducted to check for floatable debris.	
Sampling Results				
Sample Location:		Floatables:	None	
Total Chlorine:	-- ppm	Odor:		
Free Chlorine:	-- ppm	Turbidity:		
Ammonia:	-- ppm	Color:		
pH:	-- units	Gross Solids:	Slight	
Temperature	-- °F	Vegetation:		
Conductivity:	-- µS/cm	Benthic Growth:		
Detergents:	-- mg/L	Stains:		
		Non-illicit:	None	
			Condition Assessment	
			Graffiti:	None
			Erosion:	None
			Deposition:	None 0 in.
			Damage:	None

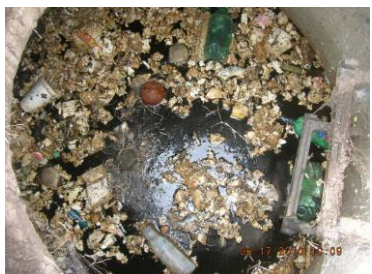
o20100817100950.JPG

Inspection Date: 8/17/2010 10:17:46 AM		Type: Ongoing	Flow: Submerged, indeterminate	Previous Rainfall (hrs): 72+
Illicit Discharge Potential: Potential		Inspector: JCW	Notes	
Submerged: Fully		Depth (in): 48	Significant floatable debris in manhole.	
Sampling Results				
Sample Location:	Pool	Floatables:	None	
Total Chlorine:	0 ppm	Odor:	None	
Free Chlorine:	0 ppm	Turbidity:	None	
Ammonia:	0 ppm	Color:	None	
pH:	7.71 units	Gross Solids:	Severe	
Temperature	74 °F	Vegetation:	None	
Conductivity:	-- µS/cm	Benthic Growth:	None	
Detergents:	0 mg/L	Stains:	None	
		Non-illicit:	None	
			Condition Assessment	
			Graffiti:	None
			Erosion:	None
			Deposition:	None 0 in.
			Damage:	None

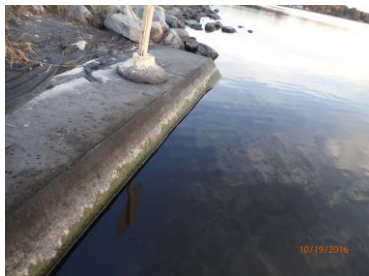
o20161019072744.JPG <div style="text-align: center; font-size: 24pt; font-weight: bold;">2016</div>

Inspection Date: 10/19/2016 7:29:32 AM		Type: Ongoing	Flow: Submerged, indeterminate	Previous Rainfall (hrs): 72+
Illicit Discharge Potential: Unlikely		Inspector: JCW		
Submerged: Fully		Depth (in): 48		
Sampling Results Sample Location: Total Chlorine: -- ppm Free Chlorine: -- ppm Ammonia: -- ppm pH: -- units Temperature -- °F Conductivity: -- µS/cm Detergents: -- mg/L		Floatables: None Odor: None Turbidity: None Color: None Gross Solids: None Vegetation: None Benthic Growth: Moderate Stains: None Non-illicit: None	Notes Outfall fully submerged - screened upstream at 11-465a US1 (upstream of pump station). Condition Assessment Graffiti: None Erosion: None Deposition: None in. Damage: None

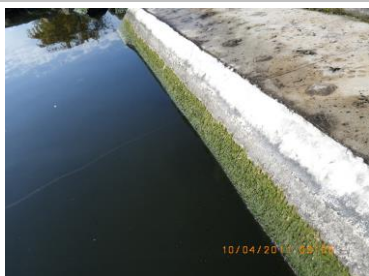
o20111004090522.JPG <div style="text-align: center; font-size: 24pt; font-weight: bold;">2011</div>

Inspection Date: 10/4/2011 9:03:56 AM		Type: Ongoing	Flow: Submerged, indeterminate	Previous Rainfall (hrs): 72+
Illicit Discharge Potential: Unlikely		Inspector: JCW		
Submerged: Fully		Depth (in): 49		
Sampling Results Sample Location: Total Chlorine: -- ppm Free Chlorine: -- ppm Ammonia: -- ppm pH: -- units Temperature -- °F Conductivity: -- µS/cm Detergents: -- mg/L		Floatables: None Odor: None Turbidity: None Color: None Gross Solids: None Vegetation: None Benthic Growth: Moderate Stains: None Non-illicit: None	Notes Outfall fully submerged. Outfall screened upstream at 11-465a US1. Condition Assessment Graffiti: None Erosion: None Deposition: None 0 in. Damage: None

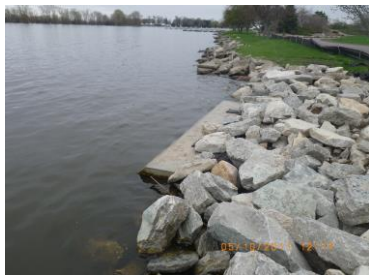
o20110510121750.JPG <div style="text-align: center; font-size: 24pt; font-weight: bold;">2011</div>

Inspection Date: 5/10/2011 12:17:00 PM		Type: Other	Flow: Submerged, indeterminate	Previous Rainfall (hrs): 0-24
Illicit Discharge Potential: Unlikely		Inspector: JCW		
Submerged: Fully		Depth (in):		
Sampling Results Sample Location: Total Chlorine: -- ppm Free Chlorine: -- ppm Ammonia: -- ppm pH: -- units Temperature -- °F Conductivity: -- µS/cm Detergents: -- mg/L		Floatables: Odor: Turbidity: Color: Gross Solids: Vegetation: Benthic Growth: Stains: Non-illicit: None	Notes Outfall fully submerged. Outfall screened upstream at 11-465a US1. Condition Assessment Graffiti: None Erosion: None Deposition: None 0 in. Damage: None

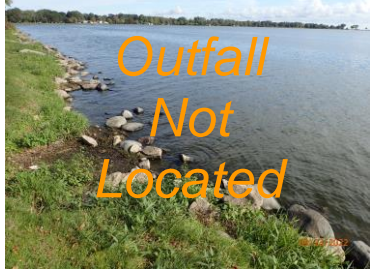
Inspection Date: 9/23/2022 10:10:00 AM		Type: Ongoing	Flow: Submerged (not located)	Previous Rainfall (hrs): 72+
Illicit Discharge Potential: Unlikely		Inspector: EJK		
Submerged: Fully		Depth (in):		
Sampling Results Sample Location: _____ Total Chlorine: -- ppm Free Chlorine: -- ppm Ammonia: -- ppm pH: -- units Temperature: -- °F Conductivity: -- µS/cm Detergents: -- mg/L		Floatables: None Odor: None Turbidity: None Color: None Gross Solids: None Vegetation: None Benthic Growth: None Stains: None Non-illicit: None	Notes Outfall fully submerged and not located - screened upstream at 11-177 US1.

o20220923100858.JPG <div style="text-align: center; font-size: 24pt; font-weight: bold;">2022</div>
		Condition Assessment Graffiti: None Erosion: None Deposition: None in. Damage: None

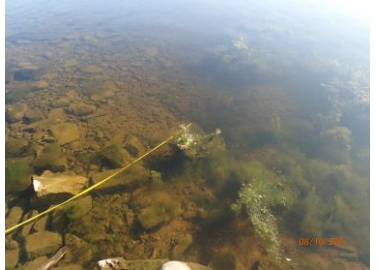
Inspection Date: 8/16/2021 8:11:25 AM		Type: Ongoing	Flow: Submerged, indeterminate	Previous Rainfall (hrs): 72+
Illicit Discharge Potential: Potential		Inspector: JCW		
Submerged: Fully		Depth (in):		
Sampling Results Sample Location: _____ Total Chlorine: -- ppm Free Chlorine: -- ppm Ammonia: -- ppm pH: -- units Temperature: -- °F Conductivity: -- µS/cm Detergents: -- mg/L		Floatables: None Odor: None Turbidity: None Color: None Gross Solids: None Vegetation: None Benthic Growth: None Stains: None Non-illicit: None	Notes Outfall partially submerged - screened upstream at 11-177 US1. Floating gross solids (litter) in upstream manhole.

o20210816080850.JPG <div style="text-align: center; font-size: 24pt; font-weight: bold;">2021</div>
		Condition Assessment Graffiti: None Erosion: None Deposition: None in. Damage: None

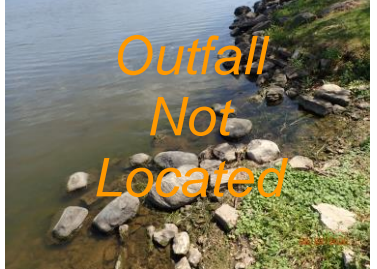
Inspection Date: 8/20/2020 1:55:03 PM		Type: Ongoing	Flow: Submerged (not located)	Previous Rainfall (hrs): 72+
Illicit Discharge Potential: Potential		Inspector: JCW		
Submerged: Fully		Depth (in):		
Sampling Results Sample Location: _____ Total Chlorine: -- ppm Free Chlorine: -- ppm Ammonia: -- ppm pH: -- units Temperature: -- °F Conductivity: -- µS/cm Detergents: -- mg/L		Floatables: None Odor: None Turbidity: None Color: None Gross Solids: None Vegetation: None Benthic Growth: None Stains: None Non-illicit: None	Notes Outfall fully submerged and not located - screened upstream at 11-177 US1. Floating gross solids (litter) in upstream manhole.

o20200820135154.JPG <div style="text-align: center; font-size: 24pt; font-weight: bold;">2020</div>
		Condition Assessment Graffiti: None Erosion: None Deposition: None in. Damage: None

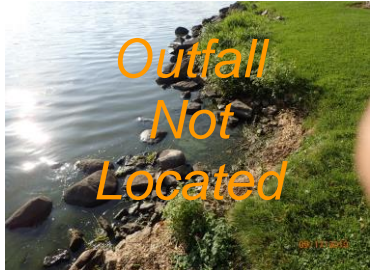
Inspection Date: 9/17/2019 8:55:55 AM		Type: Ongoing	Flow: Submerged (not located)	Previous Rainfall (hrs): 48-72
Illicit Discharge Potential: Potential		Inspector: JCW		
Submerged: Fully		Depth (in):		
Sampling Results Sample Location: _____ Total Chlorine: -- ppm Free Chlorine: -- ppm Ammonia: -- ppm pH: -- units Temperature: -- °F Conductivity: -- µS/cm Detergents: -- mg/L		Floatables: None Odor: None Turbidity: None Color: None Gross Solids: None Vegetation: None Benthic Growth: None Stains: None Non-illicit: None	Notes Outfall fully submerged and not physically located. Outfall screened upstream at 11-177 US1. Floating gross solids (litter) in manhole.

o20190917075538.JPG <div style="text-align: center; font-size: 24pt; font-weight: bold;">2019</div>
		Condition Assessment Graffiti: None Erosion: None Deposition: None in. Damage: None

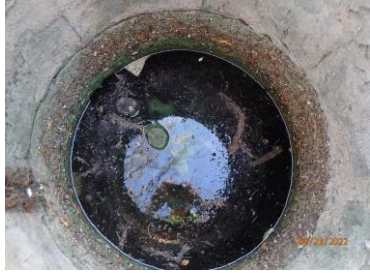
o20220923101908.JPG <div style="text-align: center; font-size: 24pt; font-weight: bold;">2022</div>

Notes Sample collected from submerged pool in manhole.																																				
		Condition Assessment Graffiti: None Erosion: None Deposition: None in. Damage: None

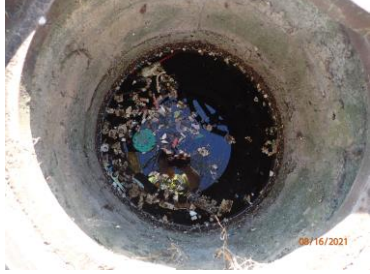
o20210816081106.JPG <div style="text-align: center; font-size: 24pt; font-weight: bold;">2021</div>

Notes Sample collected from submerged pool in manhole. Floating gross solids (litter) in manhole.																																				
		Condition Assessment Graffiti: None Erosion: None Deposition: None in. Damage: None
