IDDE Ongoing Screening Summary Report

2023 Inspection Year

Westwood

City of Oshkosh

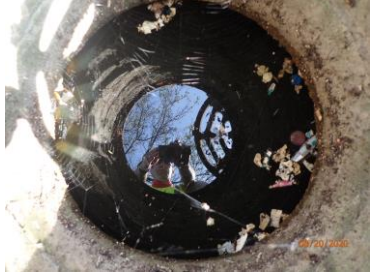
o20200820135226.JPG <div style="text-align: center; font-size: 24pt; font-weight: bold;">2020</div>

Notes Sample collected from submerged pool in manhole. Floating gross solids (litter) in manhole.																																				
		Condition Assessment Graffiti: None Erosion: None Deposition: None in. Damage: None

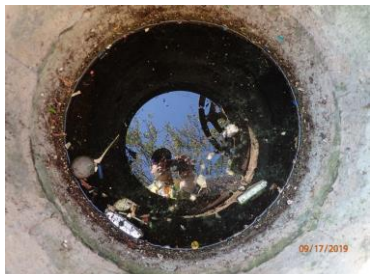
o20190917075612.JPG <div style="text-align: center; font-size: 24pt; font-weight: bold;">2019</div>

Notes Sample collected from submerged pool in manhole. Floating gross solids (litter) in manhole.																																				
		Condition Assessment Graffiti: None Erosion: None Deposition: None in. Damage: None

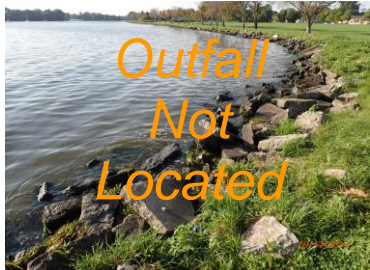
o20190917074332.JPG <div style="text-align: center; font-size: 24pt; font-weight: bold;">2019</div>

Floatables:	None	Odor:	None	Turbidity:	None	Color:	None	Gross Solids:	None	Vegetation:	None	Benthic Growth:	None	Stains:	None	Non-illicit:	None
Floatables:	None																					
Odor:	None																					
Turbidity:	None																					
Color:	None																					
Gross Solids:	None																					
Vegetation:	None																					
Benthic Growth:	None																					
Stains:	None																					
Non-illicit:	None																					
		Notes Outfall fully submerged and not located - screened upstream at 11-376 US1. Floating gross solids (litter) in manhole.																				
		Condition Assessment Graffiti: None Erosion: None Deposition: None in. Damage: None

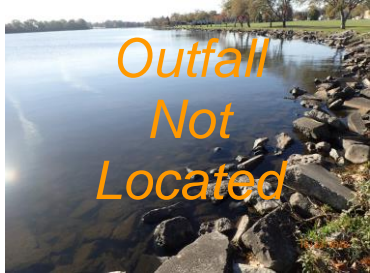
o20181022094126.JPG

Inspection Date: 10/22/2018 9:42:07 AM		Type: Ongoing	Flow: Submerged (not located)	Previous Rainfall (hrs): 48-72
Illicit Discharge Potential: Potential		Inspector: JCW	Notes	
Submerged: Fully		Depth (in):	Outfall fully submerged and not located - screened upstream at 11-376 US1. Floating gross solids (litter) in manhole.	
Sampling Results		Floatables:	Condition Assessment Graffiti: None Erosion: None Deposition: None in. Damage: None	
Sample Location:	Odor:	None		
Total Chlorine: -- ppm	Turbidity:	None		
Free Chlorine: -- ppm	Color:	None		
Ammonia: -- ppm	Gross Solids:	None		
pH: -- units	Vegetation:	None		
Temperature -- °F	Benthic Growth:	None		
Conductivity: -- µS/cm	Stains:	None		
Detergents: -- mg/L	Non-illicit:	None

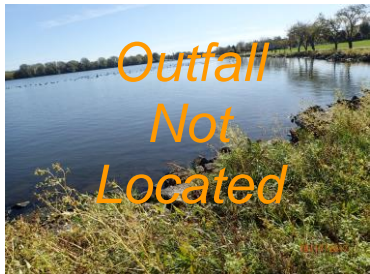
o20171017130204.JPG

Inspection Date: 10/17/2017 1:03:56 PM		Type: Ongoing	Flow: Submerged (not located)	Previous Rainfall (hrs): 48-72
Illicit Discharge Potential: Potential		Inspector: JCW	Notes	
Submerged: Fully		Depth (in):	Outfall fully submerged and not located - screened upstream at 11-376 US1. Floating gross solids (litter) in manhole.	
Sampling Results		Floatables:	Condition Assessment Graffiti: None Erosion: None Deposition: None in. Damage: None	
Sample Location:	Odor:	None		
Total Chlorine: -- ppm	Turbidity:	None		
Free Chlorine: -- ppm	Color:	None		
Ammonia: -- ppm	Gross Solids:	None		
pH: -- units	Vegetation:	None		
Temperature -- °F	Benthic Growth:	None		
Conductivity: -- µS/cm	Stains:	None		
Detergents: -- mg/L	Non-illicit:	None

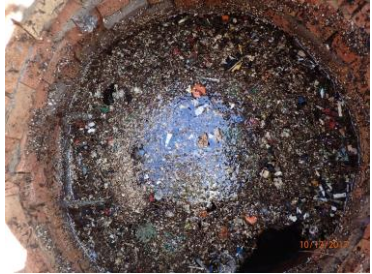
o20171017130258.JPG
2017

Inspection Date: 10/17/2017 1:07:06 PM		Type: Ongoing	Flow: Submerged, indeterminate	Previous Rainfall (hrs): 48-72
Illicit Discharge Potential: Potential		Inspector: JCW	Notes	
Submerged: Fully		Depth (in): 79	Sample collected from submerged pool in manhole. Floating gross solids (litter) in manhole.	
Sampling Results		Floatables: None	Condition Assessment Graffiti: None Erosion: None Deposition: None in. Damage: None	
Sample Location: Pool	Odor: None			
Total Chlorine: 0 ppm	Turbidity: None			
Free Chlorine: 0 ppm	Color: None			
Ammonia: 0 ppm	Gross Solids: Moderate			
pH: 7.62 units	Vegetation: None			
Temperature 67 °F	Benthic Growth: None			
Conductivity: 829 µS/cm	Stains: None			
Detergents: 0 mg/L	Non-illicit: None

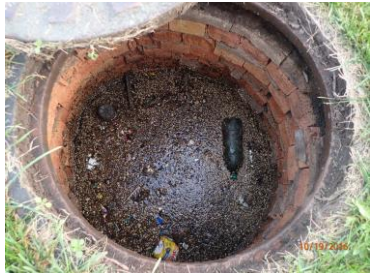
o20161019074410.JPG
2016

Inspection Date: 10/19/2016 7:46:56 AM		Type: Ongoing	Flow: Submerged, indeterminate	Previous Rainfall (hrs): 72+
Illicit Discharge Potential: Potential		Inspector: JCW	Notes	
Submerged: Fully		Depth (in): 79	Potential illicit discharge due to gross solids.	
Sampling Results		Floatables: None	Condition Assessment Graffiti: None Erosion: None Deposition: None in. Damage: None	
Sample Location: Pool	Odor: Faint			
Total Chlorine: 0 ppm	Turbidity: None			
Free Chlorine: 0 ppm	Color: Faint in bottle			
Ammonia: 0 ppm	Gross Solids: Severe			
pH: 7.89 units	Vegetation: None			
Temperature 58 °F	Benthic Growth: None			
Conductivity: 357 µS/cm	Stains: None			
Detergents: 0 mg/L	Non-illicit: None

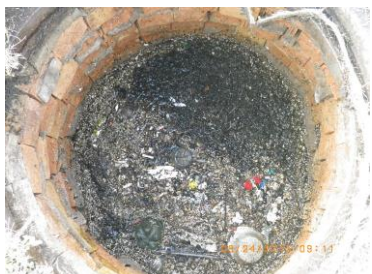
o20150924081150.JPG
2015

Inspection Date: 9/24/2015 9:10:22 AM		Type: Ongoing	Flow: Submerged, indeterminate	Previous Rainfall (hrs): 72+
Illicit Discharge Potential: Potential		Inspector: JCW	Notes	
Submerged: Fully		Depth (in): 81	Floating gross solids (litter) in manhole.	
Sampling Results		Floatables: None	Condition Assessment Graffiti: None Erosion: None Deposition: None in. Damage: None	
Sample Location: Pool	Odor: Faint			
Total Chlorine: 0 ppm	Turbidity: None			
Free Chlorine: 0 ppm	Color: None			
Ammonia: 0 ppm	Gross Solids: Severe			
pH: 7.88 units	Vegetation: None			
Temperature 68 °F	Benthic Growth: None			
Conductivity: 397 µS/cm	Stains: None			
Detergents: 0 mg/L	Non-illicit: None

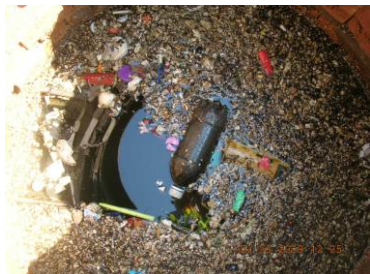
Osh09_DSCN6622.JPG <div style="text-align: center; font-size: 24pt; font-weight: bold;">2009</div>

Inspection Date: 9/8/2009		Type: Initial	Flow: Submerged, indeterminate	Previous Rainfall (hrs): 72+																																				
Illicit Discharge Potential: Potential		Inspector: JCW	Notes																																					
Submerged: Fully		Depth (in): 81	Abnormal detergent analysis result (bubbles). Significant floating debris in manhole.

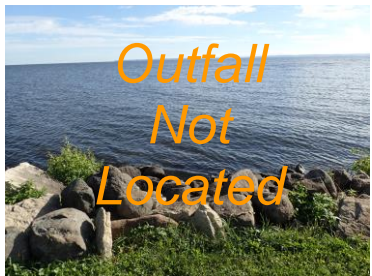
Inspection Date: 9/23/2022 9:24:00 AM		Type: Ongoing		Flow: Submerged (not located)		Previous Rainfall (hrs): 72+	
Illicit Discharge Potential: Potential		Inspector: EJK		Notes

<p style="text-align: center;">o20220923092250.JPG</p> <p style="text-align: center; font-size: 1.5em; font-weight: bold;">2022</p>	
Submerged: Fully		Depth (in):		Outfall fully submerged and not located - screened upstream at 11-512 US1. Floating gross solids (litter) in upstream manhole.			
Sampling Results Sample Location: _____ Total Chlorine: -- ppm Free Chlorine: -- ppm Ammonia: -- ppm pH: -- units Temperature -- ° F Conductivity: -- µS/cm Detergents: -- mg/L		Floatables: None Odor: None Turbidity: None Color: None Gross Solids: None Vegetation: None Benthic Growth: None Stains: None Non-illicit: None		Condition Assessment Graffiti: None Erosion: None Deposition: None in. Damage: None

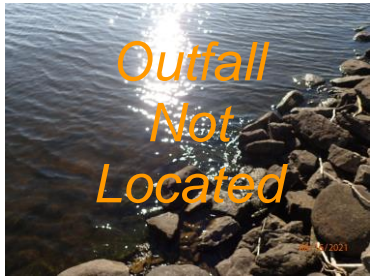
Inspection Date: 8/16/2021 8:42:01 AM		Type: Ongoing		Flow: Submerged (not located)		Previous Rainfall (hrs): 72+	
Illicit Discharge Potential: Potential		Inspector: JCW		Notes

<p style="text-align: center;">o20210816083746.JPG</p> <p style="text-align: center; font-size: 1.5em; font-weight: bold;">2021</p>	
Submerged: Fully		Depth (in):		Outfall fully submerged and not located - screened upstream at 11-512 US1. Floating gross solids (litter) in upstream manhole.			
Sampling Results Sample Location: _____ Total Chlorine: -- ppm Free Chlorine: -- ppm Ammonia: -- ppm pH: -- units Temperature -- ° F Conductivity: -- µS/cm Detergents: -- mg/L		Floatables: None Odor: None Turbidity: None Color: None Gross Solids: None Vegetation: None Benthic Growth: None Stains: None Non-illicit: None		Condition Assessment Graffiti: None Erosion: None Deposition: None in. Damage: None

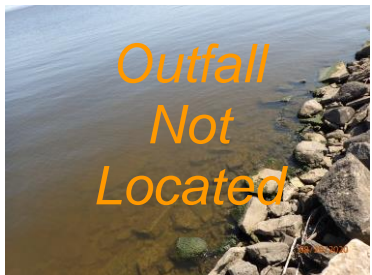
Inspection Date: 8/20/2020 1:20:27 PM		Type: Ongoing		Flow: Submerged (not located)		Previous Rainfall (hrs): 72+	
Illicit Discharge Potential: Potential		Inspector: JCW		Notes

<p style="text-align: center;">o20200820131742.JPG</p> <p style="text-align: center; font-size: 1.5em; font-weight: bold;">2020</p>	
Submerged: Fully		Depth (in):		Outfall fully submerged and not located - screened upstream at 11-512 US1. Floating gross solids (litter) in upstream manhole.			
Sampling Results Sample Location: _____ Total Chlorine: -- ppm Free Chlorine: -- ppm Ammonia: -- ppm pH: -- units Temperature -- ° F Conductivity: -- µS/cm Detergents: -- mg/L		Floatables: None Odor: None Turbidity: None Color: None Gross Solids: None Vegetation: None Benthic Growth: None Stains: None Non-illicit: None		Condition Assessment Graffiti: None Erosion: None Deposition: None in. Damage: None

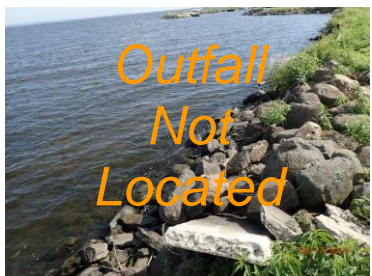
Inspection Date: 9/17/2019 2:05:48 PM		Type: Ongoing		Flow: Submerged (not located)		Previous Rainfall (hrs): 48-72	
Illicit Discharge Potential: Potential		Inspector: JCW		Notes

<p style="text-align: center;">o20190917130514.JPG</p> <p style="text-align: center; font-size: 1.5em; font-weight: bold;">2019</p>	
Submerged: Fully		Depth (in):		Outfall fully submerged and not located - screened upstream at 11-512 US1. Floating gross solids (litter) in manhole.			
Sampling Results Sample Location: _____ Total Chlorine: -- ppm Free Chlorine: -- ppm Ammonia: -- ppm pH: -- units Temperature -- ° F Conductivity: -- µS/cm Detergents: -- mg/L		Floatables: None Odor: None Turbidity: None Color: None Gross Solids: None Vegetation: None Benthic Growth: None Stains: None Non-illicit: None		Condition Assessment Graffiti: None Erosion: None Deposition: None in. Damage: None

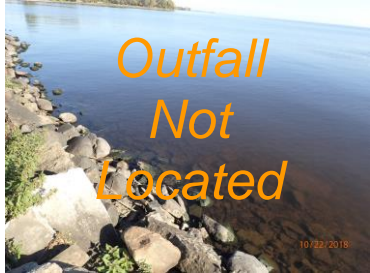
o20181022095658.JPG

Inspection Date: 10/22/2018 9:59:38 AM		Type: Ongoing	Flow: Submerged (not located)	Previous Rainfall (hrs): 48-72
Illicit Discharge Potential: Potential		Inspector: JCW		
Submerged: Fully		Depth (in):		
Sampling Results		Notes		
Sample Location:	Floatables:	Outfall fully submerged and not located - screened upstream at 11-512 US1. Floating gross solids (litter) in manhole.		
Total Chlorine: -- ppm	Odor:			
Free Chlorine: -- ppm	Turbidity:			
Ammonia: -- ppm	Color:			
pH: -- units	Gross Solids:			
Temperature -- °F	Vegetation:			
Conductivity: -- µS/cm	Benthic Growth:			
Detergents: -- mg/L	Stains:			
	Non-illicit:	Graffiti: None Erosion: None Deposition: None in. Damage: None

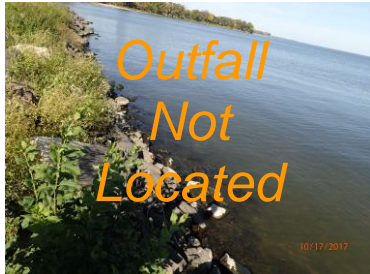
o20171017131910.JPG

Inspection Date: 10/17/2017 1:20:48 PM		Type: Ongoing	Flow: Submerged (not located)	Previous Rainfall (hrs): 48-72
Illicit Discharge Potential: Potential		Inspector: JCW		
Submerged: Fully		Depth (in):		
Sampling Results		Notes		
Sample Location:	Floatables:	Outfall fully submerged and not located - screened upstream at 11-512 US1. Floating gross solids (litter) in manhole.		
Total Chlorine: -- ppm	Odor:			
Free Chlorine: -- ppm	Turbidity:			
Ammonia: -- ppm	Color:			
pH: -- units	Gross Solids:			
Temperature -- °F	Vegetation:			
Conductivity: -- µS/cm	Benthic Growth:			
Detergents: -- mg/L	Stains:			
	Non-illicit:	Graffiti: None Erosion: None Deposition: None in. Damage: None

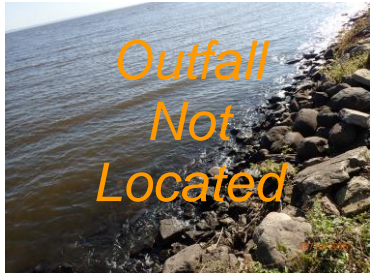
o20161010110406.JPG

Inspection Date: 10/10/2016 11:04:16 AM		Type: Ongoing	Flow: Submerged (not located)	Previous Rainfall (hrs): 72+
Illicit Discharge Potential: Potential		Inspector: JCW		
Submerged: Fully		Depth (in):		
Sampling Results		Notes		
Sample Location:	Floatables:	Outfall fully submerged and not located - screened upstream at 11-512 US1.		
Total Chlorine: -- ppm	Odor:			
Free Chlorine: -- ppm	Turbidity:			
Ammonia: -- ppm	Color:			
pH: -- units	Gross Solids:			
Temperature -- °F	Vegetation:			
Conductivity: -- µS/cm	Benthic Growth:			
Detergents: -- mg/L	Stains:			
	Non-illicit:	Graffiti: None Erosion: None Deposition: None in. Damage: None

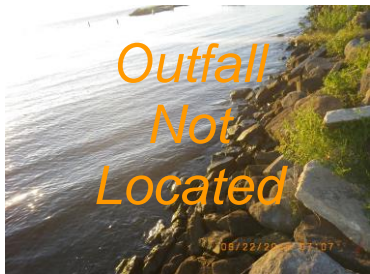
o20150922060708.JPG

Inspection Date: 9/22/2015 7:03:32 AM		Type: Ongoing	Flow: Submerged (not located)	Previous Rainfall (hrs): 72+
Illicit Discharge Potential: Potential		Inspector: JCW		
Submerged: Fully		Depth (in):		
Sampling Results		Notes		
Sample Location:	Floatables:	Outfall fully submerged and not located - screened upstream at 11-512 US1.		
Total Chlorine: -- ppm	Odor:			
Free Chlorine: -- ppm	Turbidity:			
Ammonia: -- ppm	Color:			
pH: -- units	Gross Solids:			
Temperature -- °F	Vegetation:			
Conductivity: -- µS/cm	Benthic Growth:			
Detergents: -- mg/L	Stains:			
	Non-illicit:	Graffiti: None Erosion: None Deposition: None in. Damage: None

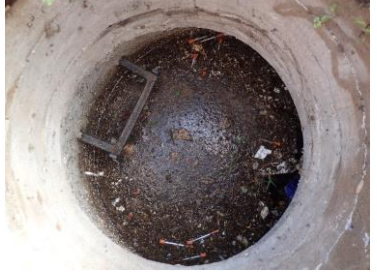
Inspection Date: 9/23/2022 9:26:00 AM		Type: Ongoing	Flow: Submerged, indeterminate	Previous Rainfall (hrs): 72+
Illicit Discharge Potential: Potential Submerged: Partially Depth (in): 36		Inspector: EJK	Notes

o20220923092448.JPG 2022
Sampling Results Sample Location: Pool Total Chlorine: 0 ppm Free Chlorine: 0 ppm Ammonia: 0 ppm pH: 7.84 units Temperature: 66 °F Conductivity: 460 µS/cm Detergents: 0 mg/L		Floatables: None Odor: None Turbidity: None Color: None Gross Solids: Moderate Vegetation: None Benthic Growth: None Stains: None Non-illicit: None	Sample collected from submerged pool in manhole. Floating gross solids (litter) in upstream manhole. Condition Assessment Graffiti: None Erosion: None Deposition: None in. Damage: None	
Inspection Date: 8/16/2021 8:42:51 AM		Type: Ongoing	Flow: Submerged, indeterminate	Previous Rainfall (hrs): 72+
Illicit Discharge Potential: Potential Submerged: Fully Depth (in): 41		Inspector: JCW	Notes

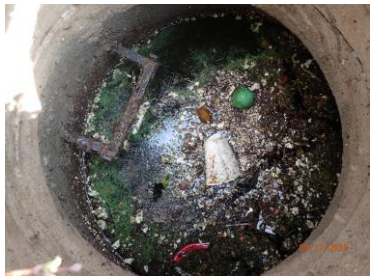
Inspection Date: 9/17/2019 2:08:21 PM		Type: Ongoing	Flow: Submerged, indeterminate	Previous Rainfall (hrs): 48-72
Illicit Discharge Potential: Potential Submerged: Fully Depth (in): 37		Inspector: JCW	Notes

o20190917130614.JPG 2019
Sampling Results Sample Location: Pool Total Chlorine: 0 ppm Free Chlorine: 0 ppm Ammonia: 0 ppm pH: 8.23 units Temperature: 76 °F Conductivity: 333 µS/cm Detergents: 0 mg/L		Floatables: None Odor: None Turbidity: None Color: None Gross Solids: Severe Vegetation: None Benthic Growth: None Stains: None Non-illicit: None	Sample collected from submerged pool in manhole. Floating gross solids (litter) in manhole. Condition Assessment Graffiti: None Erosion: None Deposition: None in. Damage: None

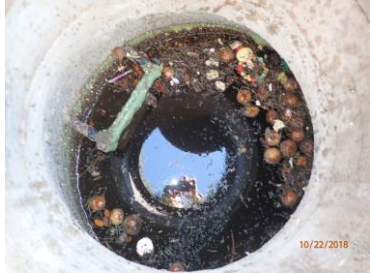
o20181022100114.JPG

Inspection Date: 10/22/2018 10:00:30 AM		Type: Ongoing	Flow: Submerged, indeterminate	Previous Rainfall (hrs): 48-72
Illicit Discharge Potential: Potential		Inspector: JCW	Notes	
Submerged: Fully		Depth (in): 42	Sample collected from submerged pool in manhole. Floating gross solids (litter) in manhole.	
Sampling Results		Floatables: None	Condition Assessment	
Sample Location:	Pool	Odor: None	Graffiti: None	
Total Chlorine:	0 ppm	Turbidity: None	Erosion: None	
Free Chlorine:	0 ppm	Color: None	Deposition: None in.	
Ammonia:	0 ppm	Gross Solids: Moderate	Damage: None	
pH:	7.35 units	Vegetation: None		
Temperature:	57 °F	Benthic Growth: Slight		
Conductivity:	470 µS/cm	Stains: None		
Detergents:	0 mg/L	Non-illicit: None

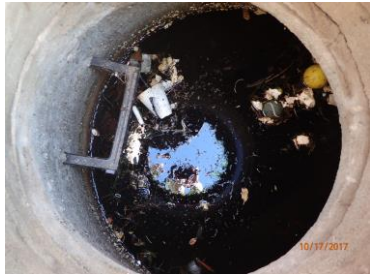
o20171017131930.JPG

Inspection Date: 10/17/2017 1:23:39 PM		Type: Ongoing	Flow: Submerged, indeterminate	Previous Rainfall (hrs): 48-72
Illicit Discharge Potential: Potential		Inspector: JCW	Notes	
Submerged: Fully		Depth (in): 35	Sample collected from submerged pool in manhole. Floating gross solids (litter) in manhole.	
Sampling Results		Floatables: None	Condition Assessment	
Sample Location:	Pool	Odor: None	Graffiti: None	
Total Chlorine:	0 ppm	Turbidity: None	Erosion: None	
Free Chlorine:	0 ppm	Color: None	Deposition: None in.	
Ammonia:	0 ppm	Gross Solids: Moderate	Damage: None	
pH:	7.47 units	Vegetation: None		
Temperature:	67 °F	Benthic Growth: None		
Conductivity:	581 µS/cm	Stains: None		
Detergents:	0 mg/L	Non-illicit: None

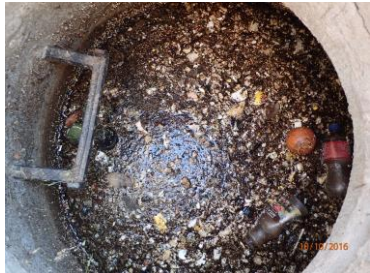
o20161010110444.JPG

Inspection Date: 10/10/2016 11:07:16 AM		Type: Ongoing	Flow: Submerged, indeterminate	Previous Rainfall (hrs): 72+
Illicit Discharge Potential: Potential		Inspector: JCW	Notes	
Submerged: Fully		Depth (in): 35	Potential illicit discharge due to gross solids.	
Sampling Results		Floatables: None	Condition Assessment	
Sample Location:	Pool	Odor: None	Graffiti: None	
Total Chlorine:	0 ppm	Turbidity: None	Erosion: None	
Free Chlorine:	0 ppm	Color: None	Deposition: None in.	
Ammonia:	0 ppm	Gross Solids: Severe	Damage: None	
pH:	7.63 units	Vegetation: None		
Temperature:	65 °F	Benthic Growth: None		
Conductivity:	514 µS/cm	Stains: None		
Detergents:	0 mg/L	Non-illicit: None

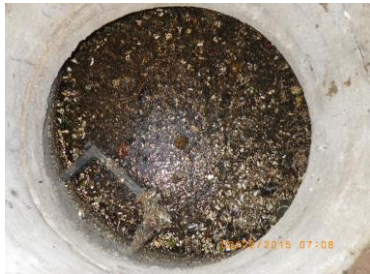
o20150922060832.JPG

Inspection Date: 9/22/2015 7:04:46 AM		Type: Ongoing	Flow: Submerged, indeterminate	Previous Rainfall (hrs): 72+
Illicit Discharge Potential: Potential		Inspector: JCW	Notes	
Submerged: Fully		Depth (in): 37	Floating gross solids (litter) in manhole.	
Sampling Results		Floatables: None	Condition Assessment	
Sample Location:	Pool	Odor: None	Graffiti: None	
Total Chlorine:	0 ppm	Turbidity: None	Erosion: None	
Free Chlorine:	0 ppm	Color: None	Deposition: None in.	
Ammonia:	0 ppm	Gross Solids: Moderate	Damage: None	
pH:	7.93 units	Vegetation: None		
Temperature:	65 °F	Benthic Growth: None		
Conductivity:	1055 µS/cm	Stains: None		
Detergents:	0 mg/L	Non-illicit: None

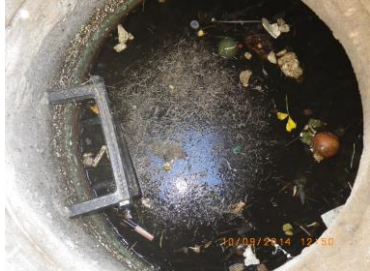
o20141009115024.JPG

Inspection Date: 10/9/2014 12:52:08 PM		Type: Ongoing	Flow: Submerged, indeterminate	Previous Rainfall (hrs): 72+
Illicit Discharge Potential: Potential		Inspector: JCW	Notes	
Submerged: Fully		Depth (in): 39	Floating gross solids (litter) in manhole.	
Sampling Results		Condition Assessment		
Sample Location: Pool	Floatables: None	Graffiti: None	Erosion: None	in.
Total Chlorine: 0 ppm	Odor: None	Deposition: None	Damage: None	
Free Chlorine: 0 ppm	Turbidity: Slight cloudiness			
Ammonia: 0 ppm	Color: None			
pH: 7.57 units	Gross Solids: Moderate			
Temperature 62 °F	Vegetation: None			
Conductivity: 548 µS/cm	Benthic Growth: Slight			
Detergents: 0 mg/L	Stains: None			
	Non-illicit: None

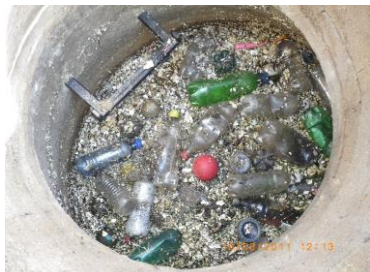
o20111003121302.JPG

Inspection Date: 10/3/2011 12:13:00 PM		Type: Ongoing	Flow: Submerged, indeterminate	Previous Rainfall (hrs): 72+
Illicit Discharge Potential: Potential		Inspector: JCW	Notes	
Submerged: Fully		Depth (in): 36	Significant floatable debris in manhole.	
Sampling Results		Condition Assessment		
Sample Location: Pool	Floatables: None	Graffiti: None	Erosion: None	0 in.
Total Chlorine: 0 ppm	Odor: None	Deposition: None	Damage: None	
Free Chlorine: 0 ppm	Turbidity: None			
Ammonia: 0 ppm	Color: None			
pH: 7.39 units	Gross Solids: Severe			
Temperature 67 °F	Vegetation: None			
Conductivity: -- µS/cm	Benthic Growth: None			
Detergents: 0 mg/L	Stains: None			
	Non-illicit: None

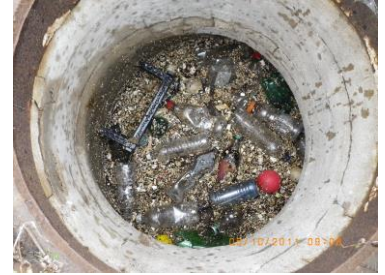
o20110510090830.JPG

Inspection Date: 5/10/2011 9:08:00 AM		Type: Other	Flow: Submerged, indeterminate	Previous Rainfall (hrs): 0-24
Illicit Discharge Potential: Potential		Inspector: JCW		Notes Limited screening conducted for upstream manhole prescreening.
Submerged: Fully		Depth (in):		
Sampling Results Sample Location: _____ Total Chlorine: -- ppm Free Chlorine: -- ppm Ammonia: -- ppm pH: -- units Temperature: -- °F Conductivity: -- µS/cm Detergents: -- mg/L		Floatables: None Odor: _____ Turbidity: _____ Color: _____ Gross Solids: Severe Vegetation: _____ Benthic Growth: _____ Stains: _____ Non-illicit: None		
		Condition Assessment Graffiti: None Erosion: None Deposition: None 0 in. Damage: None

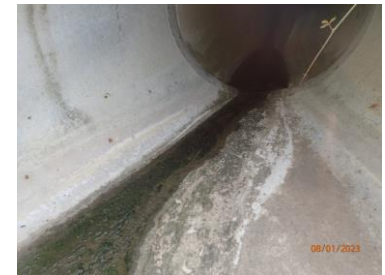
o20230801080412.JPG

Stains: Moderate

☐ Petrol. Sheen ☐ Suds ☐ Sewage ☐ Algae ☐ Other☐ Petroleum ☐ Musty ☐ Sewage ☐ Chlorine ☐ Other☐ VOC/Solvent ☐ Fishy ☐ Sulfur ☐ Fragrant☒ Litter ☐ Veg. Debris ☐ Sediment ☐ Other☐ Inhibited ☐ Excessive☒ Green ☐ Brown☒ Flow Line ☐ Oil ☐ Rust Stains☐ Paint ☐ Other☐ Natural Sheen ☐ Natural Suds/Foam

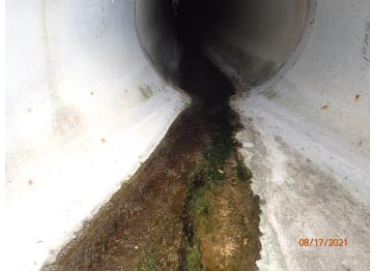
o20210817134750.JPG <div style="text-align: center; font-size: 24pt; font-weight: bold;">2021</div>
			Condition Assessment Graffiti: None Erosion: None Deposition: None in. Damage: None

Inspection Date: 8/17/2021 1:50:37 PM		Type: Ongoing	Flow: Trickle	Previous Rainfall (hrs): 72+
Illicit Discharge Potential: Unlikely		Inspector: JCW		
Submerged: None		Depth (in):		
Sampling Results Sample Location: Flow Total Chlorine: 0 ppm Free Chlorine: 0 ppm Ammonia: 0 ppm pH: 8.09 units Temperature: 78 °F Conductivity: 778 µS/cm Detergents: 0 mg/L		Floatables: None Odor: None Turbidity: None Color: None Gross Solids: None Vegetation: None Benthic Growth: Moderate Stains: Slight Non-illicit: None	Notes Sample collected from pipe flow.

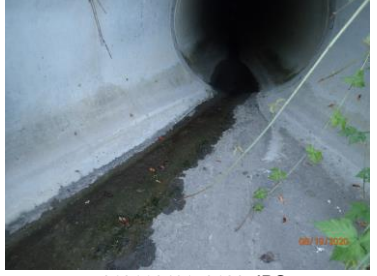
o20200819072022.JPG <div style="text-align: center; font-size: 24pt; font-weight: bold;">2020</div>
			Condition Assessment Graffiti: None Erosion: None Deposition: None in. Damage: None

Inspection Date: 8/19/2020 7:19:45 AM		Type: Ongoing	Flow: None	Previous Rainfall (hrs): 72+
Illicit Discharge Potential: Unlikely		Inspector: JCW		
Submerged: None		Depth (in):		
Sampling Results Sample Location: -- Total Chlorine: -- ppm Free Chlorine: -- ppm Ammonia: -- ppm pH: -- units Temperature: -- °F Conductivity: -- µS/cm Detergents: -- mg/L		Floatables: None Odor: None Turbidity: None Color: None Gross Solids: None Vegetation: None Benthic Growth: Slight Stains: None Non-illicit: None	Notes Pipe wet, but no collectable flow at time of inspection.

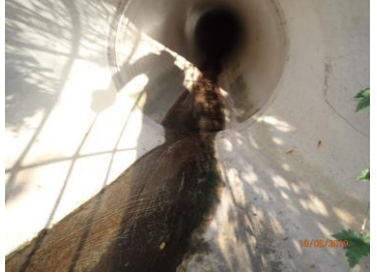
o20191008160300.JPG <div style="text-align: center; font-size: 24pt; font-weight: bold;">2019</div>
			Condition Assessment Graffiti: None Erosion: None Deposition: None in. Damage: None

Inspection Date: 10/8/2019 5:07:04 PM		Type: Ongoing	Flow: Moderate	Previous Rainfall (hrs): 48-72
Illicit Discharge Potential: Unlikely		Inspector: JCW		
Submerged: None		Depth (in):		
Sampling Results Sample Location: Flow Total Chlorine: 0 ppm Free Chlorine: 0 ppm Ammonia: 0 ppm pH: 8.16 units Temperature: 65 °F Conductivity: 1014 µS/cm Detergents: 0 mg/L		Floatables: None Odor: None Turbidity: None Color: None Gross Solids: None Vegetation: None Benthic Growth: Moderate Stains: None Non-illicit: Slight	Notes Outfall sampled from moderate flow.

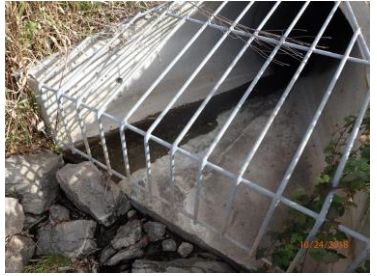
o20181024103144.JPG <div style="text-align: center; font-size: 24pt; font-weight: bold;">2018</div>
			Condition Assessment Graffiti: None Erosion: None Deposition: None in. Damage: None

Inspection Date: 10/24/2018 10:34:16 AM		Type: Ongoing	Flow: Trickle	Previous Rainfall (hrs): 72+
Illicit Discharge Potential: Potential		Inspector: JCW		
Submerged: None		Depth (in):		
Sampling Results Sample Location: Flow Total Chlorine: 0 ppm Free Chlorine: 0 ppm Ammonia: 0 ppm pH: 9.04 units Temperature: 50 °F Conductivity: 792 µS/cm Detergents: 0 mg/L		Floatables: None Odor: None Turbidity: None Color: None Gross Solids: None Vegetation: None Benthic Growth: Moderate Stains: Slight Non-illicit: None	Notes Elevated pH in sample from trickle flow. No flow in upstream curb inlet at time of inspection.

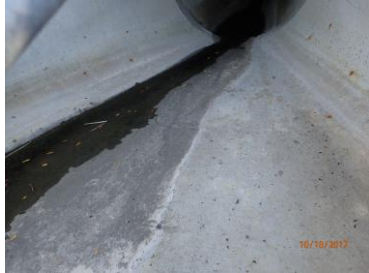
o20171018093128.JPG

Inspection Date: 10/18/2017 9:40:26 AM		Type: Ongoing	Flow: Trickle	Previous Rainfall (hrs): 72+
Illicit Discharge Potential: Potential		Inspector: JCW	Notes	
Submerged: None		Depth (in):	Elevated pH in sample from trickle flow. No flow in upstream curb inlet at time of inspection.	
Sampling Results		Floatables:	Condition Assessment Graffiti: None Erosion: None Deposition: None in. Damage: None	
Sample Location: Flow		Odor:		
Total Chlorine: 0 ppm		Turbidity:		
Free Chlorine: 0 ppm		Color:		
Ammonia: 0 ppm		Gross Solids:		
pH: 9.23 units		Vegetation:		
Temperature 65 °F		Benthic Growth:		
Conductivity: 1563 µS/cm		Stains:		
Detergents: 0 mg/L		Non-illicit:		
		None

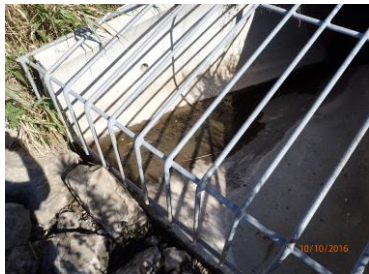
o20161010122036.JPG

Inspection Date: 10/10/2016 12:26:38 PM		Type: Ongoing	Flow: Trickle	Previous Rainfall (hrs): 72+
Illicit Discharge Potential: Potential		Inspector: JCW	Notes	
Submerged: None		Depth (in):	Elevated pH, but not as high as 2015 screening. Possible residual in upstream pipe.	
Sampling Results		Floatables:	Condition Assessment Graffiti: None Erosion: None Deposition: None in. Damage: None	
Sample Location: Flow		Odor:		
Total Chlorine: 0 ppm		Turbidity:		
Free Chlorine: 0 ppm		Color:		
Ammonia: 0 ppm		Gross Solids:		
pH: 9.45 units		Vegetation:		
Temperature 64 °F		Benthic Growth:		
Conductivity: 880 µS/cm		Stains:		
Detergents: 0 mg/L		Non-illicit:		
		None

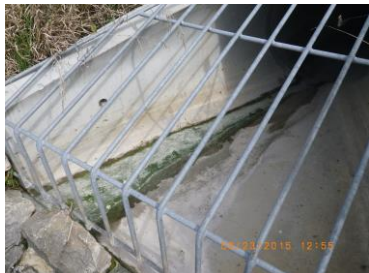
o20150923115508.JPG

Inspection Date: 9/23/2015 12:56:15 PM		Type: Ongoing	Flow: Trickle	Previous Rainfall (hrs): 72+
Illicit Discharge Potential: Obvious		Inspector: JCW	Notes	
Submerged: None		Depth (in):	White silty discharge. Chlorine patches turned yellow (not on scale). Elevated pH and conductivity.	
Sampling Results		Floatables:	Condition Assessment Graffiti: None Erosion: None Deposition: None in. Damage: None	
Sample Location: Flow		Odor:		
Total Chlorine: -- ppm		Turbidity:		
Free Chlorine: -- ppm		Color:		
Ammonia: 1 ppm		Gross Solids:		
pH: 11.66 units		Vegetation:		
Temperature 73 °F		Benthic Growth:		
Conductivity: 2470 µS/cm		Stains:		
Detergents: 0 mg/L		Non-illicit:		
		None

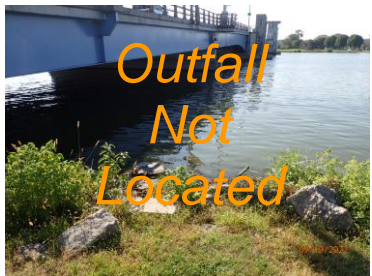
o20220919151702.JPG <div style="text-align: center; font-weight: bold; font-size: 1.2em;">2022</div>

Inspection Date: 9/19/2022 3:18:00 PM		Type: Ongoing	Flow: Submerged (not located)	Previous Rainfall (hrs): 72+
Illicit Discharge Potential: Unlikely		Inspector: EJK		
Submerged: Fully		Depth (in):		
Sampling Results Sample Location: _____ Total Chlorine: -- ppm Free Chlorine: -- ppm Ammonia: -- ppm pH: -- units Temperature: -- °F Conductivity: -- µS/cm Detergents: -- mg/L		Floatables: None Odor: None Turbidity: None Color: None Gross Solids: None Vegetation: None Benthic Growth: None Stains: None Non-illicit: None	Notes Outfall fully submerged and not located - screened upstream at 12-569 US1. Condition Assessment Graffiti: Moderate Erosion: None Deposition: None in. Damage: None

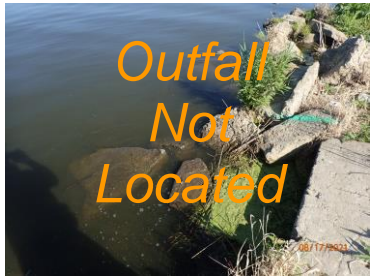
o20210817091208.JPG <div style="text-align: center; font-weight: bold; font-size: 1.2em;">2021</div>

Inspection Date: 8/17/2021 9:13:52 AM		Type: Ongoing	Flow: Submerged (not located)	Previous Rainfall (hrs): 72+
Illicit Discharge Potential: Unlikely		Inspector: JCW		
Submerged: Fully		Depth (in):		
Sampling Results Sample Location: _____ Total Chlorine: -- ppm Free Chlorine: -- ppm Ammonia: -- ppm pH: -- units Temperature: -- °F Conductivity: -- µS/cm Detergents: -- mg/L		Floatables: None Odor: None Turbidity: None Color: None Gross Solids: None Vegetation: None Benthic Growth: None Stains: None Non-illicit: None	Notes Outfall fully submerged and not located - screened upstream at 12-569 US1. Graffiti on nearby bridge abutment. Condition Assessment Graffiti: Moderate Erosion: None Deposition: None in. Damage: None

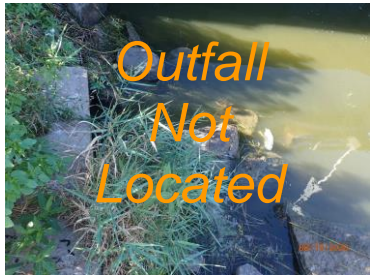
o20200819084114.JPG <div style="text-align: center; font-weight: bold; font-size: 1.2em;">2020</div>

Inspection Date: 8/19/2020 8:41:26 AM		Type: Ongoing	Flow: Submerged (not located)	Previous Rainfall (hrs): 72+
Illicit Discharge Potential: Unlikely		Inspector: JCW		
Submerged: Fully		Depth (in):		
Sampling Results Sample Location: _____ Total Chlorine: -- ppm Free Chlorine: -- ppm Ammonia: -- ppm pH: -- units Temperature: -- °F Conductivity: -- µS/cm Detergents: -- mg/L		Floatables: None Odor: None Turbidity: None Color: None Gross Solids: None Vegetation: None Benthic Growth: None Stains: None Non-illicit: None	Notes Outfall fully submerged and not physically located - screened upstream at 12-569 US1. Graffiti on bridge abutment. Condition Assessment Graffiti: Moderate Erosion: None Deposition: None in. Damage: None

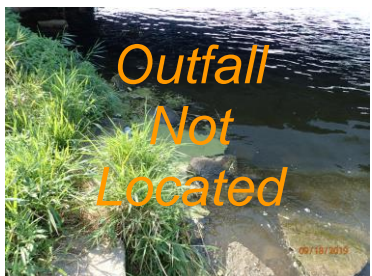
o20190918101816.JPG <div style="text-align: center; font-weight: bold; font-size: 1.2em;">2019</div>

Inspection Date: 9/18/2019 11:19:35 AM		Type: Ongoing	Flow: Submerged (not located)	Previous Rainfall (hrs): 72+
Illicit Discharge Potential: Potential		Inspector: JCW		
Submerged: Fully		Depth (in):		
Sampling Results Sample Location: _____ Total Chlorine: -- ppm Free Chlorine: -- ppm Ammonia: -- ppm pH: -- units Temperature: -- °F Conductivity: -- µS/cm Detergents: -- mg/L		Floatables: None Odor: None Turbidity: None Color: None Gross Solids: None Vegetation: None Benthic Growth: None Stains: None Non-illicit: None	Notes Outfall fully submerged and not located - screened upstream at 12-569 US1. Graffiti on nearby bridge abutment. Floating gross solids (litter) in MH. Condition Assessment Graffiti: Moderate Erosion: None Deposition: None in. Damage: None

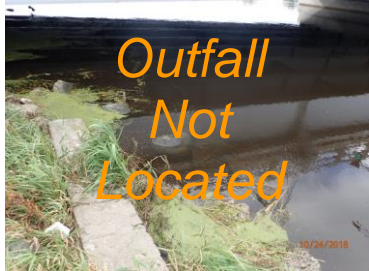
o20181024092154.JPG

Inspection Date: 10/24/2018 9:23:56 AM		Type: Ongoing	Flow: Submerged (not located)	Previous Rainfall (hrs): 72+
Illicit Discharge Potential: Potential		Inspector: JCW		
Submerged: Fully		Depth (in):		
Sampling Results		Notes		
Sample Location:	Floatables:	Outfall fully submerged and not located - screened upstream at 12-569 US1. Graffiti on nearby bridge abutment. Floating gross solids (litter) in MH.		
Total Chlorine: -- ppm	Odor:			
Free Chlorine: -- ppm	Turbidity:			
Ammonia: -- ppm	Color:			
pH: -- units	Gross Solids:			
Temperature -- °F	Vegetation:			
Conductivity: -- µS/cm	Benthic Growth:			
Detergents: -- mg/L	Stains:			
	Non-illicit:	Graffiti: Moderate Erosion: None Deposition: None in. Damage: None

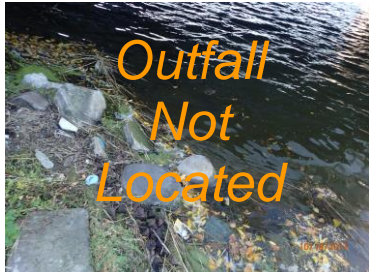
o20171018101412.JPG

Inspection Date: 10/18/2017 10:17:17 AM		Type: Ongoing	Flow: Submerged (not located)	Previous Rainfall (hrs): 72+
Illicit Discharge Potential: Potential		Inspector: JCW		
Submerged: Fully		Depth (in):		
Sampling Results		Notes		
Sample Location:	Floatables:	Outfall fully submerged and not located - screened upstream at 12-569 US1. Graffiti on nearby bridge abutment. Floating gross solids (litter) in MH.		
Total Chlorine: -- ppm	Odor:			
Free Chlorine: -- ppm	Turbidity:			
Ammonia: -- ppm	Color:			
pH: -- units	Gross Solids:			
Temperature -- °F	Vegetation:			
Conductivity: -- µS/cm	Benthic Growth:			
Detergents: -- mg/L	Stains:			
	Non-illicit:	Graffiti: Minor Erosion: None Deposition: None in. Damage: None

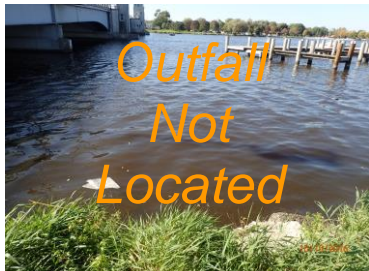
o20161010132600.JPG

Inspection Date: 10/10/2016 1:26:15 PM		Type: Ongoing	Flow: Submerged (not located)	Previous Rainfall (hrs): 72+
Illicit Discharge Potential: Potential		Inspector: JCW		
Submerged: Fully		Depth (in):		
Sampling Results		Notes		
Sample Location:	Floatables:	Graffiti on east bridge abutment. Outfall fully submerged and not located - screened upstream at 12-569 US1.		
Total Chlorine: -- ppm	Odor:			
Free Chlorine: -- ppm	Turbidity:			
Ammonia: -- ppm	Color:			
pH: -- units	Gross Solids:			
Temperature -- °F	Vegetation:			
Conductivity: -- µS/cm	Benthic Growth:			
Detergents: -- mg/L	Stains:			
	Non-illicit:	Graffiti: Minor Erosion: None Deposition: None in. Damage: None

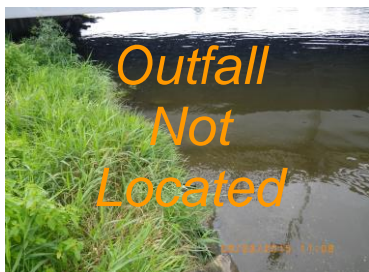
o20150923100828.JPG

Inspection Date: 9/23/2015 11:06:02 AM		Type: Ongoing	Flow: Submerged (not located)	Previous Rainfall (hrs): 72+
Illicit Discharge Potential: Potential		Inspector: JCW		
Submerged: Fully		Depth (in):		
Sampling Results		Notes		
Sample Location:	Floatables:	Outfall fully submerged and not located - screened at 12-569 US1.		
Total Chlorine: -- ppm	Odor:			
Free Chlorine: -- ppm	Turbidity:			
Ammonia: -- ppm	Color:			
pH: -- units	Gross Solids:			
Temperature -- °F	Vegetation:			
Conductivity: -- µS/cm	Benthic Growth:			
Detergents: -- mg/L	Stains:			
	Non-illicit:	Graffiti: Moderate Erosion: None Deposition: None in. Damage: None

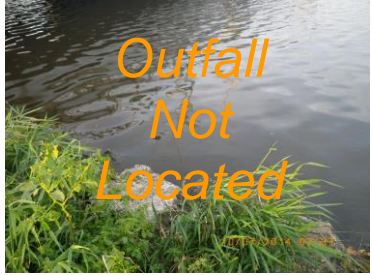
o20141007063712.JPG 2014

Sample Location:	Floatables:	None	Total Chlorine: -- ppm	Odor:	None	Free Chlorine: -- ppm	Turbidity:	None	Ammonia: -- ppm	Color:	None	pH: -- units	Gross Solids:	None	Temperature -- °F	Vegetation:	None	Conductivity: -- µS/cm	Benthic Growth:	None	Detergents: -- mg/L	Stains:	None		Non-illicit:	None	Notes Outfall fully submerged and not located - screened upstream at 12-569 US1. Graffiti on east abutment.		
Sample Location:	Floatables:	None																													
Total Chlorine: -- ppm	Odor:	None																													
Free Chlorine: -- ppm	Turbidity:	None																													
Ammonia: -- ppm	Color:	None																													
pH: -- units	Gross Solids:	None																													
Temperature -- °F	Vegetation:	None																													
Conductivity: -- µS/cm	Benthic Growth:	None																													
Detergents: -- mg/L	Stains:	None																													
	Non-illicit:	None																													
		Condition Assessment Graffiti: Moderate Erosion: None Deposition: None in. Damage: None

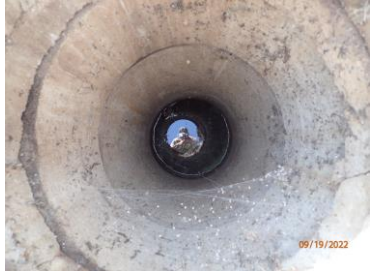
o20220919152124.JPG 2022

Sample Location:	Pool																																					
Total Chlorine:	0 ppm																																					
Free Chlorine:	0 ppm																																					
Ammonia:	0 ppm																																					
pH:	7.5 units																																					
Temperature:	75 °F																																					
Conductivity:	484 µS/cm																																					
Detergents:	0 mg/L																																					
Floatables:	None																																					
Odor:	None																																					
Turbidity:	None																																					
Color:	None																																					
Gross Solids:	Slight																																					
Vegetation:	None																																					
Benthic Growth:	None																																					
Stains:	None																																					
Non-illicit:	None

Notes Sample collected from submerged pool in manhole.																																				
		Condition Assessment <table border="1" style="width:100%; border-collapse: collapse;"> <tr><td>Graffiti:</td><td>None</td></tr> <tr><td>Erosion:</td><td>None</td></tr> <tr><td>Deposition:</td><td>None in.</td></tr> <tr><td>Damage:</td><td>None</td></tr> </table>			Graffiti:	None	Erosion:	None	Deposition:	None in.	Damage:	None																										
Graffiti:	None																																					
Erosion:	None																																					
Deposition:	None in.																																					
Damage:	None

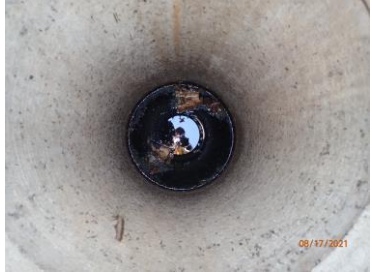
o20210817091344.JPG 2021

Sample Location:	Pool																																					
Total Chlorine:	0 ppm																																					
Free Chlorine:	0 ppm																																					
Ammonia:	0 ppm																																					
pH:	7.15 units																																					
Temperature:	77 °F																																					
Conductivity:	454 µS/cm																																					
Detergents:	0 mg/L																																					
Floatables:	None																																					
Odor:	None																																					
Turbidity:	None																																					
Color:	None																																					
Gross Solids:	Moderate																																					
Vegetation:	None																																					
Benthic Growth:	None																																					
Stains:	None																																					
Non-illicit:	None

Notes Sample collected from submerged pool in manhole.																																				
		Condition Assessment <table border="1" style="width:100%; border-collapse: collapse;"> <tr><td>Graffiti:</td><td>None</td></tr> <tr><td>Erosion:</td><td>None</td></tr> <tr><td>Deposition:</td><td>None in.</td></tr> <tr><td>Damage:</td><td>None</td></tr> </table>			Graffiti:	None	Erosion:	None	Deposition:	None in.	Damage:	None																										
Graffiti:	None																																					
Erosion:	None																																					
Deposition:	None in.																																					
Damage:	None

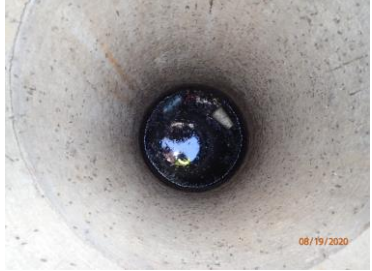
o20200819084220.JPG 2020

Notes Sample collected from submerged pool in manhole. Floating gross solids (litter) in manhole.																																				
		Condition Assessment <table border="1" style="width:100%; border-collapse: collapse;"> <tr><td>Graffiti:</td><td>None</td></tr> <tr><td>Erosion:</td><td>None</td></tr> <tr><td>Deposition:</td><td>None in.</td></tr> <tr><td>Damage:</td><td>None</td></tr> </table>			Graffiti:	None	Erosion:	None	Deposition:	None in.	Damage:	None																										
Graffiti:	None																																					
Erosion:	None																																					
Deposition:	None in.																																					
Damage:	None

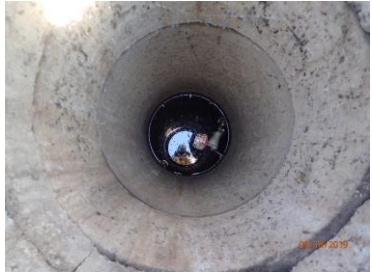
o20190918101948.JPG 2019

Notes Sample collected from submerged pool in manhole. Floating gross solids (litter) in manhole.																																				
		Condition Assessment <table border="1" style="width:100%; border-collapse: collapse;"> <tr><td>Graffiti:</td><td>None</td></tr> <tr><td>Erosion:</td><td>None</td></tr> <tr><td>Deposition:</td><td>None in.</td></tr> <tr><td>Damage:</td><td>None</td></tr> </table>			Graffiti:	None	Erosion:	None	Deposition:	None in.	Damage:	None																										
Graffiti:	None																																					
Erosion:	None																																					
Deposition:	None in.																																					
Damage:	None

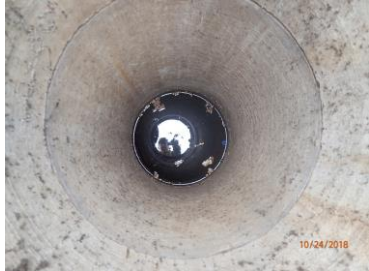
<p style="text-align: right; font-size: small;">10/24/2018</p> <p style="text-align: center;">o20181024092322.JPG</p> <p style="text-align: center; font-size: large; font-weight: bold;">2018</p>	
Submerged: Fully		Depth (in): 44		Sample collected from submerged pool in manhole. Floating gross solids (litter) in manhole.			
Sampling Results				Condition Assessment			
Sample Location: Pool		Floatables: None		Graffiti: None			
Total Chlorine: 0 ppm		Odor: None		Erosion: None			
Free Chlorine: 0 ppm		Turbidity: None		Deposition: None in.			
Ammonia: 0 ppm		Color: None		Damage: None			
pH: 7.4 units		Gross Solids: Slight					
Temperature 52 °F		Vegetation: None					
Conductivity: 714 µS/cm		Benthic Growth: None					
Detergents: 0 mg/L		Stains: None

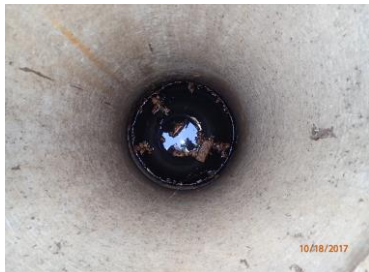
<p style="text-align: right; font-size: small;">10/18/2017</p> <p style="text-align: center;">o20171018101542.JPG</p> <p style="text-align: center; font-size: large; font-weight: bold;">2017</p>	
Submerged: Fully		Depth (in): 39		Sample collected from submerged pool in manhole. Floating gross solids (litter) in manhole.			
Sampling Results				Condition Assessment			
Sample Location: Pool		Floatables: None		Graffiti: None			
Total Chlorine: 0 ppm		Odor: None		Erosion: None			
Free Chlorine: 0 ppm		Turbidity: None		Deposition: None in.			
Ammonia: 0 ppm		Color: None		Damage: None			
pH: 7.44 units		Gross Solids: Moderate					
Temperature 65 °F		Vegetation: None					
Conductivity: 1118 µS/cm		Benthic Growth: None

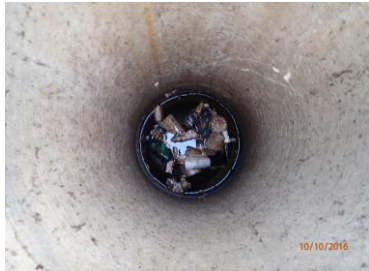
<p style="text-align: right; font-size: small;">10/10/2016</p> <p style="text-align: center;">o20161010132718.JPG</p> <p style="text-align: center; font-size: large; font-weight: bold;">2016</p>	
Submerged: Fully		Depth (in): 38		Potential illicit discharge due to gross solids.			
Sampling Results				Condition Assessment			
Sample Location: Pool		Floatables: None		Graffiti: None			
Total Chlorine: 0 ppm		Odor: None		Erosion: None			
Free Chlorine: 0 ppm		Turbidity: Slight cloudiness		Deposition: None in.			
Ammonia: 0 ppm		Color: Clearly visible in bottl		Damage: None			
pH: 7.41 units		Gross Solids: Moderate					
Temperature 69 °F		Vegetation: None					
Conductivity: 616 µS/cm		Benthic Growth: None					
Detergents: 0 mg/L		Stains: None

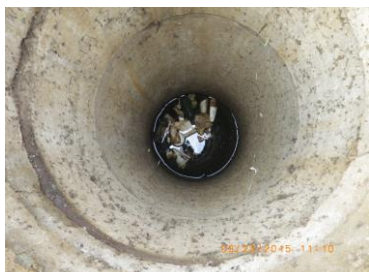
<p style="text-align: right; font-size: small;">09/23/2015 - 11:10</p> <p style="text-align: center;">o20150923101026.JPG</p> <p style="text-align: center; font-size: large; font-weight: bold;">2015</p>	
Submerged: Fully		Depth (in): 40		Floating gross solids (litter) in manhole.			
Sampling Results				Condition Assessment			
Sample Location: Pool		Floatables: None		Graffiti: None			
Total Chlorine: 0 ppm		Odor: None		Erosion: None			
Free Chlorine: 0 ppm		Turbidity: None		Deposition: None in.			
Ammonia: 0 ppm		Color: None		Damage: None			
pH: 7.5 units		Gross Solids: Moderate					
Temperature 76 °F		Vegetation: None					
Conductivity: 441 µS/cm		Benthic Growth: Slight					
Detergents: 0 mg/L		Stains: None					
		Non-illicit: None

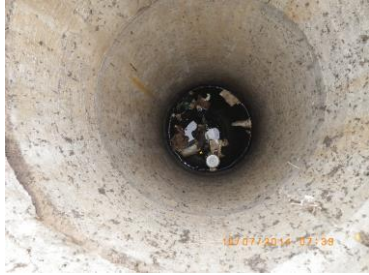
Inspection Date: 10/7/2014 7:39:34 AM		Type: Ongoing	Flow: Submerged, indeterminate	Previous Rainfall (hrs): 48-72
Illicit Discharge Potential: Potential		Inspector: JCW	Notes Floating gross solids (litter) in manhole.	
Submerged: Fully		Depth (in): 34

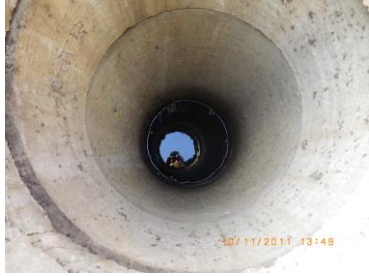
Inspection Date: 10/11/2011 1:51:24 PM		Type: Ongoing	Flow: Submerged, indeterminate	Previous Rainfall (hrs): 72+
Illicit Discharge Potential: Unlikely		Inspector: JCW	Notes 2010 screening follow-up. Floatable debris significantly reduced.	
Submerged: Fully		Depth (in): 32

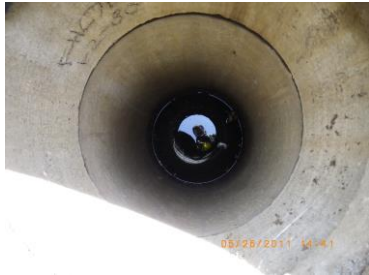
Inspection Date: 5/26/2011 2:40:00 PM		Type: Other	Flow: Submerged, indeterminate	Previous Rainfall (hrs): 72+
Illicit Discharge Potential: Unlikely		Inspector: JCW	Notes Limited screening conducted to check for floatable debris.	
Submerged: Fully		Depth (in):

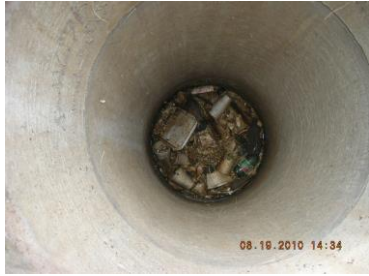
Inspection Date: 8/19/2010 2:41:43 PM		Type: Ongoing	Flow: Submerged, indeterminate	Previous Rainfall (hrs): 72+
Illicit Discharge Potential: Potential		Inspector: JCW	Notes Severe floatable debris	
Submerged: Fully		Depth (in): 38

o20100819143434.JPG <div style="text-align: center; font-weight: bold; font-size: 1.2em;">2010</div>	
Sampling Results				
Sample Location: Pool	Floatables:	None		
Total Chlorine: 0 ppm	Odor:	None		
Free Chlorine: 0 ppm	Turbidity:	None		
Ammonia: 0 ppm	Color:	Faint in bottle		
pH: 7.59 units	Gross Solids:	Severe		
Temperature 79 °F	Vegetation:	None		
Conductivity: -- µS/cm	Benthic Growth:	None		
Detergents: 0 mg/L	Stains:	Slight		
	Non-illicit:	None	Condition Assessment Graffiti: None Erosion: None Deposition: None 0 in. Damage: None

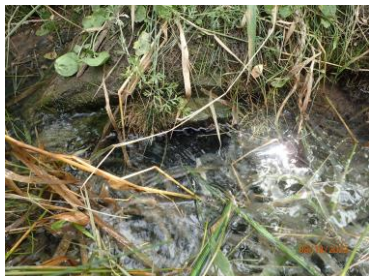
Inspection Date: 8/18/2022 2:17:00 PM		Type: Ongoing		Flow: Submerged, slight flow		Previous Rainfall (hrs): 72+	
Illicit Discharge Potential: Obvious		Inspector: EJK		Notes Sample collected from submerged flow at end of pipe. Elevated ammonia. Tracking revealed sanitary cross connection.

o20220818140940.JPG	
Submerged: Fully		Depth (in): 6					
Sampling Results Sample Location: Flow Total Chlorine: 0 ppm Free Chlorine: 0 ppm Ammonia: 3 ppm pH: 7.15 units Temperature: 80 °F Conductivity: 1805 µS/cm Detergents: 0 mg/L		Floatables: None Odor: Easily detected Turbidity: None Color: None Gross Solids: None Vegetation: None Benthic Growth: Severe Stains: None Non-illicit: None		Condition Assessment Graffiti: None Erosion: None Deposition: Moderate 18 in. Damage: None		<div style="text-align: center; font-size: 24pt; font-weight: bold;">2022</div>

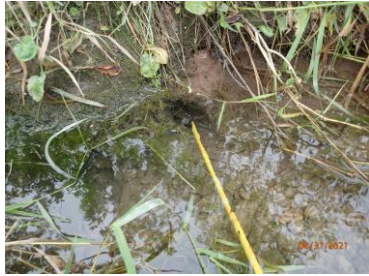
Inspection Date: 8/31/2021 7:49:46 AM		Type: Ongoing		Flow: Submerged, significant flow		Previous Rainfall (hrs): 48-72	
Illicit Discharge Potential: Unlikely		Inspector: JCW		Notes Sample collected from concentrated flow immediately downstream of pipe.

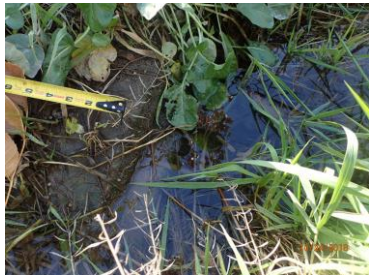
Inspection Date: 10/24/2018 3:06:28 PM		Type: Ongoing		Flow: Submerged, slight flow		Previous Rainfall (hrs): 72+	
Illicit Discharge Potential: Unlikely		Inspector: JCW		Notes Outfall partially submerged - screened upstream at 13-1098 US1.

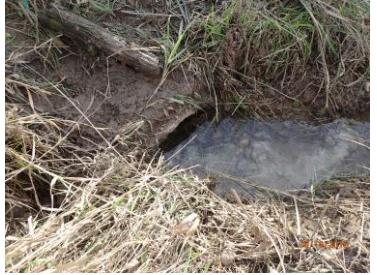
o20161019150326.JPG

Inspection Date: 10/19/2016 3:04:11 PM	Type: Ongoing	Flow: Submerged, slight flow	Previous Rainfall (hrs): 72+
Illicit Discharge Potential: Unlikely	Inspector: JCW	Notes	
Submerged: Partially	Depth (in): 22	Outfall partially submerged - screened upstream at 13-1098 US1. End of pipe recently excavated.	
Sampling Results		Condition Assessment	
Sample Location:	Floatables:	Graftiti: None	
Total Chlorine: -- ppm	Odor:	Erosion: None	
Free Chlorine: -- ppm	Turbidity:	Deposition: Severe 16 in.	
Ammonia: -- ppm	Color:	Damage: None	
pH: -- units	Gross Solids:		
Temperature -- °F	Vegetation:		
Conductivity: -- µS/cm	Benthic Growth:		
Detergents: -- mg/L	Stains:		
	Non-illicit:

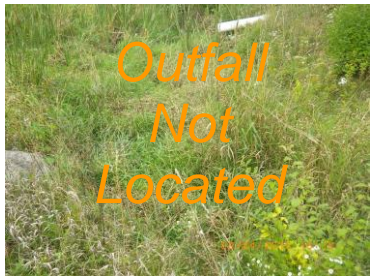
o20150924141536.JPG

Inspection Date: 9/24/2015 3:10:53 PM	Type: Ongoing	Flow: Submerged (not located)	Previous Rainfall (hrs): 72+
Illicit Discharge Potential: Unlikely	Inspector: JCW	Notes	
Submerged: None	Depth (in):	Outfall not located - screened at 13-1098 US1.	
Sampling Results		Condition Assessment	
Sample Location:	Floatables:	Graftiti: None	
Total Chlorine: -- ppm	Odor:	Erosion: None	
Free Chlorine: -- ppm	Turbidity:	Deposition: None in.	
Ammonia: -- ppm	Color:	Damage: None	
pH: -- units	Gross Solids:		
Temperature -- °F	Vegetation:		
Conductivity: -- µS/cm	Benthic Growth:		
Detergents: -- mg/L	Stains:		
	Non-illicit:

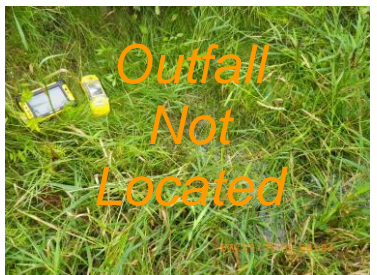
o20130730070410.JPG

Inspection Date: 7/30/2013 7:57:44 AM	Type: Ongoing	Flow: Submerged (not located)	Previous Rainfall (hrs): 72+
Illicit Discharge Potential: Unlikely	Inspector: JCW	Notes	
Submerged: Fully	Depth (in):	Pipe not located in grassy stream bank. Screened upstream at 13-1098 US1.	
Sampling Results		Condition Assessment	
Sample Location:	Floatables:	Graftiti: None	
Total Chlorine: -- ppm	Odor:	Erosion: None	
Free Chlorine: -- ppm	Turbidity:	Deposition: None in.	
Ammonia: -- ppm	Color:	Damage: None	
pH: -- units	Gross Solids:		
Temperature -- °F	Vegetation:		
Conductivity: -- µS/cm	Benthic Growth:		
Detergents: -- mg/L	Stains:		
	Non-illicit:

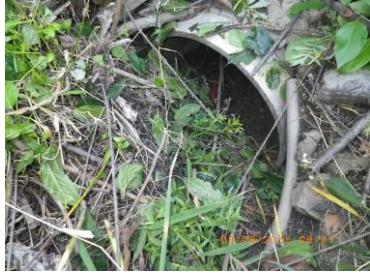
o20150928072150.JPG <div style="text-align: center; font-size: 24pt; font-weight: bold;">2015</div>

Notes Flowline damp, but no flow at time of inspection. Sediment level with crown of pipe.																																				
		Condition Assessment <table border="1" style="width: 100%; border-collapse: collapse;"> <tr> <td>Graffiti:</td> <td>None</td> </tr> <tr> <td>Erosion:</td> <td>None</td> </tr> <tr> <td>Deposition:</td> <td>Severe 18 in.</td> </tr> <tr> <td>Damage:</td> <td>None</td> </tr> </table>			Graffiti:	None	Erosion:	None	Deposition:	Severe 18 in.	Damage:	None																										
Graffiti:	None																																					
Erosion:	None																																					
Deposition:	Severe 18 in.																																					
Damage:	None

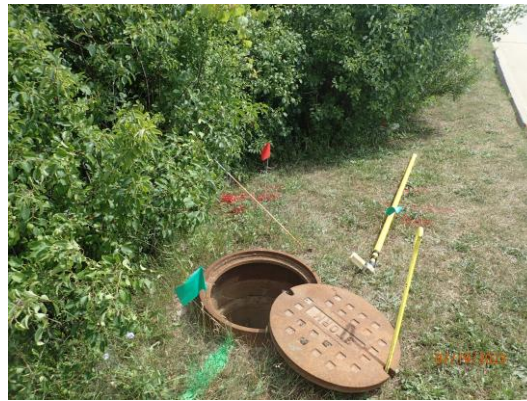
o20230719133554.JPG

Upstream manhole located approx 17 ft NNW of outfall 13-1766. Intermediate area consists of brush-covered right-of-way.

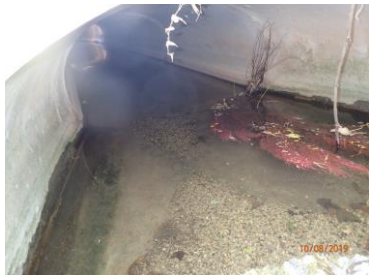
o20191008140758.jpg

Inspection Date: 10/8/2019 3:09:23 PM		Type: Ongoing	Flow: Submerged, indeterminate	Previous Rainfall (hrs): 48-72
Illicit Discharge Potential: Potential		Inspector: JCW	Notes	
Submerged: Partially Depth (in): 19			Outfall partially submerged - screened upstream at 13-2332 US1. Detergent detected in upstream manhole.	
Sampling Results			Condition Assessment	
Sample Location:	Floatables:	None	Graffiti: None Erosion: None Deposition: None in. Damage: None	
Total Chlorine: -- ppm	Odor:	None		
Free Chlorine: -- ppm	Turbidity:	None		
Ammonia: -- ppm	Color:	None		
pH: -- units	Gross Solids:	None		
Temperature -- °F	Vegetation:	None		
Conductivity: -- µS/cm	Benthic Growth:	Slight		
Detergents: -- mg/L	Stains:	None		
	Non-illicit:	Slight

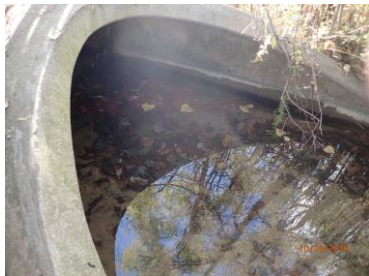
o20181024151710.JPG

Inspection Date: 10/24/2018 3:19:11 PM		Type: Ongoing	Flow: Submerged, slight flow	Previous Rainfall (hrs): 72+
Illicit Discharge Potential: Potential		Inspector: JCW	Notes	
Submerged: Partially Depth (in): 11			Outfall partially submerged - screened upstream at 13-2332 US1. Detergent detected in upstream manhole.	
Sampling Results			Condition Assessment	
Sample Location:	Floatables:	None	Graffiti: None Erosion: None Deposition: None in. Damage: None	
Total Chlorine: -- ppm	Odor:	Faint		
Free Chlorine: -- ppm	Turbidity:	None		
Ammonia: -- ppm	Color:	None		
pH: -- units	Gross Solids:	Moderate		
Temperature -- °F	Vegetation:	None		
Conductivity: -- µS/cm	Benthic Growth:	Slight		
Detergents: -- mg/L	Stains:	Moderate		
	Non-illicit:	None

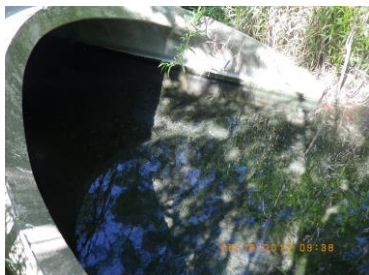
o20120612083850.JPG

Inspection Date: 6/12/2012 9:35:59 AM		Type: Ongoing	Flow: Submerged, slight flow	Previous Rainfall (hrs): 72+
Illicit Discharge Potential: Unlikely		Inspector: JCW	Notes	
Submerged: Partially Depth (in): 14			Outfall partially submerged; screened upstream at 13-2332 US1.	
Sampling Results			Condition Assessment	
Sample Location:	Floatables:	None	Graffiti: None Erosion: None Deposition: None in. Damage: None	
Total Chlorine: -- ppm	Odor:	None		
Free Chlorine: -- ppm	Turbidity:	None		
Ammonia: -- ppm	Color:	None		
pH: -- units	Gross Solids:	Slight		
Temperature -- °F	Vegetation:	None		
Conductivity: -- µS/cm	Benthic Growth:	Moderate		
Detergents: -- mg/L	Stains:	None		
	Non-illicit:	None

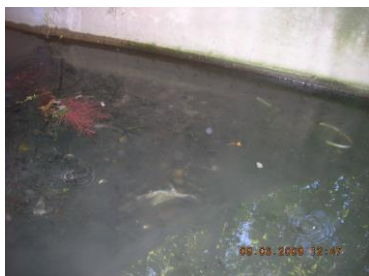
Osh09_DSCN6437.JPG

Inspection Date: 9/3/2009		Type: Initial	Flow: Submerged, slight flow	Previous Rainfall (hrs): 72+
Illicit Discharge Potential: Unlikely		Inspector: JCW	Notes	
Submerged: Partially Depth (in): 15				
Sampling Results			Condition Assessment	
Sample Location:	Floatables:	None	Graffiti: None Erosion: None Deposition: 8 in. Damage: None	
Total Chlorine: -- ppm	Odor:	Faint		
Free Chlorine: -- ppm	Turbidity:	None		
Ammonia: -- ppm	Color:	None		
pH: -- units	Gross Solids:	None		
Temperature -- °F	Vegetation:			
Conductivity: -- µS/cm	Benthic Growth:	Slight		
Detergents: -- mg/L	Stains:			
	Non-illicit:	None

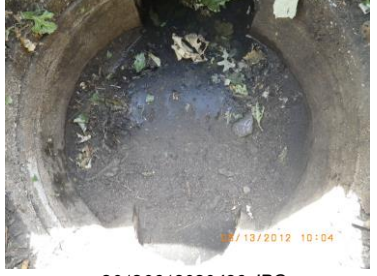
o20120613090436.JPG <div style="text-align: center; font-size: 24pt; font-weight: bold;">2012</div>

Inspection Date: 6/13/2012 10:02:18 AM		Type: Other	Flow: Submerged, indeterminate	Previous Rainfall (hrs): 72+
Illicit Discharge Potential: Potential		Inspector: JCW		
Submerged: Partially		Depth (in): 5		
Sampling Results Sample Location: Pool Total Chlorine: 0 ppm Free Chlorine: 0 ppm Ammonia: 1 ppm pH: 7.3 units Temperature: 74 °F Conductivity: 1429 µS/cm Detergents: 0 mg/L		Floatables: None Odor: None Turbidity: Cloudy Color: None Gross Solids: Moderate Vegetation: None Benthic Growth: None Stains: None Non-illicit: None	Notes Gross solids pre-screen. Condition Assessment Graffiti: None Erosion: None Deposition: Moderate 2 in. Damage: None

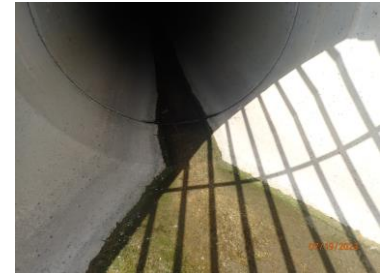
o20230719131124.JPG

Stains: Slight

☐ Petrol. Sheen ☐ Suds ☐ Sewage ☒ Algae ☐ Other☐ Petroleum ☐ Musty ☐ Sewage ☐ Chlorine ☐ Other☐ VOC/Solvent ☐ Fishy ☐ Sulfur ☐ Fragrant☐ Litter ☐ Veg. Debris ☐ Sediment ☐ Other☐ Inhibited ☐ Excessive☒ Green ☐ Brown☒ Flow Line ☐ Oil ☐ Rust Stains☐ Paint ☐ Other☐ Natural Sheen ☐ Natural Suds/Foam

Damage: Minor ☒ Displacement ☐ Undercut ☐ Crushed☐ Corrosion ☐ Cracks/Structural Damage

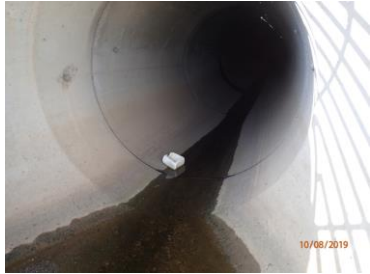
o20191008145924.JPG <div style="text-align: center; font-size: 24pt; font-weight: bold;">2019</div>

Inspection Date: 10/8/2019 4:01:14 PM		Type: Ongoing	Flow: Moderate	Previous Rainfall (hrs): 48-72
Illicit Discharge Potential: Potential		Inspector: JCW		
Submerged: None		Depth (in):		
Sampling Results Sample Location: Flow Total Chlorine: 0 ppm Free Chlorine: 0 ppm Ammonia: 0 ppm pH: 7.66 units Temperature: 65 °F Conductivity: 2470 µS/cm Detergents: 0 mg/L		Floatables: None Odor: None Turbidity: None Color: None Gross Solids: None Vegetation: None Benthic Growth: Moderate Stains: None Non-illicit: None	Notes Sample collected from submerged flow at end of pipe. Elevated conductivity. Condition Assessment Graffiti: None Erosion: None Deposition: None in. Damage: None

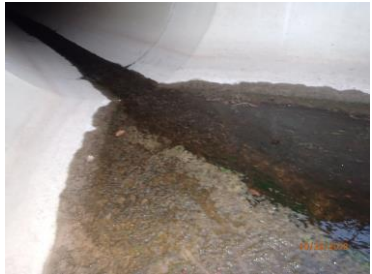
o20181025072226.JPG <div style="text-align: center; font-size: 24pt; font-weight: bold;">2018</div>

Inspection Date: 10/25/2018 7:24:13 AM		Type: Ongoing	Flow: Trickle	Previous Rainfall (hrs): 72+
Illicit Discharge Potential: Potential		Inspector: JCW		<div style="border: 1px solid black; padding: 5px;"> Notes Sample collected from submerged flow at end of pipe. Detergent detected. </div> <div style="border: 1px solid black; padding: 5px; margin-top: 10px;"> Condition Assessment Graffiti: None Erosion: None Deposition: None in. Damage: None </div>
Submerged: None		Depth (in):		
Sampling Results Sample Location: Flow Total Chlorine: 0 ppm Free Chlorine: 0 ppm Ammonia: 0 ppm pH: 7.94 units Temperature: 49 °F Conductivity: 1865 µS/cm Detergents: 0.45 mg/L		Floatables: Slight Odor: None Turbidity: None Color: None Gross Solids: None Vegetation: None Benthic Growth: Moderate Stains: Slight Non-illicit: None

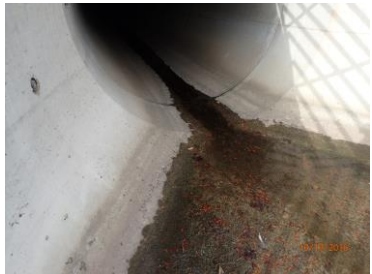
o20161019151808.JPG <div style="text-align: center; font-size: 24pt; font-weight: bold;">2016</div>

Inspection Date: 10/19/2016 3:20:01 PM		Type: Ongoing	Flow: Trickle	Previous Rainfall (hrs): 72+
Illicit Discharge Potential: Unlikely		Inspector: JCW		<div style="border: 1px solid black; padding: 5px;"> Notes </div> <div style="border: 1px solid black; padding: 5px; margin-top: 10px;"> Condition Assessment Graffiti: None Erosion: None Deposition: None in. Damage: None </div>
Submerged: None		Depth (in):		
Sampling Results Sample Location: Flow Total Chlorine: 0 ppm Free Chlorine: 0 ppm Ammonia: 0 ppm pH: 8.07 units Temperature: 66 °F Conductivity: 1396 µS/cm Detergents: 0 mg/L		Floatables: None Odor: None Turbidity: None Color: None Gross Solids: Slight Vegetation: None Benthic Growth: Moderate Stains: Slight Non-illicit: None
