IDDE Ongoing Screening Summary Report

2023 Inspection Year

Westwood

City of Oshkosh

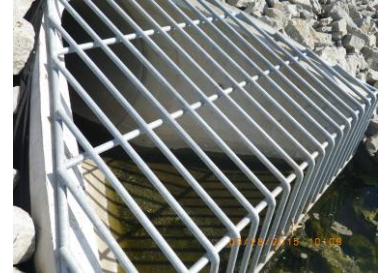
o20150928090940.JPG

Inspection Date: 9/28/2015 10:08:12 AM		Type: Ongoing	Flow: Moderate	Previous Rainfall (hrs): 72+																		
Illicit Discharge Potential: Unlikely		Inspector: JCW																				
Submerged: None		Depth (in):																				
Sampling Results <table border="1" style="width: 100%; border-collapse: collapse;"> <tr> <td style="width: 50%;">Sample Location: Flow</td> <td style="width: 50%;">Floatables: Slight</td> </tr> <tr> <td>Total Chlorine: 0 ppm</td> <td>Odor: None</td> </tr> <tr> <td>Free Chlorine: 0 ppm</td> <td>Turbidity: None</td> </tr> <tr> <td>Ammonia: 0 ppm</td> <td>Color: None</td> </tr> <tr> <td>pH: 8.07 units</td> <td>Gross Solids: None</td> </tr> <tr> <td>Temperature: 70 °F</td> <td>Vegetation: None</td> </tr> <tr> <td>Conductivity: 455 µS/cm</td> <td>Benthic Growth: Moderate</td> </tr> <tr> <td>Detergents: 0 mg/L</td> <td>Stains: Slight</td> </tr> <tr> <td></td> <td>Non-illicit: None</td> </tr> </table>		Sample Location: Flow	Floatables: Slight	Total Chlorine: 0 ppm	Odor: None	Free Chlorine: 0 ppm	Turbidity: None	Ammonia: 0 ppm	Color: None	pH: 8.07 units	Gross Solids: None	Temperature: 70 °F	Vegetation: None	Conductivity: 455 µS/cm	Benthic Growth: Moderate	Detergents: 0 mg/L	Stains: Slight		Non-illicit: None	Notes <div style="border: 1px solid black; height: 80px; width: 100%;"></div>

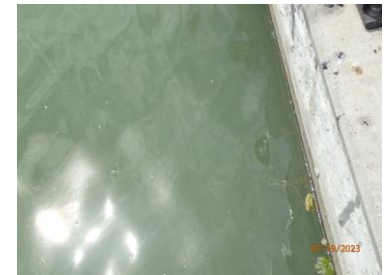
o20230719110252.JPG

Inspection Date: 7/19/2023 12:19:01 PM

Damage: None

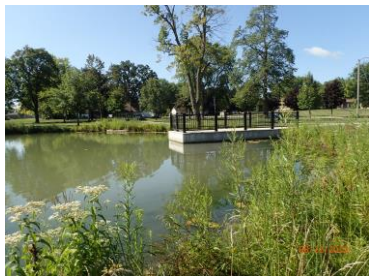
Inspection Date: 8/22/2022 10:20:00 AM		Type: Ongoing	Flow: Submerged, indeterminate	Previous Rainfall (hrs): 72+
Illicit Discharge Potential: Unlikely		Inspector: EJK		
Submerged: Fully		Depth (in):		
Sampling Results Sample Location: _____ Total Chlorine: -- ppm Free Chlorine: -- ppm Ammonia: -- ppm pH: -- units Temperature: -- °F Conductivity: -- µS/cm Detergents: -- mg/L		Floatables: None Odor: None Turbidity: None Color: None Gross Solids: None Vegetation: None Benthic Growth: None Stains: None Non-illicit: None	Notes Outfall fully submerged - screened upstream at 13-4012 US1.

o20220822101316.JPG <div style="text-align: center; font-size: 24pt; font-weight: bold;">2022</div>
			Condition Assessment Graffiti: None Erosion: None Deposition: None in. Damage: None

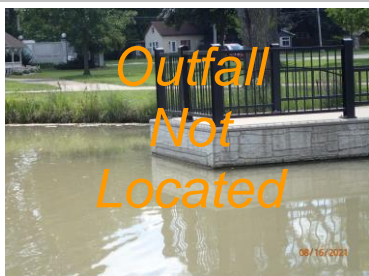
Inspection Date: 8/16/2021 1:47:39 PM		Type: Ongoing	Flow: Submerged (not located)	Previous Rainfall (hrs): 72+
Illicit Discharge Potential: Unlikely		Inspector: JCW		
Submerged: Fully		Depth (in):		
Sampling Results Sample Location: _____ Total Chlorine: -- ppm Free Chlorine: -- ppm Ammonia: -- ppm pH: -- units Temperature: -- °F Conductivity: -- µS/cm Detergents: -- mg/L		Floatables: None Odor: None Turbidity: None Color: None Gross Solids: None Vegetation: None Benthic Growth: None Stains: None Non-illicit: None	Notes Outfall fully submerged and not located - screened upstream at 13-4012 US1.

o20210816134612.JPG <div style="text-align: center; font-size: 24pt; font-weight: bold;">2021</div>
			Condition Assessment Graffiti: None Erosion: None Deposition: None in. Damage: None

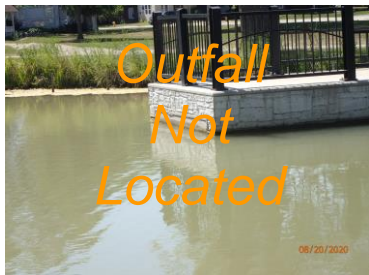
Inspection Date: 8/20/2020 12:23:12 PM		Type: Ongoing	Flow: Submerged (not located)	Previous Rainfall (hrs): 72+
Illicit Discharge Potential: Unlikely		Inspector: JCW		
Submerged: Fully		Depth (in):		
Sampling Results Sample Location: _____ Total Chlorine: -- ppm Free Chlorine: -- ppm Ammonia: -- ppm pH: -- units Temperature: -- °F Conductivity: -- µS/cm Detergents: -- mg/L		Floatables: None Odor: None Turbidity: None Color: None Gross Solids: None Vegetation: None Benthic Growth: None Stains: None Non-illicit: None	Notes Outfall fully submerged and not located - screened upstream at 13-2957 US1.

o20200820122132.JPG <div style="text-align: center; font-size: 24pt; font-weight: bold;">2020</div>
			Condition Assessment Graffiti: None Erosion: None Deposition: None in. Damage: None

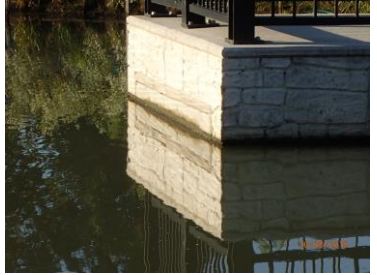
o20191008071216.JPG

Inspection Date: 10/8/2019 8:14:46 AM		Type: Repeat	Flow: Submerged, indeterminate	Previous Rainfall (hrs): 48-72
Illicit Discharge Potential: Unlikely		Inspector: JCW	Notes	
Submerged: Fully		Depth (in):	Detergent detection follow-up. Limited screening conducted beyond sampling. No detergent in follow-up sample.	
Sampling Results		Floatables:	Condition Assessment	
Sample Location:		None	Graffiti: None	
Total Chlorine: -- ppm		Odor: None	Erosion: None	
Free Chlorine: -- ppm		Turbidity: None	Deposition: None in.	
Ammonia: -- ppm		Color: None	Damage: None	
pH: -- units		Gross Solids: None		
Temperature -- °F		Vegetation: None		
Conductivity: -- µS/cm		Benthic Growth: None		
Detergents: -- mg/L		Stains: None		
		Non-illicit: None

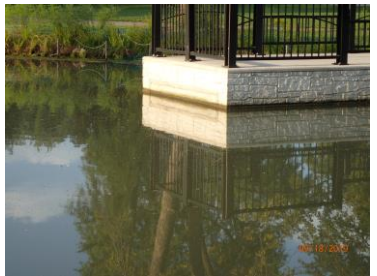
o20190918063134.JPG

Inspection Date: 9/18/2019 7:32:53 AM		Type: Ongoing	Flow: Submerged, indeterminate	Previous Rainfall (hrs): 72+
Illicit Discharge Potential: Potential		Inspector: JCW	Notes	
Submerged: Fully		Depth (in):	Outfall inaccessible - screened upstream at 13-2957 US1a. Detergent in upstream manhole.	
Sampling Results		Floatables:	Condition Assessment	
Sample Location:		None	Graffiti: None	
Total Chlorine: -- ppm		Odor: None	Erosion: None	
Free Chlorine: -- ppm		Turbidity: None	Deposition: None in.	
Ammonia: -- ppm		Color: None	Damage: None	
pH: -- units		Gross Solids: None		
Temperature -- °F		Vegetation: None		
Conductivity: -- µS/cm		Benthic Growth: None		
Detergents: -- mg/L		Stains: None		
		Non-illicit: None

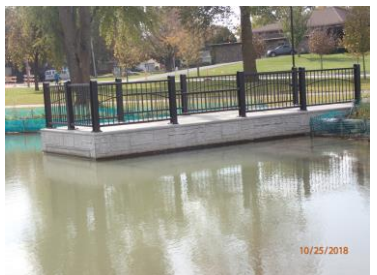
o20181025131742.JPG

Inspection Date: 10/25/2018 1:17:00 PM		Type: Ongoing	Flow: Submerged, indeterminate	Previous Rainfall (hrs): 72+
Illicit Discharge Potential: Unlikely		Inspector: JCW	Notes	
Submerged: Partially		Depth (in):	Outfall inaccessible - screened upstream at 13-2957 US1a.	
Sampling Results		Floatables:	Condition Assessment	
Sample Location:		None	Graffiti: None	
Total Chlorine: -- ppm		Odor: None	Erosion: None	
Free Chlorine: -- ppm		Turbidity: None	Deposition: None in.	
Ammonia: -- ppm		Color: None	Damage: None	
pH: -- units		Gross Solids: None		
Temperature -- °F		Vegetation: None		
Conductivity: -- µS/cm		Benthic Growth: None		
Detergents: -- mg/L		Stains: None		
		Non-illicit: None

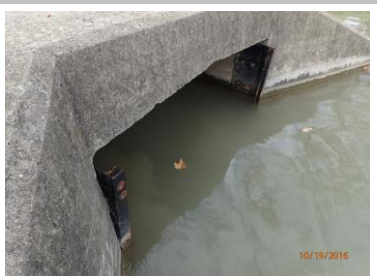
o20161019134018.JPG

Inspection Date: 10/19/2016 1:42:21 PM		Type: Ongoing	Flow: Submerged, indeterminate	Previous Rainfall (hrs): 72+
Illicit Discharge Potential: Unlikely		Inspector: JCW	Notes	
Submerged: Partially		Depth (in): 19	Outfall partially submerged - screened upstream at 13-2957 US1.	
Sampling Results		Floatables:	Condition Assessment	
Sample Location:		None	Graffiti: None	
Total Chlorine: -- ppm		Odor: None	Erosion: None	
Free Chlorine: -- ppm		Turbidity: Cloudy	Deposition: None in.	
Ammonia: -- ppm		Color: None	Damage: None	
pH: -- units		Gross Solids: None		
Temperature -- °F		Vegetation: None		
Conductivity: -- µS/cm		Benthic Growth: Moderate		
Detergents: -- mg/L		Stains: Moderate		
		Non-illicit: None

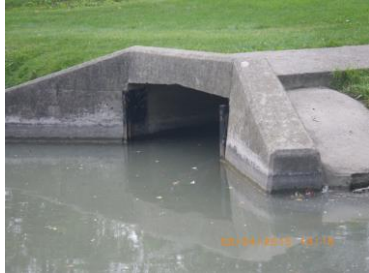
o20150924121536.JPG
2015

Inspection Date: 9/24/2015 1:12:45 PM		Type: Ongoing	Flow: Submerged, indeterminate	Previous Rainfall (hrs): 72+																									
Illicit Discharge Potential: Unlikely		Inspector: JCW	Notes Outfall partially submerged - screened at 13-2957 US1.																										
Submerged: Partially Depth (in): 17																													
Sampling Results <table border="1" style="width:100%; border-collapse: collapse;"> <tr> <td style="width:50%;">Sample Location:</td> <td style="width:50%;">Floatables:</td> </tr> <tr> <td>Total Chlorine: -- ppm</td> <td>Odor:</td> </tr> <tr> <td>Free Chlorine: -- ppm</td> <td>Turbidity:</td> </tr> <tr> <td>Ammonia: -- ppm</td> <td>Color:</td> </tr> <tr> <td>pH: -- units</td> <td>Gross Solids:</td> </tr> <tr> <td>Temperature -- °F</td> <td>Vegetation:</td> </tr> <tr> <td>Conductivity: -- µS/cm</td> <td>Benthic Growth:</td> </tr> <tr> <td>Detergents: -- mg/L</td> <td>Stains:</td> </tr> <tr> <td></td> <td>Non-illicit:</td> </tr> </table>		Sample Location:	Floatables:	Total Chlorine: -- ppm	Odor:	Free Chlorine: -- ppm	Turbidity:	Ammonia: -- ppm	Color:	pH: -- units	Gross Solids:	Temperature -- °F	Vegetation:	Conductivity: -- µS/cm	Benthic Growth:	Detergents: -- mg/L	Stains:		Non-illicit:	Condition Assessment <table border="1" style="width:100%; border-collapse: collapse;"> <tr> <td style="width:50%;">Graffiti: None</td> <td style="width:50%;"></td> </tr> <tr> <td>Erosion: None</td> <td></td> </tr> <tr> <td>Deposition: None</td> <td>in.</td> </tr> <tr> <td>Damage: None</td> <td></td> </tr> </table>		Graffiti: None		Erosion: None		Deposition: None	in.	Damage: None

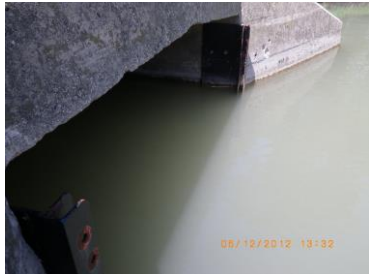
o20120612123258.JPG
2012

Inspection Date: 6/12/2012 1:30:43 PM		Type: Ongoing	Flow: Submerged, indeterminate	Previous Rainfall (hrs): 72+																									
Illicit Discharge Potential: Unlikely		Inspector: JCW	Notes Outfall partially submerged; screened upstream at 13-2957 US1.																										
Submerged: Partially Depth (in): 21																													
Sampling Results <table border="1" style="width:100%; border-collapse: collapse;"> <tr> <td style="width:50%;">Sample Location:</td> <td style="width:50%;">Floatables:</td> </tr> <tr> <td>Total Chlorine: -- ppm</td> <td>Odor:</td> </tr> <tr> <td>Free Chlorine: -- ppm</td> <td>Turbidity:</td> </tr> <tr> <td>Ammonia: -- ppm</td> <td>Color:</td> </tr> <tr> <td>pH: -- units</td> <td>Gross Solids:</td> </tr> <tr> <td>Temperature -- °F</td> <td>Vegetation:</td> </tr> <tr> <td>Conductivity: -- µS/cm</td> <td>Benthic Growth:</td> </tr> <tr> <td>Detergents: -- mg/L</td> <td>Stains:</td> </tr> <tr> <td></td> <td>Non-illicit:</td> </tr> </table>		Sample Location:	Floatables:	Total Chlorine: -- ppm	Odor:	Free Chlorine: -- ppm	Turbidity:	Ammonia: -- ppm	Color:	pH: -- units	Gross Solids:	Temperature -- °F	Vegetation:	Conductivity: -- µS/cm	Benthic Growth:	Detergents: -- mg/L	Stains:		Non-illicit:	Condition Assessment <table border="1" style="width:100%; border-collapse: collapse;"> <tr> <td style="width:50%;">Graffiti: Minor</td> <td style="width:50%;"></td> </tr> <tr> <td>Erosion: None</td> <td></td> </tr> <tr> <td>Deposition: None</td> <td>in.</td> </tr> <tr> <td>Damage: None</td> <td></td> </tr> </table>		Graffiti: Minor		Erosion: None		Deposition: None	in.	Damage: None

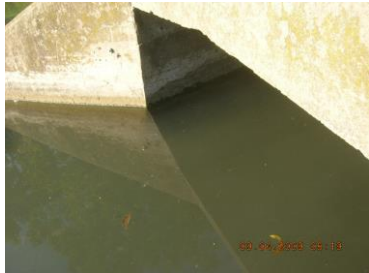
Osh09_DSCN6483.JPG
2009

Inspection Date: 9/4/2009		Type: Initial	Flow: Submerged, slight flow	Previous Rainfall (hrs): 72+																									
Illicit Discharge Potential: Unlikely		Inspector: JCW	Notes 																										
Submerged: None Depth (in): 16																													
Sampling Results <table border="1" style="width:100%; border-collapse: collapse;"> <tr> <td style="width:50%;">Sample Location:</td> <td style="width:50%;">Floatables:</td> </tr> <tr> <td>Total Chlorine: -- ppm</td> <td>Odor:</td> </tr> <tr> <td>Free Chlorine: -- ppm</td> <td>Turbidity:</td> </tr> <tr> <td>Ammonia: -- ppm</td> <td>Color:</td> </tr> <tr> <td>pH: -- units</td> <td>Gross Solids:</td> </tr> <tr> <td>Temperature -- °F</td> <td>Vegetation:</td> </tr> <tr> <td>Conductivity: -- µS/cm</td> <td>Benthic Growth:</td> </tr> <tr> <td>Detergents: -- mg/L</td> <td>Stains:</td> </tr> <tr> <td></td> <td>Non-illicit:</td> </tr> </table>		Sample Location:	Floatables:	Total Chlorine: -- ppm	Odor:	Free Chlorine: -- ppm	Turbidity:	Ammonia: -- ppm	Color:	pH: -- units	Gross Solids:	Temperature -- °F	Vegetation:	Conductivity: -- µS/cm	Benthic Growth:	Detergents: -- mg/L	Stains:		Non-illicit:	Condition Assessment <table border="1" style="width:100%; border-collapse: collapse;"> <tr> <td style="width:50%;">Graffiti: None</td> <td style="width:50%;"></td> </tr> <tr> <td>Erosion: None</td> <td></td> </tr> <tr> <td>Deposition: None</td> <td>0 in.</td> </tr> <tr> <td>Damage: None</td> <td></td> </tr> </table>		Graffiti: None		Erosion: None		Deposition: None	0 in.	Damage: None

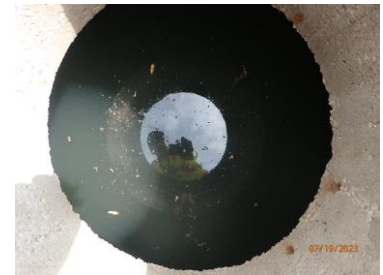
o20230719110556.JPG

**Inspection Date:** 7/19/2023 12:22:45 PM**Inspector:** JCW**Inspection Type:** Ongoing**Previous Rainfall (hrs):** 72+**Flow Description:** Submerged, indeterminate

Illicit Discharge Potential: Unlikely**Notes:** Sample collected from submerged pool in manhole.**Floatables:** None**Odor:** None**Turbidity:** Slight cloudiness**Color:** None**Gross Solids:** None**Vegetation:** None**Benthic Growth:** None**Stains:** None**Non-illicit:** None☐ Petrol. Sheen ☐ Suds ☐ Sewage ☐ Algae ☐ Other☐ Petroleum ☐ Musty ☐ Sewage ☐ Chlorine ☐ Other☐ VOC/Solvent ☐ Fishy ☐ Sulfur ☐ Fragrant☐ Litter ☐ Veg. Debris ☐ Sediment ☐ Other☐ Inhibited ☐ Excessive☐ Green ☐ Brown☐ Flow Line ☐ Oil ☐ Rust Stains☐ Paint ☐ Other☐ Natural Sheen ☐ Natural Suds/Foam**Physical Condition Assessment****Graffiti:** None**Erosion:** None**Deposition:** None **Depth (in):****Damage:** None ☐ Displacement ☐ Undercut ☐ Crushed☐ Corrosion ☐ Cracks/Structural Damage

2023**Sampling Results****Sample Location:** Pool**Sample ID:** 230719-15**Time Collected:** 12:15**Total Chlorine (field):** 0 ppm**Free Chlorine (field):** 0 ppm**Ammonia (field):** 0 ppm**pH (field):** 7.67 units**Temperature (field):** 80 °F**Conductivity (field):** 1476 µS/cm**Detergents:** 0 mg/L

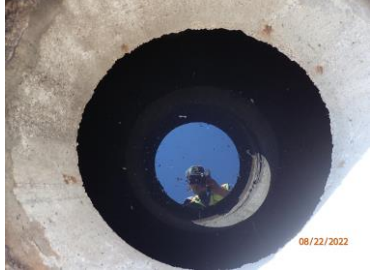
Inspection Date: 8/22/2022 10:21:00 AM		Type: Ongoing	Flow: Submerged, indeterminate	Previous Rainfall (hrs): 72+
Illicit Discharge Potential: Unlikely Submerged: Fully Depth (in):		Inspector: EJK	Notes

o20220822101526.JPG 2022
Sampling Results Sample Location: Pool Total Chlorine: 0 ppm Free Chlorine: 0 ppm Ammonia: 0 ppm pH: 7.58 units Temperature: 71 °F Conductivity: 1231 µS/cm Detergents: 0 mg/L		Floatables: None Odor: None Turbidity: None Color: None Gross Solids: None Vegetation: None Benthic Growth: None Stains: None Non-illicit: None	Sample collected from submerged pool in manhole. Condition Assessment Graffiti: None Erosion: None Deposition: None in. Damage: None	
Inspection Date: 8/16/2021 1:50:23 PM		Type: Ongoing	Flow: Submerged, indeterminate	Previous Rainfall (hrs): 72+
Illicit Discharge Potential: Unlikely Submerged: Fully Depth (in): 72		Inspector: JCW	Notes

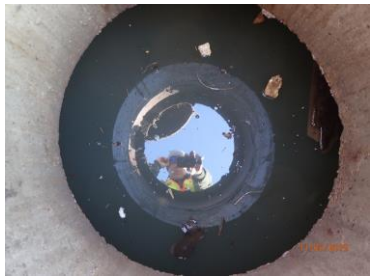
Inspection Date: 11/5/2019 1:33:38 PM		Type: Repeat	Flow: Submerged, indeterminate	Previous Rainfall (hrs): 48-72
Illicit Discharge Potential: Potential Submerged: Partially Depth (in): 71		Inspector: JCW	Notes

o20191105133254.JPG 2019
Sampling Results Sample Location: Pool Total Chlorine: -- ppm Free Chlorine: -- ppm Ammonia: -- ppm pH: -- units Temperature: -- °F Conductivity: -- µS/cm Detergents: 0.6 mg/L		Floatables: None Odor: None Turbidity: None Color: None Gross Solids: None Vegetation: None Benthic Growth: None Stains: None Non-illicit: None	Follow-up inspection for sampling - limited screening conducted. Detergent in follow-up sample. Condition Assessment Graffiti: None Erosion: None Deposition: None in. Damage: None

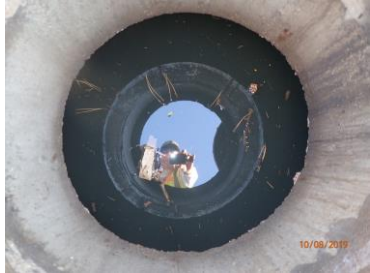
o20191008071514.JPG

Inspection Date: 10/8/2019 8:16:29 AM		Type: Repeat	Flow: Submerged, indeterminate	Previous Rainfall (hrs): 48-72
Illicit Discharge Potential: Unlikely		Inspector: JCW	Notes	
Submerged: Partially Depth (in): 72			Detergent detection follow-up. Limited screening conducted beyond sampling. No detergent in follow-up sample.	
Sampling Results		Floatables:	Condition Assessment	
Sample Location: Flow		Odor: None	Graffiti: None	
Total Chlorine: 0 ppm		Turbidity: None	Erosion: None	
Free Chlorine: 0 ppm		Color: None	Deposition: None in.	
Ammonia: 0 ppm		Gross Solids: Slight	Damage: None	
pH: 7.65 units		Vegetation: None		
Temperature 55 °F		Benthic Growth: None		
Conductivity: 1354 µS/cm		Stains: None		
Detergents: 0 mg/L		Non-illicit: None

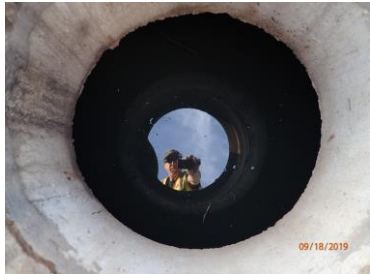
o20190918063424.JPG

Inspection Date: 9/18/2019 7:36:33 AM		Type: Ongoing	Flow: Submerged, indeterminate	Previous Rainfall (hrs): 72+
Illicit Discharge Potential: Potential		Inspector: JCW	Notes	
Submerged: Fully Depth (in): 71			Sample collected from submerged pool in manhole. Detergent detected in sample.	
Sampling Results		Floatables:	Condition Assessment	
Sample Location: Pool		Odor: None	Graffiti: None	
Total Chlorine: 0 ppm		Turbidity: None	Erosion: None	
Free Chlorine: 0 ppm		Color: None	Deposition: None in.	
Ammonia: 0 ppm		Gross Solids: None	Damage: None	
pH: 7.9 units		Vegetation: None		
Temperature 70 °F		Benthic Growth: None		
Conductivity: 1265 µS/cm		Stains: None		
Detergents: 0.75 mg/L		Non-illicit: None

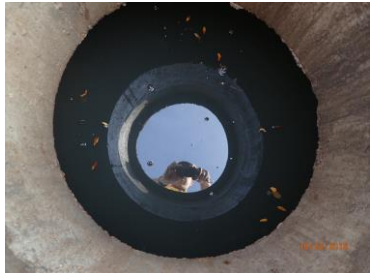
o20181025131952.JPG

Inspection Date: 10/25/2018 1:21:51 PM		Type: Ongoing	Flow: Submerged, indeterminate	Previous Rainfall (hrs): 72+
Illicit Discharge Potential: Unlikely		Inspector: JCW	Notes	
Submerged: Fully Depth (in): 72			Sample collected from submerged pool in manhole.	
Sampling Results		Floatables:	Condition Assessment	
Sample Location: Pool		Odor: None	Graffiti: None	
Total Chlorine: 0 ppm		Turbidity: None	Erosion: None	
Free Chlorine: 0 ppm		Color: None	Deposition: None in.	
Ammonia: 0 ppm		Gross Solids: None	Damage: None	
pH: 7.81 units		Vegetation: None		
Temperature 56 °F		Benthic Growth: None		
Conductivity: 1178 µS/cm		Stains: None		
Detergents: 0 mg/L		Non-illicit: None

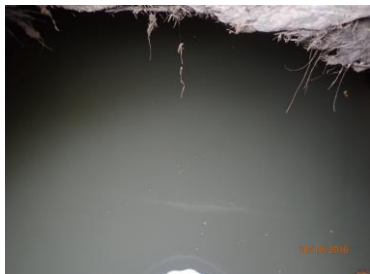
o20161019134250_1.JPG

Inspection Date: 10/19/2016 1:45:38 PM		Type: Ongoing	Flow: Submerged, slight flow	Previous Rainfall (hrs): 72+
Illicit Discharge Potential: Unlikely		Inspector: JCW	Notes	
Submerged: Partially Depth (in): 22			Screened at old location (13-2957 US1).	
Sampling Results		Floatables:	Condition Assessment	
Sample Location: Flow		Odor: None	Graffiti: None	
Total Chlorine: 0 ppm		Turbidity: Slight cloudiness	Erosion: None	
Free Chlorine: 0 ppm		Color: None	Deposition: None in.	
Ammonia: 0 ppm		Gross Solids: None	Damage: None	
pH: 7.98 units		Vegetation: None		
Temperature 65 °F		Benthic Growth: None		
Conductivity: 1234 µS/cm		Stains: None		
Detergents: 0 mg/L		Non-illicit: None

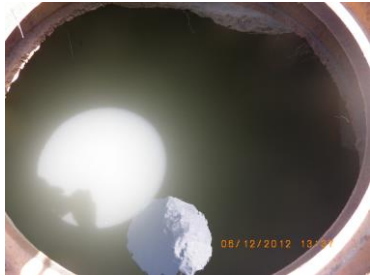
Sample Location:	Pool																																					
Total Chlorine:	0 ppm																																					
Free Chlorine:	0 ppm																																					
Ammonia:	0 ppm																																					
pH:	8.35 units																																					
Temperature:	71 °F																																					
Conductivity:	1336 µS/cm																																					
Detergents:	0 mg/L																																					
Floatables:	None																																					
Odor:	None																																					
Turbidity:	Slight cloudiness																																					
Color:	None																																					
Gross Solids:	None																																					
Vegetation:	None																																					
Benthic Growth:	None																																					
Stains:	None																																					
Non-illicit:	None

<p>Notes</p> <p>Screened at old location (13-2957 US1).</p>

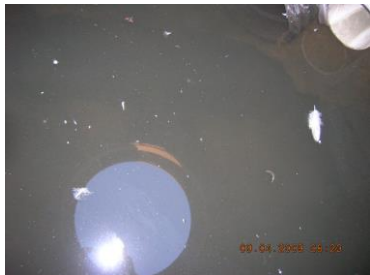
Sample Location:	Pool																																					
Total Chlorine:	0 ppm																																					
Free Chlorine:	0 ppm																																					
Ammonia:	-- ppm																																					
pH:	8.1 units																																					
Temperature:	66 °F																																					
Conductivity:	-- µS/cm																																					
Detergents:	0 mg/L																																					
Floatables:	None																																					
Odor:	None																																					
Turbidity:	None																																					
Color:	None																																					
Gross Solids:	None																																					
Vegetation:																																						
Benthic Growth:																																						
Stains:																																						
Non-illicit:	None																																					
		<p>Notes</p> <p>Screened at old location (13-2957 US1).</p>

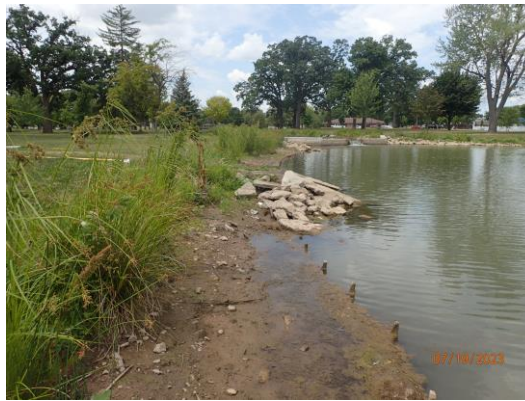
o20230719112856.JPG

Storm sewer from W South Park Ave discharges to South Park Pond from south. Replaces outfall 13-4025 (2017).

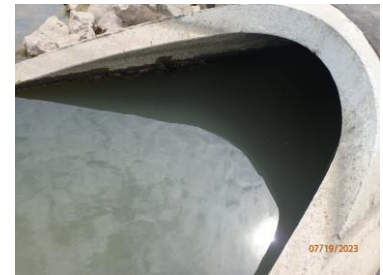
o20230719113004.JPG

Stains: Moderate

☐ Petrol. Sheen ☐ Suds ☐ Sewage ☐ Algae ☐ Other☐ Petroleum ☐ Musty ☐ Sewage ☐ Chlorine ☐ Other☐ VOC/Solvent ☐ Fishy ☐ Sulfur ☐ Fragrant☐ Litter ☐ Veg. Debris ☐ Sediment ☐ Other☐ Inhibited ☐ Excessive☒ Green ☐ Brown☒ Flow Line ☐ Oil ☐ Rust Stains☐ Paint ☐ Other☐ Natural Sheen ☐ Natural Suds/Foam

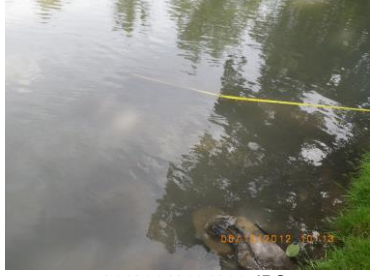
<p>o20120613091306.JPG</p> <p>2012</p>

Sample Location:																																		
Total Chlorine:	-- ppm																																	
Free Chlorine:	-- ppm																																	
Ammonia:	-- ppm																																	
pH:	-- units																																	
Temperature:	-- °F																																	
Conductivity:	-- µS/cm																																	
Detergents:	-- mg/L																																	
Notes																																		
Outfall pipes fully submerged; screened upstream at 13-819 US1.																																		
Condition Assessment																																		
Graffiti:	None																																	
Erosion:	None																																	
Deposition:	None in.																																	
Damage:	None

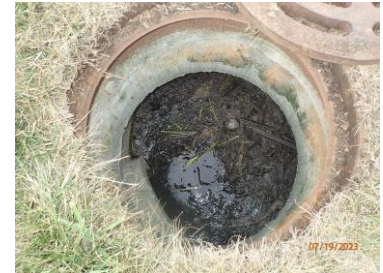
o20230719114136.JPG

☐ Petrol. Sheen ☐ Suds ☐ Sewage ☐ Algae ☐ Other☐ Petroleum ☐ Musty ☐ Sewage ☐ Chlorine ☐ Other☐ VOC/Solvent ☐ Fishy ☐ Sulfur ☐ Fragrant☒ Litter ☒ Veg. Debris ☐ Sediment ☐ Other☐ Inhibited ☐ Excessive☒ Green ☐ Brown☐ Flow Line ☐ Oil ☐ Rust Stains☐ Paint ☐ Other☐ Natural Sheen ☐ Natural Suds/Foam

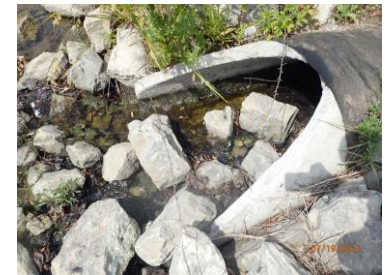
o20230719111324.JPG

Stains: Slight

☐ Petrol. Sheen ☐ Suds ☐ Sewage ☐ Algae ☐ Other☐ Petroleum ☐ Musty ☐ Sewage ☐ Chlorine ☐ Other☐ VOC/Solvent ☐ Fishy ☐ Sulfur ☐ Fragrant☐ Litter ☐ Veg. Debris ☐ Sediment ☐ Other☐ Inhibited ☐ Excessive☒ Green ☐ Brown☒ Flow Line ☐ Oil ☐ Rust Stains☐ Paint ☐ Other☐ Natural Sheen ☐ Natural Suds/Foam

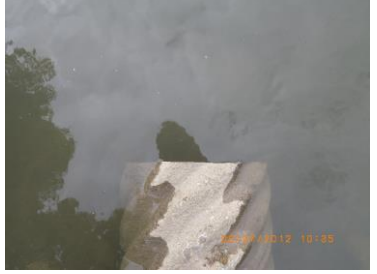
o20120927093556.JPG <div style="text-align: center; font-size: 24pt; font-weight: bold;">2012</div>

Inspection Date: 9/27/2012 10:31:48 AM		Type: Ongoing	Flow: Submerged, indeterminate	Previous Rainfall (hrs): 72+
Illicit Discharge Potential: Unlikely		Inspector: JCW		
Submerged: Partially		Depth (in): 11		
Sampling Results Sample Location: Total Chlorine: -- ppm Free Chlorine: -- ppm Ammonia: -- ppm pH: -- units Temperature: -- °F Conductivity: -- µS/cm Detergents: -- mg/L		Floatables: None Odor: None Turbidity: None Color: None Gross Solids: None Vegetation: None Benthic Growth: None Stains: None Non-illicit: None	Notes Condition Assessment Graffiti: None Erosion: None Deposition: None in. Damage: None

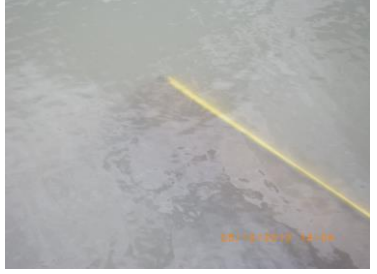
o20120612120442.JPG <div style="text-align: center; font-size: 24pt; font-weight: bold;">2012</div>

Inspection Date: 6/12/2012 1:04:23 PM		Type: Other	Flow: Submerged, indeterminate	Previous Rainfall (hrs): 72+
Illicit Discharge Potential: Unlikely		Inspector: JCW		
Submerged: Fully		Depth (in): 13		
Sampling Results Sample Location: Total Chlorine: -- ppm Free Chlorine: -- ppm Ammonia: -- ppm pH: -- units Temperature: -- °F Conductivity: -- µS/cm Detergents: -- mg/L		Floatables: None Odor: None Turbidity: None Color: None Gross Solids: None Vegetation: None Benthic Growth: None Stains: None Non-illicit: None	Notes Gross solids pre-screening. Outfall fully submerged; screened upstream at 13-3431 US1.

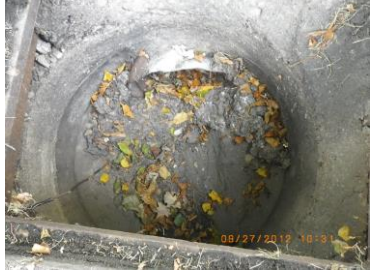
o20120927093152.JPG <div style="text-align: center; font-size: 24pt; font-weight: bold;">2012</div>

Inspection Date: 9/27/2012 10:29:26 AM		Type: Ongoing	Flow: None	Previous Rainfall (hrs): 72+
Illicit Discharge Potential: Unlikely		Inspector: JCW		
Submerged: None		Depth (in):		
Sampling Results Sample Location: --- Total Chlorine: -- ppm Free Chlorine: -- ppm Ammonia: -- ppm pH: -- units Temperature: -- °F Conductivity: -- µS/cm Detergents: -- mg/L		Floatables: None Odor: None Turbidity: None Color: None Gross Solids: None Vegetation: None Benthic Growth: None Stains: None Non-illicit: None		
		Notes Dry. Old concrete washout at pipe outlet.		
		Condition Assessment Graffiti: None Erosion: None Deposition: None in. Damage: None

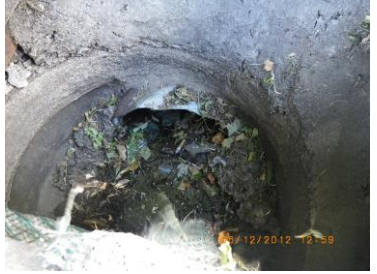
o20120612115904.JPG <div style="text-align: center; font-size: 24pt; font-weight: bold;">2012</div>

Inspection Date: 6/12/2012 12:56:45 PM		Type: Other	Flow: Submerged, indeterminate	Previous Rainfall (hrs): 72+
Illicit Discharge Potential: Potential		Inspector: JCW		
Submerged: Partially		Depth (in): 2		
Sampling Results Sample Location: Pool Total Chlorine: 0 ppm Free Chlorine: 0 ppm Ammonia: 0 ppm pH: 7.86 units Temperature: 72 °F Conductivity: 1372 µS/cm Detergents: 0 mg/L		Floatables: None Odor: Easily detected Turbidity: None Color: None Gross Solids: Moderate Vegetation: None Benthic Growth: None Stains: None Non-illicit: None		
		Notes Pre-screening for gross solids.		
		Condition Assessment Graffiti: None Erosion: None Deposition: Minor 2 in. Damage: None

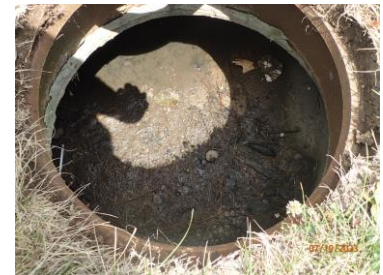
o20230719112518.JPG

☐ Petrol. Sheen ☐ Suds ☐ Sewage ☐ Algae ☐ Other☐ Petroleum ☐ Musty ☐ Sewage ☐ Chlorine ☐ Other☐ VOC/Solvent ☐ Fishy ☐ Sulfur ☐ Fragrant☐ Litter ☒ Veg. Debris ☐ Sediment ☐ Other☐ Inhibited ☐ Excessive☐ Green ☐ Brown☐ Flow Line ☐ Oil ☐ Rust Stains☐ Paint ☐ Other☐ Natural Sheen ☐ Natural Suds/Foam**Physical Condition Assessment**

Deposition: Minor Depth (in): 1

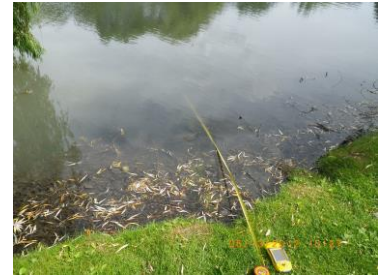
o20120613092740.JPG

Inspection Date: 6/13/2012 10:24:40 AM		Type: Ongoing	Flow: Submerged, indeterminate	Previous Rainfall (hrs): 72+
Illicit Discharge Potential: Unlikely		Inspector: JCW		
Submerged: Fully		Depth (in):		
Sampling Results		Notes		
Sample Location:		Tops of pipes missing or cut off. Outfall pipes fully submerged; screened upstream at 13-95 US1.		
Total Chlorine:	-- ppm	Floatables:	None	
Free Chlorine:	-- ppm	Odor:	None	
Ammonia:	-- ppm	Turbidity:	None	
pH:	-- units	Color:	None	
Temperature	-- °F	Gross Solids:	None	
Conductivity:	-- µS/cm	Vegetation:	None	
Detergents:	-- mg/L	Benthic Growth:	None	
		Stains:	None	
		Non-illicit:	None	
		Condition Assessment		
		Graffiti:	None	
		Erosion:	None	
		Deposition:	None in.	
		Damage:	Moderate

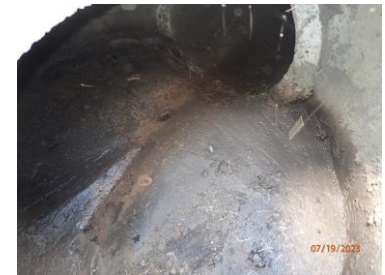
o20230719121446.JPG

Deposition: Minor Depth (in): 1

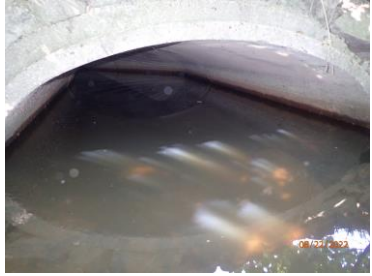
o20220822095708.JPG

Inspection Date: 8/22/2022 9:59:00 AM		Type: Ongoing	Flow: Submerged, slight flow	Previous Rainfall (hrs): 72+
Illicit Discharge Potential: Potential		Inspector: EJK		
Submerged: Partially		Depth (in): 24		
Sampling Results		Notes Sample collected from submerged flow at end of pipe. Detergent and slightly elevated ammonia in sample.		
Sample Location: Flow	Floatables: None	Condition Assessment Graffiti: None Erosion: None Deposition: None in. Damage: None		
Total Chlorine: 0 ppm	Odor: None			
Free Chlorine: 0 ppm	Turbidity: None			
Ammonia: 0.25 ppm	Color: None			
pH: 7.78 units	Gross Solids: None			
Temperature 71 °F	Vegetation: None			
Conductivity: 476 µS/cm	Benthic Growth: None			
Detergents: 0.3 mg/L	Stains: Slight			
	Non-illicit: Slight

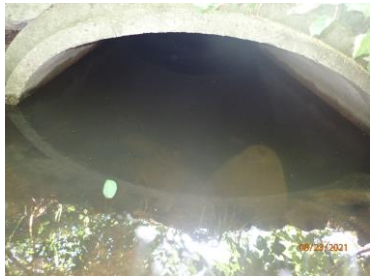
o20210823151038.JPG

Inspection Date: 8/23/2021 3:10:59 PM		Type: Ongoing	Flow: Submerged, slight flow	Previous Rainfall (hrs): 72+
Illicit Discharge Potential: Potential		Inspector: JCW		
Submerged: Partially		Depth (in): 17		
Sampling Results		Notes Severe channel erosion downstream of pipe. Sample collected from submerged flow. Detergent detected in sample.		
Sample Location: Flow	Floatables: None	Condition Assessment Graffiti: None Erosion: Severe Deposition: None in. Damage: None		
Total Chlorine: 0 ppm	Odor: None			
Free Chlorine: 0 ppm	Turbidity: None			
Ammonia: 0 ppm	Color: None			
pH: 7.81 units	Gross Solids: Slight			
Temperature 79 °F	Vegetation: None			
Conductivity: 1140 µS/cm	Benthic Growth: None			
Detergents: 1 mg/L	Stains: None			
	Non-illicit: None

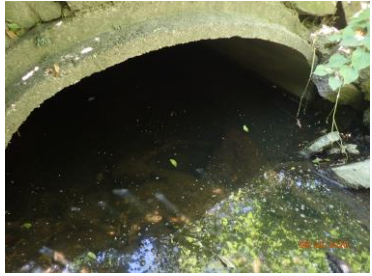
o20200820121004.JPG

Inspection Date: 8/20/2020 12:09:18 PM		Type: Ongoing	Flow: Submerged, no flow	Previous Rainfall (hrs): 72+
Illicit Discharge Potential: Potential		Inspector: JCW		
Submerged: Partially		Depth (in): 24		
Sampling Results		Notes No flow appears to be leaving pool at end of outfall. Sample collected from pool -detergent detected.		
Sample Location: Pool	Floatables: Moderate	Condition Assessment Graffiti: None Erosion: Moderate Deposition: Moderate 12 in. Damage: None		
Total Chlorine: 0 ppm	Odor: None			
Free Chlorine: 0 ppm	Turbidity: None			
Ammonia: 0 ppm	Color: None			
pH: 7.76 units	Gross Solids: None			
Temperature 81 °F	Vegetation: None			
Conductivity: 453 µS/cm	Benthic Growth: Moderate			
Detergents: 0.6 mg/L	Stains: None			
	Non-illicit: None

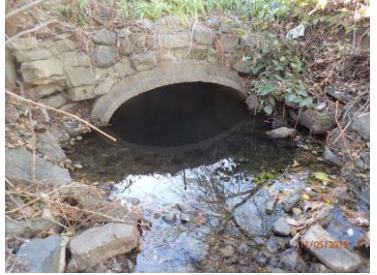
o20191105142746.JPG

Inspection Date: 11/5/2019 2:27:14 PM		Type: Repeat	Flow: Submerged, indeterminate	Previous Rainfall (hrs): 48-72
Illicit Discharge Potential: Potential		Inspector: JCW	Notes	
Submerged: Partially Depth (in): 20			Follow-up inspection for sampling - limited screening conducted. pH in normal range; detergent detected.	
Sampling Results		Floatables: None	Condition Assessment Graffiti: None Erosion: None Deposition: None in. Damage: None	
Sample Location: Pool	Odor: None			
Total Chlorine: -- ppm	Turbidity: None			
Free Chlorine: -- ppm	Color: None			
Ammonia: -- ppm	Gross Solids: None			
pH: 8.18 units	Vegetation: None			
Temperature 45 °F	Benthic Growth: None			
Conductivity: 680 µS/cm	Stains: None			
Detergents: 0.8 mg/L	Non-illicit: None

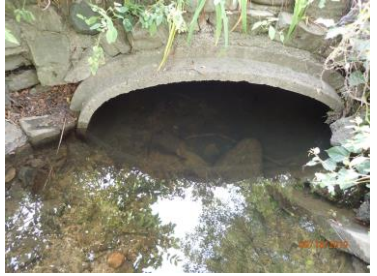
o20190918141444.JPG

Inspection Date: 9/18/2019 3:16:56 PM		Type: Ongoing	Flow: Submerged, slight flow	Previous Rainfall (hrs): 72+
Illicit Discharge Potential: Potential		Inspector: JCW	Notes	
Submerged: Partially Depth (in): 20			Downstream bank erosion. Sample collected from submerged flow in pipe. High pH detected.	
Sampling Results		Floatables: None	Condition Assessment Graffiti: None Erosion: Severe Deposition: None in. Damage: None	
Sample Location: Flow	Odor: None			
Total Chlorine: 0 ppm	Turbidity: None			
Free Chlorine: 0 ppm	Color: None			
Ammonia: 0 ppm	Gross Solids: None			
pH: 9.27 units	Vegetation: None			
Temperature 77 °F	Benthic Growth: Moderate			
Conductivity: 368 µS/cm	Stains: Slight			
Detergents: 0 mg/L	Non-illicit: None

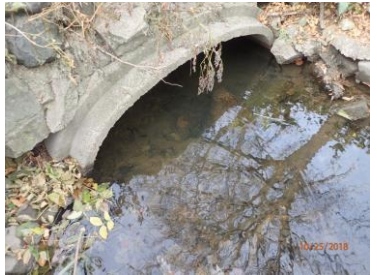
o20181025093132.JPG

Inspection Date: 10/26/2018 1:26:25 PM		Type: Repeat	Flow: Submerged, significant flow	Previous Rainfall (hrs): 72+
Illicit Discharge Potential: Potential		Inspector: KMK	Notes	
Submerged: Partially Depth (in): 26			Detergent detection follow-up. Limited screening conducted beyond sampling.	
Sampling Results		Floatables: None	Condition Assessment Graffiti: None Erosion: None Deposition: None in. Damage: None	
Sample Location: Flow	Odor: None			
Total Chlorine: 0 ppm	Turbidity: None			
Free Chlorine: 0 ppm	Color: None			
Ammonia: 0 ppm	Gross Solids: Slight			
pH: 8.18 units	Vegetation: None			
Temperature 54 °F	Benthic Growth: Slight			
Conductivity: 1183 µS/cm	Stains: None			
Detergents: 0.4 mg/L	Non-illicit: None

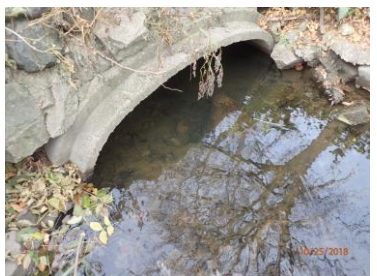
o20181025093132.JPG

Inspection Date: 10/25/2018 9:33:47 AM		Type: Ongoing	Flow: Submerged, significant flow	Previous Rainfall (hrs): 72+
Illicit Discharge Potential: Potential		Inspector: JCW	Notes	
Submerged: Partially Depth (in): 26			Downstream bank erosion. Sample collected from submerged flow in pipe. Detergent detected.	
Sampling Results		Floatables: None	Condition Assessment Graffiti: None Erosion: Moderate Deposition: None in. Damage: None	
Sample Location: Flow	Odor: None			
Total Chlorine: 0 ppm	Turbidity: None			
Free Chlorine: 0 ppm	Color: None			
Ammonia: 0 ppm	Gross Solids: Slight			
pH: 8.16 units	Vegetation: None			
Temperature 51 °F	Benthic Growth: Moderate			
Conductivity: 1209 µS/cm	Stains: None			
Detergents: 0.5 mg/L	Non-illicit: None

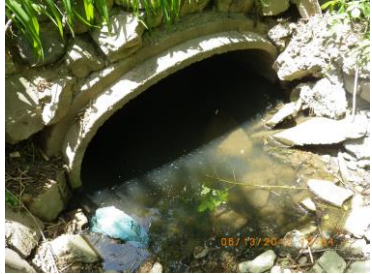
Sample Location:	Pool																																					
Total Chlorine:	0 ppm																																					
Free Chlorine:	0 ppm																																					
Ammonia:	0 ppm																																					
pH:	7.91 units																																					
Temperature:	74 °F																																					
Conductivity:	1579 µS/cm																																					
Detergents:	0 mg/L																																					
Floatables:	None																																					
Odor:	None																																					
Turbidity:	Slight cloudiness																																					
Color:	None																																					
Gross Solids:	Slight																																					
Vegetation:	None																																					
Benthic Growth:	Slight																																					
Stains:	None																																					
Non-illicit:	None

<p>Notes</p> <p>No flow leaving pool on apron. Downstream channel dry. Sample collected from apron pool.</p>

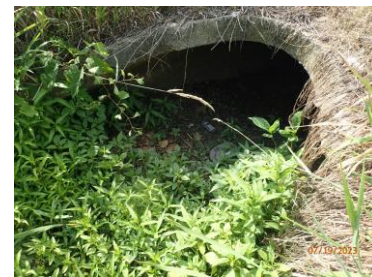
o20230719081446.JPG

Stains: Moderate

☐ Petrol. Sheen ☐ Suds ☐ Sewage ☐ Algae ☐ Other☐ Petroleum ☐ Musty ☐ Sewage ☐ Chlorine ☐ Other☐ VOC/Solvent ☐ Fishy ☐ Sulfur ☐ Fragrant☒ Litter ☐ Veg. Debris ☐ Sediment ☐ Other☐ Inhibited ☐ Excessive☐ Green ☐ Brown☒ Flow Line ☐ Oil ☐ Rust Stains☐ Paint ☐ Other☐ Natural Sheen ☐ Natural Suds/Foam

Deposition: Minor Depth (in): 2

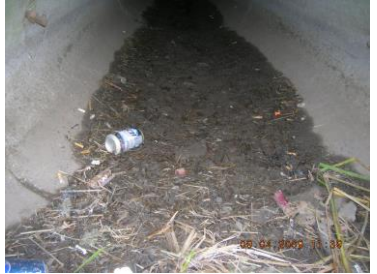
Osh09_DSCN6525.JPG 2009
Sampling Results Sample Location: Total Chlorine: -- ppm Free Chlorine: -- ppm Ammonia: -- ppm pH: -- units Temperature: -- °F Conductivity: -- µS/cm Detergents: -- mg/L		Floatables: Odor: Turbidity: Color: Gross Solids: Vegetation: Benthic Growth: Stains: Non-illicit: None	Garbage inside pipe. Condition Assessment Graffiti: None Erosion: None Deposition: 1 in. Damage: None

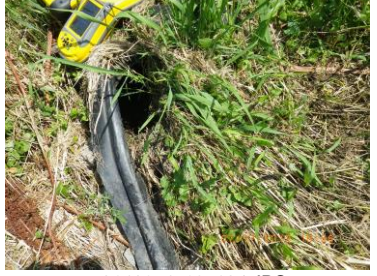
<p>o20130717095634.JPG</p> <p>2013</p>

Sample Location:																																		
Total Chlorine:	-- ppm																																	
Free Chlorine:	-- ppm																																	
Ammonia:	-- ppm																																	
pH:	-- units																																	
Temperature:	-- °F																																	
Conductivity:	-- µS/cm																																	
Detergents:	-- mg/L																																	
Notes																																		
Apron blocked with dirt and grass. Pipe dry at time of inspection.																																		
Condition Assessment																																		
Graffiti:	None																																	
Erosion:	None																																	
Deposition:	Severe 12 in.																																	
Damage:	None

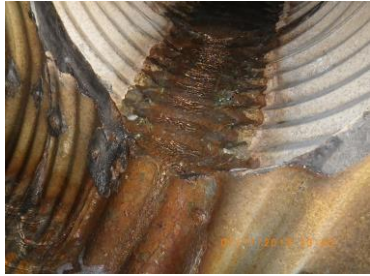
o20130717120006.JPG 2013

Inspection Date: 7/17/2013 12:56:41 PM		Type: Ongoing	Flow: Moderate	Previous Rainfall (hrs): 72+
Illicit Discharge Potential: Unlikely		Inspector: JCW	Notes Fine light color silt settled on culvert and rocks at base of outfall.	
Submerged: None Depth (in):				
Sampling Results Sample Location: Flow Total Chlorine: 0 ppm Free Chlorine: 0 ppm Ammonia: 0.5 ppm pH: 8.11 units Temperature 72 °F Conductivity: 947 µS/cm Detergents: 0 mg/L		Floatables: None Odor: None Turbidity: None Color: None Gross Solids: None Vegetation: None Benthic Growth: None Stains: Moderate Non-illicit: Slight	Condition Assessment Graffiti: None Erosion: None Deposition: None in. Damage: Moderate

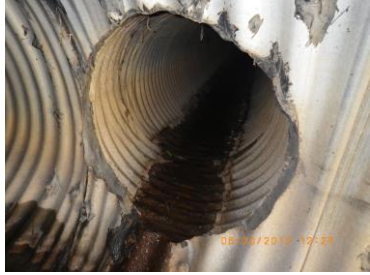
o20120620112732.JPG 2012

Inspection Date: 6/20/2012 12:29:02 PM		Type: Ongoing	Flow: None	Previous Rainfall (hrs): 24-48
Illicit Discharge Potential: Unlikely		Inspector: JCW	Notes 2011 suds (natural) follow-up. Pipe wet but no flow at outfall.	
Submerged: None Depth (in):				
Sampling Results Sample Location: _____ Total Chlorine: -- ppm Free Chlorine: -- ppm Ammonia: -- ppm pH: -- units Temperature -- °F Conductivity: -- µS/cm Detergents: -- mg/L		Floatables: None Odor: None Turbidity: None Color: None Gross Solids: None Vegetation: None Benthic Growth: None Stains: Slight Non-illicit: None	Condition Assessment Graffiti: None Erosion: None Deposition: None in. Damage: Minor

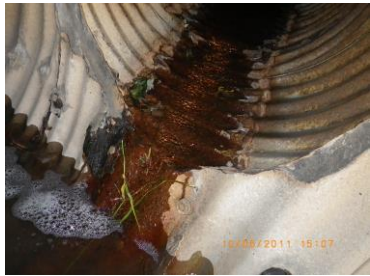
o20111006150702.JPG 2011

Inspection Date: 10/6/2011 3:04:00 PM		Type: Ongoing	Flow: Moderate	Previous Rainfall (hrs): 72+
Illicit Discharge Potential: Potential		Inspector: JCW	Notes Persistent suds still present in mixing zone and downstream.	
Submerged: None Depth (in):				
Sampling Results Sample Location: _____ Total Chlorine: -- ppm Free Chlorine: -- ppm Ammonia: -- ppm pH: -- units Temperature -- °F Conductivity: -- µS/cm Detergents: -- mg/L		Floatables: Moderate Odor: None Turbidity: None Color: None Gross Solids: None Vegetation: None Benthic Growth: None Stains: Moderate Non-illicit: None	Condition Assessment Graffiti: None Erosion: None Deposition: None 0 in. Damage: Moderate

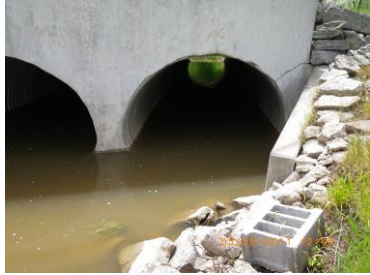
o20110526124526.JPG

Inspection Date: 5/26/2011 12:58:00 PM		Type: Other	Flow: Submerged, indeterminate	Previous Rainfall (hrs): 72+
Illicit Discharge Potential: Potential		Inspector: JCW	Notes	
Submerged: Partially Depth (in): 2			Limited screening conducted to check for suds. Slight suds - all coming from upstream of culvert.	
Sampling Results			Condition Assessment	
Sample Location:	Floatables:	None	Graffiti:	None
Total Chlorine: -- ppm	Odor:	None	Erosion:	None
Free Chlorine: -- ppm	Turbidity:	None	Deposition:	None 0 in.
Ammonia: -- ppm	Color:	None	Damage:	None
pH: -- units	Gross Solids:	None		
Temperature -- °F	Vegetation:	None		
Conductivity: -- µS/cm	Benthic Growth:	None		
Detergents: -- mg/L	Stains:	None		
	Non-illicit:	None

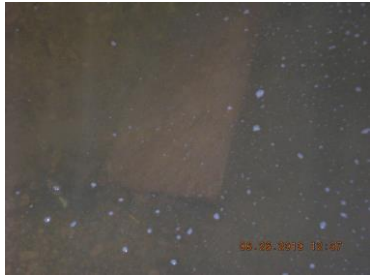
o20100826123758.JPG

Inspection Date: 8/26/2010 1:00:18 PM		Type: Other	Flow: Moderate	Previous Rainfall (hrs): 72+
Illicit Discharge Potential: Potential		Inspector: JCW	Notes	
Submerged: None Depth (in):			Sample consists of sheen skimmed from surface of downstream pool.	
Sampling Results			Condition Assessment	
Sample Location: Pool	Floatables:	Moderate	Graffiti:	None
Total Chlorine: 0 ppm	Odor:	None	Erosion:	None
Free Chlorine: 0 ppm	Turbidity:	None	Deposition:	None 0 in.
Ammonia: 0 ppm	Color:	None	Damage:	None
pH: 8.52 units	Gross Solids:	None		
Temperature 76 °F	Vegetation:	None		
Conductivity: -- µS/cm	Benthic Growth:	None		
Detergents: 0 mg/L	Stains:	Moderate		
	Non-illicit:	None

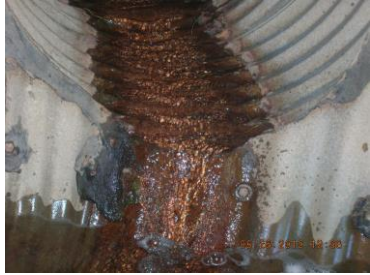
o20100826123658.JPG

Inspection Date: 8/26/2010 12:58:18 PM		Type: Ongoing	Flow: Moderate	Previous Rainfall (hrs): 72+
Illicit Discharge Potential: Potential		Inspector: JCW	Notes	
Submerged: None Depth (in):			Persistent suds and gel-like sheen downstream	
Sampling Results			Condition Assessment	
Sample Location: Flow	Floatables:	Moderate	Graffiti:	None
Total Chlorine: 0 ppm	Odor:	None	Erosion:	None
Free Chlorine: 0 ppm	Turbidity:	None	Deposition:	None 0 in.
Ammonia: 0 ppm	Color:	None	Damage:	Moderate
pH: 8.3 units	Gross Solids:	None		
Temperature 78 °F	Vegetation:	None		
Conductivity: -- µS/cm	Benthic Growth:	None		
Detergents: 0 mg/L	Stains:	Moderate		
	Non-illicit:	None

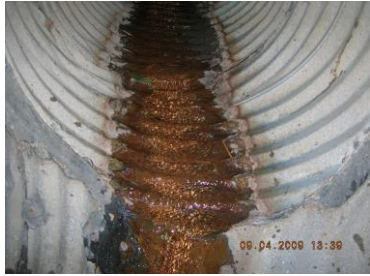
Osh09_DSCN6538.JPG

Inspection Date: 9/4/2009		Type: Initial	Flow: Moderate	Previous Rainfall (hrs): 72+
Illicit Discharge Potential: Potential		Inspector: JCW	Notes	
Submerged: None Depth (in): 0			Sample 09090411 collected from pool (suds). No detergent detected.	
Sampling Results			Condition Assessment	
Sample Location: Flow	Floatables:	Moderate	Graffiti:	None
Total Chlorine: 0 ppm	Odor:	None	Erosion:	None
Free Chlorine: 0 ppm	Turbidity:	None	Deposition:	None 0 in.
Ammonia: -- ppm	Color:	None	Damage:	Minor
pH: 8.32 units	Gross Solids:	None		
Temperature 78 °F	Vegetation:	None		
Conductivity: -- µS/cm	Benthic Growth:	None		
Detergents: 0 mg/L	Stains:	Moderate		
	Non-illicit:	None

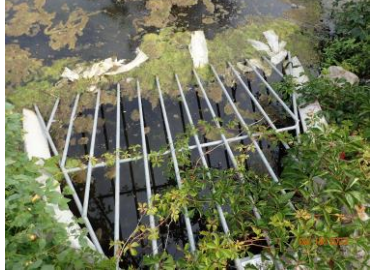
<p style="font-size: small;">o20220818145708.JPG</p>

Inspection Date: 8/18/2022 2:59:00 PM		Type: Ongoing	Flow: Submerged, slight flow	Previous Rainfall (hrs): 72+
Illicit Discharge Potential: Unlikely		Inspector: EJK		
Submerged: Partially		Depth (in): 16		
<div style="display: flex; justify-content: space-between;"> <div style="width: 45%;"> <p>Sampling Results</p> <p>Sample Location: Flow</p> <p>Total Chlorine: 0 ppm</p> <p>Free Chlorine: 0 ppm</p> <p>Ammonia: 0 ppm</p> <p>pH: 5.8 units</p> <p>Temperature: 81 °F</p> <p>Conductivity: 1358 µS/cm</p> <p>Detergents: 0 mg/L</p> </div> <div style="width: 45%;"> <p>Floatables: Moderate</p> <p>Odor: None</p> <p>Turbidity: None</p> <p>Color: None</p> <p>Gross Solids: Slight</p> <p>Vegetation: None</p> <p>Benthic Growth: None</p> <p>Stains: Slight</p> <p>Non-illicit: None</p> </div> </div>				
		<p>Notes</p> <p>Sample collected from submerged flow at end of pipe. Low pH reading due to probe malfunction. Retested 7.3.</p>

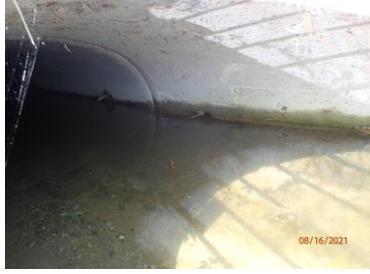
<p style="font-size: small;">o20210816123040.JPG</p>

Inspection Date: 8/16/2021 12:35:00 PM		Type: Ongoing	Flow: Submerged, slight flow	Previous Rainfall (hrs): 72+
Illicit Discharge Potential: Unlikely		Inspector: JCW		
Submerged: Partially		Depth (in): 17		
<div style="display: flex; justify-content: space-between;"> <div style="width: 45%;"> <p>Sampling Results</p> <p>Sample Location: Flow</p> <p>Total Chlorine: 0 ppm</p> <p>Free Chlorine: 0 ppm</p> <p>Ammonia: 0 ppm</p> <p>pH: 7.37 units</p> <p>Temperature: 78 °F</p> <p>Conductivity: 991 µS/cm</p> <p>Detergents: 0 mg/L</p> </div> <div style="width: 45%;"> <p>Floatables: None</p> <p>Odor: None</p> <p>Turbidity: None</p> <p>Color: None</p> <p>Gross Solids: None</p> <p>Vegetation: None</p> <p>Benthic Growth: Moderate</p> <p>Stains: None</p> <p>Non-illicit: None</p> </div> </div>				
		<p>Notes</p> <p>New HECP. Sample collected from submerged flow in pipe.</p>

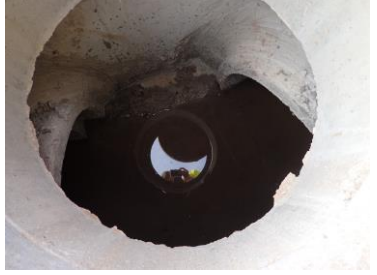
Inspection Date: 9/24/2020 9:17:59 AM		Type: Ongoing	Flow: Submerged, indeterminate	Previous Rainfall (hrs): 72+
Illicit Discharge Potential: Unlikely Submerged: Partially Depth (in): 9		Inspector: QAL	Notes Sample collected from submerged pool in manhole.	
Sampling Results Sample Location: Pool Total Chlorine: 0 ppm Free Chlorine: 0 ppm Ammonia: 0 ppm pH: 7.81 units Temperature: 66 °F Conductivity: 1112 µS/cm Detergents: 0 mg/L		Floatables: None Odor: None Turbidity: None Color: None Gross Solids: None Vegetation: None Benthic Growth: None Stains: None Non-illicit: None	Condition Assessment Graffiti: None Erosion: None Deposition: None in. Damage: None

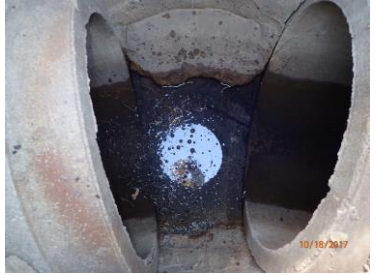
o20171018130134.JPG <div style="text-align: center; font-size: 24pt; font-weight: bold;">2017</div>

Inspection Date: 10/18/2017 1:06:00 PM		Type: Ongoing	Flow: Submerged, indeterminate	Previous Rainfall (hrs): 72+																																				
Illicit Discharge Potential: Unlikely		Inspector: JCW	Notes																																					
Submerged: Partially		Depth (in): 3	Sample collected from submerged pool in manhole.

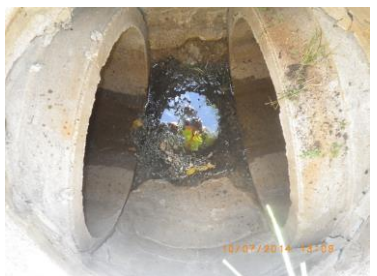
o20141007120930.JPG <div style="text-align: center; font-size: 24pt; font-weight: bold;">2014</div>

Inspection Date: 10/7/2014 1:11:52 PM		Type: Ongoing	Flow: Submerged, indeterminate	Previous Rainfall (hrs): 48-72																																				
Illicit Discharge Potential: Unlikely		Inspector: JCW	Notes																																					
Submerged: Partially		Depth (in): 2	No flow at 14-582 US7 (Hydrite lateral).

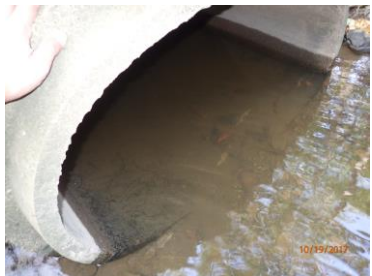
Inspection Date: 10/19/2017 12:32:13 PM		Type: Ongoing	Flow: Submerged, indeterminate	Previous Rainfall (hrs): 72+
Illicit Discharge Potential: Unlikely		Inspector: JCW		
Submerged: Partially		Depth (in): 8		
Sampling Results Sample Location: Flow Total Chlorine: 0 ppm Free Chlorine: 0 ppm Ammonia: 0 ppm pH: 7.71 units Temperature: 62 °F Conductivity: 629 µS/cm Detergents: 0 mg/L		Floatables: None Odor: None Turbidity: None Color: None Gross Solids: None Vegetation: None Benthic Growth: Moderate Stains: Slight Non-illicit: None	Notes Upstream location inside locked fence surrounding detention basin. Sample collected from submerged pool at end of pipe.

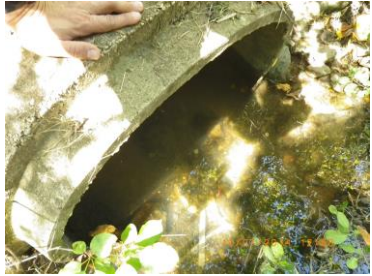
Inspection Date: 10/7/2014 12:52:01 PM		Type: Ongoing	Flow: Submerged, indeterminate	Previous Rainfall (hrs): 48-72
Illicit Discharge Potential: Unlikely		Inspector: JCW		
Submerged: Partially		Depth (in): 6		
Sampling Results Sample Location: -- Total Chlorine: -- ppm Free Chlorine: -- ppm Ammonia: -- ppm pH: -- units Temperature: -- °F Conductivity: -- µS/cm Detergents: -- mg/L		Floatables: None Odor: None Turbidity: None Color: None Gross Solids: None Vegetation: None Benthic Growth: Slight Stains: Slight Non-illicit: None	Notes Outfall partially submerged - screened upstream at 14-595 US1.

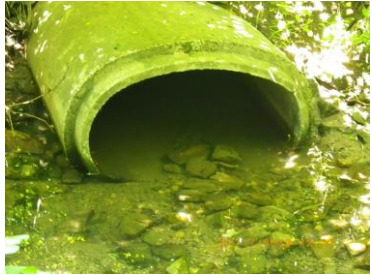
Inspection Date: 7/17/2013 11:58:51 AM		Type: Ongoing	Flow: Submerged, indeterminate	Previous Rainfall (hrs): 72+
Illicit Discharge Potential: Unlikely		Inspector: JCW		
Submerged: Partially		Depth (in): 5		
Sampling Results Sample Location: -- Total Chlorine: -- ppm Free Chlorine: -- ppm Ammonia: -- ppm pH: -- units Temperature: -- °F Conductivity: -- µS/cm Detergents: -- mg/L		Floatables: None Odor: None Turbidity: None Color: None Gross Solids: None Vegetation: None Benthic Growth: Slight Stains: Moderate Non-illicit: None	Notes Outfall partially submerged. Outfall screened upstream at 14-595 US3.

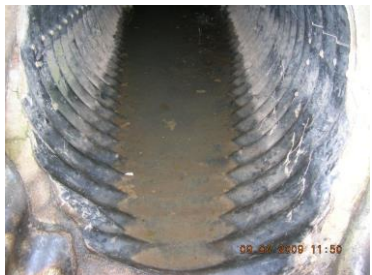
Inspection Date: 9/4/2009		Type: Initial	Flow: None	Previous Rainfall (hrs): 72+
Illicit Discharge Potential: Unlikely		Inspector: JCW		
Submerged: None		Depth (in): 0		
Sampling Results Sample Location: Total Chlorine: -- ppm Free Chlorine: -- ppm Ammonia: -- ppm pH: -- units Temperature: -- °F Conductivity: -- µS/cm Detergents: -- mg/L		Floatables: Odor: Turbidity: Color: Gross Solids: Vegetation: Benthic Growth: Stains: Non-illicit: None	Notes Water standing in pipe ribs - no flow. Black lining of pipe peeling.

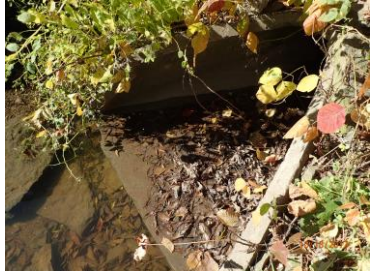
o20171018132924.JPG <div style="text-align: center; font-size: 24pt; font-weight: bold;">2017</div>

Inspection Date: 10/18/2017 1:32:37 PM		Type: Ongoing	Flow: Submerged, no flow	Previous Rainfall (hrs): 72+
Illicit Discharge Potential: Unlikely		Inspector: JCW		
Submerged: Partially		Depth (in): 0.5		
Sampling Results Sample Location: Total Chlorine: -- ppm Free Chlorine: -- ppm Ammonia: -- ppm pH: -- units Temperature -- °F Conductivity: -- µS/cm Detergents: -- mg/L		Floatables: None Odor: None Turbidity: None Color: None Gross Solids: None Vegetation: None Benthic Growth: Slight Stains: None Non-illicit: None		
		Notes Pipe was dry approx 10 ft from end of pipe - no sample collected (from stream). Apron displaced 4".		
		Condition Assessment Graffiti: None Erosion: None Deposition: None in. Damage: Minor

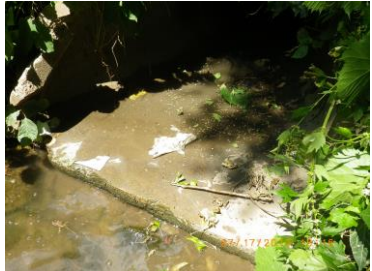
o20130717121624.JPG <div style="text-align: center; font-size: 24pt; font-weight: bold;">2013</div>

Inspection Date: 7/17/2013 1:12:46 PM		Type: Ongoing	Flow: None	Previous Rainfall (hrs): 72+
Illicit Discharge Potential: Unlikely		Inspector: JCW		
Submerged: None		Depth (in):		
Sampling Results Sample Location: Total Chlorine: -- ppm Free Chlorine: -- ppm Ammonia: -- ppm pH: -- units Temperature -- °F Conductivity: -- µS/cm Detergents: -- mg/L		Floatables: None Odor: None Turbidity: None Color: None Gross Solids: Slight Vegetation: None Benthic Growth: Slight Stains: Slight Non-illicit: None		
		Notes Pipe wet, but no flow leaving apron. Apron displaced 4".		
		Condition Assessment Graffiti: None Erosion: None Deposition: None in. Damage: Minor

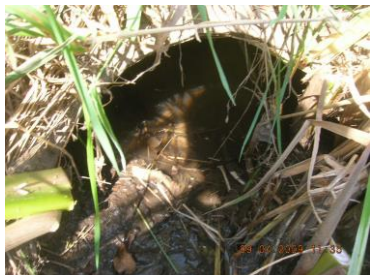
<small>Osh09_DSCN6521.JPG</small> 2009 </div>

Inspection Date: 9/4/2009		Type: Initial	Flow: None	Previous Rainfall (hrs): 72+
Illicit Discharge Potential: Unlikely		Inspector: JCW	<div style="border: 1px solid black; padding: 5px;"> Notes Standing water inside pipe due to sediment at end - no flow leaving pool. </div> <div style="border: 1px solid black; padding: 5px; margin-top: 10px;"> Condition Assessment Graffiti: None Erosion: None Deposition: 4 in. Damage: None </div>	
Submerged: None Depth (in): 0				
<div style="border: 1px solid black; padding: 5px;"> Sampling Results Sample Location: _____ Total Chlorine: -- ppm Free Chlorine: -- ppm Ammonia: -- ppm pH: -- units Temperature -- ° F Conductivity: -- µS/cm Detergents: -- mg/L </div>		Floatables: _____ Odor: _____ Turbidity: _____ Color: _____ Gross Solids: _____ Vegetation: _____ Benthic Growth: _____ Stains: _____ Non-illicit: None	<div style="text-align: center;">

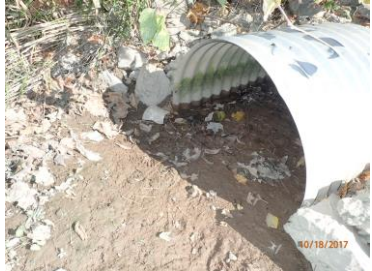
o20171018131222.JPG <div style="text-align: right; font-size: 24pt; font-weight: bold;">2017</div>

Inspection Date: 10/18/2017 1:15:47 PM		Type: Ongoing	Flow: None	Previous Rainfall (hrs): 72+
Illicit Discharge Potential: Unlikely		Inspector: JCW		
Submerged: None		Depth (in):		
Sampling Results Sample Location: Total Chlorine: -- ppm Free Chlorine: -- ppm Ammonia: -- ppm pH: -- units Temperature -- ° F Conductivity: -- µS/cm Detergents: -- mg/L		Floatables: None Odor: None Turbidity: None Color: None Gross Solids: None Vegetation: None Benthic Growth: Slight Stains: None Non-illicit: None		
		Notes Sediment inside pipe wet, but no collectable flow at time of inspection.		
		Condition Assessment Graffiti: None Erosion: None Deposition: Moderate 11 in. Damage: None

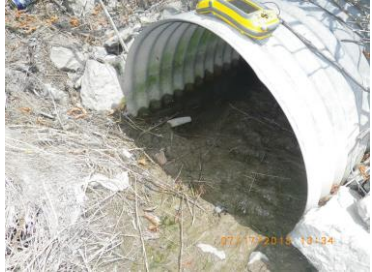
o20130717123414.JPG <div style="text-align: right; font-size: 24pt; font-weight: bold;">2013</div>

Inspection Date: 7/17/2013 1:30:26 PM		Type: Ongoing	Flow: None	Previous Rainfall (hrs): 72+
Illicit Discharge Potential: Unlikely		Inspector: JCW		
Submerged: None		Depth (in):		
Sampling Results Sample Location: Total Chlorine: -- ppm Free Chlorine: -- ppm Ammonia: -- ppm pH: -- units Temperature -- ° F Conductivity: -- µS/cm Detergents: -- mg/L		Floatables: None Odor: None Turbidity: None Color: None Gross Solids: None Vegetation: None Benthic Growth: Slight Stains: Slight Non-illicit: None		
		Notes Sediment wet, but no collectable flow at time of inspection.		
		Condition Assessment Graffiti: None Erosion: None Deposition: Moderate 10 in. Damage: None

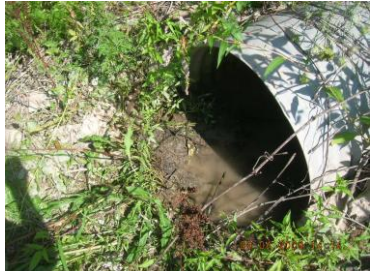
Osh09_DSCN6550.JPG <div style="text-align: right; font-size: 24pt; font-weight: bold;">2009</div>

Inspection Date: 9/4/2009		Type: Initial	Flow: Submerged, no flow	Previous Rainfall (hrs): 72+
Illicit Discharge Potential: Unlikely		Inspector: JCW		
Submerged: Partially		Depth (in): 11		
Sampling Results Sample Location: Total Chlorine: -- ppm Free Chlorine: -- ppm Ammonia: -- ppm pH: -- units Temperature -- ° F Conductivity: -- µS/cm Detergents: -- mg/L		Floatables: Odor: Turbidity: Color: Gross Solids: Vegetation: Benthic Growth: Slight Stains: Non-illicit: None		
		Notes Pool at end of pipe - no flow leaving pool.		
		Condition Assessment Graffiti: None Erosion: None Deposition: 9 in. Damage: None

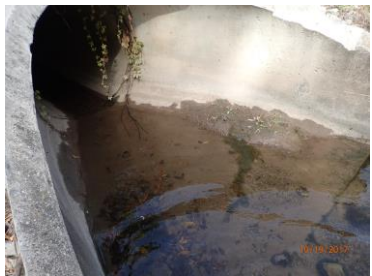
o20171019120120.JPG <div style="text-align: center; font-size: 24pt; font-weight: bold;">2017</div>

Inspection Date: 10/19/2017 12:02:52 PM		Type: Ongoing	Flow: Submerged, indeterminate	Previous Rainfall (hrs): 72+
Illicit Discharge Potential: Unlikely		Inspector: JCW		
Submerged: Partially		Depth (in): 1		
Sampling Results Sample Location: Total Chlorine: 0 ppm Free Chlorine: 0 ppm Ammonia: 0 ppm pH: 7.48 units Temperature: 61 °F Conductivity: 740 µS/cm Detergents: 0 mg/L		Floatables: None Odor: None Turbidity: None Color: None Gross Solids: None Vegetation: None Benthic Growth: Slight Stains: Slight Non-illicit: None		
		Notes Upstream inlet dry - sample collected from submerged pool at end of pipe. 4" joint displacement.		
		Condition Assessment Graffiti: None Erosion: None Deposition: None in. Damage: Moderate

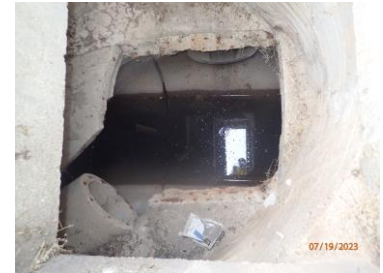
o20230719094606.JPG

☒ Petrol. Sheen ☐ Suds ☐ Sewage ☐ Algae ☐ Other☐ Petroleum ☐ Musty ☒ Sewage ☐ Chlorine ☐ Other☐ VOC/Solvent ☐ Fishy ☐ Sulfur ☐ Fragrant☐ Litter ☐ Veg. Debris ☐ Sediment ☐ Other☐ Inhibited ☐ Excessive☐ Green ☐ Brown☐ Flow Line ☐ Oil ☐ Rust Stains☐ Paint ☐ Other☐ Natural Sheen ☐ Natural Suds/Foam

Sample Location:	Pool																																					
Total Chlorine:	0 ppm																																					
Free Chlorine:	0 ppm																																					
Ammonia:	0.5 ppm																																					
pH:	7.67 units																																					
Temperature:	71 °F																																					
Conductivity:	431 µS/cm																																					
Detergents:	0 mg/L																																					
Floatables:	None																																					
Odor:	Faint																																					
Turbidity:	None																																					
Color:	None																																					
Gross Solids:	None																																					
Vegetation:	None																																					
Benthic Growth:	None																																					
Stains:	Slight																																					
Non-illicit:	None

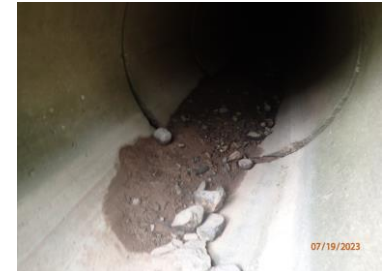
o20230719095626.JPG

Stains: Moderate

Deposition: Minor Depth (in): 1

Damage: Minor ☒ Displacement ☐ Undercut ☐ Crushed☐ Corrosion ☐ Cracks/Structural Damage
