IDDE Ongoing Screening Summary Report

2023 Inspection Year

Westwood

City of Oshkosh

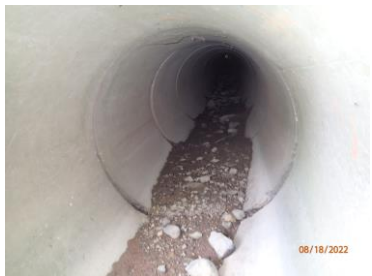
Inspection Date: 8/18/2022 3:24:00 PM		Type: Ongoing		Flow: None		Previous Rainfall (hrs): 72+	
Illicit Discharge Potential: Unlikely		Inspector: EJK		Notes Pipe dry at time of inspection. Dry sediment inside pipe. 3" joint displacement.

o20220818152328.JPG	
Submerged: None		Depth (in):					
Sampling Results Sample Location: _____ Total Chlorine: -- ppm Free Chlorine: -- ppm Ammonia: -- ppm pH: -- units Temperature: -- °F Conductivity: -- µS/cm Detergents: -- mg/L		Floatables: None Odor: None Turbidity: None Color: None Gross Solids: None Vegetation: None Benthic Growth: None Stains: Slight Non-illicit: None		Condition Assessment Graffiti: None Erosion: None Deposition: Minor 3 in. Damage: Minor

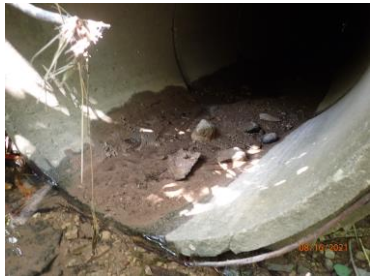
Inspection Date: 8/16/2021 12:54:23 PM		Type: Ongoing		Flow: None		Previous Rainfall (hrs): 72+	
Illicit Discharge Potential: Unlikely		Inspector: JCW		Notes Pipe wet, but no collectable flow at time of inspection. 3" joint displacement. Downed trees blocking stream channel.

o20210816124938.JPG	
Submerged: None		Depth (in):					
Sampling Results Sample Location: _____ Total Chlorine: -- ppm Free Chlorine: -- ppm Ammonia: -- ppm pH: -- units Temperature: -- °F Conductivity: -- µS/cm Detergents: -- mg/L		Floatables: None Odor: None Turbidity: None Color: None Gross Solids: None Vegetation: None Benthic Growth: Slight Stains: None Non-illicit: None		Condition Assessment Graffiti: None Erosion: None Deposition: Minor 1 in. Damage: Minor

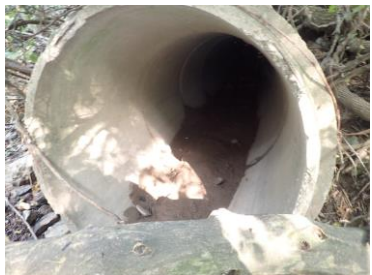
Inspection Date: 9/24/2020 9:32:24 AM		Type: Ongoing		Flow: None		Previous Rainfall (hrs): 72+	
Illicit Discharge Potential: Unlikely		Inspector: QAL		Notes Sediment damp, but no flow at time of inspection. 4" joint displacement.

o20200924093736.JPG	
Submerged: None		Depth (in):					
Sampling Results Sample Location: _____ Total Chlorine: -- ppm Free Chlorine: -- ppm Ammonia: -- ppm pH: -- units Temperature: -- °F Conductivity: -- µS/cm Detergents: -- mg/L		Floatables: None Odor: None Turbidity: None Color: None Gross Solids: None Vegetation: None Benthic Growth: None Stains: None Non-illicit: None		Condition Assessment Graffiti: None Erosion: None Deposition: Minor 4 in. Damage: Minor

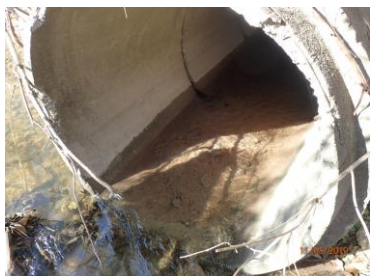
Inspection Date: 11/5/2019 12:33:00 PM		Type: Repeat		Flow: Submerged, significant flow		Previous Rainfall (hrs): 48-72	
Illicit Discharge Potential: Unlikely		Inspector: JCW		Notes Follow-up inspection for sampling - limited screening conducted. No detergent in follow-up sample.

o20191105123320.JPG	
Submerged: Partially		Depth (in): 5					
Sampling Results Sample Location: Flow Total Chlorine: -- ppm Free Chlorine: -- ppm Ammonia: -- ppm pH: -- units Temperature: -- °F Conductivity: -- µS/cm Detergents: 0 mg/L		Floatables: None Odor: None Turbidity: None Color: None Gross Solids: None Vegetation: None Benthic Growth: Slight Stains: None Non-illicit: None		Condition Assessment Graffiti: None Erosion: None Deposition: Minor 1 in. Damage: Minor

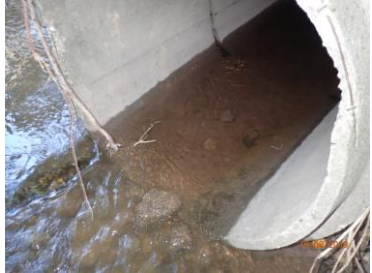
o20191008064438.JPG
2019

Inspection Date: 10/8/2019 7:44:51 AM		Type: Ongoing	Flow: Submerged, significant flow	Previous Rainfall (hrs): 48-72
Illicit Discharge Potential: Potential		Inspector: JCW	Notes	
Submerged: Partially Depth (in): 5			Sample collected from submerged flow at end of pipe. 2" joint displacement. Detergent detected.	
Sampling Results		Floatables: None	Condition Assessment Graffiti: None Erosion: None Deposition: Minor 1 in. Damage: Minor	
Sample Location: Flow		Odor: None		
Total Chlorine: 0 ppm		Turbidity: None		
Free Chlorine: 0 ppm		Color: None		
Ammonia: 0 ppm		Gross Solids: None		
pH: 7.85 units		Vegetation: None		
Temperature 51 °F		Benthic Growth: Slight		
Conductivity: 741 µS/cm		Stains: None		
Detergents: 1 mg/L		Non-illicit: None

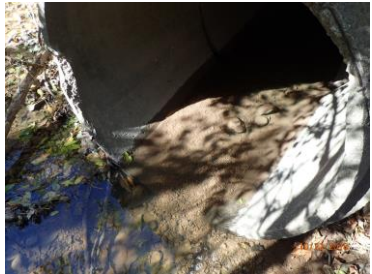
o20181022130156.JPG
2018

Inspection Date: 10/22/2018 1:04:11 PM		Type: Ongoing	Flow: Submerged, slight flow	Previous Rainfall (hrs): 48-72
Illicit Discharge Potential: Unlikely		Inspector: JCW	Notes	
Submerged: Partially Depth (in): 3			Sample collected from submerged flow at end of pipe. 4" joint displacement.	
Sampling Results		Floatables: None	Condition Assessment Graffiti: None Erosion: None Deposition: Minor 1 in. Damage: Moderate	
Sample Location: Flow		Odor: None		
Total Chlorine: 0 ppm		Turbidity: None		
Free Chlorine: 0 ppm		Color: None		
Ammonia: 0 ppm		Gross Solids: None		
pH: 7.62 units		Vegetation: None		
Temperature 57 °F		Benthic Growth: None		
Conductivity: 811 µS/cm		Stains: None		
Detergents: 0 mg/L		Non-illicit: None

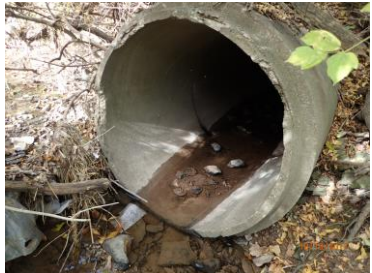
o20171019115316.JPG
2017

Inspection Date: 10/19/2017 11:55:23 AM		Type: Ongoing	Flow: Submerged, indeterminate	Previous Rainfall (hrs): 72+
Illicit Discharge Potential: Unlikely		Inspector: JCW	Notes	
Submerged: Partially Depth (in): 2			Upstream manhole dry - sample collected from submerged pool at end of pipe. 3" joint displacement and damaged concrete.	
Sampling Results		Floatables: None	Condition Assessment Graffiti: None Erosion: None Deposition: None in. Damage: Moderate	
Sample Location: Flow		Odor: None		
Total Chlorine: 0 ppm		Turbidity: None		
Free Chlorine: 0 ppm		Color: None		
Ammonia: 0 ppm		Gross Solids: None		
pH: 8.1 units		Vegetation: None		
Temperature 62 °F		Benthic Growth: Slight		
Conductivity: 725 µS/cm		Stains: None		
Detergents: 0 mg/L		Non-illicit: None

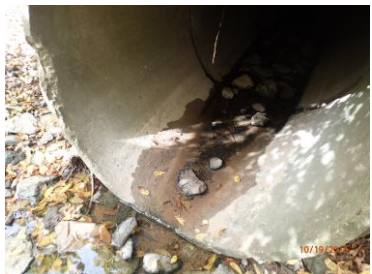
o20161019130908.JPG
2016

Inspection Date: 10/19/2016 1:11:20 PM		Type: Ongoing	Flow: Trickle	Previous Rainfall (hrs): 72+
Illicit Discharge Potential: Unlikely		Inspector: JCW	Notes	
Submerged: None Depth (in):			Last pipe segment displaced 4" at joint.	
Sampling Results		Floatables: None	Condition Assessment Graffiti: None Erosion: None Deposition: None in. Damage: Minor	
Sample Location: Flow		Odor: None		
Total Chlorine: 0 ppm		Turbidity: None		
Free Chlorine: 0 ppm		Color: Faint in bottle		
Ammonia: 0 ppm		Gross Solids: None		
pH: 8.24 units		Vegetation: None		
Temperature 65 °F		Benthic Growth: Slight		
Conductivity: 765 µS/cm		Stains: None		
Detergents: 0 mg/L		Non-illicit: None

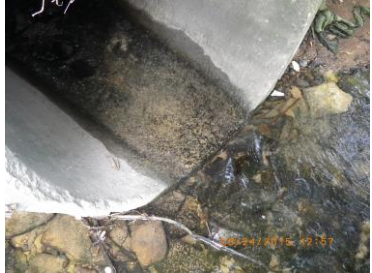
o20150924115728.JPG 2015

Inspection Date: 9/24/2015 12:55:30 PM		Type: Ongoing	Flow: Moderate	Previous Rainfall (hrs): 72+
Illicit Discharge Potential: Unlikely		Inspector: JCW	Notes 4" joint displacement.	
Submerged: None Depth (in):				
Sampling Results Sample Location: Flow Total Chlorine: 0 ppm Free Chlorine: 0 ppm Ammonia: 0 ppm pH: 8.17 units Temperature: 72 °F Conductivity: 1595 µS/cm Detergents: 0 mg/L		Floatables: None Odor: None Turbidity: None Color: None Gross Solids: None Vegetation: None Benthic Growth: None Stains: Slight Non-illicit: None	Condition Assessment Graffiti: None Erosion: None Deposition: None in. Damage: Moderate

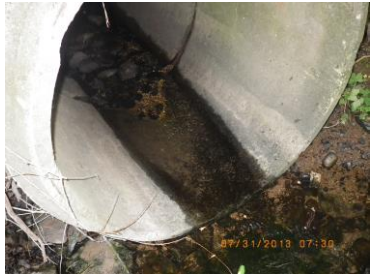
o20130731063036.JPG 2013

Inspection Date: 7/31/2013 7:27:16 AM		Type: Ongoing	Flow: Trickle	Previous Rainfall (hrs): 72+
Illicit Discharge Potential: Unlikely		Inspector: JCW	Notes End section displaced 4".	
Submerged: None Depth (in):				
Sampling Results Sample Location: Flow Total Chlorine: 0 ppm Free Chlorine: 0 ppm Ammonia: 0 ppm pH: 8.05 units Temperature: 71 °F Conductivity: 1865 µS/cm Detergents: 0 mg/L		Floatables: None Odor: None Turbidity: None Color: None Gross Solids: None Vegetation: None Benthic Growth: None Stains: Moderate Non-illicit: None	Condition Assessment Graffiti: None Erosion: None Deposition: None in. Damage: Minor

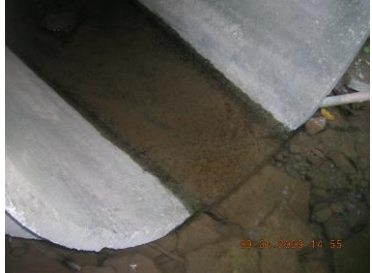
Osh09_DSCN6570.JPG 2009

Inspection Date: 9/4/2009		Type: Initial	Flow: Submerged, slight flow	Previous Rainfall (hrs): 72+
Illicit Discharge Potential: Unlikely		Inspector: JCW	Notes End section of pipe separated.	
Submerged: Partially Depth (in): 1				
Sampling Results Sample Location: Pool Total Chlorine: 0 ppm Free Chlorine: 0 ppm Ammonia: -- ppm pH: 7.82 units Temperature: 73 °F Conductivity: -- µS/cm Detergents: 0 mg/L		Floatables: None Odor: None Turbidity: None Color: None Gross Solids: None Vegetation: Slight Benthic Growth: Slight Stains: Slight Non-illicit: None	Condition Assessment Graffiti: None Erosion: None Deposition: None 0 in. Damage: Moderate

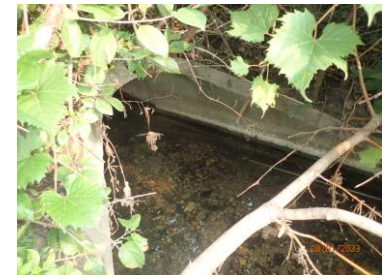
o20230801070046.JPG

Stains: Severe

Deposition: Minor Depth (in): 2

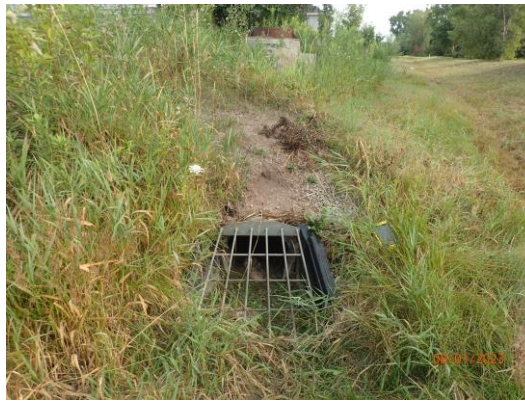
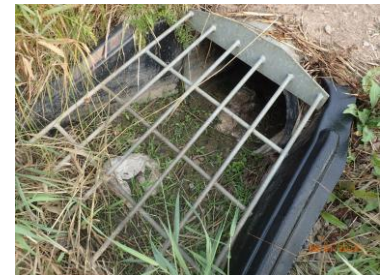
<p>o20171017133026.JPG</p> <p>2017</p>
		Condition Assessment Graffiti: None Erosion: None Deposition: None in. Damage: None

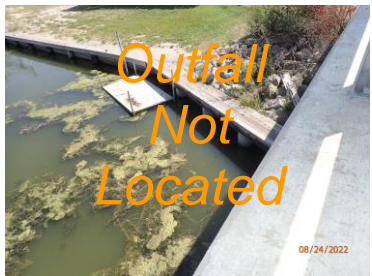
Temperature (field): -- °F

Ammonia (field): -- ppm

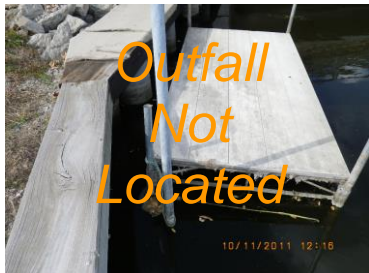
Inspection Date: 10/7/2014 1:47:08 PM		Type: Ongoing		Flow: Submerged, indeterminate		Previous Rainfall (hrs): 48-72	
Illicit Discharge Potential: Potential		Inspector: JCW		Notes

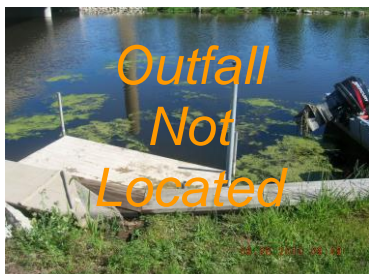
o20100826094912.JPG

Inspection Date: 8/26/2010 10:11:27 AM		Type: Ongoing	Flow: Submerged (not located)	Previous Rainfall (hrs): 72+
Illicit Discharge Potential: Potential		Inspector: JCW	Notes	
Submerged: Fully		Depth (in):	Outfall fully submerged and not physically located. Outfall screened upstream at 16-533 US1.	
Sampling Results		Floatables:	Condition Assessment Graffiti: None Erosion: None Deposition: None 0 in. Damage: None	
Sample Location:		Odor:		
Total Chlorine: -- ppm		Turbidity:		
Free Chlorine: -- ppm		Color:		
Ammonia: -- ppm		Gross Solids:		
pH: -- units		Vegetation:		
Temperature -- °F		Benthic Growth:		
Conductivity: -- µS/cm		Stains:		
Detergents: -- mg/L		Non-illicit:

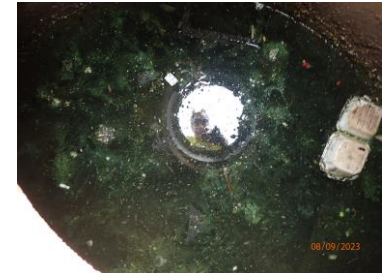
o20230809094116.JPG

**Inspection Date:** 8/9/2023 10:47:22 AM**Inspector:** JCW**Inspection Type:** Ongoing**Previous Rainfall (hrs):** 72+**Flow Description:** Submerged, indeterminate

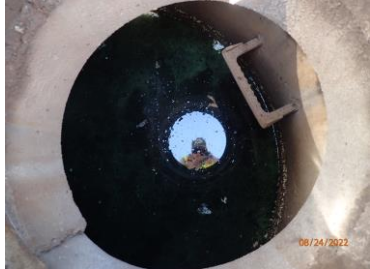
o20220824142446.JPG <div style="text-align: center; font-size: 24pt; font-weight: bold;">2022</div>

Inspection Date: 8/24/2022 2:30:00 PM		Type: Ongoing	Flow: Submerged, indeterminate	Previous Rainfall (hrs): 72+
Illicit Discharge Potential: Unlikely		Inspector: EJK		
Submerged: Fully		Depth (in):		
Sampling Results Sample Location: Pool Total Chlorine: 0 ppm Free Chlorine: 0 ppm Ammonia: 0 ppm pH: 7.64 units Temperature: 81 °F Conductivity: 354 µS/cm Detergents: 0 mg/L		Floatables: None Odor: None Turbidity: None Color: None Gross Solids: Slight Vegetation: None Benthic Growth: None Stains: None Non-illicit: None		
		Notes Sample collected from submerged pool in manhole.		
		Condition Assessment Graffiti: None Erosion: None Deposition: None in. Damage: None

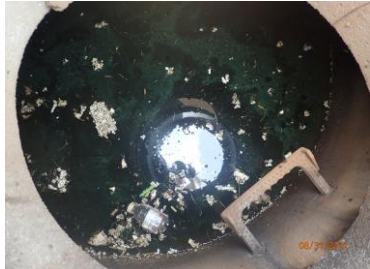
o20210831111218.JPG <div style="text-align: center; font-size: 24pt; font-weight: bold;">2021</div>

Inspection Date: 8/31/2021 11:17:57 AM		Type: Ongoing	Flow: Submerged, indeterminate	Previous Rainfall (hrs): 48-72
Illicit Discharge Potential: Potential		Inspector: JCW		
Submerged: Fully		Depth (in): 40		
Sampling Results Sample Location: Pool Total Chlorine: 0 ppm Free Chlorine: 0 ppm Ammonia: 0 ppm pH: 7.29 units Temperature: 78 °F Conductivity: 389 µS/cm Detergents: 0 mg/L		Floatables: None Odor: None Turbidity: None Color: None Gross Solids: Moderate Vegetation: None Benthic Growth: None Stains: None Non-illicit: None		
		Notes Sample collected from submerged pool in manhole. Floating gross solids (litter) in manhole.		
		Condition Assessment Graffiti: None Erosion: None Deposition: None in. Damage: None

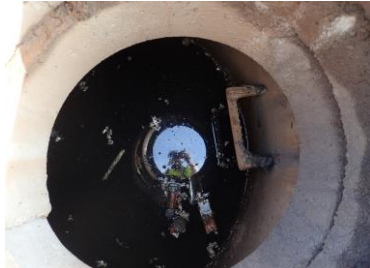
o20200924100816.JPG <div style="text-align: center; font-size: 24pt; font-weight: bold;">2020</div>

Inspection Date: 9/24/2020 10:01:33 AM		Type: Ongoing	Flow: Submerged, indeterminate	Previous Rainfall (hrs): 72+
Illicit Discharge Potential: Potential		Inspector: QAL		
Submerged: Fully		Depth (in): 33		
Sampling Results Sample Location: Pool Total Chlorine: 0 ppm Free Chlorine: 0 ppm Ammonia: 0 ppm pH: 8.8 units Temperature: 68 °F Conductivity: 433 µS/cm Detergents: 0 mg/L		Floatables: None Odor: None Turbidity: None Color: None Gross Solids: Moderate Vegetation: None Benthic Growth: None Stains: None Non-illicit: None		
		Notes Sample collected from submerged pool in manhole. Floating gross solids (litter) in manhole.		
		Condition Assessment Graffiti: None Erosion: None Deposition: None in. Damage: None

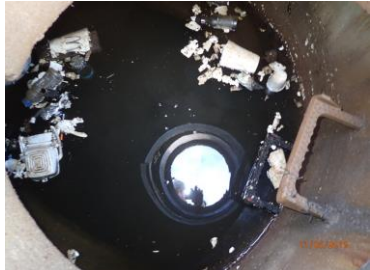
o20191105093642.JPG <div style="text-align: center; font-size: 24pt; font-weight: bold;">2019</div>

Inspection Date: 11/5/2019 9:37:43 AM		Type: Repeat	Flow: Submerged, indeterminate	Previous Rainfall (hrs): 48-72
Illicit Discharge Potential: Unlikely		Inspector: JCW		
Submerged: Partially		Depth (in): 38		
Sampling Results Sample Location: Pool Total Chlorine: -- ppm Free Chlorine: -- ppm Ammonia: -- ppm pH: -- units Temperature: -- °F Conductivity: -- µS/cm Detergents: 0 mg/L		Floatables: None Odor: None Turbidity: None Color: None Gross Solids: None Vegetation: None Benthic Growth: None Stains: None Non-illicit: None		
		Notes Follow-up inspection for sampling - limited screening conducted.		
		Condition Assessment Graffiti: None Erosion: None Deposition: None in. Damage: None

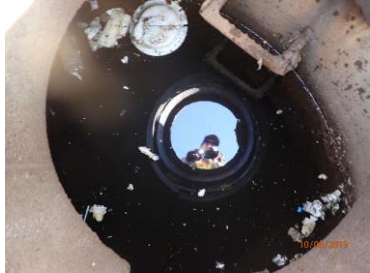
o20191008123830.JPG <div style="text-align: center; font-size: 24pt; font-weight: bold;">2019</div>

Inspection Date: 10/8/2019 1:38:32 PM		Type: Ongoing	Flow: Submerged, indeterminate	Previous Rainfall (hrs): 48-72																																										
Illicit Discharge Potential: Potential		Inspector: JCW	Notes																																											
Submerged: Partially Depth (in): 38			Sample collected from submerged pool in manhole. Floating gross solids (litter) in manhole. Detergent detected in sample.																																											
Sampling Results <table border="1" style="width:100%; border-collapse: collapse;"> <tr> <td>Sample Location:</td> <td>Pool</td> </tr> <tr> <td>Total Chlorine:</td> <td>0 ppm</td> </tr> <tr> <td>Free Chlorine:</td> <td>0 ppm</td> </tr> <tr> <td>Ammonia:</td> <td>0 ppm</td> </tr> <tr> <td>pH:</td> <td>7.34 units</td> </tr> <tr> <td>Temperature:</td> <td>66 °F</td> </tr> <tr> <td>Conductivity:</td> <td>449 µS/cm</td> </tr> <tr> <td>Detergents:</td> <td>0.5 mg/L</td> </tr> </table>		Sample Location:	Pool	Total Chlorine:	0 ppm	Free Chlorine:	0 ppm	Ammonia:	0 ppm	pH:	7.34 units	Temperature:	66 °F	Conductivity:	449 µS/cm	Detergents:	0.5 mg/L	<table border="1" style="width:100%; border-collapse: collapse;"> <tr> <td>Floatables:</td> <td>None</td> </tr> <tr> <td>Odor:</td> <td>None</td> </tr> <tr> <td>Turbidity:</td> <td>None</td> </tr> <tr> <td>Color:</td> <td>None</td> </tr> <tr> <td>Gross Solids:</td> <td>Moderate</td> </tr> <tr> <td>Vegetation:</td> <td>None</td> </tr> <tr> <td>Benthic Growth:</td> <td>None</td> </tr> <tr> <td>Stains:</td> <td>None</td> </tr> <tr> <td>Non-illicit:</td> <td>None</td> </tr> </table>	Floatables:	None	Odor:	None	Turbidity:	None	Color:	None	Gross Solids:	Moderate	Vegetation:	None	Benthic Growth:	None	Stains:	None	Non-illicit:	None	Condition Assessment <table border="1" style="width:100%; border-collapse: collapse;"> <tr> <td>Graffiti:</td> <td>None</td> </tr> <tr> <td>Erosion:</td> <td>None</td> </tr> <tr> <td>Deposition:</td> <td>None in.</td> </tr> <tr> <td>Damage:</td> <td>None</td> </tr> </table>		Graffiti:	None	Erosion:	None	Deposition:	None in.	Damage:	None

Sample Location:	Pool																																													
Total Chlorine:	0 ppm																																													
Free Chlorine:	0 ppm																																													
Ammonia:	0 ppm																																													
pH:	7.34 units																																													
Temperature:	66 °F																																													
Conductivity:	449 µS/cm																																													
Detergents:	0.5 mg/L																																													
Floatables:	None																																													
Odor:	None																																													
Turbidity:	None																																													
Color:	None																																													
Gross Solids:	Moderate																																													
Vegetation:	None																																													
Benthic Growth:	None

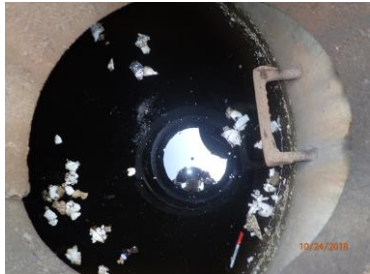
o20181024084850.JPG <div style="text-align: center; font-size: 24pt; font-weight: bold;">2018</div>

Inspection Date: 10/24/2018 8:51:52 AM		Type: Ongoing	Flow: Submerged, indeterminate	Previous Rainfall (hrs): 72+																																										
Illicit Discharge Potential: Potential		Inspector: JCW	Notes																																											
Submerged: Partially Depth (in): 46			Sample collected from submerged pool in manhole. Floating gross solids (litter) in manhole.																																											
Sampling Results <table border="1" style="width:100%; border-collapse: collapse;"> <tr> <td>Sample Location:</td> <td>Pool</td> </tr> <tr> <td>Total Chlorine:</td> <td>0 ppm</td> </tr> <tr> <td>Free Chlorine:</td> <td>0 ppm</td> </tr> <tr> <td>Ammonia:</td> <td>0 ppm</td> </tr> <tr> <td>pH:</td> <td>7.75 units</td> </tr> <tr> <td>Temperature:</td> <td>48 °F</td> </tr> <tr> <td>Conductivity:</td> <td>485 µS/cm</td> </tr> <tr> <td>Detergents:</td> <td>0 mg/L</td> </tr> </table>		Sample Location:	Pool	Total Chlorine:	0 ppm	Free Chlorine:	0 ppm	Ammonia:	0 ppm	pH:	7.75 units	Temperature:	48 °F	Conductivity:	485 µS/cm	Detergents:	0 mg/L	<table border="1" style="width:100%; border-collapse: collapse;"> <tr> <td>Floatables:</td> <td>None</td> </tr> <tr> <td>Odor:</td> <td>None</td> </tr> <tr> <td>Turbidity:</td> <td>None</td> </tr> <tr> <td>Color:</td> <td>None</td> </tr> <tr> <td>Gross Solids:</td> <td>Slight</td> </tr> <tr> <td>Vegetation:</td> <td>None</td> </tr> <tr> <td>Benthic Growth:</td> <td>None</td> </tr> <tr> <td>Stains:</td> <td>None</td> </tr> <tr> <td>Non-illicit:</td> <td>None</td> </tr> </table>	Floatables:	None	Odor:	None	Turbidity:	None	Color:	None	Gross Solids:	Slight	Vegetation:	None	Benthic Growth:	None	Stains:	None	Non-illicit:	None	Condition Assessment <table border="1" style="width:100%; border-collapse: collapse;"> <tr> <td>Graffiti:</td> <td>None</td> </tr> <tr> <td>Erosion:</td> <td>None</td> </tr> <tr> <td>Deposition:</td> <td>None in.</td> </tr> <tr> <td>Damage:</td> <td>None</td> </tr> </table>		Graffiti:	None	Erosion:	None	Deposition:	None in.	Damage:	None

Sample Location:	Pool																																													
Total Chlorine:	0 ppm																																													
Free Chlorine:	0 ppm																																													
Ammonia:	0 ppm																																													
pH:	7.75 units																																													
Temperature:	48 °F																																													
Conductivity:	485 µS/cm																																													
Detergents:	0 mg/L																																													
Floatables:	None																																													
Odor:	None																																													
Turbidity:	None																																													
Color:	None																																													
Gross Solids:	Slight																																													
Vegetation:	None																																													
Benthic Growth:	None

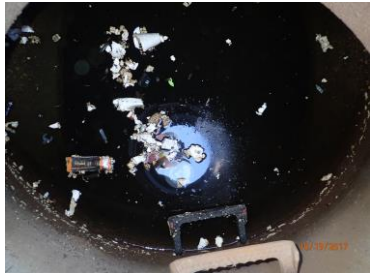
o20171019133054.JPG <div style="text-align: center; font-size: 24pt; font-weight: bold;">2017</div>

Inspection Date: 10/19/2017 1:34:48 PM		Type: Ongoing	Flow: Submerged, indeterminate	Previous Rainfall (hrs): 72+																																										
Illicit Discharge Potential: Unlikely		Inspector: JCW	Notes																																											
Submerged: Fully Depth (in):			Sample collected from submerged pool in manhole.																																											
Sampling Results <table border="1" style="width:100%; border-collapse: collapse;"> <tr> <td>Sample Location:</td> <td></td> </tr> <tr> <td>Total Chlorine:</td> <td>0 ppm</td> </tr> <tr> <td>Free Chlorine:</td> <td>0 ppm</td> </tr> <tr> <td>Ammonia:</td> <td>0 ppm</td> </tr> <tr> <td>pH:</td> <td>7.89 units</td> </tr> <tr> <td>Temperature:</td> <td>66 °F</td> </tr> <tr> <td>Conductivity:</td> <td>668 µS/cm</td> </tr> <tr> <td>Detergents:</td> <td>0 mg/L</td> </tr> </table>		Sample Location:		Total Chlorine:	0 ppm	Free Chlorine:	0 ppm	Ammonia:	0 ppm	pH:	7.89 units	Temperature:	66 °F	Conductivity:	668 µS/cm	Detergents:	0 mg/L	<table border="1" style="width:100%; border-collapse: collapse;"> <tr> <td>Floatables:</td> <td>Slight</td> </tr> <tr> <td>Odor:</td> <td>None</td> </tr> <tr> <td>Turbidity:</td> <td>None</td> </tr> <tr> <td>Color:</td> <td>None</td> </tr> <tr> <td>Gross Solids:</td> <td>Slight</td> </tr> <tr> <td>Vegetation:</td> <td>None</td> </tr> <tr> <td>Benthic Growth:</td> <td>None</td> </tr> <tr> <td>Stains:</td> <td>None</td> </tr> <tr> <td>Non-illicit:</td> <td>None</td> </tr> </table>	Floatables:	Slight	Odor:	None	Turbidity:	None	Color:	None	Gross Solids:	Slight	Vegetation:	None	Benthic Growth:	None	Stains:	None	Non-illicit:	None	Condition Assessment <table border="1" style="width:100%; border-collapse: collapse;"> <tr> <td>Graffiti:</td> <td>None</td> </tr> <tr> <td>Erosion:</td> <td>None</td> </tr> <tr> <td>Deposition:</td> <td>None in.</td> </tr> <tr> <td>Damage:</td> <td>None</td> </tr> </table>		Graffiti:	None	Erosion:	None	Deposition:	None in.	Damage:	None

Sample Location:																																														
Total Chlorine:	0 ppm																																													
Free Chlorine:	0 ppm																																													
Ammonia:	0 ppm																																													
pH:	7.89 units																																													
Temperature:	66 °F																																													
Conductivity:	668 µS/cm																																													
Detergents:	0 mg/L																																													
Floatables:	Slight																																													
Odor:	None																																													
Turbidity:	None																																													
Color:	None																																													
Gross Solids:	Slight																																													
Vegetation:	None																																													
Benthic Growth:	None

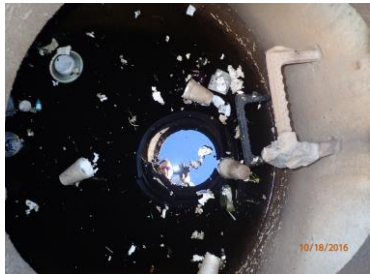
o20161018092516.JPG <div style="text-align: center; font-size: 24pt; font-weight: bold;">2016</div>

Inspection Date: 10/18/2016 9:29:17 AM		Type: Ongoing	Flow: Submerged, indeterminate	Previous Rainfall (hrs): 72+																																										
Illicit Discharge Potential: Potential		Inspector: JCW	Notes																																											
Submerged: Fully Depth (in): 40			Potential illicit discharge due to gross solids.																																											
Sampling Results <table border="1" style="width:100%; border-collapse: collapse;"> <tr> <td>Sample Location:</td> <td>Pool</td> </tr> <tr> <td>Total Chlorine:</td> <td>0 ppm</td> </tr> <tr> <td>Free Chlorine:</td> <td>0 ppm</td> </tr> <tr> <td>Ammonia:</td> <td>0 ppm</td> </tr> <tr> <td>pH:</td> <td>7.94 units</td> </tr> <tr> <td>Temperature:</td> <td>63 °F</td> </tr> <tr> <td>Conductivity:</td> <td>482 µS/cm</td> </tr> <tr> <td>Detergents:</td> <td>0 mg/L</td> </tr> </table>		Sample Location:	Pool	Total Chlorine:	0 ppm	Free Chlorine:	0 ppm	Ammonia:	0 ppm	pH:	7.94 units	Temperature:	63 °F	Conductivity:	482 µS/cm	Detergents:	0 mg/L	<table border="1" style="width:100%; border-collapse: collapse;"> <tr> <td>Floatables:</td> <td>None</td> </tr> <tr> <td>Odor:</td> <td>None</td> </tr> <tr> <td>Turbidity:</td> <td>None</td> </tr> <tr> <td>Color:</td> <td>None</td> </tr> <tr> <td>Gross Solids:</td> <td>Moderate</td> </tr> <tr> <td>Vegetation:</td> <td>None</td> </tr> <tr> <td>Benthic Growth:</td> <td>None</td> </tr> <tr> <td>Stains:</td> <td>None</td> </tr> <tr> <td>Non-illicit:</td> <td>None</td> </tr> </table>	Floatables:	None	Odor:	None	Turbidity:	None	Color:	None	Gross Solids:	Moderate	Vegetation:	None	Benthic Growth:	None	Stains:	None	Non-illicit:	None	Condition Assessment <table border="1" style="width:100%; border-collapse: collapse;"> <tr> <td>Graffiti:</td> <td>None</td> </tr> <tr> <td>Erosion:</td> <td>None</td> </tr> <tr> <td>Deposition:</td> <td>None in.</td> </tr> <tr> <td>Damage:</td> <td>None</td> </tr> </table>		Graffiti:	None	Erosion:	None	Deposition:	None in.	Damage:	None

Sample Location:	Pool																																													
Total Chlorine:	0 ppm																																													
Free Chlorine:	0 ppm																																													
Ammonia:	0 ppm																																													
pH:	7.94 units																																													
Temperature:	63 °F																																													
Conductivity:	482 µS/cm																																													
Detergents:	0 mg/L																																													
Floatables:	None																																													
Odor:	None																																													
Turbidity:	None																																													
Color:	None																																													
Gross Solids:	Moderate																																													
Vegetation:	None																																													
Benthic Growth:	None

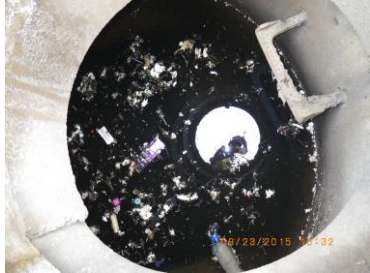
o20150923093204.JPG

Inspection Date: 9/23/2015 10:32:59 AM		Type: Ongoing	Flow: Submerged, indeterminate	Previous Rainfall (hrs): 72+
Illicit Discharge Potential: Potential		Inspector: JCW	Notes	
Submerged: Fully		Depth (in): 36	Floating gross solids (litter) - including syringe - in manhole.	
Sampling Results		Floatables: None	Condition Assessment	
Sample Location:	Pool	Odor: None	Graffiti: None Erosion: None Deposition: None in. Damage: None	
Total Chlorine:	0 ppm	Turbidity: None		
Free Chlorine:	0 ppm	Color: None		
Ammonia:	0 ppm	Gross Solids: Moderate		
pH:	7.95 units	Vegetation: None		
Temperature	71 °F	Benthic Growth: Slight		
Conductivity:	363 µS/cm	Stains: None		
Detergents:	0 mg/L	Non-illicit: None

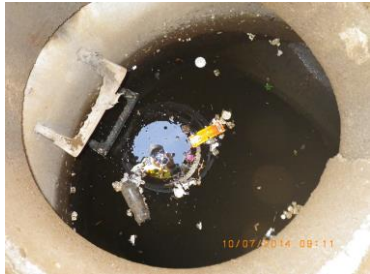
o20141007081140.JPG

Inspection Date: 10/7/2014 9:13:45 AM		Type: Ongoing	Flow: Submerged, indeterminate	Previous Rainfall (hrs): 48-72
Illicit Discharge Potential: Potential		Inspector: JCW	Notes	
Submerged: Fully		Depth (in): 34	Floating gross solids (litter) in manhole.	
Sampling Results		Floatables: None	Condition Assessment	
Sample Location:	Pool	Odor: None	Graffiti: None Erosion: None Deposition: None in. Damage: None	
Total Chlorine:	0 ppm	Turbidity: None		
Free Chlorine:	0 ppm	Color: None		
Ammonia:	0 ppm	Gross Solids: Moderate		
pH:	7.67 units	Vegetation: None		
Temperature	-- °F	Benthic Growth: None		
Conductivity:	474 µS/cm	Stains: None		
Detergents:	0 mg/L	Non-illicit: None

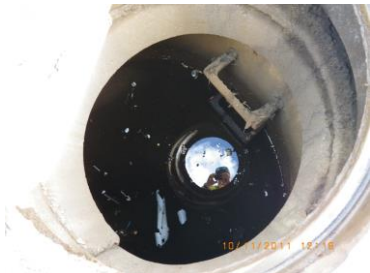
o20111011121924.JPG

Inspection Date: 10/11/2011 12:22:21 PM		Type: Ongoing	Flow: Submerged, indeterminate	Previous Rainfall (hrs): 72+
Illicit Discharge Potential: Unlikely		Inspector: JCW	Notes	
Submerged: Fully		Depth (in): 16	2010 screening follow-up. Floatable debris significantly reduced.	
Sampling Results		Floatables: None	Condition Assessment	
Sample Location:	Pool	Odor: None	Graffiti: None Erosion: None Deposition: None 0 in. Damage: None	
Total Chlorine:	0 ppm	Turbidity: None		
Free Chlorine:	0 ppm	Color: None		
Ammonia:	0 ppm	Gross Solids: Moderate		
pH:	7.9 units	Vegetation: None		
Temperature	70 °F	Benthic Growth: None		
Conductivity:	-- µS/cm	Stains: None		
Detergents:	-- mg/L	Non-illicit: None

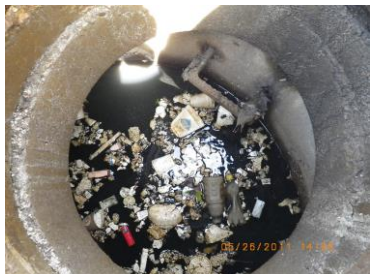
o20110526143524.JPG

Inspection Date: 5/26/2011 2:35:00 PM		Type: Other	Flow: Submerged, indeterminate	Previous Rainfall (hrs): 72+
Illicit Discharge Potential: Potential		Inspector: JCW	Notes	
Submerged: Fully		Depth (in):	Limited screening conducted to check for floatable debris.	
Sampling Results		Floatables: None	Condition Assessment	
Sample Location:		Odor:	Graffiti: None Erosion: None Deposition: None 0 in. Damage: None	
Total Chlorine:	-- ppm	Turbidity:		
Free Chlorine:	-- ppm	Color:		
Ammonia:	-- ppm	Gross Solids: Moderate		
pH:	-- units	Vegetation:		
Temperature	-- °F	Benthic Growth:		
Conductivity:	-- µS/cm	Stains:		
Detergents:	-- mg/L	Non-illicit: None

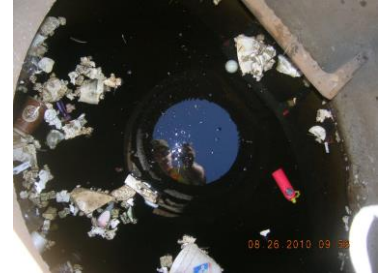
o20100826095640.JPG

Inspection Date: 8/26/2010 10:01:38 AM		Type: Ongoing	Flow: Submerged, indeterminate	Previous Rainfall (hrs): 72+
Illicit Discharge Potential: Potential		Inspector: JCW	Notes	
Submerged: Fully		Depth (in): 36	Floatable debris in manhole.	
Sampling Results				
Sample Location:	Pool	Floatables:	None	
Total Chlorine:	0 ppm	Odor:	None	
Free Chlorine:	0 ppm	Turbidity:	None	
Ammonia:	0 ppm	Color:	Faint in bottle	
pH:	7.23 units	Gross Solids:	Moderate	
Temperature	76 °F	Vegetation:	None	
Conductivity:	-- µS/cm	Benthic Growth:	Slight	
Detergents:	0 mg/L	Stains:	None	
		Non-illicit:	None	
		Condition Assessment		
		Graffiti:	None	
		Erosion:	None	
		Deposition:	None 0 in.	
		Damage:	None

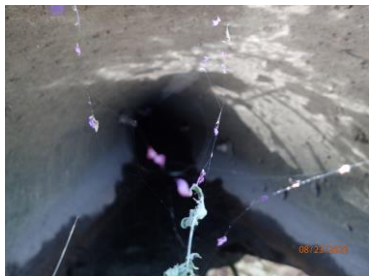
o20220823152424.JPG <div style="text-align: center; font-size: 24pt; font-weight: bold;">2022</div>

Inspection Date: 8/23/2022 3:25:00 PM		Type: Ongoing	Flow: Submerged, no flow	Previous Rainfall (hrs): 72+
Illicit Discharge Potential: Potential		Inspector: EJK		
Submerged: Partially		Depth (in): 2		
Sampling Results Sample Location: Pool Total Chlorine: 0 ppm Free Chlorine: 0 ppm Ammonia: 0 ppm pH: 8.55 units Temperature: 82 °F Conductivity: 835 µS/cm Detergents: 2.5 mg/L		Floatables: None Odor: Easily detected Turbidity: None Color: None Gross Solids: None Vegetation: None Benthic Growth: Severe Stains: Slight Non-illicit: Slight	Notes No flow escaping upstream curb inlet. Sample collected from outfall pool. Detergent in pond, possibly from car wash. Condition Assessment Graffiti: None Erosion: None Deposition: None in. Damage: None

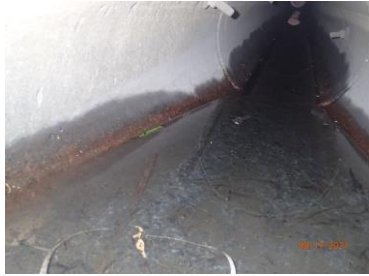
o20210817073912.JPG <div style="text-align: center; font-size: 24pt; font-weight: bold;">2021</div>

Inspection Date: 8/17/2021 7:41:43 AM		Type: Ongoing	Flow: Submerged, indeterminate	Previous Rainfall (hrs): 72+
Illicit Discharge Potential: Potential		Inspector: JCW		
Submerged: Partially		Depth (in): 3		
Sampling Results Sample Location: Pool Total Chlorine: 0 ppm Free Chlorine: 0 ppm Ammonia: 0 ppm pH: 7.4 units Temperature: 72 °F Conductivity: 2580 µS/cm Detergents: 0.6 mg/L		Floatables: None Odor: None Turbidity: None Color: None Gross Solids: None Vegetation: None Benthic Growth: Slight Stains: Slight Non-illicit: Slight	Notes Outfall partially submerged. Traffic prevented screening of upstream inlet. Pond sample from end of pipe had detergent and elevated conductivity. Condition Assessment Graffiti: None Erosion: None Deposition: None in. Damage: None

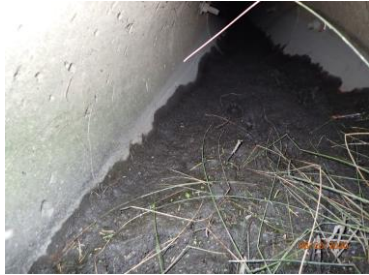
o20200820085150.JPG <div style="text-align: center; font-size: 24pt; font-weight: bold;">2020</div>

Inspection Date: 8/20/2020 8:54:14 AM		Type: Ongoing	Flow: None	Previous Rainfall (hrs): 72+
Illicit Discharge Potential: Unlikely		Inspector: JCW		
Submerged: None		Depth (in):		
Sampling Results Sample Location: -- Total Chlorine: -- ppm Free Chlorine: -- ppm Ammonia: -- ppm pH: -- units Temperature: -- °F Conductivity: -- µS/cm Detergents: -- mg/L		Floatables: None Odor: None Turbidity: None Color: None Gross Solids: None Vegetation: None Benthic Growth: Slight Stains: None Non-illicit: None	Notes Sediment wet, but no flow at time of inspection. No flow entering pipe at upstream curb inlet. Condition Assessment Graffiti: None Erosion: None Deposition: Minor 1 in. Damage: None

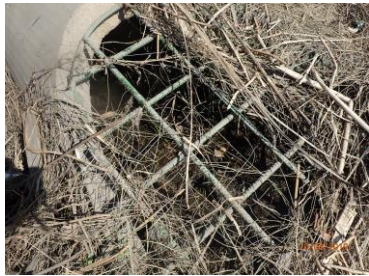
o20191008130940.JPG <div style="text-align: center; font-size: 24pt; font-weight: bold;">2019</div>

Inspection Date: 10/8/2019 2:11:11 PM		Type: Ongoing	Flow: Submerged, indeterminate	Previous Rainfall (hrs): 48-72
Illicit Discharge Potential: Potential		Inspector: JCW		
Submerged: Partially		Depth (in): 5		
Sampling Results Sample Location: -- Total Chlorine: -- ppm Free Chlorine: -- ppm Ammonia: -- ppm pH: -- units Temperature: -- °F Conductivity: -- µS/cm Detergents: -- mg/L		Floatables: None Odor: None Turbidity: None Color: None Gross Solids: Slight Vegetation: None Benthic Growth: Slight Stains: None Non-illicit: None	Notes Outfall partially submerged - screened upstream at 16-1205 US1. Detergent detected in upstream manhole. Condition Assessment Graffiti: None Erosion: None Deposition: Minor 2 in. Damage: None

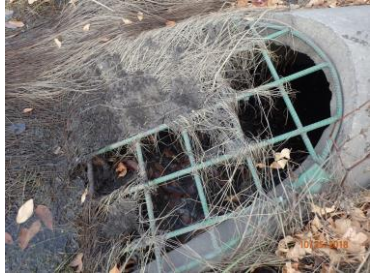
o20181025083538.JPG

Inspection Date: 10/25/2018 8:41:00 AM		Type: Ongoing	Flow: Submerged, indeterminate	Previous Rainfall (hrs): 72+
Illicit Discharge Potential: Potential		Inspector: JCW	Notes	
Submerged: Partially Depth (in): 5			Outfall partially submerged - screened upstream at 16-1205 US1. Detergent detected in upstream manhole.	
Sampling Results			Condition Assessment	
Sample Location:	Floatables:	None	Graffiti: None Erosion: None Deposition: Minor 2 in. Damage: None	
Total Chlorine: -- ppm	Odor:	None		
Free Chlorine: -- ppm	Turbidity:	None		
Ammonia: -- ppm	Color:	None		
pH: -- units	Gross Solids:	Slight		
Temperature -- °F	Vegetation:	None		
Conductivity: -- µS/cm	Benthic Growth:	None		
Detergents: -- mg/L	Stains:	None		
	Non-illicit:	None

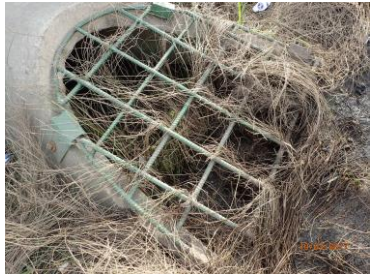
o20171003090114.JPG

Inspection Date: 10/3/2017 9:04:39 AM		Type: Ongoing	Flow: Submerged, indeterminate	Previous Rainfall (hrs): 72+
Illicit Discharge Potential: Unlikely		Inspector: JCW	Notes	
Submerged: Partially Depth (in): 1			Outfall partially submerged - screened upstream at 16-1205 US1.	
Sampling Results			Condition Assessment	
Sample Location:	Floatables:	None	Graffiti: None Erosion: None Deposition: Minor 1 in. Damage: None	
Total Chlorine: -- ppm	Odor:	None		
Free Chlorine: -- ppm	Turbidity:	None		
Ammonia: -- ppm	Color:	None		
pH: -- units	Gross Solids:	Slight		
Temperature -- °F	Vegetation:	None		
Conductivity: -- µS/cm	Benthic Growth:	None		
Detergents: -- mg/L	Stains:	None		
	Non-illicit:	None

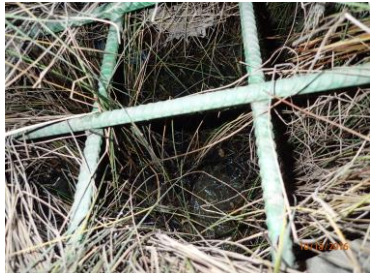
o20161018070408.JPG

Inspection Date: 10/18/2016 7:06:22 AM		Type: Ongoing	Flow: Submerged, indeterminate	Previous Rainfall (hrs): 72+
Illicit Discharge Potential: Unlikely		Inspector: JCW	Notes	
Submerged: Partially Depth (in): 2			Outfall partially submerged - screened upstream at 16-1205 US1.	
Sampling Results			Condition Assessment	
Sample Location:	Floatables:	None	Graffiti: None Erosion: None Deposition: None in. Damage: None	
Total Chlorine: -- ppm	Odor:	None		
Free Chlorine: -- ppm	Turbidity:	None		
Ammonia: -- ppm	Color:	None		
pH: -- units	Gross Solids:	None		
Temperature -- °F	Vegetation:	None		
Conductivity: -- µS/cm	Benthic Growth:	Slight		
Detergents: -- mg/L	Stains:	None		
	Non-illicit:	None

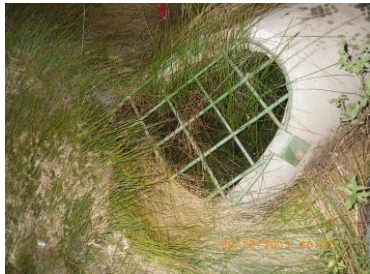
o20150928053734.JPG

Inspection Date: 9/28/2015 6:36:00 AM		Type: Ongoing	Flow: Submerged, indeterminate	Previous Rainfall (hrs): 72+
Illicit Discharge Potential: Unlikely		Inspector: JCW	Notes	
Submerged: Partially Depth (in): 3			Outfall partially submerged - screened at 16-1205 US1.	
Sampling Results			Condition Assessment	
Sample Location:	Floatables:	None	Graffiti: None Erosion: None Deposition: None in. Damage: None	
Total Chlorine: -- ppm	Odor:	None		
Free Chlorine: -- ppm	Turbidity:	None		
Ammonia: -- ppm	Color:	None		
pH: -- units	Gross Solids:	None		
Temperature -- °F	Vegetation:	None		
Conductivity: -- µS/cm	Benthic Growth:	Slight		
Detergents: -- mg/L	Stains:	Slight		
	Non-illicit:	None

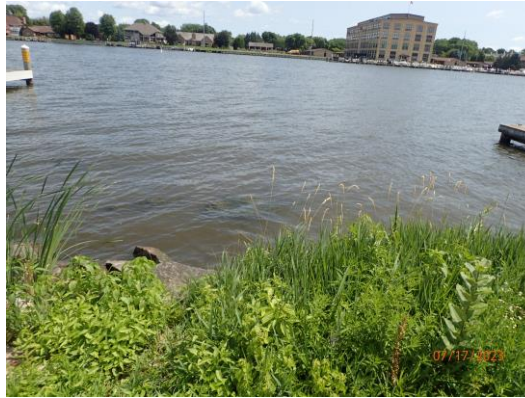
o20230717105540.JPG

Storm sewer from Graham Ave discharges to river from west. Pipe info from MS4 map.

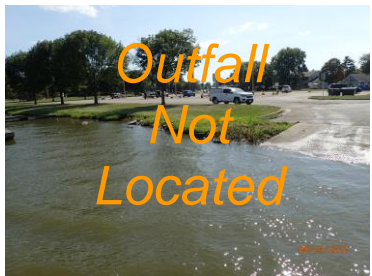
o20220824145704.JPG <div style="text-align: center; font-weight: bold; font-size: 1.2em;">2022</div>
		Condition Assessment Graffiti: None Erosion: None Deposition: None in. Damage: None

Inspection Date: 8/24/2022 3:03:00 PM		Type: Ongoing	Flow: Submerged (not located)	Previous Rainfall (hrs): 72+
Illicit Discharge Potential: Unlikely		Inspector: EJK		
Submerged: Fully		Depth (in):		
Sampling Results Sample Location: _____ Total Chlorine: -- ppm Free Chlorine: -- ppm Ammonia: -- ppm pH: -- units Temperature: -- °F Conductivity: -- µS/cm Detergents: -- mg/L		Floatables: None Odor: None Turbidity: None Color: None Gross Solids: None Vegetation: None Benthic Growth: None Stains: None Non-illicit: None	Notes Outfall fully submerged and not located - screened upstream at 16-201 US1.

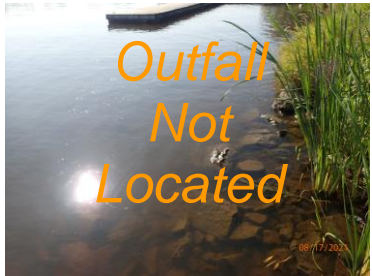
o20210817092902.JPG <div style="text-align: center; font-weight: bold; font-size: 1.2em;">2021</div>
		Condition Assessment Graffiti: None Erosion: None Deposition: None in. Damage: None

Inspection Date: 8/17/2021 9:30:31 AM		Type: Ongoing	Flow: Submerged (not located)	Previous Rainfall (hrs): 72+
Illicit Discharge Potential: Unlikely		Inspector: JCW		
Submerged: Fully		Depth (in):		
Sampling Results Sample Location: _____ Total Chlorine: -- ppm Free Chlorine: -- ppm Ammonia: -- ppm pH: -- units Temperature: -- °F Conductivity: -- µS/cm Detergents: -- mg/L		Floatables: None Odor: None Turbidity: None Color: None Gross Solids: None Vegetation: None Benthic Growth: None Stains: None Non-illicit: None	Notes Outfall fully submerged and not located - screened upstream at 16-201 US1.

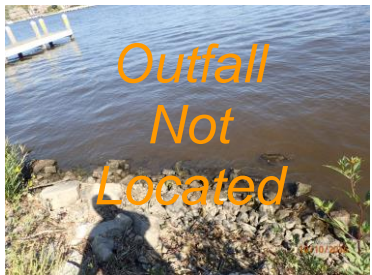
o20161010134624.JPG <div style="text-align: center; font-weight: bold; font-size: 1.2em;">2016</div>
		Condition Assessment Graffiti: None Erosion: None Deposition: None in. Damage: None

Inspection Date: 10/10/2016 1:47:19 PM		Type: Ongoing	Flow: Submerged (not located)	Previous Rainfall (hrs): 72+
Illicit Discharge Potential: Potential		Inspector: JCW		
Submerged: Fully		Depth (in):		
Sampling Results Sample Location: _____ Total Chlorine: -- ppm Free Chlorine: -- ppm Ammonia: -- ppm pH: -- units Temperature: -- °F Conductivity: -- µS/cm Detergents: -- mg/L		Floatables: None Odor: None Turbidity: None Color: None Gross Solids: None Vegetation: None Benthic Growth: None Stains: None Non-illicit: None	Notes Outfall fully submerged and not located - screened upstream at 16-201 US1.

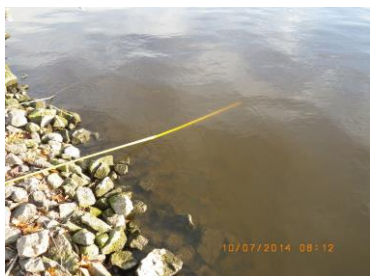
o20141007071204.JPG <div style="text-align: center; font-weight: bold; font-size: 1.2em;">2014</div>
		Condition Assessment Graffiti: None Erosion: None Deposition: None in. Damage: None

Inspection Date: 10/7/2014 8:11:23 AM		Type: Ongoing	Flow: Submerged, indeterminate	Previous Rainfall (hrs): 48-72
Illicit Discharge Potential: Unlikely		Inspector: JCW		
Submerged: Fully		Depth (in): 28		
Sampling Results Sample Location: _____ Total Chlorine: -- ppm Free Chlorine: -- ppm Ammonia: -- ppm pH: -- units Temperature: -- °F Conductivity: -- µS/cm Detergents: -- mg/L		Floatables: None Odor: None Turbidity: None Color: None Gross Solids: None Vegetation: None Benthic Growth: None Stains: None Non-illicit: None	Notes Outfall fully submerged - screened upstream at 16-201 US1.

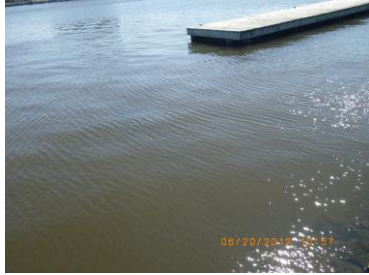
o20120620095704.JPG <div style="text-align: center; font-size: 24pt; font-weight: bold;">2012</div>

Inspection Date: 6/20/2012 10:55:37 AM		Type: Ongoing	Flow: Submerged, indeterminate	Previous Rainfall (hrs): 24-48																																			
Illicit Discharge Potential: Unlikely		Inspector: JCW	Notes																																				
Submerged: Fully		Depth (in):	Outfall fully submerged; screened upstream at 16-201 US1.																																				
Sampling Results <table border="1" style="width:100%; border-collapse: collapse;"> <tr> <td>Sample Location:</td> <td>Floatables:</td> <td>None</td> </tr> <tr> <td>Total Chlorine: -- ppm</td> <td>Odor:</td> <td>None</td> </tr> <tr> <td>Free Chlorine: -- ppm</td> <td>Turbidity:</td> <td>None</td> </tr> <tr> <td>Ammonia: -- ppm</td> <td>Color:</td> <td>None</td> </tr> <tr> <td>pH: -- units</td> <td>Gross Solids:</td> <td>None</td> </tr> <tr> <td>Temperature -- °F</td> <td>Vegetation:</td> <td>None</td> </tr> <tr> <td>Conductivity: -- µS/cm</td> <td>Benthic Growth:</td> <td>None</td> </tr> <tr> <td>Detergents: -- mg/L</td> <td>Stains:</td> <td>None</td> </tr> <tr> <td></td> <td>Non-illicit:</td> <td>None</td> </tr> </table>		Sample Location:	Floatables:	None	Total Chlorine: -- ppm	Odor:	None	Free Chlorine: -- ppm	Turbidity:	None	Ammonia: -- ppm	Color:	None	pH: -- units	Gross Solids:	None	Temperature -- °F	Vegetation:	None	Conductivity: -- µS/cm	Benthic Growth:	None	Detergents: -- mg/L	Stains:	None		Non-illicit:	None	Condition Assessment <table border="1" style="width:100%; border-collapse: collapse;"> <tr> <td>Graffiti:</td> <td>None</td> </tr> <tr> <td>Erosion:</td> <td>None</td> </tr> <tr> <td>Deposition:</td> <td>None in.</td> </tr> <tr> <td>Damage:</td> <td>None</td> </tr> </table>			Graffiti:	None	Erosion:	None	Deposition:	None in.	Damage:	None

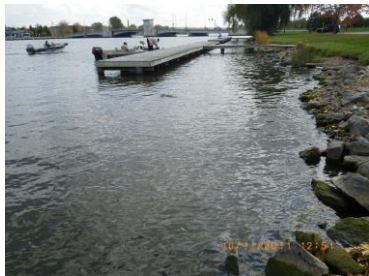
o20111011125132.JPG <div style="text-align: center; font-size: 24pt; font-weight: bold;">2011</div>

Inspection Date: 10/11/2011 12:51:01 PM		Type: Ongoing	Flow: Submerged, indeterminate	Previous Rainfall (hrs): 72+																																			
Illicit Discharge Potential: Potential		Inspector: JCW	Notes																																				
Submerged: Partially		Depth (in):	2010 screening follow-up. Outfall partially submerged. Outfall screened upstream at 16-201 US1.																																				
Sampling Results <table border="1" style="width:100%; border-collapse: collapse;"> <tr> <td>Sample Location:</td> <td>Floatables:</td> <td>None</td> </tr> <tr> <td>Total Chlorine: -- ppm</td> <td>Odor:</td> <td>None</td> </tr> <tr> <td>Free Chlorine: -- ppm</td> <td>Turbidity:</td> <td>None</td> </tr> <tr> <td>Ammonia: -- ppm</td> <td>Color:</td> <td>None</td> </tr> <tr> <td>pH: -- units</td> <td>Gross Solids:</td> <td>None</td> </tr> <tr> <td>Temperature -- °F</td> <td>Vegetation:</td> <td>None</td> </tr> <tr> <td>Conductivity: -- µS/cm</td> <td>Benthic Growth:</td> <td>None</td> </tr> <tr> <td>Detergents: -- mg/L</td> <td>Stains:</td> <td>None</td> </tr> <tr> <td></td> <td>Non-illicit:</td> <td>None</td> </tr> </table>		Sample Location:	Floatables:	None	Total Chlorine: -- ppm	Odor:	None	Free Chlorine: -- ppm	Turbidity:	None	Ammonia: -- ppm	Color:	None	pH: -- units	Gross Solids:	None	Temperature -- °F	Vegetation:	None	Conductivity: -- µS/cm	Benthic Growth:	None	Detergents: -- mg/L	Stains:	None		Non-illicit:	None	Condition Assessment <table border="1" style="width:100%; border-collapse: collapse;"> <tr> <td>Graffiti:</td> <td>None</td> </tr> <tr> <td>Erosion:</td> <td>None</td> </tr> <tr> <td>Deposition:</td> <td>None 0 in.</td> </tr> <tr> <td>Damage:</td> <td>None</td> </tr> </table>			Graffiti:	None	Erosion:	None	Deposition:	None 0 in.	Damage:	None

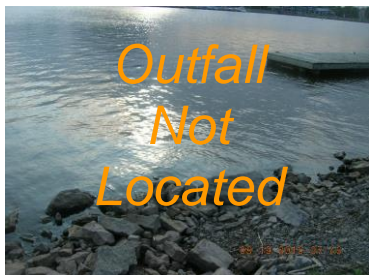
o20100819074346.JPG <div style="text-align: center; font-size: 24pt; font-weight: bold;">2010</div>

Inspection Date: 8/19/2010 7:49:43 AM		Type: Ongoing	Flow: Submerged (not located)	Previous Rainfall (hrs): 72+																																			
Illicit Discharge Potential: Potential		Inspector: JCW	Notes																																				
Submerged: Fully		Depth (in):	2010 screening follow-up. Outfall fully submerged and not physically located. Outfall screened upstream at 16-201 US1.																																				
Sampling Results <table border="1" style="width:100%; border-collapse: collapse;"> <tr> <td>Sample Location:</td> <td>Floatables:</td> <td>None</td> </tr> <tr> <td>Total Chlorine: -- ppm</td> <td>Odor:</td> <td>None</td> </tr> <tr> <td>Free Chlorine: -- ppm</td> <td>Turbidity:</td> <td>None</td> </tr> <tr> <td>Ammonia: -- ppm</td> <td>Color:</td> <td>None</td> </tr> <tr> <td>pH: -- units</td> <td>Gross Solids:</td> <td>None</td> </tr> <tr> <td>Temperature -- °F</td> <td>Vegetation:</td> <td>None</td> </tr> <tr> <td>Conductivity: -- µS/cm</td> <td>Benthic Growth:</td> <td>None</td> </tr> <tr> <td>Detergents: -- mg/L</td> <td>Stains:</td> <td>None</td> </tr> <tr> <td></td> <td>Non-illicit:</td> <td>None</td> </tr> </table>		Sample Location:	Floatables:	None	Total Chlorine: -- ppm	Odor:	None	Free Chlorine: -- ppm	Turbidity:	None	Ammonia: -- ppm	Color:	None	pH: -- units	Gross Solids:	None	Temperature -- °F	Vegetation:	None	Conductivity: -- µS/cm	Benthic Growth:	None	Detergents: -- mg/L	Stains:	None		Non-illicit:	None	Condition Assessment <table border="1" style="width:100%; border-collapse: collapse;"> <tr> <td>Graffiti:</td> <td>None</td> </tr> <tr> <td>Erosion:</td> <td>None</td> </tr> <tr> <td>Deposition:</td> <td>None 0 in.</td> </tr> <tr> <td>Damage:</td> <td>None</td> </tr> </table>			Graffiti:	None	Erosion:	None	Deposition:	None 0 in.	Damage:	None

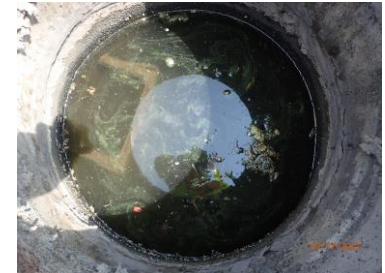
o20230717105908.JPG

Illicit Discharge Potential: Unlikely**Notes:** Sample collected from submerged pool in manhole.**Floatables:** Slight**Odor:** None**Turbidity:** None**Color:** None**Gross Solids:** Slight**Vegetation:** None**Benthic Growth:** Slight**Stains:** None**Non-illicit:** None☐ Petrol. Sheen ☐ Suds ☐ Sewage ☒ Algae ☐ Other☐ Petroleum ☐ Musty ☐ Sewage ☐ Chlorine ☐ Other☐ VOC/Solvent ☐ Fishy ☐ Sulfur ☐ Fragrant☒ Litter ☐ Veg. Debris ☐ Sediment ☐ Other☐ Inhibited ☐ Excessive☒ Green ☐ Brown☐ Flow Line ☐ Oil ☐ Rust Stains☐ Paint ☐ Other☐ Natural Sheen ☐ Natural Suds/Foam**Physical Condition Assessment****Graffiti:** None**Erosion:** None**Deposition:** None Depth (in):**Damage:** None ☐ Displacement ☐ Undercut ☐ Crushed☐ Corrosion ☐ Cracks/Structural Damage

2023**Sampling Results****Sample Location:** Pool**Sample ID:** 230717-01**Time Collected:** 11:58**Total Chlorine (field):** 0 ppm**Free Chlorine (field):** 0 ppm**Ammonia (field):** 0 ppm**pH (field):** 8.90 units**Temperature (field):** 77 °F**Conductivity (field):** 391 µS/cm**Detergents:** 0 mg/L

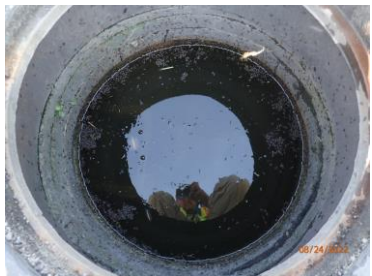
<p style="text-align: center;">o20220824150102.JPG</p> <p style="text-align: center; font-size: 24pt; font-weight: bold;">2022</p>

Sample Location:	Pool																																					
Total Chlorine:	0 ppm																																					
Free Chlorine:	0 ppm																																					
Ammonia:	0 ppm																																					
pH:	8.64 units																																					
Temperature:	79 °F																																					
Conductivity:	332 µS/cm																																					
Detergents:	0 mg/L																																					
Floatables:	None																																					
Odor:	None																																					
Turbidity:	None																																					
Color:	None																																					
Gross Solids:	Slight																																					
Vegetation:	None																																					
Benthic Growth:	None																																					
Stains:	None																																					
Non-illicit:	None

<div style="display: flex;"> <div style="flex: 1;"> <p>Notes</p> <p>Sample collected from submerged pool in manhole.</p> </div> <div style="flex: 1;"> <p>Condition Assessment</p> <p>Graffiti: None</p> <p>Erosion: None</p> <p>Deposition: None in.</p> <p>Damage: None</p> </div> </div>

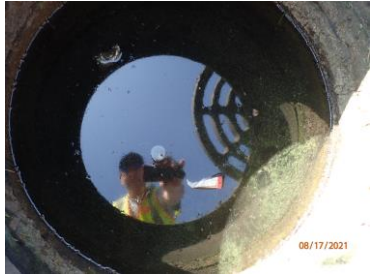
<p style="text-align: center;">o20210817093056.JPG</p> <p style="text-align: center; font-size: 24pt; font-weight: bold;">2021</p>

Sample Location:	Pool																																					
Total Chlorine:	0 ppm																																					
Free Chlorine:	0 ppm																																					
Ammonia:	0 ppm																																					
pH:	7.5 units																																					
Temperature:	78 °F																																					
Conductivity:	315 µS/cm																																					
Detergents:	0 mg/L																																					
Floatables:	Moderate																																					
Odor:	Easily detected																																					
Turbidity:	None																																					
Color:	None																																					
Gross Solids:	Slight																																					
Vegetation:	None																																					
Benthic Growth:	Moderate																																					
Stains:	None																																					
Non-illicit:	None

<div style="display: flex;"> <div style="flex: 1;"> <p>Notes</p> <p>Sample collected from submerged pool in manhole.</p> </div> <div style="flex: 1;"> <p>Condition Assessment</p> <p>Graffiti: None</p> <p>Erosion: None</p> <p>Deposition: None in.</p> <p>Damage: None</p> </div> </div>

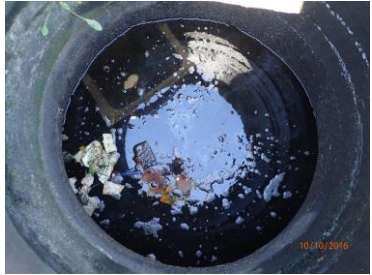
<p style="text-align: center;">o20161010134816.JPG</p> <p style="text-align: center; font-size: 24pt; font-weight: bold;">2016</p>

Sample Location:	Pool																																					
Total Chlorine:	0 ppm																																					
Free Chlorine:	0 ppm																																					
Ammonia:	0 ppm																																					
pH:	7.22 units																																					
Temperature:	69 °F																																					
Conductivity:	429 µS/cm																																					
Detergents:	0 mg/L																																					
Floatables:	Slight																																					
Odor:	Faint																																					
Turbidity:	None																																					
Color:	Faint in bottle																																					
Gross Solids:	Moderate																																					
Vegetation:	None																																					
Benthic Growth:	None																																					
Stains:	None																																					
Non-illicit:	None

<div style="display: flex;"> <div style="flex: 1;"> <p>Notes</p> <p>Potential illicit discharge due to gross solids.</p> </div> <div style="flex: 1;"> <p>Condition Assessment</p> <p>Graffiti: None</p> <p>Erosion: None</p> <p>Deposition: None in.</p> <p>Damage: None</p> </div> </div>

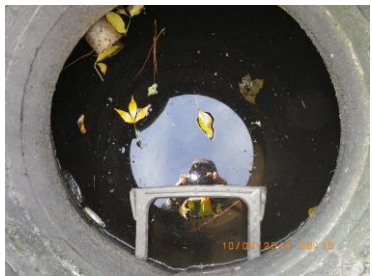
<p style="text-align: center;">o20141007071502.JPG</p> <p style="text-align: center; font-size: 24pt; font-weight: bold;">2014</p>

Sample Location:	Pool																																					
Total Chlorine:	0 ppm																																					
Free Chlorine:	0 ppm																																					
Ammonia:	0 ppm																																					
pH:	7.42 units																																					
Temperature:	-- °F																																					
Conductivity:	429 µS/cm																																					
Detergents:	0 mg/L																																					
Floatables:	None																																					
Odor:	None																																					
Turbidity:	None																																					
Color:	None																																					
Gross Solids:	Slight																																					
Vegetation:	None																																					
Benthic Growth:	Slight																																					
Stains:	None																																					
Non-illicit:	None

<div style="display: flex;"> <div style="flex: 1;"> <p>Notes</p> </div> <div style="flex: 1;"> <p>Condition Assessment</p> <p>Graffiti: None</p> <p>Erosion: None</p> <p>Deposition: None in.</p> <p>Damage: None</p> </div> </div>

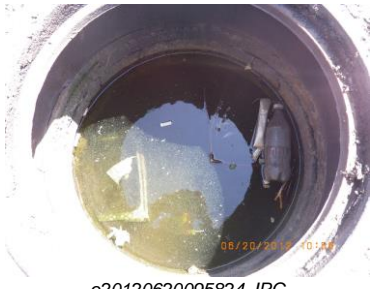
o20120620095824.JPG

Inspection Date: 6/20/2012 10:56:06 AM		Type: Ongoing	Flow: Submerged, indeterminate	Previous Rainfall (hrs): 24-48
Illicit Discharge Potential: Unlikely		Inspector: JCW	Notes	
Submerged: Fully		Depth (in): 29	2011 gross solids follow-up. Visual screening only.	
Sampling Results		Condition Assessment		
Sample Location:	Floatables:	None		
Total Chlorine: -- ppm	Odor:	None		
Free Chlorine: -- ppm	Turbidity:	None		
Ammonia: -- ppm	Color:	None		
pH: -- units	Gross Solids:	Slight		
Temperature -- °F	Vegetation:	None		
Conductivity: -- µS/cm	Benthic Growth:	Slight		
Detergents: -- mg/L	Stains:	None		
	Non-illicit:	None		
		Graffiti:	None	
		Erosion:	None	
		Deposition:	None	in.
		Damage:	None

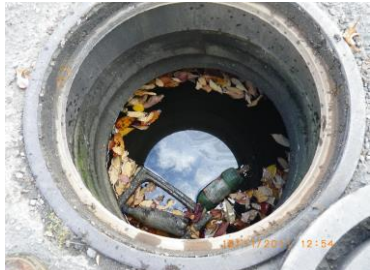
o20111011125430.JPG

Inspection Date: 10/11/2011 12:54:49 PM		Type: Ongoing	Flow: Submerged, indeterminate	Previous Rainfall (hrs): 72+
Illicit Discharge Potential: Potential		Inspector: JCW	Notes	
Submerged: Fully		Depth (in): 22	2010 screening follow-up. Floatable debris still present. Slight petroleum sheen.	
Sampling Results		Condition Assessment		
Sample Location: Pool	Floatables:	Slight		
Total Chlorine: 0 ppm	Odor:	None		
Free Chlorine: 0 ppm	Turbidity:	None		
Ammonia: 0 ppm	Color:	None		
pH: 8.44 units	Gross Solids:	Slight		
Temperature 71 °F	Vegetation:	None		
Conductivity: -- µS/cm	Benthic Growth:	None		
Detergents: -- mg/L	Stains:	None		
	Non-illicit:	None		
		Graffiti:	None	
		Erosion:	None	
		Deposition:	None	0 in.
		Damage:	None

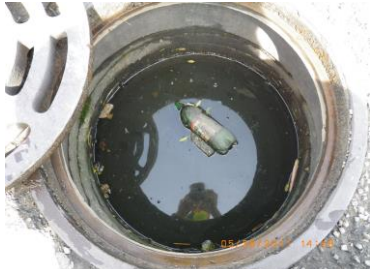
o20110526144848.JPG

Inspection Date: 5/26/2011 2:48:00 PM		Type: Other	Flow: Submerged, indeterminate	Previous Rainfall (hrs): 72+
Illicit Discharge Potential: Unlikely		Inspector: JCW	Notes	
Submerged: Fully		Depth (in):	Limited screening conducted to check for floatable debris.	
Sampling Results		Condition Assessment		
Sample Location:	Floatables:	Slight		
Total Chlorine: -- ppm	Odor:			
Free Chlorine: -- ppm	Turbidity:			
Ammonia: -- ppm	Color:			
pH: -- units	Gross Solids:	Slight		
Temperature -- °F	Vegetation:			
Conductivity: -- µS/cm	Benthic Growth:			
Detergents: -- mg/L	Stains:			
	Non-illicit:	None		
		Graffiti:	None	
		Erosion:	None	
		Deposition:	None	0 in.
		Damage:	None

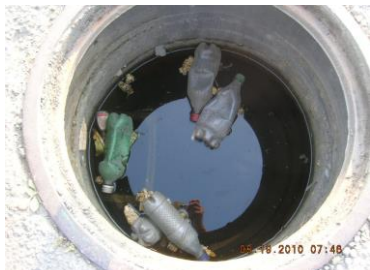
o20100819074612.JPG

Inspection Date: 8/19/2010 7:54:51 AM		Type: Ongoing	Flow: Submerged, indeterminate	Previous Rainfall (hrs): 72+
Illicit Discharge Potential: Potential		Inspector: JCW	Notes	
Submerged: Fully		Depth (in): 29	Moderate floatable debris in catchbasin.	
Sampling Results		Condition Assessment		
Sample Location: Pool	Floatables:	None		
Total Chlorine: 0 ppm	Odor:	None		
Free Chlorine: 0 ppm	Turbidity:	Slight cloudiness		
Ammonia: 0 ppm	Color:	Faint in bottle		
pH: 7.57 units	Gross Solids:	Moderate		
Temperature 74 °F	Vegetation:	None		
Conductivity: -- µS/cm	Benthic Growth:	Slight		
Detergents: 0 mg/L	Stains:	None		
	Non-illicit:	None		
		Graffiti:	None	
		Erosion:	None	
		Deposition:	None	0 in.
		Damage:	None

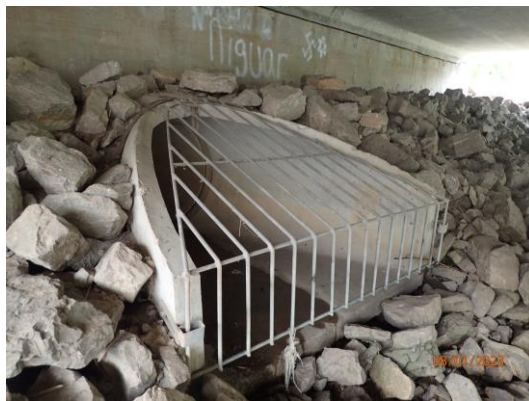
o20230801101838.JPG

Storm sewer from N Washburn St discharges to stream from south under bridge. Replaces outfall 16-646a (2009).

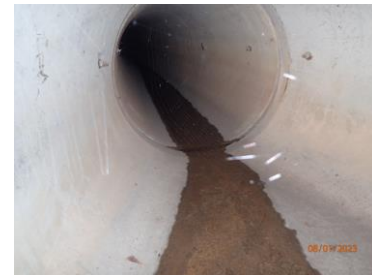
o20230801101852.JPG

Stains: Slight

Damage: Minor ☒ Displacement ☐ Undercut ☐ Crushed☐ Corrosion ☐ Cracks/Structural Damage

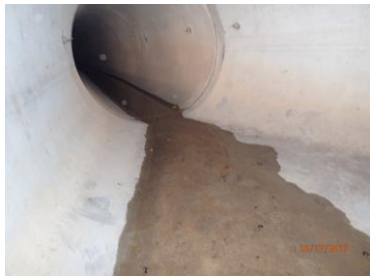
Inspection Date: 10/17/2017 10:14:25 AM		Type: Ongoing	Flow: Trickle	Previous Rainfall (hrs): 48-72
Illicit Discharge Potential: Unlikely		Inspector: JCW		
Submerged: None		Depth (in):		
Sampling Results Sample Location: Flow Total Chlorine: 0 ppm Free Chlorine: 0 ppm Ammonia: 0 ppm pH: 8.7 units Temperature: 65 °F Conductivity: 1919 µS/cm Detergents: 0 mg/L		Floatables: None Odor: None Turbidity: None Color: None Gross Solids: Slight Vegetation: None Benthic Growth: None Stains: None Non-illicit: None	Notes Sample collected from pipe flow. Loose grate.

o20171017100542.JPG <div style="font-size: 24pt; font-weight: bold; text-align: center;">2017</div>
		Condition Assessment Graffiti: None Erosion: None Deposition: None in. Damage: Minor

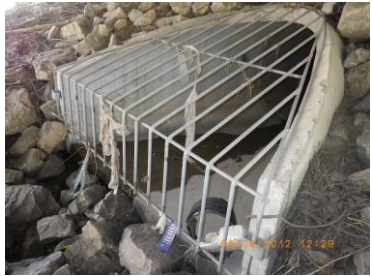
Inspection Date: 6/6/2012 12:26:31 PM		Type: Ongoing	Flow: None	Previous Rainfall (hrs): 72+
Illicit Discharge Potential: Unlikely		Inspector: JCW		
Submerged: None		Depth (in):		
Sampling Results Sample Location: -- Total Chlorine: -- ppm Free Chlorine: -- ppm Ammonia: -- ppm pH: -- units Temperature: -- °F Conductivity: -- µS/cm Detergents: -- mg/L		Floatables: None Odor: None Turbidity: None Color: None Gross Solids: Slight Vegetation: None Benthic Growth: None Stains: None Non-illicit: None	Notes Wet but no flow. Minor litter, likely from construction.
