IDDE Ongoing Screening Summary Report

2023 Inspection Year

Westwood

City of Oshkosh

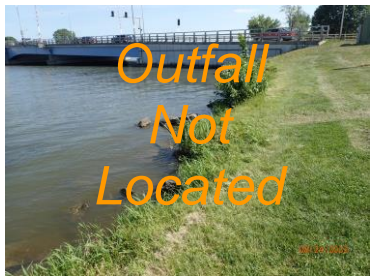
Inspection Date: 8/24/2022 2:52:00 PM		Type: Ongoing	Flow: Submerged (not located)	Previous Rainfall (hrs): 72+
Illicit Discharge Potential: Potential		Inspector: EJK	<div style="border: 1px solid black; padding: 5px;"> Notes Outfall fully submerged and not located - screened upstream at 16-594 US1. Floating gross solids (litter) in upstream manhole. </div> <div style="border: 1px solid black; padding: 5px; margin-top: 5px;"> Condition Assessment Graffiti: None Erosion: None Deposition: None in. Damage: None </div>	
Submerged: Fully Depth (in):				
<div style="border: 1px solid black; padding: 5px;"> Sampling Results Sample Location: _____ Total Chlorine: -- ppm Free Chlorine: -- ppm Ammonia: -- ppm pH: -- units Temperature -- ° F Conductivity: -- µS/cm Detergents: -- mg/L </div>		Floatables: None Odor: None Turbidity: None Color: None Gross Solids: None Vegetation: None Benthic Growth: None Stains: None Non-illicit: None	<div style="text-align: center;">

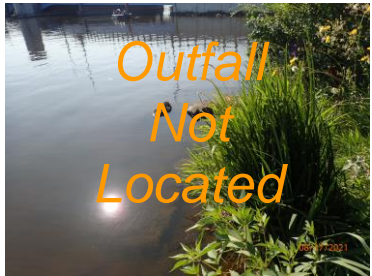
Inspection Date: 8/17/2021 9:39:49 AM		Type: Ongoing	Flow: Submerged (not located)	Previous Rainfall (hrs): 72+
Illicit Discharge Potential: Potential		Inspector: JCW	<div style="border: 1px solid black; padding: 5px;"> Notes Outfall fully submerged and not located - screened upstream at 16-594 US1. Floating gross solids (litter) in upstream manhole. </div> <div style="border: 1px solid black; padding: 5px; margin-top: 5px;"> Condition Assessment Graffiti: None Erosion: None Deposition: None in. Damage: None </div>	
Submerged: Fully Depth (in):				
<div style="border: 1px solid black; padding: 5px;"> Sampling Results Sample Location: _____ Total Chlorine: -- ppm Free Chlorine: -- ppm Ammonia: -- ppm pH: -- units Temperature -- ° F Conductivity: -- µS/cm Detergents: -- mg/L </div>		Floatables: None Odor: None Turbidity: None Color: None Gross Solids: None Vegetation: None Benthic Growth: None Stains: None Non-illicit: None	<div style="text-align: center;">

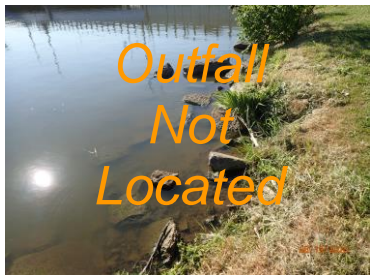
Inspection Date: 8/19/2020 9:04:07 AM		Type: Ongoing	Flow: Submerged (not located)	Previous Rainfall (hrs): 72+
Illicit Discharge Potential: Potential		Inspector: JCW	<div style="border: 1px solid black; padding: 5px;"> Notes Outfall fully submerged and not located - screened upstream at 16-594 US1. Floating gross solids (litter) in upstream manhole. </div> <div style="border: 1px solid black; padding: 5px; margin-top: 5px;"> Condition Assessment Graffiti: None Erosion: None Deposition: None in. Damage: None </div>	
Submerged: Fully Depth (in):				
<div style="border: 1px solid black; padding: 5px;"> Sampling Results Sample Location: _____ Total Chlorine: -- ppm Free Chlorine: -- ppm Ammonia: -- ppm pH: -- units Temperature -- ° F Conductivity: -- µS/cm Detergents: -- mg/L </div>		Floatables: None Odor: None Turbidity: None Color: None Gross Solids: None Vegetation: None Benthic Growth: None Stains: None Non-illicit: None	<div style="text-align: center;">

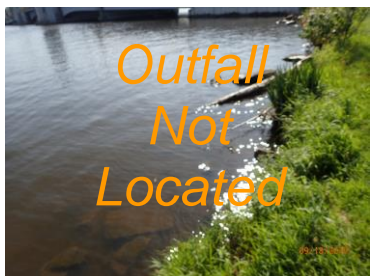
Inspection Date: 9/18/2019 11:05:33 AM		Type: Ongoing	Flow: Submerged (not located)	Previous Rainfall (hrs): 72+
Illicit Discharge Potential: Potential		Inspector: JCW	<div style="border: 1px solid black; padding: 5px;"> Notes Outfall fully submerged and not located - screened upstream at 16-594 US1. Floating gross solids (litter) in manhole. </div> <div style="border: 1px solid black; padding: 5px; margin-top: 5px;"> Condition Assessment Graffiti: None Erosion: None Deposition: None in. Damage: None </div>	
Submerged: Fully Depth (in):				
<div style="border: 1px solid black; padding: 5px;"> Sampling Results Sample Location: _____ Total Chlorine: -- ppm Free Chlorine: -- ppm Ammonia: -- ppm pH: -- units Temperature -- ° F Conductivity: -- µS/cm Detergents: -- mg/L </div>		Floatables: None Odor: None Turbidity: None Color: None Gross Solids: None Vegetation: None Benthic Growth: None Stains: None Non-illicit: None	<div style="text-align: center;">

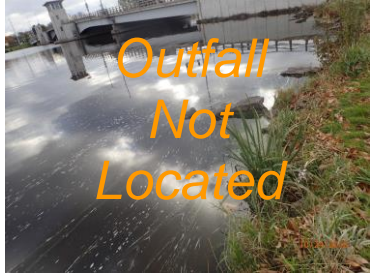
<p style="text-align: center;">o20181024090620.JPG</p> <p style="text-align: center; font-size: 1.2em; font-weight: bold;">2018</p>	
Submerged: Fully		Depth (in):		Outfall fully submerged and not located - screened upstream at 16-594 US1. Floating gross solids (litter) in manhole.			
Sampling Results		Floatables:		Condition Assessment			
Sample Location:		None		Graffiti:		None	
Total Chlorine: -- ppm		Odor:		Erosion:		None	
Free Chlorine: -- ppm		Turbidity:		Deposition:		None in.	
Ammonia: -- ppm		Color:		Damage:		None	
pH: -- units		Gross Solids:					
Temperature -- °F		Vegetation:					
Conductivity: -- µS/cm		Benthic Growth:					
Detergents: -- mg/L		Stains:					
		Non-illicit:

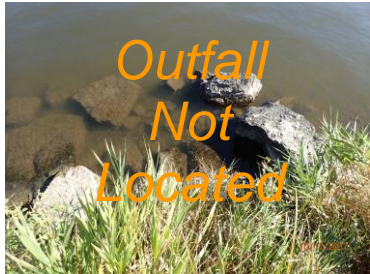
<p style="text-align: center;">o20171017112242.JPG</p> <p style="text-align: center; font-size: 1.2em; font-weight: bold;">2017</p>	
Submerged: Fully		Depth (in):		Outfall fully submerged and not located - screened upstream at 16-594 US1. Floating gross solids (litter) in manhole.			
Sampling Results		Floatables:		Condition Assessment			
Sample Location:		None		Graffiti:		None	
Total Chlorine: -- ppm		Odor:		Erosion:		None	
Free Chlorine: -- ppm		Turbidity:		Deposition:		None in.	
Ammonia: -- ppm		Color:		Damage:		None	
pH: -- units		Gross Solids:					
Temperature -- °F		Vegetation:					
Conductivity: -- µS/cm		Benthic Growth:					
Detergents: -- mg/L		Stains:					
		Non-illicit:

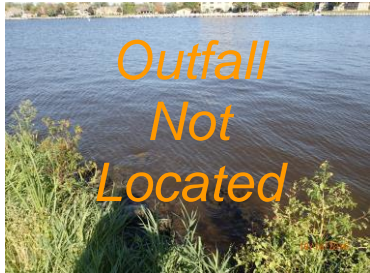
<p style="text-align: center;">o20161010140356.JPG</p> <p style="text-align: center; font-size: 1.2em; font-weight: bold;">2016</p>	
Submerged: Fully		Depth (in):		Outfall fully submerged and not located -screened upstream at 16-594 US1.			
Sampling Results		Floatables:		Condition Assessment			
Sample Location:		None		Graffiti:		None	
Total Chlorine: -- ppm		Odor:		Erosion:		None	
Free Chlorine: -- ppm		Turbidity:		Deposition:		None in.	
Ammonia: -- ppm		Color:		Damage:		None	
pH: -- units		Gross Solids:					
Temperature -- °F		Vegetation:					
Conductivity: -- µS/cm		Benthic Growth:					
Detergents: -- mg/L		Stains:					
		Non-illicit:

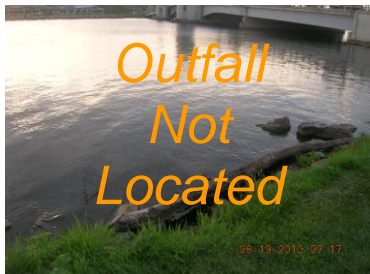
<p style="text-align: center;">o20100819071708.JPG</p> <p style="text-align: center; font-size: 1.2em; font-weight: bold;">2010</p>	
Submerged: Fully		Depth (in):		Outfall fully submerged and not physically located. Outfall screened upstream at 16-594 US1.			
Sampling Results		Floatables:		Condition Assessment			
Sample Location:		None		Graffiti:		None	
Total Chlorine: -- ppm		Odor:		Erosion:		None	
Free Chlorine: -- ppm		Turbidity:		Deposition:		None 0 in.	
Ammonia: -- ppm		Color:		Damage:		None	
pH: -- units		Gross Solids:					
Temperature -- °F		Vegetation:					
Conductivity: -- µS/cm		Benthic Growth:					
Detergents: -- mg/L		Stains:					
		Non-illicit:

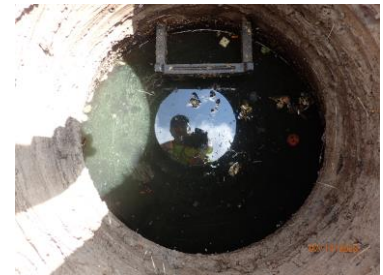
o20230717111202.JPG

☐ Petrol. Sheen ☐ Suds ☐ Sewage ☒ Algae ☐ Other☐ Petroleum ☐ Musty ☐ Sewage ☐ Chlorine ☐ Other☐ VOC/Solvent ☐ Fishy ☐ Sulfur ☐ Fragrant☒ Litter ☐ Veg. Debris ☐ Sediment ☐ Other☐ Inhibited ☐ Excessive☐ Green ☐ Brown☐ Flow Line ☐ Oil ☐ Rust Stains☐ Paint ☐ Other☐ Natural Sheen ☐ Natural Suds/Foam

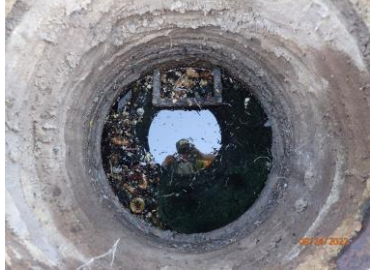
o20220824144754.JPG 2022
Sampling Results Sample Location: Pool Total Chlorine: 0 ppm Free Chlorine: 0 ppm Ammonia: 0 ppm pH: 8.12 units Temperature: 79 °F Conductivity: 336 µS/cm Detergents: 0 mg/L		Floatables: None Odor: None Turbidity: None Color: None Gross Solids: Moderate Vegetation: None Benthic Growth: None Stains: None Non-illicit: None	Condition Assessment Graffiti: None Erosion: None Deposition: None in. Damage: None	
Inspection Date: 8/17/2021 9:42:48 AM Illicit Discharge Potential: Potential Submerged: Fully Depth (in): 59		Type: Ongoing	Flow: Submerged, indeterminate	Previous Rainfall (hrs): 72+
Sampling Results Sample Location: Pool Total Chlorine: 0 ppm Free Chlorine: 0 ppm Ammonia: 0 ppm pH: 7.66 units Temperature: 79 °F Conductivity: 205 µS/cm Detergents: 0 mg/L		Inspector: JCW	Notes

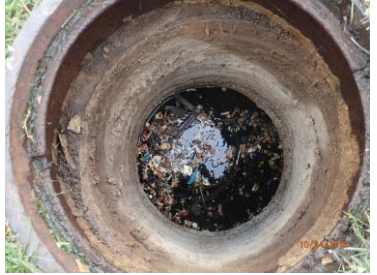
o20181024090720.JPG

Inspection Date: 10/24/2018 9:08:57 AM		Type: Ongoing	Flow: Submerged, indeterminate	Previous Rainfall (hrs): 72+
Illicit Discharge Potential: Potential		Inspector: JCW	Notes	
Submerged: Fully		Depth (in): 57	Sample collected from submerged pool in manhole. Floating gross solids (litter) in manhole.	
Sampling Results		Floatables: None	Condition Assessment Graffiti: None Erosion: None Deposition: None in. Damage: None	
Sample Location: Pool	Odor: None			
Total Chlorine: 0 ppm	Turbidity: None			
Free Chlorine: 0 ppm	Color: None			
Ammonia: 0 ppm	Gross Solids: Moderate			
pH: 7.35 units	Vegetation: None			
Temperature 50 °F	Benthic Growth: None			
Conductivity: 456 µS/cm	Stains: None			
Detergents: 0 mg/L	Non-illicit: None

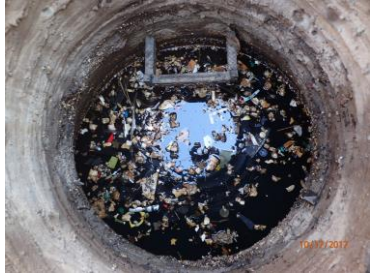
o20171017112318.JPG

Inspection Date: 10/17/2017 11:27:30 AM		Type: Ongoing	Flow: Submerged, indeterminate	Previous Rainfall (hrs): 48-72
Illicit Discharge Potential: Potential		Inspector: JCW	Notes	
Submerged: Fully		Depth (in): 51	Sample collected from submerged pool in manhole. Floating gross solids (litter) in manhole.	
Sampling Results		Floatables: None	Condition Assessment Graffiti: None Erosion: None Deposition: None in. Damage: None	
Sample Location: Pool	Odor: None			
Total Chlorine: 0 ppm	Turbidity: None			
Free Chlorine: 0 ppm	Color: None			
Ammonia: 0 ppm	Gross Solids: Moderate			
pH: 6.98 units	Vegetation: None			
Temperature 68 °F	Benthic Growth: None			
Conductivity: 741 µS/cm	Stains: None			
Detergents: 0 mg/L	Non-illicit: None

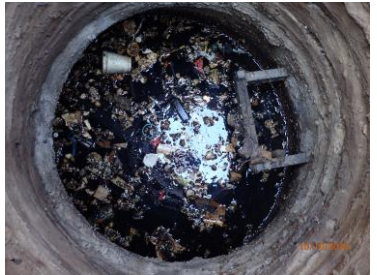
o20161010140454.JPG

Inspection Date: 10/10/2016 2:07:20 PM		Type: Ongoing	Flow: Submerged, indeterminate	Previous Rainfall (hrs): 72+
Illicit Discharge Potential: Potential		Inspector: JCW	Notes	
Submerged: Fully		Depth (in): 51	Potential illicit discharge due to gross solids.	
Sampling Results		Floatables: Slight	Condition Assessment Graffiti: None Erosion: None Deposition: None in. Damage: None	
Sample Location: Pool	Odor: Easily detected			
Total Chlorine: 0 ppm	Turbidity: None			
Free Chlorine: 0 ppm	Color: None			
Ammonia: 0.25 ppm	Gross Solids: Moderate			
pH: 7.17 units	Vegetation: None			
Temperature 71 °F	Benthic Growth: None			
Conductivity: 831 µS/cm	Stains: None			
Detergents: 0 mg/L	Non-illicit: None

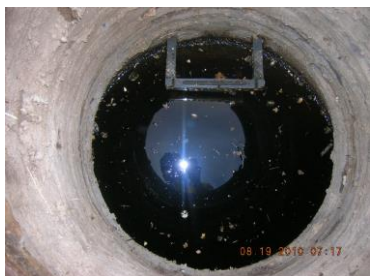
o20100819071738.JPG

Inspection Date: 8/19/2010 7:26:35 AM		Type: Ongoing	Flow: Submerged, indeterminate	Previous Rainfall (hrs): 72+
Illicit Discharge Potential: Unlikely		Inspector: JCW	Notes	
Submerged: Fully		Depth (in): 51	2 small oil drops, likely from Oshkosh Ave runoff.	
Sampling Results		Floatables: Slight	Condition Assessment Graffiti: None Erosion: None Deposition: None 0 in. Damage: None	
Sample Location: Pool	Odor: None			
Total Chlorine: 0 ppm	Turbidity: None			
Free Chlorine: 0 ppm	Color: Faint in bottle			
Ammonia: 0 ppm	Gross Solids: Slight			
pH: 7.44 units	Vegetation: None			
Temperature 75 °F	Benthic Growth: None			
Conductivity: -- µS/cm	Stains: None			
Detergents: 0 mg/L	Non-illicit: None

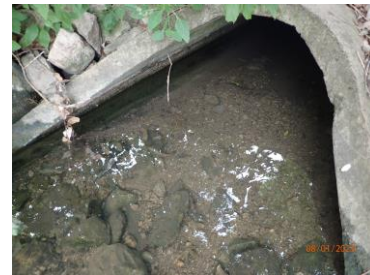
o20230801093700.JPG

Stains: Slight

Deposition: Minor Depth (in): 1

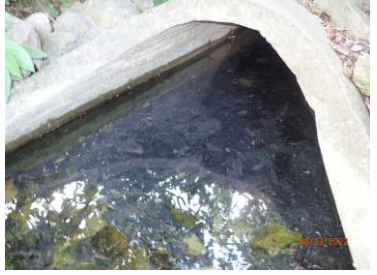
Inspection Date: 8/23/2022 2:57:00 PM		Type: Ongoing	Flow: Submerged, slight flow	Previous Rainfall (hrs): 72+
Illicit Discharge Potential: Unlikely Submerged: Partially Depth (in): 10		Inspector: EJK	Notes Sample collected from submerged flow inside pipe.	
Sampling Results Sample Location: Flow Total Chlorine: 0 ppm Free Chlorine: 0 ppm Ammonia: 0 ppm pH: 6.81 units Temperature: 73 °F Conductivity: 1058 µS/cm Detergents: 0 mg/L		Floatables: None Odor: None Turbidity: None Color: None Gross Solids: None Vegetation: None Benthic Growth: Slight Stains: Slight Non-illicit: None	Condition Assessment Graffiti: None Erosion: None Deposition: None in. Damage: None

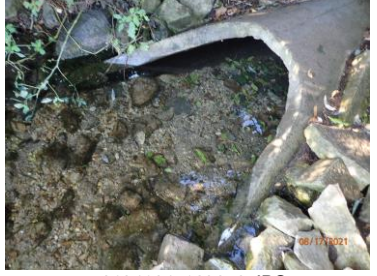
o20220823145452.JPG 2022	
Inspection Date: 8/17/2021 8:31:17 AM Submerged: Partially Depth (in): 14		Type: Ongoing	Flow: Submerged, indeterminate	Previous Rainfall (hrs): 72+
Illicit Discharge Potential: Unlikely Submerged: Partially Depth (in): 14		Inspector: JCW	Notes Outfall partially submerged - screened upstream at 16-660 US1. Neighbor reported occasional sewage odor and suds at outfall.

Sampling Results Sample Location: -- Total Chlorine: -- ppm Free Chlorine: -- ppm Ammonia: -- ppm pH: -- units Temperature: -- °F Conductivity: -- µS/cm Detergents: -- mg/L		Floatables: None Odor: None Turbidity: None Color: None Gross Solids: None Vegetation: None Benthic Growth: Moderate Stains: None Non-illicit: None	Condition Assessment Graffiti: None Erosion: None Deposition: Minor 1 in. Damage: None

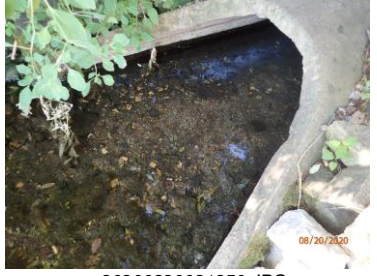
o20210817082858.JPG 2021	
Inspection Date: 8/20/2020 8:20:53 AM Submerged: Partially Depth (in): 9		Type: Ongoing	Flow: Submerged, indeterminate	Previous Rainfall (hrs): 72+
Illicit Discharge Potential: Unlikely Submerged: Partially Depth (in): 9		Inspector: JCW	Notes Outfall partially submerged - screened upstream at 16-660 US1.	
Sampling Results Sample Location: -- Total Chlorine: -- ppm Free Chlorine: -- ppm Ammonia: -- ppm pH: -- units Temperature: -- °F Conductivity: -- µS/cm Detergents: -- mg/L		Floatables: None Odor: None Turbidity: None Color: None Gross Solids: None Vegetation: None Benthic Growth: Severe Stains: Slight Non-illicit: None	Condition Assessment Graffiti: None Erosion: None Deposition: Minor 1 in. Damage: None

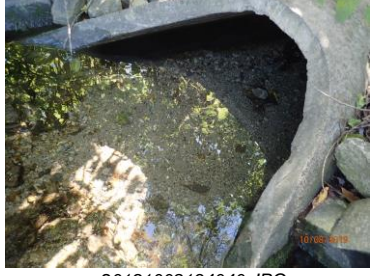
o20200820081850.JPG 2020	
Inspection Date: 10/8/2019 2:42:09 PM Submerged: Partially Depth (in): 16		Type: Ongoing	Flow: Submerged, indeterminate	Previous Rainfall (hrs): 48-72
Illicit Discharge Potential: Potential Submerged: Partially Depth (in): 16		Inspector: JCW	Notes Outfall partially submerged - screened upstream at 16-660 US1. Detergent detected in sample.	
Sampling Results Sample Location: -- Total Chlorine: -- ppm Free Chlorine: -- ppm Ammonia: -- ppm pH: -- units Temperature: -- °F Conductivity: -- µS/cm Detergents: -- mg/L		Floatables: None Odor: None Turbidity: None Color: None Gross Solids: None Vegetation: None Benthic Growth: Slight Stains: None Non-illicit: None	Condition Assessment Graffiti: None Erosion: None Deposition: Minor 3 in. Damage: None

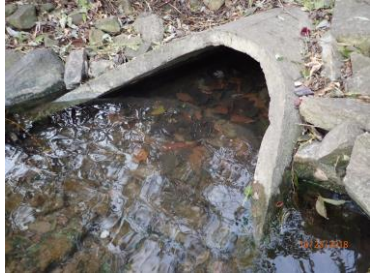
o20181025081252.JPG

Inspection Date: 10/25/2018 8:13:23 AM		Type: Ongoing	Flow: Submerged, indeterminate	Previous Rainfall (hrs): 72+
Illicit Discharge Potential: Potential		Inspector: JCW	Notes	
Submerged: Partially Depth (in): 14			Outfall partially submerged - screened upstream at 16-660 US1. Detergent detected in sample.	
Sampling Results			Condition Assessment	
Sample Location:	Floatables:	None	Graffiti: None Erosion: None Deposition: None in. Damage: None	
Total Chlorine: -- ppm	Odor:	None		
Free Chlorine: -- ppm	Turbidity:	None		
Ammonia: -- ppm	Color:	None		
pH: -- units	Gross Solids:	Slight		
Temperature -- °F	Vegetation:	None		
Conductivity: -- µS/cm	Benthic Growth:	Moderate		
Detergents: -- mg/L	Stains:	Moderate		
	Non-illicit:	None

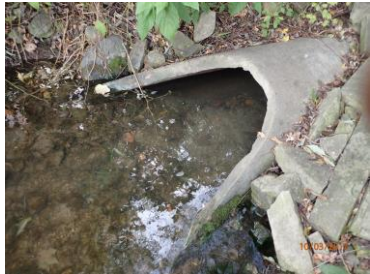
o20171003110156.JPG

Inspection Date: 10/3/2017 11:03:37 AM		Type: Ongoing	Flow: Submerged, indeterminate	Previous Rainfall (hrs): 72+
Illicit Discharge Potential: Potential		Inspector: JCW	Notes	
Submerged: Partially Depth (in): 12			Outfall partially submerged - screened upstream at 16-660 US1. Detergent detected in sample.	
Sampling Results			Condition Assessment	
Sample Location:	Floatables:	None	Graffiti: None Erosion: None Deposition: None in. Damage: None	
Total Chlorine: -- ppm	Odor:	None		
Free Chlorine: -- ppm	Turbidity:	None		
Ammonia: -- ppm	Color:	None		
pH: -- units	Gross Solids:	None		
Temperature -- °F	Vegetation:	None		
Conductivity: -- µS/cm	Benthic Growth:	Moderate		
Detergents: -- mg/L	Stains:	Moderate		
	Non-illicit:	None

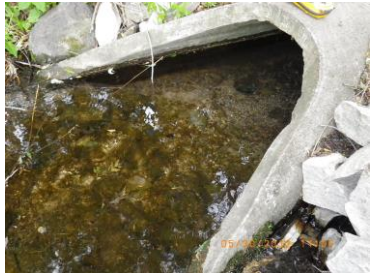
o20120530100048.JPG

Inspection Date: 5/30/2012 10:59:58 AM		Type: Ongoing	Flow: Submerged, indeterminate	Previous Rainfall (hrs): 72+
Illicit Discharge Potential: Unlikely		Inspector: JCW	Notes	
Submerged: Partially Depth (in): 10			Outfall partially submerged. Outfall screened upstream at 16-660.	
Sampling Results			Condition Assessment	
Sample Location:	Floatables:	None	Graffiti: None Erosion: None Deposition: Minor 1 in. Damage: None	
Total Chlorine: -- ppm	Odor:	None		
Free Chlorine: -- ppm	Turbidity:	None		
Ammonia: -- ppm	Color:	None		
pH: -- units	Gross Solids:	Slight		
Temperature -- °F	Vegetation:	None		
Conductivity: -- µS/cm	Benthic Growth:	Moderate		
Detergents: -- mg/L	Stains:	Slight		
	Non-illicit:	None

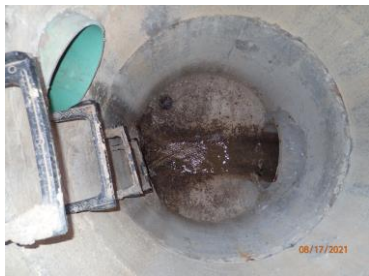
Inspection Date: 8/17/2021 8:24:19 AM		Type: Ongoing	Flow: Moderate	Previous Rainfall (hrs): 72+
Illicit Discharge Potential: Unlikely		Inspector: JCW		
Submerged: None		Depth (in):		
Sampling Results Sample Location: Pool Total Chlorine: 0 ppm Free Chlorine: 0 ppm Ammonia: 0 ppm pH: 7.53 units Temperature: 73 °F Conductivity: 918 µS/cm Detergents: 0 mg/L		Floatables: None Odor: None Turbidity: None Color: None Gross Solids: None Vegetation: None Benthic Growth: None Stains: None Non-illicit: None	Notes Sample collected from flow in manhole.

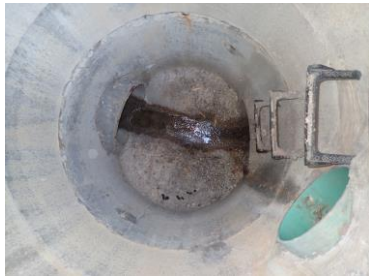
Inspection Date: 8/20/2020 8:24:59 AM		Type: Ongoing	Flow: None	Previous Rainfall (hrs): 72+
Illicit Discharge Potential: Unlikely		Inspector: JCW		
Submerged: None		Depth (in):		
Sampling Results Sample Location: -- Total Chlorine: -- ppm Free Chlorine: -- ppm Ammonia: -- ppm pH: -- units Temperature: -- °F Conductivity: -- µS/cm Detergents: -- mg/L		Floatables: None Odor: None Turbidity: None Color: None Gross Solids: None Vegetation: None Benthic Growth: None Stains: None Non-illicit: None	Notes Flowline damp, but no collectable flow at time of inspection.

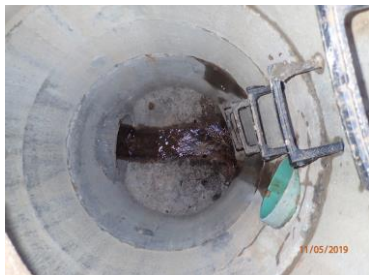
Inspection Date: 11/5/2019 2:41:00 PM		Type: Repeat	Flow: Moderate	Previous Rainfall (hrs): 48-72
Illicit Discharge Potential: Potential		Inspector: JCW		
Submerged: None		Depth (in):		
Sampling Results Sample Location: Flow Total Chlorine: -- ppm Free Chlorine: -- ppm Ammonia: -- ppm pH: -- units Temperature: -- °F Conductivity: -- µS/cm Detergents: 0.9 mg/L		Floatables: None Odor: None Turbidity: None Color: None Gross Solids: None Vegetation: None Benthic Growth: None Stains: None Non-illicit: None	Notes Follow-up inspection for sampling - limited screening conducted.

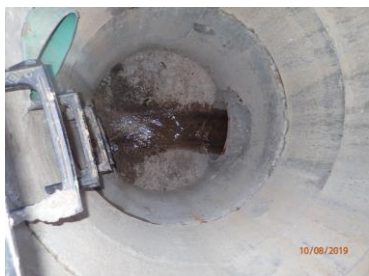
Inspection Date: 10/8/2019 2:44:41 PM		Type: Ongoing	Flow: Moderate	Previous Rainfall (hrs): 48-72
Illicit Discharge Potential: Potential		Inspector: JCW		
Submerged: None		Depth (in):		
Sampling Results Sample Location: Flow Total Chlorine: 0 ppm Free Chlorine: 0 ppm Ammonia: 0 ppm pH: 7.68 units Temperature: 65 °F Conductivity: 943 µS/cm Detergents: 0.5 mg/L		Floatables: None Odor: None Turbidity: None Color: None Gross Solids: None Vegetation: None Benthic Growth: None Stains: None Non-illicit: None	Notes Sample collected from flow in manhole. Detergent detected in sample.

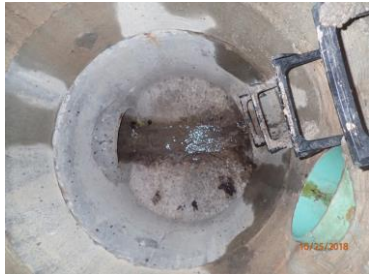
o20181025081632.JPG

Inspection Date: 10/25/2018 8:16:19 AM		Type: Ongoing	Flow: Trickle	Previous Rainfall (hrs): 72+
Illicit Discharge Potential: Potential		Inspector: JCW	Notes	
Submerged: None		Depth (in):	Sample collected from flow in manhole. Detergent detected in sample.	
Sampling Results		Floatables: None	Condition Assessment	
Sample Location: Flow		Odor: None	Graffiti: None	
Total Chlorine: 0 ppm		Turbidity: None	Erosion: None	
Free Chlorine: 0 ppm		Color: None	Deposition: None in.	
Ammonia: 0 ppm		Gross Solids: None	Damage: None	
pH: 7.9 units		Vegetation: None		
Temperature 52 °F		Benthic Growth: None		
Conductivity: 1037 µS/cm		Stains: None		
Detergents: 0.35 mg/L		Non-illicit: None

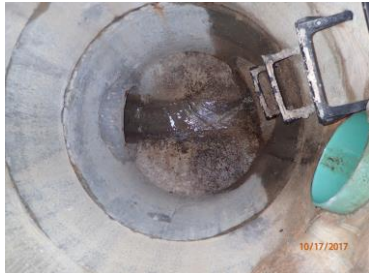
o20171017085628.JPG

Inspection Date: 10/17/2017 9:02:21 AM		Type: Repeat	Flow: Moderate	Previous Rainfall (hrs): 48-72
Illicit Discharge Potential: Unlikely		Inspector: JCW	Notes	
Submerged: None		Depth (in):	Repeat inspection due to detergent. No detergent detected in manhole sample.	
Sampling Results		Floatables: None	Condition Assessment	
Sample Location: Flow		Odor: None	Graffiti: None	
Total Chlorine: 0 ppm		Turbidity: None	Erosion: None	
Free Chlorine: 0 ppm		Color: None	Deposition: None in.	
Ammonia: 0 ppm		Gross Solids: None	Damage: None	
pH: 7.78 units		Vegetation: None		
Temperature 61 °F		Benthic Growth: Slight		
Conductivity: 926 µS/cm		Stains: None		
Detergents: 0 mg/L		Non-illicit: None

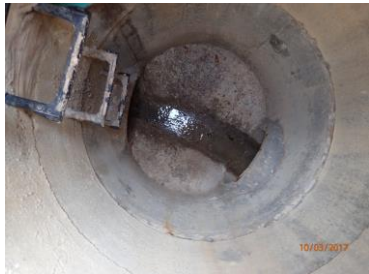
o20171003110702.JPG

Inspection Date: 10/3/2017 11:12:57 AM		Type: Ongoing	Flow: Trickle	Previous Rainfall (hrs): 72+
Illicit Discharge Potential: Potential		Inspector: JCW	Notes	
Submerged: None		Depth (in):	Sample collected from flow in manhole. Detergent detected in sample.	
Sampling Results		Floatables: None	Condition Assessment	
Sample Location: Flow		Odor: None	Graffiti: None	
Total Chlorine: 0 ppm		Turbidity: None	Erosion: None	
Free Chlorine: 0 ppm		Color: None	Deposition: None in.	
Ammonia: 0 ppm		Gross Solids: None	Damage: None	
pH: 8.26 units		Vegetation: None		
Temperature 76 °F		Benthic Growth: None		
Conductivity: 845 µS/cm		Stains: None		
Detergents: 0.55 mg/L		Non-illicit: None

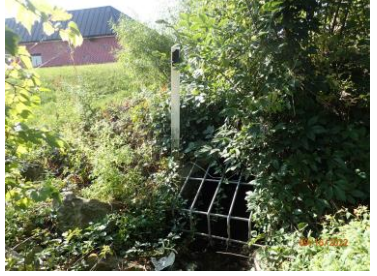
Inspection Date: 9/16/2022 9:45:00 AM		Type: Ongoing	Flow: Trickle	Previous Rainfall (hrs): 72+
Illicit Discharge Potential: Potential		Inspector: EJK		
Submerged: None		Depth (in):		
Sampling Results Sample Location: Flow Total Chlorine: 0 ppm Free Chlorine: 0 ppm Ammonia: 0 ppm pH: 7.99 units Temperature: 70 °F Conductivity: 2310 µS/cm Detergents: 0 mg/L		Floatables: None Odor: None Turbidity: None Color: None Gross Solids: Slight Vegetation: None Benthic Growth: Moderate Stains: Slight Non-illicit: None	Notes Sample collected from pipe flow. Elevated conductivity in sample. Tracked upstream without finding source.

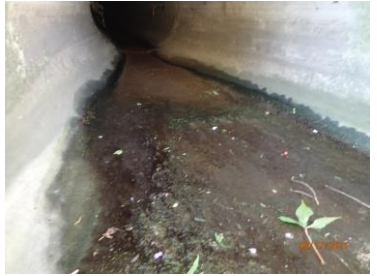
Inspection Date: 8/17/2021 8:47:50 AM		Type: Ongoing	Flow: Trickle	Previous Rainfall (hrs): 72+
Illicit Discharge Potential: Potential		Inspector: JCW		
Submerged: None		Depth (in):		
Sampling Results Sample Location: Flow Total Chlorine: 0 ppm Free Chlorine: 0 ppm Ammonia: 0 ppm pH: 8.14 units Temperature: 76 °F Conductivity: 1990 µS/cm Detergents: 0.65 mg/L		Floatables: None Odor: None Turbidity: None Color: None Gross Solids: Slight Vegetation: None Benthic Growth: Severe Stains: Moderate Non-illicit: None	Notes Sample collected from pipe flow. Detergent detected in sample.

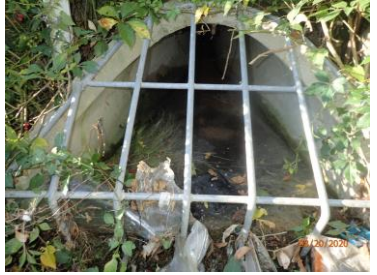
Inspection Date: 8/20/2020 7:55:43 AM		Type: Ongoing	Flow: None	Previous Rainfall (hrs): 72+
Illicit Discharge Potential: Unlikely		Inspector: JCW		
Submerged: None		Depth (in):		
Sampling Results Sample Location: -- Total Chlorine: -- ppm Free Chlorine: -- ppm Ammonia: -- ppm pH: -- units Temperature: -- °F Conductivity: -- µS/cm Detergents: -- mg/L		Floatables: None Odor: None Turbidity: None Color: None Gross Solids: Moderate Vegetation: None Benthic Growth: Slight Stains: None Non-illicit: None	Notes Pipe wet, but no collectable flow at time of inspection.

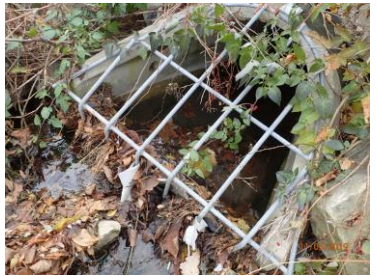
Inspection Date: 11/5/2019 8:43:00 AM		Type: Repeat	Flow: Trickle	Previous Rainfall (hrs): 48-72
Illicit Discharge Potential: Potential		Inspector: JCW		
Submerged: None		Depth (in):		
Sampling Results Sample Location: Flow Total Chlorine: -- ppm Free Chlorine: -- ppm Ammonia: -- ppm pH: -- units Temperature: -- °F Conductivity: -- µS/cm Detergents: 0.8 mg/L		Floatables: None Odor: None Turbidity: None Color: None Gross Solids: Slight Vegetation: None Benthic Growth: Slight Stains: None Non-illicit: None	Notes Follow-up inspection for sampling - limited screening conducted.

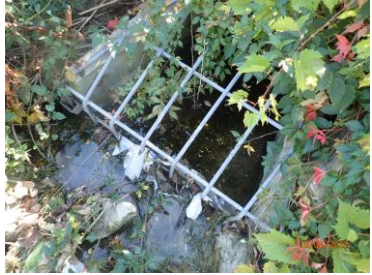
Inspection Date: 10/8/2019 1:59:59 PM		Type: Ongoing	Flow: Trickle	Previous Rainfall (hrs): 48-72
Illicit Discharge Potential: Potential		Inspector: JCW	Notes	
Submerged: None		Depth (in):	Sample collected from pipe flow. Detergent and elevated conductivity in sample.	
Sampling Results Sample Location: Flow Total Chlorine: 0 ppm Free Chlorine: 0 ppm Ammonia: 0 ppm pH: 8.09 units Temperature: 66 °F Conductivity: 2640 µS/cm Detergents: 0.5 mg/L		Floatables: None Odor: None Turbidity: None Color: None Gross Solids: Slight Vegetation: None Benthic Growth: Slight Stains: None Non-illicit: None	Condition Assessment Graffiti: None Erosion: None Deposition: None in. Damage: None

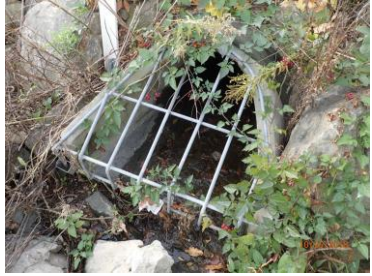
Inspection Date: 10/26/2018 1:46:37 PM		Type: Repeat	Flow: Trickle	Previous Rainfall (hrs): 72+
Illicit Discharge Potential: Potential		Inspector: KMK	Notes	
Submerged: None		Depth (in):	Detergent detection follow-up. Limited screening conducted beyond sampling.	
Sampling Results Sample Location: Flow Total Chlorine: 0 ppm Free Chlorine: 0 ppm Ammonia: 0 ppm pH: 8.19 units Temperature: 56 °F Conductivity: 3550 µS/cm Detergents: 0.5 mg/L		Floatables: None Odor: None Turbidity: None Color: None Gross Solids: None Vegetation: None Benthic Growth: Moderate Stains: None Non-illicit: None	Condition Assessment Graffiti: None Erosion: None Deposition: None in. Damage: None

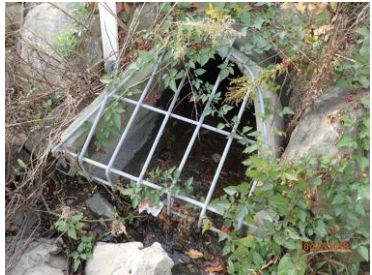
Inspection Date: 10/25/2018 8:55:36 AM		Type: Ongoing	Flow: Trickle	Previous Rainfall (hrs): 72+
Illicit Discharge Potential: Potential		Inspector: JCW	Notes	
Submerged: None		Depth (in):	Sample collected from pipe flow. Detergent and elevated conductivity in sample.	
Sampling Results Sample Location: Flow Total Chlorine: 0 ppm Free Chlorine: 0 ppm Ammonia: 0 ppm pH: 8.22 units Temperature: 52 °F Conductivity: 3300 µS/cm Detergents: 0.45 mg/L		Floatables: None Odor: None Turbidity: None Color: None Gross Solids: None Vegetation: None Benthic Growth: Moderate Stains: None Non-illicit: None	Condition Assessment Graffiti: None Erosion: None Deposition: None in. Damage: None

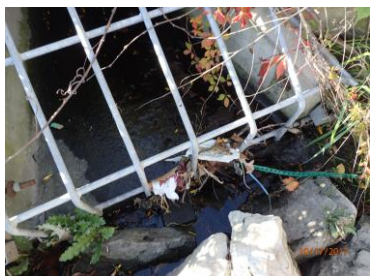
Inspection Date: 10/17/2017 10:32:21 AM		Type: Ongoing	Flow: Trickle	Previous Rainfall (hrs): 48-72
Illicit Discharge Potential: Unlikely		Inspector: JCW	Notes	
Submerged: None		Depth (in):	Sample collected from pipe flow.	
Sampling Results Sample Location: Flow Total Chlorine: 0 ppm Free Chlorine: 0 ppm Ammonia: 0 ppm pH: 8.35 units Temperature: 65 °F Conductivity: 1704 µS/cm Detergents: 0 mg/L		Floatables: None Odor: None Turbidity: None Color: None Gross Solids: Slight Vegetation: None Benthic Growth: Slight Stains: None Non-illicit: None	Condition Assessment Graffiti: None Erosion: None Deposition: None in. Damage: None

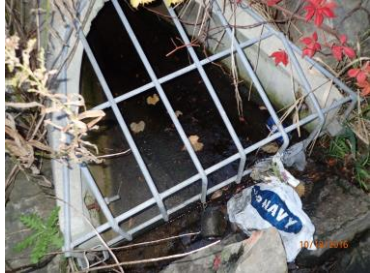
o20161018071712.JPG

Sample Location:	Flow																																					
Total Chlorine:	0 ppm																																					
Free Chlorine:	0 ppm																																					
Ammonia:	0 ppm																																					
pH:	8.29 units																																					
Temperature:	64 °F																																					
Conductivity:	3880 µS/cm																																					
Detergents:	0 mg/L																																					
Floatables:	None																																					
Odor:	Faint																																					
Turbidity:	None																																					
Color:	None																																					
Gross Solids:	Slight																																					
Vegetation:	None																																					
Benthic Growth:	Moderate																																					
Stains:	None																																					
Non-illicit:	None

Notes Elevated conductivity, but no other parameters out of range.																																				
		Condition Assessment <table border="1" style="width:100%; border-collapse: collapse;"> <tr> <td>Graffiti:</td> <td>None</td> </tr> <tr> <td>Erosion:</td> <td>None</td> </tr> <tr> <td>Deposition:</td> <td>None</td> </tr> <tr> <td>Damage:</td> <td>None</td> </tr> </table>			Graffiti:	None	Erosion:	None	Deposition:	None	Damage:	None																										
Graffiti:	None																																					
Erosion:	None																																					
Deposition:	None																																					
Damage:	None

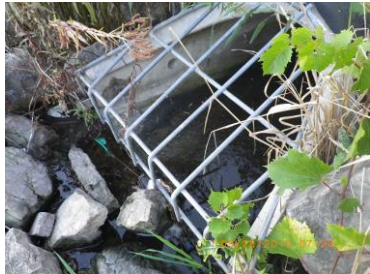
o20150928062340.JPG

Sample Location:																																						
Total Chlorine:	-- ppm																																					
Free Chlorine:	-- ppm																																					
Ammonia:	-- ppm																																					
pH:	-- units																																					
Temperature:	-- °F																																					
Conductivity:	-- µS/cm																																					
Detergents:	-- mg/L																																					
Floatables:	None																																					
Odor:	None																																					
Turbidity:	None																																					
Color:	None																																					
Gross Solids:	Slight																																					
Vegetation:	None																																					
Benthic Growth:	Moderate																																					
Stains:	None																																					
Non-illicit:	None

Notes Flowline wet, but no flow at time of inspection.																																				
		Condition Assessment <table border="1" style="width:100%; border-collapse: collapse;"> <tr> <td>Graffiti:</td> <td>None</td> </tr> <tr> <td>Erosion:</td> <td>None</td> </tr> <tr> <td>Deposition:</td> <td>None</td> </tr> <tr> <td>Damage:</td> <td>None</td> </tr> </table>			Graffiti:	None	Erosion:	None	Deposition:	None	Damage:	None																										
Graffiti:	None																																					
Erosion:	None																																					
Deposition:	None																																					
Damage:	None

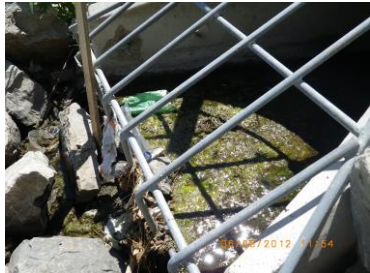
o20120606105408.JPG

Sample Location:	Flow																																					
Total Chlorine:	0 ppm																																					
Free Chlorine:	0 ppm																																					
Ammonia:	0 ppm																																					
pH:	8.1 units																																					
Temperature:	78 °F																																					
Conductivity:	5050 µS/cm																																					
Detergents:	0 mg/L																																					
Floatables:	Slight																																					
Odor:	None																																					
Turbidity:	None																																					
Color:	None																																					
Gross Solids:	Slight																																					
Vegetation:	None																																					
Benthic Growth:	Moderate																																					
Stains:	Slight																																					
Non-illicit:	None

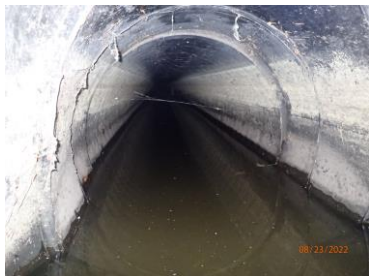
o20220823151212.JPG <div style="text-align: right; font-weight: bold; font-size: 1.2em;">2022</div>

Floatables:	None	Odor:	None	Turbidity:	None	Color:	None	Gross Solids:	None	Vegetation:	None	Benthic Growth:	None	Stains:	Slight	Non-illicit:	None
Floatables:	None																					
Odor:	None																					
Turbidity:	None																					
Color:	None																					
Gross Solids:	None																					
Vegetation:	None																					
Benthic Growth:	None																					
Stains:	Slight																					
Non-illicit:	None																					
		Notes No flow leaving apron. Sample collected from apron pool. Detergent detected in sample.																				
		Condition Assessment Graffiti: None Erosion: None Deposition: None in. Damage: None

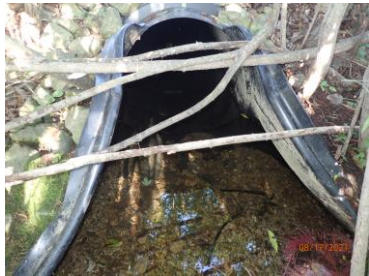
o20210817080534.JPG <div style="text-align: right; font-weight: bold; font-size: 1.2em;">2021</div>

Floatables:	None	Odor:	None	Turbidity:	None	Color:	None	Gross Solids:	None	Vegetation:	None	Benthic Growth:	Slight	Stains:	None	Non-illicit:	None
Floatables:	None																					
Odor:	None																					
Turbidity:	None																					
Color:	None																					
Gross Solids:	None																					
Vegetation:	None																					
Benthic Growth:	Slight																					
Stains:	None																					
Non-illicit:	None																					
		Notes Outfall partially submerged - screened upstream at 16-995 US1.																				
		Condition Assessment Graffiti: None Erosion: None Deposition: None in. Damage: None

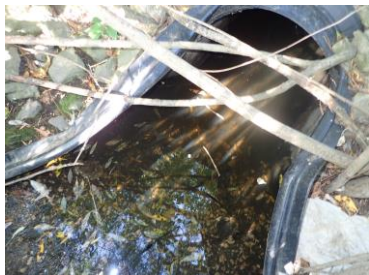
o20200820083238.JPG <div style="text-align: right; font-weight: bold; font-size: 1.2em;">2020</div>

Floatables:	None	Odor:	None	Turbidity:	None	Color:	None	Gross Solids:	None	Vegetation:	None	Benthic Growth:	None	Stains:	None	Non-illicit:	None
Floatables:	None																					
Odor:	None																					
Turbidity:	None																					
Color:	None																					
Gross Solids:	None																					
Vegetation:	None																					
Benthic Growth:	None																					
Stains:	None																					
Non-illicit:	None																					
		Notes 10 inch berm of roots blocking flow from apron. Outfall partially submerged - screened upstream at 16-995 US1.																				
		Condition Assessment Graffiti: None Erosion: None Deposition: None in. Damage: None

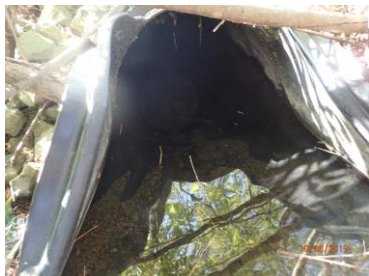
o20191008132854.JPG <div style="text-align: right; font-weight: bold; font-size: 1.2em;">2019</div>

Floatables:	None	Odor:	None	Turbidity:	None	Color:	None	Gross Solids:	None	Vegetation:	None	Benthic Growth:	Slight	Stains:	None	Non-illicit:	None
Floatables:	None																					
Odor:	None																					
Turbidity:	None																					
Color:	None																					
Gross Solids:	None																					
Vegetation:	None																					
Benthic Growth:	Slight																					
Stains:	None																					
Non-illicit:	None																					
		Notes Outfall partially submerged - screened upstream at 16-995 US1. Detergent detected in sample.																				
		Condition Assessment Graffiti: None Erosion: None Deposition: None in. Damage: None

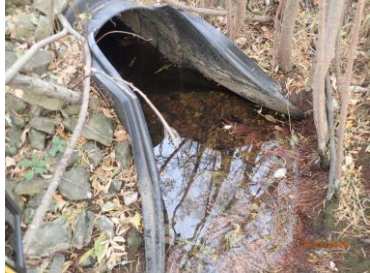
o20181025082506.JPG

Inspection Date: 10/25/2018 8:27:19 AM		Type: Ongoing	Flow: Submerged, indeterminate	Previous Rainfall (hrs): 72+
Illicit Discharge Potential: Potential		Inspector: JCW	Notes	
Submerged: Partially Depth (in): 12			Outfall partially submerged - screened upstream at 16-995 US1. Detergent detected in sample.	
Sampling Results			Condition Assessment	
Sample Location:	Floatables:	None	Graffiti: None Erosion: None Deposition: None in. Damage: None	
Total Chlorine: -- ppm	Odor:	None		
Free Chlorine: -- ppm	Turbidity:	None		
Ammonia: -- ppm	Color:	None		
pH: -- units	Gross Solids:	Slight		
Temperature -- °F	Vegetation:	None		
Conductivity: -- µS/cm	Benthic Growth:	None		
Detergents: -- mg/L	Stains:	None		
	Non-illicit:	None

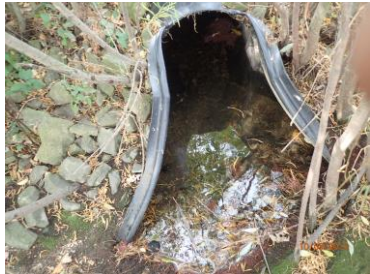
o20171003101614.JPG

Inspection Date: 10/3/2017 10:18:12 AM		Type: Ongoing	Flow: Submerged, indeterminate	Previous Rainfall (hrs): 72+
Illicit Discharge Potential: Potential		Inspector: JCW	Notes	
Submerged: Partially Depth (in): 8			Outfall partially submerged - screened upstream at 16-995 US1. Detergent detected in sample.	
Sampling Results			Condition Assessment	
Sample Location:	Floatables:	None	Graffiti: None Erosion: None Deposition: Minor 1 in. Damage: None	
Total Chlorine: -- ppm	Odor:	None		
Free Chlorine: -- ppm	Turbidity:	None		
Ammonia: -- ppm	Color:	None		
pH: -- units	Gross Solids:	None		
Temperature -- °F	Vegetation:	None		
Conductivity: -- µS/cm	Benthic Growth:	Slight		
Detergents: -- mg/L	Stains:	None		
	Non-illicit:	None

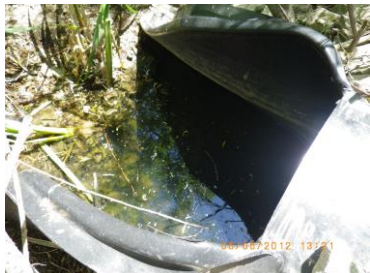
o20120606122140.JPG

Inspection Date: 6/6/2012 1:21:40 PM		Type: Ongoing	Flow: Submerged, indeterminate	Previous Rainfall (hrs): 72+
Illicit Discharge Potential: Unlikely		Inspector: JCW	Notes	
Submerged: Partially Depth (in): 9			No flow leaving pool at end of outfall. Deposition in swale downstream. Screened upstream at 16-995 US1.	
Sampling Results			Condition Assessment	
Sample Location:	Floatables:	None	Graffiti: None Erosion: None Deposition: Moderate 8 in. Damage: None	
Total Chlorine: -- ppm	Odor:	None		
Free Chlorine: -- ppm	Turbidity:	None		
Ammonia: -- ppm	Color:	None		
pH: -- units	Gross Solids:	Slight		
Temperature -- °F	Vegetation:	None		
Conductivity: -- µS/cm	Benthic Growth:	Slight		
Detergents: -- mg/L	Stains:	Slight		
	Non-illicit:	None

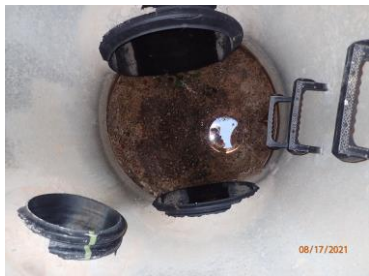
o20210817080912.JPG 2021

Notes Sample collected from submerged pool in manhole.																																				
		Condition Assessment <table border="1" style="width:100%; border-collapse: collapse;"> <tr><td>Graffiti:</td><td>None</td></tr> <tr><td>Erosion:</td><td>None</td></tr> <tr><td>Deposition:</td><td>None in.</td></tr> <tr><td>Damage:</td><td>None</td></tr> </table>			Graffiti:	None	Erosion:	None	Deposition:	None in.	Damage:	None																										
Graffiti:	None																																					
Erosion:	None																																					
Deposition:	None in.																																					
Damage:	None

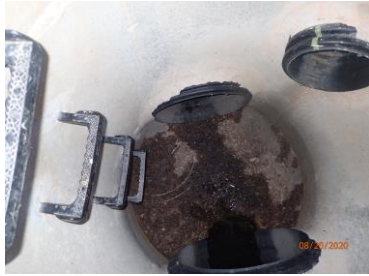
o20200820083626.JPG 2020

Notes Flowline damp, but no collectable flow at time of inspection.																																				
		Condition Assessment <table border="1" style="width:100%; border-collapse: collapse;"> <tr><td>Graffiti:</td><td>None</td></tr> <tr><td>Erosion:</td><td>None</td></tr> <tr><td>Deposition:</td><td>None in.</td></tr> <tr><td>Damage:</td><td>None</td></tr> </table>			Graffiti:	None	Erosion:	None	Deposition:	None in.	Damage:	None																										
Graffiti:	None																																					
Erosion:	None																																					
Deposition:	None in.																																					
Damage:	None

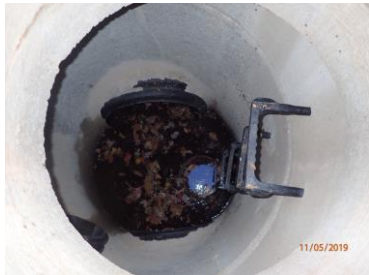
o20191105145942.JPG 2019

Notes Follow-up inspection for sampling - limited screening conducted.																																				
		Condition Assessment <table border="1" style="width:100%; border-collapse: collapse;"> <tr><td>Graffiti:</td><td>None</td></tr> <tr><td>Erosion:</td><td>None</td></tr> <tr><td>Deposition:</td><td>None in.</td></tr> <tr><td>Damage:</td><td>None</td></tr> </table>			Graffiti:	None	Erosion:	None	Deposition:	None in.	Damage:	None																										
Graffiti:	None																																					
Erosion:	None																																					
Deposition:	None in.																																					
Damage:	None

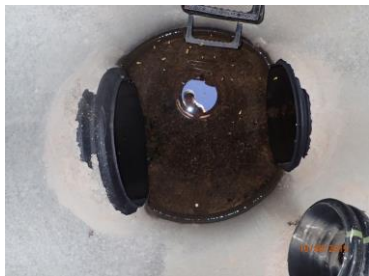
o20191008133058.JPG 2019

Notes Sample collected from submerged pool in outfall. Detergent detected in sample.																																				
		Condition Assessment <table border="1" style="width:100%; border-collapse: collapse;"> <tr><td>Graffiti:</td><td>None</td></tr> <tr><td>Erosion:</td><td>None</td></tr> <tr><td>Deposition:</td><td>None in.</td></tr> <tr><td>Damage:</td><td>None</td></tr> </table>			Graffiti:	None	Erosion:	None	Deposition:	None in.	Damage:	None																										
Graffiti:	None																																					
Erosion:	None																																					
Deposition:	None in.																																					
Damage:	None

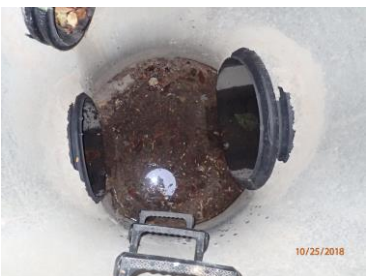
<p style="text-align: right; font-size: small;">10/25/2018</p> <p style="text-align: center;">o20181025082910.JPG</p> <p style="text-align: center; font-size: large; font-weight: bold;">2018</p>																																		
Submerged: Partially		Depth (in):																																				
Sampling Results <table border="1" style="width:100%; border-collapse: collapse;"> <tr><td>Sample Location:</td><td>Pool</td></tr> <tr><td>Total Chlorine:</td><td>0 ppm</td></tr> <tr><td>Free Chlorine:</td><td>0 ppm</td></tr> <tr><td>Ammonia:</td><td>0 ppm</td></tr> <tr><td>pH:</td><td>8.02 units</td></tr> <tr><td>Temperature:</td><td>54 °F</td></tr> <tr><td>Conductivity:</td><td>1143 µS/cm</td></tr> <tr><td>Detergents:</td><td>0.85 mg/L</td></tr> </table>		Sample Location:	Pool		Total Chlorine:	0 ppm	Free Chlorine:	0 ppm	Ammonia:	0 ppm	pH:	8.02 units	Temperature:	54 °F	Conductivity:	1143 µS/cm	Detergents:	0.85 mg/L	<table border="1" style="width:100%; border-collapse: collapse;"> <tr><td>Floatables:</td><td>None</td></tr> <tr><td>Odor:</td><td>None</td></tr> <tr><td>Turbidity:</td><td>None</td></tr> <tr><td>Color:</td><td>None</td></tr> <tr><td>Gross Solids:</td><td>None</td></tr> <tr><td>Vegetation:</td><td>None</td></tr> <tr><td>Benthic Growth:</td><td>None</td></tr> <tr><td>Stains:</td><td>None</td></tr> <tr><td>Non-illicit:</td><td>None</td></tr> </table>		Floatables:	None	Odor:	None	Turbidity:	None	Color:	None	Gross Solids:	None	Vegetation:	None	Benthic Growth:	None	Stains:	None	Non-illicit:	None

Notes Detergent detection follow-up. Limited screening conducted beyond sampling.																																				
		Condition Assessment <table border="1" style="width:100%; border-collapse: collapse;"> <tr><td>Graffiti:</td><td>None</td></tr> <tr><td>Erosion:</td><td>None</td></tr> <tr><td>Deposition:</td><td>None in.</td></tr> <tr><td>Damage:</td><td>None</td></tr> </table>		Graffiti:	None	Erosion:	None	Deposition:	None in.	Damage:	None																											
Graffiti:	None																																					
Erosion:	None																																					
Deposition:	None in.																																					
Damage:	None

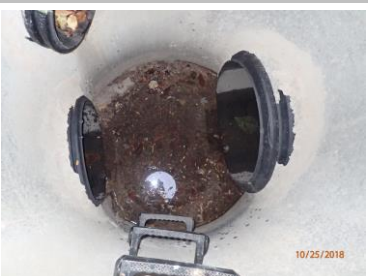
<p style="text-align: right; font-size: small;">10/25/2018</p> <p style="text-align: center;">o20181025082910.JPG</p> <p style="text-align: center; font-size: large; font-weight: bold;">2018</p>																																		
Submerged: Partially		Depth (in): 2																																				
Sampling Results <table border="1" style="width:100%; border-collapse: collapse;"> <tr><td>Sample Location:</td><td>Pool</td></tr> <tr><td>Total Chlorine:</td><td>0 ppm</td></tr> <tr><td>Free Chlorine:</td><td>0 ppm</td></tr> <tr><td>Ammonia:</td><td>0 ppm</td></tr> <tr><td>pH:</td><td>7.86 units</td></tr> <tr><td>Temperature:</td><td>50 °F</td></tr> <tr><td>Conductivity:</td><td>1011 µS/cm</td></tr> <tr><td>Detergents:</td><td>0.4 mg/L</td></tr> </table>		Sample Location:	Pool		Total Chlorine:	0 ppm	Free Chlorine:	0 ppm	Ammonia:	0 ppm	pH:	7.86 units	Temperature:	50 °F	Conductivity:	1011 µS/cm	Detergents:	0.4 mg/L	<table border="1" style="width:100%; border-collapse: collapse;"> <tr><td>Floatables:</td><td>None</td></tr> <tr><td>Odor:</td><td>None</td></tr> <tr><td>Turbidity:</td><td>None</td></tr> <tr><td>Color:</td><td>None</td></tr> <tr><td>Gross Solids:</td><td>Slight</td></tr> <tr><td>Vegetation:</td><td>None</td></tr> <tr><td>Benthic Growth:</td><td>None</td></tr> <tr><td>Stains:</td><td>None</td></tr> <tr><td>Non-illicit:</td><td>None</td></tr> </table>		Floatables:	None	Odor:	None	Turbidity:	None	Color:	None	Gross Solids:	Slight	Vegetation:	None	Benthic Growth:	None	Stains:	None	Non-illicit:	None

Notes Sample collected from submerged pool in outfall. Detergent detected in sample.																																				
		Condition Assessment <table border="1" style="width:100%; border-collapse: collapse;"> <tr><td>Graffiti:</td><td>None</td></tr> <tr><td>Erosion:</td><td>None</td></tr> <tr><td>Deposition:</td><td>None in.</td></tr> <tr><td>Damage:</td><td>None</td></tr> </table>		Graffiti:	None	Erosion:	None	Deposition:	None in.	Damage:	None																											
Graffiti:	None																																					
Erosion:	None																																					
Deposition:	None in.																																					
Damage:	None

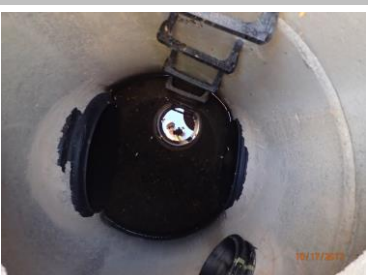
<p style="text-align: right; font-size: small;">10/17/2017</p> <p style="text-align: center;">o20171017084622.JPG</p> <p style="text-align: center; font-size: large; font-weight: bold;">2017</p>																																		
Submerged: Partially		Depth (in): 7																																				
Sampling Results <table border="1" style="width:100%; border-collapse: collapse;"> <tr><td>Sample Location:</td><td>Pool</td></tr> <tr><td>Total Chlorine:</td><td>0 ppm</td></tr> <tr><td>Free Chlorine:</td><td>0 ppm</td></tr> <tr><td>Ammonia:</td><td>0 ppm</td></tr> <tr><td>pH:</td><td>7.54 units</td></tr> <tr><td>Temperature:</td><td>61 °F</td></tr> <tr><td>Conductivity:</td><td>582 µS/cm</td></tr> <tr><td>Detergents:</td><td>0.8 mg/L</td></tr> </table>		Sample Location:	Pool		Total Chlorine:	0 ppm	Free Chlorine:	0 ppm	Ammonia:	0 ppm	pH:	7.54 units	Temperature:	61 °F	Conductivity:	582 µS/cm	Detergents:	0.8 mg/L	<table border="1" style="width:100%; border-collapse: collapse;"> <tr><td>Floatables:</td><td>None</td></tr> <tr><td>Odor:</td><td>None</td></tr> <tr><td>Turbidity:</td><td>None</td></tr> <tr><td>Color:</td><td>None</td></tr> <tr><td>Gross Solids:</td><td>None</td></tr> <tr><td>Vegetation:</td><td>None</td></tr> <tr><td>Benthic Growth:</td><td>None</td></tr> <tr><td>Stains:</td><td>None</td></tr> <tr><td>Non-illicit:</td><td>None</td></tr> </table>		Floatables:	None	Odor:	None	Turbidity:	None	Color:	None	Gross Solids:	None	Vegetation:	None	Benthic Growth:	None	Stains:	None	Non-illicit:	None

Notes Repeat inspection due to detergent. Detergent detected in manhole sample.																																				
		Condition Assessment <table border="1" style="width:100%; border-collapse: collapse;"> <tr><td>Graffiti:</td><td>None</td></tr> <tr><td>Erosion:</td><td>None</td></tr> <tr><td>Deposition:</td><td>None in.</td></tr> <tr><td>Damage:</td><td>None</td></tr> </table>		Graffiti:	None	Erosion:	None	Deposition:	None in.	Damage:	None																											
Graffiti:	None																																					
Erosion:	None																																					
Deposition:	None in.																																					
Damage:	None

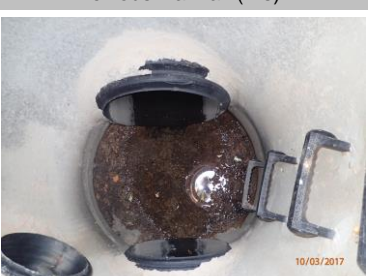
<p style="text-align: right; font-size: small;">10/03/2017</p> <p style="text-align: center;">o20171003101932.JPG</p> <p style="text-align: center; font-size: large; font-weight: bold;">2017</p>																																		
Submerged: Partially		Depth (in): 3																																				
Sampling Results <table border="1" style="width:100%; border-collapse: collapse;"> <tr><td>Sample Location:</td><td>Pool</td></tr> <tr><td>Total Chlorine:</td><td>0 ppm</td></tr> <tr><td>Free Chlorine:</td><td>0 ppm</td></tr> <tr><td>Ammonia:</td><td>0 ppm</td></tr> <tr><td>pH:</td><td>7.45 units</td></tr> <tr><td>Temperature:</td><td>72 °F</td></tr> <tr><td>Conductivity:</td><td>333 µS/cm</td></tr> <tr><td>Detergents:</td><td>1.3 mg/L</td></tr> </table>		Sample Location:	Pool		Total Chlorine:	0 ppm	Free Chlorine:	0 ppm	Ammonia:	0 ppm	pH:	7.45 units	Temperature:	72 °F	Conductivity:	333 µS/cm	Detergents:	1.3 mg/L	<table border="1" style="width:100%; border-collapse: collapse;"> <tr><td>Floatables:</td><td>None</td></tr> <tr><td>Odor:</td><td>None</td></tr> <tr><td>Turbidity:</td><td>None</td></tr> <tr><td>Color:</td><td>None</td></tr> <tr><td>Gross Solids:</td><td>None</td></tr> <tr><td>Vegetation:</td><td>None</td></tr> <tr><td>Benthic Growth:</td><td>None</td></tr> <tr><td>Stains:</td><td>None</td></tr> <tr><td>Non-illicit:</td><td>None</td></tr> </table>		Floatables:	None	Odor:	None	Turbidity:	None	Color:	None	Gross Solids:	None	Vegetation:	None	Benthic Growth:	None	Stains:	None	Non-illicit:	None

Notes Sample collected from submerged pool in outfall. Detergent detected in sample.																																				
		Condition Assessment <table border="1" style="width:100%; border-collapse: collapse;"> <tr><td>Graffiti:</td><td>None</td></tr> <tr><td>Erosion:</td><td>None</td></tr> <tr><td>Deposition:</td><td>None in.</td></tr> <tr><td>Damage:</td><td>None</td></tr> </table>		Graffiti:	None	Erosion:	None	Deposition:	None in.	Damage:	None																											
Graffiti:	None																																					
Erosion:	None																																					
Deposition:	None in.																																					
Damage:	None

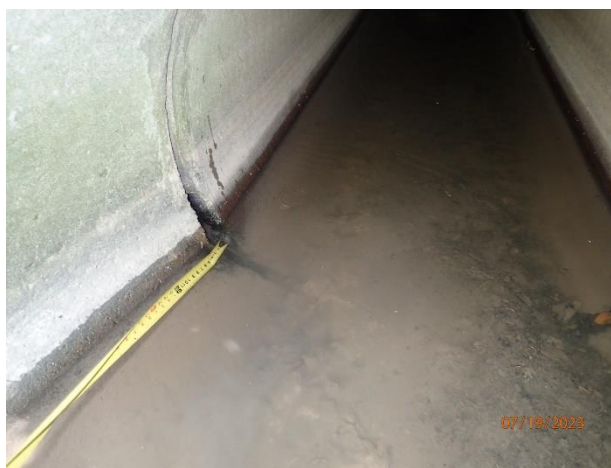
Figure 2 – Outfall 06-1136

Outfall	Severity	Description
06-2798	Minor	Apron undercut 4"
06-1136	Minor	3" joint displacement
06-478	Minor	3" joint displacement/deterioration
13-2332	Minor	2" joint displacement
13-3774	Minor	2" joint displacement
14-999	Minor	3" joint displacement, downed trees at end of pipe
15-3339	Minor	Debris (log) on apron
16-2092	Minor	3" joint displacement

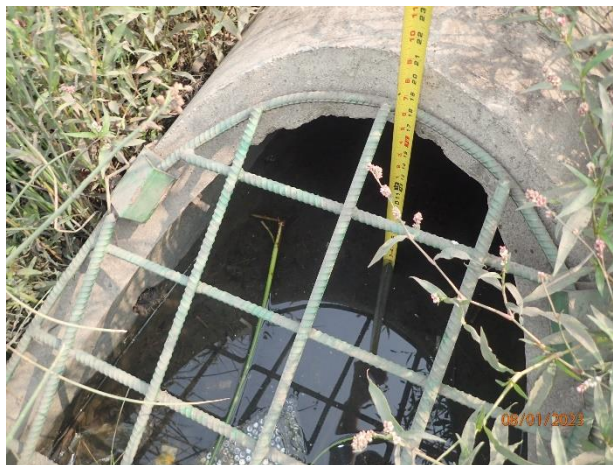
Figure 28 – Outfall 16-1205

16-1205	Minor	2" sediment inside pipe and on apron
16-660	Minor	1" sediment inside pipe and on apron
16-995	Moderate	15" sediment immediate downstream of outfall creating berm

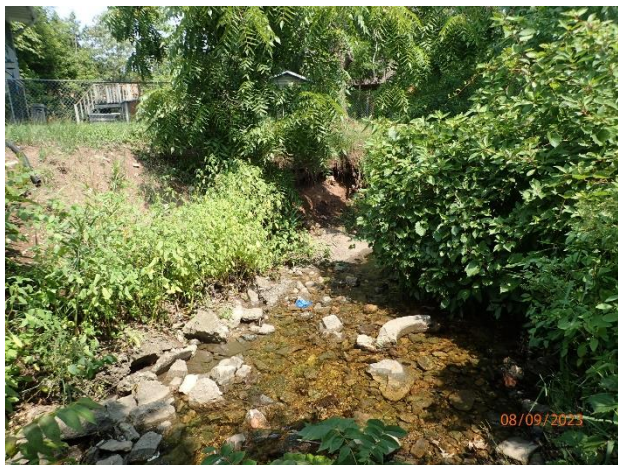
Outfall	Severity	Description
13-471	Moderate	Downstream channel erosion
13-2332	Moderate	Downstream channel erosion

Figure 31 – Channel erosion downstream of outfall 13-471

Two of the outfalls showed signs of erosion at the end of the outfall pipe or channel. Most outfalls with minor erosion could be repaired with minor landscaping repairs. Those outfalls with moderate or severe erosion may need additional structural reinforcement, such as turf reinforcement mat or riprap.

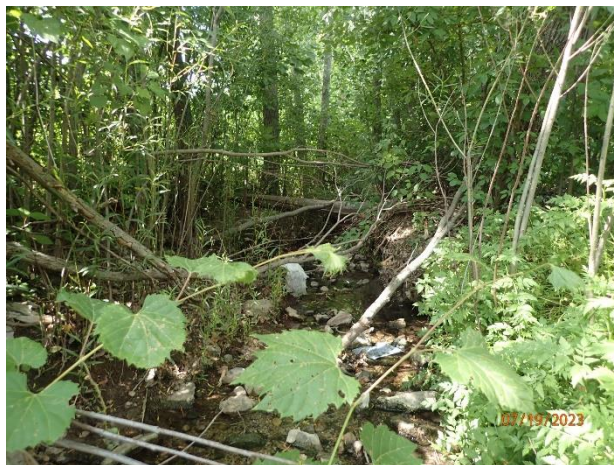
Figure 32 – Channel erosion downstream of outfall 13-2332

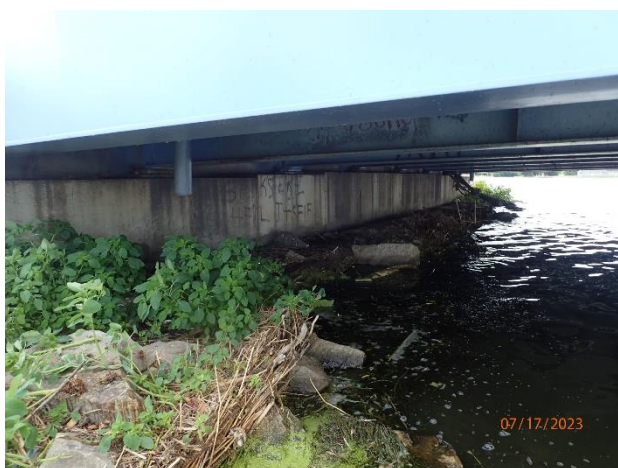
Outfall	Severity	Description
12-569	Moderate	Graffiti on bridge abutment near outfall
16-2092	Moderate	Graffiti on bridge abutment near outfall

Figure 33 – Abutment near outfall 12-569

Graffiti was observed in or around two outfalls. The graffiti was not severe but should probably be monitored to make sure that it does not become more severe.

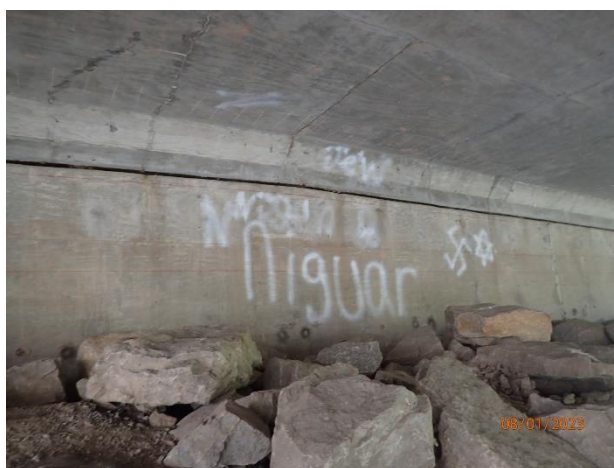
Figure 34 – Abutment near outfall 16-2092
