Ongoing Screening Summary Report 2012 Inspection Year

Illicit Discharge Detection and Elimination Program

City of Oshkosh

March 25, 2013

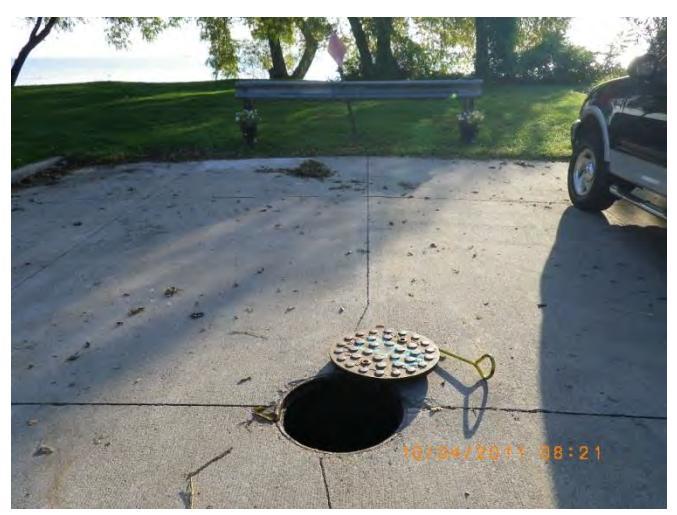
Figure 14 - Upstream manhole 02-322 US1 (2011)

The upstream manhole was partially submerged, with an 8-inch deep pool at the bottom of the manhole. A sample was collected from the pool, and the pH of the sample was 5.21, which is below typical range for pH in stormwater samples.

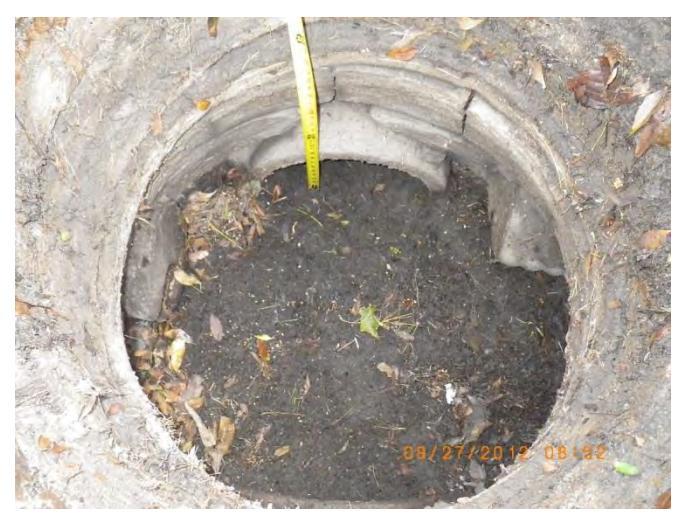
Figure 18 - Upstream manhole 02-321 (9/27/2012)

The next upstream manhole (02-321) was inspected, and similar to 2011, it was dry, although it had significant sediment.

Based on this observation, it appears that the ammonia is entering the storm sewer between manholes 02-321 and 02-322.

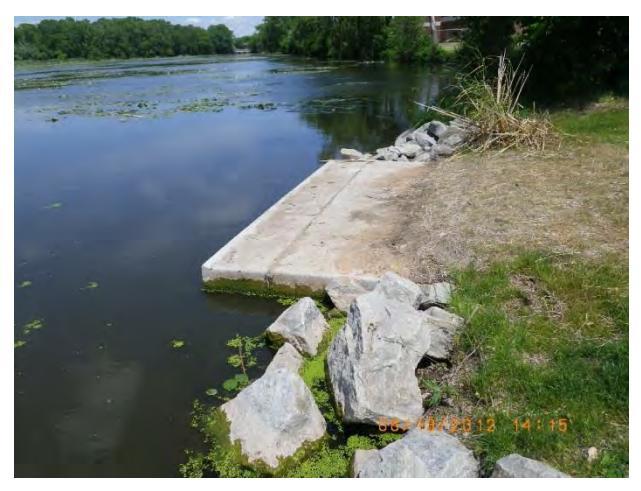
Figure 19 - Outfall 06-2241 (6/13/2012)

Outfall 06-2241 is a concrete box culvert under N. Knapp Street that discharges to Campbell Creek from the south. It is located immediately west of the wastewater treatment plant and city garage. It was installed in 2011, and replaces former outfalls 06-15 and 06-560.

The outfall was initially screened on June 13, 2012 as part of the gross solids pre-screening. At that time, the outfall was partially submerged, and a sample was collected from the first upstream manhole. This sample had a faint sewage odor, and had an ammonia concentration of 3 ppm. The manhole was resampled on June 20, and had an ammonia concentration of 0.5 ppm and no odor. A sample was also collected from the receiving water, upstream of the outfall, and this stream sample also had an ammonia concentration of 0.5 ppm.

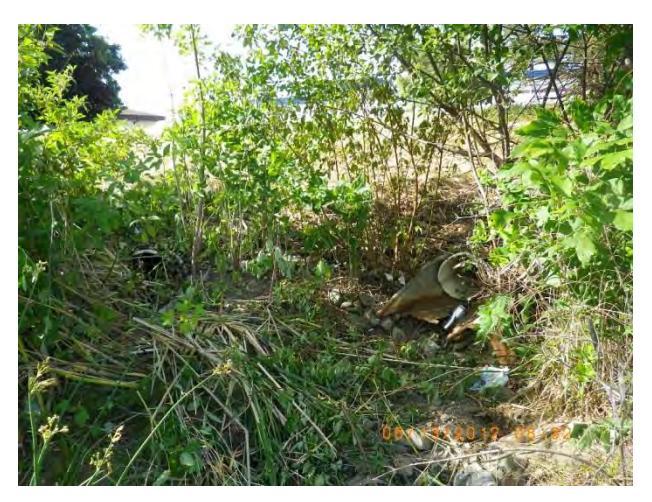
Figure 20 - Outfall 13-1715 (right) and pond outlet 13-1716 (left)

"Outfall" 13-1716 consists of an 18-inch PVC pipe on the south side of the detention basin on Capital Drive. The pipe is located immediately east of outfall 13-1715, and was assumed to be another pond inlet (supplemental outfall) during the field screening on June 12, 2012. Upon further review, it was discovered that this pipe is actually the pond outlet, and the adjacent manhole that was screened was the first downstream manhole.

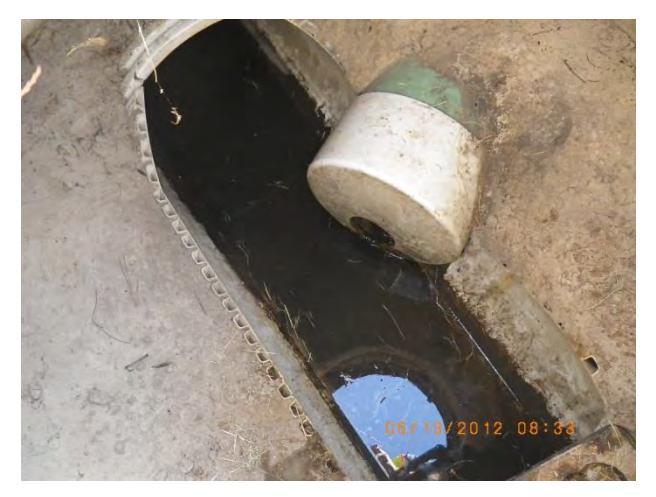
Figure 21 - Manhole 13-1716 US1 (6/12/2012)

Because the pipe was partially submerged, the manhole was screened. Upon opening the manhole, a black pool was observed along the flowline, and a petroleum odor was noted. A sample collected from the pool had an ammonia concentration of 3 ppm and a detergent concentration of 1.3 mg/L. The Illicit Discharge Coordinator was notified of the discovery on June 12.

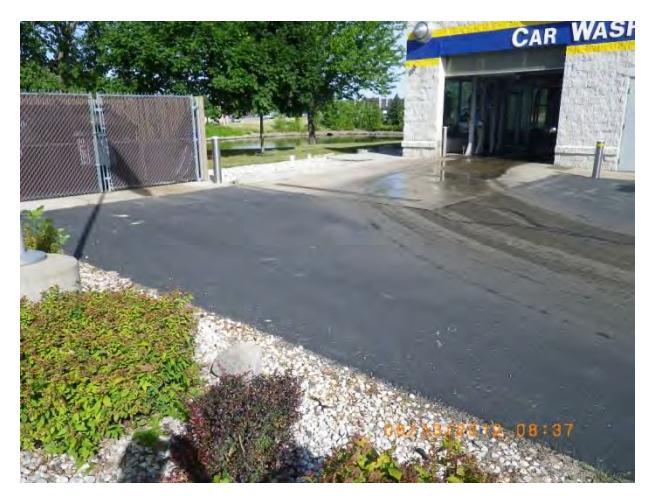
Figure 22 - Trench drain at Victory Car Wash

OMNNI met with the Illicit Discharge Coordinator on June 13 to investigate the discharge. It appeared that the PVC pipe discharging to the manhole was coming from the trench drain at the exit of the Victory Car Wash, immediately east of the pond. A sample was collected from the water in the trench drain, but there was too much turbidity interference to get a good reading. Another sample was collected from the manhole pool, which had a detergent concentration of 1.3 mg/L. A sample collected from the pond had a detergent concentration of 0.6 mg/L.

Based on the information collected during the June 13 investigation, it appeared that the detergent was likely coming from the trench drain at Victory Car Wash. The City planned to have the plumbing inspector investigate the trench drain connection. Because parts of the parking lot drain to this location, it may not be possible to connect this drain to the sanitary sewer due to infiltration/inflow issues.

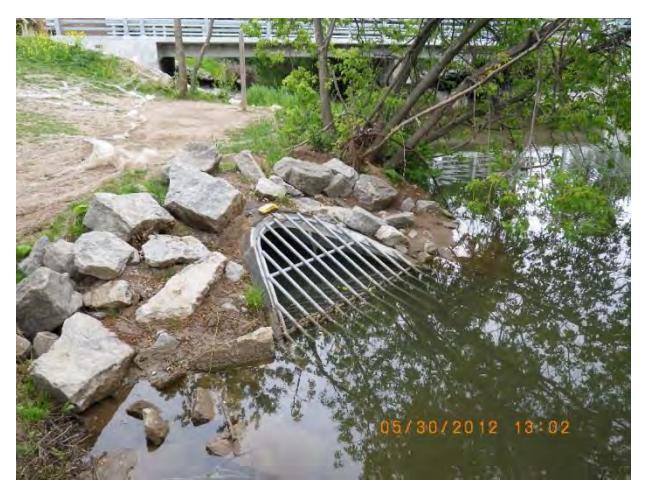
Figure 23 - Outfall 16-1508 (5/30/2012)

The outfall was initially screened on May 30, 2012 as part of the gross solids prescreening. Because the outfall was partially submerged, the upstream manhole was screened. A sample was collected from the submerged pool in the manhole, and the sample had an ammonia concentration of 1 ppm. The Illicit Discharge Coordinator was informed of the detection on May 30, 2012.

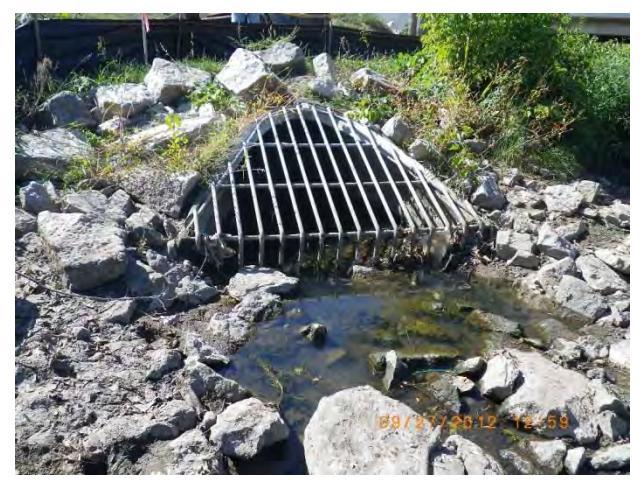
Figure 24 - Outfall 16-1508 (9/27/2012)

The sample collected from the upstream manhole had an ammonia concentration of 3 ppm, which was higher than the May 30 sample, and warranted tracing of the source. The various manholes upstream of the outfall were sampled in an attempt to isolate the segment of the storm sewer where the ammonia was being introduced.

After collecting samples from the various upstream manholes, it was determined that the ammonia concentration was 3 ppm at manholes 16-1508 and 16-1504. However, at the next upstream manhole (16-430), no ammonia was detected. It appeared that the ammonia was being introduced between manholes 16-460 and 16-1504.

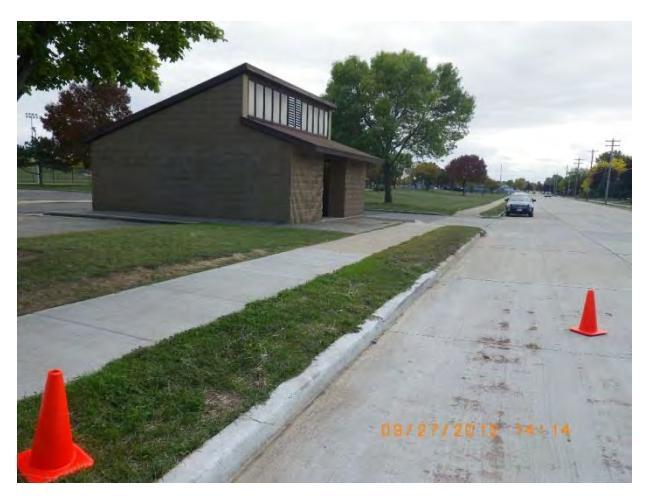
Figure 25 - Park restroom building upstream of 16-1504

The land use in this area consists of multifamily residential property on the west side of Westfield Street, and Red Arrow Park on the east side of the street. A building housing the restrooms for the park is located immediately to the east of this segment. Based on the elevated ammonia levels in the segment adjacent to the park restroom building, this was identified as a potential source. Additionally, Red Arrow Park is a former landfill site, and infiltration of groundwater from the site could be another potential source.

The Illicit Discharge Coordinator was notified of the findings on September 28. At that time, OMNNI recommended that the storm sewer segment between manholes 16-460 and 16-1504 be televised to inspect for potential leaks or cross connections, particularly in the area of the restroom building.

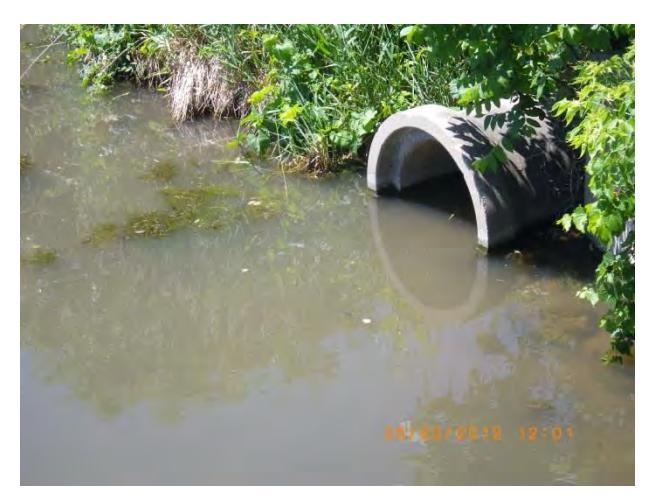
As recommended in the 2011 Summary Report, the outfall was rescreened as part of the 2012 ongoing screening program. The outfall was screened on June 20, 2012. No abnormal physical or chemical indicators were observed at the outfall. The upstream manhole near Hydrite Chemical was also screened. The manhole was wet at the time of the inspection, but there was no flow observed. Based on the observations, it appeared that the illicit discharge from 2011 had been resolved.

Figure 26 - Outfall 14-582 (6/20/2012)

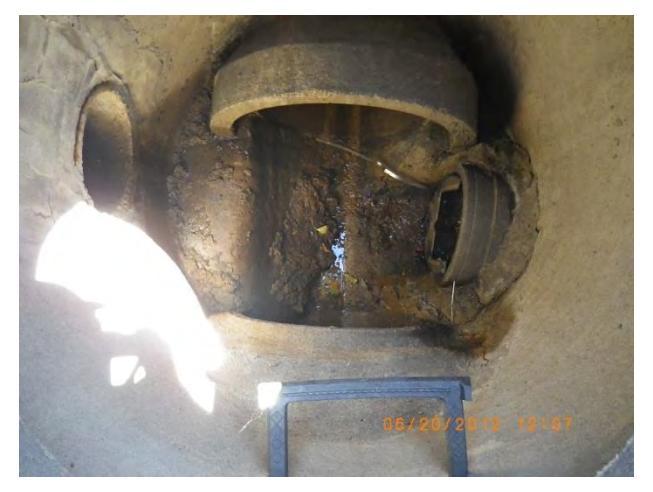
Figure 27 - Manhole 14-582 US1 (6/20/2012)

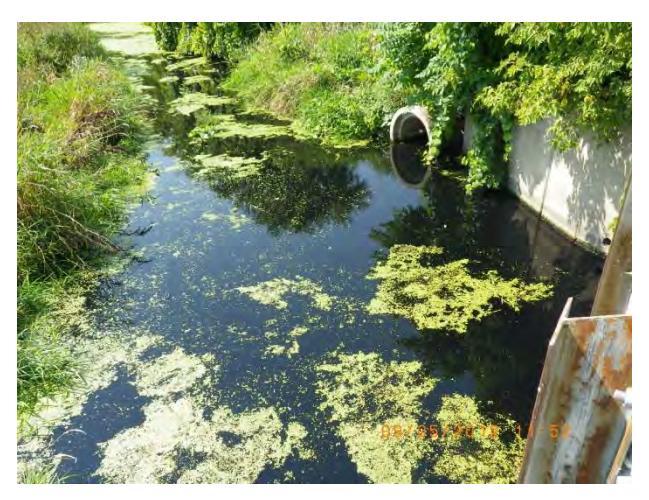
The City contacted OMNNI on September 5, 2012 with a request to investigate a report of a black discharge into the stream near the outfall pipe. OMNNI investigated the outfall on September 5. Upon arriving, a black pool was observed in the stream around the outfall pipe, and a strong odor was present in the surrounding area. The odor was similar to the odor associated with anaerobic decomposition.

Figure 28 - Black discharge at outfall 14-582 (9/5/2012)

The samples collected from the stream did not contain any abnormal chemical indicators to help identify the substance in the stream, other than a low pH. A sanitary sewer line and lift station was observed in the area around the outfall, so OMNNI recommended that the City investigate if there were any leaks in the sanitary sewer or lift station. Another potential source would be an illegal dumping of material from the bridge. OMNNI notified the City of the inspection results in an email on September 5.

Based on this discharge and the history of illicit discharges at this outfall, it is recommended that this outfall be rescreened during the 2013 ongoing screening program.

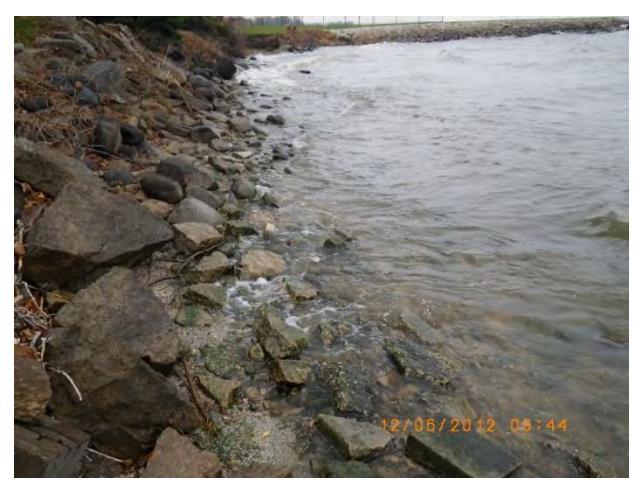
Figure 29 - Suds along shoreline north of outfall 02-184

The suds observed on December 6 were consistent with the appearance of the suds that can be formed by natural surfactants in surface water. However, the sample that was collected from the pool in the upstream manhole had a detergent concentration of 0.2 mg/L, and an ammonia concentration of 3-6 ppm. These chemical indicators suggest that sanitary sewage may be present in the storm sewer, which could be causing the suds in the lake.

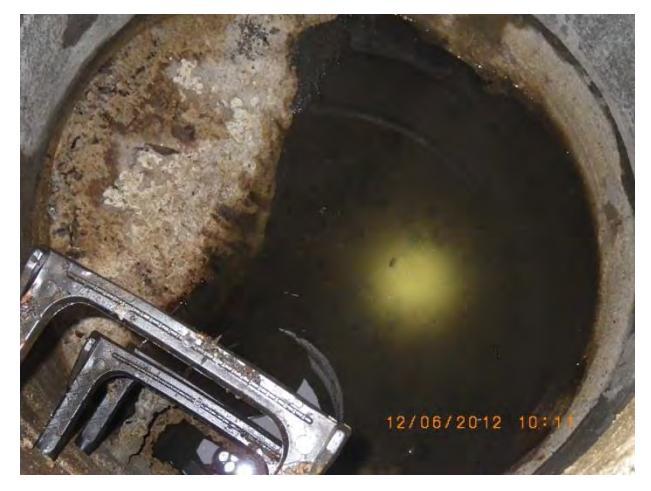
Figure 30 - Pool in upstream manhole 02-184 US1

Based on the sample results, OMNNI recommended that the City televise the entire storm sewer branch to locate any potential sanitary cross connections. An email was sent to the Illicit Discharge Coordinator on December 6 summarizing the results and the recommended action. After the storm sewer was televised, it appeared that the storm sewer outfall had been abandoned. The City will conduct additional follow-up to check for connections.

It is recommended that this outfall be screened again in 2013 to determine if the discharge of ammonia and detergent is ongoing.

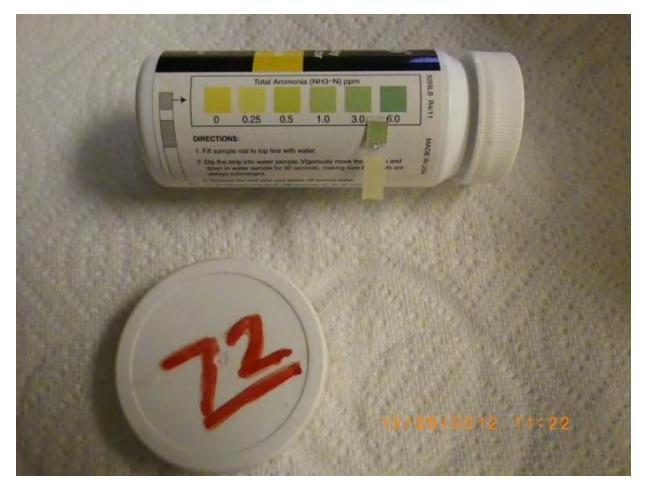
Figure 31 - Ammonia test from upstream manhole 02-184 US1

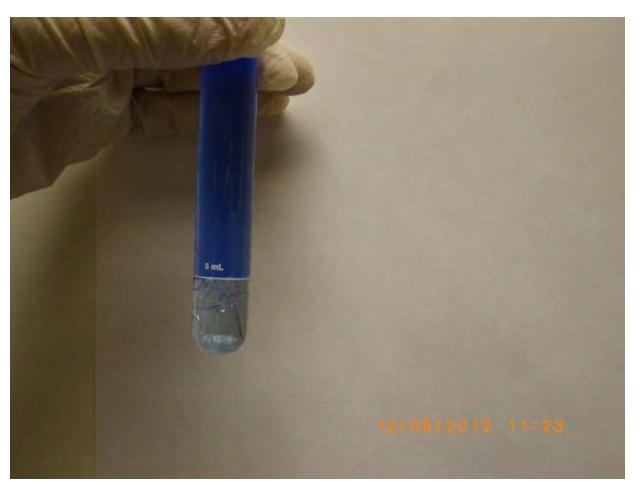
Figure 32 - Detergent test from upstream manhole 02-184 US1

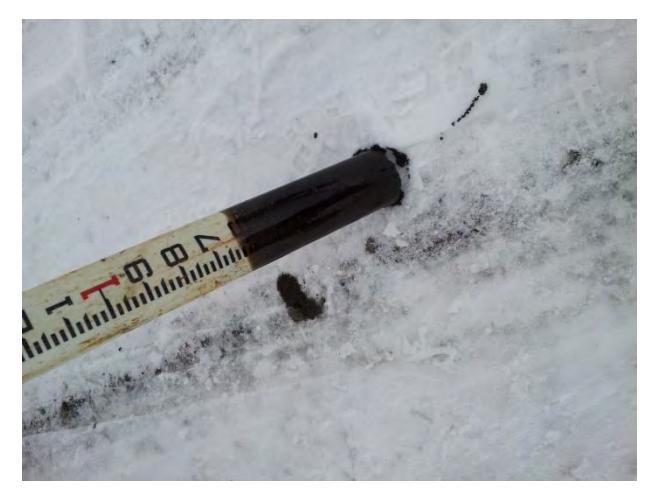
The City contacted OMNNI on December 11, 2012 to report that city crews had encountered oil in a storm sewer manhole while surveying the area around Washburn Street just south of STH 44, and requested that OMNNI assist with identifying the source of the oil. OMNNI conducted an investigation on December 12 to identify the source of the oil and define the downstream extent of the contamination.

Figure 33 - Oil on survey rod from storm manhole 13-1743 (12/11/2012)

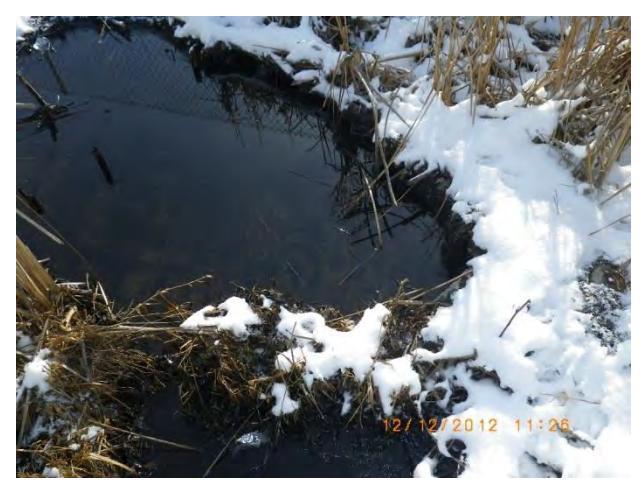
With assistance from two city survey staff, the storm sewer branch for outfall 13-1758 was investigated. Outfall 13-1758 is a reinforced concrete pipe that discharges to the USH 41 southbound right-of-way, south of STH 44. The pipe was partially submerged, and an oil sheen was present in the pool at the end of the pipe. After discharging from the outfall, the flow followed a swale in the USH 41 right-of-way, and crossed under STH 44 through another concrete pipe. This pipe discharged to the USH 41 right-of-way north of STH 44. There is a small pool at the discharge of this culvert pipe, which also contained an oil sheen. The pool stopped a short distance north of the pipe, and no additional flow or sheen was observed.

Figure 34 - Pool at end of outfall 13-1748 (12/12/2012)

It is recommended that this outfall be rescreened during the 2013 ongoing screening program to monitor the progress of the cleanup and check for any additional discharges.

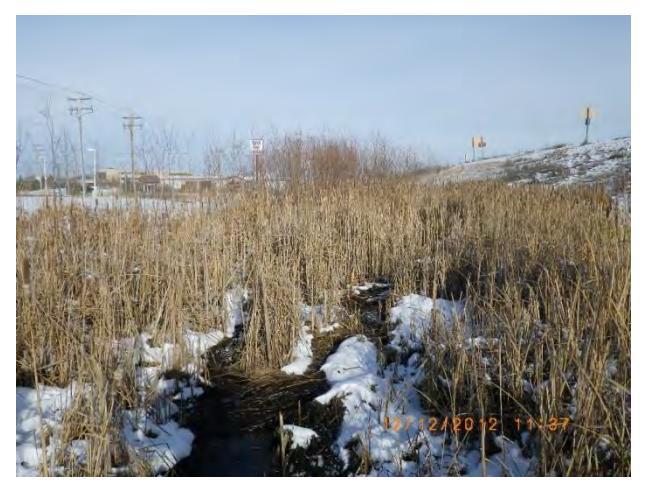
Figure 35 - Downstream extent of oil sheen

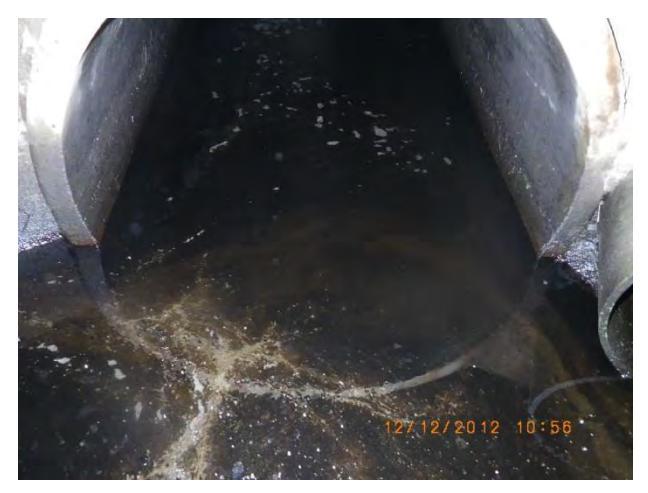
Various branches of the storm sewer system upstream of outfall 13-1748 were investigated to determine the extent of the oil, and to identify potential sources. Oil was present in the detention basin on the east side of Washburn Street, and the heaviest concentration of oil seemed to be in manhole 13-1743, which received flow from the swale on the west side of Washburn Street.

Figure 36 - Drainage swale pipe connection to manhole 13-1743

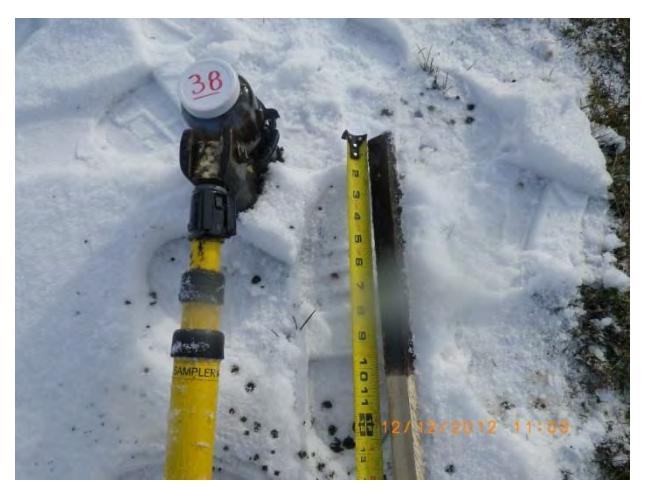
A sample was collected from manhole 13-1743. No chemical tests were conducted on this sample, as it was obviously a petroleum product. Based on the odor, it appeared to be diesel fuel or a heavier oil.

Figure 37 - Sample collected from manhole 13-1743

After investigating the area around the drainage swale, a 4-inch PVC pipe was located coming from Quent's service center. When the pipe was exposed, water and petroleum discharged to the drainage swale. The appearance and odor from the discharge was consistent with the oil that was observed in the downstream manholes.

The pipe was identified as the sump pump discharge from Quent's Service Center. The Fire Chief investigated the inside of the building on December 12, and observed oil on the surface of the sump pit. The City reported the discharge to the WDNR spills hotline.

The Illicit Discharge Coordinator was called at approximately 12:00 pm and notified of the discovery. OMNNI marked the pipe location and left the site. The Illicit Discharge Coordinator visited the site during the afternoon and had the Hazardous Materials Response Team deploy oil containment booms in the area.

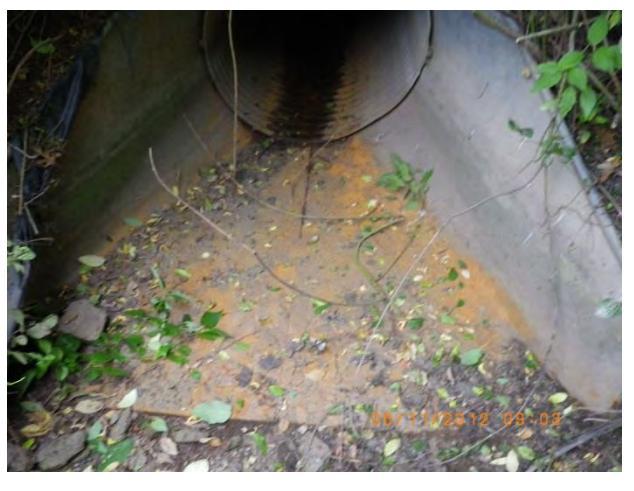
Figure 38 - Outfall 06-3 corrosion on pipe and apron (minor damage)

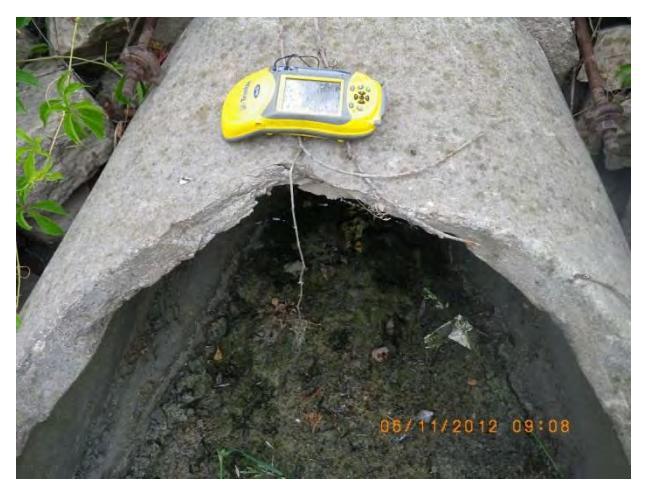
Figure 39 - Outfall 06-1083 damaged concrete pipe (minor damage)

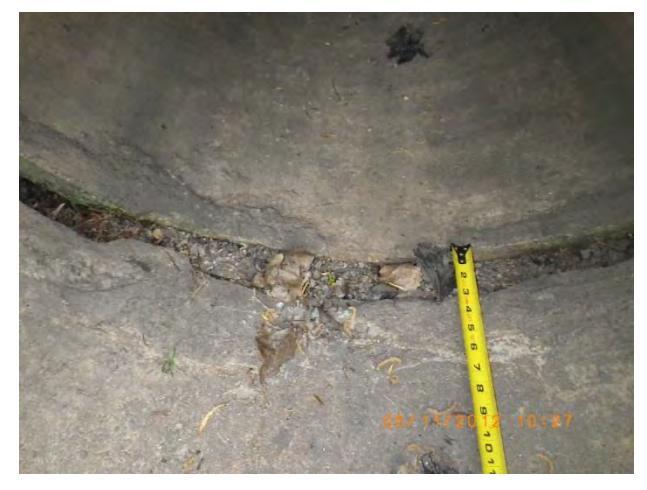
Figure 40 - Outfall 06-1132 apron displacement (minor damage)

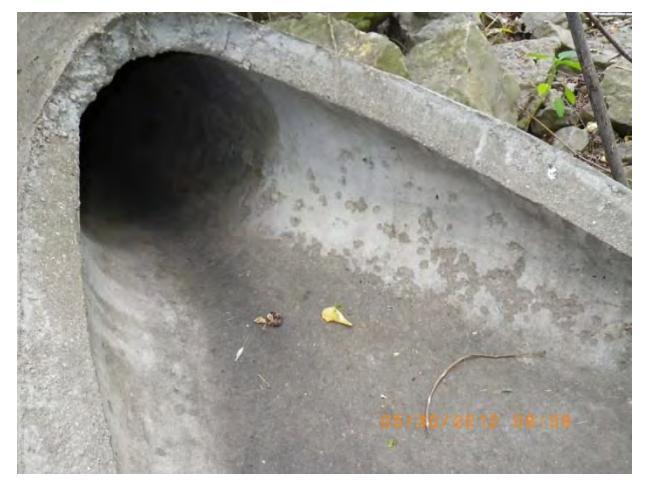
Figure 42 - Outfall 06-1814 concrete spalling on apron (minor damage)

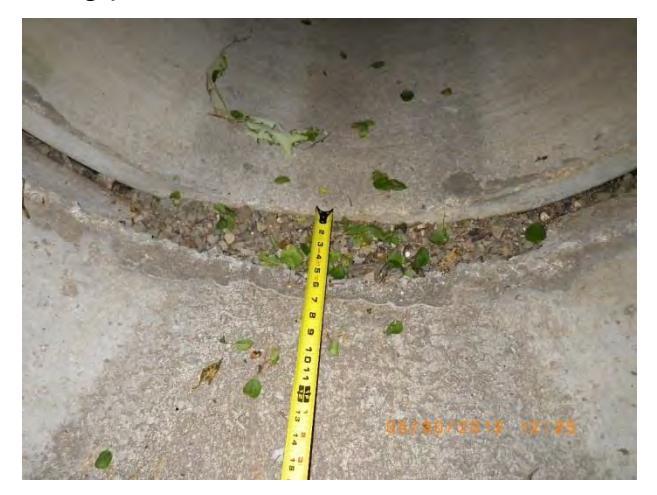
Figure 44 - Outfall 06-977 apron displacement and undercut (minor damage)

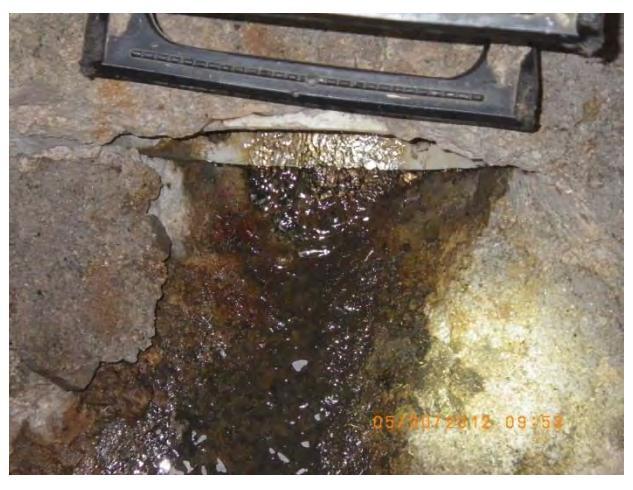
Figure 41 - Manhole 06-1149 US1 concrete damage (minor damage)

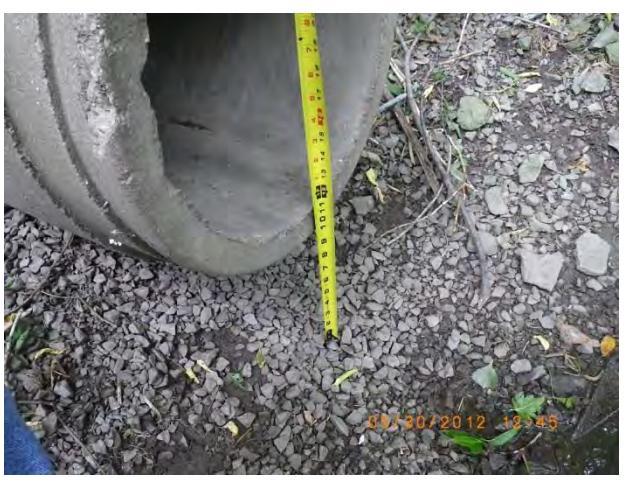
Figure 43 - Outfall 06-961 undercut outfall pipe (minor damage)

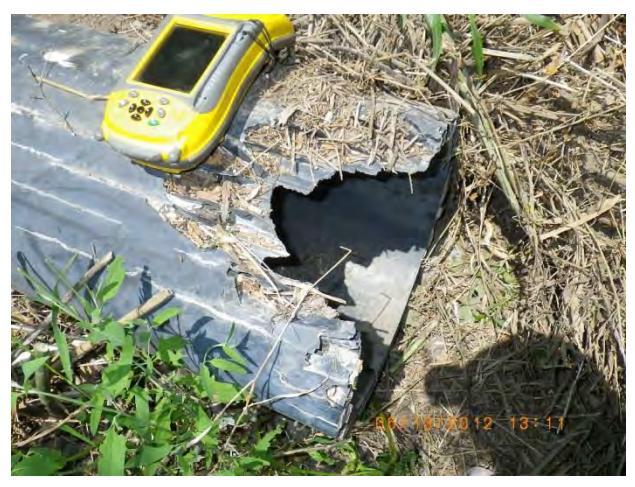
Figure 45 - Outfall 13-1109 damaged plastic pipe (minor damage)

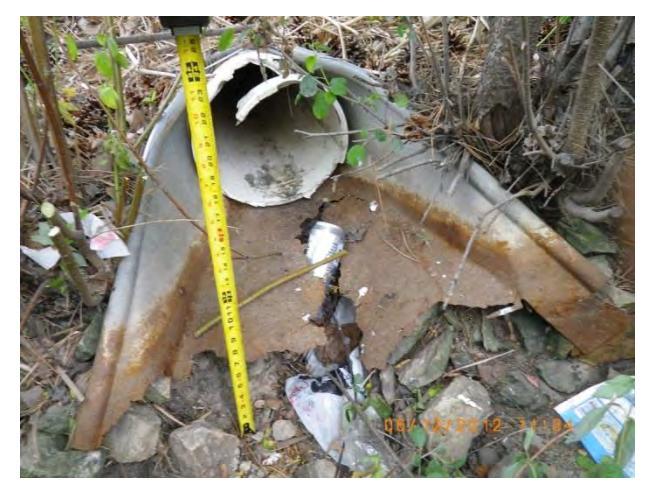
Figure 46 - Outfall 13-1715 damaged plastic pipe and corroded and undercut apron (moderate damage)

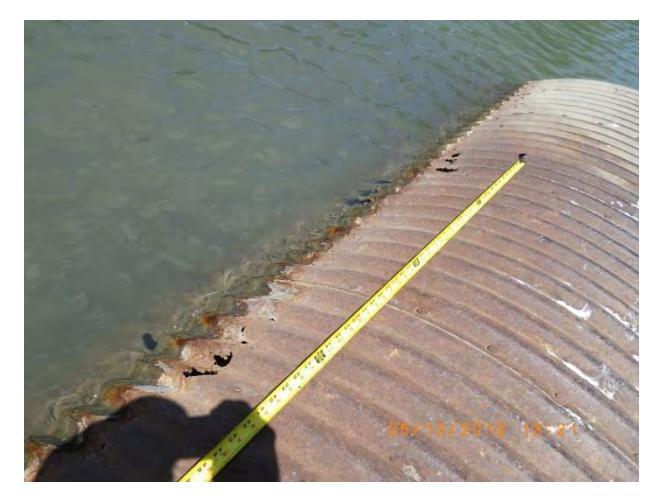
Figure 48 - Outfall 13-337 corroded pipe (moderate damage)

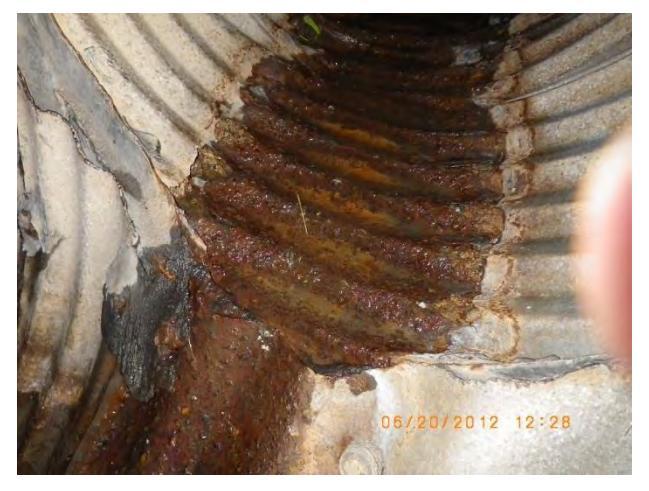
Figure 50 - Outfall 14-676 corroded pipe (minor damage)

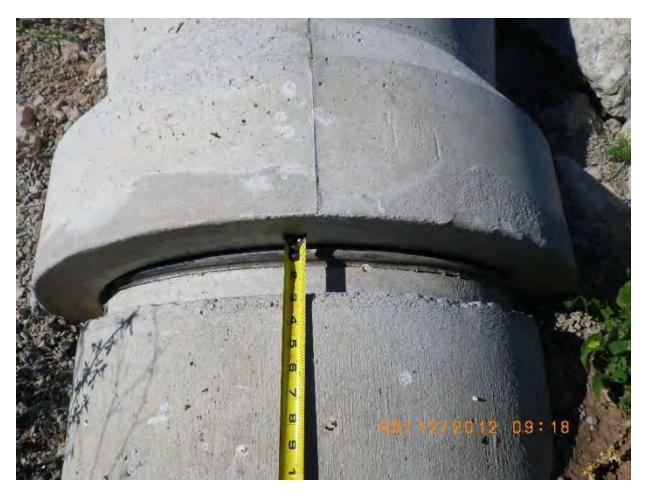
Figure 47 - Outfall 13-3127a apron displacement (minor damage)

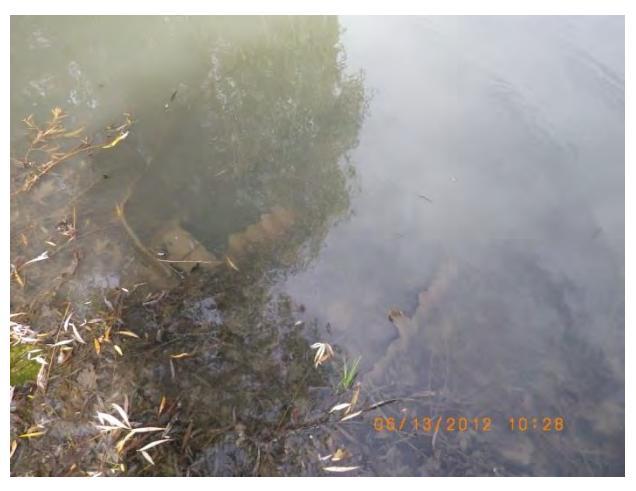
Figure 49 - Outfall 13-95 corroded pipe (moderate damage)

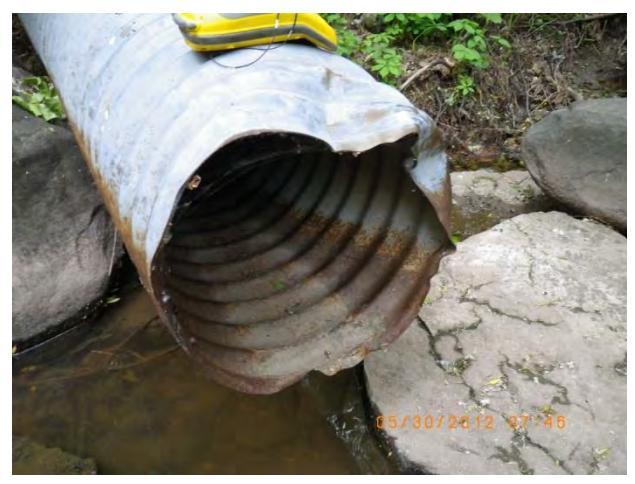
Figure 51 - Outfall 16-622 corroded and crushed pipe (minor damage)

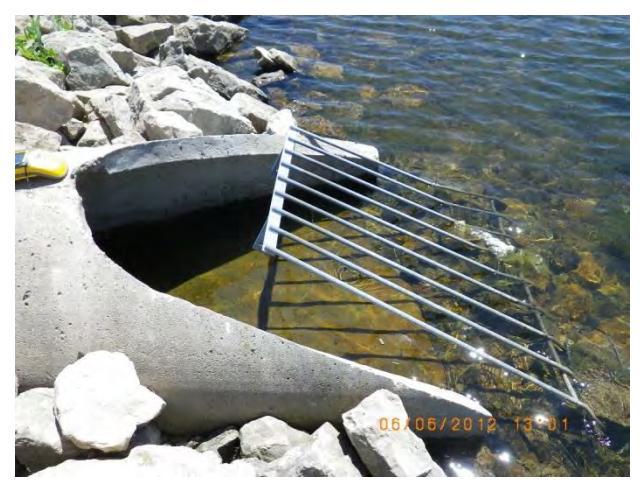
Figure 55 - Outfall 16-941 displaced grate (minor damage)

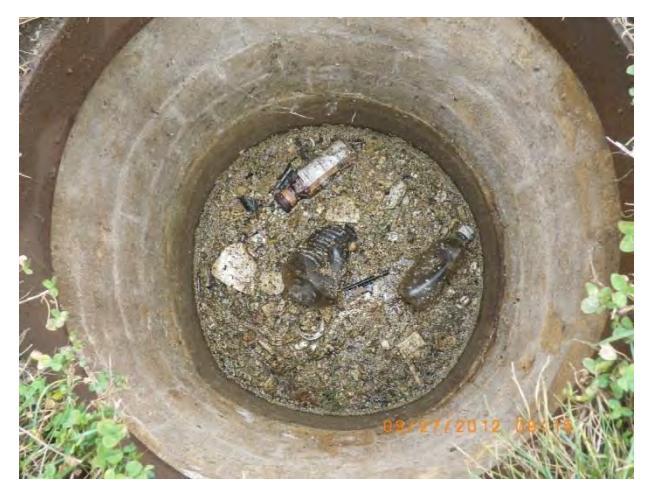
Figure 56 - Minor deposition at manhole 03-35 US1

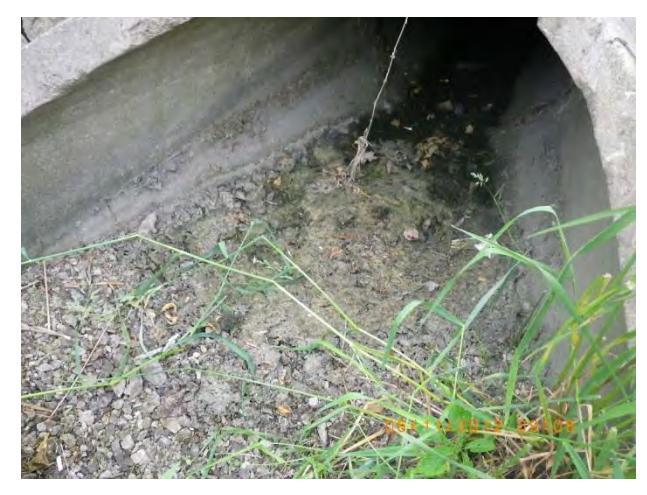
Figure 57 - Minor deposition at outfall 06-1083

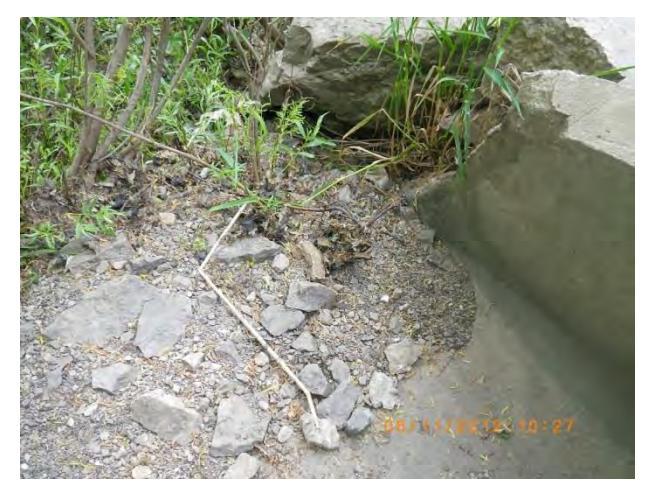
Figure 58 - Minor deposition at outfall 06-1132

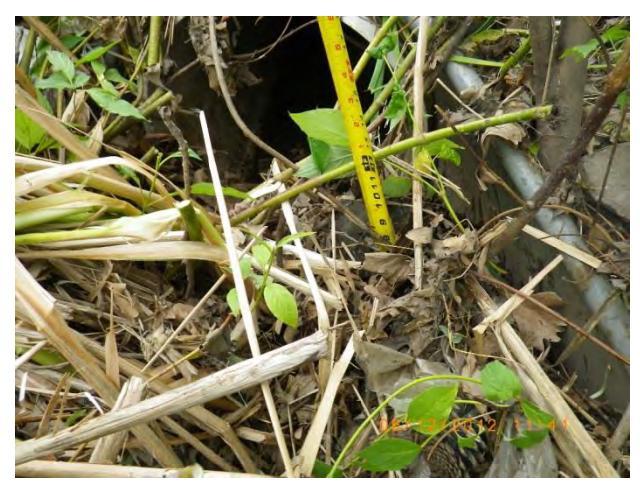
Figure 60 - Moderate deposition at outfall 13-1716

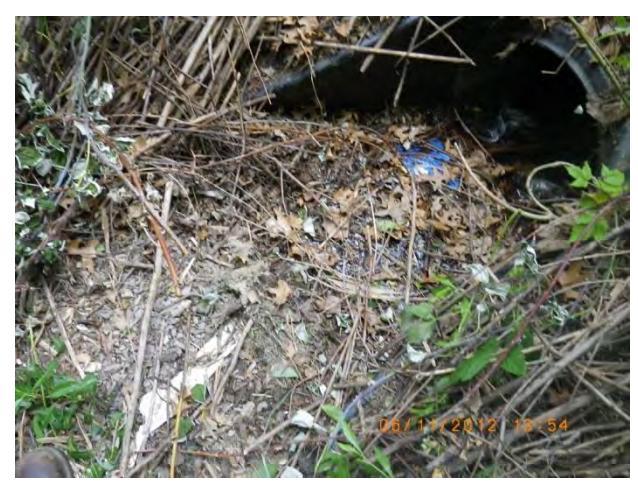
Figure 62 - Minor deposition at outfall 13-2768

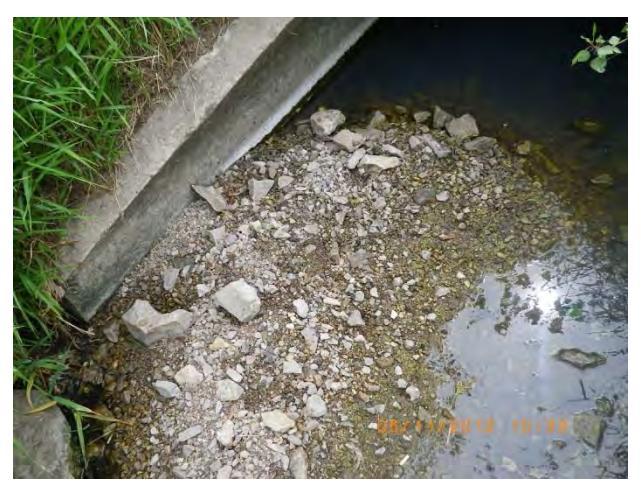
Figure 59 - Moderate deposition at outfall 06-1136

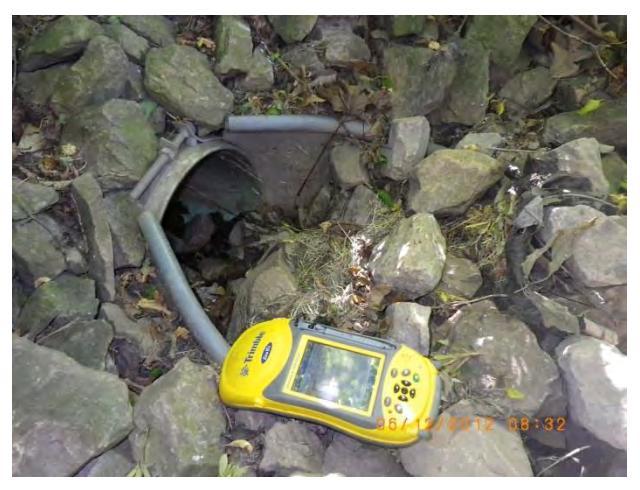
Figure 61 - Moderate deposition at outfall 13-2666

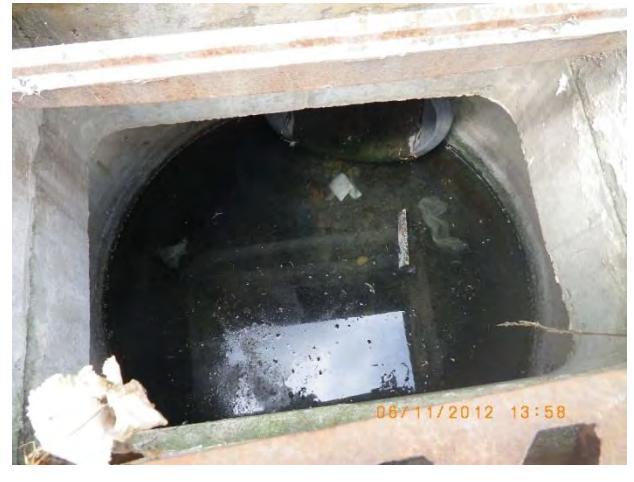
Figure 63 - Minor deposition at inlet 13-2768 US1

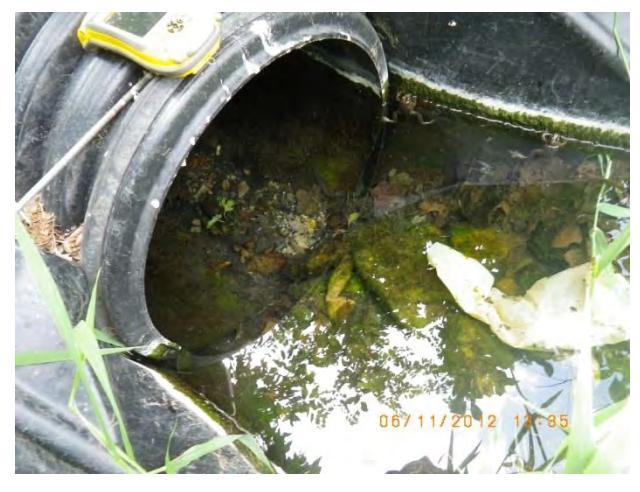
Figure 64 - Minor deposition at outfall 13-2886

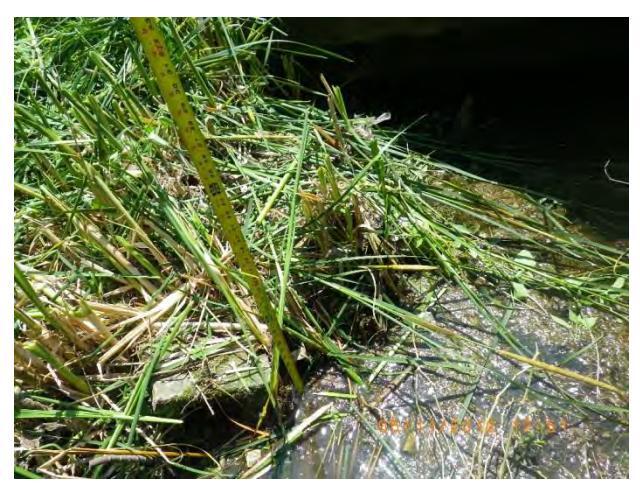
Figure 66 - Moderate deposition at outfall 13-3099

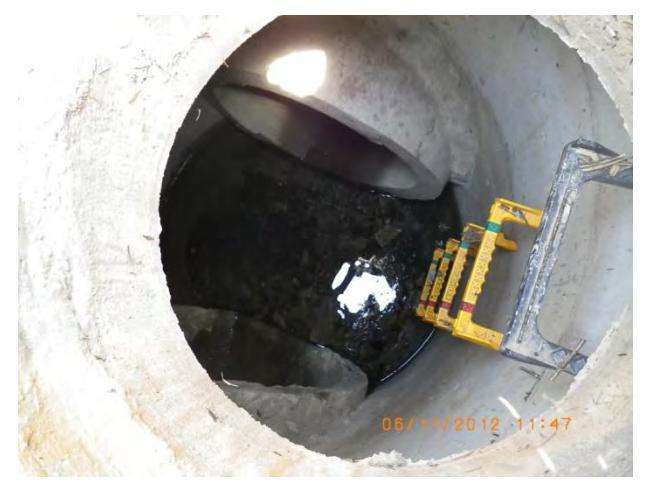
Figure 68 - Minor deposition at manhole 13-947 US1

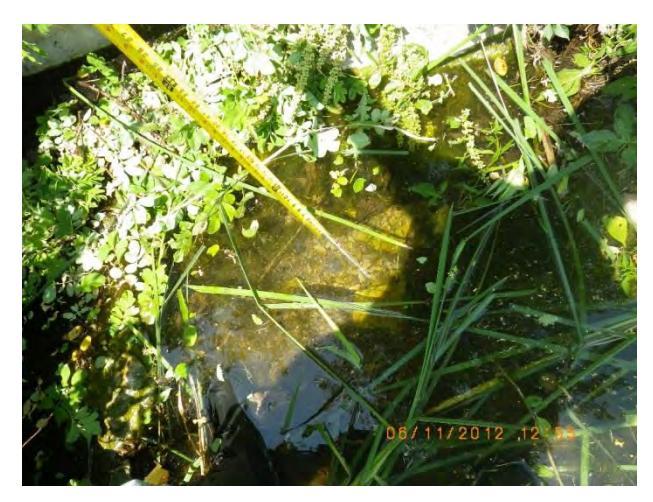
Figure 65 - Minor deposition at outfall 13-3097

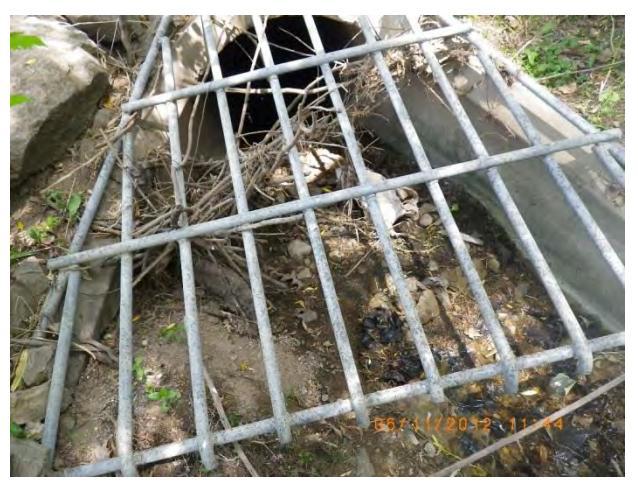
Figure 67 - Moderate deposition at outfall 13-3243

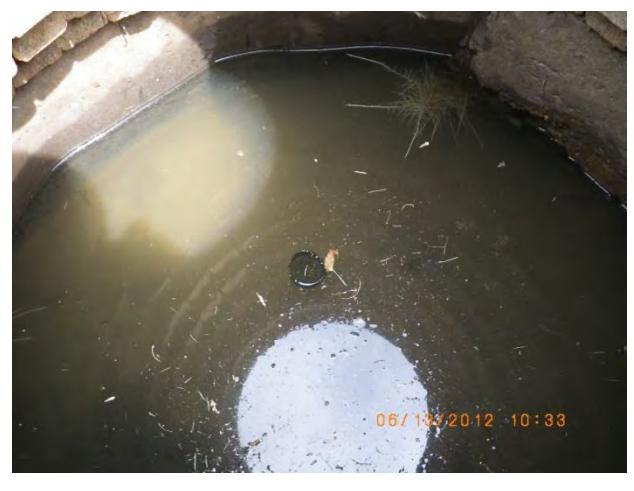
Figure 69 - Moderate deposition at manhole 13-95 US1

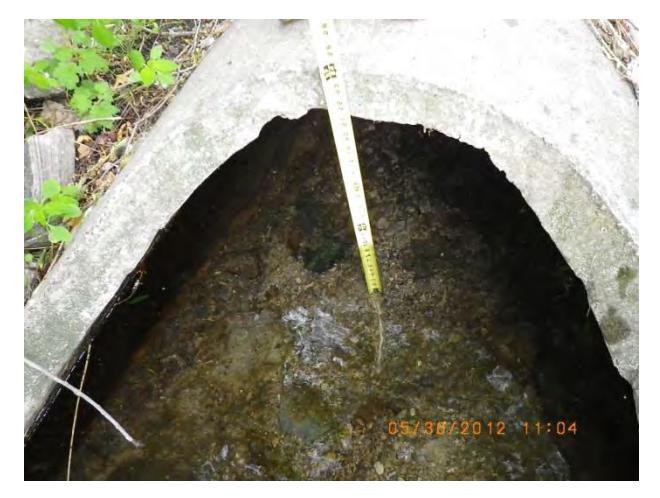
Figure 70 - Minor deposition at outfall 16-660

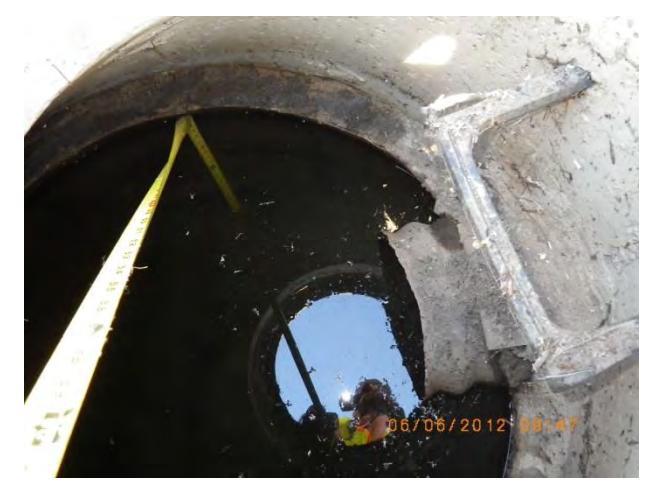
Figure 72 - Moderate deposition at manhole 16-93 US2

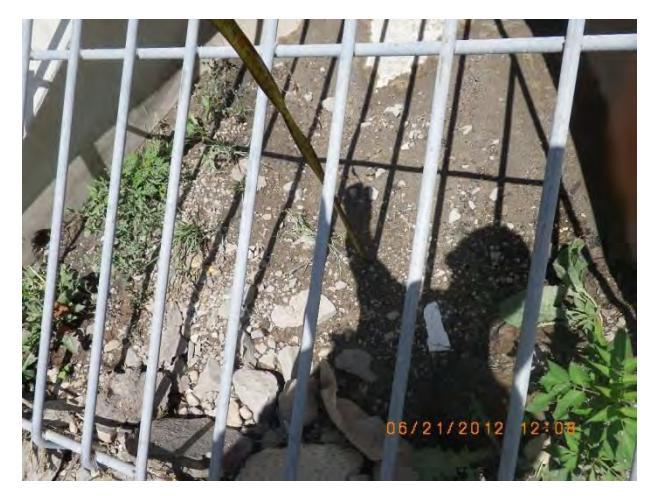
Figure 71 - Minor deposition at outfall 16-828

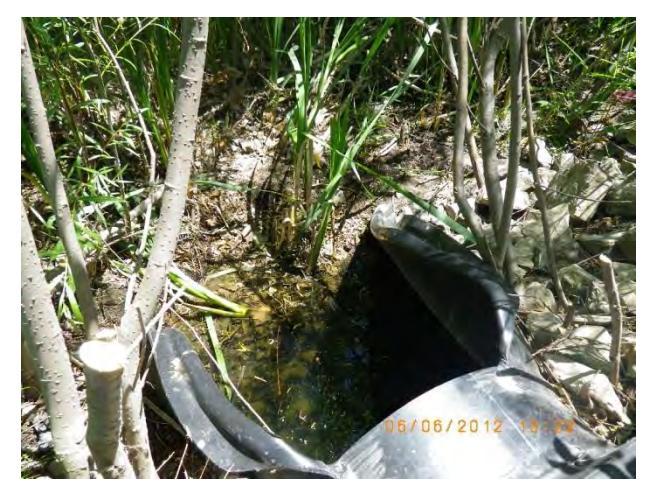
Figure 73 - Moderate deposition at outfall 16-995

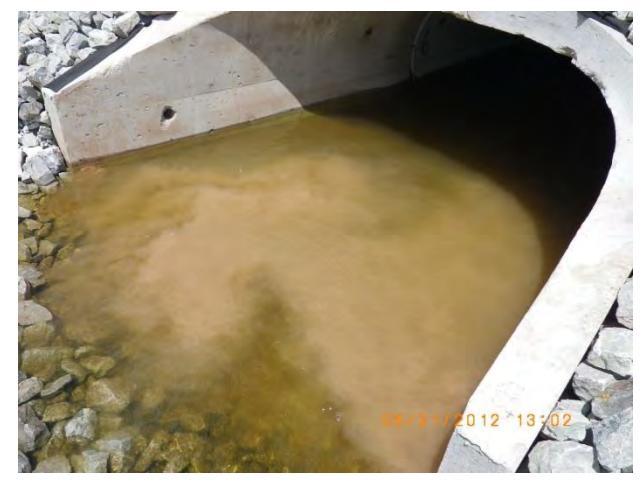
Figure 74 - Minor deposition at outfall STH21_Out

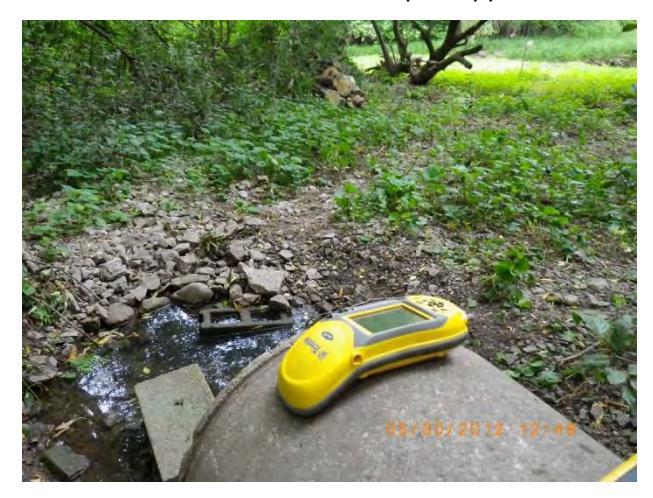
Figure 75 - Minor erosion near outfall 06-961

Four of the outfalls showed signs of erosion at the end of the outfall pipe or channel. Most of the outfalls with minor erosion could be repaired with minor landscaping repairs. Those outfalls

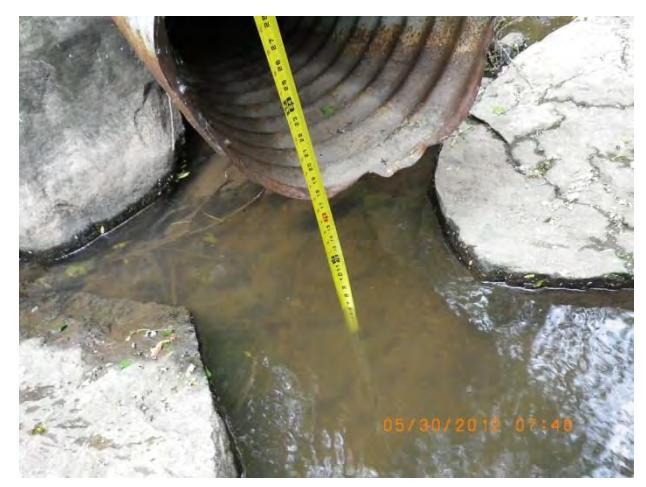
Figure 77 - Minor erosion near outfall 16-622

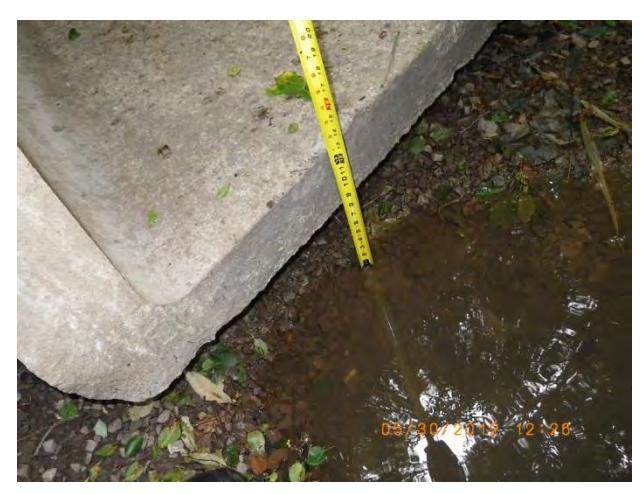
Figure 76 - Minor erosion near outfall 06-977

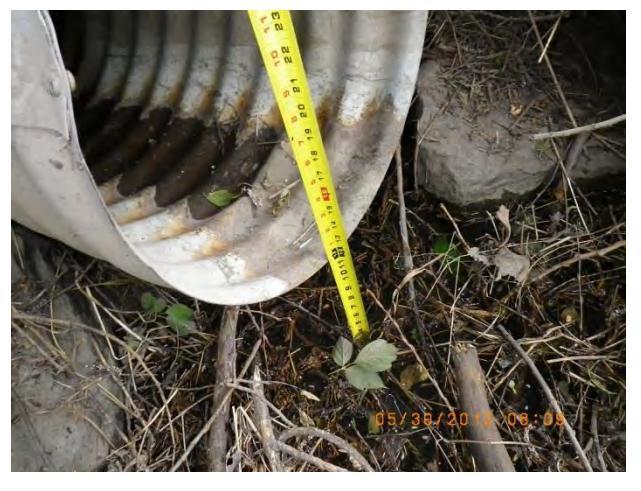
Figure 78 - Moderate erosion near outfall X47-15B
