Ongoing Screening Summary Report 2012 Inspection Year

Illicit Discharge Detection and Elimination Program

City of Oshkosh

March 25, 2013

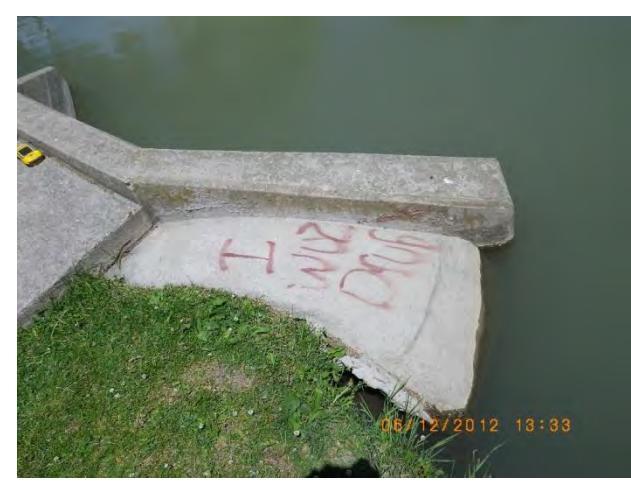
Outfall	Severity	Description
13-2957	Minor	Graffiti painted on concrete behind wingwall
16-826	Moderate	Graffiti painted on bridge abutment
16-830	Minor	Graffiti painted on bridge abutment

Figure 79 - Graffiti near outfall 13-2957

Graffiti was observed in or around three outfalls. The graffiti was relatively minor, but should probably be monitored to make sure that it does not become more severe.

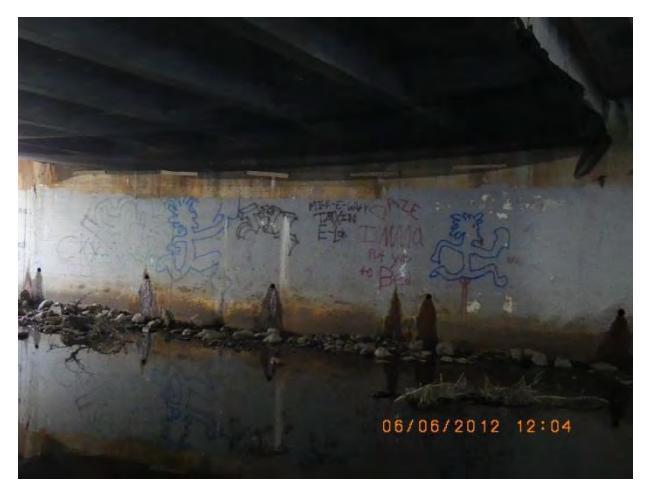
Figure 80 - Graffiti near outfall 16-826

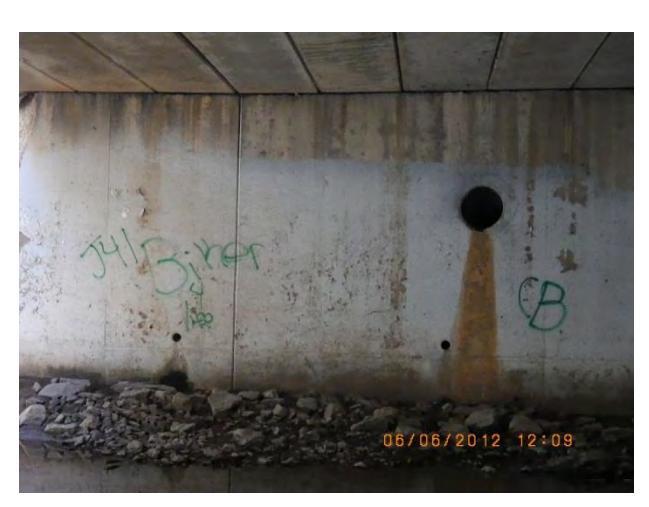
Figure 81 - Graffiti near outfall 16-826

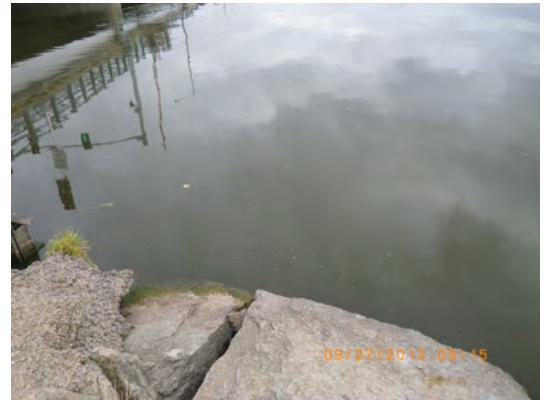
o20120927081500.JPG

JCW Inspection Date: 9/27/2012 9:13:17 AM Inspector: Inspection Type: Ongoing Previous Rainfall (hrs): 72+ Outfall fully submerged; screened upstream Flow Description: Submerged (not located) Notes: at 03-35 US1. Submerged: Fully Depth (in): Illicit Discharge Potential: Potential Field Follow-up Office Follow-up Floatables: None Petrol. Sheen Suds Sewage Other Algae Odor: None Petroleum Musty Sewage Chlorine Other VOC/Solvent Fishy Sulfur Fragrant Turbidity: None o20120927081506.JPG Color: None Gross Solids: None Litter Debris Sediment Other Sampling Results None Inhibited Vegetation: Excessive Sample Location: Benthic Growth: None Green Brown Sample ID: None Stains: Rust Stains **Time Collected** Flow Line Oil Corrosion Paint Other Total Chlorine (field): ppm --Free Chlorine (field): ppm --Non-illicit: None Natural Sheen Natural Suds/Foam Total Copper (field): -ррт Physical Condition Assessment ррт Ammonia (field): Graffiti: None pH (field): units --Erosion: None Temperature: °F --Deposition: None Depth (in): Conductivity: µS/cm --Damage: None Displacement Undercut Crushed Detergents: -mg/L Phenol: Corrosion Cracks/Structural Damage -mg/L

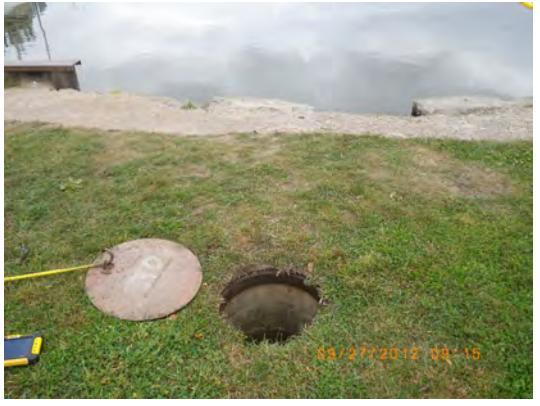
o20120927081516.JPG

Inspection	Date: 9/27/	/2012 9:13:54 AM	nspector:	JCW	Inspection Type:	Ongoing	Previous Rainfall (h	rs): 72+	-
Flow Descr	ription: Subi	merged, indeterminate	Notes:	2011 g	ross solids follow-up.		1. A. de	a very a	
Submerged	: Fully	Depth (in): 31					6.65	AT -	
Illicit Disch	arge Potentia	al: Potential		Field F	ollow-up 🗌 O	ffice Follow-up			
Floatables:	None	Petrol.	Sheen	Suds	🗌 Sewage 🗌 A	lgae 🗌 Other		2-2	
Odor:	None	Petrol	eum 🗌	Musty	🗌 Sewage 🗌 C	hlorine 🗌 Other	r 👗	1. Saint	11 1 3
			Solvent	Fishy	Sulfur F	ragrant			
Turbidity:	None								AND NOT
Color:	None						02012092	7081522.JI	PG
Gross Solid	s: Severe	✓ Litter		Debris	Sediment	Other	-Sampling Results —		
Vegetation:	None	🗌 Inhibit	ed 🗌	Excessiv	e		Sample Location:	Pool	
Benthic Gro	wth: None	Green		Brown			Sample ID:	120927-2	2
Stains:	Slight	✓ Flow L	ine	Oil	Rust Stains		Time Collected	09:12	
			ion 🗌	Paint	Other		Total Chlorine (field)	: 0	ppm

Non-illicit:	None	Natura	l Sheen	Natu	ral Suds/Foam		Free Chlorine (field):	0	ррт
- Physical	Condition Ass	essment					Total Copper (field):	0	ррт
Oreffiti	Nama	cosment					Ammonia (field):	0	ppm
Gramiti:	None						pH (field):	8.42	units
Erosion:	None						Temperature:	59	°F
Depositio	n: Minor	Depth (in): 3					Conductivity:	723	µS/cm
Damage:	None	Displacement	Jndercut		Crushed		Detergents:	0	mg/L
		Corrosion	Cracks/St	ructural E	Damage		Phenol:		mg/L

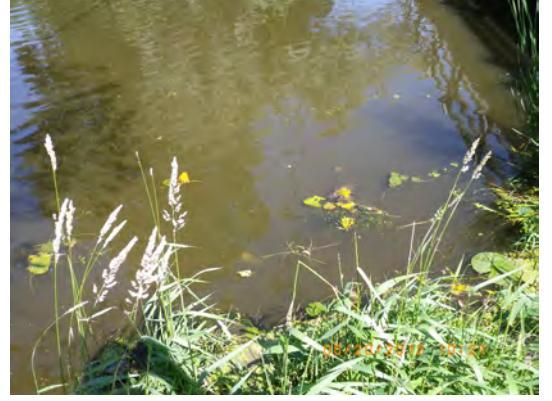
o20120620092742.JPG

JCW Inspection Type: Ongoing **Inspection Date:** 6/20/2012 10:25:32 AM Inspector: Previous Rainfall (hrs): 24-48 the N Flow Description: Submerged (not located) Notes: Outfall fully submerged; screened upstream at 06-1028 US1. Submerged: Fully Depth (in): Illicit Discharge Potential: Unlikely Field Follow-up Office Follow-up Floatables: None Petrol. Sheen Suds Sewage Other Algae Odor: None Petroleum Musty Sewage Chlorine Other VOC/Solvent Fishy Sulfur Fragrant Turbidity: None o20120620092748.JPG Color: None Gross Solids: None Litter Debris Sediment Other Sampling Results None Inhibited Vegetation: Excessive Sample Location: Benthic Growth: None Green Brown Sample ID: None Stains: Rust Stains **Time Collected** Flow Line Oil Corrosion Paint Other Total Chlorine (field): ppm --Free Chlorine (field): ppm --Non-illicit: None Natural Sheen Natural Suds/Foam Total Copper (field): -ррт Physical Condition Assessment ррт Ammonia (field): Graffiti: None pH (field): units --Erosion: None Temperature: °F --Deposition: None Depth (in): Conductivity: µS/cm --Damage: None Displacement Undercut Crushed Detergents: -mg/L Phenol: Corrosion Cracks/Structural Damage -mg/L

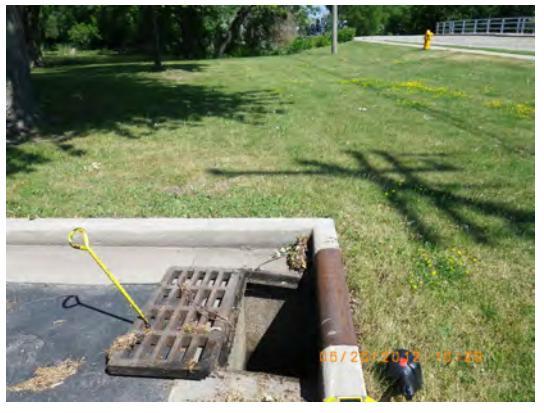
o20120620092940.JPG

Upstream curb inlet located approx 122 ft SSE of outfall 06-1028. Intermediate area consists of open area and paved parking lot.

Inspection	Date: 6/20/2	2012 10:29:02 AM	nspector: JC	W Inspe	ection Type:	Ongoing	Previous Rainfall (hrs):	24-4	48
Flow Desci	ription: Subr	nerged, indeterminate	Notes: 20	11 gross solic	ds follow-up.		and an out of the second	20	195
Submerged	: Fully	Depth (in): 21					A Strift The		
Illicit Disch	arge Potentia	I: Unlikely	🗌 Fie	eld Follow-up	0	ffice Follow-up		1	PAN -
Floatables:	None	Petrol	Sheen 🗌 Su	ids 🗌 Sev	vage 🗌 Al	gae 🗌 Other			
Odor:	None	Petrol	eum 🗌 Mu	usty 🗌 Sev	wage 🗌 C	hlorine 🗌 Other			
			Solvent 🗌 Fis	shy 🗌 Sul	fur 🗌 Fr	ragrant		05/25/	2012 10:24
Turbidity:	None						1000 March 1		
Color:	None						0201206200929	948.JI	G
Gross Solid	ls: Moderate	✓ Litter	🖌 Deb	ris 🗌 Sec	diment	Other	Sampling Results		
Vegetation:	None	🗌 Inhibit	ed 🗌 Exce	essive			Sample Location:		
Benthic Gro	wth: Slight	✓ Green	Brow	vn			Sample ID:		
Stains:	None	Flow L	ine 🗌 Oil	🗌 Rus	st Stains		Time Collected

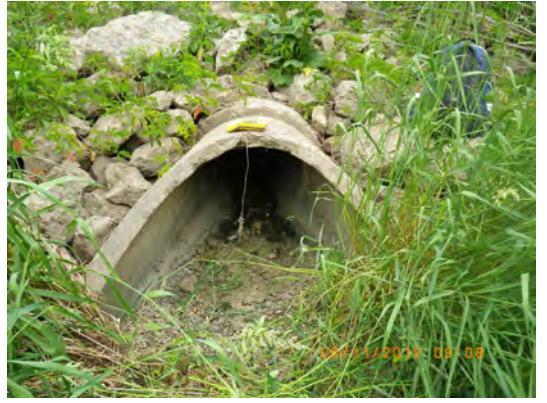
o20120611080824.JPG

Inspection Date: 6/11/2012 9:05:58 AM Inspection Type: Ongoing Inspector: JCW Previous Rainfall (hrs): 72+ Flow Description: None Notes: Damp flowline, but no flow leaving pipe. Submerged: None Depth (in): Illicit Discharge Potential: Unlikely Field Follow-up Office Follow-up Floatables: None Petrol. Sheen Suds Sewage Other Algae Odor: None Petroleum Musty Sewage Chlorine Other VOC/Solvent Fishy Sulfur Fragrant Turbidity: None o20120611080832.JPG Color: None ✓ Litter Gross Solids: Slight ✓ Debris Sediment Other Sampling Results None Inhibited Vegetation: Excessive Sample Location: Benthic Growth: None Green Brown Sample ID: Flow Line Stains: Slight Rust Stains Time Collected Oil Corrosion Paint Other Total Chlorine (field): ppm --Free Chlorine (field): -ppm Non-illicit: None Natural Sheen Natural Suds/Foam Total Copper (field): -ррт Physical Condition Assessment ррт Ammonia (field): Graffiti: None pH (field): units --Erosion: None Temperature: °F --Minor Deposition: Depth (in): 1 Conductivity: µS/cm --Damage: Minor Displacement Undercut Crushed Detergents: -mg/L Cracks/Structural Damage Phenol: Corrosion -mg/L

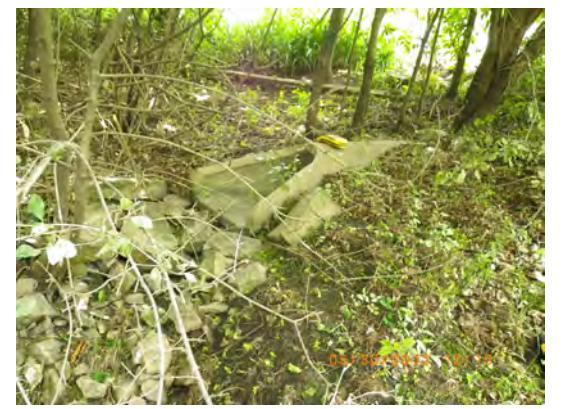
o20120530111500.JPG

Inspection Date: 5/30/2012 12:13:49 PM Inspection Type: Ongoing Inspector: JCW Previous Rainfall (hrs): 72+ Flow Description: None Notes: Apron damp but no flow at time of inspection. Submerged: None Depth (in): Illicit Discharge Potential: Unlikely Field Follow-up Office Follow-up Floatables: None Petrol. Sheen Suds Sewage Other Algae Odor: None Petroleum Musty Sewage Chlorine Other VOC/Solvent Fishy Sulfur Fragrant Turbidity: None o20120530111508.JPG Color: None Gross Solids: None Litter Debris Sediment Other Sampling Results None Inhibited Vegetation: Excessive Sample Location: Benthic Growth: None Green Brown Sample ID: Flow Line Stains: Slight Rust Stains Time Collected Oil Corrosion Paint Other Total Chlorine (field): ppm --Free Chlorine (field): -ppm Non-illicit: None Natural Sheen Natural Suds/Foam Total Copper (field): -ррт Physical Condition Assessment ррт Ammonia (field): Graffiti: None pH (field): units --Erosion: None Temperature: °F --Deposition: None Depth (in): Conductivity: µS/cm --Damage: None Displacement Undercut Crushed Detergents: -mg/L Phenol: Corrosion Cracks/Structural Damage -mg/L

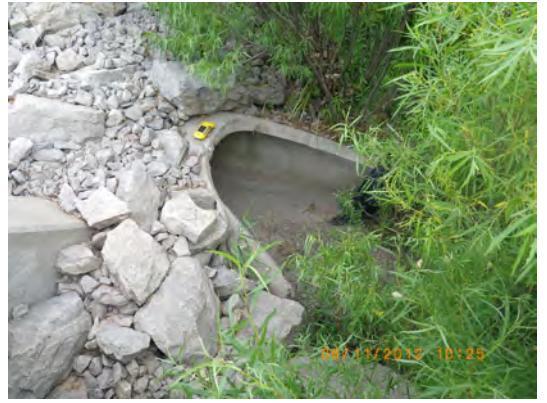
o20120611092516.JPG

Inspection Da	ate: 6/11/2012 10:22:	55 AM Inspector: J	ICW Inspec	tion Type: Ongoing	Previous Rainfall (hrs):	72+
Flow Descrip	otion: None	Notes: C	Gravel deposit at	end of apron.		
Submerged:	None Depth (n):				and the second sec
Illicit Dischar	rge Potential: Unlike	∦ □ F	ield Follow-up	Office Follow-u	q	
Floatables: N	lone	Petrol. Sheen S	Suds 🗌 Sewa	age 🗌 Algae 🗌 C	Dther	
Odor: N	lone	Petroleum N VOC/Solvent F	∕lusty Sewa Fishy Sulfu	age 🗌 Chlorine 🗌 C r 🗌 Fragrant	Dther	
Turbidity: N	lone					007117203010-28
Color: N	lone				o2012061109.	2654.JPG
Gross Solids:	None	Litter De	bris 🗌 Sedir	nent 🗌 Other	Sampling Results	
Vegetation:	None	Inhibited Ex	cessive		Sample Location:	
Benthic Growt	th: None	 Green Bro	own		Sample ID:	
Stains:	Slight	_ ☐ ✔ Flow Line □ Oil	Rust	Stains	Time Collected	
		Corrosion Pa	int 🗌 Other	r	Total Chlorine (field):	ppm
Non-illicit:	None	Natural Sheen	Natural Suds/Fo	oam	Free Chlorine (field):	ppm

– Physical Co	ondition Assessment –		-		Total Copper (field):	ppm
Groffiti	Nono				Ammonia (field):	ppm
Graniu.	None				pH (field):	units
Dependition:	Minor Dooth (in	N- 0			Temperature:	°F
Deposition.	Minor Deptri (in	μ. ο 	_		Conductivity:	μS/cm
Damage:	Displa	cement 📋 Undercut	Crushed		Detergents:	mg/L
	Corros	ion Cracks/Struc	tural Damage		Phenol:	mg/L

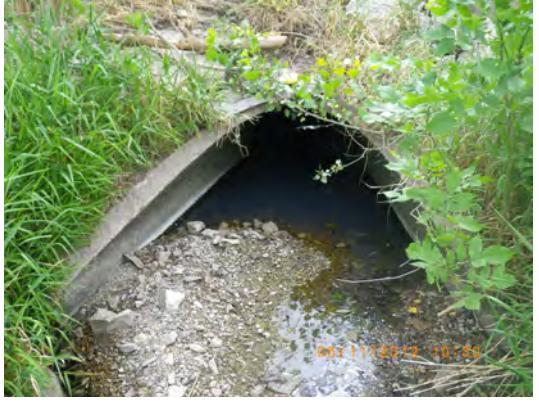
o20120611093044.JPG

Inspection	Date: 6/11/2012 10:29:34	AM Inspector:	JCW Insp	ection Type:	Ongoing	Previous Rainfall (hrs):	72+	
Flow Descr	Flow Description: Submerged, slight flow Notes: Gravel deposition on apron. Outfall partially submerged. Outfall screened upstream at							
Submerged:	Submerged: Partially Depth (in): 10 06-1136 US1.							
Illicit Disch	Illicit Discharge Potential: Unlikely 🗌 Field Follow-up 🗌 Office Follow-up							
Floatables:	None	Petrol. Sheen	Suds Se	wage 🗌 Al	gae 🗌 Other		4.24	
Odor:	None	Petroleum] Musty 🗌 Se	wage 🗌 C	hlorine 🗌 Other			
	VOC/Solvent Fishy Sulfur Fragrant							
Turbidity:	Slight cloudiness							
Color:	None					0201206110930	052.JPG	
Gross Solids	s: None	Litter	Debris 🗌 Se	diment	Other	-Sampling Results		
Vegetation:	None	Inhibited	Excessive			Sample Location:		
Benthic Gro	wth: None	Green	Brown			Sample ID:		
Stains:	Moderate	Flow Line	Oil 🗌 Ru	st Stains		Time Collected

Corrosion	Paint Ot	her		Total Chlorine (field):	ppm	
Non-illicit:	None	Natural Sheen	Natural Suds	/Foam		Free Chlorine (field):	ppm	
- Physical	Condition Assessment			_		Total Copper (field):	ppm	
Creffit	Nege					Ammonia (field):	ppm	
Gramiti:	None					pH (field):	units	
Erosion:						Temperature:	°F	
Depositio	n: Moderate Depth (in):	4				Conductivity:	μS/cm	
Damage:	None Displace	ment 🗌 Undercut	Crushed			Detergents:	mg/L	
		n Cracks/Str	ructural Damage			Phenol:	mg/L

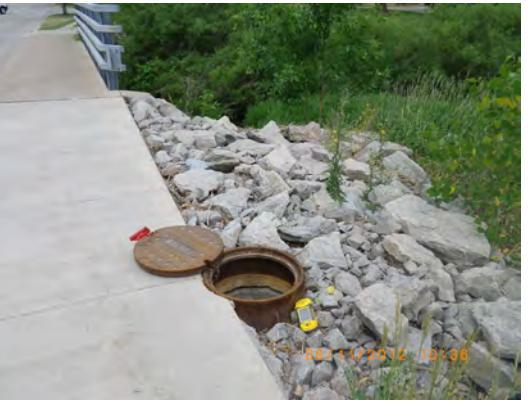
o20120611093602.JPG

Inspection Date: JCW 6/11/2012 10:33:33 AM Inspector: Inspection Type: Ongoing Previous Rainfall (hrs): 72+ Flow Description: Submerged, indeterminate Notes: Submerged: Partially Depth (in): 12 Illicit Discharge Potential: Unlikely Field Follow-up Office Follow-up Floatables: None Petrol. Sheen Suds Sewage Other Algae Faint Odor: Petroleum Musty Sewage Chlorine Other VOC/Solvent V Fishy Sulfur Fragrant 012 10:36 Turbidity: Slight cloudiness o20120611093616.JPG Color: None Gross Solids: Slight Litter ✓ Debris Sediment Other Sampling Results None Inhibited Vegetation: Excessive Sample Location: Pool Benthic Growth: None Green Brown Sample ID: 120611-43 Flow Line Stains: Slight Rust Stains **Time Collected** 10:35 Oil Corrosion Paint Other Total Chlorine (field): 0 ppm Free Chlorine (field): 0 ppm Non-illicit: None Natural Sheen Natural Suds/Foam Total Copper (field): 0 ppm Physical Condition Assessment Ammonia (field): 0 ppm Graffiti: None pH (field): 7.59 units Erosion: None Temperature: 73 °F Deposition: None Depth (in): Conductivity: 1490 µS/cm Damage: None Displacement Undercut Crushed Detergents: 0 mg/L Phenol: Corrosion Cracks/Structural Damage 0 mg/L

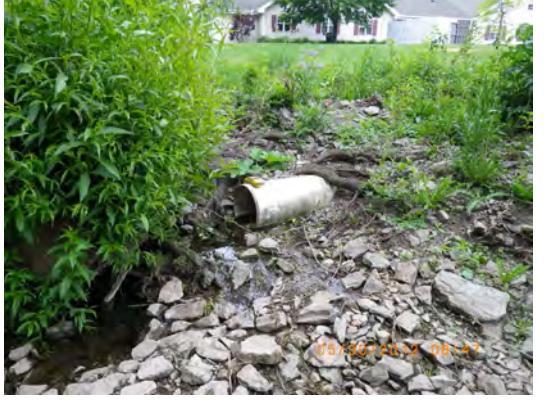
o20120530074712.JPG

Inspection	Date: 5/30	/2012 8:46:17 AM Ir	nspector: JC	V Inspec	tion Type:	Ongoing	Previous Rainfall (hrs):	72+	
Flow Description: Submerged, indeterminate Notes: Outfall partially sub Submerged: Partially Depth (in): 3						Outfall screened	EVANT -		
Submergeu									
Illicit Disch	arge Potenti	al: Unlikely	E Fiel	d Follow-up	Of	fice Follow-up			5 1-2h
Floatables:	None	Petrol.	Sheen 🗌 Suc	ls 🗌 Sewa	ige 🗌 Alç	gae 🗌 Other			200
Odor:	None	Petrole	eum 🗌 Mus	sty 🗌 Sewa	ige 🗌 Ch	nlorine 🗌 Other		Y	CE AS
	r		Solvent 🗌 Fish	ny 🗌 Sulfu	r 🗌 Fra	agrant		4130/	201
Turbidity:	None							1	
Color:	None						020120530074	728.JF	²G
Gross Solid	s: None	Litter	🗌 Debri	s 🗌 Sedin	nent 🗌 C	Other	Sampling Results]
Vegetation:	None		ed 🗌 Exces	ssive			Sample Location:		
Benthic Gro	wth: Slight	✓ Green	Srow	n			Sample ID:		
Stains:	Slight	✓ Flow L	ine 🗌 Oil	Rust	Stains		Time Collected		
			ion 🗌 Paint	Other			Total Chlorine (field):		ppm

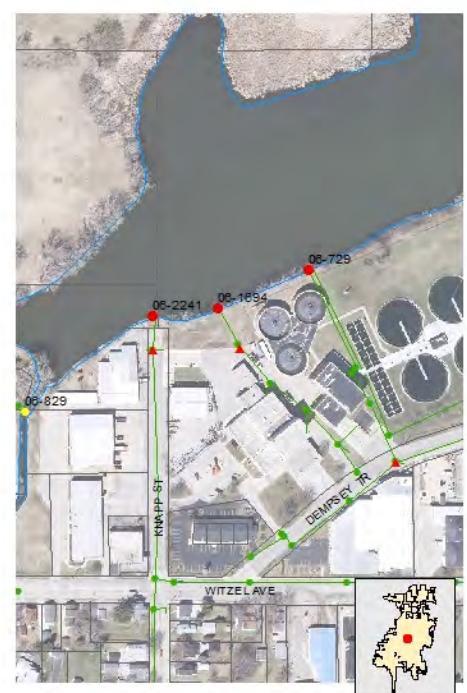
Outfall ID: 06-1694 US1

Inspection	Date: 10/11	/2011 11:25:47 AM Ir	nspector: JC	W Inspec	ction Type:	Ongoing	Previous Rainfall (r	ırs): 72+	
Flow Descr Submerged	ription: Subn : Fully	Depth (in): 34	Notes: 20 de	10 screening fo bris. Slight pe	ollow-up. Moo troleum shee	derate solid en.	1 Kon	and the	
Illicit Disch	arge Potentia	: Potential	E Fie	eld Follow-up	Offic	ce Follow-up	1 State		1.
Floatables:	Moderate	✓ Petrol.	Sheen 🗌 Su	ds 🗌 Sewa	age 🗌 Alga	ae 🗌 Othe	r Consis		
Odor:	None	Petrole	eum 🗌 Mu	isty 🗌 Sewa	age 🗌 Chlo	orine 🗌 Othe	r 💦	-	
			Solvent 🗌 Fis	shy 🗌 Sulfu	ur 🗌 Fraç	grant		- And	SAC
Turbidity:	None						St. Stand Street	J.	
Color:	None						02011101	1112518.JF	PG
Gross Solid	s: Moderate	Litter	Deb	ris 🗌 Sedi	ment 🗌 Ot	ther	-Sampling Results —]
Vegetation:	None	🗌 Inhibite	ed 🗌 Exce	essive			Sample Location:	Pool	
Benthic Gro	wth: Slight	✓ Green	Brov	vn			Sample ID:	111011-6	6
Stains:	Slight	✓ Flow L	ine 🗌 Oil	🗌 Rust	Stains		Time Collected	11:25

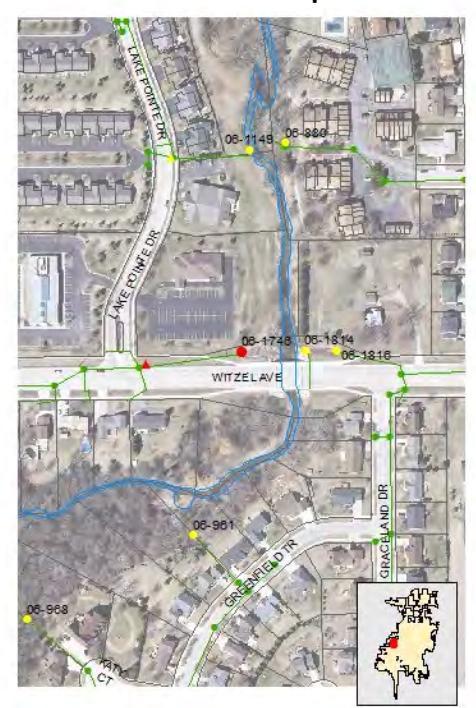
Inspection	Date: 5	/30/2012 9:14:05 AM	Inspector:	JCW Insp	ection Type:	Ongoing	Previous Rainfall (hrs):	72+	
Flow Descr	ription: S	ubmerged, slight flow	Notes: 0	Outfall partially	submerged.	Outfall screened	in the		Contraction of the second
Submerged	: Partially	Depth (in): 5	l	upstream at 06-	1746 US1.				A
Illicit Disch	arge Pote	ntial: Unlikely	F	Field Follow-up	Of	fice Follow-up		11	
Floatables:	None	Pe	trol. Sheen 🗌 S	Suds 🗌 Sev	wage 🗌 Alg	gae 🗌 Other	A Date		
Odor:	None	Pe VO	troleum	Musty 🗌 Ser Fishy 🗌 Sul	wage 🗌 Ch fur 🗌 Fra	nlorine 🗌 Other agrant			14.5
Turbidity:	None							08/30/	
Color:	None						020120530081	528.JF	PG
Gross Solid	s: Slight	Litt	ter 🗸 De	ebris 🗌 See	diment 🗌 0	Other	Sampling Results		
Vegetation:	None	🗌 Inh	nibited 🗌 Ex	cessive			Sample Location:		
Benthic Gro	wth: None	Gre	een 🗌 Br	own			Sample ID:		
Stains:	Slight	Flo	w Line 🗌 Oi	I 🗌 Ru	st Stains		Time Collected		
		🗌 Co	rrosion 🗌 Pa	aint 🗌 Oth	er		Total Chlorine (field):		ррт

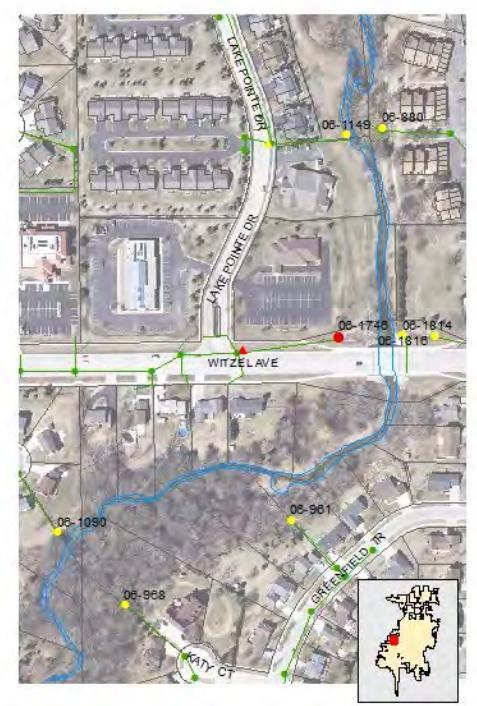
Inspection Date: 5/30/2012 9:35:08	AM Inspector: JCW Inspection Type: Ongoing	Previous Rainfall (hrs): 72+						
Flow Description: Submerged, inde	Iow Description: Submerged, indeterminate Notes:							
Submerged: Partially Depth (ir	ı): 3							
Illicit Discharge Potential: Unlikely	Field Follow-up							
Floatables: None	Petrol. Sheen Suds Sewage Algae Othe	er						
Odor: None	Petroleum Musty Sewage Ohlorine Othe	er V						
Turkiditur	UVOC/Solvent Fishy Sulfur Fragrant	11.05/30/2012 11-30						
		020120530102826 JPG						
Color: None		02012030102020.01 G						
Gross Solids: Slight	Litter 🖌 Debris 🗌 Sediment 🗌 Other	Sampling Results						
Vegetation: None	Inhibited Excessive	Sample Location: Pool						
Benthic Growth: None	Green Brown	Sample ID: 120530-28						
Stains: None	Flow Line Oil Rust Stains	Time Collected 09:35						
	Corrosion Paint Other	Total Chlorine (field): 0 ppm						
Non-illicit: None	Natural Sheen Natural Suds/Foam	Free Chlorine (field): 0 ppm

- Physical Condition Assocsment		Total Copper (field): 0 ppm						
Physical Condition Assessment		Ammonia (field): 0 ppm						
Graffiti: None		pH (field): 7.76 units						
Erosion: None		Temperature: 64 °F						
Deposition: None Depth (in)		Conductivity: 707 μ S/cm						
Damage: None 🗌 Displac	ement 🗌 Undercut 📄 Crushed	Detergents: 0 mg/L						
Corrosi	on Cracks/Structural Damage	Phenol: 0 mg/L

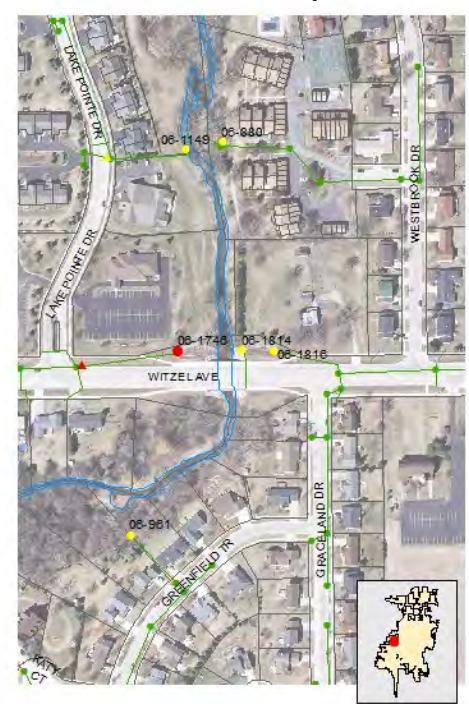
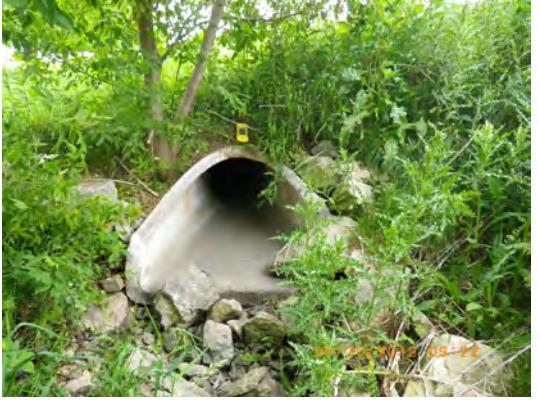
Outfall ID: 06-1816

Inspection	Date: 5/30/	2012 9:22:04 AM	Inspector:	JCW	Inspect	ion Type:	Ongoing	Previous Rainfall (hrs):	72+	
Flow Descr	ription: None	•	Notes:	Minor g	arbage in c	lownstrear	n channel -			
Submerged	: None	Depth (in):		potentia	ally from sto	orm sewer		Provide State	3.00	
Illicit Disch	arge Potentia	I: Unlikely] Field Fo	ollow-up	Of	fice Follow-up			
Floatables:	None	Pet	trol. Sheen	Suds	Sewa	ge 🗌 Alg	gae 🗌 Othe	r		4
Odor:	None	Pei	troleum] Musty] Fishy	Sewa	ge 🗌 Ch ·	nlorine 🗌 Othe agrant	r		
Turbidity:	None						Ū.			2012 08:22
Color:	None							020120530082	212.JF	°G
Gross Solid	s: Slight	✓ Litt	er 🗌	Debris	Sedim	nent 🗌 (Other	- Sampling Results		
Vegetation:	None	Inh	ibited	Excessiv	e			Sample Location:		
Benthic Gro	wth: None	Gre	een	Brown				Sample ID:		
Stains:	Slight	V Flo	w Line 🗌	Oil	Rust S	Stains		Time Collected		
			rrosion	Paint	Other			Total Chlorine (field):		ррт
Non-illicit:	None	Na [®]	tural Sheen	Natu	ral Suds/Fo	am		Free Chlorine (field):		ррт

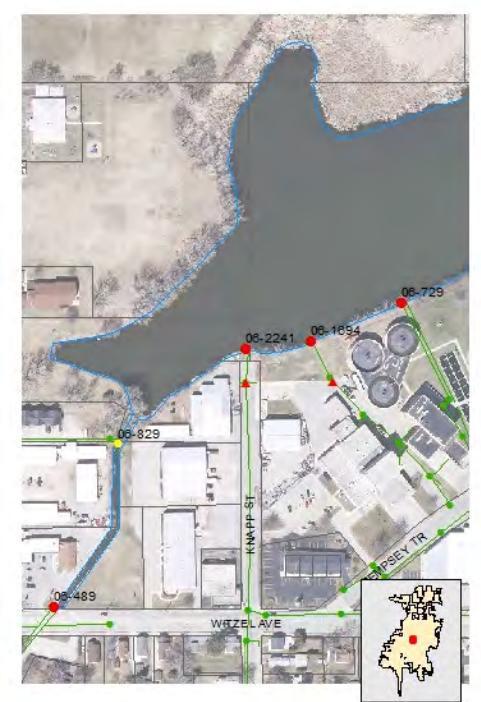
Inspection	Date: 9/2	7/2012 12:15:16 PM Ir	spector: J	CW Inspec	ction Type:	Repeat	Previous Rainfall (hrs):	72+	
Flow Desci	ription: Sul	bmerged, indeterminate	Notes: O	utfall partially s	ubmerged;	screened	SANK.	Files	and al
Submerged	: Partially	Depth (in): 36	u	ostream at 06-2	241.				ANY.
Illicit Disch	arge Potent	ial: Unlikely	Fi	eld Follow-up	Of	fice Follow-up			o- 5.
Floatables:	None	Petrol.	Sheen 🗌 Si	uds 🗌 Sew	age 🗌 Alç	gae 🗌 Other	A STATE		A CONTRACT
Odor:	None	Petrole	um 🗌 M	usty 🗌 Sew	age 🗌 Ch	lorine 🗌 Other			AR LAN
			olvent 🗌 Fi	shy 🗌 Sulfi	ur 🗌 Fra	agrant			2012 1210
Turbidity:	None								
Color:	None						0201209271119	938.JI	G
Gross Solid	ls: None	Litter	Deb	oris 🗌 Sedi	ment 🗌 C	Dther	Sampling Results		
Vegetation:	None	🗌 Inhibite	ed 🗌 Exc	essive			Sample Location:		
Benthic Gro	wth: None	Green	🗌 Bro	wn			Sample ID:		
Stains:	None	Flow L	ne 🗌 Oil	Rust	Stains		Time Collected		
			ion 🗌 Pai	nt 🗌 Othe	er		Total Chlorine (field):		ppm

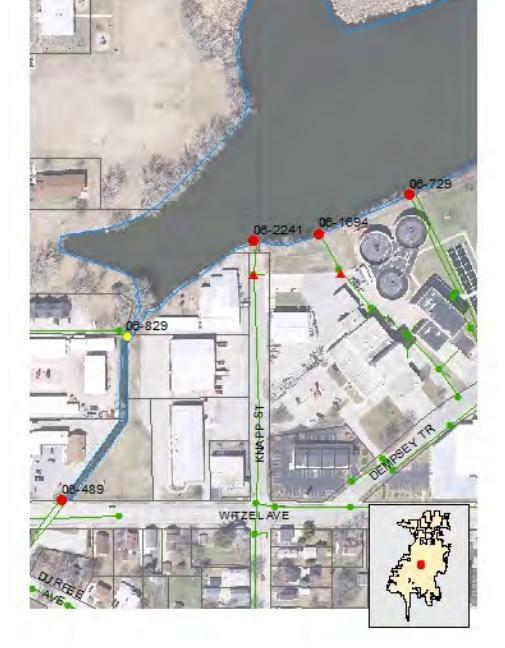
Inspection Dat	te: 9/27/2012 12:18:	PM Inspector: JCW Inspection	on Type: Repeat	Previous Rainfall (hrs):	72+
Flow Descripti	ion: Submerged, ind	erminate Notes: Ammonia follow-up	. Duckweed in manhole.		and the
Submerged: F	Fully Depth (i	: 54		A	
Illicit Discharg	e Potential: Unlikely	Field Follow-up	Office Follow-up		
Floatables: No	one	Petrol. Sheen Suds Sewag	e 🗌 Algae 🗌 Other		Seatting:
Odor: No	one	Petroleum Musty Sewag	e 🗌 Chlorine 🗌 Other	A store	and the
		VOC/Solvent Fishy Sulfur	Fragrant	1. 1. 1. 1. 1. 1. 1. 1. 1. 1. 1. 1. 1. 1	2012 12:23
Turbidity: No	one			and the second se	and the second
Color: No	one			020120927112	2310.JPG
Gross Solids:	None	Litter Debris Sedime	ent 🗌 Other	Sampling Results	
Vegetation:	None	✓ Inhibited □ Excessive		Sample Location: Poo	I
Benthic Growth	: None	Green Brown		Sample ID: 120	927-78
Stains:	None	Flow Line Oil Rust S	tains	Time Collected 12:1	2
		Corrosion Paint Other		Total Chlorine (field):	0 ppm

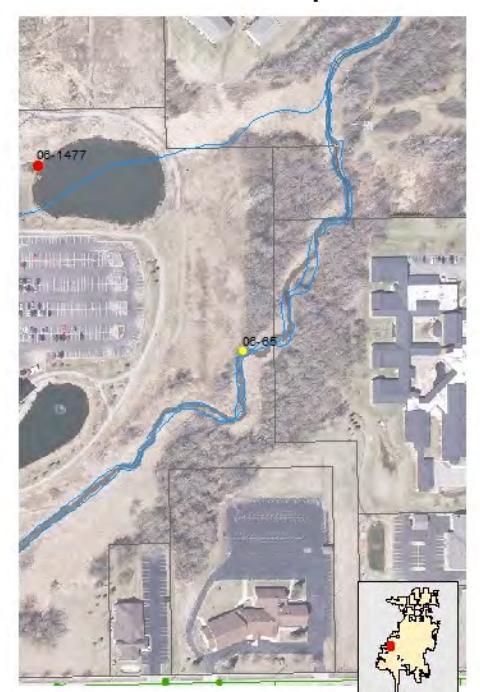
Inspection	Date: 6/11/	2012 10:12:21 AM	Inspector:	JCW	Inspectio	n Type:	Ongoing	Previous Rainfall (hrs):	72+	
Flow Descr	iption: None	•	Notes:	Outfall	dry at time o	f inspecti	on.	STANK -	5	
Submerged:	None	Depth (in):						11-27-1-	É	
Illicit Disch	arge Potentia	I: Unlikely		Field Fo	ollow-up	Off	fice Follow-up		\square	
Floatables:	None	F	Petrol. Sheen	Suds	Sewage	e 🗌 Alg	gae 🗌 Othe	er		
Odor:	None	F	Petroleum	Musty	Sewage	e 🗌 Ch	lorine 🗌 Othe	er		THE
	[V	OC/Solvent	Fishy	Sulfur	Fra	agrant	BREAK		
Turbidity:	None									
Color:	None							020120611091	302.JI	G
Gross Solids	s: None	L	.itter	Debris	Sedime	nt 🗌 C	Other	- Sampling Results		
Vegetation:	None		nhibited	Excessive	e			Sample Location:		
Benthic Grov	wth: None		Green	Brown				Sample ID:		
Stains:	Slight	✓ F	low Line	Oil	Rust St	ains		Time Collected		
			Corrosion	Paint	Other			Total Chlorine (field):		ppm
Non-illicit:	None		latural Sheen	Natu	ral Suds/Foa	m		Free Chlorine (field):		ppm

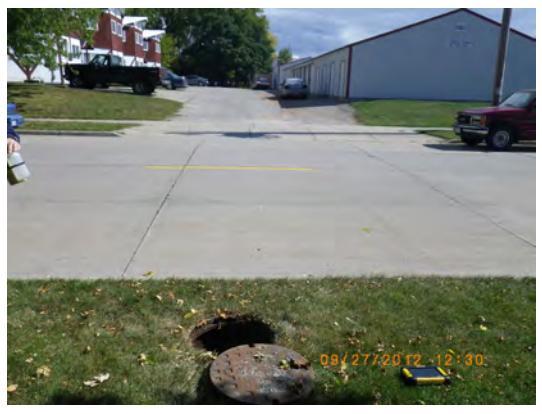
o20120927113038.JPG

Upstream manhole located approx 360 ft W of outfall 06-829. Intermediate area consists of multifamily residential and commercial properties. Two downstream manholes not located.

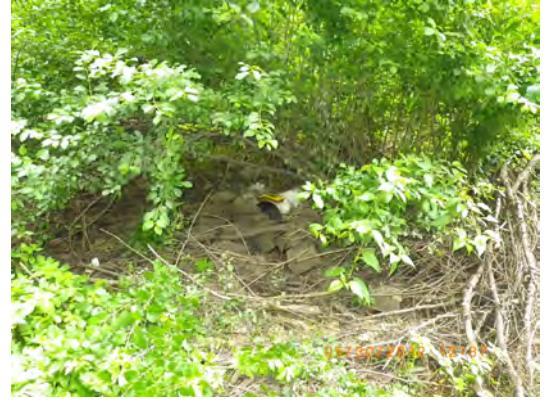
o20120530113710.JPG

Inspection	Date: 5/30/	2012 12:44:53 PM	Inspector:	JCW	Inspection Type	e: Ongoing	Previous Rainfall (hrs):	72+	
Flow Descr	iption: Non	e	Notes:	Small po	ool at end of pipe.	No flow at time of	of //	ALC: N	A State
Submerged	: None	Depth (in):		inspection	on.		19 11 12		6/22
Illicit Disch	arge Potentia	l: Unlikely		Field Fo	llow-up	Office Follow-up		and and	
Floatables:	None	Pet	rol. Sheen	Suds		Algae 🗌 Oth	er	(Calledon)	
Odor:	None	Pet	roleum	Musty	Sewage	Chlorine 🗌 Oth	er	T	
		VO	C/Solvent	Fishy	Sulfur	Fragrant	A Carl Shares	100	
Turbidity:	None							a the said	
Color:	None						020120530114	522.JI	PG
Gross Solid	s: None	Litt	er 🗌	Debris	Sediment	Other	Sampling Results		
Vegetation:	None	🗌 Inh	ibited 🗌 I	Excessive			Sample Location:		
Benthic Gro	wth: None	🗌 Gre	en 🗌	Brown			Sample ID:		
Stains:	None	🗌 Flo	w Line 🗌 🤇	Dil	Rust Stains		Time Collected		
			rrosion 🗌 I	Paint	Other		Total Chlorine (field):		ppm

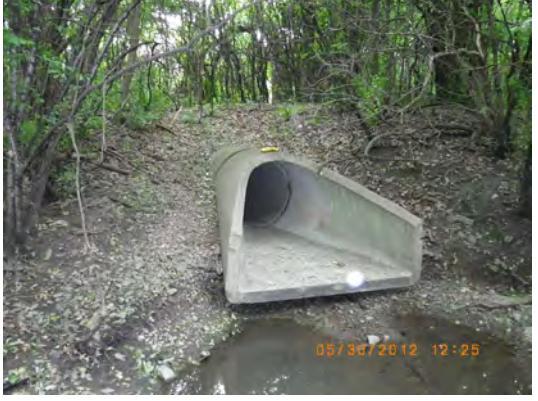
o20120530112504.JPG

Inspection	Date: 5/30	/2012 12:36:36 PM	Inspector:	JCW	Inspection Typ	e: Ongoing	Previous Rainfall (hrs):	72+	
Flow Descr	iption: Non	е	Notes:	Outfall	dry at time of inspe	ction.			
Submerged:	None	Depth (in):						2	
Illicit Discha	arge Potentia	al: Unlikely		Field Fo	ollow-up	Office Follow-up		100	
Floatables:	None	Petro	l. Sheen 🗌	Suds	Sewage	Algae 🗌 Othe	er	1	and the
Odor:	None		leum	Musty Fishy	Sewage	Chlorine 🗌 Othe	er	ALC: NO	
Turbidity:	None			1 lony		lagiant	1 and the second		VI AN
Color:	None						020120530113	720.JF	PG
Gross Solids	s: None	Litter		Debris	Sediment	Other	Sampling Results]
Vegetation:	None	Inhib	ited 🗌 E	Excessive	е		Sample Location:		
Benthic Grov	wth: None	Gree	n 🗌 E	Brown			Sample ID:		
Stains:	None	Flow	Line 🗌 C	Dil	Rust Stains		Time Collected		
			osion 🗌 P	Paint	Other		Total Chlorine (field):		ррт
Non-illicit:	None	Natu	ral Sheen [Natur	ral Suds/Foam		Free Chlorine (field):		ppm

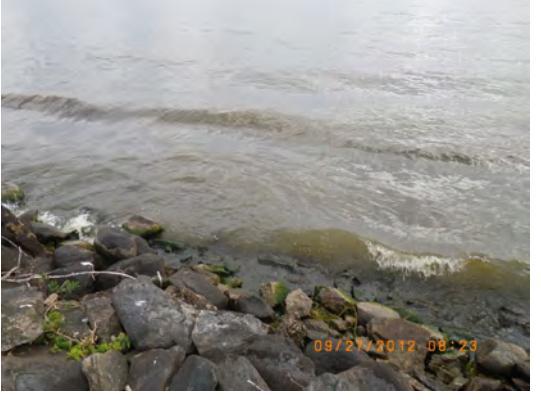
o20120927072318.JPG

Inspection Date: 9/27/2012 8:21:03 AM Inspector: JCW Inspection Type: Ongoing Previous Rainfall (hrs): 72+ Flow Description: Submerged (not located) Notes: Outfall fully submerged; screened upstream at 11-512 US1. Submerged: Fully Depth (in): Illicit Discharge Potential: Unlikely Field Follow-up Office Follow-up Floatables: None Petrol. Sheen Suds Sewage Other Algae Odor: None Petroleum Musty Sewage Chlorine Other VOC/Solvent Fishy Sulfur Fragrant Turbidity: None o20120927072324 JPG Color: None Gross Solids: None Litter Debris Sediment Other Sampling Results Inhibited Vegetation: None Excessive Sample Location: Benthic Growth: None Green Brown Sample ID: None Stains: Rust Stains **Time Collected** Flow Line Oil Corrosion Paint Other Total Chlorine (field): ppm --Free Chlorine (field): ppm --Non-illicit: None Natural Sheen Natural Suds/Foam Total Copper (field): -ррт Physical Condition Assessment ррт Ammonia (field): Graffiti: None pH (field): units --Erosion: None Temperature: °F --Deposition: None Depth (in): Conductivity: µS/cm --Damage: None Displacement Undercut Crushed Detergents: mg/L --Phenol: Corrosion Cracks/Structural Damage -mg/L

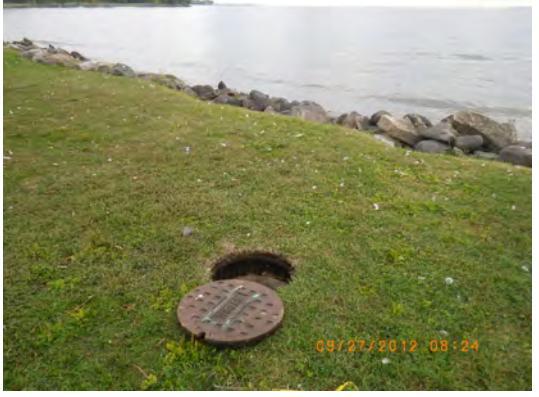
o20120927072432.JPG

Inspection Date: Inspection Type: Ongoing 9/27/2012 8:22:20 AM Inspector: JCW Previous Rainfall (hrs): 72+ Flow Description: Submerged, indeterminate Notes: 2011 gross solids follow-up. Submerged: Fully Depth (in): 34 Illicit Discharge Potential: Unlikely Field Follow-up Office Follow-up Floatables: None Petrol. Sheen Suds Sewage Other Algae Odor: None Petroleum Musty Sewage Chlorine Other VOC/Solvent Fishy Sulfur Fragrant Turbidity: None o20120927072438.JPG Color: None ✓ Litter Gross Solids: Slight ✓ Debris Sediment Other Sampling Results Inhibited Vegetation: None Excessive Sample Location: Pool Benthic Growth: Slight Green Brown Sample ID: 120927-06 Flow Line Stains: Slight Rust Stains **Time Collected** Oil 08:20 Corrosion Paint Other Total Chlorine (field): 0 ppm Free Chlorine (field): 0 ppm Non-illicit: None Natural Sheen Natural Suds/Foam Total Copper (field): 0 ppm Physical Condition Assessment Ammonia (field): 0 ppm Graffiti: None pH (field): 8.73 units Erosion: None Temperature: 59 °F Deposition: None Depth (in): Conductivity: 416 µS/cm Damage: None Displacement Undercut Crushed Detergents: 0 mg/L Phenol: Corrosion Cracks/Structural Damage -mg/L

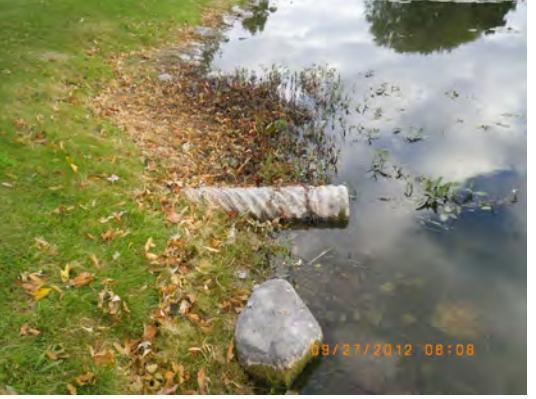
o20120927070832.JPG

Inspection	Date: 9	27/2012 8:05:18 AM	Inspector:	JCW	Inspection T	ype: On	ngoing	Previous Rainfall (hrs):	72+	
Flow Descr	ription: S	ubmerged, indeterminate	Notes:	2011 ar submer	mmonia follow-u ged; screened u	p. Outfa Ipstream	ll partially at 11-803		NY.	E.
Submerged	: Partially	Depth (in): 7		US1.	.	•			-	a subs
Illicit Disch	arge Pote	ntial: Unlikely] Field Fo	ollow-up	Office	Follow-up	10119	-10	S AS
Floatables:	None	Petro	l. Sheen	Suds	Sewage	Algae	Other			1 Part
Odor:	None		leum] Musty] Fishy	Sewage	Chlori	ne 🗌 Other		4	1 a a
Turbidity:	None			JIISHY		_ rrayra	111		11211	2012 08:08
Color:	None							0201209270708	846.JI	PG
Gross Solid	s: None			Debris	Sediment	Othe	er 🗌	Sampling Results		
Vegetation:	None	🗌 Inhib	ited 🗌 I	Excessive	е			Sample Location:		
Benthic Gro	wth: Slight	✓ Gree	n 🗌 I	Brown				Sample ID:		
Stains:	Slight	Flow	Line	Oil	Rust Stain	S		Time Collected		
		✓ Corr	osion 🔄 I	Paint	Other			Total Chlorine (field):		ppm

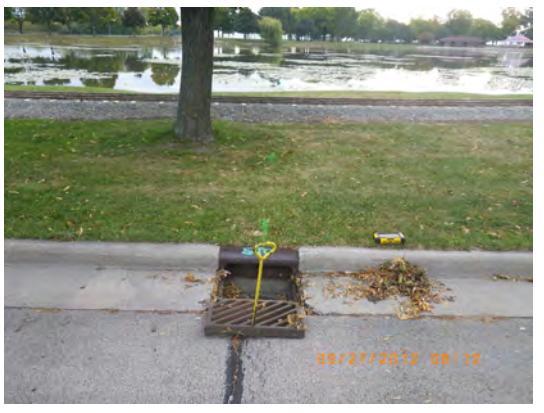
o20120927071218.JPG

Inspection Date: 9/27/2012 8:07:19 AM Inspection Type: Ongoing Inspector: JCW Previous Rainfall (hrs): 72+ Flow Description: Submerged, indeterminate Notes: 2011 ammonia follow-up. Submerged: Partially Depth (in): 3 Illicit Discharge Potential: Unlikely Field Follow-up Office Follow-up Floatables: None Petrol. Sheen Suds Sewage Other Algae Odor: None Petroleum Musty Sewage Chlorine Other VOC/Solvent Fishy Sulfur Fragrant Turbidity: None o20120927071234.JPG Color: None Gross Solids: None Litter Debris Sediment Other Sampling Results None Inhibited Vegetation: Excessive Sample Location: Pool Benthic Growth: None Green Brown Sample ID: 120927-44 Stains: Slight Rust Stains **Time Collected** Flow Line Oil 08:00 Corrosion Paint Other Total Chlorine (field): 0 ppm Free Chlorine (field): 0 ppm Non-illicit: None Natural Sheen Natural Suds/Foam Total Copper (field): 0 ppm Physical Condition Assessment Ammonia (field): 0 ppm Graffiti: None pH (field): 8.25 units Erosion: None Temperature: 58 °F Deposition: None Depth (in): Conductivity: 655 µS/cm Damage: None Displacement Undercut Crushed Detergents: 0 mg/L

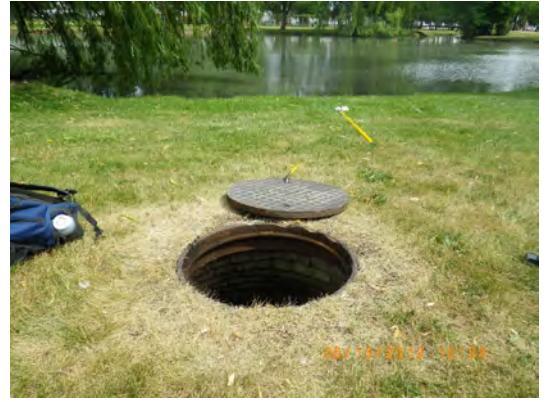
o20120613093326.JPG

Inspection Date: Inspection Type: Ongoing 6/13/2012 10:28:59 AM Inspector: JCW Previous Rainfall (hrs): 72+ Flow Description: Submerged, indeterminate Notes: Submerged: Fully Depth (in): 20 Illicit Discharge Potential: Unlikely Field Follow-up Office Follow-up Floatables: None Petrol. Sheen Suds Sewage Other Algae Odor: None Petroleum Musty Sewage Chlorine Other VOC/Solvent Fishy Sulfur Fragrant Turbidity: None o20120613093332.JPG Color: None Gross Solids: Moderate Litter Debris Sediment Other Sampling Results None Inhibited Vegetation: Excessive Sample Location: Pool Benthic Growth: None Green Brown Sample ID: 120613-32 Flow Line Stains: Slight Rust Stains **Time Collected** 10:32 Oil Corrosion Paint Other Total Chlorine (field): 0 ppm Free Chlorine (field): 0 ppm Non-illicit: None Natural Sheen Natural Suds/Foam Total Copper (field): 0 ppm Physical Condition Assessment Ammonia (field): 0 ppm Graffiti: None pH (field): 8.07 units Erosion: None Temperature: 77 °F Deposition: Moderate Depth (in): 8 Conductivity: 1340 µS/cm Damage: None Displacement Undercut Crushed Detergents: 0 mg/L Phenol: mg/L Corrosion Cracks/Structural Damage --

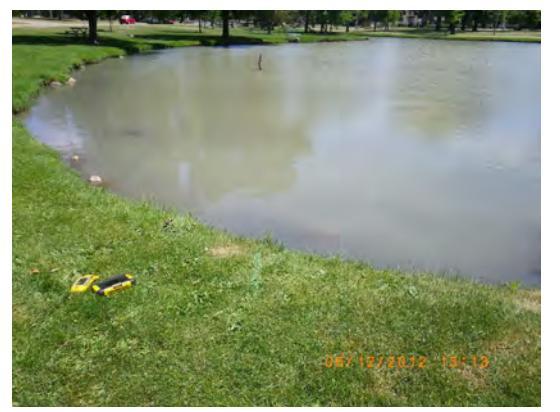
o20120612121308.JPG

Storm sewer from Georgia St discharges to detention basin from west. Outfall not located. Pipe info from MS4 map.

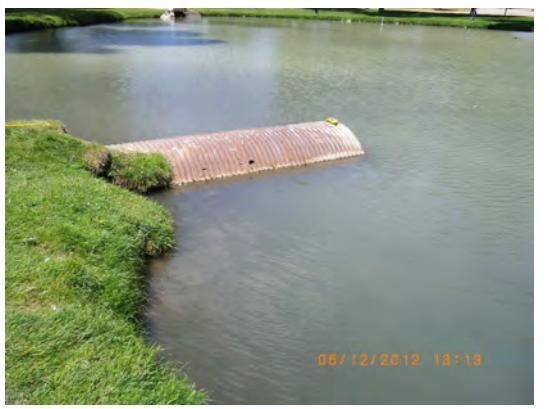
o20120612121950.JPG

Inspection	Date: 6/12/2	2012 1:20:10 PM	Inspector:	JCW	Inspectio	n Type:	Ongoing	Previous Rainfall (hrs):	72+	
Flow Descr	iption: Subn	nerged, indeterminate	e Notes:	Outfall	partially subr	nerged;	screened			and the second s
Submerged:	Partially	Depth (in): 19		upstrea	am at 13-337	US1.				
Illicit Disch	arge Potential	: Unlikely		Field Fo	ollow-up	Of	fice Follow-up			
Floatables:	None	Petr	ol. Sheen	Suds	Sewage	e 🗌 Alç	gae 🗌 Othe	er		
Odor:	None		oleum] Musty	Sewage	e 🗌 Ch	llorine 🗌 Othe	r		
Turbidity:	None						agram			2012 13:20
Color:	None							020120612122	2034.JI	PG
Gross Solids	s: None	Litte	r 🗌	Debris	Sedime	ent 🗌 C	Other	- Sampling Results		
Vegetation:	None	🗌 Inhit	oited	Excessive	e			Sample Location:		
Benthic Gro	wth: Slight	✓ Gree	en 🗸	Brown				Sample ID:		
Stains:	Moderate	✓ Flow	Line	Oil	Rust St	ains		Time Collected		
		✓ Corr	osion	Paint	Other			Total Chlorine (field):		ppm
Non-illicit:	None	🗌 Natı	ıral Sheen	Natu	ral Suds/Foa	m		Free Chlorine (field):		ppm

- Physical	Condition Asse	ssment						Total Copper (field):		ррт
Groffiti	Nono							Ammonia (field):		ppm
Granni.	None							pH (field):		units
Erosion.	None							Temperature:		°F
Depositio	n: None	Deptn (in):						Conductivity:		µS/cm
Damage:	Moderate	Displacement	Undercut		Crushed			Detergents:		mg/L
		Corrosion] Cracks/Sti	ructural D	amage			Phenol:		mg/L

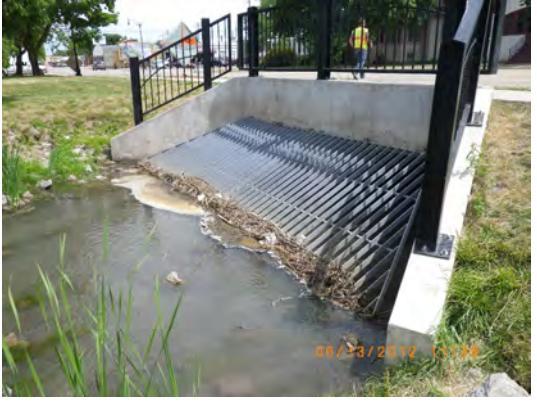
o20120613103900.JPG

Inspection	Date: 6/13/2	2012 10:41:39 AM	Inspector:	JCW	Inspect	ion Type:	Ongoing	Previous Rainfall (h	rs): 72+	-
Flow Descr	iption: Subs	tantial	Notes:					A A A A A A A A A A A A A A A A A A A	-	in the second second
Submerged:	None	Depth (in):						and the second		
Illicit Disch	arge Potentia	: Unlikely		Field Fo	ollow-up	Of	ffice Follow-up			
Floatables:	None	Pe	etrol. Sheen	Suds	Sewa	ge 🗌 Al	gae 🗌 Othe	er	the state	H
Odor:	None	Pe	etroleum] Musty] Fishy	Sewa	ge 🗌 Cl · 🗌 Fr	hlorine 🗌 Othe agrant	er		
Turbidity:	None								067.190	S.C.
Color:	None							020120613	3103906.J	PG
Gross Solids	s: None	Li*	tter	Debris	Sedim	nent 🗌 (Other	- Sampling Results		
Vegetation:	None	In	hibited	Excessiv	e			Sample Location:	Flow	
Benthic Gro	wth: None	G	reen	Brown				Sample ID:	120613-1	4
Stains:	None	FI	low Line	Oil	Rust S	Stains		Time Collected	10:42	
			orrosion	Paint	Other			Total Chlorine (field)	: 0	ppm
Non-illicit:	None	N;	atural Sheen	🗌 Natu	ral Suds/Fo	am		Free Chlorine (field):	0	ppm

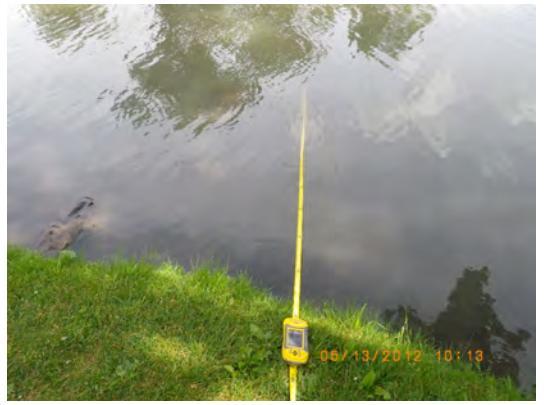
o20120613091300.JPG

Inspection	Date: 6/13/	2012 10:10:31 AM	nspector: JCV	V Inspec	ction Type:	Ongoing	Previous Rainfall (hrs):	72+	
Flow Desci Submerged	ription: None	Depth (in):	Notes: Out ups	fall pipes fully tream at 13-8	submergec 19 US1.	l; screened	Maria Maria		
Illicit Disch	arge Potentia	l: Unlikely	Field	d Follow-up	Off	fice Follow-up			-
Floatables:	None	Petrol.	Sheen Sud	s 🗌 Sew	age 🗌 Alg	jae 🗌 Othe	·		
Odor:	None	Petrole	eum 🗌 Mus Solvent 🗌 Fish	ty 🗌 Sew y 🗌 Sulfu	age 🗌 Ch ur 🗌 Fra	lorine 🗌 Othe agrant		3. S.	
Turbidity:	None						1	00/13/2	012 00.113
Color:	None						020120613091	306.JF	'G
Gross Solid	ls: None	Litter	Debris	s 🗌 Sedi	ment 🗌 C	Other	-Sampling Results]
Vegetation:	None	Inhibit	ed 🗌 Exces	sive			Sample Location:		
Benthic Gro	wth: None	Green	Brown	ı			Sample ID:		
Stains:	None	Flow L	ine 🗌 Oil	🗌 Rust	Stains		Time Collected		
		Corros	sion 🗌 Paint	Other	er		Total Chlorine (field):		ppm
Non-illicit:	None	Natura	al Sheen 🗌 N	atural Suds/F	oam		Free Chlorine (field):		ррт

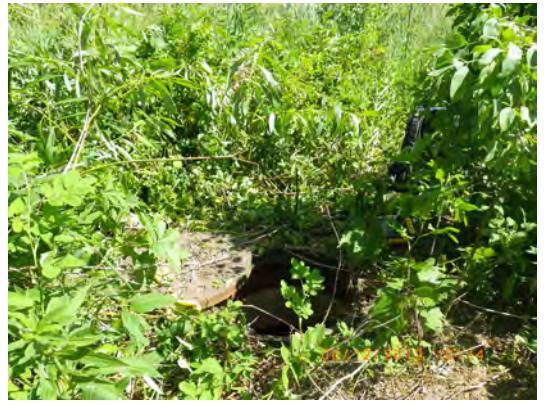
o20120612091402.JPG

Inspection Date: JCW 6/12/2012 10:14:13 AM Inspector: Inspection Type: Ongoing Previous Rainfall (hrs): 72+ Flow Description: Submerged, indeterminate Notes: Submerged: Partially Depth (in): 17 Illicit Discharge Potential: Unlikely Field Follow-up Office Follow-up Floatables: None Petrol. Sheen Suds Sewage Other Algae Odor: None Petroleum Musty Sewage Chlorine Other VOC/Solvent Fishy Sulfur Fragrant 116 Turbidity: None o20120612091410.JPG Color: None Gross Solids: None Litter Debris Sediment Other Sampling Results None Inhibited Vegetation: Excessive Sample Location: Pool Benthic Growth: Slight Green Brown Sample ID: 120612-23 Stains: None Rust Stains **Time Collected** 10:12 Flow Line Oil Corrosion Paint Other Total Chlorine (field): 0 ppm Free Chlorine (field): 0 ppm Non-illicit: None Natural Sheen Natural Suds/Foam Total Copper (field): 0 ppm Physical Condition Assessment Ammonia (field): 0 ppm Graffiti: None pH (field): 8.51 units Erosion: None Temperature: 67 °F Deposition: None Depth (in): Conductivity: 1110 µS/cm Damage: None Displacement Undercut Crushed Detergents: 0 mg/L Phenol: Corrosion Cracks/Structural Damage 0 mg/L

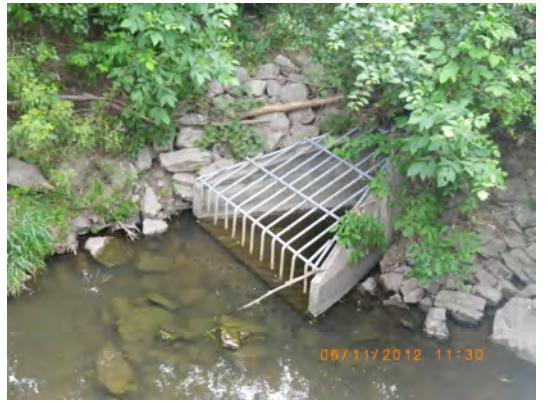
o20120611103004.JPG

Inspection	Date: 6/11/2	2012 11:33:2	1 AM	Inspector	: JCW	Inspectio	n Type:	Ongoing	Previous Rainfall (hrs):	72+	
Flow Descr	iption: Subn	nerged, sligh	nt flow	Notes	: Outfall upstrea	partially subn am at 13-948	nerged. US1.	Outfall screened	d		
Submerged	: Partially	Depth (in): 2		- [-	
Illicit Disch	arge Potentia	I: Unlikely		[Field F	ollow-up	Of	fice Follow-up		-	
Floatables:	None		Petr	ol. Sheen [Suds	Sewage	Al	gae 🗌 Othe	er	11 A.	
Odor:	None		Petr	oleum [Musty	Sewage	e 🗌 Cl	nlorine 🗌 Othe	er	ALC: NOT	
Turbidity:	None			Solvent [Fishy	Sulfur	🗌 Fr	agrant			
Color:	None								020120611103	322.JI	PG
Gross Solid	s: None		Litte	r 🗌	Debris	Sedime	nt 🗌 (Other	-Sampling Results		
Vegetation:	None		🗌 Inhit	pited	Excessiv	e			Sample Location:		
Benthic Gro	wth: Moderate		Gree	en 🗸	Brown				Sample ID:		
Stains:	Slight		Flow	/ Line	Oil	Rust Sta	ains		Time Collected		
			Corr	osion	Paint	Other			Total Chlorine (field):		ppm

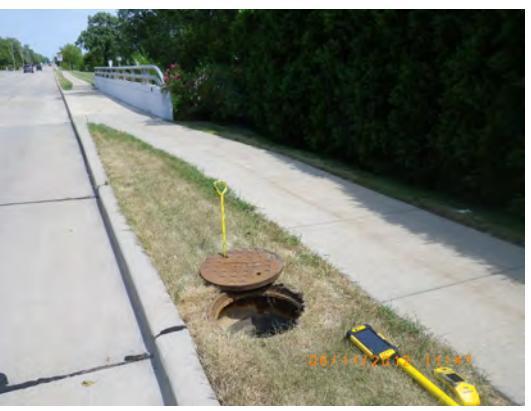
o20120611104724.JPG

Inspection	Date:	6/11/2012 11:47:2	2 7 AM Ir	spector:	JCW	Inspec	tion Type:	Ongoing	Previous Rainfall (hrs): 72	2+
Flow Description: Submerged, indeterminate Notes: Gravel/stone at bottom of manhole below											
Submerged	: Partia	lly Depth (ir	n): 6		flowline	Э.				- 18	
Illicit Disch	arge Po	tential: Unlikely] Field Fo	ollow-up	Of	fice Follow-up		-	
Floatables:	None		Petrol.	Sheen	Suds	Sewa	age 🗌 Ale	gae 🗌 Othe	r的武士	120	
Odor:	None			um 🗌	Musty	Sewa	age 🗌 Cł	nlorine 🗌 Othe	r V		
Turbidity:	None		VOC/S	olvent] Fishy	Sulfu	ır 🗌 Fra	agrant			1/2012 11:47
Color:	None								0201206	11104732	.JPG
Gross Solid	s: Nor	ne	Litter		Debris	🗌 Sedi	ment 🗌 (Other	-Sampling Results -		
Vegetation:	Nor	ne	🗌 Inhibite	ed 🗌	Excessiv	е			Sample Location:	Pool	
Benthic Gro	wth: Nor	ne	Green		Brown				Sample ID:	120611	-02
Stains:	Nor	ne	Flow L	ne 🗌	Oil	🗌 Rust	Stains		Time Collected	11:45	
			Corros	ion 🗌	Paint	Othe	r		Total Chlorine (field	d):	0 ppm

Non-illicit:	Nor	ne	🗌 Natura	l Sheen	🗌 Natu	ral Suds/F	oam		Free Chlorine (field):	0 ppm
– Physical	Conditio	n Assessment —	1				1		Total Copper (field)	:	0 ppm
Groffiti	Nor								Ammonia (field):		0 ppm
Graniu. Erosion:	Nor								pH (field):	7.3	3 units
Dopositio	INUI Inui Min	or Dooth (in):							Temperature:	6	7 °F
Depositio	n. IVIIII Nor				_				Conductivity:	101	6 μ <i>S/cm</i>
Damage:	Nor	Displac	ement 🗌 l	Indercut		Crushed			Detergents:		0 <i>mg/L</i>
		Corrosi	on 🗌 🤇	Cracks/St	ructural D	Damage			Phenol:		0 <i>mg/L</i>

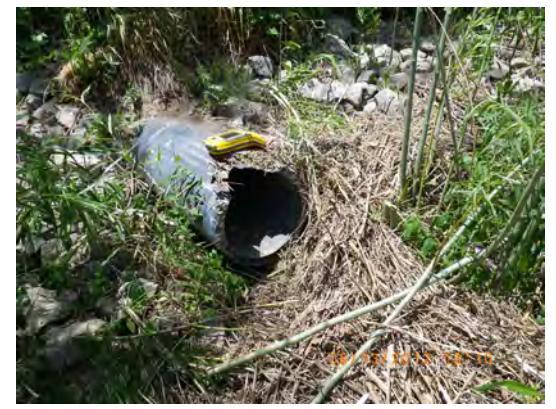
o20120613121040.JPG

Inspection	Date:	6/13/2012 1:08:33	B PM Inspe	ector: JCW	Inspec	tion Type:	Ongoing	Previous Rainfall (hrs):	72+	
Flow Descr	iption:	None	Ν	otes: Pipe	dry at time c	f inspectior	n. Minor damage			NOT S
Submerged:	None	Depth (ir	ו):	to to	o of pipe.					
Illicit Disch	arge Pot	ential: Unlikely	,	E Field	Follow-up	Of	fice Follow-up			
Floatables:	None		Petrol. She	een 🗌 Suds	Sewa	age 🗌 Alç	gae 🗌 Other			No.
Odor:	None		Petroleum	Must	y 🗌 Sewa	age 🗌 Ch	lorine		- (K	NAC A
				ent 🗌 Fishy	/ 🗌 Sulfu	ir 🗌 Fra	agrant	THE REAL OF	- Ann	
Turbidity:	None									
Color:	None							020120613121	044.JF	G
Gross Solids	s: Non	e	Litter	Debris	🗌 Sedii	ment 🗌 C	Other	Sampling Results		
Vegetation:	Non	e	Inhibited	Excess	sive			Sample Location:		
Benthic Grov	wth: Non	e	Green	Brown				Sample ID:		
Stains:	Non	е	Flow Line	🗌 Oil	Rust	Stains		Time Collected		
			Corrosion	Paint	Othe	r		Total Chlorine (field):		ррт
Non-illicit:	Non	е	Natural Sh	neen 🗌 Na	tural Suds/F	oam		Free Chlorine (field):		ррт

– Physical I	Condition	Assessment —						Total Copper (field):		ppm
Oneffitie	Nie	-						Ammonia (field):		ррт
Gramiti:	Non	e						pH (field):		units
Erosion:	Non	e						Temperature:		°F
Deposition	n: Non	e Depth (in):	:					Conductivity:		µS/cm
Damage:	Mine	or 🗌 Displac	ement 🗌 Und	ercut	Crushed			Detergents:		mg/L
		Corrosi	ion 🔽 Crac	cks/Structura	l Damage			Phenol:		mg/L

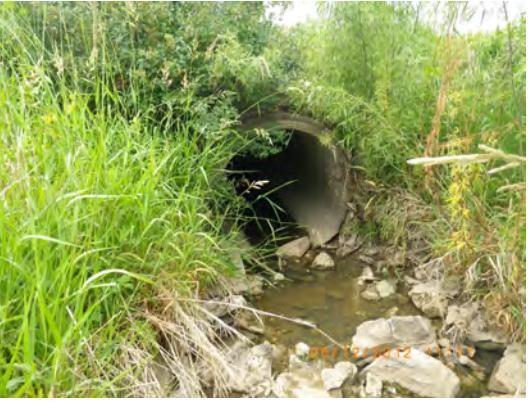
o20120612101120.JPG

Inspection	Date: 6/12/2	2012 11:10:21 AM	nspector: JCW	Inspection Type	: Ongoing	Previous Rainfall (hrs):	72+	
Flow Desci	ription: Subn	nerged, indeterminate	Notes: Outfa	Il partially submerged	; screened	/		
Submerged	: Partially	Depth (in): 2	upstre	eam at 13-1219 US1.		Z	1	
Illicit Disch	arge Potentia	I: Unlikely	Field	Follow-up	Office Follow-up		A Start	振
Floatables:	None	Petrol	. Sheen 🗌 Suds	Sewage	Algae 🗌 Other	- Hit		A STATE
Odor:	None	Petrol	eum 🗌 Musty Solvent 🗌 Fishy	/ Sewage (Sulfur F	Chlorine 🗌 Other Fragrant	Kar -		and a
Turbidity:	None						A CHARTER AND	1
Color:	None					0201206121012	234.JPG	
Gross Solid	ls: Slight	✓ Litter	Debris	Sediment	Other	Sampling Results		
Vegetation:	None	🗌 Inhibit	ed 🗌 Excess	ive		Sample Location:		
Benthic Gro	wth: Slight	✓ Green	n 🖌 Brown			Sample ID:		
Stains:	Slight	V Flow L	_ine 🗌 Oil	Rust Stains		Time Collected		
			sion 🗌 Paint	Other		Total Chlorine (field):	ppm

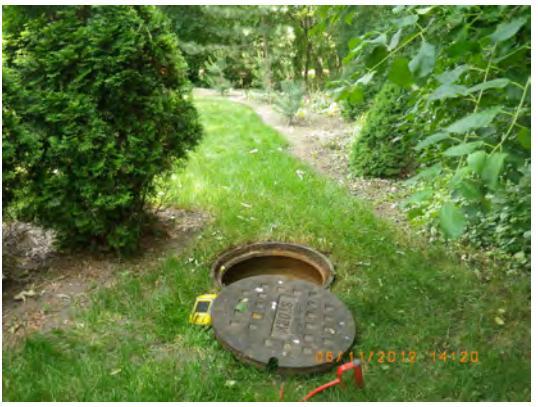
o20120611132004.JPG

Inspection	Date: 6/11/2	2012 2:17:56 PM	Inspector:	JCW	Inspectio	on Type:	Ongoing	Previous Rainfall (I	ırs): 72-	F
Flow Descr	ription: Trick	e	Notes:					Mag	4	115
Submerged	: None	Depth (in):						PILIA		111-2
Illicit Disch	arge Potential	: Unlikely		Field Fo	ollow-up	Of	fice Follow-up			
Floatables:	None	🗌 Pe	trol. Sheen	Suds	Sewag	e 🗌 Alg	gae 🗌 Othe	A CALLER		1
Odor:	None		troleum] Musty] Fishv	Sewag	e 🗌 Ch	nlorine 🗌 Othe agrant		T.	
Turbidity:	Slight cloudine	ess		. .,				S. S. C.	05/11/	2012 14:20
Color:	None							02012061	1132014.J	PG
Gross Solid	s: None	Litt	ter	Debris	Sedime	ent 🗌 (Other	-Sampling Results —		
Vegetation:	None	Inf	nibited	Excessiv	е			Sample Location:	Flow	
Benthic Gro	wth: None	Gr	een	Brown				Sample ID:	120611-0)4
Stains:	Slight	V Flo	w Line	Oil	🗌 Rust S	tains		Time Collected	14:20	
		Co	rrosion	Paint	Other			Total Chlorine (field): 0	ppm
Non-illicit:	None	🗌 Na	tural Sheen	🗌 Natu	ral Suds/Foa	am		Free Chlorine (field)	: 0	ppm

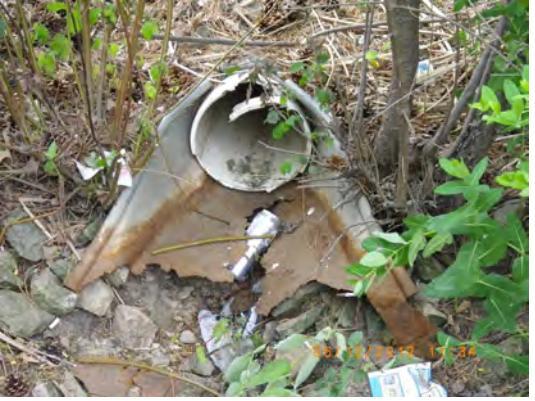
o20120612103404.JPG

Inspection	Date: 6/12/2012 11:33	:36 AM Inspector:	JCW Inspe	ction Type:	Ongoing	Previous Rainfall (hrs):	72+	
Flow Descr Submerged:	iption: None : None Depth (in):	Dry. End of pipe and corroded.	e cracked. A	pron undercut			
Illicit Disch	arge Potential: Unlikel	у [Field Follow-up	Of	fice Follow-up		9	
Floatables:	None	Petrol. Sheen	Suds Sew	vage 🗌 Alg	gae 🗌 Other		a de	
Odor:	None	Petroleum	Musty Sev	vage 🗌 Ch	nlorine 🗌 Other	Later and	-

- Physical	Condition Accoccmont			_		Total Copper (field):		ррт
Fliysical	Condition Assessment					Ammonia (field):		ррт
Graffiti:	None					pH (field):		units
Erosion:	None					Temperature:		°F
Depositio	n: None Depth (in):				Conductivity:		µS/cm
Damage:	Moderate 🗌 Displa	cement 🖌 Undercut	Crushed			Detergents:		mg/L
	Corros	sion 🗸 Cracks/St	tructural Damage			Phenol:		mg/L

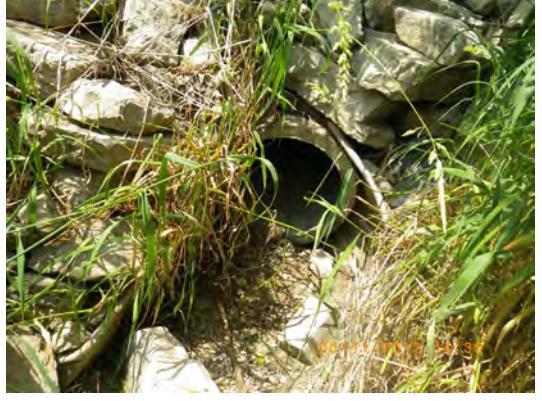
o20120611133604.JPG

Inspection Date: 6/11/2012 2:35:41 PM Inspector: JCW Inspection Type: Ongoing Previous Rainfall (hrs): 72+ Flow Description: None Notes: Outfall dry at time of inspection. Submerged: None Depth (in): Illicit Discharge Potential: Unlikely Field Follow-up Office Follow-up Floatables: None Petrol. Sheen Suds Sewage Other Algae Odor: None Petroleum Musty Sewage Chlorine Other VOC/Solvent Fishy Sulfur Fragrant Turbidity: None o20120611133610.JPG Color: None Gross Solids: None Litter Debris Sediment Other Sampling Results None Inhibited Vegetation: Excessive Sample Location: Benthic Growth: None Green Brown Sample ID: Stains: None Rust Stains Time Collected Flow Line Oil Corrosion Paint Other Total Chlorine (field): ppm --Free Chlorine (field): ppm --Non-illicit: None Natural Sheen Natural Suds/Foam Total Copper (field): -ррт Physical Condition Assessment ррт Ammonia (field): --Graffiti: None pH (field): units ---Erosion: None Temperature: °F --Deposition: None Depth (in): Conductivity: µS/cm --Damage: None Displacement Undercut Crushed Detergents: -mg/L Phenol: Corrosion Cracks/Structural Damage -mg/L

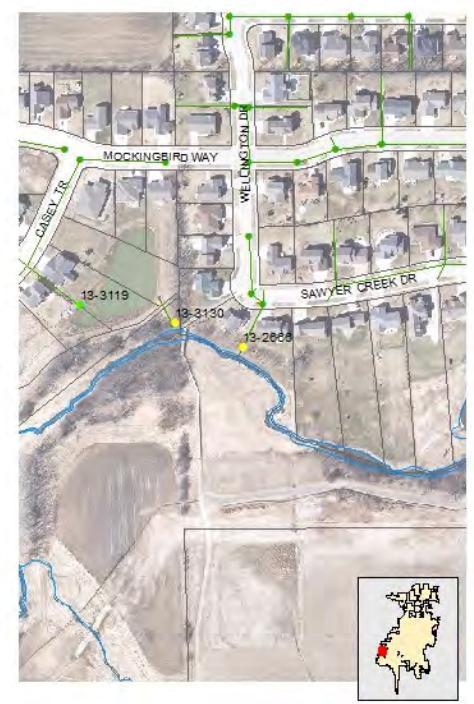
Inspection D	ate: 6/12/2012 8	8:33:10 AM	nspector:	JCW	Inspectio	n Type:	Ongoing	Previous Rainfall (hrs):	72+	
Flow Description: None Notes: Flowline damp. Riprap blocking end of pipe.										
Submerged:	Submerged: None Depth (in):									
Illicit Dischar	rge Potential: U	nlikely		Field Fo	ollow-up	Of	fice Follow-up	- An Asta		260
Floatables: N	None	Petrol	Sheen	Suds	Sewage	e 🗌 Alç	gae 🗌 Other	Alles Martin		
Odor:	None	Petrol	eum	Musty	Sewage	e 🗌 Ch	lorine 🗌 Other	C Act of	1	S119 2
			Solvent	Fishy	Sulfur	Fra	agrant			
Turbidity:	None								R	Sar 1
Color: N	None							0201206120732	224.JF	G
Gross Solids:	Slight	Litter	\checkmark	Debris	Sedime	nt 🗌 C	Other	Sampling Results		
Vegetation:	None	🗌 Inhibit	ed 🗌	Excessive	е			Sample Location:		
Benthic Grow	th: None	Green		Brown				Sample ID:		
Stains:	None	Flow L	ine	Oil	Rust St	ains		Time Collected		
		Corros	sion	Paint	Other			Total Chlorine (field):		ррт

Non-illicit:	None	Natura	al Sheen	Natu	ral Suds/Foa	m		Free Chlorine (field):		ррт
- Physical C	ondition Assessme	ont						Total Copper (field):		ррт
T Hysical O		7/10						Ammonia (field):		ррт
Graffiti:	None							pH (field):		units
Erosion:	None							Temperature:		°F
Deposition	: Moderate Dep	pth (in): 6						Conductivity:		µS/cm
Damage:	None	Displacement	Undercut		Crushed			Detergents:		mg/L
		Corrosion	Cracks/St	ructural D	amage			Phenol:		mg/L
