Ongoing Screening Summary Report 2012 Inspection Year

Illicit Discharge Detection and Elimination Program

City of Oshkosh

March 25, 2013

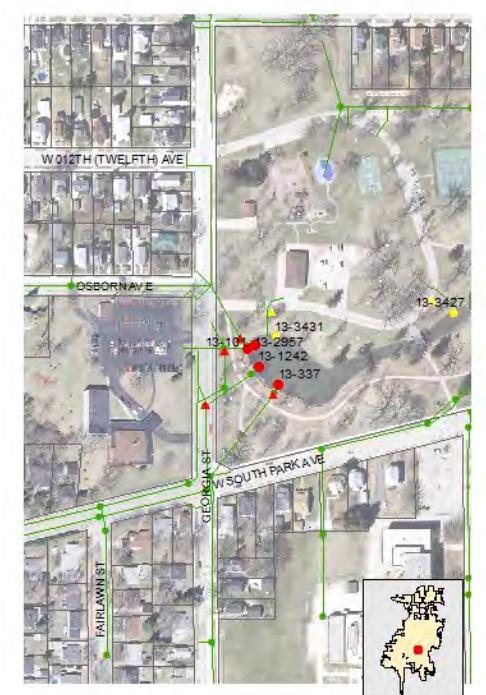
Inspection Date: 6/12/2012 1:30:43	PM Inspector:	JCW Inspec	tion Type:	Ongoing	Previous Rainfall (hrs):	72+	
Flow Description: Submerged, indet	erminate Notes: 0	Outfall partially su	ibmerged; so	creened		-	>
Submerged: Partially Depth (in)	: 21	upstream at 13-2	957 US1.				
Illicit Discharge Potential: Unlikely	F	Field Follow-up	Offic	ce Follow-up			
Floatables: None	Petrol. Sheen	Suds 🗌 Sewa	age 🗌 Alga	ae 🗌 Other	a second		
Odor: None		Musty 🗌 Sewa	age 🗌 Chlo	orine 🗌 Other	-M		
Turbidity: None	VOC/Solvent F	-ishy ∐ Sulfu	r 📋 Fraq	grant	1.		2012 13:32
Color: None					0201206121232	258.JF	PG
Gross Solids: None	Litter De	ebris 🗌 Sedii	ment 🗌 Ot	ther	Sampling Results		
Vegetation: None	Inhibited Ex	cessive			Sample Location:		
Benthic Growth: Moderate	Green Sreen	own			Sample ID:		
Stains: Moderate	Flow Line Oil	I 🗌 Rust	Stains		Time Collected		
	Corrosion Pa	aint 🗌 Othe	r		Total Chlorine (field):		ррт

Non-illicit: None	Natural Sheen] Natural Suds/F	oam		Free Chlorine (field):		ppm
Physical Condition Assessment					Total Copper (field):		ppm
Graffiti: Minor					Ammonia (field):		ppm .,
Frosion: None					pH (field):		units
Deposition: None Depth (in):					Temperature:		°F
Damage: None Deput (iii).	waant 🖂 Unalawa st						μ5/cm
	ment 📋 Undercut	tural Damage			Detergents: Phenol:		mg/L ma/l
		and Burnago

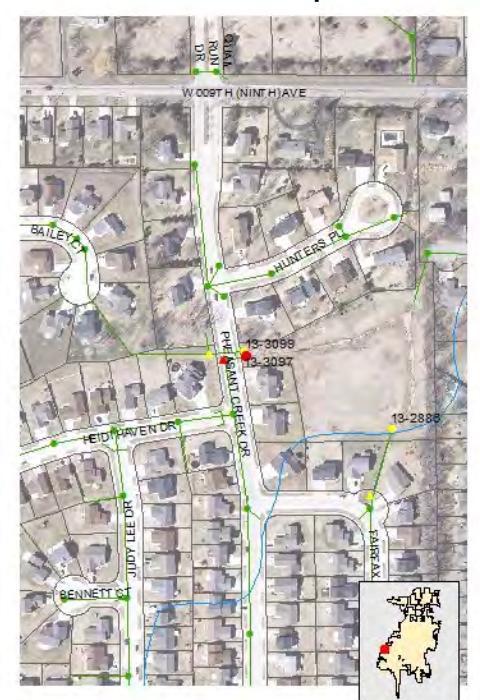
Inspection	Date: 6/11/20	012 12:52:47 PM Ir	spector:	JCW Inspe	ction Type:	Ongoing	Previous Rainfall (hrs):	72+	
Flow Descr	iption: Subme	erged, indeterminate	Notes:	Stones and catta	ils on apror	n. Outfall			Star Be
Submerged	: Partially	Depth (in): 6		13-3097 US1.	jed; screene	ed upstream at			1000
Illicit Disch	arge Potential:	Unlikely		Field Follow-up	Of	fice Follow-up			
Floatables:	None	Petrol.	Sheen	Suds 🗌 Sew	age 🗌 Al	gae 🗌 Othe	r 🚱 🖉		attain 2
Odor:	None	Petrole	um	Musty 🗌 Sew	vage 🗌 Cł	nlorine 🗌 Othe	r	17	
			olvent	Fishy 🗌 Sulf	ur 🗌 Fr	agrant	The the	an and	
Turbidity:	None								
Color:	None						020120611115	508.JI	G
Gross Solid	s: None	Litter	🗌 D	ebris 🗌 Sed	iment 🗌 (Other	- Sampling Results		
Vegetation:	None		ed 🗌 E	xcessive			Sample Location:		
Benthic Gro	wth: Moderate	✓ Green	🗌 B	rown			Sample ID:		
Stains:	Slight	✓ Flow L	ine 🗌 O	il 🗌 Rus	t Stains		Time Collected		
			ion 🗌 Pa	aint 🗌 Othe	er		Total Chlorine (field):		ррт

Non-illicit:	None	Natura	I Sheen	Natural Suds/	oam		Free Chlorine (field):		ррт
- Physical	Condition Asses	sement			_		Total Copper (field):		ppm
n nysicai		Sinem					Ammonia (field):		ppm
Graffiti:	None						pH (field):		units
Erosion:	None						Temperature:		°F
Depositio	n: Minor	Depth (in): 2					Conductivity:		µS/cm
Damage:	None	Displacement U	Indercut	Crushed			Detergents:		mg/L
		Corrosion	Cracks/Stru	ctural Damage			Phenol:		mg/L

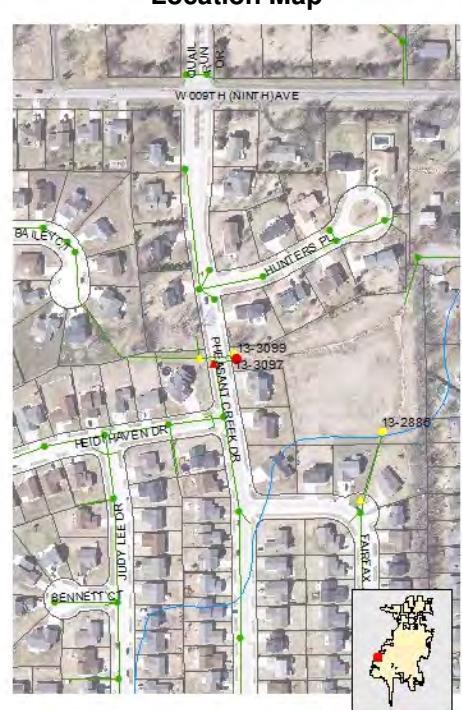
Outfall ID: 13-3099

Inspection Da	ate: 6/11/2012 12:50	:19 PM Inspect	tor: JCW	Inspection Type:	Ongoing	Previous Rainfall (hrs):	72+
Flow Descrip	otion: Submerged, ind	leterminate Not	es: Rocks and	cattails at end of	apron. Outfall	The state of the state	
Submerged:	Partially Depth	in): 6	partially su 13-3099 U	omerged; screen S1.	ed upstream at	1 Aller	
Illicit Dischar	rge Potential: Unlike	у	Field Follow	v-up 🗌 Of	fice Follow-up		
Floatables: N	lone	Petrol. Shee	n 🗌 Suds 🗌	Sewage 🗌 Al	gae 🗌 Other		
Odor: N	lone	Petroleum	Musty] Sewage 🗌 Cl	nlorine 🗌 Other	Part of the second s	
Turbidity:	lone				agrant		Contraction of the second
Color: N	lone					0201206111150	054.JPG
Gross Solids:	Slight	Litter	✔ Debris] Sediment	Other	Sampling Results	
Vegetation:	None	Inhibited	Excessive			Sample Location:	
Benthic Growt	th: None	Green	Brown			Sample ID:	
Stains:	Slight	✓ Flow Line	🗌 Oil 🗌	Rust Stains		Time Collected	
		Corrosion	Paint] Other		Total Chlorine (field):	ррт

Non-illicit:	None	Natural She	en 🗌 Natural S	Suds/Foam		Free Chlorine (field):	ррт
– Physical Co	ondition Assessment –					Total Copper (field):	ppm
Graffiti	None					Ammonia (field):	ppm
Erosion:	None					pH (field):	units
Doposition:	Moderate Dopth (ir). 6				Temperature:	°F
Deposition.). U				Conductivity:	μS/cm
Damaye.		cement 📋 Under	cut 📋 Crus	hed		Detergents:	mg/L
		sion 🗌 Cracks	s/Structural Dam	age		Phenol:	mg/L

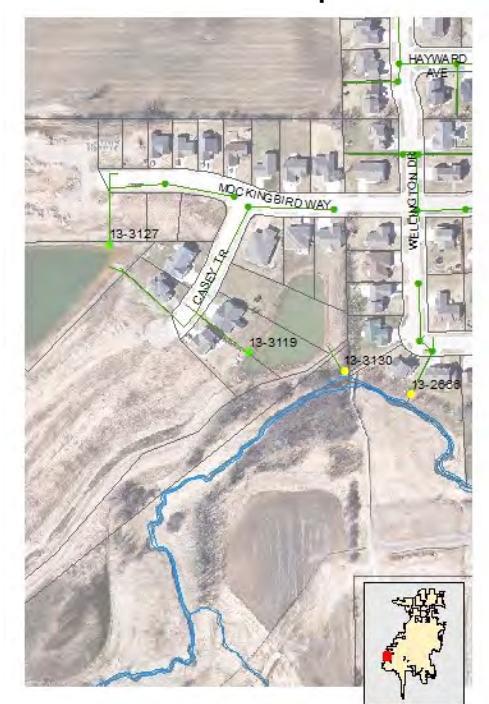
Inspection	Date: 6/12/2	2012 8:58:32 AM	Inspector:	JCW	Inspection	Type:	Ongoing	Previous Rainfall (hrs):	72+	
Flow Descr	iption: None	•	Notes:	Dry. Fl	owline sedime	nt				
Submerged	None	Depth (in):								
Illicit Disch	arge Potentia	I: Unlikely		Field F	ollow-up	Off	ice Follow-up			A
Floatables:	None	Pet	rol. Sheen	Suds	Sewage	🗌 Alg	jae 🗌 Oth	er	Chi	
Odor:	None	Pet	roleum	Musty	Sewage	🗌 Ch	lorine 🗌 Oth	er		
Turbidity:	Nono		C/Solvent	Fishy	Sulfur	🗌 Fra	agrant		99 - 24	in part -
rubluity.	None							020120612080	0046	PG
Color:	None							020120012000	040.01	u
Gross Solids	s: Slight	Litte	er 🗌	Debris	 Sediment 	nt 🗌 C	Other	Sampling Results		
Vegetation:	None	🗌 Inhi	bited	Excessiv	'e			Sample Location:		
Benthic Gro	wth: Slight	✓ Gre	en 🗌	Brown				Sample ID:		
Stains:	None		v Line	Oil	Rust Sta	ins		Time Collected		
		Cor	rosion	Paint	Other			Total Chlorine (field):		ppm
Non-illicit:	None	□ Nat	ural Sheen	🗌 Natu	Iral Suds/Foam	า		Free Chlorine (field):		ppm

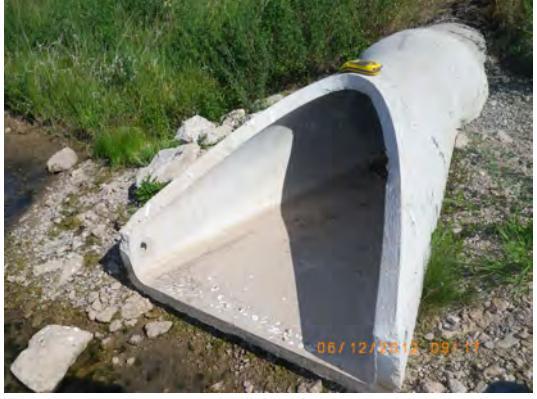
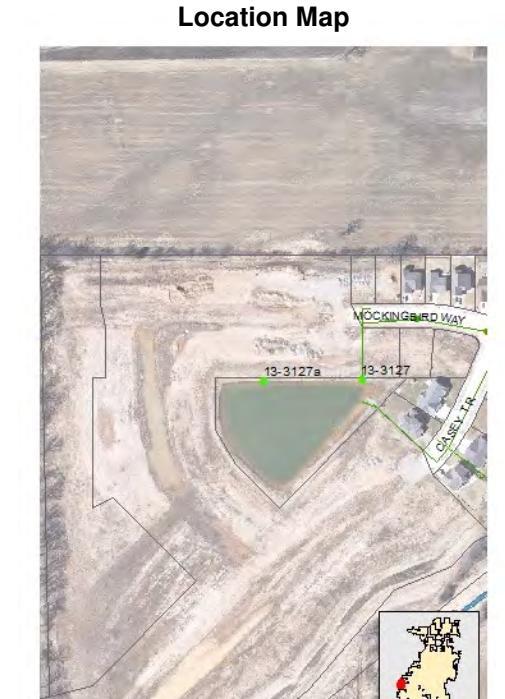
o20120612081732.JPG

Inspection	Date: 6/12/	2012 9:15:18 AM	Inspector:	JCW	Inspection	Type: Ong	joing	Previous Rainfall (hrs):	72-	F
Flow Description: None Notes: Pipe dry at time of				/ at time of ins	spection. Ap	oron slightly	A STREET, STRE			
Submerged	: None	Depth (in):		displace	ed from pipe.			A BERT		Net S
Illicit Disch	arge Potentia	l: Unlikely] Field Fo	ollow-up	✓ Office F	ollow-up			C. Con
Floatables:	None	Petr	ol. Sheen	Suds	Sewage	Algae	Other	1		
Odor:	None	Petr	oleum	Musty	Sewage	Chlorin	e 🗌 Other	artist .		and a little
			/Solvent	Fishy	Sulfur	Fragrar	it	72 3		
Turbidity:	None							and the second sec		
Color:	None							02012061208	1748.J	PG
Gross Solid	s: None	Litte	· 🗌	Debris	Sedimen	t 🗌 Other	Г	Sampling Results		
Vegetation:	None	🗌 Inhit	ited	Excessive	9			Sample Location:		
Benthic Gro	wth: None	Gree	n 🗌	Brown				Sample ID:		
Stains:	None	E Flow	Line	Oil	Rust Sta	ins		Time Collected		
		Corr	osion	Paint	Other			Total Chlorine (field):		ррт

Non-illicit:	None	Natu	ral Sheen	Natur	al Suds/Foam	ı		Free Chlorine (field):		ррт
– Physical	Condition Ass	essment						Total Copper (field):		ррт
Groffiti	Nono	cooment						Ammonia (field):		ррт
Graniu.	None							pH (field):		units
Erosion.	None	Denth (in):						Temperature:		°F
Depositio	n. None	Deptn (in):						Conductivity:		μS/cm
Damage:	Minor	Displacement	Undercut	C	Crushed			Detergents:		mg/L
		Corrosion	Cracks/Str	ructural D	amage			Phenol:		mg/L

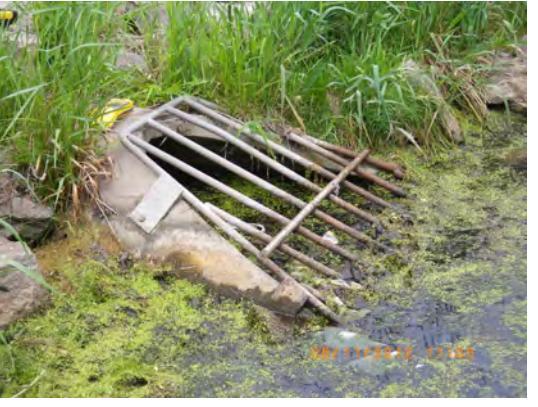
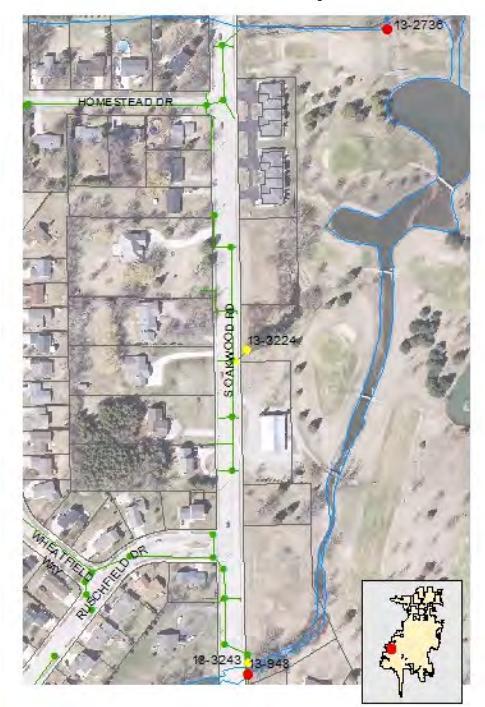
o20120611100528.JPG

Inspection	Date: 6/11/2	2012 11:04:58 AM	nspector:	JCW	Inspection	Type:	Ongoing	Previous Rainfall (hrs):	72+	
Flow Descr	ription: Subm	nerged, indeterminate	Notes:	Outfall	partially subm	erged.	Outfall screened			No and A
Submerged	: Partially	Depth (in): 12		upstrea	m at 13-3224	US1.			N 10	
Illicit Disch	arge Potential	: Unlikely		Field Fo	ollow-up	Of	fice Follow-up		ENG.	
Floatables:	Slight	Petrol	. Sheen 🗌	Suds	Sewage	🖌 Alç	gae 🗌 Other			Stor .
Odor:	None			Musty			nlorine 🗌 Other		and an	
Turbidity:	None			FISHY			agrant	MA I	067117	A Sec
Color:	None							0201206111005	546.JF	PG
Gross Solid	s: Slight	✓ Litter		Debris	Sedimen	t 🗌 C	Other	-Sampling Results		
Vegetation:	None	🗌 Inhibit	ed 🗌 E	Excessive	е			Sample Location:		
Benthic Gro	wth: Moderate	✓ Green	. E	Brown				Sample ID:		
Stains:	Moderate	✓ Flow I	_ine 🗌 C	Dil	Rust Sta	ins		Time Collected		
			sion 🗌 F	Paint	Other			Total Chlorine (field):		ррт

Non-illicit:	Slight	✓ Natura	al Sheen	🗌 Natur	ral Suds/Foarr	า		Free Chlorine (field):		ppm
- Physical	Condition Asse	essment						Total Copper (field):		ррт
Oreffiti	Name							Ammonia (field):		ppm
Graniti.	None							pH (field):		units
Erosion:	None	Develop (inc)						Temperature:		°F
Depositio	n: None	Deptn (in):						Conductivity:		µS/cm
Damage:	None	Displacement	Undercut		Crushed			Detergents:		mg/L
		Corrosion	Cracks/Str	uctural D	amage			Phenol:		mg/L

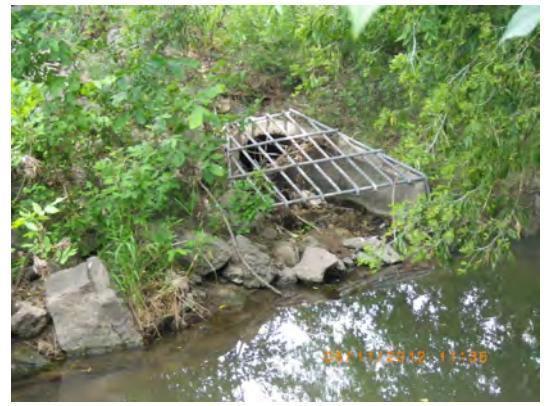
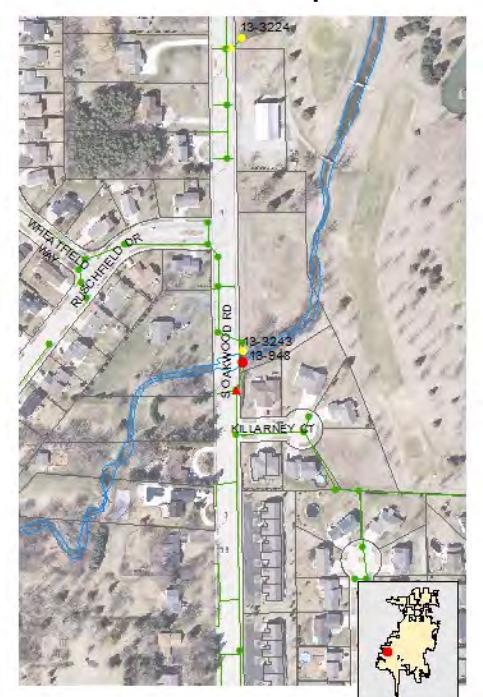
o20120611103656.JPG

Inspection	Date: 6/11/2012	2 11:40:07 AM	Inspector:	JCW	Inspection Type	: Ongoing	Previous Rainfall (hrs):	72+	
Flow Descr	iption: None		Notes:	Damp fl	owline but no flow.	Rocks and			
Submerged	: None	Depth (in):		sedimer	nt on apron.			>	No.
Illicit Disch	arge Potential:	Unlikely] Field Fo	llow-up	Office Follow-up		$\langle \rangle$	
Floatables:	None		trol. Sheen	Suds		Algae 🗌 Othe	er 🚺		
Odor:	None	🗌 Pe	troleum	Musty	Sewage	Chlorine 🗌 Othe	er 💽	A.N.	$X \land$
			C/Solvent	Fishy	Sulfur F	Fragrant			
Turbidity:	None								
Color:	None						0201206111042	222.JI	G
Gross Solid	s: Moderate	🖌 Litt	ter 🗌	Debris	Sediment	Other	Sampling Results		
Vegetation:	None	🗌 Inh	ibited	Excessive	9		Sample Location:		
Benthic Gro	wth: None	Gre	een	Brown			Sample ID:		
Stains:	Slight	V Flo	w Line	Oil	Rust Stains		Time Collected		
		Co	rrosion	Paint	Other		Total Chlorine (field):		ppm
Non-illicit:	None	🗌 Na	tural Sheen	Natur	al Suds/Foam		Free Chlorine (field):		ррт

- Physical	Condition Assess	ment					Total Copper (field):		ppm
Croffiti	Nono						Ammonia (field):		ррт
Gramu:	None						pH (field):		units
Erosion:	None						Temperature:		°F
Depositio	n: Moderate D	eptn (in): 6					Conductivity:		μS/cm
Damage:	None] Displacement [Undercut		rushed		Detergents:		mg/L
		Corrosion [Cracks/Str	ructural D	amage		Phenol:		mg/L

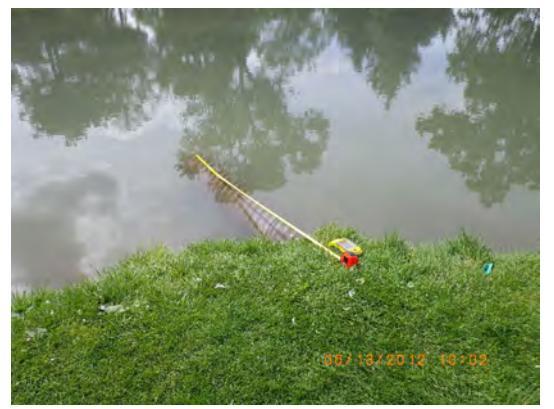
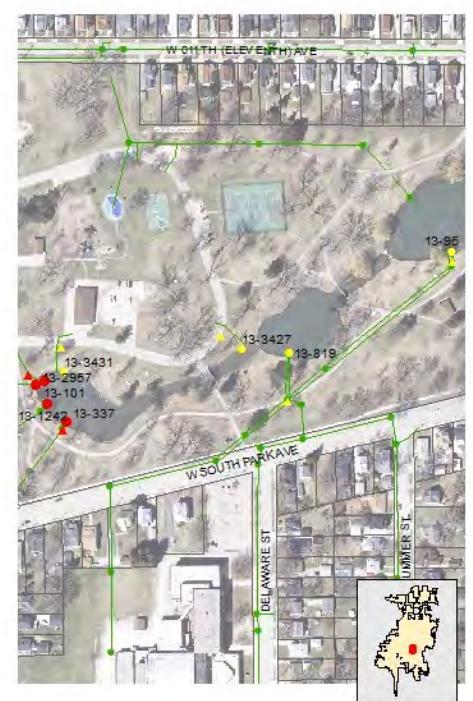
o20120613090218.JPG

Inspection	Date: 9/27/	2012 10:39:10 AM Ir	nspector: JCW	Inspection Type:	Ongoing	Previous Rainfall (hrs):	72+
Flow Descr Submerged	iption: Subr Partially	merged, indeterminate Depth (in): 10	Notes: Outfall upstrea	partially submerged; am at 13-3427 US1.	screened		
Illicit Disch	arge Potentia	al: Unlikely	Field F	ollow-up 🗌 Of	fice Follow-up	1	
Floatables:	None	Petrol.	Sheen 🗌 Suds	Sewage Al	gae 🗌 Other		
Odor:	None	Petrole	eum 🗌 Musty Solvent 🗌 Fishy	Sewage CH	nlorine 🗌 Other agrant		
Turbidity:	None					Photo Not A	vailable
Color:	None						
Gross Solid	s: None	Litter	Debris	Sediment	Other	Sampling Results	
Vegetation:	None	🗌 Inhibite	ed 🗌 Excessiv	re		Sample Location:	
Benthic Gro	wth: None	Green	Brown			Sample ID:	
Stains:	None	Flow L	ine 🗌 Oil	Rust Stains		Time Collected	
			ion 🗌 Paint	Other		Total Chlorine (field):	<i>ppm</i>
Non-illicit:	None	Natura	I Sheen 🗌 Natu	ral Suds/Foam		Free Chlorine (field):	<i>ppm</i>

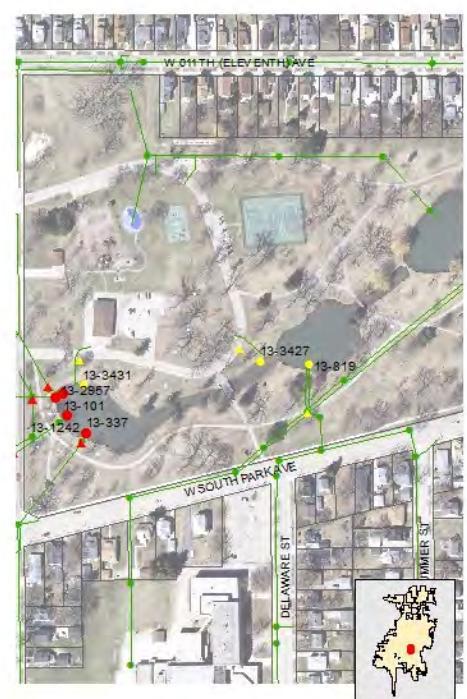
Outfall ID: 13-3427 US1

Inspection Date: 6/13/2012 10:02:18 AM Inspector: JCW	Inspection Type: Other	Previous Rainfall (hrs):	72+
Flow Description: Submerged, indeterminate Notes: Gross s	olids pre-screen.		
Submerged: Partially Depth (in): 5		A AND AND AND AND AND AND AND AND AND AN	
Illicit Discharge Potential: Potential Field Fo	llow-up Office Follow-up		A THE N
Floatables: None Petrol. Sheen Suds	Sewage Algae Other	A BE	Ser La
Odor: None Detroleum Musty	Sewage Chlorine Other		1 1 1 1 1 1 1 1 1 1 1 1 1 1 1 1 1 1 1
VOC/Solvent Fishy	Sulfur Fragrant	A life View	/ 13/2012 10:04
Turbidity: Cloudy			
Color: None		0201206130904	36.JPG
Gross Solids: Moderate 🖌 Litter 🖌 Debris	Sediment Other	Sampling Results	
Vegetation: None Inhibited Excessive	9	Sample Location: Pool	
Benthic Growth: None		Sample ID: 1206	13-17
Stains: None I Flow Line Oil	Rust Stains	Time Collected 10:03	3
Corrosion Paint	Other	Total Chlorine (field):	0 ppm
Non-illicit: None Natural Sheen Natur	al Suds/Foam	Free Chlorine (field):	0 ppm

- Physical Condition Assessment		Total Copper (field):	0 <i>ppm</i>
		Ammonia (field):	1 <i>ppm</i>
		pH (field):	7.3 units
Erosion: None		Temperature:	74 ° <i>F</i>
Deposition: Moderate Depth (in): 2		Conductivity: 1	429 μ <i>S/cm</i>
Damage: None Displacement Undercut C	rushed	Detergents:	0 <i>mg/L</i>
Corrosion Cracks/Structural D	amage	Phenol:	mg/L

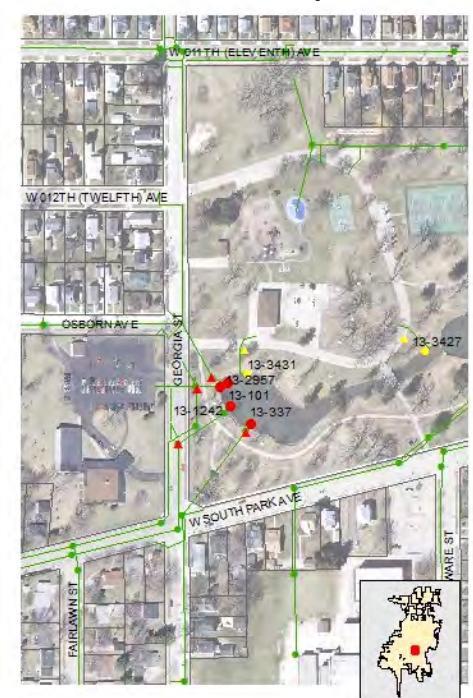
Outfall ID: 13-3431 US1

Inspection Date: 6/12/2012 12:56:45 PM Inspector: JCW Inspection Type: Other	Previous Rainfall (hrs): 72+
Flow Description: Submerged, indeterminate Notes: Pre-screening for gross solids.	A second second second second
Submerged: Partially Depth (in): 2	Anather and the
Illicit Discharge Potential: Potential Field Follow-up Office Follow-up	
Floatables: None	her
Odor: Easily detected Detroleum Musty Sewage Chlorine Ott	her
□ VOC/Solvent □ Fishy VoC/Solvent □ Fishy	V12/2012 - 23.8
Turbidity: None	
Color: None	020120612115904.JPG
Gross Solids: Moderate □ Litter ✓ Debris □ Sediment □ Other	- Sampling Results
Vegetation: None Inhibited Excessive	Sample Location: Pool
Benthic Growth: None Green Brown	Sample ID: 120612-26
Stains: None Flow Line Oil Rust Stains	Time Collected 12:57
Corrosion Paint Other	Total Chlorine (field): 0 ppm
Non-illicit: None Natural Sheen Natural Suds/Foam	Free Chlorine (field): 0 ppm
	Total Copper (field): 0 ppm

Ammonia (field): 0 ppm
Graftiti: None	pH (field): 7.86 units
Erosion: None	Temperature: 72 °F
Deposition: Minor Depth (in): 2	Conductivity: 1372 μ S/cm
Damage: None Displacement Undercut Crushed	Detergents: 0 mg/L
Corrosion Cracks/Structural Damage	Phenol: mg/L

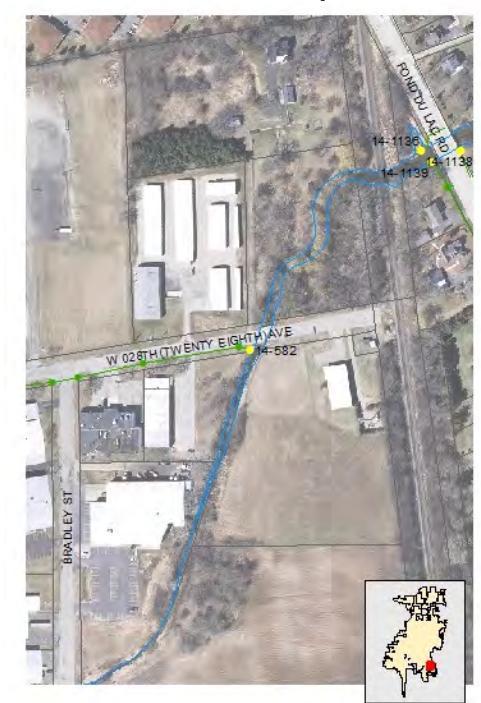
Outfall ID: 14-582

Inspection	Date: 9/5/20	012 11:52:00 AM li	nspector: JC	W Inspe	ction Type: 0	Complaint	Previous Rainfall (h	rs): 72+	
Flow Description: Submerged, indeterminate Notes: Dark bla and brid Submerged: Partially Depth (in): 12 Depth dial					rk black substance in water around outfall bridge. Sample collected from stream.			n	and the second
Illicit Discha	arge Potentia	I: Potential	Fie	Field Follow-up Office Follow-up					
Floatables:	None	Petrol.	Sheen 🗌 Su	ds 🗌 Sew	age 🗌 Alga	ae 🗌 Othe	r 💦 🖓		·
Odor:	Noticeable fro	m a distanc 🗌 Petrole	eum 🗌 Mu	isty 🔽 Sew	age 🗌 Chlo	orine 🗌 Othe	r	and and	
			Solvent 🗌 Fis	shy 🔽 Sulfi	ur 🗌 Frag	grant	1 Here		×. 118
Turbidity:	Cloudy								
Color:	Clearly visible	in flow Dark/Blac	:k				020120903	5105212.JI	PG
Gross Solids	s: None	Litter	Debi	ris 🗌 Sedi	ment 🗌 Ot	her	-Sampling Results —		
Vegetation:	None	Inhibite	ed 🗌 Exce	essive			Sample Location:	Pool	
Benthic Grov	wth: Moderate	✓ Green	Srow	vn			Sample ID:	120905-4	7

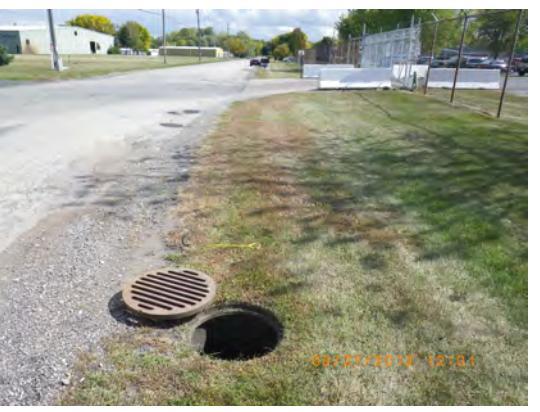
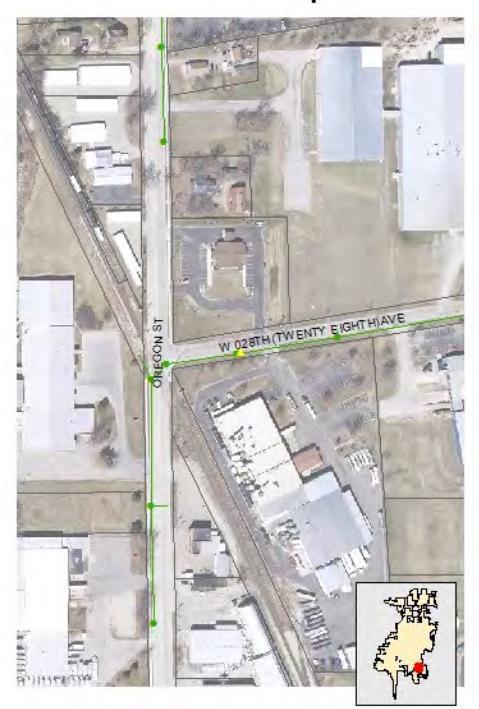
o20120927110124.JPG

Upstream catchbasin located approx 1255 ft WSW of outfall 14-582. Intermediate area consists of industrial properties.

Inspection	Date: 9/27/2	2012 11:59:39 AM	Inspector:	JCW	Inspection Type	Repeat	Previous Rainfall (hrs):	72+	
Flow Descr Submerged:	iption: None None	Depth (in):	Notes:	Inlet dry of recer	v at time of inspection time of inspection to a time of inspection to a time of the time of time of time of the time of time of the time of the time of the time of time of the time of ti	n. No indication	5		
Illicit Disch	arge Potentia	I: Potential] Field Fo	ollow-up	office Follow-up			
Floatables:	None	Petr	ol. Sheen	Suds	Sewage A	lgae 🗌 Oth	er		19
Odor:	None	Petr	oleum	Musty	Sewage C	hlorine 🗌 Oth	er	Aler.	6 1

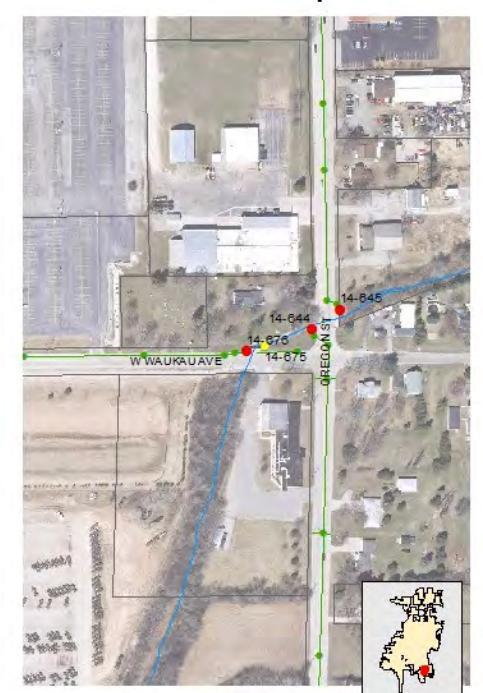
Inspection	Date: 6/20/	2012 12:29:02 PM	Inspector:	JCW	Inspection Type:	Ongoing	Previous Rainfall (hrs):	24-4	48
Flow Descr	iption: None	•	Notes:	2011 suds	(natural) follow-up	o. Pipe wet but		1. 9	SY.
Submerged	: None	Depth (in):		no now at o	outrall.			In	1 1
Illicit Disch	arge Potentia	I: Unlikely		Field Follov	w-up 🗌 Of	fice Follow-up		1	
Floatables:	None	Petro	I. Sheen	Suds] Sewage 🗌 Alg	gae 🗌 Other		1	
Odor:	None	Petro	leum	Musty] Sewage 🗌 Ch	nlorine 🗌 Other	LAKEN S	E	
			Solvent	Fishy] Sulfur 🛛 Fra	agrant	ASTR RAN	05/20/	2012 12:27
Turbidity:	None								1
Color:	None						020120620112	732.JI	G
Gross Solid	s: None	Litter		Debris] Sediment	Other	Sampling Results		
Vegetation:	None	🗌 Inhibi	ted 🗌 I	Excessive			Sample Location:		
Benthic Gro	wth: None	Gree	n 🗌 I	Brown			Sample ID:		
Stains:	Slight	Flow	Line 🗌 (Dil 🗌] Rust Stains		Time Collected		
		Corro	sion 🗌 I	Paint	Other		Total Chlorine (field):		ррт

Non-illicit:	None	Natur	al Sheen	Natural S	Suds/Foam		Free Chlorine (field):		ppm
- Physical	Condition Ass	esment					Total Copper (field):		ppm
1 Trysical							Ammonia (field):		ppm
Graffiti:	None						pH (field):		units
Erosion:	None						Temperature:		°F
Depositio	n: None	Depth (in):					Conductivity:		µS/cm
Damage:	Minor	Displacement	Undercut	Crus	shed		Detergents:		mg/L
		Corrosion	Cracks/Str	uctural Dam	age		Phenol:		mg/L

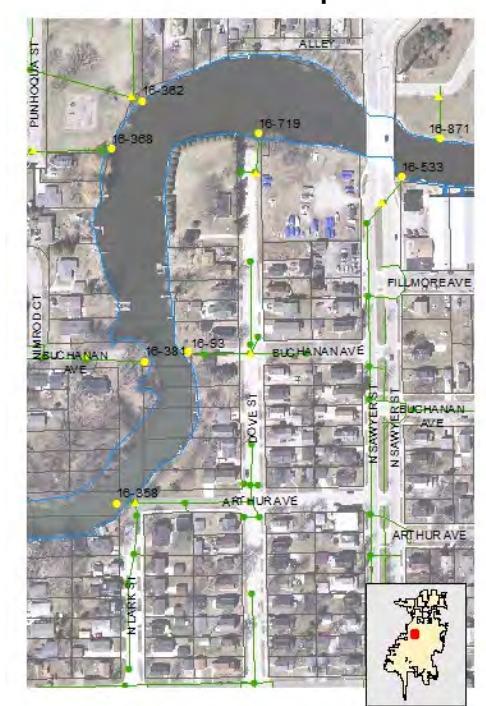
In some cases, outfalls can be either partially or fully submerged. A partially submerged outfall is an outfall where the elevation of the invert is below the water level of the receiving water. A fully submerged outfall is a pipe that is entirely below the water surface. In either condition, the water is "backed up" into the discharging pipe or channel, and is not free-flowing. Under these conditions, if a sample is collected at the outfall point, the sample could consist almost entirely of the receiving water.

In the case of partially or fully submerged outfalls, OMNNI developed a sampling procedure that was approved by WDNR. The submerged outfall is screened for physical indicators. However, the flow sample is collected from the first access point (i.e., manhole, catchbasin, curb inlet) upstream of the outfall. This reduces the influence of the receiving water. Typically, if there is no flow or pooled water at the upstream location, then no sample is collected. For all upstream sampling, a note is made of the distance and land use of the area between the outfall and the upstream area to assess the potential for illicit connections between the outfall and the upstream location.

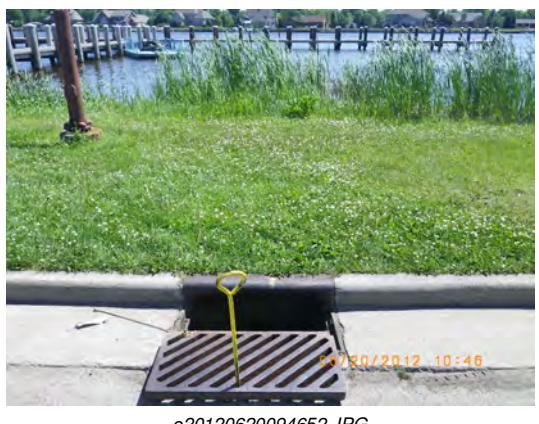
PHYSICAL INDICATOR ASSESSMENT

Floatables include situations like petroleum sheens, suds, algae, and evidence of raw sewage. These conditions would typically be observed in an area of stagnant water, such as a downstream pool or an upstream manhole, although some may be observed in the actual flow. Some conditions (petroleum sheens and sewage) are almost always the result of an illicit discharge. Other floatables, like suds and algae, can have non-illicit sources, but their presence can also indicate the potential for an illicit discharge, and the source should be traced.

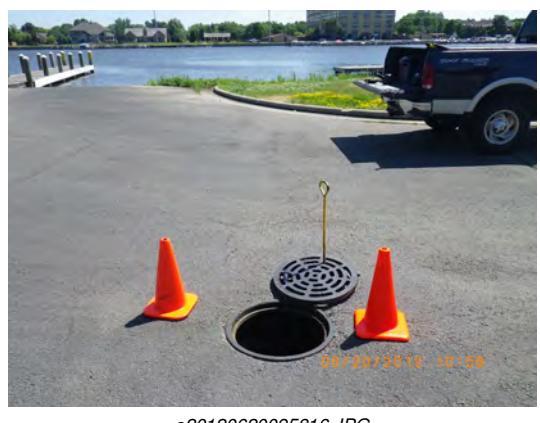
Under section 2.3.3, the ongoing screening of all outfalls could be modified to include other parameters. For the ongoing screening program, OMNNI tested for the following chemical indicators:

Flow samples were collected at all outfalls that exhibited dry-weather flow at the time of the inspection. For partially-submerged or fully-submerged outfalls, a sample was collected from the flow or submerged pool at the first upstream sampling location. A total of 54 stormwater samples were collected and analyzed as part of the ongoing screening process in 2012 – 9 from flow streams and 45 from pools. Depending on the specific conditions for the outfall, not all tests were run for all samples.

Background

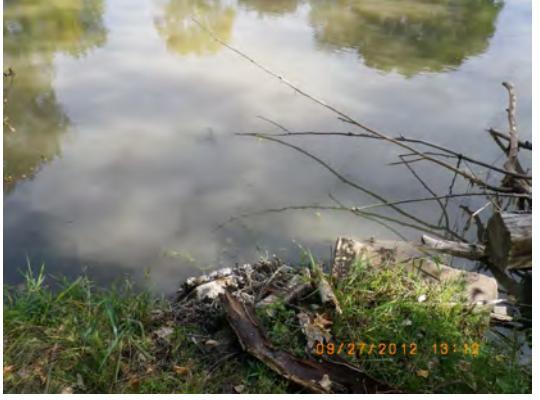
o20120927121238.JPG

Storm sewer from Buchanan Ave discharges to stream from west. Outfall fully submerged and not physically located. Pipe info from MS4 map

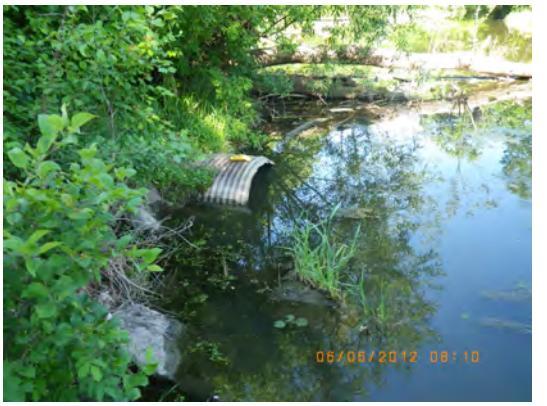
o20120606071048.JPG

Storm sewer from Taft Ave and water park discharges to stream from south. Pipe info from MS4 map.

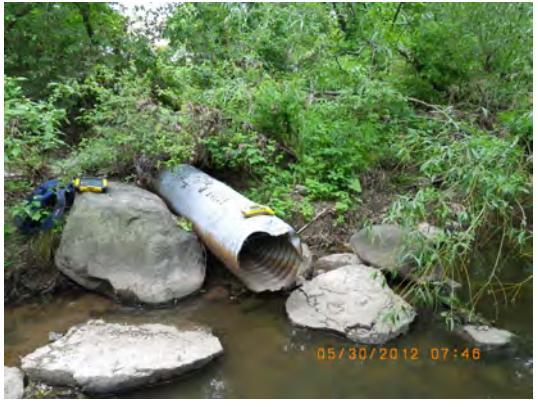
o20120530064602.JPG

Inspection	Date: 5/30/2	2012 7:46:42 AM	Inspector:	JCW	Inspection	Туре: С	Ongoing	Previous Rainfall (hrs):	72+	
Flow Descr	ription: None	1	Notes:	Pipe dry	/ at time of ins	spection.				
Submerged	: None	Depth (in):								12.10
Illicit Disch	arge Potentia	l: Unlikely] Field Fo	ollow-up		ce Follow-up		n))	
Floatables:	None	Pe	etrol. Sheen	Suds	Sewage	🗌 Alga	e Other		41	1 Contractor
Odor:	None	Pe	etroleum	Musty	Sewage	Chlc	orine 🗌 Other		1	Ale
Turkiditur	None	L] VC	OC/Solvent	Fishy	Sulfur	Frag	grant		05/30.	2012 01:44
Turbidity:	None							020120530064	61 <i>8</i> .JI	PG
Color:	None							02072000004	510.01	u
Gross Solid	s: None	🗌 Lit	tter	Debris	Sedimen	nt 🗌 Ot	her	Sampling Results		
Vegetation:	None		hibited	Excessive	e			Sample Location:		
Benthic Gro	wth: None	🗌 🗌 Gi	reen	Brown				Sample ID:		
Stains:	Slight	🗌 Fle	ow Line 🗌	Oil	Rust Sta	ins		Time Collected		
		Co	orrosion	Paint	Other			Total Chlorine (field):		ppm

Non-illicit:	None	N≀	atural Sheen	☐ Natur	al Suds/Foam	า		Free Chlorine (field):		ppm
- Physical	Condition Ass							Total Copper (field):		ppm
Croffit	News	Soment						Ammonia (field):		ppm
Gramiti:	None							pH (field):		units
Erosion:	Minor	Denth (in)						Temperature:		°F
Depositio	n: None							Conductivity:		µS/cm
Damage:	winor	Displacement	Undercut	✓ C	Crushed			Detergents:		mg/L
		 Corrosion 	Cracks/Str	uctural D	amage			Phenol:		mg/L

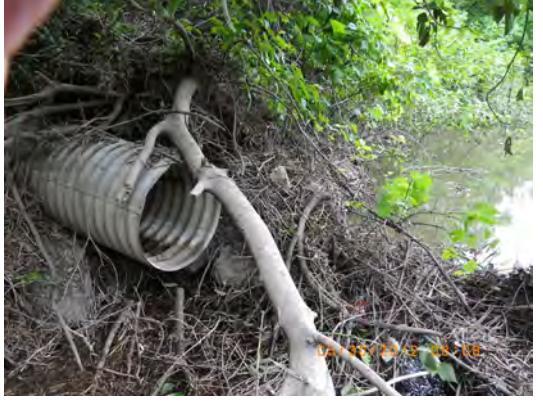
o20120530070832.JPG

Inspection	Date: 5/30/2	2012 8:08:34 AM	Inspector:	JCW	Inspection Type:	Ongoing	Previous Rainfall (hrs):	72+	
Flow Descr	iption: None		Notes:	Pipe wet	but no flow at time	of inspection.		\mathbf{n}	TARY.
Submerged:	None	Depth (in):					A CONTRACTOR	11	19-2
Illicit Disch	arge Potentia	: Unlikely] Field Fol	low-up O	ffice Follow-up		5	A A
Floatables:	None		Petrol. Sheen	Suds	Sewage Al	gae 🗌 Other			1000
Odor:	None		Petroleum] Musty] Fishy	Sewage Cl	hlorine 🗌 Other agrant	A CARGE		
Turbidity:	None					0		97/201	
Color:	None						0201205300708	842.JI	PG
Gross Solids	s: None		Litter	Debris	Sediment	Other	Sampling Results		
Vegetation:	None		Inhibited	Excessive			Sample Location:		
Benthic Gro	wth: None		Green	Brown			Sample ID:		
Stains:	Slight	\checkmark	Flow Line	Oil	Rust Stains		Time Collected		
			Corrosion	Paint	Other		Total Chlorine (field):		ррт
Non-illicit:	None		Natural Sheen	Natura	al Suds/Foam		Free Chlorine (field):		ррт

– Physical	Condition Asse	essment					Total Copper (field):		ррт
Graffiti	None						Ammonia (field):		ppm
Erosion	Minor						pH (field):		units
Depositio	n: None	Denth (in):					Temperature:		۰F
Damage.	Minor						Conductivity:		μS/cm
Damaye.	WILLOI		ent 🖌 Undercut		rushed		Detergents:		mg/L "
		Corrosion	Cracks/Str	ructural Da	image		Phenol:		mg/L

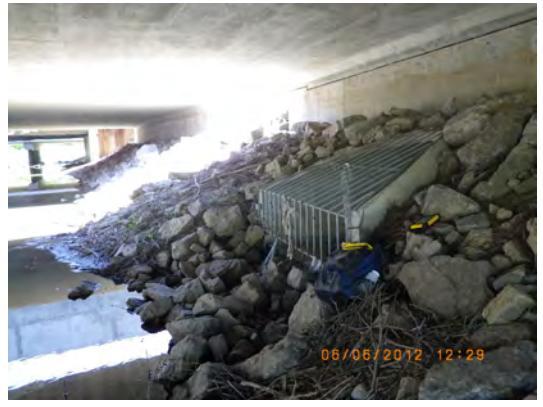
o20120606112906.JPG

Storm sewer from Washburn St discharges to stream from south. No GPS under bridge - location approximate. Replaces 16-646 (2012).

JCW Inspection Type: Ongoing **Inspection Date:** 6/6/2012 12:26:31 PM Inspector: Previous Rainfall (hrs): 72+ Flow Description: None Notes: Wet but no flow. Minor litter, likely from construction. Submerged: None Depth (in): Illicit Discharge Potential: Unlikely Field Follow-up Office Follow-up Floatables: None Petrol. Sheen Suds Sewage Other Algae Odor: None Petroleum Musty Sewage Chlorine Other VOC/Solvent Fishy Sulfur Fragrant Turbidity: None o20120606112916.JPG Color: None ✓ Litter Gross Solids: Slight Debris Sediment Other Sampling Results Inhibited Vegetation: None Excessive Sample Location: Benthic Growth: None Green Brown Sample ID: None Stains: Rust Stains **Time Collected** Flow Line Oil Corrosion Paint Other Total Chlorine (field): ppm --Free Chlorine (field): ppm --Non-illicit: None Natural Sheen Natural Suds/Foam Total Copper (field): -ррт Physical Condition Assessment ррт Ammonia (field): Graffiti: None pH (field): units --Erosion: None Temperature: °F --Deposition: None Depth (in): Conductivity: µS/cm --Damage: None Displacement Undercut Crushed Detergents: mg/L --Phenol: Corrosion Cracks/Structural Damage -mg/L

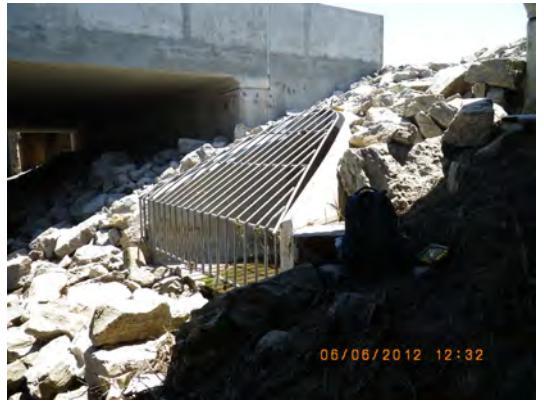
o20120606113228.JPG

Storm sewer from swale discharges to stream from south. Limited GPS next to bridge - location approximate. Added 2012.

Inspection	Date: 6/6/2012 12:	30:06 PM Inspec	tor: JCW	Inspection Type:	Ongoing	Previous Rainfall (hr	s): 72+	-
Flow Desci	ription: Trickle	No	tes:				///	
Submerged	: None Dep	pth (in):					11	
Illicit Disch	arge Potential: Unl	likely	Field Fo	ollow-up 🗌 Of	fice Follow-up		4	
Floatables:	Moderate	Petrol. Shee	en 🖌 Suds	Sewage Al	gae 🗌 Other		22	
Odor:	None	Petroleum	Musty	🗌 Sewage 🗌 Cl	nlorine 🗌 Other		221	112
		VOC/Solver	nt 🗌 Fishy	Sulfur Fr	agrant	Ser Mart		2012 12792
Turbidity:	None							1
Color:	None					020120606	113236.JI	PG
Gross Solid	s: None	Litter	Debris	Sediment	Other	Sampling Results —		
Vegetation:	None	Inhibited	Excessiv	e		Sample Location: F	low	
Benthic Gro	wth: Slight	🖌 Green	Brown			Sample ID: 1	20606-1	0
Stains:	None	Flow Line	🗌 Oil	Rust Stains		Time Collected	2:31	
		Corrosion	Paint	Other		Total Chlorine (field):	0	ppm
Non-illicit:	Moderate	Natural She	en 🗸 Natu	ral Suds/Foam		Free Chlorine (field):	0	ppm

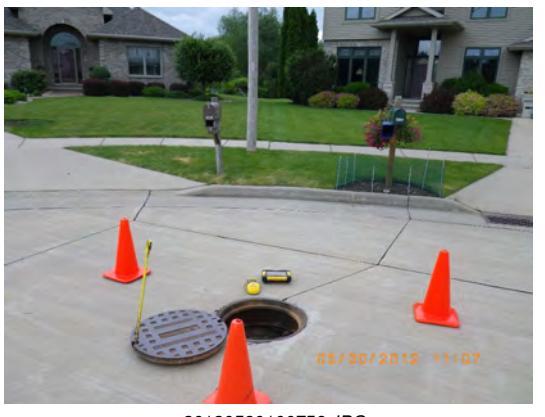
o20120530100758.JPG

Upstream manhole located approx 257 ft WSW of outfall 16-660. Intermediate area consists of residential property.

Inspection	Date: 5/30	/2012 11:04:45 AM	Inspector:	JCW	Inspect	ion Type:	Ongoing	Previous Rainfall (hrs): 72-	F
Flow Descr	iption: Tric	kle	Notes:					1 1 150		
Submerged	None	Depth (in):						1- 3000	STATE	
Illicit Disch	arge Potenti	al: Unlikely		Field F	ollow-up	0 Ot	ffice Follow-up			
Floatables:	None	Pet	rol. Sheen	Suds	Sewag	ge 🗌 Al	gae 🗌 Othe	er		
Odor:	None	Pet	roleum	Musty	Sewag	ge 🗌 Cl	hlorine 🗌 Othe	er	- de	TSI
		VO	C/Solvent	Fishy	Sulfur	🗌 Fr	agrant		05/30	2012 11:08
Turbidity:	None								1 1 8 18 m	
Color:	None							0201205	30100806.J	PG
Gross Solids	s: None	Litt	er 🗌	Debris	Sedim	ent	Other	-Sampling Results-		
Vegetation:	None	🗌 Inh	ibited	Excessiv	e			Sample Location:	Flow	
Benthic Gro	wth: None	Gre	en 🗌	Brown				Sample ID:	120530-9	3
Stains:	None	Flo	w Line	Oil	Rust S	Stains		Time Collected	11:08	
			rosion	Paint	Other			Total Chlorine (field	l): 0	ppm
Non-illicit:	None	Nat	ural Sheen	🗌 Natu	iral Suds/Fo	am		Free Chlorine (field): 0	ррт

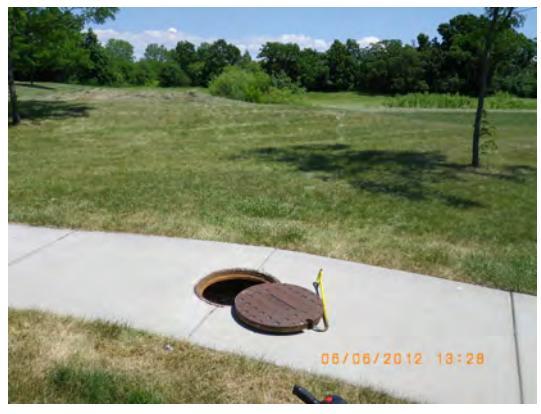
o20120606122840.JPG

Upstream manhole located approx 112 ft W of outfall 16-995. Intermediate area consists of open space.

Inspection	Date:	6/6/2012 1:28:22	PM Inspec	ctor: JCW	Inspecti	on Type:	Ongoing	Previous Rainfall (h	ırs): 72+	
Flow Descr	iption:	Submerged, no f	low No	otes: Sample	e collected f	rom pool i	n manhole. No	Mar 1		
Submerged	: None	Depth (in	ו): 1	flow en	itering eithei	pipe.		1 1 1	D.D.	1000
Illicit Disch	arge Pot	ential: Unlikely	,	Field F	ollow-up	Off	fice Follow-up			
Floatables:	None		Petrol. She	en 🗌 Suds	Sewag	je 🗌 Alg	gae 🗌 Othe	er e		
Odor:	Faint		Petroleum	Musty	Sewa	ge 🗌 Ch	llorine 🗌 Othe	er 💦	-	1
Turbidity:	None						ayranı		08/06/	2012 13:28
Color:	None]					02012060	6122856.JI	PG
Gross Solid	s: Sligi	nt	Litter	 Debris 	Sedim	ent 🗌 C	Other	- Sampling Results]
Vegetation:	Non	e	Inhibited	Excessiv	/e			Sample Location:	Pool	
Benthic Gro	wth: Non	e	Green	Brown				Sample ID:	120606-8	6
Stains:	Sligh	nt	✓ Flow Line	🗌 Oil	Rust S	Stains		Time Collected	13:33	
			Corrosion	Paint	Other			Total Chlorine (field)	: 0	ppm

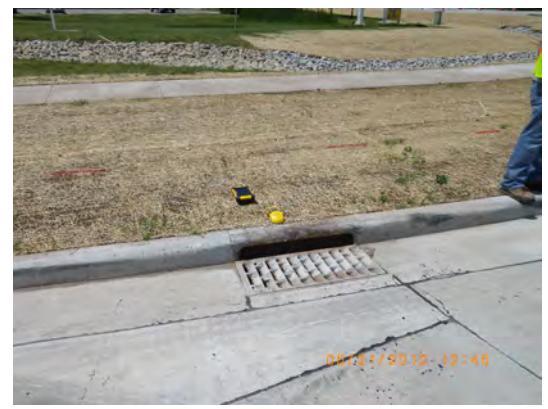
o20120621114700.JPG

Upstream curb inlet located approx 33 ft ESE of outfall 16-1204a. Intermediate area consists of street right-of-way.

Inspection	Date: 6	/21/2012 12:44:56 P	M Inspecto	or: JCW	Inspection Type:	Ongoing	Previous Rainfall (hrs):	0-24	4
Flow Descr	iption: S	Submerged, indeter	minate Note	es: Concre	te washout on grate.	No evidence in		1	Contraction of the
Submerged	: Partially	Depth (in):	7	storm s for sam	sewer. Grate could no	ot be removed	100		NO 1
Illicit Discharge Potential: Unlikely				Field F	ollow-up 🗌 Of	fice Follow-up			
Floatables:	None		Petrol. Sheer	n 🗌 Suds	Sewage Ale	gae 🗌 Other			
Odor:	None		Petroleum	Musty	🗌 Sewage 🗌 Cł	nlorine 🗌 Other			Aller -
			VOC/Solvent	Fishy	Sulfur Fra	agrant	- 14 ACT -	08/21/	2012 12:47
Turbidity:	None							740.0	
Color:	None						020120621114	/18.JF	G
Gross Solids	s: None		Litter	Debris	Sediment 🗌 0	Other	Sampling Results		
Vegetation:	None		Inhibited [Excessiv	e		Sample Location:		
Benthic Gro	wth: None		Green [Brown			Sample ID:		
Stains:	Slight	t] Flow Line [Oil	Rust Stains		Time Collected

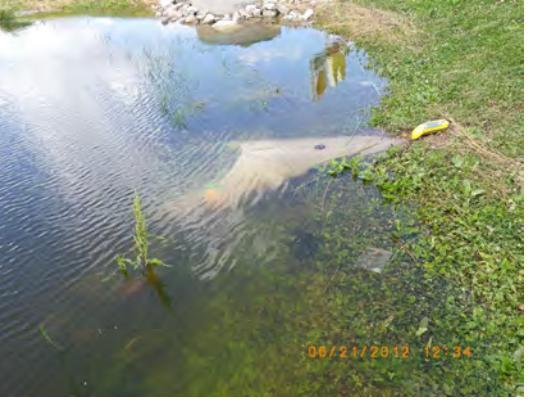
o20120621113432.JPG

Inspection Date: JCW Inspection Type: Ongoing 6/21/2012 12:32:35 PM Inspector: Previous Rainfall (hrs): 0-24 Flow Description: Submerged, indeterminate Notes: Outfall fully submerged; screened upstream at 16-1205 US1. Submerged: Fully Depth (in): 21 Illicit Discharge Potential: Unlikely Field Follow-up Office Follow-up Floatables: None Petrol. Sheen Suds Sewage Other Algae Odor: None Petroleum Musty Sewage Chlorine Other VOC/Solvent Fishy Sulfur Fragrant Turbidity: None o20120621113440.JPG Color: None Gross Solids: None Litter Debris Sediment Other Sampling Results None Inhibited Vegetation: Excessive Sample Location: Benthic Growth: None Green Brown Sample ID: Stains: None Rust Stains **Time Collected** Flow Line Oil Corrosion Paint Other Total Chlorine (field): ppm --Free Chlorine (field): ppm --Non-illicit: None Natural Sheen Natural Suds/Foam Total Copper (field): -ррт Physical Condition Assessment ррт Ammonia (field): Graffiti: None pH (field): units --Erosion: None Temperature: °F --Deposition: None Depth (in): Conductivity: µS/cm --Damage: None Displacement Undercut Crushed Detergents: -mg/L Phenol: Corrosion Cracks/Structural Damage -mg/L

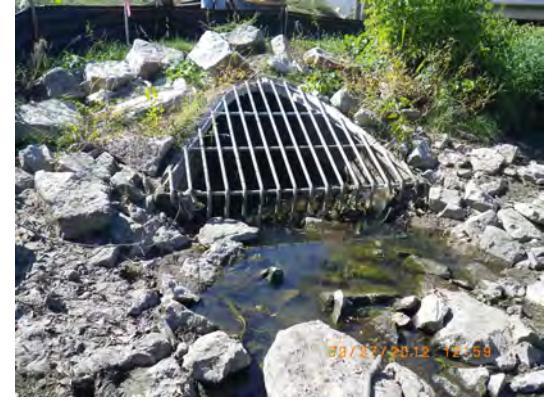
o20120927115912.JPG

Replaces outfall 16-487 (2011).

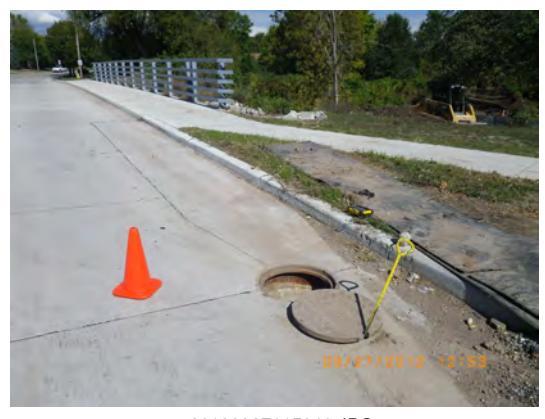
o20120927115346.JPG

Upstream manhole located approx 83 ft SW of outfall 16-487. Intermediate area consists of open space. Replaces 16-487 US1 (2011).

One outfall that was inspected on Wednesday had a slightly elevated level of ammonia in the upstream manhole. Outfall 16-487 is located on N Westfield St, and discharges into Sawyer Creek from the south (south of Robin Ave). The outfall pipe was partially submerged, so a sample was collected from the upstream manhole (16-487). The ammonia concentration of this sample was 1 mg/L. No other chemical indicators were out of range, and no physical indicators were observed. (It appeared that the storm sewer had been recently reconstructed, so it appeared fairly clean.)

1 mg/L is what we usually use as the threshold for follow-up investigation, especially if no other indicators are present. Since the sample was collected from a pool sample, natural sources of ammonia (decaying vegetation, etc.) could all cause slightly elevated ammonia levels. However, to be proactive, we will collect an additional sample the next time we are screening in Oshkosh (next week) to determine if the ammonia is still present, and if any additional investigation is warranted.

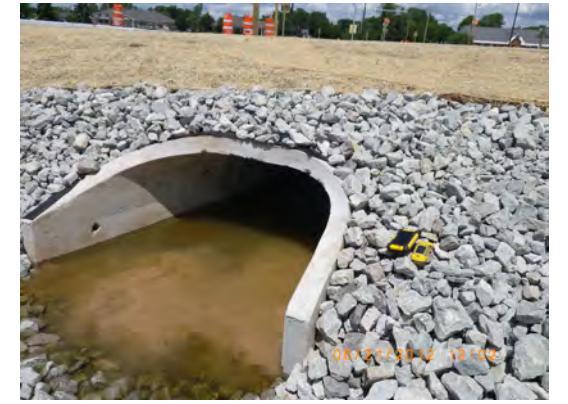
o20120621120234.JPG

Inspection	Date: 6/2	1/2012 12:59:23 PM In	spector: JCW	Inspection Type:	Ongoing	Previous Rainfall (hrs):	0-24	1
Flow Descr	ription: Sub	omerged, no flow	Notes: Apron	submerged, but no up	stream flow	e starter and a	36	
Submerged	: Partially	Depth (in): 12	observ	ed.				
Illicit Disch	arge Potenti	al: Unlikely	Field F	ollow-up 🗌 Of	fice Follow-up			
Floatables:	None	Petrol.	Sheen 🗌 Suds	Sewage Al	gae 🗌 Other			-
Odor:	None	Petrole	eum 🗌 Musty	🗌 Sewage 🗌 Cł	nlorine 🗌 Other	2		1
			olvent 🗌 Fishy	Sulfur Fr	agrant	A. L		E.
Turbidity:	None					Printer .	1	11
Color:	None					0201206211202	240.JF	PG
Gross Solid	s: None	Litter	Debris	Sediment	Other	Sampling Results		
Vegetation:	None	🗌 Inhibite	ed 🗌 Excessiv	e		Sample Location:		
Benthic Gro	wth: None	Green	Brown			Sample ID:		
Stains:	None	Flow Li	ne 🗌 Oil	Rust Stains		Time Collected		
			ion 🗌 Paint	Other		Total Chlorine (field):		ppm
Non-illicit:	None	Natura	Sheen 🗌 Natu	ral Suds/Foam		Free Chlorine (field):		ppm

– Physical	Condition As	sessment				Total Copper (field):		ppm
Oneffilie	Name	beboment				Ammonia (field):		ррт
Gramiti:	None					pH (field):		units
Erosion:	None	Denth (in) 0				Temperature:		°F
Depositio	n: Minor	Depth (in): 3				Conductivity:		µS/cm
Damage:	None	🗌 Displacement 🗌 L	Indercut	Crushed		Detergents:		mg/L
			Cracks/Structural E	Damage		Phenol:		mg/L

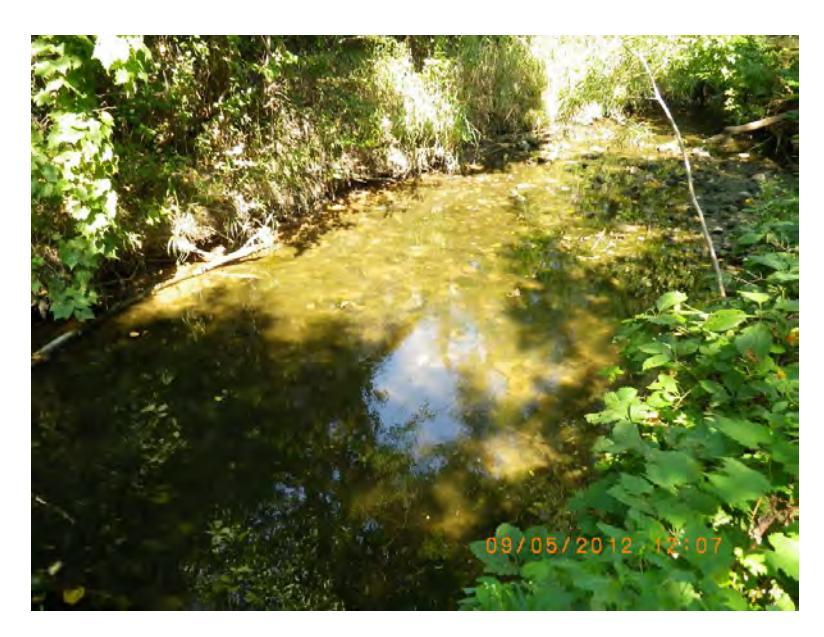
Figure 2 - Upstream location (control sample)

An attempt was made to locate the upstream extent of the black plume and odor. A sample was collected from the southwest corner of the parcel on the east side of the stream. No odor was detected at the stream bed, and the water in the stream appeared fairly clear. A sample was collected at this location. The sample had no odor and no tint. This sample was also field tested, and showed no chlorine or ammonia. The pH of this upstream sample was 7.62, which is fairly typical for stormwater. Using this sample as a control sample, it appeared that the black discharge had reduced the pH of the

stream approximately 1.0 unit lower than the baseline. (The sample locations and upstream and downstream extents of contamination are shown on the attached map.)

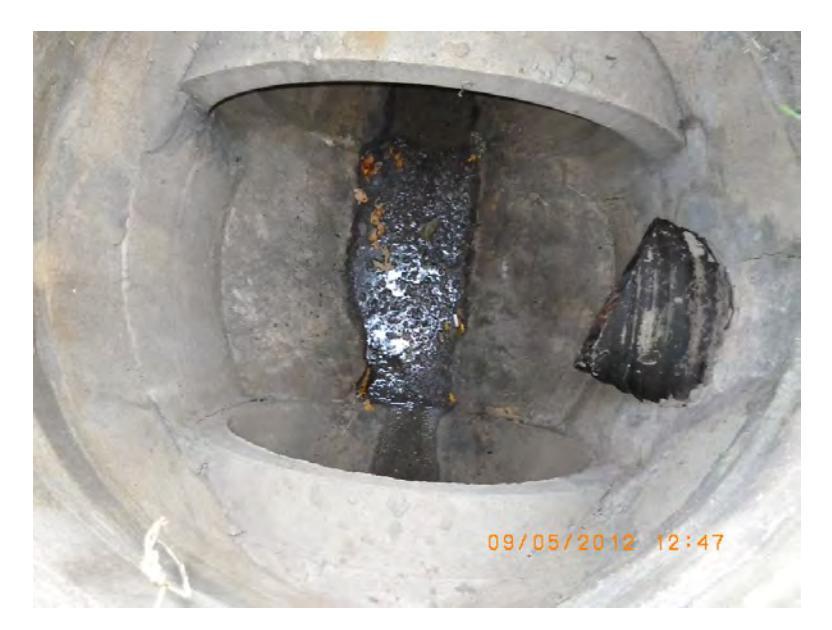
Figure 4 - Upstream manhole at W. 28th Ave and Bradley St (east at top)

Because the outfall pipe was partially submerged, upstream manholes on the storm sewer branch were screened to attempt to identify flow. The manhole immediately west of the intersection of W. 28th Ave and Bradley Street was the first upstream manhole that was located. When this manhole was screened, there was a trickle flow, with no evidence of black tint or staining. The sulfur odor was not apparent, and the sides of the manhole were dry, indicating that a large flow had not occurred in the recent past.

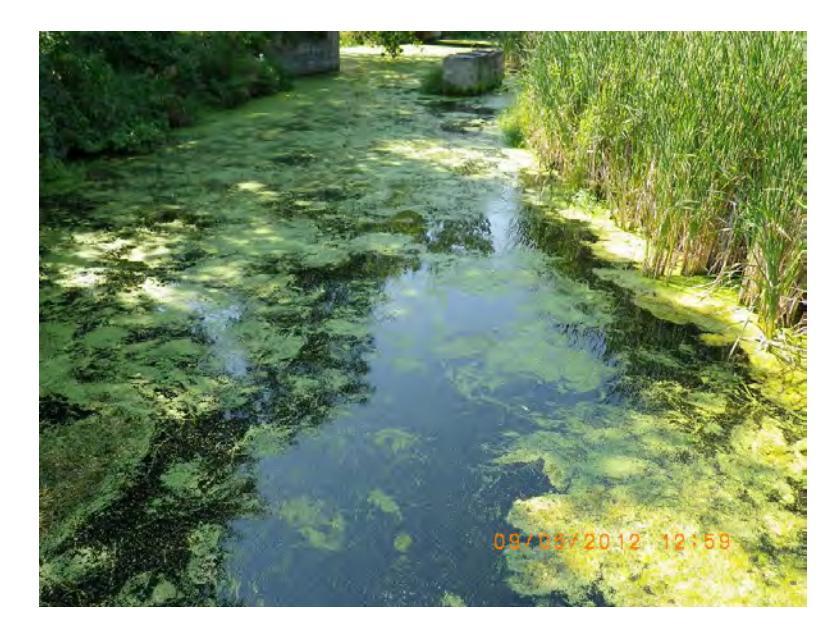
Figure 5 - Stream upstream of Fond du Lac Ave bridge

An attempt was made to locate the downstream extent of the plume. Samples of the stream water were taken from the Fond du Lac Ave bridge and the railroad bridge. Neither sample had a black tint or sulfur odor, so the plume apparently did not migrate downstream to the railroad bridge.

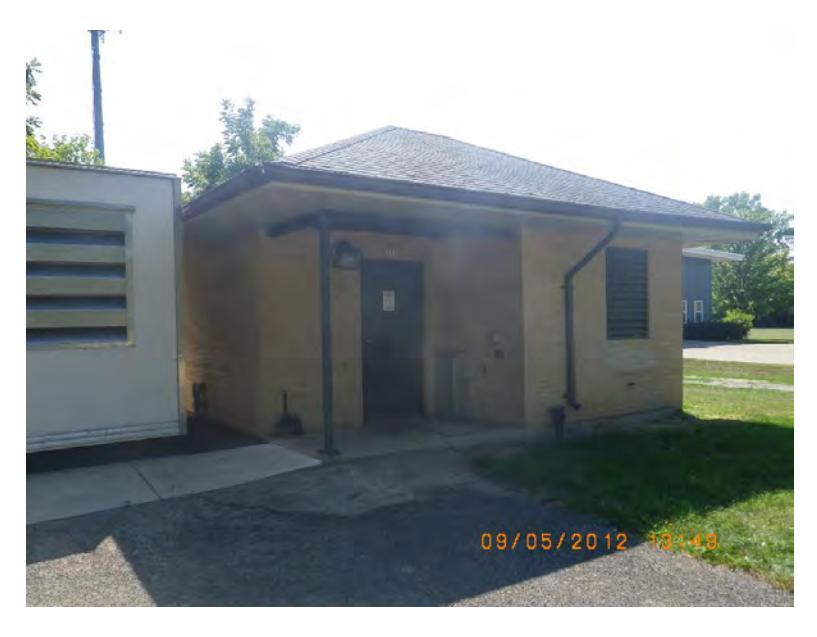
Figure 8 - Sanitary sewer lift station at end of W. 28th Ave

Finally, a sanitary sewer lift station was observed at the far east end of W. 28th Ave, approximately 280 feet east of the outfall. It appears that the sanitary sewer is located in the center of W. 28th Ave, and travels east to the lift station. To do this, it must cross the bridge near the outfall. While the discharge in the stream behaves more like anaerobic sludge than sanitary sewer (no ammonia present, different odor), it may be worth investigating the potential of a sanitary sewer leak coming into the lift station or in the force main downstream of the lift station.

It is recommended that the City continue to monitor this contamination plume and investigate potential sources of the contamination. Due to the lack of chemical indicators, it appears that the most effective method of tracking the contamination is by the presence of the sulfur odor and the black tint in the water. OMNNI would be happy to assist with any additional tracking or sampling that may be required.

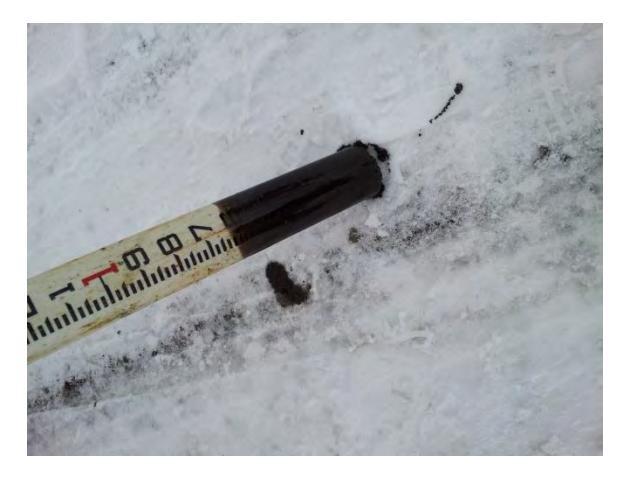
On December 11, 2012, a survey crew for the City of Oshkosh was working along S. Washburn Street, south of STH 44. While surveying storm sewer manhole 13-1743 on the south side of Washburn Street, they encountered an oily substance in the manhole. The manhole had approximately 0.6 feet of water trapped in it, with the oily substance floating on the water surface. The oil coated the survey rod with an opaque black film (Figure 1).

Figure 1 – Oil on survey rod from storm manhole 13-1743

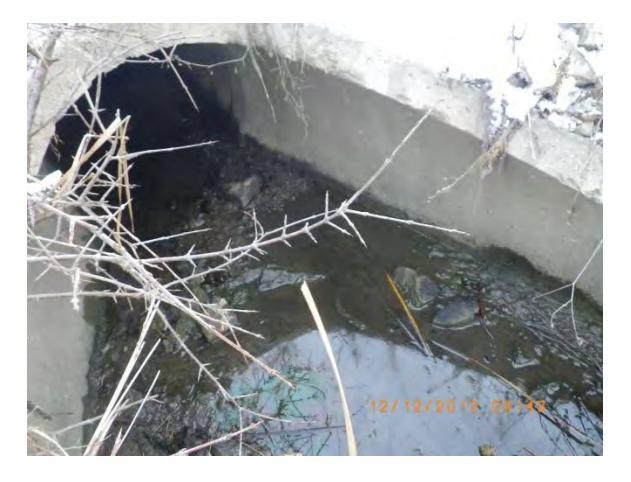
The investigation began by inspecting the various manholes in the storm sewer network to identify the extent of the oil contamination. An oil sheen and petroleum odor was observed at the pipe at the end of the drainage swale south of Quent's Service Center. The flow was traced upstream through the drainage swale for approximately 20 feet, at which point no additional surface flow was observed.

Figure 2 – Oil sheen at the end of the drainage swale

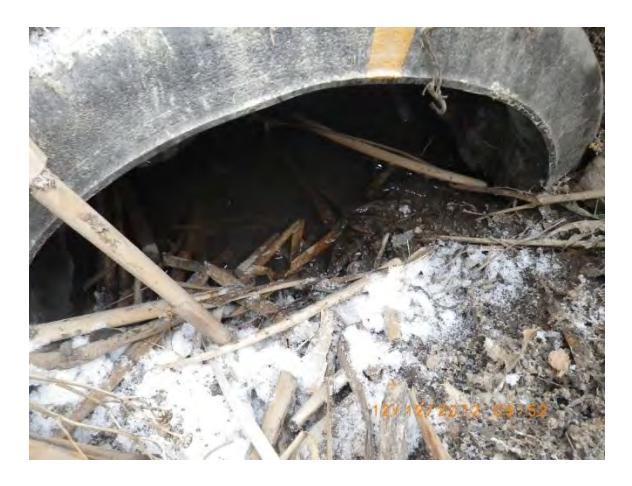
A private storm sewer is located in the west parking lot of Quent's Service Center. This storm sewer discharges to the drainage swale from the north. The outfall pipe was located, and was partially blocked by sediment and vegetation. A shallow pool of water was trapped at the end of the pipe. A sample was collected from this pool, and no sheen or odor was observed.

Figure 3 – Private storm sewer outfall in swale
