Ongoing Screening Summary Report 2012 Inspection Year

Illicit Discharge Detection and Elimination Program

City of Oshkosh

March 25, 2013

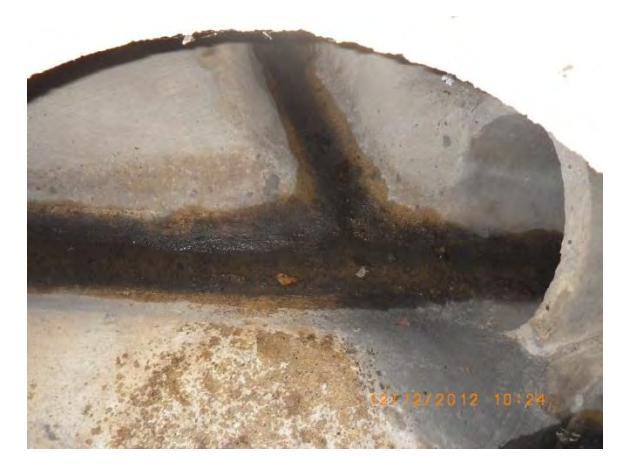
The branch of storm sewer along STH 44 south of Washburn Street was inspected. Based on the survey crew's activities on December 11, it was known that this branch entered manhole 13-1724 above the water level in the manhole. Manhole 13-2584 was inspected, and no sheen or stains were observed. A petroleum odor was present, but it was determined that this was likely venting from downstream manholes. Based on the observations in manhole 13-2584, it was determined that the discharge was not coming from this branch of the storm sewer.

Figure 4 – Clean flow in manhole 13-2584

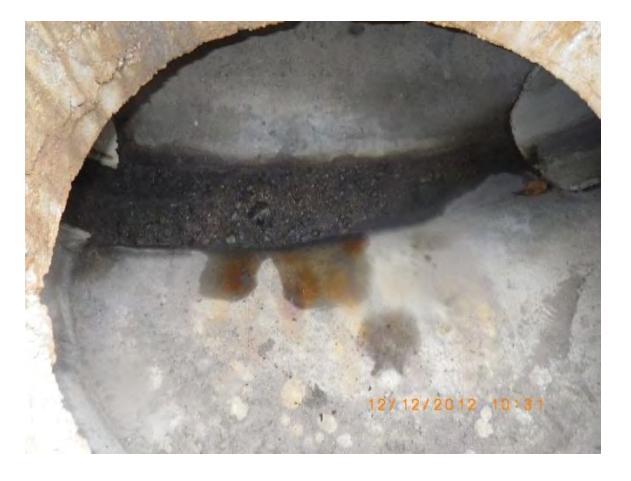
The branch on Washburn Street was investigated next. The manhole on the upstream end (13-1754) was inspected and found to be dry with no petroleum stains or odor. The next manhole (13-1749) was slightly submerged, and the flow appeared to be heading to the west (downstream). The flow entering from the east appeared to have a slight sheen, but did not have the dark, oily appearance that was observed at the end of the drainage swale.

Figure 5 – No flow in manhole 13-1754

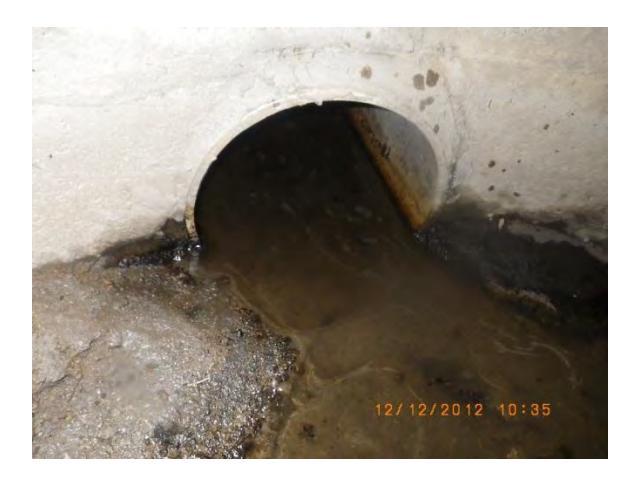
Figure 6 – Slight sheen in manhole 13-1749

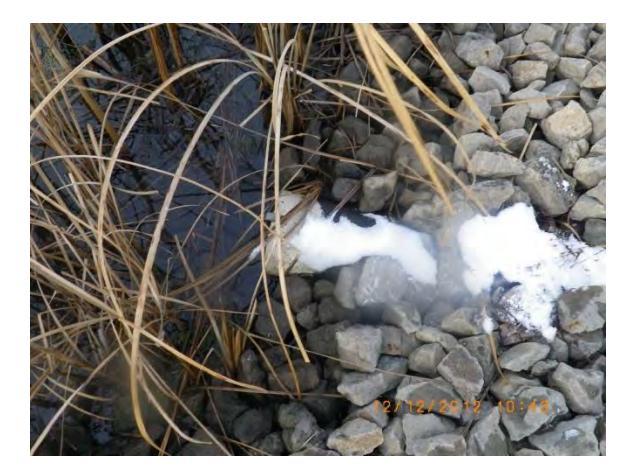
Figure 7 – Detention pond inlet pipe

The pond in front of the multi-tenant retail building on the north side of Washburn Street was inspected next. The building houses three tenants: 2nd Wind Exercise Equipment, Skiers Outlet and Golfers Outlet. The front parking lot for this building sheet flows into the detention pond. One PVC pipe was located on the north side of the pond, which appears to come from inside the building (i.e., roof drains). No catchbasins, inlets, or other private storm sewer were identified on the property.

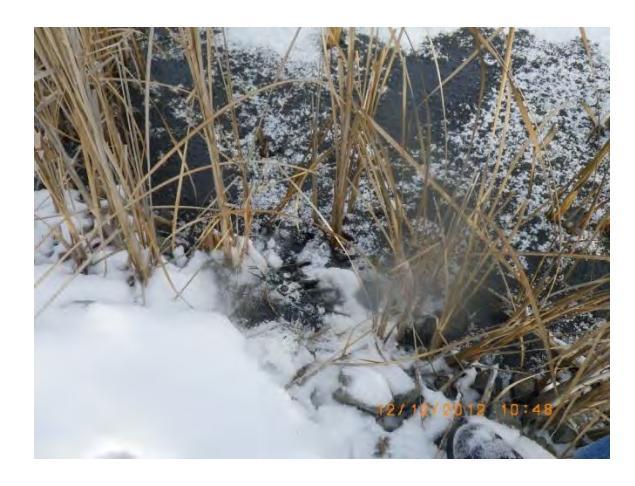
Figure 8 – Detention pond outlet pipe

An oil sheen was observed on the surface of the detention pond. Near the inlet pipe, the sheen appeared to consist of clear oil droplets. Near the pond's outlet pipe, near manhole/inlet 13-1743, the oil sheen was more opaque. The pond is likely designed to discharge to the storm sewer in Washburn Street. However, due to the partially-submerged condition at the outfall and the backed-up water in the storm sewer, the pond surface was at the same level as the storm sewer flow, and the water was free to flow between the storm sewer and the pond based on wind and other influences on flow.

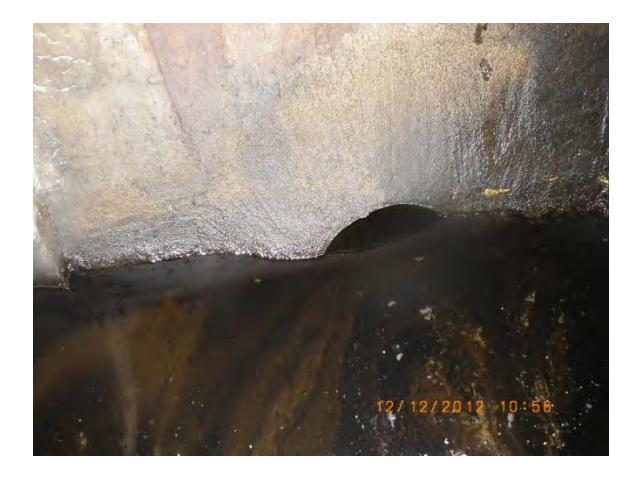
Figure 9 – Detention pond outlet pipe connection to manhole 13-1743

The junction of the detention pond and drainage swale with the storm sewer is located at manhole/inlet 13-1743. This inlet was inspected, and the opaque oil sheen observed in the drainage ditch was also observed in this inlet. No obvious source of the oil was identified, but there appeared to be a slight flow to the west (downstream).

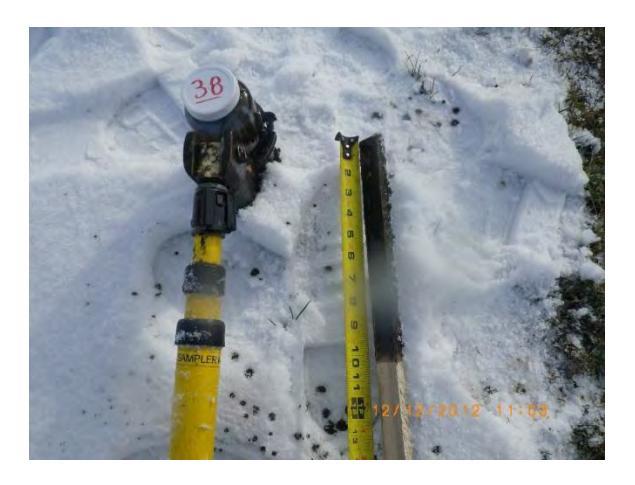
A water sample was collected from this manhole. The water was ten inches deep, with an opaque film on the surface. The oily substance coated the sample pole and sample bottle. A strong petroleum odor was present.

Figure 11 – Sample collected from manhole 13-1743

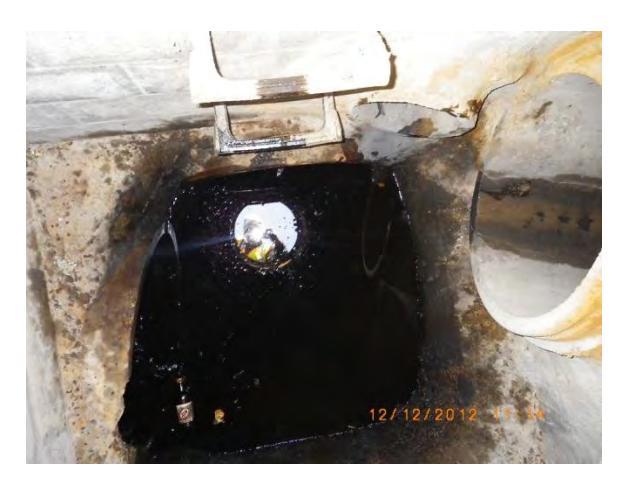
The remaining manholes between manhole 13-1743 and the outfall were inspected, and the oily substance was observed in each manhole. The inspection at manhole 13-1724 confirmed that the flow entering from the southwest branch did not contain oil.

Figure 12 – Pipe from southwest branch entering manhole 13-1724 above the water level

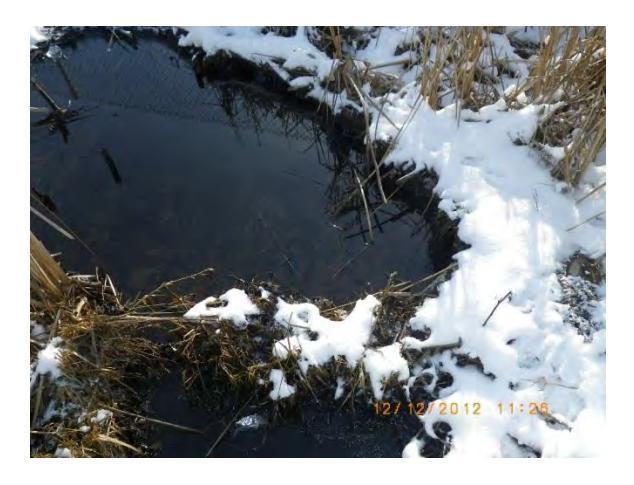
Outfall 13-1758 was located in the USH 41 right-of-way, south of the southbound on-ramp. The outfall pipe was approximately 90% submerged. The pool at the end of the outfall pipe had a brown-black opaque sheen with a strong petroleum odor, similar to the upstream manholes.

Figure 13 – Pool at end of outfall 13-1758

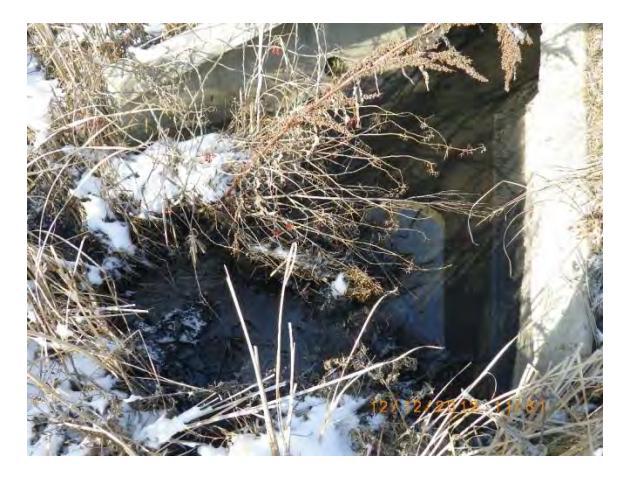
After leaving the outfall, the flow traveled northeast approximately 50 feet through a grass swale. A sheen was observed on this flow. The flow then entered a concrete culvert that traveled under STH 44 and discharged on the north side of STH 44. A dark sheen was observed on both the upstream and downstream ends of this culvert.

Figure 14 – Sheen on pool in upstream end of STH 44 culvert

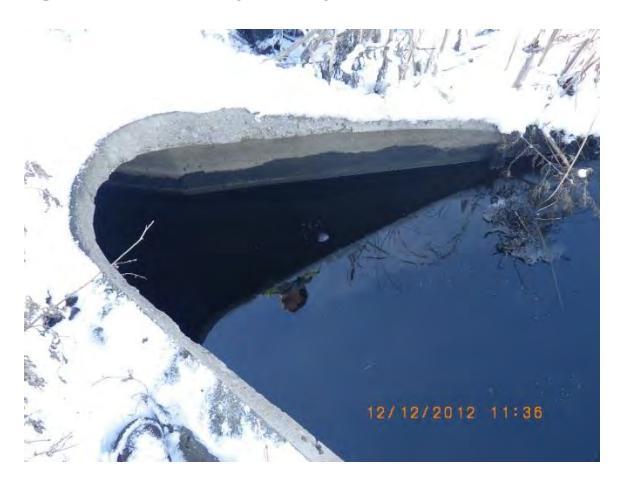
Figure 15 – Sheen on pool in downstream end of STH 44 culvert

The stains on the downstream culvert apron showed that the oil level had once been 4 to 5 inches higher than the present level.

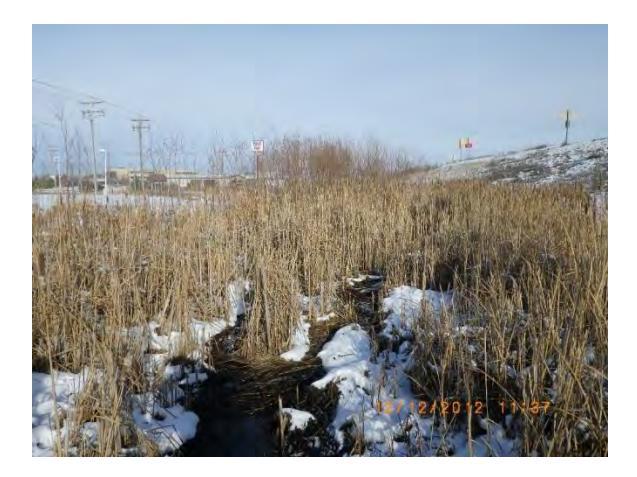
After leaving the STH 44 culvert, the flow traveled north along the USH 41 off-ramp ditch. The flow was traced for approximately 45 feet past the end of the culvert, at which point no surface flow was visible. The survey crew placed a pair of lath at the estimated downstream extent of the flow.

Figure 16 – Downstream extent of oil sheen

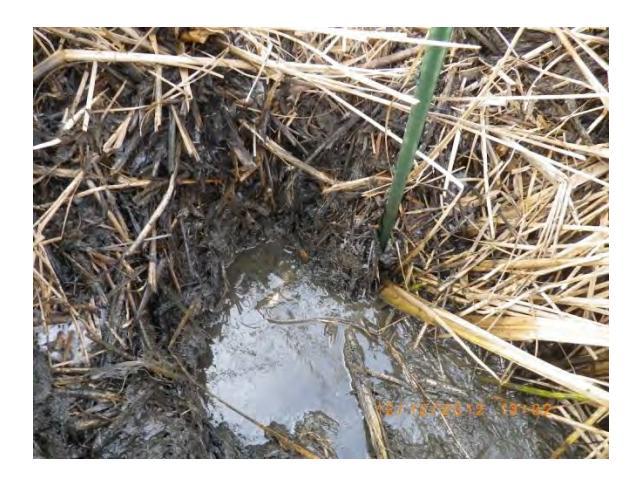
Based on the observations in the upstream manholes, the most likely source for the oil appeared to be the drainage swale south of Quent's Service Center. Starting at the downstream end of the swale, the surface flow was traced back up through the grass in the swale. Approximately 20 feet upstream from the end of the swale, the surface flow appeared to intensify from the north side of the swale. A metal fence post was located, which sometimes marks the location of a pipe. The area around the fence post was probed with a shovel, and a 4-inch PVC pipe was located. The pipe appeared to come from Quent's Service Center. When the area around the end of the pipe was cleared with the shovel, the pipe appeared to discharge the oily substance, which quickly flooded the area and submerged the pipe. Based on the appearance of the discharge and the strong odor that was present with the new discharge, this 4-inch PVC was identified as a probable source. The location of the pipe was marked with a lath, and the Illicit Discharge Coordinator was informed of the discovery.

Figure 17 – 4-inch PVC pipe from Quent's Service Center (submerged)

The source appears to be coming from a sump pump discharge pipe from Quent's Service Station at 2167 STH 44. A pipe discharging to a drainage ditch was partially plugged by dirt and cattails. When the end of the pipe was exposed (below water elevation) a rush of water and petroleum came from the pipe. Fire Chief Franz and I further investigated with Quent's Service Station. They checked their sump pump pit, and found oil present in the pit. The owner began working on clearing the oil from the surface.

Mr. Rabe investigated the site during the afternoon of December 12, 2012. Due to the severity of the contamination, he contacted the Fire Chief and asked to have the Hazardous Materials Response team deploy oil containment booms in the area. The Fire Chief spoke with the owner of Quent's Service Center, who identified the PVC pipe as their sump pump discharge line. After investigating the inside of the building, oil was observed on the surface of the sump pit. The Fire Department will follow up with Quent's Service Center on December 13.
