Ongoing Screening Summary Report 2014 Inspection Year

Illicit Discharge Detection and Elimination Program

City of Oshkosh

February 23, 2015

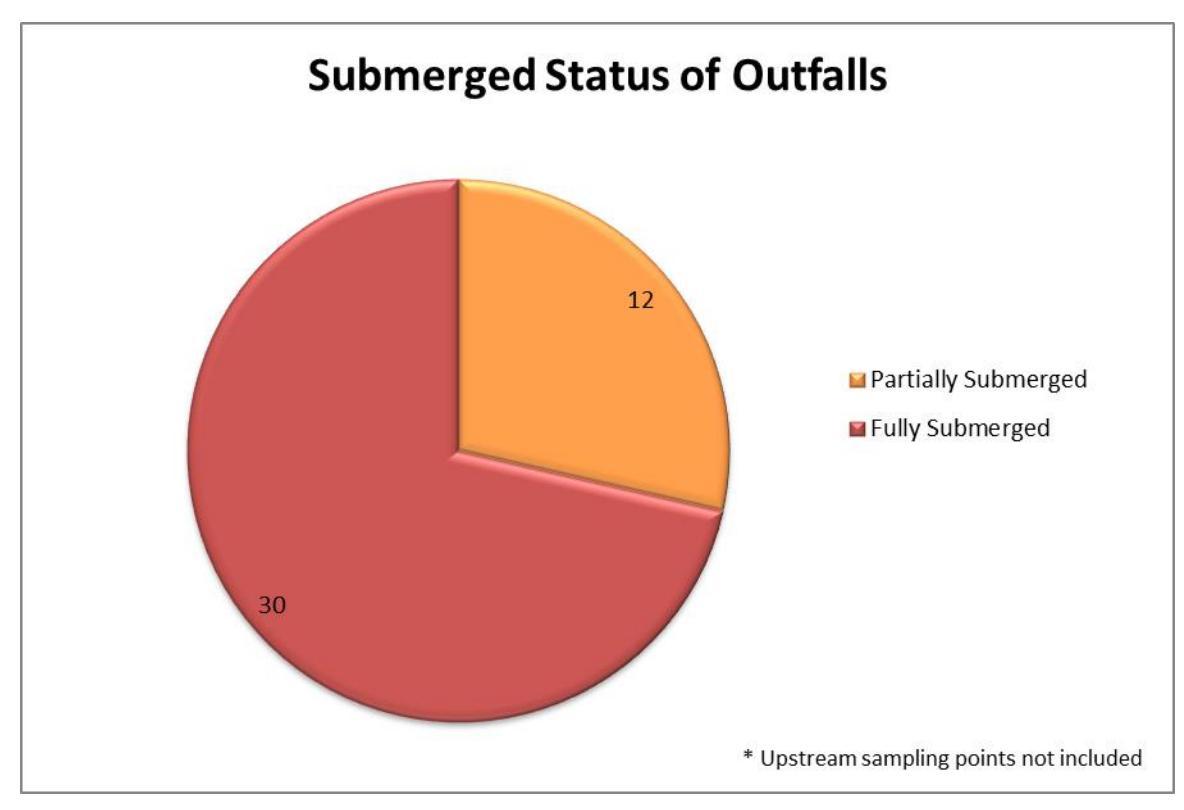
Figure 5 – Submerged status of outfalls

Most of the outfalls in the City were located at or below the normal levels of their respective receiving waters. Of the 42 inspected outfalls, 12 were partially submerged, and 30 were fully submerged (Figure 5). Of the 30 fully submerged outfalls, 24 could not be physically located.

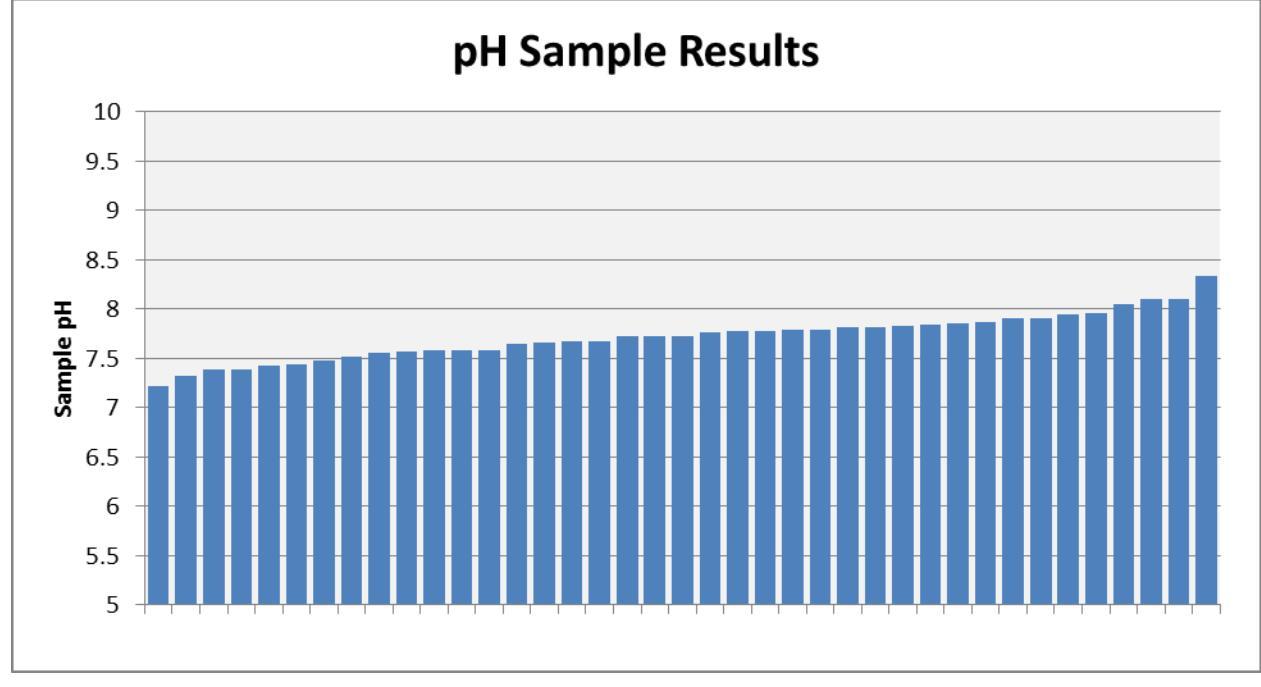
Figure 7 – pH sample results

The pH values ranged from 7.22 to 8.34. None of the samples were outside of the standard 6.0 to 9.0 pH range, so none of the samples were considered suspect due to pH.

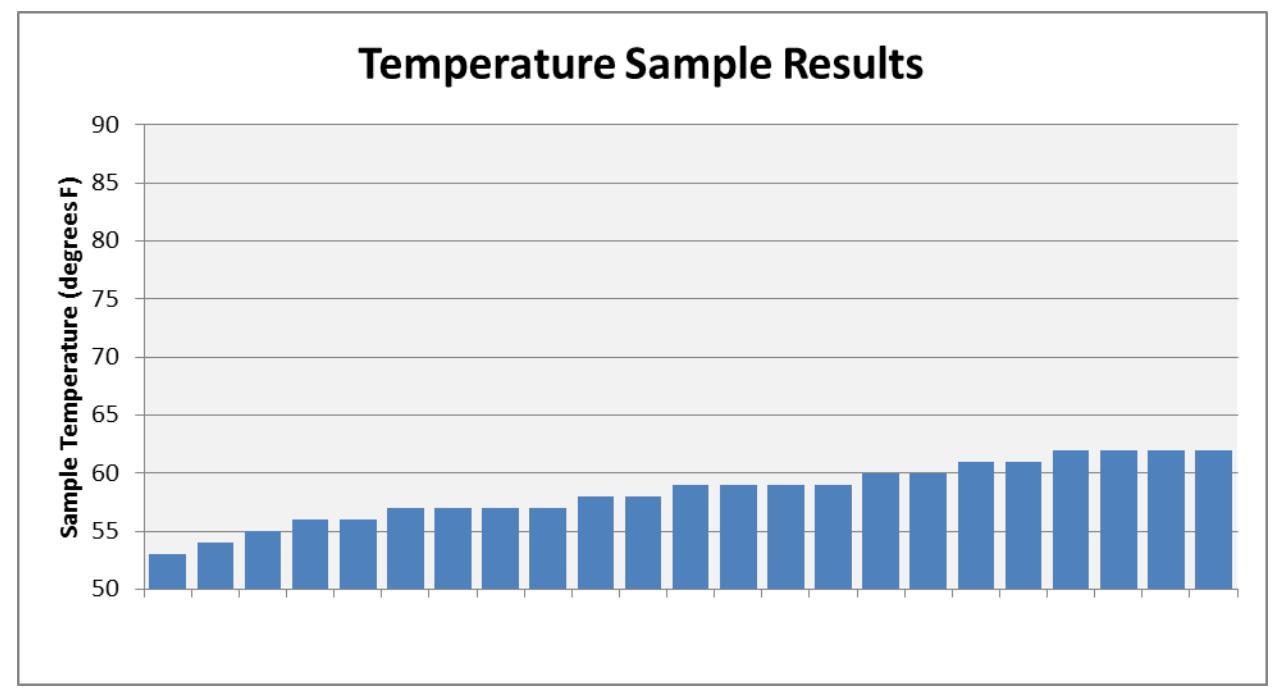
Figure 8 – Temperature sample results

The temperature values ranged from 53 to 62 °F. The samples with the highest temperatures were collected from locations that could be influenced by solar heating, so the upper values were not considered suspect. Due to a malfunction of the field testing equipment, 16 samples could not be analyzed for temperature. None of the samples exhibited abnormal temperatures, so none of the samples were considered suspect due to temperature.

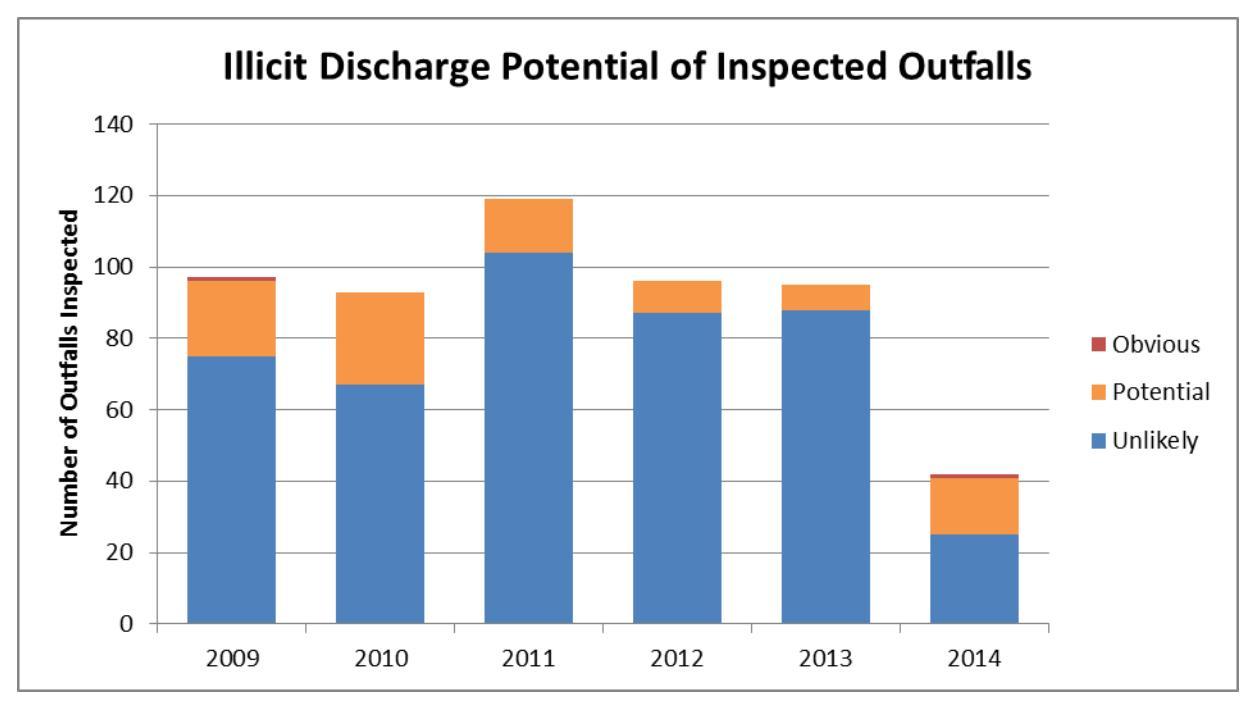
Figure 13 – Illicit discharge potential of inspected outfalls

A chart showing the number of outfalls inspected over the past five years (starting with the initial screening in 2009) and the number of potential or obvious illicit discharges is shown in Figure 13.

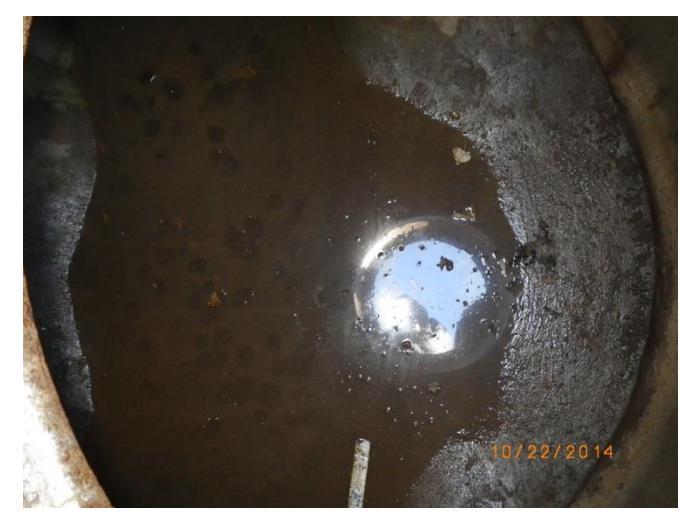
There appears to be an ongoing intermittent discharge of petroleum from a source on E. 10th Street. OMNNI recommends that the City televise the storm sewer branches along this segment to identify any potential cross connections. It may also be necessary for City inspectors to inspect the areas where the storm sewer crosses private property to check for potential sources of industrial runoff that may enter the storm sewer system.

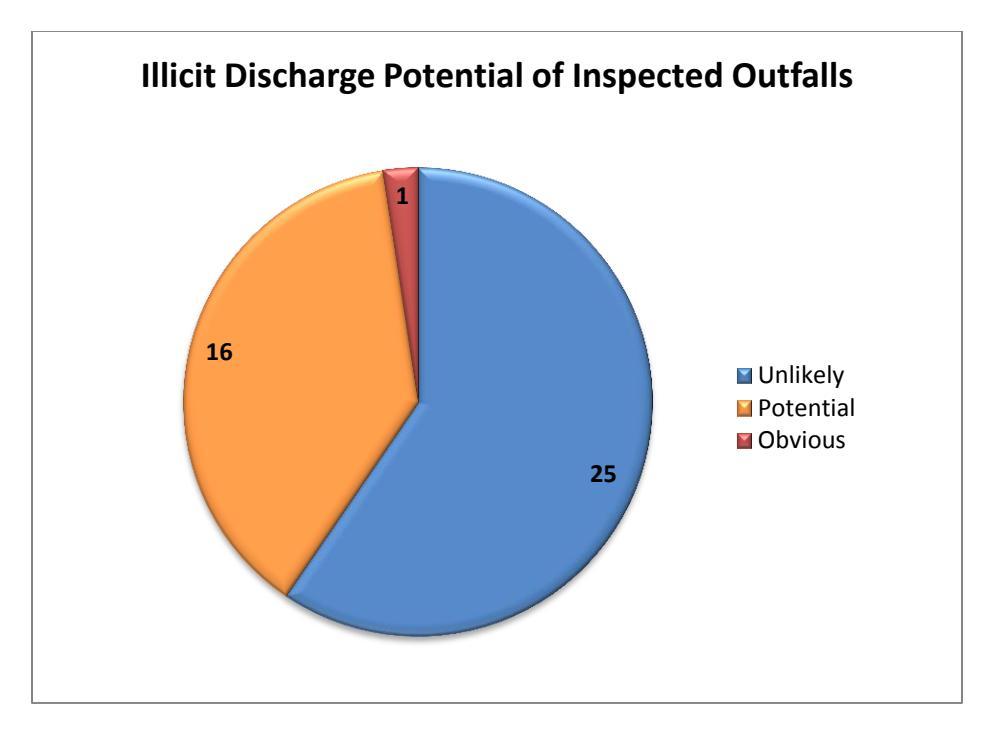
Figure 47 – Illicit discharge potential

OMNNI assisted the City of Oshkosh with the 2014 ongoing screening of the MS4 outfalls, as required by the MS4 permit. A total of 42 outfalls were screened, along with upstream monitoring locations when necessary. Of those 42 outfalls, 25 exhibited unlikely potential of past illicit discharges, 16 were classified as "potential," and one was classified as "obvious." These results are summarized in Figure 47:

Those outfalls classified as "potential" or "obvious" should be given special attention in the ongoing screening program.
