# Ongoing Screening Summary Report 2016 Inspection Year

Illicit Discharge Detection and Elimination Program

City of Oshkosh

November 30, 2016

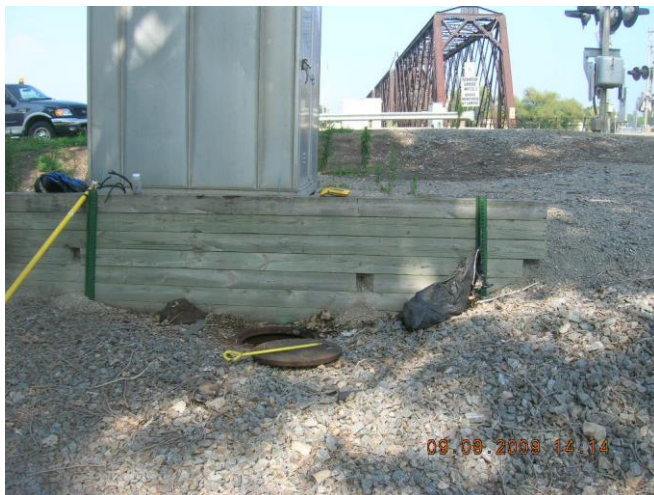
**Figure 13 – Upstream manhole 03-81 US1 (2009)**

The outfall was first screened in 2009. The first upstream manhole was located on the south side of Pioneer Drive, behind the railroad control shed. When the manhole was opened, a strong smell of diesel fuel was detected inside the manhole. The manhole was also submerged, and had a significant amount of floatable debris, which appeared to be coated with oil and grease.

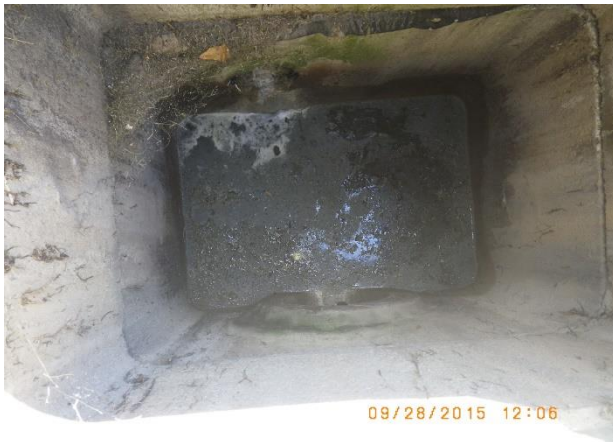
**Figure 18 – Pipe discharging into inlet 582A (9/28/2015)**

The Illicit Discharge Coordinator was notified of this pipe on September 28, 2015, and OMNNI and City personnel met with a representative of Carew Concrete on September 29, 2015 to attempt to identify the source of the discharge. No upstream inlets or catchbasins were located on the property. City personnel inserted a temporary plug in the end of the pipe to stop the discharge.

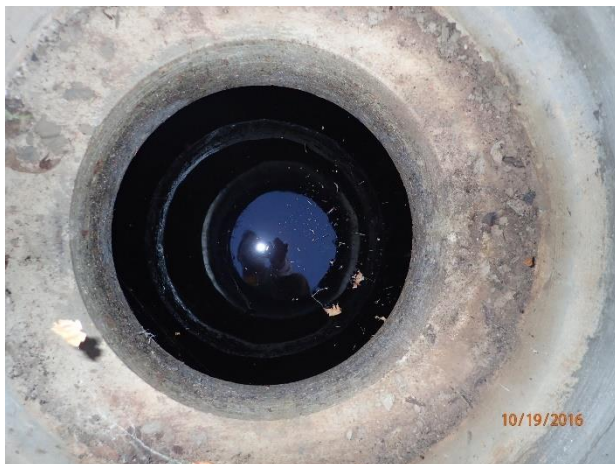
**Figure 22 – Minor deposition in manhole 11-1097 US1**

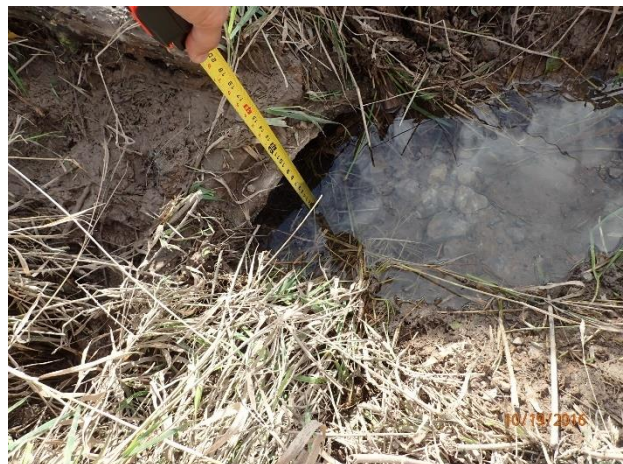
**Figure 23 – Severe deposition at outfall 13-1098**

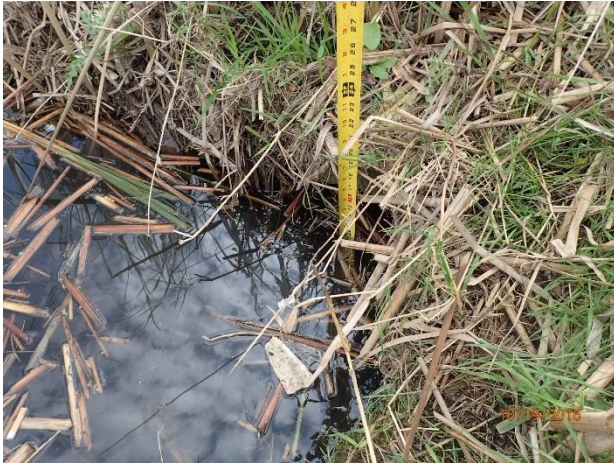
**Figure 24 – Moderate deposition at outfall 13-1758**

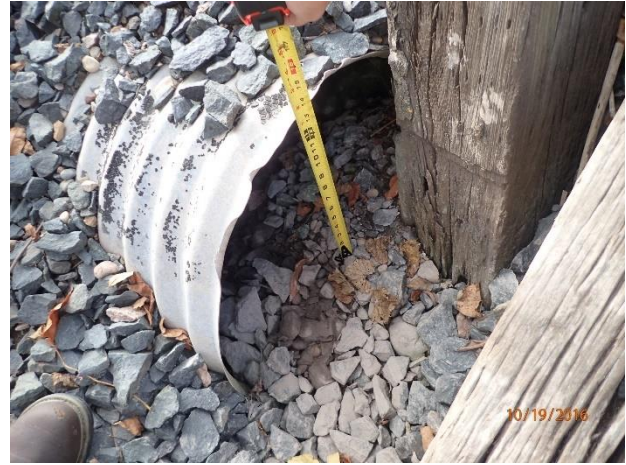
**Figure 25 – Moderate deposition in outfall 14-1514**

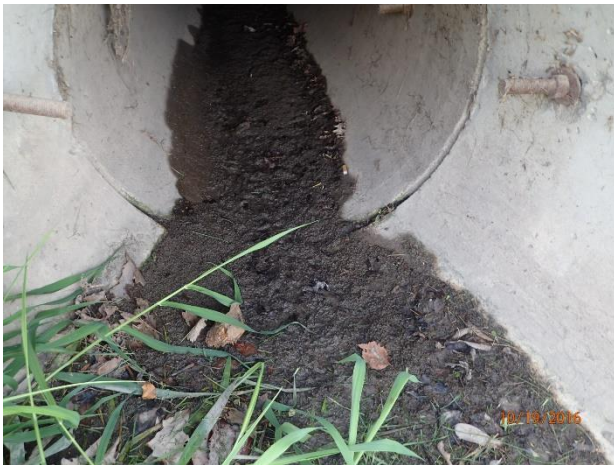
**Figure 26 – Minor deposition at outfall 15-2409**

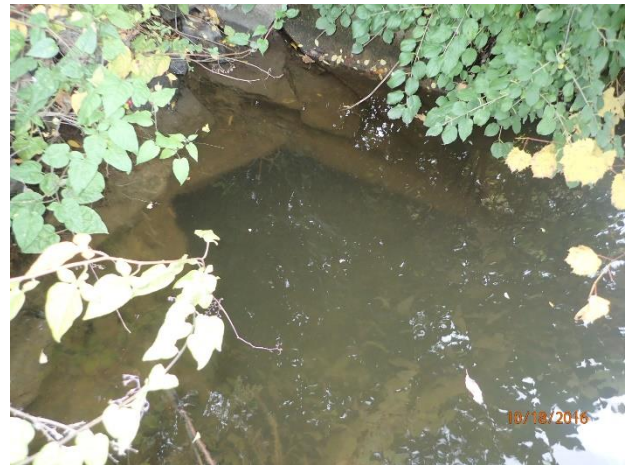
**Figure 27 – Moderate deposition at outfall 16-381**

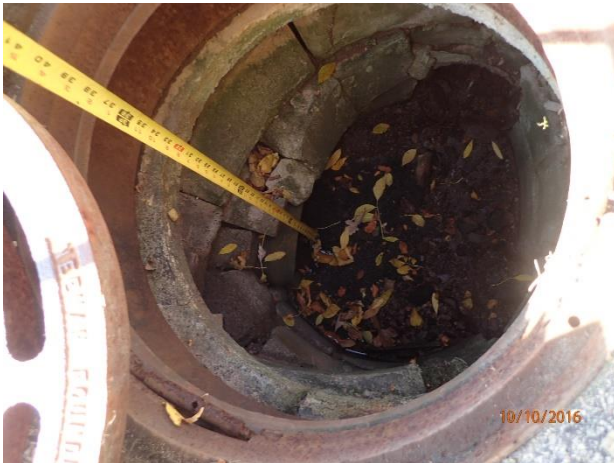
**Figure 28 – Minor deposition at catchbasin 16-47 US2**

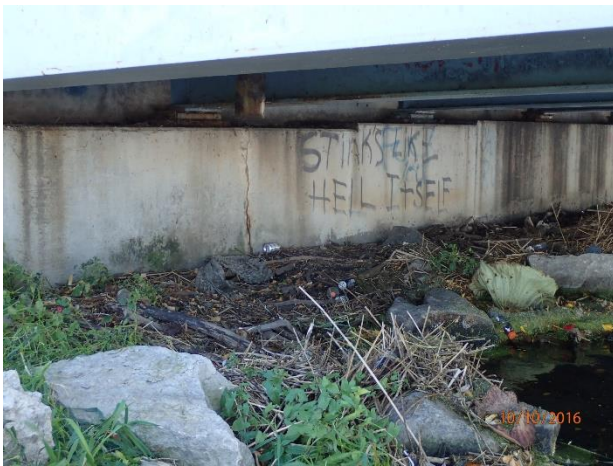
**Figure 29 – Graffiti near outfall 12-569**

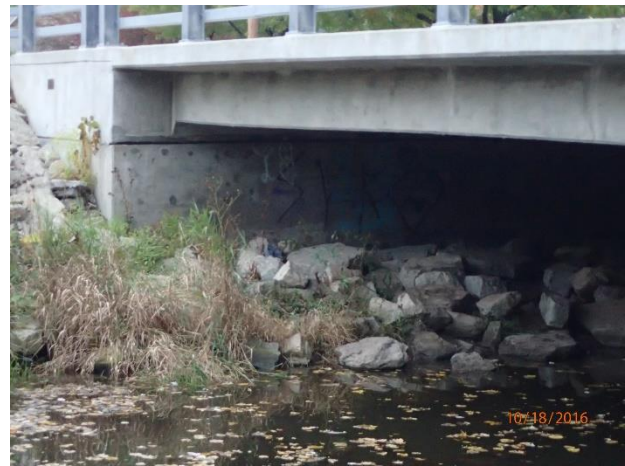
**Figure 30 – Graffiti near outfall 16-1508**

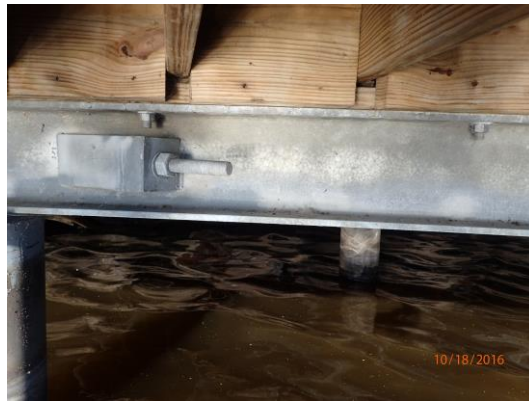
o20161018155156.JPG

Storm sewer from Commerce St discharges to river from north. Outfall fully submerged and not physically located. GPS coordinates approximate. Pipe info from MS4 map.

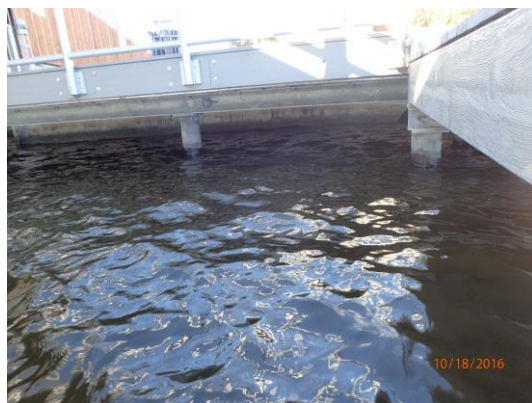
o20161018152726.JPG

Division St storm sewer discharges to river from north. Dock constructed over outfall since 2010 - outfall no longer visible.

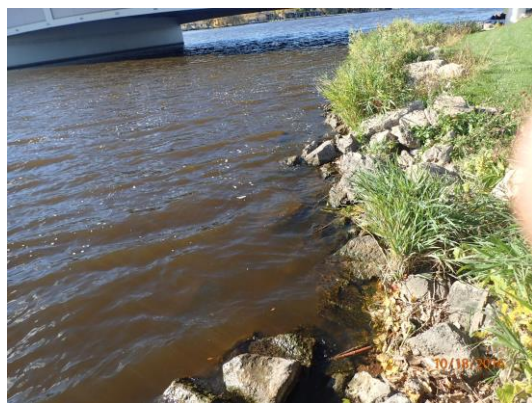
o20161018151650.JPG

Storm sewer from Wisconsin St discharges to river from north. Outfall fully submerged and not physically located. GPS coordinates approximate. Pipe info from MS4 map.

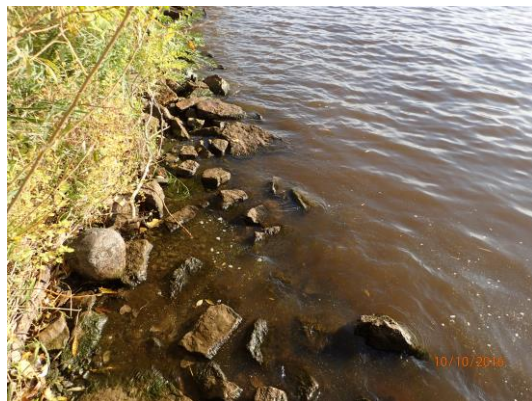
o20161010160642.JPG

Storm sewer from High Ave discharges to river from east. Outfall fully submerged and not physically located. GPS coordinates approximate. Pipe info from MS4 map.

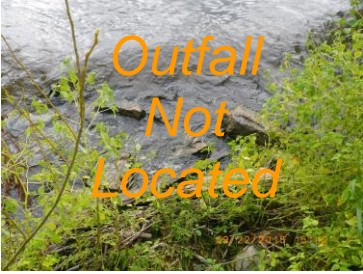
<p>o20150922141210.JPG</p>	
Submerged: Fully		Depth (in):		Outfall fully submerged and not located - screened upstream at 01-318 US1.			
<b>Sampling Results</b> Sample Location: Total Chlorine: -- ppm Free Chlorine: -- ppm Ammonia: -- ppm pH: -- units Temperature: -- °F Conductivity: -- µS/cm Detergents: -- mg/L		Floatables: None Odor: None Turbidity: None Color: None Gross Solids: None Vegetation: None Benthic Growth: None Stains: None Non-illicit: None		<b>Condition Assessment</b> Graffiti: None Erosion: None Damage: None Deposition: None 0 in.

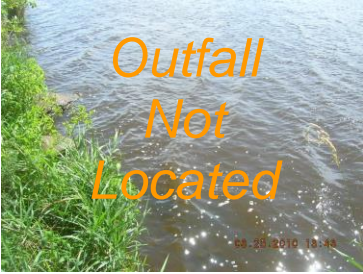
<p>o20100825134846.JPG</p>	
Submerged: Fully		Depth (in):		Outfall fully submerged and not physically located. Outfall screened upstream at 01-318 US1.			
<b>Sampling Results</b> Sample Location: Total Chlorine: -- ppm Free Chlorine: -- ppm Ammonia: -- ppm pH: -- units Temperature: -- °F Conductivity: -- µS/cm Detergents: -- mg/L		Floatables: None Odor: None Turbidity: None Color: None Gross Solids: None Vegetation: None Benthic Growth: None Stains: None Non-illicit: None		<b>Condition Assessment</b> Graffiti: None Erosion: None Damage: None Deposition: None 0 in.

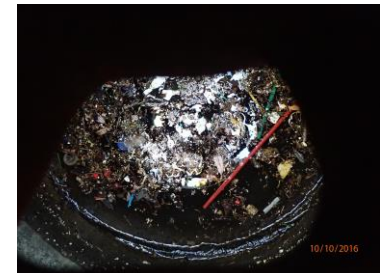
o20161010160844.JPG

<b>Notes</b> Floating gross solids (litter) in manhole.																																				
		<b>Condition Assessment</b> <table border="1" style="width:100%; border-collapse: collapse;"> <tr> <td>Graffiti:</td> <td>None</td> </tr> <tr> <td>Erosion:</td> <td>None</td> </tr> <tr> <td>Damage:</td> <td>None</td> </tr> <tr> <td>Deposition:</td> <td>None in.</td> </tr> </table>			Graffiti:	None	Erosion:	None	Damage:	None	Deposition:	None in.																										
Graffiti:	None																																					
Erosion:	None																																					
Damage:	None																																					
Deposition:	None in.

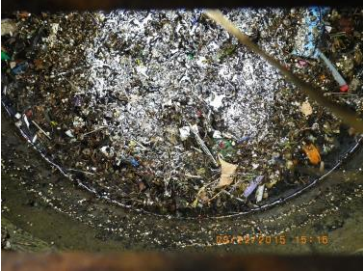
o20150922141626.JPG

<b>Notes</b>																																				
		<b>Condition Assessment</b> <table border="1" style="width:100%; border-collapse: collapse;"> <tr> <td>Graffiti:</td> <td>None</td> </tr> <tr> <td>Erosion:</td> <td>None</td> </tr> <tr> <td>Damage:</td> <td>None</td> </tr> <tr> <td>Deposition:</td> <td>Moderate 4 in.</td> </tr> </table>			Graffiti:	None	Erosion:	None	Damage:	None	Deposition:	Moderate 4 in.																										
Graffiti:	None																																					
Erosion:	None																																					
Damage:	None																																					
Deposition:	Moderate 4 in.

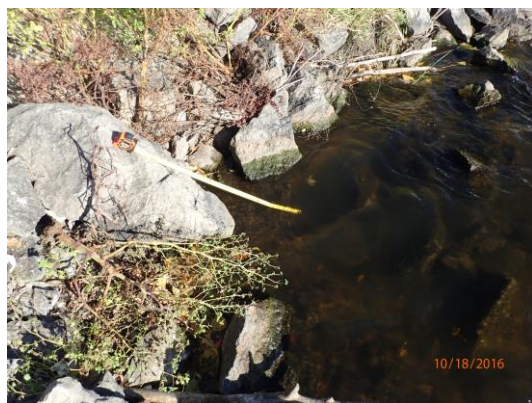
o20161018153648.JPG

Storm sewer from Jackson St discharges to river from north. Outfall fully submerged - pipe info from MS4 map. (OSH-9424 in early reports.)

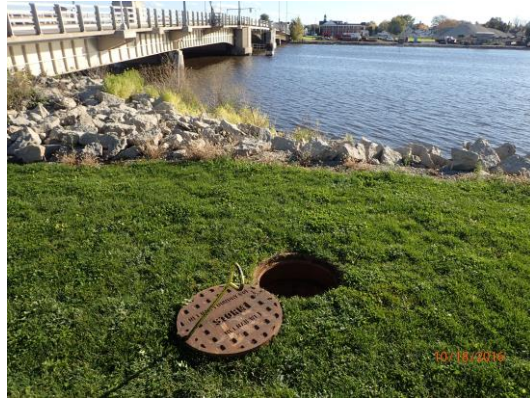
o20161018153902.JPG

Upstream manhole located approx 25 ft N of outfall 01-520. Intermediate area consists of rip-rap shoreline. (OSH-9424 US1 in early reports.)

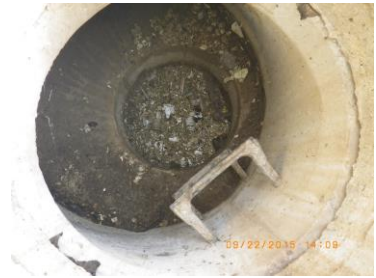
o20150922130946.JPG

<b>Inspection Date:</b> 9/22/2015 2:08:37 PM		<b>Type:</b> Ongoing	<b>Flow:</b> Submerged, indeterminate	<b>Previous Rainfall (hrs):</b> 72+
<b>Illicit Discharge Potential:</b> Potential		<b>Inspector:</b> JCW		
Submerged: Fully		Depth (in): 70		
<b>Sampling Results</b>		<b>Notes</b> Floating gross solids (litter) in manhole.		
Sample Location: Pool	Floatables: None	<b>Condition Assessment</b> Graffiti: None Erosion: None Damage: None Deposition: None in.		
Total Chlorine: 0 ppm	Odor: None			
Free Chlorine: 0 ppm	Turbidity: None			
Ammonia: 0 ppm	Color: None			
pH: 8.1 units	Gross Solids: Severe			
Temperature 76 °F	Vegetation: None			
Conductivity: 917 µS/cm	Benthic Growth: None			
Detergents: 0 mg/L	Stains: None			
	Non-illicit: None

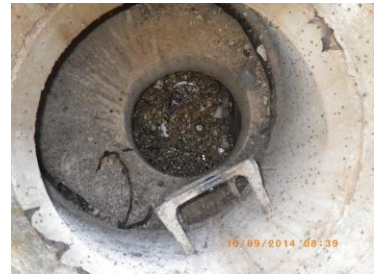
o20141009073910.JPG

<b>Inspection Date:</b> 10/9/2014 8:42:09 AM		<b>Type:</b> Ongoing	<b>Flow:</b> Submerged, indeterminate	<b>Previous Rainfall (hrs):</b> 72+
<b>Illicit Discharge Potential:</b> Potential		<b>Inspector:</b> JCW		
Submerged: Fully		Depth (in): 64		
<b>Sampling Results</b>		<b>Notes</b> Floating gross solids (litter) inside manhole.		
Sample Location: Pool	Floatables: None	<b>Condition Assessment</b> Graffiti: None Erosion: None Damage: None Deposition: None in.		
Total Chlorine: 0 ppm	Odor: Faint			
Free Chlorine: 0 ppm	Turbidity: None			
Ammonia: 0 ppm	Color: None			
pH: 7.84 units	Gross Solids: Severe			
Temperature 57 °F	Vegetation: None			
Conductivity: 1318 µS/cm	Benthic Growth: Slight			
Detergents: 0 mg/L	Stains: None			
	Non-illicit: None

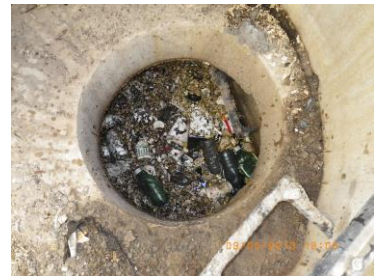
o20130905120924.JPG

<b>Inspection Date:</b> 9/5/2013 1:02:45 PM		<b>Type:</b> Ongoing	<b>Flow:</b> Submerged, indeterminate	<b>Previous Rainfall (hrs):</b> 72+
<b>Illicit Discharge Potential:</b> Potential		<b>Inspector:</b> JCW		
Submerged: Fully		Depth (in): 69		
<b>Sampling Results</b>		<b>Notes</b> 2012 screening follow-up. Significant gross solids in manhole - similar to previous years.		
Sample Location: Pool	Floatables: None	<b>Condition Assessment</b> Graffiti: None Erosion: None Damage: None Deposition: None in.		
Total Chlorine: 0 ppm	Odor: None			
Free Chlorine: 0 ppm	Turbidity: None			
Ammonia: 0 ppm	Color: None			
pH: 8.51 units	Gross Solids: Severe			
Temperature 76 °F	Vegetation: None			
Conductivity: 424 µS/cm	Benthic Growth: None			
Detergents: 0 mg/L	Stains: None			
	Non-illicit: None

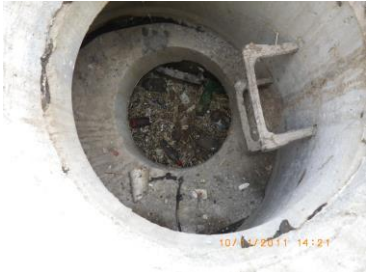
o20111011142110.JPG

<b>Inspection Date:</b> 10/11/2011 2:24:37 PM		<b>Type:</b> Ongoing	<b>Flow:</b> Submerged, indeterminate	<b>Previous Rainfall (hrs):</b> 72+
<b>Illicit Discharge Potential:</b> Potential		<b>Inspector:</b> JCW	<b>Notes</b>	
Submerged: Fully		Depth (in): 64	2010 screening follow-up. Floatable debris still present.	
<b>Sampling Results</b>		<b>Condition Assessment</b>		
Sample Location: Pool	Floatables:	Gross Solids: Severe		
Total Chlorine: 0 ppm	Odor:	Vegetation: None		
Free Chlorine: 0 ppm	Turbidity:	Benthic Growth: None		
Ammonia: 0 ppm	Color:	Stains: None		
pH: 8.49 units	Gross Solids:	Non-illicit: None		
Temperature 71 °F	Vegetation:	Deposition: None 0 in.		
Conductivity: -- µS/cm	Benthic Growth:			
Detergents: -- mg/L	Stains:			
	Non-illicit:

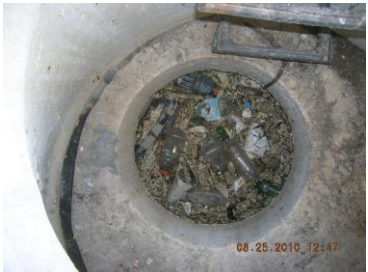
o20100825124708.JPG

<b>Inspection Date:</b> 8/25/2010 12:53:35 PM		<b>Type:</b> Ongoing	<b>Flow:</b> Submerged, indeterminate	<b>Previous Rainfall (hrs):</b> 72+
<b>Illicit Discharge Potential:</b> Potential		<b>Inspector:</b> JCW	<b>Notes</b>	
Submerged: Fully		Depth (in): 72	Significant floatable debris in manhole.	
<b>Sampling Results</b>		<b>Condition Assessment</b>		
Sample Location: Pool	Floatables:	Gross Solids: Severe		
Total Chlorine: 0 ppm	Odor:	Vegetation: None		
Free Chlorine: 0 ppm	Turbidity:	Benthic Growth: None		
Ammonia: 0 ppm	Color:	Stains: None		
pH: 8.18 units	Gross Solids:	Non-illicit: None		
Temperature 73 °F	Vegetation:	Deposition: None 0 in.		
Conductivity: -- µS/cm	Benthic Growth:			
Detergents: 0 mg/L	Stains:			
	Non-illicit:

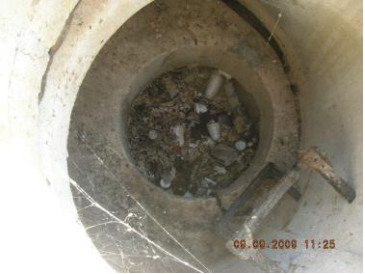
Osh09\_DSCN6718.JPG

<b>Inspection Date:</b> 9/9/2009		<b>Type:</b> Initial		<b>Flow:</b> Submerged, indeterminate		<b>Previous Rainfall (hrs):</b> 72+	
<b>Illicit Discharge Potential:</b> Potential		Inspector: JCW		<b>Notes</b> Abnormal detergent analysis result (bubbles). Significant floatables in manhole. Brown color.

Submerged: Fully		Depth (in): 61					
<b>Sampling Results</b>				<b>Condition Assessment</b>			
Sample Location: Pool		Floatables: None		Graffiti: None			
Total Chlorine: 0 ppm		Odor: None		Erosion: None			
Free Chlorine: 0 ppm		Turbidity: None		Damage: None			
Ammonia: -- ppm		Color: Clearly visible in bottl		Deposition: None		0 in.	
pH: 8.6 units		Gross Solids: Severe					
Temperature 78 °F		Vegetation: None					
Conductivity: -- µS/cm		Benthic Growth: None					
Detergents: 0 mg/L		Stains: None					
		Non-illicit: None

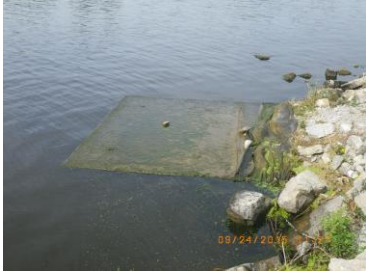
<b>Inspection Date:</b> 9/24/2015 11:22:55 AM		<b>Type:</b> Ongoing		<b>Flow:</b> Submerged, indeterminate		<b>Previous Rainfall (hrs):</b> 72+	
<b>Illicit Discharge Potential:</b> Potential		<b>Inspector:</b> JCW		<b>Notes</b> Outfall fully submerged - screened at 01-642 US1.

o20150924102710.JPG	
Submerged: Fully		Depth (in):					
<b>Sampling Results</b>		Floatables: None Odor: None Turbidity: None Color: None Gross Solids: None Vegetation: None Benthic Growth: None Stains: None Non-illicit: None		<b>Condition Assessment</b> Graffiti: None Erosion: None Damage: None Deposition: None in.			
Sample Location: Total Chlorine: -- ppm Free Chlorine: -- ppm Ammonia: -- ppm pH: -- units Temperature: -- °F Conductivity: -- µS/cm Detergents: -- mg/L

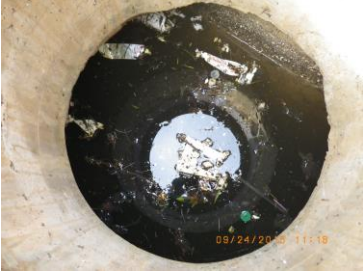
<p>o20150924101848.JPG</p>	
Submerged: Fully		Depth (in): 66		Floating gross solids (litter) in manhole.			
<b>Sampling Results</b>				<b>Condition Assessment</b>			
Sample Location: Pool		Floatables: None		Graffiti: None			
Total Chlorine: 0 ppm		Odor: None		Erosion: None			
Free Chlorine: 0 ppm		Turbidity: None		Damage: None			
Ammonia: 0 ppm		Color: None		Deposition: None in.			
pH: 7.61 units		Gross Solids: Moderate					
Temperature 71 °F		Vegetation: None					
Conductivity: 481 µS/cm		Benthic Growth: None					
Detergents: 0 mg/L		Stains: None					
		Non-illicit: Slight

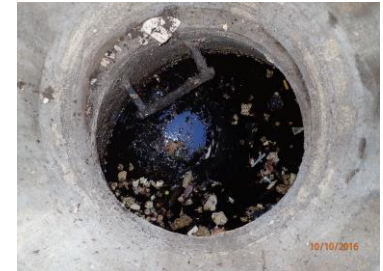
o20161010105436.JPG

Gross Solids: Moderate ☒ Litter ☐ Debris ☐ Sediment ☐ OtherVegetation: None ☐ Inhibited ☐ ExcessiveBenthic Growth: None ☐ Green ☐ BrownStains: None ☐ Flow Line ☐ Oil ☐ Rust Stains☐ Paint ☐ OtherNon-illicit: None ☐ Natural Sheen ☐ Natural Suds/Foam

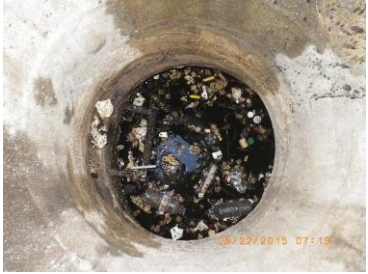
<p style="text-align: right; font-size: small;">o20150922061944.JPG</p>

<div style="display: flex; justify-content: space-between;"> <div> <p><b>Notes</b></p> <p>Floating gross solids (litter) in manhole.</p> </div> <div> <p><b>Condition Assessment</b></p> <p><b>Graffiti:</b> None</p> <p><b>Erosion:</b> None</p> <p><b>Damage:</b> None</p> <p><b>Deposition:</b> None in.</p> </div> </div>

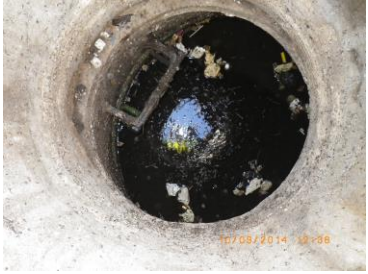
<p style="text-align: right; font-size: small;">o20141009113842.JPG</p>

<div style="display: flex; justify-content: space-between;"> <div> <p><b>Notes</b></p> <p>Floating gross solids (litter) in manhole.</p> </div> <div> <p><b>Condition Assessment</b></p> <p><b>Graffiti:</b> None</p> <p><b>Erosion:</b> None</p> <p><b>Damage:</b> None</p> <p><b>Deposition:</b> None in.</p> </div> </div>

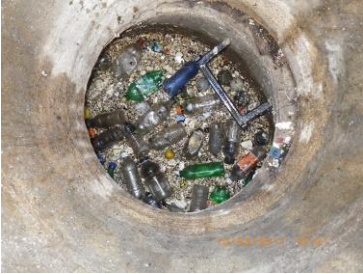
o20111003103104.JPG

Floatables:	None	Odor:	None	Turbidity:	None	Color:	None	Gross Solids:	Severe	Vegetation:	None	Benthic Growth:	None	Stains:	None	Non-illicit:	None
Floatables:	None																					
Odor:	None																					
Turbidity:	None																					
Color:	None																					
Gross Solids:	Severe																					
Vegetation:	None																					
Benthic Growth:	None																					
Stains:	None																					
Non-illicit:	None																					
		<b>Notes</b> Significant floatable debris in manhole.																				
		<b>Condition Assessment</b> Graffiti: None Erosion: None Damage: None Deposition: None 0 in.

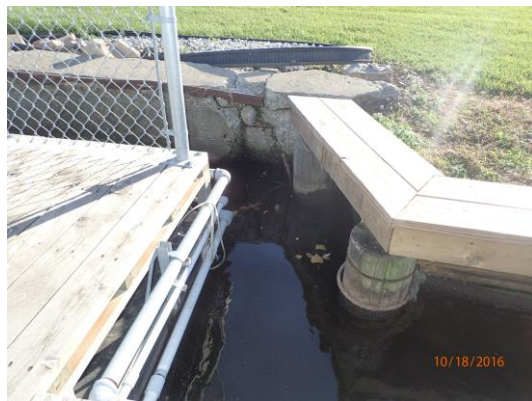
o20161018160256.JPG

Storm sewer from Nebraska St discharges to river from south. Outfall not located - pipe info from MS4 map.

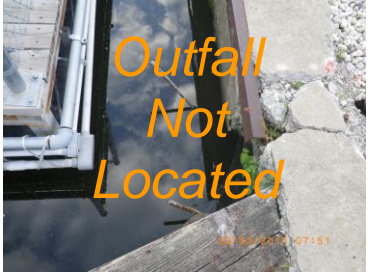
o20150923065132.JPG

<b>Inspection Date:</b> 9/23/2015 7:47:01 AM		<b>Type:</b> Ongoing	<b>Flow:</b> Submerged (not located)	<b>Previous Rainfall (hrs):</b> 72+
<b>Illicit Discharge Potential:</b> Potential		<b>Inspector:</b> JCW		
Submerged: Fully		Depth (in):		
<b>Sampling Results</b> Sample Location: Total Chlorine: -- ppm Free Chlorine: -- ppm Ammonia: -- ppm pH: -- units Temperature: -- °F Conductivity: -- µS/cm Detergents: -- mg/L		Floatables: None Odor: None Turbidity: None Color: None Gross Solids: None Vegetation: None Benthic Growth: None Stains: None Non-illicit: None	<b>Notes</b> Significant sinking above suspected pipe. Outfall not located - screened at 03-22 US1.  <b>Condition Assessment</b> Graffiti: None Erosion: None Damage: Severe Deposition: None in.

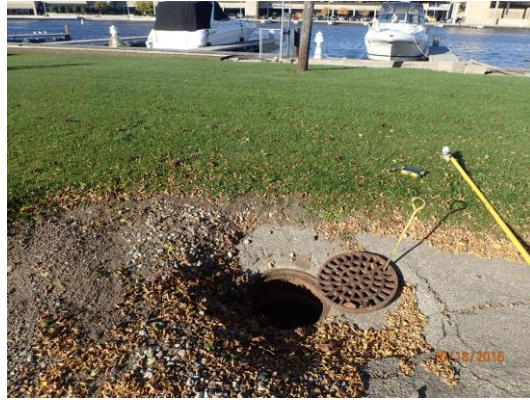
o20161018160424.JPG

Upstream catchbasin located approx 55 ft S of outfall 03-22. Intermediate area consists of open space.

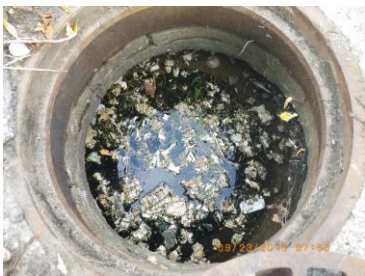
o20150923065324.JPG																									
Submerged: Fully		Depth (in): 46		Floating gross solids (litter) in manhole.																											
<b>Sampling Results</b>		<table border="1"> <tr><td>Floatables:</td><td>None</td></tr> <tr><td>Odor:</td><td>None</td></tr> <tr><td>Turbidity:</td><td>None</td></tr> <tr><td>Color:</td><td>None</td></tr> <tr><td>Gross Solids:</td><td>Moderate</td></tr> <tr><td>Vegetation:</td><td>None</td></tr> <tr><td>Benthic Growth:</td><td>None</td></tr> <tr><td>Stains:</td><td>None</td></tr> <tr><td>Non-illicit:</td><td>None</td></tr> </table>		Floatables:	None	Odor:	None	Turbidity:	None	Color:	None	Gross Solids:	Moderate	Vegetation:	None	Benthic Growth:	None	Stains:	None	Non-illicit:	None	<b>Condition Assessment</b>

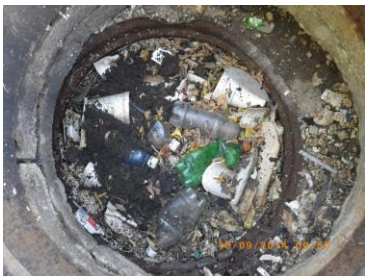
o20141009085040.JPG																									
Submerged: Fully		Depth (in): 40		Floatable litter in catchbasin.																											
<b>Sampling Results</b>		<table border="1"> <tr><td>Floatables:</td><td>None</td></tr> <tr><td>Odor:</td><td>None</td></tr> <tr><td>Turbidity:</td><td>None</td></tr> <tr><td>Color:</td><td>Faint in bottle</td></tr> <tr><td>Gross Solids:</td><td>Severe</td></tr> <tr><td>Vegetation:</td><td>None</td></tr> <tr><td>Benthic Growth:</td><td>None</td></tr> <tr><td>Stains:</td><td>None</td></tr> <tr><td>Non-illicit:</td><td>None</td></tr> </table>		Floatables:	None	Odor:	None	Turbidity:	None	Color:	Faint in bottle	Gross Solids:	Severe	Vegetation:	None	Benthic Growth:	None	Stains:	None	Non-illicit:	None	<b>Condition Assessment</b>

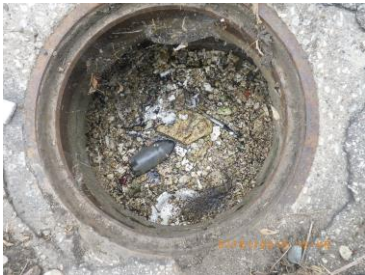
o20130731114610.JPG																									
Submerged: Fully		Depth (in): 44		2012 screening follow-up. Significant gross solids - similar to previous years.																											
<b>Sampling Results</b>		<table border="1"> <tr><td>Floatables:</td><td>None</td></tr> <tr><td>Odor:</td><td>Faint</td></tr> <tr><td>Turbidity:</td><td>None</td></tr> <tr><td>Color:</td><td>Faint in bottle</td></tr> <tr><td>Gross Solids:</td><td>Severe</td></tr> <tr><td>Vegetation:</td><td>None</td></tr> <tr><td>Benthic Growth:</td><td>None</td></tr> <tr><td>Stains:</td><td>None</td></tr> <tr><td>Non-illicit:</td><td>None</td></tr> </table>		Floatables:	None	Odor:	Faint	Turbidity:	None	Color:	Faint in bottle	Gross Solids:	Severe	Vegetation:	None	Benthic Growth:	None	Stains:	None	Non-illicit:	None	<b>Condition Assessment</b>

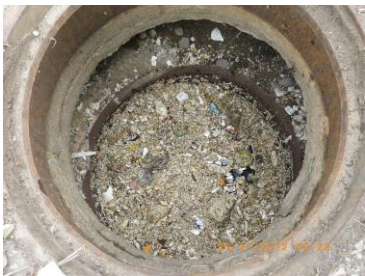
o20120927082922.JPG																									
Submerged: Fully		Depth (in): 39		2011 gross solids follow-up.																											
<b>Sampling Results</b>		<table border="1"> <tr><td>Floatables:</td><td>None</td></tr> <tr><td>Odor:</td><td>None</td></tr> <tr><td>Turbidity:</td><td>None</td></tr> <tr><td>Color:</td><td>None</td></tr> <tr><td>Gross Solids:</td><td>Severe</td></tr> <tr><td>Vegetation:</td><td>None</td></tr> <tr><td>Benthic Growth:</td><td>None</td></tr> <tr><td>Stains:</td><td>None</td></tr> <tr><td>Non-illicit:</td><td>None</td></tr> </table>		Floatables:	None	Odor:	None	Turbidity:	None	Color:	None	Gross Solids:	Severe	Vegetation:	None	Benthic Growth:	None	Stains:	None	Non-illicit:	None	<b>Condition Assessment</b>

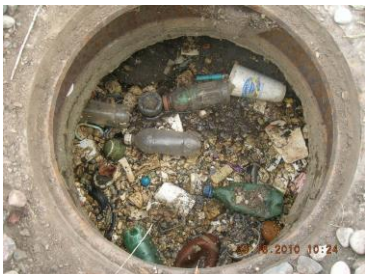
o20100818102410.JPG

<b>Inspection Date:</b> 8/18/2010 10:29:59 AM		<b>Type:</b> Ongoing	<b>Flow:</b> Submerged, indeterminate	<b>Previous Rainfall (hrs):</b> 72+
<b>Illicit Discharge Potential:</b> Potential		<b>Inspector:</b> JCW	<b>Notes</b>	
Submerged: Fully      Depth (in): 44			Severe floatable debris in catchbasin.	
<b>Sampling Results</b>			<b>Condition Assessment</b>	
Sample Location: Pool	Floatables:	None	Graffiti: None	
Total Chlorine: 0 ppm	Odor:	None	Erosion: None	
Free Chlorine: 0 ppm	Turbidity:	None	Damage: None	
Ammonia: 0 ppm	Color:	Faint in bottle	Deposition: None 0 in.	
pH: 7.38 units	Gross Solids:	Severe		
Temperature 76 °F	Vegetation:	None		
Conductivity: -- µS/cm	Benthic Growth:	None		
Detergents: 0 mg/L	Stains:	None		
	Non-illicit:	None

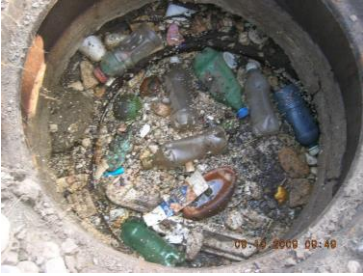
Osh09\_DSCN6768.JPG

<b>Inspection Date:</b> 9/10/2009		<b>Type:</b> Initial		<b>Flow:</b> Submerged, indeterminate		<b>Previous Rainfall (hrs):</b> 72+	
<b>Illicit Discharge Potential:</b> Potential		<b>Inspector:</b> JCW		<b>Notes</b> Abnormal detergent analysis result (bubbles). Significant floatables in manhole.

Submerged: Fully		Depth (in): 44					
<b>Sampling Results</b> Sample Location: Pool Total Chlorine: 0 ppm Free Chlorine: 0 ppm Ammonia: -- ppm pH: 8.3 units Temperature: 75 °F Conductivity: -- µS/cm Detergents: 0 mg/L		Floatables: None Odor: None Turbidity: None Color: None Gross Solids: Severe Vegetation: None Benthic Growth: None Stains: None Non-illicit: None		<b>Condition Assessment</b> Graffiti: None Erosion: None Damage: None Deposition: None		0 in.

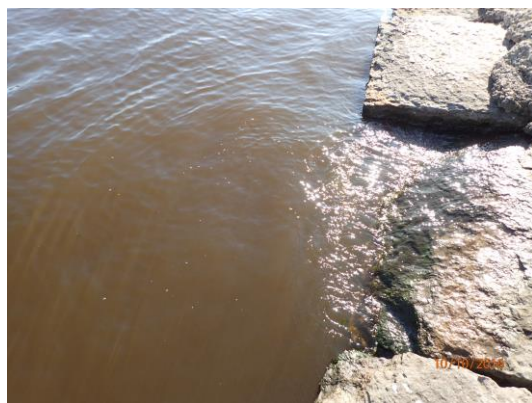
o20161010094928.JPG

Storm sewer from S Main St discharges to river from south. Outfall not located - pipe info from MS4 map.

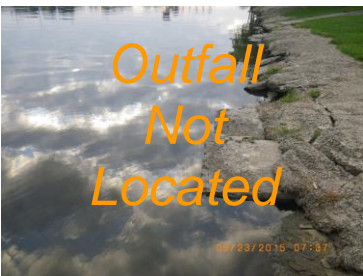
o20150923063720.JPG

<b>Inspection Date:</b> 9/23/2015 7:34:32 AM		<b>Type:</b> Ongoing	<b>Flow:</b> Submerged (not located)	<b>Previous Rainfall (hrs):</b> 72+
<b>Illicit Discharge Potential:</b> Potential		<b>Inspector:</b> JCW		
Submerged: Fully		Depth (in):		
<b>Sampling Results</b> Sample Location: Total Chlorine: -- ppm Free Chlorine: -- ppm Ammonia: -- ppm pH: -- units Temperature: -- °F Conductivity: -- µS/cm Detergents: -- mg/L		Floatables: None Odor: None Turbidity: None Color: None Gross Solids: None Vegetation: None Benthic Growth: None Stains: None Non-illicit: None		
		<b>Notes</b> Outfall fully submerged and not located - screened at 03-35 US1.		
		<b>Condition Assessment</b> Graffiti: None Erosion: None Damage: None Deposition: None in.

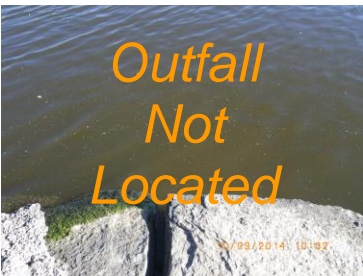
o20141009093222.JPG

<b>Inspection Date:</b> 10/9/2014 10:33:07 AM		<b>Type:</b> Ongoing	<b>Flow:</b> Submerged (not located)	<b>Previous Rainfall (hrs):</b> 72+
<b>Illicit Discharge Potential:</b> Unlikely		<b>Inspector:</b> JCW		
Submerged: Fully		Depth (in):		
<b>Sampling Results</b> Sample Location: Total Chlorine: -- ppm Free Chlorine: -- ppm Ammonia: -- ppm pH: -- units Temperature: -- °F Conductivity: -- µS/cm Detergents: -- mg/L		Floatables: None Odor: None Turbidity: None Color: None Gross Solids: None Vegetation: None Benthic Growth: None Stains: None Non-illicit: None		
		<b>Notes</b> Outfall fully submerged and not located - screened upstream at 03-35 US1		
		<b>Condition Assessment</b> Graffiti: None Erosion: None Damage: None Deposition: None in.

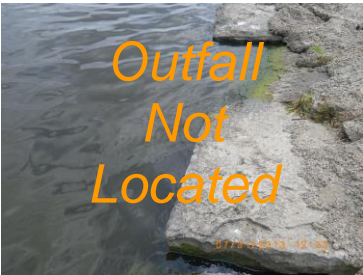
o20130731113304.JPG

<b>Inspection Date:</b> 7/31/2013 12:30:28 PM		<b>Type:</b> Ongoing	<b>Flow:</b> Submerged (not located)	<b>Previous Rainfall (hrs):</b> 72+
<b>Illicit Discharge Potential:</b> Potential		<b>Inspector:</b> JCW		
Submerged: Fully		Depth (in):		
<b>Sampling Results</b> Sample Location: Total Chlorine: -- ppm Free Chlorine: -- ppm Ammonia: -- ppm pH: -- units Temperature: -- °F Conductivity: -- µS/cm Detergents: -- mg/L		Floatables: None Odor: None Turbidity: None Color: None Gross Solids: None Vegetation: None Benthic Growth: None Stains: None Non-illicit: None		
		<b>Notes</b> 2012 screening follow-up. Outfall not located. Outfall screened upstream at 03-35 US1. Gross solids in upstream mh.		
		<b>Condition Assessment</b> Graffiti: None Erosion: None Damage: None Deposition: None in.

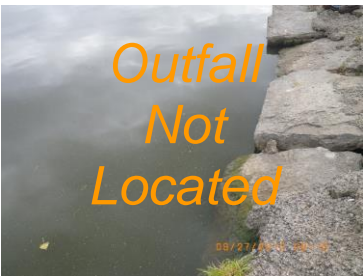
o20120927081506.JPG

<b>Inspection Date:</b> 9/27/2012 9:13:17 AM		<b>Type:</b> Ongoing	<b>Flow:</b> Submerged (not located)	<b>Previous Rainfall (hrs):</b> 72+
<b>Illicit Discharge Potential:</b> Potential		<b>Inspector:</b> JCW		
Submerged: Fully		Depth (in):		
<b>Sampling Results</b> Sample Location: Total Chlorine: -- ppm Free Chlorine: -- ppm Ammonia: -- ppm pH: -- units Temperature: -- °F Conductivity: -- µS/cm Detergents: -- mg/L		Floatables: None Odor: None Turbidity: None Color: None Gross Solids: None Vegetation: None Benthic Growth: None Stains: None Non-illicit: None		
		<b>Notes</b> Outfall fully submerged; screened upstream at 03-35 US1.		
		<b>Condition Assessment</b> Graffiti: None Erosion: None Damage: None Deposition: None in.

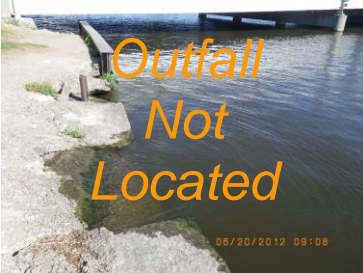
o20120620080844.JPG

<b>Inspection Date:</b> 6/20/2012 9:06:10 AM		<b>Type:</b> Other	<b>Flow:</b> Submerged (not located)	<b>Previous Rainfall (hrs):</b> 24-48
<b>Illicit Discharge Potential:</b> Potential		<b>Inspector:</b> JCW	<b>Notes</b>	
Submerged: Fully      Depth (in):			Gross solids pre-screening.	
<b>Sampling Results</b>			<b>Condition Assessment</b>	
Sample Location:	Floatables:	None	Graffiti: None	
Total Chlorine: -- ppm	Odor:	None	Erosion: None	
Free Chlorine: -- ppm	Turbidity:	None	Damage: None	
Ammonia: -- ppm	Color:	None	Deposition: None in.	
pH: -- units	Gross Solids:	None		
Temperature -- °F	Vegetation:	None		
Conductivity: -- µS/cm	Benthic Growth:	None		
Detergents: -- mg/L	Stains:	None		
	Non-illicit:	None

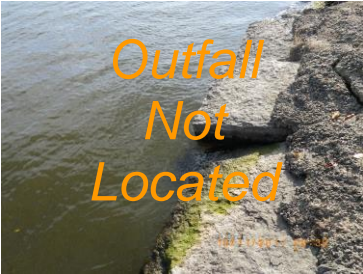
o20111011093254.JPG

<b>Inspection Date:</b> 10/11/2011 9:36:03 AM		<b>Type:</b> Ongoing	<b>Flow:</b> Submerged (not located)	<b>Previous Rainfall (hrs):</b> 72+
<b>Illicit Discharge Potential:</b> Potential		<b>Inspector:</b> JCW	<b>Notes</b>	
Submerged: Fully      Depth (in):			2010 screening follow-up. Outfall fully submerged and not physically located. Outfall screened upstream at 03-35 US1.	
<b>Sampling Results</b>			<b>Condition Assessment</b>	
Sample Location:	Floatables:	None	Graffiti: None	
Total Chlorine: -- ppm	Odor:	None	Erosion: None	
Free Chlorine: -- ppm	Turbidity:	None	Damage: None	
Ammonia: -- ppm	Color:	None	Deposition: None 0 in.	
pH: -- units	Gross Solids:	None		
Temperature -- °F	Vegetation:	None		
Conductivity: -- µS/cm	Benthic Growth:	None		
Detergents: -- mg/L	Stains:	None		
	Non-illicit:	None

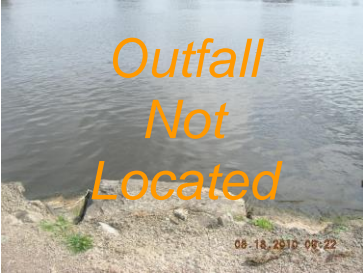
o20100818092204.JPG

<b>Inspection Date:</b> 8/18/2010 9:27:46 AM		<b>Type:</b> Ongoing	<b>Flow:</b> Submerged (not located)	<b>Previous Rainfall (hrs):</b> 72+
<b>Illicit Discharge Potential:</b> Potential		<b>Inspector:</b> JCW	<b>Notes</b>	
Submerged: Fully      Depth (in):			Outfall fully submerged and not physically located. Outfall screened upstream at 03-35 US1.	
<b>Sampling Results</b>			<b>Condition Assessment</b>	
Sample Location:	Floatables:	None	Graffiti: None	
Total Chlorine: -- ppm	Odor:	None	Erosion: None	
Free Chlorine: -- ppm	Turbidity:	None	Damage: None	
Ammonia: -- ppm	Color:	None	Deposition: None 0 in.	
pH: -- units	Gross Solids:	None		
Temperature -- °F	Vegetation:	None		
Conductivity: -- µS/cm	Benthic Growth:	None		
Detergents: -- mg/L	Stains:	None		
	Non-illicit:	None

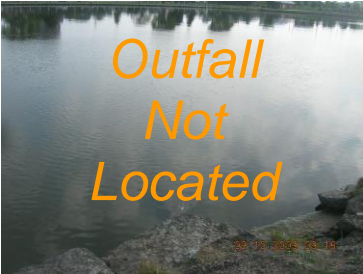
Osh09\_DSCN6761.JPG

<b>Inspection Date:</b> 9/10/2009		<b>Type:</b> Initial	<b>Flow:</b> Submerged (not located)	<b>Previous Rainfall (hrs):</b> 72+
<b>Illicit Discharge Potential:</b> Potential		<b>Inspector:</b> JCW	<b>Notes</b>	
Submerged: Fully      Depth (in):			Outfall fully submerged and not physically located. Outfall screened upstream at 03-35 US1.	
<b>Sampling Results</b>			<b>Condition Assessment</b>	
Sample Location:	Floatables:	None	Graffiti: None	
Total Chlorine: -- ppm	Odor:	None	Erosion: None	
Free Chlorine: -- ppm	Turbidity:	None	Damage: None	
Ammonia: -- ppm	Color:	None	Deposition: None 0 in.	
pH: -- units	Gross Solids:	None		
Temperature -- °F	Vegetation:	None		
Conductivity: -- µS/cm	Benthic Growth:	None		
Detergents: -- mg/L	Stains:	None		
	Non-illicit:	None

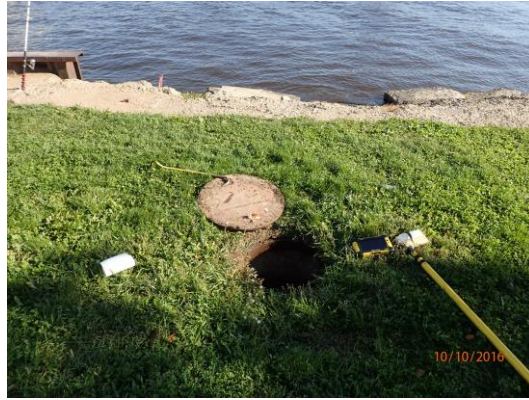
o20161010094952.JPG

Upstream manhole located approx 20 ft WSW of outfall 03-35. Intermediate area consists of open space.

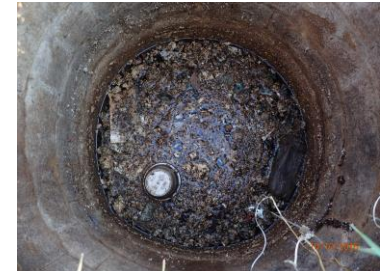
o20161010094958.JPG

Gross Solids: Moderate ☒ Litter ☐ Debris ☐ Sediment ☐ OtherVegetation: None ☐ Inhibited ☐ ExcessiveBenthic Growth: None ☐ Green ☐ BrownStains: None ☐ Flow Line ☐ Oil ☐ Rust Stains☐ Paint ☐ OtherNon-illicit: None ☐ Natural Sheen ☐ Natural Suds/Foam

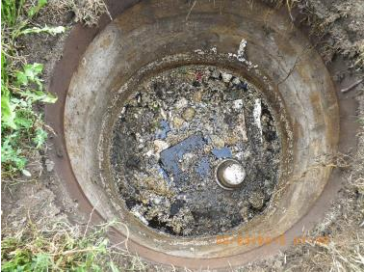
o20150923063950.JPG

<b>Inspection Date:</b> 9/23/2015 7:36:00 AM		<b>Type:</b> Ongoing	<b>Flow:</b> Submerged, indeterminate	<b>Previous Rainfall (hrs):</b> 72+
<b>Illicit Discharge Potential:</b> Potential		<b>Inspector:</b> JCW		
Submerged: Fully		Depth (in): 30		
<b>Sampling Results</b> Sample Location: Pool Total Chlorine: 0 ppm Free Chlorine: 0 ppm Ammonia: 0 ppm pH: 8.64 units Temperature: 69 °F Conductivity: 359 µS/cm Detergents: 0 mg/L		Floatables: None Odor: None Turbidity: None Color: Faint in bottle Gross Solids: Moderate Vegetation: None Benthic Growth: None Stains: None Non-illicit: None	<b>Notes</b> Floating gross solids (litter) in manhole.  <b>Condition Assessment</b> Graffiti: None Erosion: None Damage: None Deposition: Minor 1 in.

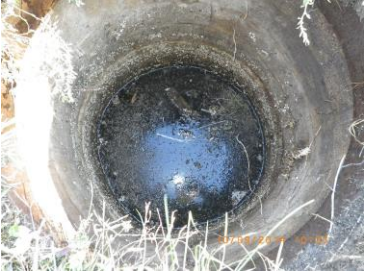
o20141009093356.JPG

<b>Inspection Date:</b> 10/9/2014 10:35:52 AM		<b>Type:</b> Ongoing	<b>Flow:</b> Submerged, indeterminate	<b>Previous Rainfall (hrs):</b> 72+
<b>Illicit Discharge Potential:</b> Unlikely		<b>Inspector:</b> JCW		
Submerged: Fully		Depth (in): 32		
<b>Sampling Results</b> Sample Location: Pool Total Chlorine: 0 ppm Free Chlorine: 0 ppm Ammonia: 0 ppm pH: 7.86 units Temperature: 58 °F Conductivity: 476 µS/cm Detergents: 0 mg/L		Floatables: None Odor: None Turbidity: None Color: Faint in bottle Gross Solids: Slight Vegetation: None Benthic Growth: None Stains: None Non-illicit: None	<b>Notes</b> Vegetative debris in photo from opening lid.  <b>Condition Assessment</b> Graffiti: None Erosion: None Damage: None Deposition: Minor 1 in.

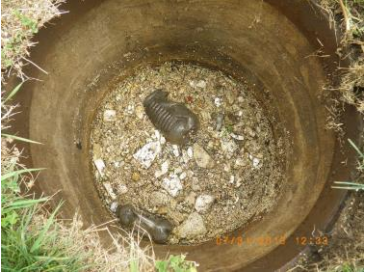
o20130731113346.JPG

<b>Inspection Date:</b> 7/31/2013 12:31:00 PM		<b>Type:</b> Ongoing	<b>Flow:</b> Submerged, indeterminate	<b>Previous Rainfall (hrs):</b> 72+
<b>Illicit Discharge Potential:</b> Potential		<b>Inspector:</b> JCW		
Submerged: Fully		Depth (in): 33		
<b>Sampling Results</b> Sample Location: Pool Total Chlorine: 0 ppm Free Chlorine: 0 ppm Ammonia: 0 ppm pH: 8.47 units Temperature: 75 °F Conductivity: 425 µS/cm Detergents: 0 mg/L		Floatables: None Odor: None Turbidity: None Color: Faint in bottle Gross Solids: Severe Vegetation: None Benthic Growth: None Stains: Moderate Non-illicit: None	<b>Notes</b> 2012 screening follow-up. Significant gross solids. Similar to previous years.  <b>Condition Assessment</b> Graffiti: None Erosion: None Damage: None Deposition: None in.

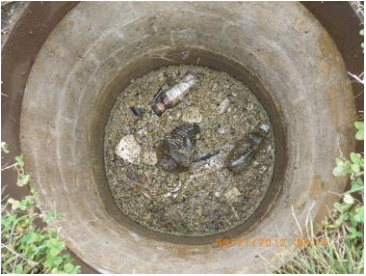
o20120927081522.JPG

<b>Inspection Date:</b> 9/27/2012 9:13:54 AM		<b>Type:</b> Ongoing	<b>Flow:</b> Submerged, indeterminate	<b>Previous Rainfall (hrs):</b> 72+
<b>Illicit Discharge Potential:</b> Potential		<b>Inspector:</b> JCW		
Submerged: Fully		Depth (in): 31		
<b>Sampling Results</b> Sample Location: Pool Total Chlorine: 0 ppm Free Chlorine: 0 ppm Ammonia: 0 ppm pH: 8.42 units Temperature: 59 °F Conductivity: 723 µS/cm Detergents: 0 mg/L		Floatables: None Odor: None Turbidity: None Color: None Gross Solids: Severe Vegetation: None Benthic Growth: None Stains: Slight Non-illicit: None	<b>Notes</b> 2011 gross solids follow-up.  <b>Condition Assessment</b> Graffiti: None Erosion: None Damage: None Deposition: Minor 3 in.

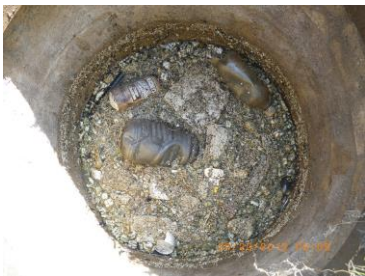
o20120620080918.JPG

<b>Inspection Date:</b> 6/20/2012 9:08:12 AM		<b>Type:</b> Other	<b>Flow:</b> Submerged, indeterminate	<b>Previous Rainfall (hrs):</b> 24-48
<b>Illicit Discharge Potential:</b> Potential		<b>Inspector:</b> JCW	<b>Notes</b>	
Submerged: Fully		Depth (in): 39	Gross solids pre-screening.	
<b>Sampling Results</b>		<b>Condition Assessment</b>		
Sample Location:	Floatables:	Gross Solids: Severe		
Total Chlorine: -- ppm	Odor:	Vegetation: None		
Free Chlorine: -- ppm	Turbidity:	Benthic Growth: None		
Ammonia: -- ppm	Color:	Stains: None		
pH: -- units	Gross Solids:	Non-illicit: None		
Temperature -- °F	Vegetation:	Deposition: None in.		
Conductivity: -- µS/cm	Benthic Growth:			
Detergents: -- mg/L	Stains:			
	Non-illicit:

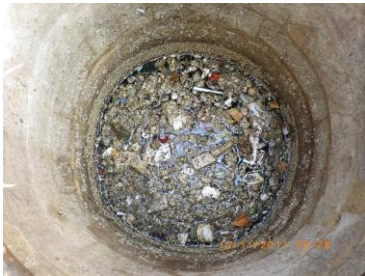
o20111011092832.JPG

<b>Inspection Date:</b> 10/11/2011 9:29:50 AM		<b>Type:</b> Ongoing	<b>Flow:</b> Submerged, indeterminate	<b>Previous Rainfall (hrs):</b> 72+
<b>Illicit Discharge Potential:</b> Potential		<b>Inspector:</b> JCW	<b>Notes</b>	
Submerged: Fully		Depth (in): 19	2010 screening follow-up. Floatable debris still present. Slight petroleum sheen.	
<b>Sampling Results</b>		<b>Condition Assessment</b>		
Sample Location: Pool	Floatables:	Gross Solids: Severe		
Total Chlorine: 0 ppm	Odor:	Vegetation: None		
Free Chlorine: 0 ppm	Turbidity:	Benthic Growth: None		
Ammonia: 0 ppm	Color:	Stains: None		
pH: 8.01 units	Gross Solids:	Non-illicit: None		
Temperature 71 °F	Vegetation:	Deposition: None 0 in.		
Conductivity: -- µS/cm	Benthic Growth:			
Detergents: -- mg/L	Stains:			
	Non-illicit:

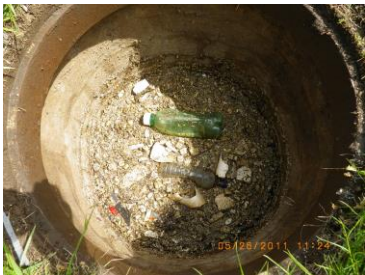
o20110526112400.JPG

<b>Inspection Date:</b> 5/26/2011 11:23:00 AM		<b>Type:</b> Other	<b>Flow:</b> Submerged, indeterminate	<b>Previous Rainfall (hrs):</b> 72+
<b>Illicit Discharge Potential:</b> Potential		<b>Inspector:</b> JCW	<b>Notes</b>	
Submerged: Fully		Depth (in):	Limited screening conducted to check for floatable debris.	
<b>Sampling Results</b>		<b>Condition Assessment</b>		
Sample Location:	Floatables:	Gross Solids: Severe		
Total Chlorine: -- ppm	Odor:	Vegetation:		
Free Chlorine: -- ppm	Turbidity:	Benthic Growth:		
Ammonia: -- ppm	Color:	Stains:		
pH: -- units	Gross Solids:	Non-illicit: None		
Temperature -- °F	Vegetation:	Deposition: None 0 in.		
Conductivity: -- µS/cm	Benthic Growth:			
Detergents: -- mg/L	Stains:			
	Non-illicit:

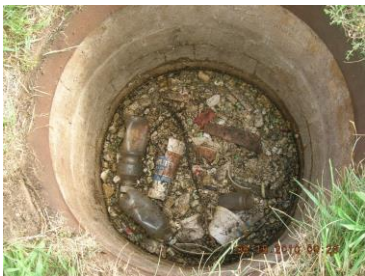
o20100818092304.JPG

<b>Inspection Date:</b> 8/18/2010 9:32:06 AM		<b>Type:</b> Ongoing	<b>Flow:</b> Submerged, indeterminate	<b>Previous Rainfall (hrs):</b> 72+
<b>Illicit Discharge Potential:</b> Potential		<b>Inspector:</b> JCW	<b>Notes</b>	
Submerged: Fully		Depth (in): 34	Severe floatable debris in catchbasin.	
<b>Sampling Results</b>		<b>Condition Assessment</b>		
Sample Location: Pool	Floatables:	Gross Solids: Severe		
Total Chlorine: 0 ppm	Odor:	Vegetation: None		
Free Chlorine: 0 ppm	Turbidity:	Benthic Growth: None		
Ammonia: 0.5 ppm	Color:	Stains: None		
pH: 7.46 units	Gross Solids:	Non-illicit: None		
Temperature 73 °F	Vegetation:	Deposition: None 0 in.		
Conductivity: -- µS/cm	Benthic Growth:			
Detergents: 0 mg/L	Stains:			
	Non-illicit:

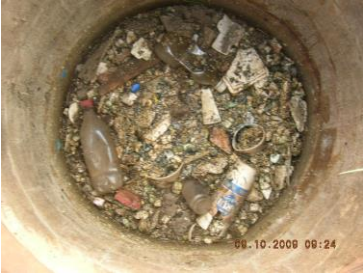
<b>Inspection Date:</b> 9/10/2009		<b>Type:</b> Initial		<b>Flow:</b> Submerged, indeterminate		<b>Previous Rainfall (hrs):</b> 72+	
<b>Illicit Discharge Potential:</b> Potential		Inspector: JCW		<b>Notes</b> Abnormal detergent analysis result (bubbles). Significant floatables in manhole.

Submerged: Fully		Depth (in): 33					
<b>Sampling Results</b>		Floatables:		<b>Condition Assessment</b> Graffiti: None Erosion: None Damage: None Deposition: None 0 in.			
Sample Location: Pool		Odor:					
Total Chlorine: 0 ppm		Turbidity:					
Free Chlorine: 0 ppm		Color:					
Ammonia: -- ppm		Gross Solids:					
pH: 8.23 units		Vegetation:					
Temperature 73 °F		Benthic Growth:					
Conductivity: -- µS/cm		Stains:					
Detergents: 0 mg/L		Non-illicit:

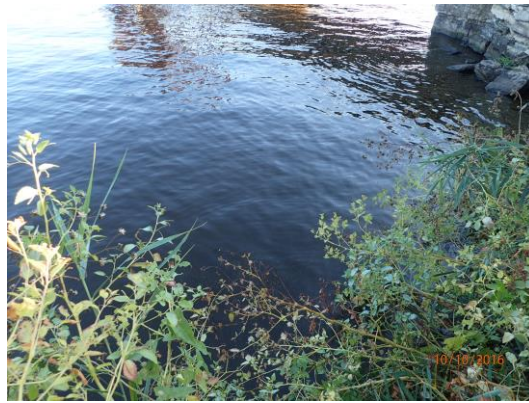
o20161010085804.JPG

10th Ave storm sewer discharges to river from south. Outfall fully submerged and not physically located. GPS coordinates approximate. Pipe info from MS4 map.

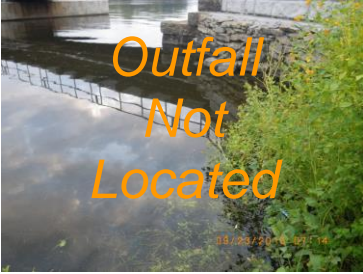
<b>Inspection Date:</b> 9/23/2015 7:10:20 AM		<b>Type:</b> Ongoing	<b>Flow:</b> Submerged (not located)	<b>Previous Rainfall (hrs):</b> 72+
<b>Illicit Discharge Potential:</b> Unlikely		<b>Inspector:</b> JCW		
Submerged: Fully      Depth (in):				
<b>Sampling Results</b> Sample Location: Total Chlorine: -- ppm Free Chlorine: -- ppm Ammonia: -- ppm pH: -- units Temperature: -- °F Conductivity: -- µS/cm Detergents: -- mg/L		Floatables: None Odor: None Turbidity: None Color: None Gross Solids: None Vegetation: None Benthic Growth: None Stains: None Non-illicit: None	<b>Notes</b> Outfall fully submerged and not located - screened at 03-81 US1.

o20150923061430.JPG
		<b>Condition Assessment</b> Graffiti: None Erosion: None Damage: None Deposition: None      in.

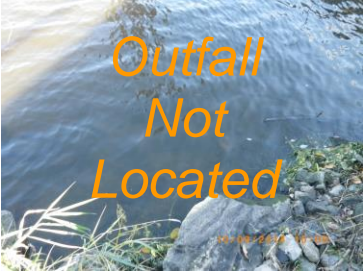
<b>Inspection Date:</b> 10/9/2014 10:00:10 AM		<b>Type:</b> Ongoing	<b>Flow:</b> Submerged (not located)	<b>Previous Rainfall (hrs):</b> 72+
<b>Illicit Discharge Potential:</b> Obvious		<b>Inspector:</b> JCW		
Submerged: Fully      Depth (in):				
<b>Sampling Results</b> Sample Location: Total Chlorine: -- ppm Free Chlorine: -- ppm Ammonia: -- ppm pH: -- units Temperature: -- °F Conductivity: -- µS/cm Detergents: -- mg/L		Floatables: None Odor: None Turbidity: None Color: None Gross Solids: None Vegetation: None Benthic Growth: None Stains: None Non-illicit: None	<b>Notes</b> Outfall fully submerged and not located - screened upstream at 03-81 US1.

o20141009090032.JPG
		<b>Condition Assessment</b> Graffiti: None Erosion: None Damage: None Deposition: None      in.

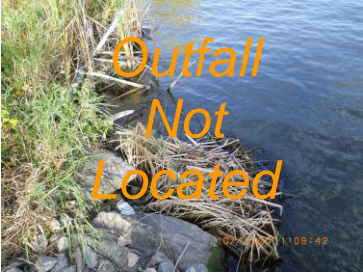
<b>Inspection Date:</b> 10/11/2011 9:42:33 AM		<b>Type:</b> Ongoing	<b>Flow:</b> Submerged (not located)	<b>Previous Rainfall (hrs):</b> 72+
<b>Illicit Discharge Potential:</b> Unlikely		<b>Inspector:</b> JCW		
Submerged: Fully      Depth (in):				
<b>Sampling Results</b> Sample Location: Total Chlorine: -- ppm Free Chlorine: -- ppm Ammonia: -- ppm pH: -- units Temperature: -- °F Conductivity: -- µS/cm Detergents: -- mg/L		Floatables: None Odor: None Turbidity: None Color: None Gross Solids: None Vegetation: None Benthic Growth: None Stains: None Non-illicit: None	<b>Notes</b> 2010 screening follow-up. Outfall fully submerged and not physically located. Outfall screened upstream at 03-81 US1.

o20111011094236.JPG
		<b>Condition Assessment</b> Graffiti: None Erosion: None Damage: None Deposition: None      0 in.

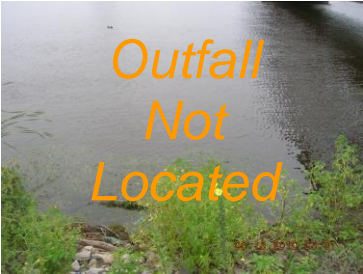
<b>Inspection Date:</b> 8/18/2010 8:38:23 AM		<b>Type:</b> Ongoing	<b>Flow:</b> Submerged (not located)	<b>Previous Rainfall (hrs):</b> 72+
<b>Illicit Discharge Potential:</b> Potential		<b>Inspector:</b> JCW		
Submerged: Fully      Depth (in):				
<b>Sampling Results</b> Sample Location: Total Chlorine: -- ppm Free Chlorine: -- ppm Ammonia: -- ppm pH: -- units Temperature: -- °F Conductivity: -- µS/cm Detergents: -- mg/L		Floatables: None Odor: None Turbidity: None Color: None Gross Solids: None Vegetation: None Benthic Growth: None Stains: None Non-illicit: None	<b>Notes</b> Outfall fully submerged and not physically located. Outfall screened upstream at 03-81 US1.

o20100818083116.JPG
		<b>Condition Assessment</b> Graffiti: None Erosion: None Damage: None Deposition: None      0 in.

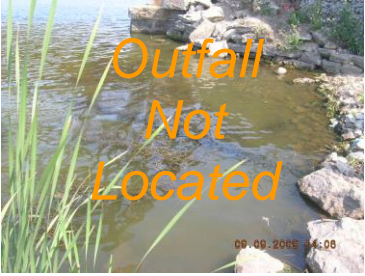
<b>Inspection Date:</b> 9/9/2009		<b>Type:</b> Initial		<b>Flow:</b> Submerged (not located)		<b>Previous Rainfall (hrs):</b> 72+	
<b>Illicit Discharge Potential:</b> Obvious		<b>Inspector:</b> JCW		<b>Notes</b>

<p>Osh09_DSCN6745.JPG</p>	
Submerged: Fully		Depth (in):		Outfall fully submerged and not physically located. Outfall screened upstream at 03-81 US1.			
<b>Sampling Results</b> Sample Location: Total Chlorine: -- ppm Free Chlorine: -- ppm Ammonia: -- ppm pH: -- units Temperature: -- °F Conductivity: -- µS/cm Detergents: -- mg/L		Floatables: None Odor: None Turbidity: None Color: None Gross Solids: None Vegetation: None Benthic Growth: None Stains: None Non-illicit: None		<b>Condition Assessment</b> Graffiti: None Erosion: None Damage: None Deposition: None 0 in.

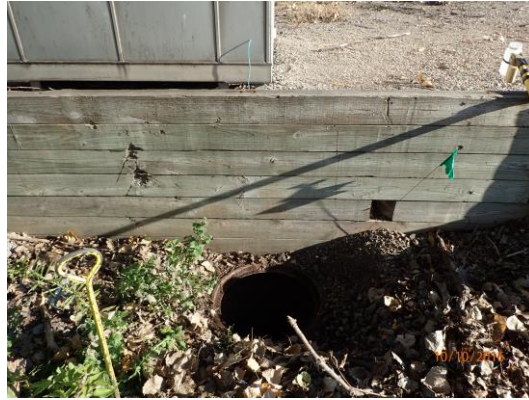
o20161010090126.JPG

Upstream manhole located approx 115 ft SSW of outfall 03-81. Located behind railroad control shed. Intermediate area consists of open space, street right-of-way and railroad right-of-way.

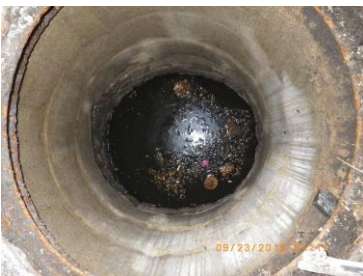
<p style="text-align: center;">o20150923061754.JPG</p>

Floatables:	None																													
Odor:	None																													
Turbidity:	None																													
Color:	Faint in bottle																													
Gross Solids:	Slight																													
Vegetation:	None																													
Benthic Growth:	None																													
Stains:	Slight																													
Non-illicit:	None																													
<table border="1" style="width:100%; border-collapse: collapse;"> <tr><td>Sample Location:</td><td>Pool</td></tr> <tr><td>Total Chlorine:</td><td>0 ppm</td></tr> <tr><td>Free Chlorine:</td><td>0 ppm</td></tr> <tr><td>Ammonia:</td><td>1 ppm</td></tr> <tr><td>pH:</td><td>7.32 units</td></tr> <tr><td>Temperature:</td><td>69 °F</td></tr> <tr><td>Conductivity:</td><td>638 µS/cm</td></tr> <tr><td>Detergents:</td><td>0 mg/L</td></tr> </table>		Sample Location:	Pool	Total Chlorine:	0 ppm	Free Chlorine:	0 ppm	Ammonia:	1 ppm	pH:	7.32 units	Temperature:	69 °F	Conductivity:	638 µS/cm	Detergents:	0 mg/L	<table border="1" style="width:100%; border-collapse: collapse;"> <tr><td colspan="2"><b>Condition Assessment</b></td></tr> <tr><td>Graffiti:</td><td>None</td></tr> <tr><td>Erosion:</td><td>None</td></tr> <tr><td>Damage:</td><td>None</td></tr> <tr><td>Deposition:</td><td>None in.</td></tr> </table>			<b>Condition Assessment</b>		Graffiti:	None	Erosion:	None	Damage:	None	Deposition:	None in.

Sample Location:	Pool																													
Total Chlorine:	0 ppm																													
Free Chlorine:	0 ppm																													
Ammonia:	1 ppm																													
pH:	7.32 units																													
Temperature:	69 °F																													
Conductivity:	638 µS/cm																													
Detergents:	0 mg/L																													
<b>Condition Assessment</b>																														
Graffiti:	None																													
Erosion:	None																													
Damage:	None																													
Deposition:	None in.

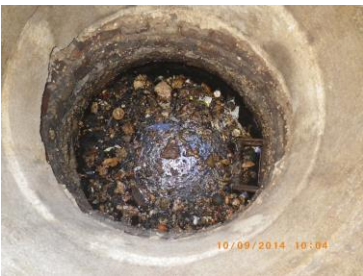
<p style="text-align: center;">o20141009090404.JPG</p>

Floatables:	Moderate																													
Odor:	Faint																													
Turbidity:	None																													
Color:	None																													
Gross Solids:	Severe																													
Vegetation:	None																													
Benthic Growth:	None																													
Stains:	None																													
Non-illicit:	None																													
<table border="1" style="width:100%; border-collapse: collapse;"> <tr><td>Sample Location:</td><td>Pool</td></tr> <tr><td>Total Chlorine:</td><td>0 ppm</td></tr> <tr><td>Free Chlorine:</td><td>0 ppm</td></tr> <tr><td>Ammonia:</td><td>0.5 ppm</td></tr> <tr><td>pH:</td><td>7.58 units</td></tr> <tr><td>Temperature:</td><td>58 °F</td></tr> <tr><td>Conductivity:</td><td>679 µS/cm</td></tr> <tr><td>Detergents:</td><td>0 mg/L</td></tr> </table>		Sample Location:	Pool	Total Chlorine:	0 ppm	Free Chlorine:	0 ppm	Ammonia:	0.5 ppm	pH:	7.58 units	Temperature:	58 °F	Conductivity:	679 µS/cm	Detergents:	0 mg/L	<table border="1" style="width:100%; border-collapse: collapse;"> <tr><td colspan="2"><b>Condition Assessment</b></td></tr> <tr><td>Graffiti:</td><td>None</td></tr> <tr><td>Erosion:</td><td>None</td></tr> <tr><td>Damage:</td><td>None</td></tr> <tr><td>Deposition:</td><td>Minor 2 in.</td></tr> </table>			<b>Condition Assessment</b>		Graffiti:	None	Erosion:	None	Damage:	None	Deposition:	Minor 2 in.

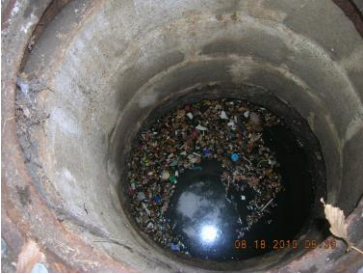
<b>Inspection Date:</b> 8/18/2010 8:43:09 AM		<b>Type:</b> Ongoing		<b>Flow:</b> Submerged, indeterminate		<b>Previous Rainfall (hrs):</b> 72+	
<b>Illicit Discharge Potential:</b> <b>Potential</b>		<b>Inspector:</b> JCW		<b>Notes</b>

<p>o20100818083958.JPG</p>	
Submerged: Fully		Depth (in): 47		Petroleum odor likely from residual petroleum in pipes after 2009 jetting.			
<b>Sampling Results</b> Sample Location: Pool Total Chlorine: 0 ppm Free Chlorine: 0 ppm Ammonia: 0 ppm pH: 6.63 units Temperature: 71 °F Conductivity: -- µS/cm Detergents: 0 mg/L		Floatables: None Odor: Faint Turbidity: None Color: None Gross Solids: Moderate Vegetation: None Benthic Growth: None Stains: Moderate Non-illicit: None		<b>Condition Assessment</b> Graffiti: None Erosion: None Damage: None Deposition: None 0 in.
