# Ongoing Screening Summary Report 2016 Inspection Year

Illicit Discharge Detection and Elimination Program

City of Oshkosh

November 30, 2016

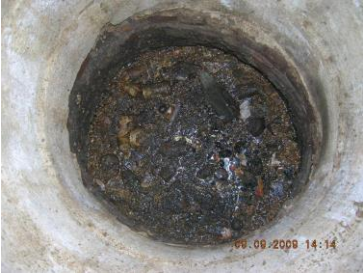
<b>Inspection Date:</b> 9/9/2009		<b>Type:</b> Initial		<b>Flow:</b> Submerged, indeterminate		<b>Previous Rainfall (hrs):</b> 72+	
<b>Illicit Discharge Potential:</b> <b>Obvious</b>		<b>Inspector:</b> JCW		<b>Notes</b>

<p>Osh09_DSCN6747.JPG</p>	
Submerged: Fully		Depth (in): 44		Diesel/oil odor, sheen on surface. Floatables with grease. Brown/gray color.			
<b>Sampling Results</b> Sample Location: Pool Total Chlorine: 0 ppm Free Chlorine: 0 ppm Ammonia: -- ppm pH: 6.98 units Temperature: 73 °F Conductivity: -- µS/cm Detergents: 0 mg/L		Floatables: Severe Odor: Easily detected Turbidity: None Color: Faint in bottle Gross Solids: Severe Vegetation: None Benthic Growth: None Stains: None Non-illicit: None		<b>Condition Assessment</b> Graffiti: None Erosion: None Damage: None Deposition: None 0 in.

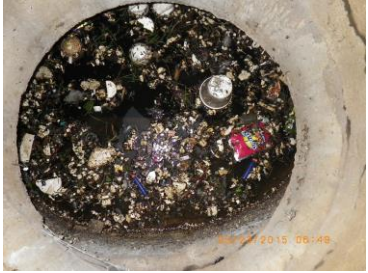
<p style="text-align: center;">o20150923054948.JPG</p>	
Submerged: Fully		Depth (in): 42		Floating gross solids (litter) - including 5 baseballs - in manhole.			
<b>Sampling Results</b>				<b>Condition Assessment</b>			
Sample Location:	Pool	Floatables:	None	Graffiti:	None	Erosion:	None
Total Chlorine:	0 ppm	Odor:	None	Erosion:	None	Damage:	None
Free Chlorine:	0 ppm	Turbidity:	None	Deposition:	None		in.
Ammonia:	0 ppm	Color:	None				
pH:	8.19 units	Gross Solids:	Moderate				
Temperature	68 °F	Vegetation:	None				
Conductivity:	476 µS/cm	Benthic Growth:	None				
Detergents:	0 mg/L	Stains:	None				
		Non-illicit:	None

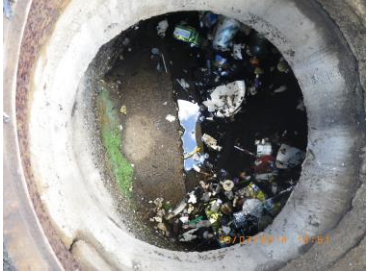
<p style="text-align: center;">o20141007125104.JPG</p>	
Submerged: Fully		Depth (in): 38		Floating gross solids (litter) in manhole.			
<b>Sampling Results</b>				<b>Condition Assessment</b>			
Sample Location:	Pool	Floatables:	None	Graffiti:	None	Erosion:	None
Total Chlorine:	0 ppm	Odor:	None	Erosion:	None	Damage:	None
Free Chlorine:	0 ppm	Turbidity:	None	Deposition:	None		in.
Ammonia:	0 ppm	Color:	None				
pH:	7.73 units	Gross Solids:	Moderate				
Temperature	-- °F	Vegetation:	None				
Conductivity:	401 µS/cm	Benthic Growth:	Slight				
Detergents:	0 mg/L	Stains:	None				
		Non-illicit:	None

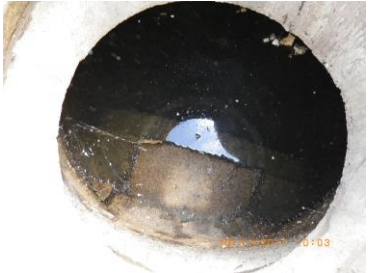
<p style="text-align: center;">o20111011100336.JPG</p>	
Submerged: Fully		Depth (in): 39		2010 screening follow-up. Floatable debris significantly reduced.			
<b>Sampling Results</b>				<b>Condition Assessment</b>			
Sample Location:	Pool	Floatables:	None	Graffiti:	None	Erosion:	None
Total Chlorine:	0 ppm	Odor:	None	Erosion:	None	Damage:	None
Free Chlorine:	0 ppm	Turbidity:	None	Deposition:	None		0 in.
Ammonia:	0.5 ppm	Color:	None				
pH:	7.39 units	Gross Solids:	None				
Temperature	70 °F	Vegetation:	None				
Conductivity:	-- µS/cm	Benthic Growth:	None				
Detergents:	-- mg/L	Stains:	None				
		Non-illicit:	None

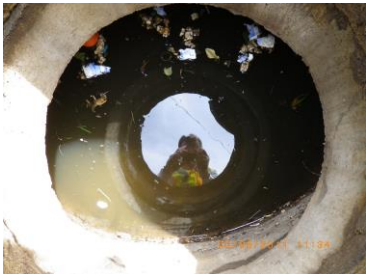
<p style="text-align: center;">o20110526113426.JPG</p>	
Submerged: Fully		Depth (in):		Limited screening conducted to check for floatable debris.			
<b>Sampling Results</b>				<b>Condition Assessment</b>			
Sample Location:		Floatables:	None	Graffiti:	None	Erosion:	None
Total Chlorine:	-- ppm	Odor:		Erosion:	None	Damage:	None
Free Chlorine:	-- ppm	Turbidity:		Deposition:	None		0 in.
Ammonia:	-- ppm	Color:					
pH:	-- units	Gross Solids:	Slight				
Temperature	-- °F	Vegetation:					
Conductivity:	-- µS/cm	Benthic Growth:					
Detergents:	-- mg/L	Stains:					
		Non-illicit:	None

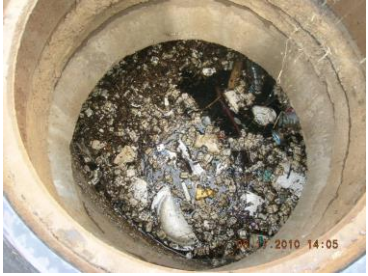
o20100817140504.JPG

<b>Inspection Date:</b> 8/17/2010 2:11:27 PM		<b>Type:</b> Ongoing		<b>Flow:</b> Submerged, indeterminate		<b>Previous Rainfall (hrs):</b> 72+	
<b>Illicit Discharge Potential:</b> Potential		<b>Inspector:</b> JCW		<b>Notes</b> Floatable debris in manhole.

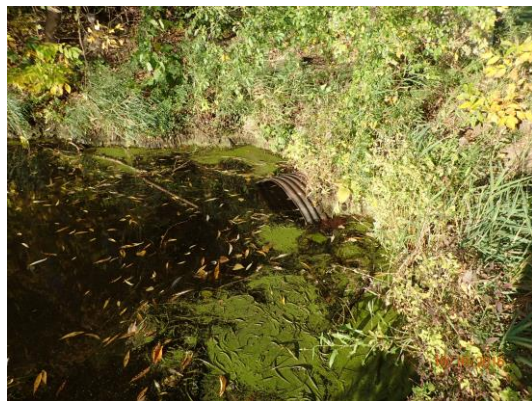
o20161010083442.JPG

Storm sewer from E 14th Ave discharges to lake from west. Outfall partially submerged - pipe dimensions from MS4 map.

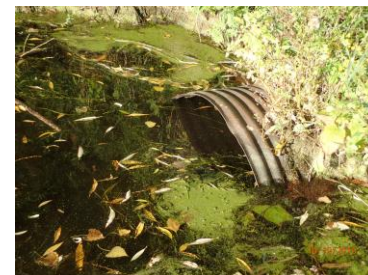
o20161010083458.JPG

Damage: Minor

☐ Displacement☐ Undercut☐ Crushed☒ Corrosion☐ Cracks/Structural Damage

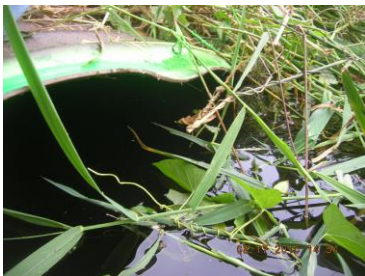
<b>Inspection Date:</b> 8/17/2010 3:02:36 PM		<b>Type:</b> Ongoing	<b>Flow:</b> Submerged, indeterminate	<b>Previous Rainfall (hrs):</b> 72+
<b>Illicit Discharge Potential:</b> Unlikely		<b>Inspector:</b> JCW		
Submerged: Partially      Depth (in): 38				
<b>Sampling Results</b> Sample Location: Total Chlorine: -- ppm Free Chlorine: -- ppm Ammonia: -- ppm pH: -- units Temperature: -- °F Conductivity: -- µS/cm Detergents: -- mg/L		Floatables: None Odor: None Turbidity: None Color: None Gross Solids: None Vegetation: None Benthic Growth: None Stains: None Non-illicit: None	<b>Notes</b> Outfall partially submerged. Outfall screened upstream at 03-293 US1.

o20100817145430.JPG
		<b>Condition Assessment</b> Graffiti: None Erosion: None Damage: Minor Deposition: None      0 in.

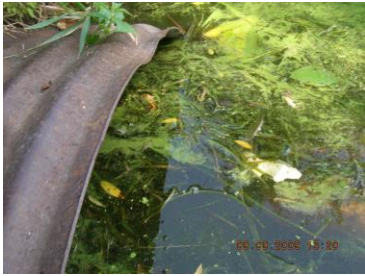
<b>Inspection Date:</b> 9/9/2009		<b>Type:</b> Initial	<b>Flow:</b> Submerged, indeterminate	<b>Previous Rainfall (hrs):</b> 72+
<b>Illicit Discharge Potential:</b> Potential		<b>Inspector:</b> JCW		
Submerged: Partially      Depth (in): 32				
<b>Sampling Results</b> Sample Location: Total Chlorine: -- ppm Free Chlorine: -- ppm Ammonia: -- ppm pH: -- units Temperature: -- °F Conductivity: -- µS/cm Detergents: -- mg/L		Floatables: None Odor: None Turbidity: None Color: None Gross Solids: None Vegetation: None Benthic Growth: Slight Stains: None Non-illicit: None	<b>Notes</b> Outfall partially submerged. Outfall screened upstream at 03-293 US1.

Osh09_DSCN6736.JPG
		<b>Condition Assessment</b> Graffiti: None Erosion: None Damage: Minor Deposition: None      0 in.

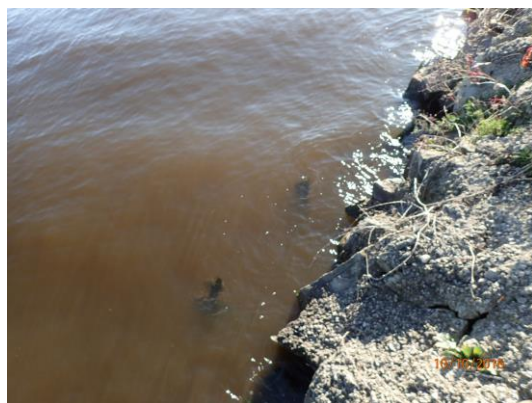
o20161010091654.JPG

Pioneer Dr storm sewer discharges to river from south. Outfall fully submerged and not physically located. GPS coordinates approximate. Pipe info from MS4 map.

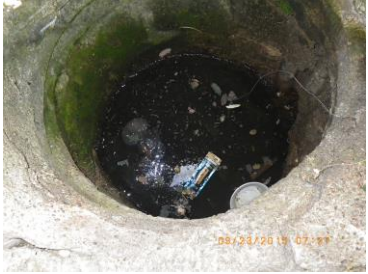
<p style="text-align: right; font-size: small;">o20150923062728.JPG</p>

<div style="display: flex;"> <div style="flex: 1;"> <p><b>Notes</b></p> <p>Floating gross solids (litter) in manhole.</p> </div> <div style="flex: 1;"> <p><b>Condition Assessment</b></p> <table border="1" style="width:100%; border-collapse: collapse;"> <tr><td>Graffiti:</td><td>None</td></tr> <tr><td>Erosion:</td><td>None</td></tr> <tr><td>Damage:</td><td>None</td></tr> <tr><td>Deposition:</td><td>None in.</td></tr> </table> </div> </div>			Graffiti:	None	Erosion:	None	Damage:	None	Deposition:	None in.																										
Graffiti:	None																																					
Erosion:	None																																					
Damage:	None																																					
Deposition:	None in.

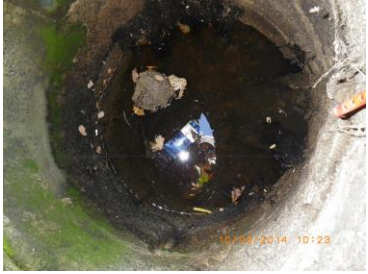
<p style="text-align: right; font-size: small;">o20141009092338.JPG</p>

<div style="display: flex;"> <div style="flex: 1;"> <p><b>Notes</b></p> </div> <div style="flex: 1;"> <p><b>Condition Assessment</b></p> <table border="1" style="width:100%; border-collapse: collapse;"> <tr><td>Graffiti:</td><td>None</td></tr> <tr><td>Erosion:</td><td>None</td></tr> <tr><td>Damage:</td><td>None</td></tr> <tr><td>Deposition:</td><td>Minor 2 in.</td></tr> </table> </div> </div>			Graffiti:	None	Erosion:	None	Damage:	None	Deposition:	Minor 2 in.																										
Graffiti:	None																																					
Erosion:	None																																					
Damage:	None																																					
Deposition:	Minor 2 in.

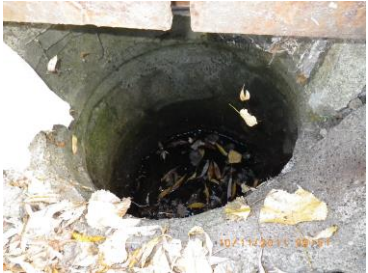
<p style="text-align: right; font-size: small;">o20111011095140.JPG</p>

<div style="display: flex;"> <div style="flex: 1;"> <p><b>Notes</b></p> <p>2010 screening follow-up. Floatable debris significantly reduced.</p> </div> <div style="flex: 1;"> <p><b>Condition Assessment</b></p> <table border="1" style="width:100%; border-collapse: collapse;"> <tr><td>Graffiti:</td><td>None</td></tr> <tr><td>Erosion:</td><td>None</td></tr> <tr><td>Damage:</td><td>None</td></tr> <tr><td>Deposition:</td><td>None 0 in.</td></tr> </table> </div> </div>			Graffiti:	None	Erosion:	None	Damage:	None	Deposition:	None 0 in.																										
Graffiti:	None																																					
Erosion:	None																																					
Damage:	None																																					
Deposition:	None 0 in.

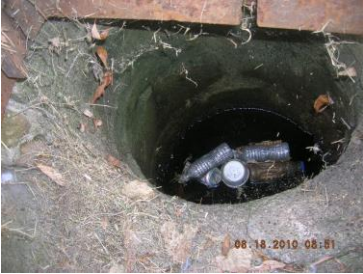
o20100818085124.JPG

<b>Inspection Date:</b> 8/18/2010 9:03:59 AM		<b>Type:</b> Ongoing		<b>Flow:</b> Submerged, indeterminate		<b>Previous Rainfall (hrs):</b> 72+	
<b>Illicit Discharge Potential:</b> Potential		<b>Inspector:</b> JCW		<b>Notes</b> Floating debris, slight oil sheen in manhole.

Submerged: Fully		Depth (in): 13					
<b>Sampling Results</b>				<b>Condition Assessment</b>			
Sample Location: Pool		Floatables: Moderate		Graffiti: None			
Total Chlorine: 0 ppm		Odor: Faint		Erosion: None			
Free Chlorine: 0 ppm		Turbidity: None		Damage: None			
Ammonia: 0 ppm		Color: Faint in bottle		Deposition: None		0 in.	
pH: 7.13 units		Gross Solids: Moderate					
Temperature: 72 °F		Vegetation: None					
Conductivity: -- µS/cm		Benthic Growth: None					
Detergents: 0 mg/L		Stains: None					
		Non-illicit: None

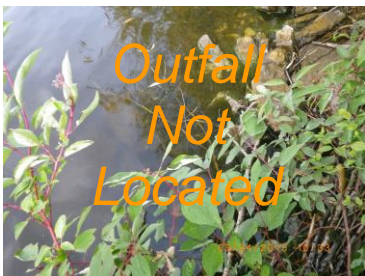
o20150924093340.JPG	
Submerged: Fully		Depth (in):		Outfall fully submerged and not located - screened at 05-14 US1.			
<b>Sampling Results</b> Sample Location: Total Chlorine: -- ppm Free Chlorine: -- ppm Ammonia: -- ppm pH: -- units Temperature: -- °F Conductivity: -- µS/cm Detergents: -- mg/L		Floatables: None Odor: None Turbidity: None Color: None Gross Solids: None Vegetation: None Benthic Growth: None Stains: None Non-illicit: None		<b>Condition Assessment</b> Graffiti: None Erosion: None Damage: None Deposition: None in.

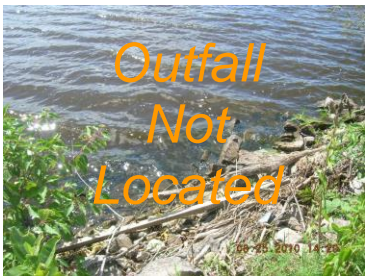
o20100825142900.JPG	
Submerged: Fully		Depth (in):		Outfall fully submerged and not physically located. Outfall screened upstream at 05-14 US2.			
<b>Sampling Results</b> Sample Location: Total Chlorine: -- ppm Free Chlorine: -- ppm Ammonia: -- ppm pH: -- units Temperature: -- °F Conductivity: -- µS/cm Detergents: -- mg/L		Floatables: None Odor: None Turbidity: None Color: None Gross Solids: None Vegetation: None Benthic Growth: None Stains: None Non-illicit: None		<b>Condition Assessment</b> Graffiti: None Erosion: None Damage: None Deposition: None 0 in.

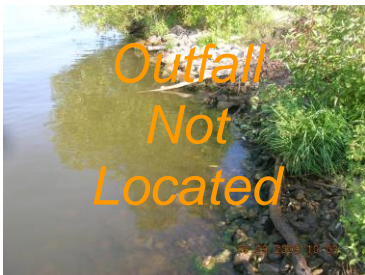
Osh09_DSCN6696.JPG	
Submerged: Fully		Depth (in):		Outfall fully submerged and not physically located. Outfall screened upstream at 05-14 US2.			
<b>Sampling Results</b> Sample Location: Total Chlorine: -- ppm Free Chlorine: -- ppm Ammonia: -- ppm pH: -- units Temperature: -- °F Conductivity: -- µS/cm Detergents: -- mg/L		Floatables: None Odor: None Turbidity: None Color: None Gross Solids: None Vegetation: None Benthic Growth: None Stains: None Non-illicit: None		<b>Condition Assessment</b> Graffiti: None Erosion: None Damage: None Deposition: None 0 in.

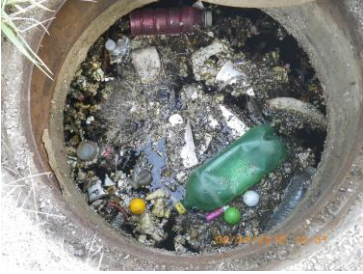
<b>Inspection Date:</b> 9/24/2015 10:36:18 AM		<b>Type:</b> Ongoing		<b>Flow:</b> Submerged, indeterminate		<b>Previous Rainfall (hrs):</b> 72+	
<b>Illicit Discharge Potential:</b> Potential		<b>Inspector:</b> JCW		<b>Notes</b> Floating gross solids (litter) in manhole.

<p>o20150924093714.JPG</p>	
Submerged: Fully		Depth (in): 44					
<b>Sampling Results</b>		<b>Floatables:</b> None <b>Odor:</b> None <b>Turbidity:</b> None <b>Color:</b> None <b>Gross Solids:</b> Severe <b>Vegetation:</b> None <b>Benthic Growth:</b> None <b>Stains:</b> None <b>Non-illicit:</b> None		<b>Condition Assessment</b> <b>Graffiti:</b> None <b>Erosion:</b> None <b>Damage:</b> None <b>Deposition:</b> None in.			
<b>Sample Location:</b> Pool <b>Total Chlorine:</b> 0 ppm <b>Free Chlorine:</b> 0 ppm <b>Ammonia:</b> 0 ppm <b>pH:</b> 7.98 units <b>Temperature:</b> 70 °F <b>Conductivity:</b> 424 µS/cm <b>Detergents:</b> 0 mg/L

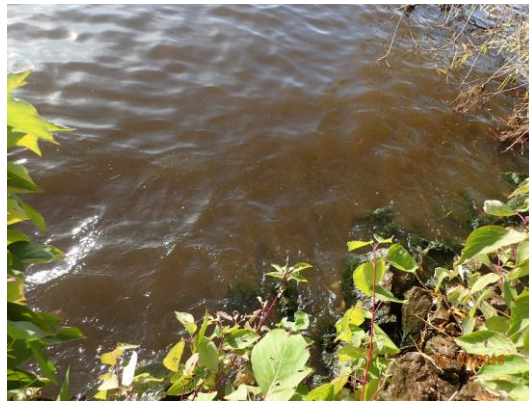
o20161010154046.JPG

Storm sewer from Rockwell Ave discharges to river from east. Outfall fully submerged and not physically located. GPS coordinates approximate. Pipe info from MS4 map.

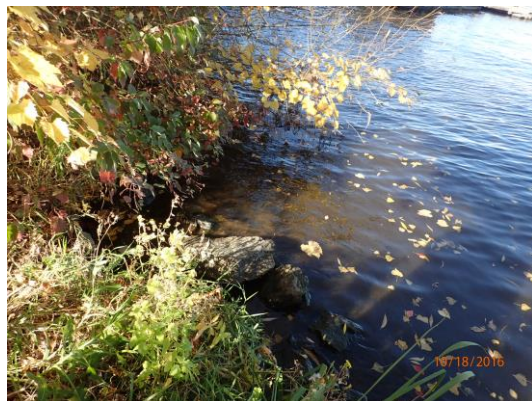
o20161018145648.JPG

W 4th Ave storm sewer discharges to river from south. Outfall fully submerged and not physically located. GPS coordinates approximate. Pipe info from MS4 map.

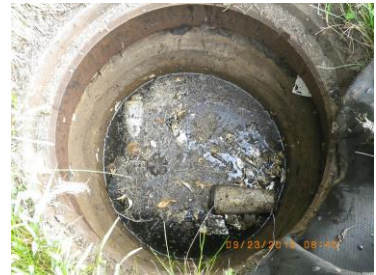
o20150923074542.JPG

<b>Inspection Date:</b> 9/23/2015 8:42:53 AM		<b>Type:</b> Ongoing	<b>Flow:</b> Submerged, indeterminate	<b>Previous Rainfall (hrs):</b> 72+
<b>Illicit Discharge Potential:</b> Potential		<b>Inspector:</b> JCW		
Submerged: Fully		Depth (in): 44		
<b>Sampling Results</b>		<b>Notes</b> Floating gross solids (litter) in manhole.		
Sample Location: Pool	Floatables: None	<b>Condition Assessment</b> Graffiti: None Erosion: None Damage: None Deposition: None in.		
Total Chlorine: 0 ppm	Odor: None			
Free Chlorine: 0 ppm	Turbidity: None			
Ammonia: 0 ppm	Color: None			
pH: 8.74 units	Gross Solids: Moderate			
Temperature 70 °F	Vegetation: None			
Conductivity: 351 µS/cm	Benthic Growth: None			
Detergents: 0 mg/L	Stains: None			
	Non-illicit: None

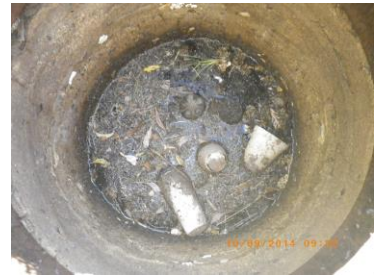
o20141009083526.JPG

<b>Inspection Date:</b> 10/9/2014 9:37:13 AM		<b>Type:</b> Ongoing	<b>Flow:</b> Submerged, indeterminate	<b>Previous Rainfall (hrs):</b> 72+
<b>Illicit Discharge Potential:</b> Potential		<b>Inspector:</b> JCW		
Submerged: Fully		Depth (in): 35		
<b>Sampling Results</b>		<b>Notes</b> Floating gross solids (litter) in manhole. Filter fabric installed in inlet.		
Sample Location: Pool	Floatables: None	<b>Condition Assessment</b> Graffiti: None Erosion: None Damage: None Deposition: None in.		
Total Chlorine: 0 ppm	Odor: None			
Free Chlorine: 0 ppm	Turbidity: Slight cloudiness			
Ammonia: 0 ppm	Color: None			
pH: 7.82 units	Gross Solids: Severe			
Temperature 56 °F	Vegetation: None			
Conductivity: 471 µS/cm	Benthic Growth: Slight			
Detergents: 0 mg/L	Stains: None			
	Non-illicit: None

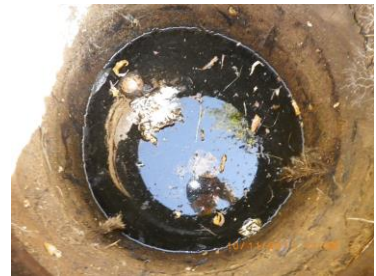
o20111011110824.JPG

<b>Inspection Date:</b> 10/11/2011 11:09:29 AM		<b>Type:</b> Ongoing	<b>Flow:</b> Submerged, indeterminate	<b>Previous Rainfall (hrs):</b> 72+
<b>Illicit Discharge Potential:</b> Unlikely		<b>Inspector:</b> JCW		
Submerged: Fully		Depth (in): 35		
<b>Sampling Results</b>		<b>Notes</b> 2010 screening follow-up. Floatable debris significantly reduced.		
Sample Location: Pool	Floatables: None	<b>Condition Assessment</b> Graffiti: None Erosion: None Damage: None Deposition: None 0 in.		
Total Chlorine: 0 ppm	Odor: None			
Free Chlorine: 0 ppm	Turbidity: None			
Ammonia: 0 ppm	Color: None			
pH: 8.13 units	Gross Solids: Moderate			
Temperature 70 °F	Vegetation: None			
Conductivity: -- µS/cm	Benthic Growth: None			
Detergents: -- mg/L	Stains: None			
	Non-illicit: None

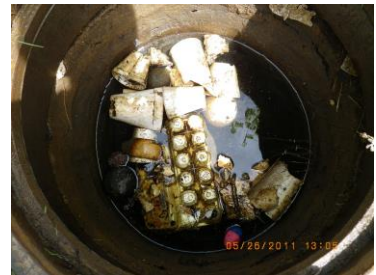
o20110526130522.JPG

<b>Inspection Date:</b> 5/26/2011 1:05:00 PM		<b>Type:</b> Other	<b>Flow:</b> Submerged, indeterminate	<b>Previous Rainfall (hrs):</b> 72+
<b>Illicit Discharge Potential:</b> Potential		<b>Inspector:</b> JCW		
Submerged: Fully		Depth (in):		
<b>Sampling Results</b>		<b>Notes</b> Limited screening conducted to check for floatable debris.		
Sample Location: --	Floatables: None	<b>Condition Assessment</b> Graffiti: None Erosion: None Damage: None Deposition: None 0 in.		
Total Chlorine: -- ppm	Odor: --			
Free Chlorine: -- ppm	Turbidity: --			
Ammonia: -- ppm	Color: --			
pH: -- units	Gross Solids: Moderate			
Temperature -- °F	Vegetation: --			
Conductivity: -- µS/cm	Benthic Growth: --			
Detergents: -- mg/L	Stains: --			
	Non-illicit: None

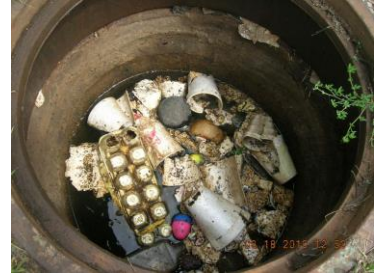
o20100818125018.JPG

<b>Inspection Date:</b> 8/18/2010 1:00:07 PM		<b>Type:</b> Ongoing	<b>Flow:</b> Submerged, indeterminate	<b>Previous Rainfall (hrs):</b> 72+
<b>Illicit Discharge Potential:</b> Potential		<b>Inspector:</b> JCW		
Submerged: Fully		Depth (in): 41		
<b>Sampling Results</b>				
Sample Location:	Pool	Floatables:	None	
Total Chlorine:	0 ppm	Odor:	None	
Free Chlorine:	0 ppm	Turbidity:	Slight cloudiness	
Ammonia:	0 ppm	Color:	Faint in bottle	
pH:	7.98 units	Gross Solids:	Severe	
Temperature:	76 °F	Vegetation:	None	
Conductivity:	-- µS/cm	Benthic Growth:	None	
Detergents:	0 mg/L	Stains:	None	
		Non-illicit:	None	
<b>Notes</b>			<b>Condition Assessment</b>	
Significant floatable debris in manhole.			Graffiti: None	
			Erosion: None	
			Damage: None	
			Deposition: None 0 in.

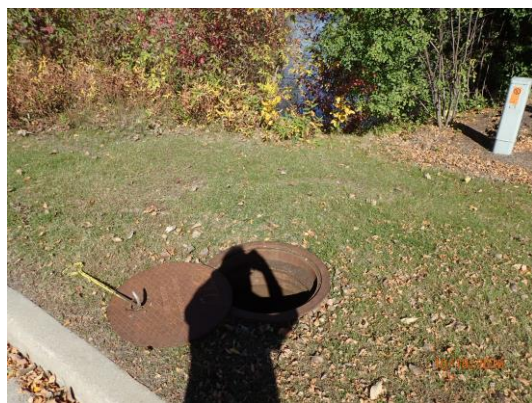
o20161018134022.JPG

Upstream manhole located approx 25 ft SSW of outfall 06-221. Intermediate area consists of open space. 1.5" hose through side of manhole - tied around steps

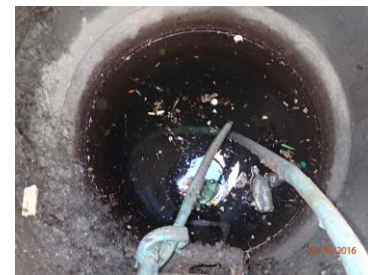
o20161018134038.JPG

Damage: Minor

☐ Displacement☐ Undercut☐ Crushed☐ Corrosion☒ Cracks/Structural Damage

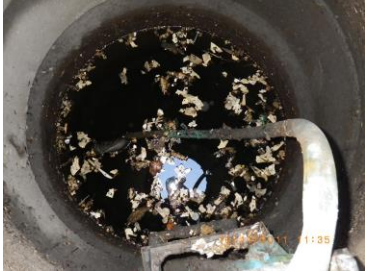
<p style="text-align: center; font-size: small;">o20111011113522.JPG</p>

<div style="display: flex; justify-content: space-between;"> <div style="width: 45%;"> <p><b>Notes</b></p> <p>2010 screening follow-up. Floatable debris still present.</p> </div> <div style="width: 45%;"> <p><b>Condition Assessment</b></p> <table border="1" style="width:100%; border-collapse: collapse;"> <tr><td>Graffiti:</td><td>None</td></tr> <tr><td>Erosion:</td><td>None</td></tr> <tr><td>Damage:</td><td>None</td></tr> <tr><td>Deposition:</td><td>None 0 in.</td></tr> </table> </div> </div>			Graffiti:	None	Erosion:	None	Damage:	None	Deposition:	None 0 in.																										
Graffiti:	None																																					
Erosion:	None																																					
Damage:	None																																					
Deposition:	None 0 in.

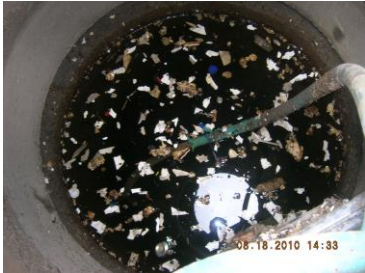
<p style="text-align: center; font-size: small;">o20100818143354.JPG</p>

<div style="display: flex; justify-content: space-between;"> <div style="width: 45%;"> <p><b>Notes</b></p> <p>Torn paper and other floatable debris in manhole.</p> </div> <div style="width: 45%;"> <p><b>Condition Assessment</b></p> <table border="1" style="width:100%; border-collapse: collapse;"> <tr><td>Graffiti:</td><td>None</td></tr> <tr><td>Erosion:</td><td>None</td></tr> <tr><td>Damage:</td><td>None</td></tr> <tr><td>Deposition:</td><td>None 0 in.</td></tr> </table> </div> </div>			Graffiti:	None	Erosion:	None	Damage:	None	Deposition:	None 0 in.																										
Graffiti:	None																																					
Erosion:	None																																					
Damage:	None																																					
Deposition:	None 0 in.

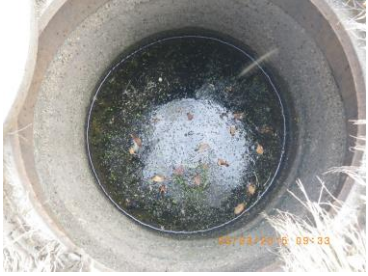
o20150923083310.JPG	
Submerged: Fully		Depth (in): 42		Significant current detected in pool. Many flies emerging from water.			
<b>Sampling Results</b>				<b>Condition Assessment</b>			
Sample Location: Pool		Floatables: None		Graffiti: None			
Total Chlorine: 0 ppm		Odor: None		Erosion: None			
Free Chlorine: 0 ppm		Turbidity: None		Damage: None			
Ammonia: 0 ppm		Color: None		Deposition: None		in.	
pH: 7.53 units		Gross Solids: Slight					
Temperature 70 °F		Vegetation: None					
Conductivity: 1220 µS/cm		Benthic Growth: Slight					
Detergents: 0 mg/L		Stains: None					
		Non-illicit: None

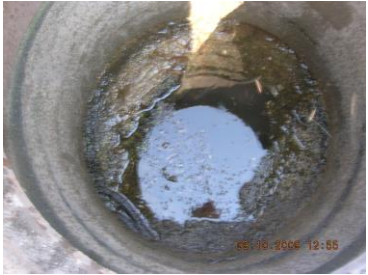
Osh09_DSCN6791.JPG	
Submerged: Fully		Depth (in): 38		River fly swarm inside manhole.			
<b>Sampling Results</b>				<b>Condition Assessment</b>			
Sample Location: Pool		Floatables: None		Graffiti: None			
Total Chlorine: 0 ppm		Odor: None		Erosion: None			
Free Chlorine: 0 ppm		Turbidity: None		Damage: None			
Ammonia: -- ppm		Color: None		Deposition: None		0 in.	
pH: 6.92 units		Gross Solids: None					
Temperature 79 °F		Vegetation: None					
Conductivity: -- µS/cm		Benthic Growth: None					
Detergents: 0 mg/L		Stains: None					
		Non-illicit: None

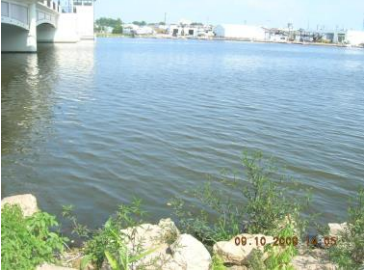
<b>Inspection Date:</b> 9/10/2009		<b>Type:</b> Initial	<b>Flow:</b> Submerged, indeterminate	<b>Previous Rainfall (hrs):</b> 72+
<b>Illicit Discharge Potential:</b> Potential		<b>Inspector:</b> JCW		
Submerged: Fully      Depth (in):				
<b>Sampling Results</b> Sample Location: Total Chlorine: -- ppm Free Chlorine: -- ppm Ammonia: -- ppm pH: -- units Temperature: -- °F Conductivity: -- µS/cm Detergents: -- mg/L		Floatables: None Odor: None Turbidity: None Color: None Gross Solids: None Vegetation: None Benthic Growth: None Stains: None Non-illicit: None	<b>Notes</b>

Osh09_DSCN6798.JPG
		<b>Condition Assessment</b> Graffiti: None Erosion: None Damage: None Deposition: None 0 in.

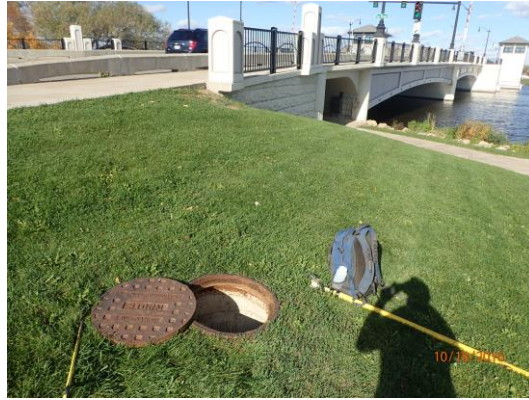
o20161018144418.JPG

Upstream manhole located approx 77 ft SW of outfall 06-810. Intermediate area consists of open area.

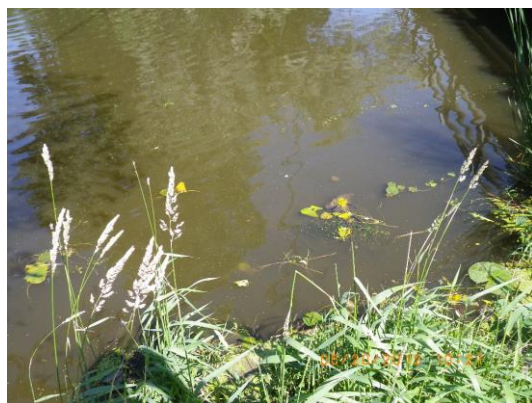
o20120620092742.JPG

Storm sewer from Campbell Rd discharges to stream from south. Outfall not located - pipe info from MS4 map.

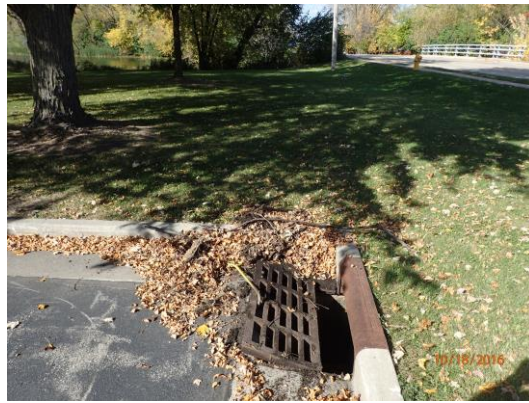
o20161018133218.JPG

Upstream curb inlet located approx 122 ft SSE of outfall 06-1028. Intermediate area consists of open area and paved parking lot.

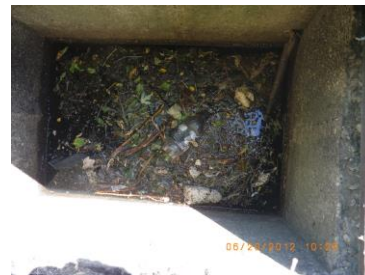
<b>Inspection Date:</b> 6/20/2012 10:29:02 AM		<b>Type:</b> Ongoing	<b>Flow:</b> Submerged, indeterminate	<b>Previous Rainfall (hrs):</b> 24-48
<b>Illicit Discharge Potential:</b> Unlikely		<b>Inspector:</b> JCW		
Submerged: Fully		Depth (in): 21		
<b>Sampling Results</b>		<b>Notes</b>		
Sample Location:	Floatables:	2011 gross solids follow-up.		
Total Chlorine: -- ppm	Odor:			
Free Chlorine: -- ppm	Turbidity:			
Ammonia: -- ppm	Color:			
pH: -- units	Gross Solids:			
Temperature -- °F	Vegetation:			
Conductivity: -- µS/cm	Benthic Growth:			
Detergents: -- mg/L	Stains:			
	Non-illicit:	<b>Condition Assessment</b>		
		Graffiti: None		
		Erosion: None		
		Damage: None		
		Deposition: None in.

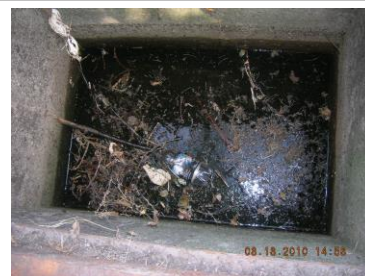
<b>Inspection Date:</b> 8/18/2010 3:07:00 PM		<b>Type:</b> Ongoing	<b>Flow:</b> Submerged, indeterminate	<b>Previous Rainfall (hrs):</b> 72+
<b>Illicit Discharge Potential:</b> Unlikely		<b>Inspector:</b> JCW		
Submerged: Fully		Depth (in): 18		
<b>Sampling Results</b>		<b>Notes</b>		
Sample Location: Pool	Floatables:			
Total Chlorine: 0 ppm	Odor:			
Free Chlorine: 0 ppm	Turbidity:			
Ammonia: 0 ppm	Color:			
pH: 7.46 units	Gross Solids:			
Temperature 76 °F	Vegetation:			
Conductivity: -- µS/cm	Benthic Growth:			
Detergents: 0 mg/L	Stains:			
	Non-illicit:	<b>Condition Assessment</b>		
		Graffiti: None		
		Erosion: None		
		Damage: None		
		Deposition: None 0 in.

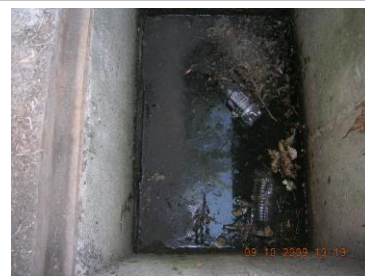
<b>Inspection Date:</b> 9/10/2009		<b>Type:</b> Initial	<b>Flow:</b> Submerged, indeterminate	<b>Previous Rainfall (hrs):</b> 72+
<b>Illicit Discharge Potential:</b> Unlikely		<b>Inspector:</b> JCW		
Submerged: Fully		Depth (in): 16		
<b>Sampling Results</b>		<b>Notes</b>		
Sample Location: Pool	Floatables:	Slight sulfide odor.		
Total Chlorine: 0 ppm	Odor:			
Free Chlorine: 0 ppm	Turbidity:			
Ammonia: -- ppm	Color:			
pH: 7.72 units	Gross Solids:			
Temperature 80 °F	Vegetation:			
Conductivity: -- µS/cm	Benthic Growth:			
Detergents: 0 mg/L	Stains:			
	Non-illicit:	<b>Condition Assessment</b>		
		Graffiti: None		
		Erosion: None		
		Damage: None		
		Deposition: None 3 in.

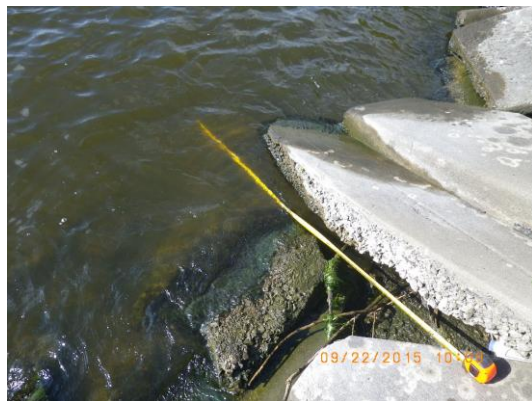
o20150922090924.JPG

Bay St storm sewer discharges to river from north.  
Outfall fully submerged. Pipe info from MS4 map.

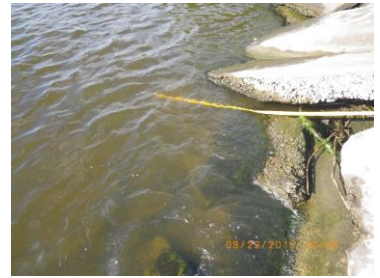
o20150922090932.JPG

<b>Inspection Date:</b> 9/22/2015 10:04:59 AM		<b>Type:</b> Ongoing	<b>Flow:</b> Submerged, indeterminate	<b>Previous Rainfall (hrs):</b> 72+
<b>Illicit Discharge Potential:</b> Potential		<b>Inspector:</b> JCW		
Submerged: Fully		Depth (in): 30		
<b>Sampling Results</b>		<b>Notes</b> Outfall fully submerged - screened at 08-284 US1.		
Sample Location:	Floatables:	None		
Total Chlorine: -- ppm	Odor:	None		
Free Chlorine: -- ppm	Turbidity:	None		
Ammonia: -- ppm	Color:	None		
pH: -- units	Gross Solids:	None		
Temperature -- °F	Vegetation:	None		
Conductivity: -- µS/cm	Benthic Growth:	Moderate		
Detergents: -- mg/L	Stains:	None		
	Non-illicit:	None		
		<b>Condition Assessment</b> Graffiti: None Erosion: None Damage: None Deposition: None in.

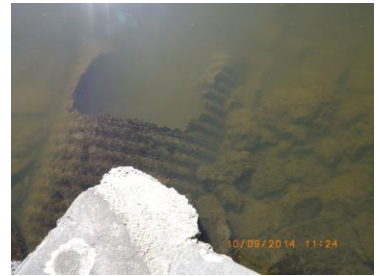
o20141009102400.JPG

<b>Inspection Date:</b> 10/9/2014 11:24:44 AM		<b>Type:</b> Ongoing	<b>Flow:</b> Submerged, indeterminate	<b>Previous Rainfall (hrs):</b> 72+
<b>Illicit Discharge Potential:</b> Potential		<b>Inspector:</b> JCW		
Submerged: Fully		Depth (in): 29		
<b>Sampling Results</b>		<b>Notes</b> Outfall fully submerged - screened upstream at 08-284 US1.		
Sample Location:	Floatables:	None		
Total Chlorine: -- ppm	Odor:	None		
Free Chlorine: -- ppm	Turbidity:	None		
Ammonia: -- ppm	Color:	None		
pH: -- units	Gross Solids:	None		
Temperature -- °F	Vegetation:	None		
Conductivity: -- µS/cm	Benthic Growth:	None		
Detergents: -- mg/L	Stains:	None		
	Non-illicit:	None		
		<b>Condition Assessment</b> Graffiti: None Erosion: None Damage: Minor Deposition: Minor 3 in.

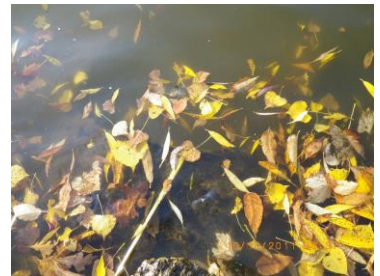
o20111011083728.JPG

<b>Inspection Date:</b> 10/11/2011 8:37:04 AM		<b>Type:</b> Ongoing	<b>Flow:</b> Submerged, indeterminate	<b>Previous Rainfall (hrs):</b> 72+
<b>Illicit Discharge Potential:</b> Unlikely		<b>Inspector:</b> JCW		
Submerged: Fully		Depth (in): 25		
<b>Sampling Results</b>		<b>Notes</b> 2010 screening follow-up. Outfall fully submerged. Outfall screened upstream at 08-284 US1.		
Sample Location:	Floatables:	None		
Total Chlorine: -- ppm	Odor:	None		
Free Chlorine: -- ppm	Turbidity:	None		
Ammonia: -- ppm	Color:	None		
pH: -- units	Gross Solids:	None		
Temperature -- °F	Vegetation:	None		
Conductivity: -- µS/cm	Benthic Growth:	None		
Detergents: -- mg/L	Stains:	None		
	Non-illicit:	None		
		<b>Condition Assessment</b> Graffiti: None Erosion: None Damage: None Deposition: None 0 in.

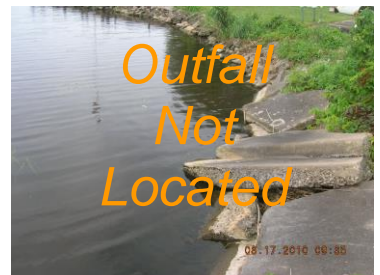
o20100817093554.JPG

<b>Inspection Date:</b> 8/17/2010 9:35:00 AM		<b>Type:</b> Ongoing	<b>Flow:</b> Submerged (not located)	<b>Previous Rainfall (hrs):</b> 72+
<b>Illicit Discharge Potential:</b> Potential		<b>Inspector:</b> JCW		
Submerged: Fully		Depth (in):		
<b>Sampling Results</b>		<b>Notes</b> Outfall fully submerged and not physically located. Outfall screened upstream at 08-284 US1.		
Sample Location:	Floatables:	None		
Total Chlorine: -- ppm	Odor:	None		
Free Chlorine: -- ppm	Turbidity:	None		
Ammonia: -- ppm	Color:	None		
pH: -- units	Gross Solids:	None		
Temperature -- °F	Vegetation:	None		
Conductivity: -- µS/cm	Benthic Growth:	None		
Detergents: -- mg/L	Stains:	None		
	Non-illicit:	None		
		<b>Condition Assessment</b> Graffiti: None Erosion: None Damage: None Deposition: None 0 in.

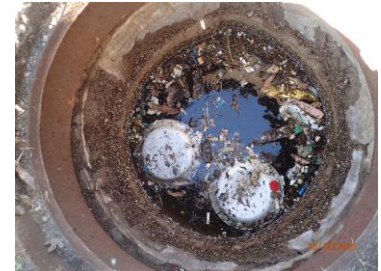
o20161010101916.JPG

Color: Clearly visible in bottle Brown

Gross Solids: Moderate ☒ Litter ☐ Debris ☐ Sediment ☐ OtherVegetation: None ☐ Inhibited ☐ ExcessiveBenthic Growth: None ☐ Green ☐ BrownStains: None ☐ Flow Line ☐ Oil ☐ Rust Stains☐ Paint ☐ OtherNon-illicit: None ☐ Natural Sheen ☐ Natural Suds/Foam

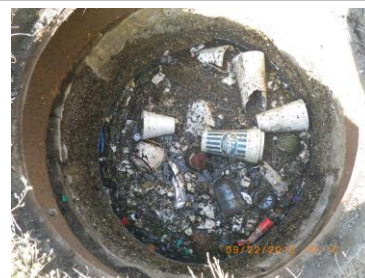
o20150922091040.JPG

<b>Inspection Date:</b> 9/22/2015 10:09:39 AM		<b>Type:</b> Ongoing	<b>Flow:</b> Submerged, indeterminate	<b>Previous Rainfall (hrs):</b> 72+
<b>Illicit Discharge Potential:</b> Potential		<b>Inspector:</b> JCW		
Submerged: Fully		Depth (in): 34		
<b>Sampling Results</b>		<b>Notes</b> Floating gross solids (litter) in manhole.		
Sample Location: Pool	Floatables: None	<b>Condition Assessment</b> Graffiti: None Erosion: None Damage: None Deposition: None in.		
Total Chlorine: 0 ppm	Odor: None			
Free Chlorine: 0 ppm	Turbidity: None			
Ammonia: 0 ppm	Color: None			
pH: 8.8 units	Gross Solids: Severe			
Temperature 70 °F	Vegetation: None			
Conductivity: 335 µS/cm	Benthic Growth: None			
Detergents: 0 mg/L	Stains: None			
	Non-illicit: None

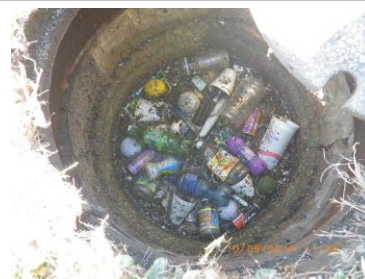
o20141009102622.JPG

<b>Inspection Date:</b> 10/9/2014 11:28:19 AM		<b>Type:</b> Ongoing	<b>Flow:</b> Submerged, indeterminate	<b>Previous Rainfall (hrs):</b> 72+
<b>Illicit Discharge Potential:</b> Potential		<b>Inspector:</b> JCW		
Submerged: Fully		Depth (in): 29		
<b>Sampling Results</b>		<b>Notes</b> Floating gross solids (litter) in manhole.		
Sample Location: Pool	Floatables: None	<b>Condition Assessment</b> Graffiti: None Erosion: None Damage: None Deposition: None in.		
Total Chlorine: 0 ppm	Odor: None			
Free Chlorine: 0 ppm	Turbidity: None			
Ammonia: 0 ppm	Color: Faint in bottle			
pH: 8.34 units	Gross Solids: Severe			
Temperature 57 °F	Vegetation: None			
Conductivity: 400 µS/cm	Benthic Growth: None			
Detergents: 0 mg/L	Stains: None			
	Non-illicit: None

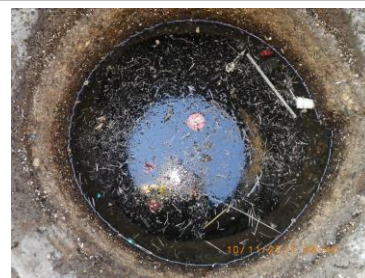
o20111011084038.JPG

<b>Inspection Date:</b> 10/11/2011 8:41:22 AM		<b>Type:</b> Ongoing	<b>Flow:</b> Submerged, indeterminate	<b>Previous Rainfall (hrs):</b> 72+
<b>Illicit Discharge Potential:</b> Unlikely		<b>Inspector:</b> JCW		
Submerged: Fully		Depth (in): 18		
<b>Sampling Results</b>		<b>Notes</b> 2010 screening follow-up. Floatable debris significantly reduced.		
Sample Location: Pool	Floatables: None	<b>Condition Assessment</b> Graffiti: None Erosion: None Damage: None Deposition: None 0 in.		
Total Chlorine: 0 ppm	Odor: None			
Free Chlorine: 0 ppm	Turbidity: None			
Ammonia: 0 ppm	Color: None			
pH: 8.11 units	Gross Solids: Slight			
Temperature 72 °F	Vegetation: None			
Conductivity: -- µS/cm	Benthic Growth: None			
Detergents: -- mg/L	Stains: None			
	Non-illicit: None

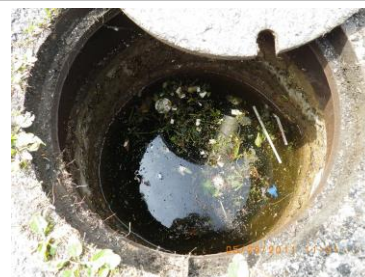
o20110526110156.JPG

<b>Inspection Date:</b> 5/26/2011 11:01:00 AM		<b>Type:</b> Other	<b>Flow:</b> Submerged, indeterminate	<b>Previous Rainfall (hrs):</b> 72+
<b>Illicit Discharge Potential:</b> Potential		<b>Inspector:</b> JCW		
Submerged: Fully		Depth (in):		
<b>Sampling Results</b>		<b>Notes</b> Limited screening conducted to check for floatable debris.		
Sample Location: --	Floatables: None	<b>Condition Assessment</b> Graffiti: None Erosion: None Damage: None Deposition: None 0 in.		
Total Chlorine: -- ppm	Odor: --			
Free Chlorine: -- ppm	Turbidity: --			
Ammonia: -- ppm	Color: --			
pH: -- units	Gross Solids: Moderate			
Temperature -- °F	Vegetation: --			
Conductivity: -- µS/cm	Benthic Growth: --			
Detergents: -- mg/L	Stains: --			
	Non-illicit: None

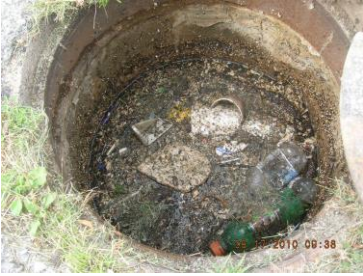
o20100817093838.JPG

<b>Inspection Date:</b> 8/17/2010 9:47:15 AM		<b>Type:</b> Ongoing		<b>Flow:</b> Submerged, indeterminate		<b>Previous Rainfall (hrs):</b> 72+	
<b>Illicit Discharge Potential:</b> Potential		<b>Inspector:</b> JCW		<b>Notes</b> Significant floatable debris in manhole.

Submerged: Fully		Depth (in): 31					
<b>Sampling Results</b>				<b>Condition Assessment</b>			
Sample Location: Pool		Floatables: None		Graffiti: None			
Total Chlorine: 0 ppm		Odor: None		Erosion: None			
Free Chlorine: 0 ppm		Turbidity: None		Damage: None			
Ammonia: 0 ppm		Color: Faint in bottle		Deposition: None		0 in.	
pH: 7.64 units		Gross Solids: Severe					
Temperature: 74 °F		Vegetation: None					
Conductivity: -- µS/cm		Benthic Growth: None					
Detergents: 0 mg/L		Stains: None					
		Non-illicit: None

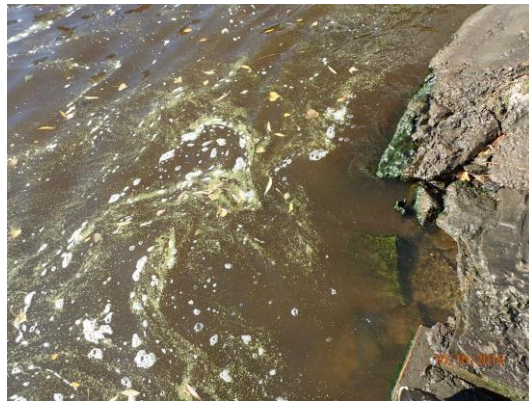
o20161010101240.JPG

Broad St storm sewer discharges to river from north. Outfall fully submerged and not physically located. GPS coordinates approximate. Pipe info from MS4 map.

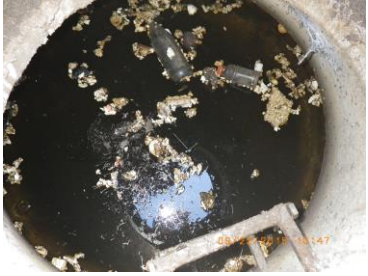
o20150922094746.JPG	
Submerged: Fully		Depth (in): 48		Floating gross solids (litter) in manhole.			
<b>Sampling Results</b>				<b>Condition Assessment</b>			
Sample Location:	Pool	Floatables:	None	Graffiti:	None	Erosion:	None
Total Chlorine:	0 ppm	Odor:	None	Damage:	None	Deposition:	None in.
Free Chlorine:	0 ppm	Turbidity:	None				
Ammonia:	0 ppm	Color:	None				
pH:	8.33 units	Gross Solids:	Moderate				
Temperature:	73 °F	Vegetation:	None				
Conductivity:	352 µS/cm	Benthic Growth:	None				
Detergents:	0 mg/L	Stains:	None				
		Non-illicit:	None

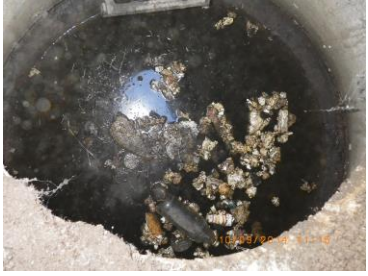
o20141009101552.JPG	
Submerged: Fully		Depth (in): 43		Floating gross solids (litter) in manhole.			
<b>Sampling Results</b>				<b>Condition Assessment</b>			
Sample Location:	Pool	Floatables:	None	Graffiti:	None	Erosion:	None
Total Chlorine:	0 ppm	Odor:	None	Damage:	None	Deposition:	None in.
Free Chlorine:	0 ppm	Turbidity:	None				
Ammonia:	0 ppm	Color:	None				
pH:	7.67 units	Gross Solids:	Moderate				
Temperature:	59 °F	Vegetation:	None				
Conductivity:	422 µS/cm	Benthic Growth:	None				
Detergents:	0 mg/L	Stains:	None				
		Non-illicit:	None

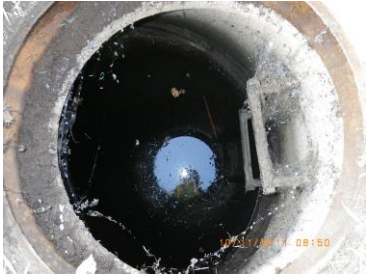
o20111011085018.JPG	
Submerged: Fully		Depth (in): 43		2010 screening follow-up. Floatable debris significantly reduced.			
<b>Sampling Results</b>				<b>Condition Assessment</b>			
Sample Location:	Pool	Floatables:	None	Graffiti:	None	Erosion:	None
Total Chlorine:	0 ppm	Odor:	None	Damage:	None	Deposition:	None 0 in.
Free Chlorine:	0 ppm	Turbidity:	None				
Ammonia:	0 ppm	Color:	Faint in bottle				
pH:	7.87 units	Gross Solids:	Slight				
Temperature:	71 °F	Vegetation:	None				
Conductivity:	-- µS/cm	Benthic Growth:	None				
Detergents:	-- mg/L	Stains:	None				
		Non-illicit:	None

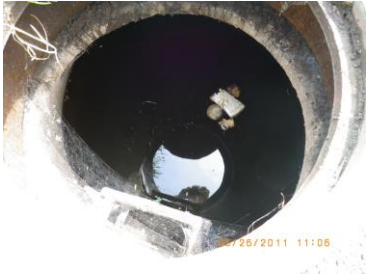
o20110526110604.JPG	
Submerged: Fully		Depth (in):		Limited screening conducted to check for floatable debris.			
<b>Sampling Results</b>				<b>Condition Assessment</b>			
Sample Location:		Floatables:	None	Graffiti:	None	Erosion:	None
Total Chlorine:	-- ppm	Odor:		Damage:	None	Deposition:	None 0 in.
Free Chlorine:	-- ppm	Turbidity:					
Ammonia:	-- ppm	Color:					
pH:	-- units	Gross Solids:	Slight				
Temperature:	-- °F	Vegetation:					
Conductivity:	-- µS/cm	Benthic Growth:					
Detergents:	-- mg/L	Stains:					
		Non-illicit:	None

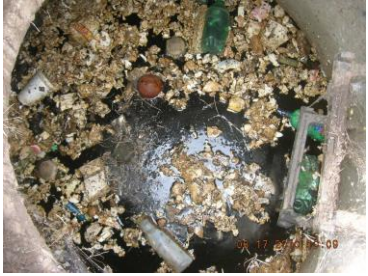
<b>Inspection Date:</b> 8/17/2010 10:17:46 AM		<b>Type:</b> Ongoing		<b>Flow:</b> Submerged, indeterminate		<b>Previous Rainfall (hrs):</b> 72+	
<b>Illicit Discharge Potential:</b> Potential		<b>Inspector:</b> JCW		<b>Notes</b> Significant floatable debris in manhole.

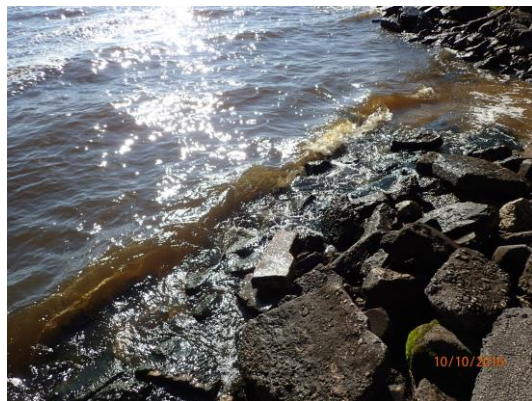
o20161010104146.JPG

Ceape Ave storm sewer discharges to lake from west. Outfall fully submerged and not physically located. GPS coordinates approximate. Pipe info from MS4 map.

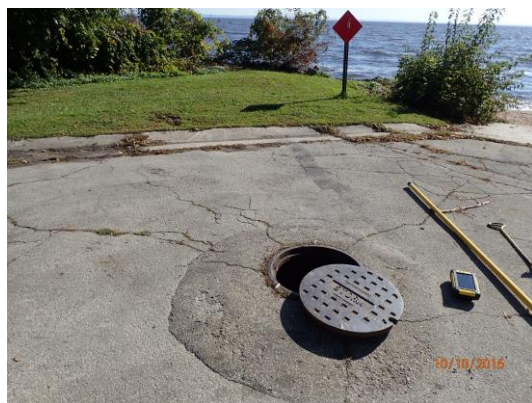
o20161010104300.JPG

Upstream manhole located approx 62 ft WNW of outfall 08-364. Intermediate area consists of street right-of-way.

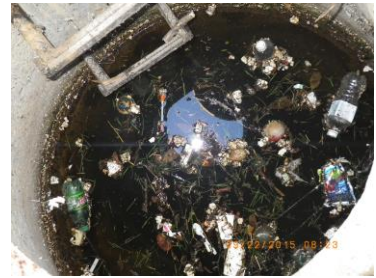
<b>Inspection Date:</b> 9/22/2015 8:19:00 AM		<b>Type:</b> Ongoing	<b>Flow:</b> Submerged, indeterminate	<b>Previous Rainfall (hrs):</b> 72+
<b>Illicit Discharge Potential:</b> Potential		<b>Inspector:</b> JCW		
Submerged: Fully		Depth (in): 36		
<b>Sampling Results</b>		<b>Notes</b> Floating gross solids (litter) - including syringe - in manhole.		
Sample Location: Pool	Floatables: None	<b>Condition Assessment</b> Graffiti: None Erosion: None Damage: None Deposition: None in.		
Total Chlorine: 0 ppm	Odor: None			
Free Chlorine: 0 ppm	Turbidity: None			
Ammonia: 0 ppm	Color: None			
pH: 7.85 units	Gross Solids: Moderate			
Temperature 67 °F	Vegetation: None			
Conductivity: 515 µS/cm	Benthic Growth: Slight			
Detergents: 0 mg/L	Stains: None			
	Non-illicit: None

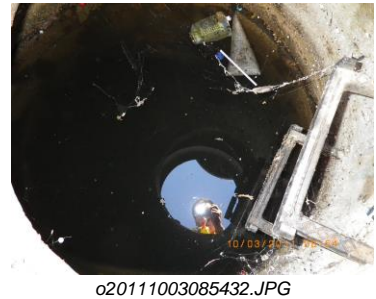
<b>Inspection Date:</b> 10/3/2011 8:58:48 AM		<b>Type:</b> Ongoing	<b>Flow:</b> Submerged, indeterminate	<b>Previous Rainfall (hrs):</b> 72+
<b>Illicit Discharge Potential:</b> Unlikely		<b>Inspector:</b> JCW		
Submerged: Fully		Depth (in): 35		
<b>Sampling Results</b>		<b>Notes</b> Sweet odor in sample bottle.		
Sample Location: Pool	Floatables: None	<b>Condition Assessment</b> Graffiti: None Erosion: None Damage: None Deposition: None 0 in.		
Total Chlorine: 0 ppm	Odor: Faint			
Free Chlorine: 0 ppm	Turbidity: None			
Ammonia: 0 ppm	Color: None			
pH: 7.2 units	Gross Solids: Slight			
Temperature 61 °F	Vegetation: None			
Conductivity: -- µS/cm	Benthic Growth: None			
Detergents: 0 mg/L	Stains: None			
	Non-illicit: None

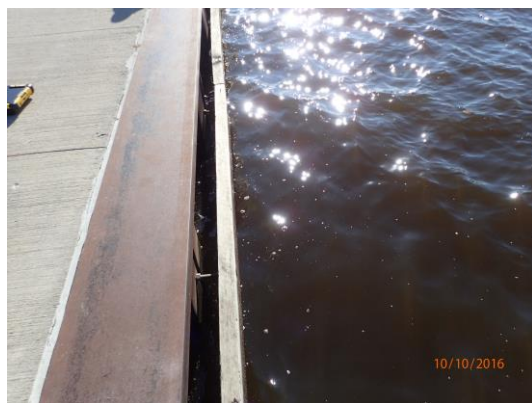
o20161010100204.JPG

Storm sewer from parking lot discharges to river from north. Outfall fully submerged and not physically located. GPS coordinates approximate. Pipe info from MS4 map.

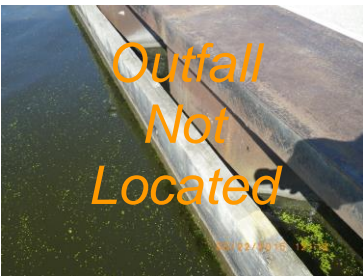
<p>o20150922111358.JPG</p>																																									
Submerged: Fully		Depth (in):		Outfall under walkway and not located - screened at 08-937 US1.																																											
<b>Sampling Results</b> <table border="1"> <tr> <td>Sample Location:</td> <td></td> <td>Floatables:</td> <td>None</td> </tr> <tr> <td>Total Chlorine:</td> <td>-- ppm</td> <td>Odor:</td> <td>None</td> </tr> <tr> <td>Free Chlorine:</td> <td>-- ppm</td> <td>Turbidity:</td> <td>None</td> </tr> <tr> <td>Ammonia:</td> <td>-- ppm</td> <td>Color:</td> <td>None</td> </tr> <tr> <td>pH:</td> <td>-- units</td> <td>Gross Solids:</td> <td>None</td> </tr> <tr> <td>Temperature:</td> <td>-- °F</td> <td>Vegetation:</td> <td>None</td> </tr> <tr> <td>Conductivity:</td> <td>-- µS/cm</td> <td>Benthic Growth:</td> <td>None</td> </tr> <tr> <td>Detergents:</td> <td>-- mg/L</td> <td>Stains:</td> <td>None</td> </tr> <tr> <td></td> <td></td> <td>Non-illicit:</td> <td>None</td> </tr> </table>		Sample Location:		Floatables:	None			Total Chlorine:	-- ppm	Odor:	None	Free Chlorine:	-- ppm	Turbidity:	None	Ammonia:	-- ppm	Color:	None	pH:	-- units	Gross Solids:	None	Temperature:	-- °F	Vegetation:	None	Conductivity:	-- µS/cm	Benthic Growth:	None	Detergents:	-- mg/L	Stains:	None			Non-illicit:	None	<b>Condition Assessment</b> <table border="1"> <tr> <td>Graffiti:</td> <td>None</td> </tr> <tr> <td>Erosion:</td> <td>None</td> </tr> <tr> <td>Damage:</td> <td>None</td> </tr> <tr> <td>Deposition:</td> <td>None in.</td> </tr> </table>		Graffiti:	None	Erosion:	None	Damage:	None

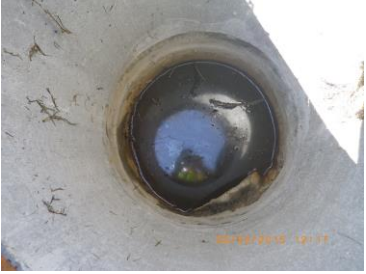
o20150922111710.JPG

<b>Notes</b> Cloudy sheen - did not appear to be typical bacterial sheen.

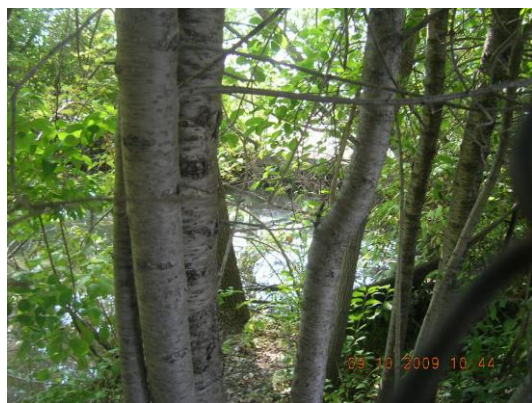
Osh09\_DSCN6774.JPG

Outfall not physically screened - behind fence. May consist of three outfalls within one concrete box culvert.

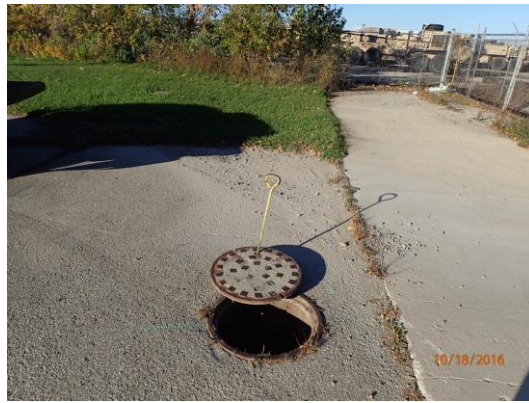
o20161018161526.JPG

Upstream manhole located approx 292 ft SSW of outfall 09-101a. Intermediate area consists of gravel parking area for industrial property.

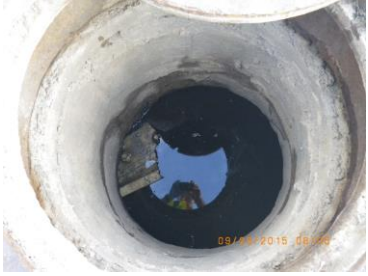
<p style="text-align: center;">o20150923070520.JPG</p>

Sample Location:	Pool	Floatables:	None																																													
Total Chlorine:	0 ppm	Odor:	None																																													
Free Chlorine:	0 ppm	Turbidity:	Slight cloudiness																																													
Ammonia:	0 ppm	Color:	None																																													
pH:	7.93 units	Gross Solids:	Slight																																													
Temperature	70 °F	Vegetation:	None																																													
Conductivity:	1112 µS/cm	Benthic Growth:	None																																													
Detergents:	0 mg/L	Stains:	None																																													
		Non-illicit:	None																																													
Graffiti:	None																																															
Erosion:	None																																															
Damage:	None																																															
Deposition:	None in.

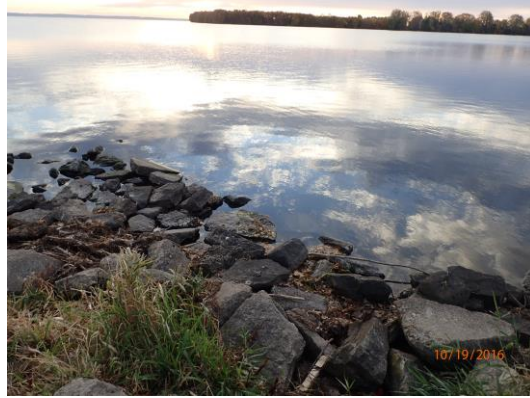
o20161019074236.JPG

Baldwin Ave storm sewer discharges to lake from west. Outfall fully submerged and not physically located. GPS coordinates approximate. Pipe info from MS4 map.

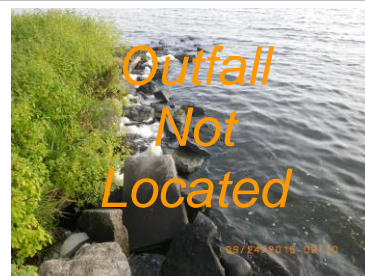
o20150924081044.JPG

<b>Inspection Date:</b> 9/24/2015 9:06:24 AM		<b>Type:</b> Ongoing	<b>Flow:</b> Submerged (not located)	<b>Previous Rainfall (hrs):</b> 72+
<b>Illicit Discharge Potential:</b> Potential		<b>Inspector:</b> JCW	<b>Notes</b>	
<b>Submerged:</b> Fully <b>Depth (in):</b>			Outfall fully submerged and not located - screened at 11-376 US1.	
<b>Sampling Results</b>		<b>Floatables:</b> None	<b>Condition Assessment</b> Graffiti: None Erosion: None Damage: None Deposition: None in.	
<b>Sample Location:</b>		<b>Odor:</b> None		
<b>Total Chlorine:</b> -- ppm		<b>Turbidity:</b> None		
<b>Free Chlorine:</b> -- ppm		<b>Color:</b> None		
<b>Ammonia:</b> -- ppm		<b>Gross Solids:</b> None		
<b>pH:</b> -- units		<b>Vegetation:</b> None		
<b>Temperature:</b> -- °F		<b>Benthic Growth:</b> None		
<b>Conductivity:</b> -- µS/cm		<b>Stains:</b> None		
<b>Detergents:</b> -- mg/L		<b>Non-illicit:</b> Moderate

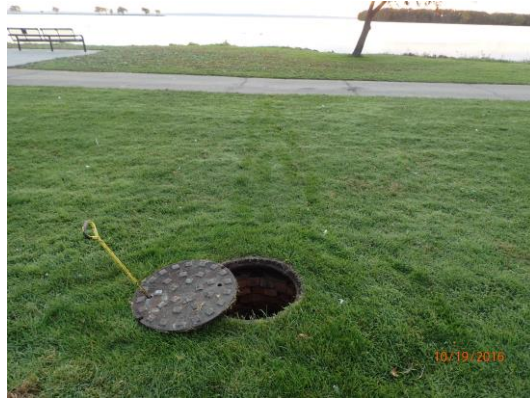
o20161019074402.JPG

Upstream manhole located approx 82 ft W of outfall 11-376. Intermediate area consists of open space in park.

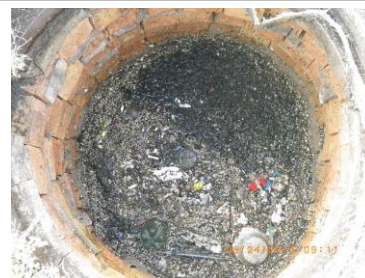
o20150924081150.JPG

<b>Inspection Date:</b> 9/24/2015 9:10:22 AM		<b>Type:</b> Ongoing	<b>Flow:</b> Submerged, indeterminate	<b>Previous Rainfall (hrs):</b> 72+
<b>Illicit Discharge Potential:</b> Potential		<b>Inspector:</b> JCW		
Submerged: Fully		Depth (in): 81		
<b>Sampling Results</b>		<b>Notes</b> Floating gross solids (litter) in manhole.		
Sample Location: Pool	Floatables: None	<b>Condition Assessment</b> Graffiti: None Erosion: None Damage: None Deposition: None in.		
Total Chlorine: 0 ppm	Odor: Faint			
Free Chlorine: 0 ppm	Turbidity: None			
Ammonia: 0 ppm	Color: None			
pH: 7.88 units	Gross Solids: Severe			
Temperature 68 °F	Vegetation: None			
Conductivity: 397 µS/cm	Benthic Growth: None			
Detergents: 0 mg/L	Stains: None			
	Non-illicit: None

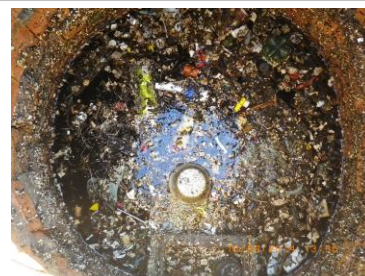
o20141009123616.JPG

<b>Inspection Date:</b> 10/9/2014 1:36:18 PM		<b>Type:</b> Ongoing	<b>Flow:</b> Submerged, indeterminate	<b>Previous Rainfall (hrs):</b> 72+
<b>Illicit Discharge Potential:</b> Potential		<b>Inspector:</b> JCW		
Submerged: Fully		Depth (in): 74		
<b>Sampling Results</b>		<b>Notes</b> Floating gross solids (litter) in manhole.		
Sample Location: Pool	Floatables: None	<b>Condition Assessment</b> Graffiti: None Erosion: None Damage: None Deposition: None in.		
Total Chlorine: 0 ppm	Odor: None			
Free Chlorine: 0 ppm	Turbidity: None			
Ammonia: 0 ppm	Color: Faint in bottle			
pH: 7.76 units	Gross Solids: Severe			
Temperature 59 °F	Vegetation: None			
Conductivity: 381 µS/cm	Benthic Growth: None			
Detergents: 0 mg/L	Stains: None			
	Non-illicit: None

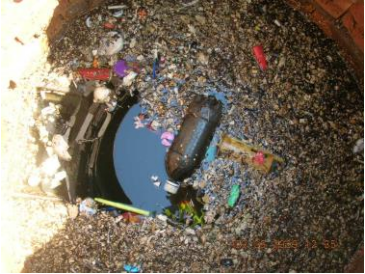
<b>Inspection Date:</b> 9/8/2009		<b>Type:</b> Initial		<b>Flow:</b> Submerged, indeterminate		<b>Previous Rainfall (hrs):</b> 72+	
<b>Illicit Discharge Potential:</b> Potential		<b>Inspector:</b> JCW		<b>Notes</b> Abnormal detergent analysis result (bubbles). Significant floating debris in manhole.

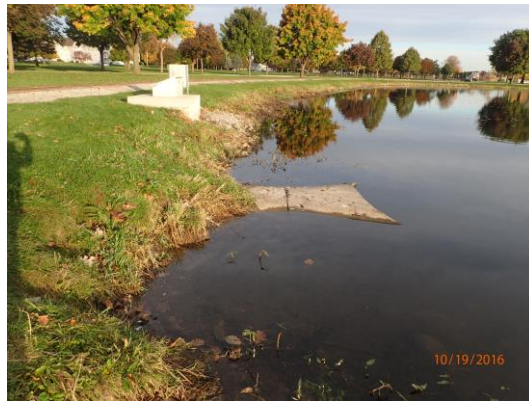
o20161019080722.JPG

Storm sewer from E Parkway Ave discharges to lake from west. Pipe specs updated in 2011.

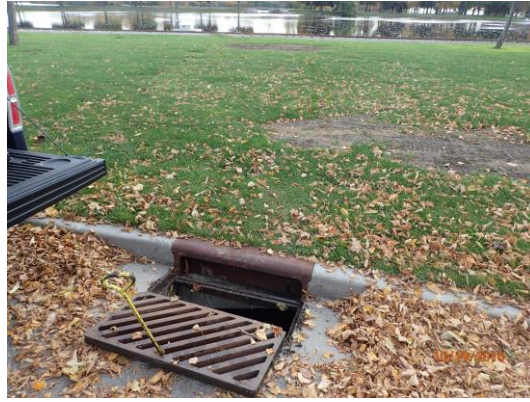
o20161019080940.JPG

Upstream curb inlet located approx 108 ft SW of outfall 11-400. Intermediate area consists of open space.

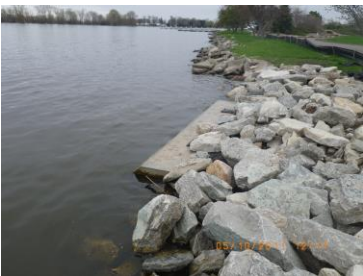
<b>Inspection Date:</b> 5/10/2011 12:17:00 PM		<b>Type:</b> Other		<b>Flow:</b> Submerged, indeterminate		<b>Previous Rainfall (hrs):</b> 0-24	
<b>Illicit Discharge Potential:</b> Unlikely		<b>Inspector:</b> JCW		<b>Notes</b> Outfall fully submerged. Outfall screened upstream at 11-465a US1.

o20110510121750.JPG	
Submerged: Fully		Depth (in):					
<b>Sampling Results</b> Sample Location: Total Chlorine: -- ppm Free Chlorine: -- ppm Ammonia: -- ppm pH: -- units Temperature: -- °F Conductivity: -- µS/cm Detergents: -- mg/L		Floatables: Odor: Turbidity: Color: Gross Solids: Vegetation: Benthic Growth: Stains: Non-illicit: None		<b>Condition Assessment</b> Graffiti: None Erosion: None Damage: None Deposition: None 0 in.

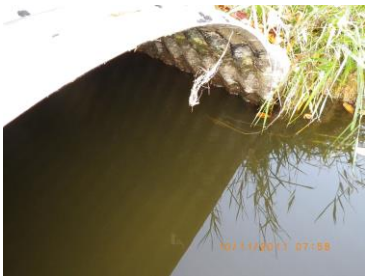
<b>Inspection Date:</b> 10/11/2011 7:59:34 AM		<b>Type:</b> Ongoing	<b>Flow:</b> Submerged, indeterminate	<b>Previous Rainfall (hrs):</b> 72+
<b>Illicit Discharge Potential:</b> Unlikely		<b>Inspector:</b> JCW		
Submerged: Partially      Depth (in): 19				
<b>Sampling Results</b> Sample Location: Total Chlorine: -- ppm Free Chlorine: -- ppm Ammonia: -- ppm pH: -- units Temperature: -- °F Conductivity: -- µS/cm Detergents: -- mg/L		Floatables: None Odor: None Turbidity: None Color: None Gross Solids: None Vegetation: None Benthic Growth: Moderate Stains: Slight Non-illicit: None	<b>Notes</b> Outfall partially submerged. Outfall screened upstream at 11-479 US1.

o20111011075834.JPG
		<b>Condition Assessment</b> Graffiti: None Erosion: None Damage: Minor Deposition: None      0 in.

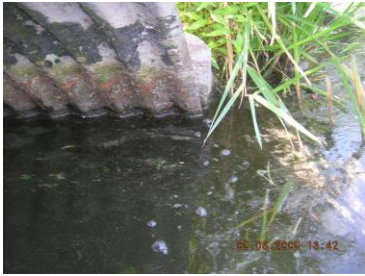
<b>Inspection Date:</b> 9/8/2009		<b>Type:</b> Initial	<b>Flow:</b> Submerged, indeterminate	<b>Previous Rainfall (hrs):</b> 72+
<b>Illicit Discharge Potential:</b> Unlikely		<b>Inspector:</b> JCW		
Submerged: Partially      Depth (in): 21				
<b>Sampling Results</b> Sample Location: Total Chlorine: -- ppm Free Chlorine: -- ppm Ammonia: -- ppm pH: -- units Temperature: -- °F Conductivity: -- µS/cm Detergents: -- mg/L		Floatables: Odor: Turbidity: Color: Gross Solids: Vegetation: Benthic Growth: Slight Stains: Non-illicit: None	<b>Notes</b>

Osh09_DSCN6639.JPG
		<b>Condition Assessment</b> Graffiti: None Erosion: None Damage: Minor Deposition: None      0 in.
