# Ongoing Screening Summary Report 2016 Inspection Year

Illicit Discharge Detection and Elimination Program

City of Oshkosh

November 30, 2016

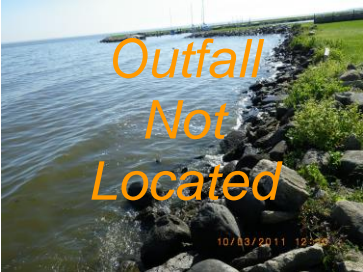
<b>Inspection Date:</b> 10/3/2011 12:09:11 PM		<b>Type:</b> Ongoing		<b>Flow:</b> Submerged (not located)		<b>Previous Rainfall (hrs):</b> 72+	
<b>Illicit Discharge Potential:</b> Potential		<b>Inspector:</b> JCW		<b>Notes</b> Outfall fully submerged and not physically located. Outfall screened upstream at 11-512 US1.

o20111003121010.JPG	
Submerged: Fully		Depth (in):					
<b>Sampling Results</b> Sample Location: Total Chlorine: -- ppm Free Chlorine: -- ppm Ammonia: -- ppm pH: -- units Temperature: -- °F Conductivity: -- µS/cm Detergents: -- mg/L		Floatables: None Odor: None Turbidity: None Color: None Gross Solids: None Vegetation: None Benthic Growth: None Stains: None Non-illicit: None		<b>Condition Assessment</b> Graffiti: None Erosion: None Damage: None Deposition: None 0 in.

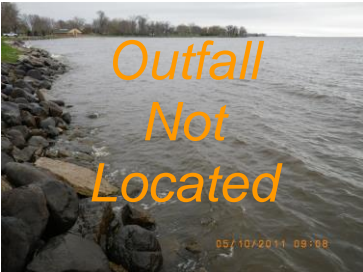
<b>Inspection Date:</b> 5/10/2011 9:08:00 AM		<b>Type:</b> Other		<b>Flow:</b> Submerged (not located)		<b>Previous Rainfall (hrs):</b> 0-24	
<b>Illicit Discharge Potential:</b> Potential		<b>Inspector:</b> JCW		<b>Notes</b> Outfall fully submerged and not physically located. Outfall screened upstream at 11-512 US1.

o20110510090810.JPG	
Submerged: Fully		Depth (in):					
<b>Sampling Results</b> Sample Location: Total Chlorine: -- ppm Free Chlorine: -- ppm Ammonia: -- ppm pH: -- units Temperature: -- °F Conductivity: -- µS/cm Detergents: -- mg/L		Floatables: Odor: Turbidity: Color: Gross Solids: Vegetation: Benthic Growth: Stains: Non-illicit: None		<b>Condition Assessment</b> Graffiti: None Erosion: None Damage: None Deposition: None 0 in.

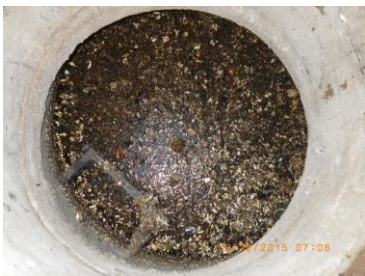
<b>Inspection Date:</b> 9/22/2015 7:04:46 AM		<b>Type:</b> Ongoing		<b>Flow:</b> Submerged, indeterminate		<b>Previous Rainfall (hrs):</b> 72+	
<b>Illicit Discharge Potential:</b> Potential		<b>Inspector:</b> JCW		<b>Notes</b>

o20150922060832.JPG	
Submerged: Fully		Depth (in): 37		Floating gross solids (litter) in manhole.			
<b>Sampling Results</b>				<b>Condition Assessment</b>			
Sample Location: Pool		Floatables: None		Graffiti: None			
Total Chlorine: 0 ppm		Odor: None		Erosion: None			
Free Chlorine: 0 ppm		Turbidity: None		Damage: None			
Ammonia: 0 ppm		Color: None		Deposition: None in.			
pH: 7.93 units		Gross Solids: Moderate					
Temperature: 65 °F		Vegetation: None					
Conductivity: 1055 µS/cm		Benthic Growth: None					
Detergents: 0 mg/L		Stains: None					
		Non-illicit: None

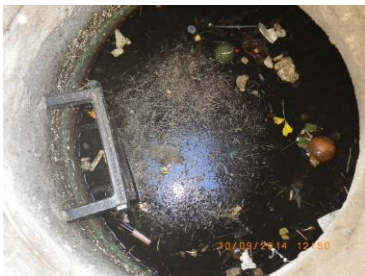
o20141009115024.JPG	
Submerged: Fully		Depth (in): 39		Floating gross solids (litter) in manhole.			
<b>Sampling Results</b>				<b>Condition Assessment</b>			
Sample Location: Pool		Floatables: None		Graffiti: None			
Total Chlorine: 0 ppm		Odor: None		Erosion: None			
Free Chlorine: 0 ppm		Turbidity: Slight cloudiness		Damage: None			
Ammonia: 0 ppm		Color: None		Deposition: None in.			
pH: 7.57 units		Gross Solids: Moderate					
Temperature: 62 °F		Vegetation: None					
Conductivity: 548 µS/cm		Benthic Growth: Slight					
Detergents: 0 mg/L		Stains: None					
		Non-illicit: None

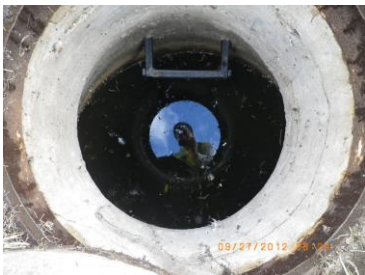
o20120927072438.JPG	
Submerged: Fully		Depth (in): 34		2011 gross solids follow-up.			
<b>Sampling Results</b>				<b>Condition Assessment</b>			
Sample Location: Pool		Floatables: None		Graffiti: None			
Total Chlorine: 0 ppm		Odor: None		Erosion: None			
Free Chlorine: 0 ppm		Turbidity: None		Damage: None			
Ammonia: 0 ppm		Color: None		Deposition: None in.			
pH: 8.73 units		Gross Solids: Slight					
Temperature: 59 °F		Vegetation: None					
Conductivity: 416 µS/cm		Benthic Growth: Slight					
Detergents: 0 mg/L		Stains: Slight					
		Non-illicit: None

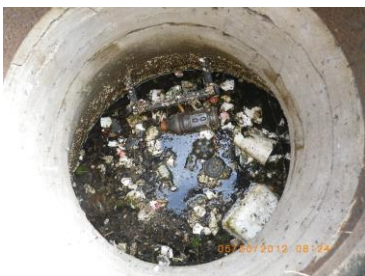
o20120620072408.JPG	
Submerged: Fully		Depth (in): 40		Gross solids pre-screening.			
<b>Sampling Results</b>				<b>Condition Assessment</b>			
Sample Location: --		Floatables: None		Graffiti: None			
Total Chlorine: -- ppm		Odor: None		Erosion: None			
Free Chlorine: -- ppm		Turbidity: None		Damage: None			
Ammonia: -- ppm		Color: None		Deposition: None in.			
pH: -- units		Gross Solids: Severe					
Temperature: -- °F		Vegetation: None					
Conductivity: -- µS/cm		Benthic Growth: None					
Detergents: -- mg/L		Stains: None					
		Non-illicit: None

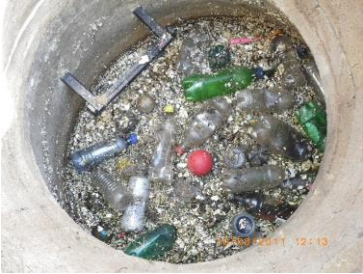
o20111003121302.JPG

Floatables:	None	Odor:	None	Turbidity:	None	Color:	None	Gross Solids:	Severe	Vegetation:	None	Benthic Growth:	None	Stains:	None	Non-illicit:	None
Floatables:	None																					
Odor:	None																					
Turbidity:	None																					
Color:	None																					
Gross Solids:	Severe																					
Vegetation:	None																					
Benthic Growth:	None																					
Stains:	None																					
Non-illicit:	None																					
		<b>Notes</b> Significant floatable debris in manhole.																				
		<b>Condition Assessment</b> Graffiti: None Erosion: None Damage: None Deposition: None 0 in.

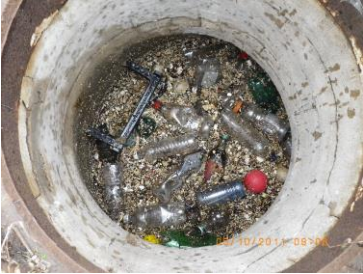
o20110510090830.JPG

Floatables:	None	Odor:		Turbidity:		Color:		Gross Solids:	Severe	Vegetation:		Benthic Growth:		Stains:		Non-illicit:	None
Floatables:	None																					
Odor:																						
Turbidity:																						
Color:																						
Gross Solids:	Severe																					
Vegetation:																						
Benthic Growth:																						
Stains:																						
Non-illicit:	None																					
		<b>Notes</b> Limited screening conducted for upstream manhole prescreening.																				
		<b>Condition Assessment</b> Graffiti: None Erosion: None Damage: None Deposition: None 0 in.

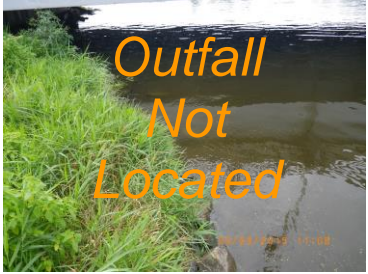
<b>Inspection Date:</b> 9/23/2015 11:06:02 AM		<b>Type:</b> Ongoing	<b>Flow:</b> Submerged (not located)	<b>Previous Rainfall (hrs):</b> 72+
<b>Illicit Discharge Potential:</b> Potential		<b>Inspector:</b> JCW		
Submerged: Fully		Depth (in):		
<b>Sampling Results</b> Sample Location: Total Chlorine: -- ppm Free Chlorine: -- ppm Ammonia: -- ppm pH: -- units Temperature: -- °F Conductivity: -- µS/cm Detergents: -- mg/L		Floatables: None Odor: None Turbidity: None Color: None Gross Solids: None Vegetation: None Benthic Growth: None Stains: None Non-illicit: None	<b>Notes</b> Outfall fully submerged and not located - screened at 12-569 US1.

o20150923100828.JPG
			<b>Condition Assessment</b> Graffiti: Moderate Erosion: None Damage: None Deposition: None in.

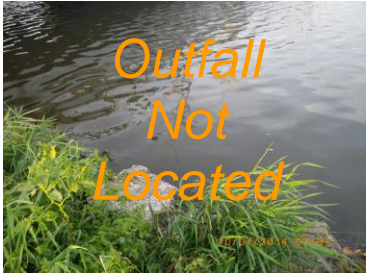
<b>Inspection Date:</b> 10/7/2014 7:38:26 AM		<b>Type:</b> Ongoing	<b>Flow:</b> Submerged (not located)	<b>Previous Rainfall (hrs):</b> 48-72
<b>Illicit Discharge Potential:</b> Potential		<b>Inspector:</b> JCW		
Submerged: Fully		Depth (in):		
<b>Sampling Results</b> Sample Location: Total Chlorine: -- ppm Free Chlorine: -- ppm Ammonia: -- ppm pH: -- units Temperature: -- °F Conductivity: -- µS/cm Detergents: -- mg/L		Floatables: None Odor: None Turbidity: None Color: None Gross Solids: None Vegetation: None Benthic Growth: None Stains: None Non-illicit: None	<b>Notes</b> Outfall fully submerged and not located - screened upstream at 12-569 US1. Graffiti on east abutment.

o20141007063712.JPG
			<b>Condition Assessment</b> Graffiti: Moderate Erosion: None Damage: None Deposition: None in.

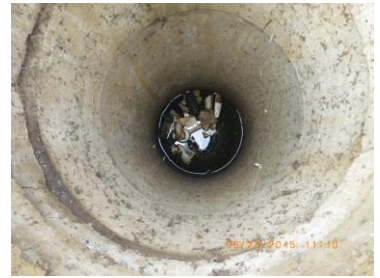
o20150923101026.JPG

<b>Inspection Date:</b> 9/23/2015 11:06:51 AM		<b>Type:</b> Ongoing	<b>Flow:</b> Submerged, indeterminate	<b>Previous Rainfall (hrs):</b> 72+
<b>Illicit Discharge Potential:</b> Potential		<b>Inspector:</b> JCW		
Submerged: Fully		Depth (in): 40		
<b>Sampling Results</b>		<b>Notes</b> Floating gross solids (litter) in manhole.		
Sample Location: Pool	Floatables: None	<b>Condition Assessment</b> Graffiti: None Erosion: None Damage: None Deposition: None in.		
Total Chlorine: 0 ppm	Odor: None			
Free Chlorine: 0 ppm	Turbidity: None			
Ammonia: 0 ppm	Color: None			
pH: 7.5 units	Gross Solids: Moderate			
Temperature 76 °F	Vegetation: None			
Conductivity: 441 µS/cm	Benthic Growth: Slight			
Detergents: 0 mg/L	Stains: None			
	Non-illicit: None

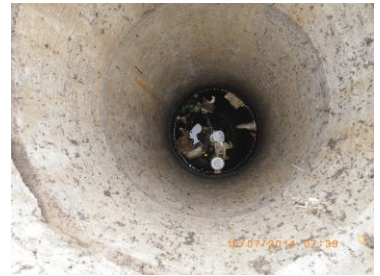
o20141007063948.JPG

<b>Inspection Date:</b> 10/7/2014 7:39:34 AM		<b>Type:</b> Ongoing	<b>Flow:</b> Submerged, indeterminate	<b>Previous Rainfall (hrs):</b> 48-72
<b>Illicit Discharge Potential:</b> Potential		<b>Inspector:</b> JCW		
Submerged: Fully		Depth (in): 34		
<b>Sampling Results</b>		<b>Notes</b> Floating gross solids (litter) in manhole.		
Sample Location: Pool	Floatables: None	<b>Condition Assessment</b> Graffiti: None Erosion: None Damage: None Deposition: None in.		
Total Chlorine: 0 ppm	Odor: None			
Free Chlorine: 0 ppm	Turbidity: None			
Ammonia: 0 ppm	Color: None			
pH: 7.66 units	Gross Solids: Moderate			
Temperature 59 °F	Vegetation: None			
Conductivity: 771 µS/cm	Benthic Growth: None			
Detergents: 0 mg/L	Stains: None			
	Non-illicit: None

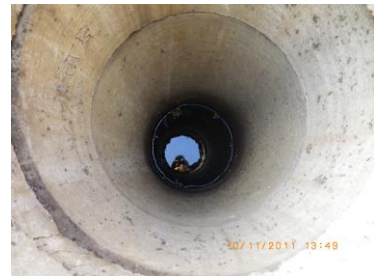
o20111011134946.JPG

<b>Inspection Date:</b> 10/11/2011 1:51:24 PM		<b>Type:</b> Ongoing	<b>Flow:</b> Submerged, indeterminate	<b>Previous Rainfall (hrs):</b> 72+
<b>Illicit Discharge Potential:</b> Unlikely		<b>Inspector:</b> JCW		
Submerged: Fully		Depth (in): 32		
<b>Sampling Results</b>		<b>Notes</b> 2010 screening follow-up. Floatable debris significantly reduced.		
Sample Location: Pool	Floatables: None	<b>Condition Assessment</b> Graffiti: None Erosion: None Damage: None Deposition: None 0 in.		
Total Chlorine: 0 ppm	Odor: None			
Free Chlorine: 0 ppm	Turbidity: None			
Ammonia: 0 ppm	Color: None			
pH: 8.63 units	Gross Solids: None			
Temperature 73 °F	Vegetation: None			
Conductivity: -- µS/cm	Benthic Growth: None			
Detergents: -- mg/L	Stains: None			
	Non-illicit: None

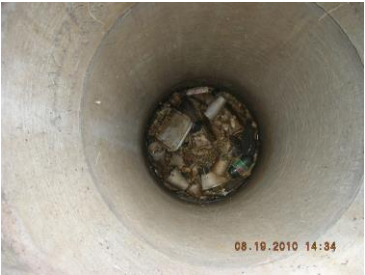
o20100819143434.JPG

<b>Inspection Date:</b> 8/19/2010 2:41:43 PM		<b>Type:</b> Ongoing	<b>Flow:</b> Submerged, indeterminate	<b>Previous Rainfall (hrs):</b> 72+
<b>Illicit Discharge Potential:</b> Potential		<b>Inspector:</b> JCW		<b>Notes</b> Severe floatable debris
Submerged: Fully		Depth (in): 38		
<b>Sampling Results</b> Sample Location: Pool Total Chlorine: 0 ppm Free Chlorine: 0 ppm Ammonia: 0 ppm pH: 7.59 units Temperature: 79 °F Conductivity: -- µS/cm Detergents: 0 mg/L		Floatables: None Odor: None Turbidity: None Color: Faint in bottle Gross Solids: Severe Vegetation: None Benthic Growth: None Stains: Slight Non-illicit: None		
		<b>Condition Assessment</b> Graffiti: None Erosion: None Damage: None Deposition: None 0 in.

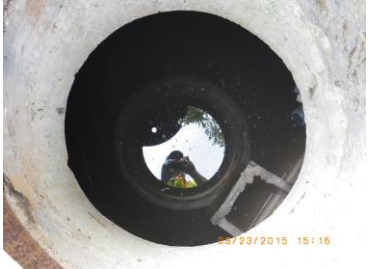
o20150923141608.JPG

<b>Inspection Date:</b> 9/23/2015 3:14:15 PM	<b>Type:</b> Ongoing	<b>Flow:</b> Submerged, indeterminate	<b>Previous Rainfall (hrs):</b> 72+
<b>Illicit Discharge Potential:</b> Unlikely	<b>Inspector:</b> JCW	<b>Notes</b>	
<b>Submerged:</b> Fully	<b>Depth (in):</b> 70		
<b>Sampling Results</b>		<b>Condition Assessment</b>	
Sample Location: Pool	Floatables: None	Graffiti: None	
Total Chlorine: 0 ppm	Odor: None	Erosion: None	
Free Chlorine: 0 ppm	Turbidity: None	Damage: None	
Ammonia: 0 ppm	Color: None	Deposition: None	in.
pH: 8.45 units	Gross Solids: Slight		
Temperature 75 °F	Vegetation: None		
Conductivity: 361 µS/cm	Benthic Growth: Slight		
Detergents: 0 mg/L	Stains: None		
	Non-illicit: None

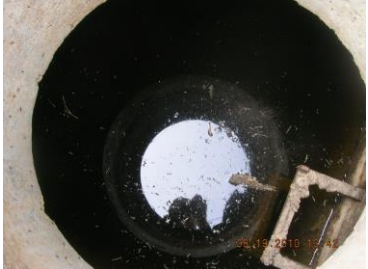
o20100819134200.JPG

<b>Inspection Date:</b> 8/19/2010 1:50:40 PM	<b>Type:</b> Ongoing	<b>Flow:</b> Submerged, indeterminate	<b>Previous Rainfall (hrs):</b> 72+
<b>Illicit Discharge Potential:</b> Unlikely	<b>Inspector:</b> JCW	<b>Notes</b>	
<b>Submerged:</b> Fully	<b>Depth (in):</b> 72		
<b>Sampling Results</b>		<b>Condition Assessment</b>	
Sample Location: Pool	Floatables: None	Graffiti: None	
Total Chlorine: 0 ppm	Odor: None	Erosion: None	
Free Chlorine: 0 ppm	Turbidity: None	Damage: None	
Ammonia: 0 ppm	Color: Faint in bottle	Deposition: None	0 in.
pH: 7.85 units	Gross Solids: None		
Temperature 76 °F	Vegetation: None		
Conductivity: -- µS/cm	Benthic Growth: Moderate		
Detergents: 0 mg/L	Stains: Slight		
	Non-illicit: None

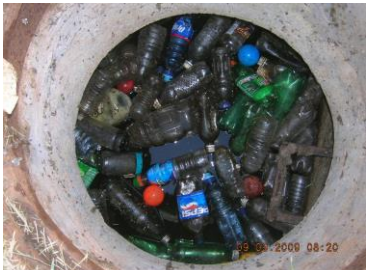
Osh09\_DSCN6675.JPG

<b>Inspection Date:</b> 9/9/2009	<b>Type:</b> Initial	<b>Flow:</b> Submerged, indeterminate	<b>Previous Rainfall (hrs):</b> 72+
<b>Illicit Discharge Potential:</b> Potential	<b>Inspector:</b> JCW	<b>Notes</b>	
<b>Submerged:</b> Fully	<b>Depth (in):</b> 68	Abnormal detergent analysis result (bubbles). Significant floatables (bottles) in manhole.	
<b>Sampling Results</b>		<b>Condition Assessment</b>	
Sample Location: Pool	Floatables: None	Graffiti: None	
Total Chlorine: 0 ppm	Odor: None	Erosion: None	
Free Chlorine: 0 ppm	Turbidity: None	Damage: None	
Ammonia: -- ppm	Color: None	Deposition: None	0 in.
pH: 8.46 units	Gross Solids: Severe		
Temperature 69 °F	Vegetation: None		
Conductivity: -- µS/cm	Benthic Growth: None		
Detergents: 0 mg/L	Stains: None		
	Non-illicit: None

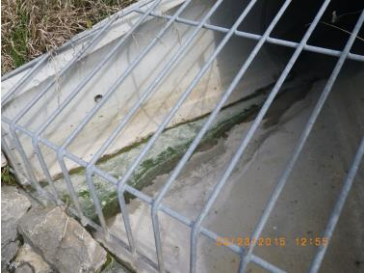
Inspection Date: 9/23/2015 12:56:15 PM		Type: Ongoing	Flow: Trickle	Previous Rainfall (hrs): 72+
Illicit Discharge Potential: Obvious		Inspector: JCW		
Submerged: None		Depth (in):		
Sampling Results		Notes		
Sample Location: Flow	Floatables: None	White silty discharge. Chlorine patches turned yellow (not on scale). Elevated pH and conductivity.

Total Chlorine: -- ppm	Odor: None			
Free Chlorine: -- ppm	Turbidity: None			
Ammonia: 1 ppm	Color: None			
pH: 11.66 units	Gross Solids: Slight			
Temperature 73 °F	Vegetation: None	Condition Assessment		
Conductivity: 2470 µS/cm	Benthic Growth: Moderate	Graffiti: None	Erosion: None	
Detergents: 0 mg/L	Stains: Moderate	Damage: None	Deposition: None	in.
	Non-illicit: None

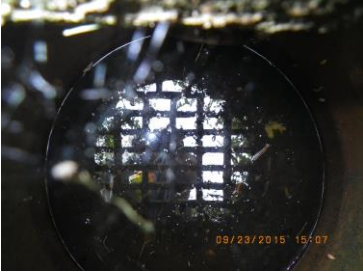
<b>Inspection Date:</b> 9/23/2015 3:05:59 PM		<b>Type:</b> Ongoing		<b>Flow:</b> Submerged, no flow		<b>Previous Rainfall (hrs):</b> 72+	
<b>Illicit Discharge Potential:</b> Unlikely		<b>Inspector:</b> JCW		<b>Notes</b> 7" in sump, below exit pipe invert. Grate stuck, so no sample collected.

Submerged: Partially      Depth (in): 7							
<b>Sampling Results</b>				<b>Condition Assessment</b> Graffiti: None Erosion: None Damage: None Deposition: None in.		o20150923140716.JPG	
Sample Location: Total Chlorine: -- ppm Free Chlorine: -- ppm Ammonia: -- ppm pH: -- units Temperature: -- °F Conductivity: -- µS/cm Detergents: -- mg/L		Floatables: None Odor: None Turbidity: None Color: None Gross Solids: None Vegetation: None Benthic Growth: None Stains: None Non-illicit: None

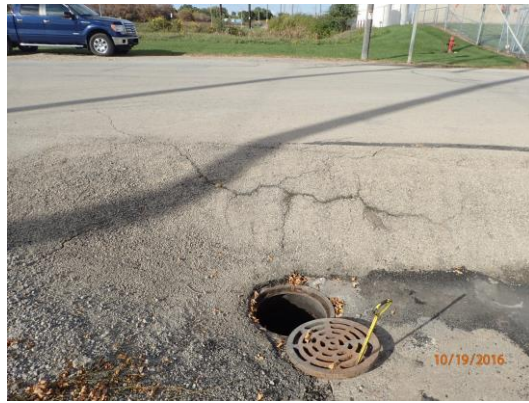
o20161019150604.JPG

Upstream inlet located approx 103 ft S of outfall 13-1098. Intermediate area consists of driveway to industrial property.

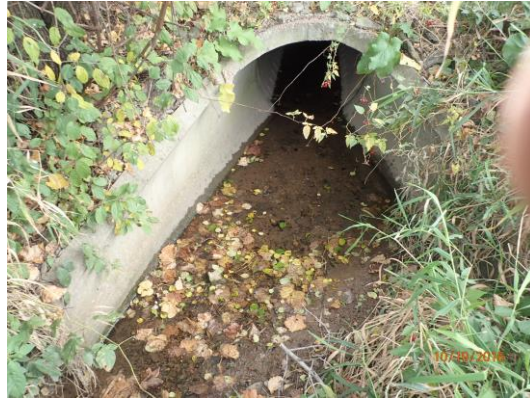
o20161019145222.JPG

Universal St storm sewer discharges to stream from east.

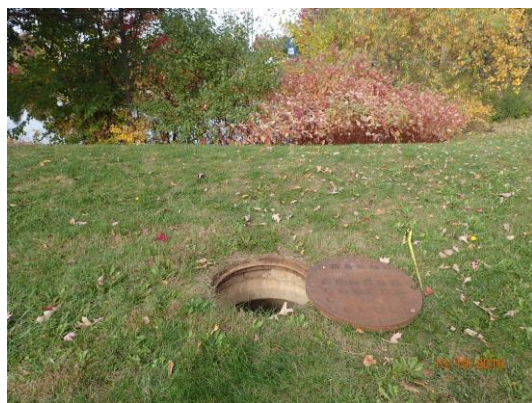
o20161019135344.JPG

Manhole located approx 17 ft S of pond outlet pipe (13-1716 US2). Pipe from car wash enters from east.

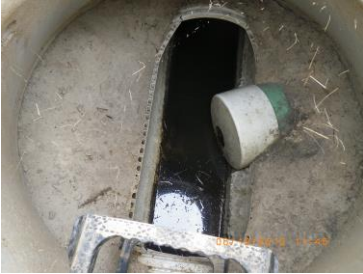
Sample Location:	Pool																																					
Total Chlorine:	0 ppm																																					
Free Chlorine:	0 ppm																																					
Ammonia:	3 ppm																																					
pH:	7.89 units																																					
Temperature:	64 °F																																					
Conductivity:	1011 µS/cm																																					
Detergents:	1.3 mg/L																																					
Floatables:	None																																					
Odor:	Faint																																					
Turbidity:	Cloudy																																					
Color:	Clearly visible in bottl																																					
Gross Solids:	Slight																																					
Vegetation:	None																																					
Benthic Growth:	None																																					
Stains:	Moderate																																					
Non-illicit:	Moderate

<b>Notes</b> Black pool on flowline with petroleum odor.

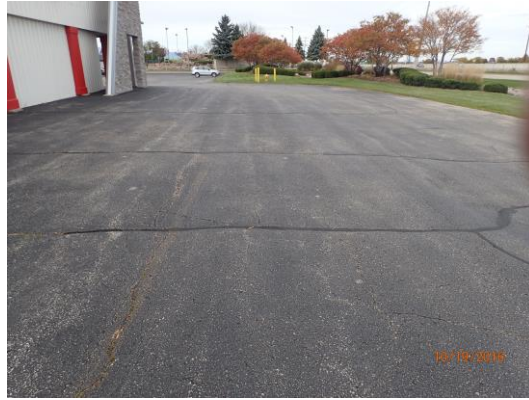
o20161019144214.JPG

Storm sewer from Waukau Ave enters private property before flowing to USH 41 right-of-way. End of pipe not located - based on MS4 map.

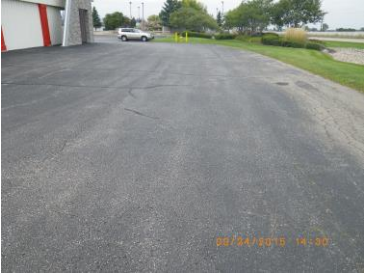
o20150924133032.JPG

Inspection Date: 9/24/2015 2:29:22 PM		Type: Ongoing	Flow: None	Previous Rainfall (hrs): 72+
Illicit Discharge Potential: Unlikely		Inspector: JCW		
Submerged: None		Depth (in):		
Sampling Results		Notes		
Sample Location:	Floatables: None	Outfall not located - screened at 13-1718 US1.		
Total Chlorine: -- ppm	Odor: None			
Free Chlorine: -- ppm	Turbidity: None			
Ammonia: -- ppm	Color: None			
pH: -- units	Gross Solids: None	Condition Assessment		
Temperature -- °F	Vegetation: None	Graffiti: None		
Conductivity: -- µS/cm	Benthic Growth: None	Erosion: None		
Detergents: -- mg/L	Stains: None	Damage: None		
	Non-illicit: None	Deposition: None in.

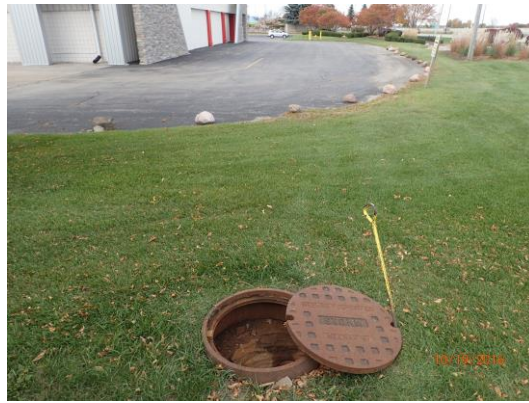
o20161019144316.JPG

Upstream manhole located approx 80 ft S of outfall 13-1718. Intermediate area consists of street right-of-way and commercial parking lot.

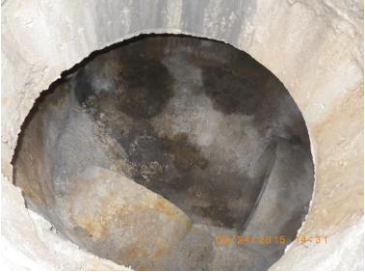
<p>o20150924133136.JPG</p>	
Submerged: None		Depth (in):		Flowline damp, but no flow at time of inspection.			
<b>Sampling Results</b> Sample Location: Total Chlorine: -- ppm Free Chlorine: -- ppm Ammonia: -- ppm pH: -- units Temperature: -- °F Conductivity: -- µS/cm Detergents: -- mg/L		Floatables: None Odor: None Turbidity: None Color: None Gross Solids: None Vegetation: None Benthic Growth: None Stains: Slight Non-illicit: 0		<b>Condition Assessment</b> Graffiti: None Erosion: None Damage: None Deposition: None in.

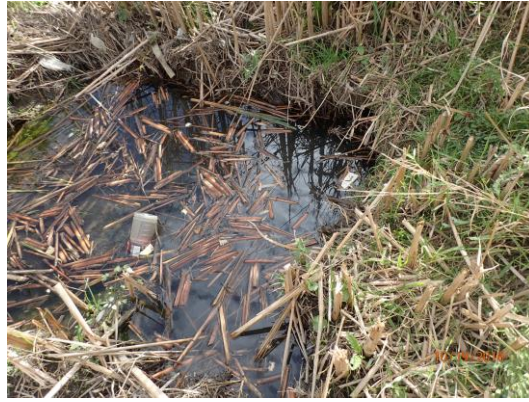
o20161019142734.JPG

STH 44 storm sewer discharges to USH 41 right-of-way from west.

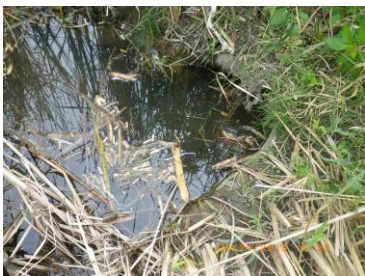
<b>Inspection Date:</b> 9/24/2015 1:57:20 PM		<b>Type:</b> Ongoing	<b>Flow:</b> Submerged, indeterminate	<b>Previous Rainfall (hrs):</b> 72+
<b>Illicit Discharge Potential:</b> Unlikely		<b>Inspector:</b> JCW		
Submerged: Partially      Depth (in): 24				
<b>Sampling Results</b> Sample Location: Total Chlorine: -- ppm Free Chlorine: -- ppm Ammonia: -- ppm pH: -- units Temperature -- °F Conductivity: -- µS/cm Detergents: -- mg/L		Floatables: None Odor: None Turbidity: None Color: None Gross Solids: 1 Vegetation: 0 Benthic Growth: 2 Stains: 0 Non-illicit: 0	<b>Notes</b> Outfall partially submerged - screened at 13-1758 US1.

o20150924125956.JPG
		<b>Condition Assessment</b> Graffiti: 0 Erosion: 0 Damage: 0 Deposition: 2      8 in.

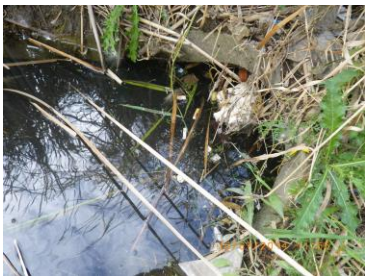
<b>Inspection Date:</b> 10/7/2014 11:57:15 AM		<b>Type:</b> Ongoing	<b>Flow:</b> Submerged, indeterminate	<b>Previous Rainfall (hrs):</b> 48-72
<b>Illicit Discharge Potential:</b> Potential		<b>Inspector:</b> JCW		
Submerged: Partially      Depth (in): 26				
<b>Sampling Results</b> Sample Location: Total Chlorine: -- ppm Free Chlorine: -- ppm Ammonia: -- ppm pH: -- units Temperature -- °F Conductivity: -- µS/cm Detergents: -- mg/L		Floatables: None Odor: None Turbidity: None Color: None Gross Solids: 1 Vegetation: 0 Benthic Growth: 1 Stains: 0 Non-illicit: 0	<b>Notes</b> Outfall partially submerged - screened upstream at 13-1758 US1.

o20141007105524.JPG
		<b>Condition Assessment</b> Graffiti: 0 Erosion: 0 Damage: 0 Deposition: 2      8 in.

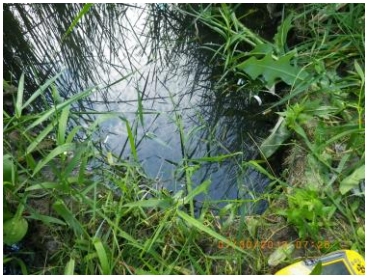
<b>Inspection Date:</b> 7/30/2013 7:19:09 AM		<b>Type:</b> Ongoing	<b>Flow:</b> Submerged, indeterminate	<b>Previous Rainfall (hrs):</b> 72+
<b>Illicit Discharge Potential:</b> Potential		<b>Inspector:</b> JCW		
Submerged: Fully      Depth (in): 30				
<b>Sampling Results</b> Sample Location: Total Chlorine: -- ppm Free Chlorine: -- ppm Ammonia: -- ppm pH: -- units Temperature -- °F Conductivity: -- µS/cm Detergents: -- mg/L		Floatables: Slight Odor: Faint Turbidity: None Color: None Gross Solids: 1 Vegetation: 0 Benthic Growth: 0 Stains: 0 Non-illicit: 0	<b>Notes</b> Oil containment booms still present in downstream pool. Outfall fully submerged. Screened upstream at 13-1758 US1.

o20130730062618.JPG
		<b>Condition Assessment</b> Graffiti: 0 Erosion: 0 Damage: 0 Deposition: 2      10 in.

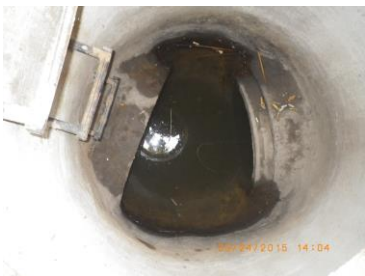
<p style="text-align: center;">o20150924130406.JPG</p>

Sample Location:	Pool																																					
Total Chlorine:	0 ppm																																					
Free Chlorine:	0 ppm																																					
Ammonia:	0 ppm																																					
pH:	7.66 units																																					
Temperature:	72 °F																																					
Conductivity:	1138 µS/cm																																					
Detergents:	0 mg/L																																					
Floatables:	0																																					
Odor:	0																																					
Turbidity:	1																																					
Color:	0																																					
Gross Solids:	0																																					
Vegetation:	0																																					
Benthic Growth:	1																																					
Stains:	2																																					
Non-illicit:	1																																					
		<p><u>Notes</u></p> <p>No remaining evidence of former petroleum discharge.</p>

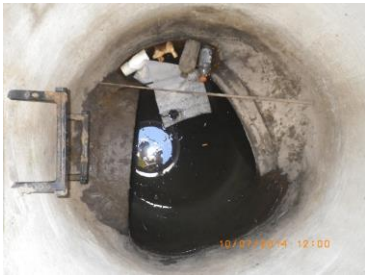
<p style="text-align: center;">o20141007110058.JPG</p>

Sample Location:	Pool																																					
Total Chlorine:	0 ppm																																					
Free Chlorine:	0 ppm																																					
Ammonia:	0 ppm																																					
pH:	7.72 units																																					
Temperature:	-- °F																																					
Conductivity:	1629 µS/cm																																					
Detergents:	0 mg/L																																					
Floatables:	0																																					
Odor:	0																																					
Turbidity:	0																																					
Color:	0																																					
Gross Solids:	2																																					
Vegetation:	0																																					
Benthic Growth:	1																																					
Stains:	2																																					
Non-illicit:	0																																					
		<p><u>Notes</u></p> <p>Floating gross solids (litter) in manhole.</p>

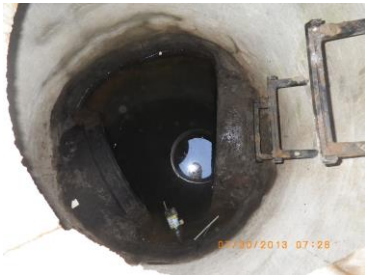
<p style="text-align: center;">o20130730062844.JPG</p>

Sample Location:	Pool																																					
Total Chlorine:	0 ppm																																					
Free Chlorine:	0 ppm																																					
Ammonia:	0 ppm																																					
pH:	7.6 units																																					
Temperature:	67 °F																																					
Conductivity:	1071 µS/cm																																					
Detergents:	0 mg/L																																					
Floatables:	2																																					
Odor:	2																																					
Turbidity:	0																																					
Color:	0																																					
Gross Solids:	1																																					
Vegetation:	0																																					
Benthic Growth:	0																																					
Stains:	3																																					
Non-illicit:	0																																					
		<p><u>Notes</u></p> <p>Petroleum odor still present. Slight sheen observed.</p>

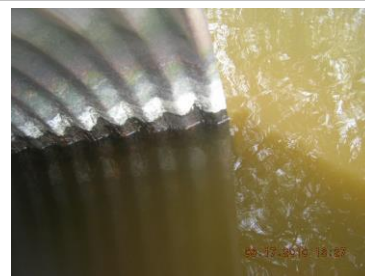
Latitude: 43.98194

Sample Location:	Floatables:																					
Total Chlorine: -- ppm	Odor:																					
Free Chlorine: -- ppm	Turbidity:																					
Ammonia: -- ppm	Color:																					
pH: -- units	Gross Solids:																					
Temperature -- °F	Vegetation:																					
Conductivity: -- µS/cm	Benthic Growth:																					
Detergents: -- mg/L	Stains:																					
	Non-illicit:																					
		<b>Condition Assessment</b> <table border="1" style="width: 100%; border-collapse: collapse;"> <tr> <td>Graffiti:</td> <td>None</td> </tr> <tr> <td>Erosion:</td> <td>None</td> </tr> <tr> <td>Damage:</td> <td>Minor</td> </tr> <tr> <td>Deposition:</td> <td>None      0 in.</td> </tr> </table>			Graffiti:	None	Erosion:	None	Damage:	Minor	Deposition:	None      0 in.										
Graffiti:	None																					
Erosion:	None																					
Damage:	Minor

<b>Inspection Date:</b> 9/9/2009		<b>Type:</b> Initial	<b>Flow:</b> Submerged, indeterminate	<b>Previous Rainfall (hrs):</b> 72+																		
<b>Illicit Discharge Potential:</b> Unlikely		<b>Inspector:</b> JCW																				
Submerged: Partially      Depth (in): 14																						
<b>Sampling Results</b> <table border="1" style="width: 100%; border-collapse: collapse;"> <tr> <td style="width: 50%;">Sample Location:</td> <td style="width: 50%;">Floatables:</td> </tr> <tr> <td>Total Chlorine: -- ppm</td> <td>Odor:</td> </tr> <tr> <td>Free Chlorine: -- ppm</td> <td>Turbidity:</td> </tr> <tr> <td>Ammonia: -- ppm</td> <td>Color:</td> </tr> <tr> <td>pH: -- units</td> <td>Gross Solids:</td> </tr> <tr> <td>Temperature -- °F</td> <td>Vegetation:</td> </tr> <tr> <td>Conductivity: -- µS/cm</td> <td>Benthic Growth:</td> </tr> <tr> <td>Detergents: -- mg/L</td> <td>Stains:</td> </tr> <tr> <td></td> <td>Non-illicit:</td> </tr> </table>		Sample Location:	Floatables:	Total Chlorine: -- ppm	Odor:	Free Chlorine: -- ppm	Turbidity:	Ammonia: -- ppm	Color:	pH: -- units	Gross Solids:	Temperature -- °F	Vegetation:	Conductivity: -- µS/cm	Benthic Growth:	Detergents: -- mg/L	Stains:		Non-illicit:	<b>Notes</b> Outfall partially submerged. Outfall screened upstream at 14-400 US1.

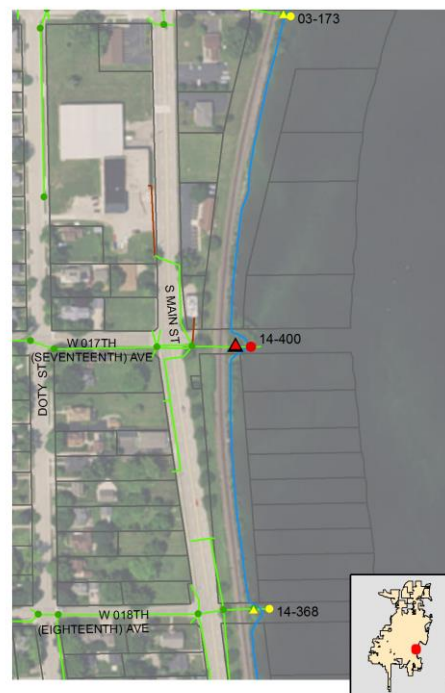
Upstream manhole located approx 38 ft W of outfall 14-400. Intermediate area consists of wooded shoreline.

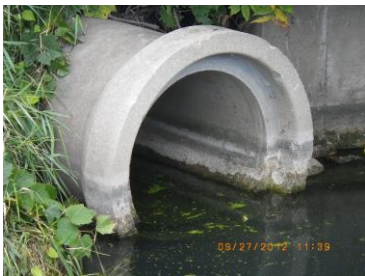
<b>Inspection Date:</b> 9/27/2012 11:43:23 AM		<b>Type:</b> Repeat		<b>Flow:</b> Submerged, slight flow		<b>Previous Rainfall (hrs):</b> 72+	
<b>Illicit Discharge Potential:</b> Potential		<b>Inspector:</b> JCW		<b>Notes</b>

o20120927103918.JPG	
Submerged: Partially      Depth (in): 6				Gel-like sheen on surface of stream. Outfall partially submerged; additional screening upstream at 14-582 US7.			
<b>Sampling Results</b>		<b>Floatables:</b> None <b>Odor:</b> None <b>Turbidity:</b> None <b>Color:</b> None <b>Gross Solids:</b> None <b>Vegetation:</b> None <b>Benthic Growth:</b> Moderate <b>Stains:</b> Severe <b>Non-illicit:</b> None		<b>Condition Assessment</b> <b>Graffiti:</b> None <b>Erosion:</b> None <b>Damage:</b> None <b>Deposition:</b> None      in.			
<b>Sample Location:</b> Pool <b>Total Chlorine:</b> 0 ppm <b>Free Chlorine:</b> 0 ppm <b>Ammonia:</b> 0 ppm <b>pH:</b> 7.77 units <b>Temperature:</b> 64 °F <b>Conductivity:</b> 1077 µS/cm <b>Detergents:</b> 0 mg/L

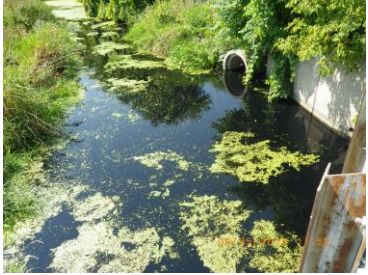
<b>Inspection Date:</b> 9/5/2012 11:52:00 AM		<b>Type:</b> Complaint		<b>Flow:</b> Submerged, indeterminate		<b>Previous Rainfall (hrs):</b> 72+	
<b>Illicit Discharge Potential:</b> Potential		<b>Inspector:</b> JCW		<b>Notes</b>

<p>o20120905105212.JPG</p>	
Submerged: Partially		Depth (in): 12		Dark black substance in water around outfall and bridge. Sample collected from stream.			
<b>Sampling Results</b> Sample Location: Pool Total Chlorine: 0 ppm Free Chlorine: 0 ppm Ammonia: 0 ppm pH: 75 units Temperature: -- °F Conductivity: 1419 µS/cm Detergents: 0 mg/L		Floatables: None Odor: Noticeable from a dist Turbidity: Cloudy Color: Clearly visible in flow Gross Solids: None Vegetation: None Benthic Growth: Moderate Stains: None Non-illicit: None		<b>Condition Assessment</b> Graffiti: None Erosion: None Damage: None Deposition: None in.

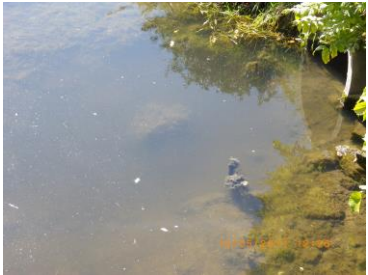
<b>Inspection Date:</b> 10/5/2011 12:26:00 PM		<b>Type:</b> Repeat		<b>Flow:</b> Submerged, indeterminate		<b>Previous Rainfall (hrs):</b> 72+	
<b>Illicit Discharge Potential:</b> Obvious		<b>Inspector:</b> JCW		<b>Notes</b>

<p>o20111005122620.JPG</p>	
Submerged: Partially		Depth (in):		Complaint follow-up. Outfall partially submerged. Outfall screened upstream at 14-585 US7. Limited screening conducted.			
<b>Sampling Results</b> Sample Location: Total Chlorine: -- ppm Free Chlorine: -- ppm Ammonia: -- ppm pH: -- units Temperature: -- °F Conductivity: -- µS/cm Detergents: -- mg/L		Floatables: Odor: Turbidity: Color: Gross Solids: Vegetation: Benthic Growth: Stains: Non-illicit: None		<b>Condition Assessment</b> Graffiti: Erosion: Damage: Deposition: in.

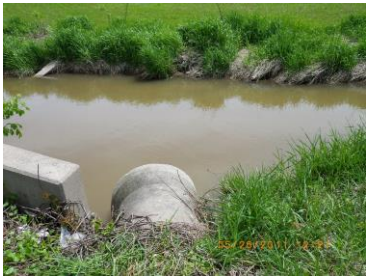
<b>Inspection Date:</b> 5/26/2011 12:21:00 PM		<b>Type:</b> Repeat		<b>Flow:</b> Submerged, indeterminate		<b>Previous Rainfall (hrs):</b> 72+	
<b>Illicit Discharge Potential:</b> Obvious		<b>Inspector:</b> JCW		<b>Notes</b>

<p>o20110526112114.jpg</p>	
Submerged: Partially		Depth (in):		Complaint follow-up. Strong chlorine smell inside pipe. Chemical interference with chlorine test. Limited screening conducted.			
<b>Sampling Results</b> Sample Location: Pool Total Chlorine: -- ppm Free Chlorine: -- ppm Ammonia: -- ppm pH: -- units Temperature: -- °F Conductivity: -- µS/cm Detergents: -- mg/L		Floatables: Odor: Noticeable from a dist Turbidity: Color: Gross Solids: Vegetation: Benthic Growth: Stains: Non-illicit:		<b>Condition Assessment</b> Graffiti: Erosion: Damage: Deposition: in.

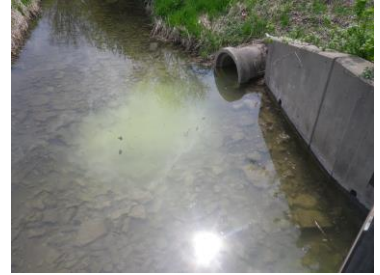
o20110512133142.jpg

<b>Inspection Date:</b> 5/12/2011 1:03:00 PM		<b>Type:</b> Complaint	<b>Flow:</b> Submerged, indeterminate	<b>Previous Rainfall (hrs):</b> 72+
<b>Illicit Discharge Potential:</b> Obvious		<b>Inspector:</b> JCW		
Submerged: Partially		Depth (in):		
<u>Sampling Results</u>		<b>Notes</b> Responded to complaint about discharge from pipe. Outfall partially submerged. Yellow pool at end of pipe. Chemical smell inside pipe.		
Sample Location:	Pool	Floatables:		
Total Chlorine:	2 ppm	Odor:	Noticeable from a dist	
Free Chlorine:	2 ppm	Turbidity:		
Ammonia:	2 ppm	Color:	Clearly visible in flow	
pH:	-- units	Gross Solids:		
Temperature	-- °F	Vegetation:		
Conductivity:	-- µS/cm	Benthic Growth:		
Detergents:	-- mg/L	Stains:		
		Non-illicit:	None	
		<b>Condition Assessment</b> Graffiti: Erosion: Damage: Deposition: in.

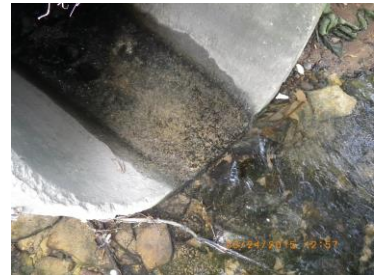
o20150924115728.JPG

<b>Inspection Date:</b> 9/24/2015 12:55:30 PM		<b>Type:</b> Ongoing	<b>Flow:</b> Moderate	<b>Previous Rainfall (hrs):</b> 72+
<b>Illicit Discharge Potential:</b> Unlikely		<b>Inspector:</b> JCW		
Submerged: None		Depth (in):		
<b>Sampling Results</b>		Notes: 4" joint displacement.		
Sample Location: Flow	Floatables: None	<b>Condition Assessment</b> Graffiti: None Erosion: None Damage: Moderate Deposition: None in.		
Total Chlorine: 0 ppm	Odor: None			
Free Chlorine: 0 ppm	Turbidity: None			
Ammonia: 0 ppm	Color: None			
pH: 8.17 units	Gross Solids: None			
Temperature: 72 °F	Vegetation: None			
Conductivity: 1595 µS/cm	Benthic Growth: None			
Detergents: 0 mg/L	Stains: Slight			
	Non-illicit: None

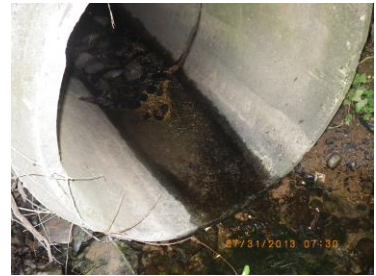
o20130731063036.JPG

<b>Inspection Date:</b> 7/31/2013 7:27:16 AM		<b>Type:</b> Ongoing	<b>Flow:</b> Trickle	<b>Previous Rainfall (hrs):</b> 72+
<b>Illicit Discharge Potential:</b> Unlikely		<b>Inspector:</b> JCW		
Submerged: None		Depth (in):		
<b>Sampling Results</b>		Notes: End section displaced 4".		
Sample Location: Flow	Floatables: None	<b>Condition Assessment</b> Graffiti: None Erosion: None Damage: Minor Deposition: None in.		
Total Chlorine: 0 ppm	Odor: None			
Free Chlorine: 0 ppm	Turbidity: None			
Ammonia: 0 ppm	Color: None			
pH: 8.05 units	Gross Solids: None			
Temperature: 71 °F	Vegetation: None			
Conductivity: 1865 µS/cm	Benthic Growth: None			
Detergents: 0 mg/L	Stains: Moderate			
	Non-illicit: None

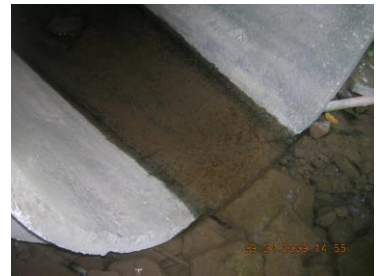
Osh09\_DSCN6570.JPG

<b>Inspection Date:</b> 9/4/2009		<b>Type:</b> Initial	<b>Flow:</b> Submerged, slight flow	<b>Previous Rainfall (hrs):</b> 72+
<b>Illicit Discharge Potential:</b> Unlikely		<b>Inspector:</b> JCW		
Submerged: Partially		Depth (in): 1		
<b>Sampling Results</b>		Notes: End section of pipe separated.		
Sample Location: Pool	Floatables: None	<b>Condition Assessment</b> Graffiti: None Erosion: None Damage: Moderate Deposition: None 0 in.		
Total Chlorine: 0 ppm	Odor: None			
Free Chlorine: 0 ppm	Turbidity: None			
Ammonia: -- ppm	Color: None			
pH: 7.82 units	Gross Solids: None			
Temperature: 73 °F	Vegetation: Slight			
Conductivity: -- µS/cm	Benthic Growth: Slight			
Detergents: 0 mg/L	Stains: Slight			
	Non-illicit: None

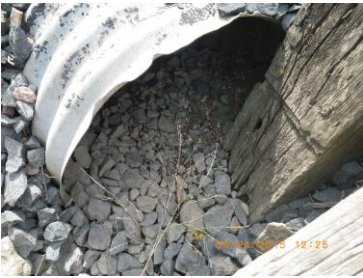
Inspection Date: 9/24/2015 12:22:34 PM		Type: Ongoing	Flow: None	Previous Rainfall (hrs): 72+	
Illicit Discharge Potential: Unlikely		Inspector: JCW			
Submerged: None		Depth (in):			
Sampling Results		Notes			
Sample Location:		Partially filled with stone.			
Total Chlorine: -- ppm	Floatables: None	Condition Assessment		o20150924112622.JPG	
Free Chlorine: -- ppm	Odor: None				
Ammonia: -- ppm	Turbidity: None				
pH: -- units	Color: None				
Temperature -- °F	Gross Solids: None				
Conductivity: -- µS/cm	Vegetation: None				
Detergents: -- mg/L	Benthic Growth: None				
	Stains: None				
	Non-illicit: None	Graffiti: None	Erosion: None	Damage: None	Deposition: Moderate 10 in.

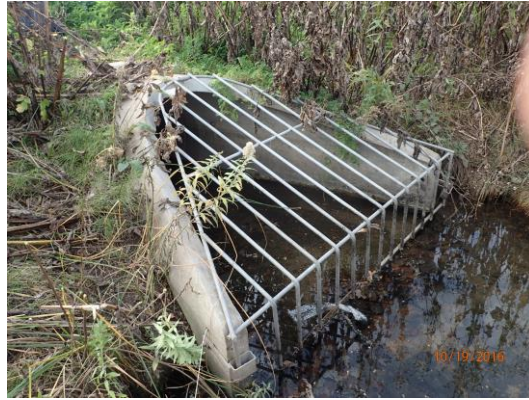
o20161019120656.JPG

Storm sewer from W Murdock Ave discharges to SW corner of detention basin. MS4 mapping does not show distinction from 15-146.

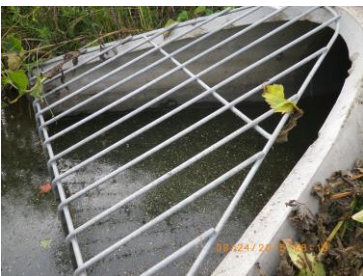
o20150924071336.JPG

<b>Inspection Date:</b> 9/24/2015 8:10:48 AM		<b>Type:</b> Ongoing	<b>Flow:</b> Submerged, indeterminate	<b>Previous Rainfall (hrs):</b> 72+
<b>Illicit Discharge Potential:</b> Unlikely		<b>Inspector:</b> JCW		
Submerged: Partially      Depth (in): 8				
<b>Sampling Results</b> Sample Location: Pool Total Chlorine: 0 ppm Free Chlorine: 0 ppm Ammonia: 0 ppm pH: 7.99 units Temperature: 67 °F Conductivity: 1153 µS/cm Detergents: 0 mg/L		Floatables: None Odor: None Turbidity: None Color: None Gross Solids: None Vegetation: None Benthic Growth: Moderate Stains: Moderate Non-illicit: None	<b>Notes</b> Construction and traffic prevented screening at US1. Sample collected from outfall pool.  <b>Condition Assessment</b> Graffiti: None Erosion: None Damage: None Deposition: None in.

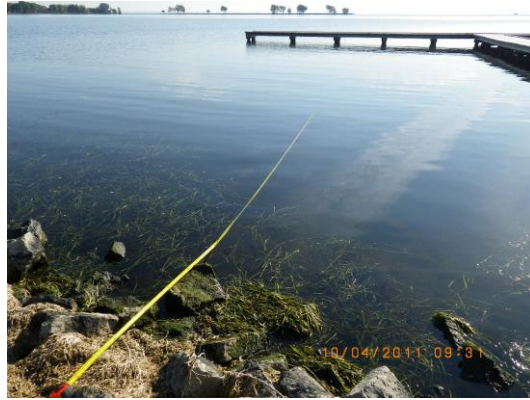
o20111004093140.JPG

Storm sewer from New York Ave discharges to lake from west. Outfall fully submerged and extends more than 25 ft into water. GPS coordinate at shoreline.

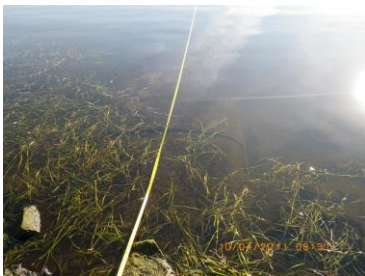
<b>Inspection Date:</b> 10/4/2011 9:33:13 AM		<b>Type:</b> Ongoing	<b>Flow:</b> Submerged, indeterminate	<b>Previous Rainfall (hrs):</b> 72+
<b>Illicit Discharge Potential:</b> Unlikely		<b>Inspector:</b> JCW		
Submerged: Fully		Depth (in):		
<b>Sampling Results</b> Sample Location: Total Chlorine: -- ppm Free Chlorine: -- ppm Ammonia: -- ppm pH: -- units Temperature: -- °F Conductivity: -- µS/cm Detergents: -- mg/L		Floatables: None Odor: None Turbidity: None Color: None Gross Solids: None Vegetation: None Benthic Growth: Moderate Stains: None Non-illicit: None	<b>Notes</b> Outfall fully submerged. Outfall screened upstream at 15-636 US1.

o20111004093148.JPG
		<b>Condition Assessment</b> Graffiti: None Erosion: None Damage: None Deposition: None 0 in.

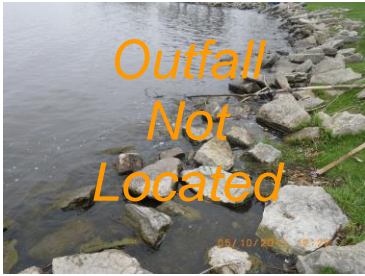
<b>Inspection Date:</b> 5/10/2011 12:30:00 PM		<b>Type:</b> Other	<b>Flow:</b> Submerged (not located)	<b>Previous Rainfall (hrs):</b> 0-24
<b>Illicit Discharge Potential:</b> Unlikely		<b>Inspector:</b> JCW		
Submerged: Fully		Depth (in):		
<b>Sampling Results</b> Sample Location: Total Chlorine: -- ppm Free Chlorine: -- ppm Ammonia: -- ppm pH: -- units Temperature: -- °F Conductivity: -- µS/cm Detergents: -- mg/L		Floatables: Odor: Turbidity: Color: Gross Solids: Vegetation: Benthic Growth: Stains: Non-illicit: None	<b>Notes</b> Outfall fully submerged and not physically located. Outfall screened upstream at 15-636 US1.

o20110510122252.JPG
		<b>Condition Assessment</b> Graffiti: None Erosion: None Damage: None Deposition: None 0 in.

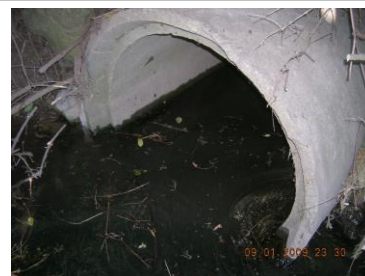
Osh09\_DSCN6391.JPG

<b>Inspection Date:</b> 9/2/2009		<b>Type:</b> Initial	<b>Flow:</b> Submerged, slight flow	<b>Previous Rainfall (hrs):</b> 72+
<b>Illicit Discharge Potential:</b> Unlikely		<b>Inspector:</b> JCW		
Submerged: Partially      Depth (in): 12				
<b>Sampling Results</b>		<b>Notes</b>		
Sample Location:	Floatables:	None		
Total Chlorine: -- ppm	Odor:	None		
Free Chlorine: -- ppm	Turbidity:	None		
Ammonia: -- ppm	Color:	None		
pH: -- units	Gross Solids:	None		
Temperature -- °F	Vegetation:			
Conductivity: -- µS/cm	Benthic Growth:	Slight		
Detergents: -- mg/L	Stains:			
	Non-illicit:	None		
		<b>Condition Assessment</b> Graffiti: None Erosion: None Damage: None Deposition: Minor      2 in.

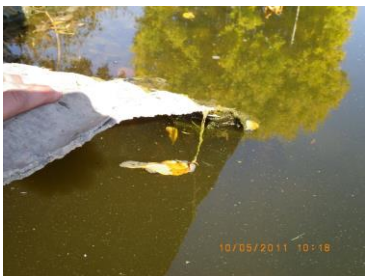
o20111005101848.JPG	
Submerged: Partially      Depth (in): 26				Outfall partially submerged. Outfall screened upstream at 15-787 US1.			
<b>Sampling Results</b>		Floatables: None Odor: None Turbidity: None Color: None Gross Solids: None Vegetation: None Benthic Growth: Moderate Stains: None Non-illicit: None		<b>Condition Assessment</b>			
Sample Location: Total Chlorine: -- ppm Free Chlorine: -- ppm Ammonia: -- ppm pH: -- units Temperature: -- °F Conductivity: -- µS/cm Detergents: -- mg/L				Graffiti: None Erosion: None Damage: None Deposition: None      0 in.

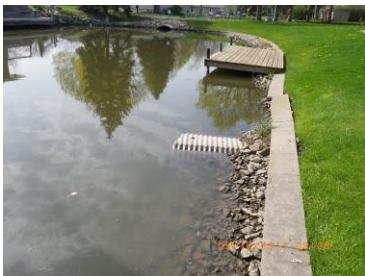
o20110512093638.JPG	
Submerged: Partially      Depth (in):				Outfall partially submerged. Outfall screened upstream at 15-787 US1.			
<b>Sampling Results</b>		Floatables: Odor: Turbidity: Color: Gross Solids: Vegetation: Benthic Growth: Stains: Non-illicit: None		<b>Condition Assessment</b>			
Sample Location: Total Chlorine: -- ppm Free Chlorine: -- ppm Ammonia: -- ppm pH: -- units Temperature: -- °F Conductivity: -- µS/cm Detergents: -- mg/L				Graffiti: None Erosion: None Damage: None Deposition: None      0 in.

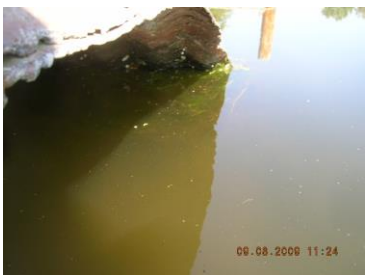
Osh09_DSCN6609.JPG	
Submerged: Partially      Depth (in): 27							
<b>Sampling Results</b>		Floatables: Odor: Turbidity: Color: Gross Solids: Vegetation: Benthic Growth: Slight Stains: Non-illicit: None		<b>Condition Assessment</b>			
Sample Location: Total Chlorine: -- ppm Free Chlorine: -- ppm Ammonia: -- ppm pH: -- units Temperature: -- °F Conductivity: -- µS/cm Detergents: -- mg/L				Graffiti: None Erosion: None Damage: Minor Deposition: None      0 in.

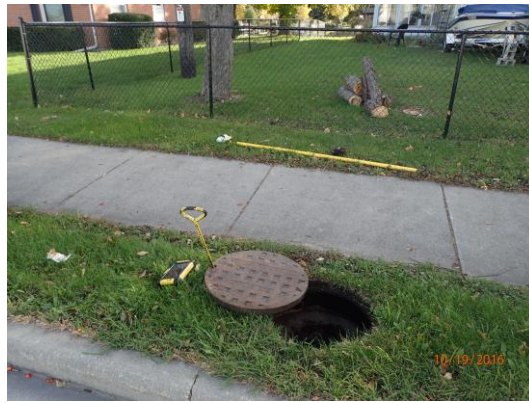
o20161019091358.JPG

Upstream manhole located approx 142 ft W of outfall 15-787. Intermediate area consists of residential property.

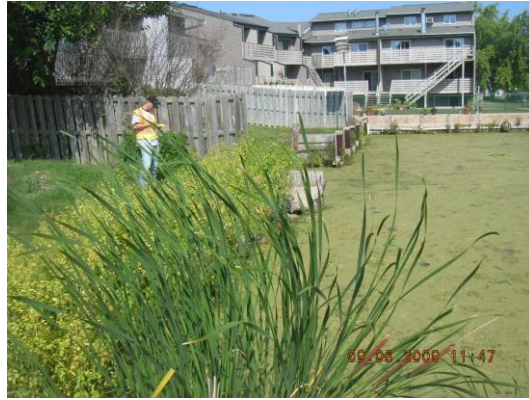
Osh09\_DSCN6616.JPG

Storm sewer from Grove St discharges to stream from west. Outfall fully submerged and not physically located. GPS coordinates approximate. Pipe info from MS4 map.

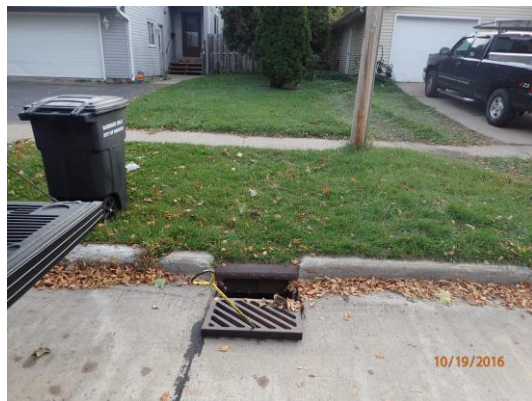
o20161019084622.JPG

Upstream curb inlet located approx 138 ft W of outfall 15-910. Intermediate area consists of residential property.

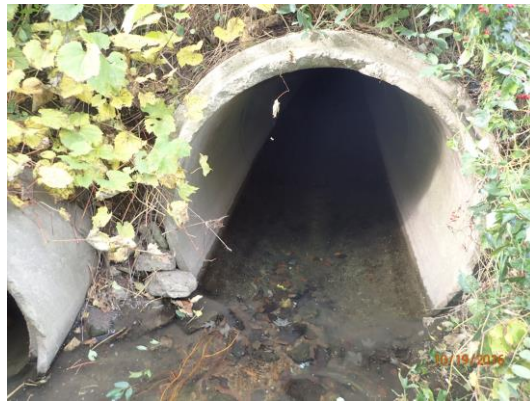
o20161019102416.JPG

Storm sewer from Libbey Ave discharges to stream from west. Middle pipe.

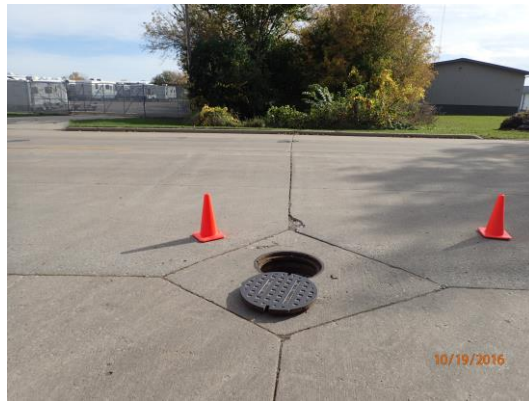
o20161019103900.JPG

Upstream manhole located approx 47 ft W of outfall 15-940. Intermediate area consists of road right-of-way.

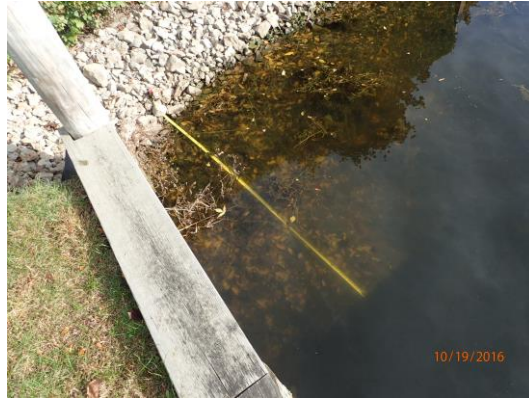
o20161019094516.JPG

Storm sewer from Nicolet Ave discharges to lagoon from north. Outfall fully submerged - pipe info from MS4 map.

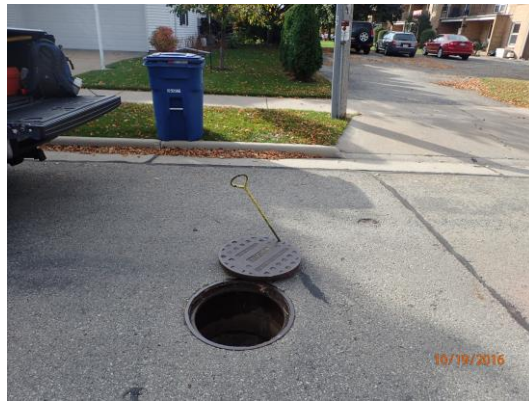
o20161019094806.JPG

Upstream manhole located approx 115 ft N of outfall 15-959. Intermediate area consists of residential property.

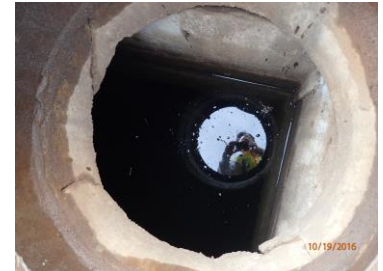
o20161019094812.JPG

Stains: Moderate

☒ Flow Line☐ Oil☐ Rust Stains☐ Paint☐ Other

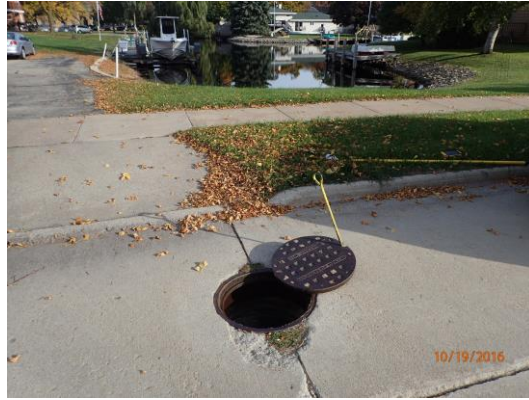
o20161019092932.JPG

Upstream manhole located approx 46 ft SSW of outfall 115-1108. Intermediate area consists of street right-of-way and open space.

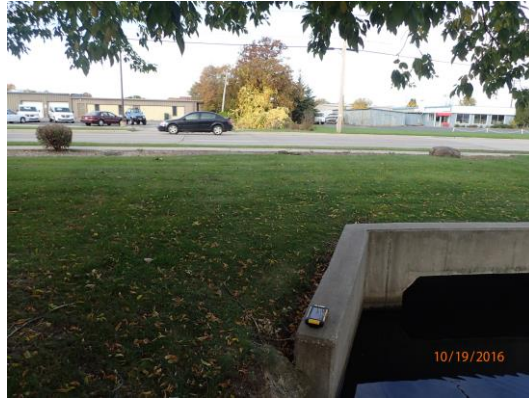
o20161019085704.JPG

12" RCP from Bowen St storm sewer tapped into box culvert. Not physically located. GPS coordinates approximate. Pipe info from MS4 map.

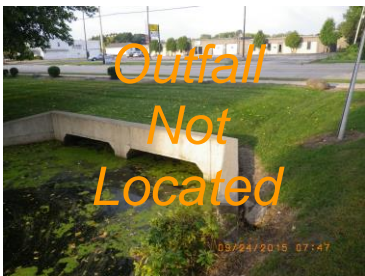
o20150924064728.JPG
		<b>Condition Assessment</b> Graffiti: None Erosion: None Damage: None Deposition: None in.

<b>Inspection Date:</b> 9/24/2015 7:44:54 AM		<b>Type:</b> Ongoing	<b>Flow:</b> Submerged (not located)	<b>Previous Rainfall (hrs):</b> 72+
<b>Illicit Discharge Potential:</b> Unlikely		<b>Inspector:</b> JCW		
Submerged: Fully      Depth (in):				
<b>Sampling Results</b> Sample Location: Total Chlorine: -- ppm Free Chlorine: -- ppm Ammonia: -- ppm pH: -- units Temperature: -- °F Conductivity: -- µS/cm Detergents: -- mg/L		Floatables: None Odor: None Turbidity: None Color: None Gross Solids: None Vegetation: None Benthic Growth: None Stains: None Non-illicit: None	<b>Notes</b> Outfall inaccessible under street - screened at 15-1237 US1.

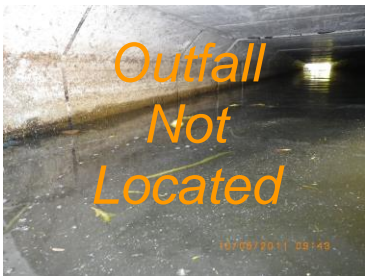
o20111006094330.JPG
		<b>Condition Assessment</b> Graffiti: None Erosion: None Damage: None Deposition: None 0 in.

<b>Inspection Date:</b> 10/6/2011 9:49:59 AM		<b>Type:</b> Ongoing	<b>Flow:</b> Submerged (not located)	<b>Previous Rainfall (hrs):</b> 72+
<b>Illicit Discharge Potential:</b> Unlikely		<b>Inspector:</b> JCW		
Submerged: Fully      Depth (in): 28				
<b>Sampling Results</b> Sample Location: Total Chlorine: -- ppm Free Chlorine: -- ppm Ammonia: -- ppm pH: -- units Temperature: -- °F Conductivity: -- µS/cm Detergents: -- mg/L		Floatables: None Odor: None Turbidity: None Color: None Gross Solids: None Vegetation: None Benthic Growth: None Stains: None Non-illicit: None	<b>Notes</b> Outfall fully submerged and not physically located. Outfall screened upstream at 15-1237 US1.

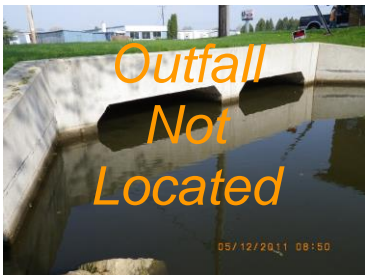
o20110512085004.JPG
		<b>Condition Assessment</b> Graffiti: None Erosion: None Damage: None Deposition: None 0 in.

<b>Inspection Date:</b> 5/12/2011 8:50:00 AM		<b>Type:</b> Other	<b>Flow:</b> Submerged (not located)	<b>Previous Rainfall (hrs):</b> 48-72
<b>Illicit Discharge Potential:</b> Unlikely		<b>Inspector:</b> JCW		
Submerged: Fully      Depth (in):				
<b>Sampling Results</b> Sample Location: Total Chlorine: -- ppm Free Chlorine: -- ppm Ammonia: -- ppm pH: -- units Temperature: -- °F Conductivity: -- µS/cm Detergents: -- mg/L		Floatables: Odor: Turbidity: Color: Gross Solids: Vegetation: Benthic Growth: Stains: Non-illicit: None	<b>Notes</b> Outfall fully submerged and not physically located. Outfall screened upstream at 15-1237 US1.

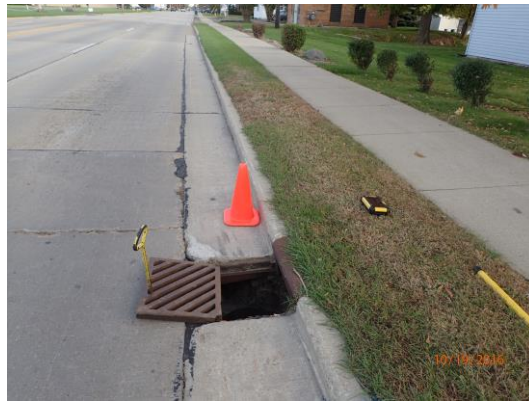
o20161019090032.JPG

Upstream curb inlet located approx 87 ft S of outfall 15-1237. Intermediate area consists of street right-of-way.

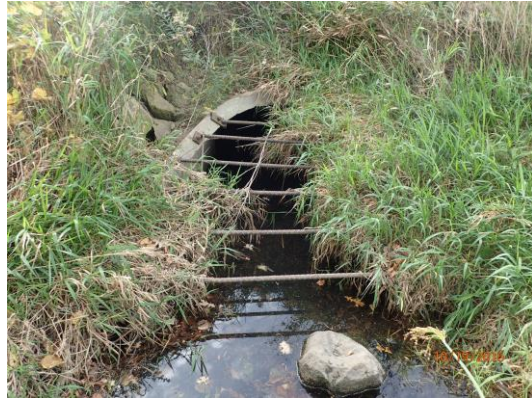
o20161019105836.JPG

Storm sewer from Murdock Ave discharges to stream from south.

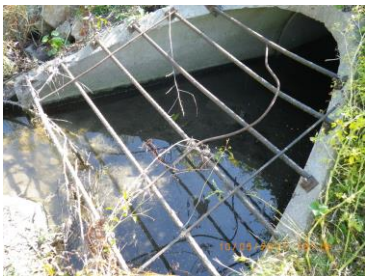
o20111006131854.JPG
		<b>Condition Assessment</b> Graffiti: None Erosion: None Damage: None Deposition: None      0 in.

<b>Inspection Date:</b> 10/6/2011 1:19:29 PM		<b>Type:</b> Ongoing	<b>Flow:</b> Submerged, indeterminate	<b>Previous Rainfall (hrs):</b> 72+
<b>Illicit Discharge Potential:</b> Unlikely		<b>Inspector:</b> JCW		
Submerged: Partially      Depth (in): 12				
<b>Sampling Results</b> Sample Location: Total Chlorine:    -- ppm Free Chlorine:    -- ppm Ammonia:           -- ppm pH:                    -- units Temperature       -- °F Conductivity:      -- µS/cm Detergents:        -- mg/L		Floatables: None Odor: None Turbidity: None Color: None Gross Solids: None Vegetation: None Benthic Growth: Moderate Stains: Moderate Non-illicit: None	<b>Notes</b> Outfall partially submerged. Outfall screened upstream at 15-1277 US1.

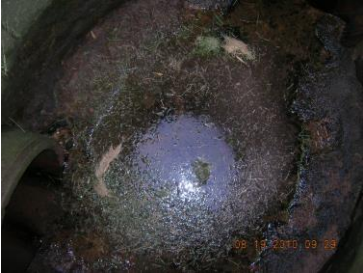
o20100819092912.JPG

<b>Inspection Date:</b> 8/19/2010 9:39:34 AM		<b>Type:</b> Ongoing		<b>Flow:</b> Submerged, no flow		<b>Previous Rainfall (hrs):</b> 72+	
<b>Illicit Discharge Potential:</b> Unlikely		<b>Inspector:</b> JCW		<b>Notes</b> Sample collected from pool at bottom of catchbasin.

Submerged: Partially      Depth (in): 1							
<b>Sampling Results</b> Sample Location: Pool Total Chlorine: 0 ppm Free Chlorine: 0 ppm Ammonia: 0 ppm pH: 8.08 units Temperature: 80 °F Conductivity: -- µS/cm Detergents: 0 mg/L		Floatables: None Odor: None Turbidity: None Color: None Gross Solids: None Vegetation: None Benthic Growth: None Stains: None Non-illicit: None		<b>Condition Assessment</b> Graffiti: None Erosion: None Damage: None Deposition: None      0 in.

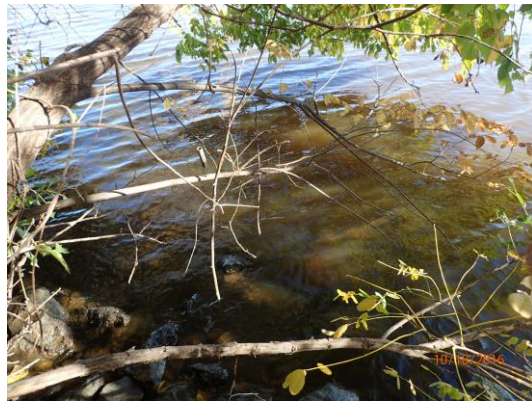
o20161018122810.JPG

Storm sewer from Van Buren Ave discharges to river from west. Outfall fully submerged and not physically located. GPS coordinates approximate. Pipe info from MS4 map.

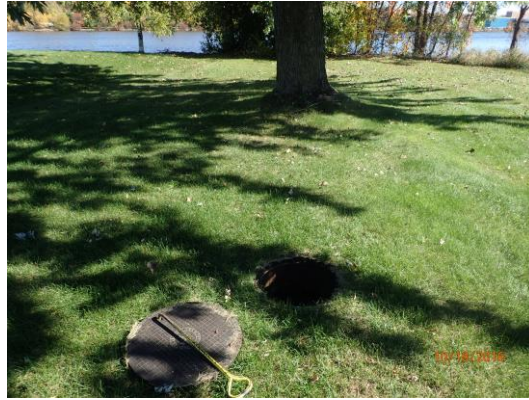
o20161018122918.JPG

Upstream manhole located approx 85 ft W of outfall 16-71. Intermediate area consists of open space.

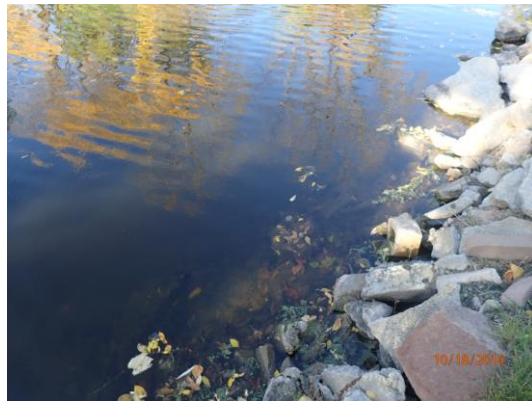
o20161018094858.JPG

Storm sewer from Buchanan Ave discharges to stream from east. Pipe info from MS4 map.
