# Ongoing Screening Summary Report 2016 Inspection Year

Illicit Discharge Detection and Elimination Program

City of Oshkosh

November 30, 2016

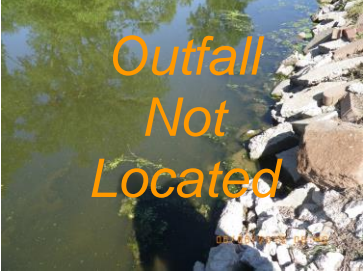
<p>o20120606084204.JPG</p>	
Submerged: Fully      Depth (in):				Outfall fully submerged and not physically located. Outfall screened upstream at 16-93 US2.			
<b>Sampling Results</b>				<b>Condition Assessment</b>			
Sample Location:		Floatables:	None	Graffiti:	None		
Total Chlorine:	-- ppm	Odor:	None	Erosion:	None		
Free Chlorine:	-- ppm	Turbidity:	None	Damage:	None		
Ammonia:	-- ppm	Color:	None	Deposition:	None	in.	
pH:	-- units	Gross Solids:	None				
Temperature	-- °F	Vegetation:	None				
Conductivity:	-- µS/cm	Benthic Growth:	None				
Detergents:	-- mg/L	Stains:	None				
		Non-illicit:	None

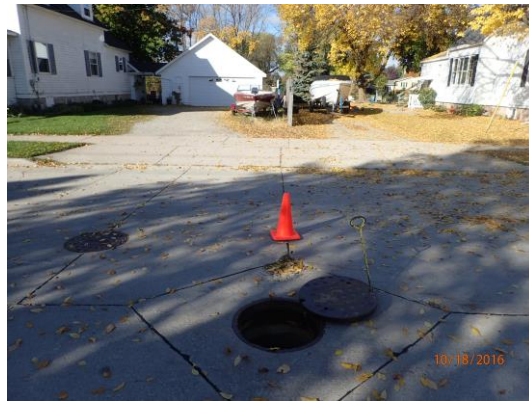
o20161018095102.JPG

Upstream manhole located approx 155 ft E of outfall 16-93. Intermediate area consists of residential property. First upstream manhole not located.

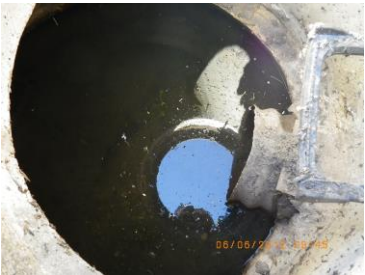
o20120606084550.JPG

Sample Location:	Pool	Floatables:	None																																				
Total Chlorine:	0 ppm	Odor:	None																																				
Free Chlorine:	0 ppm	Turbidity:	None																																				
Ammonia:	0 ppm	Color:	None																																				
pH:	8.1 units	Gross Solids:	Moderate																																				
Temperature:	72 °F	Vegetation:	None																																				
Conductivity:	749 µS/cm	Benthic Growth:	Slight																																				
Detergents:	0 mg/L	Stains:	None																																				
		Non-illicit:	None																																				
		<b>Condition Assessment</b> <table border="1"> <tr> <td>Graffiti:</td> <td>None</td> </tr> <tr> <td>Erosion:</td> <td>None</td> </tr> <tr> <td>Damage:</td> <td>None</td> </tr> <tr> <td>Deposition:</td> <td>Moderate 8 in.</td> </tr> </table>			Graffiti:	None	Erosion:	None	Damage:	None	Deposition:	Moderate 8 in.

Graffiti:	None																																						
Erosion:	None																																						
Damage:	None																																						
Deposition:	Moderate 8 in.

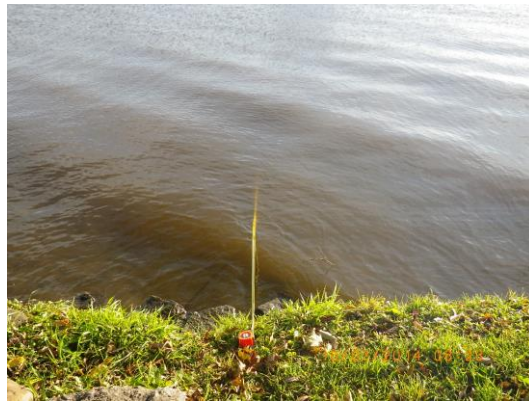
o20141007072346.JPG

Outfall fully submerged and not physically located. GPS coordinates approximate. Pipe info from MS4 map.

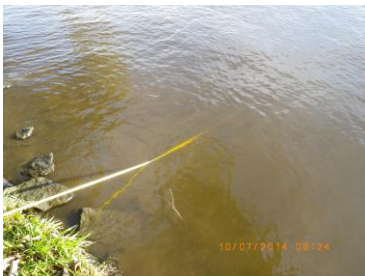
<b>Inspection Date:</b> 10/7/2014 8:22:14 AM		<b>Type:</b> Ongoing	<b>Flow:</b> Submerged, indeterminate	<b>Previous Rainfall (hrs):</b> 48-72
<b>Illicit Discharge Potential:</b> Unlikely		<b>Inspector:</b> JCW		
Submerged: Fully		Depth (in): 22		
<b>Sampling Results</b> Sample Location: Total Chlorine: -- ppm Free Chlorine: -- ppm Ammonia: -- ppm pH: -- units Temperature: -- °F Conductivity: -- µS/cm Detergents: -- mg/L		Floatables: None Odor: None Turbidity: None Color: None Gross Solids: None Vegetation: None Benthic Growth: None Stains: None Non-illicit: None	<b>Notes</b> Outfall fully submerged - screened upstream at 16-119 US1. Estimated submerged depth.

o20141007072412.JPG
		<b>Condition Assessment</b> Graffiti: None Erosion: None Damage: None Deposition: None in.

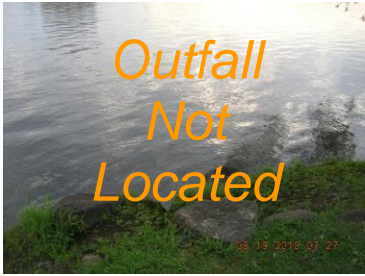
<b>Inspection Date:</b> 8/19/2010 7:33:20 AM		<b>Type:</b> Ongoing	<b>Flow:</b> Submerged (not located)	<b>Previous Rainfall (hrs):</b> 72+
<b>Illicit Discharge Potential:</b> Potential		<b>Inspector:</b> JCW		
Submerged: Fully		Depth (in):		
<b>Sampling Results</b> Sample Location: Total Chlorine: -- ppm Free Chlorine: -- ppm Ammonia: -- ppm pH: -- units Temperature: -- °F Conductivity: -- µS/cm Detergents: -- mg/L		Floatables: None Odor: None Turbidity: None Color: None Gross Solids: None Vegetation: None Benthic Growth: None Stains: None Non-illicit: None	<b>Notes</b> Outfall fully submerged and not physically located. Outfall screened upstream at 16-119 US1.

o20100819072722.JPG
		<b>Condition Assessment</b> Graffiti: None Erosion: None Damage: None Deposition: None 0 in.

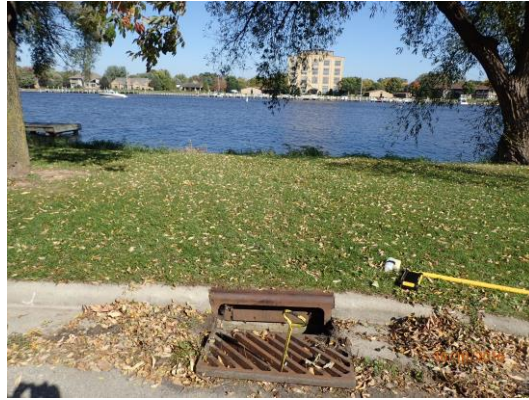
o20161010135648.JPG

Upstream curb inlet located approx 52 ft WSW of outfall 16-119. Intermediate area consists of open space between parking lot and shoreline.

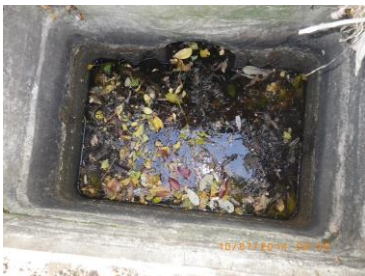
o20141007072656.JPG

<b>Sampling Results</b>		<b>Floatables:</b>	None	<b>Sample Location:</b>	Pool	<b>Odor:</b>	Faint	<b>Total Chlorine:</b>	0 ppm	<b>Turbidity:</b>	None	<b>Free Chlorine:</b>	0 ppm	<b>Color:</b>	Clearly visible in bottl	<b>Ammonia:</b>	0 ppm	<b>Gross Solids:</b>	Moderate	<b>pH:</b>	7.32 units	<b>Vegetation:</b>	None	<b>Temperature</b>	-- °F	<b>Benthic Growth:</b>	Slight	<b>Conductivity:</b>	423 µS/cm	<b>Stains:</b>	Moderate	<b>Detergents:</b>	0 mg/L	<b>Non-illicit:</b>	None
<b>Sampling Results</b>		<b>Floatables:</b>	None																																					
<b>Sample Location:</b>	Pool	<b>Odor:</b>	Faint																																					
<b>Total Chlorine:</b>	0 ppm	<b>Turbidity:</b>	None																																					
<b>Free Chlorine:</b>	0 ppm	<b>Color:</b>	Clearly visible in bottl																																					
<b>Ammonia:</b>	0 ppm	<b>Gross Solids:</b>	Moderate																																					
<b>pH:</b>	7.32 units	<b>Vegetation:</b>	None																																					
<b>Temperature</b>	-- °F	<b>Benthic Growth:</b>	Slight																																					
<b>Conductivity:</b>	423 µS/cm	<b>Stains:</b>	Moderate																																					
<b>Detergents:</b>	0 mg/L	<b>Non-illicit:</b>	None																																					
		<b>Notes</b> Vegetative debris in inlet.																																						
		<b>Condition Assessment</b> Graffiti: None Erosion: None Damage: None Deposition: Minor 1 in.

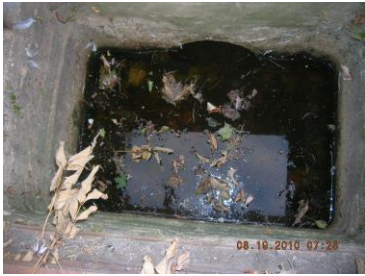
o20100819072808.JPG

<b>Sampling Results</b>		<b>Floatables:</b>	Slight	<b>Sample Location:</b>	Pool	<b>Odor:</b>	Faint	<b>Total Chlorine:</b>	0 ppm	<b>Turbidity:</b>	None	<b>Free Chlorine:</b>	0 ppm	<b>Color:</b>	Faint in bottle	<b>Ammonia:</b>	0 ppm	<b>Gross Solids:</b>	None	<b>pH:</b>	7.5 units	<b>Vegetation:</b>	None	<b>Temperature</b>	74 °F	<b>Benthic Growth:</b>	Slight	<b>Conductivity:</b>	-- µS/cm	<b>Stains:</b>	None	<b>Detergents:</b>	0 mg/L	<b>Non-illicit:</b>	None
<b>Sampling Results</b>		<b>Floatables:</b>	Slight																																					
<b>Sample Location:</b>	Pool	<b>Odor:</b>	Faint																																					
<b>Total Chlorine:</b>	0 ppm	<b>Turbidity:</b>	None																																					
<b>Free Chlorine:</b>	0 ppm	<b>Color:</b>	Faint in bottle																																					
<b>Ammonia:</b>	0 ppm	<b>Gross Solids:</b>	None																																					
<b>pH:</b>	7.5 units	<b>Vegetation:</b>	None																																					
<b>Temperature</b>	74 °F	<b>Benthic Growth:</b>	Slight																																					
<b>Conductivity:</b>	-- µS/cm	<b>Stains:</b>	None																																					
<b>Detergents:</b>	0 mg/L	<b>Non-illicit:</b>	None																																					
		<b>Notes</b> Oil sheen likely from parking lot runoff.																																						
		<b>Condition Assessment</b> Graffiti: None Erosion: None Damage: None Deposition: None 0 in.

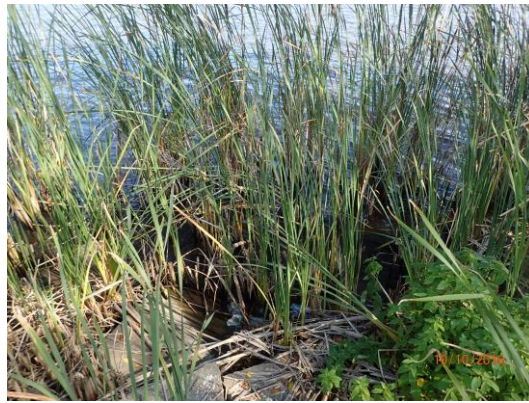
o20161010133804.JPG

Curb inlets from Veterans Trail discharge to river from west. Outfall not located - pipe info from MS4 map.

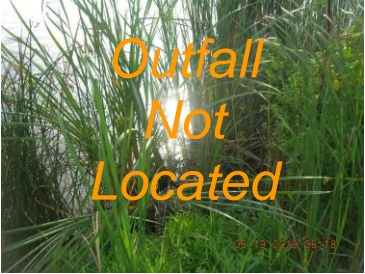
<p>o20100819081820.JPG</p>	
Submerged: Fully		Depth (in):		Outfall fully submerged and not physically located. Outfall screened upstream at 16-142 US1.			
<b>Sampling Results</b> Sample Location: Total Chlorine: -- ppm Free Chlorine: -- ppm Ammonia: -- ppm pH: -- units Temperature: -- °F Conductivity: -- µS/cm Detergents: -- mg/L		Floatables: None Odor: None Turbidity: None Color: None Gross Solids: None Vegetation: None Benthic Growth: None Stains: None Non-illicit: None		<b>Condition Assessment</b> Graffiti: None Erosion: None Damage: None Deposition: None 0 in.

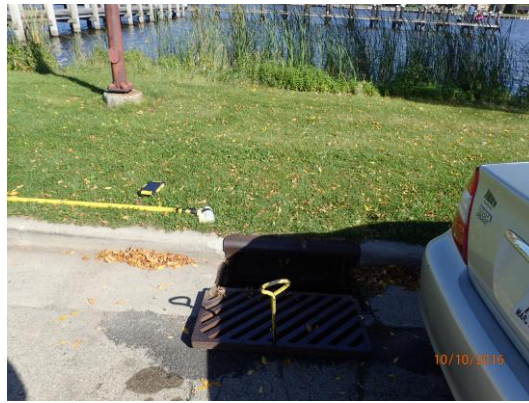
o20161010133930.JPG

Upstream curb inlet located approx 36 ft WSW of outfall 16-142. Intermediate area consists of open space between parking lot and shoreline.

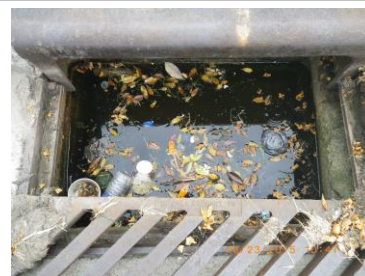
o20150923094718.JPG

<b>Inspection Date:</b> 9/23/2015 10:45:16 AM		<b>Type:</b> Ongoing	<b>Flow:</b> Submerged, indeterminate	<b>Previous Rainfall (hrs):</b> 72+
<b>Illicit Discharge Potential:</b> Potential		<b>Inspector:</b> JCW		
Submerged: Fully		Depth (in): 21		
<b>Sampling Results</b>		<b>Notes</b> Floating gross solids (litter) in manhole.		
Sample Location: Pool	Floatables: None	<b>Condition Assessment</b> Graffiti: None Erosion: None Damage: None Deposition: None in.		
Total Chlorine: 0 ppm	Odor: None			
Free Chlorine: 0 ppm	Turbidity: None			
Ammonia: 0 ppm	Color: None			
pH: 8.06 units	Gross Solids: Moderate			
Temperature 71 °F	Vegetation: None			
Conductivity: 345 µS/cm	Benthic Growth: Slight			
Detergents: 0 mg/L	Stains: None			
	Non-illicit: None

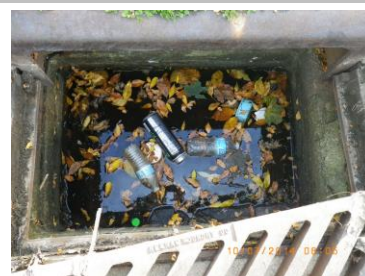
o20141007070512.JPG

<b>Inspection Date:</b> 10/7/2014 8:03:39 AM		<b>Type:</b> Ongoing	<b>Flow:</b> Submerged, indeterminate	<b>Previous Rainfall (hrs):</b> 48-72
<b>Illicit Discharge Potential:</b> Potential		<b>Inspector:</b> JCW		
Submerged: Fully		Depth (in): 15		
<b>Sampling Results</b>		<b>Notes</b> Floating gross solids (litter) in catchbasin.		
Sample Location: Pool	Floatables: None	<b>Condition Assessment</b> Graffiti: None Erosion: None Damage: None Deposition: Minor 1 in.		
Total Chlorine: 0 ppm	Odor: Faint			
Free Chlorine: 0 ppm	Turbidity: None			
Ammonia: 0 ppm	Color: None			
pH: 7.55 units	Gross Solids: Moderate			
Temperature -- °F	Vegetation: None			
Conductivity: 430 µS/cm	Benthic Growth: Slight			
Detergents: 0 mg/L	Stains: None			
	Non-illicit: Slight

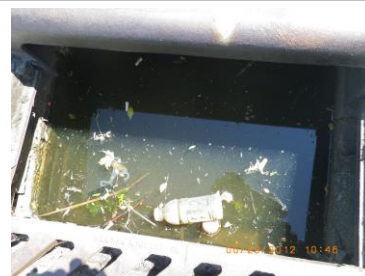
o20120620094656.JPG

<b>Inspection Date:</b> 6/20/2012 10:46:43 AM		<b>Type:</b> Ongoing	<b>Flow:</b> Submerged, indeterminate	<b>Previous Rainfall (hrs):</b> 24-48
<b>Illicit Discharge Potential:</b> Unlikely		<b>Inspector:</b> JCW		
Submerged: Fully		Depth (in): 23		
<b>Sampling Results</b>		<b>Notes</b> 2011 gross solids follow-up. Visual screening only.		
Sample Location: --	Floatables: None	<b>Condition Assessment</b> Graffiti: None Erosion: None Damage: None Deposition: None in.		
Total Chlorine: -- ppm	Odor: None			
Free Chlorine: -- ppm	Turbidity: None			
Ammonia: -- ppm	Color: None			
pH: -- units	Gross Solids: Slight			
Temperature -- °F	Vegetation: None			
Conductivity: -- µS/cm	Benthic Growth: Moderate			
Detergents: -- mg/L	Stains: Slight			
	Non-illicit: None

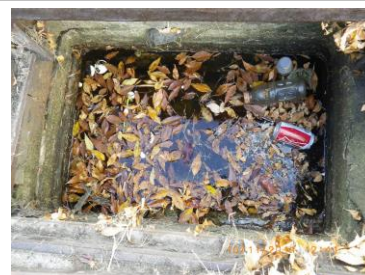
o20111011124148.JPG

<b>Inspection Date:</b> 10/11/2011 12:44:57 PM		<b>Type:</b> Ongoing	<b>Flow:</b> Submerged, indeterminate	<b>Previous Rainfall (hrs):</b> 72+
<b>Illicit Discharge Potential:</b> Potential		<b>Inspector:</b> JCW		
Submerged: Fully		Depth (in): 16		
<b>Sampling Results</b>		<b>Notes</b> 2010 screening follow-up. Floatable debris still present.		
Sample Location: Pool	Floatables: None	<b>Condition Assessment</b> Graffiti: None Erosion: None Damage: None Deposition: None 0 in.		
Total Chlorine: 0 ppm	Odor: None			
Free Chlorine: 0 ppm	Turbidity: None			
Ammonia: 0 ppm	Color: None			
pH: 8.15 units	Gross Solids: Slight			
Temperature 71 °F	Vegetation: None			
Conductivity: -- µS/cm	Benthic Growth: None			
Detergents: -- mg/L	Stains: None			
	Non-illicit: None

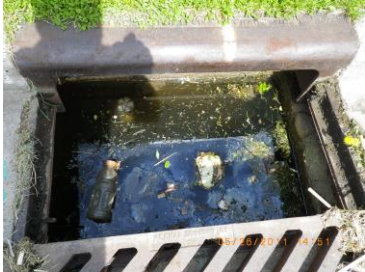
o20110526145102.JPG

<b>Inspection Date:</b> 5/26/2011 2:50:00 PM		<b>Type:</b> Other	<b>Flow:</b> Submerged, indeterminate	<b>Previous Rainfall (hrs):</b> 72+
<b>Illicit Discharge Potential:</b> Potential		<b>Inspector:</b> JCW		<b>Notes</b> Limited screening conducted to check for floatable debris.
Submerged: Fully		Depth (in):		
<b>Sampling Results</b> Sample Location:		Floatables: Moderate		
Total Chlorine: -- ppm Free Chlorine: -- ppm Ammonia: -- ppm pH: -- units Temperature: -- °F Conductivity: -- µS/cm Detergents: -- mg/L		Odor: Turbidity: Color: Gross Solids: None Vegetation: Benthic Growth: Stains: Non-illicit: Moderate		
		<b>Condition Assessment</b> Graffiti: None Erosion: None Damage: None Deposition: None 0 in.

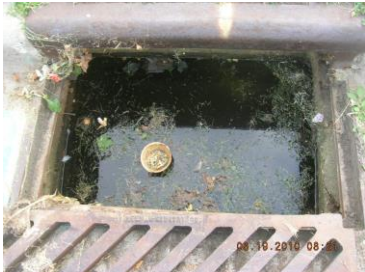
o20100819082134.JPG

<b>Inspection Date:</b> 8/19/2010 8:30:49 AM		<b>Type:</b> Ongoing	<b>Flow:</b> Submerged, indeterminate	<b>Previous Rainfall (hrs):</b> 72+
<b>Illicit Discharge Potential:</b> Potential		<b>Inspector:</b> JCW		<b>Notes</b> Floatable debris in catchbasin.
Submerged: Fully		Depth (in): 22		
<b>Sampling Results</b> Sample Location: Pool		Floatables: None		
Total Chlorine: 0 ppm Free Chlorine: 0 ppm Ammonia: 0 ppm pH: 7.84 units Temperature: 73 °F Conductivity: -- µS/cm Detergents: 0 mg/L		Odor: None Turbidity: Slight cloudiness Color: Faint in bottle Gross Solids: Moderate Vegetation: None Benthic Growth: Slight Stains: None Non-illicit: None		
		<b>Condition Assessment</b> Graffiti: None Erosion: None Damage: None Deposition: None 0 in.

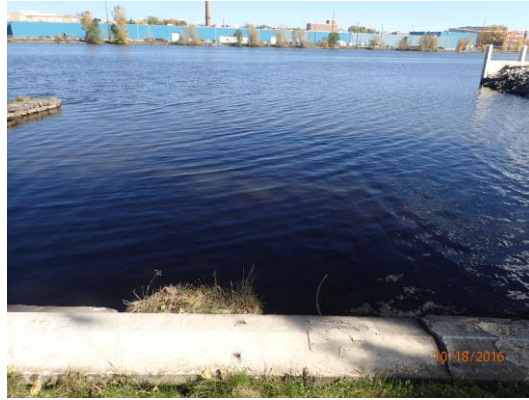
o20161018130904.JPG

Storm sewer from Adams Ave discharges to river from west. Outfall fully submerged and not physically located. GPS coordinates approximate. Pipe info from MS4 map.

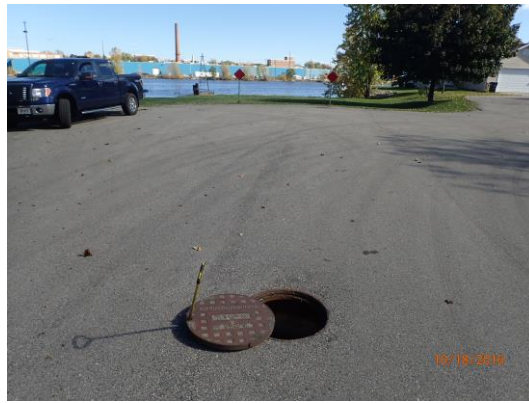
o20161018131204.JPG

Upstream manhole located approx 180 ft W of outfall 16-155. Intermediate area consists of street right-of-way and open space.

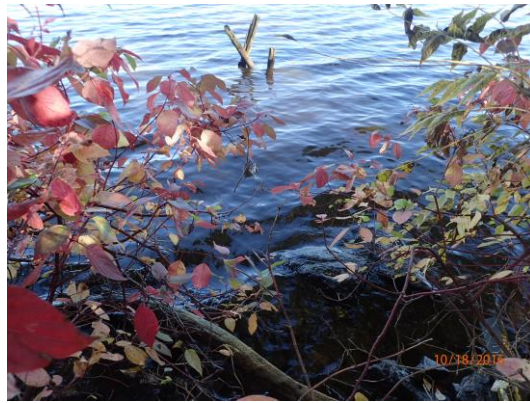
o20161018124934.JPG

Storm sewer from Tyler Ave discharges to river from west. Outfall fully submerged and not physically located. GPS coordinates approximate. Pipe info from MS4 map.

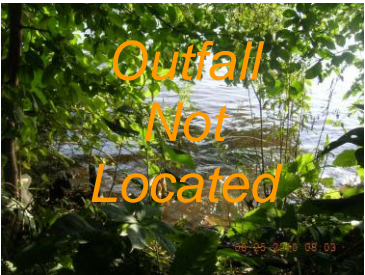
o20100825080326.JPG

<b>Notes</b> Outfall fully submerged and not physically located. Outfall screened upstream at 16-164 US1.																																				
		<b>Condition Assessment</b> <table border="1"> <tr> <td>Graffiti:</td> <td>None</td> </tr> <tr> <td>Erosion:</td> <td>None</td> </tr> <tr> <td>Damage:</td> <td>None</td> </tr> <tr> <td>Deposition:</td> <td>None 0 in.</td> </tr> </table>			Graffiti:	None	Erosion:	None	Damage:	None	Deposition:	None 0 in.																										
Graffiti:	None																																					
Erosion:	None																																					
Damage:	None																																					
Deposition:	None 0 in.

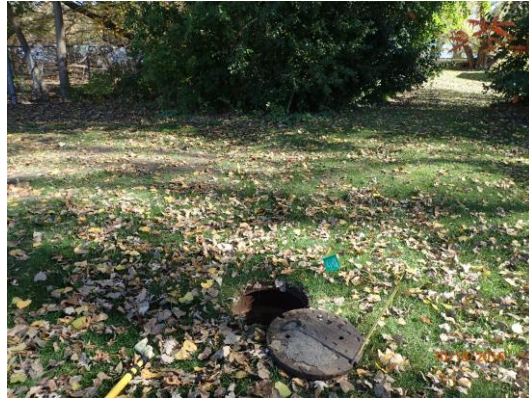
o20161018125136.JPG

Upstream manhole located approx 245 ft W of outfall 16-164. Intermediate area consists of wooded area to shoreline.

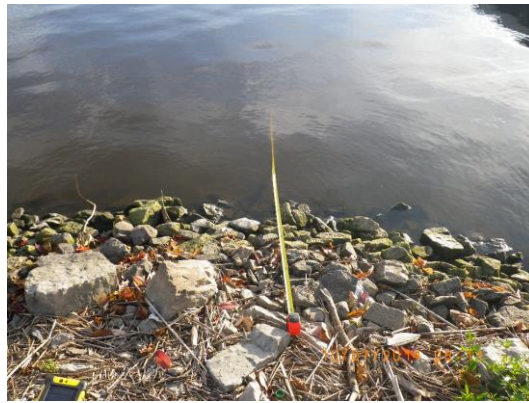
o20141007071152.JPG

Storm sewer from Graham Ave discharges to river from west. Pipe info from MS4 map.

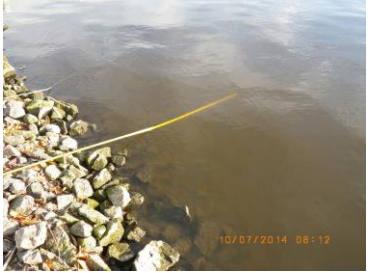
o20141007071204.JPG	
Submerged: Fully		Depth (in): 28		Outfall fully submerged - screened upstream at 16-201 US1.			
<b>Sampling Results</b> Sample Location: Total Chlorine: -- ppm Free Chlorine: -- ppm Ammonia: -- ppm pH: -- units Temperature: -- °F Conductivity: -- µS/cm Detergents: -- mg/L		Floatables: None Odor: None Turbidity: None Color: None Gross Solids: None Vegetation: None Benthic Growth: None Stains: None Non-illicit: None		<b>Condition Assessment</b> Graffiti: None Erosion: None Damage: None Deposition: None in.

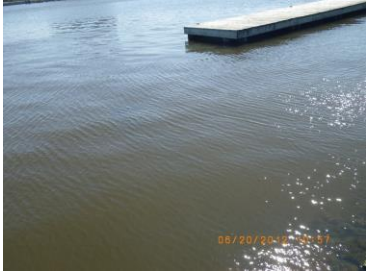
o20120620095704.JPG	
Submerged: Fully		Depth (in):		Outfall fully submerged; screened upstream at 16-201 US1.			
<b>Sampling Results</b> Sample Location: Total Chlorine: -- ppm Free Chlorine: -- ppm Ammonia: -- ppm pH: -- units Temperature: -- °F Conductivity: -- µS/cm Detergents: -- mg/L		Floatables: None Odor: None Turbidity: None Color: None Gross Solids: None Vegetation: None Benthic Growth: None Stains: None Non-illicit: None		<b>Condition Assessment</b> Graffiti: None Erosion: None Damage: None Deposition: None in.

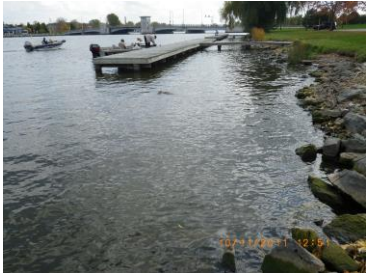
o20111011125132.JPG	
Submerged: Partially		Depth (in):		2010 screening follow-up. Outfall partially submerged. Outfall screened upstream at 16-201 US1.			
<b>Sampling Results</b> Sample Location: Total Chlorine: -- ppm Free Chlorine: -- ppm Ammonia: -- ppm pH: -- units Temperature: -- °F Conductivity: -- µS/cm Detergents: -- mg/L		Floatables: None Odor: None Turbidity: None Color: None Gross Solids: None Vegetation: None Benthic Growth: None Stains: None Non-illicit: None		<b>Condition Assessment</b> Graffiti: None Erosion: None Damage: None Deposition: None 0 in.

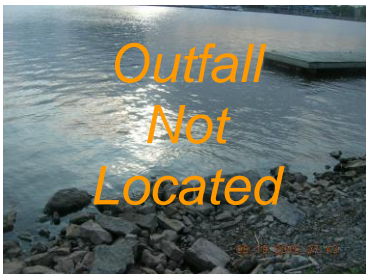
o20100819074346.JPG	
Submerged: Fully		Depth (in):		Outfall fully submerged and not physically located. Outfall screened upstream at 16-201 US1.			
<b>Sampling Results</b> Sample Location: Total Chlorine: -- ppm Free Chlorine: -- ppm Ammonia: -- ppm pH: -- units Temperature: -- °F Conductivity: -- µS/cm Detergents: -- mg/L		Floatables: None Odor: None Turbidity: None Color: None Gross Solids: None Vegetation: None Benthic Growth: None Stains: None Non-illicit: None		<b>Condition Assessment</b> Graffiti: None Erosion: None Damage: None Deposition: None 0 in.

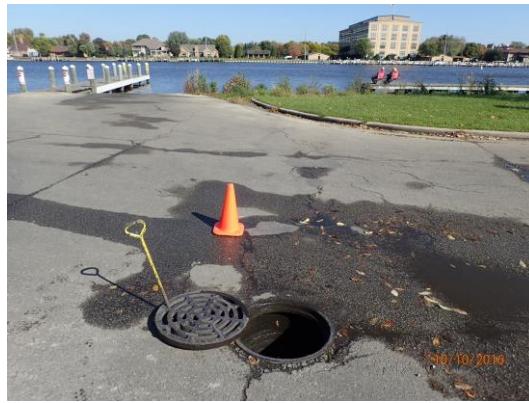
o20161010134810.JPG

Upstream catchbasin located approx 74 ft SW of outfall 16-201. Intermediate area consists of paved parking area and shoreline.

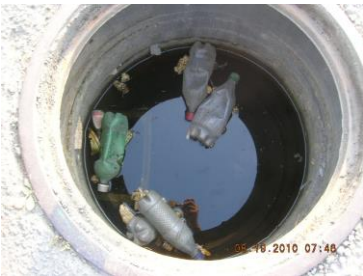
<b>Notes</b> Moderate floatable debris in catchbasin.

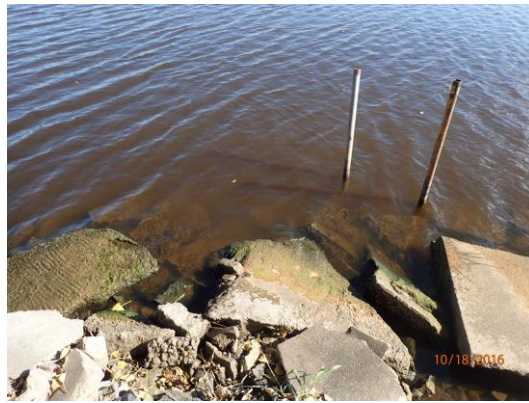
o20161018130004.JPG

Storm sewer from Coolidge Ave discharges to river from west. Outfall fully submerged and not physically located. GPS coordinates approximate. 24" CMP inside larger CMP at manhole.

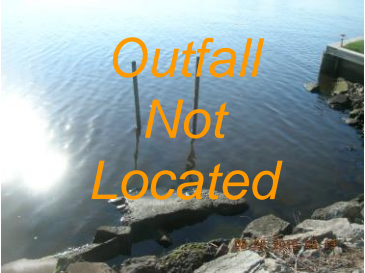
Inspection Date: 8/25/2010 8:24:56 AM		Type: Ongoing	Flow: Submerged (not located)	Previous Rainfall (hrs): 72+
Illicit Discharge Potential: Unlikely		Inspector: JCW		
Submerged: Fully		Depth (in):		
Sampling Results		Notes		
Sample Location:	Floatables: None	Outfall fully submerged and not physically located. Outfall screened upstream at 16-289 US1.

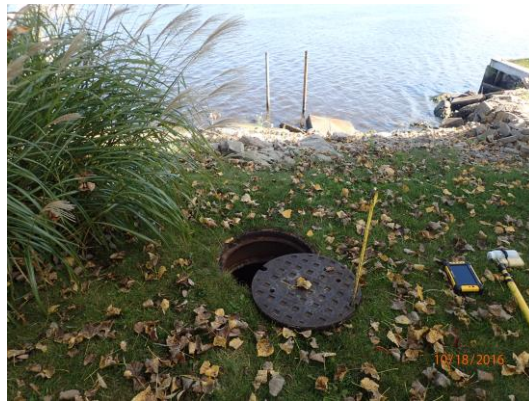
o20161018130206.JPG

Upstream manhole located approx 19 ft ENE of outfall 16-289. Intermediate area consists of open space.

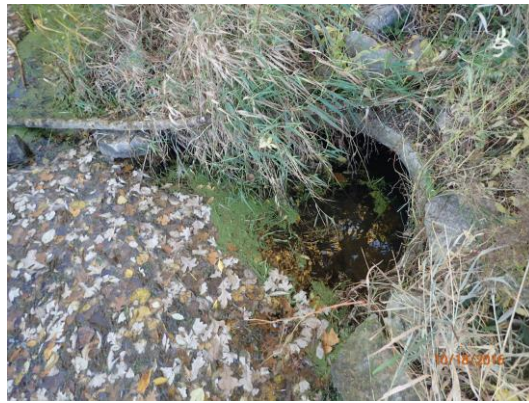
o20161018104646.JPG

Storm sewer from Eagle St discharges to stream from south. Pipe specs updated in 2011.

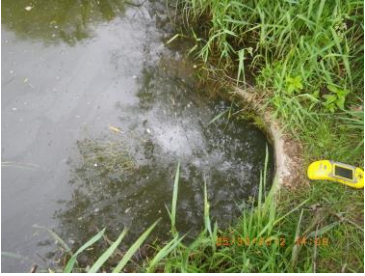
<b>Inspection Date:</b> 5/30/2012 2:06:18 PM		<b>Type:</b> Ongoing		<b>Flow:</b> Submerged, indeterminate		<b>Previous Rainfall (hrs):</b> 72+	
<b>Illicit Discharge Potential:</b> Unlikely		<b>Inspector:</b> JCW		<b>Notes</b> Outfall fully submerged. Outfall screened upstream at 16-328 US1.

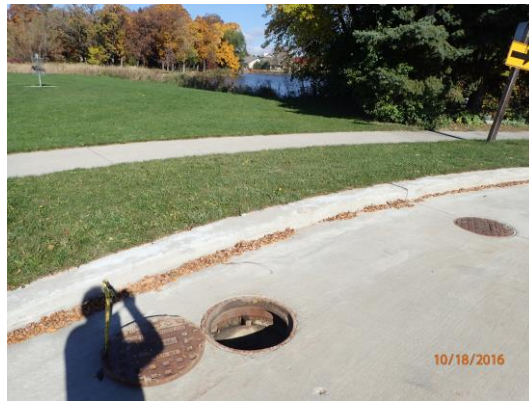
o20161018104844.JPG

Upstream manhole located approx 75 ft S of outfall 16-328. Intermediate area consists of open space.

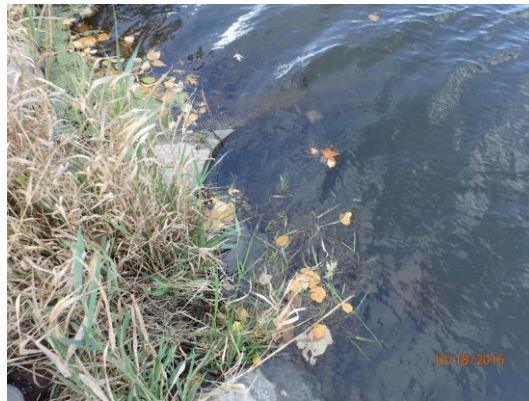
o20161018102044.JPG

Storm sewer from Coolidge Ave discharges to stream from east. Pipe dimensions from MS4 map

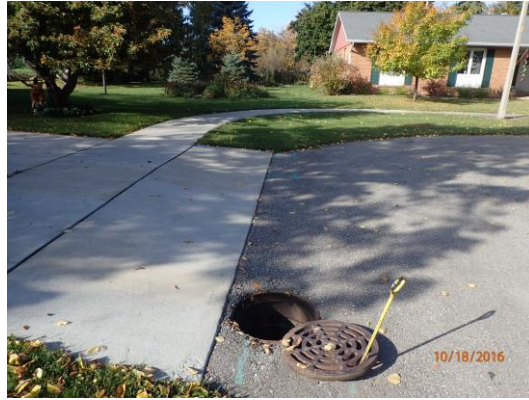
o20161018102354.JPG

Upstream catchbasin located approx 165 ft E of outfall 16-334. Intermediate area consists of residential property. First upstream manhole not located.

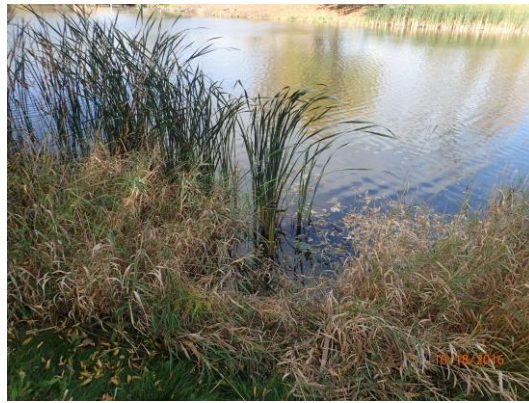
o20161018100722.JPG

Storm sewer from Van Buren Ave discharges to stream from east. Pipe information from MS4 map

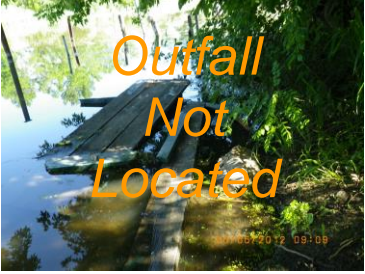
<p>o20120606080948.JPG</p>																																									
Submerged: Fully		Depth (in):		Outfall fully submerged and not physically located. Outfall screened upstream at 16-351 US2.																																											
<b>Sampling Results</b> <table border="1"> <tr> <td>Sample Location:</td> <td></td> <td>Floatables:</td> <td>None</td> </tr> <tr> <td>Total Chlorine:</td> <td>-- ppm</td> <td>Odor:</td> <td>None</td> </tr> <tr> <td>Free Chlorine:</td> <td>-- ppm</td> <td>Turbidity:</td> <td>None</td> </tr> <tr> <td>Ammonia:</td> <td>-- ppm</td> <td>Color:</td> <td>None</td> </tr> <tr> <td>pH:</td> <td>-- units</td> <td>Gross Solids:</td> <td>None</td> </tr> <tr> <td>Temperature:</td> <td>-- °F</td> <td>Vegetation:</td> <td>None</td> </tr> <tr> <td>Conductivity:</td> <td>-- µS/cm</td> <td>Benthic Growth:</td> <td>None</td> </tr> <tr> <td>Detergents:</td> <td>-- mg/L</td> <td>Stains:</td> <td>None</td> </tr> <tr> <td></td> <td></td> <td>Non-illicit:</td> <td>None</td> </tr> </table>		Sample Location:		Floatables:	None			Total Chlorine:	-- ppm	Odor:	None	Free Chlorine:	-- ppm	Turbidity:	None	Ammonia:	-- ppm	Color:	None	pH:	-- units	Gross Solids:	None	Temperature:	-- °F	Vegetation:	None	Conductivity:	-- µS/cm	Benthic Growth:	None	Detergents:	-- mg/L	Stains:	None			Non-illicit:	None	<b>Condition Assessment</b> <table border="1"> <tr> <td>Graffiti:</td> <td>None</td> </tr> <tr> <td>Erosion:</td> <td>None</td> </tr> <tr> <td>Damage:</td> <td>None</td> </tr> <tr> <td>Deposition:</td> <td>None in.</td> </tr> </table>		Graffiti:	None	Erosion:	None	Damage:	None

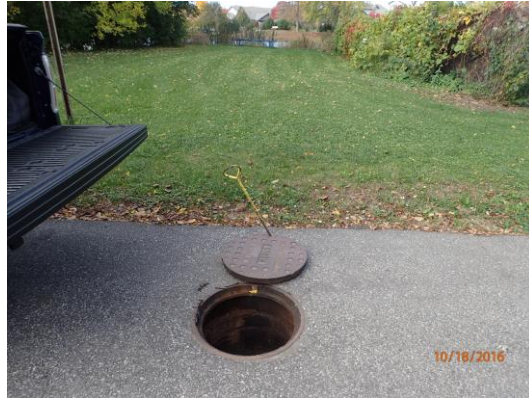
o20161018101040.JPG

Upstream manhole located approx 132 ft E of outfall 16-351. Intermediate area consists of open space. First upstream manhole not located.

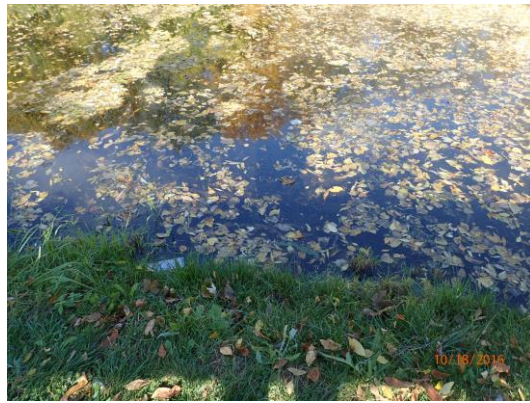
o20161018095848.JPG

Storm sewer from Arthur Ave discharges to stream from east. Pipe info from MS4 map

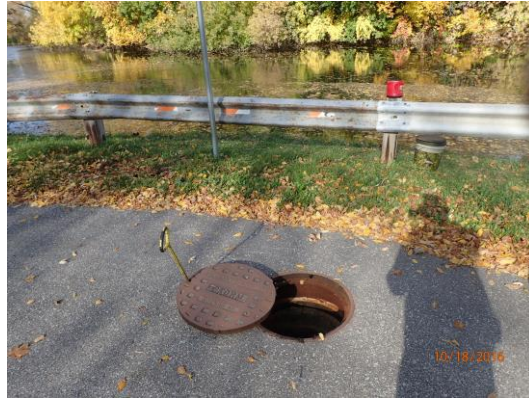
o20161018100050.JPG

Upstream manhole located approx 23 ft S of outfall 16-358. Intermediate area consists of open space.

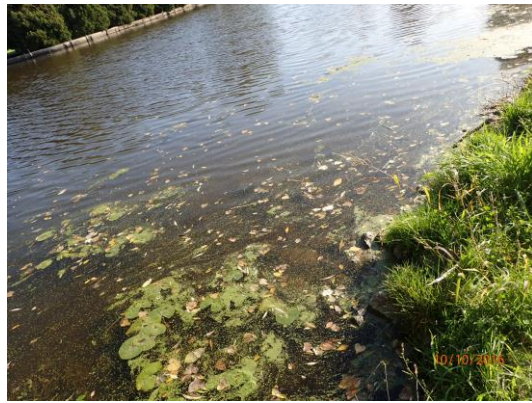
o20161010152650.JPG

Storm sewer from Oshkosh Ave and Punhoqua St discharges to river from west. Outfall fully submerged and not physically located. GPS coordinates approximate. Pipe info from MS4 map. 18" CMP in upstream manhole.

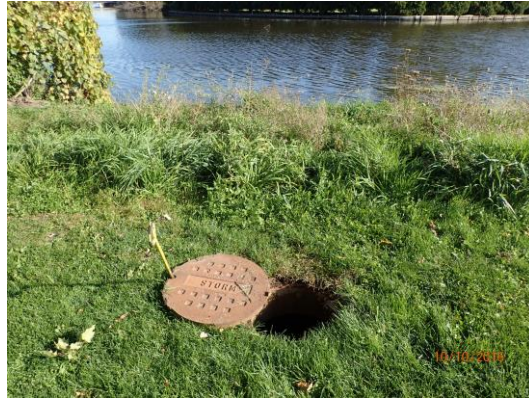
o20161010152704.JPG

Upstream manhole located approx 28 ft NW of outfall 16-362. Intermediate area consists of open space. 18" CMP discharges to SE.

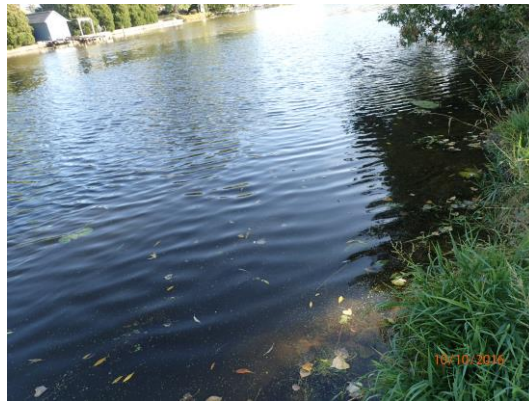
o20161010151914.JPG

Storm sewer from Maple Ave discharges to river from west. Outfall fully submerged and not physically located. GPS coordinates approximate. Pipe info from MS4 map.

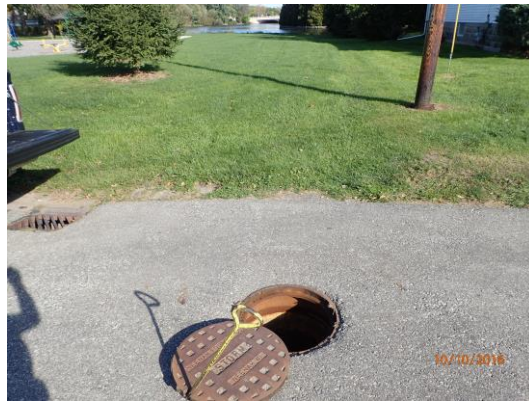
o20161010152034.JPG

Upstream manhole located approx 193 ft W of outfall 16-368. Intermediate area consists of street right-of-way, residential property and park space.

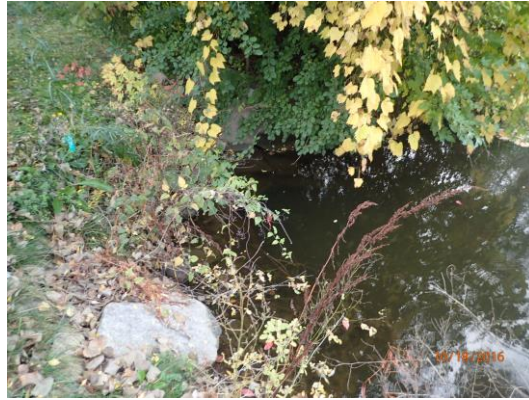
o20161018081844.JPG

Storm sewer from Buchanan Ave discharges to stream from west. Outfall fully submerged. Pipe info from MS4 map

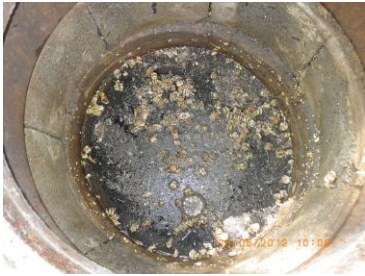
o20120606090934.JPG

<b>Inspection Date:</b> 6/6/2012 10:09:20 AM		<b>Type:</b> Other	<b>Flow:</b> Submerged, indeterminate	<b>Previous Rainfall (hrs):</b> 72+																																			
<b>Illicit Discharge Potential:</b> Potential		<b>Inspector:</b> JCW																																					
Submerged: Fully		Depth (in): 25																																					
<b>Sampling Results</b> <table border="1" style="width: 100%; border-collapse: collapse;"> <tr> <td>Sample Location:</td> <td>Pool</td> <td>Floatables:</td> <td>None</td> </tr> <tr> <td>Total Chlorine:</td> <td>0 ppm</td> <td>Odor:</td> <td>Faint</td> </tr> <tr> <td>Free Chlorine:</td> <td>0 ppm</td> <td>Turbidity:</td> <td>None</td> </tr> <tr> <td>Ammonia:</td> <td>0 ppm</td> <td>Color:</td> <td>None</td> </tr> <tr> <td>pH:</td> <td>8.01 units</td> <td>Gross Solids:</td> <td>Moderate</td> </tr> <tr> <td>Temperature:</td> <td>70 °F</td> <td>Vegetation:</td> <td>None</td> </tr> <tr> <td>Conductivity:</td> <td>1225 µS/cm</td> <td>Benthic Growth:</td> <td>Slight</td> </tr> <tr> <td>Detergents:</td> <td>0 mg/L</td> <td>Stains:</td> <td>None</td> </tr> <tr> <td></td> <td></td> <td>Non-illicit:</td> <td>None</td> </tr> </table>		Sample Location:	Pool	Floatables:	None	Total Chlorine:	0 ppm	Odor:	Faint	Free Chlorine:	0 ppm	Turbidity:	None	Ammonia:	0 ppm	Color:	None	pH:	8.01 units	Gross Solids:	Moderate	Temperature:	70 °F	Vegetation:	None	Conductivity:	1225 µS/cm	Benthic Growth:	Slight	Detergents:	0 mg/L	Stains:	None			Non-illicit:	None	<b>Notes</b> Manhole pre-screening. Reinspect after manhole is cleaned.

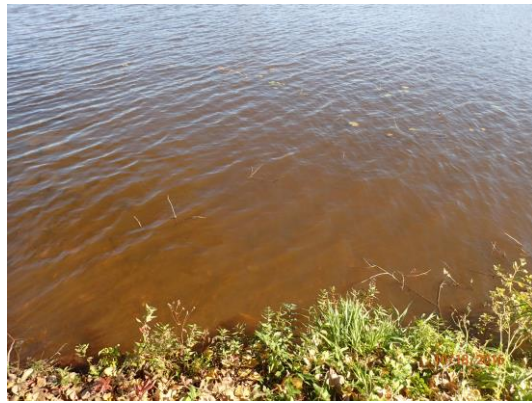
o20161018121832.JPG

Storm sewer from Buchanan Ave discharges to river from west. Outfall fully submerged and not physically located. GPS coordinates approximate. Pipe info from MS4 map.

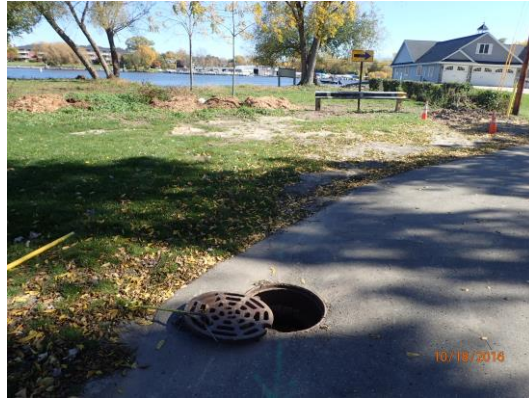
o20161018122002.JPG

Upstream catchbasin located approx 172 ft W of outfall 16-386. Intermediate area consists of open space and wooded area.

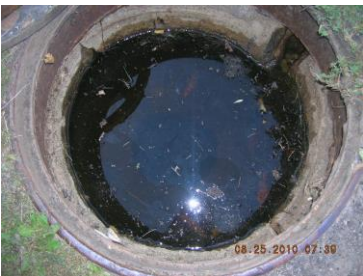
<b>Notes</b> First upstream manhole on MS4 map not located.

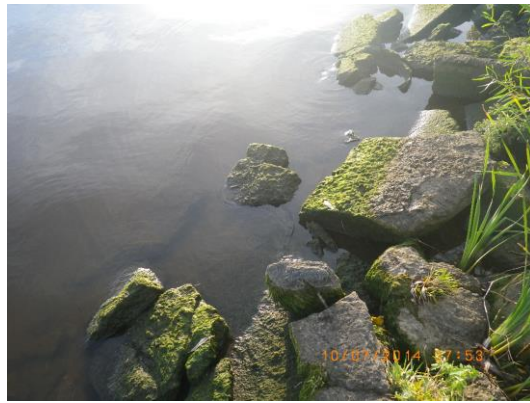
o20141007065340.JPG

Storm sewer from Rainbow Dr discharges to river from west. Outfall not located - pipe info from MS4 map.

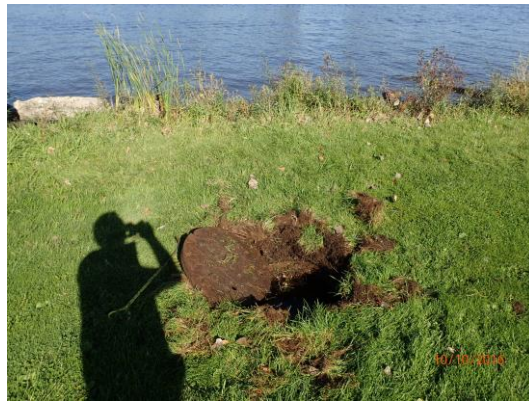
o20161010144722.JPG

Upstream manhole located approx 28 ft WSW of outfall 16-463. Intermediate area consists of open space along shoreline.

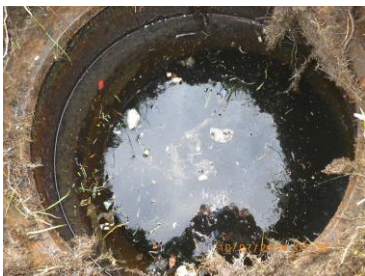
<p style="text-align: center; font-size: small;">o20141007065402.JPG</p>

<div style="display: flex; justify-content: space-between;"> <div style="width: 45%;"> <p><b>Notes</b></p> <p>2011 gross solids follow-up. Visual screening only.</p> </div> <div style="width: 45%;"> <p><b>Condition Assessment</b></p> <table border="1" style="width:100%; border-collapse: collapse;"> <tr><td>Graffiti:</td><td>None</td></tr> <tr><td>Erosion:</td><td>None</td></tr> <tr><td>Damage:</td><td>None</td></tr> <tr><td>Deposition:</td><td>None in.</td></tr> </table> </div> </div>			Graffiti:	None	Erosion:	None	Damage:	None	Deposition:	None in.																										
Graffiti:	None																																					
Erosion:	None																																					
Damage:	None																																					
Deposition:	None in.

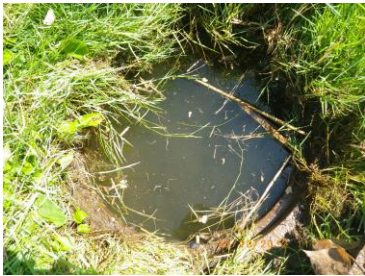
<p style="text-align: center; font-size: small;">o20120620100626.JPG</p>

<div style="display: flex; justify-content: space-between;"> <div style="width: 45%;"> <p><b>Notes</b></p> <p>2010 screening follow-up. Floatable debris still present.</p> </div> <div style="width: 45%;"> <p><b>Condition Assessment</b></p> <table border="1" style="width:100%; border-collapse: collapse;"> <tr><td>Graffiti:</td><td>None</td></tr> <tr><td>Erosion:</td><td>None</td></tr> <tr><td>Damage:</td><td>None</td></tr> <tr><td>Deposition:</td><td>None 0 in.</td></tr> </table> </div> </div>			Graffiti:	None	Erosion:	None	Damage:	None	Deposition:	None 0 in.																										
Graffiti:	None																																					
Erosion:	None																																					
Damage:	None																																					
Deposition:	None 0 in.

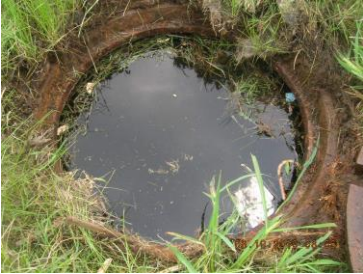
o20100819080644.JPG

<b>Inspection Date:</b> 8/19/2010 8:09:08 AM		<b>Type:</b> Ongoing		<b>Flow:</b> Submerged, indeterminate		<b>Previous Rainfall (hrs):</b> 72+	
<b>Illicit Discharge Potential:</b> Potential		<b>Inspector:</b> JCW		<b>Notes</b> Water level at manhole rim. Floatable debris in manhole.

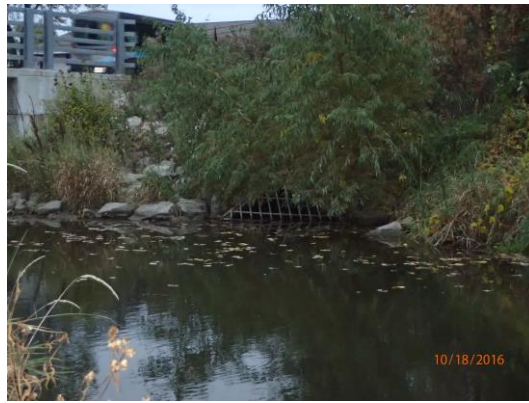
o20161018073038.JPG

Storm sewer from Westfield St discharges to stream from north.

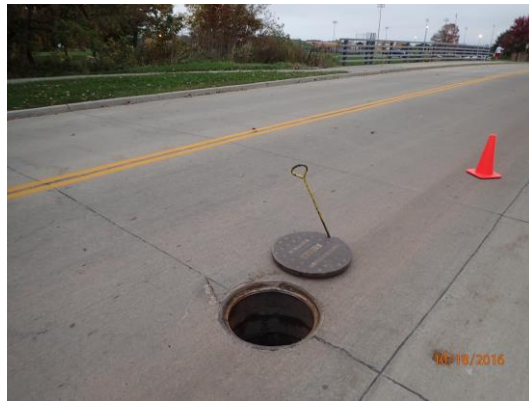
o20161018074820.JPG

Upstream manhole located approx 97 ft NW of outfall 16-488. Intermediate area consists of street right-of-way.

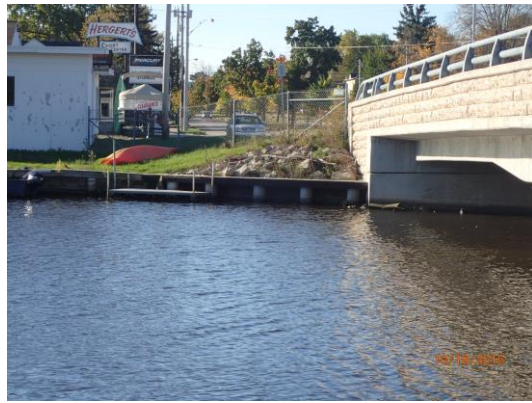
o20161018091944.JPG

N Sawyer St storm sewer discharges to river from south. Outfall fully submerged and not physically located. GPS coordinates approximate. Pipe info from MS4 map.

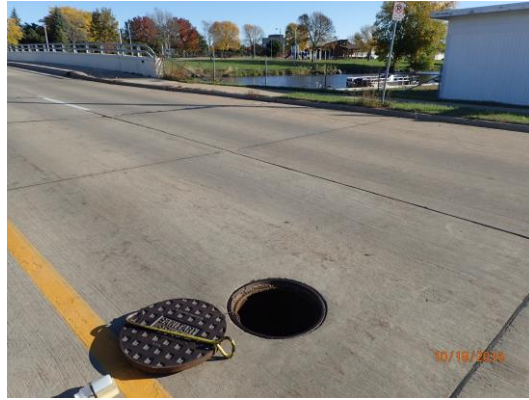
o20161018092508.JPG

Upstream manhole located approx 75 ft NE of outfall 16-533. Intermediate area consists of street right-of-way and commercial property.

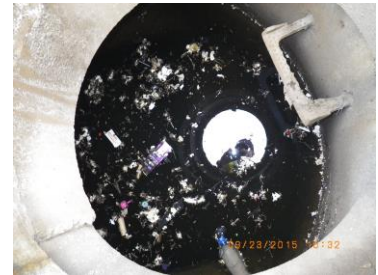
<b>Inspection Date:</b> 9/23/2015 10:32:59 AM		<b>Type:</b> Ongoing	<b>Flow:</b> Submerged, indeterminate	<b>Previous Rainfall (hrs):</b> 72+
<b>Illicit Discharge Potential:</b> Potential		<b>Inspector:</b> JCW		
Submerged: Fully		Depth (in): 36		
<b>Sampling Results</b>		<b>Notes</b> Floating gross solids (litter) - including syringe - in manhole.		
Sample Location: Pool	Floatables: None	<b>Condition Assessment</b> Graffiti: None Erosion: None Damage: None Deposition: None in.		
Total Chlorine: 0 ppm	Odor: None			
Free Chlorine: 0 ppm	Turbidity: None			
Ammonia: 0 ppm	Color: None			
pH: 7.95 units	Gross Solids: Moderate			
Temperature 71 °F	Vegetation: None			
Conductivity: 363 µS/cm	Benthic Growth: Slight			
Detergents: 0 mg/L	Stains: None			
	Non-illicit: None

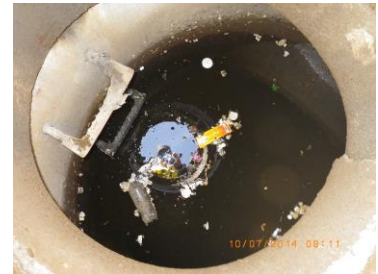
<b>Inspection Date:</b> 10/7/2014 9:13:45 AM		<b>Type:</b> Ongoing	<b>Flow:</b> Submerged, indeterminate	<b>Previous Rainfall (hrs):</b> 48-72
<b>Illicit Discharge Potential:</b> Potential		<b>Inspector:</b> JCW		
Submerged: Fully		Depth (in): 34		
<b>Sampling Results</b>		<b>Notes</b> Floating gross solids (litter) in manhole.		
Sample Location: Pool	Floatables: None	<b>Condition Assessment</b> Graffiti: None Erosion: None Damage: None Deposition: None in.		
Total Chlorine: 0 ppm	Odor: None			
Free Chlorine: 0 ppm	Turbidity: None			
Ammonia: 0 ppm	Color: None			
pH: 7.67 units	Gross Solids: Moderate			
Temperature -- °F	Vegetation: None			
Conductivity: 474 µS/cm	Benthic Growth: None			
Detergents: 0 mg/L	Stains: None			
	Non-illicit: None

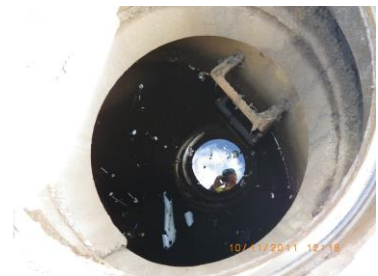
<b>Inspection Date:</b> 10/11/2011 12:22:21 PM		<b>Type:</b> Ongoing	<b>Flow:</b> Submerged, indeterminate	<b>Previous Rainfall (hrs):</b> 72+
<b>Illicit Discharge Potential:</b> Unlikely		<b>Inspector:</b> JCW		
Submerged: Fully		Depth (in): 16		
<b>Sampling Results</b>		<b>Notes</b> 2010 screening follow-up. Floatable debris significantly reduced.		
Sample Location: Pool	Floatables: None	<b>Condition Assessment</b> Graffiti: None Erosion: None Damage: None Deposition: None 0 in.		
Total Chlorine: 0 ppm	Odor: None			
Free Chlorine: 0 ppm	Turbidity: None			
Ammonia: 0 ppm	Color: None			
pH: 7.9 units	Gross Solids: Moderate			
Temperature 70 °F	Vegetation: None			
Conductivity: -- µS/cm	Benthic Growth: None			
Detergents: -- mg/L	Stains: None			
	Non-illicit: None

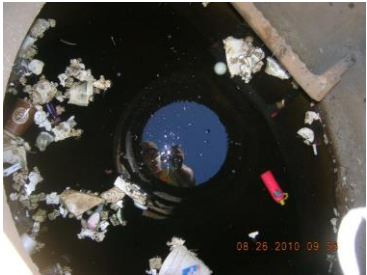
o20100826095640.JPG

<b>Inspection Date:</b> 8/26/2010 10:01:38 AM		<b>Type:</b> Ongoing	<b>Flow:</b> Submerged, indeterminate	<b>Previous Rainfall (hrs):</b> 72+																		
<b>Illicit Discharge Potential:</b> Potential		<b>Inspector:</b> JCW																				
Submerged: Fully		Depth (in): 36																				
<b>Sampling Results</b>		<b>Notes</b> Floatable debris in manhole.																				
Sample Location: Pool Total Chlorine: 0 ppm Free Chlorine: 0 ppm Ammonia: 0 ppm pH: 7.23 units Temperature: 76 °F Conductivity: -- µS/cm Detergents: 0 mg/L

Floatables:	None	Odor:	None	Turbidity:	None	Color:	Faint in bottle	Gross Solids:	Moderate	Vegetation:	None	Benthic Growth:	Slight	Stains:	None	Non-illicit:	None
Floatables:	None																					
Odor:	None																					
Turbidity:	None																					
Color:	Faint in bottle																					
Gross Solids:	Moderate																					
Vegetation:	None																					
Benthic Growth:	Slight																					
Stains:	None																					
Non-illicit:	None																					
		<b>Condition Assessment</b> Graffiti: None Erosion: None Damage: None Deposition: None 0 in.

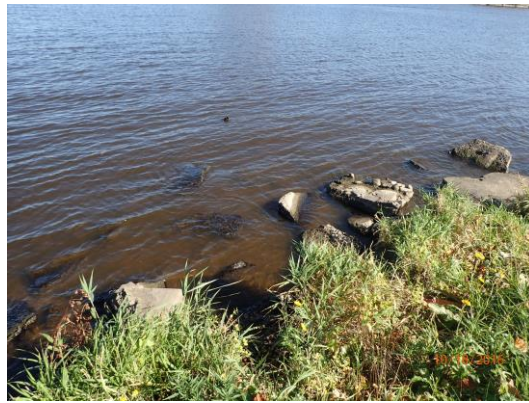
o20161018120922.JPG

Fillmore Ave storm sewer discharges to river from west. Outfall fully submerged and not physically located. GPS coordinates approximate. Pipe info from MS4 map.

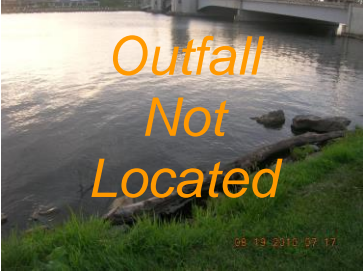
<p>o20100819071708.JPG</p>																																									
Submerged: Fully		Depth (in):		Outfall fully submerged and not physically located. Outfall screened upstream at 16-594 US1.																																											
<b>Sampling Results</b> <table border="1"> <tr> <td>Sample Location:</td> <td></td> </tr> <tr> <td>Total Chlorine:</td> <td>-- ppm</td> </tr> <tr> <td>Free Chlorine:</td> <td>-- ppm</td> </tr> <tr> <td>Ammonia:</td> <td>-- ppm</td> </tr> <tr> <td>pH:</td> <td>-- units</td> </tr> <tr> <td>Temperature:</td> <td>-- °F</td> </tr> <tr> <td>Conductivity:</td> <td>-- µS/cm</td> </tr> <tr> <td>Detergents:</td> <td>-- mg/L</td> </tr> </table>		Sample Location:		Total Chlorine:	-- ppm			Free Chlorine:	-- ppm	Ammonia:	-- ppm	pH:	-- units	Temperature:	-- °F	Conductivity:	-- µS/cm	Detergents:	-- mg/L	<table border="1"> <tr> <td>Floatables:</td> <td>None</td> </tr> <tr> <td>Odor:</td> <td>None</td> </tr> <tr> <td>Turbidity:</td> <td>None</td> </tr> <tr> <td>Color:</td> <td>None</td> </tr> <tr> <td>Gross Solids:</td> <td>None</td> </tr> <tr> <td>Vegetation:</td> <td>None</td> </tr> <tr> <td>Benthic Growth:</td> <td>None</td> </tr> <tr> <td>Stains:</td> <td>None</td> </tr> <tr> <td>Non-illicit:</td> <td>None</td> </tr> </table>		Floatables:	None	Odor:	None	Turbidity:	None	Color:	None	Gross Solids:	None	Vegetation:	None	Benthic Growth:	None	Stains:	None	Non-illicit:	None	<b>Condition Assessment</b> <table border="1"> <tr> <td>Graffiti:</td> <td>None</td> </tr> <tr> <td>Erosion:</td> <td>None</td> </tr> <tr> <td>Damage:</td> <td>None</td> </tr> <tr> <td>Deposition:</td> <td>None 0 in.</td> </tr> </table>		Graffiti:	None	Erosion:	None	Damage:	None

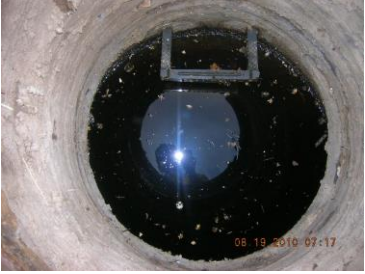
<b>Notes</b> 2 small oil drops, likely from Oshkosh Ave runoff.

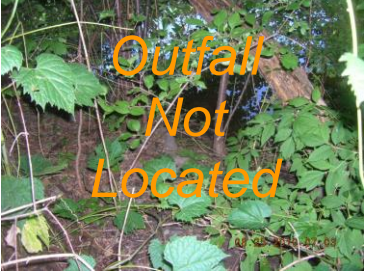
<p>o20100825070344.JPG</p>	
Submerged: Fully		Depth (in):		Outfall fully submerged and not physically located. Outfall screened upstream at 16-719 US1.			
<b>Sampling Results</b>				<b>Condition Assessment</b>			
Sample Location:		Floatables:	None	Graffiti:		None	
Total Chlorine: -- ppm		Odor:	None	Erosion:		None	
Free Chlorine: -- ppm		Turbidity:	None	Damage:		None	
Ammonia: -- ppm		Color:	None	Deposition:		None 0 in.	
pH: -- units		Gross Solids:	None				
Temperature -- °F		Vegetation:	None				
Conductivity: -- µS/cm		Benthic Growth:	None				
Detergents: -- mg/L		Stains:	None				
		Non-illicit:	None

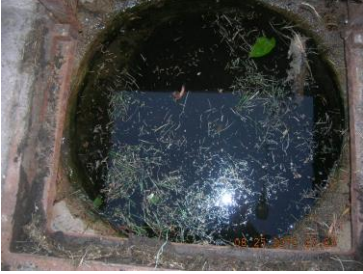
<b>Notes</b> "Smoky" odor in bottle.

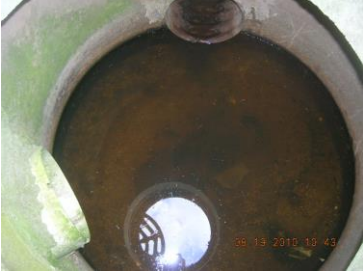
**Notes:** Grate could not be opened - no sample collected. Next upstream manhole not located.

Depth (in): 67

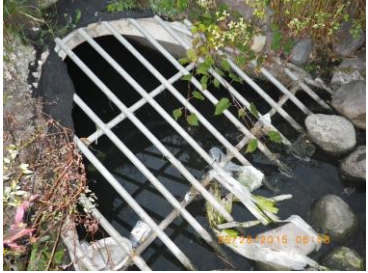
<b>Inspection Date:</b> 9/28/2015 6:56:23 AM		<b>Type:</b> Ongoing	<b>Flow:</b> Submerged, indeterminate	<b>Previous Rainfall (hrs):</b> 72+
<b>Illicit Discharge Potential:</b> Potential		<b>Inspector:</b> JCW		
Submerged: Partially      Depth (in): 27				
<b>Sampling Results</b> Sample Location: Total Chlorine: -- ppm Free Chlorine: -- ppm Ammonia: -- ppm pH: -- units Temperature: -- °F Conductivity: -- µS/cm Detergents: -- mg/L		Floatables: None Odor: None Turbidity: None Color: None Gross Solids: Slight Vegetation: None Benthic Growth: Moderate Stains: Moderate Non-illicit: None	<b>Notes</b> Outfall partially submerged - screened at 16-1508 US1. Elevated ammonia.

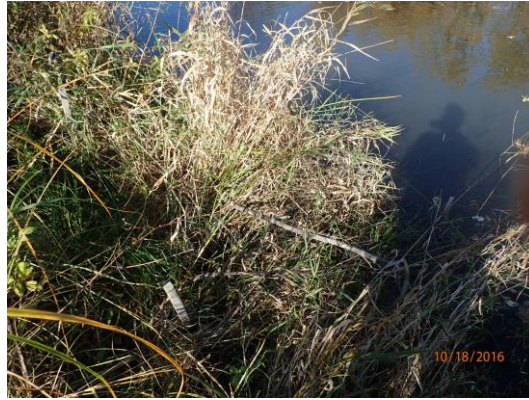
o20161018103528.JPG

Storm sewer from Taft Ave and water park discharges to stream from south. Replaces outfall 16-532 (2012). Pipe info from MS4 map.

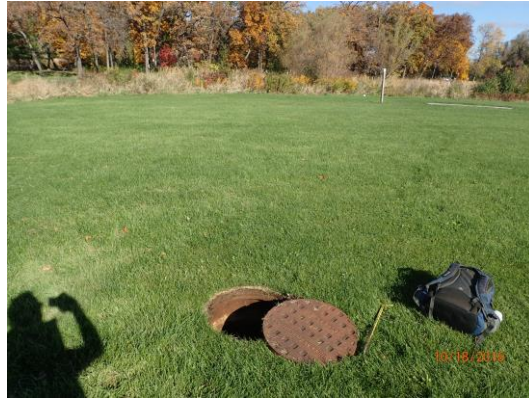
o20161018104022.JPG

Upstream manhole located approx 100 ft SSW of outfall 16-16-1571. Intermediate area consists of open space in park.

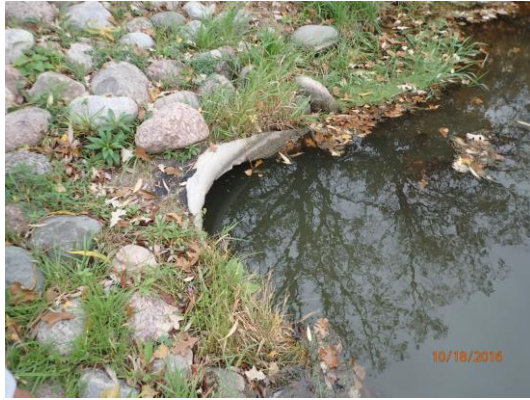
o20161018080330.JPG

Storm sewer from N Westfield St discharges to stream from north. Replaces outfall 16-514 (2012). Dimensions from MS4 map.

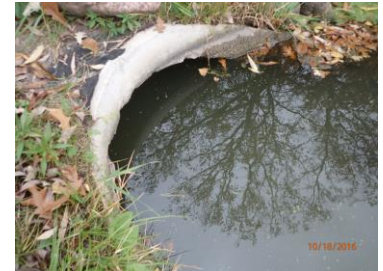
o20161018080338.JPG

Stains: Slight
