# Ongoing Screening Summary Report 2016 Inspection Year

Illicit Discharge Detection and Elimination Program

City of Oshkosh

November 30, 2016

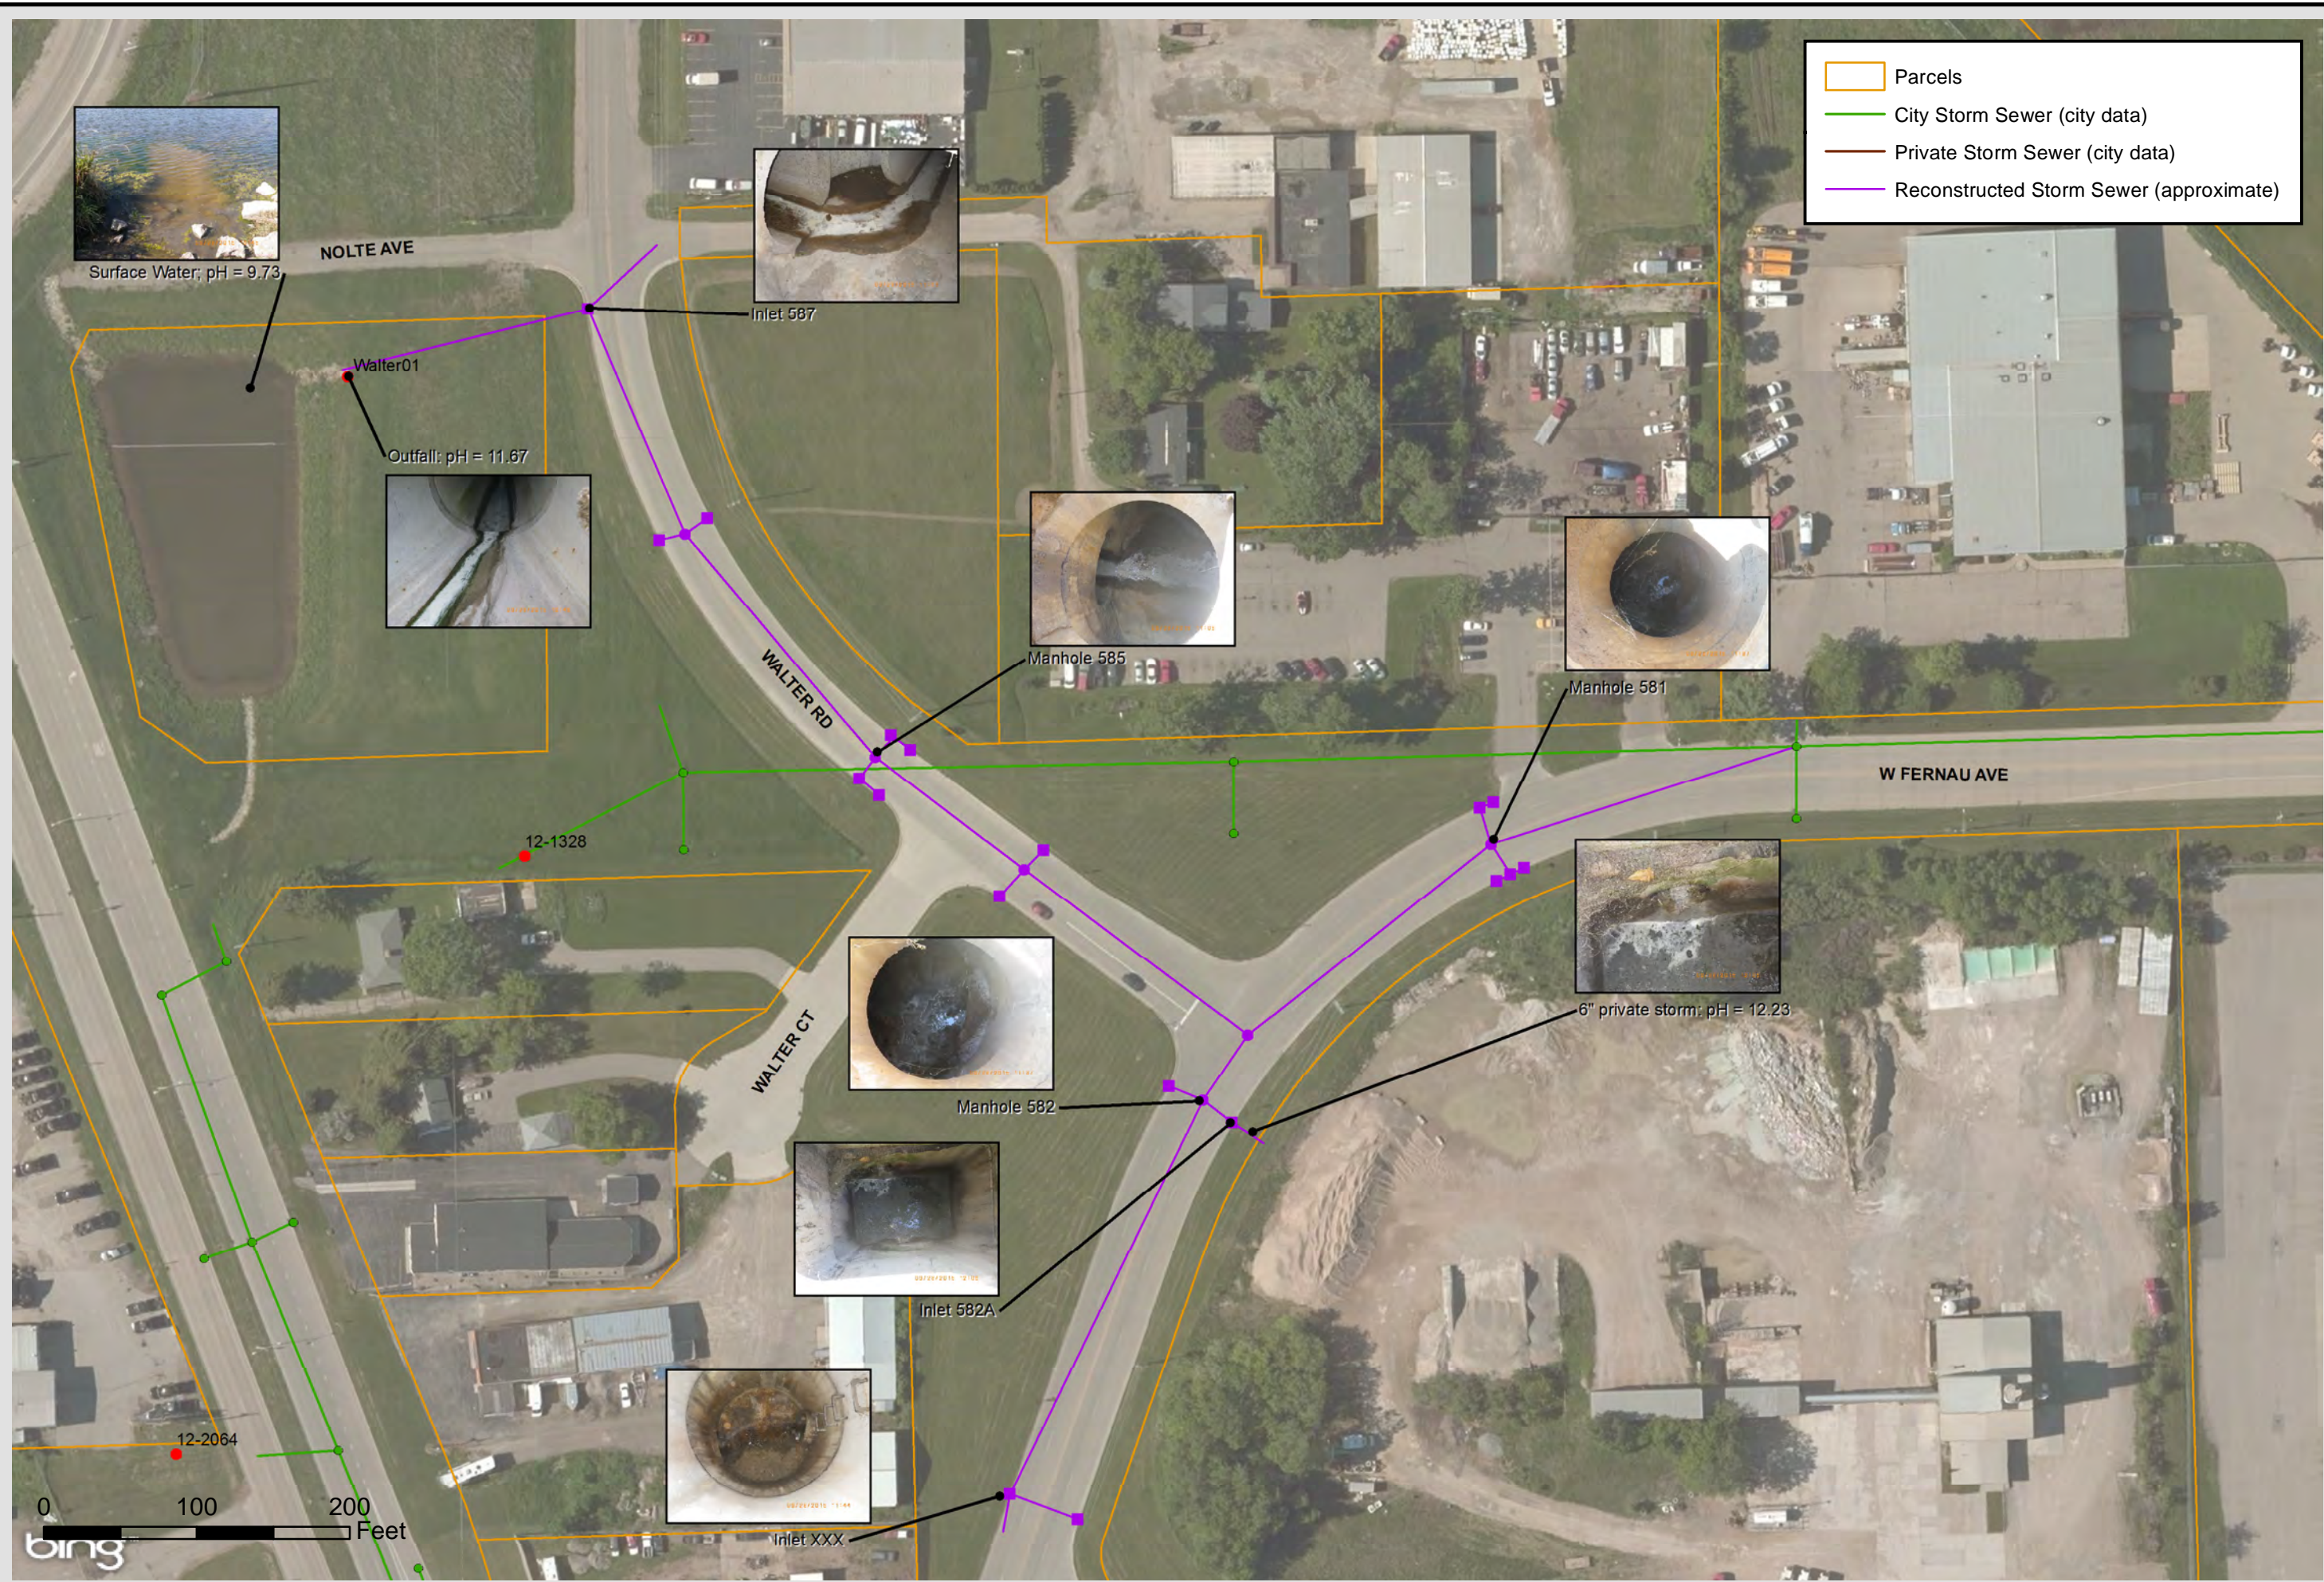
IDE ONGOING SCREENING PROGRAM  
WALTER ROAD/NOLTE AVE DETENTION BASIN  
ILLICIT DISCHARGE TRACKING (9/28/2015)

I have attached a map that summarizes the tracking activities from today. The staining and elevated pH discharge was observed at the outfall, and a surface water sample from the detention basin also had an elevated pH (9.73). The white stain was present at the upstream inlet on Walter Road, and clearly came from the south. The white stain in the manhole near Walter Road and Walter Court reinforced that the discharge was coming from the direction of Fernau Ave.

The new storm sewer branches to the northeast and southwest at Fernau Ave. Due to traffic issues, the manhole at the intersection of Walter and Fernau could not be inspected to determine which branch was contributing the stain. Several of the inlets and manholes from the "original" Fernau Avenue storm sewer (northeast branch) were inspected, and there were no signs of white stains. The first "new" manhole northeast of the intersection was inspected, and there were also no signs of white stains, suggesting that the discharge was coming from the southwest branch.

The first manhole southwest of the intersection (#562) was wet and had some of the white substance in it. The stain appeared to come from the inlet to the east. The inlet on the west side of Fernau (582B) was dry and clean. The inlet on the east side of Fernau (582A) was wet and had the white substance. Upon further inspection of the inlet, a 6" pipe was identified protruding through the back side (east/south) of the structure, with white staining and a trickle flow. This pipe appeared to originate from the property to the east (Carew). A sample was collected from this trickle flow, and the pH was 12.23. The elevated pH, along with the white staining from the pipe, indicate that this is the likely source of the discharge.

A sample collected from this pipe had a pH of 12.23. There was also white staining coming from this pipe. Therefore, this should be the location where the discharge is entering the MS4. The City will likely need to determine the source of this pipe on the Carew property. OMNNI can assist if needed.

I have attached a few additional photos to this email, along with a map showing the general layout and investigation findings. It is recommended that the City investigate the origin of this 6" pipe, along with any potential sources of the illicit discharge on the Carew property. If the City needs assistance with this tracking, OMNNI would be happy to help.
