Illicit Discharge Detection and Elimination
Conducted For
City of Oshkosh

Ongoing Screening Summary Report

2017 Inspection Year

OMNNI Project Number N2029C17

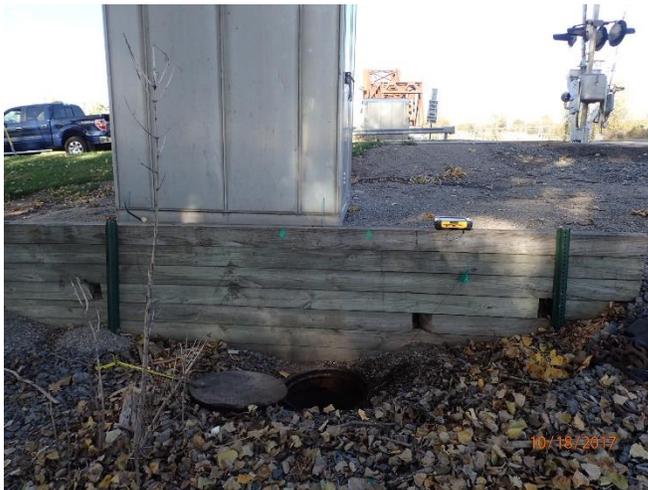
Figure 14 – Upstream manhole 03-81 US1 (2017)

The outfall was first screened in 2009. The first upstream manhole was located on the south side of Pioneer Drive, behind the railroad control shed. When the manhole was opened, a strong smell of diesel fuel was detected inside the manhole. The manhole was also submerged, and had a significant amount of floatable debris, which appeared to be coated with oil and grease.

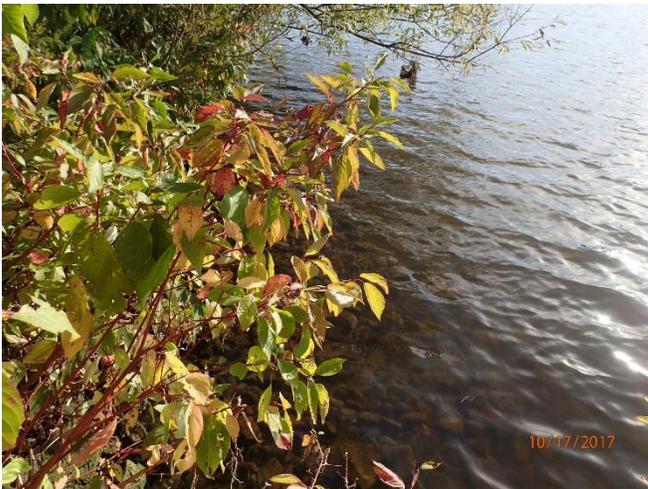
Figure 20 - Outfall 05-241 (2017)

Outfall 05-241 consists of an 18-inch corrugated metal pipe (CMP) that discharges into the Fox River at the end of Rockwell Ave. The pipe is fully submerged, and has not been physically located during outfall screenings.

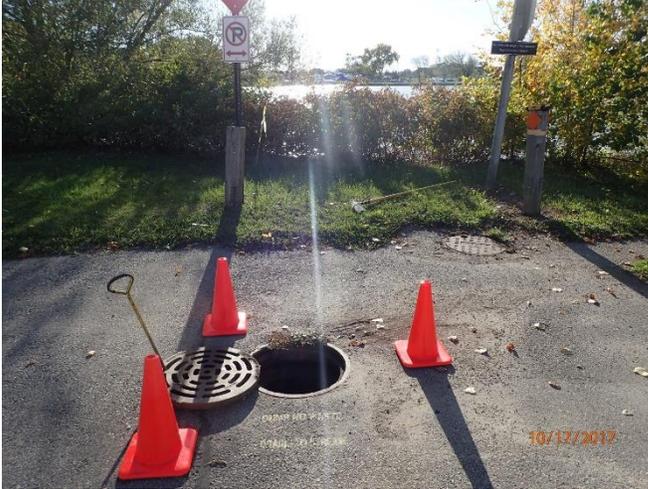
Figure 21 – Upstream manhole 05-241 US1 (2017)

During the 2017 screening, the sample collected from manhole 05-241 US1 had a detergent detection. No other parameters were outside of the normal range.

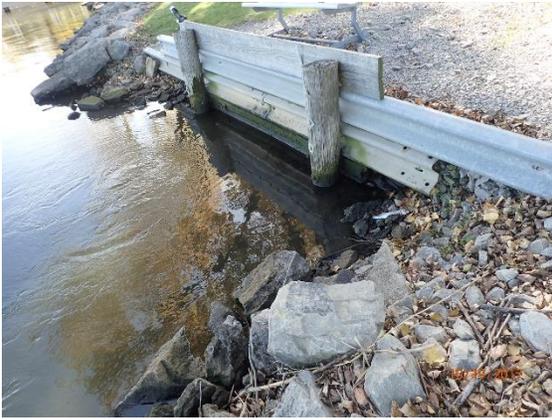
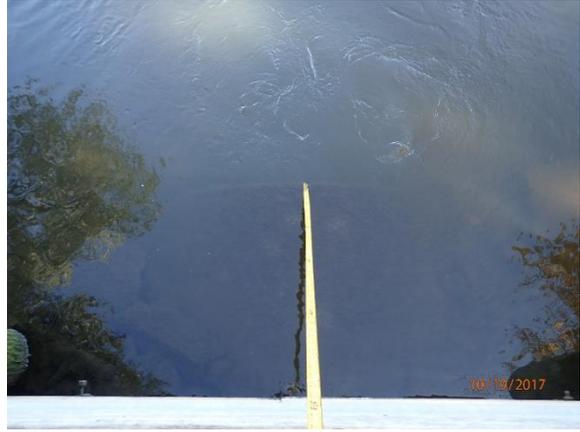
Figure 22 - Outfall 06-253 (2017)

Outfall 06-253 consists of a 34x53 inch RCP that discharges into the Fox River at the end of the extension of Campbell Road. The pipe may be the effluent pipe for the wastewater treatment plant. The pipe is fully submerged.

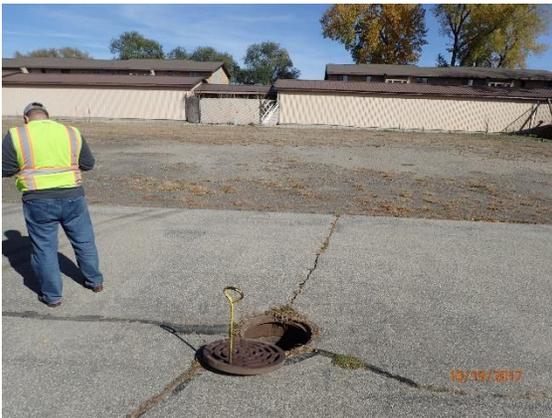
Figure 23 – Upstream manhole 06-253 US1 (2017)

During the 2017 screening, the sample collected from manhole 06-253 US1 had an elevated level of ammonia. No other parameters were outside of the normal range, although conductivity was approaching the 2,000 $\mu\text{S}/\text{cm}$ action level.

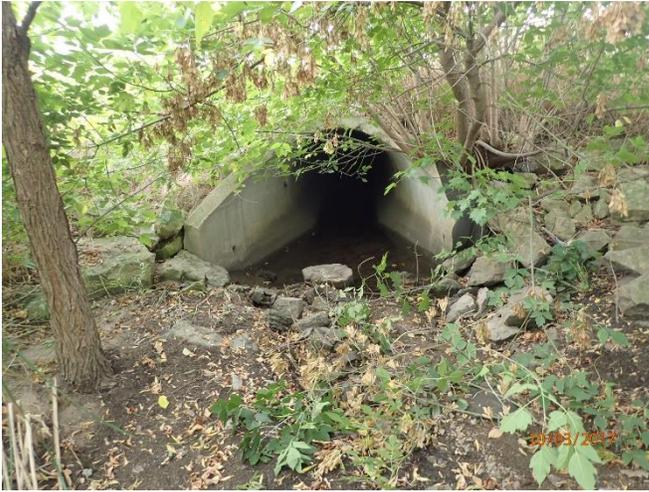
Figure 26 - Outfall 06-1746 (2017)

During the 2017 screening, the upstream manhole was dry, so a sample was collected from the outfall pool. This pool sample had a detergent detection. No other parameters were outside of the normal range.

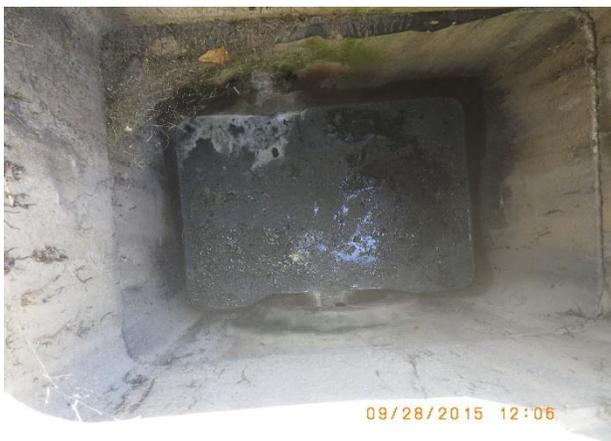
Figure 30 – Pipe discharging into inlet 582A (9/28/2015)

The Illicit Discharge Coordinator was notified of this pipe on September 28, 2015, and OMNNI and City personnel met with a representative of Carew Concrete on September 29, 2015 to attempt to identify the source of the discharge. No upstream inlets or catchbasins were located on the property. City personnel inserted a temporary plug in the end of the pipe to stop the discharge.

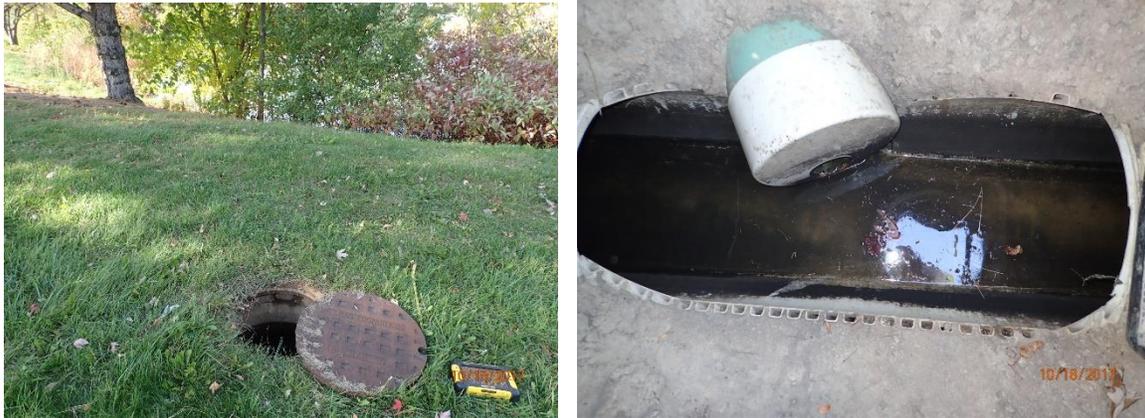
Figure 31 - Outfall 13-1716 (2017)

During the 2017 screening, a sample collected from the pool in the manhole had elevated levels of ammonia. The manhole has had elevated levels of ammonia and/or detergent in prior screenings.

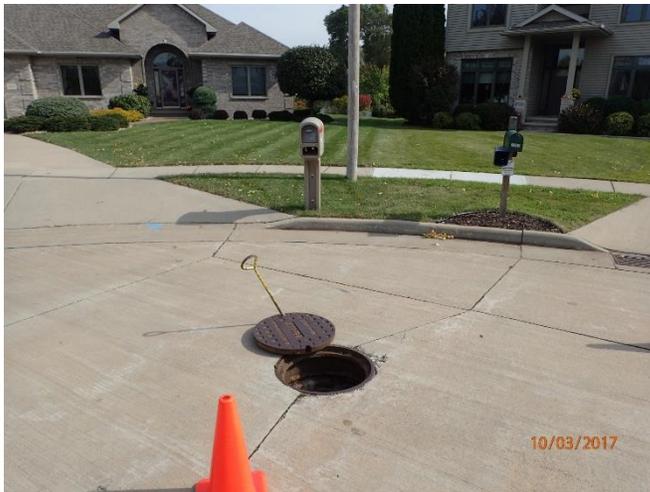
Figure 33 – Upstream manhole 16-660 US1 (2017)

During the 2017 screening, the sample collected from manhole 16-660 US1 had a detergent detection. No other parameters were outside of the normal range.

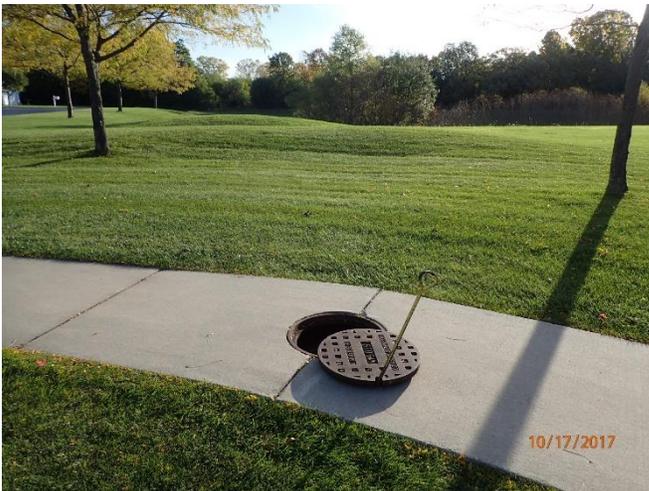
Figure 35 – Upstream manhole 16-995 US1 (2017)

During the 2017 screening, the sample collected from manhole 16-995 US1 had a detergent detection. No other parameters were outside of the normal range.

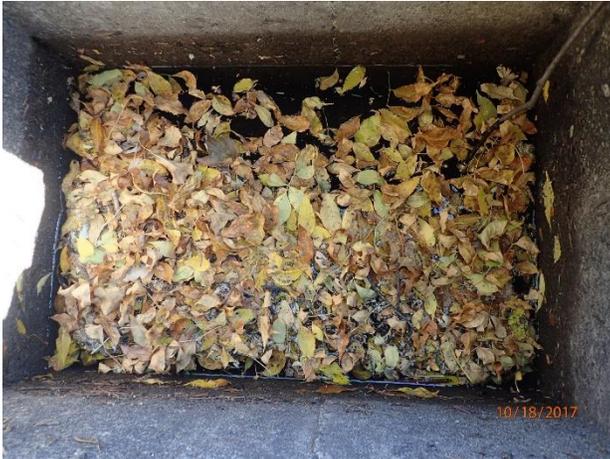
Figure 54 – Moderate deposition in inlet 06-1028 US1

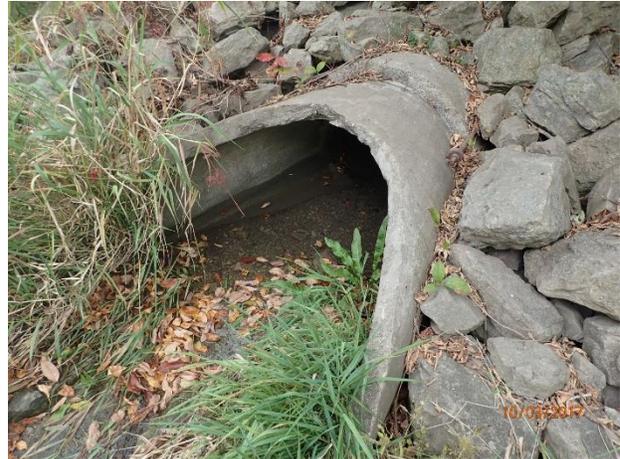
Figure 55 – Minor deposition at outfall 06-1083

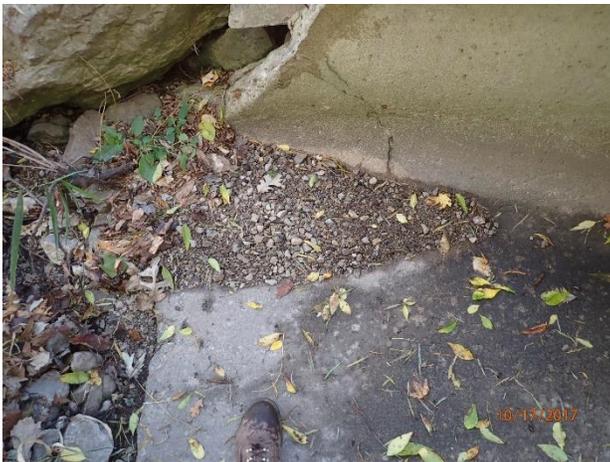
Figure 56 – Minor deposition at outfall 06-1132

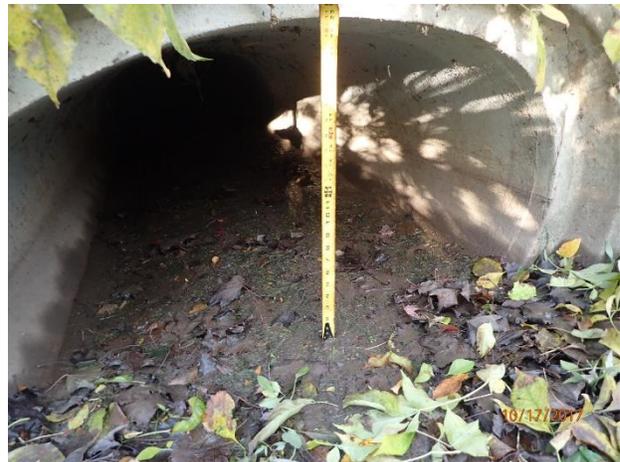
Figure 57 – Moderate deposition at outfall 06-1601

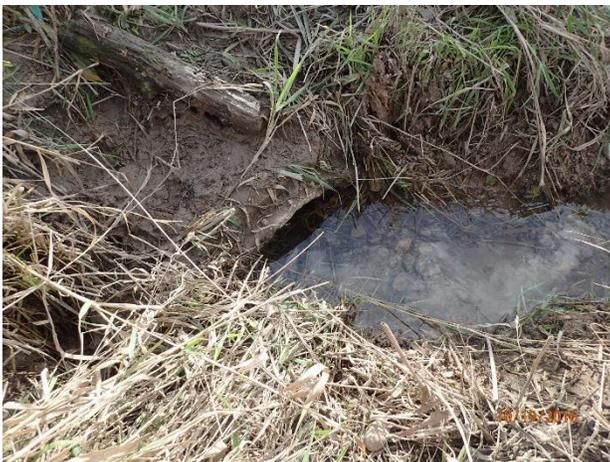
Figure 58 – Moderate deposition at outfall 13-1098

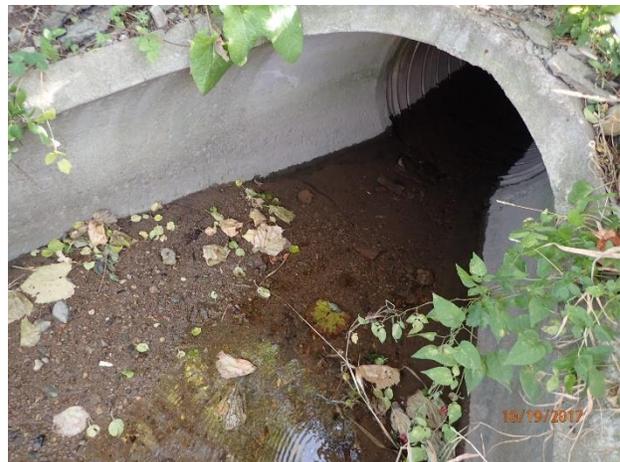
Figure 59 – Minor deposition at outfall 13-1588

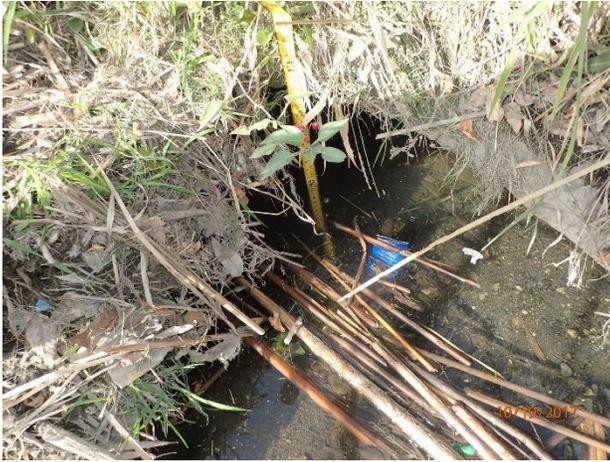
Figure 60 – Moderate deposition at outfall 13-1758

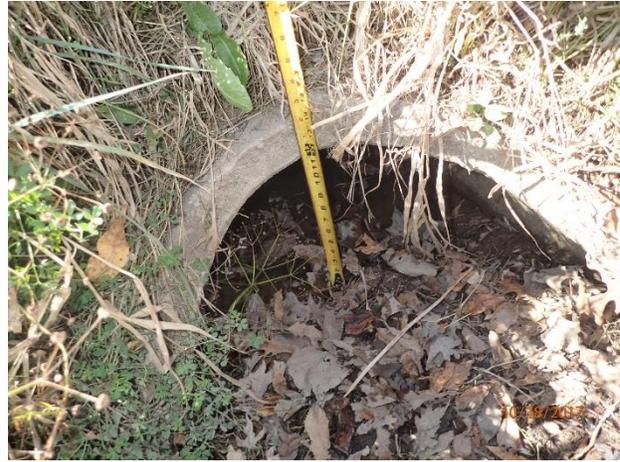
Figure 61 – Moderate deposition at outfall 14-670

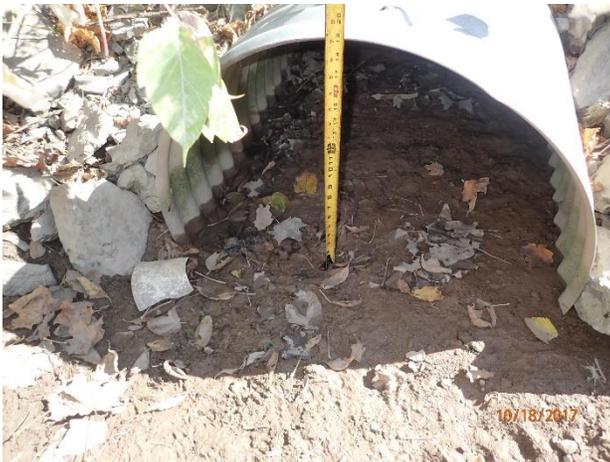
Figure 62 – Moderate deposition at outfall 14-766

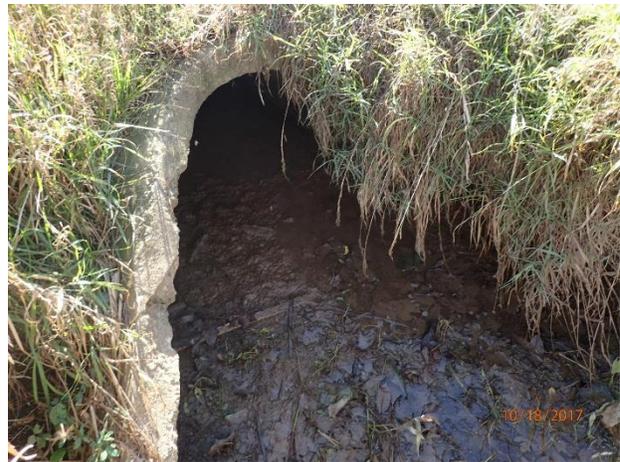
Figure 63 – Minor deposition at outfall 14-1007

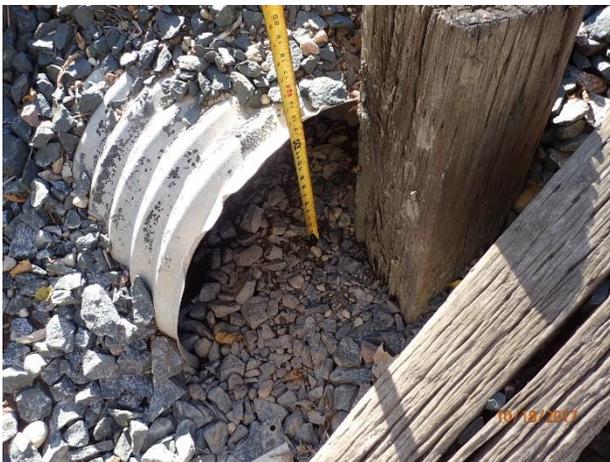
Figure 64 – Moderate deposition at outfall 14-1514

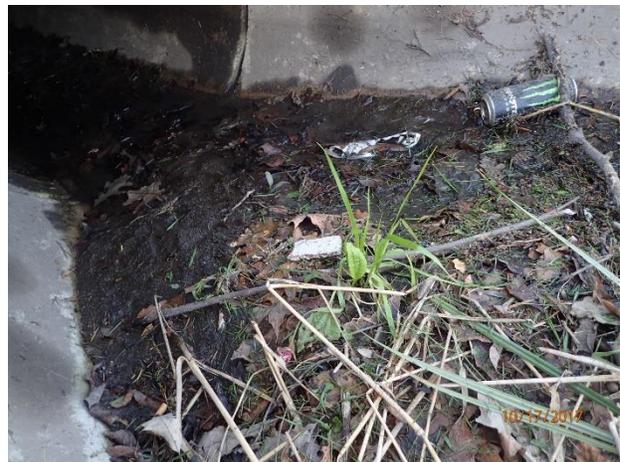
Figure 65 – Minor deposition at outfall 15-2409

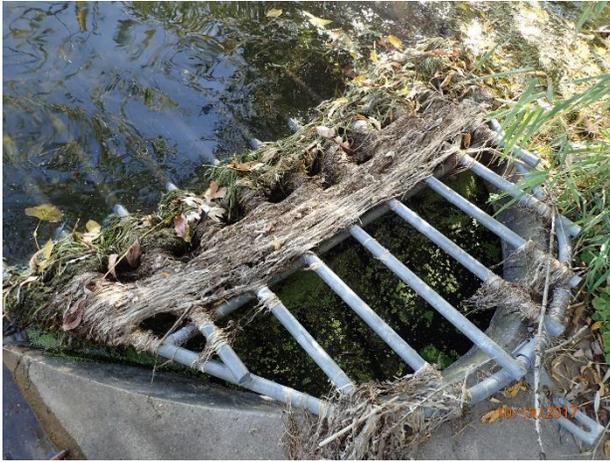
Figure 66 – Minor deposition at outfall 15.2477

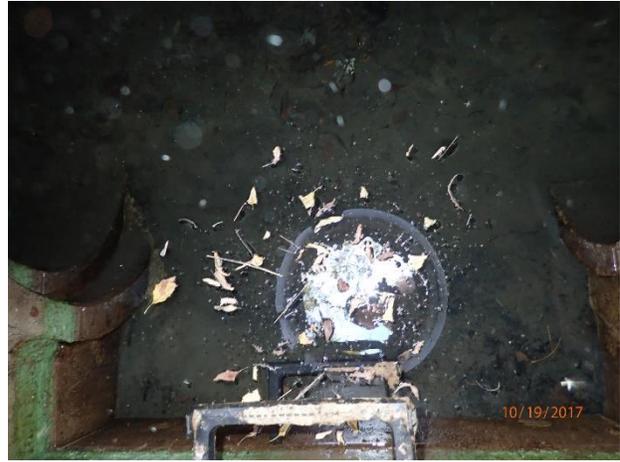
Figure 67 – Minor deposition in manhole 15-2477 US2

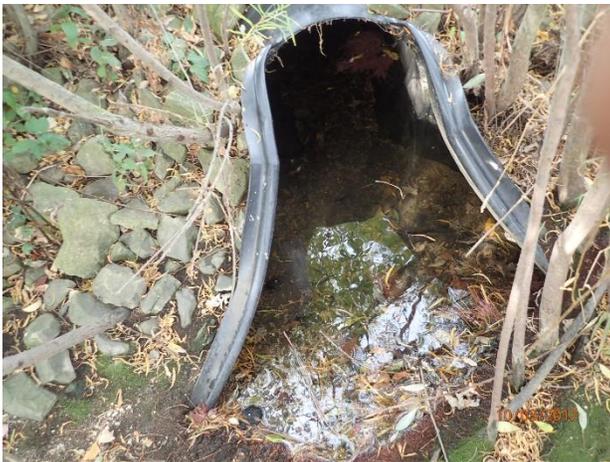
Figure 68 – Minor deposition at outfall 16-995

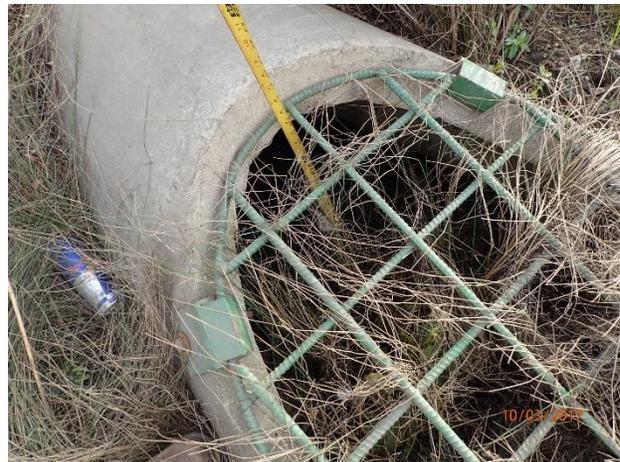
Figure 69 – Minor deposition at outfall 16-1205

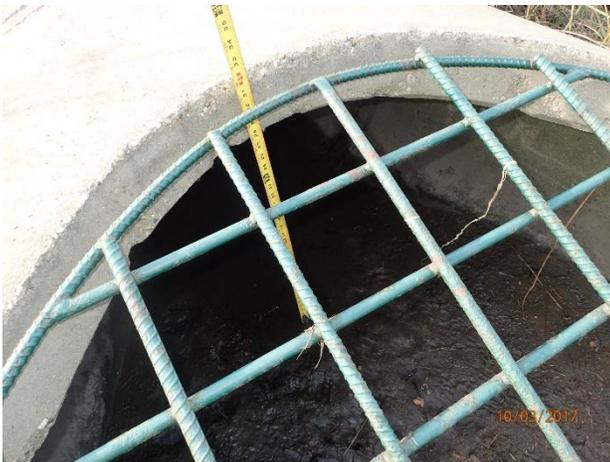
Figure 70 – Minor deposition at outfall 16-1207

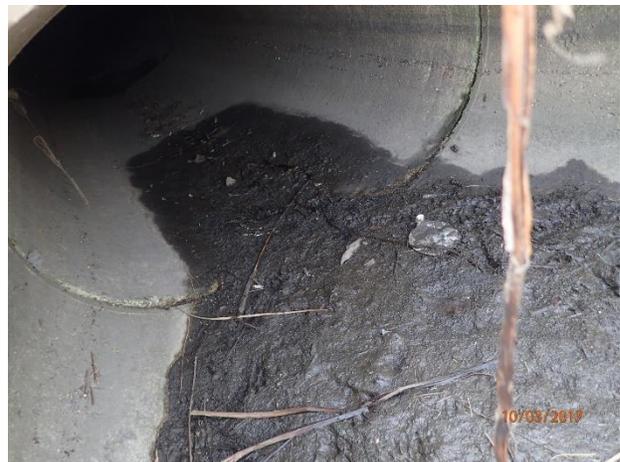
Figure 71 – Minor deposition at outfall 16-1213

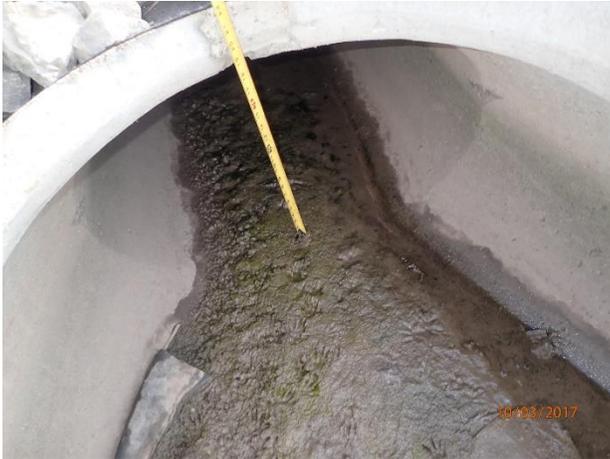
Figure 72 – Minor deposition at outfall 16-1633

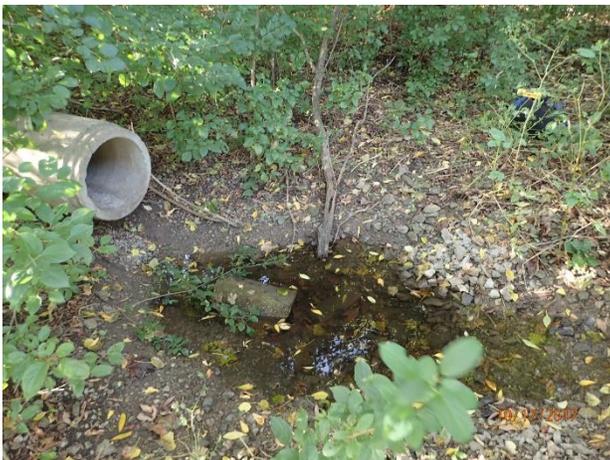
Outfall	Severity	Description
06-961	Minor	Scour hole / erosion downstream from pipe.
16-622	Moderate	Erosion downstream from pipe.

Figure 73 – Minor erosion downstream of outfall 06-961

Two of the outfalls showed signs of erosion at the end of the outfall pipe or channel. Most of the outfalls with minor erosion could be repaired with minor landscaping repairs. Those outfalls with moderate or severe erosion may need additional structural reinforcement, such as turf reinforcement mat or riprap.

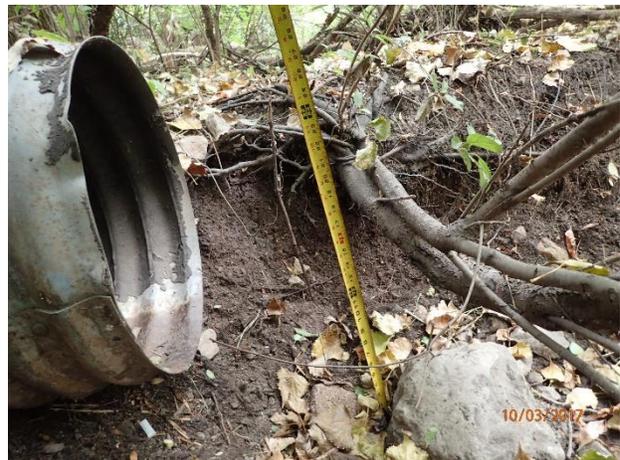
Figure 74 – Moderate erosion downstream of outfall 16-622

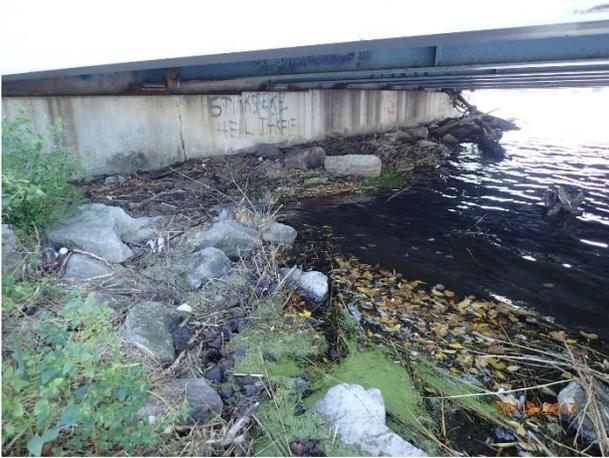
Graffiti was observed in or around one outfall. The graffiti was not severe, but should probably be monitored to make sure that it does not become more severe.

Outfall	Severity	Description
12-569	Minor	Graffiti on bridge abutment adjacent to outfall.

Figure 75 – Graffiti near outfall 12-569

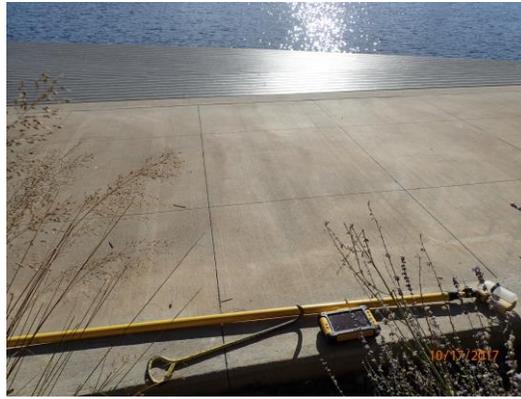
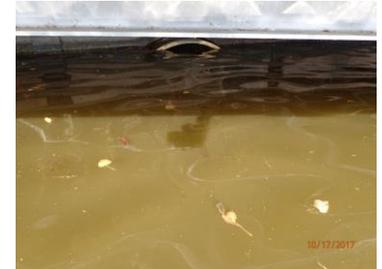
Notes: Outfall inaccessible and partially submerged - screened upstream at 01-20 US1.

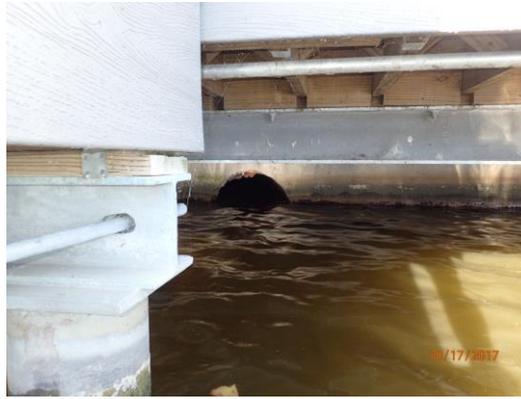
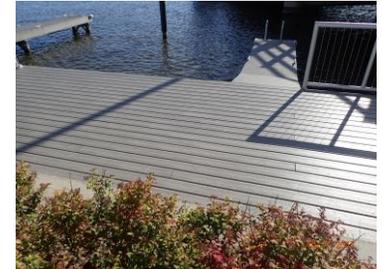
Division St storm sewer discharges to river from north. Dock constructed over outfall since 2010 - outfall no longer visible.

Notes: Outfall inaccessible and partially submerged - screened upstream at 01-35 US1.

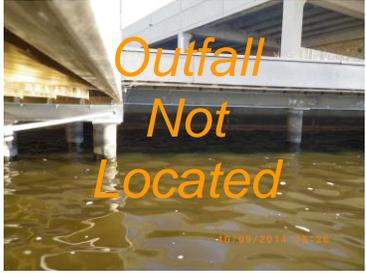
<p style="text-align: center; font-weight: bold; color: orange; font-size: 1.2em;">Outfall Not Located</p> <p style="text-align: center; font-size: 0.8em;">o20141009072648.JPG</p> <p style="text-align: center; font-weight: bold; font-size: 1.5em;">2014</p>										
Submerged: Fully Depth (in):		Notes Outfall fully submerged and not located - screened upstream at 01-35 US1.												
Sampling Results		Floatables:	None

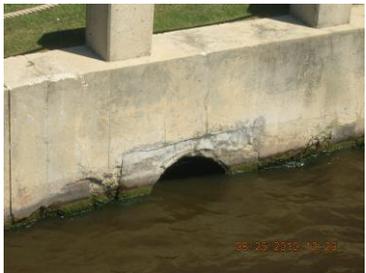
<p style="text-align: center; font-weight: bold; color: orange; font-size: 1.2em;">Outfall Not Located</p> <p style="text-align: center; font-size: 0.8em;">o20100825122350.JPG</p> <p style="text-align: center; font-weight: bold; font-size: 1.5em;">2010</p>										
Submerged: Partially Depth (in): 15		Notes Outfall partially submerged. Outfall screened upstream at 01-35 US1. Estimated submerged depth.												
Sampling Results		Floatables:	None

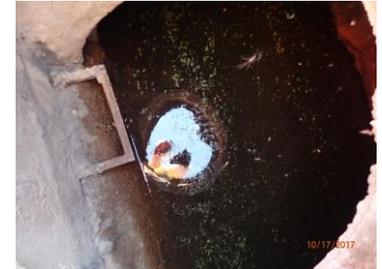
o20171017150646.JPG

Notes: Sample collected from submerged pool in outfall.

Sample Location:	Pool	Floatables:	None
Total Chlorine:	0 ppm	Odor:	None
Free Chlorine:	0 ppm	Turbidity:	None
Ammonia:	0 ppm	Color:	Faint in bottle
pH:	8.18 units	Gross Solids:	None
Temperature:	66 °F	Vegetation:	None
Conductivity:	380 µS/cm	Benthic Growth:	None
Detergents:	0 mg/L	Stains:	None
		Non-illicit:	None

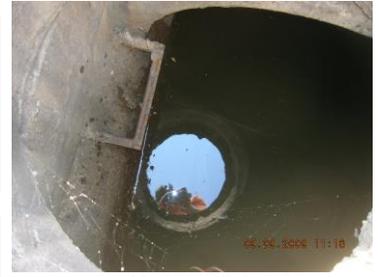
Osh09_DSCN6712.JPG

Inspection Date: 9/9/2009		Type: Initial	Flow: Submerged, indeterminate	Previous Rainfall (hrs): 72+
Illicit Discharge Potential: Potential		Inspector: JCW	Notes Abnormal detergent analysis result (bubbles)	
Submerged: Partially	Depth (in): 14			
Sampling Results			Condition Assessment Graffiti: None Erosion: None Deposition: None 0 in. Damage: None	
Sample Location: Pool	Floatables: None			
Total Chlorine: 0 ppm	Odor: None			
Free Chlorine: 0 ppm	Turbidity: None			
Ammonia: -- ppm	Color: None			
pH: 8.61 units	Gross Solids: None			
Temperature 78 °F	Vegetation: None			
Conductivity: -- µS/cm	Benthic Growth: None			
Detergents: 0 mg/L	Stains: None			
	Non-illicit: None

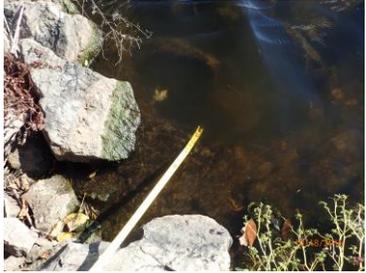
o20161018153652.JPG

Inspection Date: 10/18/2016 3:38:45 PM		Type: Ongoing	Flow: Submerged, indeterminate	Previous Rainfall (hrs): 72+
Illicit Discharge Potential: Potential		Inspector: JCW		
Submerged: Fully		Depth (in): 33		
<i>Sampling Results</i>		Notes		
Sample Location:	Floatables:	None		
Total Chlorine: -- ppm	Odor:	None		
Free Chlorine: -- ppm	Turbidity:	None		
Ammonia: -- ppm	Color:	None		
pH: -- units	Gross Solids:	None		
Temperature -- °F	Vegetation:	None		
Conductivity: -- µS/cm	Benthic Growth:	Severe		
Detergents: -- mg/L	Stains:	None		
	Non-illicit:	None		
		Condition Assessment		
		Graffiti:	None	
		Erosion:	None	
		Deposition:	None in.	
		Damage:	None

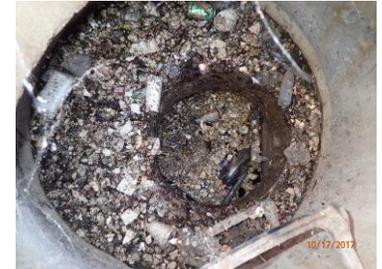
o20171017151640.JPG

Notes: Sample collected from submerged pool in manhole. Floating gross solids (litter) in manhole.

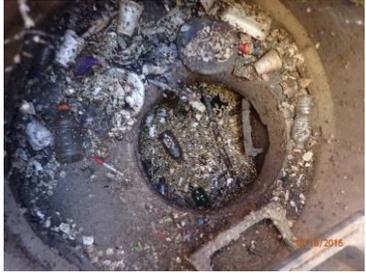
o20161018153916.JPG	
Submerged: Fully		Depth (in): 67		Potential illicit discharge due to gross solids.			
Sampling Results		Floatables:		None		2016	
Sample Location: Pool		Odor:		None			
Total Chlorine: 0 ppm		Turbidity:		None			
Free Chlorine: 0 ppm		Color:		Faint in bottle			
Ammonia: 0 ppm		Gross Solids:		Severe			
pH: 8.16 units		Vegetation:		None			
Temperature 66 °F		Benthic Growth:		None			
Conductivity: 531 µS/cm		Stains:		None			
Detergents: 0 mg/L		Non-illicit:		None			
		Condition Assessment		Graffiti: None			
				Erosion: None			
				Deposition: None			
				Damage: None

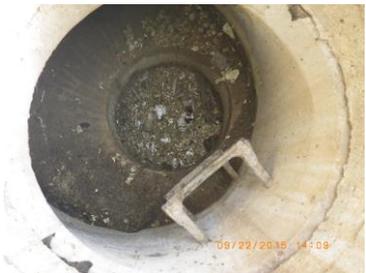
o20150922130946.JPG	
Submerged: Fully		Depth (in): 70		Floating gross solids (litter) in manhole.			
Sampling Results		Floatables:		None		2015	
Sample Location: Pool		Odor:		None			
Total Chlorine: 0 ppm		Turbidity:		None			
Free Chlorine: 0 ppm		Color:		None			
Ammonia: 0 ppm		Gross Solids:		Severe			
pH: 8.1 units		Vegetation:		None			
Temperature 76 °F		Benthic Growth:		None			
Conductivity: 917 µS/cm		Stains:		None			
Detergents: 0 mg/L		Non-illicit:		None			
		Condition Assessment		Graffiti: None			
				Erosion: None			
				Deposition: None			
				Damage: None

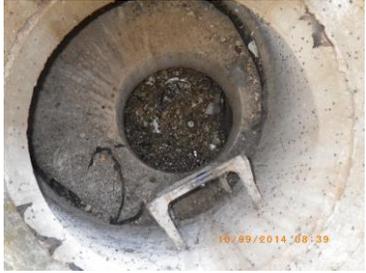
o20141009073910.JPG	
Submerged: Fully		Depth (in): 64		Floating gross solids (litter) inside manhole.			
Sampling Results		Floatables:		None		2014	
Sample Location: Pool		Odor:		Faint			
Total Chlorine: 0 ppm		Turbidity:		None			
Free Chlorine: 0 ppm		Color:		None			
Ammonia: 0 ppm		Gross Solids:		Severe			
pH: 7.84 units		Vegetation:		None			
Temperature 57 °F		Benthic Growth:		Slight			
Conductivity: 1318 µS/cm		Stains:		None			
Detergents: 0 mg/L		Non-illicit:		None			
		Condition Assessment		Graffiti: None			
				Erosion: None			
				Deposition: None			
				Damage: None

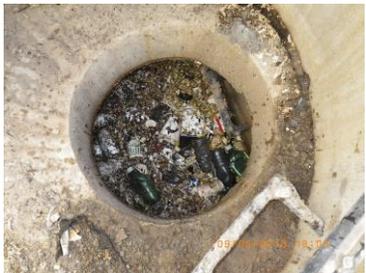
o20130905120924.JPG	
Submerged: Fully		Depth (in): 69		2012 screening follow-up. Significant gross solids in manhole - similar to previous years.			
Sampling Results		Floatables:		None		2013	
Sample Location: Pool		Odor:		None			
Total Chlorine: 0 ppm		Turbidity:		None			
Free Chlorine: 0 ppm		Color:		None			
Ammonia: 0 ppm		Gross Solids:		Severe			
pH: 8.51 units		Vegetation:		None			
Temperature 76 °F		Benthic Growth:		None			
Conductivity: 424 µS/cm		Stains:		None			
Detergents: 0 mg/L		Non-illicit:		None			
		Condition Assessment		Graffiti: None			
				Erosion: None			
				Deposition: None			
				Damage: None

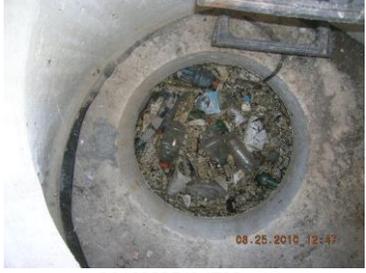
<small>08.25.2010 12:47</small> o20100825124708.JPG 2010	
Submerged: Fully Depth (in): 72				Significant floatable debris in manhole.			
Sampling Results				Condition Assessment			
Sample Location: Pool		Floatables:	None	Graffiti:		None	
Total Chlorine: 0 ppm		Odor:	None	Erosion:		None	
Free Chlorine: 0 ppm		Turbidity:	None	Deposition:		None 0 in.	
Ammonia: 0 ppm		Color:	Faint in bottle	Damage:		None	
pH: 8.18 units		Gross Solids:	Severe				
Temperature 73 °F		Vegetation:	None				
Conductivity: -- µS/cm		Benthic Growth:	None				
Detergents: 0 mg/L		Stains:	None				
		Non-illicit:	None

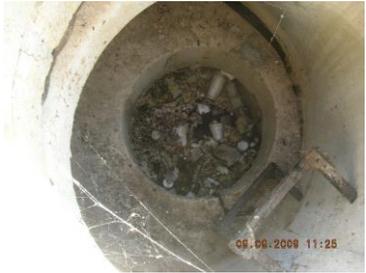
<small>09.09.2009 11:25</small> Osh09_DSCN6718.JPG 2009	
Submerged: Fully Depth (in): 61				Abnormal detergent analysis result (bubbles). Significant floatables in manhole. Brown color.			
Sampling Results				Condition Assessment			
Sample Location: Pool		Floatables:	None	Graffiti:		None	
Total Chlorine: 0 ppm		Odor:	None	Erosion:		None	
Free Chlorine: 0 ppm		Turbidity:	None	Deposition:		None 0 in.	
Ammonia: -- ppm		Color:	Clearly visible in bottl	Damage:		None	
pH: 8.6 units		Gross Solids:	Severe				
Temperature 78 °F		Vegetation:	None				
Conductivity: -- µS/cm		Benthic Growth:	None				
Detergents: 0 mg/L		Stains:	None				
		Non-illicit:	None

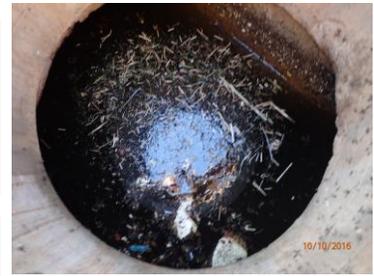
o20161010161634.JPG

Inspection Date: 10/10/2016 4:18:29 PM		Type: Ongoing	Flow: Submerged, indeterminate	Previous Rainfall (hrs): 72+
Illicit Discharge Potential: Potential		Inspector: JCW		
Submerged: Fully		Depth (in): 59		
<i>Sampling Results</i>		Notes		
Sample Location: Pool	Floatables: None	Potential illicit discharge due to gross solids.		
Total Chlorine: 0 ppm	Odor: None			
Free Chlorine: 0 ppm	Turbidity: None			
Ammonia: 0 ppm	Color: Faint in bottle			
pH: 8.37 units	Gross Solids: Slight			
Temperature 68 °F	Vegetation: None			
Conductivity: 369 µS/cm	Benthic Growth: None			
Detergents: 0 mg/L	Stains: None			
	Non-illicit: Slight			
		Graffiti: None		
		Erosion: None		
		Deposition: None in.		
		Damage: None

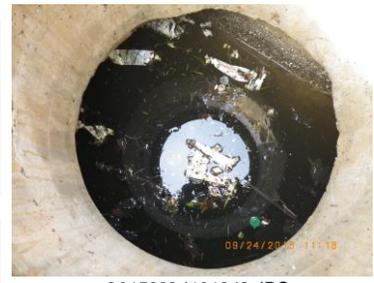
o20150924101848.JPG

Inspection Date: 9/24/2015 11:20:01 AM		Type: Ongoing	Flow: Submerged, indeterminate	Previous Rainfall (hrs): 72+
Illicit Discharge Potential: Potential		Inspector: JCW		
Submerged: Fully		Depth (in): 66		
<i>Sampling Results</i>		Notes		
Sample Location: Pool	Floatables: None	Floating gross solids (litter) in manhole.		
Total Chlorine: 0 ppm	Odor: None			
Free Chlorine: 0 ppm	Turbidity: None			
Ammonia: 0 ppm	Color: None			
pH: 7.61 units	Gross Solids: Moderate			
Temperature 71 °F	Vegetation: None			
Conductivity: 481 µS/cm	Benthic Growth: None			
Detergents: 0 mg/L	Stains: None			
	Non-illicit: Slight			
		Graffiti: None		
		Erosion: None		
		Deposition: None in.		
		Damage: None

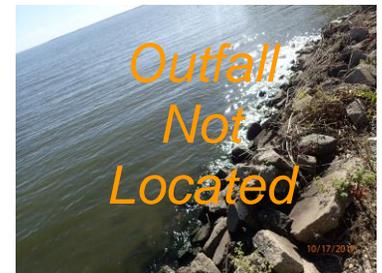
o20171017133948.JPG

Notes: Outfall fully submerged and not located - screened upstream at 02-309 US1. Floating gross solids (litter) in manhole.

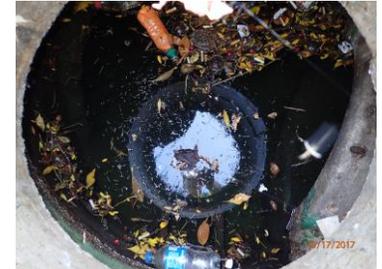
o20171017134106.JPG

Notes: Sample collected from submerged pool in manhole. Floating gross solids (litter) in manhole.

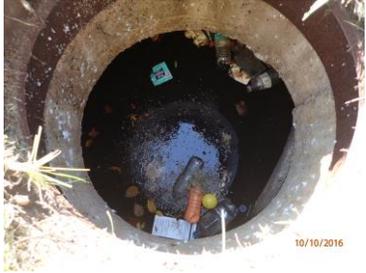
o20161010103236.JPG 2016

Inspection Date: 10/10/2016 10:35:02 AM		Type: Ongoing	Flow: Submerged, indeterminate	Previous Rainfall (hrs): 72+
Illicit Discharge Potential: Potential		Inspector: JCW		Notes Potential illicit discharge due to gross solids.
Submerged: Fully Depth (in): 28				
Sampling Results Sample Location: Pool Total Chlorine: 0 ppm Free Chlorine: 0 ppm Ammonia: 0 ppm pH: 7.54 units Temperature: 64 °F Conductivity: 592 µS/cm Detergents: 0 mg/L		Floatables: None Odor: None Turbidity: None Color: None Gross Solids: Moderate Vegetation: None Benthic Growth: None Stains: None Non-illicit: None	Condition Assessment Graffiti: None Erosion: None Deposition: None in. Damage: None

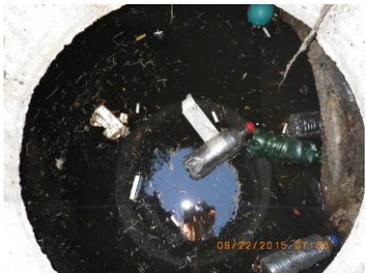
o20150922065636.JPG 2015

Inspection Date: 9/22/2015 7:50:50 AM		Type: Ongoing	Flow: Submerged, indeterminate	Previous Rainfall (hrs): 72+
Illicit Discharge Potential: Potential		Inspector: JCW		Notes Floating gross solids (litter) in manhole.
Submerged: Fully Depth (in): 28				
Sampling Results Sample Location: Pool Total Chlorine: 0 ppm Free Chlorine: 0 ppm Ammonia: 0 ppm pH: 7.74 units Temperature: 66 °F Conductivity: 853 µS/cm Detergents: 0 mg/L		Floatables: None Odor: None Turbidity: None Color: None Gross Solids: Slight Vegetation: None Benthic Growth: Slight Stains: Slight Non-illicit: None	Condition Assessment Graffiti: None Erosion: None Deposition: None in. Damage: None

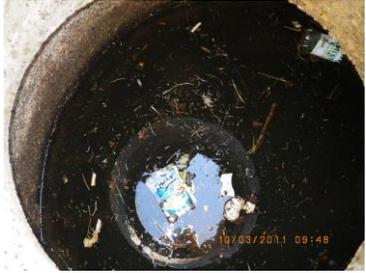
o20111003094830.JPG 2011

Inspection Date: 10/3/2011 9:47:42 AM		Type: Ongoing	Flow: Submerged, indeterminate	Previous Rainfall (hrs): 72+
Illicit Discharge Potential: Unlikely		Inspector: JCW		Notes (Empty)
Submerged: Fully Depth (in): 32				
Sampling Results Sample Location: Pool Total Chlorine: 0 ppm Free Chlorine: 0 ppm Ammonia: 0 ppm pH: 7.71 units Temperature: 60 °F Conductivity: -- µS/cm Detergents: 0 mg/L		Floatables: None Odor: Faint Turbidity: None Color: None Gross Solids: Slight Vegetation: None Benthic Growth: None Stains: None Non-illicit: None	Condition Assessment Graffiti: None Erosion: None Deposition: None 0 in. Damage: None

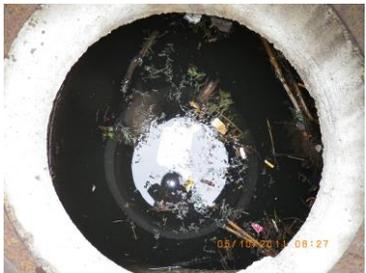
o20110510082708.JPG 2011

Inspection Date: 5/10/2011 8:27:00 AM		Type: Other	Flow: Submerged, indeterminate	Previous Rainfall (hrs): 0-24
Illicit Discharge Potential: Potential		Inspector: JCW		Notes Limited screening conducted for upstream manhole prescreening.
Submerged: Fully Depth (in):				
Sampling Results Sample Location: Total Chlorine: -- ppm Free Chlorine: -- ppm Ammonia: -- ppm pH: -- units Temperature: -- °F Conductivity: -- µS/cm Detergents: -- mg/L		Floatables: None Odor: Turbidity: Color: Gross Solids: Slight Vegetation: Benthic Growth: Stains: Non-illicit: None	Condition Assessment Graffiti: None Erosion: None Deposition: None 0 in. Damage: None

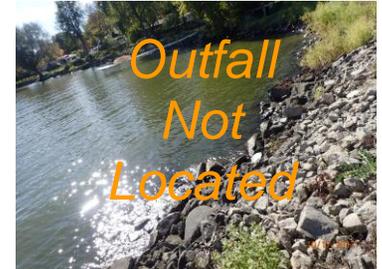
o20171017133026.JPG

Notes: Outfall fully submerged and not located - screened upstream at 02-357 US1. Floating gross solids (litter) in manhole.

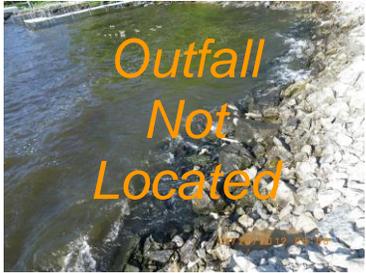
o20120620070830.JPG

Inspection Date: 6/20/2012 8:05:53 AM		Type: Other	Flow: Submerged (not located)	Previous Rainfall (hrs): 24-48
Illicit Discharge Potential: Unlikely		Inspector: JCW	Notes	
Submerged: Fully		Depth (in):	Gross solids pre-screening. Outfall fully submerged; screened upstream at 02-357 US1.	
Sampling Results		Floatables:	Condition Assessment	
Sample Location:		None	Graffiti: None	
Total Chlorine: -- ppm		Odor:	Erosion: None	
Free Chlorine: -- ppm		None	Deposition: None in.	
Ammonia: -- ppm		Turbidity:	Damage: None	
pH: -- units		None		
Temperature -- °F		Color:		
Conductivity: -- µS/cm		None		
Detergents: -- mg/L		Gross Solids:		
		None		
		Vegetation:		
		None		
		Benthic Growth:		
		None		
		Stains:		
		None		
		Non-illicit:		
		None

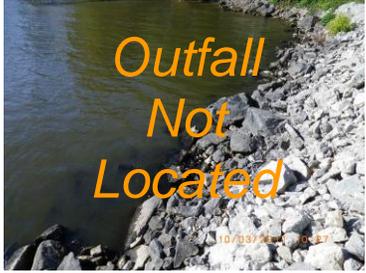
o20111003102714.JPG

Inspection Date: 10/3/2011 10:26:14 AM		Type: Ongoing	Flow: Submerged (not located)	Previous Rainfall (hrs): 72+
Illicit Discharge Potential: Potential		Inspector: JCW	Notes	
Submerged: Fully		Depth (in):	Outfall fully submerged and not physically located. Outfall screened upstream at 02-357 US1.	
Sampling Results		Floatables:	Condition Assessment	
Sample Location:		None	Graffiti: None	
Total Chlorine: -- ppm		Odor:	Erosion: None	
Free Chlorine: -- ppm		None	Deposition: None 0 in.	
Ammonia: -- ppm		Turbidity:	Damage: None	
pH: -- units		None		
Temperature -- °F		Color:		
Conductivity: -- µS/cm		None		
Detergents: -- mg/L		Gross Solids:		
		None		
		Vegetation:		
		None		
		Benthic Growth:		
		None		
		Stains:		
		None		
		Non-illicit:		
		None

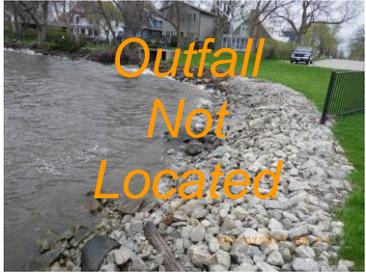
o20110510085116.JPG

Inspection Date: 5/10/2011 8:51:00 AM		Type: Other	Flow: Submerged (not located)	Previous Rainfall (hrs): 0-24
Illicit Discharge Potential: Potential		Inspector: JCW	Notes	
Submerged: Fully		Depth (in):	Outfall fully submerged and not physically located. Outfall screened upstream at 02-357 US1.	
Sampling Results		Floatables:	Condition Assessment	
Sample Location:			Graffiti: None	
Total Chlorine: -- ppm		Odor:	Erosion: None	
Free Chlorine: -- ppm			Deposition: None 0 in.	
Ammonia: -- ppm		Turbidity:	Damage: None	
pH: -- units				
Temperature -- °F		Color:		
Conductivity: -- µS/cm				
Detergents: -- mg/L		Gross Solids:		
		Vegetation:		
		Benthic Growth:		
		Stains:		
		Non-illicit:		
		None

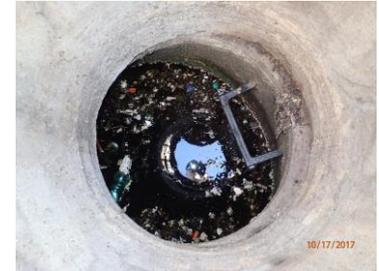
o20171017133104.JPG

Notes: Sample collected from submerged pool in manhole. Floating gross solids (litter) in manhole.

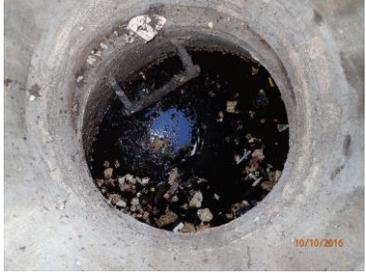
o20161010105436.JPG 2016

Inspection Date: 10/10/2016 10:57:04 AM		Type: Ongoing	Flow: Submerged, indeterminate	Previous Rainfall (hrs): 72+
Illicit Discharge Potential: Potential		Inspector: JCW		Notes Potential illicit discharge due to gross solids.
Submerged: Fully		Depth (in): 37		
Sampling Results Sample Location: Pool Total Chlorine: 0 ppm Free Chlorine: 0 ppm Ammonia: 0 ppm pH: 7.54 units Temperature: 65 °F Conductivity: 654 µS/cm Detergents: 0 mg/L		Floatables: None Odor: None Turbidity: None Color: None Gross Solids: Moderate Vegetation: None Benthic Growth: None Stains: None Non-illicit: None	Condition Assessment Graffiti: None Erosion: None Deposition: None in. Damage: None

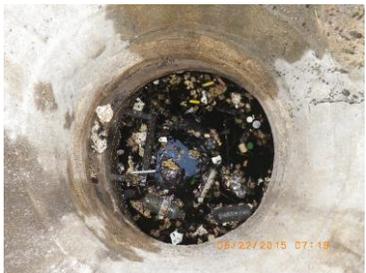
o20150922061944.JPG 2015

Inspection Date: 9/22/2015 7:15:12 AM		Type: Ongoing	Flow: Submerged, indeterminate	Previous Rainfall (hrs): 72+
Illicit Discharge Potential: Potential		Inspector: JCW		Notes Floating gross solids (litter) in manhole.
Submerged: Fully		Depth (in): 39		
Sampling Results Sample Location: Pool Total Chlorine: 0 ppm Free Chlorine: 0 ppm Ammonia: 0 ppm pH: 7.84 units Temperature: 65 °F Conductivity: 459 µS/cm Detergents: 0 mg/L		Floatables: None Odor: None Turbidity: None Color: None Gross Solids: Moderate Vegetation: None Benthic Growth: None Stains: None Non-illicit: None	Condition Assessment Graffiti: None Erosion: None Deposition: None in. Damage: None

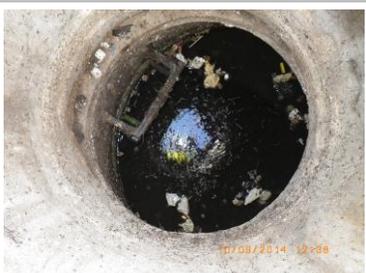
o20141009113842.JPG 2014

Inspection Date: 10/9/2014 12:40:37 PM		Type: Ongoing	Flow: Submerged, indeterminate	Previous Rainfall (hrs): 72+
Illicit Discharge Potential: Potential		Inspector: JCW		Notes Floating gross solids (litter) in manhole.
Submerged: Fully		Depth (in): 35		
Sampling Results Sample Location: Pool Total Chlorine: 0 ppm Free Chlorine: 0 ppm Ammonia: 0 ppm pH: 7.58 units Temperature: 62 °F Conductivity: 707 µS/cm Detergents: 0 mg/L		Floatables: None Odor: None Turbidity: None Color: None Gross Solids: Moderate Vegetation: None Benthic Growth: None Stains: None Non-illicit: None	Condition Assessment Graffiti: None Erosion: None Deposition: None in. Damage: None

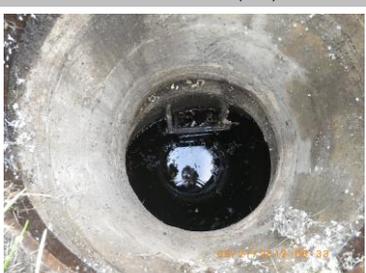
o20120927073352.JPG 2012

Inspection Date: 9/27/2012 8:31:15 AM		Type: Ongoing	Flow: Submerged, indeterminate	Previous Rainfall (hrs): 72+
Illicit Discharge Potential: Unlikely		Inspector: JCW		Notes 2011 gross solids follow-up.
Submerged: Fully		Depth (in): 36		
Sampling Results Sample Location: Pool Total Chlorine: 0 ppm Free Chlorine: 0 ppm Ammonia: 0 ppm pH: 7.73 units Temperature: 60 °F Conductivity: 518 µS/cm Detergents: 0 mg/L		Floatables: None Odor: None Turbidity: None Color: None Gross Solids: Slight Vegetation: None Benthic Growth: None Stains: None Non-illicit: None	Condition Assessment Graffiti: None Erosion: None Deposition: None in. Damage: None

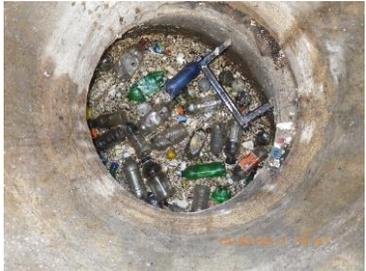
o20111003103104.JPG

Inspection Date: 10/3/2011 10:30:08 AM		Type: Ongoing	Flow: Submerged, indeterminate	Previous Rainfall (hrs): 72+
Illicit Discharge Potential: Potential		Inspector: JCW	Notes Significant floatable debris in manhole.	
Submerged: Fully	Depth (in): 39			
Sampling Results		Floatables: None	Condition Assessment Graffiti: None Erosion: None Deposition: None 0 in. Damage: None	
Sample Location: Pool		Odor: None		
Total Chlorine: 0 ppm		Turbidity: None		
Free Chlorine: 0 ppm		Color: None		
Ammonia: 0 ppm		Gross Solids: Severe		
pH: 7.1 units		Vegetation: None		
Temperature 61 °F		Benthic Growth: None		
Conductivity: -- µS/cm		Stains: None		
Detergents: 0 mg/L		Non-illicit: None

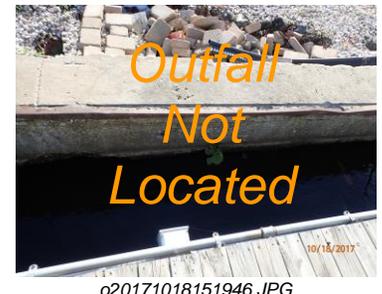
o20171018151946.JPG

Notes: Outfall fully submerged and not located - screened upstream at 03-22 US1. Floating gross solids (litter) in manhole.

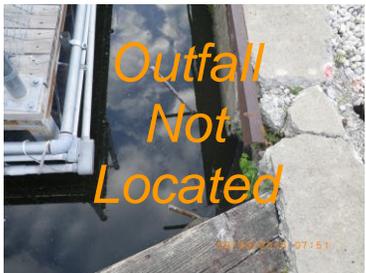
<p style="text-align: center; color: orange; font-weight: bold; font-size: 1.2em;">Outfall Not Located</p> <p style="text-align: center; font-size: 0.8em;">o20150923065132.JPG</p> <p style="text-align: center; font-weight: bold; font-size: 1.5em;">2015</p>
Submerged: Fully Depth (in):		Notes Significant sinking above suspected pipe. Outfall not located - screened at 03-22 US1.		
Sampling Results		Floatables:	None	Condition Assessment Graffiti: None Erosion: None Deposition: None in. Damage: Severe
Sample Location:		Odor:	None	
Total Chlorine: -- ppm		Turbidity:	None	
Free Chlorine: -- ppm		Color:	None	
Ammonia: -- ppm		Gross Solids:	None	
pH: -- units		Vegetation:	None	
Temperature -- °F		Benthic Growth:	None	
Conductivity: -- µS/cm		Stains:	None

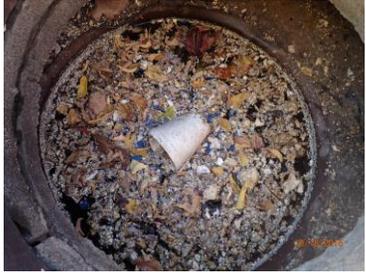
Submerged: Partially Depth (in): 17

Inspection Date: 10/18/2016 4:06:54 PM		Type: Ongoing	Flow: Submerged, indeterminate	Previous Rainfall (hrs): 72+
Illicit Discharge Potential: Potential		Inspector: JCW		Notes Potential illicit discharge due to gross solids.
Submerged: Fully Depth (in): 44				
Sampling Results Sample Location: Pool Total Chlorine: 0 ppm Free Chlorine: 0 ppm Ammonia: 0 ppm pH: 8.15 units Temperature: 66 °F Conductivity: 403 µS/cm Detergents: 0 mg/L		Floatables: None Odor: None Turbidity: None Color: Faint in bottle Gross Solids: Severe Vegetation: None Benthic Growth: None Stains: None Non-illicit: None	Condition Assessment Graffiti: None Erosion: None Deposition: None in. Damage: None

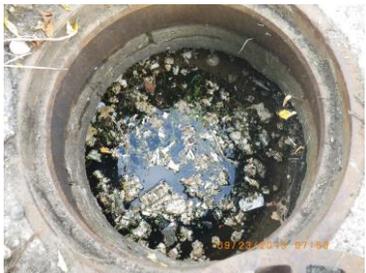
o20150923065324.JPG <h2 style="margin: 0;">2015</h2>

Inspection Date: 9/23/2015 7:51:33 AM		Type: Ongoing	Flow: Submerged, indeterminate	Previous Rainfall (hrs): 72+
Illicit Discharge Potential: Potential		Inspector: JCW		Notes Floating gross solids (litter) in manhole.
Submerged: Fully Depth (in): 46				
Sampling Results Sample Location: Pool Total Chlorine: 0 ppm Free Chlorine: 0 ppm Ammonia: 0 ppm pH: 8.44 units Temperature: 70 °F Conductivity: 354 µS/cm Detergents: 0 mg/L		Floatables: None Odor: None Turbidity: None Color: None Gross Solids: Moderate Vegetation: None Benthic Growth: None Stains: None Non-illicit: None	Condition Assessment Graffiti: None Erosion: None Deposition: None in. Damage: None

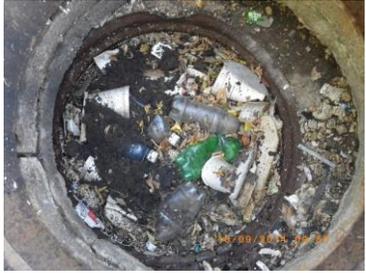
o20141009085040.JPG <h2 style="margin: 0;">2014</h2>

Inspection Date: 10/9/2014 9:52:24 AM		Type: Ongoing	Flow: Submerged, indeterminate	Previous Rainfall (hrs): 72+
Illicit Discharge Potential: Potential		Inspector: JCW		Notes Floatable litter in catchbasin.
Submerged: Fully Depth (in): 40				
Sampling Results Sample Location: Pool Total Chlorine: 0 ppm Free Chlorine: 0 ppm Ammonia: 0 ppm pH: 7.79 units Temperature: 57 °F Conductivity: 442 µS/cm Detergents: 0 mg/L		Floatables: None Odor: None Turbidity: None Color: Faint in bottle Gross Solids: Severe Vegetation: None Benthic Growth: None Stains: None Non-illicit: None	Condition Assessment Graffiti: None Erosion: None Deposition: None in. Damage: None

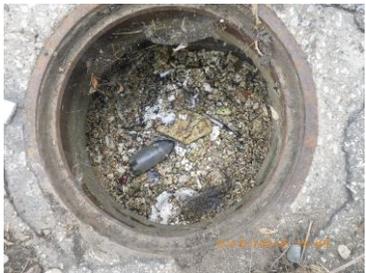
o20130731114610.JPG <h2 style="margin: 0;">2013</h2>

Inspection Date: 7/31/2013 12:42:35 PM		Type: Ongoing	Flow: Submerged, indeterminate	Previous Rainfall (hrs): 72+
Illicit Discharge Potential: Potential		Inspector: JCW		Notes 2012 screening follow-up. Significant gross solids - similar to previous years.
Submerged: Fully Depth (in): 44				
Sampling Results Sample Location: Pool Total Chlorine: 0 ppm Free Chlorine: 0 ppm Ammonia: 0 ppm pH: 7.95 units Temperature: 76 °F Conductivity: 450 µS/cm Detergents: 0 mg/L		Floatables: None Odor: Faint Turbidity: None Color: Faint in bottle Gross Solids: Severe Vegetation: None Benthic Growth: None Stains: None Non-illicit: None	Condition Assessment Graffiti: None Erosion: None Deposition: None in. Damage: None

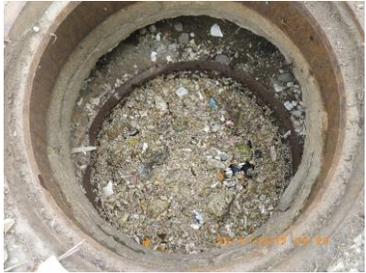
o20120927082922.JPG 2012

Inspection Date: 9/27/2012 9:27:45 AM		Type: Ongoing	Flow: Submerged, indeterminate	Previous Rainfall (hrs): 72+																																				
Illicit Discharge Potential: Potential		Inspector: JCW	Notes: 2011 gross solids follow-up.																																					
Submerged: Fully		Depth (in): 39	Condition Assessment: Graffiti: None, Erosion: None, Deposition: None in., Damage: None

Sampling Results		Floatables:	None	Sample Location:	Pool	Odor:	None	Total Chlorine:	0 ppm	Turbidity:	None	Free Chlorine:	0 ppm	Color:	None	Ammonia:	0 ppm	Gross Solids:	Severe	pH:	8.32 units	Vegetation:	None	Temperature:	59 °F	Benthic Growth:	None	Conductivity:	398 µS/cm	Stains:	None	Detergents:	0 mg/L	Non-illicit:	None
Sampling Results		Floatables:	None																																					
Sample Location:	Pool	Odor:	None																																					
Total Chlorine:	0 ppm	Turbidity:	None																																					
Free Chlorine:	0 ppm	Color:	None																																					
Ammonia:	0 ppm	Gross Solids:	Severe																																					
pH:	8.32 units	Vegetation:	None																																					
Temperature:	59 °F	Benthic Growth:	None																																					
Conductivity:	398 µS/cm	Stains:	None																																					
Detergents:	0 mg/L	Non-illicit:	None

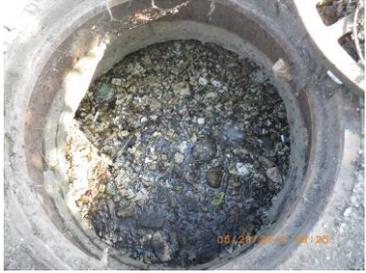
o20120620082508.JPG 2012

Inspection Date: 6/20/2012 9:24:19 AM		Type: Other	Flow: Submerged, indeterminate	Previous Rainfall (hrs): 24-48																																				
Illicit Discharge Potential: Potential		Inspector: JCW	Notes: Gross solids pre-screening.																																					
Submerged: Fully		Depth (in): 46	Condition Assessment: Graffiti: None, Erosion: None, Deposition: None in., Damage: None

Sampling Results		Floatables:	None	Sample Location:		Odor:	None	Total Chlorine:	-- ppm	Turbidity:	None	Free Chlorine:	-- ppm	Color:	None	Ammonia:	-- ppm	Gross Solids:	Severe	pH:	-- units	Vegetation:	None	Temperature:	-- °F	Benthic Growth:	None	Conductivity:	-- µS/cm	Stains:	None	Detergents:	-- mg/L	Non-illicit:	None
Sampling Results		Floatables:	None																																					
Sample Location:		Odor:	None																																					
Total Chlorine:	-- ppm	Turbidity:	None																																					
Free Chlorine:	-- ppm	Color:	None																																					
Ammonia:	-- ppm	Gross Solids:	Severe																																					
pH:	-- units	Vegetation:	None																																					
Temperature:	-- °F	Benthic Growth:	None																																					
Conductivity:	-- µS/cm	Stains:	None																																					
Detergents:	-- mg/L	Non-illicit:	None

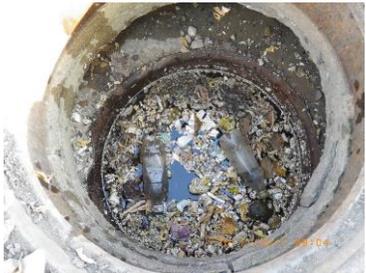
o20111011090446.JPG 2011

Inspection Date: 10/11/2011 9:05:50 AM		Type: Ongoing	Flow: Submerged, indeterminate	Previous Rainfall (hrs): 72+																																				
Illicit Discharge Potential: Potential		Inspector: JCW	Notes: 2010 screening follow-up. No significant change in volume of floatable debris.																																					
Submerged: Fully		Depth (in): 37	Condition Assessment: Graffiti: None, Erosion: None, Deposition: None 0 in., Damage: None

Sampling Results		Floatables:	None	Sample Location:	Pool	Odor:	None	Total Chlorine:	0 ppm	Turbidity:	None	Free Chlorine:	0 ppm	Color:	None	Ammonia:	0 ppm	Gross Solids:	Moderate	pH:	8.13 units	Vegetation:	None	Temperature:	70 °F	Benthic Growth:	None	Conductivity:	-- µS/cm	Stains:	None	Detergents:	-- mg/L	Non-illicit:	None
Sampling Results		Floatables:	None																																					
Sample Location:	Pool	Odor:	None																																					
Total Chlorine:	0 ppm	Turbidity:	None																																					
Free Chlorine:	0 ppm	Color:	None																																					
Ammonia:	0 ppm	Gross Solids:	Moderate																																					
pH:	8.13 units	Vegetation:	None																																					
Temperature:	70 °F	Benthic Growth:	None																																					
Conductivity:	-- µS/cm	Stains:	None																																					
Detergents:	-- mg/L	Non-illicit:	None
