Illicit Discharge Detection and Elimination
Conducted For
City of Oshkosh

Ongoing Screening Summary Report

2017 Inspection Year

OMNNI Project Number N2029C17

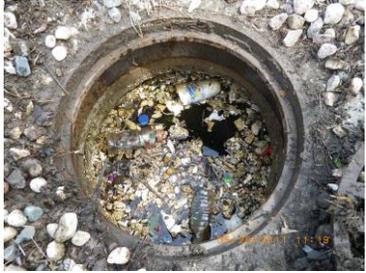
o20110526111930.JPG 2011

Inspection Date: 5/26/2011 11:19:00 AM		Type: Other	Flow: Submerged, indeterminate	Previous Rainfall (hrs): 72+																																				
Illicit Discharge Potential: Potential		Inspector: JCW	Notes: Limited screening conducted to check for floatable debris.																																					
Submerged: Fully		Depth (in):	Condition Assessment: Graffiti: None, Erosion: None, Deposition: None 0 in., Damage: None

Sampling Results		Floatables:	None	Sample Location:		Odor:		Total Chlorine:	-- ppm	Turbidity:		Free Chlorine:	-- ppm	Color:		Ammonia:	-- ppm	Gross Solids:	Moderate	pH:	-- units	Vegetation:		Temperature:	-- °F	Benthic Growth:		Conductivity:	-- µS/cm	Stains:		Detergents:	-- mg/L	Non-illicit:	None
Sampling Results		Floatables:	None																																					
Sample Location:		Odor:																																						
Total Chlorine:	-- ppm	Turbidity:																																						
Free Chlorine:	-- ppm	Color:																																						
Ammonia:	-- ppm	Gross Solids:	Moderate																																					
pH:	-- units	Vegetation:																																						
Temperature:	-- °F	Benthic Growth:																																						
Conductivity:	-- µS/cm	Stains:																																						
Detergents:	-- mg/L	Non-illicit:	None

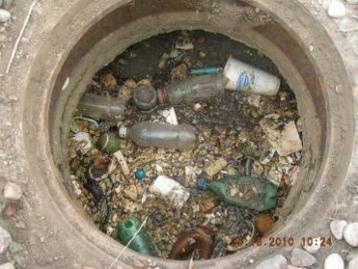
o20100818102410.JPG 2010

Inspection Date: 8/18/2010 10:29:59 AM		Type: Ongoing	Flow: Submerged, indeterminate	Previous Rainfall (hrs): 72+
Illicit Discharge Potential: Potential		Inspector: JCW	Notes: Severe floatable debris in catchbasin.	
Submerged: Fully		Depth (in): 44	Condition Assessment: Graffiti: None, Erosion: None, Deposition: None 0 in., Damage: None	
Sampling Results Sample Location: Pool Total Chlorine: 0 ppm Free Chlorine: 0 ppm Ammonia: 0 ppm pH: 7.38 units Temperature: 76 °F Conductivity: -- µS/cm Detergents: 0 mg/L		Floatables: None Odor: None Turbidity: None Color: Faint in bottle Gross Solids: Severe Vegetation: None Benthic Growth: None Stains: None Non-illicit: None

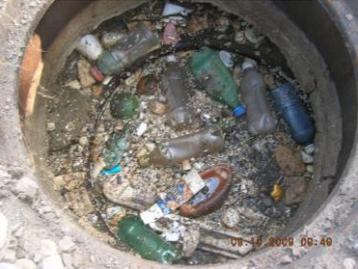
Osh09_DSCN6768.JPG 2009

Inspection Date: 9/10/2009		Type: Initial	Flow: Submerged, indeterminate	Previous Rainfall (hrs): 72+
Illicit Discharge Potential: Potential		Inspector: JCW	Notes: Abnormal detergent analysis result (bubbles). Significant floatables in manhole.	
Submerged: Fully		Depth (in): 44	Condition Assessment: Graffiti: None, Erosion: None, Deposition: None 0 in., Damage: None	
Sampling Results Sample Location: Pool Total Chlorine: 0 ppm Free Chlorine: 0 ppm Ammonia: -- ppm pH: 8.3 units Temperature: 75 °F Conductivity: -- µS/cm Detergents: 0 mg/L		Floatables: None Odor: None Turbidity: None Color: None Gross Solids: Severe Vegetation: None Benthic Growth: None Stains: None Non-illicit: None

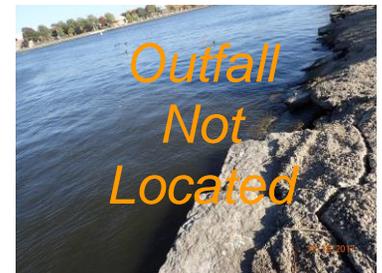
o20171018150844.JPG

Notes: Outfall fully submerged and not located - screened upstream at 03-35 US1. Floating gross solids (litter) in manhole.

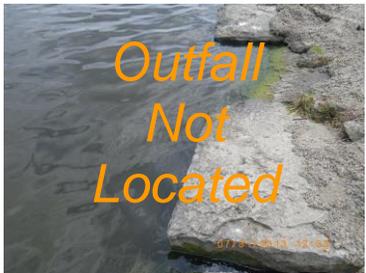
Non-illicit:	None																																						
		<table border="1" style="width:100%; border-collapse: collapse;"> <tr><td colspan="2"><i>Notes</i></td></tr> <tr><td colspan="2">2012 screening follow-up. Outfall not located. Outfall screened upstream at 03-35 US1. Gross solids in upstream mh.</td></tr> <tr><td colspan="2"><i>Condition Assessment</i></td></tr> <tr><td>Graffiti:</td><td>None</td></tr> <tr><td>Erosion:</td><td>None</td></tr> <tr><td>Deposition:</td><td>None in.</td></tr> <tr><td>Damage:</td><td>None</td></tr> </table>		<i>Notes</i>		2012 screening follow-up. Outfall not located. Outfall screened upstream at 03-35 US1. Gross solids in upstream mh.		<i>Condition Assessment</i>		Graffiti:	None	Erosion:	None	Deposition:	None in.	Damage:	None																						
<i>Notes</i>																																							
2012 screening follow-up. Outfall not located. Outfall screened upstream at 03-35 US1. Gross solids in upstream mh.

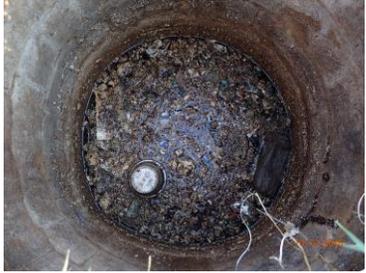
o20161010094958.JPG <h2 style="margin: 0;">2016</h2>

Inspection Date: 10/10/2016 9:52:43 AM		Type: Ongoing	Flow: Submerged, indeterminate	Previous Rainfall (hrs): 72+
Illicit Discharge Potential: Potential		Inspector: JCW		Notes Potential illicit discharge due to gross solids.
Submerged: Fully		Depth (in): 32		
Sampling Results Sample Location: Pool Total Chlorine: 0 ppm Free Chlorine: 0 ppm Ammonia: 0 ppm pH: 7.54 units Temperature: 63 °F Conductivity: 391 µS/cm Detergents: 0 mg/L		Floatables: None Odor: Faint Turbidity: None Color: None Gross Solids: Moderate Vegetation: None Benthic Growth: None Stains: None Non-illicit: None	Condition Assessment Graffiti: None Erosion: None Deposition: None in. Damage: None

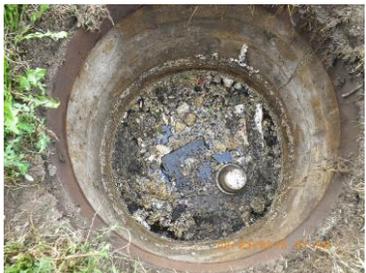
o20150923063950.JPG <h2 style="margin: 0;">2015</h2>

Inspection Date: 9/23/2015 7:36:00 AM		Type: Ongoing	Flow: Submerged, indeterminate	Previous Rainfall (hrs): 72+
Illicit Discharge Potential: Potential		Inspector: JCW		Notes Floating gross solids (litter) in manhole.
Submerged: Fully		Depth (in): 30		
Sampling Results Sample Location: Pool Total Chlorine: 0 ppm Free Chlorine: 0 ppm Ammonia: 0 ppm pH: 8.64 units Temperature: 69 °F Conductivity: 359 µS/cm Detergents: 0 mg/L		Floatables: None Odor: None Turbidity: None Color: Faint in bottle Gross Solids: Moderate Vegetation: None Benthic Growth: None Stains: None Non-illicit: None	Condition Assessment Graffiti: None Erosion: None Deposition: Minor 1 in. Damage: None

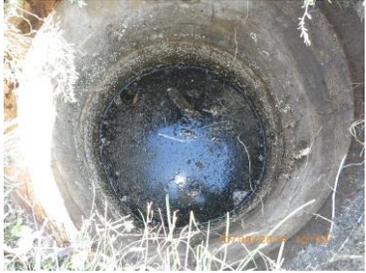
o20141009093356.JPG <h2 style="margin: 0;">2014</h2>

Inspection Date: 10/9/2014 10:35:52 AM		Type: Ongoing	Flow: Submerged, indeterminate	Previous Rainfall (hrs): 72+
Illicit Discharge Potential: Unlikely		Inspector: JCW		Notes Vegetative debris in photo from opening lid.
Submerged: Fully		Depth (in): 32		
Sampling Results Sample Location: Pool Total Chlorine: 0 ppm Free Chlorine: 0 ppm Ammonia: 0 ppm pH: 7.86 units Temperature: 58 °F Conductivity: 476 µS/cm Detergents: 0 mg/L		Floatables: None Odor: None Turbidity: None Color: Faint in bottle Gross Solids: Slight Vegetation: None Benthic Growth: None Stains: None Non-illicit: None	Condition Assessment Graffiti: None Erosion: None Deposition: Minor 1 in. Damage: None

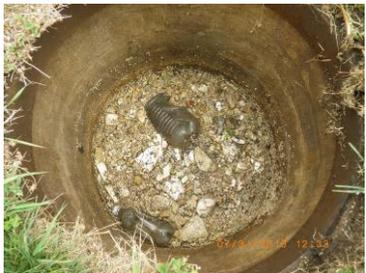
o20130731113346.JPG <h2 style="margin: 0;">2013</h2>

Inspection Date: 7/31/2013 12:31:00 PM		Type: Ongoing	Flow: Submerged, indeterminate	Previous Rainfall (hrs): 72+
Illicit Discharge Potential: Potential		Inspector: JCW		Notes 2012 screening follow-up. Significant gross solids. Similar to previous years.
Submerged: Fully		Depth (in): 33		
Sampling Results Sample Location: Pool Total Chlorine: 0 ppm Free Chlorine: 0 ppm Ammonia: 0 ppm pH: 8.47 units Temperature: 75 °F Conductivity: 425 µS/cm Detergents: 0 mg/L		Floatables: None Odor: None Turbidity: None Color: Faint in bottle Gross Solids: Severe Vegetation: None Benthic Growth: None Stains: Moderate Non-illicit: None	Condition Assessment Graffiti: None Erosion: None Deposition: None in. Damage: None

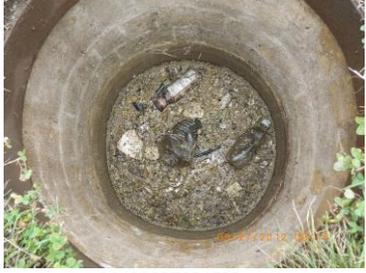
<p style="text-align: center;">o20120927081522.JPG</p> <p style="text-align: center; font-size: 24pt; font-weight: bold;">2012</p>

Inspection Date: 9/27/2012 9:13:54 AM		Type: Ongoing	Flow: Submerged, indeterminate	Previous Rainfall (hrs): 72+																																												
Illicit Discharge Potential: Potential		Inspector: JCW	Notes: 2011 gross solids follow-up.																																													
Submerged: Fully	Depth (in): 31		Condition Assessment																																													
<table border="1" style="width:100%; border-collapse: collapse;"> <tr><td colspan="2">Sampling Results</td></tr> <tr><td>Sample Location:</td><td>Pool</td></tr> <tr><td>Total Chlorine:</td><td>0 ppm</td></tr> <tr><td>Free Chlorine:</td><td>0 ppm</td></tr> <tr><td>Ammonia:</td><td>0 ppm</td></tr> <tr><td>pH:</td><td>8.42 units</td></tr> <tr><td>Temperature:</td><td>59 °F</td></tr> <tr><td>Conductivity:</td><td>723 µS/cm</td></tr> <tr><td>Detergents:</td><td>0 mg/L</td></tr> </table>		Sampling Results		Sample Location:	Pool	Total Chlorine:	0 ppm	Free Chlorine:	0 ppm	Ammonia:	0 ppm	pH:	8.42 units	Temperature:	59 °F	Conductivity:	723 µS/cm	Detergents:	0 mg/L	<table border="1" style="width:100%; border-collapse: collapse;"> <tr><td>Floatables:</td><td>None</td></tr> <tr><td>Odor:</td><td>None</td></tr> <tr><td>Turbidity:</td><td>None</td></tr> <tr><td>Color:</td><td>None</td></tr> <tr><td>Gross Solids:</td><td>Severe</td></tr> <tr><td>Vegetation:</td><td>None</td></tr> <tr><td>Benthic Growth:</td><td>None</td></tr> <tr><td>Stains:</td><td>Slight</td></tr> <tr><td>Non-illicit:</td><td>None</td></tr> </table>	Floatables:	None	Odor:	None	Turbidity:	None	Color:	None	Gross Solids:	Severe	Vegetation:	None	Benthic Growth:	None	Stains:	Slight	Non-illicit:	None	<table border="1" style="width:100%; border-collapse: collapse;"> <tr><td>Graffiti:</td><td>None</td></tr> <tr><td>Erosion:</td><td>None</td></tr> <tr><td>Deposition:</td><td>Minor 3 in.</td></tr> <tr><td>Damage:</td><td>None</td></tr> </table>		Graffiti:	None	Erosion:	None	Deposition:	Minor 3 in.	Damage:	None

Sampling Results																																																
Sample Location:	Pool																																															
Total Chlorine:	0 ppm																																															
Free Chlorine:	0 ppm																																															
Ammonia:	0 ppm																																															
pH:	8.42 units																																															
Temperature:	59 °F																																															
Conductivity:	723 µS/cm																																															
Detergents:	0 mg/L																																															
Floatables:	None																																															
Odor:	None																																															
Turbidity:	None																																															
Color:	None																																															
Gross Solids:	Severe																																															
Vegetation:	None

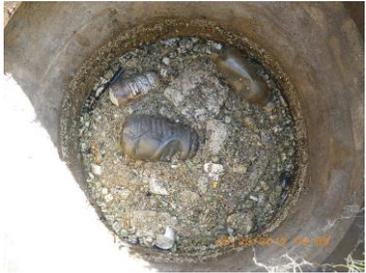
<p style="text-align: center;">o20120620080918.JPG</p> <p style="text-align: center; font-size: 24pt; font-weight: bold;">2012</p>

Inspection Date: 6/20/2012 9:08:12 AM		Type: Other	Flow: Submerged, indeterminate	Previous Rainfall (hrs): 24-48																																												
Illicit Discharge Potential: Potential		Inspector: JCW	Notes: Gross solids pre-screening.																																													
Submerged: Fully	Depth (in): 39		Condition Assessment																																													
<table border="1" style="width:100%; border-collapse: collapse;"> <tr><td colspan="2">Sampling Results</td></tr> <tr><td>Sample Location:</td><td></td></tr> <tr><td>Total Chlorine:</td><td>-- ppm</td></tr> <tr><td>Free Chlorine:</td><td>-- ppm</td></tr> <tr><td>Ammonia:</td><td>-- ppm</td></tr> <tr><td>pH:</td><td>-- units</td></tr> <tr><td>Temperature:</td><td>-- °F</td></tr> <tr><td>Conductivity:</td><td>-- µS/cm</td></tr> <tr><td>Detergents:</td><td>-- mg/L</td></tr> </table>		Sampling Results		Sample Location:		Total Chlorine:	-- ppm	Free Chlorine:	-- ppm	Ammonia:	-- ppm	pH:	-- units	Temperature:	-- °F	Conductivity:	-- µS/cm	Detergents:	-- mg/L	<table border="1" style="width:100%; border-collapse: collapse;"> <tr><td>Floatables:</td><td>None</td></tr> <tr><td>Odor:</td><td>None</td></tr> <tr><td>Turbidity:</td><td>None</td></tr> <tr><td>Color:</td><td>None</td></tr> <tr><td>Gross Solids:</td><td>Severe</td></tr> <tr><td>Vegetation:</td><td>None</td></tr> <tr><td>Benthic Growth:</td><td>None</td></tr> <tr><td>Stains:</td><td>None</td></tr> <tr><td>Non-illicit:</td><td>None</td></tr> </table>	Floatables:	None	Odor:	None	Turbidity:	None	Color:	None	Gross Solids:	Severe	Vegetation:	None	Benthic Growth:	None	Stains:	None	Non-illicit:	None	<table border="1" style="width:100%; border-collapse: collapse;"> <tr><td>Graffiti:</td><td>None</td></tr> <tr><td>Erosion:</td><td>None</td></tr> <tr><td>Deposition:</td><td>None in.</td></tr> <tr><td>Damage:</td><td>None</td></tr> </table>		Graffiti:	None	Erosion:	None	Deposition:	None in.	Damage:	None

Sampling Results																																																
Sample Location:																																																
Total Chlorine:	-- ppm																																															
Free Chlorine:	-- ppm																																															
Ammonia:	-- ppm																																															
pH:	-- units																																															
Temperature:	-- °F																																															
Conductivity:	-- µS/cm																																															
Detergents:	-- mg/L																																															
Floatables:	None																																															
Odor:	None																																															
Turbidity:	None																																															
Color:	None																																															
Gross Solids:	Severe																																															
Vegetation:	None

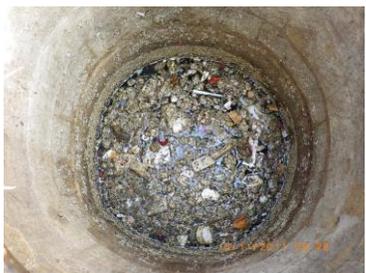
<p style="text-align: center;">o20111011092832.JPG</p> <p style="text-align: center; font-size: 24pt; font-weight: bold;">2011</p>

Inspection Date: 10/11/2011 9:29:50 AM		Type: Ongoing	Flow: Submerged, indeterminate	Previous Rainfall (hrs): 72+																																												
Illicit Discharge Potential: Potential		Inspector: JCW	Notes: 2010 screening follow-up. Floatable debris still present. Slight petroleum sheen.																																													
Submerged: Fully	Depth (in): 19		Condition Assessment																																													
<table border="1" style="width:100%; border-collapse: collapse;"> <tr><td colspan="2">Sampling Results</td></tr> <tr><td>Sample Location:</td><td>Pool</td></tr> <tr><td>Total Chlorine:</td><td>0 ppm</td></tr> <tr><td>Free Chlorine:</td><td>0 ppm</td></tr> <tr><td>Ammonia:</td><td>0 ppm</td></tr> <tr><td>pH:</td><td>8.01 units</td></tr> <tr><td>Temperature:</td><td>71 °F</td></tr> <tr><td>Conductivity:</td><td>-- µS/cm</td></tr> <tr><td>Detergents:</td><td>-- mg/L</td></tr> </table>		Sampling Results		Sample Location:	Pool	Total Chlorine:	0 ppm	Free Chlorine:	0 ppm	Ammonia:	0 ppm	pH:	8.01 units	Temperature:	71 °F	Conductivity:	-- µS/cm	Detergents:	-- mg/L	<table border="1" style="width:100%; border-collapse: collapse;"> <tr><td>Floatables:</td><td>Severe</td></tr> <tr><td>Odor:</td><td>None</td></tr> <tr><td>Turbidity:</td><td>None</td></tr> <tr><td>Color:</td><td>None</td></tr> <tr><td>Gross Solids:</td><td>Severe</td></tr> <tr><td>Vegetation:</td><td>None</td></tr> <tr><td>Benthic Growth:</td><td>None</td></tr> <tr><td>Stains:</td><td>None</td></tr> <tr><td>Non-illicit:</td><td>None</td></tr> </table>	Floatables:	Severe	Odor:	None	Turbidity:	None	Color:	None	Gross Solids:	Severe	Vegetation:	None	Benthic Growth:	None	Stains:	None	Non-illicit:	None	<table border="1" style="width:100%; border-collapse: collapse;"> <tr><td>Graffiti:</td><td>None</td></tr> <tr><td>Erosion:</td><td>None</td></tr> <tr><td>Deposition:</td><td>None 0 in.</td></tr> <tr><td>Damage:</td><td>None</td></tr> </table>		Graffiti:	None	Erosion:	None	Deposition:	None 0 in.	Damage:	None

Sampling Results																																																
Sample Location:	Pool																																															
Total Chlorine:	0 ppm																																															
Free Chlorine:	0 ppm																																															
Ammonia:	0 ppm																																															
pH:	8.01 units																																															
Temperature:	71 °F																																															
Conductivity:	-- µS/cm																																															
Detergents:	-- mg/L																																															
Floatables:	Severe																																															
Odor:	None																																															
Turbidity:	None																																															
Color:	None																																															
Gross Solids:	Severe																																															
Vegetation:	None

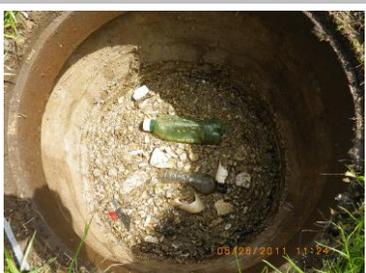
<p style="text-align: center;">o20110526112400.JPG</p> <p style="text-align: center; font-size: 24pt; font-weight: bold;">2011</p>

Inspection Date: 5/26/2011 11:23:00 AM		Type: Other	Flow: Submerged, indeterminate	Previous Rainfall (hrs): 72+																																												
Illicit Discharge Potential: Potential		Inspector: JCW	Notes: Limited screening conducted to check for floatable debris.																																													
Submerged: Fully	Depth (in):		Condition Assessment																																													
<table border="1" style="width:100%; border-collapse: collapse;"> <tr><td colspan="2">Sampling Results</td></tr> <tr><td>Sample Location:</td><td></td></tr> <tr><td>Total Chlorine:</td><td>-- ppm</td></tr> <tr><td>Free Chlorine:</td><td>-- ppm</td></tr> <tr><td>Ammonia:</td><td>-- ppm</td></tr> <tr><td>pH:</td><td>-- units</td></tr> <tr><td>Temperature:</td><td>-- °F</td></tr> <tr><td>Conductivity:</td><td>-- µS/cm</td></tr> <tr><td>Detergents:</td><td>-- mg/L</td></tr> </table>		Sampling Results		Sample Location:		Total Chlorine:	-- ppm	Free Chlorine:	-- ppm	Ammonia:	-- ppm	pH:	-- units	Temperature:	-- °F	Conductivity:	-- µS/cm	Detergents:	-- mg/L	<table border="1" style="width:100%; border-collapse: collapse;"> <tr><td>Floatables:</td><td>None</td></tr> <tr><td>Odor:</td><td></td></tr> <tr><td>Turbidity:</td><td></td></tr> <tr><td>Color:</td><td></td></tr> <tr><td>Gross Solids:</td><td>Severe</td></tr> <tr><td>Vegetation:</td><td></td></tr> <tr><td>Benthic Growth:</td><td></td></tr> <tr><td>Stains:</td><td></td></tr> <tr><td>Non-illicit:</td><td>None</td></tr> </table>	Floatables:	None	Odor:		Turbidity:		Color:		Gross Solids:	Severe	Vegetation:		Benthic Growth:		Stains:		Non-illicit:	None	<table border="1" style="width:100%; border-collapse: collapse;"> <tr><td>Graffiti:</td><td>None</td></tr> <tr><td>Erosion:</td><td>None</td></tr> <tr><td>Deposition:</td><td>None 0 in.</td></tr> <tr><td>Damage:</td><td>None</td></tr> </table>		Graffiti:	None	Erosion:	None	Deposition:	None 0 in.	Damage:	None

Sampling Results																																																
Sample Location:																																																
Total Chlorine:	-- ppm																																															
Free Chlorine:	-- ppm																																															
Ammonia:	-- ppm																																															
pH:	-- units																																															
Temperature:	-- °F																																															
Conductivity:	-- µS/cm																																															
Detergents:	-- mg/L																																															
Floatables:	None																																															
Odor:																																																
Turbidity:																																																
Color:																																																
Gross Solids:	Severe																																															
Vegetation:

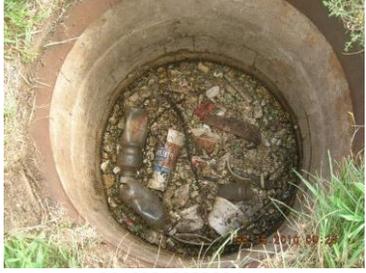
<small>o20100818092304.JPG</small> 2010	
Submerged: Fully Depth (in): 34				Severe floatable debris in catchbasin.			
Sampling Results				Condition Assessment			
Sample Location: Pool		Floatables:	None	Graffiti:		None	
Total Chlorine: 0 ppm		Odor:	Faint	Erosion:		None	
Free Chlorine: 0 ppm		Turbidity:	None	Deposition:		None 0 in.	
Ammonia: 0.5 ppm		Color:	Faint in bottle	Damage:		None	
pH: 7.46 units		Gross Solids:	Severe				
Temperature 73 °F		Vegetation:	None				
Conductivity: -- µS/cm		Benthic Growth:	None				
Detergents: 0 mg/L		Stains:	None				
		Non-illicit:	None

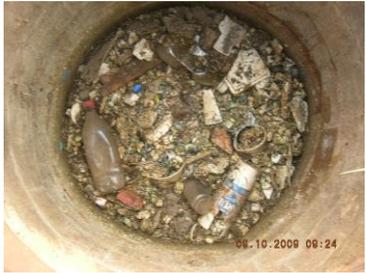
<small>Osh09_DSCN6763.JPG</small> 2009	
Submerged: Fully Depth (in): 33				Abnormal detergent analysis result (bubbles). Significant floatables in manhole.			
Sampling Results				Condition Assessment			
Sample Location: Pool		Floatables:	None	Graffiti:		None	
Total Chlorine: 0 ppm		Odor:	None	Erosion:		None	
Free Chlorine: 0 ppm		Turbidity:	None	Deposition:		None 0 in.	
Ammonia: -- ppm		Color:	None	Damage:		None	
pH: 8.23 units		Gross Solids:	Severe				
Temperature 73 °F		Vegetation:	None				
Conductivity: -- µS/cm		Benthic Growth:	None				
Detergents: 0 mg/L		Stains:	None				
		Non-illicit:	None

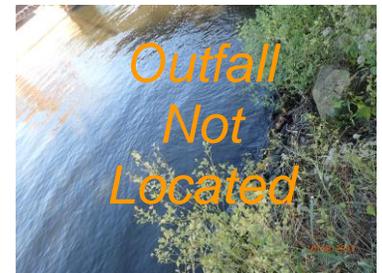
o20171018144750.JPG

Notes: Outfall fully submerged and not located - screened upstream at 03-81 US1. Ammonia, detergent and sheen in upstream manhole.

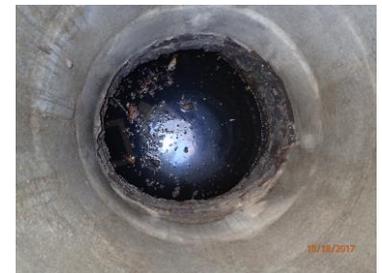
o20171018145016.JPG

Notes: Elevated ammonia and detergent in sample from manhole pool. Slight sheen observed on surface.

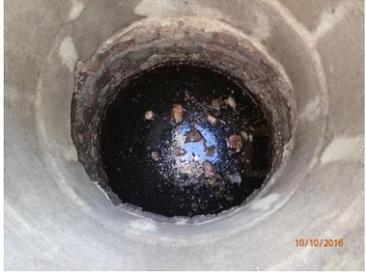
o20161010090136.JPG 2016

Inspection Date: 10/10/2016 9:04:32 AM		Type: Ongoing	Flow: Submerged, indeterminate	Previous Rainfall (hrs): 72+
Illicit Discharge Potential: Potential		Inspector: JCW		Notes Potential illicit discharge due to gross solids and petroleum odor and sheen and elevated ammonia.
Submerged: Fully Depth (in): 46				
Sampling Results Sample Location: Pool Total Chlorine: 0 ppm Free Chlorine: 0 ppm Ammonia: 1 ppm pH: 7.41 units Temperature: 63 °F Conductivity: 565 µS/cm Detergents: 0 mg/L		Floatables: Moderate Odor: Faint Turbidity: None Color: Faint in bottle Gross Solids: Slight Vegetation: None Benthic Growth: None Stains: None Non-illicit: None	Condition Assessment Graffiti: None Erosion: None Deposition: None in. Damage: None

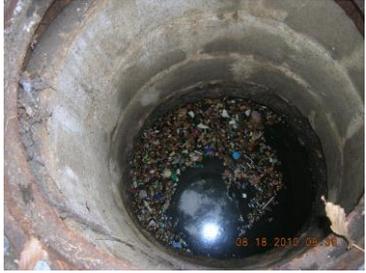
Inspection Date: 8/18/2010 8:43:09 AM		Type: Ongoing	Flow: Submerged, indeterminate	Previous Rainfall (hrs): 72+		
Illicit Discharge Potential: Potential		Inspector: JCW	Notes: Petroleum odor likely from residual petroleum in pipes after 2009 jetting.			
Submerged: Fully		Depth (in): 47

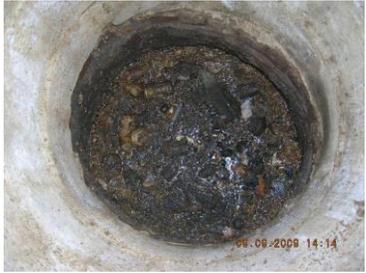
Inspection Date: 9/9/2009		Type: Initial	Flow: Submerged, indeterminate	Previous Rainfall (hrs): 72+		
Illicit Discharge Potential: Obvious		Inspector: JCW	Notes: Diesel/oil odor, sheen on surface. Floatables with grease. Brown/gray color.			
Submerged: Fully		Depth (in): 44

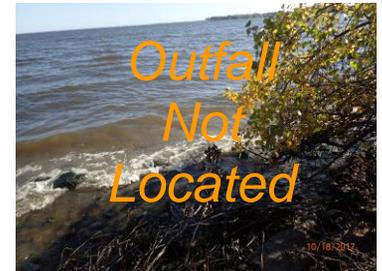
o20171018142348.JPG

Notes: Outfall fully submerged and not located - screened upstream at 03-173 US2. Floating gross solids (litter) in manhole.

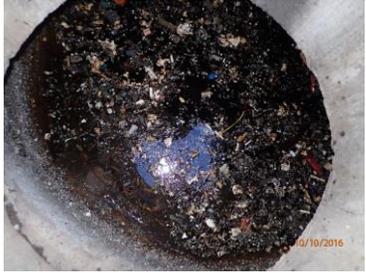
o20161010082808.JPG <h2 style="margin: 0;">2016</h2>

Inspection Date: 10/10/2016 8:30:16 AM		Type: Ongoing	Flow: Submerged, indeterminate	Previous Rainfall (hrs): 72+
Illicit Discharge Potential: Potential		Inspector: JCW		Notes Potential illicit discharge due to gross solids.
Submerged: Fully Depth (in): 40				
Sampling Results Sample Location: Pool Total Chlorine: 0 ppm Free Chlorine: 0 ppm Ammonia: 0 ppm pH: 7.56 units Temperature: 62 °F Conductivity: 422 µS/cm Detergents: 0 mg/L		Floatables: None Odor: None Turbidity: None Color: None Gross Solids: Moderate Vegetation: None Benthic Growth: Slight Stains: None Non-illicit: None	Condition Assessment Graffiti: None Erosion: None Deposition: None in. Damage: None

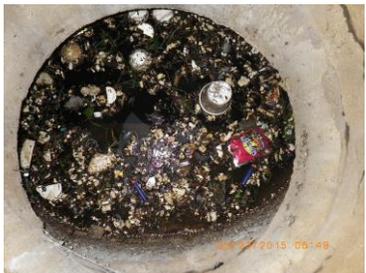
o20150923054948.JPG <h2 style="margin: 0;">2015</h2>

Inspection Date: 9/23/2015 6:51:23 AM		Type: Ongoing	Flow: Submerged, indeterminate	Previous Rainfall (hrs): 72+
Illicit Discharge Potential: Potential		Inspector: JCW		Notes Floating gross solids (litter) - including 5 baseballs - in manhole.
Submerged: Fully Depth (in): 42				
Sampling Results Sample Location: Pool Total Chlorine: 0 ppm Free Chlorine: 0 ppm Ammonia: 0 ppm pH: 8.19 units Temperature: 68 °F Conductivity: 476 µS/cm Detergents: 0 mg/L		Floatables: None Odor: None Turbidity: None Color: None Gross Solids: Moderate Vegetation: None Benthic Growth: None Stains: None Non-illicit: None	Condition Assessment Graffiti: None Erosion: None Deposition: None in. Damage: None

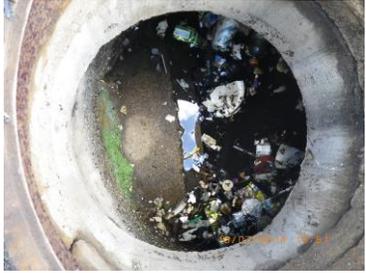
o20141007125104.JPG <h2 style="margin: 0;">2014</h2>

Inspection Date: 10/7/2014 1:52:27 PM		Type: Ongoing	Flow: Submerged, indeterminate	Previous Rainfall (hrs): 48-72
Illicit Discharge Potential: Potential		Inspector: JCW		Notes Floating gross solids (litter) in manhole.
Submerged: Fully Depth (in): 38				
Sampling Results Sample Location: Pool Total Chlorine: 0 ppm Free Chlorine: 0 ppm Ammonia: 0 ppm pH: 7.73 units Temperature: -- °F Conductivity: 401 µS/cm Detergents: 0 mg/L		Floatables: None Odor: None Turbidity: None Color: None Gross Solids: Moderate Vegetation: None Benthic Growth: Slight Stains: None Non-illicit: None	Condition Assessment Graffiti: None Erosion: None Deposition: None in. Damage: None

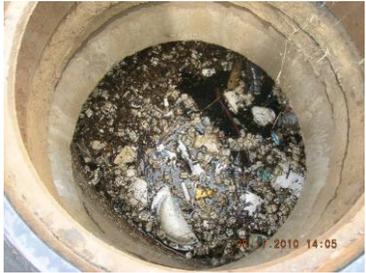
o20100817140504.JPG

Inspection Date: 8/17/2010 2:11:27 PM		Type: Ongoing	Flow: Submerged, indeterminate	Previous Rainfall (hrs): 72+
Illicit Discharge Potential: Potential		Inspector: JCW	Notes Floatable debris in manhole.	
Submerged: Fully	Depth (in): 42			
Sampling Results Sample Location: Pool		Floatables: None	Condition Assessment Graffiti: None Erosion: None Deposition: None 0 in. Damage: None	
Total Chlorine: 0 ppm		Odor: None		
Free Chlorine: 0 ppm		Turbidity: None		
Ammonia: 0 ppm		Color: None		
pH: 7.69 units		Gross Solids: Moderate		
Temperature: 77 °F		Vegetation: None		
Conductivity: -- µS/cm		Benthic Growth: None		
Detergents: 0 mg/L		Stains: None		
		Non-illicit: None

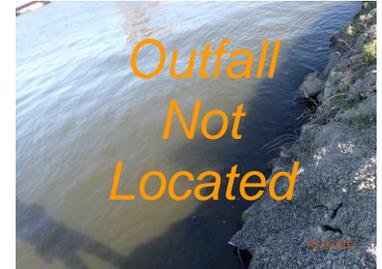
o20171018150108.JPG

Notes: Outfall fully submerged and not located - screened upstream at 03-381 US1. Floating gross solids (litter) in manhole.

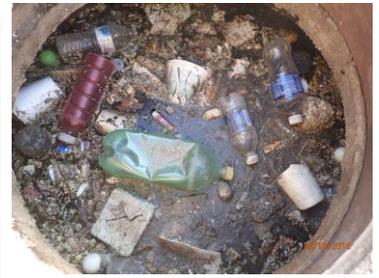
Notes: Sample collected from submerged pool in manhole.

Submerged: Fully Depth (in): 60

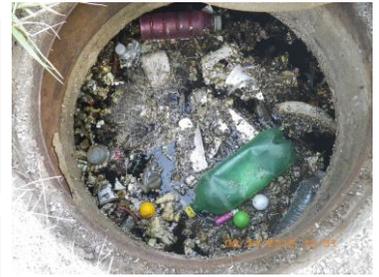
Odor: Petroleum Musty Sewage Chlorine Other

o20171017145250.JPG

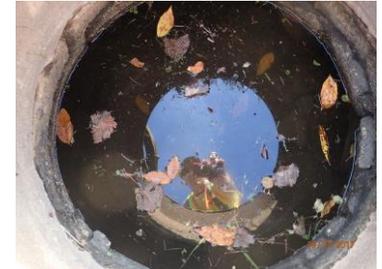
Corrosion Cracks/Structural Damage

Deposition: None Depth (in):

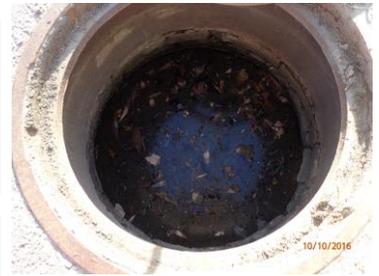
<table><tr><td colspan="2">Condition Assessment</td></tr><tr><td>Damage:</td><td>None</td></tr></table>

<table><tr><td colspan="2">Condition Assessment</td></tr><tr><td>Erosion:</td><td>None</td></tr></table>

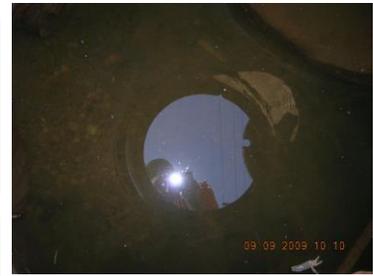
Osh09_DSCN6698.JPG

Inspection Date: 9/9/2009		Type: Initial	Flow: Submerged, indeterminate	Previous Rainfall (hrs): 72+
Illicit Discharge Potential: Potential		Inspector: JCW		
Submerged: Partially		Depth (in): 13		
Sampling Results		Notes		
Sample Location: Pool	Floatables: None	Abnormal detergent analysis result (bubbles)		
Total Chlorine: 0 ppm	Odor: None			
Free Chlorine: 0 ppm	Turbidity: None			
Ammonia: -- ppm	Color: None			
pH: 8.1 units	Gross Solids: None			
Temperature 76 °F	Vegetation: None			
Conductivity: -- µS/cm	Benthic Growth: None			
Detergents: 0 mg/L	Stains: None			
	Non-illicit: None			
		Graffiti: None	0 in.	
		Erosion: None		
		Deposition: None		
		Damage: None

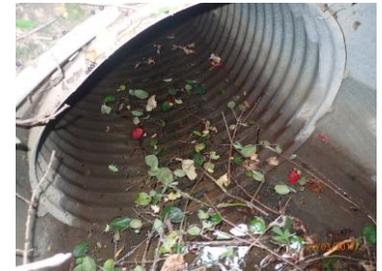
o20171003151556.JPG

Notes: Outfall buried under downed trees and brush from power line trimming - limited screening. Sample collected from submerged flow at end of pipe.

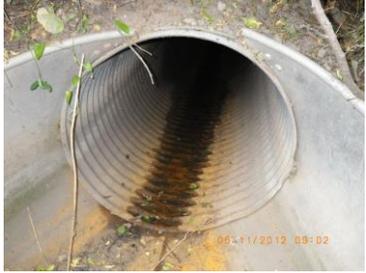
o20120611080232.JPG

Notes
 Water in corrugations, but no flow at time of inspection.

Graffiti:	None
Erosion:	None
Deposition:	None
Damage:	Minor

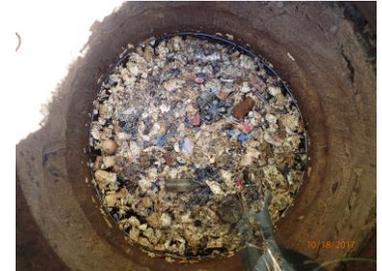
o20171018112938.JPG

Notes: Sample collected from submerged pool in manhole. Floating gross solids (litter) in manhole.

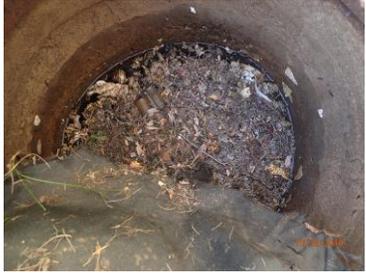
o20161018145924.JPG 2016

Inspection Date: 10/18/2016 3:00:00 PM		Type: Ongoing	Flow: Submerged, indeterminate	Previous Rainfall (hrs): 72+
Illicit Discharge Potential: Potential		Inspector: JCW		Notes Potential illicit discharge due to gross solids.
Submerged: Fully		Depth (in):		
Sampling Results Sample Location: Pool Total Chlorine: 0 ppm Free Chlorine: 0 ppm Ammonia: 0 ppm pH: 8.02 units Temperature: 67 °F Conductivity: 418 µS/cm Detergents: 0 mg/L		Floatables: None Odor: None Turbidity: None Color: None Gross Solids: Moderate Vegetation: None Benthic Growth: None Stains: None Non-illicit: None	Condition Assessment Graffiti: None Erosion: None Deposition: None 0 in. Damage: None

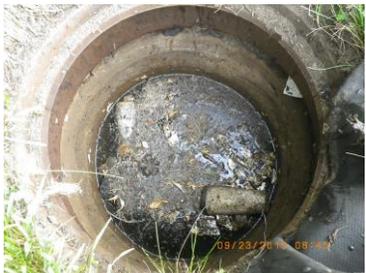
o20150923074542.JPG 2015

Inspection Date: 9/23/2015 8:42:53 AM		Type: Ongoing	Flow: Submerged, indeterminate	Previous Rainfall (hrs): 72+
Illicit Discharge Potential: Potential		Inspector: JCW		Notes Floating gross solids (litter) in manhole.
Submerged: Fully		Depth (in): 44		
Sampling Results Sample Location: Pool Total Chlorine: 0 ppm Free Chlorine: 0 ppm Ammonia: 0 ppm pH: 8.74 units Temperature: 70 °F Conductivity: 351 µS/cm Detergents: 0 mg/L		Floatables: None Odor: None Turbidity: None Color: None Gross Solids: Moderate Vegetation: None Benthic Growth: None Stains: None Non-illicit: None	Condition Assessment Graffiti: None Erosion: None Deposition: None in. Damage: None

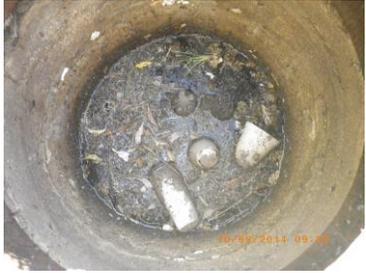
o20141009083526.JPG 2014

Inspection Date: 10/9/2014 9:37:13 AM		Type: Ongoing	Flow: Submerged, indeterminate	Previous Rainfall (hrs): 72+
Illicit Discharge Potential: Potential		Inspector: JCW		Notes Floating gross solids (litter) in manhole. Filter fabric installed in inlet.
Submerged: Fully		Depth (in): 35		
Sampling Results Sample Location: Pool Total Chlorine: 0 ppm Free Chlorine: 0 ppm Ammonia: 0 ppm pH: 7.82 units Temperature: 56 °F Conductivity: 471 µS/cm Detergents: 0 mg/L		Floatables: None Odor: None Turbidity: Slight cloudiness Color: None Gross Solids: Severe Vegetation: None Benthic Growth: Slight Stains: None Non-illicit: None	Condition Assessment Graffiti: None Erosion: None Deposition: None in. Damage: None

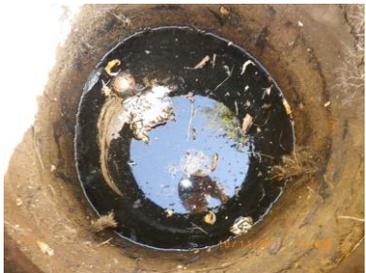
o20111011110824.JPG 2011

Inspection Date: 10/11/2011 11:09:29 AM		Type: Ongoing	Flow: Submerged, indeterminate	Previous Rainfall (hrs): 72+
Illicit Discharge Potential: Unlikely		Inspector: JCW		Notes 2010 screening follow-up. Floatable debris significantly reduced.
Submerged: Fully		Depth (in): 35		
Sampling Results Sample Location: Pool Total Chlorine: 0 ppm Free Chlorine: 0 ppm Ammonia: 0 ppm pH: 8.13 units Temperature: 70 °F Conductivity: -- µS/cm Detergents: -- mg/L		Floatables: None Odor: None Turbidity: None Color: None Gross Solids: Moderate Vegetation: None Benthic Growth: None Stains: None Non-illicit: None	Condition Assessment Graffiti: None Erosion: None Deposition: None 0 in. Damage: None

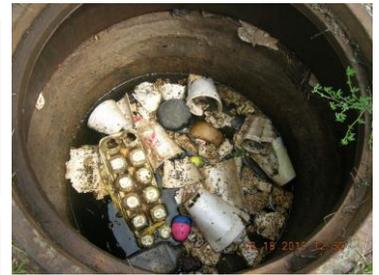
o20100818125018.JPG

Inspection Date: 8/18/2010 1:00:07 PM		Type: Ongoing	Flow: Submerged, indeterminate	Previous Rainfall (hrs): 72+
Illicit Discharge Potential: Potential		Inspector: JCW	Notes Significant floatable debris in manhole.	
Submerged: Fully	Depth (in): 41			
Sampling Results Sample Location: Pool		Floatables: None	Condition Assessment Graffiti: None Erosion: None Deposition: None 0 in. Damage: None	
Total Chlorine: 0 ppm		Odor: None		
Free Chlorine: 0 ppm		Turbidity: Slight cloudiness		
Ammonia: 0 ppm		Color: Faint in bottle		
pH: 7.98 units		Gross Solids: Severe		
Temperature: 76 °F		Vegetation: None		
Conductivity: -- µS/cm		Benthic Growth: None		
Detergents: 0 mg/L		Stains: None		
		Non-illicit: None

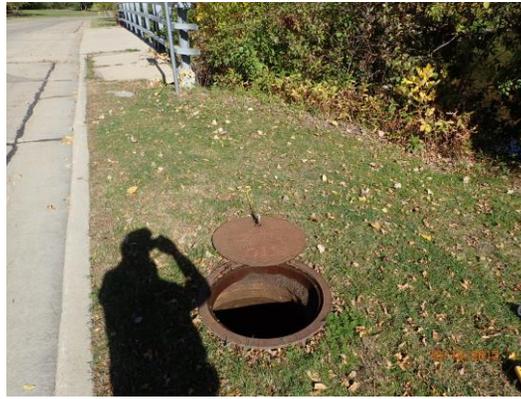
o20171018105542.JPG

Upstream manhole located approx 25 ft SSW of outfall 06-221. Intermediate area consists of open space. 1.5" hose through side of manhole - tied around steps

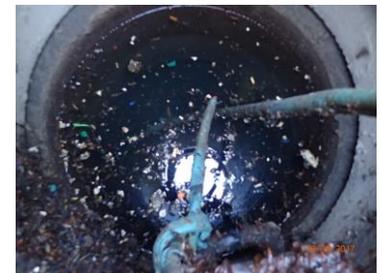
o20171018105550.JPG

Notes: Sample collected from submerged pool in manhole. Floating gross solids (litter) in manhole.

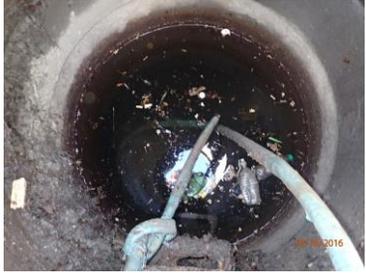
o20161018134038.JPG

Notes
Casting displaced 2". Potential illicit discharge due to gross solids.

Condition Assessment
Graffiti: None
Erosion: None
Deposition: None in.
Damage: Minor

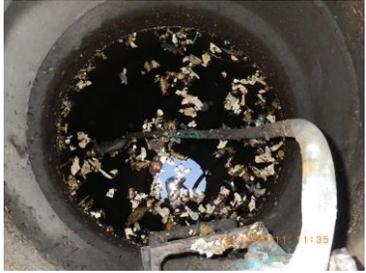
o20111011113522.JPG

Notes
2010 screening follow-up. Floatable debris still present.

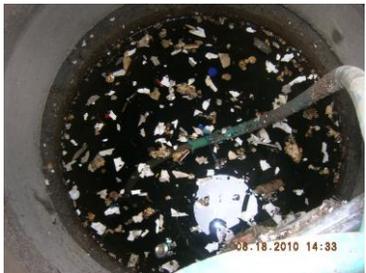
o20100818143354.JPG

Notes
Torn paper and other floatable debris in manhole.

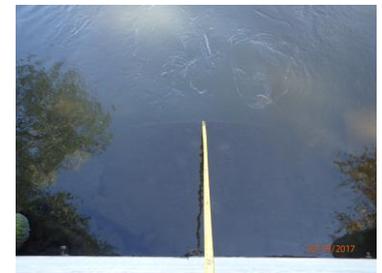
o20171019131334.JPG

Notes: Outfall fully submerged with significant flow causing surface disturbance. Screened upstream at 06-253 US1. Elevated ammonia in manhole.

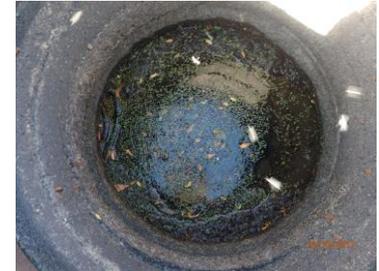
o20171019131708.JPG

Notes: Sample collected from submerged flow in manhole. Elevated ammonia.

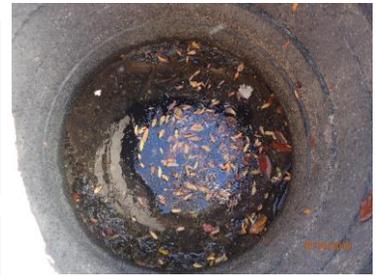
o20161018140148.JPG

Inspection Date: 10/18/2016 2:03:25 PM		Type: Ongoing	Flow: Submerged, significant flow	Previous Rainfall (hrs): 72+
Illicit Discharge Potential: Unlikely		Inspector: JCW		
Submerged: Fully		Depth (in): 40		
<u>Sampling Results</u>		Notes		
Sample Location: Flow	Floatables: None	Strong current; significant flies in manhole.		
Total Chlorine: 0 ppm	Odor: Faint			
Free Chlorine: 0 ppm	Turbidity: None			
Ammonia: 0 ppm	Color: None			
pH: 7.01 units	Gross Solids: None			
Temperature 70 °F	Vegetation: None			
Conductivity: 1228 µS/cm	Benthic Growth: None			
Detergents: 0 mg/L	Stains: None			
	Non-illicit: None			
		Graffiti: None		
		Erosion: None		
		Deposition: None in.		
		Damage: None

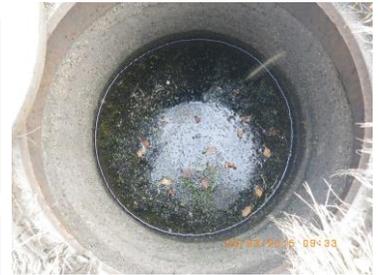
o20150923083310.JPG

Inspection Date: 9/23/2015 9:31:39 AM		Type: Ongoing	Flow: Submerged, significant flow	Previous Rainfall (hrs): 72+
Illicit Discharge Potential: Unlikely		Inspector: JCW		
Submerged: Fully		Depth (in): 42		
<u>Sampling Results</u>		Notes		
Sample Location: Pool	Floatables: None	Significant current detected in pool. Many flies emerging from water.		
Total Chlorine: 0 ppm	Odor: None			
Free Chlorine: 0 ppm	Turbidity: None			
Ammonia: 0 ppm	Color: None			
pH: 7.53 units	Gross Solids: Slight			
Temperature 70 °F	Vegetation: None			
Conductivity: 1220 µS/cm	Benthic Growth: Slight			
Detergents: 0 mg/L	Stains: None			
	Non-illicit: None			
		Graffiti: None		
		Erosion: None		
		Deposition: None in.		
		Damage: None

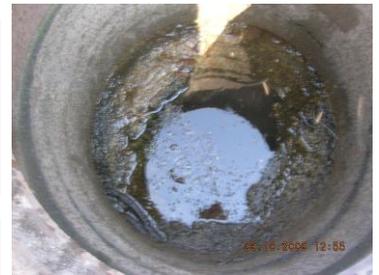
Osh09_DSCN6791.JPG

Inspection Date: 9/10/2009		Type: Initial	Flow: Submerged, slight flow	Previous Rainfall (hrs): 72+
Illicit Discharge Potential: Unlikely		Inspector: JCW		
Submerged: Fully		Depth (in): 38		
<u>Sampling Results</u>		Notes		
Sample Location: Pool	Floatables: None	River fly swarm inside manhole.		
Total Chlorine: 0 ppm	Odor: None			
Free Chlorine: 0 ppm	Turbidity: None			
Ammonia: -- ppm	Color: None			
pH: 6.92 units	Gross Solids: None			
Temperature 79 °F	Vegetation: None			
Conductivity: -- µS/cm	Benthic Growth: None			
Detergents: 0 mg/L	Stains: None			
	Non-illicit: None			
		Graffiti: None		
		Erosion: None		
		Deposition: None 0 in.		
		Damage: None

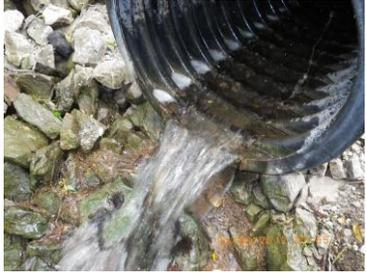
Inspection Date: 5/30/2012 7:51:12 AM		Type: Ongoing		Flow: Moderate		Previous Rainfall (hrs): 72+	
Illicit Discharge Potential: Unlikely		Inspector: JCW		Notes Small pockets of suds/foam on rocks below discharge.

<small>o20120530065530.JPG</small> 2012	
Submerged: None		Depth (in):					
Sampling Results Sample Location: Flow Total Chlorine: 0 ppm Free Chlorine: 0 ppm Ammonia: 0 ppm pH: 8.11 units Temperature: 66 °F Conductivity: 734 µS/cm Detergents: 0 mg/L		Floatables: Slight Odor: None Turbidity: None Color: None Gross Solids: None Vegetation: None Benthic Growth: None Stains: None Non-illicit: None		Condition Assessment Graffiti: None Erosion: None Deposition: None Damage: None		in.

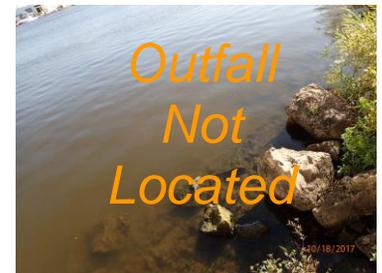
o20171018111512.JPG

Notes: Outfall fully submerged and not located - screened upstream at 06-810 US1.

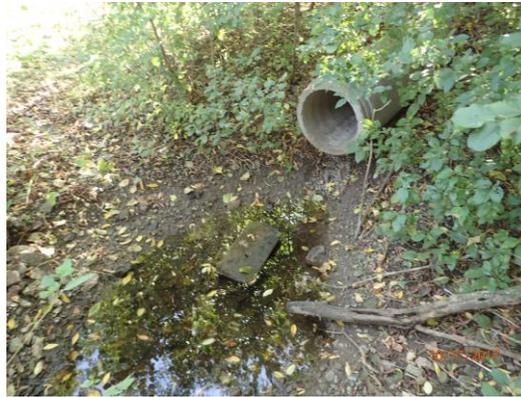
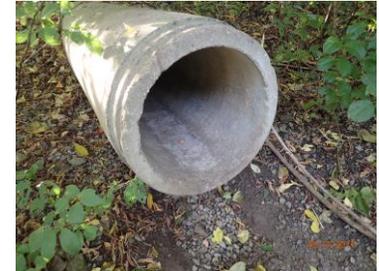
o20171017083742.JPG

Notes: Pipe dry at time of inspection. Pipe undercut 11". Scour hole and downstream channel erosion.

Damage: Moderate Displacement Undercut Crushed

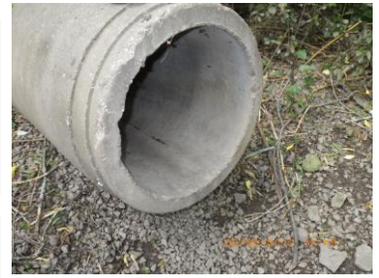
o20120530114522.JPG

Notes
 Small pool at end of pipe. No flow at time of inspection.

Condition Assessment
 Graffiti: None
 Erosion: Minor
 Deposition: None in.
 Damage: Minor

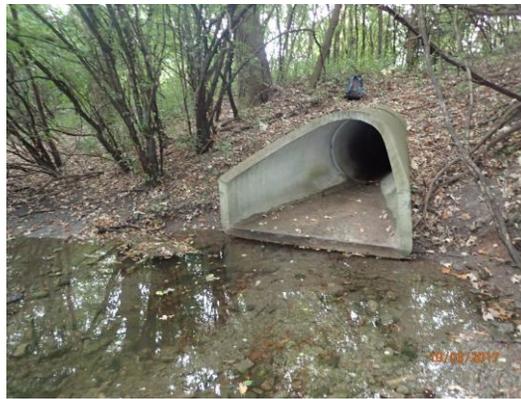
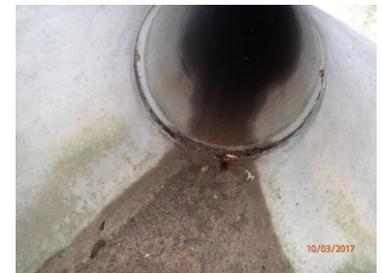
o20171003153144.JPG

Notes: Flowline damp, but no flow at time of inspection. 5" joint displacement at apron.

Damage: Moderate Displacement Undercut Crushed
 Corrosion Cracks/Structural Damage

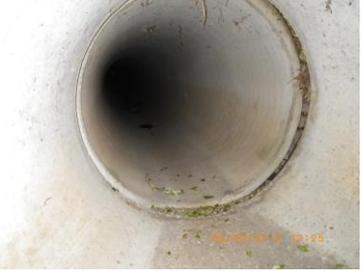
<p style="font-size: small; margin-top: 5px;">o20120530112522.JPG</p> <p style="font-size: large; font-weight: bold; margin-top: 10px;">2012</p>																		
Submerged: None Depth (in):		Notes Apron displaced 5" from pipe. Dry at time of inspection.																				
Sampling Results Sample Location: Total Chlorine: -- ppm Free Chlorine: -- ppm Ammonia: -- ppm pH: -- units Temperature -- ° F Conductivity: -- µS/cm Detergents: -- mg/L

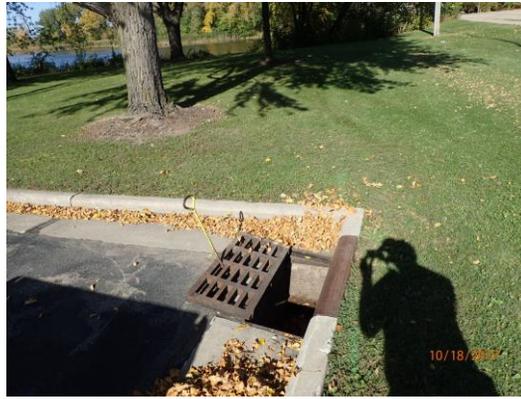
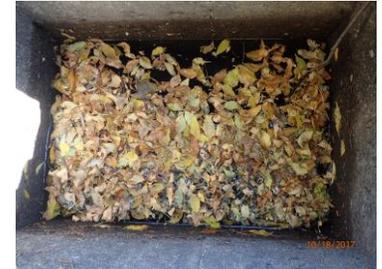
o20171018110504.JPG

Notes: Sample collected from submerged pool in manhole. 5" of organic sediment on bottom.

Graffiti: None
 Erosion: None
 Deposition: Moderate Depth (in): 5
 Damage: None Displacement Undercut Crushed
 Corrosion Cracks/Structural Damage

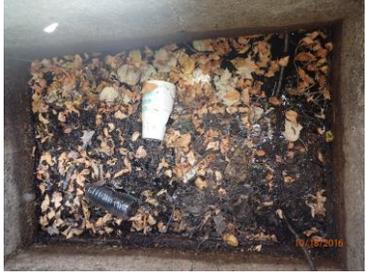
o20161018133224.JPG	
Submerged: Fully		Depth (in): 22		Potential illicit discharge due to gross solids.			
Sampling Results				Condition Assessment		2016	
Sample Location: Pool		Floatables: None		Graffiti: None			
Total Chlorine: 0 ppm		Odor: Faint		Erosion: None			
Free Chlorine: 0 ppm		Turbidity: None		Deposition: None in.			
Ammonia: 0 ppm		Color: None		Damage: None			
pH: 7.38 units		Gross Solids: Moderate					
Temperature 68 °F		Vegetation: None					
Conductivity: 1432 µS/cm		Benthic Growth: Slight					
Detergents: 0 mg/L		Stains: None					
		Non-illicit: None

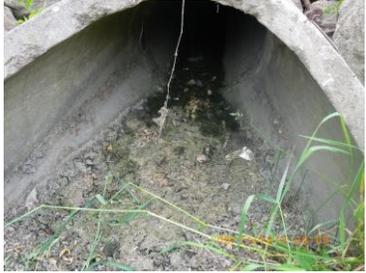
o20120611080832.JPG

Notes
 Damp flowline, but no flow leaving pipe.

Condition Assessment
 Graffiti: None
 Erosion: None
 Deposition: Minor 1 in.
 Damage: Minor

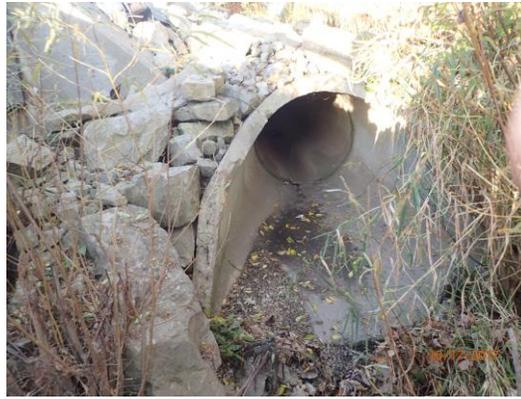
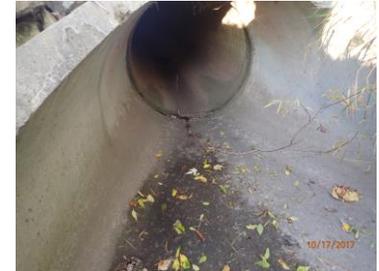
o20171017075656.JPG

Notes: Pipe dry at time of inspection. 3" apron displacement and cracked concrete.

Damage: Moderate Displacement Undercut Crushed

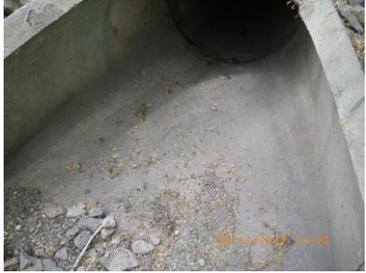
Inspection Date: 6/11/2012 10:22:55 AM		Type: Ongoing		Flow: None		Previous Rainfall (hrs): 72+	
Illicit Discharge Potential: Unlikely		Inspector: JCW		Notes Gravel deposit at end of apron.

o20120611092654.JPG	
Submerged: None		Depth (in):					
Sampling Results Sample Location: Total Chlorine: -- ppm Free Chlorine: -- ppm Ammonia: -- ppm pH: -- units Temperature -- °F Conductivity: -- µS/cm Detergents: -- mg/L		Floatables: None Odor: None Turbidity: None Color: None Gross Solids: None Vegetation: None Benthic Growth: None Stains: Slight Non-illicit: None		Condition Assessment Graffiti: None Erosion: None Deposition: Minor 3 in. Damage: Minor		2012

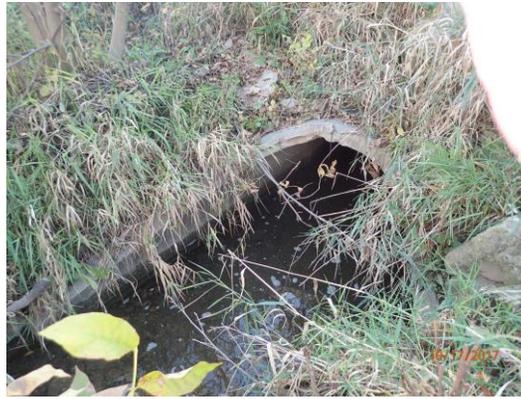
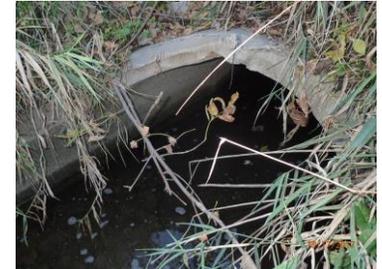
o20171017080100.JPG

Notes: Outfall partially submerged - screened upstream at 06-1136 US1. Suds appeared to behave as natural (surfactant) source.

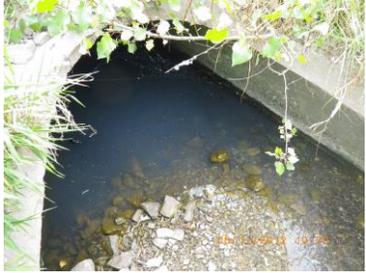
Inspection Date: 6/11/2012 10:29:34 AM		Type: Ongoing		Flow: Submerged, slight flow		Previous Rainfall (hrs): 72+	
Illicit Discharge Potential: Unlikely		Inspector: JCW		Notes Gravel deposition on apron. Outfall partially submerged. Outfall screened upstream at 06-1136 US1.

<p style="text-align: center; font-size: small;">o20120611093052.JPG</p>	
Submerged: Partially Depth (in): 10							
Sampling Results Sample Location:		Floatables: None		Condition Assessment Graffiti: None Erosion: None Deposition: Moderate 4 in. Damage: None		<h1 style="margin: 0;">2012</h1>	
Total Chlorine: -- ppm Free Chlorine: -- ppm Ammonia: -- ppm pH: -- units Temperature -- ° F Conductivity: -- µS/cm Detergents: -- mg/L		Odor: None Turbidity: Slight cloudiness Color: None Gross Solids: None Vegetation: None Benthic Growth: None Stains: Moderate Non-illicit: None

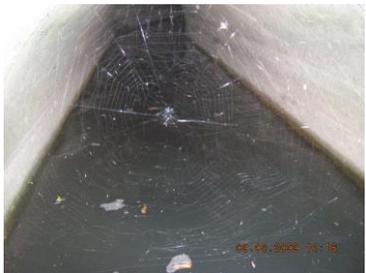
Inspection Date: 9/3/2009		Type: Initial		Flow: Submerged, slight flow		Previous Rainfall (hrs): 72+	
Illicit Discharge Potential: Unlikely		Inspector: JCW		Notes

<p style="text-align: center; font-size: small;">Osh09_DSCN6460.JPG</p>	
Submerged: Partially Depth (in): 11							
Sampling Results Sample Location:		Floatables: None		Condition Assessment Graffiti: None Erosion: None Deposition: 1 in. Damage: None		<h1 style="margin: 0;">2009</h1>	
Total Chlorine: -- ppm Free Chlorine: -- ppm Ammonia: -- ppm pH: -- units Temperature -- ° F Conductivity: -- µS/cm Detergents: -- mg/L		Odor: Faint Turbidity: Cloudy Color: None Gross Solids: None Vegetation: Benthic Growth: Slight Stains: Non-illicit: None

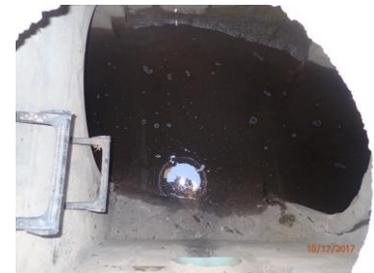
o20171017080640.JPG

Notes: Sample collected from submerged pool in manhole.

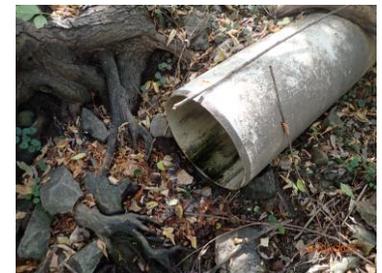
o20171003130330.JPG

Notes: Sample collected from flow from pipe.

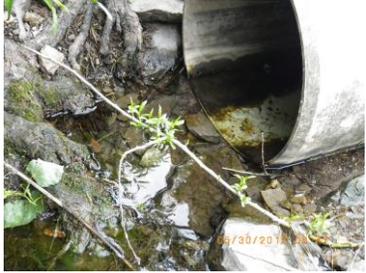
Inspection Date: 5/30/2012 8:46:17 AM		Type: Ongoing		Flow: Submerged, indeterminate		Previous Rainfall (hrs): 72+	
Illicit Discharge Potential: Unlikely		Inspector: JCW		Notes Outfall partially submerged. Outfall screened upstream at 06-1149 US1.

<p style="font-size: small; text-align: center;">o20120530074728.JPG</p> <p style="font-size: large; font-weight: bold; text-align: center;">2012</p>	
Submerged: Partially Depth (in): 3							
<i>Sampling Results</i>				Condition Assessment Graffiti: None Erosion: None Deposition: None in. Damage: None			
Sample Location: Total Chlorine: -- ppm Free Chlorine: -- ppm Ammonia: -- ppm pH: -- units Temperature -- ° F Conductivity: -- µS/cm Detergents: -- mg/L		Floatables: None Odor: None Turbidity: None Color: None Gross Solids: None Vegetation: None Benthic Growth: Slight Stains: Slight Non-illicit: None

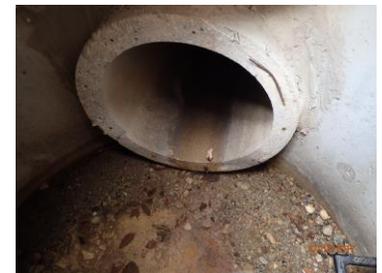
o20171003124848.JPG

Notes: Flowline wet, but no flow at time of inspection.

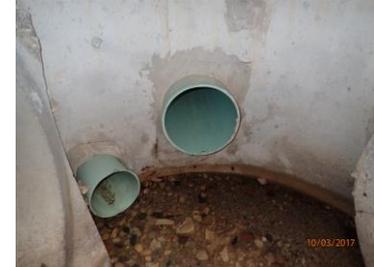
o20171003124926.JPG

Notes: Pipe dry at time of inspection.

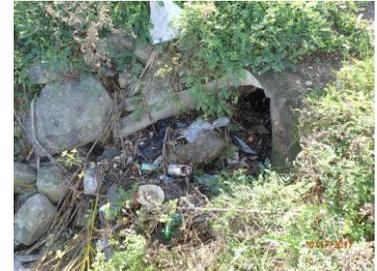
o20171017093916.JPG

Notes: Pipe dry at time of inspection. Significant gross solids (litter) that appeared to come from the pipe.

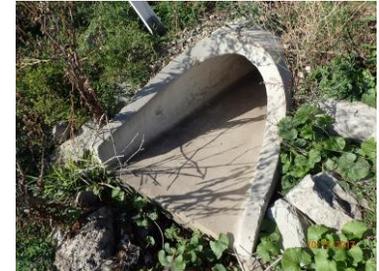
o20171017094224.JPG

Notes: Pipe dry at time of inspection.

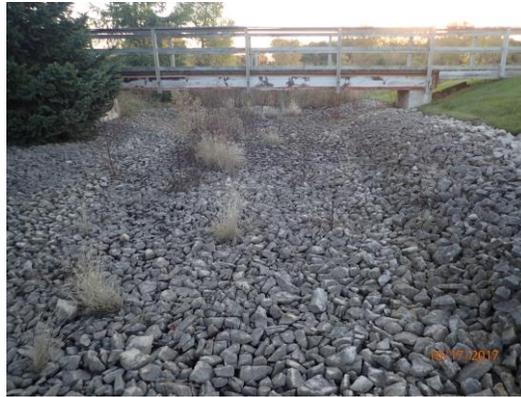
o20171017072626.JPG

Rip-rap channel from Oakwood Rd discharges into detention basin. Upstream dimensions recorded.

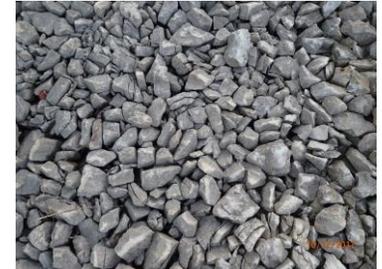
o20171017072634.JPG

Notes: Water level extends farther up riprap than normal, but no observed flow at time of inspection.

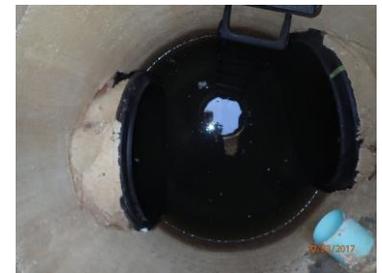
o20171003122158.JPG

Notes: Sample collected from submerged pool in outfall.

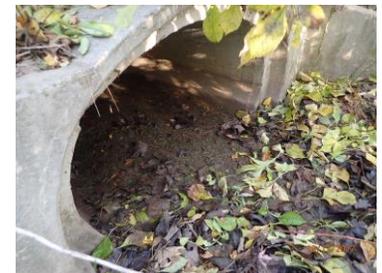
o20171017081720.JPG

Notes: Sediment wet, but no flow at time of inspection.

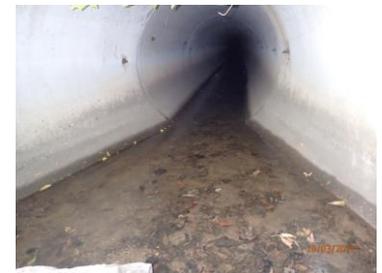
o20171003132032.JPG

Notes: Outfall partially submerged - screened upstream at 06-1746 US1. Sample collected from outfall pool - detergent detected.

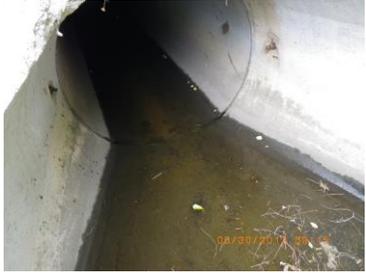
Inspection Date: 5/30/2012 9:14:05 AM		Type: Ongoing		Flow: Submerged, slight flow		Previous Rainfall (hrs): 72+	
Illicit Discharge Potential: Unlikely		Inspector: JCW		Notes Outfall partially submerged. Outfall screened upstream at 06-1746 US1.

<p style="text-align: center; font-size: small;">o20120530081528.JPG</p> <p style="text-align: center; font-size: large; font-weight: bold;">2012</p>	
Submerged: Partially Depth (in): 5							
Sampling Results Sample Location:		Floatables: None Odor: None Turbidity: None Color: None Gross Solids: Slight Vegetation: None Benthic Growth: None Stains: Slight Non-illicit: None		Condition Assessment Graffiti: None Erosion: None Deposition: None in. Damage: None			
Total Chlorine: -- ppm Free Chlorine: -- ppm Ammonia: -- ppm pH: -- units Temperature -- ° F Conductivity: -- µS/cm Detergents: -- mg/L

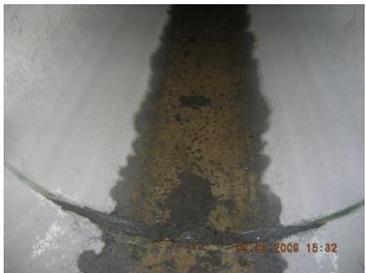
Inspection Date: 9/3/2009		Type: Initial		Flow: None		Previous Rainfall (hrs): 72+	
Illicit Discharge Potential: Unlikely		Inspector: JCW		Notes Wet, no flow.

<p style="text-align: center; font-size: small;">Osh09_DSCN6473.JPG</p> <p style="text-align: center; font-size: large; font-weight: bold;">2009</p>	
Submerged: None Depth (in): 0							
Sampling Results Sample Location:		Floatables: Odor: Turbidity: Color: Gross Solids: Vegetation: Benthic Growth: Stains: Non-illicit: None		Condition Assessment Graffiti: None Erosion: None Deposition: None 0 in. Damage: None			
Total Chlorine: -- ppm Free Chlorine: -- ppm Ammonia: -- ppm pH: -- units Temperature -- ° F Conductivity: -- µS/cm Detergents: -- mg/L

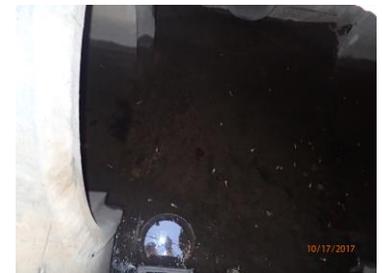
o20171017090542.JPG

Inspection Date: 10/3/2017 1:32:29 PM		Type: Ongoing	Flow: None	Previous Rainfall (hrs): 72+
Illicit Discharge Potential: Potential		Inspector: JCW		<div style="border: 1px solid black; padding: 5px;"> Notes Flowline wet, but no flow at time of inspection. Detergent detected in sample from outfall pool. </div>
Submerged: None	Depth (in):			
<i>Sampling Results</i>		Floatables:	None	<div style="border: 1px solid black; padding: 5px;"> Condition Assessment Graffiti: None Erosion: None Deposition: None in. Damage: None </div>
Sample Location:		Odor:	None	
Total Chlorine:	-- ppm	Turbidity:	None	
Free Chlorine:	-- ppm	Color:	None	
Ammonia:	-- ppm	Gross Solids:	None	
pH:	-- units	Vegetation:	None	
Temperature	-- °F	Benthic Growth:	None	
Conductivity:	-- µS/cm	Stains:	Slight	
Detergents:	-- mg/L	Non-illicit:	None

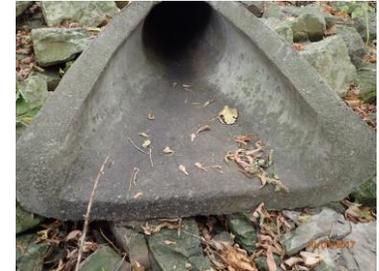
o20171003142738.JPG

Notes: Pipe dry at time of inspection.

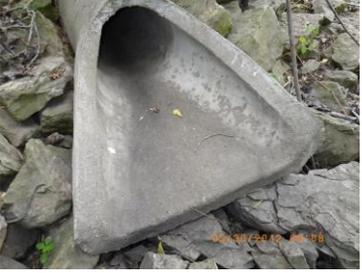
Inspection Date: 5/30/2012 9:06:11 AM		Type: Ongoing		Flow: None		Previous Rainfall (hrs): 72+	
Illicit Discharge Potential: Unlikely		Inspector: JCW		Notes Minor concrete spalling. Garbage in swale not likely from storm sewer.

<p style="font-size: small; margin-top: 5px;">o20120530080858.JPG</p>	
Submerged: None		Depth (in):					
Sampling Results Sample Location: Total Chlorine: -- ppm Free Chlorine: -- ppm Ammonia: -- ppm pH: -- units Temperature -- °F Conductivity: -- µS/cm Detergents: -- mg/L		Floatables: None Odor: None Turbidity: None Color: None Gross Solids: Vegetation: None Benthic Growth: None Stains: None Non-illicit: None		Condition Assessment Graffiti: None Erosion: None Deposition: None in. Damage: Minor		<h1 style="margin: 0;">2012</h1>

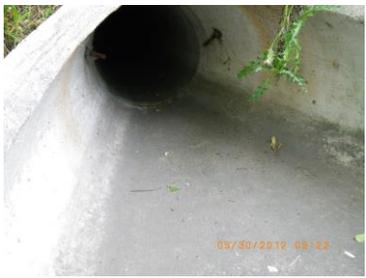
o20120530082212.JPG

Notes
 Minor garbage in downstream channel - potentially from storm sewer.

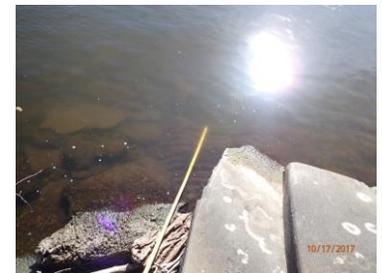
o20171017135302.JPG

Notes: Outfall fully submerged with approx 9" of water over crown of pipe - screened upstream at 08-284 US1. Floating gross solids (litter) in manhole.
