Illicit Discharge Detection and Elimination
Conducted For
City of Oshkosh

Ongoing Screening Summary Report

2017 Inspection Year

OMNNI Project Number N2029C17

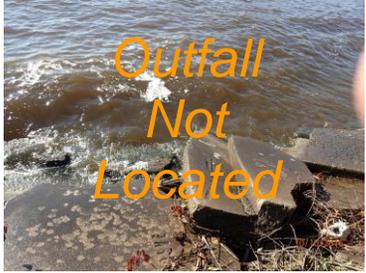
o20161010101832.JPG 2016

Inspection Date: 10/10/2016 10:18:48 AM		Type: Ongoing	Flow: Submerged (not located)	Previous Rainfall (hrs): 72+
Illicit Discharge Potential: Potential		Inspector: JCW		Notes Outfall fully submerged and not located - screened upstream at 08-284 US1.
Submerged: Fully		Depth (in):		
Sampling Results Sample Location: Total Chlorine: -- ppm Free Chlorine: -- ppm Ammonia: -- ppm pH: -- units Temperature -- °F Conductivity: -- µS/cm Detergents: -- mg/L		Floatables: None Odor: None Turbidity: None Color: None Gross Solids: None Vegetation: None Benthic Growth: None Stains: None Non-illicit: None	Condition Assessment Graffiti: None Erosion: None Deposition: None in. Damage: None

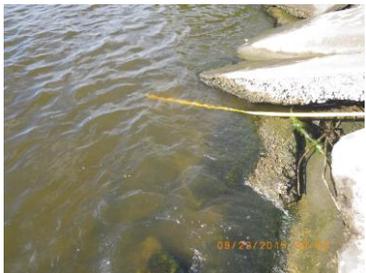
o20150922090932.JPG 2015

Inspection Date: 9/22/2015 10:04:59 AM		Type: Ongoing	Flow: Submerged, indeterminate	Previous Rainfall (hrs): 72+
Illicit Discharge Potential: Potential		Inspector: JCW		Notes Outfall fully submerged - screened at 08-284 US1.
Submerged: Fully		Depth (in): 30		
Sampling Results Sample Location: Total Chlorine: -- ppm Free Chlorine: -- ppm Ammonia: -- ppm pH: -- units Temperature -- °F Conductivity: -- µS/cm Detergents: -- mg/L		Floatables: None Odor: None Turbidity: None Color: None Gross Solids: None Vegetation: None Benthic Growth: Moderate Stains: None Non-illicit: None	Condition Assessment Graffiti: None Erosion: None Deposition: None in. Damage: None

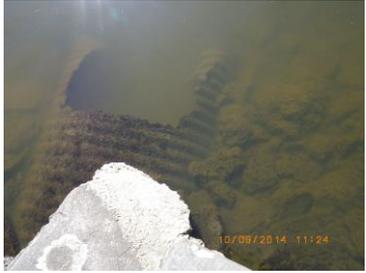
o20141009102400.JPG 2014

Inspection Date: 10/9/2014 11:24:44 AM		Type: Ongoing	Flow: Submerged, indeterminate	Previous Rainfall (hrs): 72+
Illicit Discharge Potential: Potential		Inspector: JCW		Notes Outfall fully submerged - screened upstream at 08-284 US1.
Submerged: Fully		Depth (in): 29		
Sampling Results Sample Location: Total Chlorine: -- ppm Free Chlorine: -- ppm Ammonia: -- ppm pH: -- units Temperature -- °F Conductivity: -- µS/cm Detergents: -- mg/L		Floatables: None Odor: None Turbidity: None Color: None Gross Solids: None Vegetation: None Benthic Growth: None Stains: None Non-illicit: None	Condition Assessment Graffiti: None Erosion: None Deposition: Minor 3 in. Damage: Minor

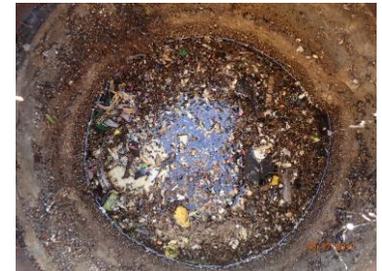
o20171017135518.JPG

Notes: Sample collected from submerged pool in outfall. Floating gross solids (litter) in manhole.

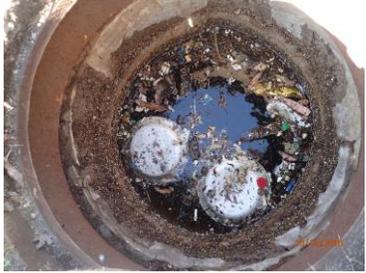
o20161010101916.JPG <h2 style="margin: 0;">2016</h2>

Inspection Date: 10/10/2016 10:21:35 AM		Type: Ongoing	Flow: Submerged, indeterminate	Previous Rainfall (hrs): 72+
Illicit Discharge Potential: Potential		Inspector: JCW		Notes Potential illicit discharge due to gross solids.
Submerged: Fully Depth (in): 32				
Sampling Results Sample Location: Pool Total Chlorine: 0 ppm Free Chlorine: 0 ppm Ammonia: 0 ppm pH: 8.15 units Temperature: 63 °F Conductivity: 369 µS/cm Detergents: 0 mg/L		Floatables: None Odor: None Turbidity: None Color: Clearly visible in bottl Gross Solids: Moderate Vegetation: None Benthic Growth: None Stains: None Non-illicit: None	Condition Assessment Graffiti: None Erosion: None Deposition: None in. Damage: None

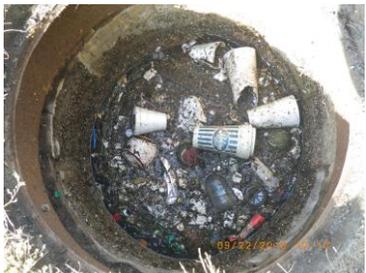
o20150922091040.JPG <h2 style="margin: 0;">2015</h2>

Inspection Date: 9/22/2015 10:09:39 AM		Type: Ongoing	Flow: Submerged, indeterminate	Previous Rainfall (hrs): 72+
Illicit Discharge Potential: Potential		Inspector: JCW		Notes Floating gross solids (litter) in manhole.
Submerged: Fully Depth (in): 34				
Sampling Results Sample Location: Pool Total Chlorine: 0 ppm Free Chlorine: 0 ppm Ammonia: 0 ppm pH: 8.8 units Temperature: 70 °F Conductivity: 335 µS/cm Detergents: 0 mg/L		Floatables: None Odor: None Turbidity: None Color: None Gross Solids: Severe Vegetation: None Benthic Growth: None Stains: None Non-illicit: None	Condition Assessment Graffiti: None Erosion: None Deposition: None in. Damage: None

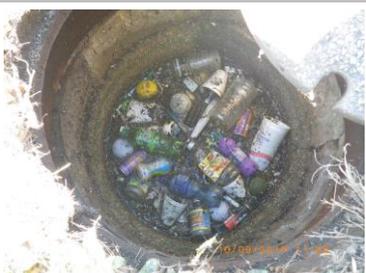
o20141009102622.JPG <h2 style="margin: 0;">2014</h2>

Inspection Date: 10/9/2014 11:28:19 AM		Type: Ongoing	Flow: Submerged, indeterminate	Previous Rainfall (hrs): 72+
Illicit Discharge Potential: Potential		Inspector: JCW		Notes Floating gross solids (litter) in manhole.
Submerged: Fully Depth (in): 29				
Sampling Results Sample Location: Pool Total Chlorine: 0 ppm Free Chlorine: 0 ppm Ammonia: 0 ppm pH: 8.34 units Temperature: 57 °F Conductivity: 400 µS/cm Detergents: 0 mg/L		Floatables: None Odor: None Turbidity: None Color: Faint in bottle Gross Solids: Severe Vegetation: None Benthic Growth: None Stains: None Non-illicit: None	Condition Assessment Graffiti: None Erosion: None Deposition: None in. Damage: None

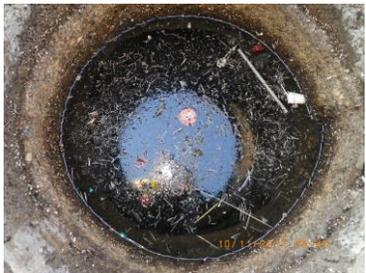
o20111011084038.JPG <h2 style="margin: 0;">2011</h2>

Inspection Date: 10/11/2011 8:41:22 AM		Type: Ongoing	Flow: Submerged, indeterminate	Previous Rainfall (hrs): 72+
Illicit Discharge Potential: Unlikely		Inspector: JCW		Notes 2010 screening follow-up. Floatable debris significantly reduced.
Submerged: Fully Depth (in): 18				
Sampling Results Sample Location: Pool Total Chlorine: 0 ppm Free Chlorine: 0 ppm Ammonia: 0 ppm pH: 8.11 units Temperature: 72 °F Conductivity: -- µS/cm Detergents: -- mg/L		Floatables: None Odor: None Turbidity: None Color: None Gross Solids: Slight Vegetation: None Benthic Growth: None Stains: None Non-illicit: None	Condition Assessment Graffiti: None Erosion: None Deposition: None 0 in. Damage: None

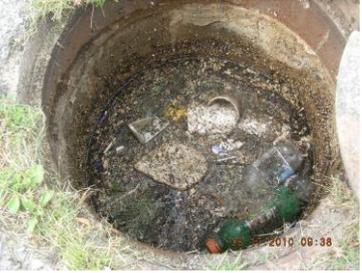
o20100817093838.JPG

Inspection Date: 8/17/2010 9:47:15 AM		Type: Ongoing	Flow: Submerged, indeterminate	Previous Rainfall (hrs): 72+
Illicit Discharge Potential: Potential		Inspector: JCW	Notes Significant floatable debris in manhole.	
Submerged: Fully	Depth (in): 31			
Sampling Results		Floatables:	Condition Assessment Graffiti: None Erosion: None Deposition: None 0 in. Damage: None	
Sample Location:	Pool	Odor:		
Total Chlorine:	0 ppm	Turbidity:	None	
Free Chlorine:	0 ppm	Color:	Faint in bottle	
Ammonia:	0 ppm	Gross Solids:	Severe	
pH:	7.64 units	Vegetation:	None	
Temperature:	74 °F	Benthic Growth:	None	
Conductivity:	-- µS/cm	Stains:	None	
Detergents:	0 mg/L	Non-illicit:	None

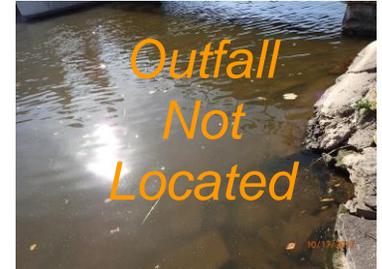
o20171017140150.JPG

Notes: Outfall fully submerged and not located - screened upstream at 08-347 US1. Floating gross solids (litter) in manhole.

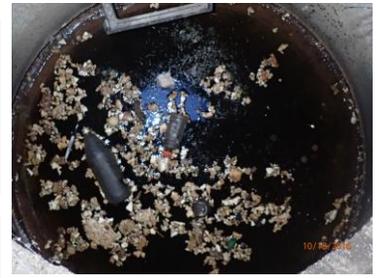
o20161018170248.JPG

Inspection Date: 10/18/2016 5:02:56 PM		Type: Ongoing	Flow: Submerged, indeterminate	Previous Rainfall (hrs): 72+
Illicit Discharge Potential: Potential		Inspector: JCW		Notes Potential illicit discharge due to gross solids.
Submerged: Partially	Depth (in): 46			
<i>Sampling Results</i>				
Sample Location: Pool	Floatables: None			
Total Chlorine: 0 ppm	Odor: None			
Free Chlorine: 0 ppm	Turbidity: None			
Ammonia: 0 ppm	Color: Faint in bottle			
pH: 8.18 units	Gross Solids: Severe	Condition Assessment Graffiti: None Erosion: None Deposition: None in. Damage: None		
Temperature 66 °F	Vegetation: None			
Conductivity: 361 µS/cm	Benthic Growth: None			
Detergents: 0 mg/L	Stains: None			
	Non-illicit: None

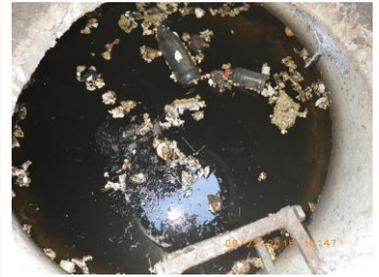
o20150922094746.JPG

Inspection Date: 9/22/2015 10:46:05 AM		Type: Ongoing	Flow: Submerged, indeterminate	Previous Rainfall (hrs): 72+
Illicit Discharge Potential: Potential		Inspector: JCW		Notes Floating gross solids (litter) in manhole.
Submerged: Fully	Depth (in): 48			
<i>Sampling Results</i>				
Sample Location: Pool	Floatables: None			
Total Chlorine: 0 ppm	Odor: None			
Free Chlorine: 0 ppm	Turbidity: None			
Ammonia: 0 ppm	Color: None			
pH: 8.33 units	Gross Solids: Moderate	Condition Assessment Graffiti: None Erosion: None Deposition: None in. Damage: None		
Temperature 73 °F	Vegetation: None			
Conductivity: 352 µS/cm	Benthic Growth: None			
Detergents: 0 mg/L	Stains: None			
	Non-illicit: None

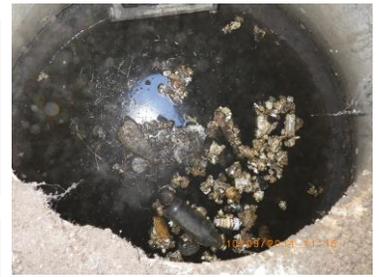
o20141009101552.JPG

Inspection Date: 10/9/2014 11:17:38 AM		Type: Ongoing	Flow: Submerged, indeterminate	Previous Rainfall (hrs): 72+
Illicit Discharge Potential: Potential		Inspector: JCW		Notes Floating gross solids (litter) in manhole.
Submerged: Fully	Depth (in): 43			
<i>Sampling Results</i>				
Sample Location: Pool	Floatables: None			
Total Chlorine: 0 ppm	Odor: None			
Free Chlorine: 0 ppm	Turbidity: None			
Ammonia: 0 ppm	Color: None			
pH: 7.67 units	Gross Solids: Moderate	Condition Assessment Graffiti: None Erosion: None Deposition: None in. Damage: None		
Temperature 59 °F	Vegetation: None			
Conductivity: 422 µS/cm	Benthic Growth: None			
Detergents: 0 mg/L	Stains: None			
	Non-illicit: None

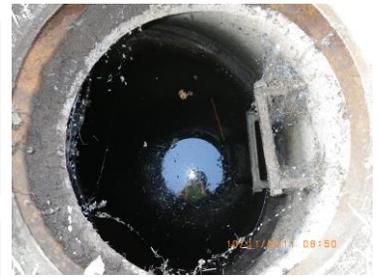
o20111011085018.JPG

Inspection Date: 10/11/2011 8:51:38 AM		Type: Ongoing	Flow: Submerged, indeterminate	Previous Rainfall (hrs): 72+
Illicit Discharge Potential: Unlikely		Inspector: JCW		Notes 2010 screening follow-up. Floatable debris significantly reduced.
Submerged: Fully	Depth (in): 43			
<i>Sampling Results</i>				
Sample Location: Pool	Floatables: None			
Total Chlorine: 0 ppm	Odor: None			
Free Chlorine: 0 ppm	Turbidity: None			
Ammonia: 0 ppm	Color: Faint in bottle			
pH: 7.87 units	Gross Solids: Slight	Condition Assessment Graffiti: None Erosion: None Deposition: None 0 in. Damage: None		
Temperature 71 °F	Vegetation: None			
Conductivity: -- µS/cm	Benthic Growth: None			
Detergents: -- mg/L	Stains: None			
	Non-illicit: None

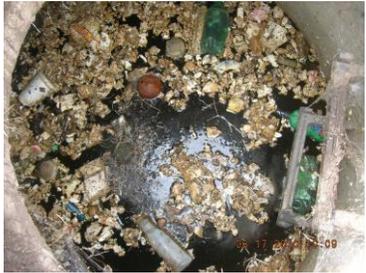
o20100817100950.JPG

Inspection Date: 8/17/2010 10:17:46 AM		Type: Ongoing	Flow: Submerged, indeterminate	Previous Rainfall (hrs): 72+
Illicit Discharge Potential: Potential		Inspector: JCW	Notes Significant floatable debris in manhole.	
Submerged: Fully	Depth (in): 48			
Sampling Results Sample Location: Pool		Floatables: None	Condition Assessment Graffiti: None Erosion: None Deposition: None 0 in. Damage: None	
Total Chlorine: 0 ppm	Odor: None			
Free Chlorine: 0 ppm	Turbidity: None			
Ammonia: 0 ppm	Color: None			
pH: 7.71 units	Gross Solids: Severe			
Temperature 74 °F	Vegetation: None			
Conductivity: -- µS/cm	Benthic Growth: None			
Detergents: 0 mg/L	Stains: None			
	Non-illicit: None

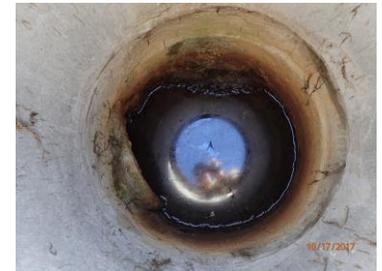
o20171017141426.JPG

Notes: Sample collected from submerged pool in manhole. Ammonia assumed natural decomposition product.

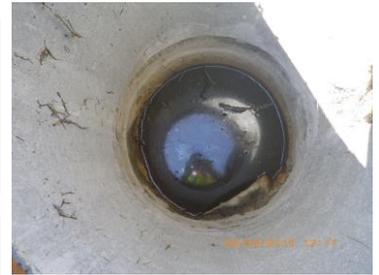
o20150922111710.JPG

Notes		Cloudy sheen - did not appear to be typical bacterial sheen.		Condition Assessment		Graffiti:	None	Erosion:	None	Deposition:	None in.	Damage:	None
Notes																		
Cloudy sheen - did not appear to be typical bacterial sheen.																		
Condition Assessment																		
Graffiti:	None																	
Erosion:	None																	
Deposition:	None in.																	
Damage:	None																	
Sample Location:	Pool																	
Total Chlorine:	0 ppm																	
Free Chlorine:	0 ppm																	
Ammonia:	0 ppm																	
pH:	7.48 units																	
Temperature:	75 °F																	
Conductivity:	499 µS/cm																	
Detergents:	0 mg/L																	
Floatables:	Moderate																	
Odor:	None																	
Turbidity:	None																	
Color:	None																	
Gross Solids:	None																	
Vegetation:	None																	
Benthic Growth:	None																	
Stains:	Slight																	
Non-illicit:	None

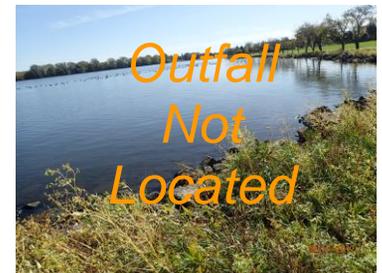
o20171017130204.JPG

Notes: Outfall fully submerged and not located - screened upstream at 11-376 US1. Floating gross solids (litter) in manhole.

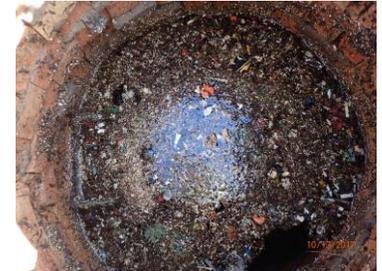
o20171017130258.JPG

Notes: Sample collected from submerged pool in manhole. Floating gross solids (litter) in manhole.

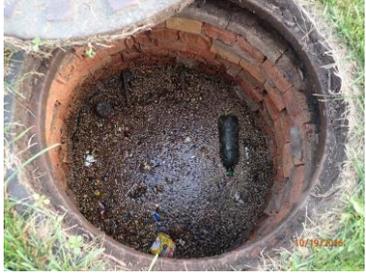
o20161019074410.JPG <h2 style="margin: 0;">2016</h2>

Inspection Date: 10/19/2016 7:46:56 AM		Type: Ongoing	Flow: Submerged, indeterminate	Previous Rainfall (hrs): 72+
Illicit Discharge Potential: Potential		Inspector: JCW		Notes Potential illicit discharge due to gross solids.
Submerged: Fully Depth (in): 79				
Sampling Results Sample Location: Pool Total Chlorine: 0 ppm Free Chlorine: 0 ppm Ammonia: 0 ppm pH: 7.89 units Temperature: 58 °F Conductivity: 357 µS/cm Detergents: 0 mg/L		Floatables: None Odor: Faint Turbidity: None Color: Faint in bottle Gross Solids: Severe Vegetation: None Benthic Growth: None Stains: None Non-illicit: None	Condition Assessment Graffiti: None Erosion: None Deposition: None in. Damage: None

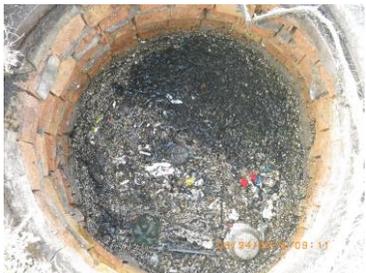
o20150924081150.JPG <h2 style="margin: 0;">2015</h2>

Inspection Date: 9/24/2015 9:10:22 AM		Type: Ongoing	Flow: Submerged, indeterminate	Previous Rainfall (hrs): 72+
Illicit Discharge Potential: Potential		Inspector: JCW		Notes Floating gross solids (litter) in manhole.
Submerged: Fully Depth (in): 81				
Sampling Results Sample Location: Pool Total Chlorine: 0 ppm Free Chlorine: 0 ppm Ammonia: 0 ppm pH: 7.88 units Temperature: 68 °F Conductivity: 397 µS/cm Detergents: 0 mg/L		Floatables: None Odor: Faint Turbidity: None Color: None Gross Solids: Severe Vegetation: None Benthic Growth: None Stains: None Non-illicit: None	Condition Assessment Graffiti: None Erosion: None Deposition: None in. Damage: None

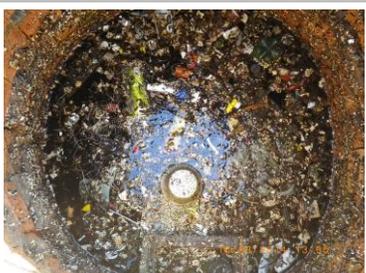
o20141009123616.JPG <h2 style="margin: 0;">2014</h2>

Inspection Date: 10/9/2014 1:36:18 PM		Type: Ongoing	Flow: Submerged, indeterminate	Previous Rainfall (hrs): 72+
Illicit Discharge Potential: Potential		Inspector: JCW		Notes Floating gross solids (litter) in manhole.
Submerged: Fully Depth (in): 74				
Sampling Results Sample Location: Pool Total Chlorine: 0 ppm Free Chlorine: 0 ppm Ammonia: 0 ppm pH: 7.76 units Temperature: 59 °F Conductivity: 381 µS/cm Detergents: 0 mg/L		Floatables: None Odor: None Turbidity: None Color: Faint in bottle Gross Solids: Severe Vegetation: None Benthic Growth: None Stains: None Non-illicit: None	Condition Assessment Graffiti: None Erosion: None Deposition: None in. Damage: None

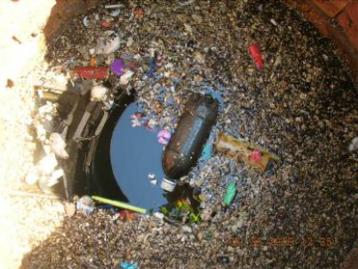
Osh09_DSCN6622.JPG 2009

Inspection Date: 9/8/2009		Type: Initial	Flow: Submerged, indeterminate	Previous Rainfall (hrs): 72+
Illicit Discharge Potential: Potential		Inspector: JCW	Notes: Abnormal detergent analysis result (bubbles). Significant floating debris in manhole.	
Submerged: Fully		Depth (in): 81	Condition Assessment	
Sampling Results Sample Location: Pool Total Chlorine: 0 ppm Free Chlorine: 0 ppm Ammonia: -- ppm pH: 7.82 units Temperature: 76 °F Conductivity: -- µS/cm Detergents: 0 mg/L		Floatables: None Odor: _____ Turbidity: _____ Color: _____ Gross Solids: Severe Vegetation: _____ Benthic Growth: _____ Stains: _____ Non-illicit: None	Graffiti: None Erosion: None Deposition: None 0 in. Damage: None

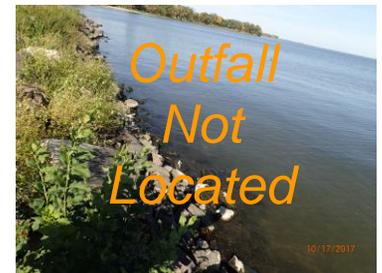
o20171017131910.JPG

Notes: Outfall fully submerged and not located - screened upstream at 11-512 US1. Floating gross solids (litter) in manhole.

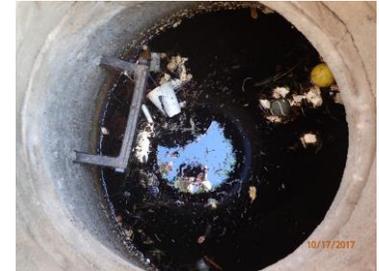
o20171017131930.JPG

Notes: Sample collected from submerged pool in manhole. Floating gross solids (litter) in manhole.

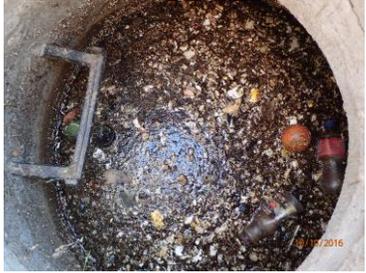
o20161010110444.JPG

Sample Location:	Pool	Floatables:	None
Total Chlorine:	0 ppm	Odor:	None
Free Chlorine:	0 ppm	Turbidity:	None
Ammonia:	0 ppm	Color:	None
pH:	7.63 units	Gross Solids:	Severe
Temperature:	65 °F	Vegetation:	None
Conductivity:	514 µS/cm	Benthic Growth:	None
Detergents:	0 mg/L	Stains:	None
		Non-illicit:	None

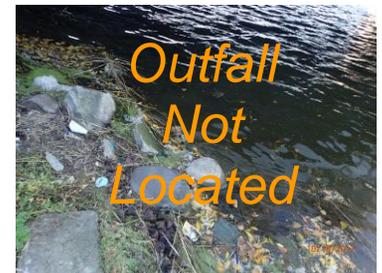
o20171018101412.JPG

Notes: Outfall fully submerged and not located - screened upstream at 12-569 US1. Graffiti on nearby bridge abutment. Floating gross solids (litter) in MH.

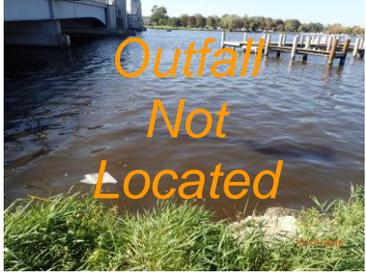
o20161010132600.JPG

Notes
Graffiti on east bridge abutment. Outfall fully submerged and not located - screened upstream at 12-569 US1.

Condition Assessment
Graffiti: Minor
Erosion: None
Deposition: None in.
Damage: None

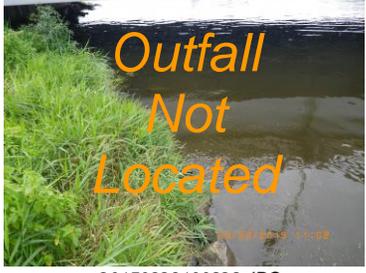
o20150923100828.JPG

Notes
Outfall fully submerged and not located - screened at 12-569 US1.

Condition Assessment
Graffiti: Moderate
Erosion: None
Deposition: None in.
Damage: None

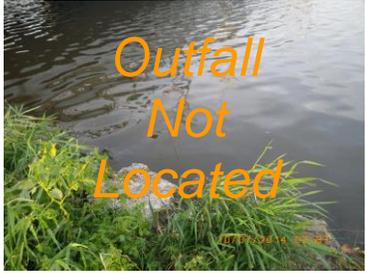
o20141007063712.JPG

Notes
Outfall fully submerged and not located - screened upstream at 12-569 US1. Graffiti on east abutment.

Condition Assessment
Graffiti: Moderate
Erosion: None
Deposition: None in.
Damage: None

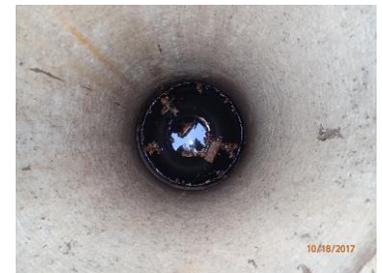
o20171018101542.JPG

Notes: Sample collected from submerged pool in manhole. Floating gross solids (litter) in manhole.

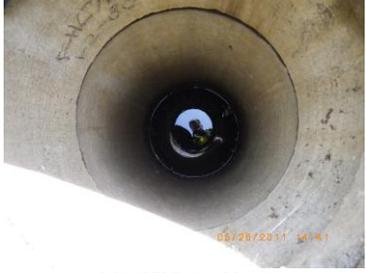
o20110526144100.JPG

Inspection Date: 8/19/2010 2:41:43 PM		Type: Ongoing	Flow: Submerged, indeterminate	Previous Rainfall (hrs): 72+
Illicit Discharge Potential: Potential		Inspector: JCW	Notes Severe floatable debris	
Submerged: Fully	Depth (in): 38			
Sampling Results Sample Location: Pool		Floatables: None	Condition Assessment Graffiti: None Erosion: None Deposition: None 0 in. Damage: None	
Total Chlorine: 0 ppm		Odor: None		
Free Chlorine: 0 ppm		Turbidity: None		
Ammonia: 0 ppm		Color: Faint in bottle		
pH: 7.59 units		Gross Solids: Severe		
Temperature 79 °F		Vegetation: None		
Conductivity: -- µS/cm		Benthic Growth: None		
Detergents: 0 mg/L		Stains: Slight		
		Non-illicit: None

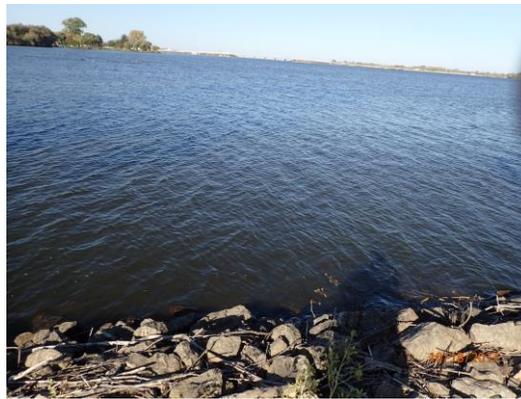
o20171018100250.JPG

Algoma Blvd storm sewer discharges to Fox River from east. Outfall fully submerged and not physically located. GPS coordinates approximate. Pipe info from MS4 map.

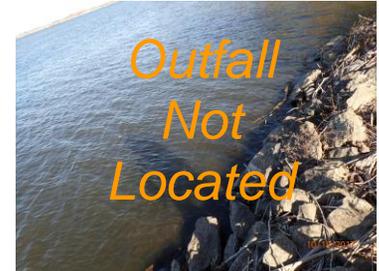
o20171018100254.JPG

Notes: Outfall fully submerged and not located - screened upstream at 12-576 US1.

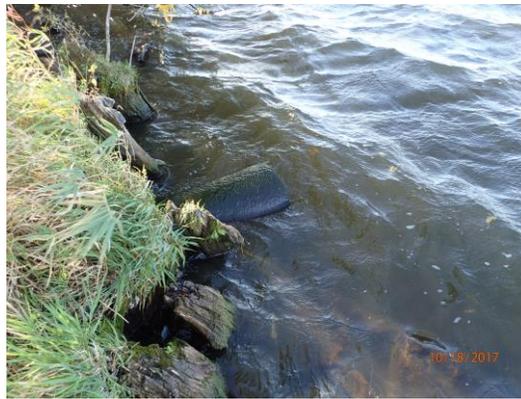
o20171018094806.JPG

Storm sewer from Algoma Blvd and cemetery discharges to river from east.

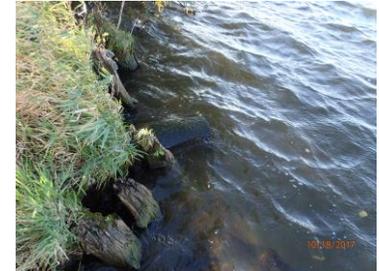
o20171018094812.JPG

Notes: Outfall partially submerged - screened upstream at 12-1313 US1.

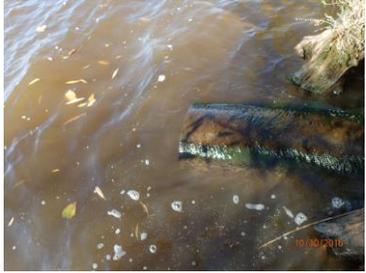
Inspection Date: 10/10/2016 12:50:26 PM		Type: Ongoing	Flow: Submerged, indeterminate	Previous Rainfall (hrs): 72+
Illicit Discharge Potential: Unlikely		Inspector: JCW

o20161010124844.JPG
Submerged: Partially Depth (in): 17		Notes Submerged depth estimated. Outfall partially submerged - screened upstream at 12-1313 US1.		
Sampling Results		Condition Assessment		2016
Sample Location:	Floatables: None	Graffiti: None	Erosion: None Deposition: None in. Damage: None	
Total Chlorine: -- ppm	Odor: None			
Free Chlorine: -- ppm	Turbidity: None			
Ammonia: -- ppm	Color: None			
pH: -- units	Gross Solids: None			
Temperature -- °F	Vegetation: None			
Conductivity: -- µS/cm	Benthic Growth: Severe			
Detergents: -- mg/L	Stains: None			
	Non-illicit: None

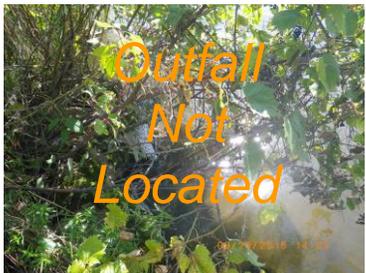
Inspection Date: 9/23/2015 2:02:54 PM		Type: Ongoing	Flow: Submerged (not located)	Previous Rainfall (hrs): 72+
Illicit Discharge Potential: Unlikely		Inspector: JCW

o20150923130558.JPG
Submerged: Fully Depth (in):		Notes Outfall fully submerged and not located - screened at 12-1313 US1.		
Sampling Results		Condition Assessment		2015
Sample Location:	Floatables: None	Graffiti: None	Erosion: None Deposition: None in. Damage: None	
Total Chlorine: -- ppm	Odor: None			
Free Chlorine: -- ppm	Turbidity: None			
Ammonia: -- ppm	Color: None			
pH: -- units	Gross Solids: None			
Temperature -- °F	Vegetation: None			
Conductivity: -- µS/cm	Benthic Growth: None			
Detergents: -- mg/L	Stains: None			
	Non-illicit: None

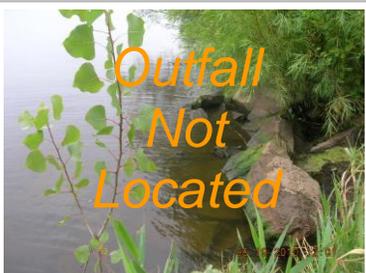
Inspection Date: 8/19/2010 12:09:32 PM		Type: Ongoing	Flow: Submerged (not located)	Previous Rainfall (hrs): 72+
Illicit Discharge Potential: Unlikely		Inspector: JCW

o20100819120152.JPG
Submerged: Fully Depth (in):		Notes Outfall fully submerged and not physically located. Outfall screened upstream at 12-1313 US1.		
Sampling Results		Condition Assessment		2010
Sample Location:	Floatables: None	Graffiti: None	Erosion: None Deposition: None 0 in. Damage: None	
Total Chlorine: -- ppm	Odor: None			
Free Chlorine: -- ppm	Turbidity: None			
Ammonia: -- ppm	Color: None			
pH: -- units	Gross Solids: None			
Temperature -- °F	Vegetation: None			
Conductivity: -- µS/cm	Benthic Growth: None			
Detergents: -- mg/L	Stains: None			
	Non-illicit: None

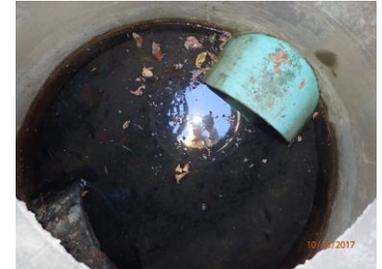
o20171018095044.JPG

Notes: Sample collected from submerged pool in manhole.

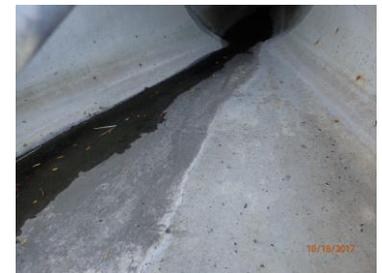
o20171018093128.JPG

Notes: Elevated pH in sample from trickle flow. No flow in upstream curb inlet at time of inspection.

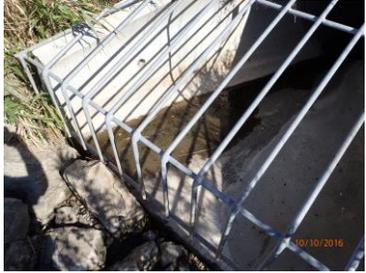
o20161010122036.JPG 2016

Inspection Date: 10/10/2016 12:26:38 PM		Type: Ongoing	Flow: Trickle	Previous Rainfall (hrs): 72+
Illicit Discharge Potential: Potential		Inspector: JCW		Notes Elevated pH, but not as high as 2015 screening. Possible residual in upstream pipe.
Submerged: None		Depth (in):		
Sampling Results Sample Location: Flow Total Chlorine: 0 ppm Free Chlorine: 0 ppm Ammonia: 0 ppm pH: 9.45 units Temperature: 64 °F Conductivity: 880 µS/cm Detergents: 0 mg/L		Floatables: None Odor: None Turbidity: None Color: None Gross Solids: None Vegetation: None Benthic Growth: Moderate Stains: Slight Non-illicit: None	Condition Assessment Graffiti: None Erosion: None Deposition: None in. Damage: None

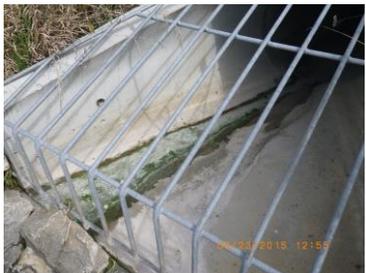
o20150923115508.JPG 2015

Inspection Date: 9/23/2015 12:56:15 PM		Type: Ongoing	Flow: Trickle	Previous Rainfall (hrs): 72+
Illicit Discharge Potential: Obvious		Inspector: JCW		Notes White silty discharge. Chlorine patches turned yellow (not on scale). Elevated pH and conductivity.
Submerged: None		Depth (in):		
Sampling Results Sample Location: Flow Total Chlorine: -- ppm Free Chlorine: -- ppm Ammonia: 1 ppm pH: 11.66 units Temperature: 73 °F Conductivity: 2470 µS/cm Detergents: 0 mg/L		Floatables: None Odor: None Turbidity: None Color: None Gross Solids: Slight Vegetation: None Benthic Growth: Moderate Stains: Moderate Non-illicit: None	Condition Assessment Graffiti: None Erosion: None Deposition: None in. Damage: None

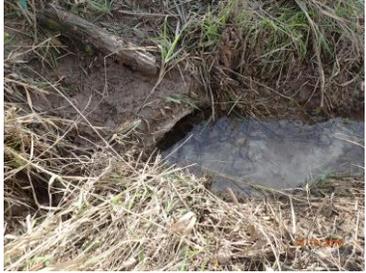
o20161019150326.JPG

Graffiti: None
Erosion: None
Deposition: Moderate Depth (in): 16
Damage: None Displacement Undercut Crushed
 Corrosion Cracks/Structural Damage

Inspection Date: 10/19/2016 3:04:11 PM		Type: Ongoing	Flow: Submerged, slight flow	Previous Rainfall (hrs): 72+
Illicit Discharge Potential: Unlikely		Inspector: JCW		Notes Outfall partially submerged - screened upstream at 13-1098 US1. End of pipe recently excavated.
Submerged: Partially	Depth (in): 22			
<i>Sampling Results</i>		Floatables:	None	Condition Assessment Graffiti: None Erosion: None Deposition: Severe 16 in. Damage: None
Sample Location:		Odor:	None	
Total Chlorine:	-- ppm	Turbidity:	None	
Free Chlorine:	-- ppm	Color:	None	
Ammonia:	-- ppm	Gross Solids:	None	
pH:	-- units	Vegetation:	None	
Temperature:	-- °F	Benthic Growth:	None	
Conductivity:	-- µS/cm	Stains:	None	
Detergents:	-- mg/L	Non-illicit:	None

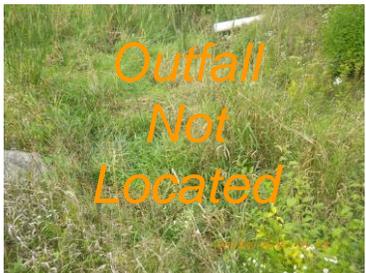
o20150924141536.JPG

Inspection Date: 9/24/2015 3:10:53 PM		Type: Ongoing	Flow: Submerged (not located)	Previous Rainfall (hrs): 72+
Illicit Discharge Potential: Unlikely		Inspector: JCW		Notes Outfall not located - screened at 13-1098 US1.
Submerged: None	Depth (in):			
<i>Sampling Results</i>		Floatables:	None	Condition Assessment Graffiti: None Erosion: None Deposition: None in. Damage: None
Sample Location:		Odor:	None	
Total Chlorine:	-- ppm	Turbidity:	None	
Free Chlorine:	-- ppm	Color:	None	
Ammonia:	-- ppm	Gross Solids:	None	
pH:	-- units	Vegetation:	None	
Temperature:	-- °F	Benthic Growth:	None	
Conductivity:	-- µS/cm	Stains:	None	
Detergents:	-- mg/L	Non-illicit:	None

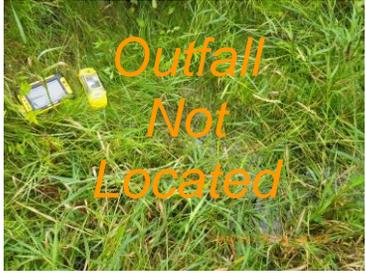
o20130730070410.JPG

Inspection Date: 7/30/2013 7:57:44 AM		Type: Ongoing	Flow: Submerged (not located)	Previous Rainfall (hrs): 72+
Illicit Discharge Potential: Unlikely		Inspector: JCW		Notes Pipe not located in grassy stream bank. Screened upstream at 13-1098 US1.
Submerged: Fully	Depth (in):			
<i>Sampling Results</i>		Floatables:	None	Condition Assessment Graffiti: None Erosion: None Deposition: None in. Damage: None
Sample Location:		Odor:	None	
Total Chlorine:	-- ppm	Turbidity:	None	
Free Chlorine:	-- ppm	Color:	None	
Ammonia:	-- ppm	Gross Solids:	None	
pH:	-- units	Vegetation:	None	
Temperature:	-- °F	Benthic Growth:	None	
Conductivity:	-- µS/cm	Stains:	None	
Detergents:	-- mg/L	Non-illicit:	None

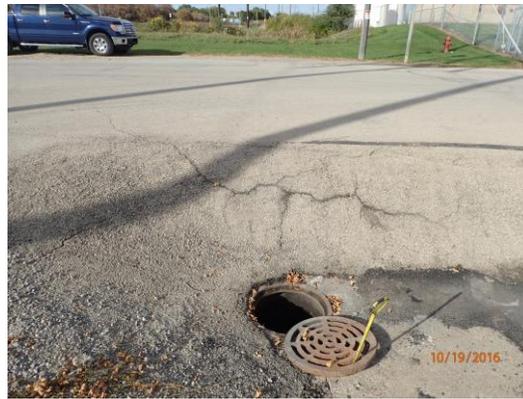
o20161019150604.JPG

Upstream inlet located approx 103 ft S of outfall 13-1098. Intermediate area consists of driveway to industrial property.

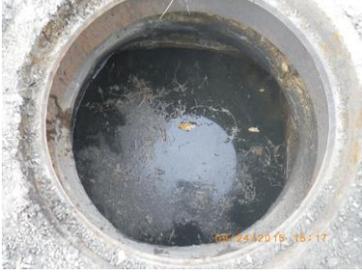
<p>o20150924141732.JPG</p>																																									
Submerged: Partially Depth (in): 20				Trash around inlet grate, but none in storm sewer.																																											
Sampling Results				Condition Assessment		<p>2015</p>																																									
<table border="1" style="width:100%; border-collapse: collapse;"> <tr><td>Sample Location:</td><td>Pool</td></tr> <tr><td>Total Chlorine:</td><td>0 ppm</td></tr> <tr><td>Free Chlorine:</td><td>0 ppm</td></tr> <tr><td>Ammonia:</td><td>0 ppm</td></tr> <tr><td>pH:</td><td>7.1 units</td></tr> <tr><td>Temperature:</td><td>70 °F</td></tr> <tr><td>Conductivity:</td><td>1386 µS/cm</td></tr> <tr><td>Detergents:</td><td>0 mg/L</td></tr> </table>		Sample Location:	Pool	Total Chlorine:	0 ppm			Free Chlorine:	0 ppm	Ammonia:	0 ppm	pH:	7.1 units	Temperature:	70 °F	Conductivity:	1386 µS/cm	Detergents:	0 mg/L	<table border="1" style="width:100%; border-collapse: collapse;"> <tr><td>Floatables:</td><td>None</td></tr> <tr><td>Odor:</td><td>None</td></tr> <tr><td>Turbidity:</td><td>None</td></tr> <tr><td>Color:</td><td>None</td></tr> <tr><td>Gross Solids:</td><td>Slight</td></tr> <tr><td>Vegetation:</td><td>None</td></tr> <tr><td>Benthic Growth:</td><td>Slight</td></tr> <tr><td>Stains:</td><td>None</td></tr> <tr><td>Non-illicit:</td><td>None</td></tr> </table>		Floatables:	None	Odor:	None	Turbidity:	None	Color:	None	Gross Solids:	Slight	Vegetation:	None	Benthic Growth:	Slight	Stains:	None	Non-illicit:	None	<table border="1" style="width:100%; border-collapse: collapse;"> <tr><td>Graffiti:</td><td>None</td></tr> <tr><td>Erosion:</td><td>None</td></tr> <tr><td>Deposition:</td><td>None in.</td></tr> <tr><td>Damage:</td><td>None</td></tr> </table>		Graffiti:	None	Erosion:	None	Deposition:	None in.

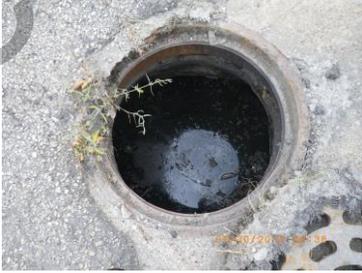
<p>o20130730073636.JPG</p>																																									
Submerged: Partially Depth (in): 22																																															
Sampling Results				Condition Assessment		<p>2013</p>																																									
<table border="1" style="width:100%; border-collapse: collapse;"> <tr><td>Sample Location:</td><td>Pool</td></tr> <tr><td>Total Chlorine:</td><td>0 ppm</td></tr> <tr><td>Free Chlorine:</td><td>0 ppm</td></tr> <tr><td>Ammonia:</td><td>0 ppm</td></tr> <tr><td>pH:</td><td>7.4 units</td></tr> <tr><td>Temperature:</td><td>65 °F</td></tr> <tr><td>Conductivity:</td><td>1654 µS/cm</td></tr> <tr><td>Detergents:</td><td>0 mg/L</td></tr> </table>		Sample Location:	Pool	Total Chlorine:	0 ppm			Free Chlorine:	0 ppm	Ammonia:	0 ppm	pH:	7.4 units	Temperature:	65 °F	Conductivity:	1654 µS/cm	Detergents:	0 mg/L	<table border="1" style="width:100%; border-collapse: collapse;"> <tr><td>Floatables:</td><td>None</td></tr> <tr><td>Odor:</td><td>None</td></tr> <tr><td>Turbidity:</td><td>None</td></tr> <tr><td>Color:</td><td>None</td></tr> <tr><td>Gross Solids:</td><td>Slight</td></tr> <tr><td>Vegetation:</td><td>None</td></tr> <tr><td>Benthic Growth:</td><td>None</td></tr> <tr><td>Stains:</td><td>None</td></tr> <tr><td>Non-illicit:</td><td>None</td></tr> </table>		Floatables:	None	Odor:	None	Turbidity:	None	Color:	None	Gross Solids:	Slight	Vegetation:	None	Benthic Growth:	None	Stains:	None	Non-illicit:	None	<table border="1" style="width:100%; border-collapse: collapse;"> <tr><td>Graffiti:</td><td>None</td></tr> <tr><td>Erosion:</td><td>None</td></tr> <tr><td>Deposition:</td><td>Minor 2 in.</td></tr> <tr><td>Damage:</td><td>None</td></tr> </table>		Graffiti:	None	Erosion:	None	Deposition:	Minor 2 in.

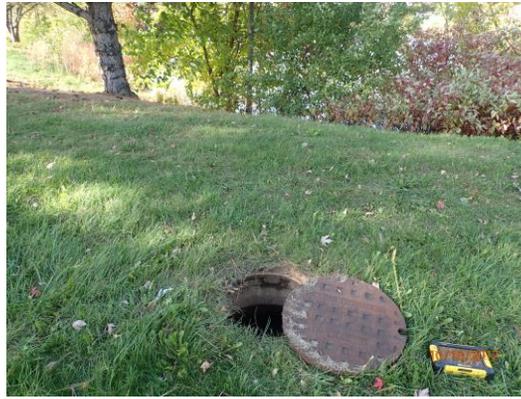
o20171018160256.JPG

Manhole located approx 17 ft S of pond outlet pipe (13-1716 US2). Pipe from car wash enters from east.

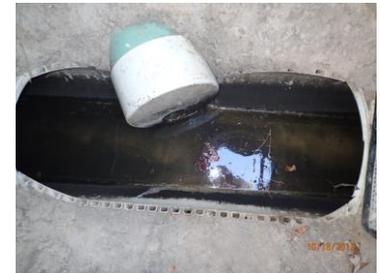
o20171018160304.JPG

Notes: Sample collected from submerged flow near orifice on inlet pipe. Elevated ammonia in sample.

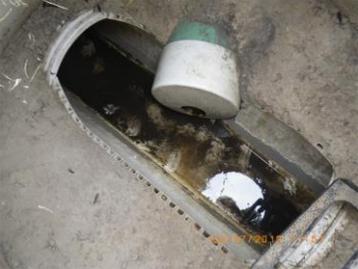
o20120927100116.JPG 2012

Inspection Date: 9/27/2012 10:59:11 AM		Type: Repeat	Flow: Submerged, indeterminate	Previous Rainfall (hrs): 72+
Illicit Discharge Potential: Potential		Inspector: JCW	Notes Ammonia/detergent follow-up.	
Submerged: Partially	Depth (in): 2			
Sampling Results Sample Location: Pool Total Chlorine: 0 ppm Free Chlorine: 0 ppm Ammonia: 0 ppm pH: 7.88 units Temperature: 64 °F Conductivity: 686 µS/cm Detergents: 0 mg/L		Floatables: None Odor: None Turbidity: Slight cloudiness Color: Faint in bottle Gross Solids: None Vegetation: None Benthic Growth: Slight Stains: Slight Non-illicit: None	Condition Assessment Graffiti: None Erosion: None Deposition: None in. Damage: None

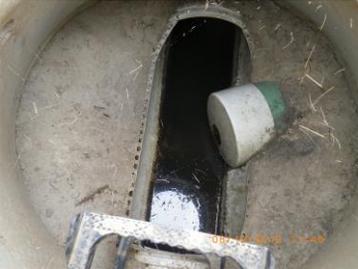
o20120612104548.JPG 2012

Inspection Date: 6/12/2012 11:42:38 AM		Type: Ongoing	Flow: Submerged, indeterminate	Previous Rainfall (hrs): 72+
Illicit Discharge Potential: Potential		Inspector: JCW	Notes Black pool on flowline with petroleum odor.	
Submerged: Partially	Depth (in): 2			
Sampling Results Sample Location: Pool Total Chlorine: 0 ppm Free Chlorine: 0 ppm Ammonia: 3 ppm pH: 7.89 units Temperature: 64 °F Conductivity: 1011 µS/cm Detergents: 1.3 mg/L		Floatables: None Odor: Faint Turbidity: Cloudy Color: Clearly visible in bottl Gross Solids: Slight Vegetation: None Benthic Growth: None Stains: Moderate Non-illicit: Moderate	Condition Assessment Graffiti: None Erosion: None Deposition: None in. Damage: None

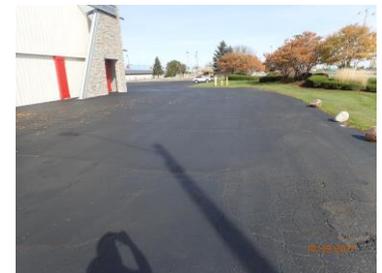
o20171019105604.JPG

Notes: Outfall not located - screened upstream at 13-1718 US1.

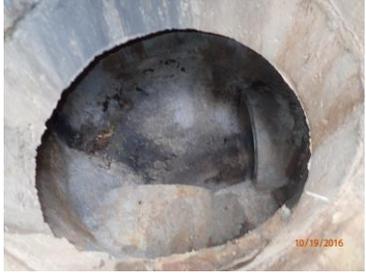
<small>o20161019144328.JPG</small> 2016
Submerged: None	Depth (in):	Notes Manhole dry at time of inspection.		
<i>Sampling Results</i>		Condition Assessment Graffiti: None Erosion: None Deposition: None in. Damage: None		
Sample Location:	Floatables:	None		
Total Chlorine: -- ppm	Odor:	None		
Free Chlorine: -- ppm	Turbidity:	None		
Ammonia: -- ppm	Color:	None		
pH: -- units	Gross Solids:	None		
Temperature -- °F	Vegetation:	None		
Conductivity: -- µS/cm	Benthic Growth:	None		
Detergents: -- mg/L	Stains:	Slight		
	Non-illicit:	None

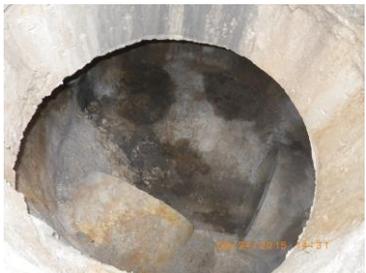
<small>o20150924133136.JPG</small> 2015
Submerged: None	Depth (in):	Notes Flowline damp, but no flow at time of inspection.		
<i>Sampling Results</i>		Condition Assessment Graffiti: None Erosion: None Deposition: None in. Damage: None		
Sample Location:	Floatables:	None		
Total Chlorine: -- ppm	Odor:	None		
Free Chlorine: -- ppm	Turbidity:	None		
Ammonia: -- ppm	Color:	None		
pH: -- units	Gross Solids:	None		
Temperature -- °F	Vegetation:	None		
Conductivity: -- µS/cm	Benthic Growth:	None		
Detergents: -- mg/L	Stains:	Slight		
	Non-illicit:	None

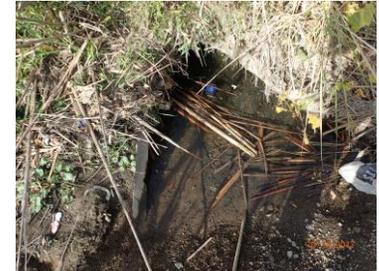
o20171019103654.JPG

Notes: Outfall partially submerged - screened upstream at 13-1758 US1.

Graffiti: None
Erosion: None
Deposition: Moderate Depth (in): 8
Damage: None Displacement Undercut Crushed
 Corrosion Cracks/Structural Damage

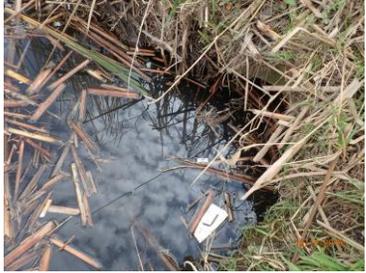
o20161019142738.JPG

Inspection Date: 10/19/2016 2:28:19 PM		Type: Ongoing	Flow: Submerged, indeterminate	Previous Rainfall (hrs): 72+
Illicit Discharge Potential: Unlikely		Inspector: JCW		
Submerged: Partially		Depth (in): 24		
<u>Sampling Results</u>		Notes		
Sample Location:	Floatables:	None		
Total Chlorine: -- ppm	Odor:	Easily detected		
Free Chlorine: -- ppm	Turbidity:	None		
Ammonia: -- ppm	Color:	None		
pH: -- units	Gross Solids:	Slight		
Temperature -- °F	Vegetation:	None		
Conductivity: -- µS/cm	Benthic Growth:	None		
Detergents: -- mg/L	Stains:	None		
	Non-illicit:	None		
		Condition Assessment		
		Graffiti: None		
		Erosion: None		
		Deposition: Moderate 13 in.		
		Damage: None

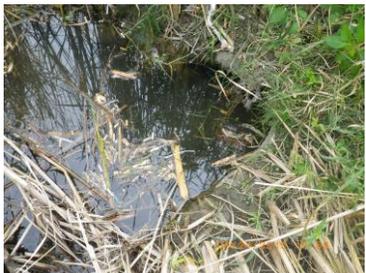
o20150924125956.JPG

Inspection Date: 9/24/2015 1:57:20 PM		Type: Ongoing	Flow: Submerged, indeterminate	Previous Rainfall (hrs): 72+
Illicit Discharge Potential: Unlikely		Inspector: JCW		
Submerged: Partially		Depth (in): 24		
<u>Sampling Results</u>		Notes		
Sample Location:	Floatables:	None		
Total Chlorine: -- ppm	Odor:	None		
Free Chlorine: -- ppm	Turbidity:	None		
Ammonia: -- ppm	Color:	None		
pH: -- units	Gross Solids:	Slight		
Temperature -- °F	Vegetation:	None		
Conductivity: -- µS/cm	Benthic Growth:	Moderate		
Detergents: -- mg/L	Stains:	None		
	Non-illicit:	None		
		Condition Assessment		
		Graffiti: None		
		Erosion: None		
		Deposition: Moderate 8 in.		
		Damage: None

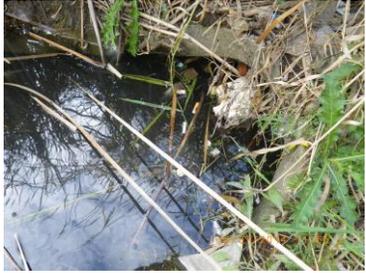
o20141007105524.JPG

Inspection Date: 10/7/2014 11:57:15 AM		Type: Ongoing	Flow: Submerged, indeterminate	Previous Rainfall (hrs): 48-72
Illicit Discharge Potential: Potential		Inspector: JCW		
Submerged: Partially		Depth (in): 26		
<u>Sampling Results</u>		Notes		
Sample Location:	Floatables:	None		
Total Chlorine: -- ppm	Odor:	None		
Free Chlorine: -- ppm	Turbidity:	None		
Ammonia: -- ppm	Color:	None		
pH: -- units	Gross Solids:	Slight		
Temperature -- °F	Vegetation:	None		
Conductivity: -- µS/cm	Benthic Growth:	Slight		
Detergents: -- mg/L	Stains:	None		
	Non-illicit:	None		
		Condition Assessment		
		Graffiti: None		
		Erosion: None		
		Deposition: Moderate 8 in.		
		Damage: None

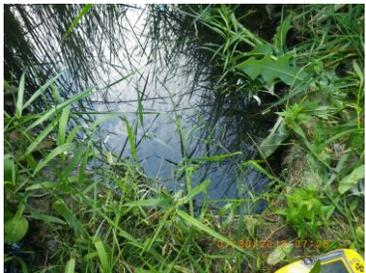
o20130730062618.JPG

Inspection Date: 7/30/2013 7:19:09 AM		Type: Ongoing	Flow: Submerged, indeterminate	Previous Rainfall (hrs): 72+
Illicit Discharge Potential: Potential		Inspector: JCW		
Submerged: Fully		Depth (in): 30		
<u>Sampling Results</u>		Notes		
Sample Location:	Floatables:	Slight		
Total Chlorine: -- ppm	Odor:	Faint		
Free Chlorine: -- ppm	Turbidity:	None		
Ammonia: -- ppm	Color:	None		
pH: -- units	Gross Solids:	Slight		
Temperature -- °F	Vegetation:	None		
Conductivity: -- µS/cm	Benthic Growth:	None		
Detergents: -- mg/L	Stains:	None		
	Non-illicit:	None		
		Condition Assessment		
		Graffiti: None		
		Erosion: None		
		Deposition: Moderate 10 in.		
		Damage: None

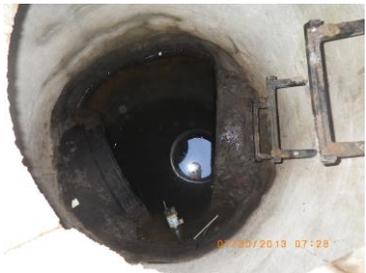
o20130730062844.JPG

Petroleum odor still present. Slight sheen observed.

Sample Location:	Pool	Floatables:	Moderate
Total Chlorine:	0 ppm	Odor:	Easily detected
Free Chlorine:	0 ppm	Turbidity:	None
Ammonia:	0 ppm	Color:	None
pH:	7.6 units	Gross Solids:	Slight
Temperature:	67 °F	Vegetation:	None
Conductivity:	1071 µS/cm	Benthic Growth:	None
Detergents:	0 mg/L	Stains:	Severe
		Non-illicit:	None

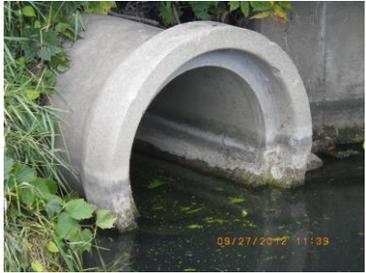
o20120927103918.JPG

Sample Location:	Pool	Floatables:	None
Total Chlorine:	0 ppm	Odor:	None
Free Chlorine:	0 ppm	Turbidity:	None
Ammonia:	0 ppm	Color:	None
pH:	7.77 units	Gross Solids:	None
Temperature:	64 °F	Vegetation:	None
Conductivity:	1077 µS/cm	Benthic Growth:	Moderate
Detergents:	0 mg/L	Stains:	Severe
		Non-illicit:	None

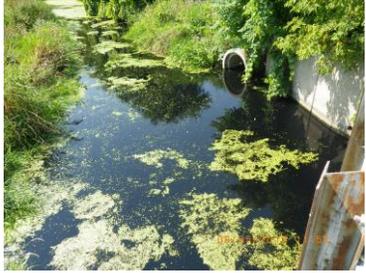
o20120905105212.JPG

Sample Location:	Pool	Floatables:	None
Total Chlorine:	0 ppm	Odor:	Noticeable from a dist
Free Chlorine:	0 ppm	Turbidity:	Cloudy
Ammonia:	0 ppm	Color:	Clearly visible in flow
pH:	75 units	Gross Solids:	None
Temperature:	-- °F	Vegetation:	None
Conductivity:	1419 µS/cm	Benthic Growth:	Moderate
Detergents:	0 mg/L	Stains:	None
		Non-illicit:	None

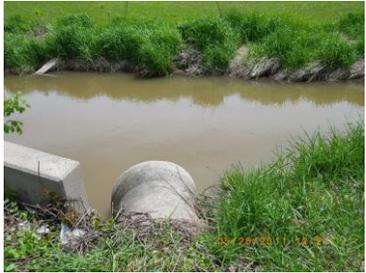
o20110526112114.jpg 2011

Inspection Date: 5/26/2011 12:21:00 PM		Type: Repeat	Flow: Submerged, indeterminate	Previous Rainfall (hrs): 72+
Illicit Discharge Potential: Obvious		Inspector: JCW	Notes Complaint follow-up. Strong chlorine smell inside pipe. Chemical interference with chlorine test. Limited screening conducted.	
Submerged: Partially	Depth (in):			
Sampling Results Sample Location: Pool Total Chlorine: -- ppm Free Chlorine: -- ppm Ammonia: -- ppm pH: -- units Temperature: -- °F Conductivity: -- µS/cm Detergents: -- mg/L		Floatables: Odor: Noticeable from a dist Turbidity: Color: Gross Solids: Vegetation: Benthic Growth: Stains: Non-illicit:	Condition Assessment Graffiti: Erosion: Deposition: in. Damage:

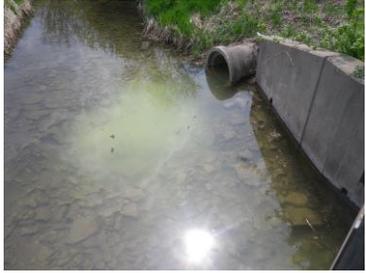
o20110512133142.jpg 2011

Inspection Date: 5/12/2011 1:03:00 PM		Type: Complaint	Flow: Submerged, indeterminate	Previous Rainfall (hrs): 72+
Illicit Discharge Potential: Obvious		Inspector: JCW	Notes Responded to complaint about discharge from pipe. Outfall partially submerged. Yellow pool at end of pipe. Chemical smell inside pipe.	
Submerged: Partially	Depth (in):			
Sampling Results Sample Location: Pool Total Chlorine: 2 ppm Free Chlorine: 2 ppm Ammonia: 2 ppm pH: -- units Temperature: -- °F Conductivity: -- µS/cm Detergents: -- mg/L		Floatables: Odor: Noticeable from a dist Turbidity: Color: Clearly visible in flow Gross Solids: Vegetation: Benthic Growth: Stains: Non-illicit: None	Condition Assessment Graffiti: Erosion: Deposition: in. Damage:

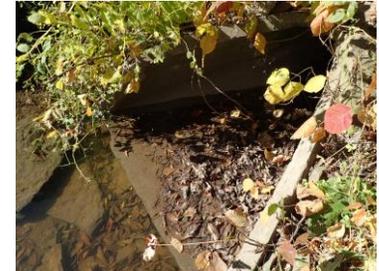
o20171018132924.JPG

Notes: Pipe was dry approx 10 ft from end of pipe - no sample collected (from stream). Apron displaced 4".

Damage: Minor Displacement Undercut Crushed

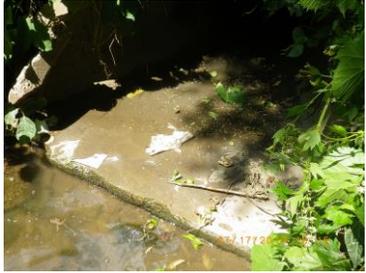
Inspection Date: 7/17/2013 1:12:46 PM		Type: Ongoing		Flow: None		Previous Rainfall (hrs): 72+	
Illicit Discharge Potential: Unlikely		Inspector: JCW		Notes Pipe wet, but no flow leaving apron. Apron displaced 4".

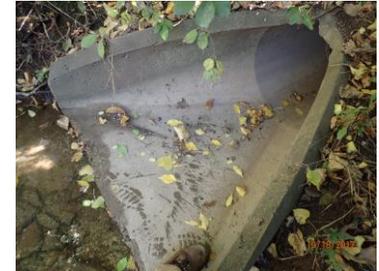
o20171018141336.JPG

Notes: Pipe dry at time of inspection. Apron displaced 7".

Damage: Moderate Displacement Undercut Crushed

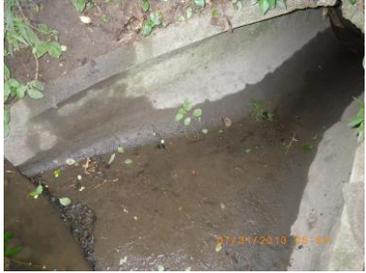
o20130731055412.JPG

Inspection Date: 7/31/2013 6:52:38 AM		Type: Ongoing		Flow: Trickle		Previous Rainfall (hrs): 72+	
Illicit Discharge Potential: Unlikely		Inspector: JCW		Notes 7" apron displacement

Submerged: None		Depth (in):					
Sampling Results		Floatables:		Condition Assessment		Graffiti: Minor Erosion: None Deposition: None in. Damage: Moderate	
Sample Location: Flow		Odor: None					
Total Chlorine: 0 ppm		Turbidity: None					
Free Chlorine: 0 ppm		Color: None					
Ammonia: 0 ppm		Gross Solids: None					
pH: 8.19 units		Vegetation: None					
Temperature: 70 °F		Benthic Growth: None					
Conductivity: 638 µS/cm		Stains: Slight					
Detergents: 0 mg/L		Non-illicit: None

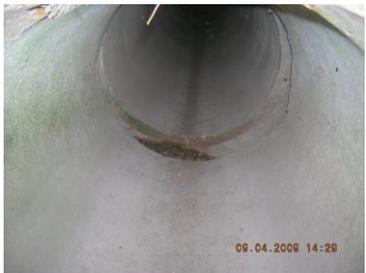
Osh09_DSCN6559.JPG

Inspection Date: 9/4/2009		Type: Initial		Flow: None		Previous Rainfall (hrs): 72+	
Illicit Discharge Potential: Unlikely		Inspector: JCW		Notes Apron separating from pipe. Grafitti on bridge.

Submerged: None		Depth (in): 0					
Sampling Results		Floatables:		Condition Assessment		Graffiti: Moderate Erosion: None Deposition: None 0 in. Damage: Moderate	
Sample Location:		Odor:					
Total Chlorine: -- ppm		Turbidity:					
Free Chlorine: -- ppm		Color:					
Ammonia: -- ppm		Gross Solids:					
pH: -- units		Vegetation:					
Temperature: -- °F		Benthic Growth:					
Conductivity: -- µS/cm		Stains:					
Detergents: -- mg/L		Non-illicit: None

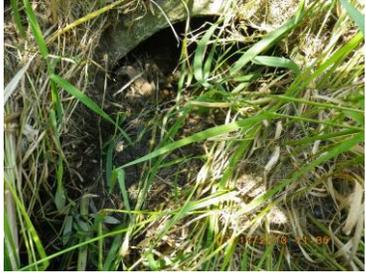
Inspection Date: 7/17/2013 11:32:29 AM		Type: Ongoing		Flow: None		Previous Rainfall (hrs): 72+	
Illicit Discharge Potential: Unlikely		Inspector: JCW		Notes Apron sediment wet, but no collectable flow at time of inspection.

<p style="font-size: small; text-align: center;">o20130717103632.JPG</p> <p style="font-size: large; text-align: center; font-weight: bold;">2013</p>	
Submerged: None		Depth (in):					
Sampling Results Sample Location:		Floatables: None		Condition Assessment Graffiti: None Erosion: None Deposition: Moderate 4 in. Damage: None			
Total Chlorine: -- ppm Free Chlorine: -- ppm Ammonia: -- ppm pH: -- units Temperature -- ° F Conductivity: -- µS/cm Detergents: -- mg/L		Odor: None Turbidity: None Color: None Gross Solids: Slight Vegetation: None Benthic Growth: Slight Stains: Slight Non-illicit: None

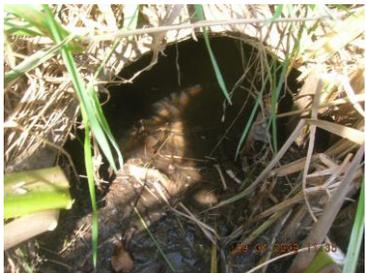
Inspection Date: 9/4/2009		Type: Initial		Flow: None		Previous Rainfall (hrs): 72+	
Illicit Discharge Potential: Unlikely		Inspector: JCW		Notes Standing water inside pipe due to sediment at end - no flow leaving pool.

<p style="font-size: small; text-align: center;">Osh09_DSCN6521.JPG</p> <p style="font-size: large; text-align: center; font-weight: bold;">2009</p>	
Submerged: None		Depth (in): 0					
Sampling Results Sample Location:		Floatables:		Condition Assessment Graffiti: None Erosion: None Deposition: 4 in. Damage: None			
Total Chlorine: -- ppm Free Chlorine: -- ppm Ammonia: -- ppm pH: -- units Temperature -- ° F Conductivity: -- µS/cm Detergents: -- mg/L		Odor: Turbidity: Color: Gross Solids: Vegetation: Benthic Growth: Stains: Non-illicit: None

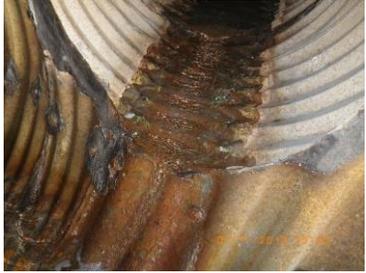
o20130717120006.JPG

Inspection Date: 7/17/2013 12:56:41 PM		Type: Ongoing	Flow: Moderate	Previous Rainfall (hrs): 72+
Illicit Discharge Potential: Unlikely		Inspector: JCW		Notes Fine light color silt settled on culvert and rocks at base of outfall.
Submerged: None	Depth (in):			
<i>Sampling Results</i>		Floatables:	None	Condition Assessment Graffiti: None Erosion: None Deposition: None in. Damage: Moderate
Sample Location: Flow		Odor:	None	
Total Chlorine:	0 ppm	Turbidity:	None	
Free Chlorine:	0 ppm	Color:	None	
Ammonia:	0.5 ppm	Gross Solids:	None	
pH:	8.11 units	Vegetation:	None	
Temperature:	72 °F	Benthic Growth:	None	
Conductivity:	947 µS/cm	Stains:	Moderate	
Detergents:	0 mg/L	Non-illicit:	Slight

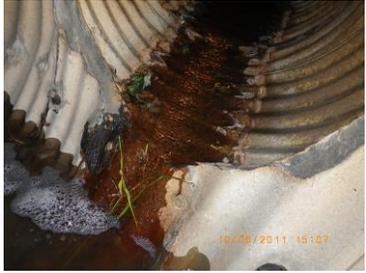
o20111006150702.JPG

Inspection Date: 10/6/2011 3:04:00 PM		Type: Ongoing	Flow: Moderate	Previous Rainfall (hrs): 72+
Illicit Discharge Potential: Potential		Inspector: JCW		Notes Persistent suds still present in mixing zone and downstream.
Submerged: None	Depth (in):			
<i>Sampling Results</i>		Floatables:	Moderate	Condition Assessment Graffiti: None Erosion: None Deposition: None 0 in. Damage: Moderate
Sample Location:		Odor:	None	
Total Chlorine:	-- ppm	Turbidity:	None	
Free Chlorine:	-- ppm	Color:	None	
Ammonia:	-- ppm	Gross Solids:	None	
pH:	-- units	Vegetation:	None	
Temperature:	-- °F	Benthic Growth:	None	
Conductivity:	-- µS/cm	Stains:	Moderate	
Detergents:	-- mg/L	Non-illicit:	None

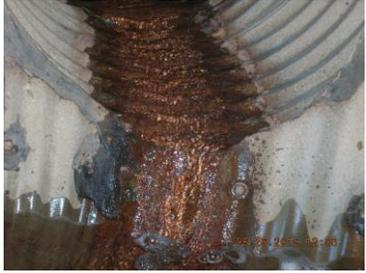
Inspection Date: 8/26/2010 12:58:18 PM		Type: Ongoing	Flow: Moderate	Previous Rainfall (hrs): 72+
Illicit Discharge Potential: Potential		Inspector: JCW	Notes: Persistent suds and gel-like sheen downstream	
Submerged: None	Depth (in):		Condition Assessment: Graffiti: None, Erosion: None, Deposition: None 0 in., Damage: Moderate	
Sampling Results		Floatables: Moderate

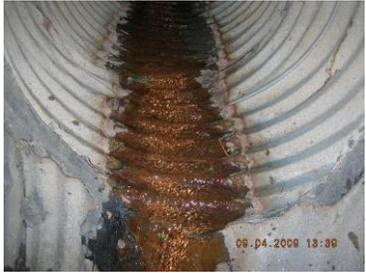
Inspection Date: 9/4/2009		Type: Initial	Flow: Moderate	Previous Rainfall (hrs): 72+
Illicit Discharge Potential: Potential		Inspector: JCW	Notes: Sample 09090411 collected from pool (suds). No detergent detected.	
Submerged: None	Depth (in): 0		Condition Assessment: Graffiti: None, Erosion: None, Deposition: None 0 in., Damage: Minor	
Sampling Results		Floatables: Moderate

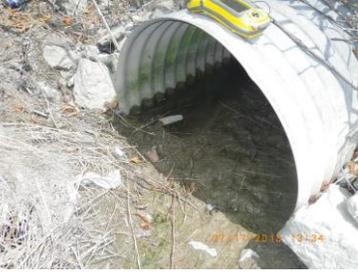
Inspection Date: 7/17/2013 1:30:26 PM		Type: Ongoing		Flow: None		Previous Rainfall (hrs): 72+	
Illicit Discharge Potential: Unlikely		Inspector: JCW		Notes Sediment wet, but no collectable flow at time of inspection.

<p style="font-size: small; text-align: center;">o20130717123414.JPG</p>	
Submerged: None		Depth (in):					
Sampling Results Sample Location:		Floatables: None		Condition Assessment Graffiti: None Erosion: None Deposition: Moderate 10 in. Damage: None		<h1 style="margin: 0;">2013</h1>	
Total Chlorine: -- ppm Free Chlorine: -- ppm Ammonia: -- ppm pH: -- units Temperature -- ° F Conductivity: -- µS/cm Detergents: -- mg/L		Odor: None Turbidity: None Color: None Gross Solids: None Vegetation: None Benthic Growth: Slight Stains: Slight Non-illicit: None

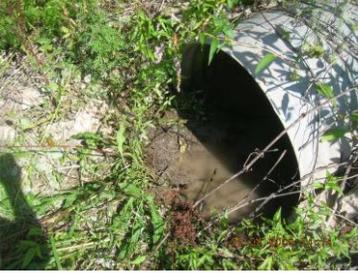
Inspection Date: 9/4/2009		Type: Initial		Flow: Submerged, no flow		Previous Rainfall (hrs): 72+	
Illicit Discharge Potential: Unlikely		Inspector: JCW		Notes Pool at end of pipe - no flow leaving pool.

<p style="font-size: small; text-align: center;">Osh09_DSCN6550.JPG</p>	
Submerged: Partially		Depth (in): 11					
Sampling Results Sample Location:		Floatables:		Condition Assessment Graffiti: None Erosion: None Deposition: 9 in. Damage: None		<h1 style="margin: 0;">2009</h1>	
Total Chlorine: -- ppm Free Chlorine: -- ppm Ammonia: -- ppm pH: -- units Temperature -- ° F Conductivity: -- µS/cm Detergents: -- mg/L		Odor: Turbidity: Color: Gross Solids: Vegetation: Benthic Growth: Slight Stains: Non-illicit: None

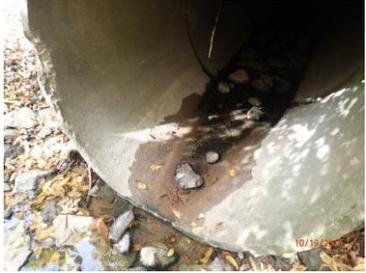
Inspection Date: 10/19/2016 1:11:20 PM		Type: Ongoing		Flow: Trickle		Previous Rainfall (hrs): 72+	
Illicit Discharge Potential: Unlikely		Inspector: JCW		Notes

o20161019130908.JPG	
Submerged: None		Depth (in):		Last pipe segment displaced 4" at joint.			
Sampling Results		Floatables: None		Condition Assessment		2016	
Sample Location: Flow		Odor: None		Graffiti: None			
Total Chlorine: 0 ppm		Turbidity: None		Erosion: None			
Free Chlorine: 0 ppm		Color: Faint in bottle		Deposition: None in.			
Ammonia: 0 ppm		Gross Solids: None		Damage: Minor			
pH: 8.24 units		Vegetation: None					
Temperature 65 °F		Benthic Growth: Slight					
Conductivity: 765 µS/cm		Stains: None					
Detergents: 0 mg/L		Non-illicit: None

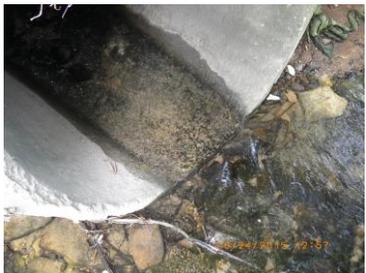
Inspection Date: 9/24/2015 12:55:30 PM		Type: Ongoing		Flow: Moderate		Previous Rainfall (hrs): 72+	
Illicit Discharge Potential: Unlikely		Inspector: JCW		Notes

o20150924115728.JPG	
Submerged: None		Depth (in):		4" joint displacement.			
Sampling Results		Floatables: None		Condition Assessment		2015	
Sample Location: Flow		Odor: None		Graffiti: None			
Total Chlorine: 0 ppm		Turbidity: None		Erosion: None			
Free Chlorine: 0 ppm		Color: None		Deposition: None in.			
Ammonia: 0 ppm		Gross Solids: None		Damage: Moderate			
pH: 8.17 units		Vegetation: None					
Temperature 72 °F		Benthic Growth: None					
Conductivity: 1595 µS/cm		Stains: Slight					
Detergents: 0 mg/L		Non-illicit: None

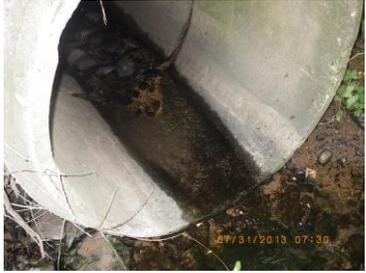
Inspection Date: 7/31/2013 7:27:16 AM		Type: Ongoing		Flow: Trickle		Previous Rainfall (hrs): 72+	
Illicit Discharge Potential: Unlikely		Inspector: JCW		Notes

o20130731063036.JPG	
Submerged: None		Depth (in):		End section displaced 4".			
Sampling Results		Floatables: None		Condition Assessment		2013	
Sample Location: Flow		Odor: None		Graffiti: None			
Total Chlorine: 0 ppm		Turbidity: None		Erosion: None			
Free Chlorine: 0 ppm		Color: None		Deposition: None in.			
Ammonia: 0 ppm		Gross Solids: None		Damage: Minor			
pH: 8.05 units		Vegetation: None					
Temperature 71 °F		Benthic Growth: None					
Conductivity: 1865 µS/cm		Stains: Moderate					
Detergents: 0 mg/L		Non-illicit: None

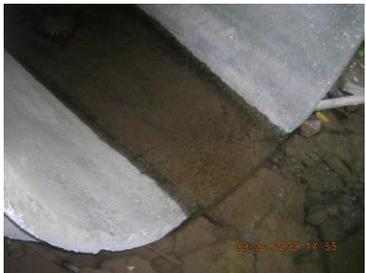
Inspection Date: 9/4/2009		Type: Initial		Flow: Submerged, slight flow		Previous Rainfall (hrs): 72+	
Illicit Discharge Potential: Unlikely		Inspector: JCW		Notes

Osh09_DSCN6570.JPG	
Submerged: Partially		Depth (in): 1		End section of pipe separated.			
Sampling Results		Floatables: None		Condition Assessment		2009	
Sample Location: Pool		Odor: None		Graffiti: None			
Total Chlorine: 0 ppm		Turbidity: None		Erosion: None			
Free Chlorine: 0 ppm		Color: None		Deposition: None 0 in.			
Ammonia: -- ppm		Gross Solids: None		Damage: Moderate			
pH: 7.82 units		Vegetation:					
Temperature 73 °F		Benthic Growth: Slight					
Conductivity: -- µS/cm		Stains:					
Detergents: 0 mg/L		Non-illicit: None

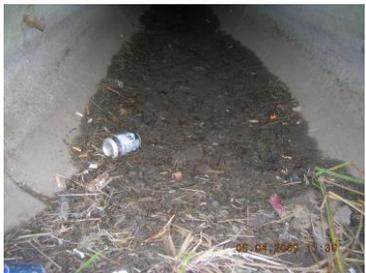
Inspection Date: 9/4/2009		Type: Initial	Flow: None	Previous Rainfall (hrs): 72+																		
Illicit Discharge Potential: Unlikely		Inspector: JCW		<div style="border: 1px solid black; padding: 5px;"> Notes Garbage inside pipe. </div> <div style="border: 1px solid black; padding: 5px; margin-top: 10px;"> Condition Assessment Graffiti: None Erosion: None Deposition: 1 in. Damage: None </div>																		
Submerged: None Depth (in): 0																						
<div style="border: 1px solid black; padding: 5px;"> Sampling Results Sample Location: Total Chlorine: -- ppm Free Chlorine: -- ppm Ammonia: -- ppm pH: -- units Temperature -- °F Conductivity: -- µS/cm Detergents: -- mg/L </div>

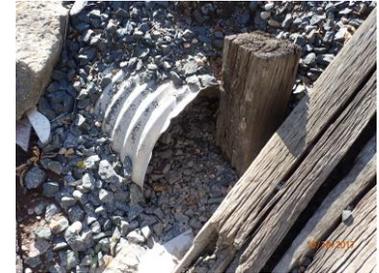
o20171018131410.JPG

Notes: Dry railroad ballast inside pipe. No flow observed at time of inspection.
