Illicit Discharge Detection and Elimination
Conducted For
City of Oshkosh

Ongoing Screening Summary Report

2017 Inspection Year

OMNNI Project Number N2029C17

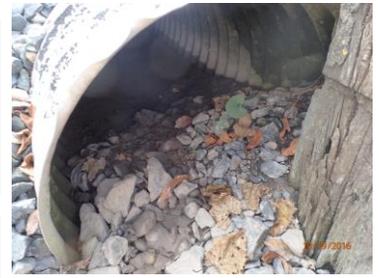
o20161019124104.JPG

Inspection Date: 10/19/2016 12:41:44 PM		Type: Ongoing	Flow: None	Previous Rainfall (hrs): 72+
Illicit Discharge Potential: Unlikely		Inspector: JCW		
Submerged: None		Depth (in):		
<i>Sampling Results</i>		Notes		
Sample Location:	Floatables: None	Corrugations wet, but no flow. 10" of stone in end of pipe. RR ties obstructing end.		
Total Chlorine: -- ppm	Odor: None			
Free Chlorine: -- ppm	Turbidity: None			
Ammonia: -- ppm	Color: None			
pH: -- units	Gross Solids: None			
Temperature -- °F	Vegetation: None			
Conductivity: -- µS/cm	Benthic Growth: Slight			
Detergents: -- mg/L	Stains: None			
	Non-illicit: None			
		Graffiti: None Erosion: None Deposition: Moderate 10 in. Damage: None

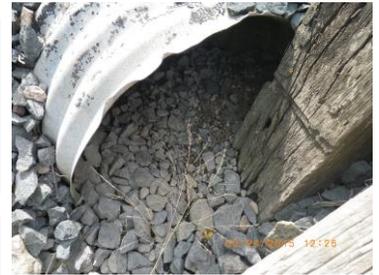
o20150924112622.JPG

Inspection Date: 9/24/2015 12:22:34 PM		Type: Ongoing	Flow: None	Previous Rainfall (hrs): 72+
Illicit Discharge Potential: Unlikely		Inspector: JCW		
Submerged: None		Depth (in):		
<i>Sampling Results</i>		Notes		
Sample Location:	Floatables: None	Partially filled with stone.		
Total Chlorine: -- ppm	Odor: None			
Free Chlorine: -- ppm	Turbidity: None			
Ammonia: -- ppm	Color: None			
pH: -- units	Gross Solids: None			
Temperature -- °F	Vegetation: None			
Conductivity: -- µS/cm	Benthic Growth: None			
Detergents: -- mg/L	Stains: None			
	Non-illicit: None			
		Graffiti: None Erosion: None Deposition: Moderate 10 in. Damage: None

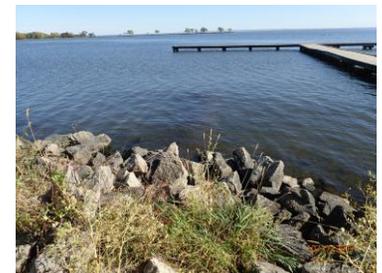
o20171017125138.JPG

Notes: Fully submerged - water 2"+ over crown of pipe. Screened upstream at 15-636 US1.

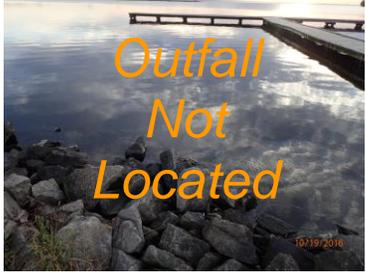
o20161019075416.JPG

Inspection Date: 10/19/2016 7:55:27 AM		Type: Ongoing	Flow: Submerged (not located)	Previous Rainfall (hrs): 72+
Illicit Discharge Potential: Potential		Inspector: JCW		
Submerged: Fully		Depth (in):		
<i>Sampling Results</i>		Floatables:	None	
Sample Location:		Odor:	None	
Total Chlorine: -- ppm		Turbidity:	None	
Free Chlorine: -- ppm		Color:	None	
Ammonia: -- ppm		Gross Solids:	None	
pH: -- units		Vegetation:	None	
Temperature -- °F		Benthic Growth:	None	
Conductivity: -- µS/cm		Stains:	None	
Detergents: -- mg/L		Non-illicit:	None	
		Notes		
		Outfall fully submerged and not located - screened upstream at 15-636 US1.		
		Condition Assessment		
		Graffiti:	None	
		Erosion:	None	
		Deposition:	None in.	
		Damage:	None

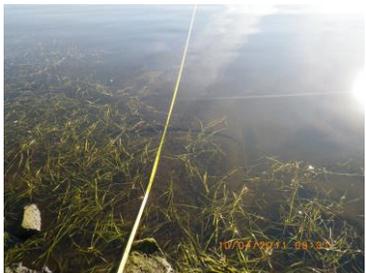
o20111004093148.JPG

Inspection Date: 10/4/2011 9:33:13 AM		Type: Ongoing	Flow: Submerged, indeterminate	Previous Rainfall (hrs): 72+
Illicit Discharge Potential: Unlikely		Inspector: JCW		
Submerged: Fully		Depth (in):		
<i>Sampling Results</i>		Floatables:	None	
Sample Location:		Odor:	None	
Total Chlorine: -- ppm		Turbidity:	None	
Free Chlorine: -- ppm		Color:	None	
Ammonia: -- ppm		Gross Solids:	None	
pH: -- units		Vegetation:	None	
Temperature -- °F		Benthic Growth:	Moderate	
Conductivity: -- µS/cm		Stains:	None	
Detergents: -- mg/L		Non-illicit:	None	
		Notes		
		Outfall fully submerged. Outfall screened upstream at 15-636 US1.		
		Condition Assessment		
		Graffiti:	None	
		Erosion:	None	
		Deposition:	None 0 in.	
		Damage:	None

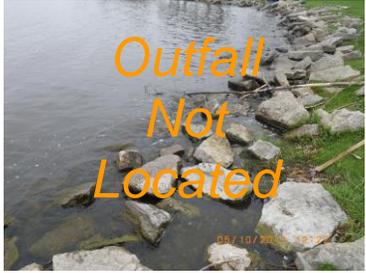
o20110510122252.JPG

Inspection Date: 5/10/2011 12:30:00 PM		Type: Other	Flow: Submerged (not located)	Previous Rainfall (hrs): 0-24
Illicit Discharge Potential: Unlikely		Inspector: JCW		
Submerged: Fully		Depth (in):		
<i>Sampling Results</i>		Floatables:		
Sample Location:		Odor:		
Total Chlorine: -- ppm		Turbidity:		
Free Chlorine: -- ppm		Color:		
Ammonia: -- ppm		Gross Solids:		
pH: -- units		Vegetation:		
Temperature -- °F		Benthic Growth:		
Conductivity: -- µS/cm		Stains:		
Detergents: -- mg/L		Non-illicit:	None	
		Notes		
		Outfall fully submerged and not physically located. Outfall screened upstream at 15-636 US1.		
		Condition Assessment		
		Graffiti:	None	
		Erosion:	None	
		Deposition:	None 0 in.	
		Damage:	None

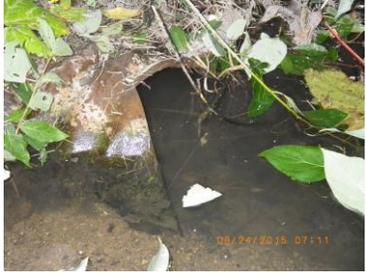
o20150924061136.JPG

Graffiti: None
Erosion: None
Deposition: Moderate 6 in.
Damage: None

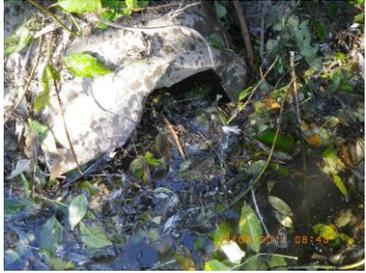
o20111006084300.JPG

Graffiti: None
Erosion: None
Deposition: None 0 in.
Damage: Minor

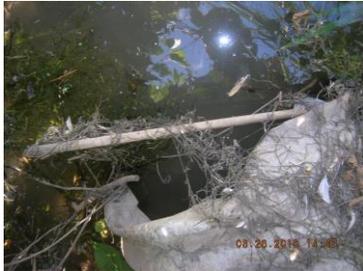
o20100826144742.JPG 2010

Inspection Date: 8/26/2010 2:56:31 PM		Type: Ongoing	Flow: Submerged, indeterminate	Previous Rainfall (hrs): 72+																																												
Illicit Discharge Potential: Unlikely		Inspector: JCW	Notes: Outfall partially submerged. Outfall screened upstream at 15-1093 US1.																																													
Submerged: Partially Depth (in): 7		Condition Assessment																																														
<table border="1" style="width:100%; border-collapse: collapse;"> <tr><td colspan="2"><i>Sampling Results</i></td></tr> <tr><td>Sample Location:</td><td></td></tr> <tr><td>Total Chlorine:</td><td>-- ppm</td></tr> <tr><td>Free Chlorine:</td><td>-- ppm</td></tr> <tr><td>Ammonia:</td><td>-- ppm</td></tr> <tr><td>pH:</td><td>-- units</td></tr> <tr><td>Temperature:</td><td>-- °F</td></tr> <tr><td>Conductivity:</td><td>-- µS/cm</td></tr> <tr><td>Detergents:</td><td>-- mg/L</td></tr> </table>		<i>Sampling Results</i>		Sample Location:		Total Chlorine:	-- ppm	Free Chlorine:	-- ppm	Ammonia:	-- ppm	pH:	-- units	Temperature:	-- °F	Conductivity:	-- µS/cm	Detergents:	-- mg/L	<table border="1" style="width:100%; border-collapse: collapse;"> <tr><td>Floatables:</td><td>None</td></tr> <tr><td>Odor:</td><td>None</td></tr> <tr><td>Turbidity:</td><td>Slight cloudiness</td></tr> <tr><td>Color:</td><td>None</td></tr> <tr><td>Gross Solids:</td><td>None</td></tr> <tr><td>Vegetation:</td><td>None</td></tr> <tr><td>Benthic Growth:</td><td>Moderate</td></tr> <tr><td>Stains:</td><td>None</td></tr> <tr><td>Non-illicit:</td><td>None</td></tr> </table>	Floatables:	None	Odor:	None	Turbidity:	Slight cloudiness	Color:	None	Gross Solids:	None	Vegetation:	None	Benthic Growth:	Moderate	Stains:	None	Non-illicit:	None	<table border="1" style="width:100%; border-collapse: collapse;"> <tr><td>Graffiti:</td><td>None</td></tr> <tr><td>Erosion:</td><td>None</td></tr> <tr><td>Deposition:</td><td>None 0 in.</td></tr> <tr><td>Damage:</td><td>Minor</td></tr> </table>		Graffiti:	None	Erosion:	None	Deposition:	None 0 in.	Damage:	Minor

<i>Sampling Results</i>																																																
Sample Location:																																																
Total Chlorine:	-- ppm																																															
Free Chlorine:	-- ppm																																															
Ammonia:	-- ppm																																															
pH:	-- units																																															
Temperature:	-- °F																																															
Conductivity:	-- µS/cm																																															
Detergents:	-- mg/L																																															
Floatables:	None																																															
Odor:	None																																															
Turbidity:	Slight cloudiness																																															
Color:	None																																															
Gross Solids:	None

Vegetation:	None																																															
Benthic Growth:	Moderate																																															
Stains:	None																																															
Non-illicit:	None																																															
Graffiti:	None																																															
Erosion:	None																																															
Deposition:	None 0 in.																																															
Damage:	Minor

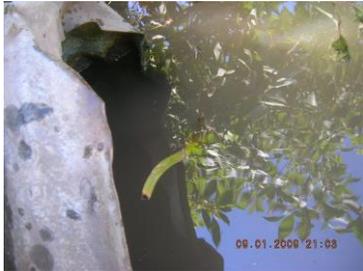
Osh09_DSCN6359.JPG 2009

Inspection Date: 9/2/2009		Type: Initial	Flow: Submerged, slight flow	Previous Rainfall (hrs): 72+																																												
Illicit Discharge Potential: Potential		Inspector: JCW	Notes: Outfall partially submerged. Outfall screened upstream at 15-1093 US1.																																													
Submerged: Partially Depth (in): 7		Condition Assessment																																														
<table border="1" style="width:100%; border-collapse: collapse;"> <tr><td colspan="2"><i>Sampling Results</i></td></tr> <tr><td>Sample Location:</td><td></td></tr> <tr><td>Total Chlorine:</td><td>-- ppm</td></tr> <tr><td>Free Chlorine:</td><td>-- ppm</td></tr> <tr><td>Ammonia:</td><td>-- ppm</td></tr> <tr><td>pH:</td><td>-- units</td></tr> <tr><td>Temperature:</td><td>-- °F</td></tr> <tr><td>Conductivity:</td><td>-- µS/cm</td></tr> <tr><td>Detergents:</td><td>-- mg/L</td></tr> </table>		<i>Sampling Results</i>		Sample Location:		Total Chlorine:	-- ppm	Free Chlorine:	-- ppm	Ammonia:	-- ppm	pH:	-- units	Temperature:	-- °F	Conductivity:	-- µS/cm	Detergents:	-- mg/L	<table border="1" style="width:100%; border-collapse: collapse;"> <tr><td>Floatables:</td><td>None</td></tr> <tr><td>Odor:</td><td>Faint</td></tr> <tr><td>Turbidity:</td><td>Cloudy</td></tr> <tr><td>Color:</td><td>None</td></tr> <tr><td>Gross Solids:</td><td>None</td></tr> <tr><td>Vegetation:</td><td>None</td></tr> <tr><td>Benthic Growth:</td><td>Slight</td></tr> <tr><td>Stains:</td><td>None</td></tr> <tr><td>Non-illicit:</td><td>None</td></tr> </table>	Floatables:	None	Odor:	Faint	Turbidity:	Cloudy	Color:	None	Gross Solids:	None	Vegetation:	None	Benthic Growth:	Slight	Stains:	None	Non-illicit:	None	<table border="1" style="width:100%; border-collapse: collapse;"> <tr><td>Graffiti:</td><td>None</td></tr> <tr><td>Erosion:</td><td>None</td></tr> <tr><td>Deposition:</td><td>None 0 in.</td></tr> <tr><td>Damage:</td><td>Minor</td></tr> </table>		Graffiti:	None	Erosion:	None	Deposition:	None 0 in.	Damage:	Minor

<i>Sampling Results</i>																																																
Sample Location:																																																
Total Chlorine:	-- ppm																																															
Free Chlorine:	-- ppm																																															
Ammonia:	-- ppm																																															
pH:	-- units																																															
Temperature:	-- °F																																															
Conductivity:	-- µS/cm																																															
Detergents:	-- mg/L																																															
Floatables:	None																																															
Odor:	Faint																																															
Turbidity:	Cloudy																																															
Color:	None																																															
Gross Solids:	None

Vegetation:	None																																															
Benthic Growth:	Slight																																															
Stains:	None																																															
Non-illicit:	None																																															
Graffiti:	None																																															
Erosion:	None																																															
Deposition:	None 0 in.																																															
Damage:	Minor

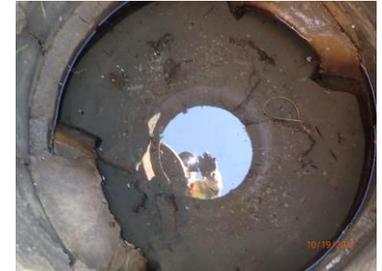
o20171019143218.JPG

Notes: Sample collected from submerged pool in manhole.

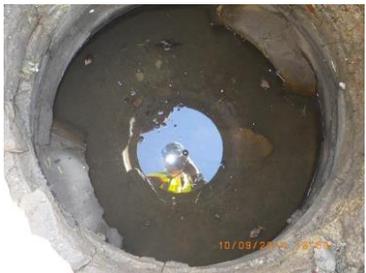
o20141009125920.JPG

Sample Location:	Pool	Floatables:	None
Total Chlorine:	0 ppm	Odor:	None
Free Chlorine:	0 ppm	Turbidity:	Slight cloudiness
Ammonia:	0 ppm	Color:	None
pH:	7.87 units	Gross Solids:	None
Temperature:	60 °F	Vegetation:	None
Conductivity:	2030 µS/cm	Benthic Growth:	Slight
Detergents:	0 mg/L	Stains:	None
		Non-illicit:	None

Graffiti: None
Erosion: None
Deposition: Moderate 3 in.
Damage: None

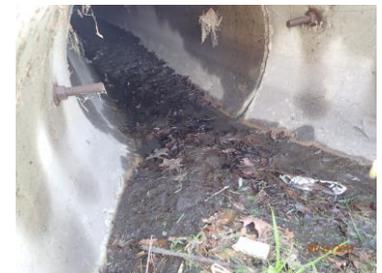
o20171017123304.JPG

Notes: Saturated sediment on apron. Outfall partially submerged - screened upstream at 15-2409 US1.

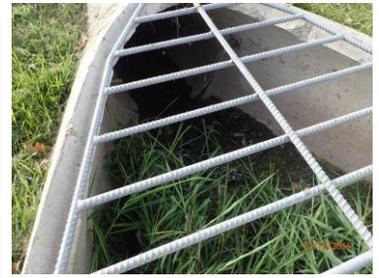
o20161019122450.JPG

Inspection Date: 10/19/2016 12:25:36 PM		Type: Ongoing	Flow: None	Previous Rainfall (hrs): 72+
Illicit Discharge Potential: Unlikely		Inspector: JCW		
Submerged: None		Depth (in):		
<i>Sampling Results</i>		Notes		
Sample Location:	Floatables: None	Sediment wet, but no flow at time of inspection.		
Total Chlorine: -- ppm	Odor: None			
Free Chlorine: -- ppm	Turbidity: None			
Ammonia: -- ppm	Color: None			
pH: -- units	Gross Solids: None			
Temperature -- °F	Vegetation: None			
Conductivity: -- µS/cm	Benthic Growth: Slight			
Detergents: -- mg/L	Stains: None			
	Non-illicit: None			
		Graffiti: None	1 in.	
		Erosion: None		
		Deposition: Minor		
		Damage: None

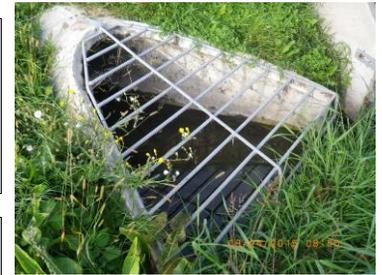
o20150924075004.JPG

Inspection Date: 9/24/2015 8:45:17 AM		Type: Ongoing	Flow: Submerged, indeterminate	Previous Rainfall (hrs): 72+
Illicit Discharge Potential: Unlikely		Inspector: JCW		
Submerged: Partially		Depth (in): 2		
<i>Sampling Results</i>		Notes		
Sample Location:	Floatables: None	Outfall partially submerged - screened at 15-2409 US1.		
Total Chlorine: -- ppm	Odor: None			
Free Chlorine: -- ppm	Turbidity: None			
Ammonia: -- ppm	Color: None			
pH: -- units	Gross Solids: None			
Temperature -- °F	Vegetation: None			
Conductivity: -- µS/cm	Benthic Growth: Slight			
Detergents: -- mg/L	Stains: None			
	Non-illicit: None			
		Graffiti: None	in.	
		Erosion: None		
		Deposition: None		
		Damage: None

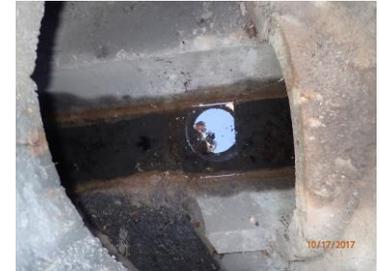
o20171017123758.JPG

Notes: Sample collected from submerged pool in manhole.

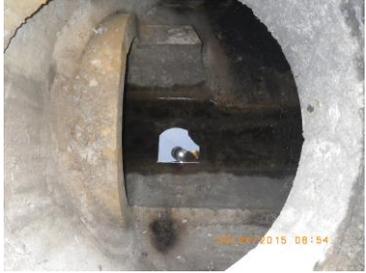
<p style="text-align: center;">o20150924075444.JPG</p> <p style="text-align: center; font-size: 24pt; font-weight: bold;">2015</p>	
Submerged: Partially Depth (in): 2							
Sampling Results				Condition Assessment			
Sample Location: Flow		Floatables:	None	Graffiti:		None	
Total Chlorine: 0 ppm		Odor:	None	Erosion:		None	
Free Chlorine: 0 ppm		Turbidity:	None	Deposition:		None	in.
Ammonia: 0 ppm		Color:	None	Damage:		None	
pH: 7.82 units		Gross Solids:	None				
Temperature 68 °F		Vegetation:	None				
Conductivity: 600 µS/cm		Benthic Growth:	None				
Detergents: 0 mg/L		Stains:	None				
		Non-illicit:	None

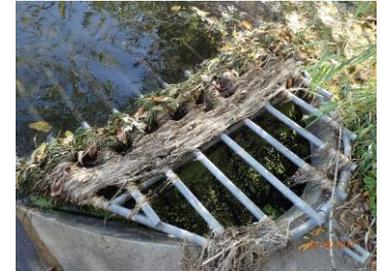
o20171019145658.JPG

Notes: Outfall partially submerged - screened upstream at 15-2477 US2.

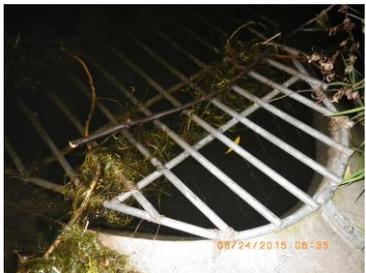
<p style="text-align: center;">o20150924053500.JPG</p> <p style="text-align: center; font-size: 24pt; font-weight: bold;">2015</p>

Vegetation:	None																																																	
Benthic Growth:	Slight																																																	
Stains:	None																																																	
Non-illicit:	None																																																	
Condition Assessment																																																		
Graffiti:	None																																																	
Erosion:	None																																																	
Deposition:	Minor 7 in.																																																	
Damage:	None

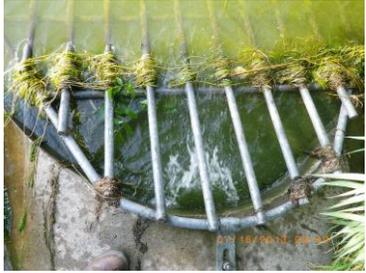
<p style="text-align: center;">o20130716074040.JPG</p> <p style="text-align: center; font-size: 24pt; font-weight: bold;">2013</p>

Vegetation:	None																																																	
Benthic Growth:	Moderate																																																	
Stains:	None																																																	
Non-illicit:	None																																																	
Condition Assessment																																																		
Graffiti:	None																																																	
Erosion:	None																																																	
Deposition:	Moderate 9 in.																																																	
Damage:	None

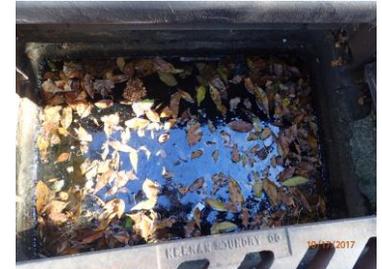
o20171017110926.JPG

Notes: Sample collected from submerged pool in manhole. Ammonia assumed due to decomposing leaves.

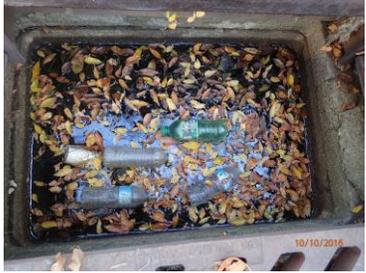
o20161010133936.JPG

Inspection Date: 10/10/2016 1:41:25 PM		Type: Ongoing	Flow: Submerged, indeterminate	Previous Rainfall (hrs): 72+
Illicit Discharge Potential: Potential		Inspector: JCW		
Submerged: Fully		Depth (in): 18		
<i>Sampling Results</i>		Notes		
Sample Location: Pool	Floatables: None	Potential illicit discharge due to gross solids.		
Total Chlorine: 0 ppm	Odor: Easily detected	Condition Assessment Graffiti: None Erosion: None Deposition: None in. Damage: None		
Free Chlorine: 0 ppm	Turbidity: None			
Ammonia: 1 ppm	Color: None			
pH: 6.65 units	Gross Solids: Moderate			
Temperature 70 °F	Vegetation: None			
Conductivity: 809 µS/cm	Benthic Growth: None			
Detergents: 0 mg/L	Stains: None			
	Non-illicit: Moderate

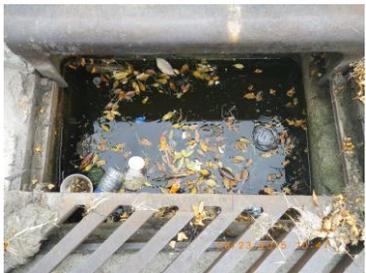
o20150923094718.JPG

Inspection Date: 9/23/2015 10:45:16 AM		Type: Ongoing	Flow: Submerged, indeterminate	Previous Rainfall (hrs): 72+
Illicit Discharge Potential: Potential		Inspector: JCW		
Submerged: Fully		Depth (in): 21		
<i>Sampling Results</i>		Notes		
Sample Location: Pool	Floatables: None	Floating gross solids (litter) in manhole.		
Total Chlorine: 0 ppm	Odor: None	Condition Assessment Graffiti: None Erosion: None Deposition: None in. Damage: None		
Free Chlorine: 0 ppm	Turbidity: None			
Ammonia: 0 ppm	Color: None			
pH: 8.06 units	Gross Solids: Moderate			
Temperature 71 °F	Vegetation: None			
Conductivity: 345 µS/cm	Benthic Growth: Slight			
Detergents: 0 mg/L	Stains: None			
	Non-illicit: None

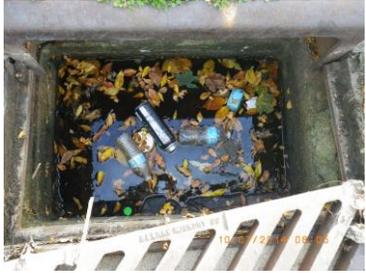
o20141007070512.JPG

Inspection Date: 10/7/2014 8:03:39 AM		Type: Ongoing	Flow: Submerged, indeterminate	Previous Rainfall (hrs): 48-72
Illicit Discharge Potential: Potential		Inspector: JCW		
Submerged: Fully		Depth (in): 15		
<i>Sampling Results</i>		Notes		
Sample Location: Pool	Floatables: None	Floating gross solids (litter) in catchbasin.		
Total Chlorine: 0 ppm	Odor: Faint	Condition Assessment Graffiti: None Erosion: None Deposition: Minor 1 in. Damage: None		
Free Chlorine: 0 ppm	Turbidity: None			
Ammonia: 0 ppm	Color: None			
pH: 7.55 units	Gross Solids: Moderate			
Temperature -- °F	Vegetation: None			
Conductivity: 430 µS/cm	Benthic Growth: Slight			
Detergents: 0 mg/L	Stains: None			
	Non-illicit: Slight

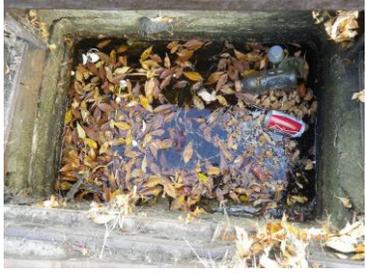
o20111011124148.JPG 2011	
Submerged: Fully Depth (in): 16				2010 screening follow-up. Floatable debris still present.			
Sampling Results				Condition Assessment			
Sample Location: Pool		Floatables: None		Graffiti: None			
Total Chlorine: 0 ppm		Odor: None		Erosion: None			
Free Chlorine: 0 ppm		Turbidity: None		Deposition: None 0 in.			
Ammonia: 0 ppm		Color: None		Damage: None			
pH: 8.15 units		Gross Solids: Slight					
Temperature 71 °F		Vegetation: None					
Conductivity: -- µS/cm		Benthic Growth: None					
Detergents: -- mg/L		Stains: None					
		Non-illicit: None

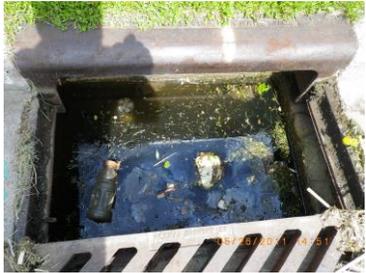
o20110526145102.JPG 2011	
Submerged: Fully Depth (in):				Limited screening conducted to check for floatable debris.			
Sampling Results				Condition Assessment			
Sample Location:		Floatables: Moderate		Graffiti: None			
Total Chlorine: -- ppm		Odor:		Erosion: None			
Free Chlorine: -- ppm		Turbidity:		Deposition: None 0 in.			
Ammonia: -- ppm		Color:		Damage: None			
pH: -- units		Gross Solids: None					
Temperature -- °F		Vegetation:					
Conductivity: -- µS/cm		Benthic Growth:					
Detergents: -- mg/L		Stains:					
		Non-illicit: Moderate

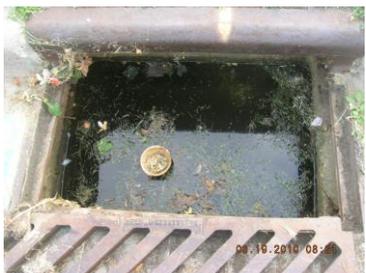
o20100819082134.JPG 2010	
Submerged: Fully Depth (in): 22				Floatable debris in catchbasin.			
Sampling Results				Condition Assessment			
Sample Location: Pool		Floatables: None		Graffiti: None			
Total Chlorine: 0 ppm		Odor: None		Erosion: None			
Free Chlorine: 0 ppm		Turbidity: Slight cloudiness		Deposition: None 0 in.			
Ammonia: 0 ppm		Color: Faint in bottle		Damage: None			
pH: 7.84 units		Gross Solids: Moderate					
Temperature 73 °F		Vegetation: None					
Conductivity: -- µS/cm		Benthic Growth: Slight					
Detergents: 0 mg/L		Stains: None					
		Non-illicit: None

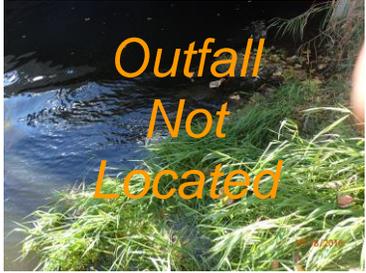
o20161018134846.JPG

Inspection Date: 10/18/2016 1:49:21 PM		Type: Ongoing	Flow: Submerged (not located)	Previous Rainfall (hrs): 72+
Illicit Discharge Potential: Potential		Inspector: JCW		
Submerged: Fully		Depth (in):		
<i>Sampling Results</i>		Notes		
Sample Location:	Floatables: None	Outfall fully submerged and not located - screened upstream at 16-28 US1.		
Total Chlorine: -- ppm	Odor: None			
Free Chlorine: -- ppm	Turbidity: None			
Ammonia: -- ppm	Color: None			
pH: -- units	Gross Solids: None			
Temperature -- °F	Vegetation: None			
Conductivity: -- µS/cm	Benthic Growth: None			
Detergents: -- mg/L	Stains: None			
	Non-illicit: None			
		Graffiti: None		
		Erosion: None		
		Deposition: None	in.	
		Damage: None

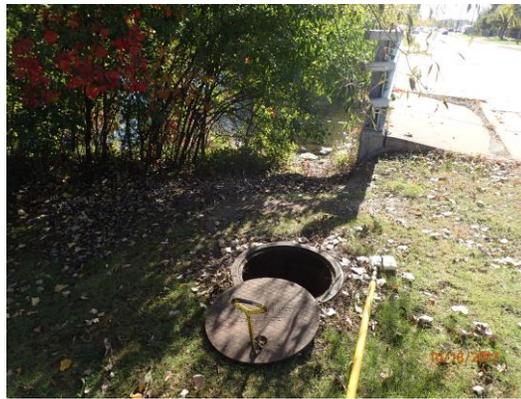
o20171018104914.JPG

Upstream manhole located approx 34 ft NW of outfall 16-28. Intermediate area consists of open space.

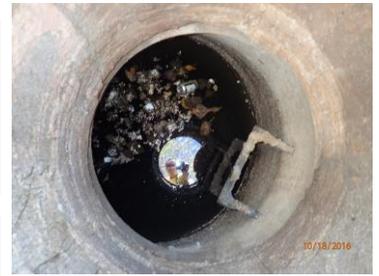
o20161018134942.JPG

Inspection Date: 10/18/2016 1:52:21 PM		Type: Ongoing	Flow: Submerged, indeterminate	Previous Rainfall (hrs): 72+
Illicit Discharge Potential: Potential		Inspector: JCW		Notes Potential illicit discharge due to gross solids.
Submerged: Fully	Depth (in): 32			
<i>Sampling Results</i>				
Sample Location: Pool	Floatables: None			
Total Chlorine: 0 ppm	Odor: None			
Free Chlorine: 0 ppm	Turbidity: None			
Ammonia: 0 ppm	Color: None			
pH: 7.43 units	Gross Solids: Moderate	Condition Assessment Graffiti: None Erosion: None Deposition: None in. Damage: None		
Temperature 68 °F	Vegetation: None			
Conductivity: 419 µS/cm	Benthic Growth: None			
Detergents: 0 mg/L	Stains: None			
	Non-illicit: None

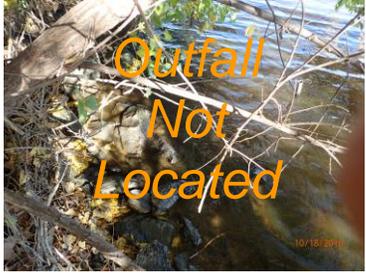
<p style="font-size: small; margin-top: 5px;">o20161018122812.JPG</p> <p style="font-size: large; font-weight: bold; margin-top: 10px;">2016</p>																															
Submerged: Fully Depth (in):		Notes Outfall fully submerged and not located - screened upstream at 16-71 US1.

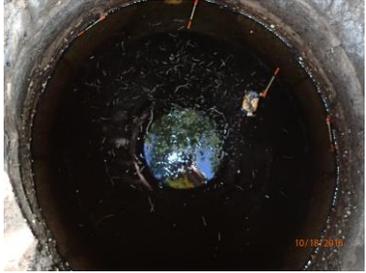
o20161018122930.JPG 2016

Inspection Date: 10/18/2016 12:32:06 PM		Type: Ongoing	Flow: Submerged, indeterminate	Previous Rainfall (hrs): 72+
Illicit Discharge Potential: Potential		Inspector: JCW		Notes Potential illicit discharge due to gross solids. Four syringes removed from manhole.
Submerged: Fully		Depth (in): 22		
Sampling Results Sample Location: Pool Total Chlorine: 0 ppm Free Chlorine: 0 ppm Ammonia: 0.5 ppm pH: 7.7 units Temperature: 66 °F Conductivity: 632 µS/cm Detergents: 0 mg/L		Floatables: None Odor: None Turbidity: None Color: None Gross Solids: Slight Vegetation: None Benthic Growth: None Stains: None Non-illicit: None	Condition Assessment Graffiti: None Erosion: None Deposition: None in. Damage: None

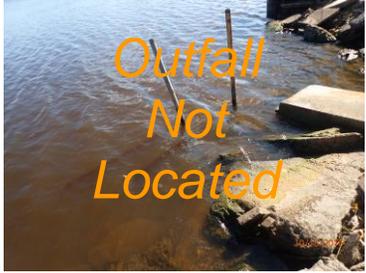
<p style="font-size: small;">o20161018130012.JPG</p> <p style="font-size: large; font-weight: bold; color: orange;">2016</p>
Submerged: Fully Depth (in):		Notes Outfall fully submerged and not located - screened upstream at 16-289 US1.		
<i>Sampling Results</i>		Condition Assessment		
Sample Location:	Floatables:	Graftiti: None		
Total Chlorine: -- ppm	Odor:	Erosion: None		
Free Chlorine: -- ppm	Turbidity:	Deposition: None in.		
Ammonia: -- ppm	Color:	Damage: None		
pH: -- units	Gross Solids:			
Temperature -- °F	Vegetation:			
Conductivity: -- µS/cm	Benthic Growth:			
Detergents: -- mg/L	Stains:			
	Non-illicit:

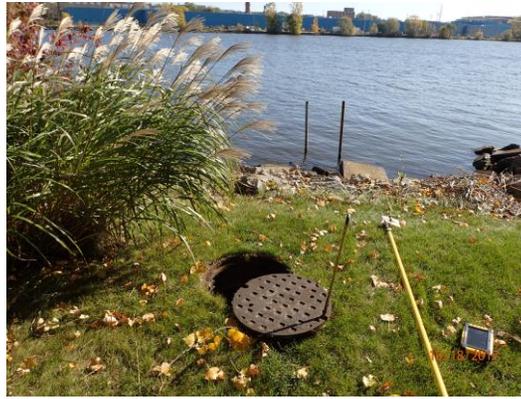
o20171018103526.JPG

Upstream manhole located approx 19 ft ENE of outfall 16-289. Intermediate area consists of open space.

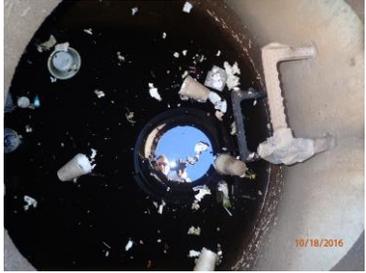
o20161018092516.JPG

Notes
Floating gross solids (litter) - including syringe - in manhole.

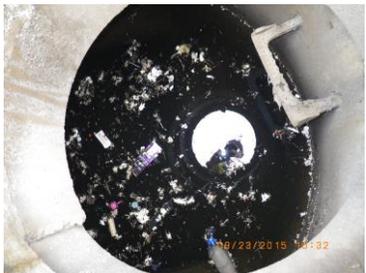
o20150923093204.JPG

Notes
Floating gross solids (litter) in manhole.

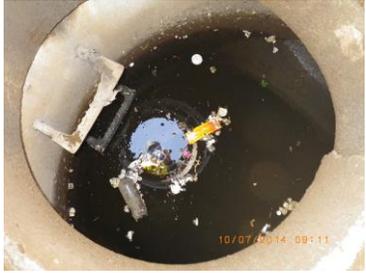
o20141007081140.JPG

Notes
2010 screening follow-up. Floatable debris significantly reduced.

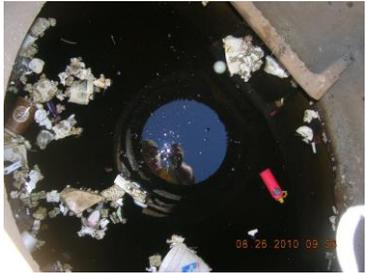
o20100826095640.JPG

Inspection Date: 8/26/2010 10:01:38 AM		Type: Ongoing	Flow: Submerged, indeterminate	Previous Rainfall (hrs): 72+
Illicit Discharge Potential: Potential		Inspector: JCW	Notes Floatable debris in manhole.	
Submerged: Fully	Depth (in): 36			
Sampling Results Sample Location: Pool		Floatables: None	Condition Assessment Graffiti: None Erosion: None Deposition: None 0 in. Damage: None	
Total Chlorine: 0 ppm		Odor: None		
Free Chlorine: 0 ppm		Turbidity: None		
Ammonia: 0 ppm		Color: Faint in bottle		
pH: 7.23 units		Gross Solids: Moderate		
Temperature: 76 °F		Vegetation: None		
Conductivity: -- µS/cm		Benthic Growth: Slight		
Detergents: 0 mg/L		Stains: None		
		Non-illicit: None

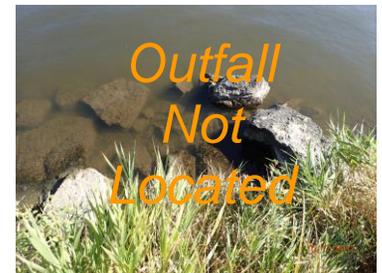
o20171017112242.JPG

Notes: Outfall fully submerged and not located - screened upstream at 16-594 US1. Floating gross solids (litter) in manhole.

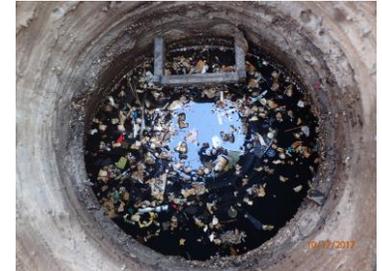
o20171017112318.JPG

Notes: Sample collected from submerged pool in manhole. Floating gross solids (litter) in manhole.

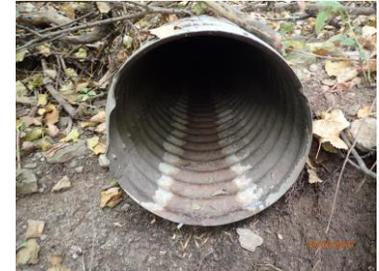
o20171003141038.JPG

Notes: Pipe dry at time of inspection. Last 1' of pipe undercut 7". Scour hole at end of pipe.

Damage: Minor Displacement Undercut Crushed

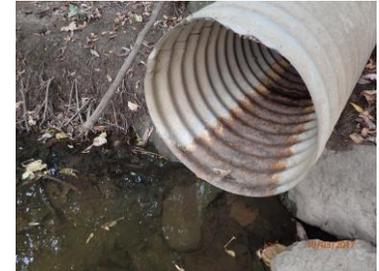
o20171003135740.JPG

Notes: Pipe dry at time of inspection. Last 2' of pipe undercut 15".

Damage: Minor Displacement Undercut Crushed

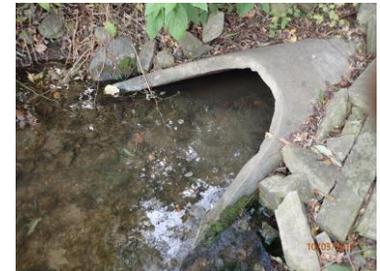
o20171003110156.JPG

Notes: Outfall partially submerged - screened upstream at 16-660 US1. Detergent detected in sample.

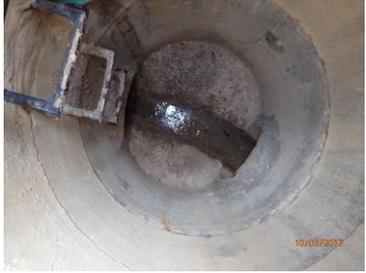
o20171003110702.JPG

Inspection Date: 10/3/2017 11:12:57 AM		Type: Ongoing		Flow: Trickle		Previous Rainfall (hrs): 72+	
Illicit Discharge Potential: Potential		Inspector: JCW		Notes Sample collected from flow in manhole. Detergent detected in sample.

Submerged: None		Depth (in):					
Sampling Results				Condition Assessment			
Sample Location: Flow		Floatables:	None	Graffiti:		None	
Total Chlorine: 0 ppm		Odor:	None	Erosion:		None	
Free Chlorine: 0 ppm		Turbidity:	None	Deposition:		None	in.
Ammonia: 0 ppm		Color:	None	Damage:		None	
pH: 8.26 units		Gross Solids:	None				
Temperature 76 °F		Vegetation:	None				
Conductivity: 845 µS/cm		Benthic Growth:	None				
Detergents: 0.55 mg/L		Stains:	None				
		Non-illicit:	None

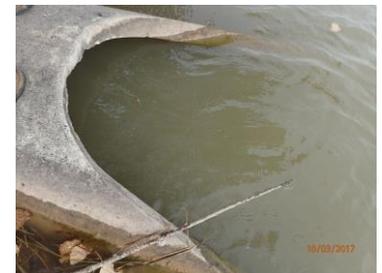
o20171003104616.JPG

Notes: Outfall partially submerged - screened upstream at 16-663 US1. Apron displaced 2".

Graffiti: None
 Erosion: None
 Deposition: None Depth (in):
 Damage: Moderate Displacement Undercut Crushed
 Corrosion Cracks/Structural Damage

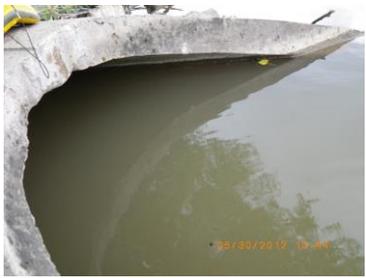
Inspection Date: 5/30/2012 10:43:21 AM		Type: Ongoing		Flow: Submerged, indeterminate		Previous Rainfall (hrs): 72+	
Illicit Discharge Potential: Unlikely		Inspector: JCW		Notes Outfall partially submerged. Outfall screened upstream at 16-663 US1.

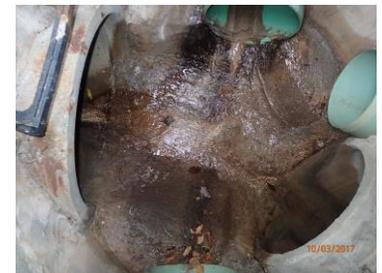
o20171003105000.JPG

Notes: Sample collected from flow in manhole.

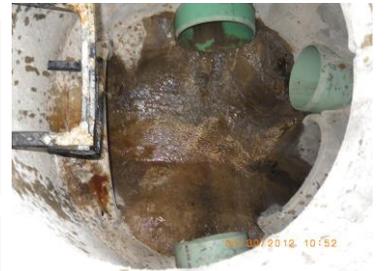
o20120530095222.JPG

Notes
 Sample collected from incoming flow (NW pipe).

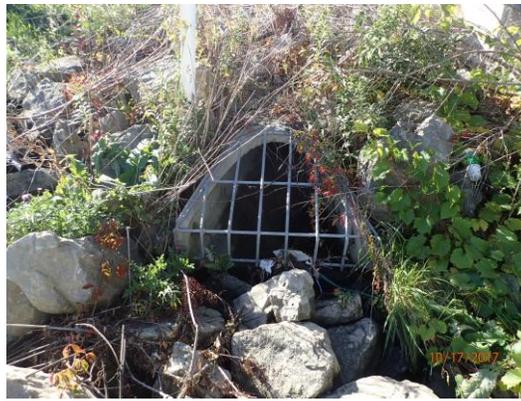
o20171017102808.JPG

Storm sewer from Koeller St discharges to stream from south.

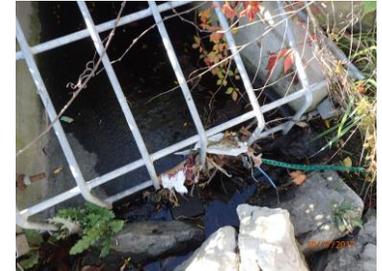
o20171017102814.JPG

Notes: Sample collected from pipe flow.

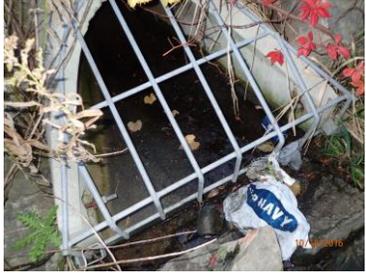
Inspection Date: 10/18/2016 7:21:24 AM		Type: Ongoing	Flow: Trickle	Previous Rainfall (hrs): 72+
Illicit Discharge Potential: Unlikely		Inspector: JCW		Notes Elevated conductivity, but no other parameters out of range.
Submerged: None Depth (in):				
Sampling Results Sample Location: Flow Total Chlorine: 0 ppm Free Chlorine: 0 ppm Ammonia: 0 ppm pH: 8.29 units Temperature: 64 °F Conductivity: 3880 µS/cm Detergents: 0 mg/L		Floatables: None Odor: Faint Turbidity: None Color: None Gross Solids: Slight Vegetation: None Benthic Growth: Moderate Stains: None Non-illicit: None	Condition Assessment Graffiti: None Erosion: None Deposition: None in. Damage: None

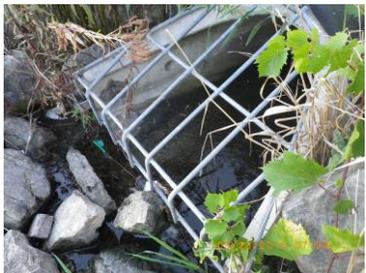
Inspection Date: 9/28/2015 7:20:55 AM		Type: Ongoing	Flow: None	Previous Rainfall (hrs): 72+
Illicit Discharge Potential: Unlikely		Inspector: JCW		Notes Flowline wet, but no flow at time of inspection.
Submerged: None Depth (in):				
Sampling Results Sample Location: Total Chlorine: -- ppm Free Chlorine: -- ppm Ammonia: -- ppm pH: -- units Temperature: -- °F Conductivity: -- µS/cm Detergents: -- mg/L		Floatables: None Odor: None Turbidity: None Color: None Gross Solids: Slight Vegetation: None Benthic Growth: Moderate Stains: None Non-illicit: None	Condition Assessment Graffiti: None Erosion: None Deposition: None in. Damage: None

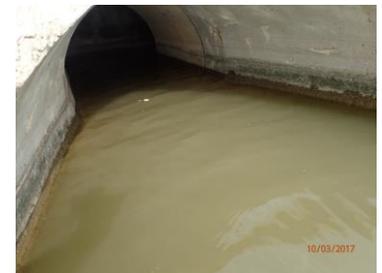
o20171003103318.JPG

Notes: Outfall partially submerged - screened upstream at 16-869 US1.

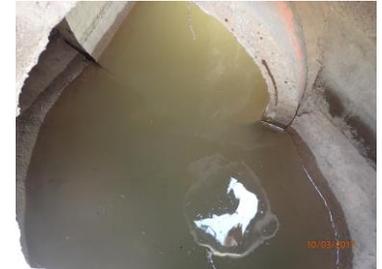
o20171003103534.JPG

Notes: Sample collected from submerged pool in manhole.

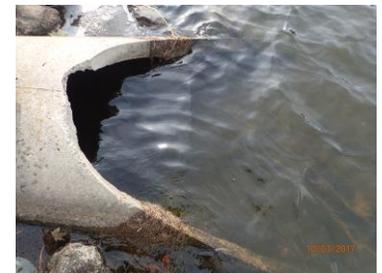
o20171003095924.JPG

Notes: Outfall partially submerged - screened upstream at 16-941 US1.

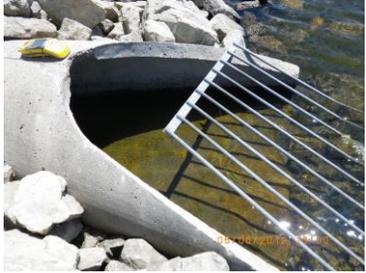
Inspection Date: 6/6/2012 1:03:13 PM		Type: Ongoing		Flow: Submerged, indeterminate		Previous Rainfall (hrs): 72+	
Illicit Discharge Potential: Unlikely		Inspector: JCW		Notes Grate detached from apron. Outfall partially submerged. Outfall screened upstream at 16-941 US1.

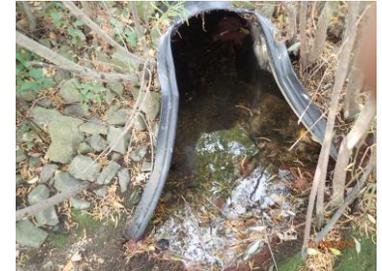
o20171003101614.JPG

Notes: Outfall partially submerged - screened upstream at 16-995 US1. Detergent detected in sample.

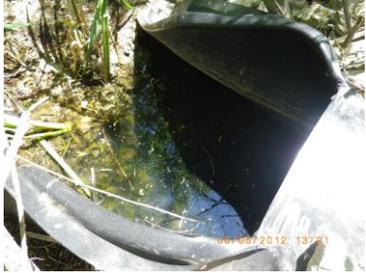
Inspection Date: 6/6/2012 1:21:40 PM		Type: Ongoing		Flow: Submerged, indeterminate		Previous Rainfall (hrs): 72+	
Illicit Discharge Potential: Unlikely		Inspector: JCW		Notes No flow leaving pool at end of outfall. Deposition in swale downstream. Screened upstream at 16-995 US1.

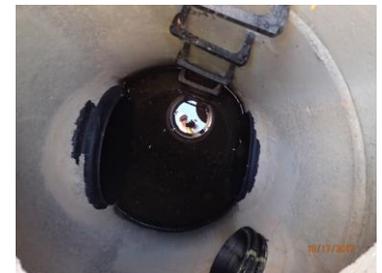
o20171017084622.JPG

Notes: Repeat inspection due to detergent. Detergent detected in manhole sample.

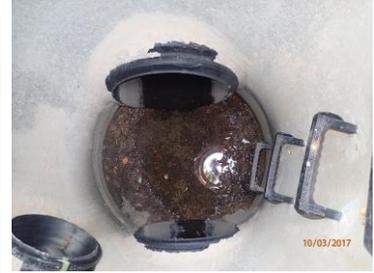
o20171003101932.JPG

Inspection Date: 10/3/2017 10:22:53 AM		Type: Ongoing	Flow: Submerged, indeterminate	Previous Rainfall (hrs): 72+
Illicit Discharge Potential: Potential		Inspector: JCW		
Submerged: Partially		Depth (in): 3		
<i>Sampling Results</i>		Notes		
Sample Location: Pool	Floatables: None	Sample collected from submerged pool in outfall. Detergent detected in sample.		
Total Chlorine: 0 ppm	Odor: None			
Free Chlorine: 0 ppm	Turbidity: None			
Ammonia: 0 ppm	Color: None			
pH: 7.45 units	Gross Solids: None			
Temperature 72 °F	Vegetation: None			
Conductivity: 333 µS/cm	Benthic Growth: None			
Detergents: 1.3 mg/L	Stains: None			
	Non-illicit: None			
		Graffiti: None	in.	
		Erosion: None		
		Deposition: None		
		Damage: None

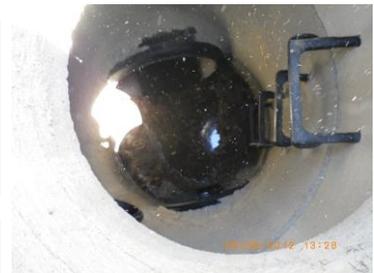
o20120606122856.JPG

Inspection Date: 6/6/2012 1:28:22 PM		Type: Ongoing	Flow: Submerged, no flow	Previous Rainfall (hrs): 72+
Illicit Discharge Potential: Unlikely		Inspector: JCW		
Submerged: None		Depth (in): 1		
<i>Sampling Results</i>		Notes		
Sample Location: Pool	Floatables: None	Sample collected from pool in manhole. No flow entering either pipe.		
Total Chlorine: 0 ppm	Odor: Faint			
Free Chlorine: 0 ppm	Turbidity: None			
Ammonia: 0 ppm	Color: None			
pH: 7.36 units	Gross Solids: Slight			
Temperature 69 °F	Vegetation: None			
Conductivity: 411 µS/cm	Benthic Growth: None			
Detergents: 0 mg/L	Stains: Slight			
	Non-illicit: None			
		Graffiti: None	in.	
		Erosion: None		
		Deposition: None		
		Damage: None

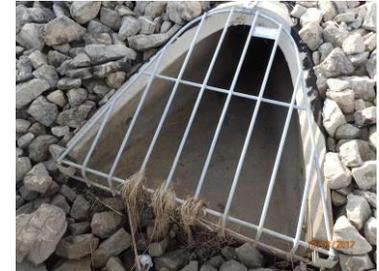
o20171003085726.JPG

Notes: Pipe dry at time of inspection.

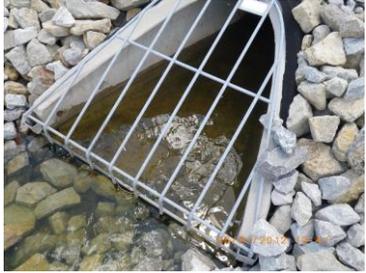
Inspection Date: 6/21/2012 12:38:48 PM		Type: Ongoing		Flow: Submerged, indeterminate		Previous Rainfall (hrs): 0-24	
Illicit Discharge Potential: Unlikely		Inspector: JCW		Notes Outfall partially submerged. Sample not collected due to screening of upstream outfalls.

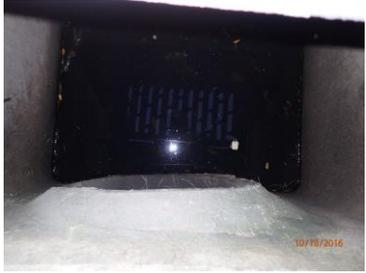
Inspection Date: 10/18/2016 7:08:50 AM		Type: Ongoing		Flow: None		Previous Rainfall (hrs): 72+	
Illicit Discharge Potential: Unlikely		Inspector: JCW		Notes Water in sump, but no flow entering pipe. No sample collected from sump.

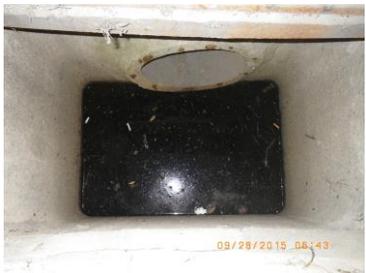
Inspection Date: 9/28/2015 6:42:48 AM		Type: Ongoing		Flow: None		Previous Rainfall (hrs): 72+	
Illicit Discharge Potential: Unlikely		Inspector: JCW		Notes Water level below outlet pipe - no sample collected. 18" of water in sump, 2" of sediment.

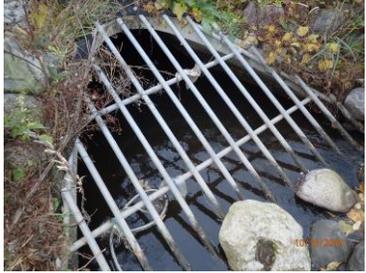
Illicit Discharge Potential: Unlikely **Inspector:** JCW

Submerged: Fully Depth (in):

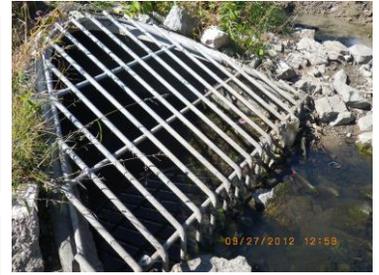
Notes
Outfall fully submerged and not located - screened at 01-278 US1.

Inspection Date: 9/22/2015 2:31:24 PM **Type:** Ongoing **Flow:** Submerged (not located) **Previous Rainfall (hrs):** 72+

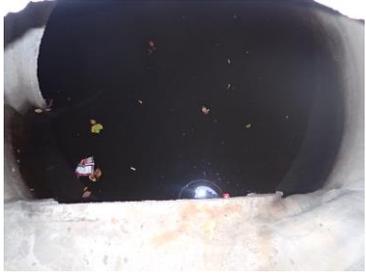
2015

Illicit Discharge Potential: Unlikely **Inspector:** JCW

Submerged: Fully Depth (in):

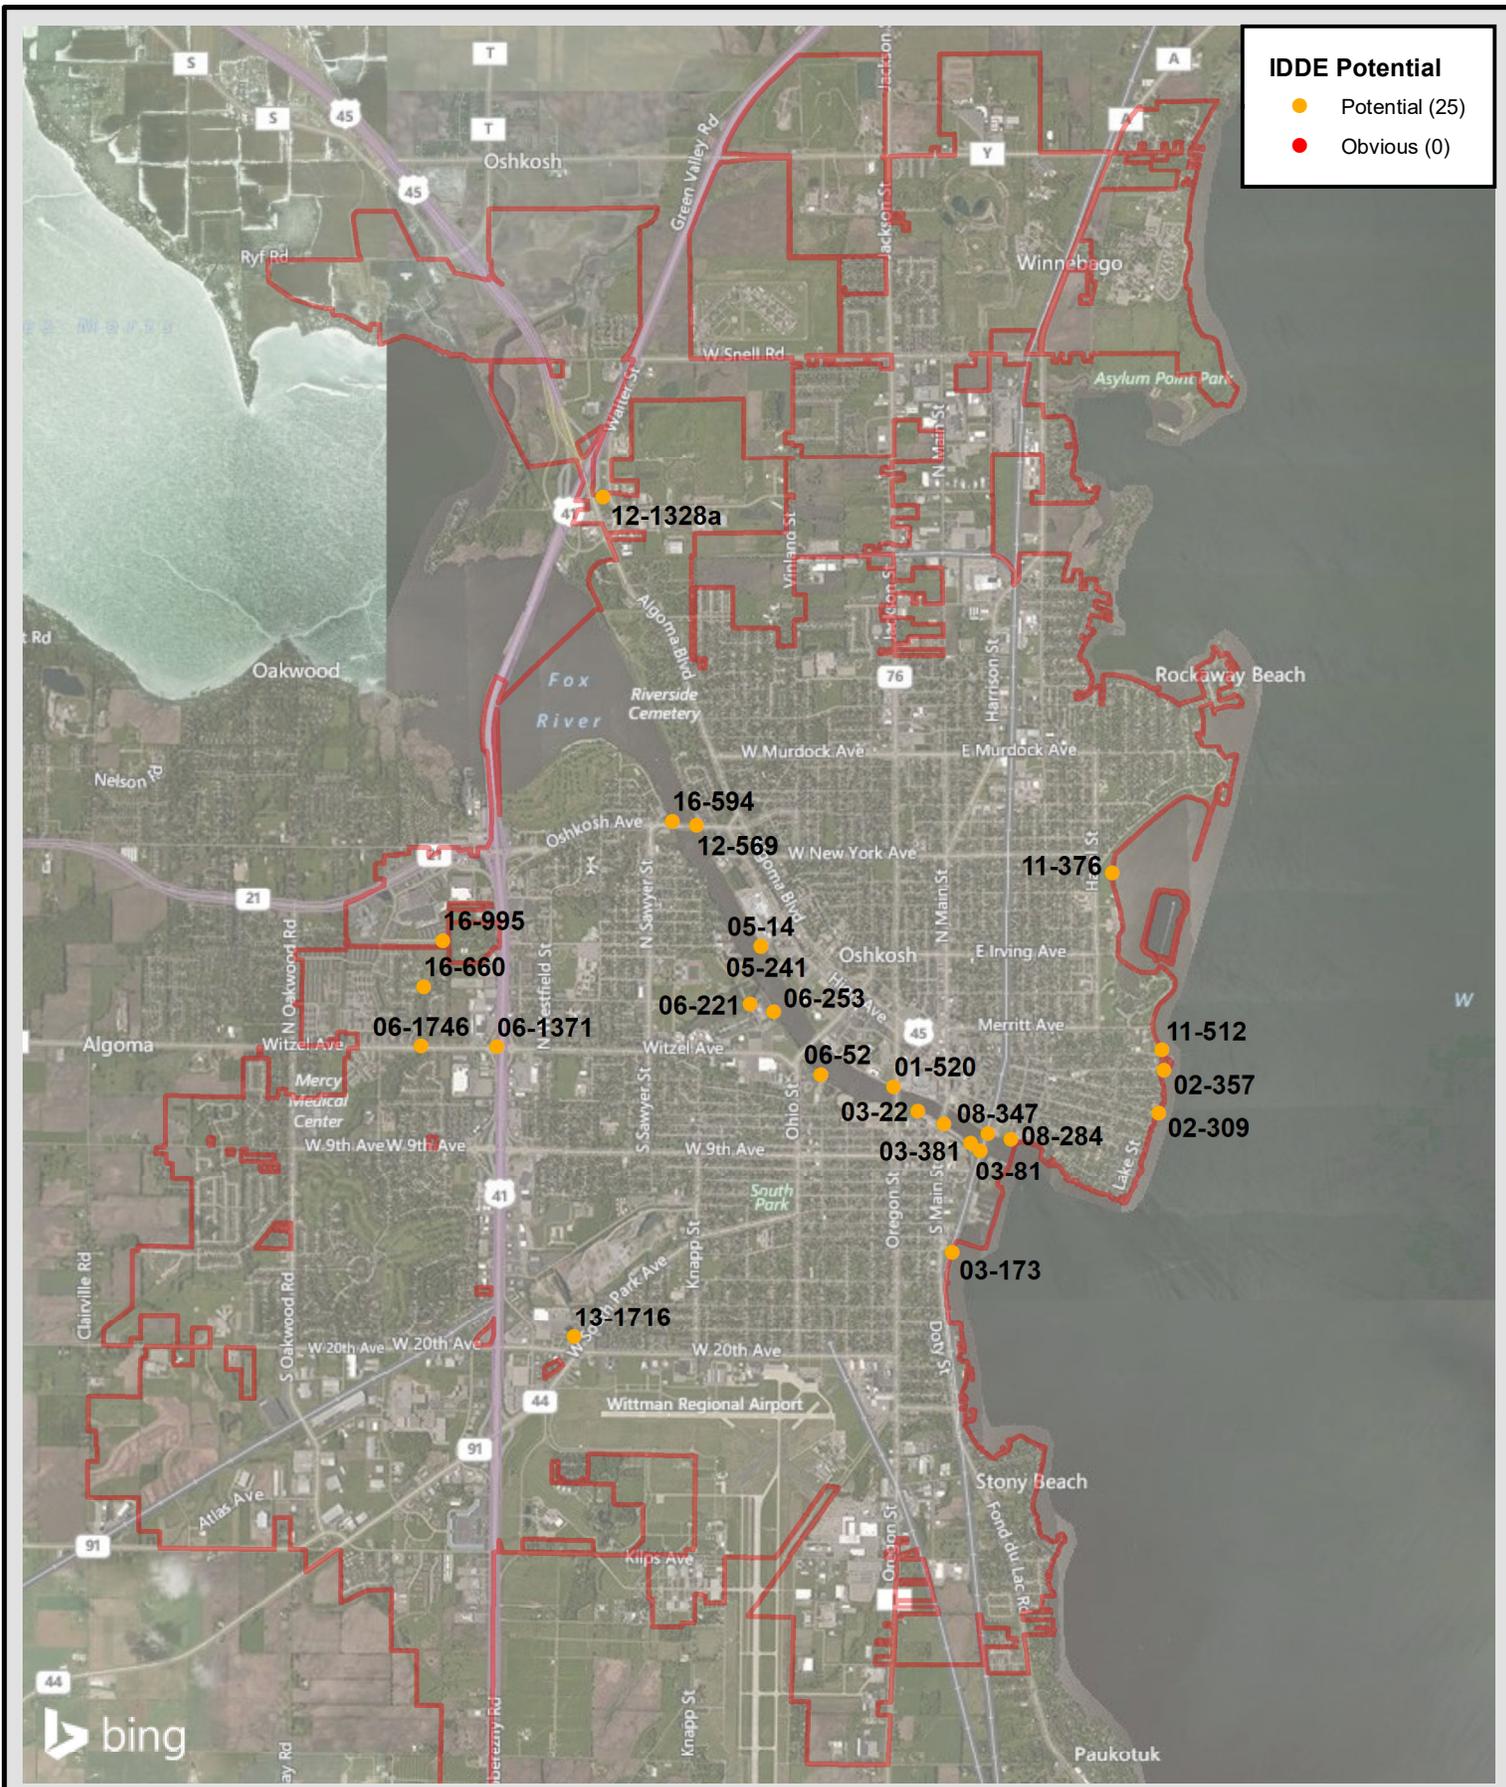
FIGURE NO.
C-1

- Potential (25)
- Obvious (0)

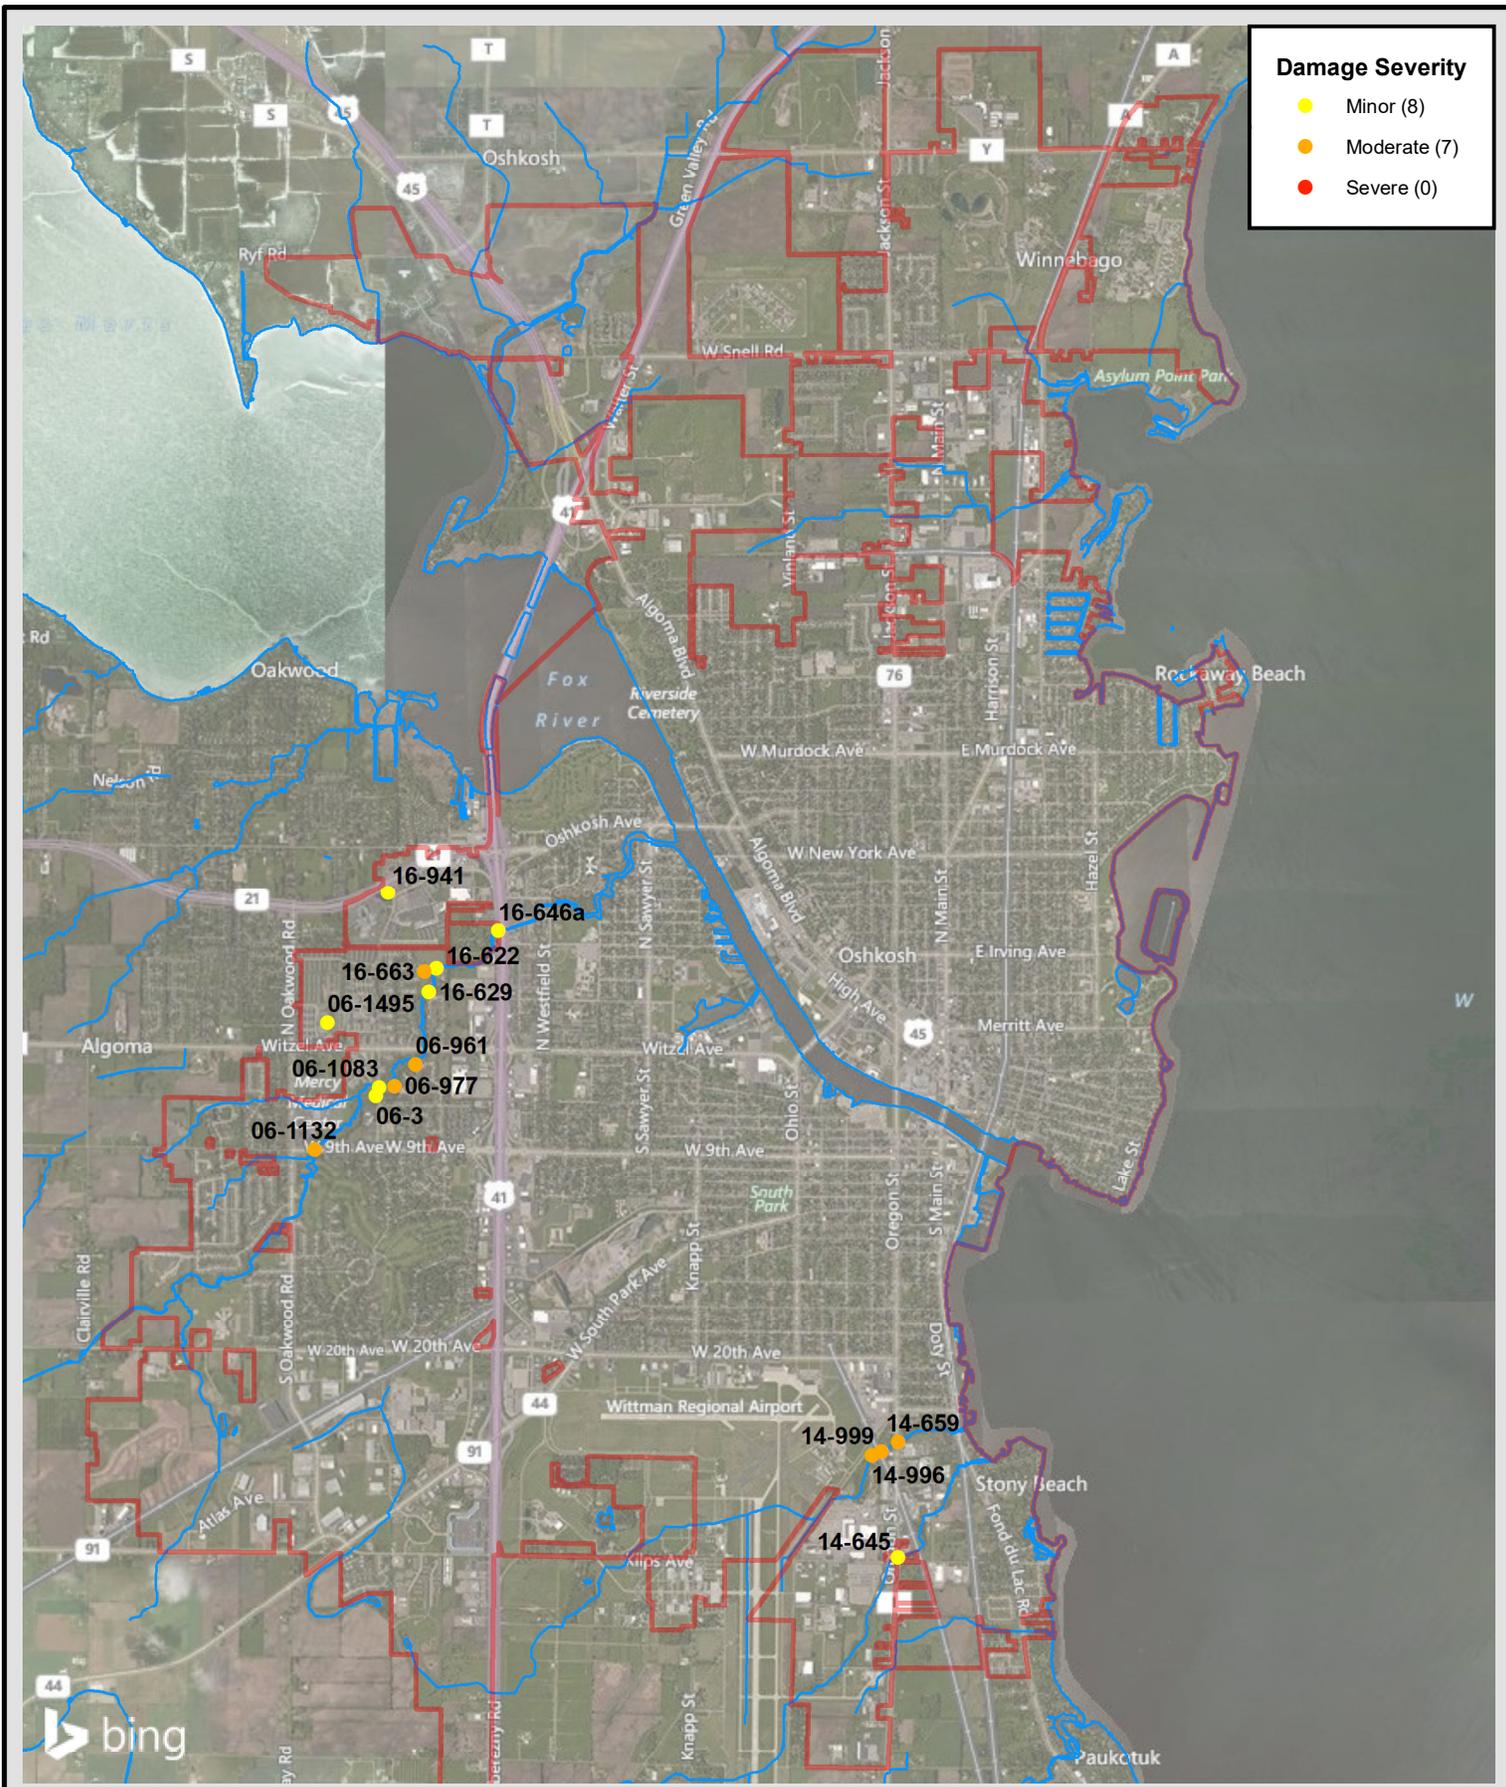
FIGURE NO.
C-2

- Minor (8)
- Moderate (7)
- Severe (0)

**2017 IDDE ONGOING SCREENING PROGRAM
OUTFALLS WITH DAMAGE**
