Illicit Discharge Detection and Elimination
Conducted For
City of Oshkosh

Ongoing Screening Summary Report

2017 Inspection Year

OMNNI Project Number N2029C17

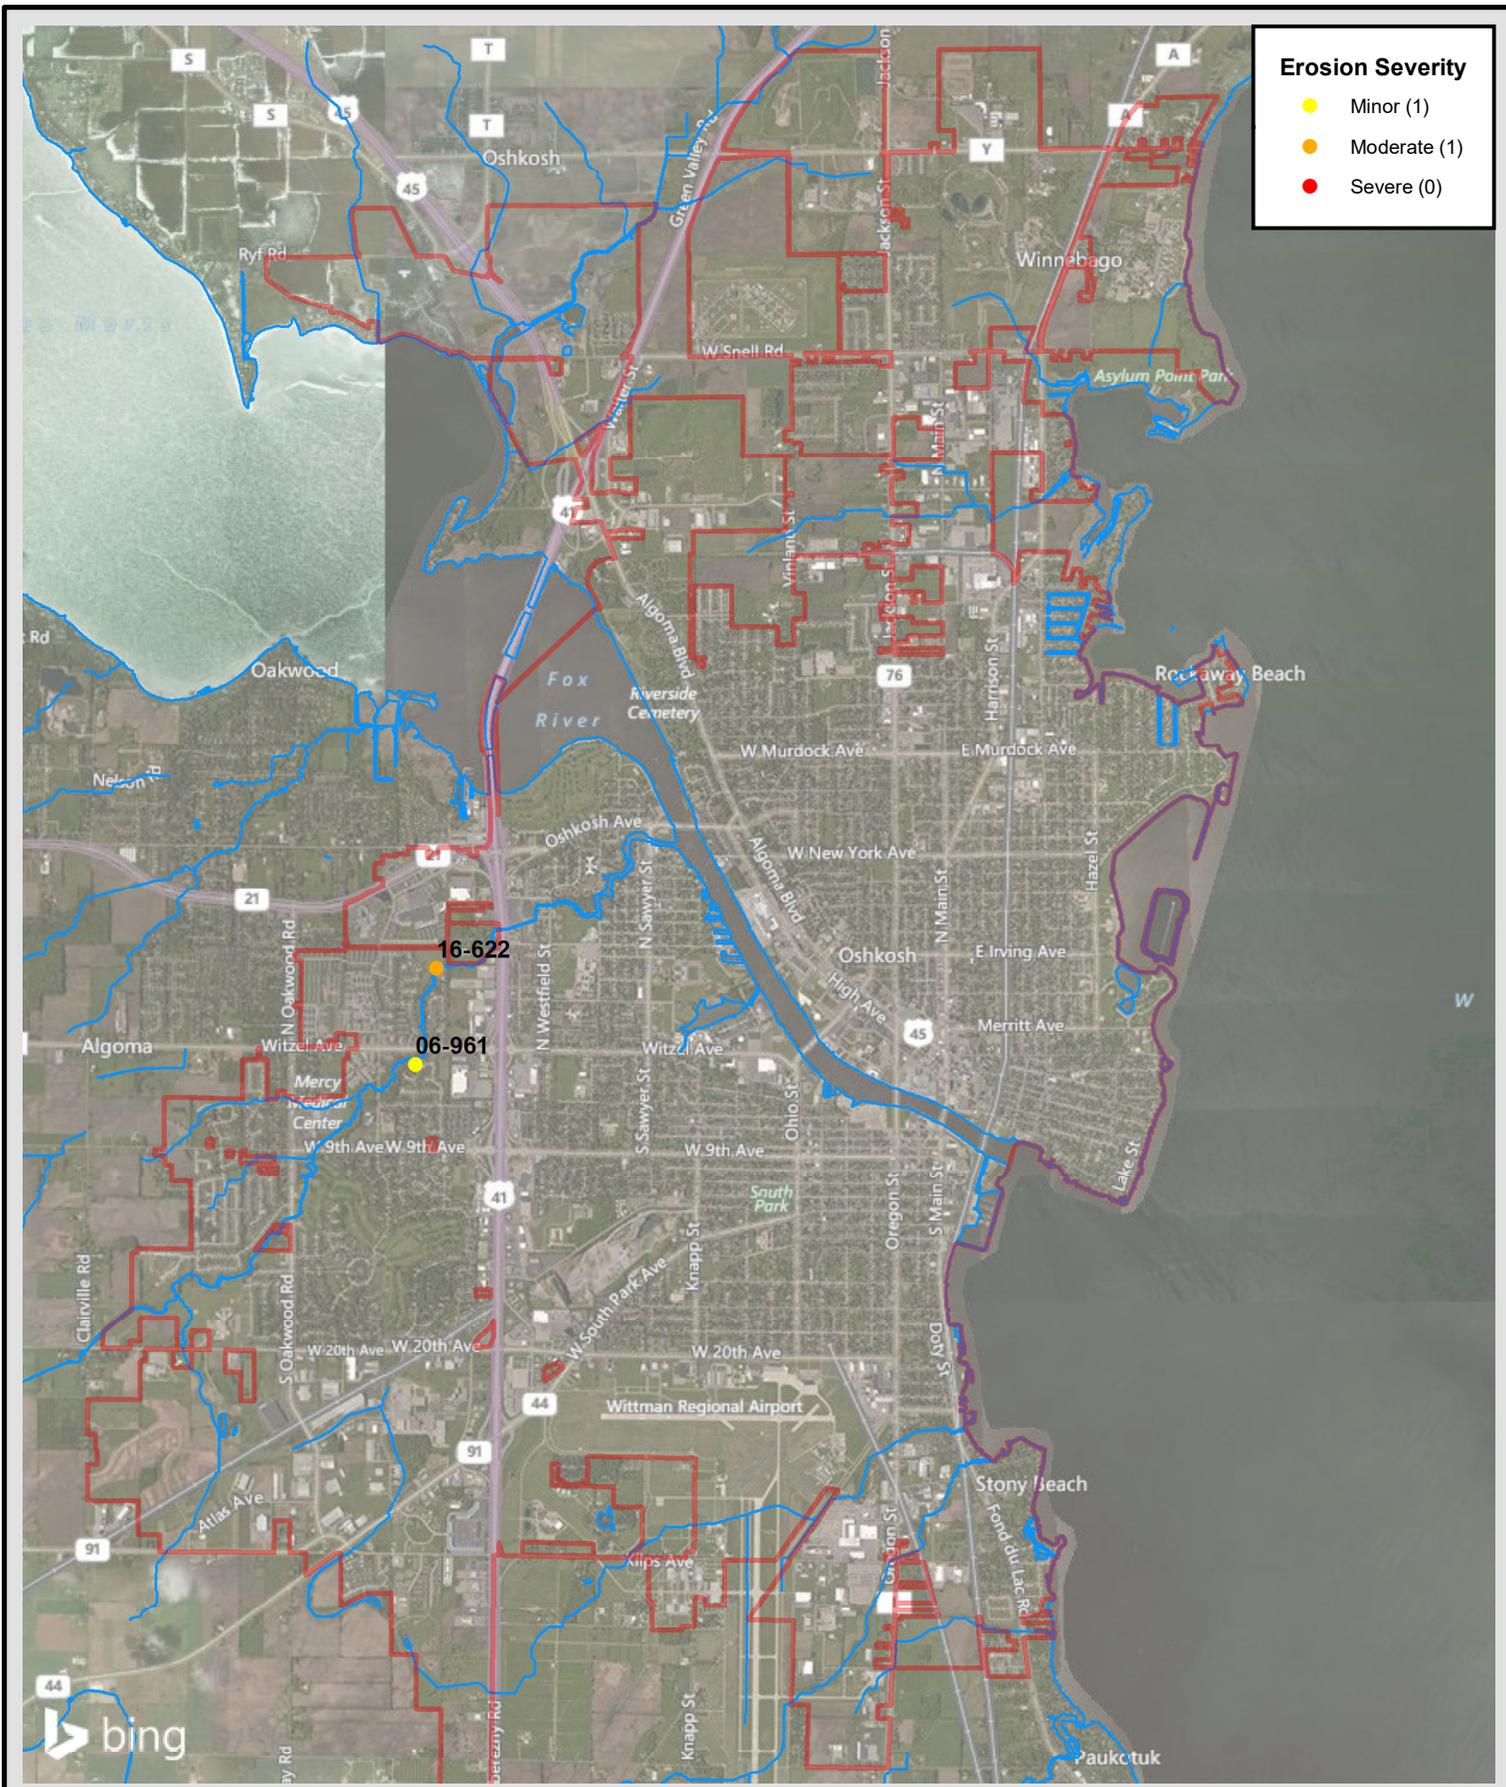
FIGURE NO.
C-4

- Minor (1)
- Moderate (1)
- Severe (0)

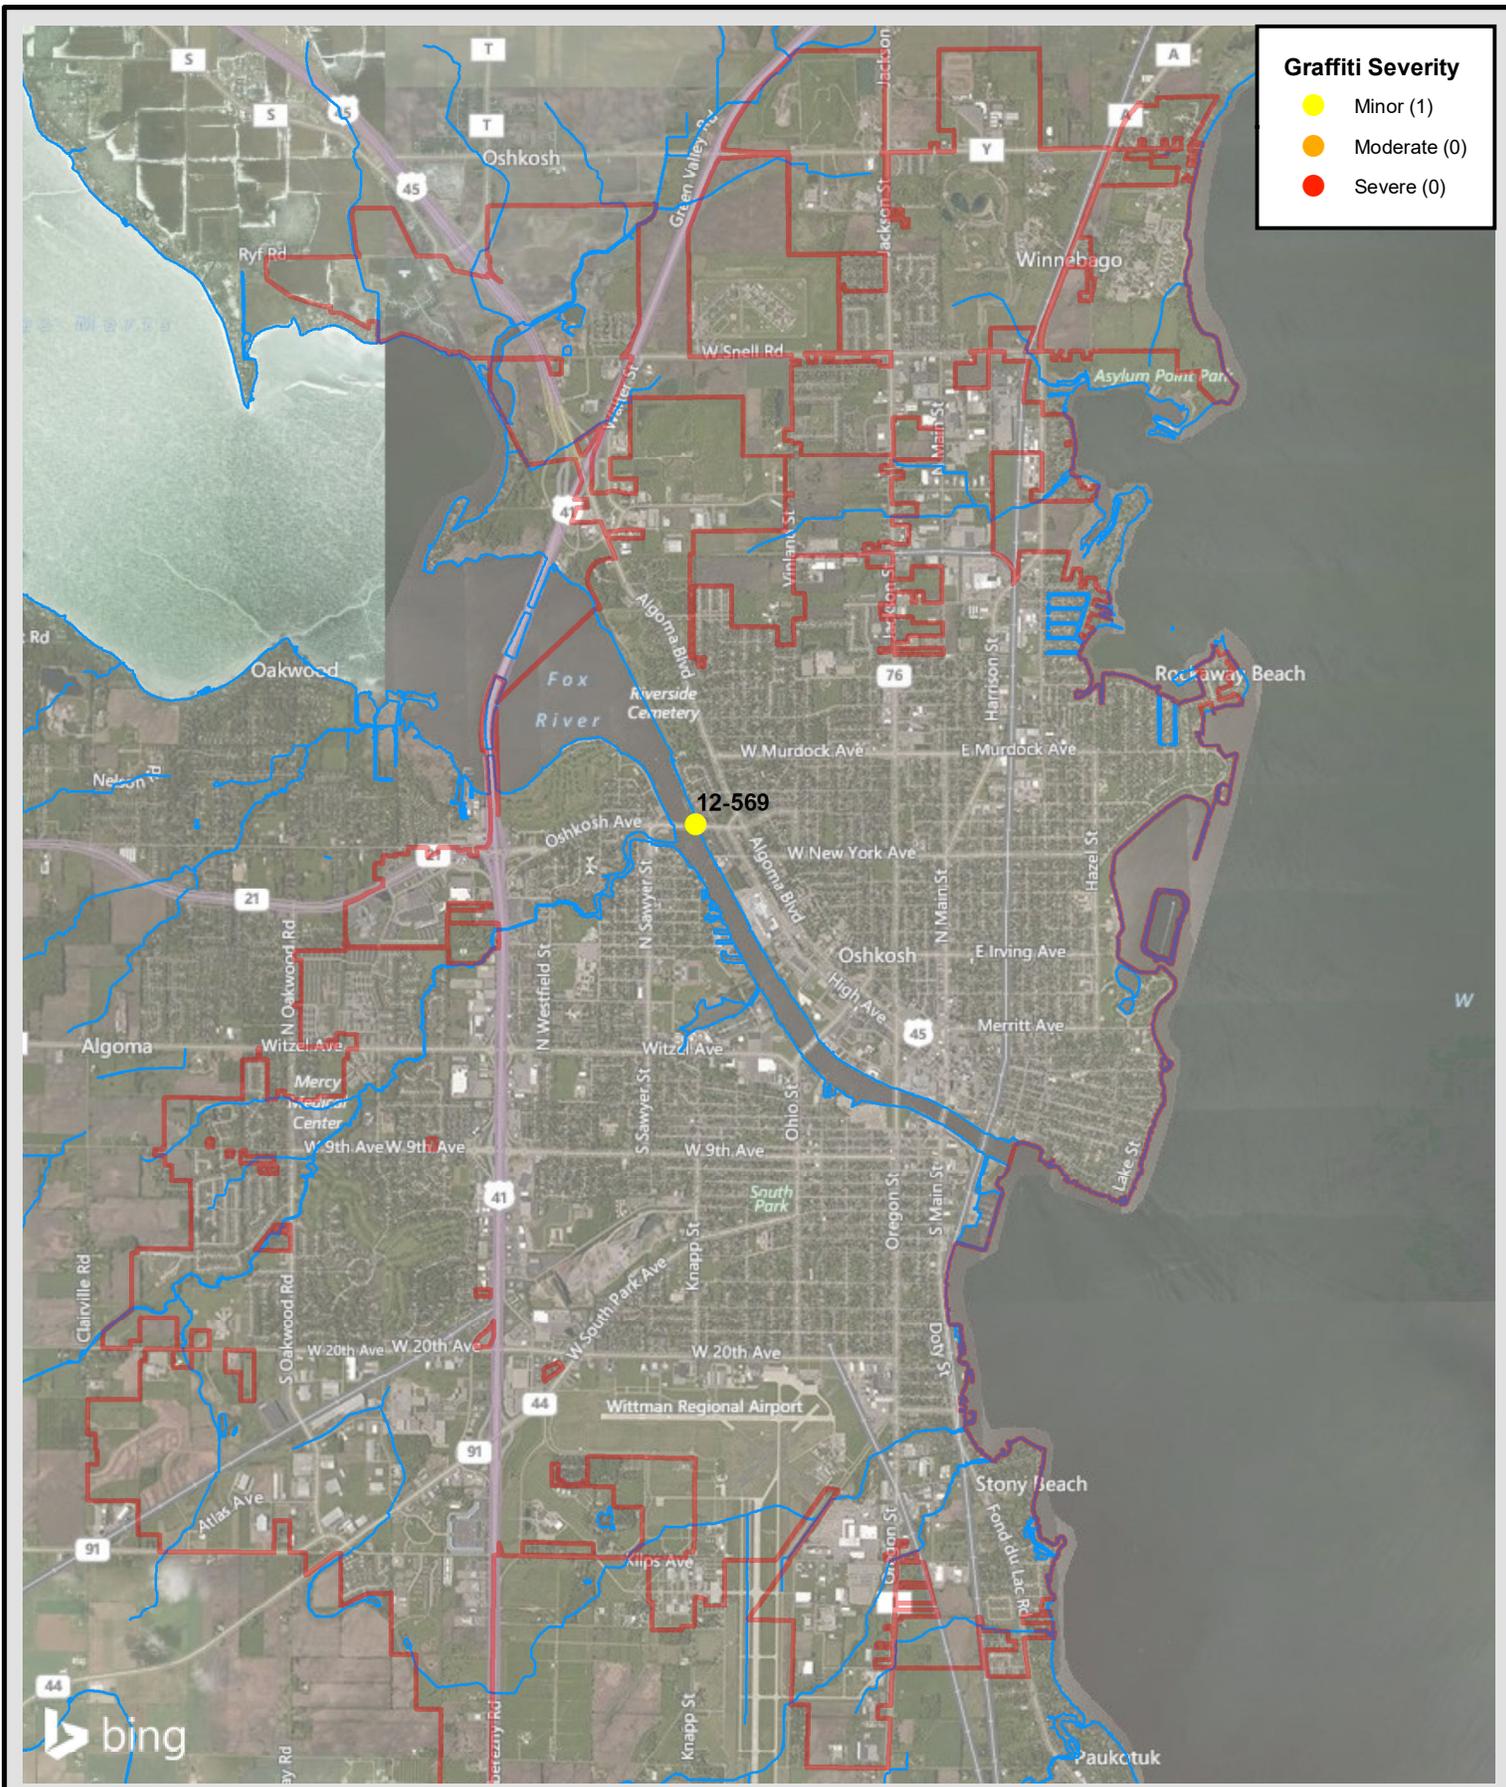
- Minor (1)
- Moderate (0)
- Severe (0)

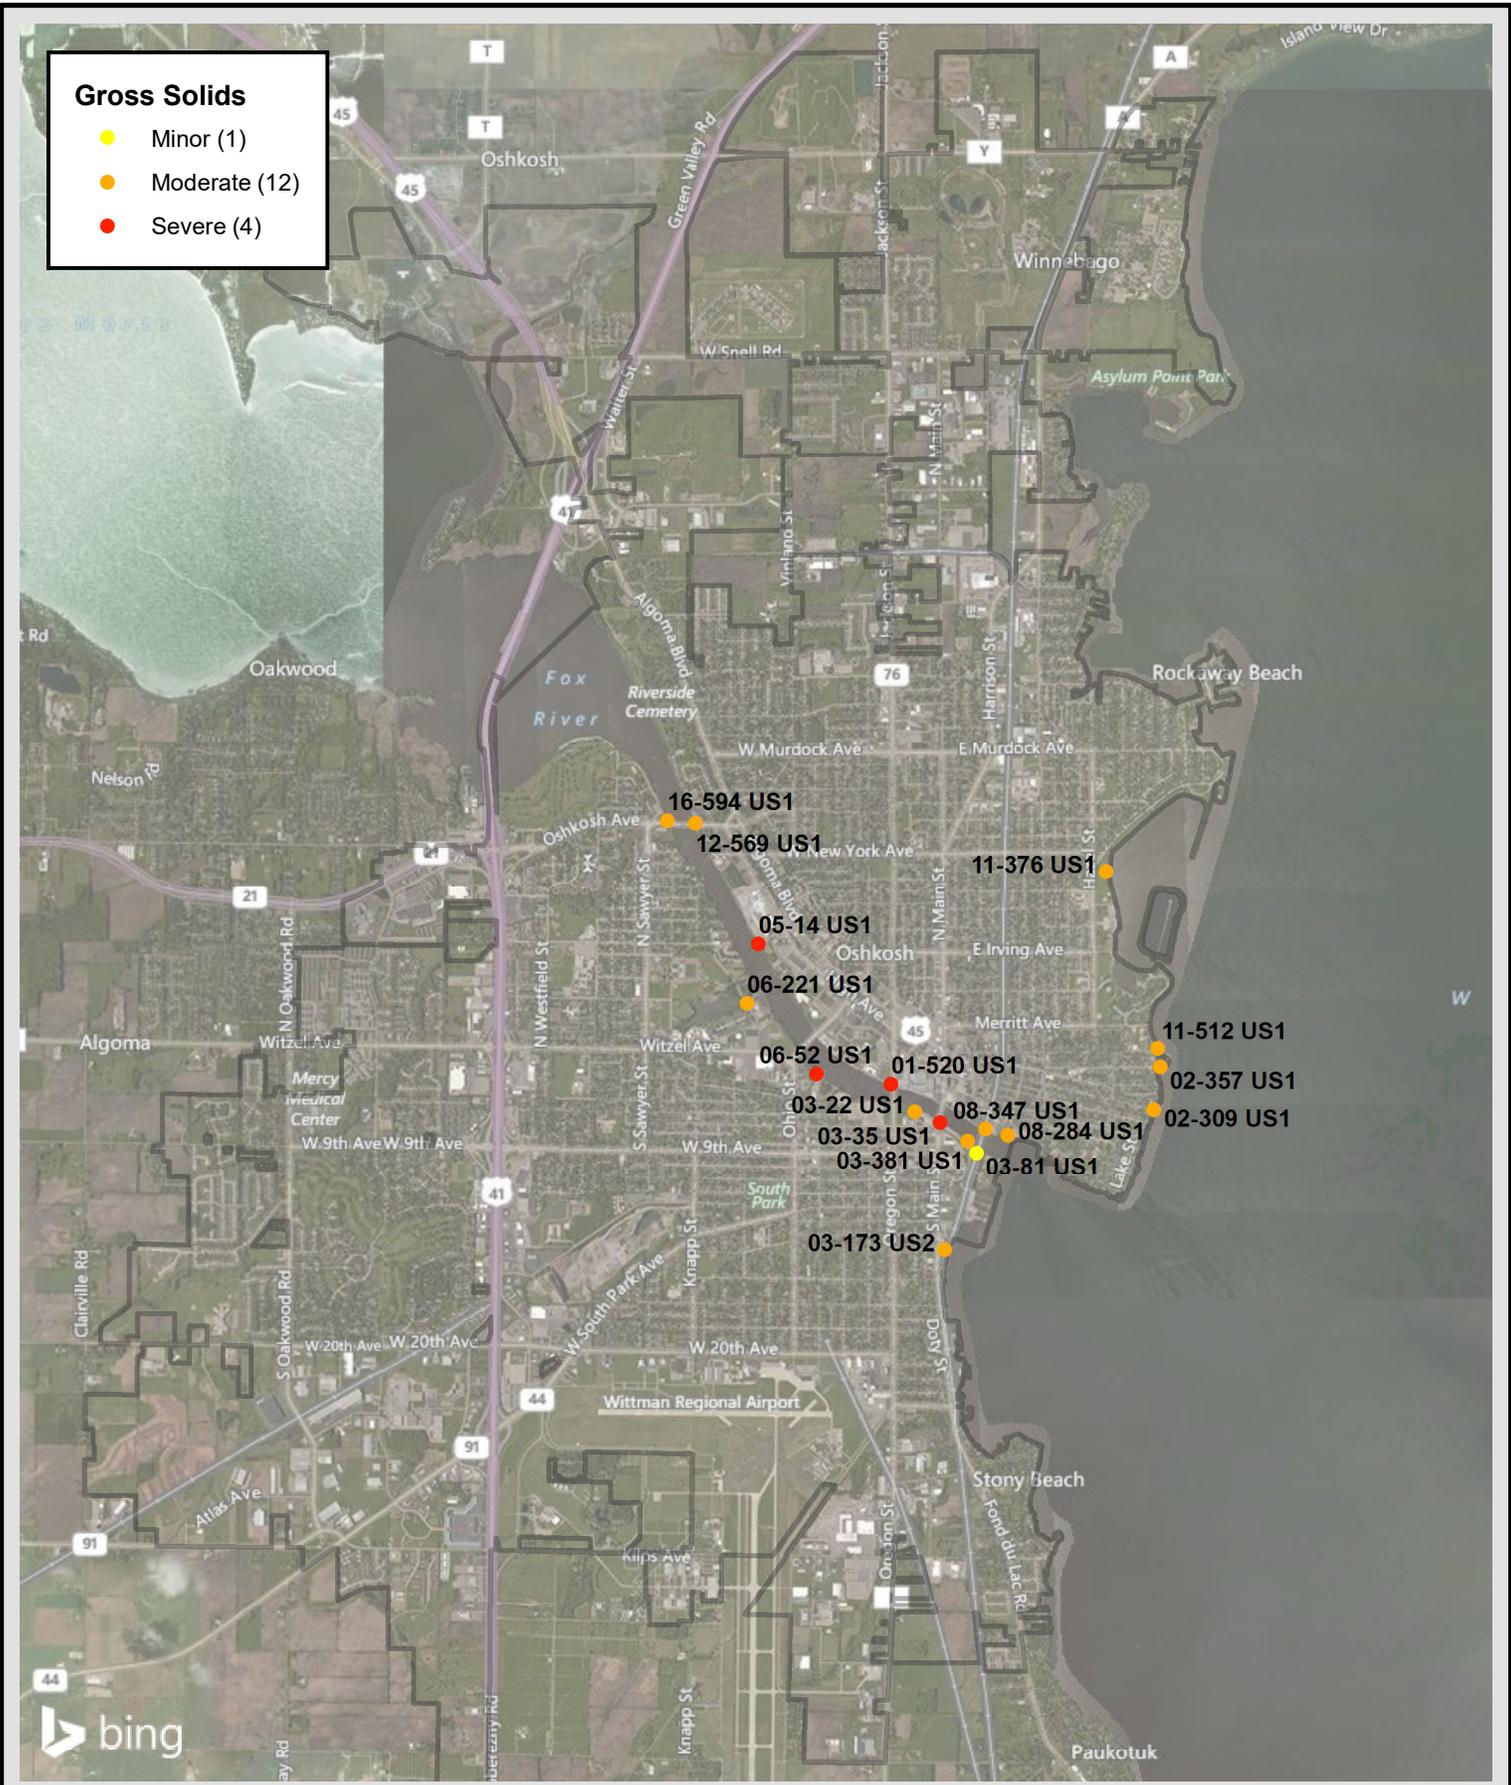
FIGURE NO.
D-1

- Minor (1)
- Moderate (12)
- Severe (4)
